# RUBBLIZING WITH BITUMINOUS CONCRETE OVERLAY – 10 YEARS’ EXPERIENCE IN ILLINOIS

**PHYSICAL RESEARCH REPORT NO. 137**

**APRIL 2002**

**Illinois Department of Transportation**

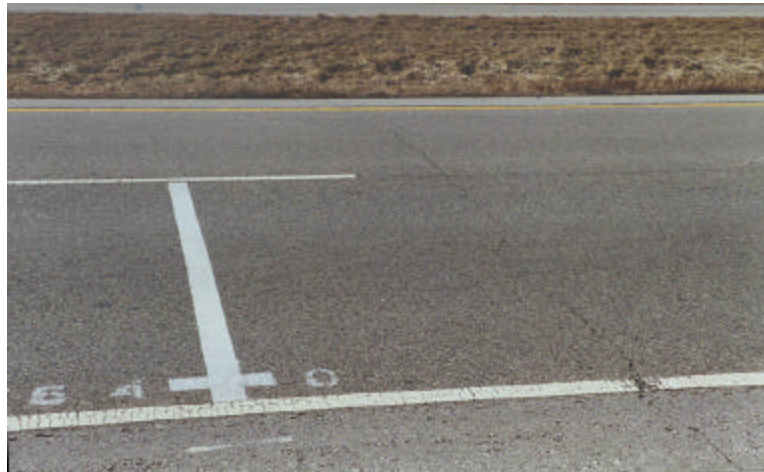
Figure 7. Rubblize and 6" Overlay in 1996 (I-57 1990).

Transverse cracking began five years later than the control section on the 6-inch overlay of rubblized pavement and eight years later on the 8-inch overlay of rubblized pavement.

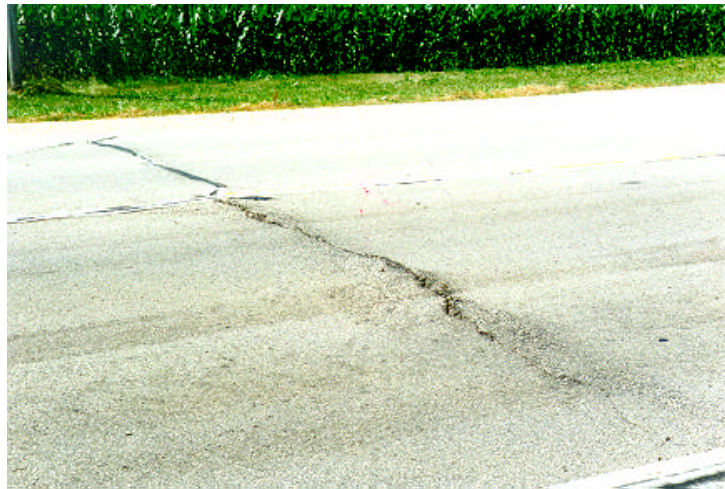
The CRS of the control section was 6.6 in 1999, considered good. The distresses for the control section are summarized in Table 9. The control section could not be surveyed in 2000 due to maintenance work being conducted on the section. Figure 15 shows the pavement, with a transverse crack that has been sealed in the far lane, in 1997. The remainder of the crack was sealed after the photo was taken.

Figure 15. Control Section in 1997 (IL 38 1994).

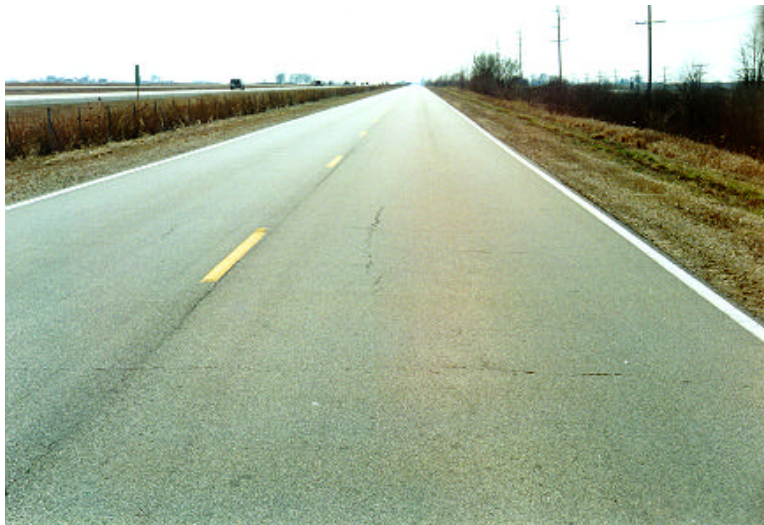
Figure 19. Rubblized/Overlaid Pavement in 1997 (I-55 FR 1994).
