**Subject: Beaver Valley Power Station, Unit No. 1  
Docket No. 50-334, License No. DPR-66  
Bulletin 2000-01 Circumferential Cracking of Reactor  
Pressure Vessel Head Penetration Nozzles**

**Evaluation Report for 1R14 Visual Inspection of  
Beaver Valley Unit 1 CRDM Penetrations**

# **Summary Report for Beaver Valley Unit 1 RVH CRDM Penetration Visual Inspection**

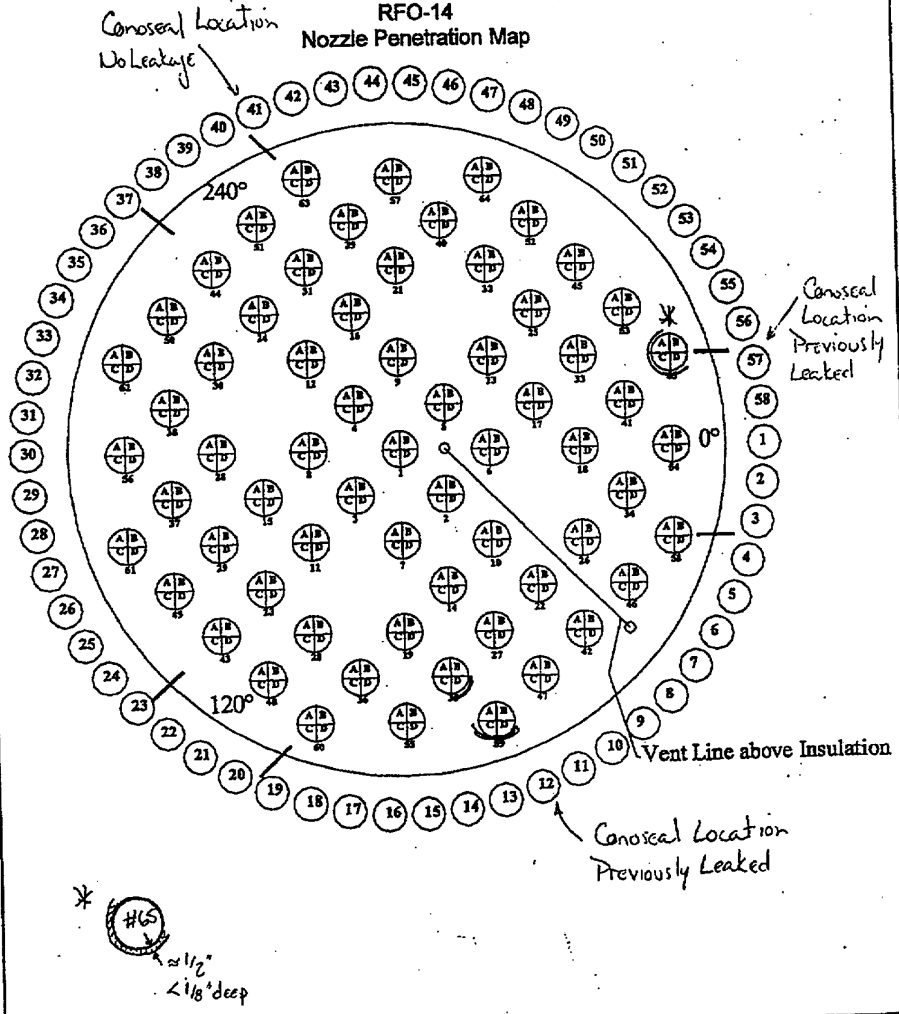
Attachment A  
Beaver Valley Unit 1  
RFO-14  
Nozzle Penetration Map

Documented leakage has occurred at the conoseals located near RPV stud location #57 and stud location #12. In both cases, the nozzles nearest to these studs (nozzles #65 and #59 respectively) showed evidence of a significant boric acid event. Refer to the attached map for stud and nozzle location data.

The second conoseal leak occurred near the reactor vessel stud location #57. As a result, the #65 nozzle was affected by a flow of boric acid. Refer to the attached map for stud and nozzle location data. In this case, the boric acid seems to flow directly down the nozzle on the uphill side. As the acid flowed around the nozzle, at operating temperatures, the carbon steel of the head was affected. Erosion to a depth of less than .125 inches for about 1/2 inch around the base of the
