**Fourth
Five-Year Review Report**

**Des Moines TCE Site
Des Moines, Iowa**

February 2008

Prepared by:
EPA Region 7
Kansas City, Kansas

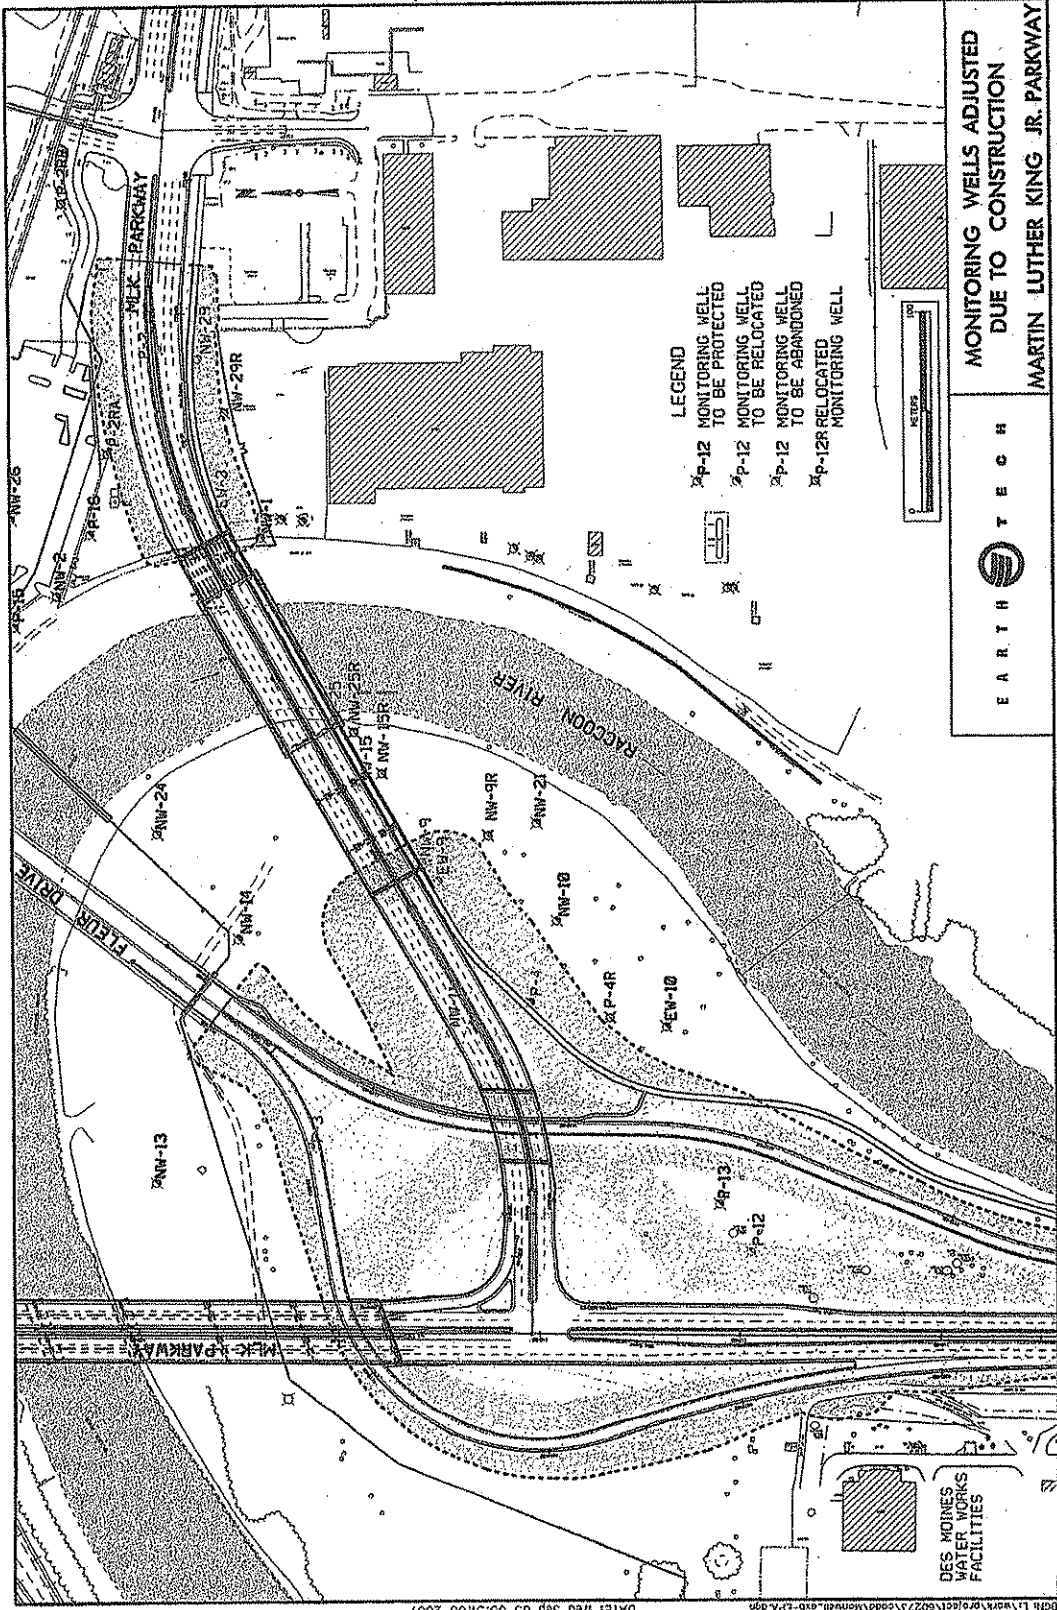
**MONITORING WELLS ADJUSTED
 DUE TO CONSTRUCTION**
MARTIN LUTHER KING JR. PARKWAY

Please find enclosed a location map showing the final monitoring well impacts at the Des Moines TCE Superfund Site caused by the construction of the Martin Luther King, Jr. Parkway Project and the Raw Water Main Relocation Project. In all, seven (7) monitoring wells and four (4) piezometers were impacted. Four (4) wells and two (2) piezometers were replaced during construction as required in the Third Supplement to the Technical Proposal and Plan of Action. (Copy of Attachment 2, Revised Page 1 is attached.) The following list shows the wells and piezometers that were abandoned, as well as those that were replaced.

<u>Wells and Piezometers Abandoned</u>	<u>Replacement Wells and Piezometers</u>
P-2	P-2A, P-2B
P-3	
P-4	P-4R
P-12	
EW-3	
EW-9	
NW-9	NW-9R
NW-11	
NW-15	NW-15R
NW-25	NW-25R
NW-29	NW-29R

Please note that piezometer P-2 was replaced under both construction projects. Both replacement piezometers may be used for testing purposes.
