RP950170

It has been determined that these 16.5" 1993 Raleigh MT 400 bicycle frames (300 total) may be susceptible to cracking at the headlug. This potential headlug cracking, during riding, could possibly lead to serious injury and/or death.

Subject: Failure Analysis of a Forged Aluminum Bicycle Head Lug

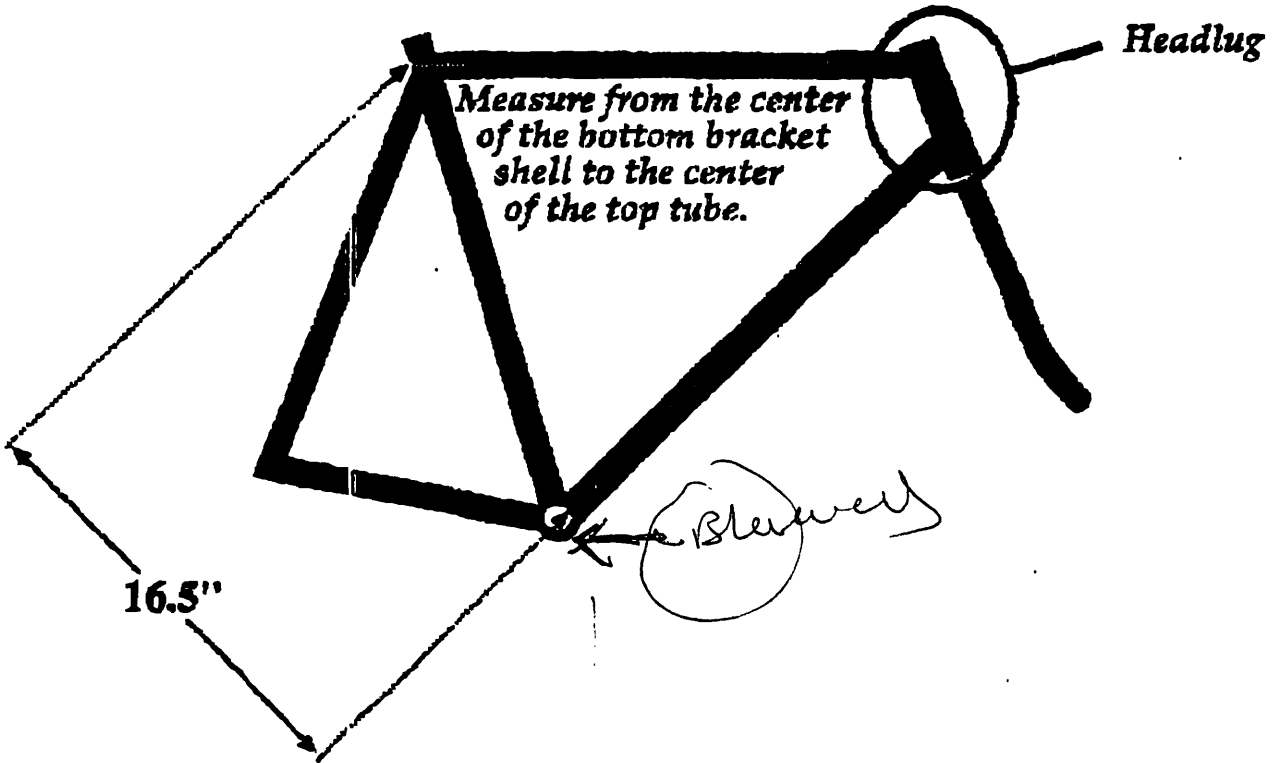
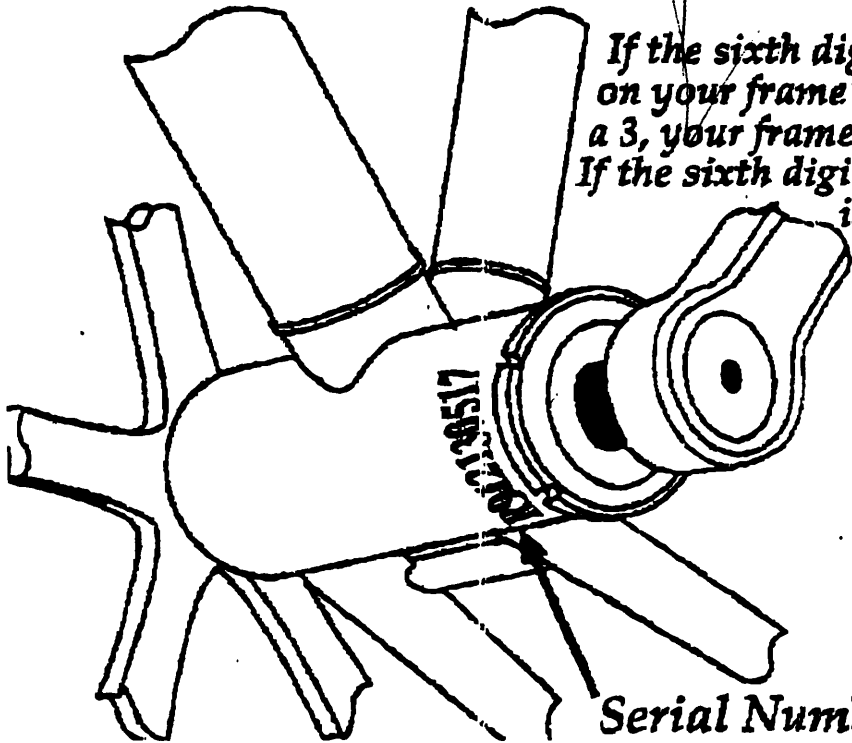
If the sixth digit from the left on your frame's serial number is a 3, your frame must be replaced.
 If the sixth digit from the left is a 2, your frame does not need to be replaced.

REPLACE FRAME

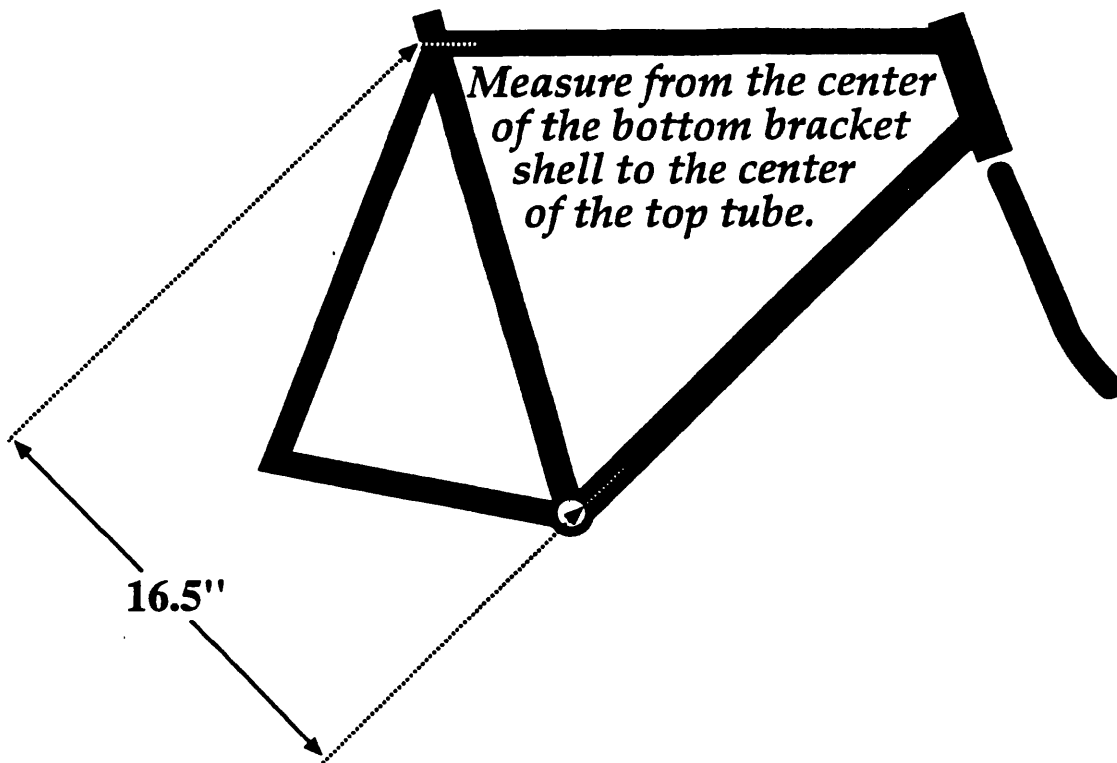
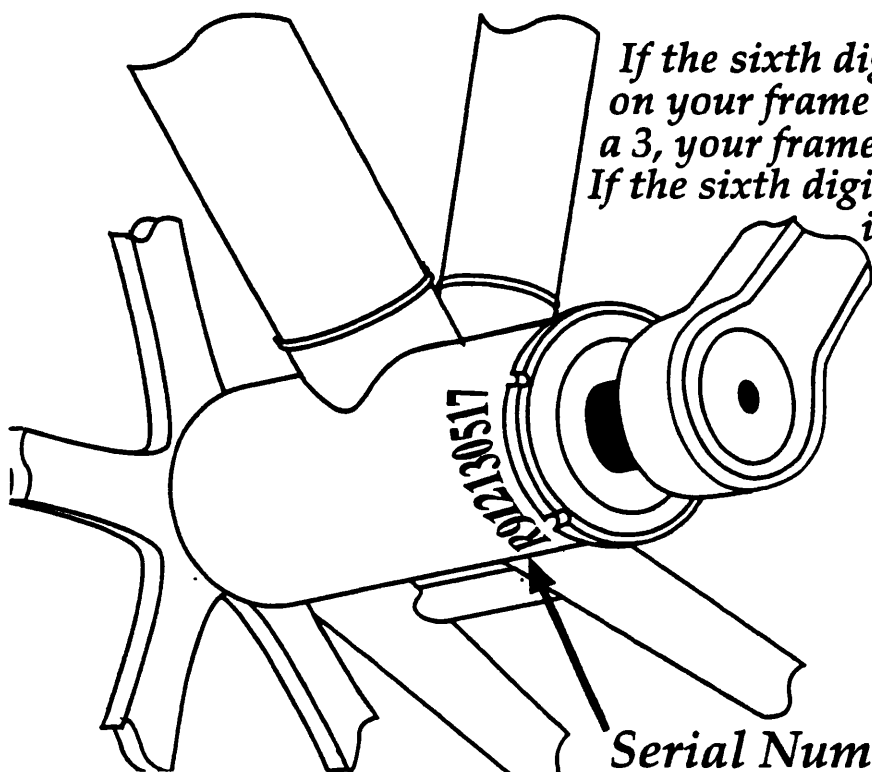
If the sixth digit from the left on your frame's serial number is a 3, your frame must be replaced.
If the sixth digit from the left is a 2, your frame does not need to be replaced.

REPLACE FRAME

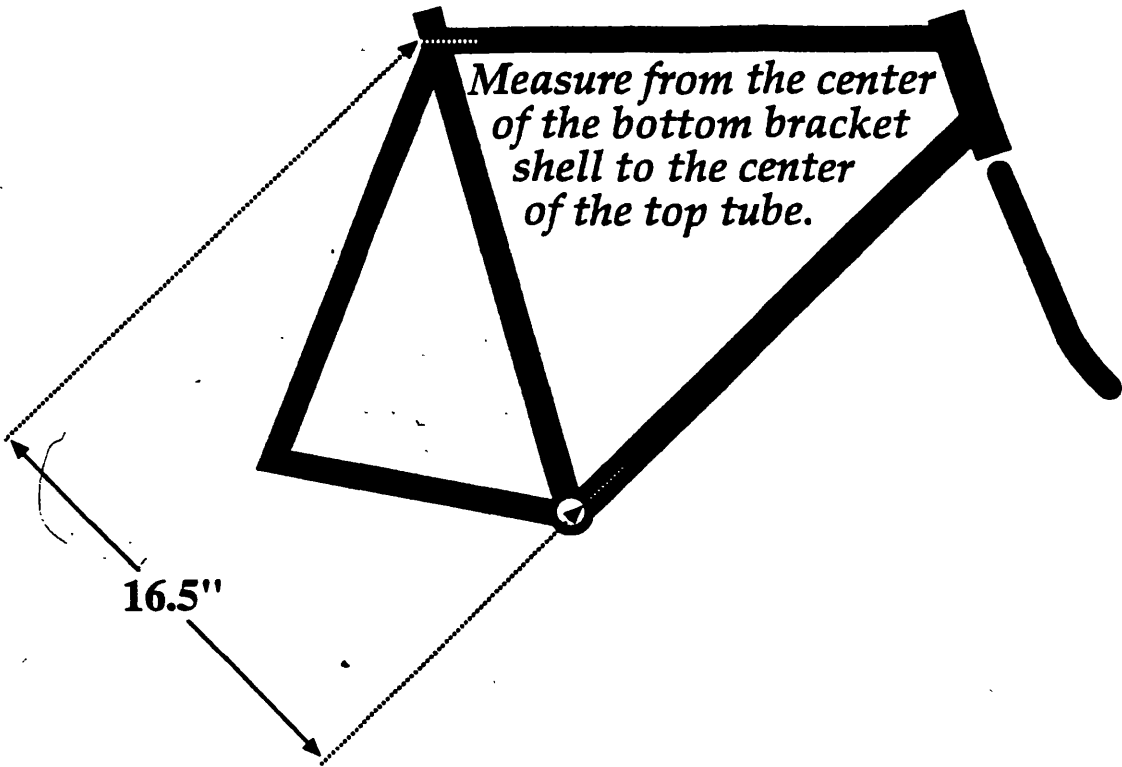
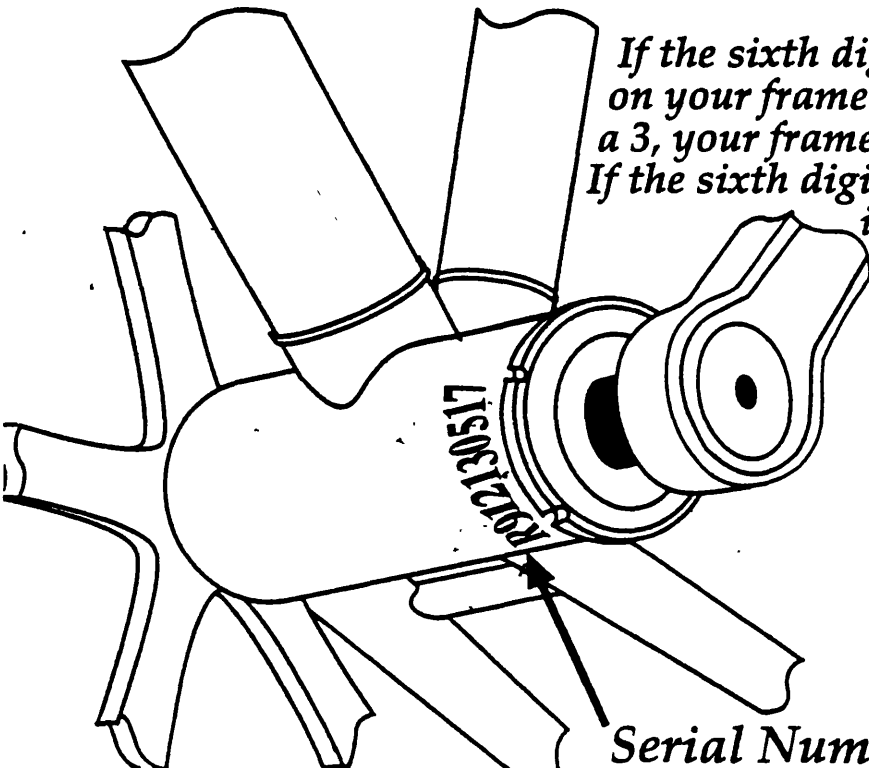
If the sixth digit from the left on your frame's serial number is a 3, your frame must be replaced.
If the sixth digit from the left is a 2, your frame does not need to be replaced.

REPLACE FRAME

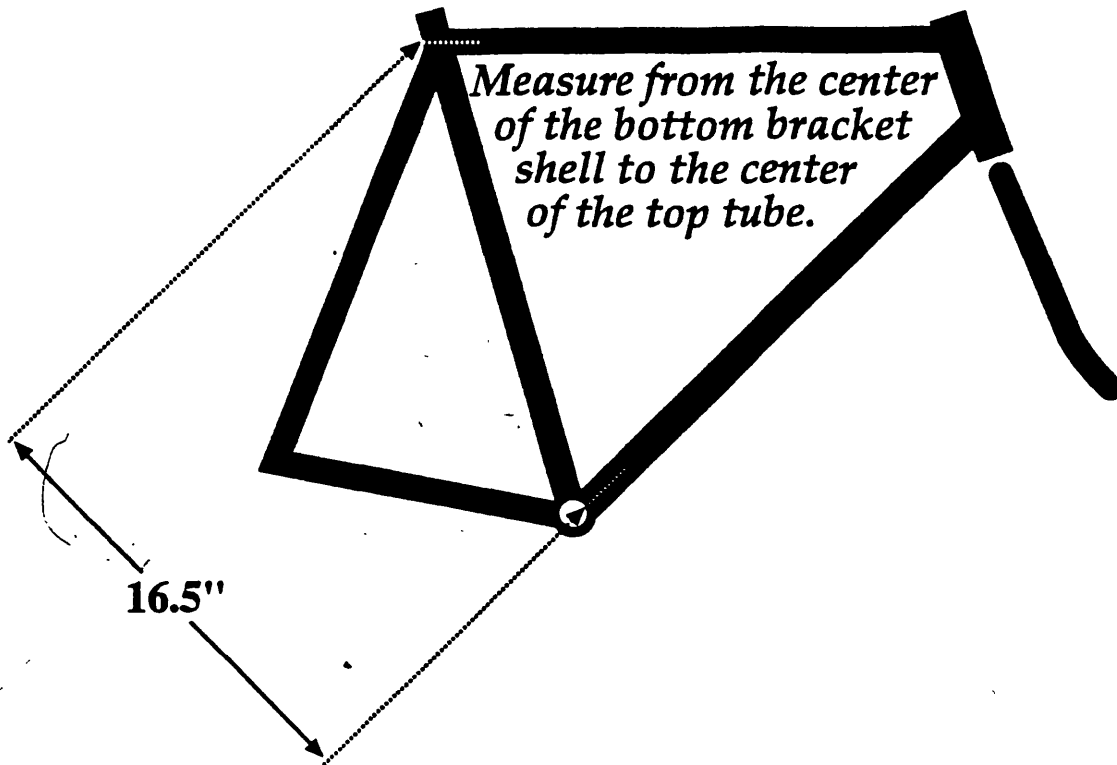
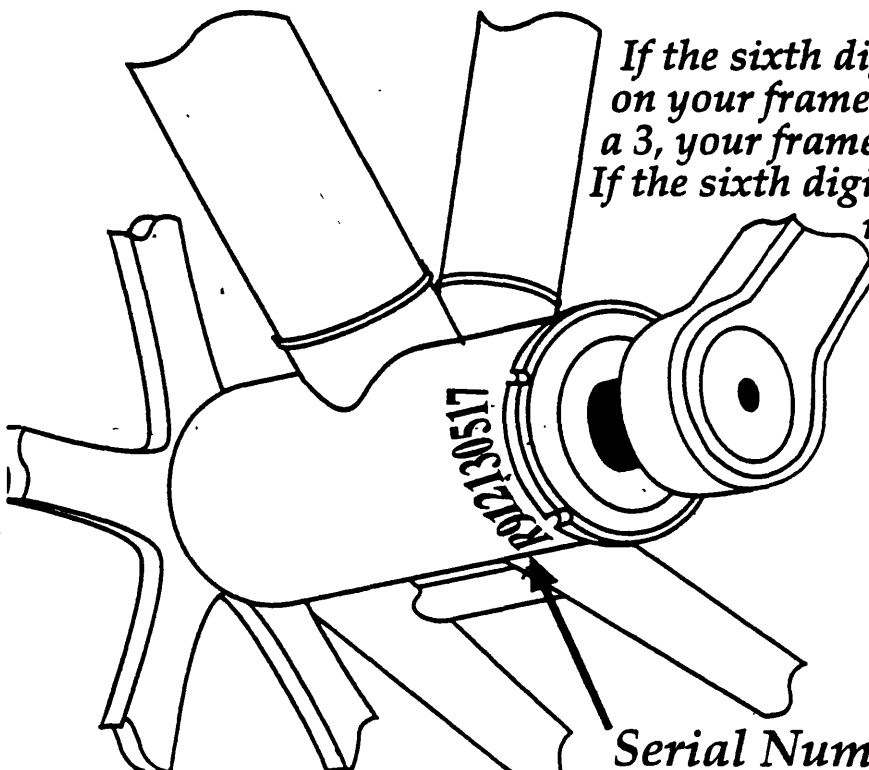
If the sixth digit from the left on your frame's serial number is a 3, your frame must be replaced.
If the sixth digit from the left is a 2, your frame does not need to be replaced.

REPLACE FRAME

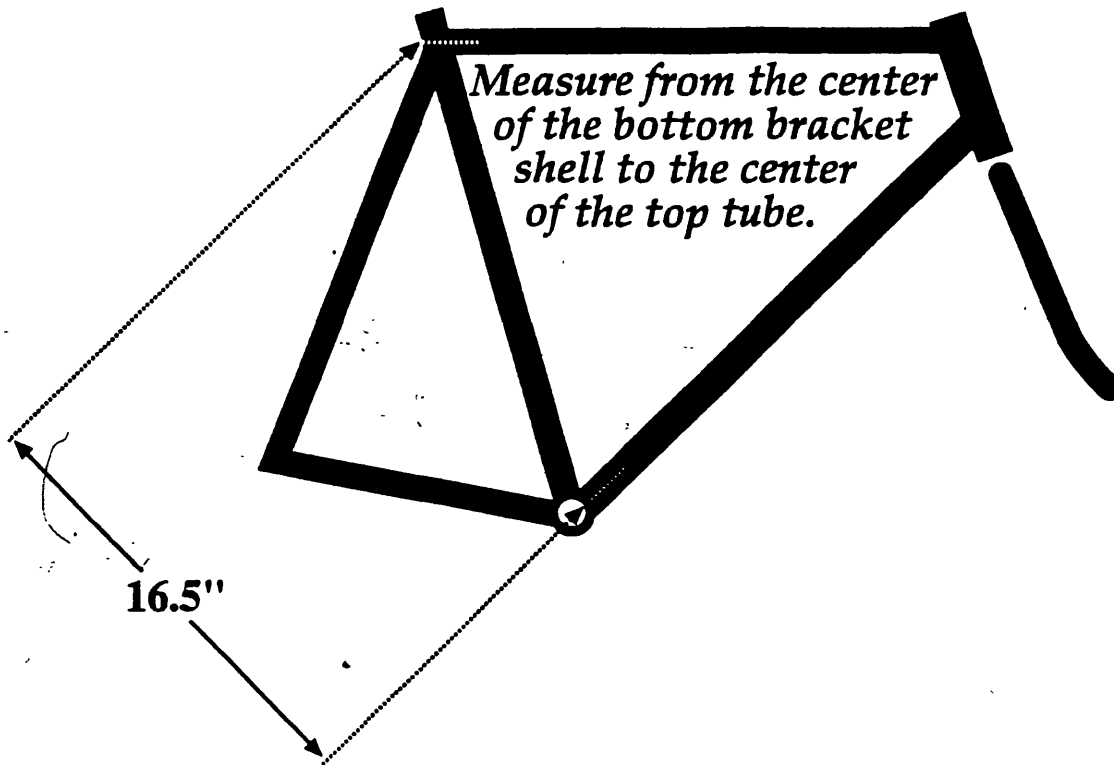
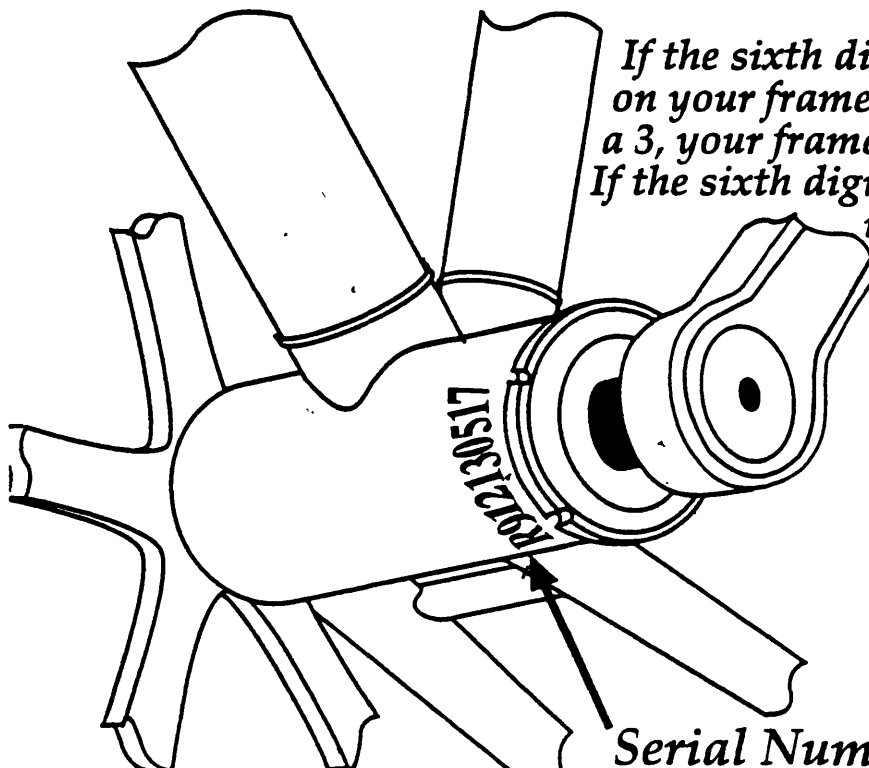
If the sixth digit from the left on your frame's serial number is a 3, your frame must be replaced.
If the sixth digit from the left is a 2, your frame does not need to be replaced.

REPLACE FRAME
