Analysis of Performance of the Inner Harbor Navigation Canal (IHNC)

Executive Summary

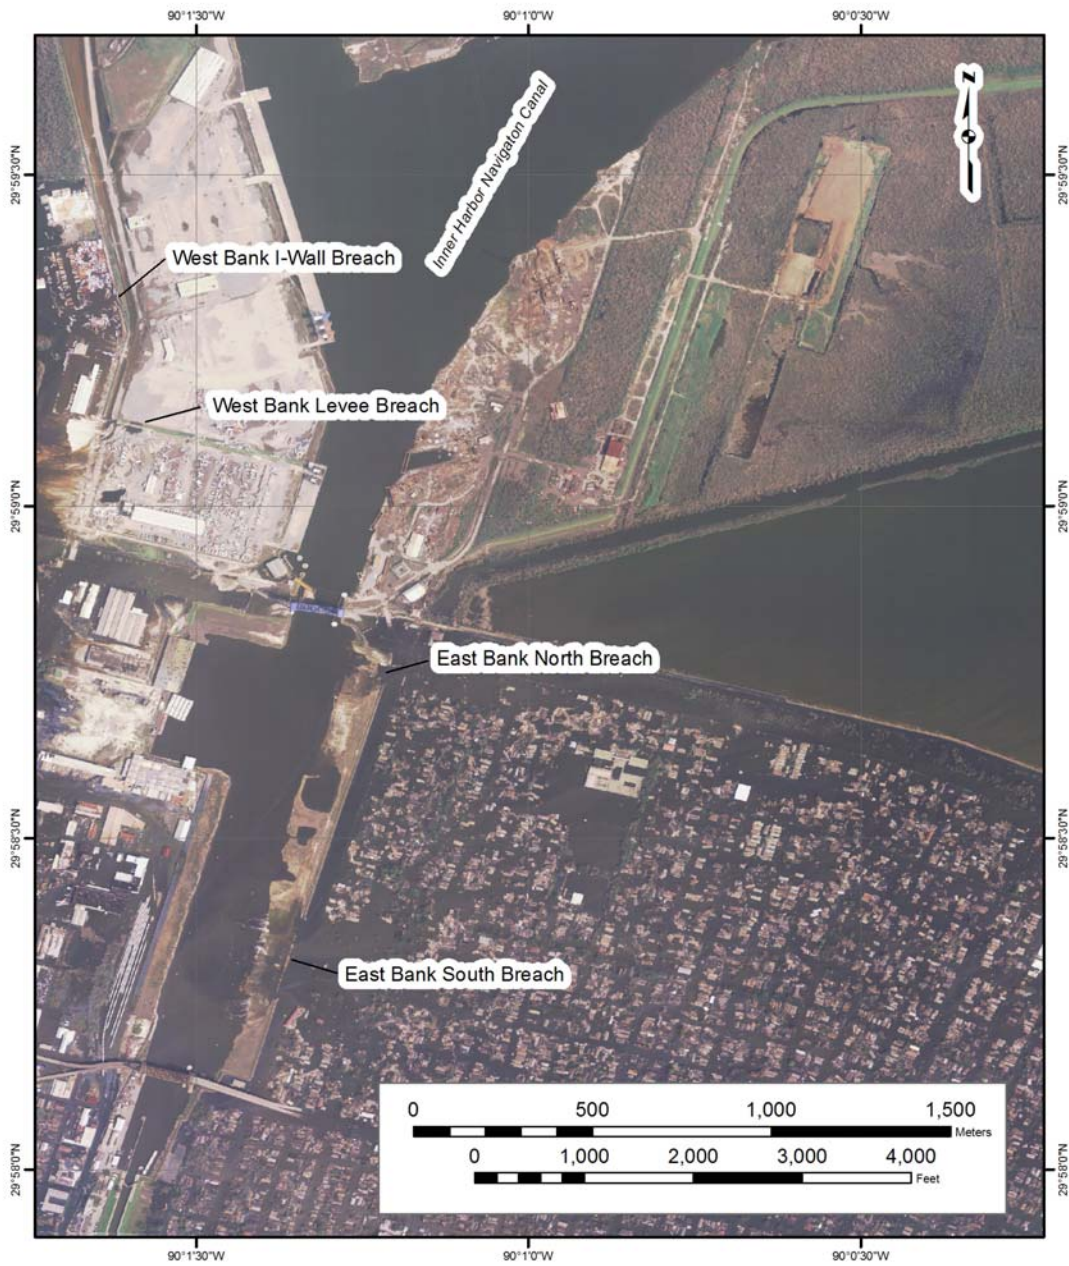
Two breaches occurred on the west bank of the IHNC, as shown in Figure 1. Both breaches occurred north of the railroad gate on France Road and just east of the France Road crossing.

Figure 1. Four Breach Locations on the Inner Harbor Navigation Canal.

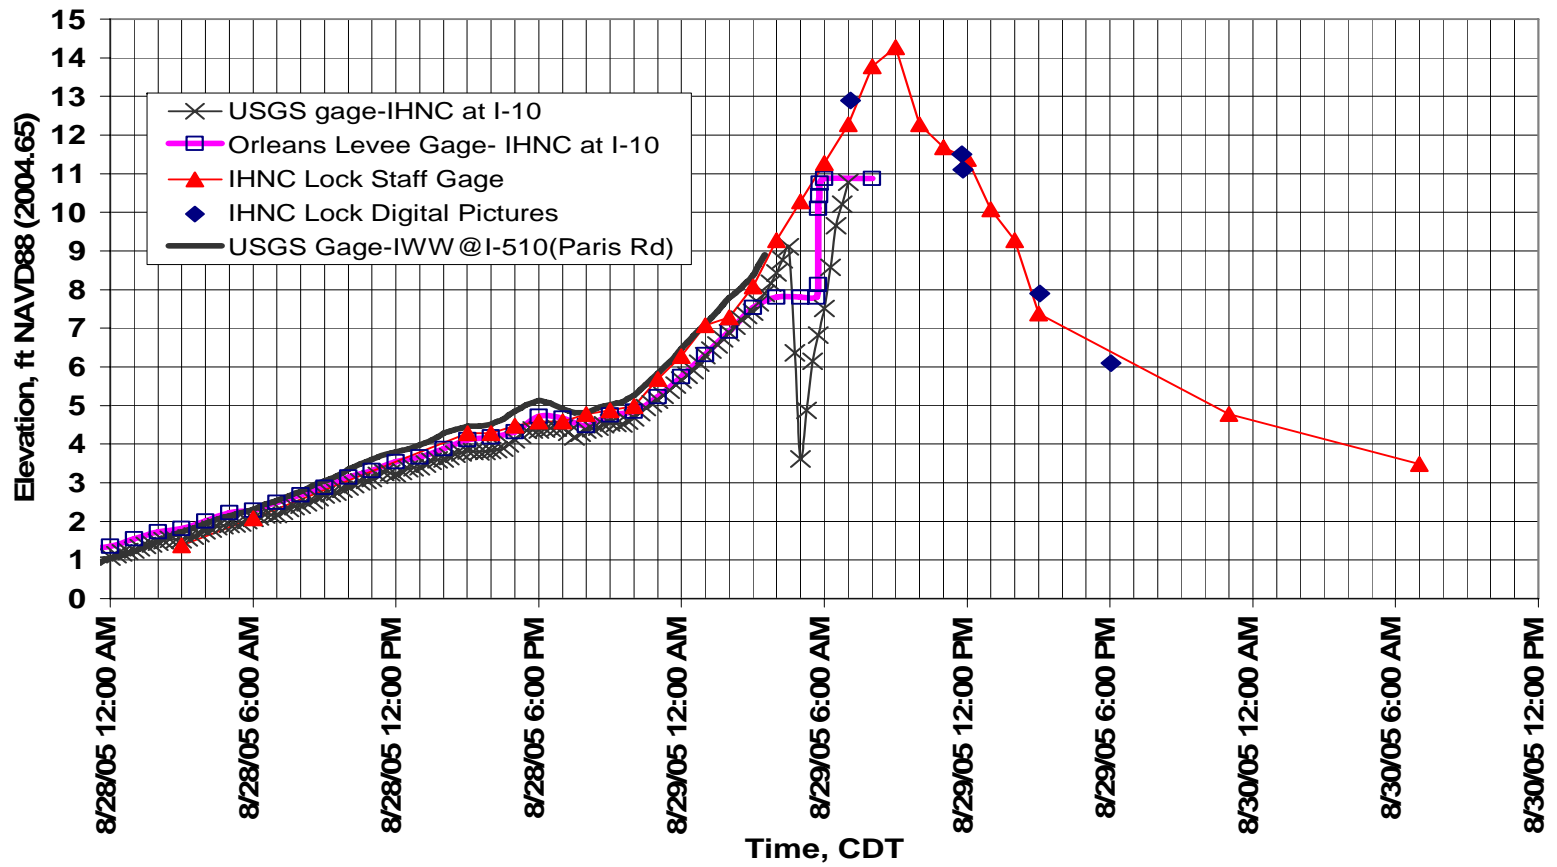
All of the IHNC floodwalls and levees were overtopped on August 29th. The peak storm surge elevation in the IHNC was 14.2 ft¹ at 9:00 AM, about 1.7 ft above the tops of the floodwalls and levees. The reaches where the floodwalls and levees did not collapse have therefore survived water loading considerably higher than the design loading.

Figure 2. Katrina Hydrograph for the Inner Harbor Navigation Canal.

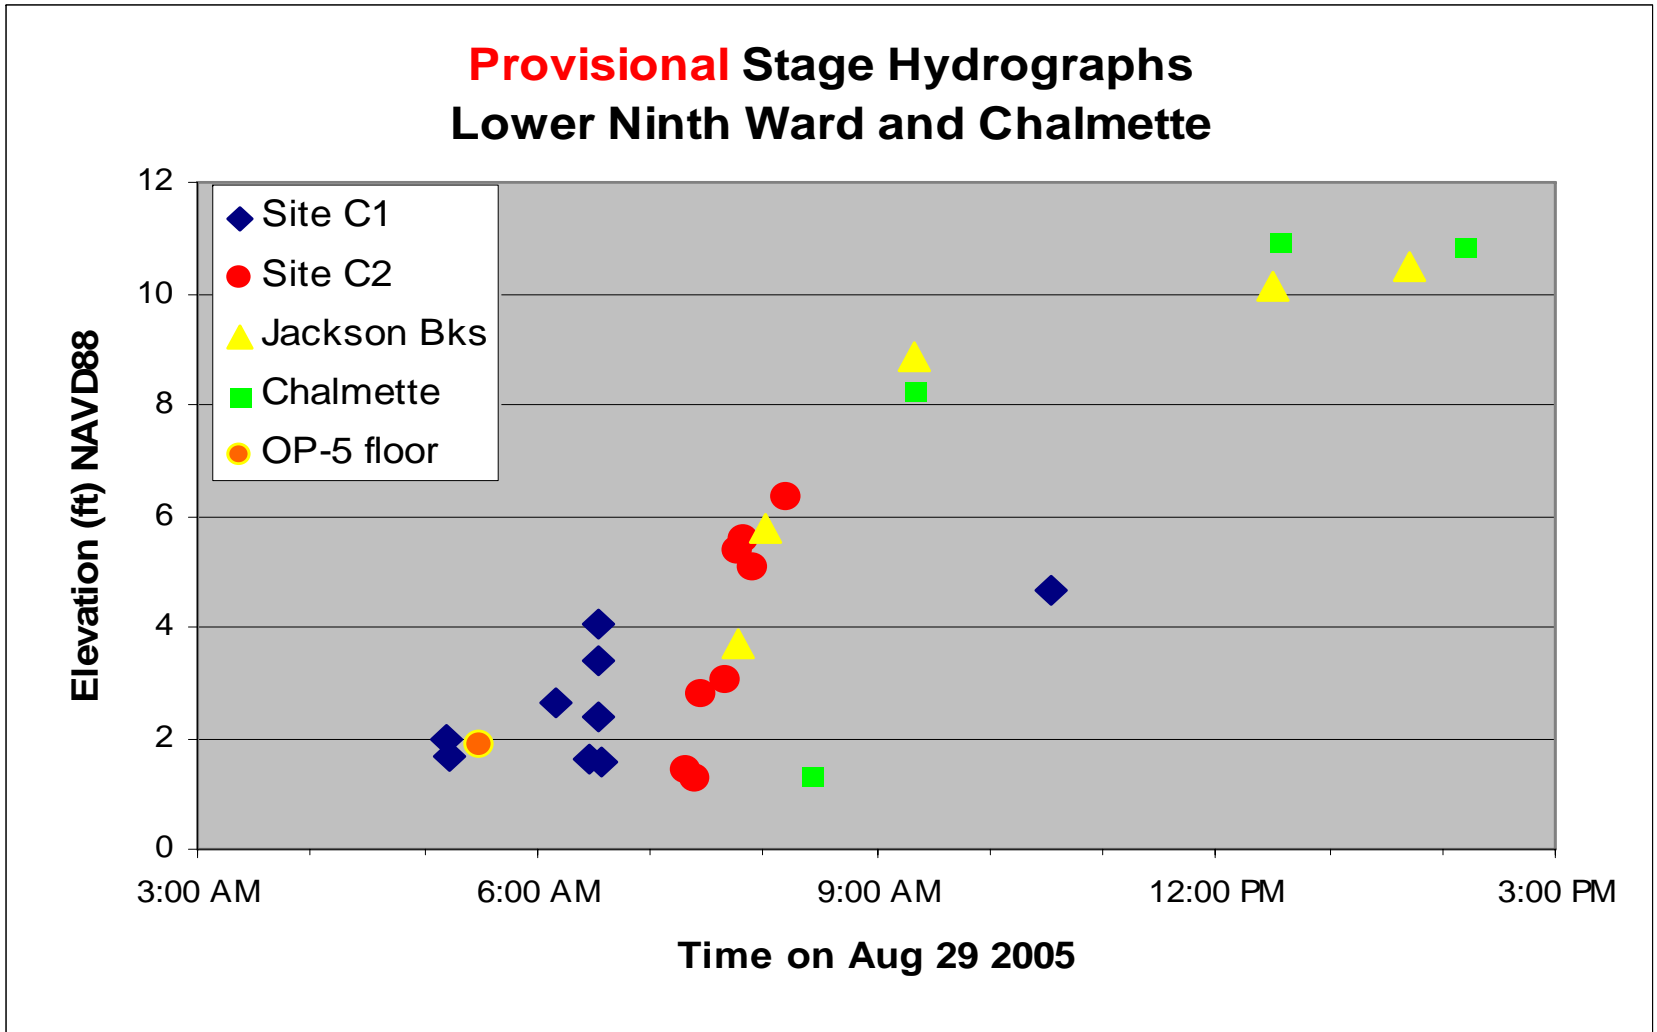
It thus appears that the north breach occurred before overtopping, and that this breach was the source of the first influx of water into the 9th Ward.

Figure 3. Hydrograph for the 9th Ward Inundation.

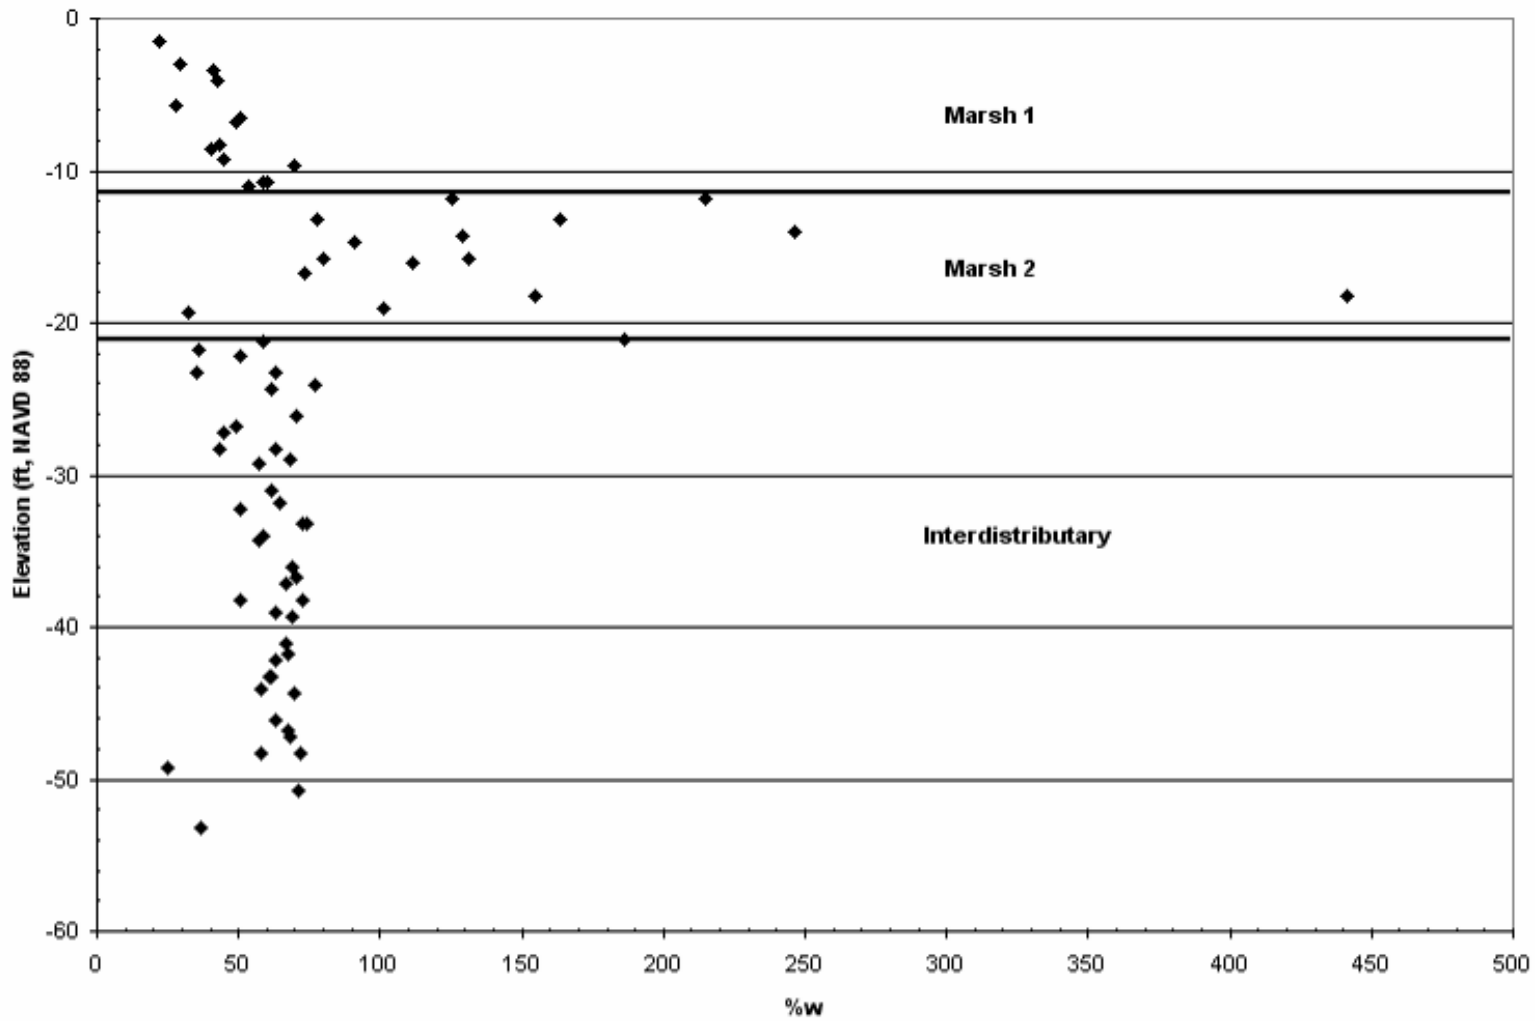
Figure 10. IHNC – East Bank (Between Florida Ave. and North Claiborne Ave.), % w versus Elevation (ft, NAVD 88), from toe borings

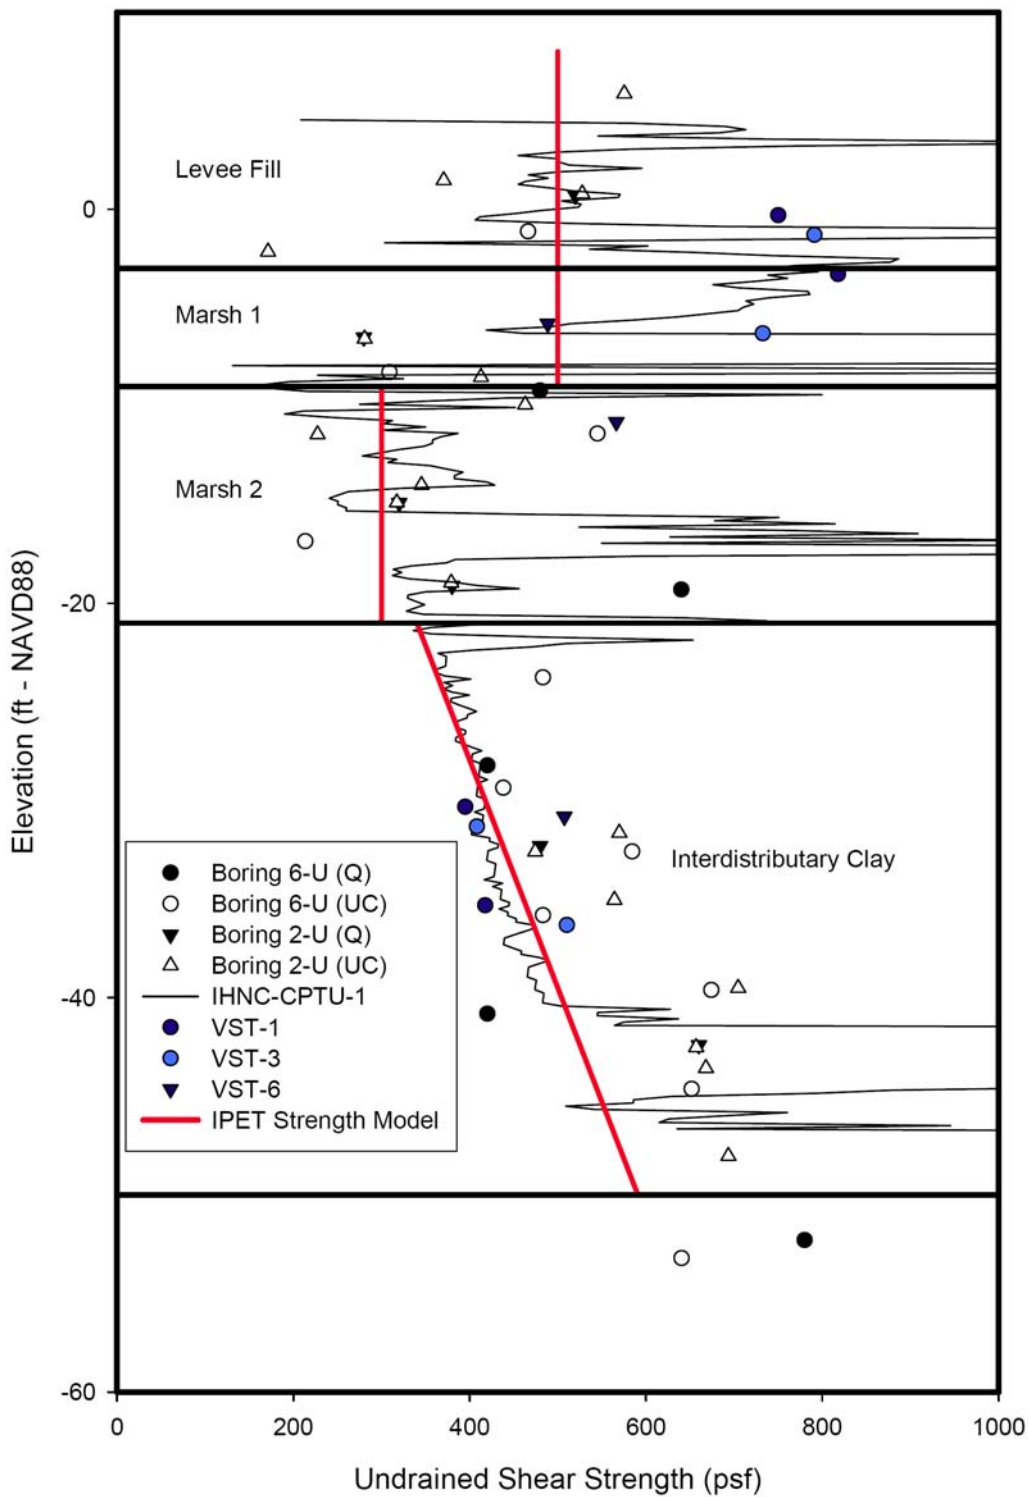
The straight line shown in Figure 12, representing the average undrained shear strength in the clay, has a slope of 8.6 psf per foot of depth. This rate of strength increase with depth appears to compare reasonably well to the laboratory strength test results.

Figure 12. IHNC – East Bank laboratory and field shear strength results for the centerline of the levee.

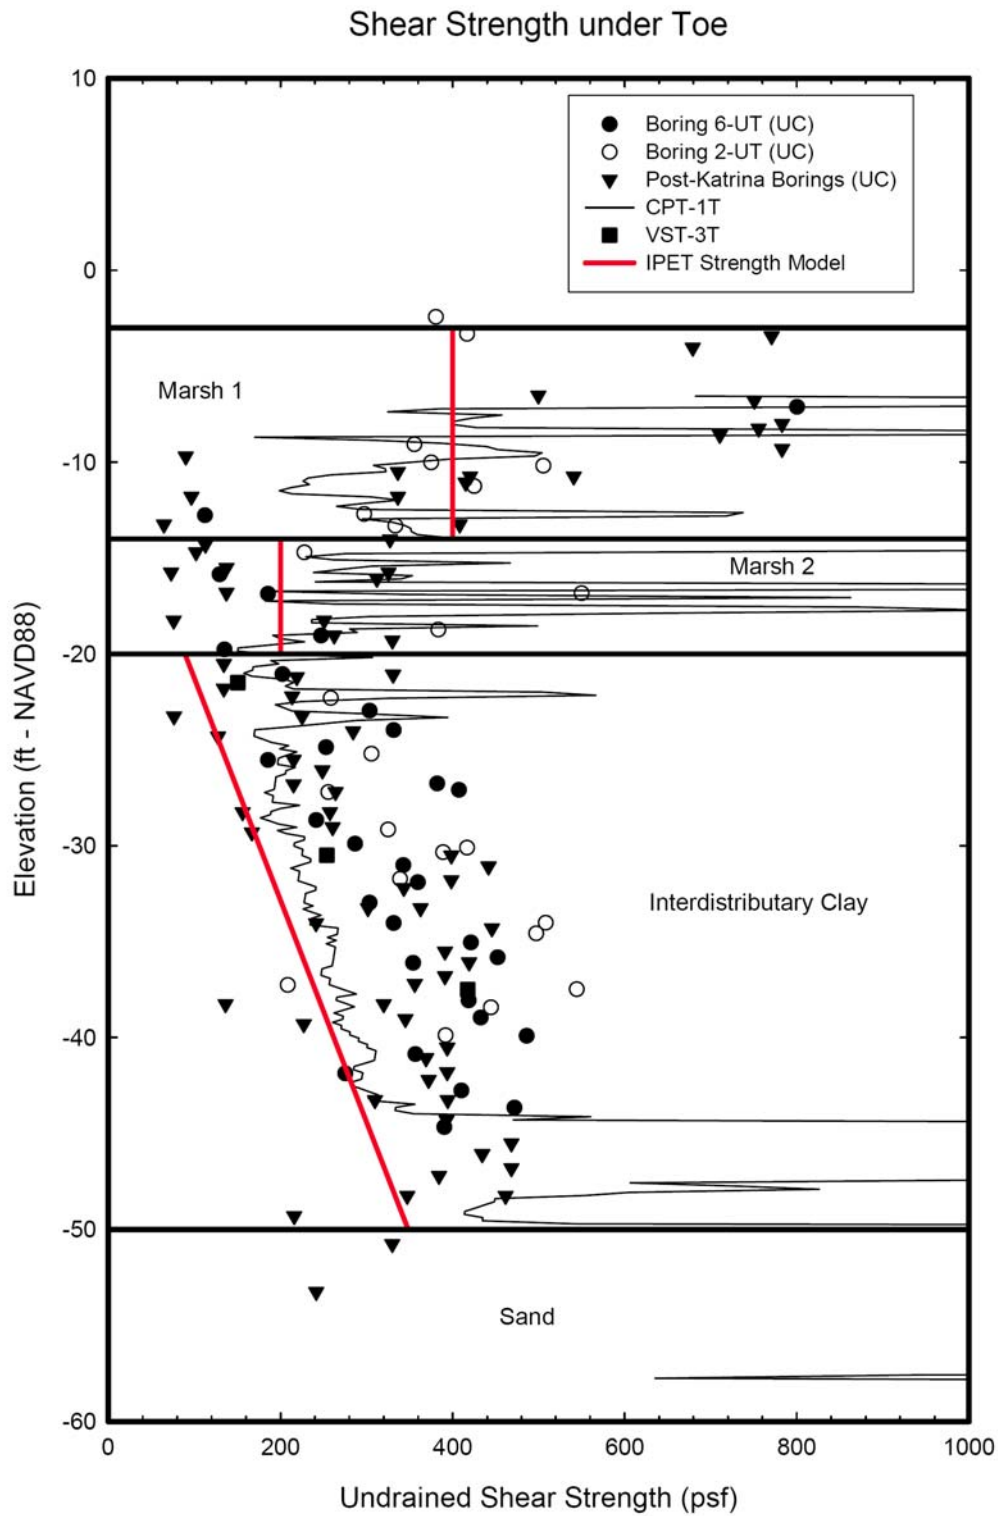
Figure 13. IHNC – East Bank laboratory and field shear strength results for toe of levee and beyond.

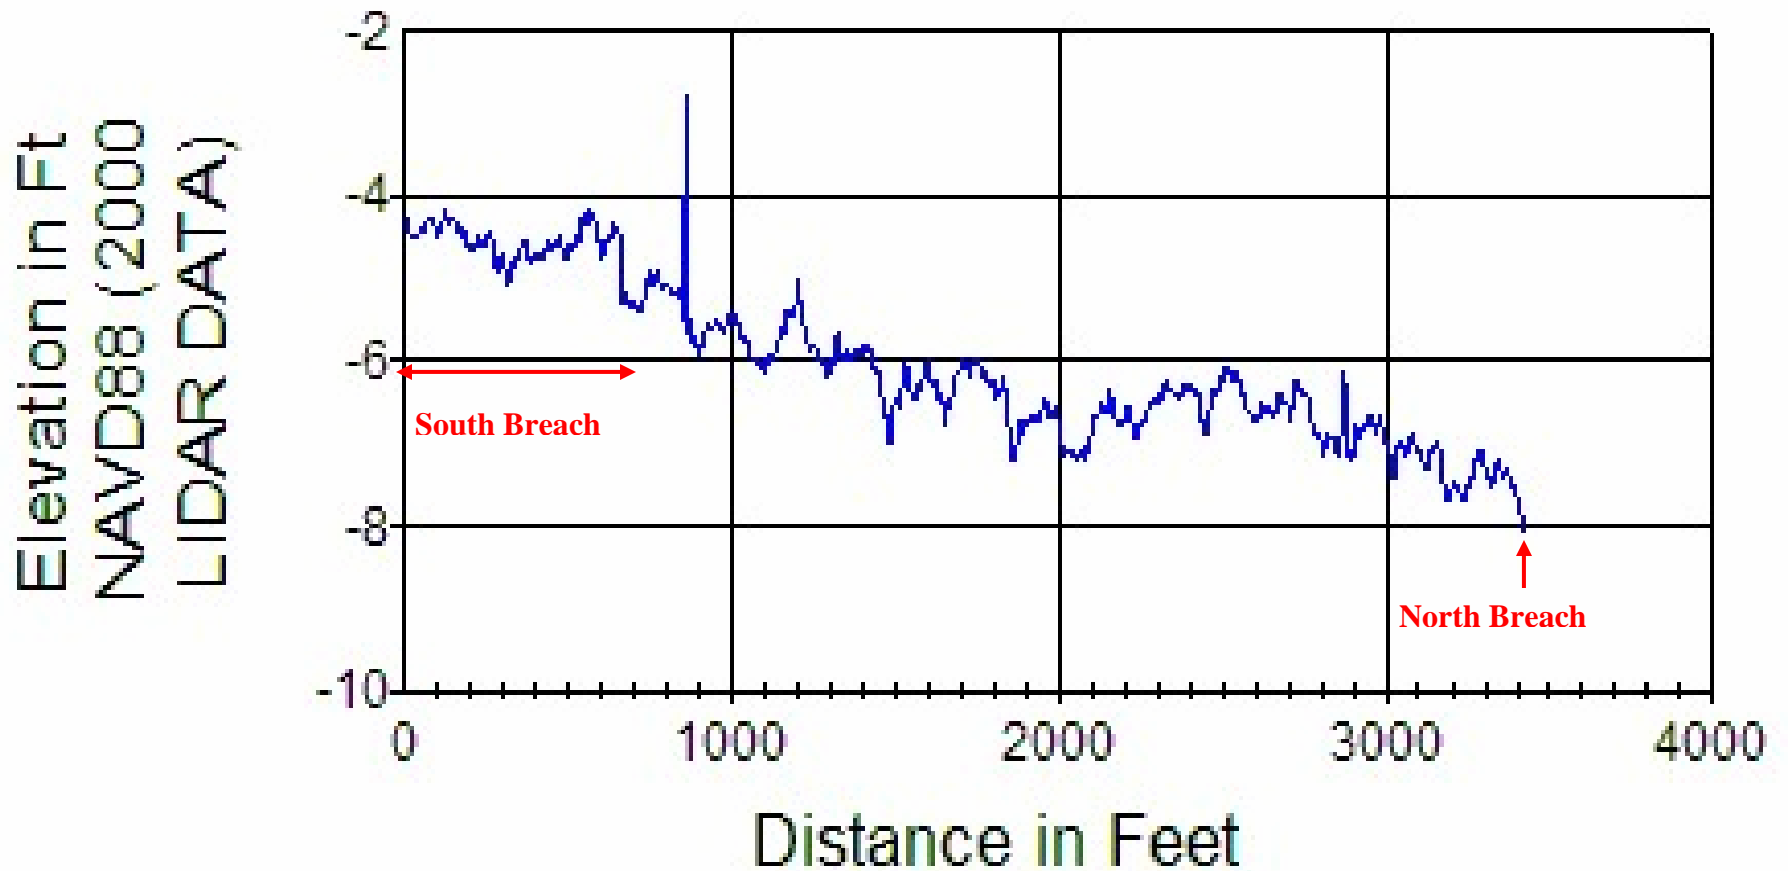
It is also important to note that the ground elevation of the toe of the levee is not constant; therefore it is not possible to use the same strength versus elevation relationship for the south breach and the north breach. The decrease in elevation of the toe from the south breach to the north breach is shown in the LIDAR survey of the area in the year 2000, which is plotted in Figure 14. The elevation of the protected side levee toe decreases about 4 ft from the south breach to the north breach.

Figure 14. LIDAR data at toe of levee.

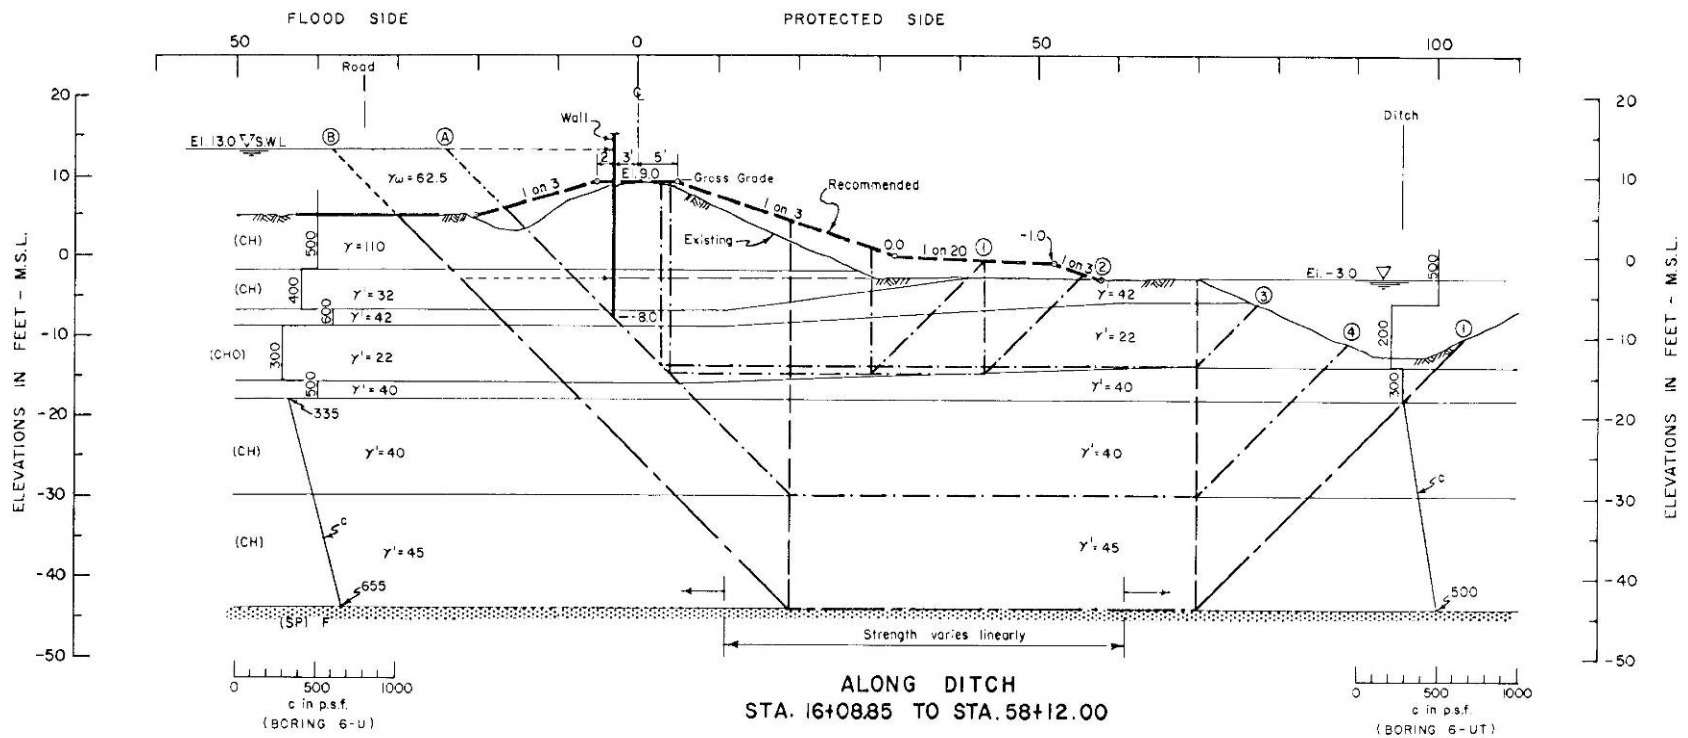
The design analyses in the Chalmette Area Plan General Design Memorandum (GDM)⁷ used undrained strengths for the levee fill, the marsh layers, and the clay, and a drained friction angle to characterize the strength of the sand layer beneath the clay, as does the IPET strength model described above. However, there are four marsh layers in the GDM interpretation compared to only two marsh layers for the IPET strength model. The design strengths are comparable to the IPET strengths discussed here and shown in Table 5 and Figure 15.

In addition, four slope stability analyses (Cases 1 through 4 in Table 8) were performed using the cross section and strength profile shown in the GDM, and presented in this report as Figure 15.

Figure 15. Cross section used for design for stations 16+09 to 58+12. Both east bank breaches occurred between these two stations.

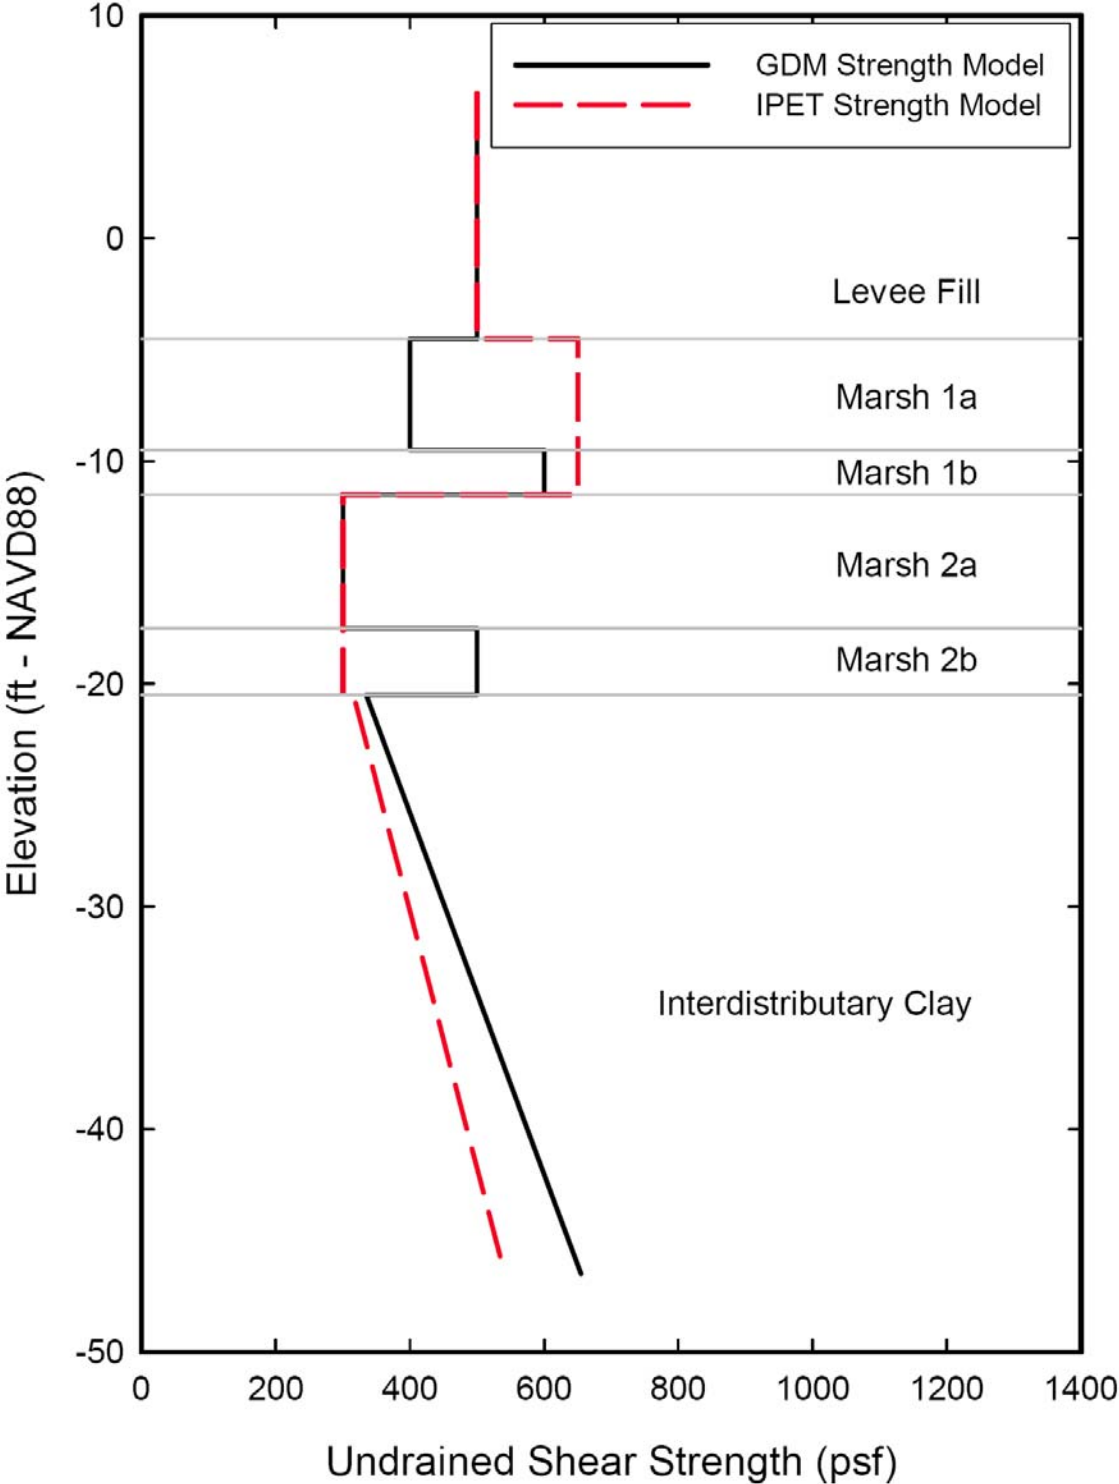
A comparison between the GDM and IPET strength models is presented in Figures 16 and 17 for the GDM design cross section. Shown in Figure 16 is the shear strength profile under the crest of the levee (horizontal coordinate of 0 ft) used in the original design, and the shear strength profile calculated using the IPET model. The IPET strength model has higher shear strengths in the Marsh 1 layer, and the GDM strength model has higher strengths in the lower portion of the Marsh 2 layer. Both models show a linear increase in undrained shear strength in the interdistributary clay layer, with the rate of increase greater for the GDM model than the IPET model. The difference in the rate of increase can be partially attributed to the difference in unit weights used in each model. The GDM strength model assumes a unit weight of the clay of 102.4 pcf for the upper portion of the clay and 107 pcf for the lower portion of the clay. The IPET model uses a unit weight of 100 pcf for the clay. The higher unit weights used in the GDM strength model would produce a larger increase in undrained shear strength per foot than the IPET model for the same undrained strength ratio. In addition, based on the assumed unit weights and the rate of strength increase, the GDM model corresponds to a greater undrained strength ratio, from about 0.28 to 0.31.

Figure 16 Comparison of GDM and IPET shear strength models for GDM design cross section at the centerline (horizontal coordinate of 0 ft in Figure 15).

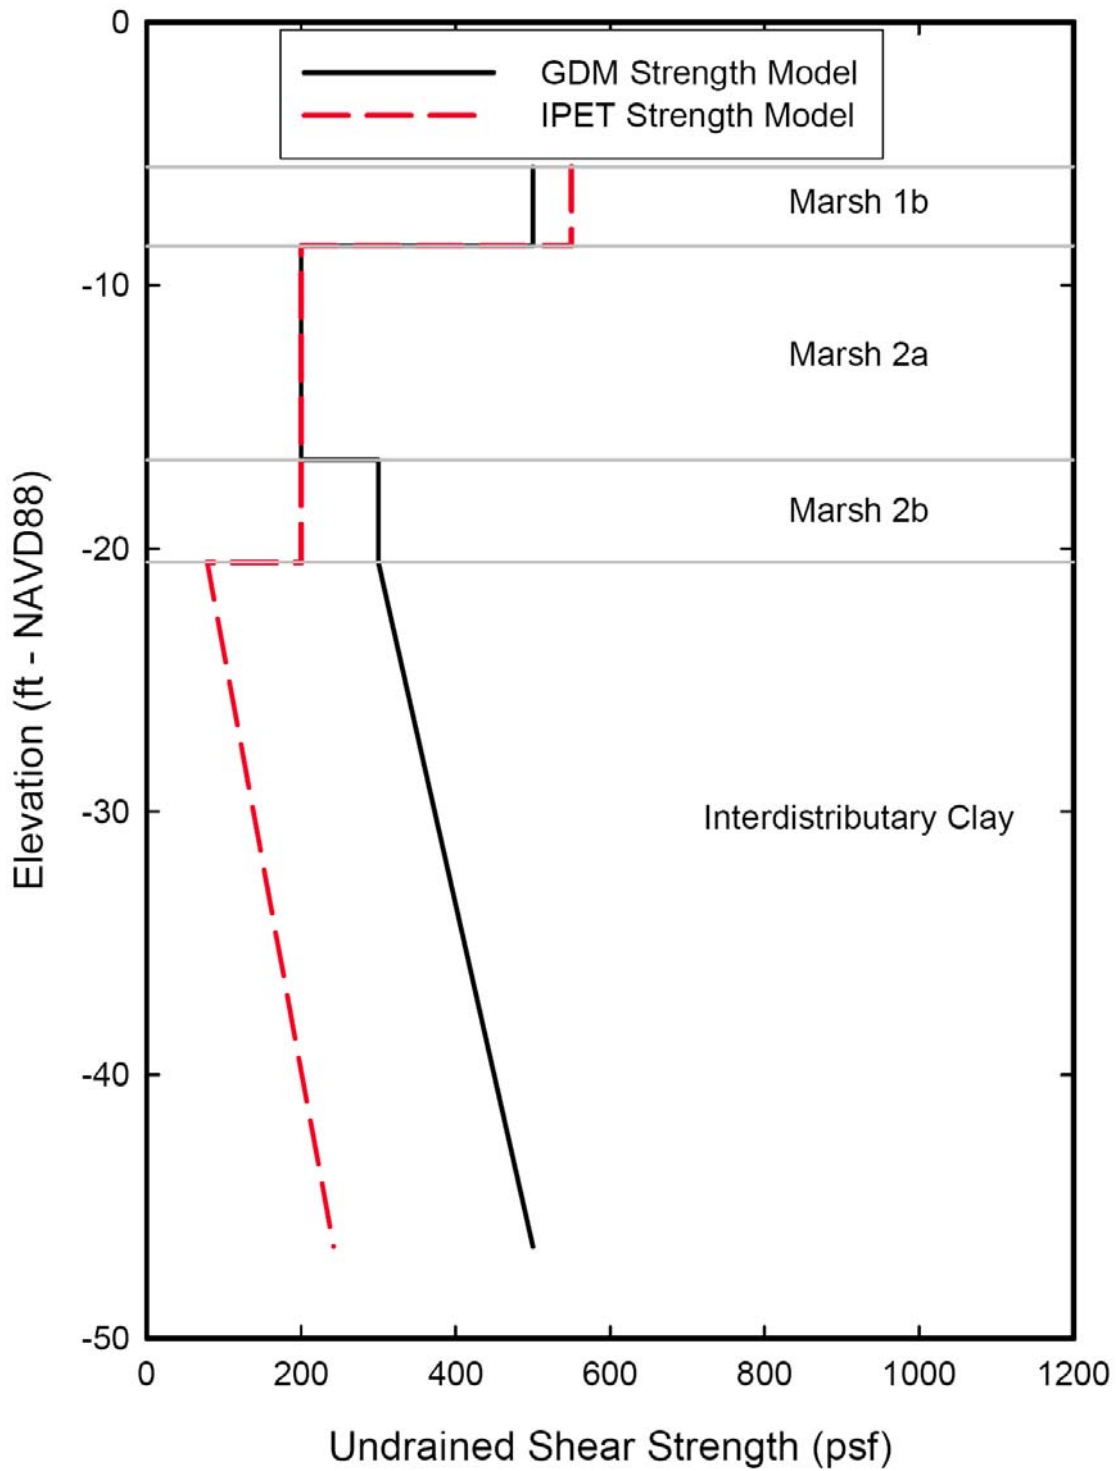
The difference between the GDM and IPET strength model is more pronounced for undrained strengths below the toe of the levee. Shown in Figure 17 is the shear strength profile under the toe of the levee (horizontal coordinate of 60 ft) used in the original design, and the shear strength profile calculated using the IPET model. The

Figure 17 Comparison of GDM and IPET shear strength models for GDM design cross section at the toe (horizontal coordinate of 60 ft in Figure 15).

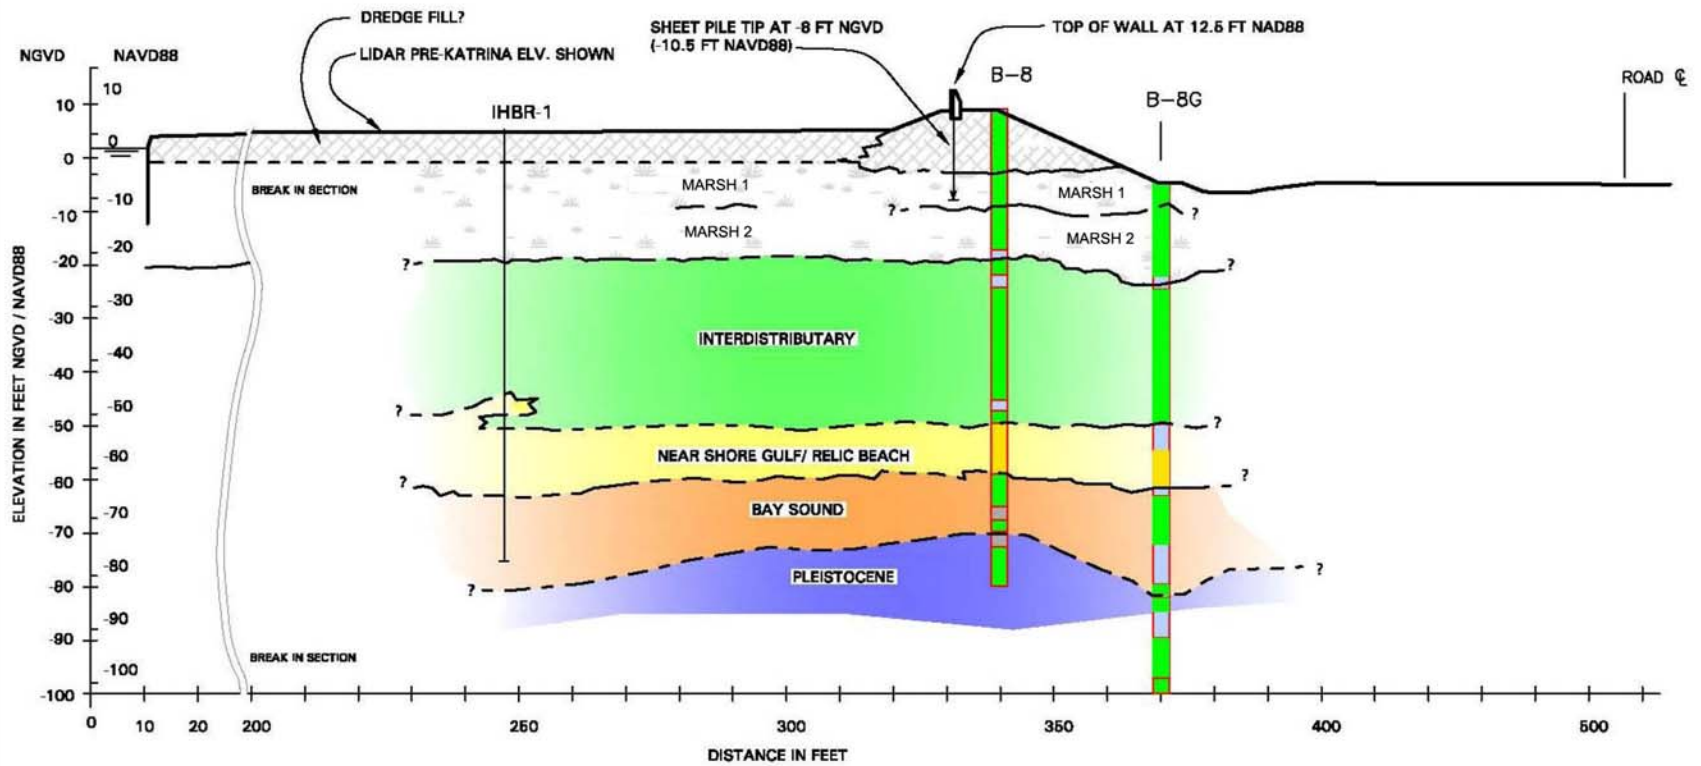
Eighteen slope stability analyses (Cases 1 through 5, 5a, and 6 through 17 in Table 6) were performed for the cross section at Station 55+00 at the north breach. The cross section used for these analyses is shown in Figure 18. Also, 17 slope stability analyses (Cases 1 through 17 in Table 7) were performed for a cross section developed for Station 26+00 at the south breach. The cross section used for these analyses is shown in Figure 19.

Figure 18. Profile of the north breach at IHNC East bank, view looking North

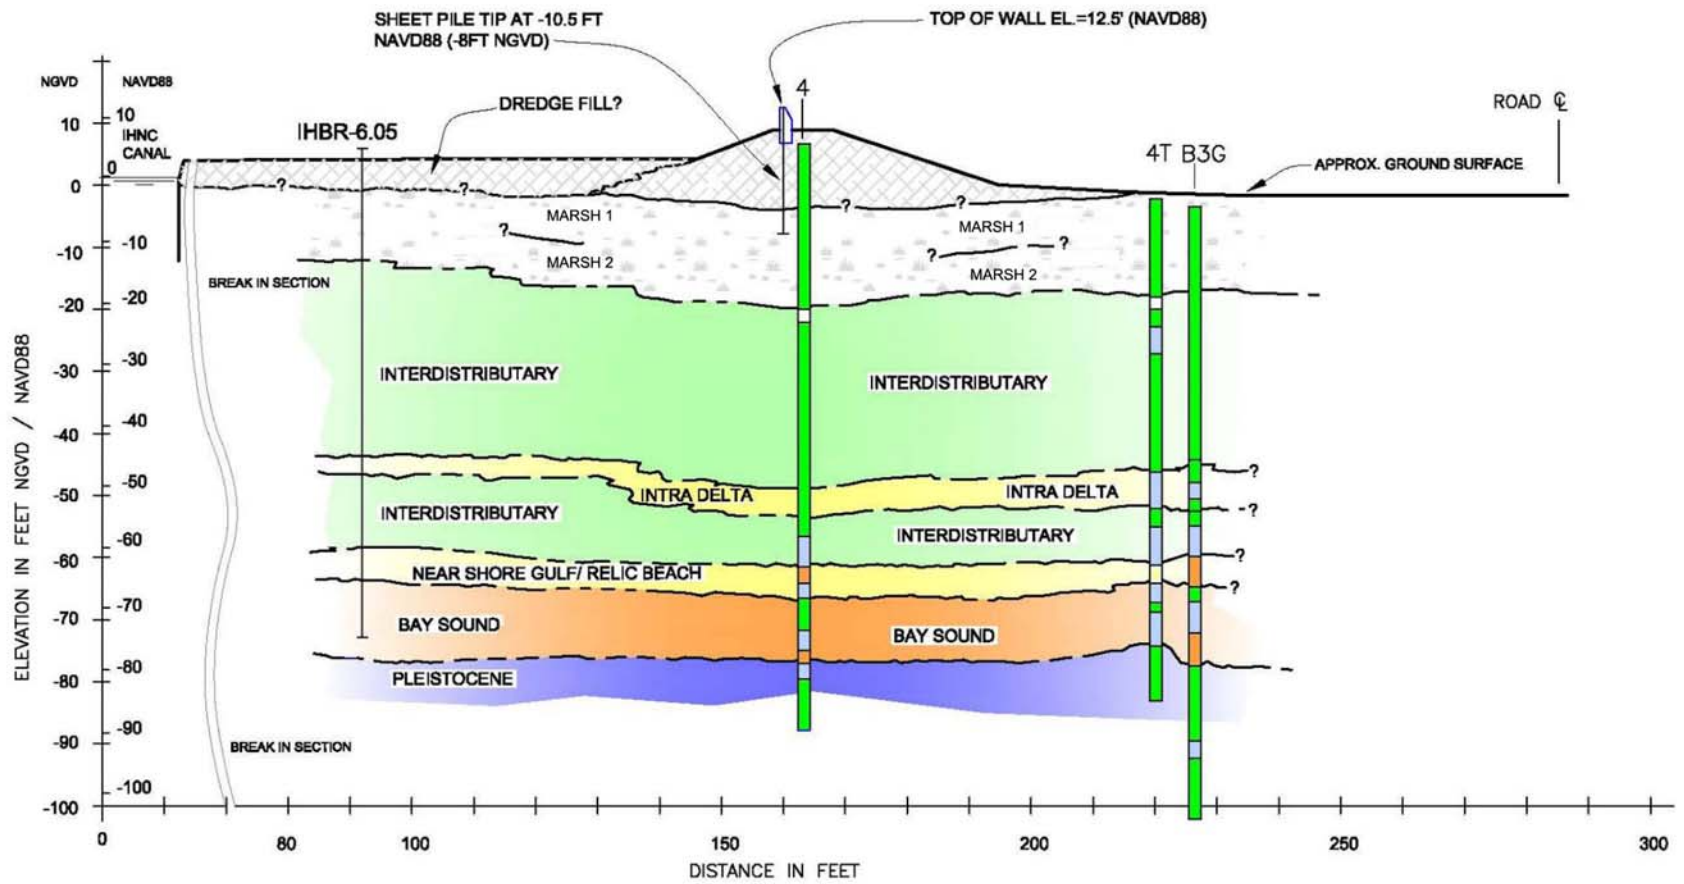
Figure 19. Profile of the south (9th Ward) breach at IHNC East bank, view looking North.

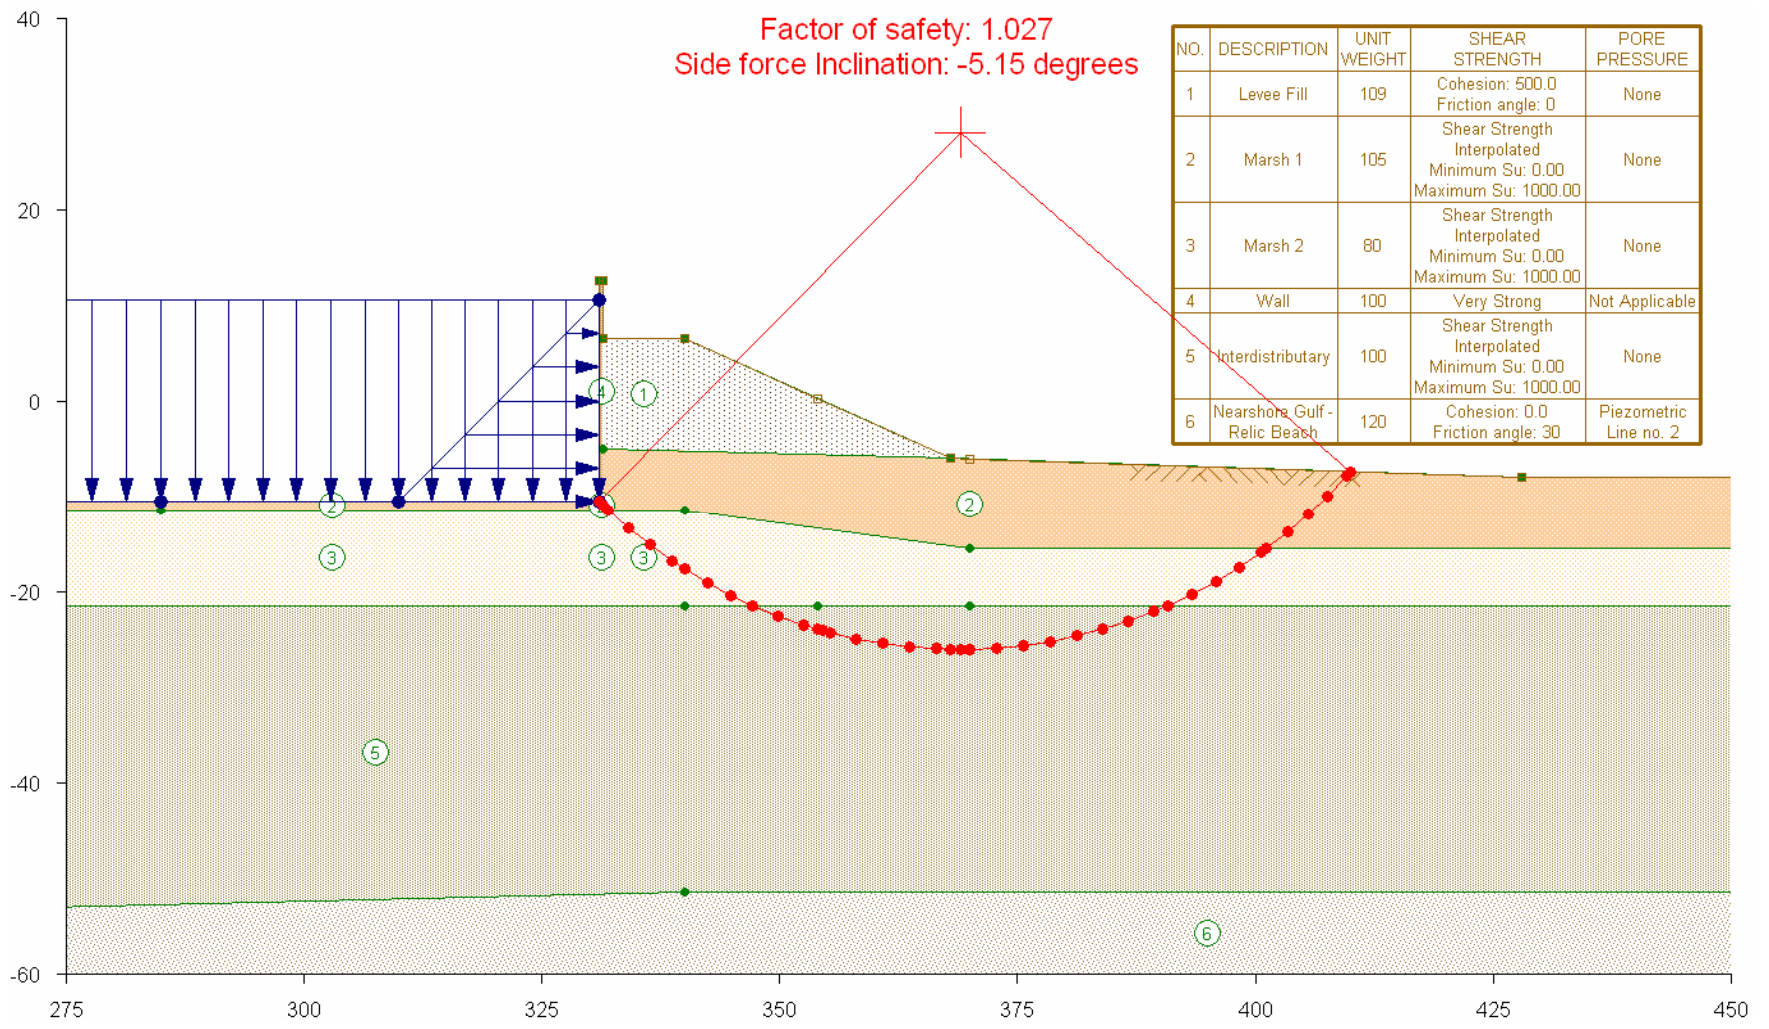
For the north breach (Station 55+00), with the canal water level at elevation 12.5 ft (top of the wall), the calculated factor of safety for the cracked condition is 0.96, as compared to 1.13 for the uncracked condition (Cases 5 and 5a). A canal water elevation of 11.2 ft produces a factor of safety of unity for the cracked condition (Case 4). Figures 20 through 25 show the critical circles from UTEXAS4 analyses for the north breach for Cases 1 through 5 and Case 5a.

Figure 21. IHNC – East Bank (North Breach), Case 2, Design Canal Water Level = 10.5 ft (NAVD 88), with Crack
