Analysis of Performance of the Inner Harbor Navigation Canal (IHNC)

Executive Summary

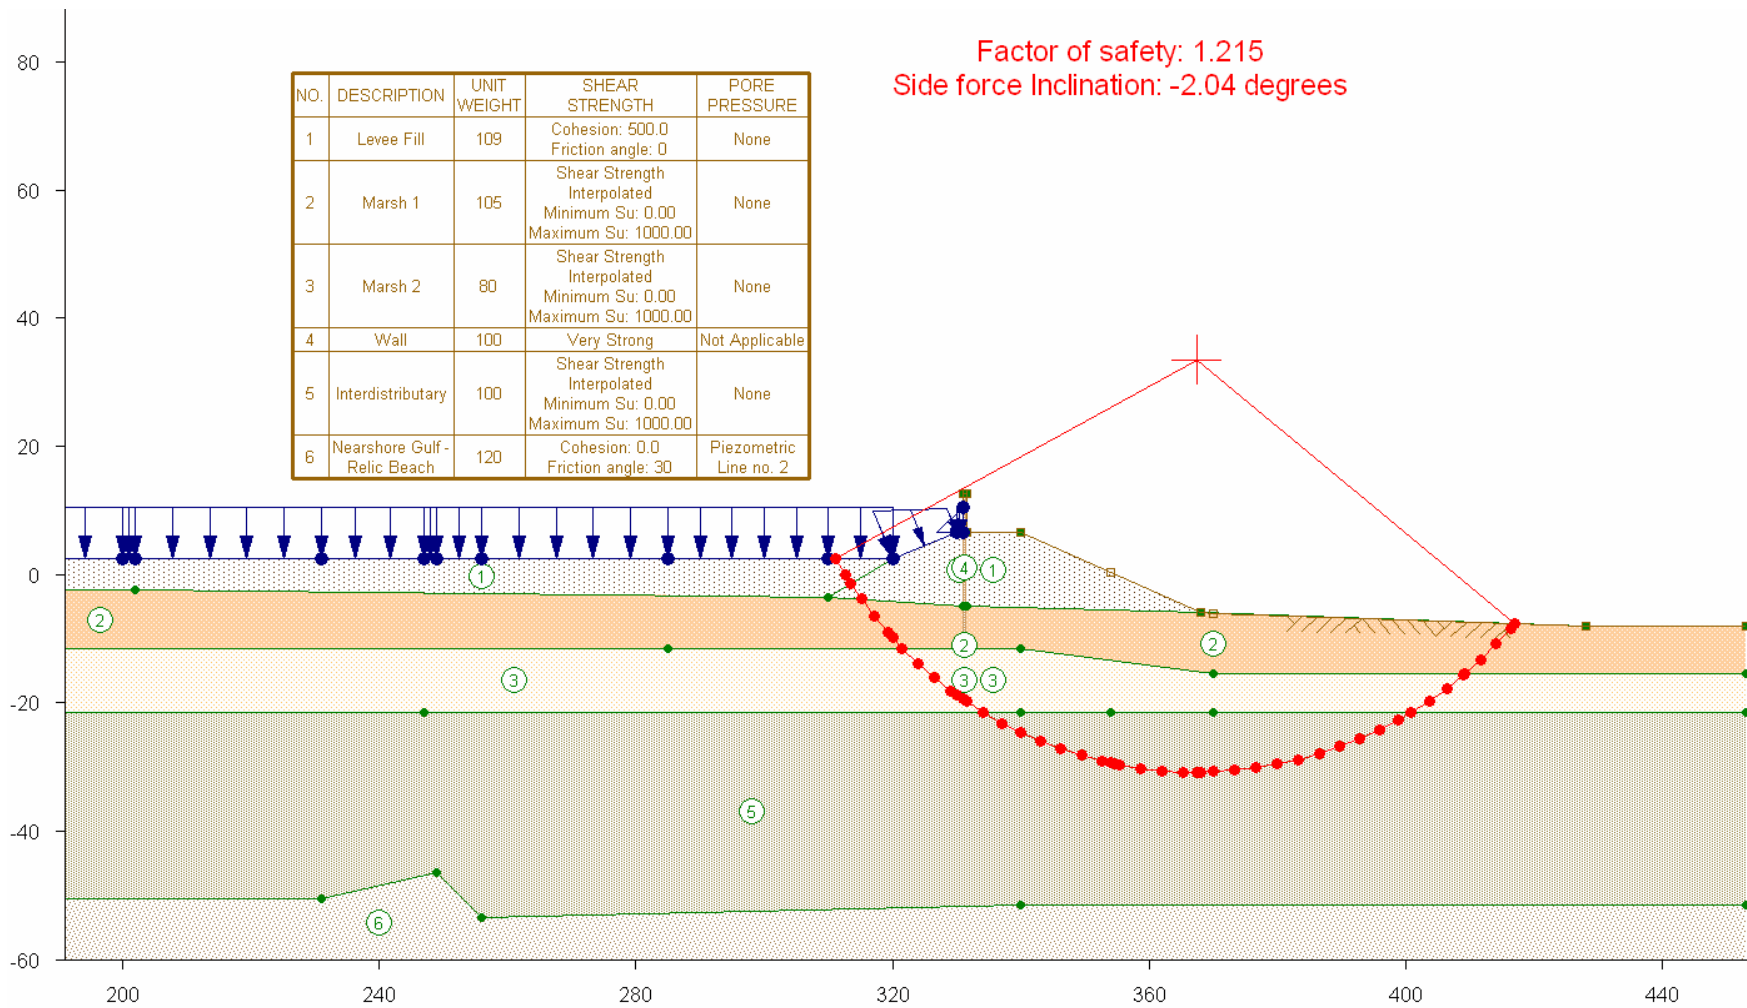
For the north breach (Station 55+00), with the canal water level at elevation 12.5 ft (top of the wall), the calculated factor of safety for the cracked condition is 0.96, as compared to 1.13 for the uncracked condition (Cases 5 and 5a). A canal water elevation of 11.2 ft produces a factor of safety of unity for the cracked condition (Case 4). Figures 20 through 25 show the critical circles from UTEXAS4 analyses for the north breach for Cases 1 through 5 and Case 5a.

Figure 22. IHNC – East Bank (North Breach), Case 3, Design Canal Water Level = 10.5 ft (NAVD 88), without Crack

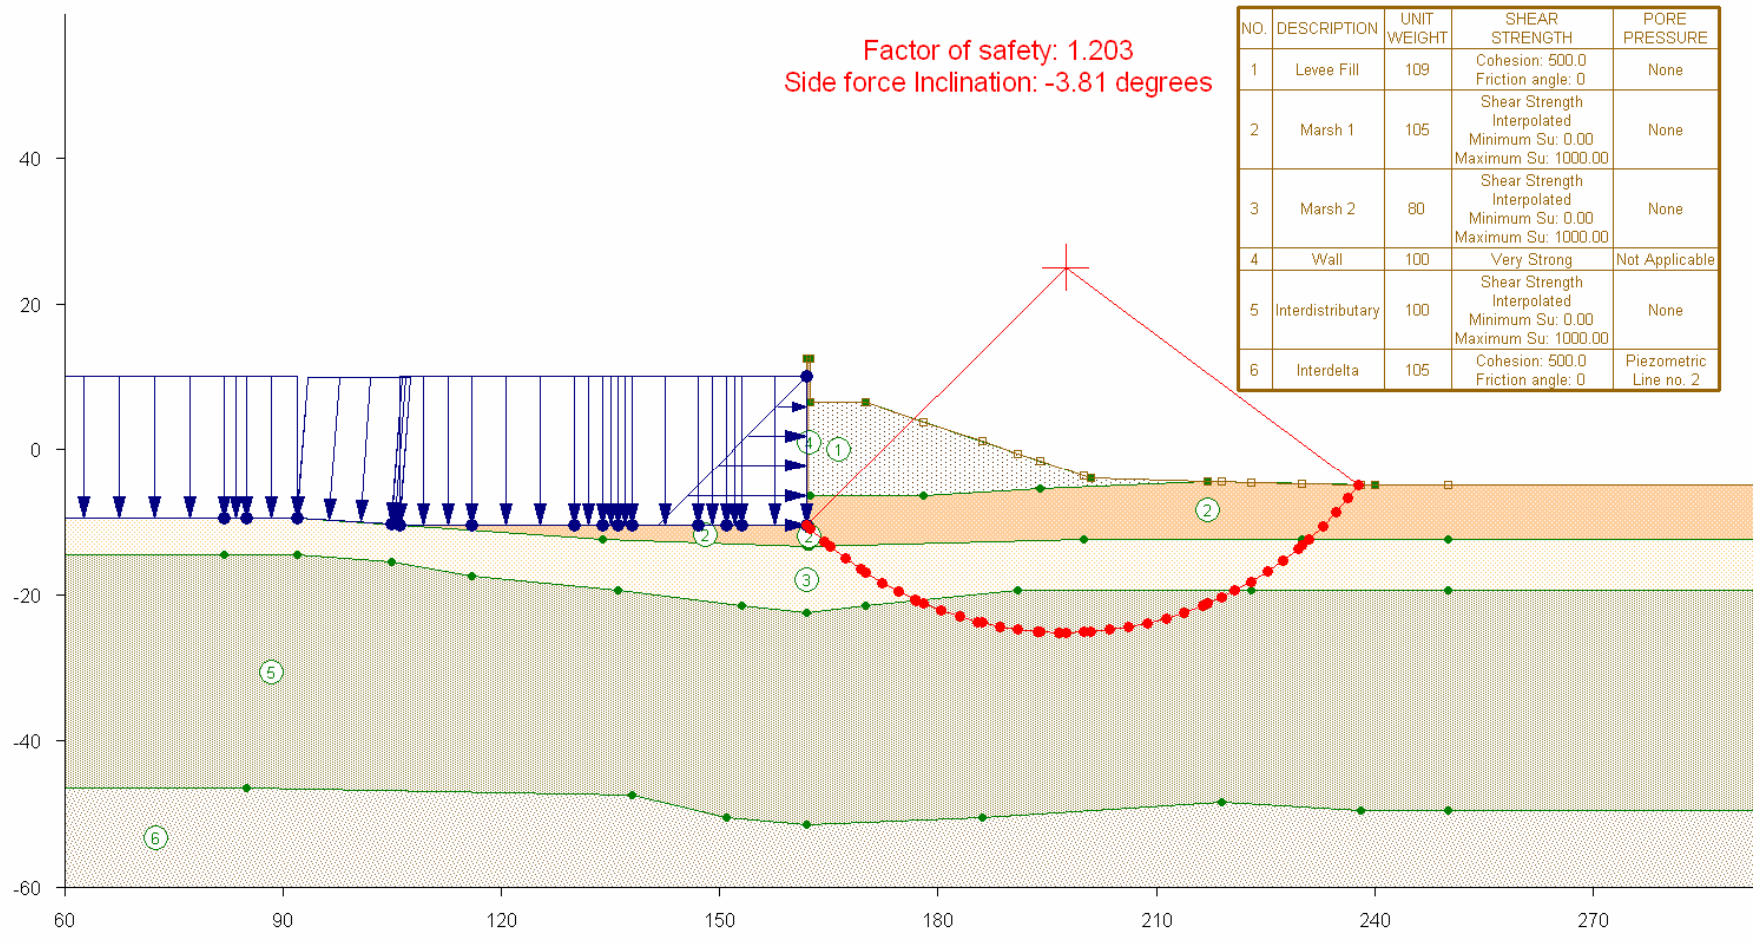
For the south breach (Station 26+00), the factor of safety was greater than unity for all canal water elevations analyzed using the IPET strength model. For the most extreme case of the canal water level at elevation 12.5 ft (top of the wall), the calculated factor of safety for the cracked condition is 1.10. The critical circles for the stability analyses performed on the south breach for Cases 1 through 5 are shown in Figures 26 through 30.

Figure 26. IHNC – East Bank (South Breach), Case 1, Canal Water Level = 10.0 ft (NAVD 88), with Crack

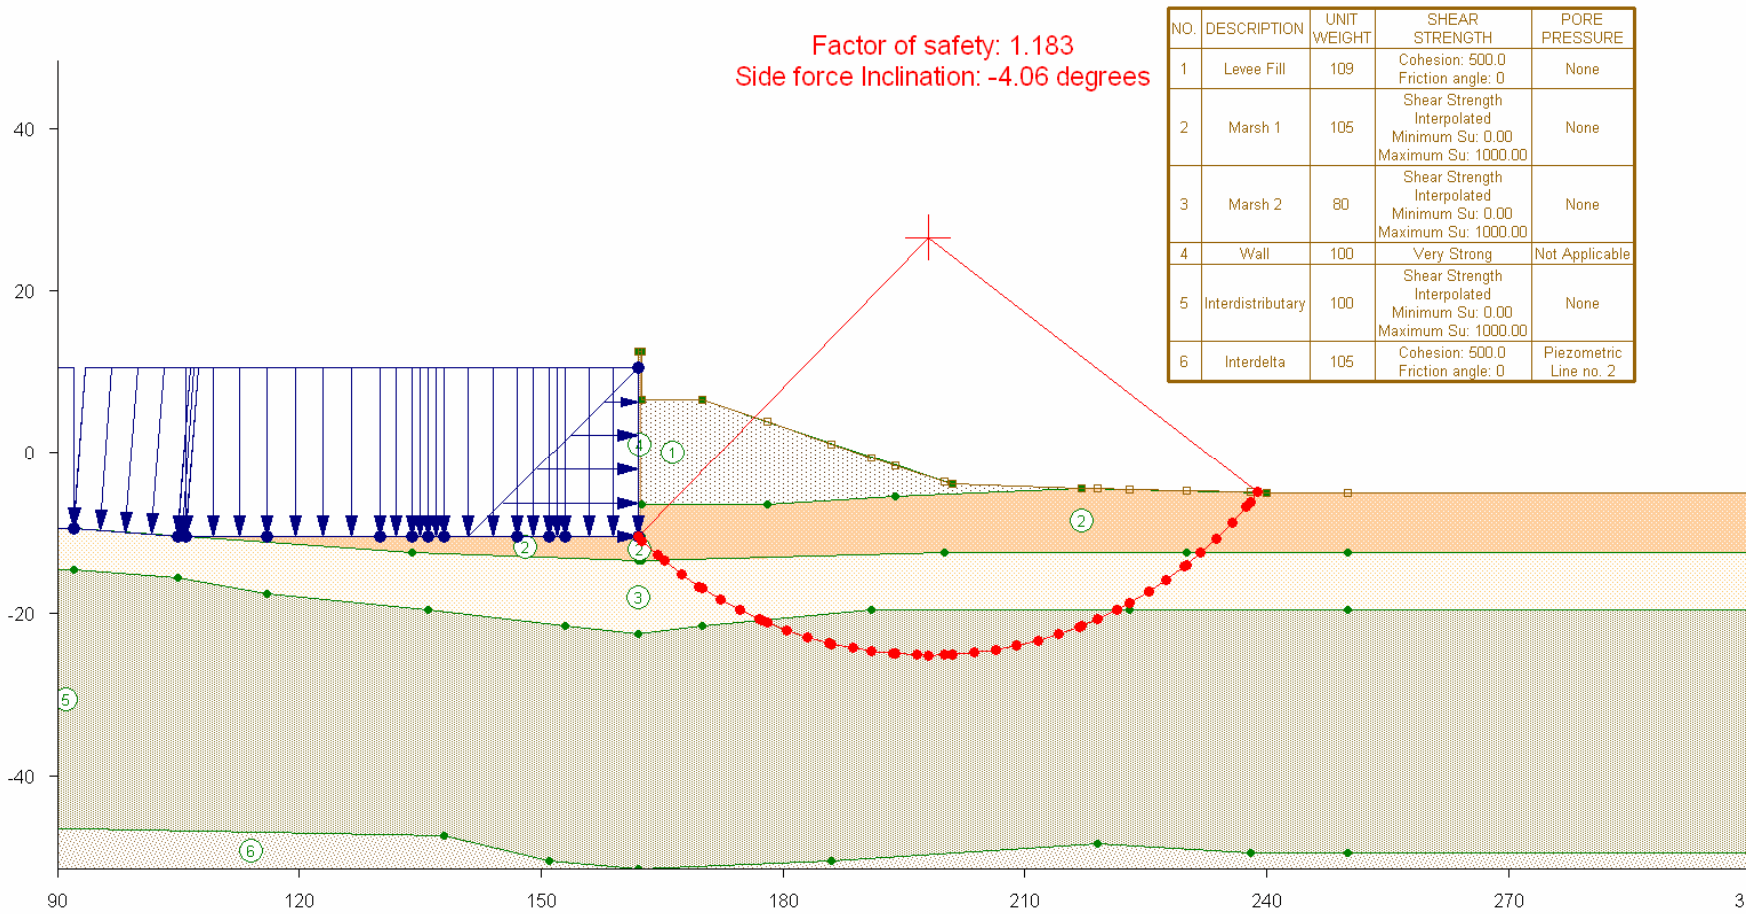
Figure 27. IHNC – East Bank (South Breach), Case 2, Design Canal Water Level = 10.5 ft (NAVD 88), with Crack

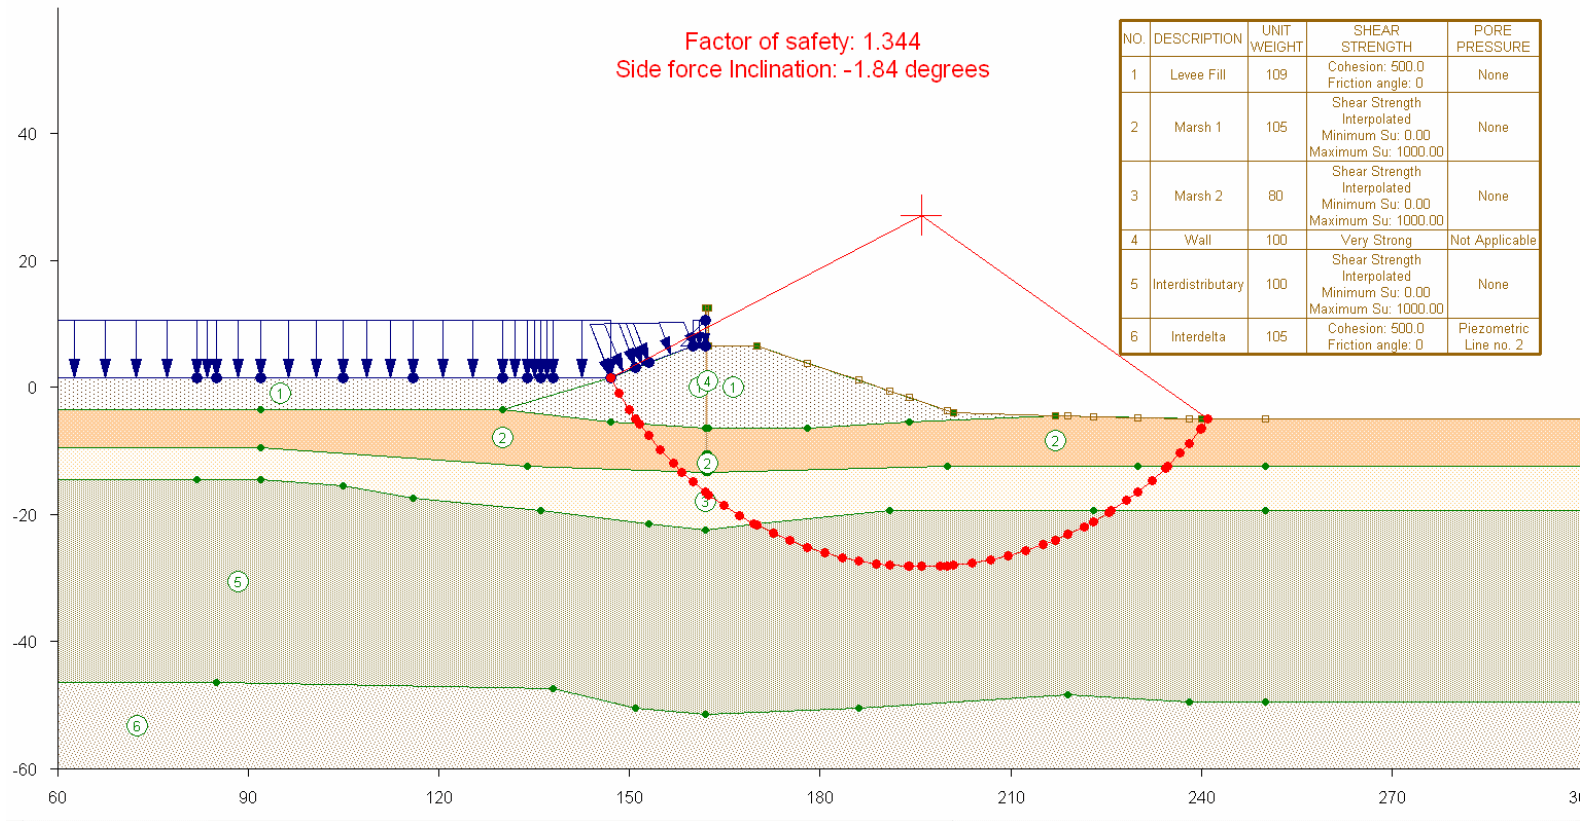
Figure 28. IHNC – East Bank (South Breach), Case 3, Design Canal Water Level = 10.5 ft (NAVD 88), without Crack

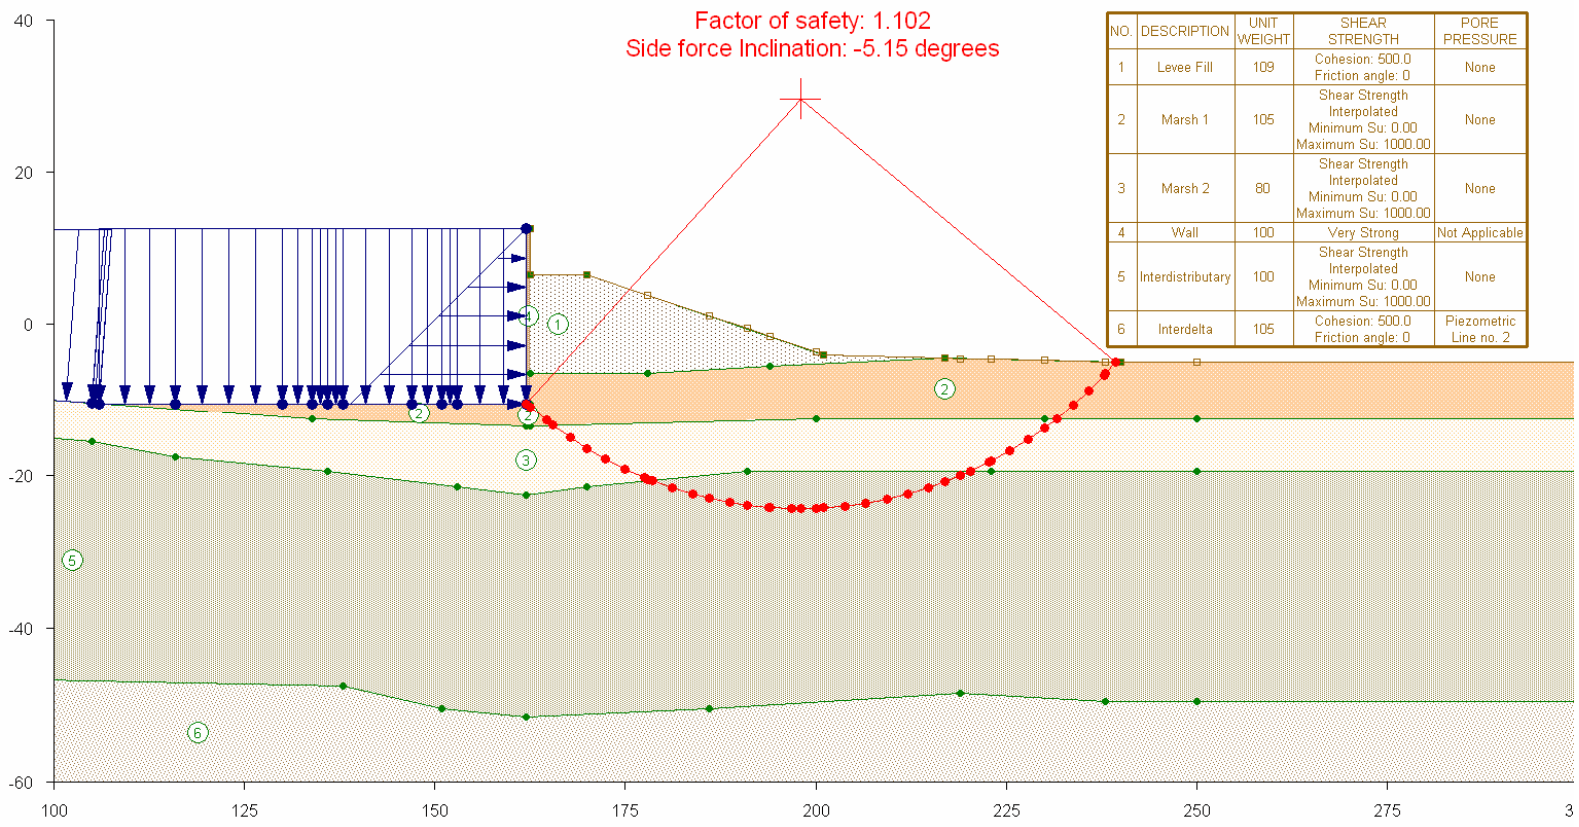
Figure 29. IHNC – East Bank (South Breach), Case 4, Canal Water Level = Top of Wall - 12.5 ft (NAVD 88), with Crack

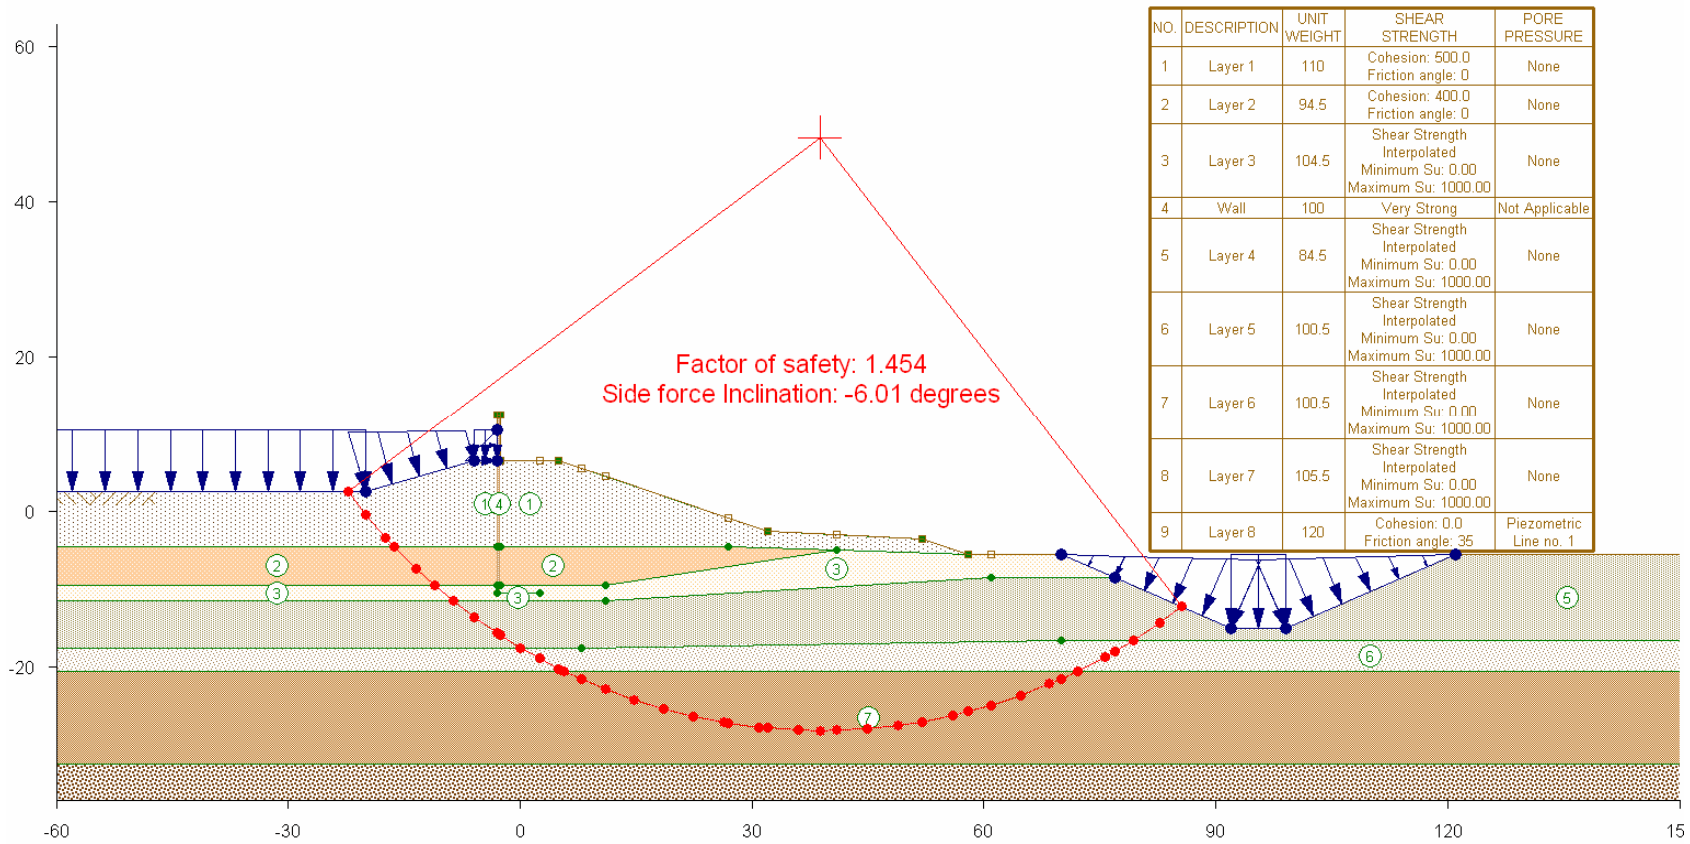
Three other variations of the design cross section were analyzed. Introducing a crack behind the wall for the design water level decreases the factor of safety to 1.19. For a canal water elevation at the top of the wall (12.5 ft NAVD88), the factor of safety is 1.35 for the uncracked condition and 1.05 for the cracked condition. The results of all analyses performed on the GDM cross section are presented in Table 8. Figures 31 through 34 show the critical circles for the UTEXAS4 analysis.

Figure 31. IHNC – East Bank (GDM Stability Plate), Case 1, Canal Water Level = Design - 10.5 ft (NAVD 88), without Crack

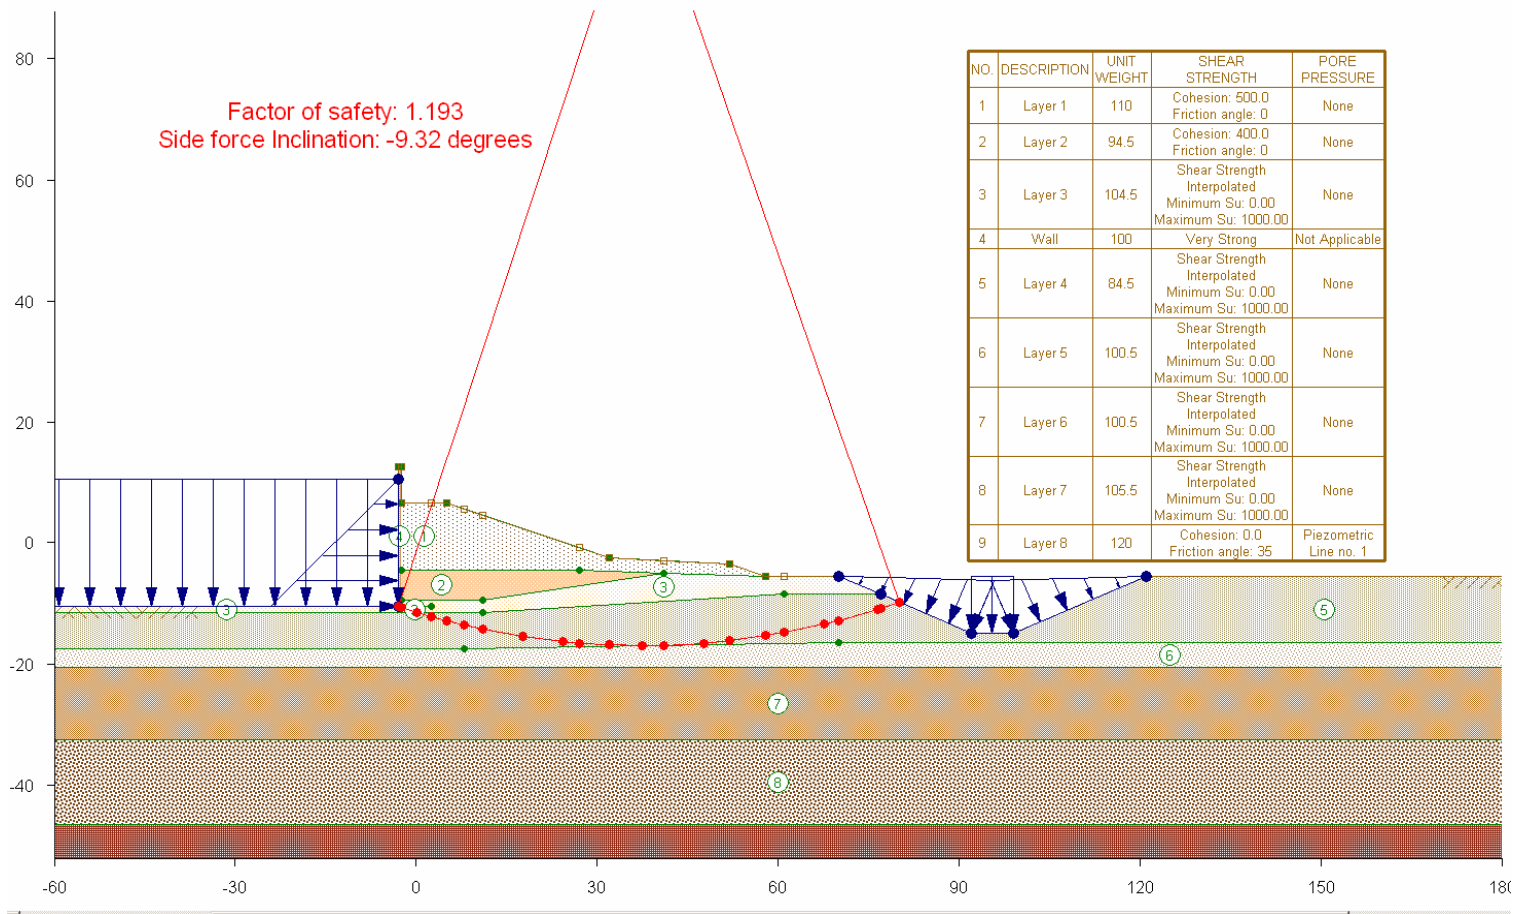
Figure 32. IHNC – East Bank (GDM Stability Plate), Case 2, Canal Water Level = Design - 10.5 ft (NAVD 88), with Crack

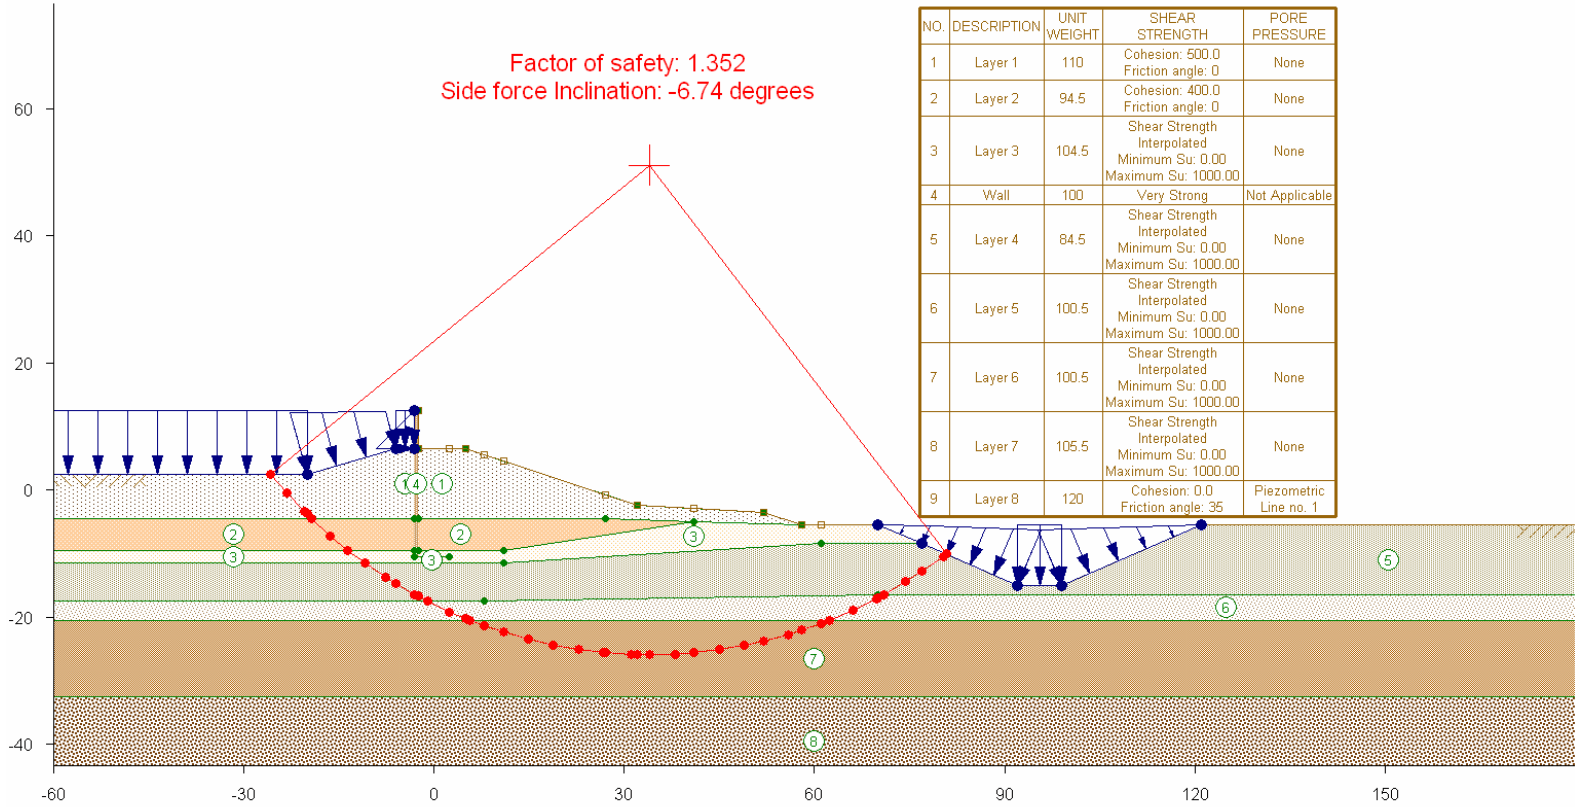
Figure 33. IHNC – East Bank (GDM Stability Plate), Case 3, Canal Water Level = Top of Wall - 12.5 ft (NAVD 88), without Crack

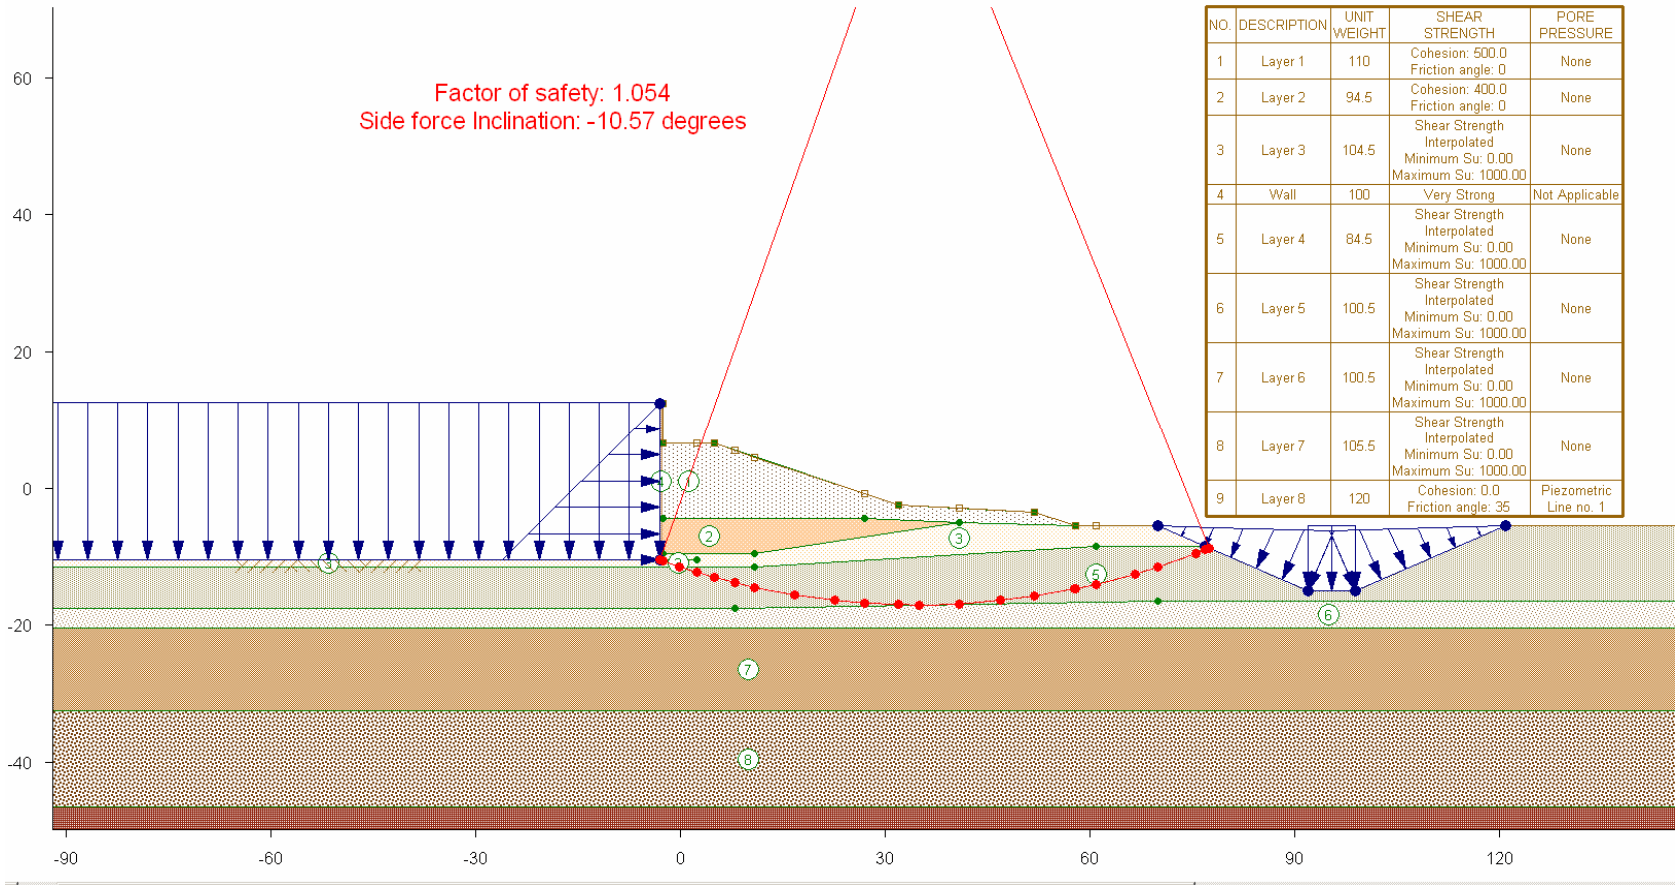
Figure 34. IHNC – East Bank (GDM Stability Plate), Case 4, Canal Water Level = Top of Wall - 12.5 ft (NAVD 88), with Crack.

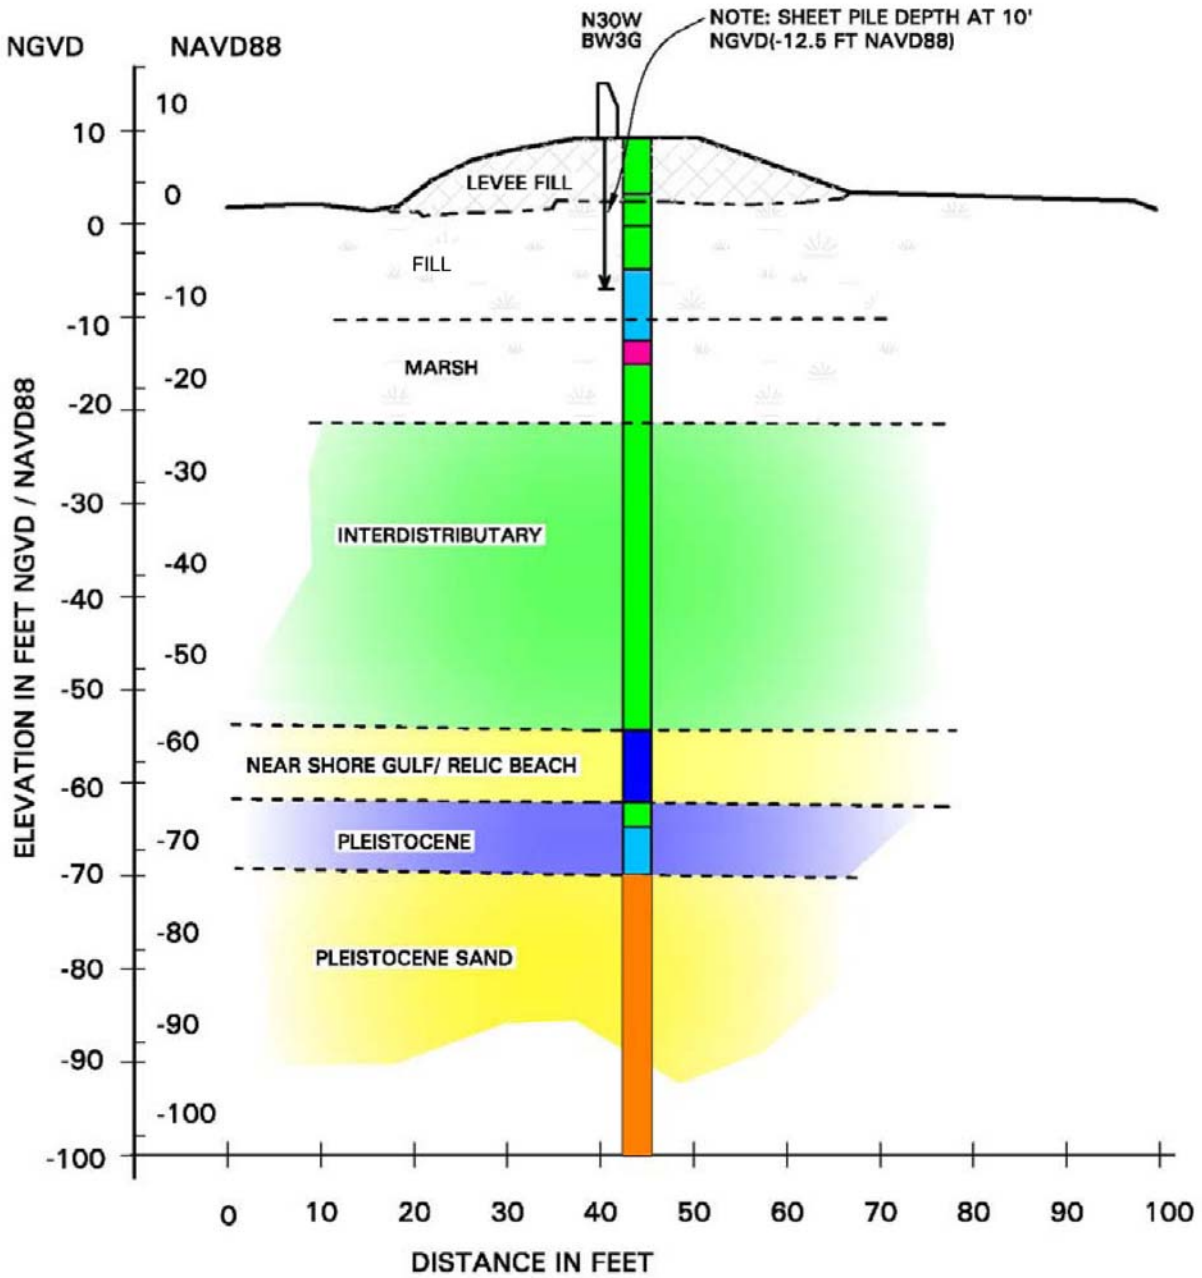
The northern breach, between Stations 195+00 and 196+40¹², occurred after the I-wall at that location was overtopped, and soil supporting the wall was removed by erosion. The water elevation of the top of the wall was 12.5 ft, 1.7 ft lower than the peak elevation reached in the IHNC. A cross section through the levee and the I-wall is shown in Figure 35.

Figure 35. IHNC – West Bank – Cross section of North Breach.
