**LAKE PONTCHARTRAIN, LOUISIANA & VICINITY
CHALMETTE AREA PLAN**

**BAYOU BIENVENUE CONTROL
STRUCTURE**

PERIODIC INSPECTION REPORT NO. 9

28 APRIL 2004

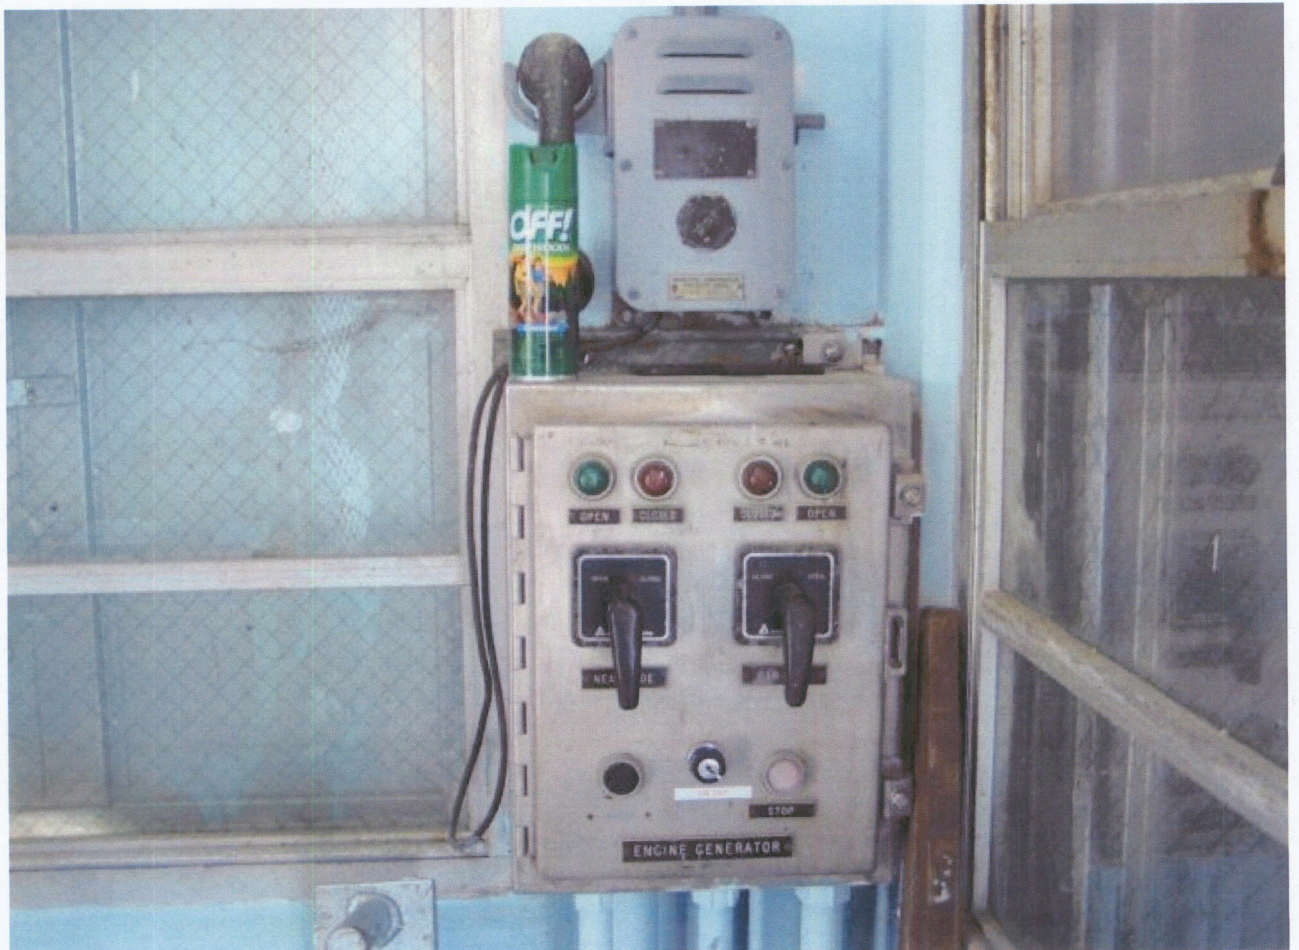
d. Gate Operating Machinery. The sector gates are controlled from consoles located in each control houses located atop the gate bay structure on either side of the channel. Controls for the gate operating machinery are original equipment, but performed well. (See photo no. 6). The limit switches appear to be operating normally. Due to a buildup of debris in the gate recess, the limits switches have been adjusted to accommodate for the inability of the gates to fully open. (See photo no. 7). The debris buildup is minor and does not result in the gates protruding into the channel, when the limit switch is set within the limits of the mounting bracket. When debris buildup prevents the gates from opening within the limits of the limit switch mounted bracket, divers are used to cleanout each gate bay. The two 2-HP, 480V gate motors, brakes, cable drives, and winch drums. (See photo nos. 8, 9, & 10) appear to function normally except during the initial operation of the west side gate. The west side motor brake appeared to set several times while the gate was in the closing motion. Later, in repeated attempts to recreate this malfunction, the brake operated normally.

Photo No. 6 – Original controls for the gate operating machinery.

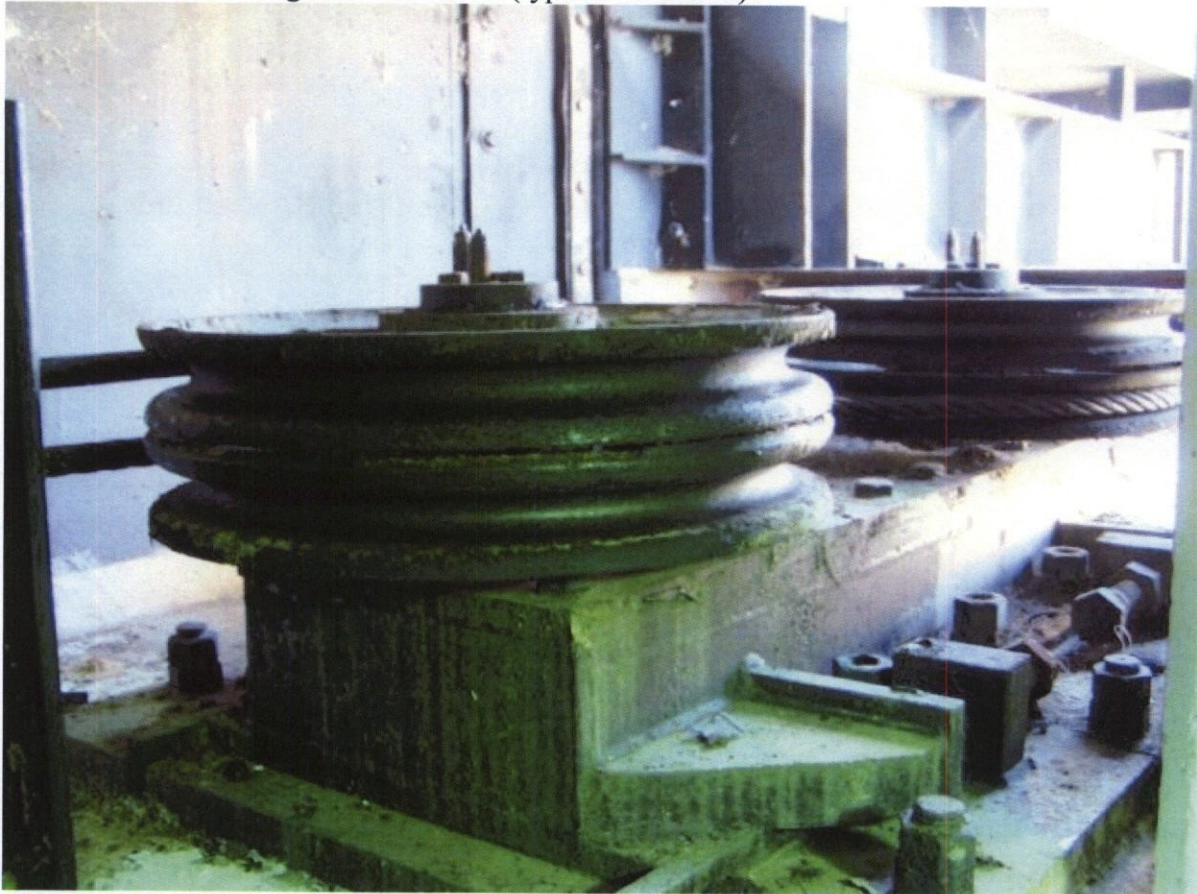
Photo No. 8 - Gate cable drives

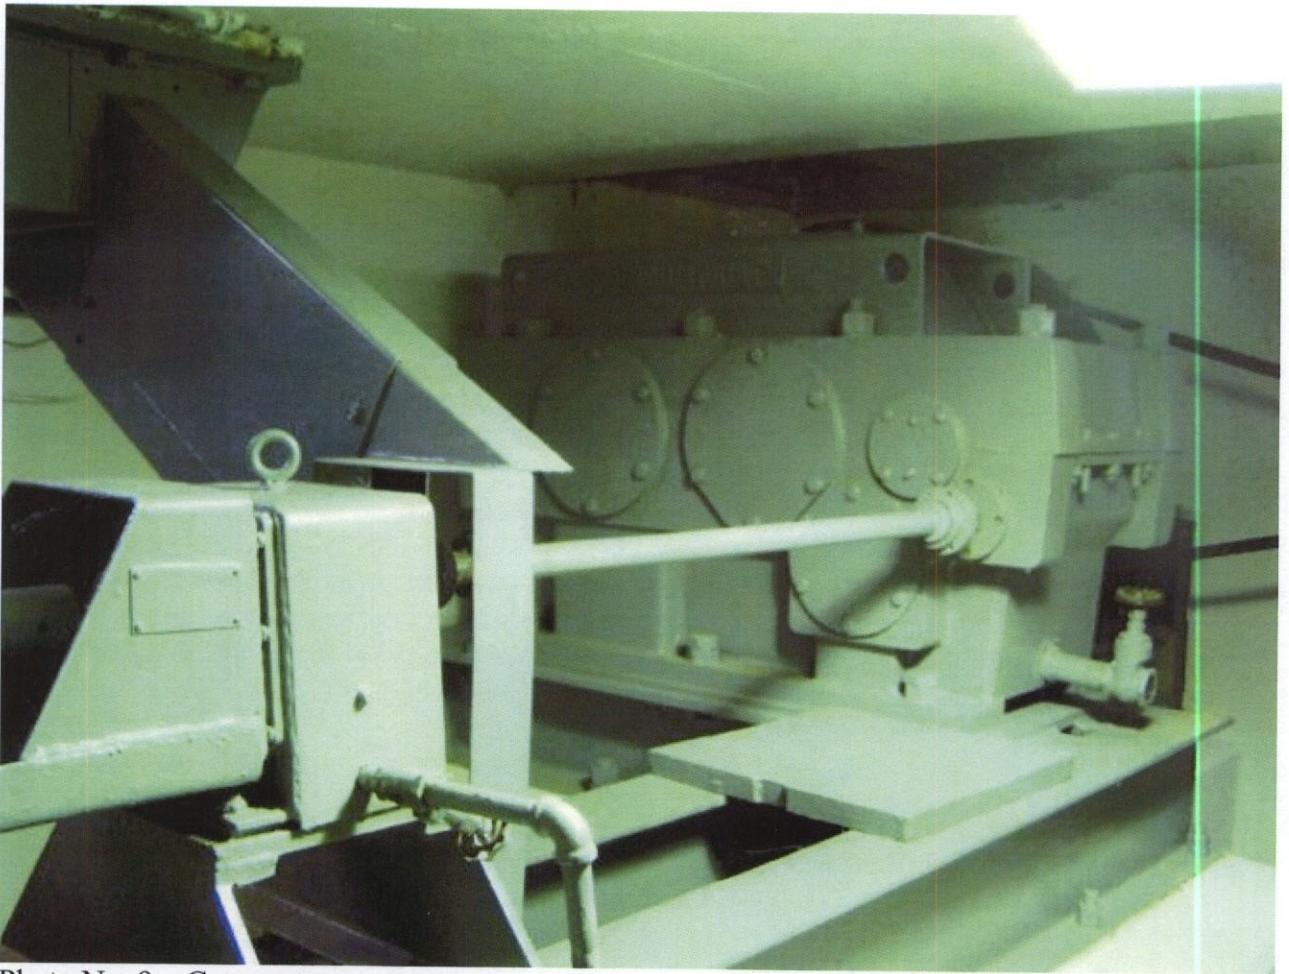
Photo No. 9 – Gate motors.

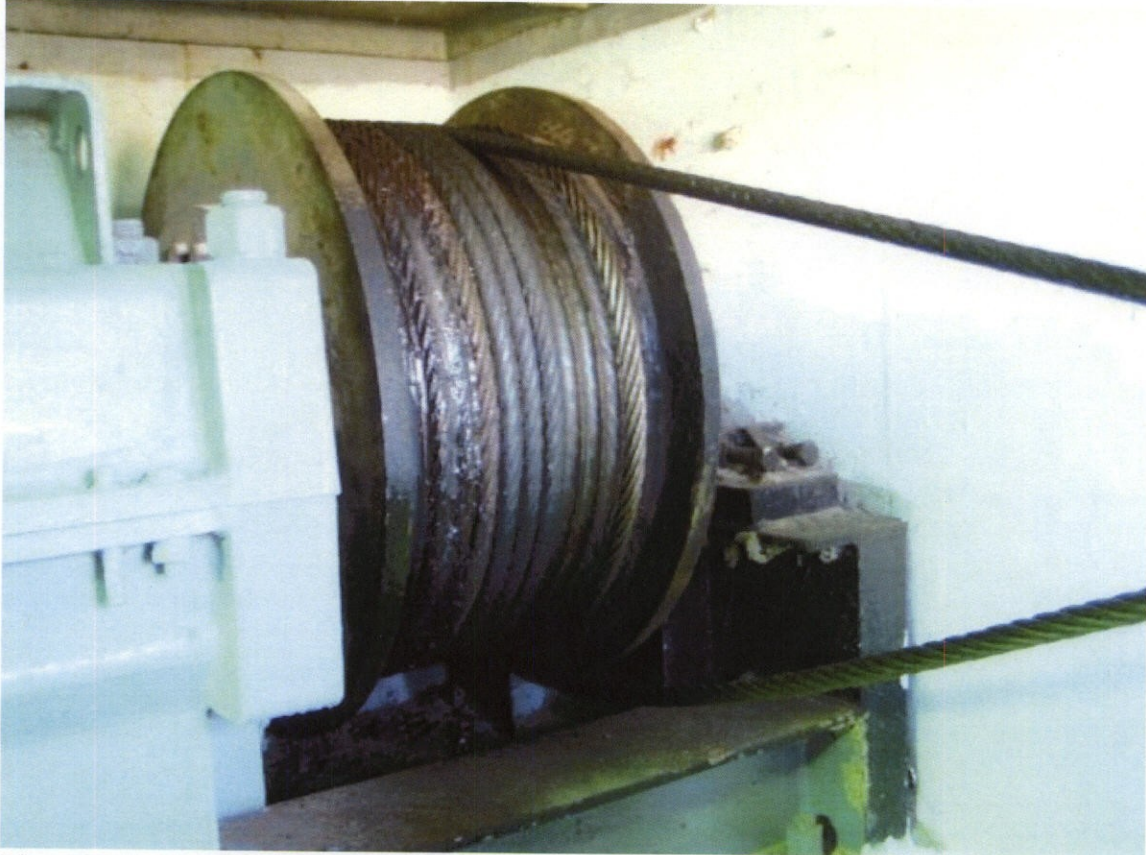
Photo No. 10 – Gate winch.

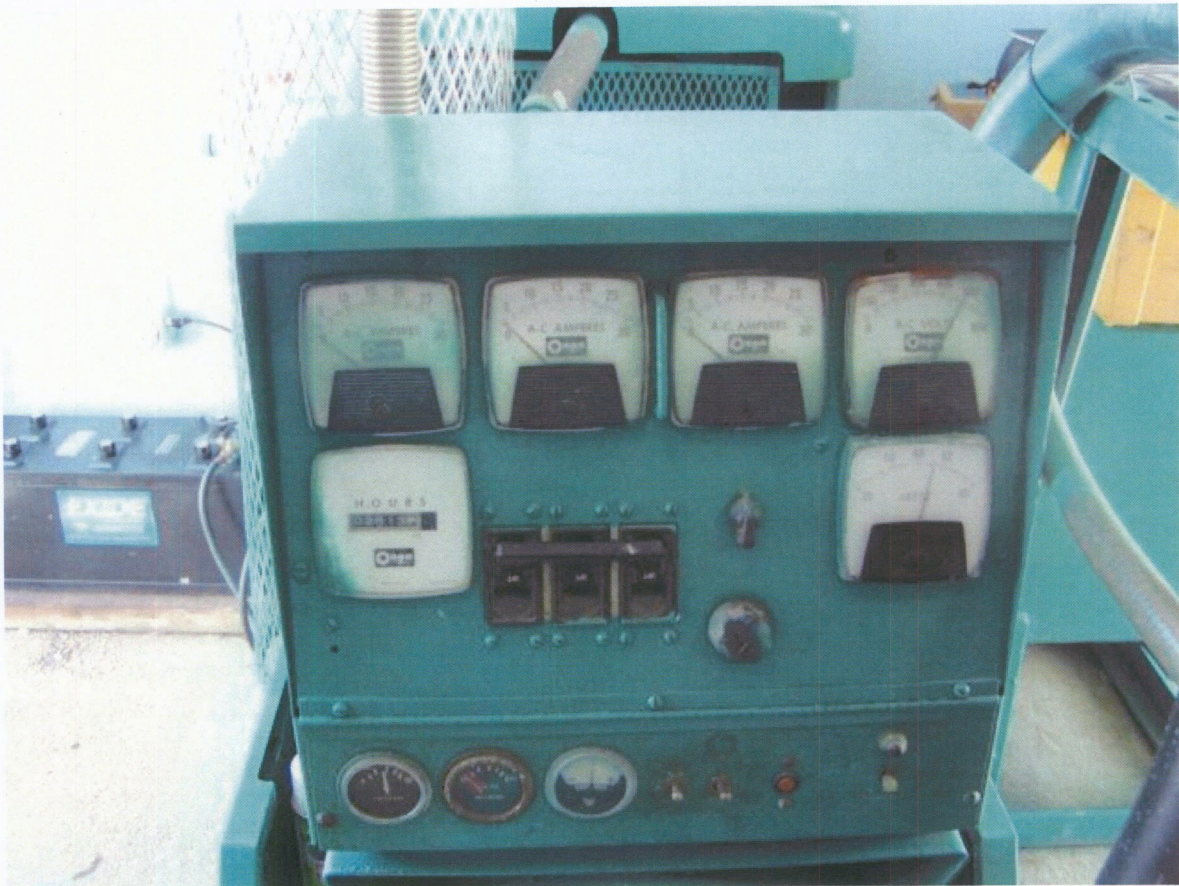
e. Power Generator. Commercial power service was connected to the facility approximately three years prior to this inspection. The 15 kW 480 V generator set, which was the primary source of electrical power, is now auxiliary. (See photo no. 11). There is a manual switch that transfers commercial and auxiliary power. (See photo no. 12). During the two hours of the inspection, the generator set was used to operate the gates. The generator and transfer switch are well maintained and functioned properly.

Photo No. 11 – Emergency generator set.

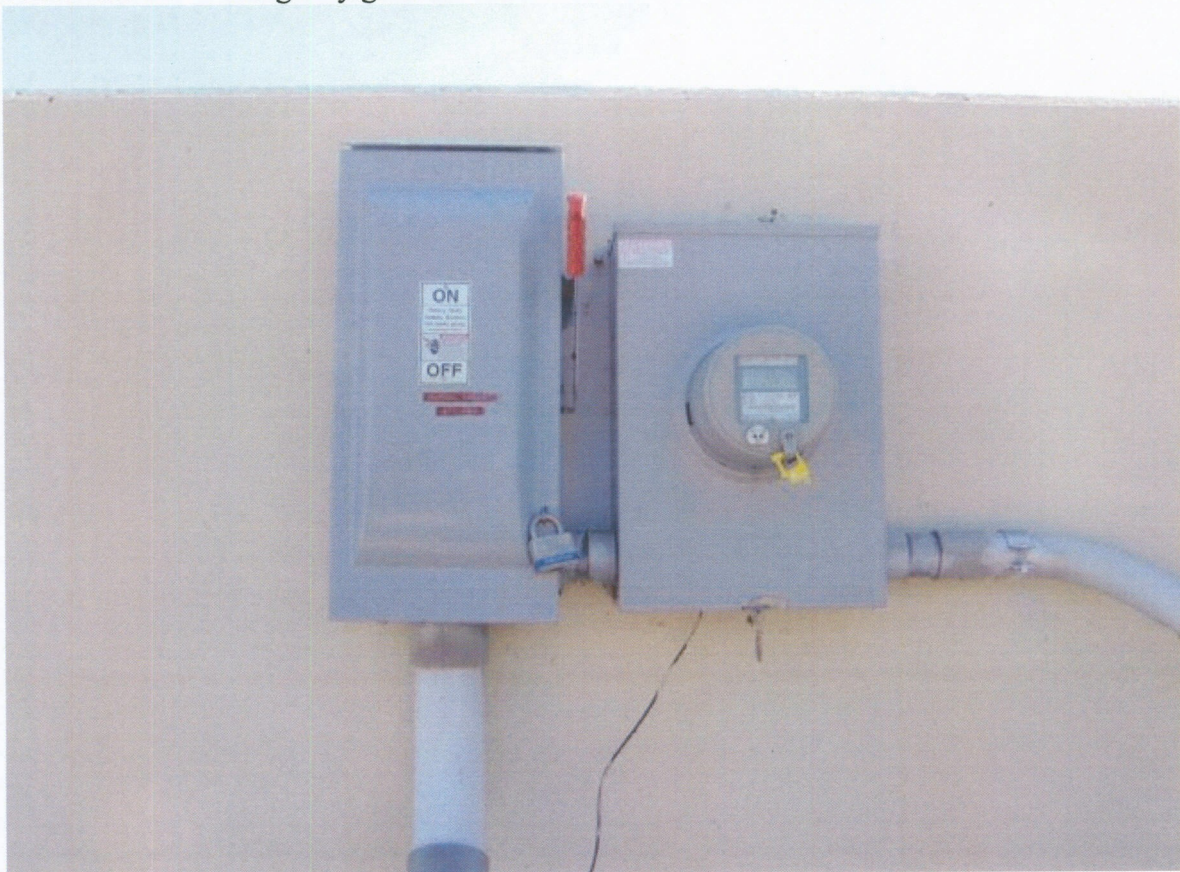
Photo No. 12 – Manual transfer switch for commercial to generator power.

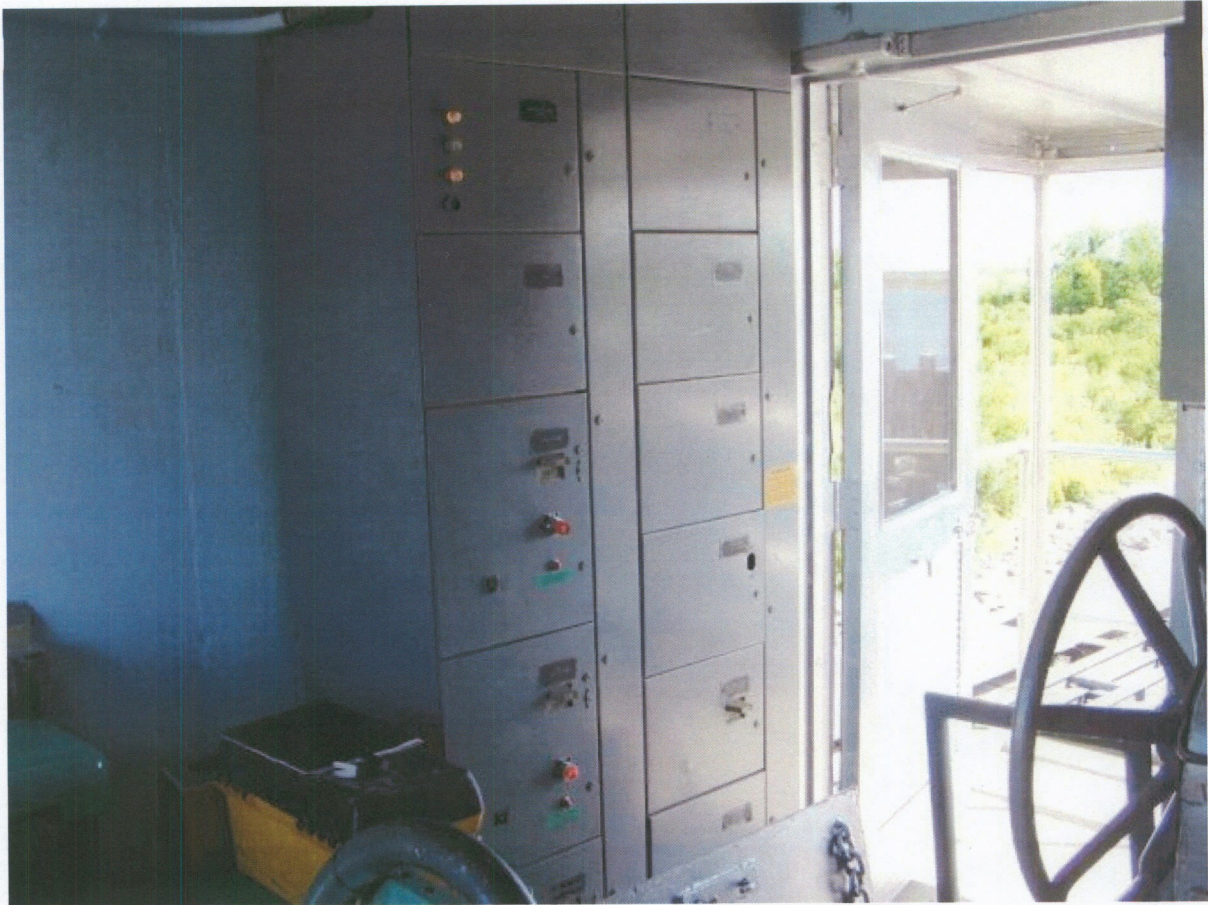
f. Power Distribution. The structure power distribution is routed through an aging Motor Control Center. (See photo no. 13). The ground fault detector lights were illuminated indicating there was a ground fault problem somewhere in the system. The ground fault is most likely located somewhere in the conductors routed under the structure. The power conductors appear to be completely immersed in water and have likely existed in this condition for an extended period of time. The following paragraph provides a brief explanation of the basis for the conductors' ground fault issue.

Photo No. 13 – Motor control center.

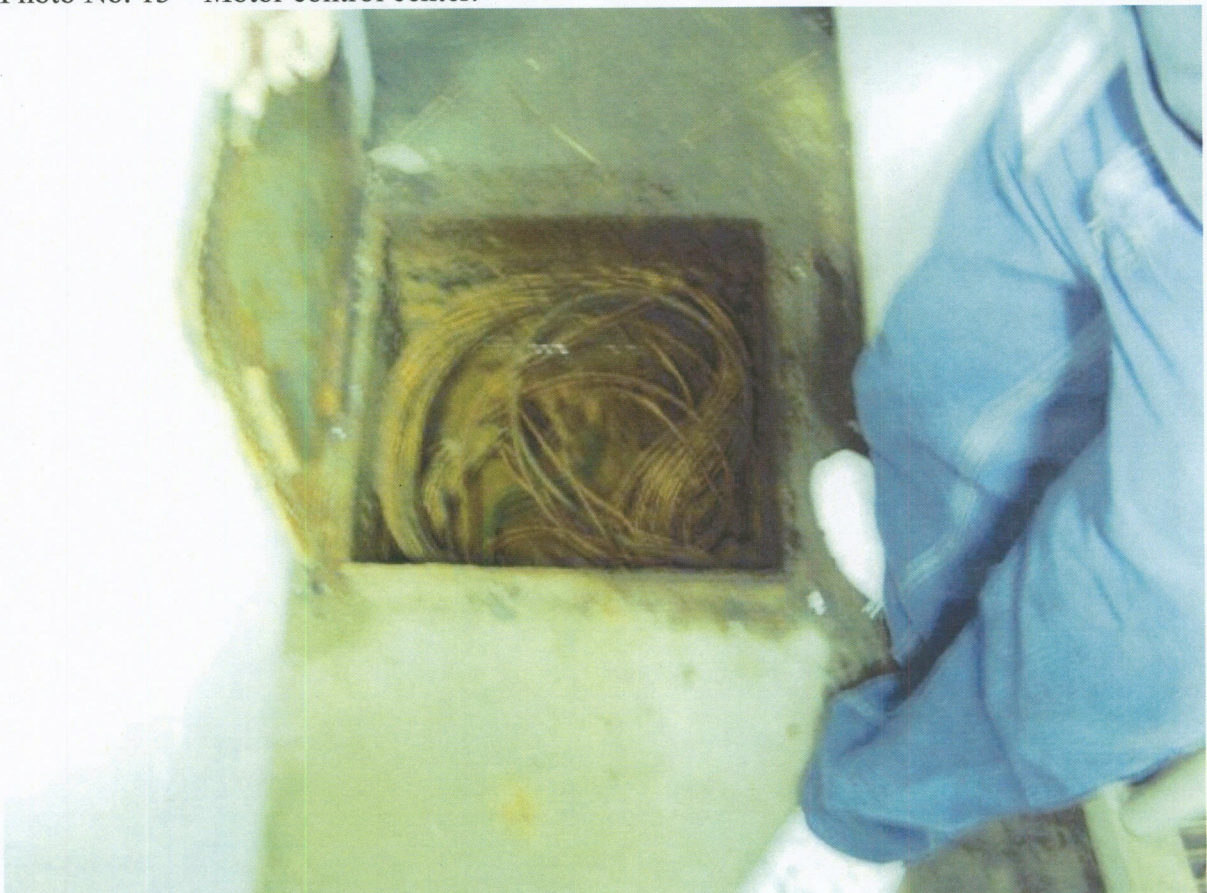
The power and control cables for the gate machinery pass under the structure in 2-inch conduits. The conductors enter the machinery rooms from below and into 18"W x 18"L x 15" deep junction box in the floor very similar to a sump. (See photo no 14). As a consequence, when rainwater enters the machinery rooms through the cable machinery opening, it collects in the junction boxes and fills the conduits. In addition, the conduits routed up to the control rooms have corroded to the point where rainwater can easily run into the junction boxes from those open conduits. (See photo no.15). The conduits and cables appear to stay wet for extended periods of time. Conductor insulation failure is imminent and the power and control circuits will eventually either fault to ground or another conductor. There is also an indication of a fault condition in the motor control center's ground fault detector.

Photo No. 14 – Conductor junction box.

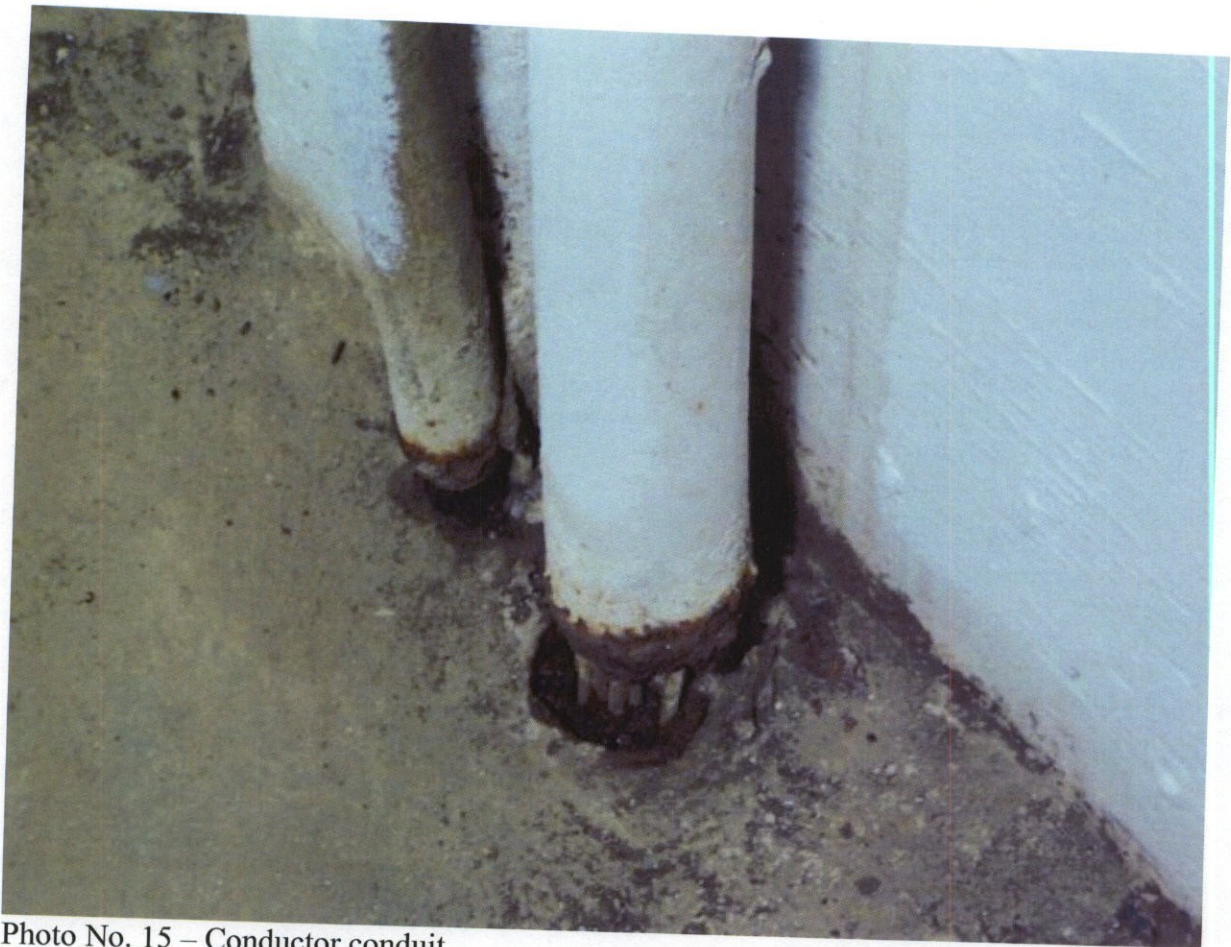
Photo No. 15 – Conductor conduit.

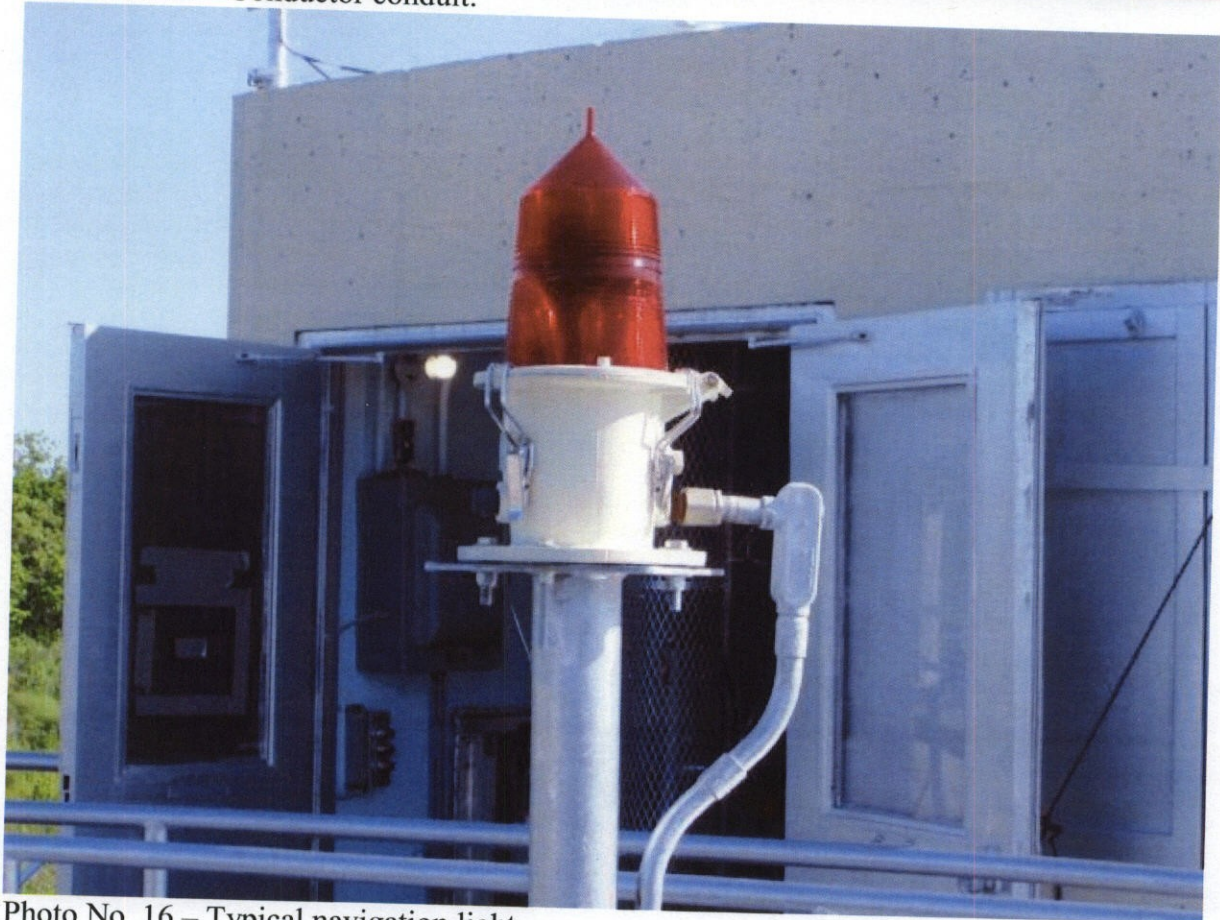
All navigation lights were inspected and in excellent condition. (See photo no.16). The tide monitoring system (see photo no. 17) appeared to be in good operating condition and was sending information to the Orleans Levee Board's emergency operation center (EOC) reliably.

Photo No. 16 – Typical navigation light.

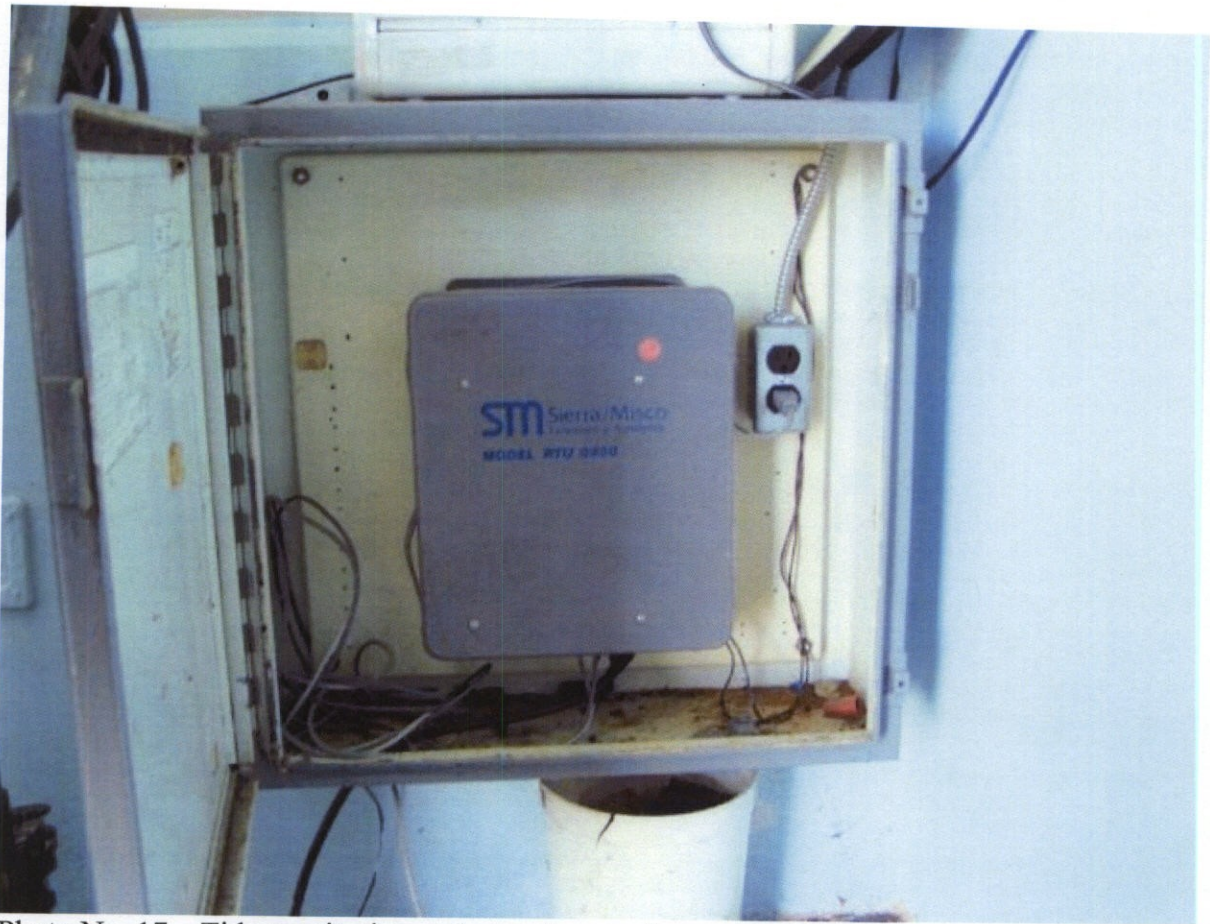
Photo No. 17 – Tide monitoring and reporting equipment.

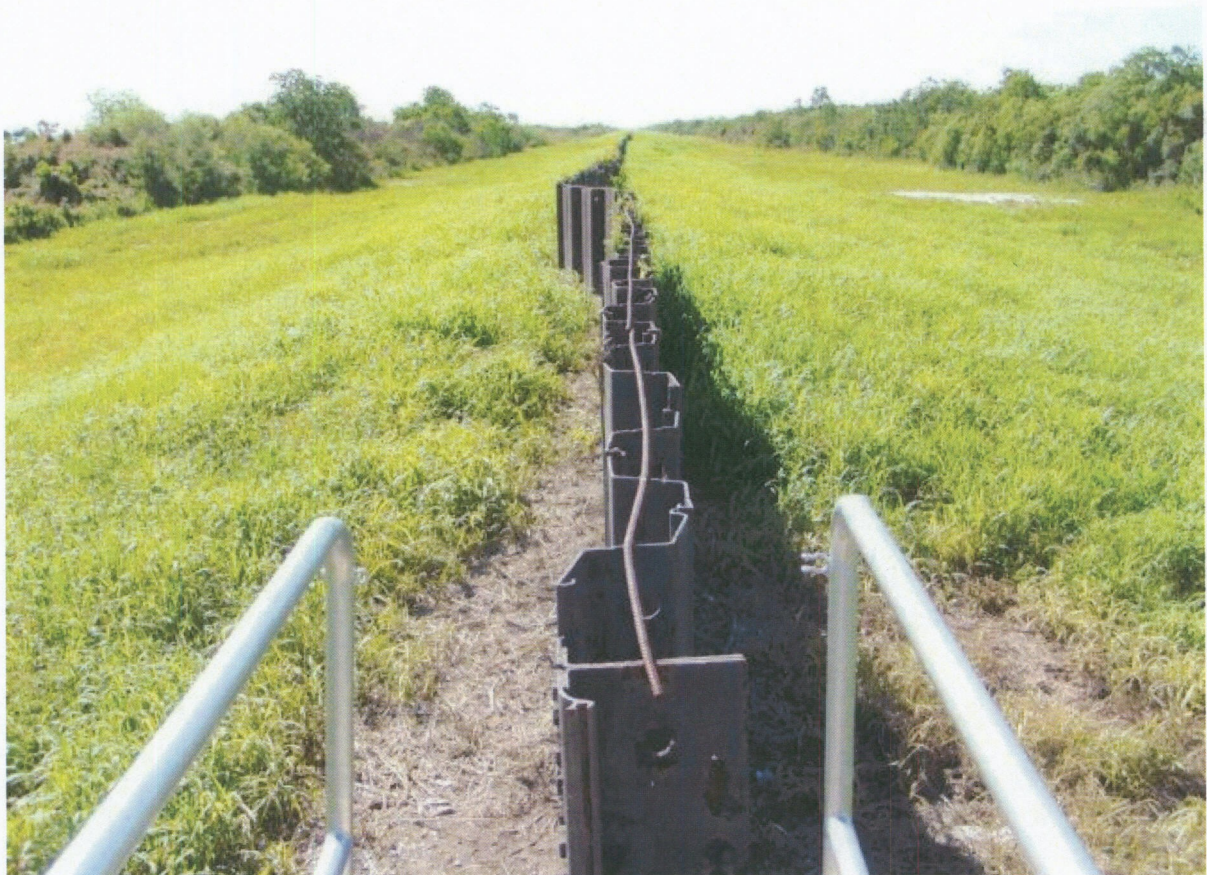
l. Sheetpile Floodwall. The overall condition of the steel sheetpile floodwall was good. Some minor corrosion was noted. (See photo no. 27)

Photo No. 27 – East side steel sheetpile “I” floodwall.

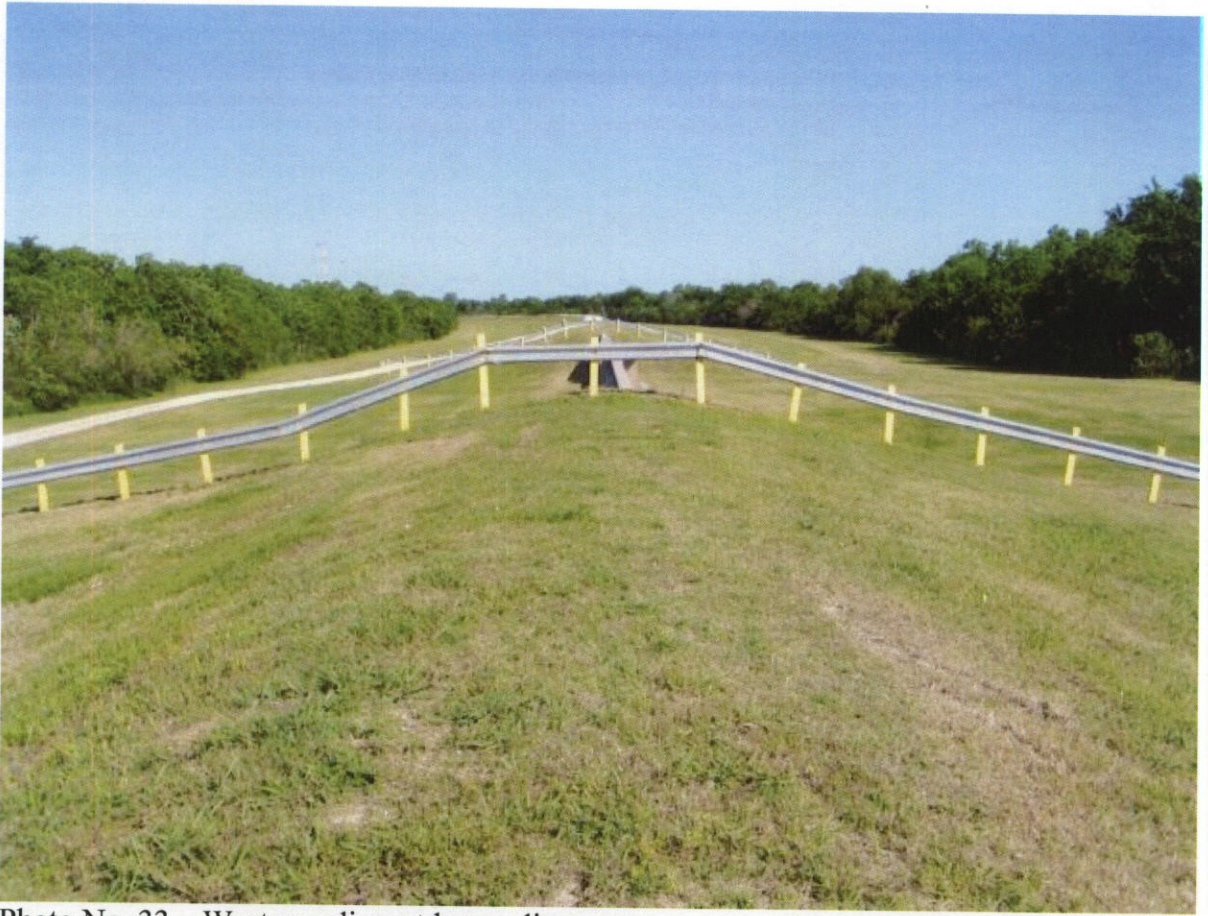
o. Embankments. The levee embankments in the vicinity of the structure were in good condition (see photo no. 33). The backfill behind the wing walls appeared to be in good condition. There is a history of erosion of the backfill behind the wing walls at this facility. Due to settlement of the northwest wing wall, the waterstop between the northwest wing wall and gatebay has separated. Minor loss of fill material was noted in this area. At the other three wing wall junctures with the structure, there were small depressions indicating minor loss of material through the "L" waterstops. Additional depressions and evidence of material loss were noted adjacent to each of the wing walls. (See photo no. 34).

Photo No. 33 – Western adjacent levee alignment.

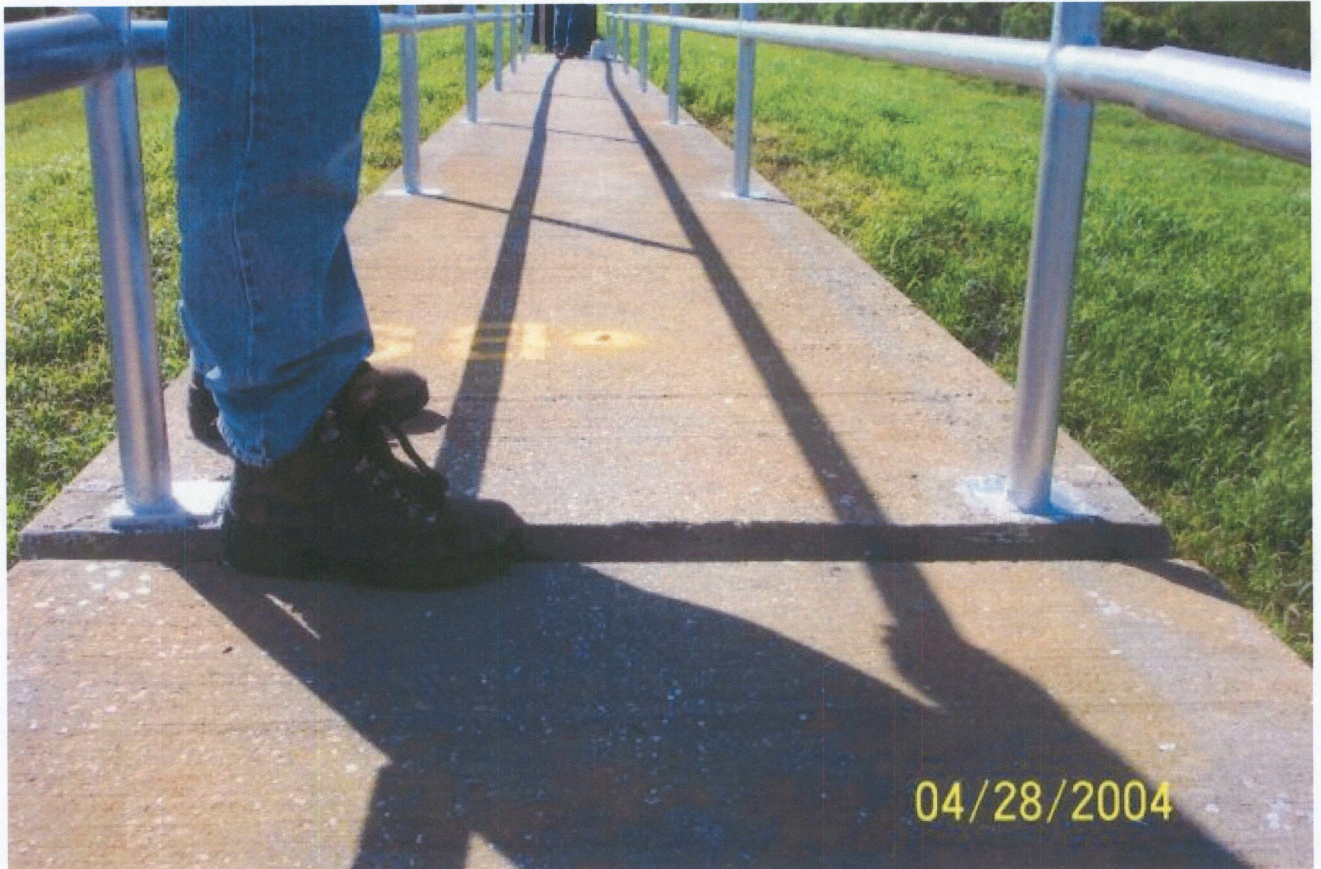
Photo No. 35 – Settlement reference markers (SRM) noted atop the “T” Floodwall.

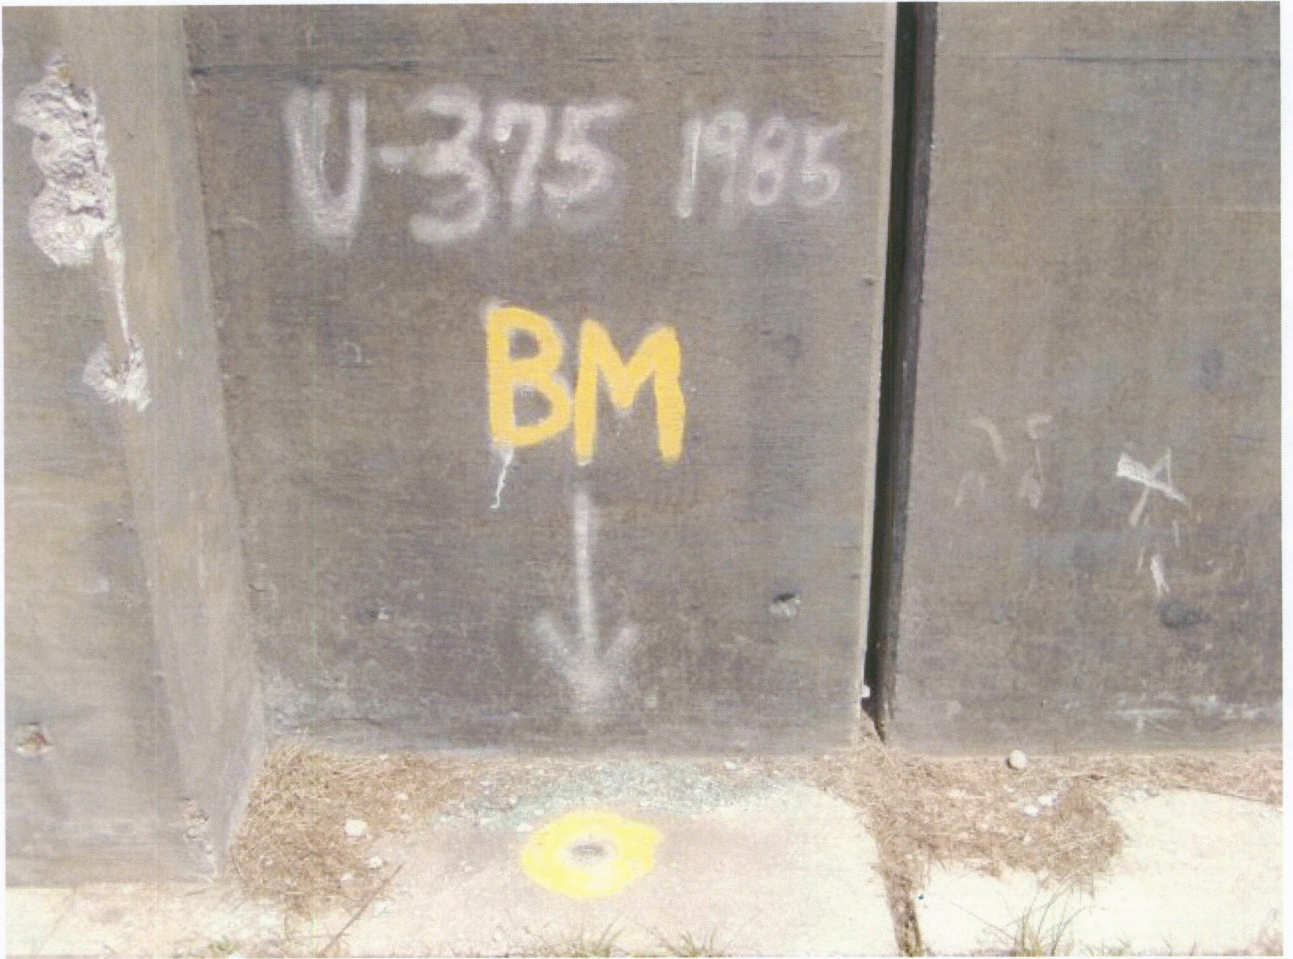
Photo No. 37 – PBM U-375 – located at the floodgate approximately 1 mile west of the structure along the levee alignment.
