**LAKE PONTCHARTRAIN, LOUISIANA AND VICINITY
CHALMETTE AREA PLAN**

**BAYOU DUPRE CONTROL STRUCTURE
PERIODIC INSPECTION REPORT NO. 6**

25 APRIL 1990

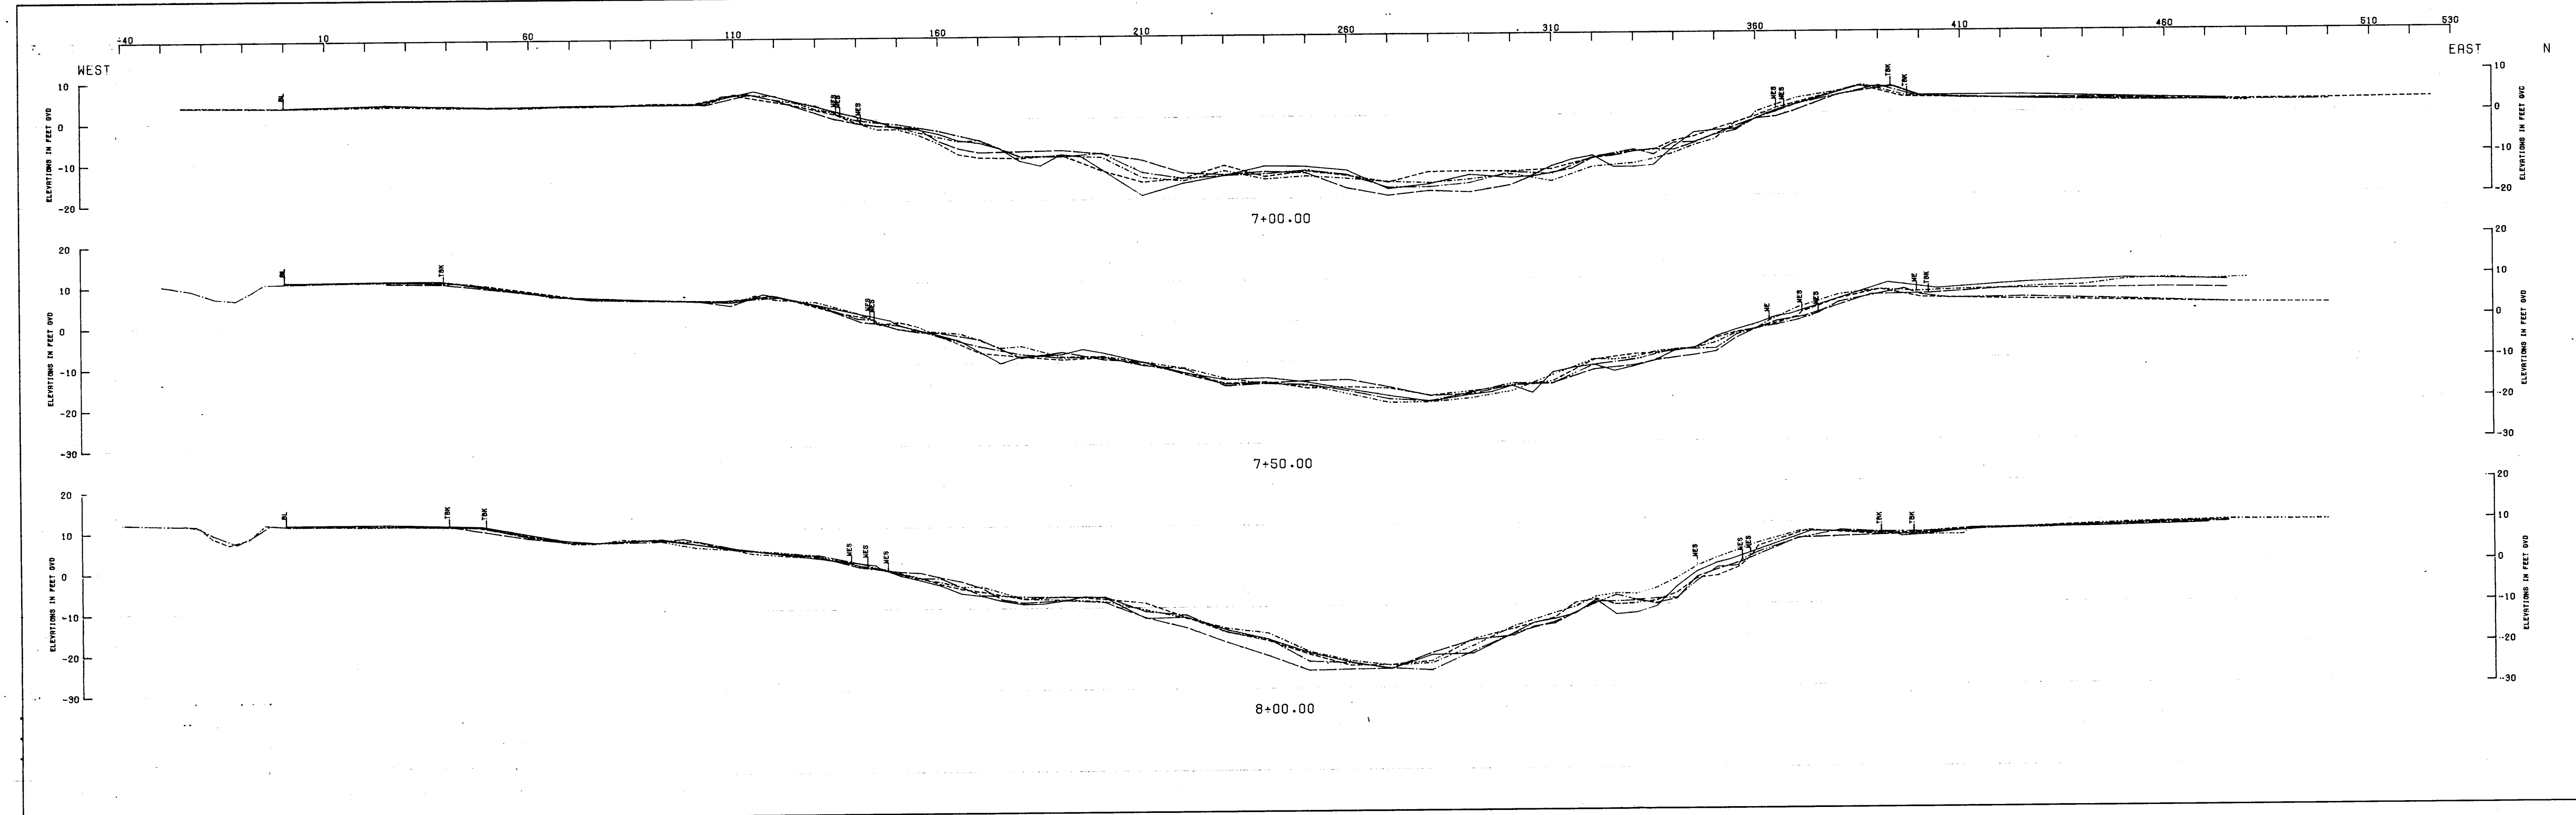
STATION
7+00.00
7+50.00
8+00.00

(1) Scour of about 4 feet in depth was noted at Stations 8+50 and 10+00; and shoal of about 10 feet at Station 5+00 in the north approach channel. There is no significant threat to the integrity of the riprap apron, at this time.
