Clearwater Dam Consensus Report

External Peer Review of DSAC-1 Projects

June 9, 2008

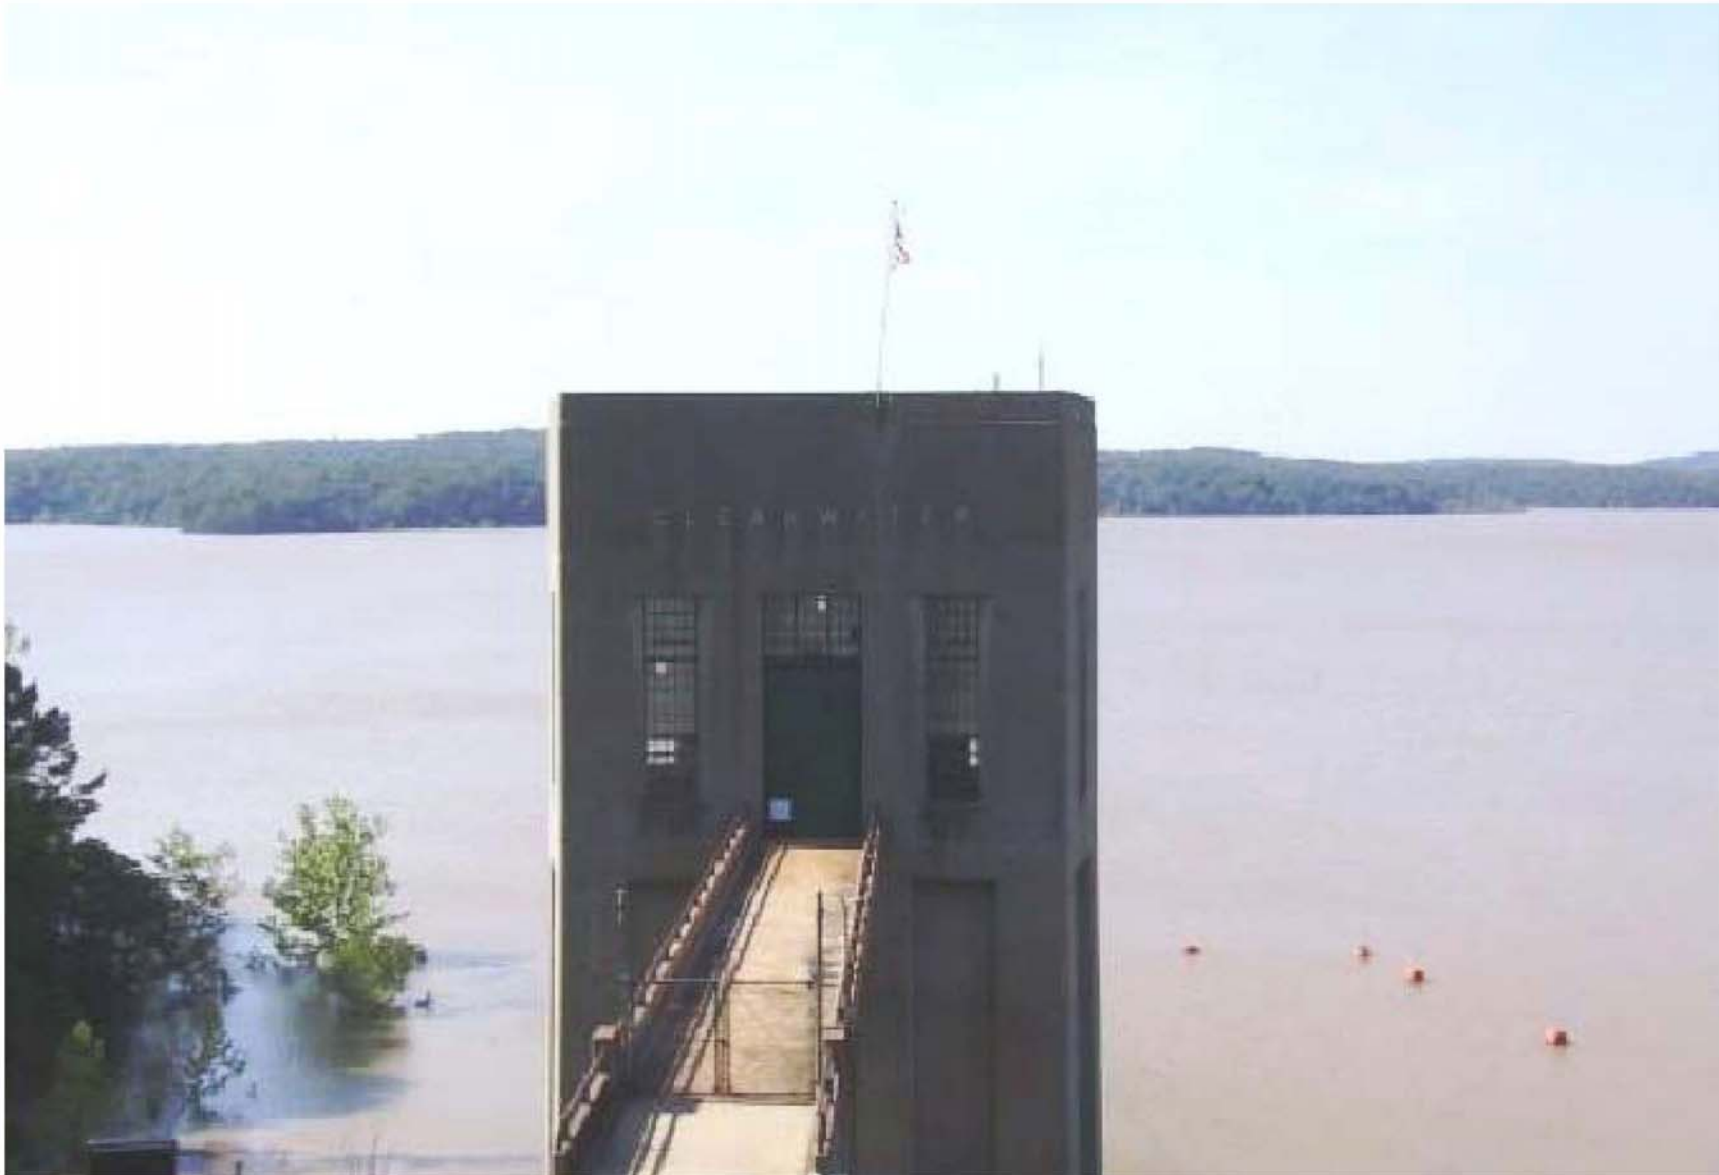
Figure 10. Record Pool

The pool of record at El. 566.7 feet occurred on May 20, 2002 as a result of a near 60 to 70 year storm event, which produced a total average rainfall of 20 inches over the drainage basin. This elevation is just below the spillway crest elevation. The pool was lowered to El. 540 in about 45 days and to El. 500 during the next 30 days. A photograph taken at normal pool is shown on Figure 9 which also shows the outlet control tower. Figure 10 shows the pool at near the maximum level. All shoreline beaches were submerged.
