LAKE PONTCHARTRAIN, LOUISIANA AND VICINITY

BAYOU DUPRE  
CONTROL STRUCTURE

PERIODIC INSPECTION REPORT NO. 3

DECEMBER 1983

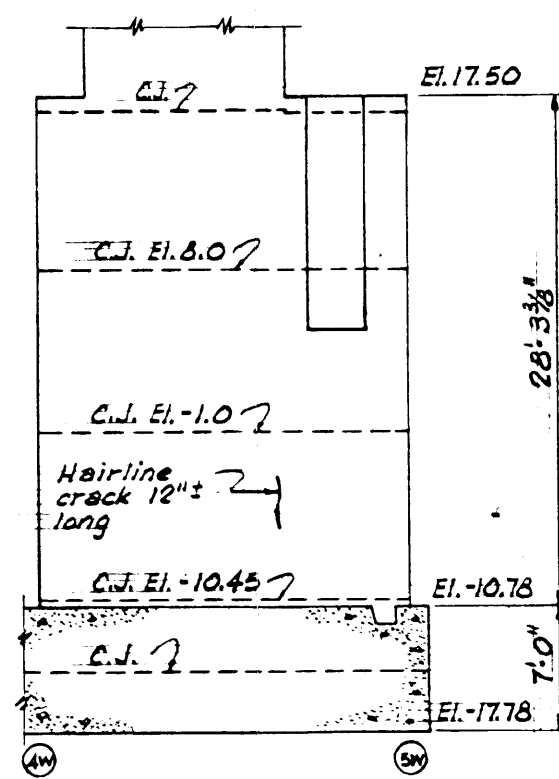
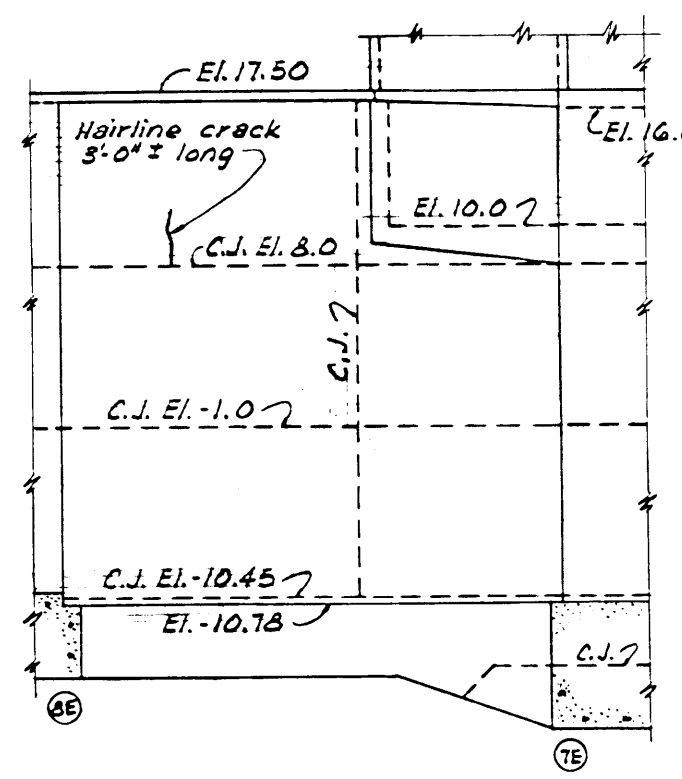
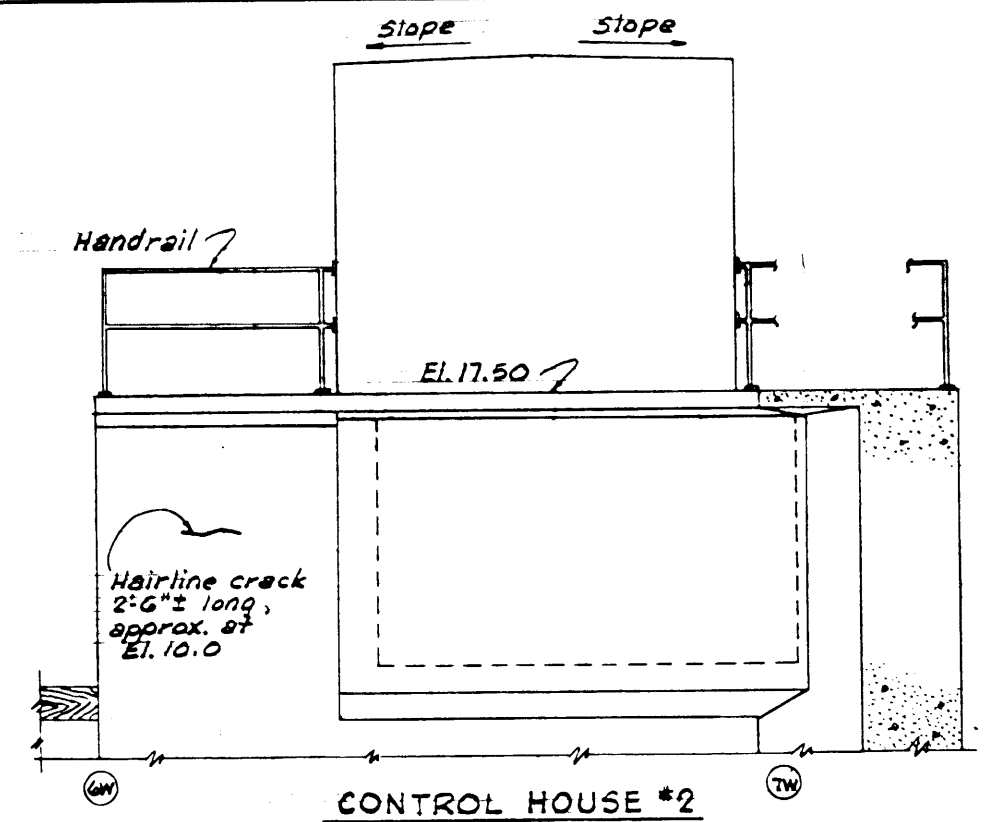
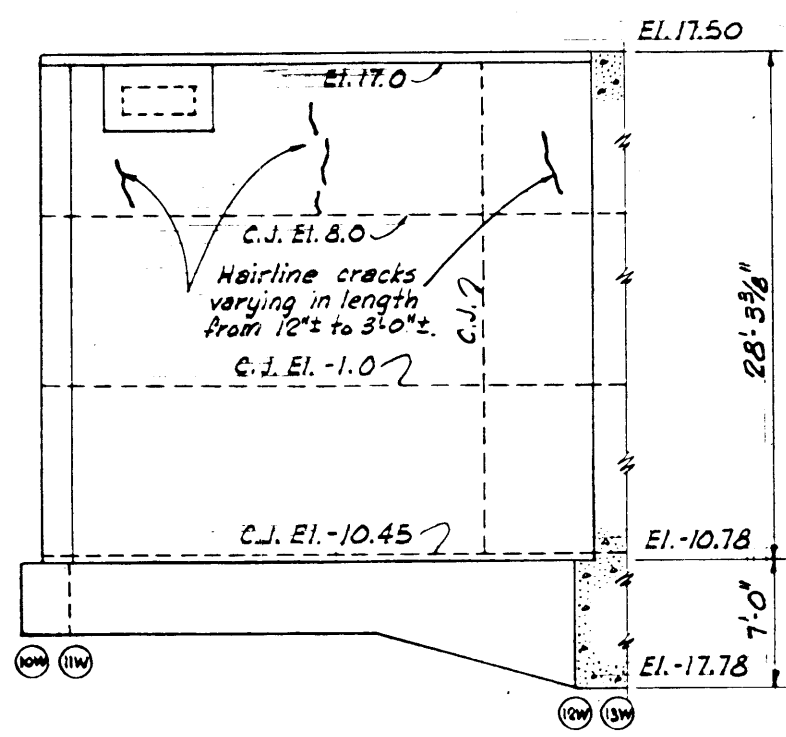
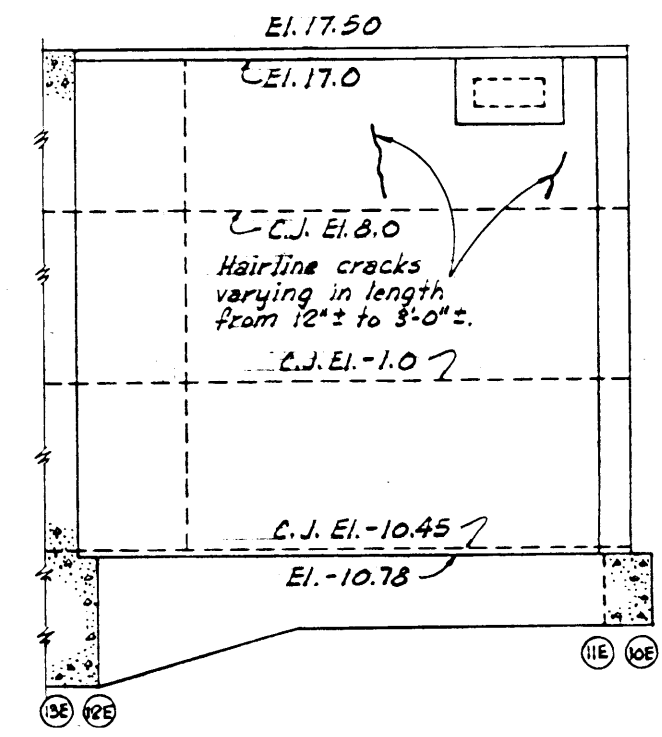
LAKE FORTCHARTRAIN, LOUISIANA AND VICINITY  
 HURRICANE PROTECTION SYSTEM  
 CHALMETTE AREA PLAN  
 BAYOU DUPRE CONTROL STRUCTURE  
 CRACK SURVEY - APRIL, '74  
 U.S. ARMY ENGINEER DISTRICT, NEW ORLEANS, LA.  
 CORPS OF ENGINEERS  
 FILE NO. H-2-26856  
 PLATE NO. 2

Cantilivered walkway hairline cracks varying in length from 6"± to 2'-0"±.
