NEW ORLEANS TO VENICE, LOUISIANA

EMPIRE FLOODGATE

PERIODIC INSPECTION REPORT NO. 5

29 January 1987

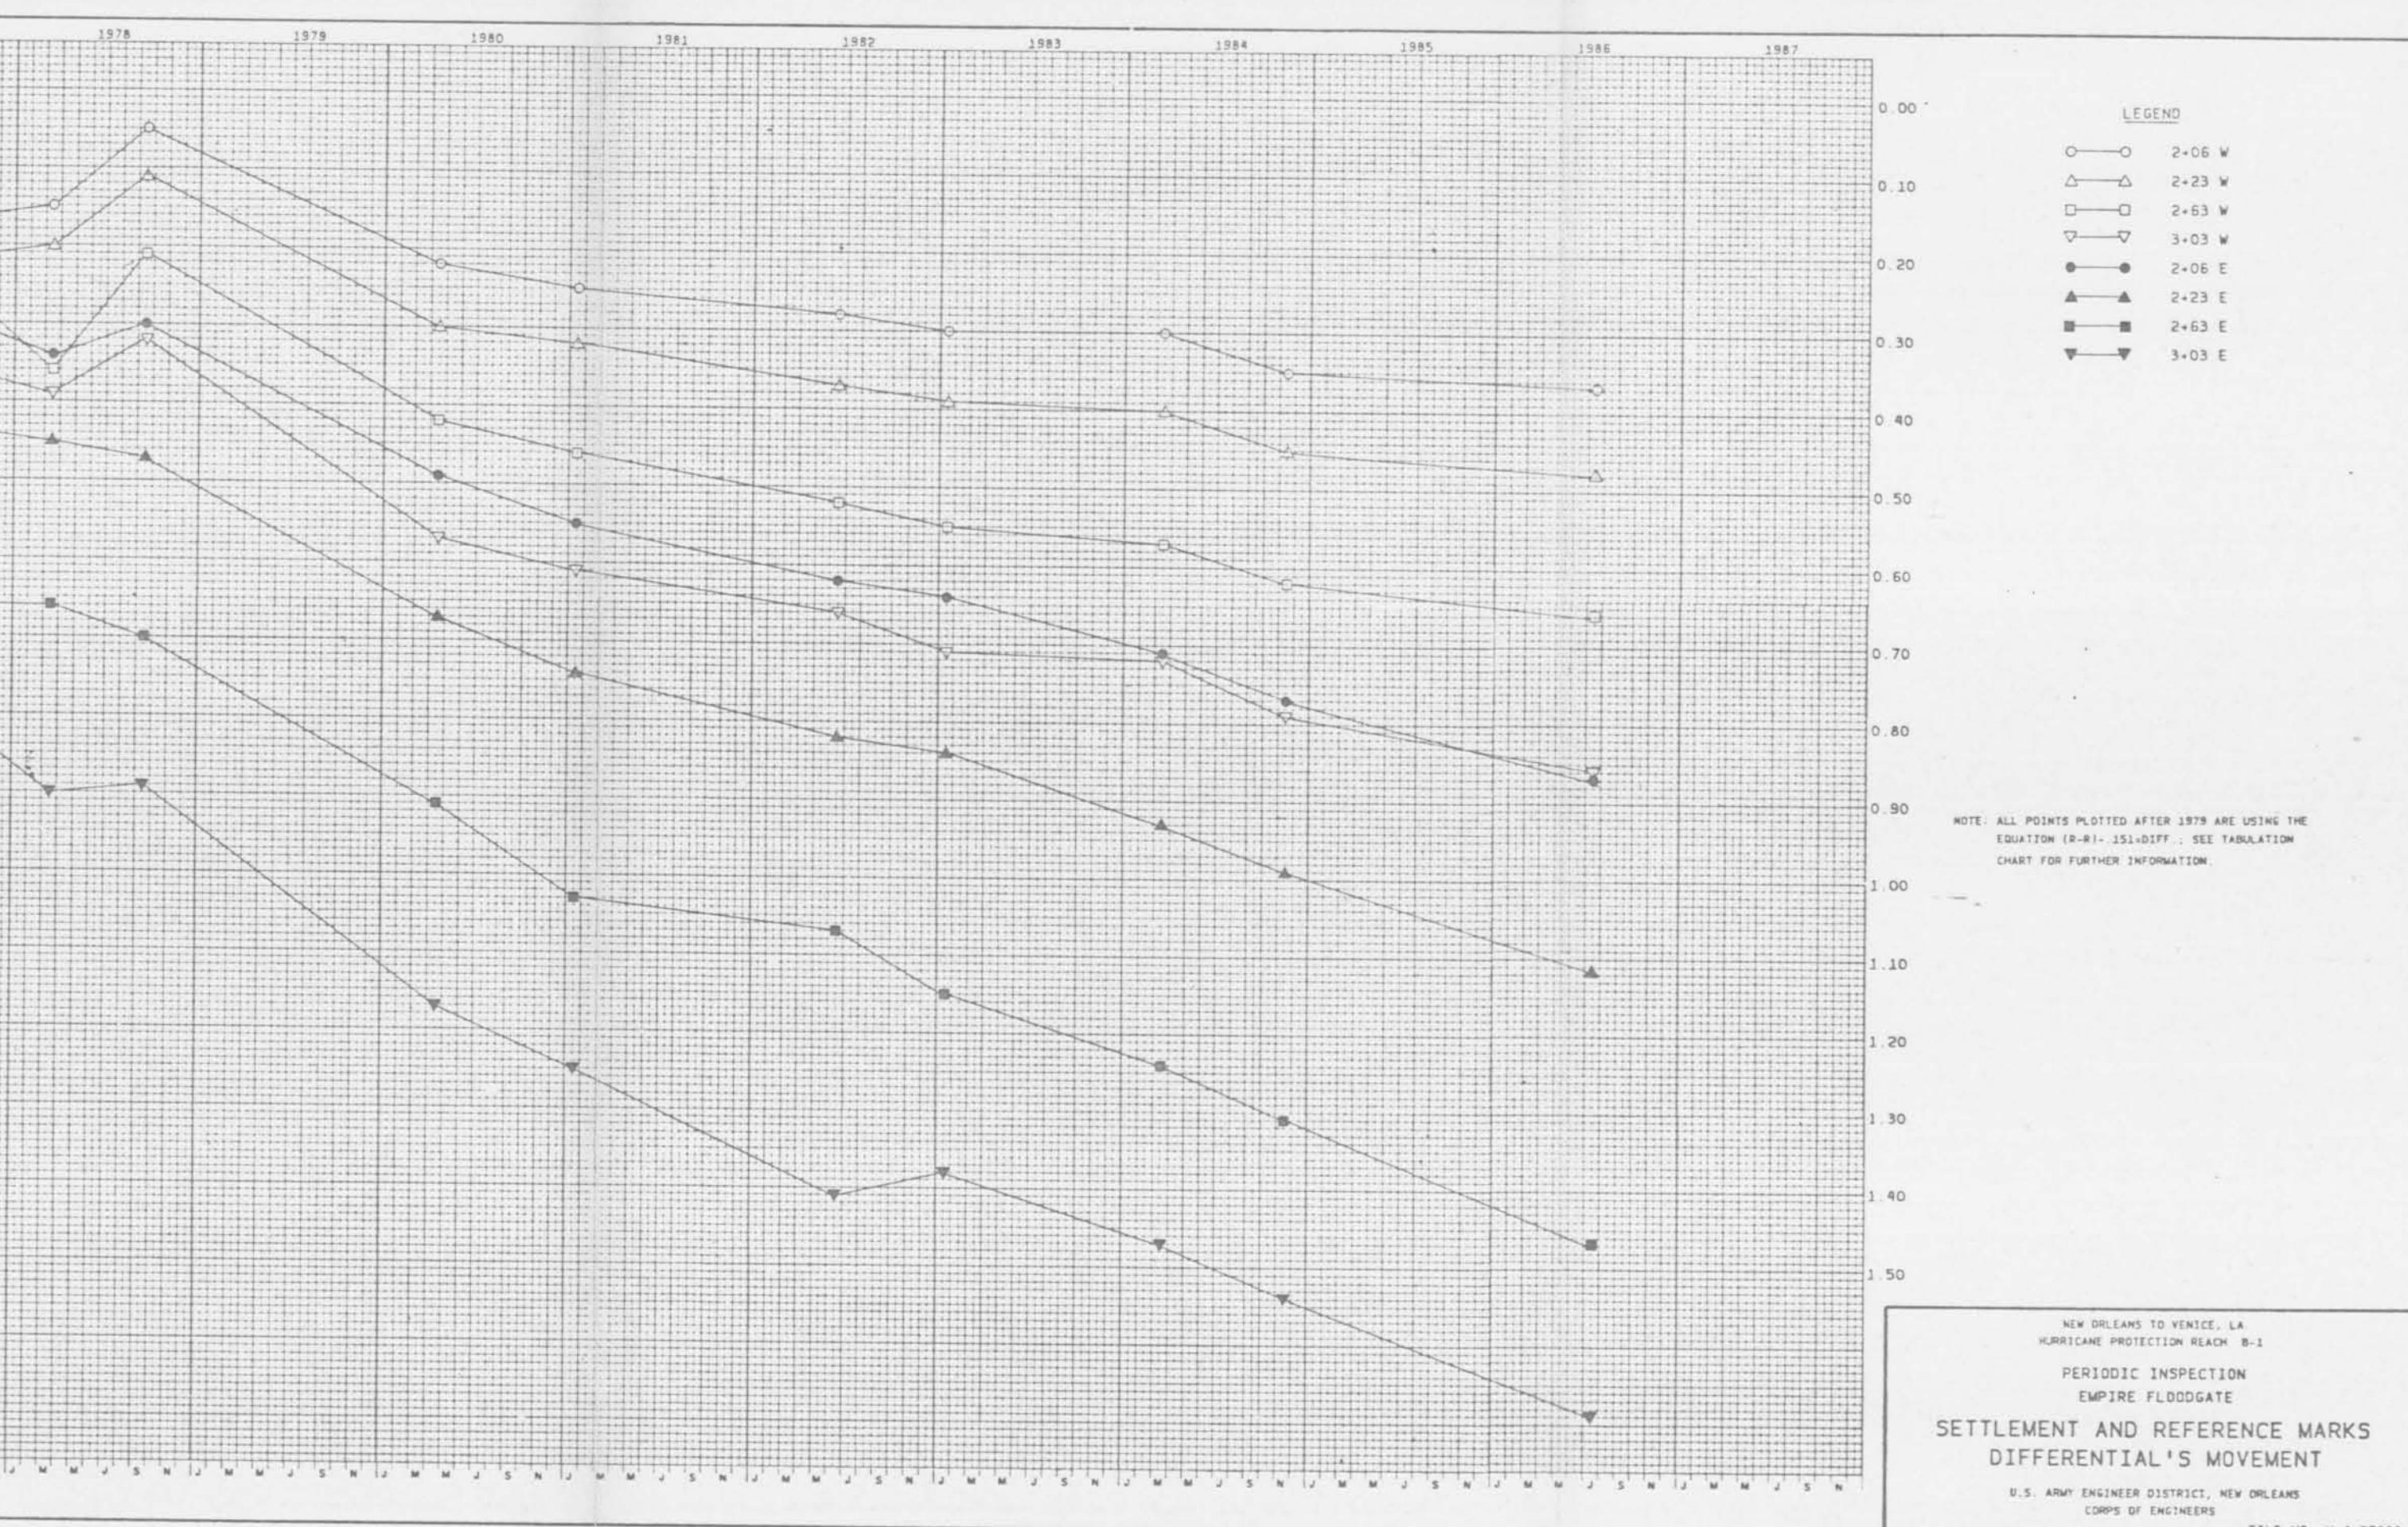
PLATE 7

NEW ORLEANS TO VENICE,
HURRICANE PROTECTION REACH
PERIODIC INSPECTION
EMPIRE FLOODGATE
REFERENCE MAP
DIFFERENTIAL CHART
