HURRICANE PROTECTION

EMPIRE FLOODGATE

PERIODIC INSPECTION REPORT NO. 8

17 JANUARY 1996

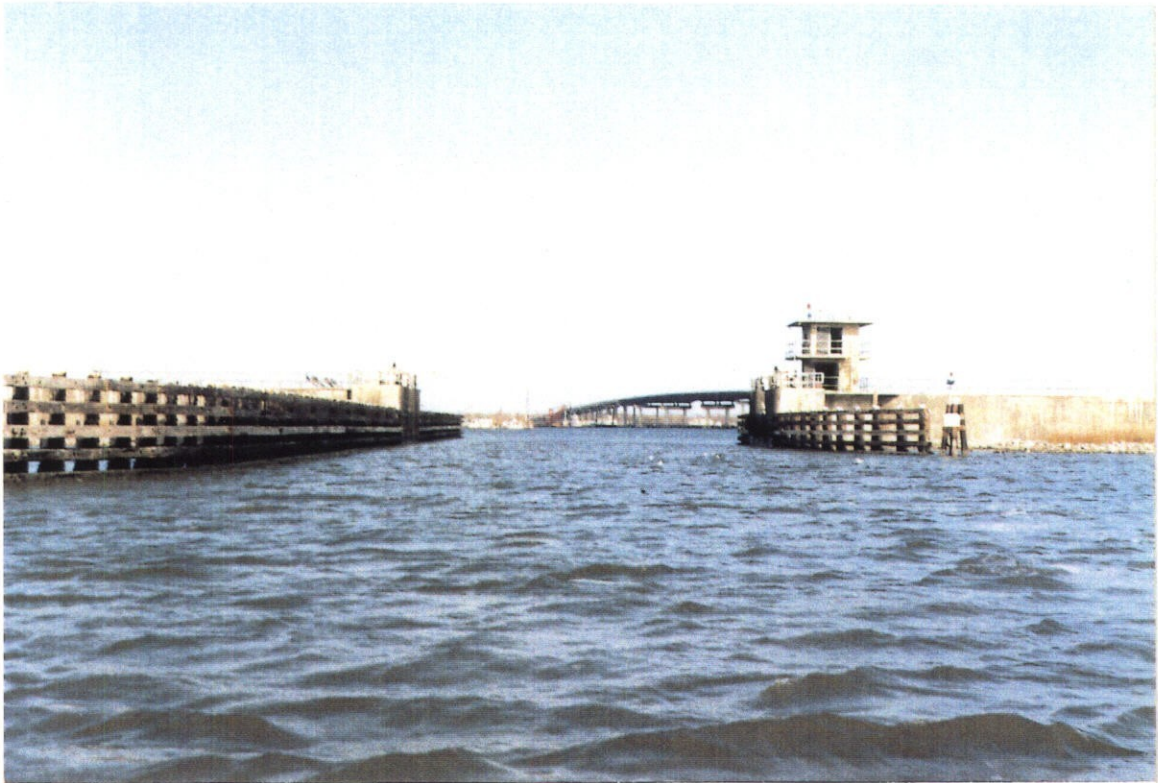
a. General. At the periodic inspection on 17 January 1996, the floodgate was not unwatered and the gate was fully open (in the recess in the sill). Mr. Victory, Plaquemines Parish, Floodgate Operator, stated that he had not received word that the gate was to be closed (raised) and that no public notice had been issued to warn navigation interests that the floodgate would be closed to marine traffic while the gate was closed for inspection. The gate was consequently operated (raised) only enough to determine that the gate operating machinery was functional, but not enough to inhibit navigation through the floodgate. At the time of the inspection the stage was 0.5 feet NGVD. A detailed visual inspection was made of all features of the structure above the water level. The gate was subsequently closed (raised) on 13 February 1996 for the supplemental inspection of the gate and its operating components. At this time the stage was 0.2 feet NGVD. The overall condition of the structure is fair. See Photo No. 1.

PHOTO NO. 1 - VIEW LOOKING NORTH ALONG THE CENTERLINE
OF EMPIRE FLOODGATE.

1. Floodwall. Overall, the floodwall was in very good condition, some concrete popouts were found on the surface of concrete walkway on top of inverted T-wall and gatebay. (See Photo #1). A gap of approximately two and a half to three inches was observed between the L-type waterstop that is attached to sheetpiling and the adjacent T-wall monolith on the west side of the structure. The L-type waterstop was not secured to the sheet pile on the floodside.

3. Gatebay monolith. The gatebay concrete was in good condition. No concrete spalled, cracked or reinforcing steel exposed was found, except those where indicated in the previous periodic inspection report. (See Photo #1).

Photo #1 Concrete popout on concrete walkway and Gatebay.

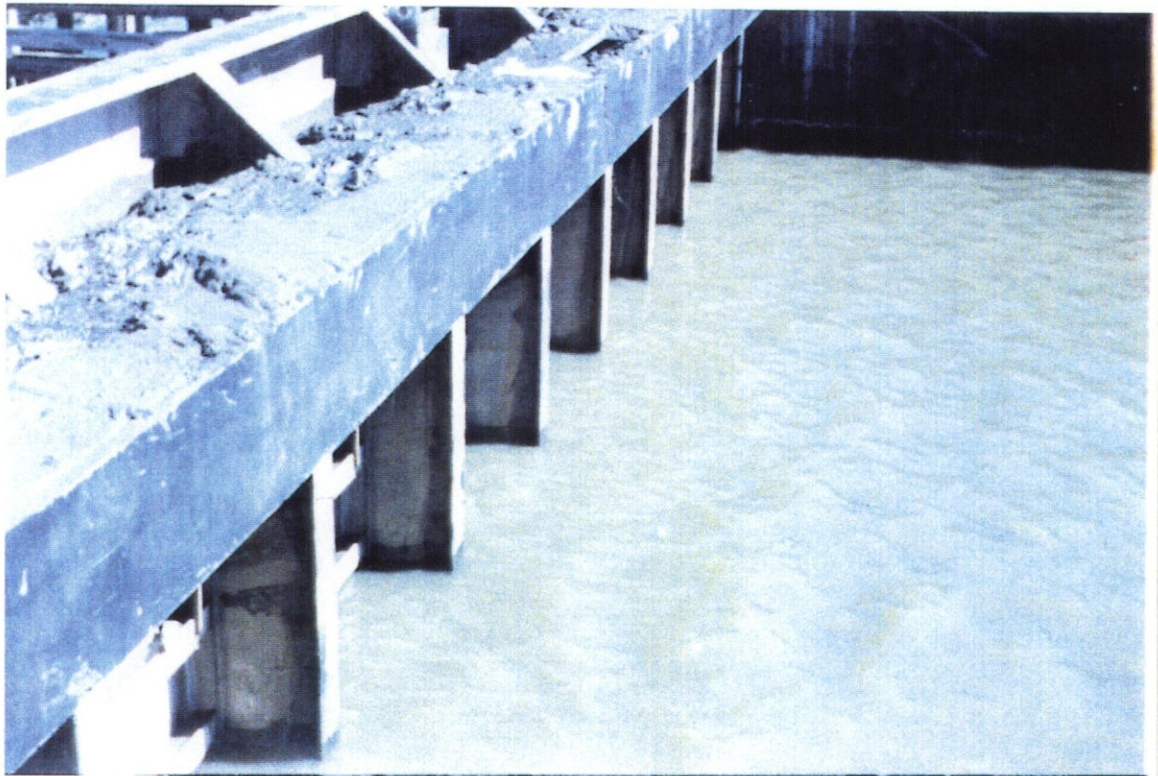
PHOTO NO. 8 - VIEW LOOKING EAST AT THE UNDERSIDE OF THE GATE. GATE IS IN THE FULLY CLOSED POSITION. NOTE LINES ON VERTICAL MEMBERS MADE BY SILT LINE WHEN THE GATE WAS OPEN (LOWERED INTO ITS RECESS).

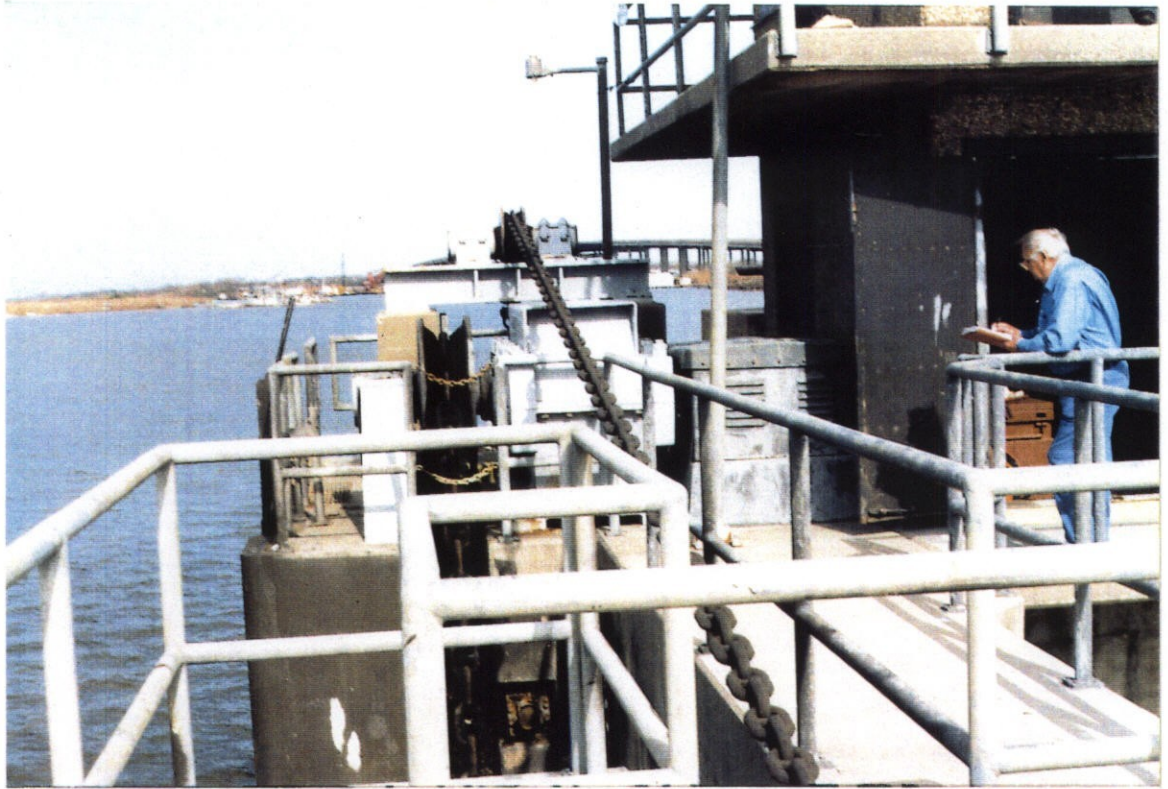
PHOTO NO. 10 - GATE OPERATING MACHINERY ON THE EAST SIDE.

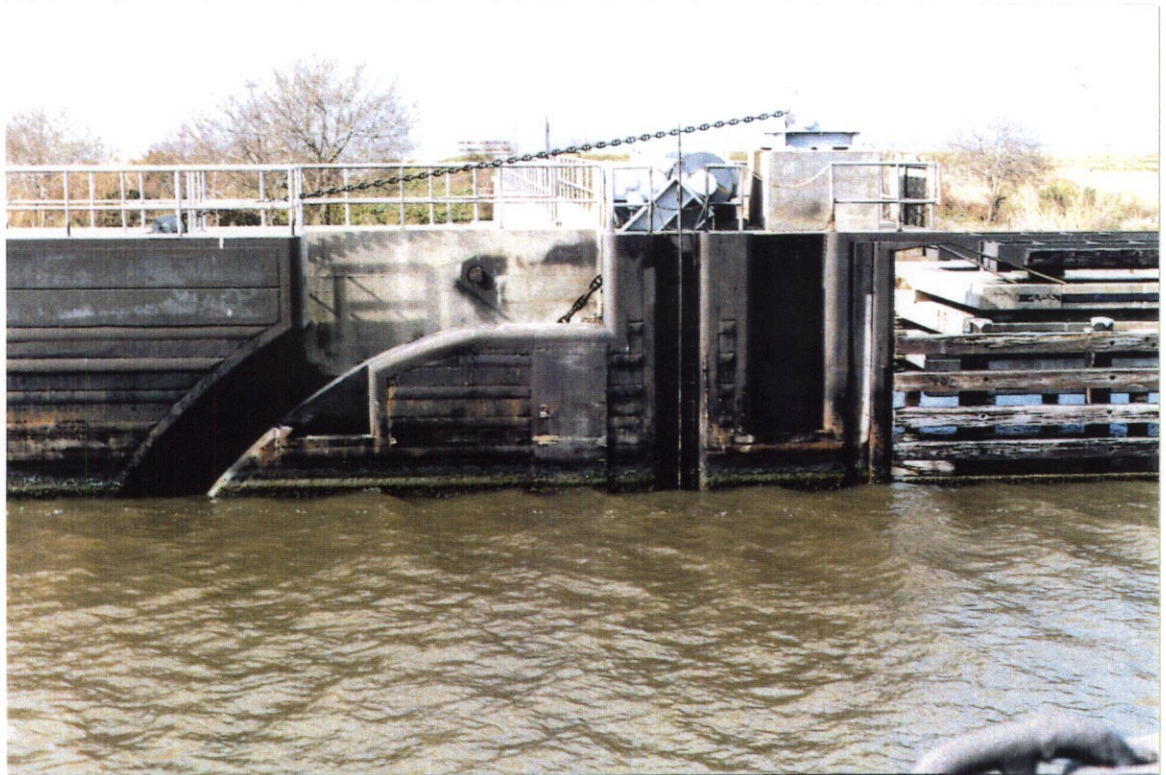
PHOTO NO. 11 - GATE OPERATING MACHINERY ON THE WEST SIDE.

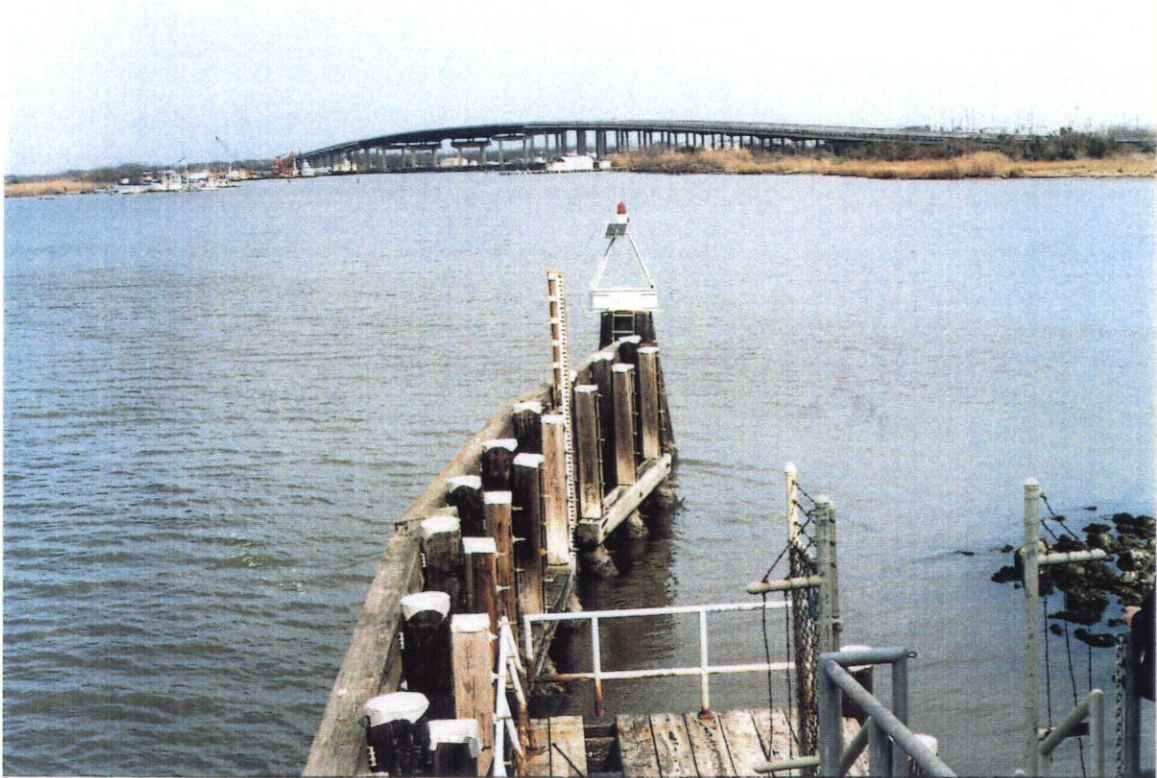
(5) The navigation lights on the dolphins were not tested but appear to be in good condition based on visual inspection. The units are solar powered and appear to have been recently installed. See Photo No. 18.

PHOTO NO. 18 - NORTHEAST GUIDEWALL. NOTE NEW APPEARANCE OF NAVIGATION LIGHT UNIT.

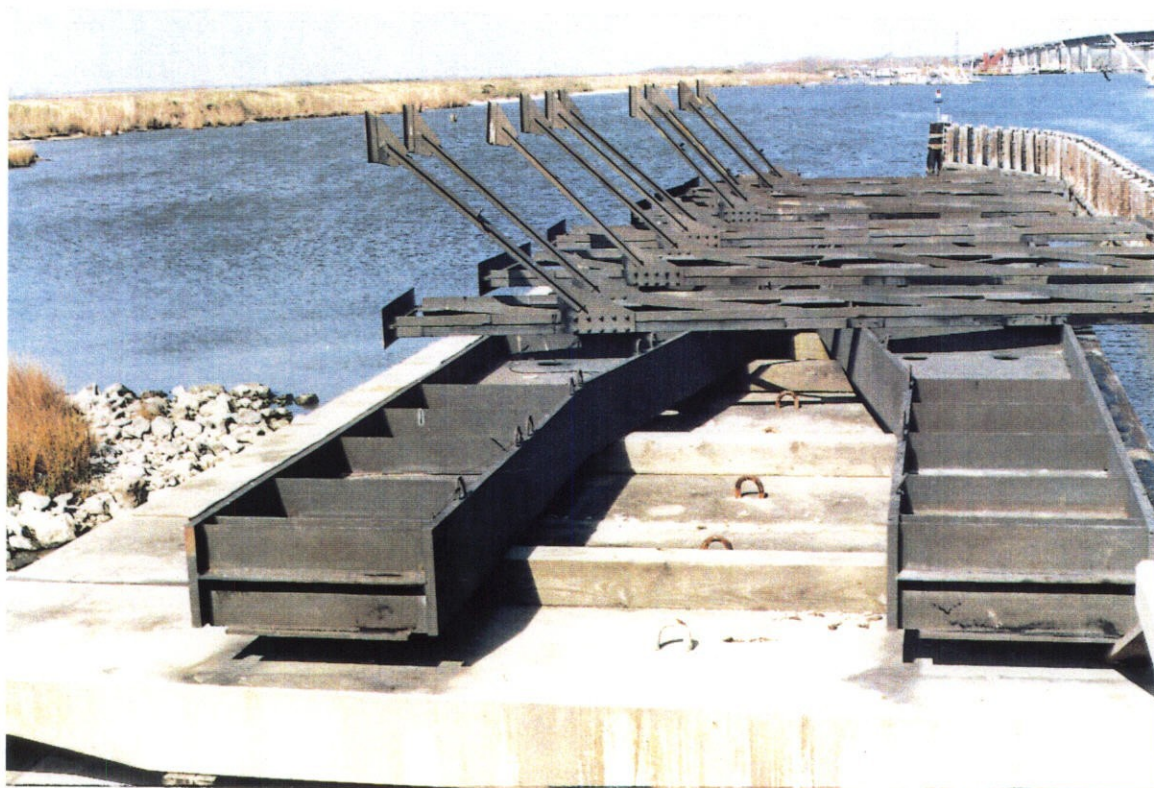
j. Needles and Needle Girders. The concrete needles and steel needle girders are properly stored and in good condition. See photo No. 19. Non-destructive testing of fracture critical welds on the steel needle girders has not been performed. Since Empire Floodgate is a "local interest" structure, the responsible "local interest" (Plaquemines Parish) is responsible for performing the necessary non-destructive weld testing. *The 12-inch treated timber used as spaces between the needles and needle girders are badly decayed.*

PHOTO NO. 19 - VIEW OF STORED NEEDLES, NEEDLE GIRDERS, AND SUPPORTS. NOTE GOOD CONDITION OF PROTECTIVE COATING SYSTEMS.

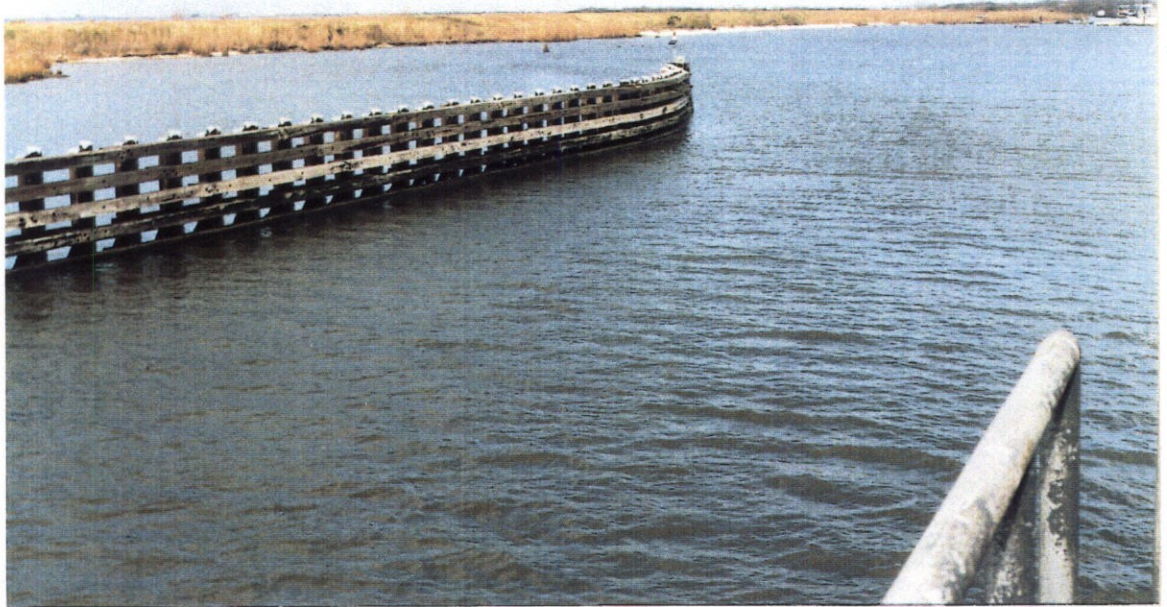
k. Timber Guidewalls. The overall condition of the timber guidewalls, fenders and dolphins was very good. Caps were in place on the timber piles. See Photo No. 20. On the northwest guidewall one timber may need replacement in the very near future and on the northeast guidewall two

PHOTO NO. 20 - VIEW OF NORTHWEST TIMBER GUIDEWALL.

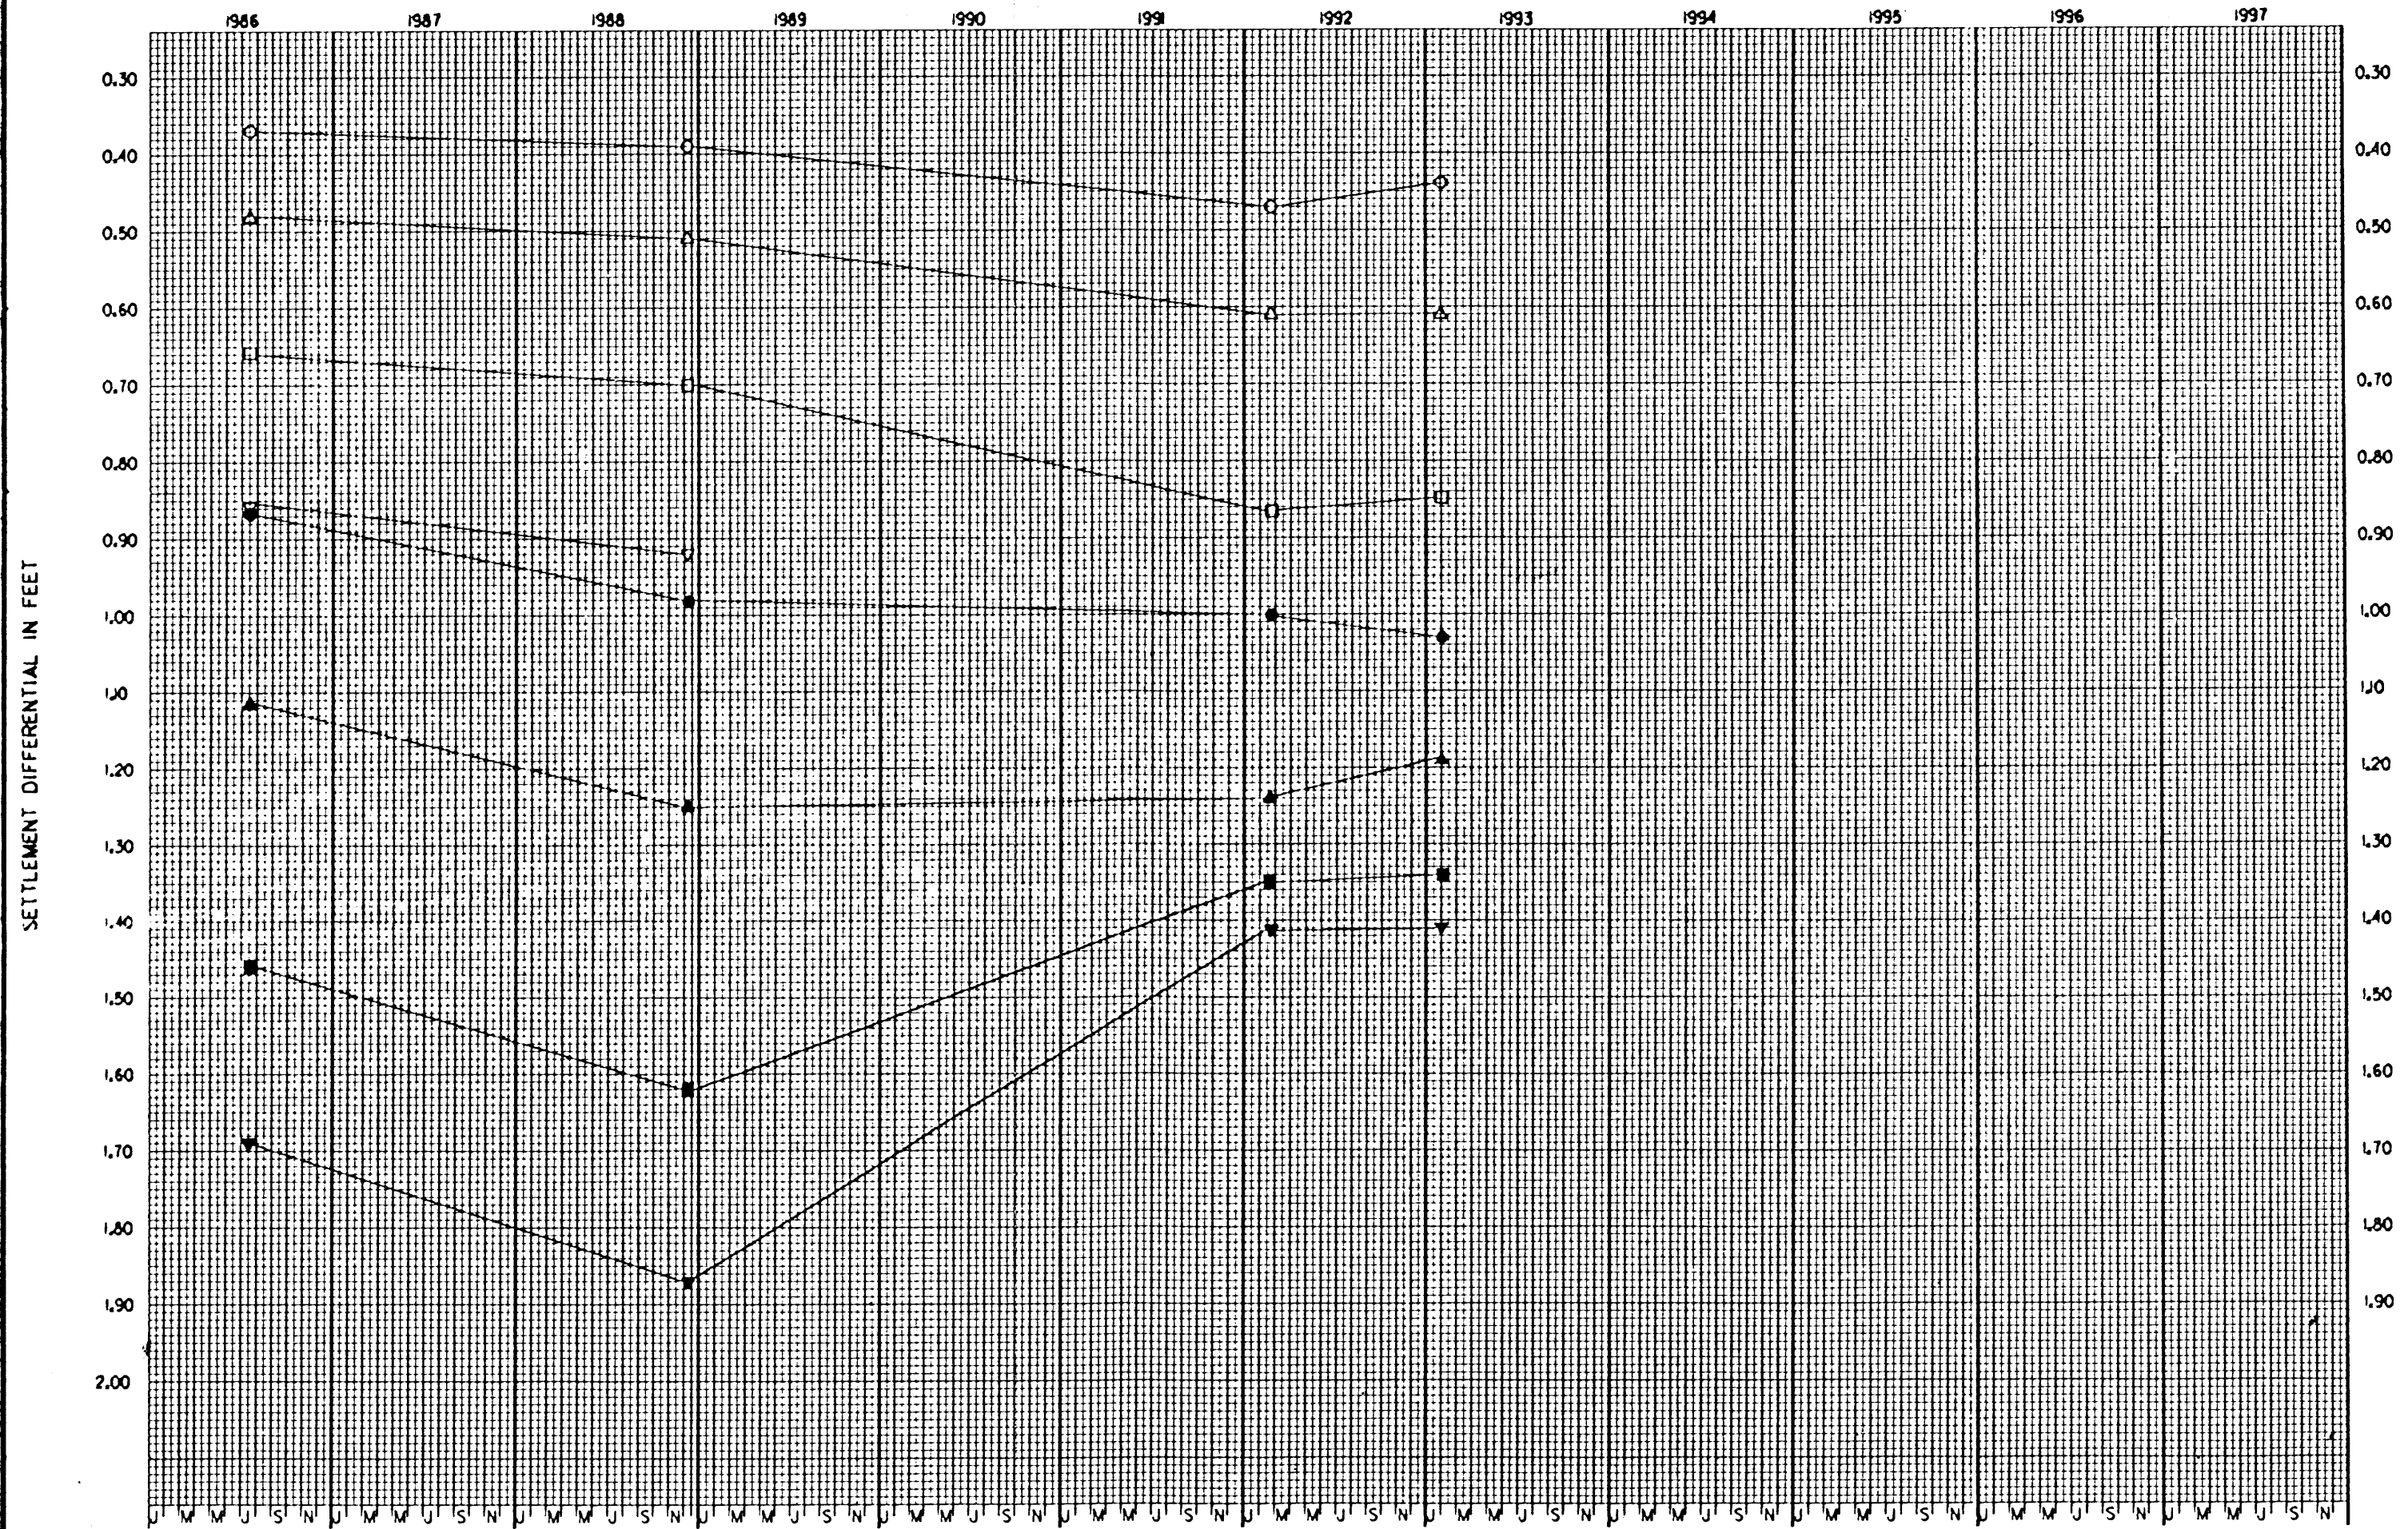
have been at the ends of the T-walls where the T-walls abut the "I"-type sheet pile walls. This is illustrated graphically by the plots on Plate No. 6. The greater settlements at the ends of the T-walls are caused by the stresses induced into the foundation soils by the presence of the levee. Differential movements from one end to the other of the easternmost and westernmost T-walls monoliths have been 0.27 and 0.11 feet, respectively. These differential movements have caused the end monoliths to rotate down on the ends. This rotation has caused significant joint openings between the end monoliths and the adjacent monoliths. The joint openings are discussed further in paragraph 4-02.c. The rate of settlement appears to be decreasing with time as would normally be expected. The settlement readings have been made over a time span of 18 years. The percent of the total measured settlement that had occurred at the end of the first nine years (1975 to 1984) was 87 to 97 for the floodgate structure, 80 to 95 for the west T-wall, and 71 to 87 for the east T-wall. The percent of the total measured settlement that has occurred over the last five years (1988 to 1993) has been from 5 to 10 for the floodgate structure, 8 to 13 for the west T-wall and 10 to 14 for the east T-wall. Differential vertical movements between monoliths have been moderately small. Total differential vertical movements between the floodgate structure and the adjacent T-wall have been about 0.02 feet
