UNITED STATES
NUCLEAR REGULATORY COMMISSION

SUBJECT: NRC SPECIAL INSPECTION REPORT - INDIAN POINT UNIT 2
STEAM GENERATOR TUBE FAILURE - REPORT NO. 05000247/2000-010

IR 05000247-00-010, March 7 thru July 20, 2000; Consolidated Edison of New York, Inc.; Indian Point Unit 2; Special Team; steam generator tube failure, visual, eddy current inspection, technique qualification, corrective actions.

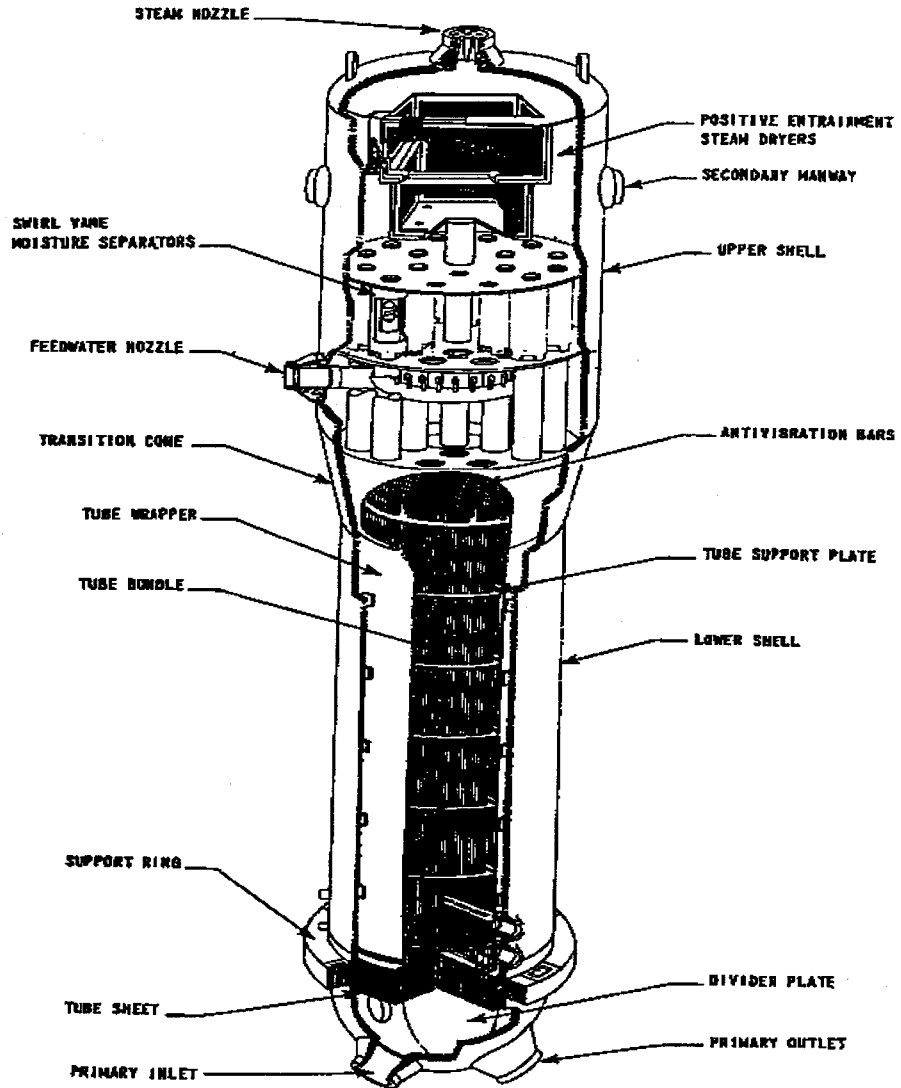
REFERENCED FIGURES 1 THROUGH 19
Figure 1 - Westinghouse Model 44 Steam Generator

Indian Point 2 is a four-loop pressurized water reactor, meaning that there are four SGs, one per loop, that transfer heat from the reactor coolant system (RCS) to the secondary water. This heat causes the secondary water to boil, and the resulting steam is used to turn the turbine, which turns the electrical generator. Figure 1 shows a Westinghouse Model 44 SG, like those in use at Indian Point 2. The four SGs are identified as SG 21 through SG 24.

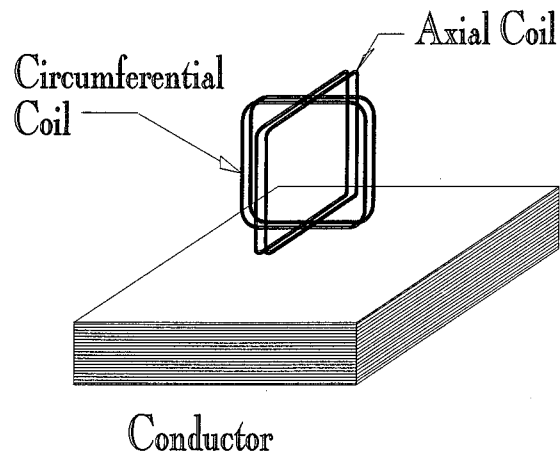
Figure 2 Directional pancake probe

Single coil probes as shown in Figure 2 will induce the eddy current in only one direction, which is a compressed mirror image of the current in the coils. Defects that are perpendicular to the eddy current flow, interrupt the eddy current flow and the probe coil voltage will be affected. Specially designed ECT probes can classify defects as axial cracks, circumferential cracks or both.

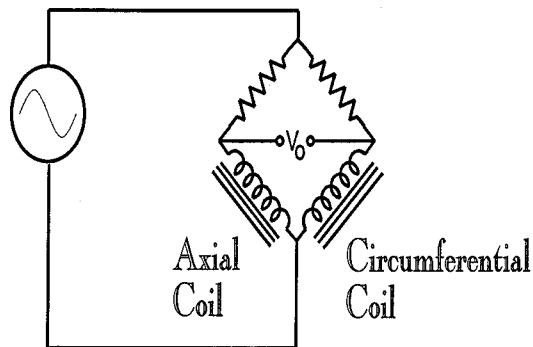
Figure 3 Plus Point probe

The Plus Point probe consists of two coils wound at 90 degrees to each other, as shown in Figure 3. The coils are mounted on a shoe that rotates as it passes through the tube to allow a complete examination. The turns of the two coils are interleaved so that both are effectively the same distance from the surface of the tube. The coils are connected in a bridge circuit, as shown in Figure 4, and the voltage difference between the two signals is amplified. The two coils allow the scanning for both axial and circumferential defects. The mid-range Plus Point probe used during the 1997 examination is a multifrequency probe, operating at 10, 100, 300, and 400 kHz.
