Analysis of Rail Car Components Exposed to a Tunnel Fire Environment

Center for Nuclear Waste Regulatory Analyses

**U.S. Nuclear Regulatory Commission
Office of Nuclear Material Safety and Safeguards
Washington, DC 20555-0001**

Manuscript Completed: November 2002
Date Published: March 2003

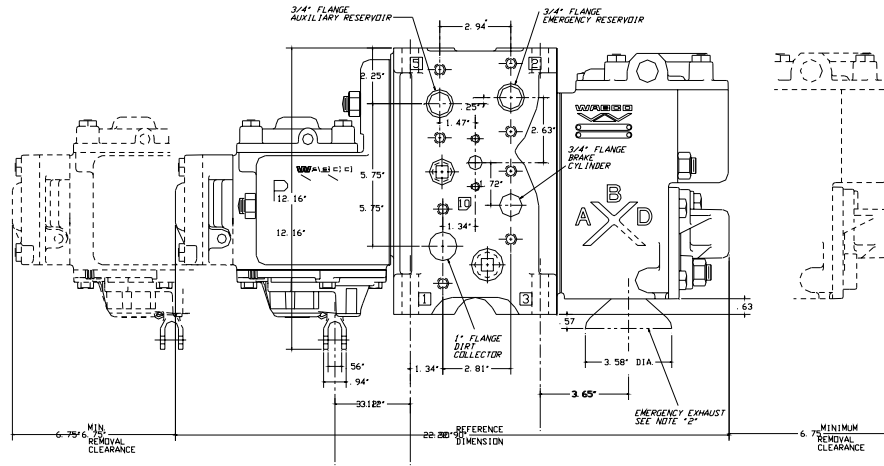
The valve assembly found on Car 52 was identified as an ABDX-L valve. The valve assembly located on Car 51 was also assumed to be an ABD valve assembly. A complete ABDX-L valve assembly is shown in Figure 3-1.

Figure 3-1. The ABDX-L Control Valve (Clockwise from Top: Valve Body Schematic, Photograph of Damaged Valve on Car 52, Corresponding Outline of the Valve Body)

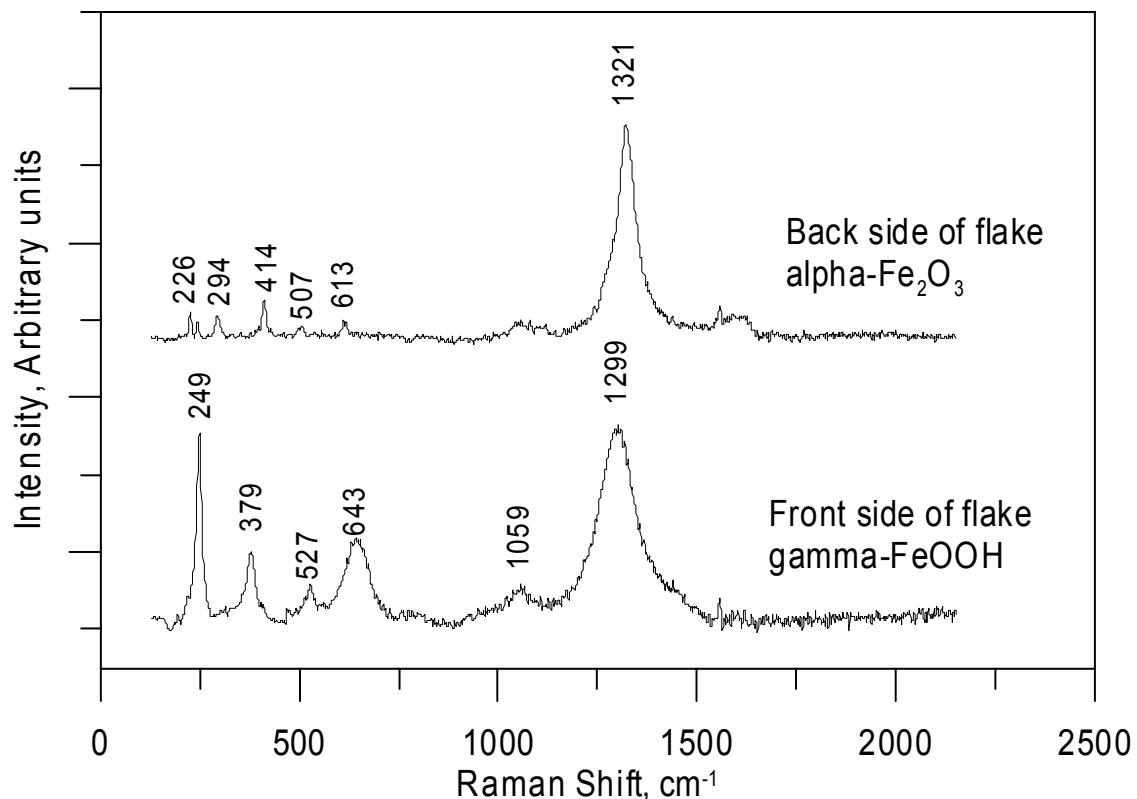
Both Raman spectroscopy (Figure 4-4) and x-ray diffraction (Figures 4-5 and 4-6) of the scale obtained from Car 51 indicate the presence of lepidocrocite (γ -FeOOH), hematite (α -Fe₂O₃) and possibly magnetite (Fe₃O₄). It should be noted that magnetite can easily be oxidized in air to hematite. The presence of γ -FeOOH, which covered large sections of the scales, indicates that the specimens were exposed to either a humid environment or water. Formation of γ -FeOOH may have occurred as a result of water contact after rupture of the water main, fire fighting efforts, or subsequent storage of the train cars involved in the derailment.

Figure 4-4. Raman Spectra for Scales Recovered from Car 51

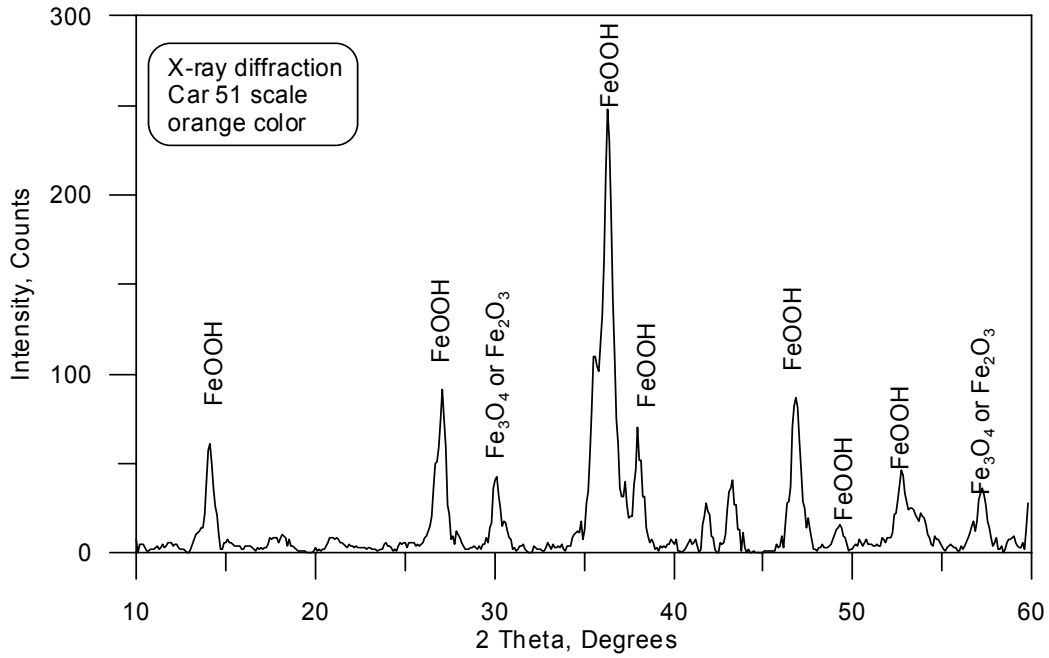
Figure 4-5. X-Ray Diffraction of Orange Colored Oxide Scales from Car 51

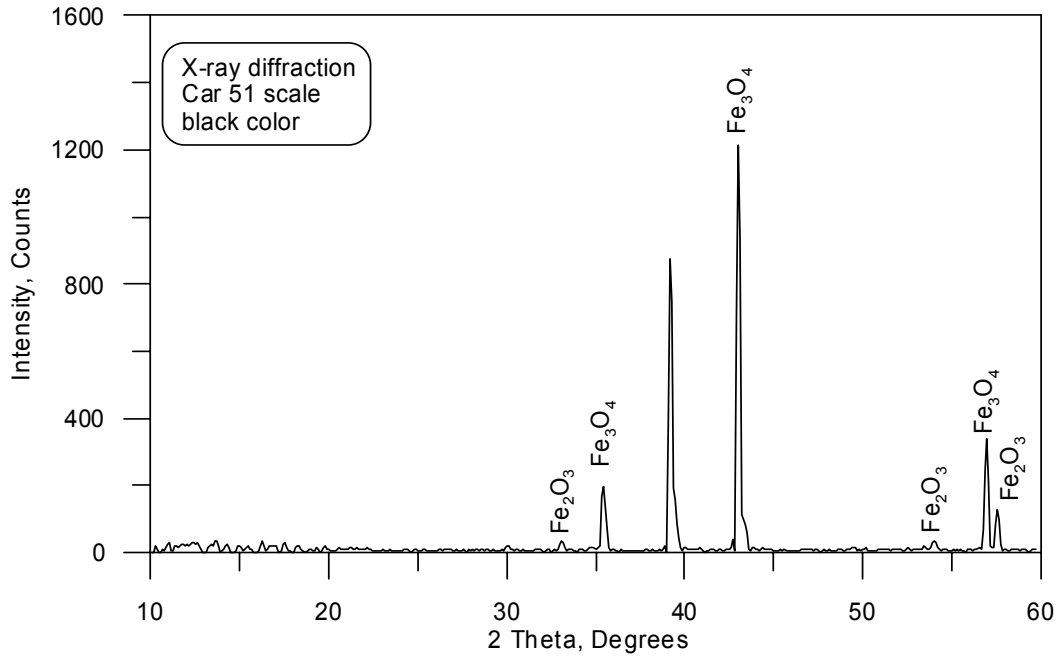
Figure 4-6. X-Ray Diffraction of Black Colored Oxide Scales from Car 51
