Research  
Paper  
FPL-RP-566

# Field Performance of Timber Bridges

## 15. Pueblo County, Colorado, Stress-Laminated Deck Bridge

Lola E. Hislop

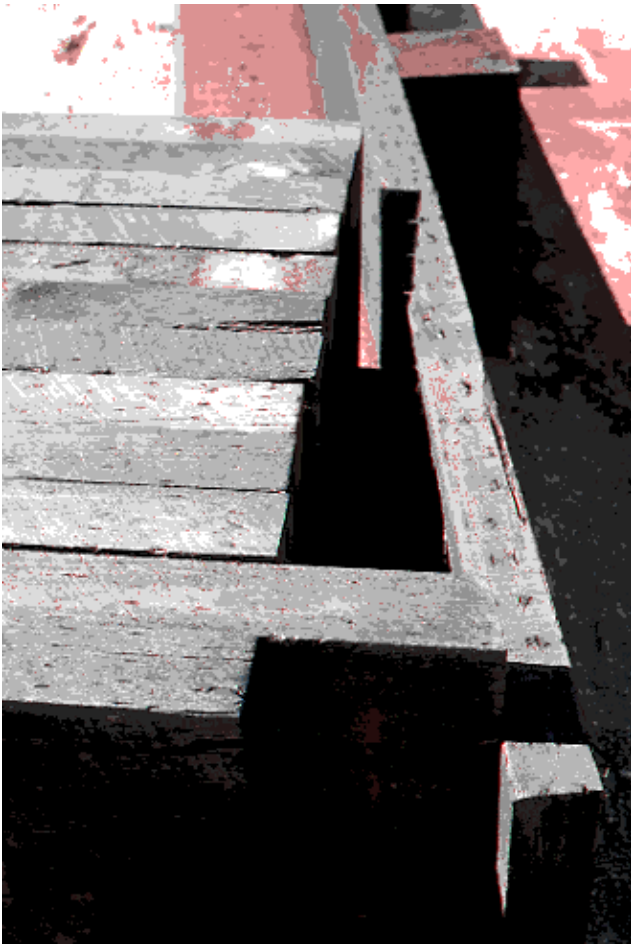
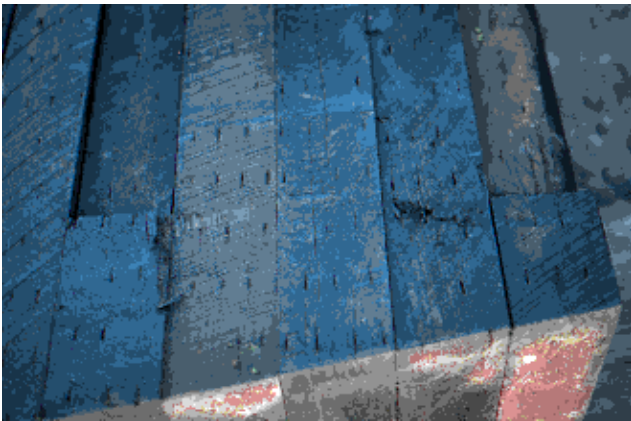
**Figure 6—Two options for obtaining longitudinal alignment: (top) a few laminations correctly cut to length or (bottom) nail-connected short pieces to ends of laminations.**

Construction of the Pueblo County 204B bridge was completed in March 1990. The superstructure was delivered in four preassembled sections of laminations, interconnected with steel spikes and banded with steel straps (Fig. 5). The delivered sections were placed on the abutments, one at a time. Looking at the ends of each section, it became apparent that many laminations were not cut to length for the skew. Longitudinal alignment of each deck section was accomplished by a few laminations correctly cut to length (Fig. 6a) or nailing very short pieces to the ends of the lamination (Fig. 6b). It is unknown if this affected the bearing area between the deck and the abutments.

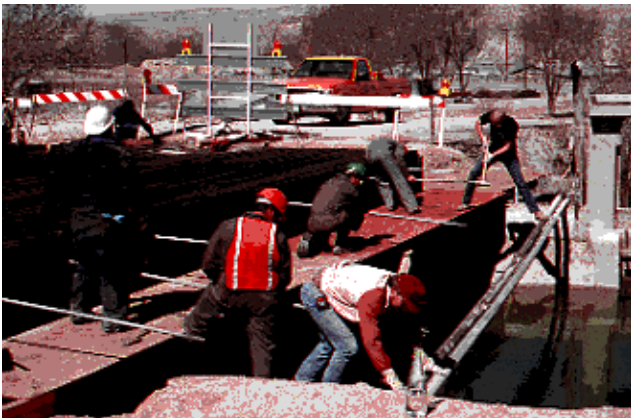
After placement of a deck section, the bars were pushed through the entire section and the steel straps were removed prior to placing the next section. This proved to be a difficult method of construction. The free ends of the full-length bars needed to be suspended; otherwise, the bars deformed and became difficult to push through the deck. In addition, it was difficult to line up the holes in the laminations between sections. Near the end of construction, a sledge hammer was used to drive the bars through, with care taken not to damage the ends of the bar (Fig. 7). Stressing began after all sections were in place and was performed using an electric pump and

**Figure 7—Stressing bars were hammered through the final deck section.**

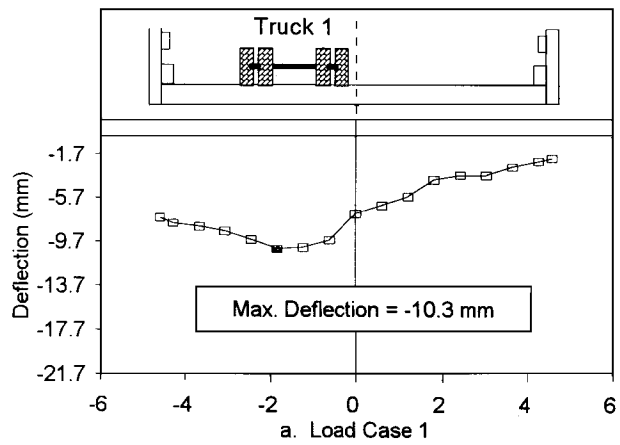
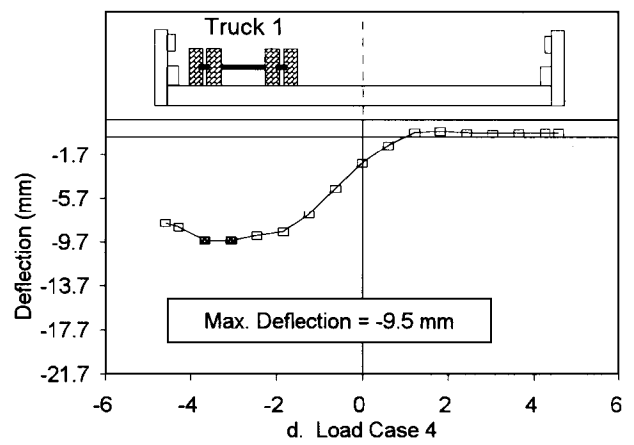
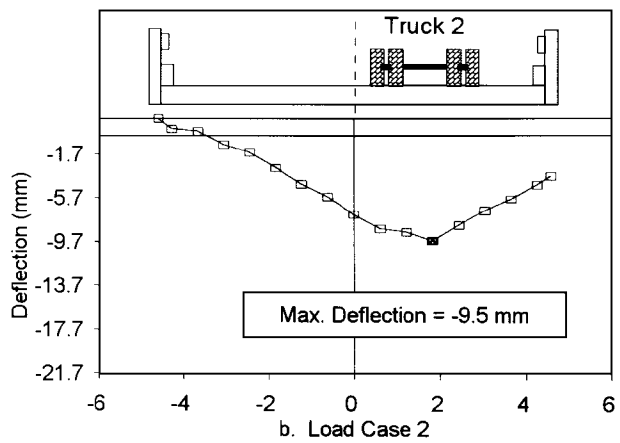
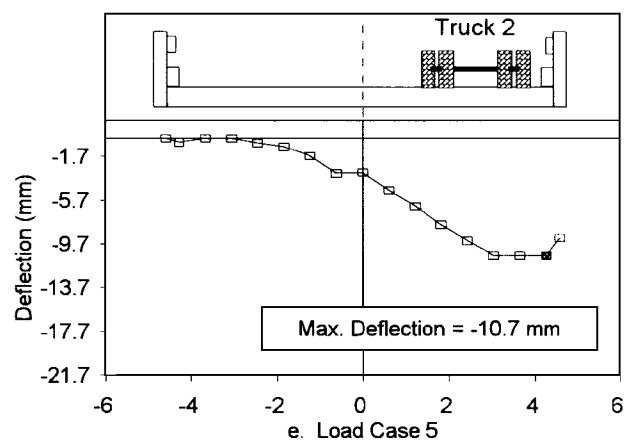
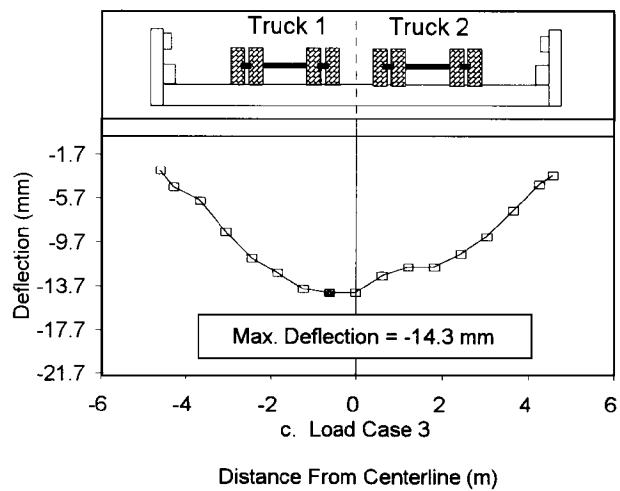
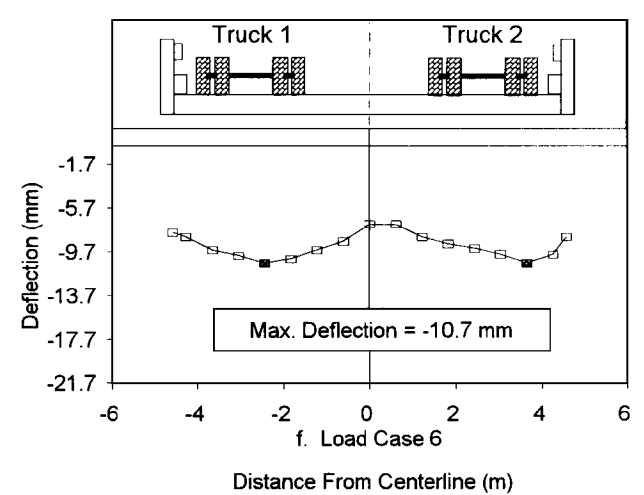
Transverse deflections for each load case are shown in Figure 19. For load cases 4 and 6, there was no apparent single point of maximum deflection. There may have been differences between the points of maximum deflection within each case, but the difference was indistinguishable as a result of the measurement accuracy. In all cases, the deflection was typical of the linear elastic orthotropic plate behavior of stress-laminated bridges, and the location of the maximum measured deflection corresponded to the location observed in similar bridges (Ritter and others 1995).

Load cases 1 and 2 (Figs. 19a,b) and load cases 4 and 5 (Figs. 19d,e) should be mirror images of each other. For load cases 1 and 2, the maximum deflection location was centered under the truck and the magnitude was  $-10.3$  and  $-9.5$  mm, respectively. For load cases 4 and 5, the general location was under the outside wheel line and the magnitude was  $-9.5$  and  $-10.7$  mm, respectively. The sum of the deflections under the single truck load cases should be similar to the deflections under the two-truck load case. Comparisons of the deflection curves of load cases 1 plus 2 to load case 3 and load cases 4 plus 5 to load case 6 are shown in Figures 20 and 21. For load cases 1 plus 2 and 3, the maximum deflection location was slightly to one side of the centerline,

Figure 19—Transverse deflection for load test 1, measured at midspan. Solid box denotes maximum deflection. Bridge cross sections and truck positions are shown to aid interpretation and are not to scale.

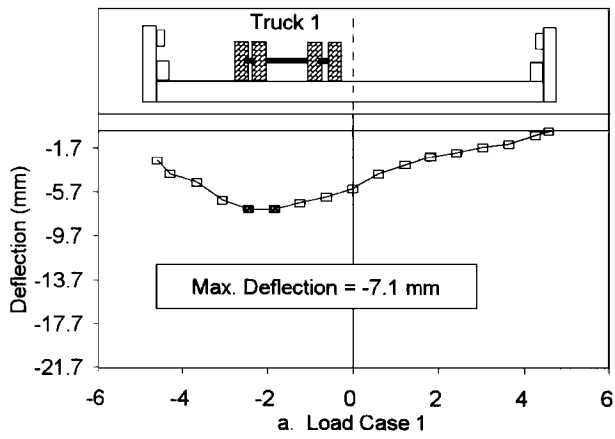
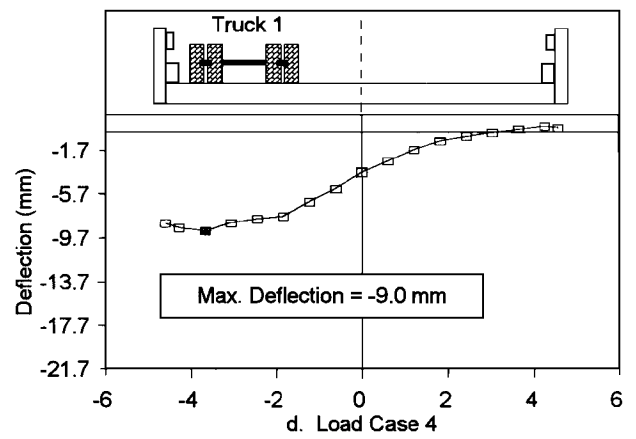
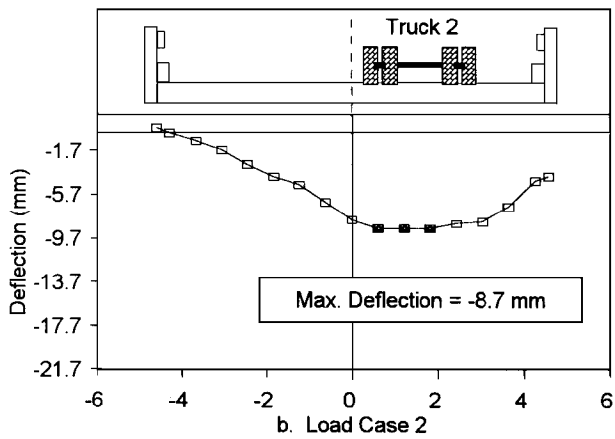
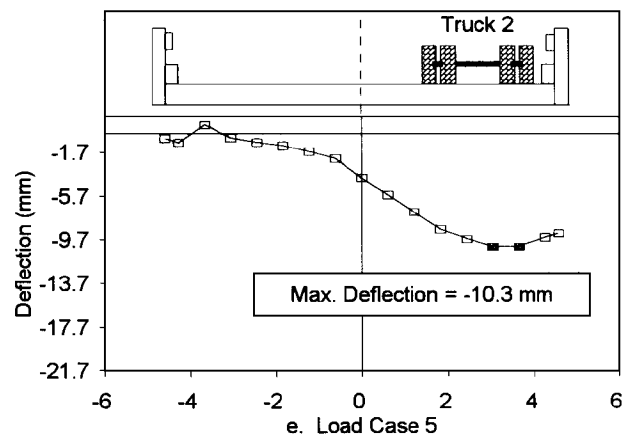
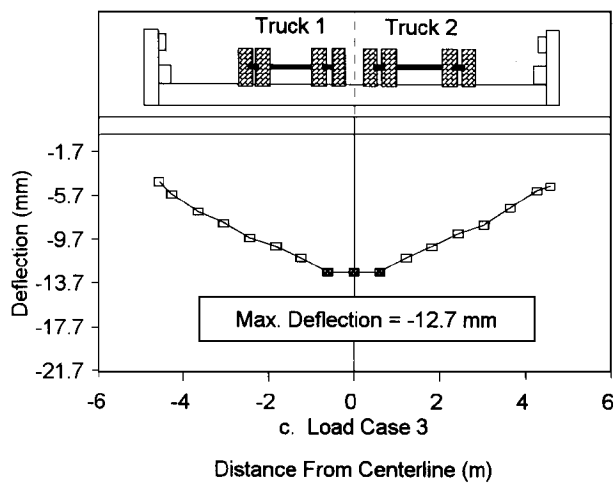
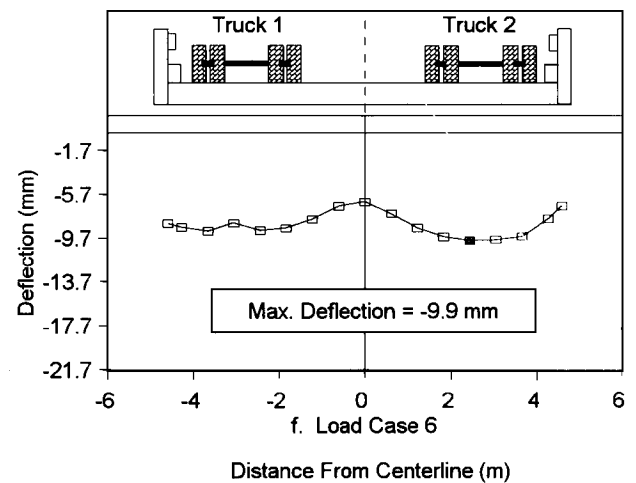
Transverse deflections for each load case are shown in Figure 22. As stated for load test 1, for some load cases, there was no apparent single point of maximum deflection and other points deflected the same magnitude. In all cases, the deflection was typical of the linear elastic orthotropic plate behavior of stress-laminated bridges and the location of maximum measured deflection corresponded to the location observed in similar bridges (Ritter and others 1995).

The same deflection comparisons that were made for load test 1 were made for load test 2. For load cases 1 and 2 (Fig. 22a,b), the maximum deflection location was under the truck and the magnitude was  $-7.1$  and  $-8.7$  mm, respectively. For load cases 4 and 5 (Fig. 22d,e), the location was under the outside wheel line and the magnitude was  $-9.0$  and  $-10.3$  mm, respectively. Load cases 1 plus 2 compared with load case 3 and load cases 4 plus 5 compared with load case 6 are shown in Figures 23 and 24. For load cases 1 plus 2 and 3, the maximum deflection location was at the centerline with a magnitude of  $-13.3$  and  $-12.7$  mm, respectively. For load cases 4 plus 5 and 6, the location was under the outside wheel line with a magnitude of  $-10.4$  and  $-9.9$  mm, respectively.

Figure 22—Transverse deflection for load test 2, measured at the midspan. Solid box denotes maximum deflection.

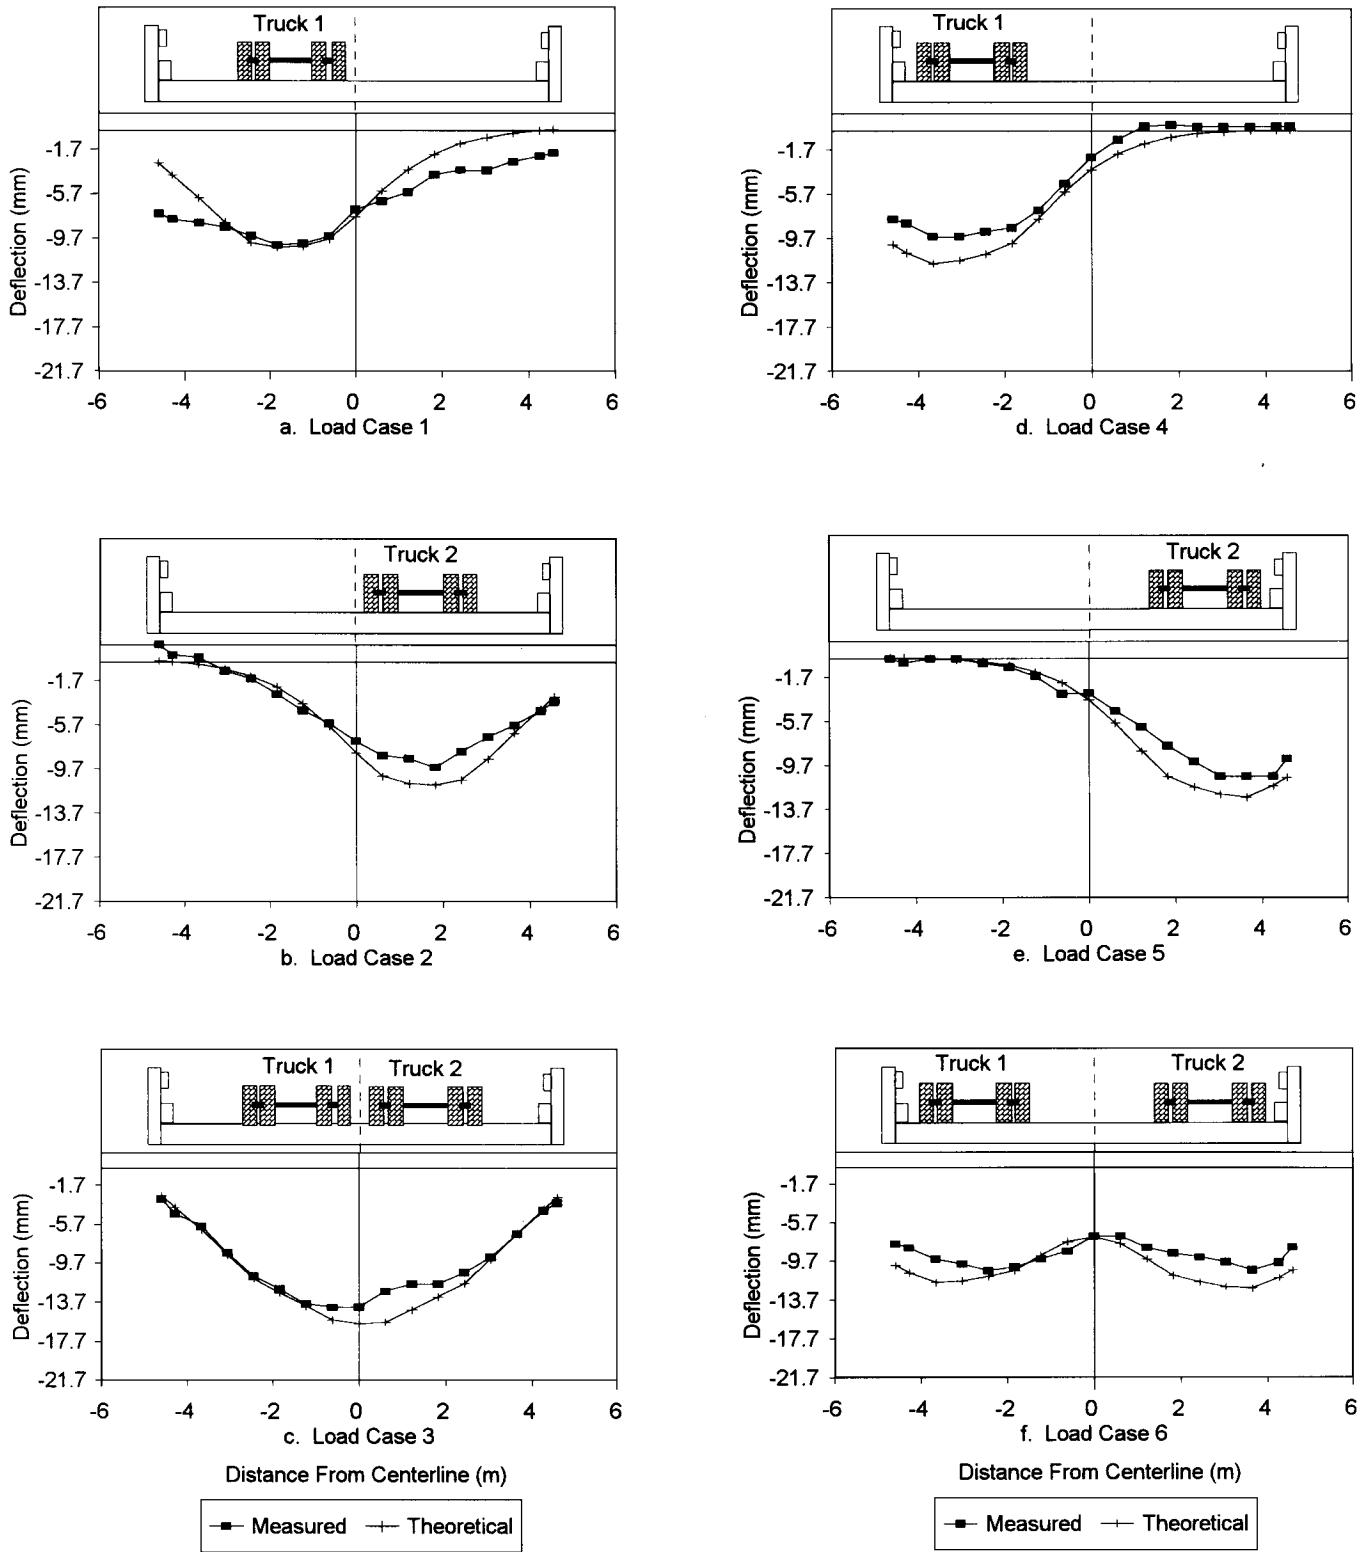
Measured deflections were compared with theoretical deflections for all load cases in each load test (Figs. 25, 26). The theoretical deflections were similar to the measured deflections, especially for load test 2. In general, the measured deflections were slightly less than the theoretical. For both load tests, the guardrail appeared to stiffen the edge significantly, as seen in load cases 4 to 6.

Figure 25—Comparison of theoretical and measured deflections at the midspan of the bridge for the test trucks, load test 1, load cases 1 through 6.

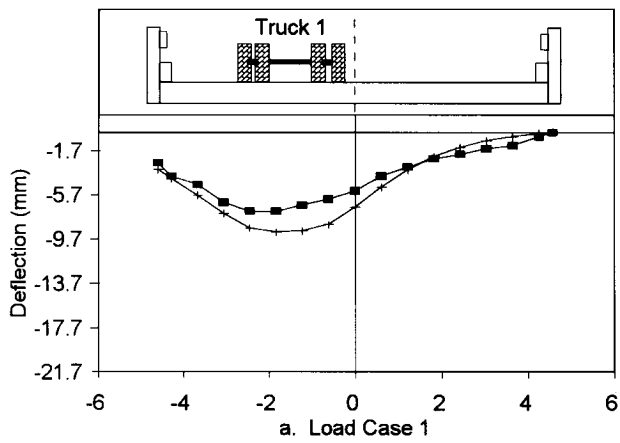
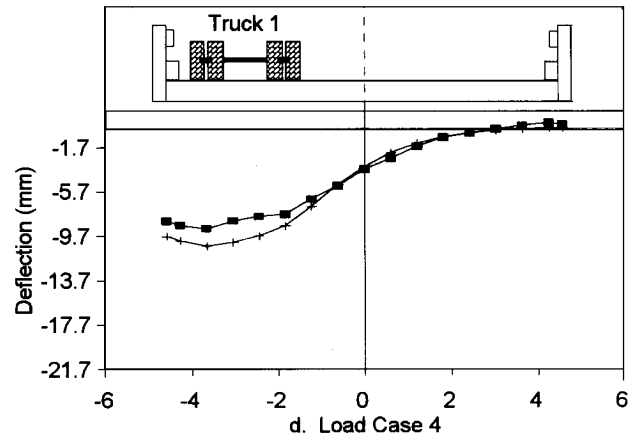
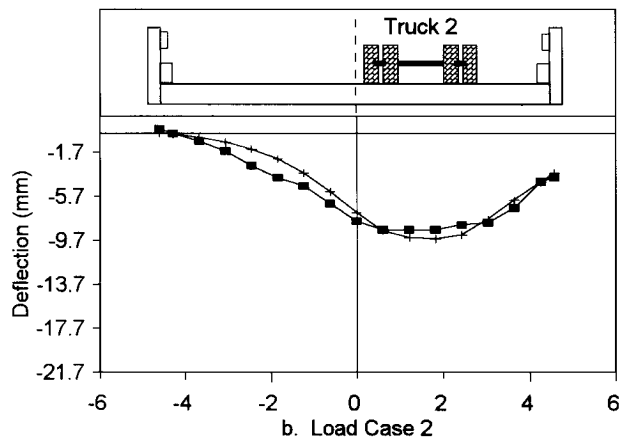
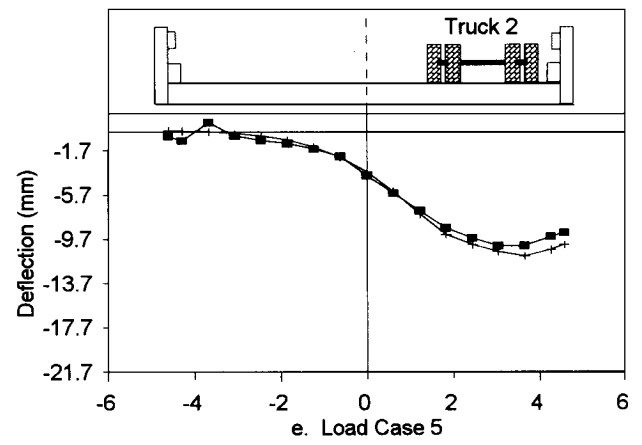
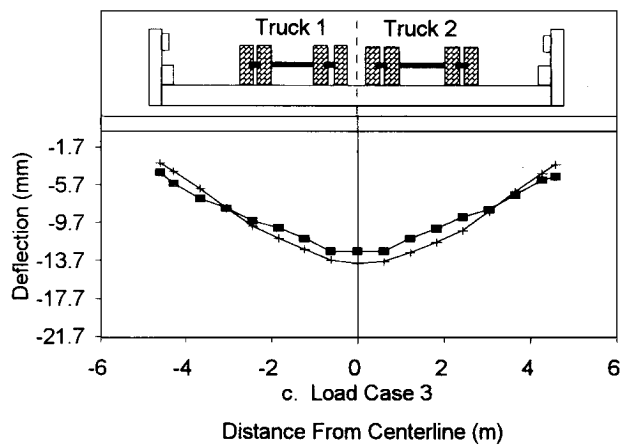
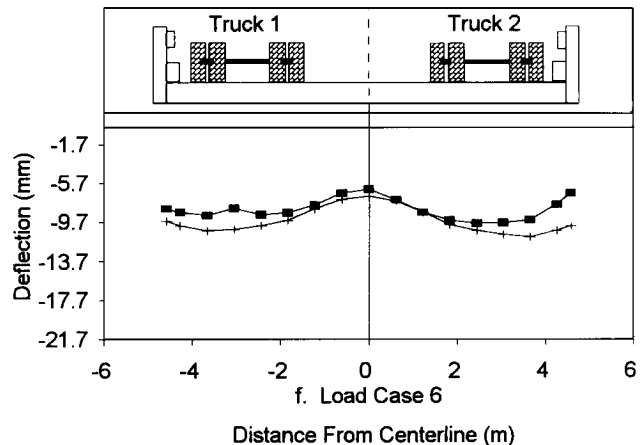
Figure 26—Comparison of theoretical and measured deflections at the midspan of the bridge for the test trucks, load test 2, load cases 1 through 6.

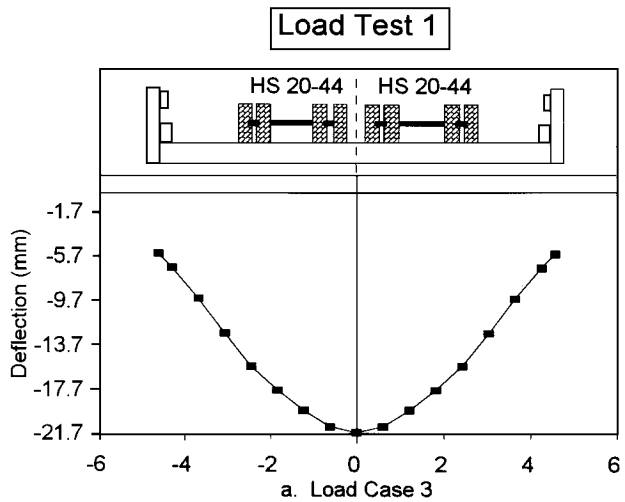
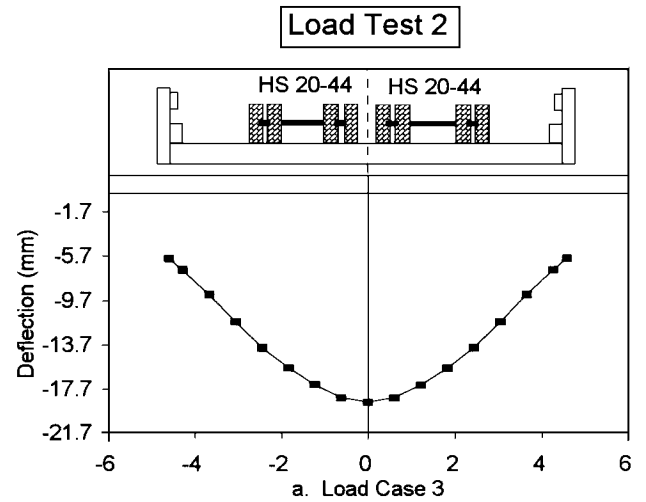
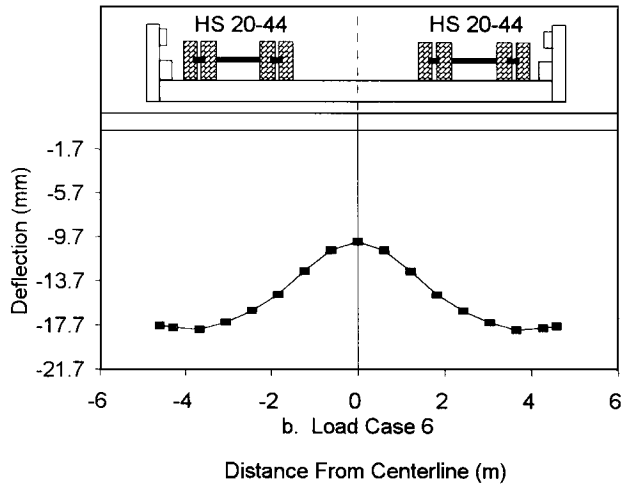
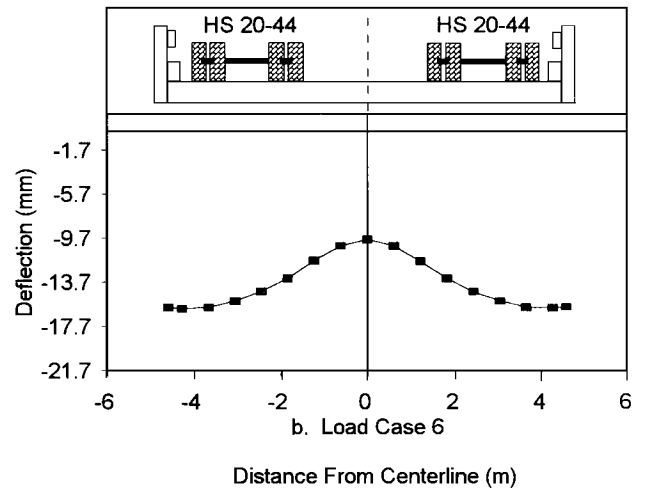
Figure 27 shows the theoretical deflections for HS 20-44 loading for load cases 3 and 6 for each load test. For load test 1, the predicted maximum deflection was  $-21.6$  mm or  $1/435$  of the span length center-center of bearing and  $-18.1$  mm or  $1/522$  for load cases 3 and 6, respectively. For load test 2, the predicted maximum deflection was  $-19$  mm or  $1/497$  and  $-16.1$  mm or  $1/585$  for load cases 3 and 6, respectively. For both load tests, the deflection was well within the original design limit of  $1/360$ . However, for both load tests, load case 3 slightly exceeded the allowable live load deflection of  $1/500$  recently established by AASHTO (1991). Comparing load tests 1 and 2, the decrease in the theoretical maximum deflection with the increase in interlaminar compression was 12% for load case 3.

**Figure 27—Theoretical deflections at the midspan of the bridge for two HS 20–44 trucks, load test 1, load cases 3 and 6 and load test 2, load cases 3 and 6.**
