In-Place Detection of Decay in Timber Bridges-An Application of Stress Wave Technology

Roy F. Pellerin and Jeff A. Lavinder (Authors), Washington State University
Robert J. Ross and Robert H. Falk, USDA Forest Products Laboratory
Norbert Volny, Volny Engineering

In: Ritter, M.A.; Duwadi, S.R.; Lee, P.D.H., ed(s). National conference on wood transportation structures; 1996 October 23-25; Madison, WI. Gen. Tech. Rep. FPL- GTR-94. Madison, WI: U.S. Department of Agriculture, Forest Service, Forest Products Laboratory.

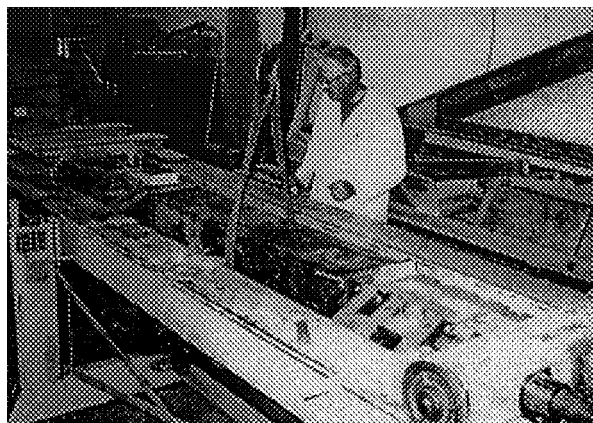
Figure 8—Column compression test

All but four of the columns were loaded to failure in compression. The setup for the compression test can be seen in Figure 8. Figures 9 and 10 show the top and bottom, respectively, of column 5 before testing. Before the compression test was performed, the ends were squared. The top of the column can be seen to have extreme rot in the center and only a shell of good wood holding the column together. Creosote penetration of the column top was minimal. The bottom of the column did not show any visual signs of severe decay. However, the stress wave analysis showed that the entire column was decayed.

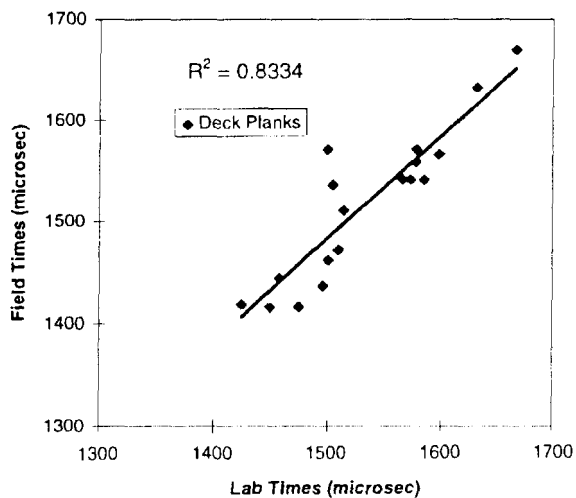
Figure 18—Graph of field longitudinal stress wave times versus laboratory longitudinal stress wave times

averages of each were plotted against each other and can be seen in Figure 18.
