Title **Final Progress Report on Los Alamos National Laboratory
Cerro Grande Fire Rehabilitation Activities**

Prepared by **Kevin J. Buckley and Jeffrey C. Walterscheid,
Water Quality and Hydrology Group
Samuel R. Loftin, Ecology Group
Gregory A. Kuyumjian, USDA Forest Service**

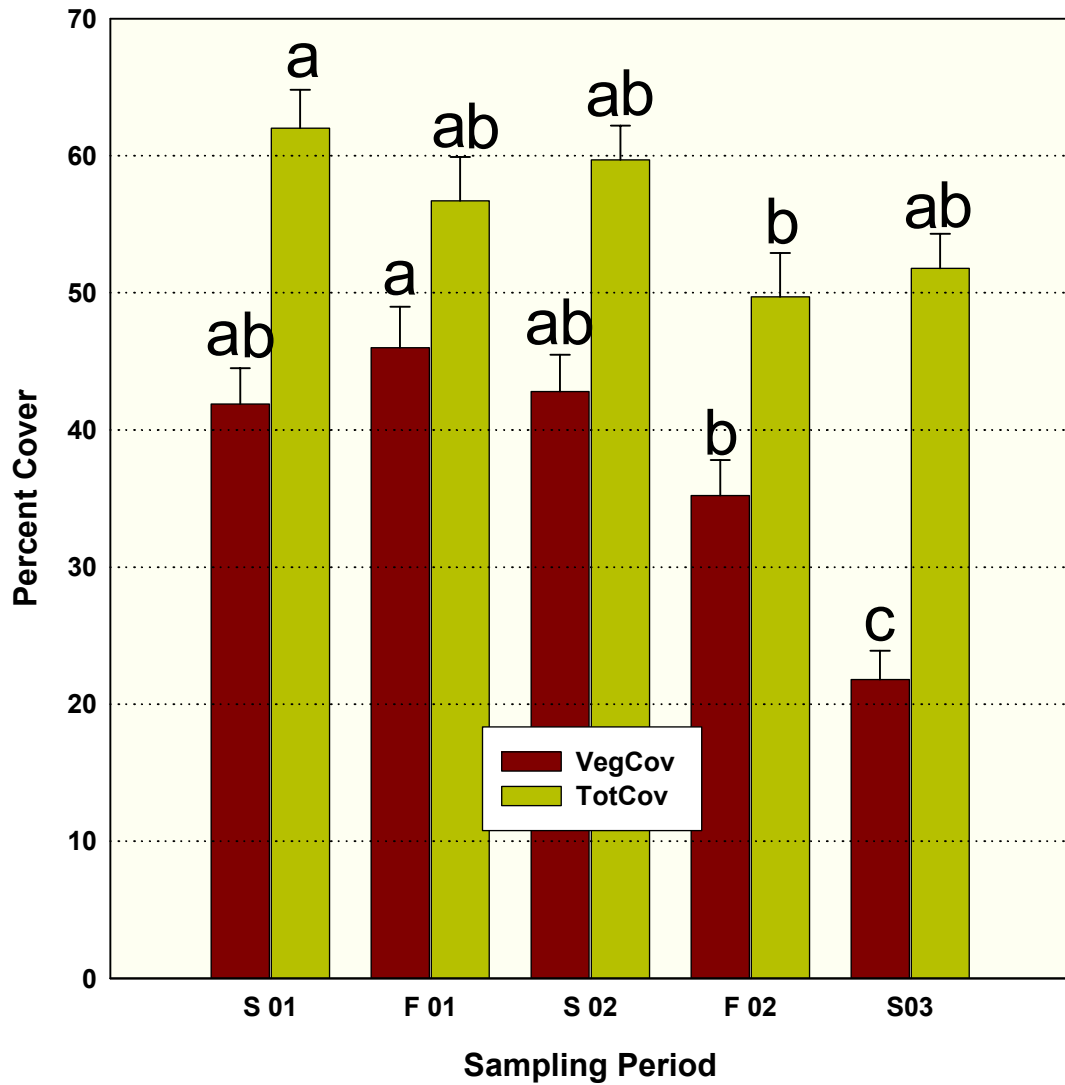
Figure 6. Total percent vegetation and ground cover for BART units. Sampling periods include summer 2001 (S 01), fall 2001 (F 01), summer 2002 (S 02), fall 2002 (F 02), and summer 2003 (S 03). Columns with the same letter (within a cover category) are not significantly different ($p>0.05$).

Total percent vegetation cover decreased significantly from a high of over 45% in fall 2001 to the low of just over 20% in summer 2003 (Fig. 6), which is an overall change of approximately 24%. The decline in vegetation cover coincides with a decrease in annual precipitation and may have been exacerbated by thinning treatments implemented after summer 2002. A significant increase in vegetation cover cannot be expected without adequate precipitation.

Total percent ground cover includes vegetation cover as well as any cover, such as litter, gravel, straw mulch, and pine needles, that protects the soil surface from erosion. Because decomposition rates are relatively slow, this form of cover is more stable than vegetation cover. There has been a significant decline in ground cover from a high of around 63% in spring 2001 to a low of around 50% in fall 2002 (Fig. 6). The slight increase in summer 2003 is not significantly different from spring 2001. Percent total ground cover has varied by approximately 13%. With the cessation of rehabilitation treatments, the only inputs to ground cover will be material from live or dead plants. Again, significant increases in ground cover are not expected until live plant productivity increases.

Overall, vegetation and ground cover levels are adequate to protect soil from erosion. Revised Universal Soil Loss Equation (RUSLE) estimates conducted in 2003 (Buckley and Loftin 2003) found that ground cover was sufficient to prevent soil loss in excess of the Natural Resource Conservation Service acceptable rate of soil loss. Exceptions were usually small in area and will receive additional rehab treatments. However, if drought conditions continue, additional treatments may be necessary.

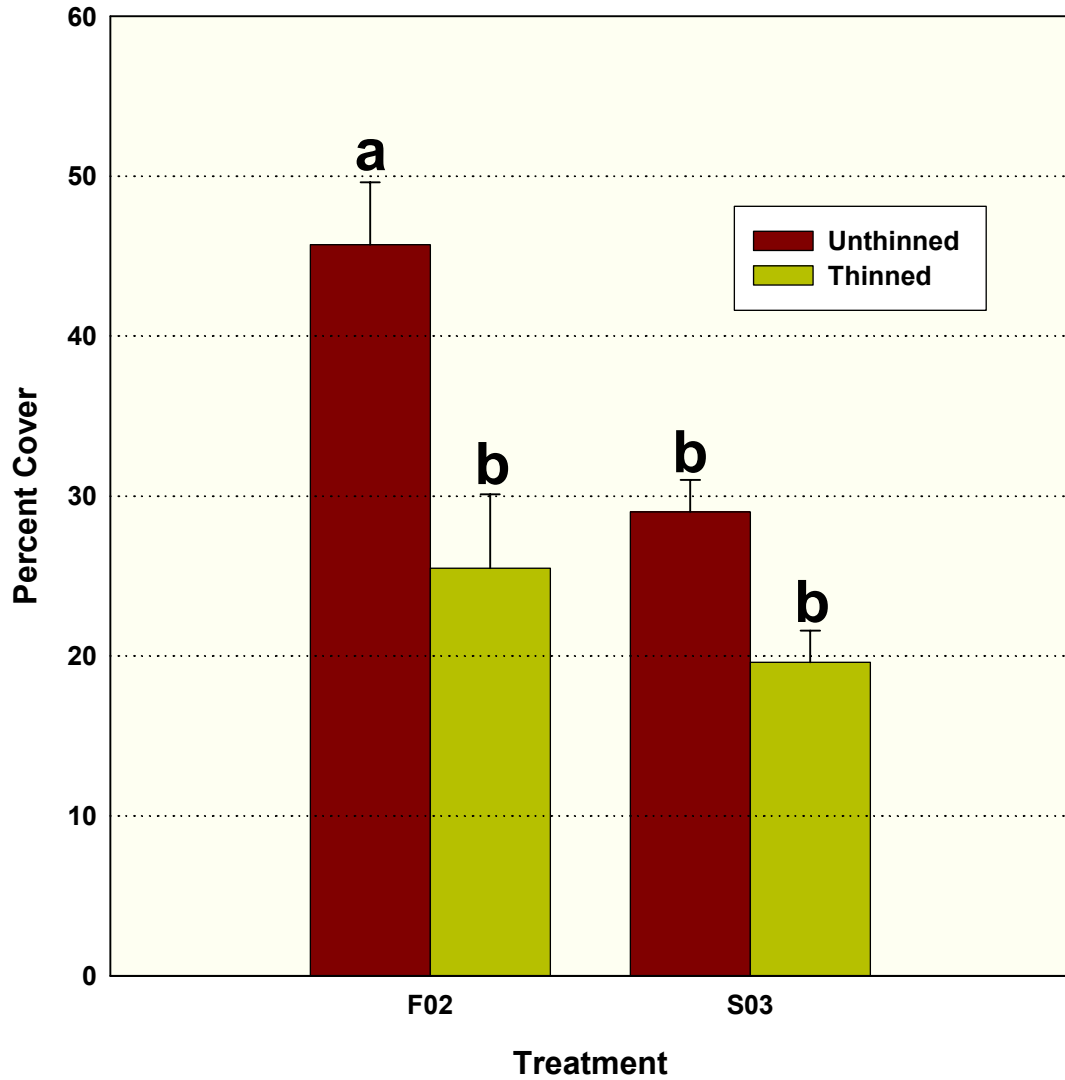
Figure 7. Total percent vegetation cover from thinned and unthinned BART units. Sampling periods include fall 2002 (F02) and summer 2003 (S03). Columns with the same letter are not significantly different ($p>0.05$).

Extensive thinning activities were implemented on some of the rehab units. Thinning has occurred on 484 ac (196 ha) of the 599 ac (242 ha), or 81%, of the total area that received rehab treatments. In most cases trees were cut on the site and chipped or skidded off site. In some cases all of the ground cover, including the rehabilitation treatments, was removed from the site. Figure 7 shows the differences between total vegetation cover on thinned and unthinned plots. There was significantly less cover on thinned units in fall 2002. In summer 2003, cover had declined in both thinned and unthinned units but much more so on the unthinned units, to the point where they are no longer significantly different. Total ground cover was also significantly less on thinned units in fall 2002 (Fig. 8). However, ground cover decreased on unthinned units and increased on thinned units to where they were no longer significantly different in summer 2003.
