UNITED STATES
DEPARTMENT OF LABOR
MINE SAFETY AND HEALTH ADMINISTRATION
COAL MINE SAFETY AND HEALTH

REPORT OF INVESTIGATION
Fatal Underground Coal Mine Explosion
January 2, 2006
Sago Mine, Wolf Run Mining Company
Tallmansville, Upshur County, West Virginia
ID No. 46-08791
By

Originating Office
Mine Safety and Health Administration
Office of the Administrator
Coal Mine Safety and Health
1100 Wilson Boulevard
Arlington, Virginia, 22209
Kevin G. Stricklin, Acting Administrator
May 9, 2007

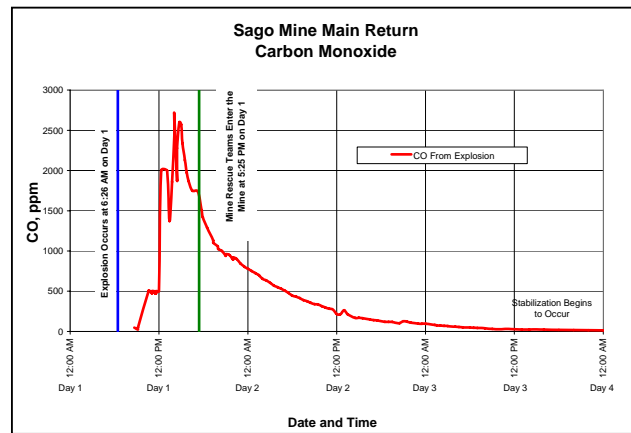
Figure 3 - CO Measurements at the No. 1 Drift Opening

The air quality readings continued trending downward. Figure 3 illustrates the results of CO measurements obtained in the No. 1 Drift Opening. While they were still at dangerous levels, it was determined that they were low enough to allow rescue efforts to commence. At 4:55 p.m., the mine operator submitted a plan for the start of exploration which was approved by MSHA and WVMHS&T. The plan called for Tri-State Team A to enter the No. 5 intake entry and to explore the first 1,000 feet. Tri-State Team B would serve as their backup in the event Team A personnel experienced any type of difficulty. At 5:12 p.m., the mine operator submitted a new plan switching the Tri-State teams to the CONSOL teams, since CONSOL's teams had more experience in mine rescue than any other team present.

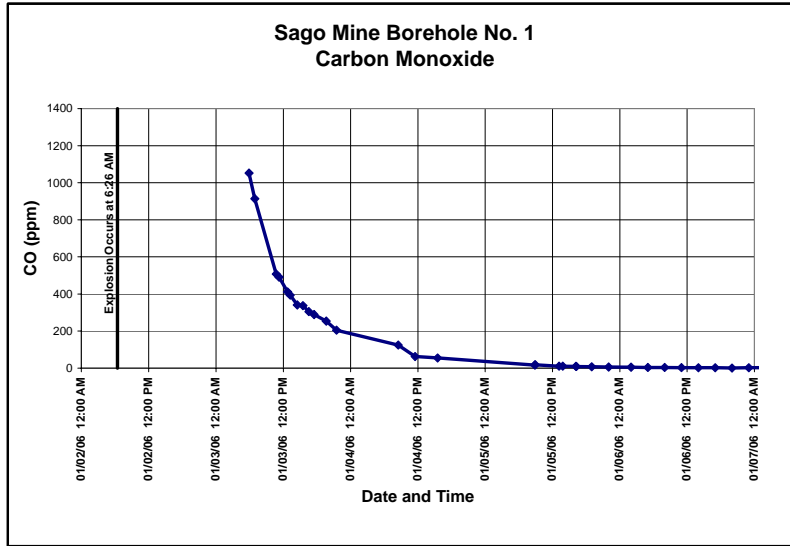
Figure 5 - Borehole No. 1 Carbon Monoxide Results

ppm CO and 20.4% oxygen. Figure 5 illustrates the results of CO measurements obtained in Borehole No. 1. Appendix E contains the gas chromatograph analysis results for samples collected at the Borehole No. 1.

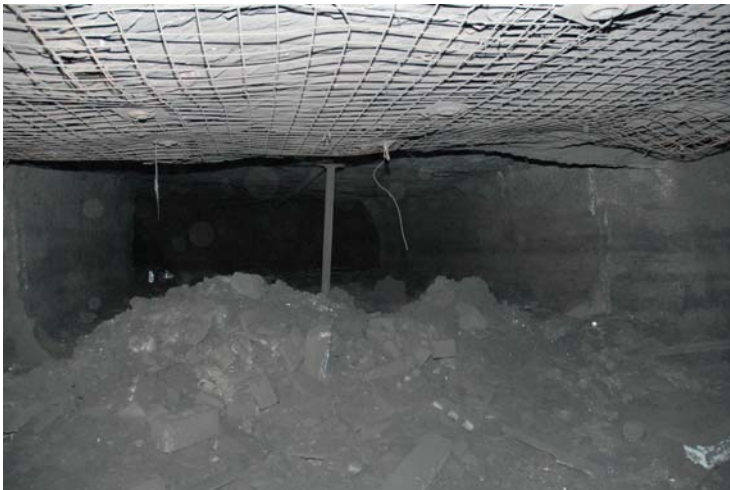
Figure 6 - Damaged Stopping at 59 Crosscut, No. 4 Belt

After the mine rescue/recovery teams examined and established ventilation throughout the mine, the underground portion of the investigation commenced on January 26, 2006. Figure 6 is a photograph of a damaged ventilation control between the Nos. 6 and 7 entries at 59 Crosscut, No. 4 Belt found during recovery of the mine.

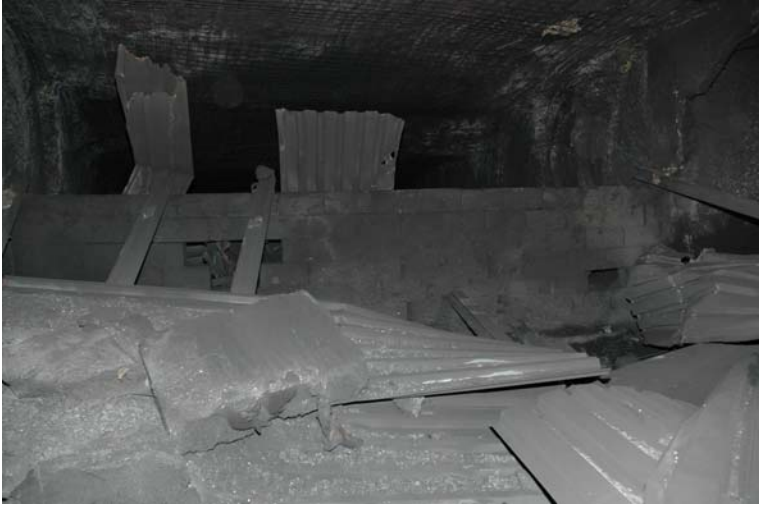
Figure 7 - Damaged Overcast at 58 Crosscut, No. 4 Belt

Figure 7 is a photograph of a damaged overcast in the No. 2 entry 58 Crosscut, No. 4 Belt found during recovery of the mine.

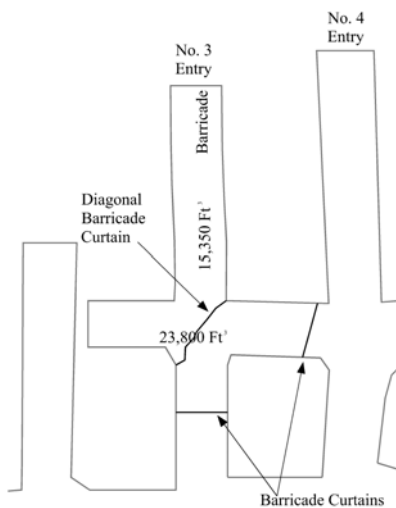
Figure 8 -Drawing of Barricade

The diagonal curtain was approximately 29 feet in length from rib to rib and balled up on the outby end, according to the captain of the McElroy mine rescue team. The volume of the larger area, (curtain in the crosscut and the curtain in the entry to the face) was about 23,800 cubic feet. The volume of the smaller area, (diagonal curtain to the face) was 15,350 cubic feet. The larger area calculated into cubic yards for 12 miners would be 73 cubic yards per miner. The smaller area for 12 miners would be only 47 cubic yards per miner. This shows that the miners had enough air to sustain them for at least 47 hours if they remained in the smaller area within the barricade and if normal air was in the barricade. This is about 6 hours longer than it took for mine rescue teams to reach the barricade. Figure 8 is a drawing of the barricade.

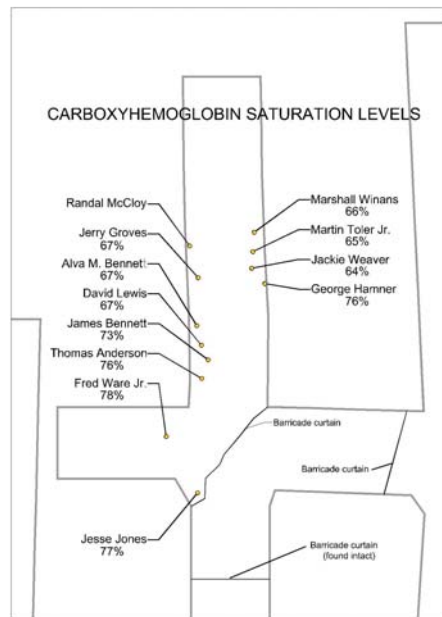
Figure 9 - Location of Miners and Their Carboxyhemoglobin Levels

The cause of death for all of the victims was carbon monoxide intoxication/poisoning. Helms was found near the mouth of the 2nd Left Parallel section and had a carboxyhemoglobin saturation of 78%. The deceased miners found in the barricade had carboxyhemoglobin saturation levels ranging from 64% to 78%. The levels do not appear to be age or size dependent but indicate a trend relative to their distance from the barricade curtains with McCloy, the surviving miner, being the furthest in by.

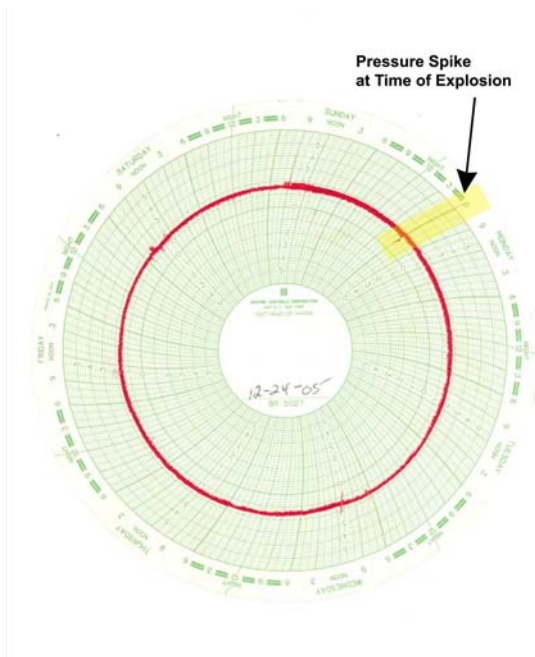
Figure 12 - Fan Chart

146,566 cfm on December 28, 2005. The total quantity of return air exiting the mine through the No. 1 Drift Opening was 101,088 cfm. The remaining 45,478 cfm would have exited the mine through the Nos. 2, 3 and 4 Drift Openings. The blowing fan was an 8 foot diameter, Joy Model Number M96-50 fan, with a blade setting of 8 degrees and operating at about 1.9 inches of water gauge. Figure 12 is a copy of the chart which was on the fan pressure recorder when the explosion occurred. Although the fan chart shows a pressure spike about 6:00 a.m., the explosion occurred about 6:26 a.m. This indicates that the fan chart was not correctly aligned on the pressure recorder to correspond with actual time.

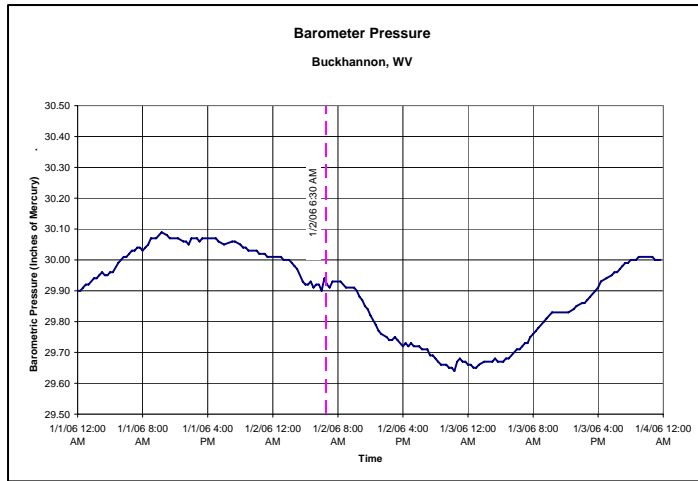
Figure 13 - Barometric Pressure for Buckhannon, WV

Figure 13 is a graph of the barometric pressure for Buckhannon, West Virginia from 12:00 a.m. on January 1 through 12:00 a.m. on January 4, 2006. These

changes in barometric pressure did not appear to significantly influence the conditions within the sealed area just prior to the explosion, since the point of origin for this explosion was more than 300 feet from the seals.

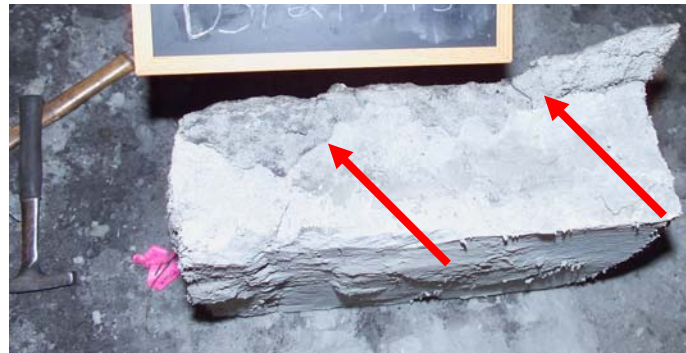
Figure 19 - Mortar in Vertical Joint

Statements indicated that dry BlocBond was spread across the mine floor at each seal location as the initial step in seal construction. A dry powder such as BlocBond must be properly mixed with quantities of water designated by the manufacturer to form mortar. The quality of the BlocBond observed after the explosion varied. The BlocBond which remained on the ribs appeared to be properly mixed. It remained attached to the ribs after the explosion. It was dark gray to black and was extremely difficult to remove. The BlocBond observed on the floor, after Omega blocks were removed, was light gray and easily removed.

The average compressive strength of the mortar cast in the laboratory exceeded 8000 psi. Only one mine core sample had a comparable compressive strength, however, the remaining mine core samples only had strengths from 830 to 2810 psi. Strength discrepancies in the mine core samples occurred because of inadequate mixing, incorrect water contents, inclusion of extraneous materials, or from fissures or tears that occurred after the mortar stiffened.

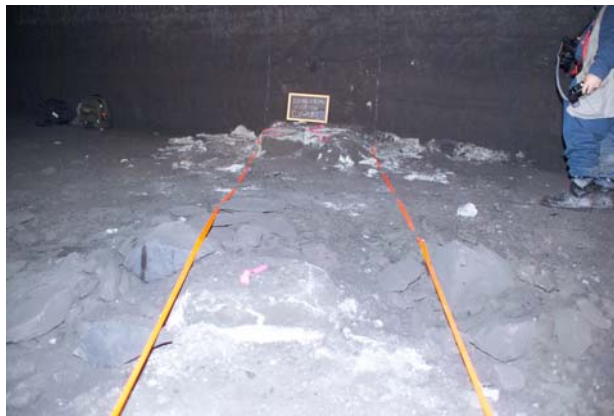
Figure 20 - Post-Explosion Location of Seal No. 1

The ten 2 North Main seal locations were evaluated during the investigation. The post-explosion location of Seal No. 1 is shown in Figure 20. Several whole and partial Omega blocks remained at the location of Seal No. 1 after the explosion. An exposed horizontal layer of BlocBond was easily removed from the remaining Omega blocks, indicating the lack of good bonding. No BlocBond was observed in some vertical joints. This seal had been constructed on a diagonal and was not perpendicular to either rib.

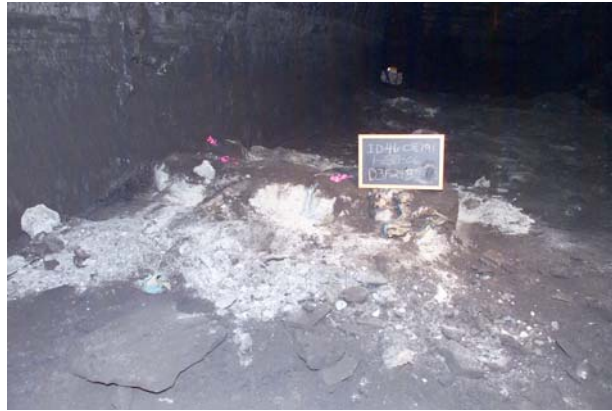
Figure 21 - Post-Explosion Location of Seal No. 2

The post-explosion location of Seal No. 2 is shown in Figure 21. Several Omega blocks remained at the location of Seal No. 2 after the explosion. Unburned paper material was observed imbedded within the mortar along one rib and also in a remaining joint between Omega blocks. No significant thickness of BlocBond was found between remaining Omega blocks. The vertical joint between two Omega blocks included BlocBond for only approximately 25% of the joint.

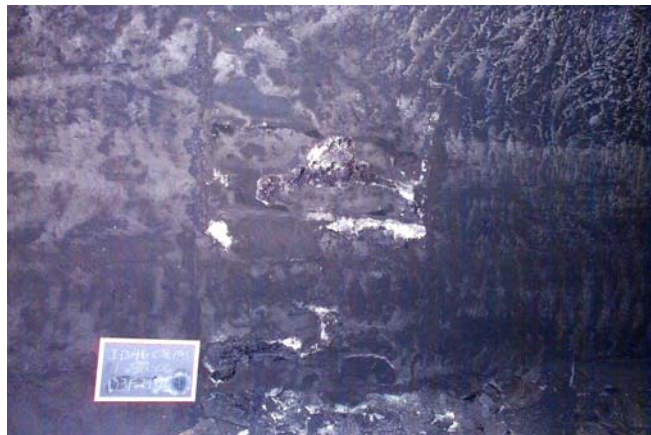
Figure 22 - Post-Explosion Location of Seal No. 3

The post-explosion location of Seal No. 3 is shown Figure 22. BlocBond on the rib was difficult to remove, indicating proper mixing prior to application. BlocBond on the floor had very little strength, indicating improper or no mixing with water prior to application.

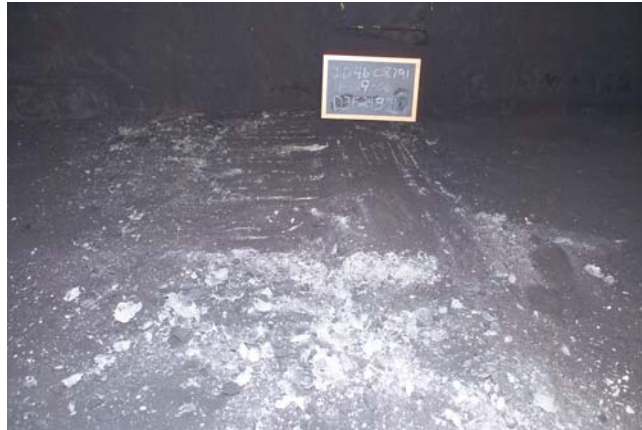
Figure 23 - Post-Explosion Location of Seal No. 4

The post-explosion location of Seal No. 4 is shown in Figure 23. BlocBond was observed on the floor as a smooth surface, indicating a lack of adherence to the Omega block.

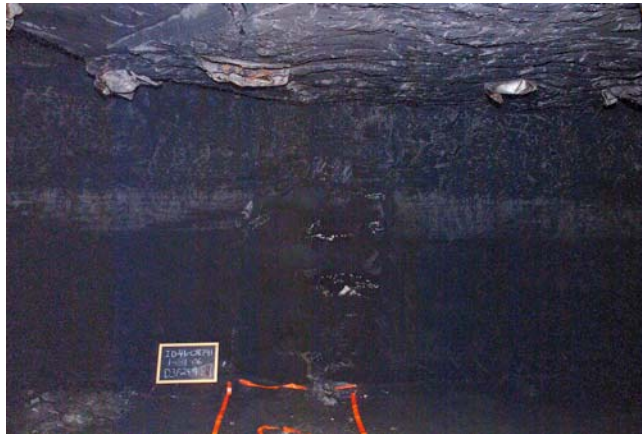
Figure 24 - Post-Explosion Location of Seal No. 5

The post-explosion location of Seal No. 5 is shown in Figure 24. BlocBond and Omega blocks were set on loose floor material at this location.

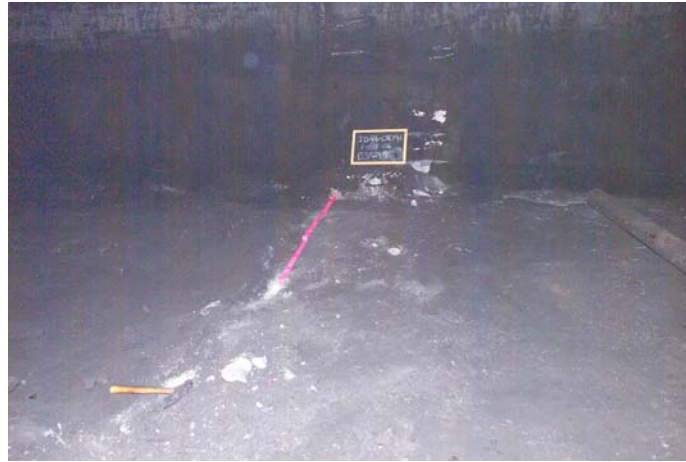
Figure 25 - Post-Explosion Location of Seal No. 6

The post-explosion location of Seal No. 6 is shown in Figure 25. It appeared that pieces of Omega block were used, along with dry BlocBond, to level the floor prior to construction of the seal.

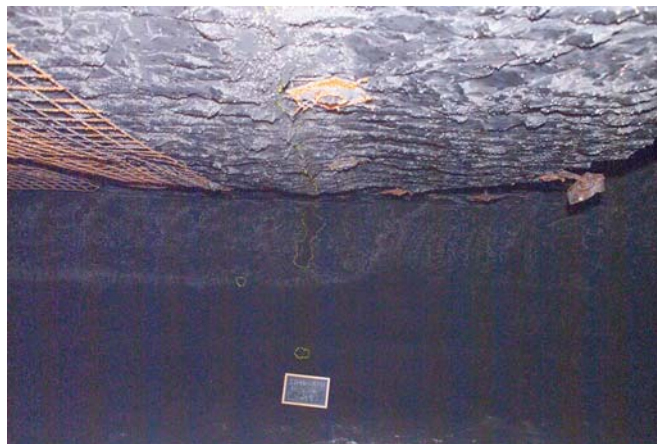
Figure 26 - Post Explosion Location of Seal No. 7

The post-explosion location of Seal No. 7 is shown in Figure 26. Very little BlocBond was observed on the ribs. The BlocBond was difficult to remove, indicating good strength characteristics.

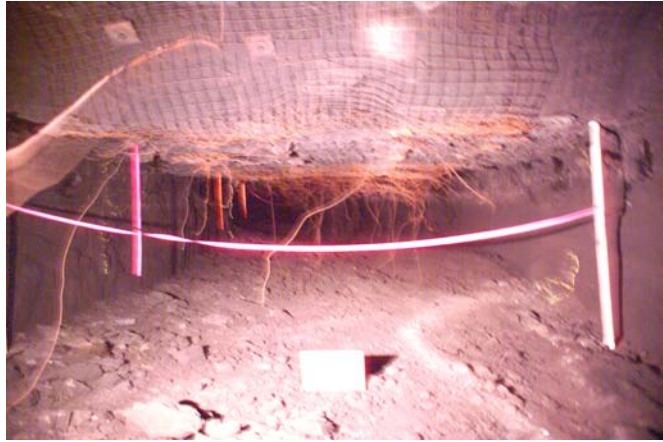
Figure 27 - Post-Explosion Location of Seal No. 8

The post-explosion location of Seal No. 8 is shown in Figure 27. Very little BlocBond was observed on the ribs. The BlocBond was difficult to remove, indicating good strength characteristics. Roof conditions deteriorated during the investigation at this location.

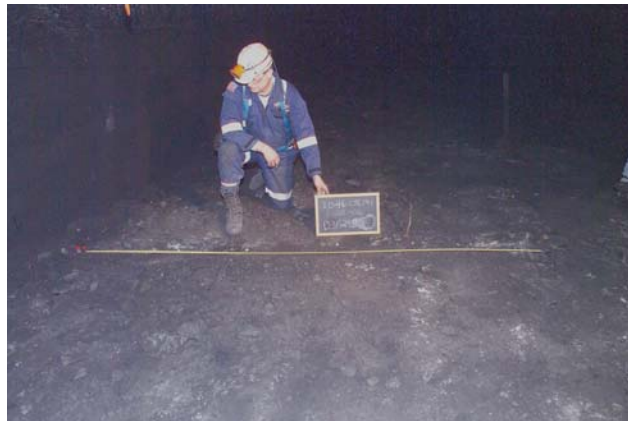
Figure 28 - Post-Explosion Location of Seal No. 9

The post-explosion location of Seal No. 9 is shown in Figure 28. Several Omega blocks remained at the location of Seal No. 9 after the explosion. Unburned plastic and paper material was observed imbedded within the mortar along one rib. A coating of dry, unmixed BlocBond was observed on the floor.

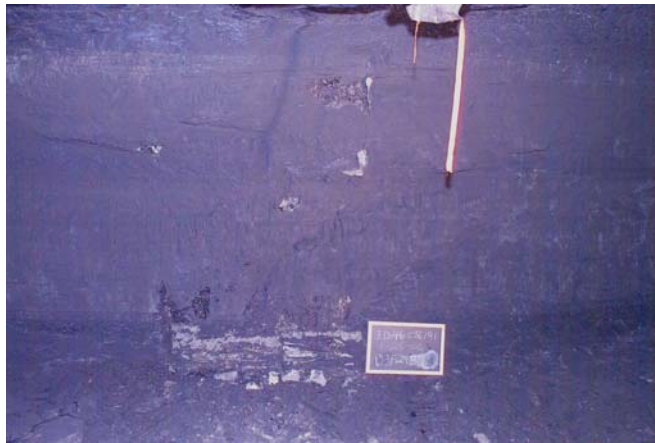
Figure 29 - Post-Explosion Location of Seal No. 10

The post-explosion location of Seal No. 10 is shown in Figure 29. No Omega blocks remained on the floor. There were some indications of mortar on the ribs.

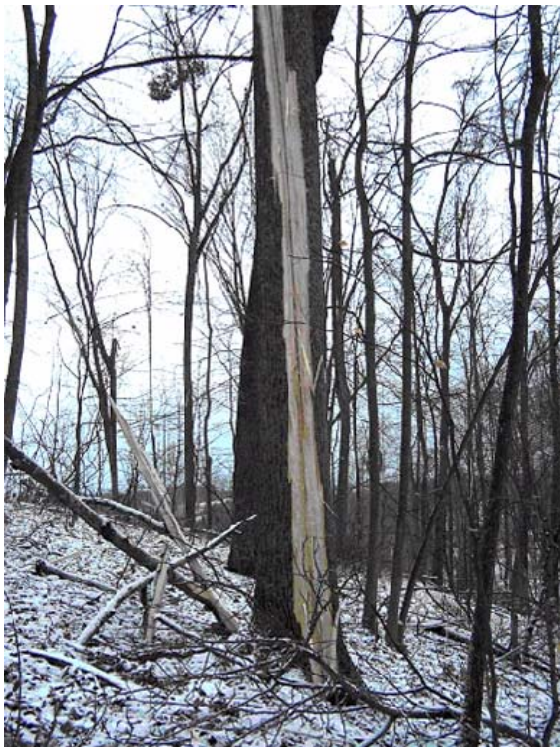
Figure 40 - Damaged Tree

The NLDN recorded two lightning strikes near the mine area at the time of the accident. The first strike occurred at 6:26:35.522 a.m. and reportedly occurred more than one mile south of the mine drift openings. This was a positively charged strike with a magnitude of 38,800 amps. Several unsuccessful attempts were made to locate evidence of a strike in this area. The other lightning strike occurred at 6:26:35.680 a.m. and was about one mile north of the mine drift openings. It was also a positive lightning strike with a magnitude exceeding 100,000 amps. Evidence of this strike hitting a tree was found. The tree had freshly splintered pieces scattered around it. This is shown in Figure 40.

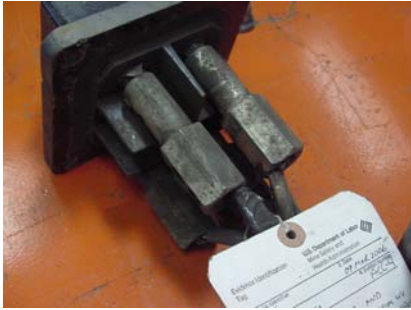
Figure 43 - Cable Coupler

When a cable is connected to a coupler, the four insulated conductors are in close proximity to grounded conductors and the grounded shell of the coupler. A cable coupler contains exposed bare copper pins that connect to the red, white, black, ground and ground check conductor. Figure 43 is a photograph of the cable coupler.

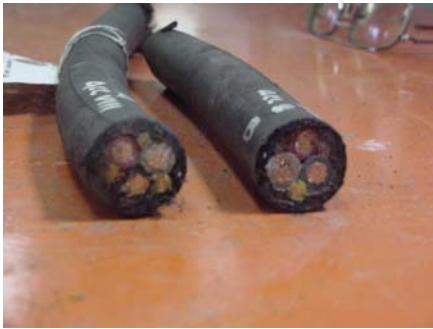
Figure 44 - Coupler with Pins and Conductors

Figure 44 is a photograph of the end of the cable coupler containing the connecting pins and the conductors. These pins become energized to the same level as their connected conductors. The coupler was lying on the damp mine floor, the coupler pins were exposed to moist dirt that could provide a path to the grounded metal shell resulting in an arc.

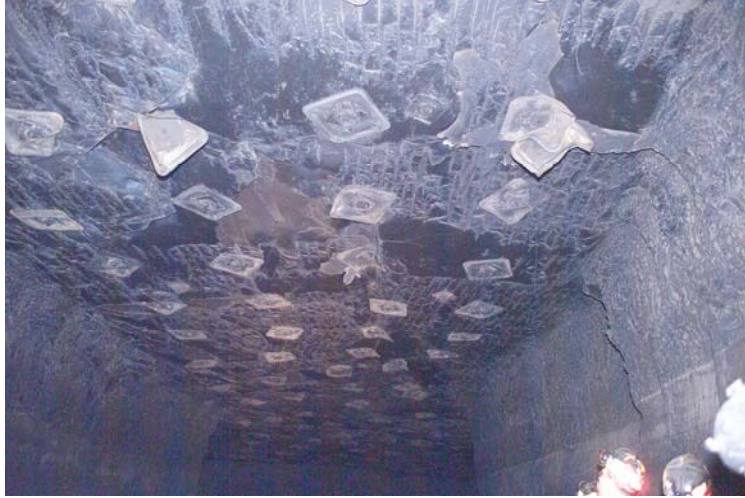
Figure 46 - Picture taken Near Survey Station 4010

Figure 46 was taken near survey station 4010, facing outby in an area that had been second mined. All but two of the roof plates appear to be unaffected by the forces of the explosion, indicating that forces had not reached their peak magnitude.

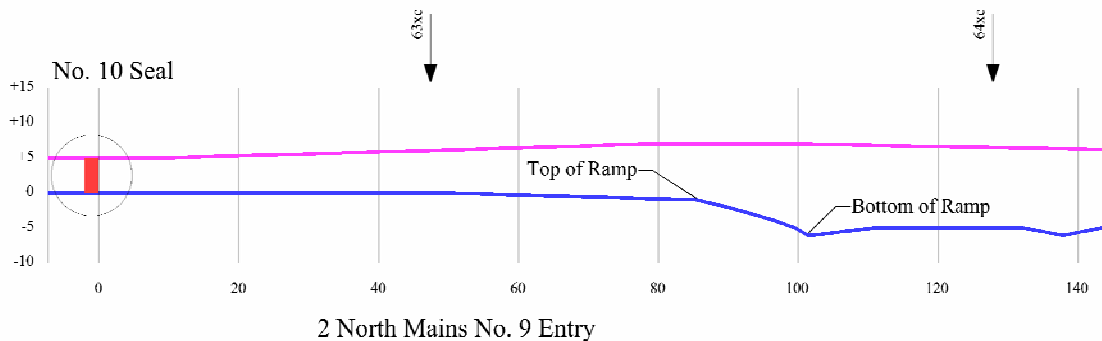
Figure 50 - Contours Near Seal No. 10 in 2 North Mains, No. 9 Entry

Figure 50 shows a typical side view of the entry in which Seal No. 10 was constructed. The seal is shown on the left. The line across the top of the figure shows the elevation of the roof. The line across the bottom of the figure details changes in the mine floor due to bottom mining. Those areas to the right of the seal location shown in the figure are part of the sealed area. The height of the entry at the bottom of the ramp, where bottom mining commenced, is approximately 2.5 times the height at the location of the seal.

As the explosion propagated toward the location of the ten seals, the mine atmosphere immediately behind the seals would have experienced increased pressure due to the shock wave of the approaching flame front. Pressures would have increased dramatically as the explosion propagated up the ramp into more restricted entry heights. The pressurized mine atmosphere immediately behind the seals would have caused pressure piling effects.

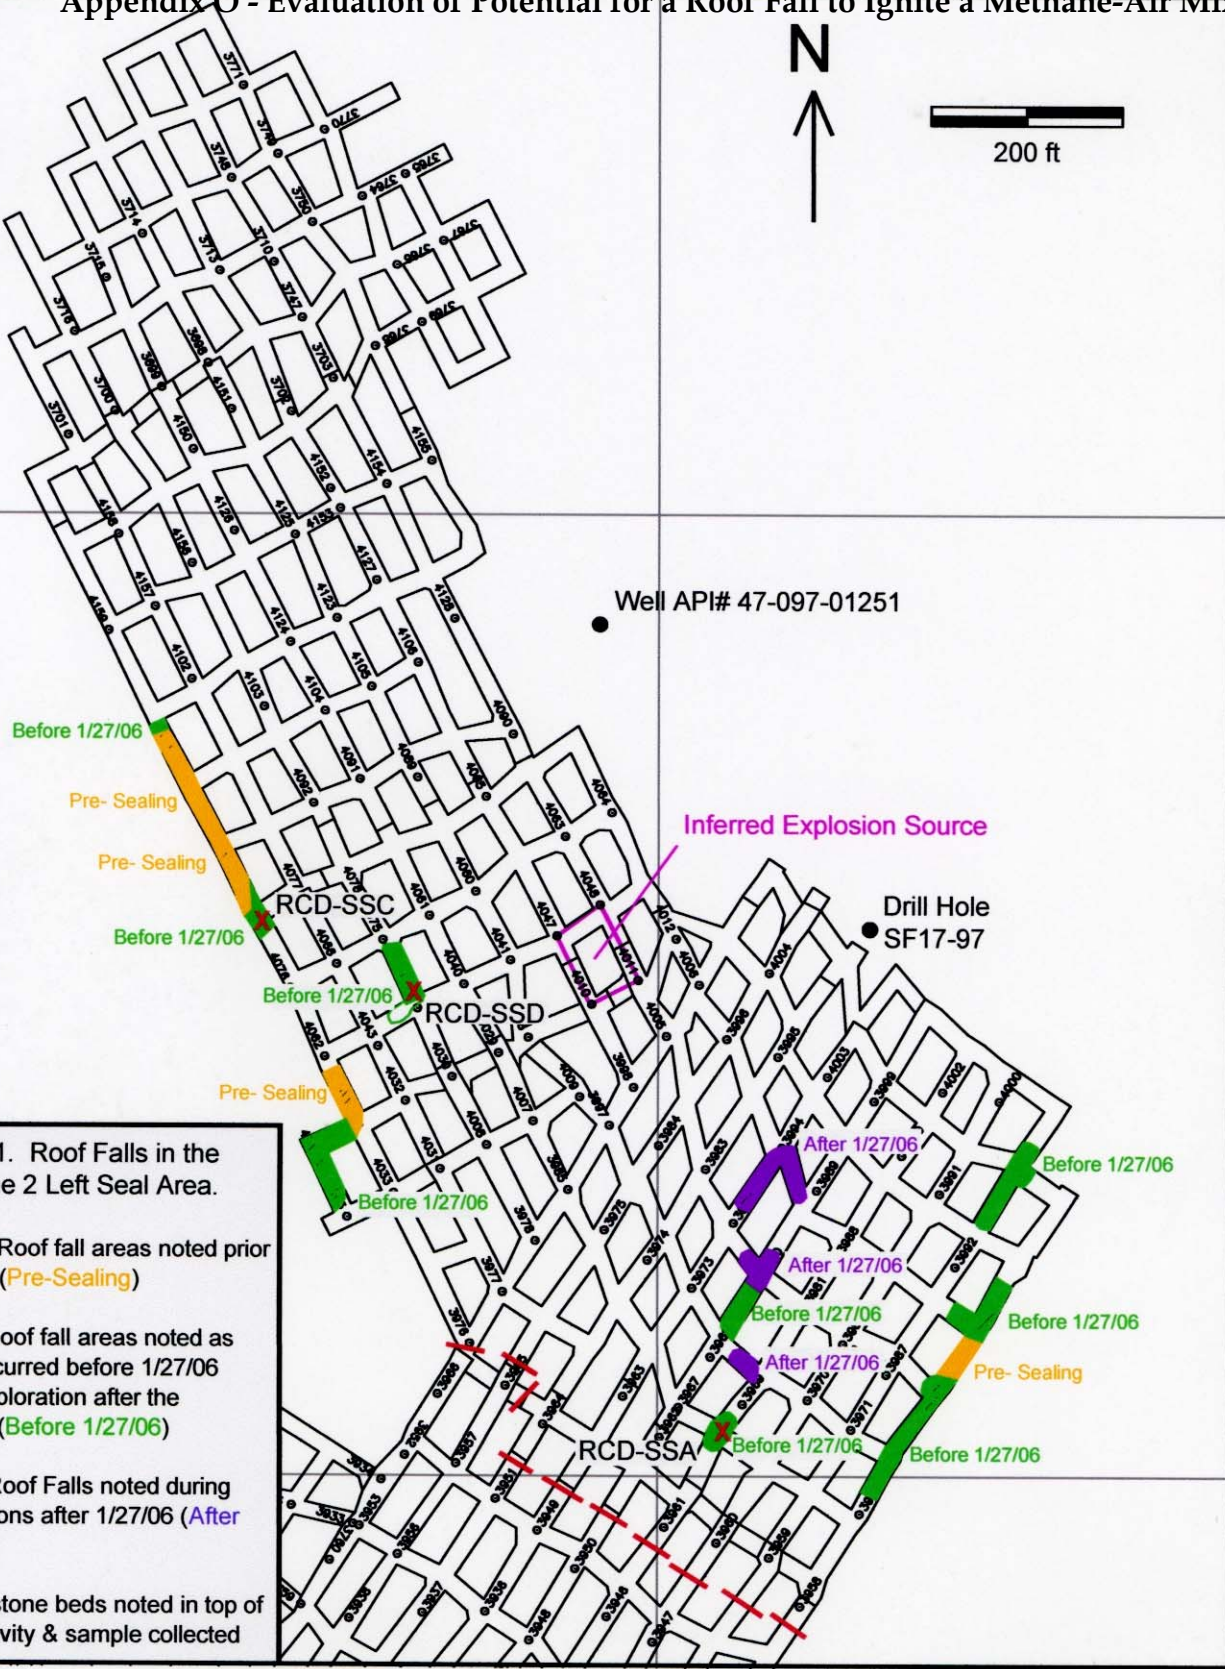
Drawing 1. Roof Falls in the Sago Mine 2 Left Seal Area.

Mining was completed in 2 Left in late October and the seals were completed on December 11, 2005. Prior to the January 2nd explosion, three pre-sealing roof falls had been identified on the mine map. Roof Control Division personnel visited the mine on January 30, 2006, and observed that these three pre-sealing roof falls had extended (see Drawing 1). Also, four additional roof falls were observed that were not shown on the mine map prior to seal completion (see Drawing 1 green shaded falls labeled "Before 1/27/06"). It is not known exactly when these four newer roof falls occurred. The roof fall areas observed were consistent with roof fall information collected by other investigators during initial exploration on January 27, 2006. Roof Control Division personnel again observed the 2 Left area on May 11, 2006, and found additional roof falls that were not present on January 27 or 30 (see Drawing 1 purple shaded falls labeled "After 1/27/06").

Other investigators have determined that the explosive forces propagated in every direction from the area near surveying spads 4010, 4011, 4047, and 4048 (see Drawing 1). The seven roof falls that were observed during the January 30 investigation range in distance from approximately 150 ft. to 470 ft. from this area. The

Orange = Roof fall areas noted prior to sealing (**Pre-Sealing**)

Green = Roof fall areas noted as having occurred before 1/27/06 during exploration after the explosion (**Before 1/27/06**)

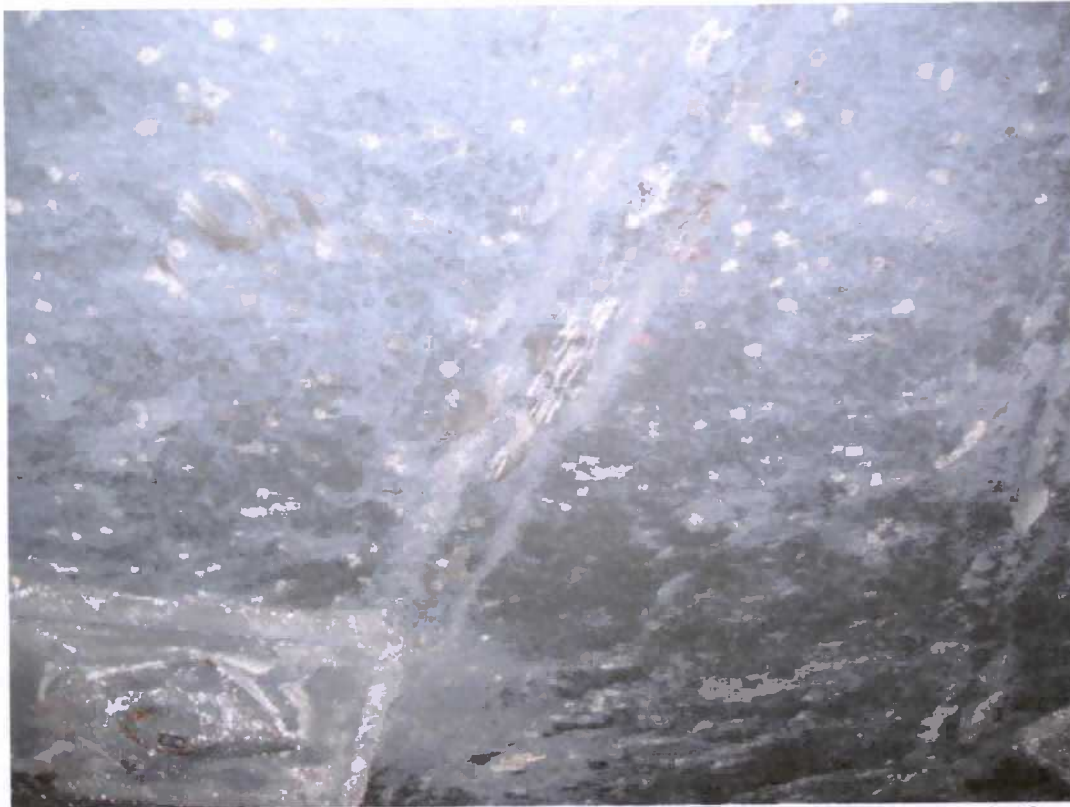
Figure 5. Light brown linear streaks along the trend of the parallel linear ridges represent knife scratch marks from an attempt to collect fossil material. Location is the vicinity just inby the spad 4010 intersection. Twin parallel ridges pass beneath the embossed, square skin control plate.

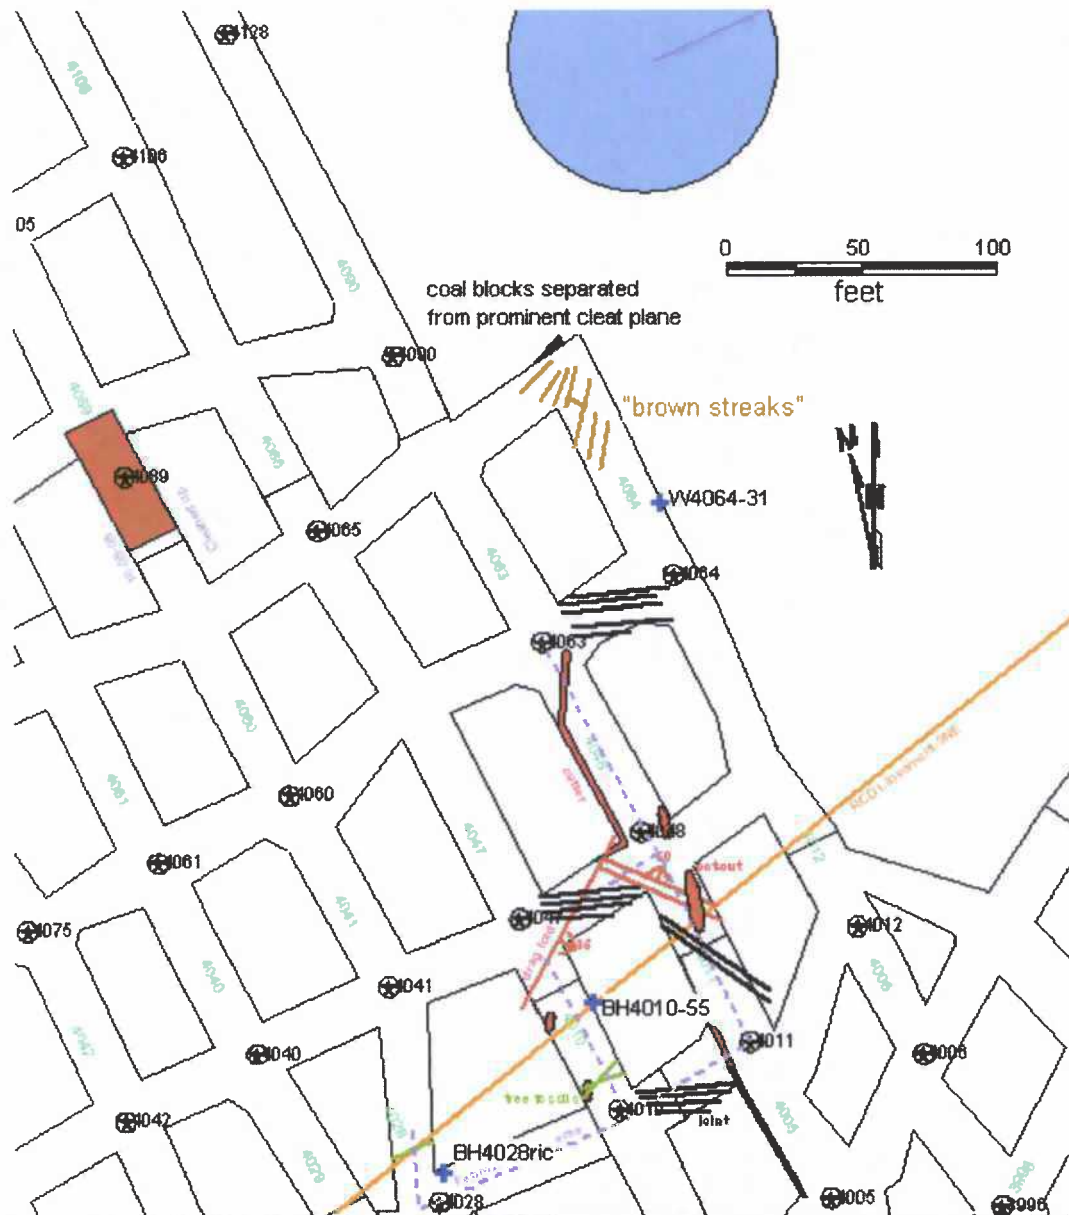
Figure 1. Map of geologic features in a portion of the 2nd Left Mains, showing results of mapping from February 21 and March 20, 2006. Sample collection area is centered on dark green features just inby spad 4010. Dashed purple line indicates February 21, 2006 observation traverse.

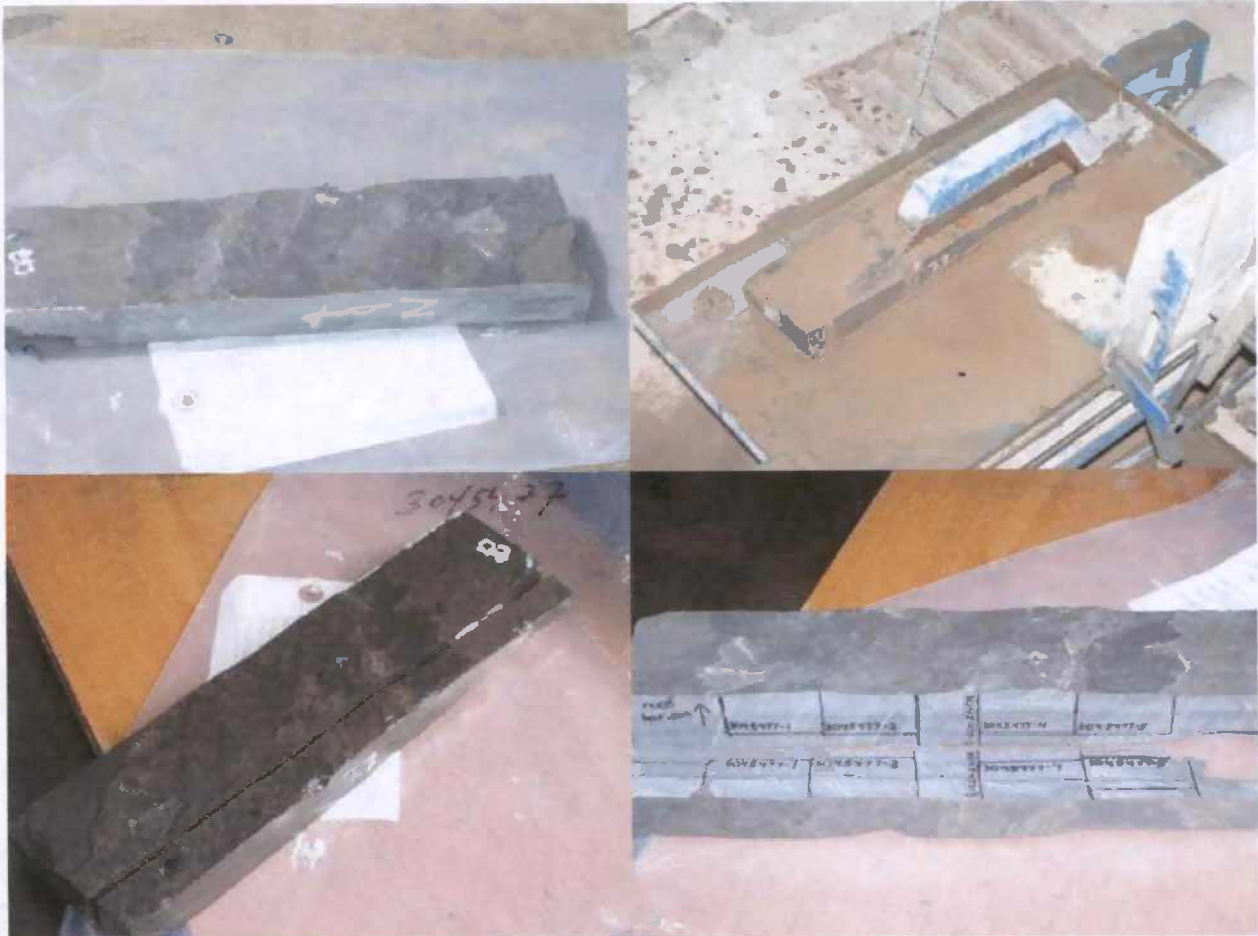
Figure 5. Split of Sample 3045477 obtained by R. J. Lee on March 1, 2006 at A&CC, showing cross section across the linear feature observed inby spad 4010, 2nd Left Mains. The work shown was performed at the Approval and Certification Center.

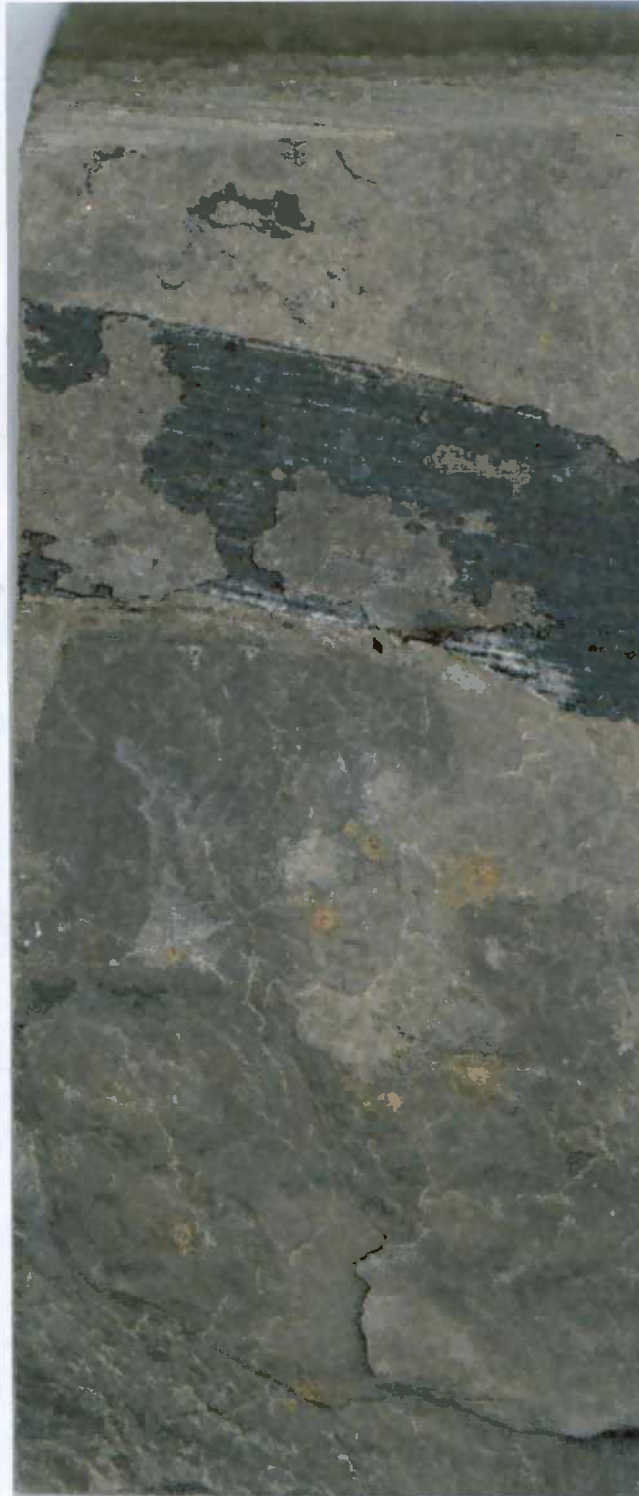
Figure 8. Enlarged view of a small, rectangular sample chip prior to being sent for thin section preparation. This piece of Sample 3045475 exhibits a black area that represents carbonized fossil plant bark. Parallel lines are interpreted to represent cellulose plant fiber. The pair of linear features observed inby spad 4010 in 2nd Left Mains is cored by this carbonized fossil material. The sample is approximately 7/8 inch wide x 1 3/4 inches long.

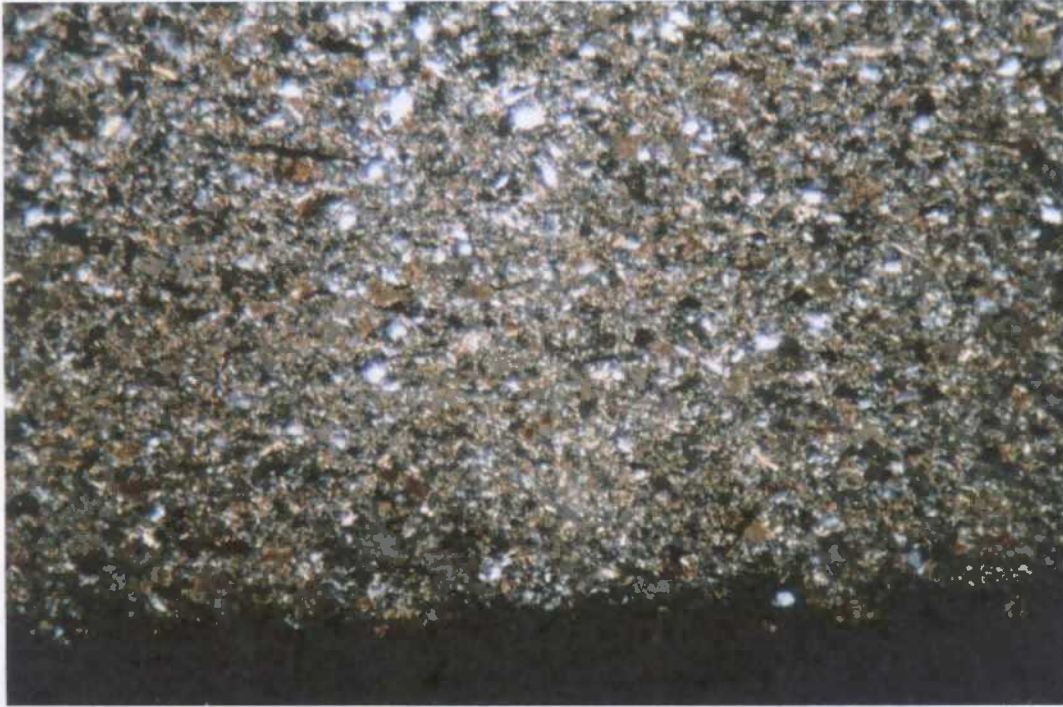
Figure 9. Lowest layer of shale immediate roof exposed at mine roof horizon, showing angular quartz grains (bright white) scattered in a matrix of very fine-grained lathes of muscovite (rectangular, brightly colored yellow/pink/blue). Brown represents patchy iron staining. Field of view 2.4 mm at 40X, taken under crossed polars.

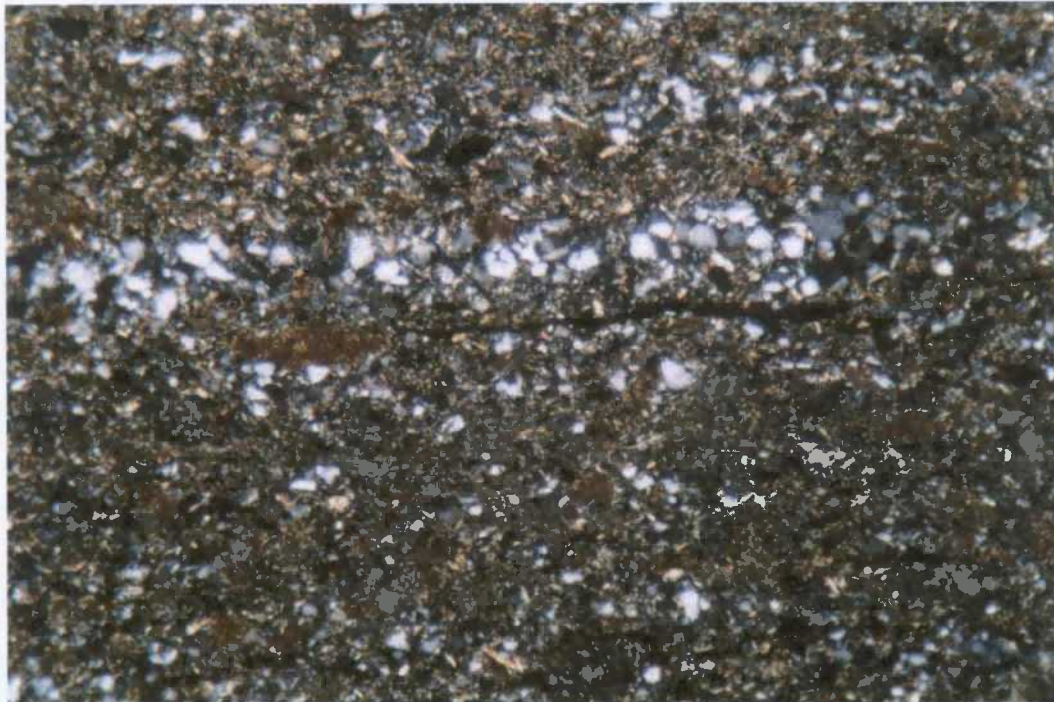
Figure 10. Lamination of angular quartz grains of "very fine sand" size. Angular grains touch along tangential contacts. Long axes of quartz grains and rectangular muscovite lathes are not strongly oriented parallel to bedding, indicating that burial compaction was not intense enough to force grain rotation. Field of view 2.4 mm at 40X, taken under crossed polars.

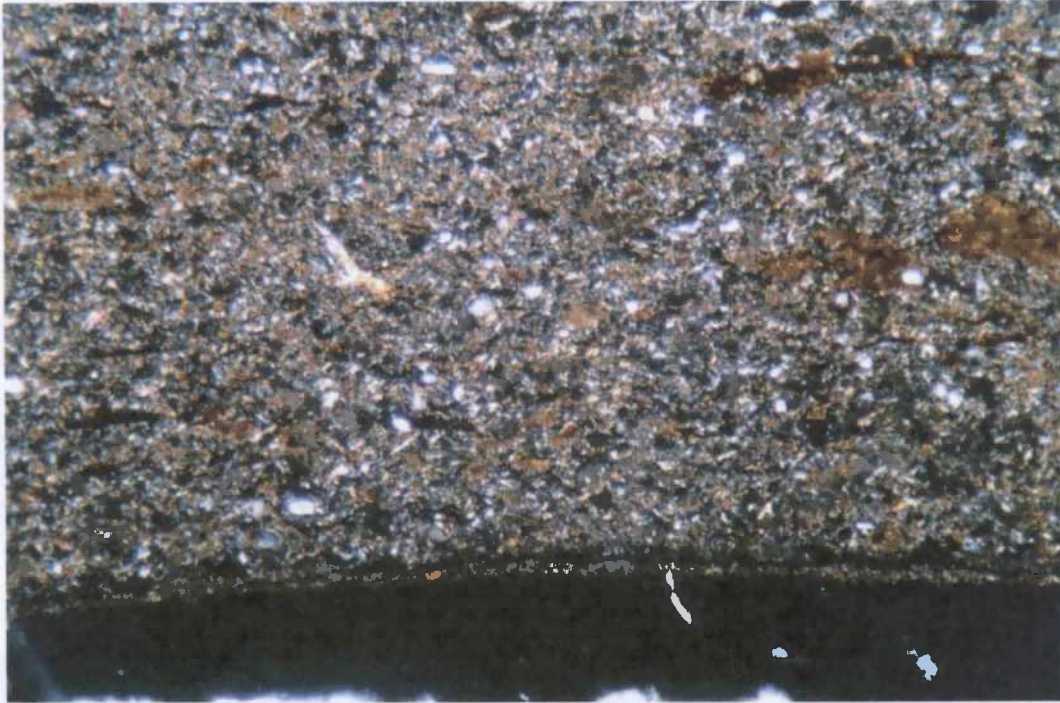
Figure 11. Lowest layer of shale immediate roof exposed at mine roof horizon, showing angular quartz grains (bright white) scattered throughout a matrix of very fine-grained muscovite (brightly colored pink/yellow). The muscovite-dominated matrix hosts patchy iron staining (brown) that is oriented along bedding laminations, and may represent leached original biotite flakes. Field of view 2.4 mm at 40X, taken under crossed polars.

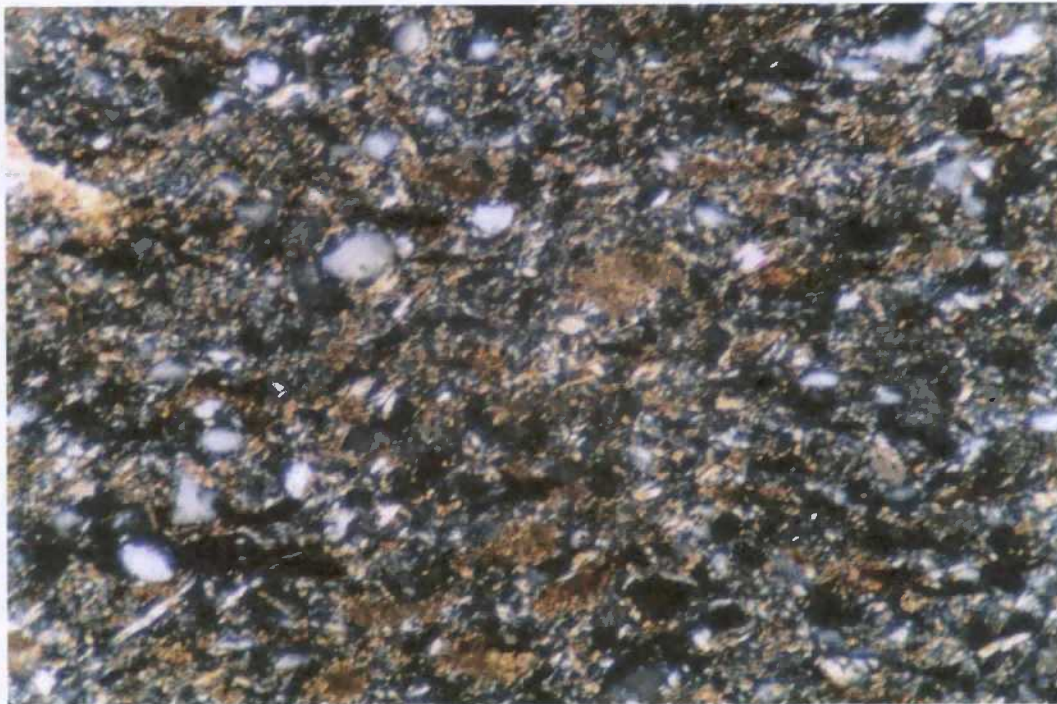
Figure 12. Same area as previous photo, showing individual, angular quartz grains (white and gray) isolated by surrounding, randomly oriented ragged flakes of muscovite (yellow/pink). Brown patchy areas represent iron staining. Field of view 1 mm at 100X, taken under crossed polars.

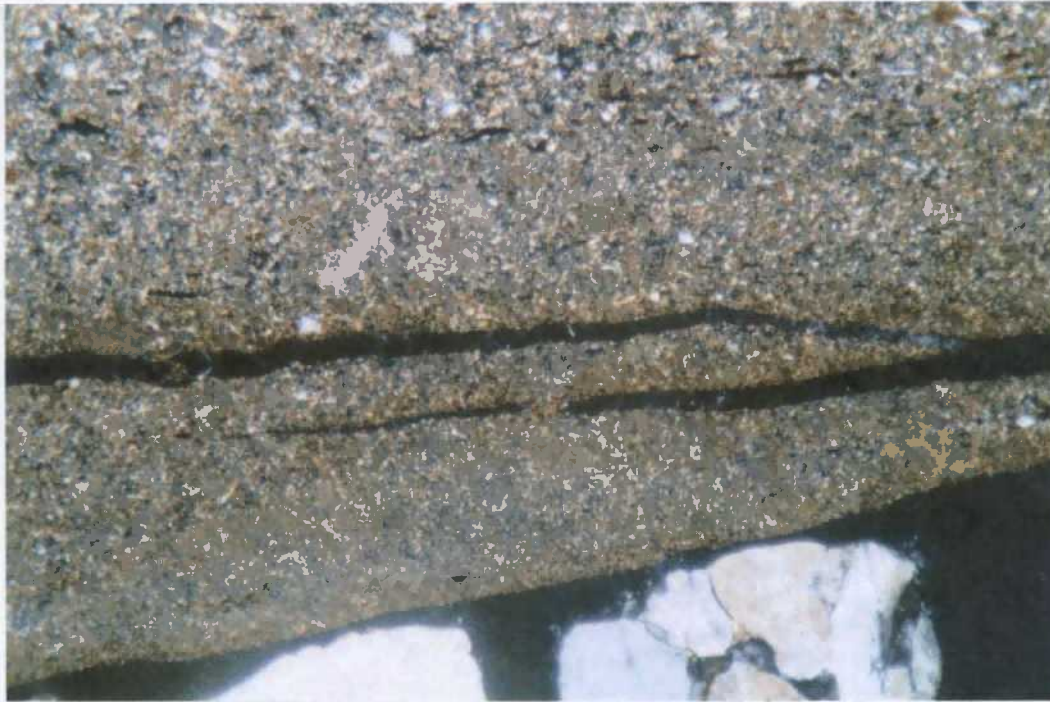
Figure 13. Lowest layer of shale immediate roof exposed at mine roof horizon, showing gradational contact between very fine-grained, muscovite-dominated layer and overlying, coarser layer that hosts greater quartz content and larger grain sizes. Lower, very fine-grained layer localizes delamination zones (parallel black lines represent glass of microscope slide where rock separated).

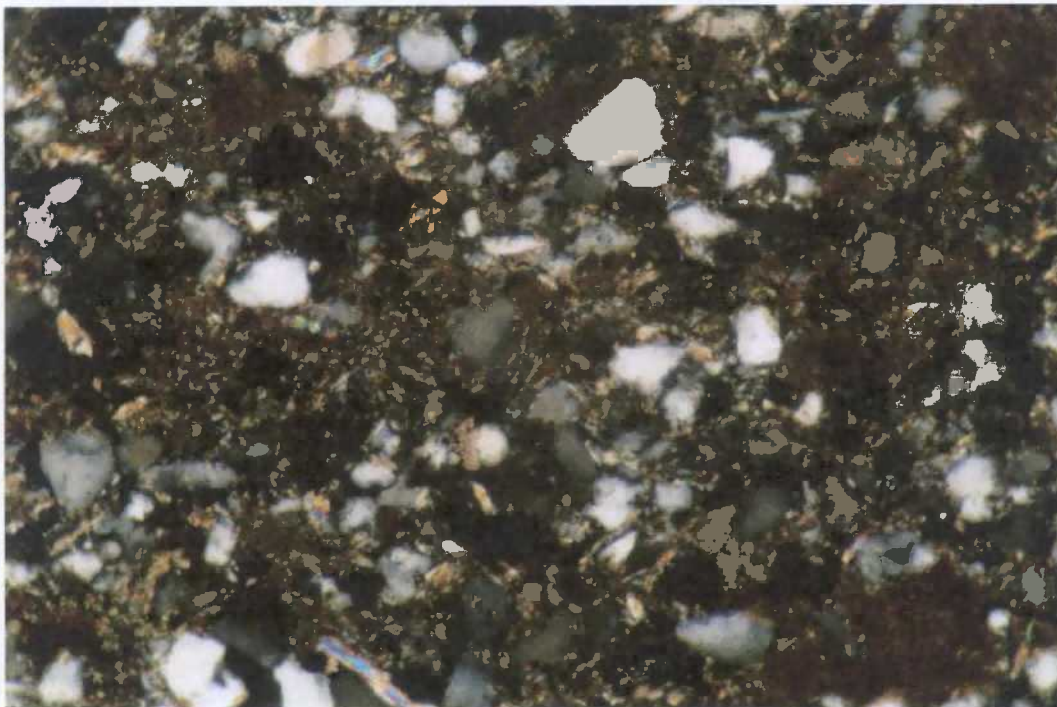
Figure 14. View of a coarser-grained, quartz-rich lamination, showing angular quartz grains (white and gray) isolated by the surrounding matrix of fine-grained muscovite lathes (pink/blue/yellow/green). Brown areas represent patchy iron staining. Field of view 1 mm at 100X, taken under crossed polars.
