UNITED STATES
DEPARTMENT OF LABOR
MINE SAFETY AND HEALTH ADMINISTRATION
COAL MINE SAFETY AND HEALTH

REPORT OF INVESTIGATION
Fatal Underground Coal Mine Explosion
January 2, 2006
Sago Mine, Wolf Run Mining Company
Tallmansville, Upshur County, West Virginia
ID No. 46-08791
By

Originating Office
Mine Safety and Health Administration
Office of the Administrator
Coal Mine Safety and Health
1100 Wilson Boulevard
Arlington, Virginia, 22209
Kevin G. Stricklin, Acting Administrator
May 9, 2007

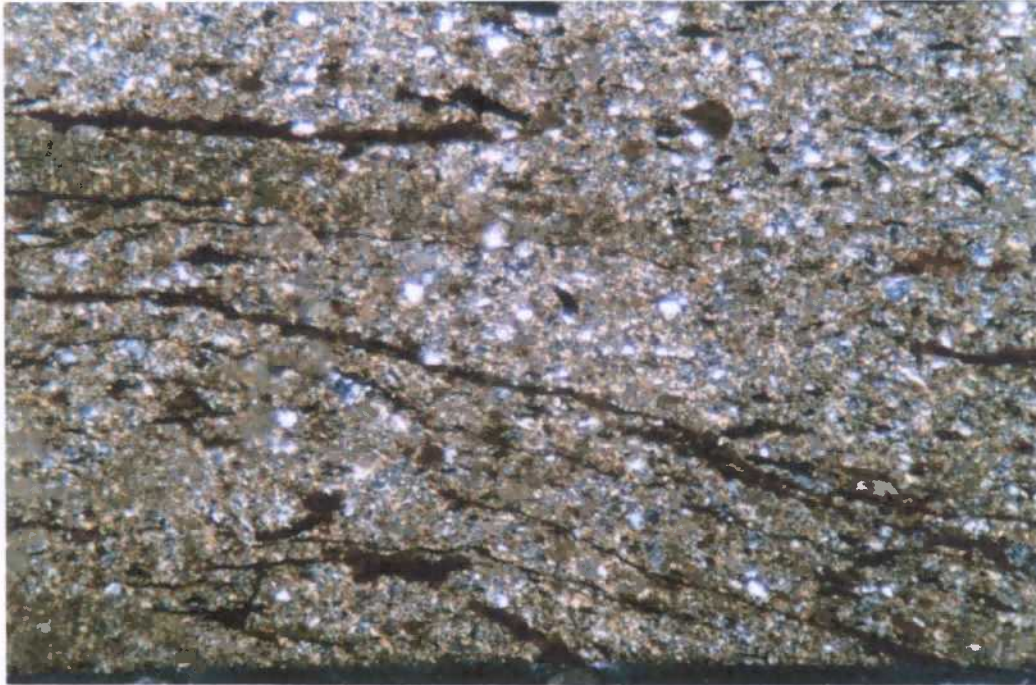
Figure 15. Long stringers of iron hydroxide (black, very dark brown) define bedding laminations in a compaction zone located near the margin of one of the linear ridges in Sample 3045477. Angular quartz grains (bright white) are scattered throughout the matrix of fine-grained muscovite (speckled pink/yellow with brown iron staining). Field of view 2.4 mm at 40X, taken under crossed polars.

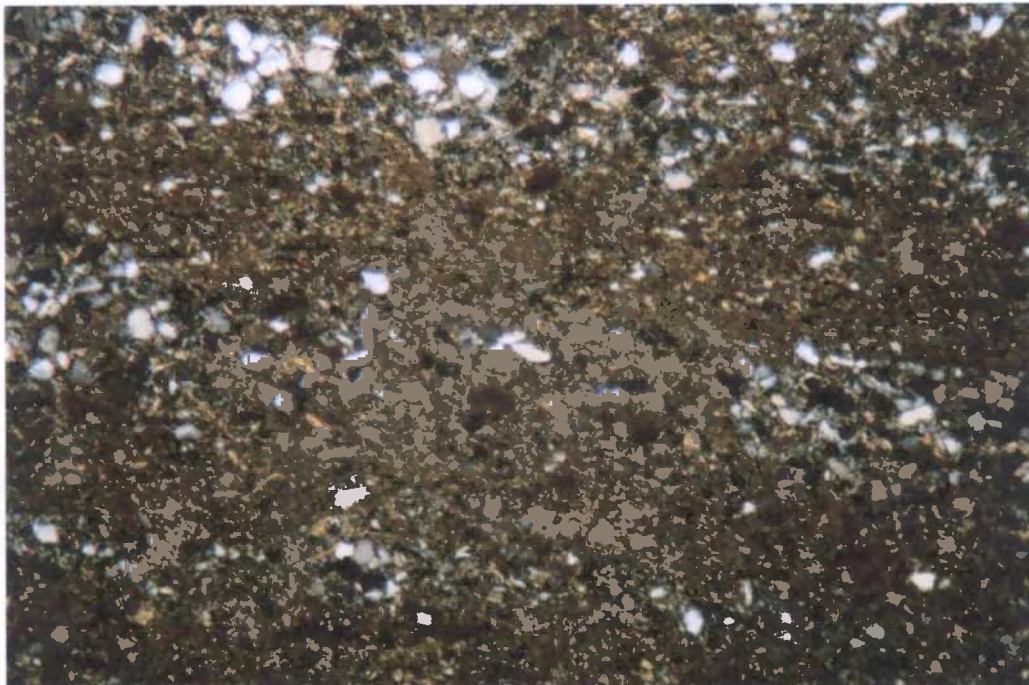
Figure 16. Field of view approximately 5 mm above the area in Figure 15, showing interbeds of quartz that gently rise from right to left above the compaction zone. Although locally a compaction zone, the long axes of quartz grains and muscovite lathes are not strongly oriented parallel to bedding, indicating that burial compaction was not sufficient to force grain rotation. Field of view 2.4 mm at 40X, taken under crossed polars.

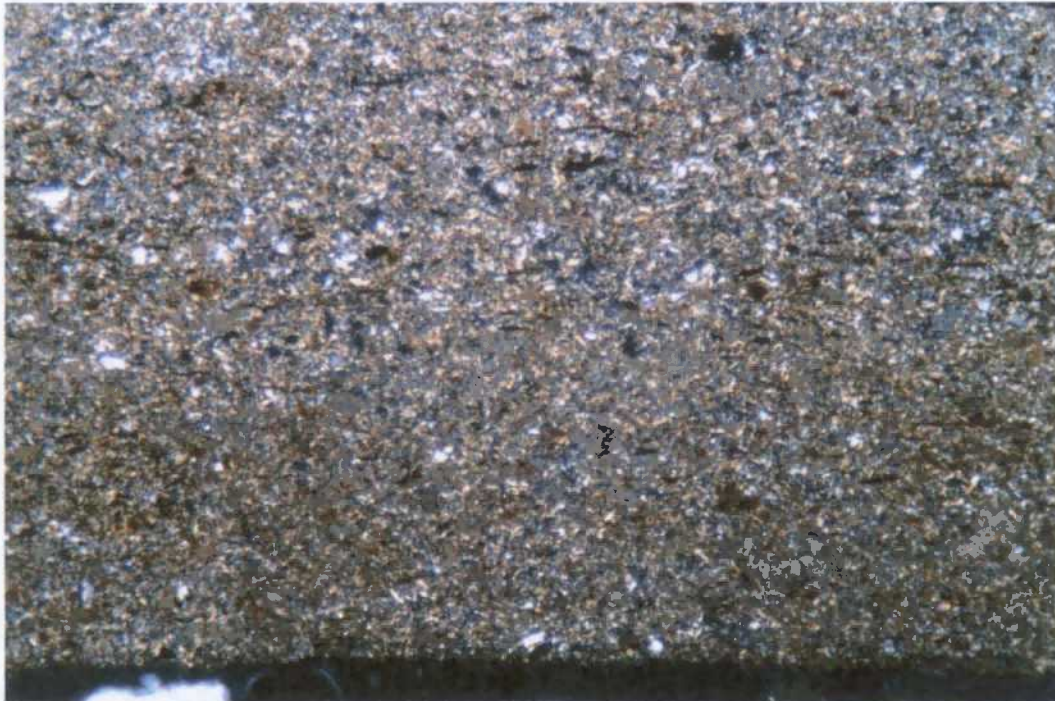
Figure 17. Lowest level of shale immediate roof exposed at mine roof horizon, showing angular quartz grains (white) scattered and isolated in the very fine-grained, muscovite-dominated matrix. Field of view 2.4 mm at 40X, taken under crossed polars.

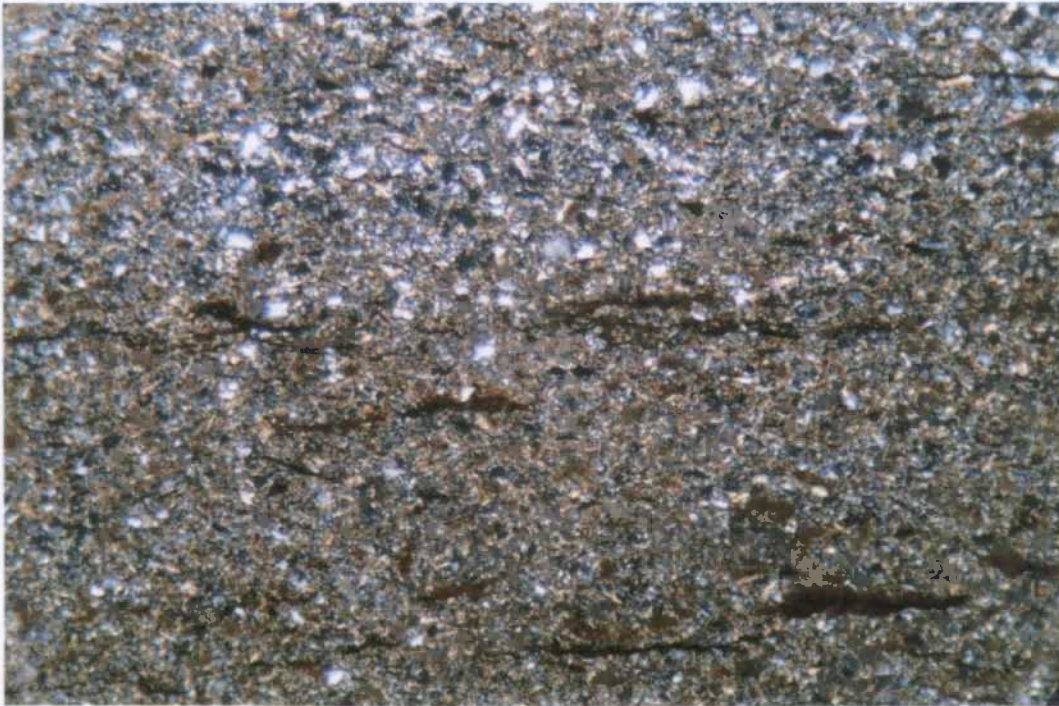
Figure 18. Very regular, continuous bedding contact between lower, fine-grained lamination characterized by scattered, angular quartz grains (bright white) in a very fine-grained matrix of muscovite (speckled yellow/pink), grading upward into lamination with abundant, angular quartz grains. Some quartz grains touch along tangential contacts, while most are isolated by surrounding muscovite. Discontinuous stringers of iron hydroxide (black to very dark brown), which may represent diagenetic alteration of original biotite flakes, are aligned parallel to define bedding. Field of view 2.4 mm at 40X, taken under crossed polars.

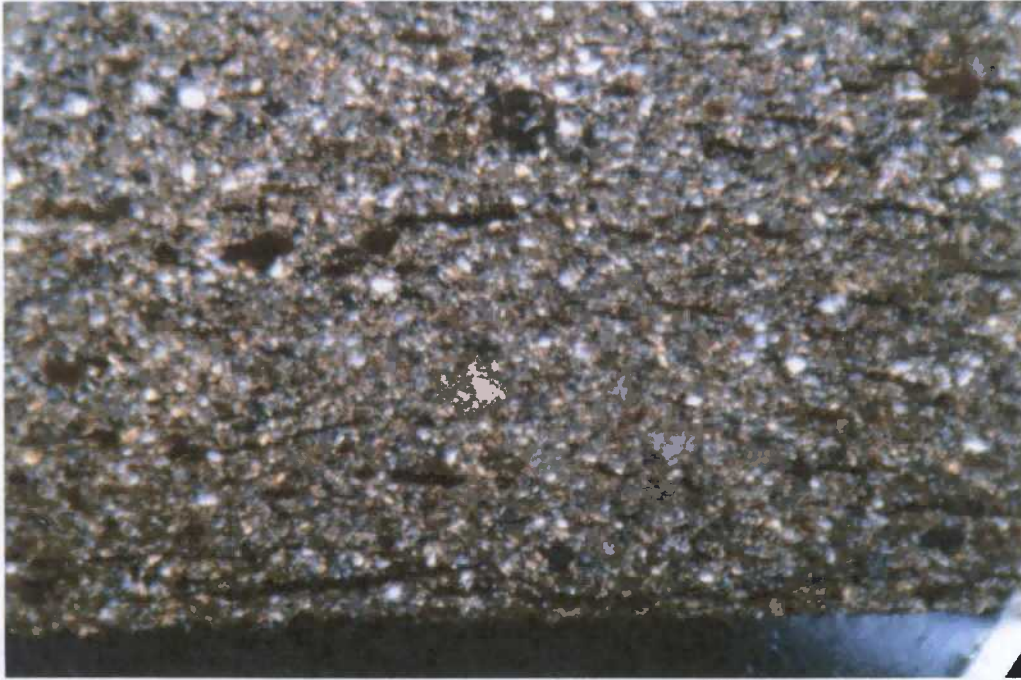
Figure 19. Lowest level of shale immediate roof exposed at mine roof horizon, showing angular quartz grains (bright white) scattered throughout a matrix composed of fine-grained muscovite lathes (speckled yellow/blue/pink/green). Wispy stringers of iron hydroxide (black to very dark brown) are aligned along bedding laminations, and may represent diagenetic alteration of original biotite flakes. Field of view 2.4 mm at 40X, taken under crossed polars.

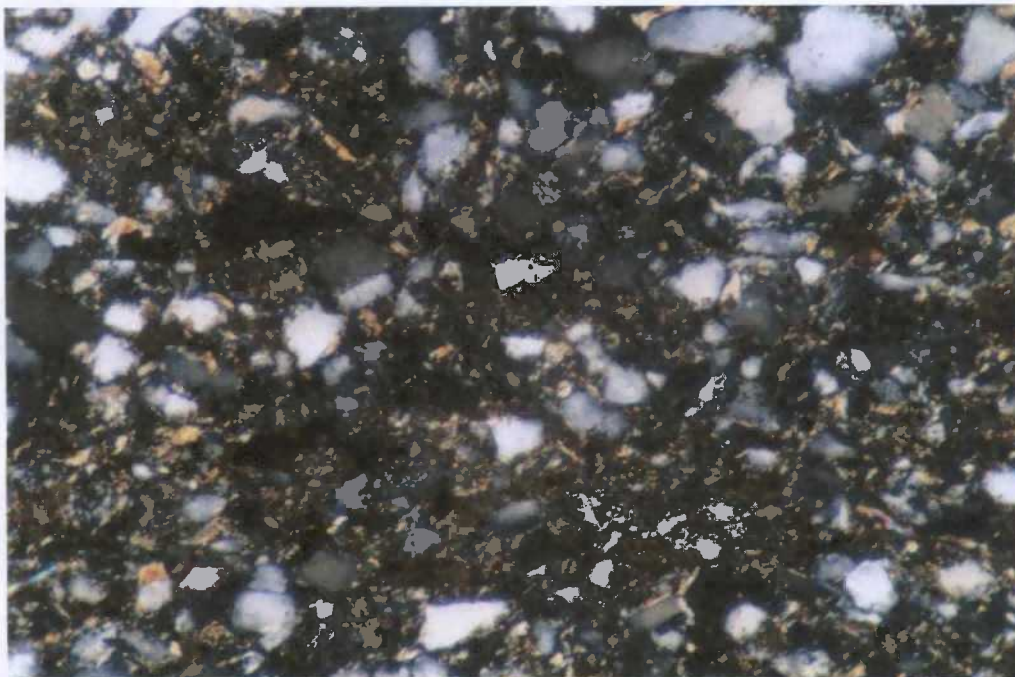
Figure 20. Angular quartz grains (white and gray) touch along tangential contacts nearly isolated in a matrix of randomly oriented muscovite lathes (yellow). Field of view 1 mm at 100X, taken under crossed polars.

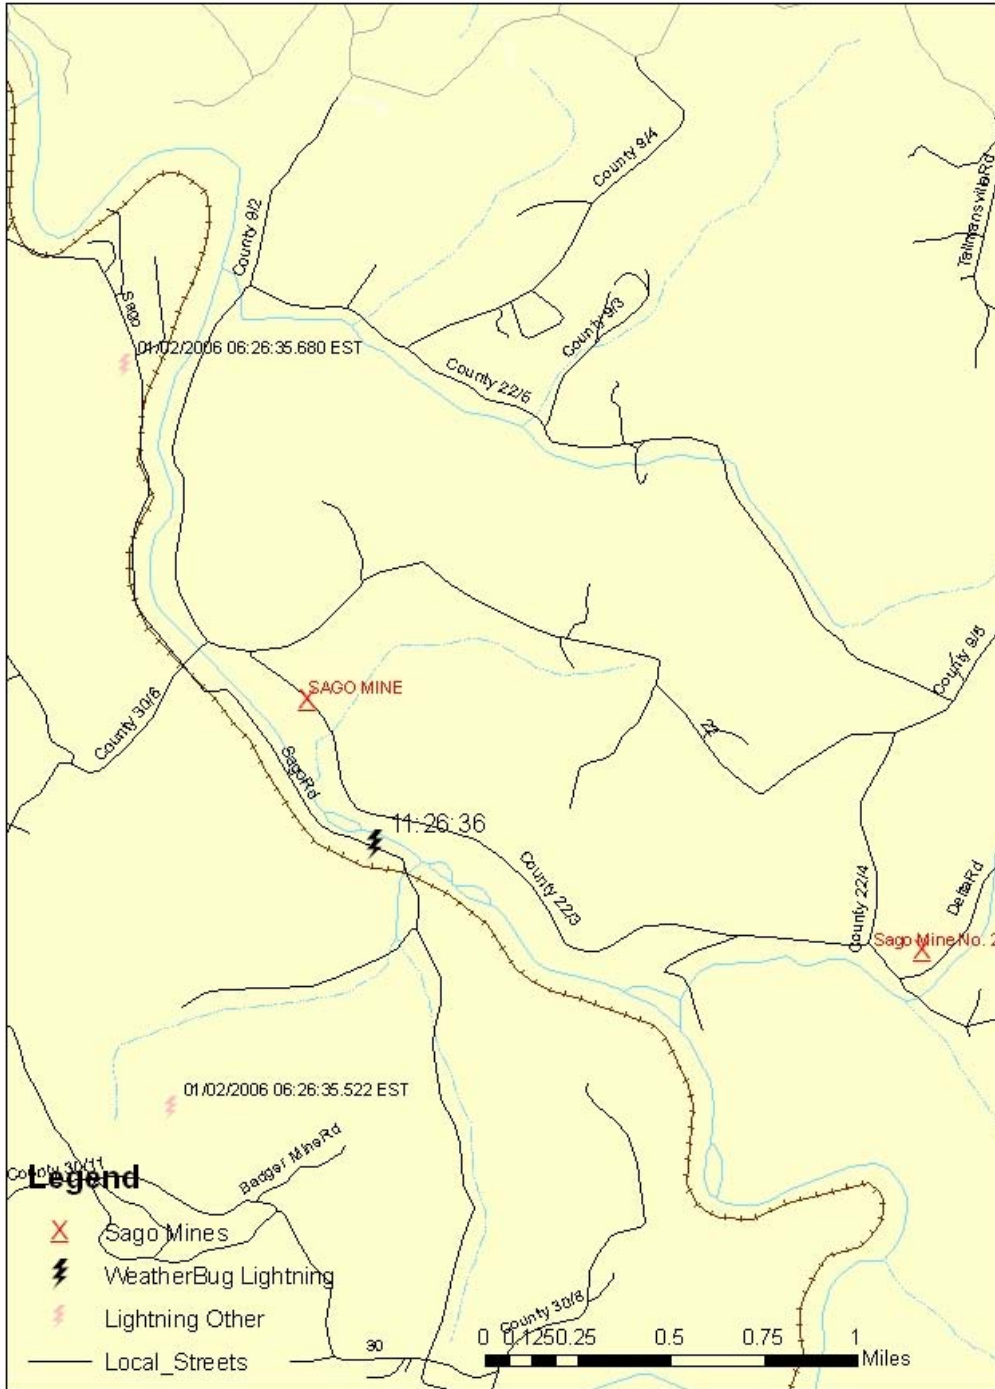
- o Individual storms have different ratios of positive and negative strokes, but typically only 10% of strokes are positive. The stroke closest to the mine was an unusual positive stroke.

The image below shows the location of the lightning stroke in relation to the mine as reported by the USPLN.

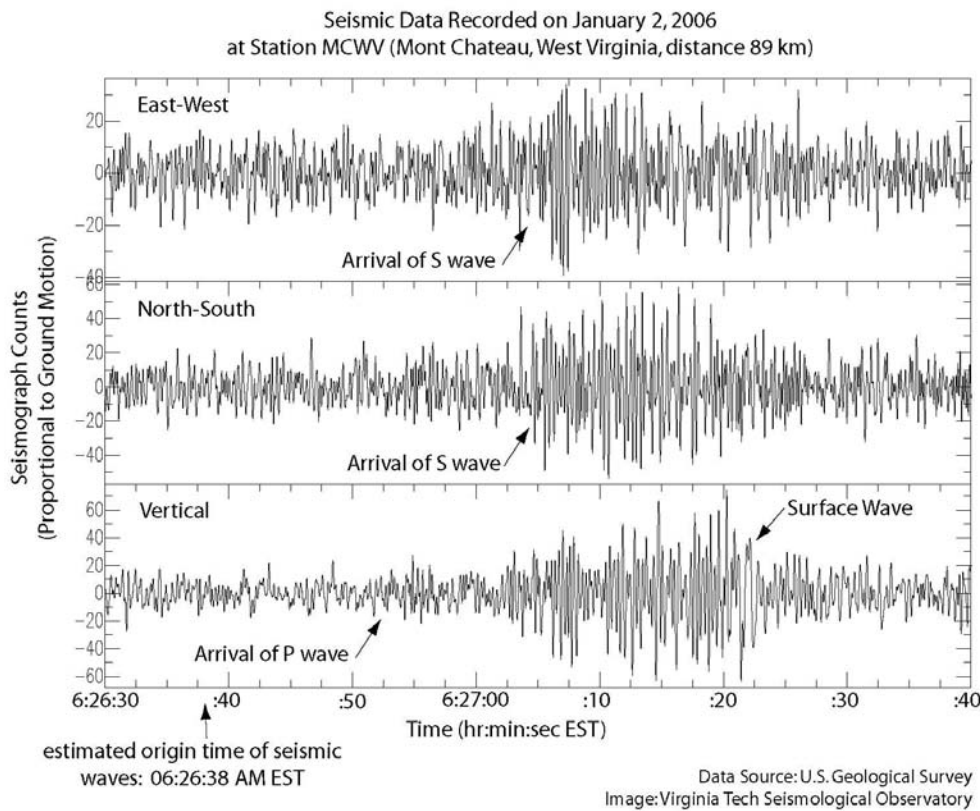
Coincident with the reported lightning strokes, WeatherBug brought in expertise from the Virginia Tech Department of Geosciences to examine whether there was seismic activity in the mine region at 6:26:38 that may have been caused by the explosion. The seismic readings have a timing error of plus or minus 3 seconds. The evidence suggests that the lightning stroke could have caused the explosion due to the correlation between the timing and location of the lightning stroke and seismic activity.

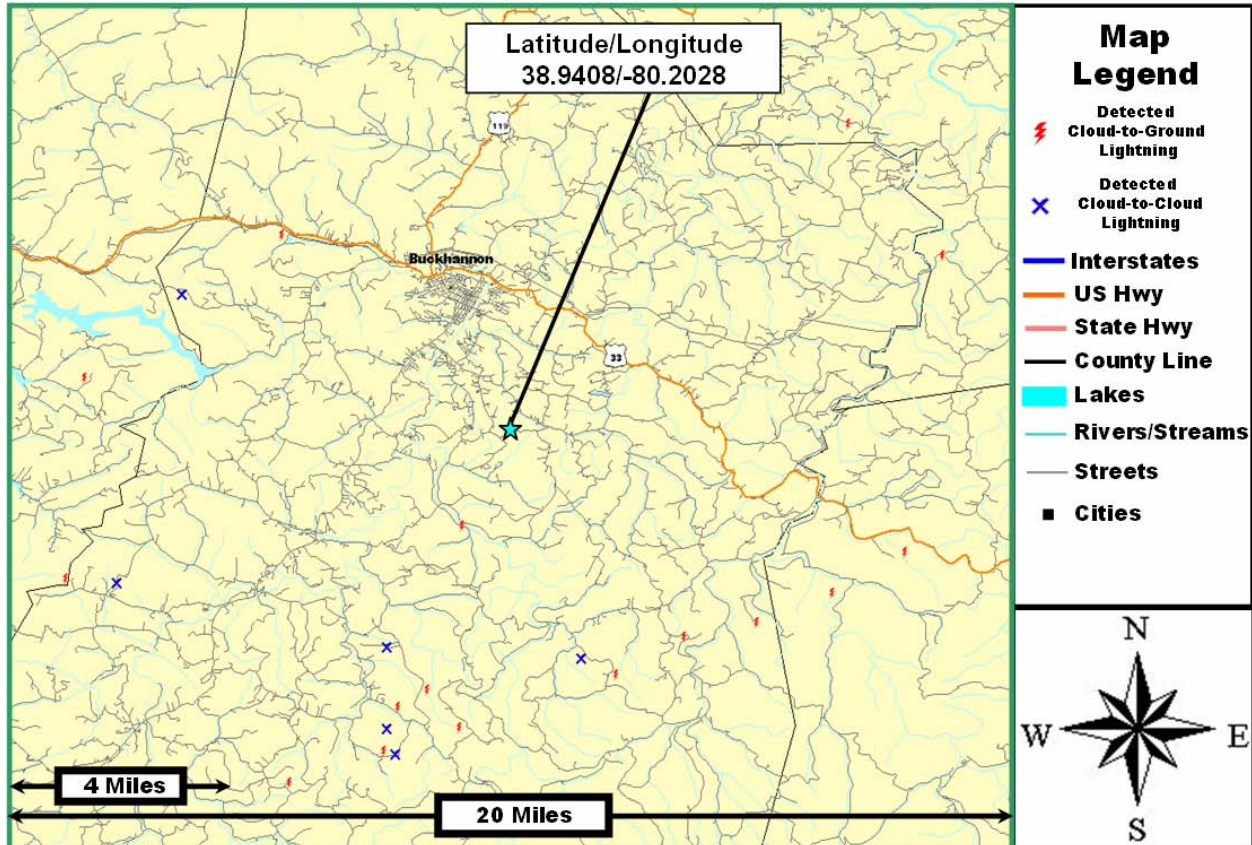
Figure 1. Map centered on the location of interest. The identified cloud-to-ground lightning strikes are depicted with red "bolts". The identified cloud-to-cloud lightning strikes are depicted with a blue "X". The light blue star depicts the location of interest. The areal extent is 2 miles by 20 miles (400 mi²). (Lightning data source: USPLN)

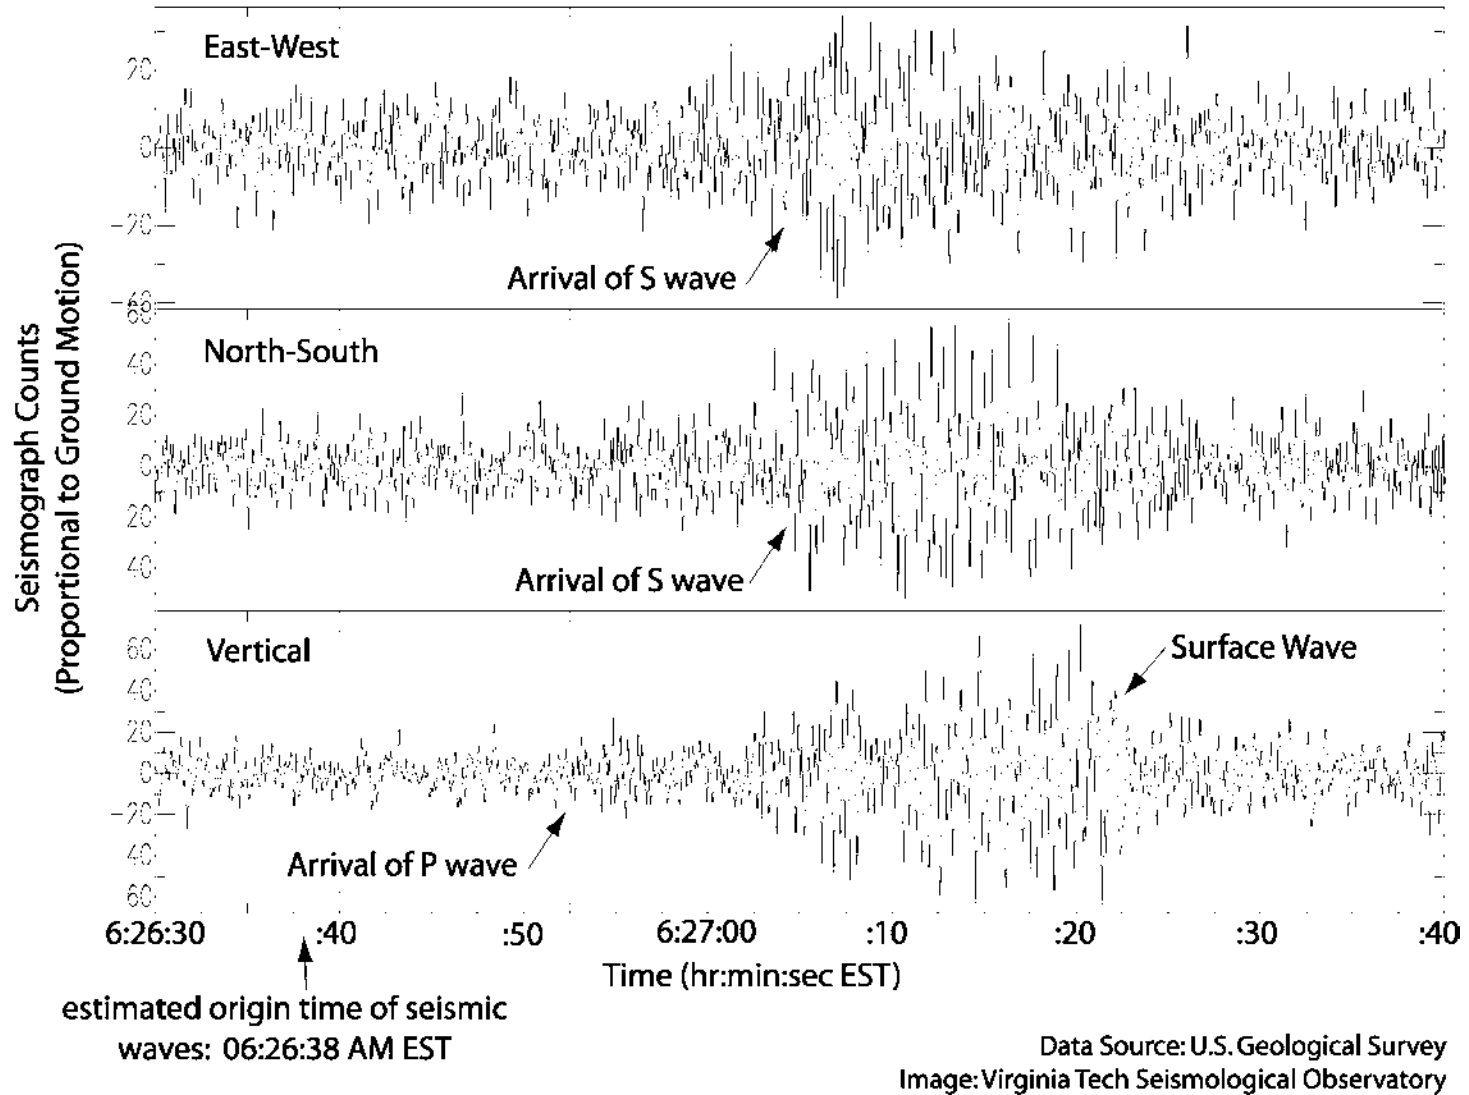
Figure 1. Waveforms recorded at station MCWV, 85.4 km from the assumed epicenter at 38.94065 degrees N, 80.20295 degrees W.

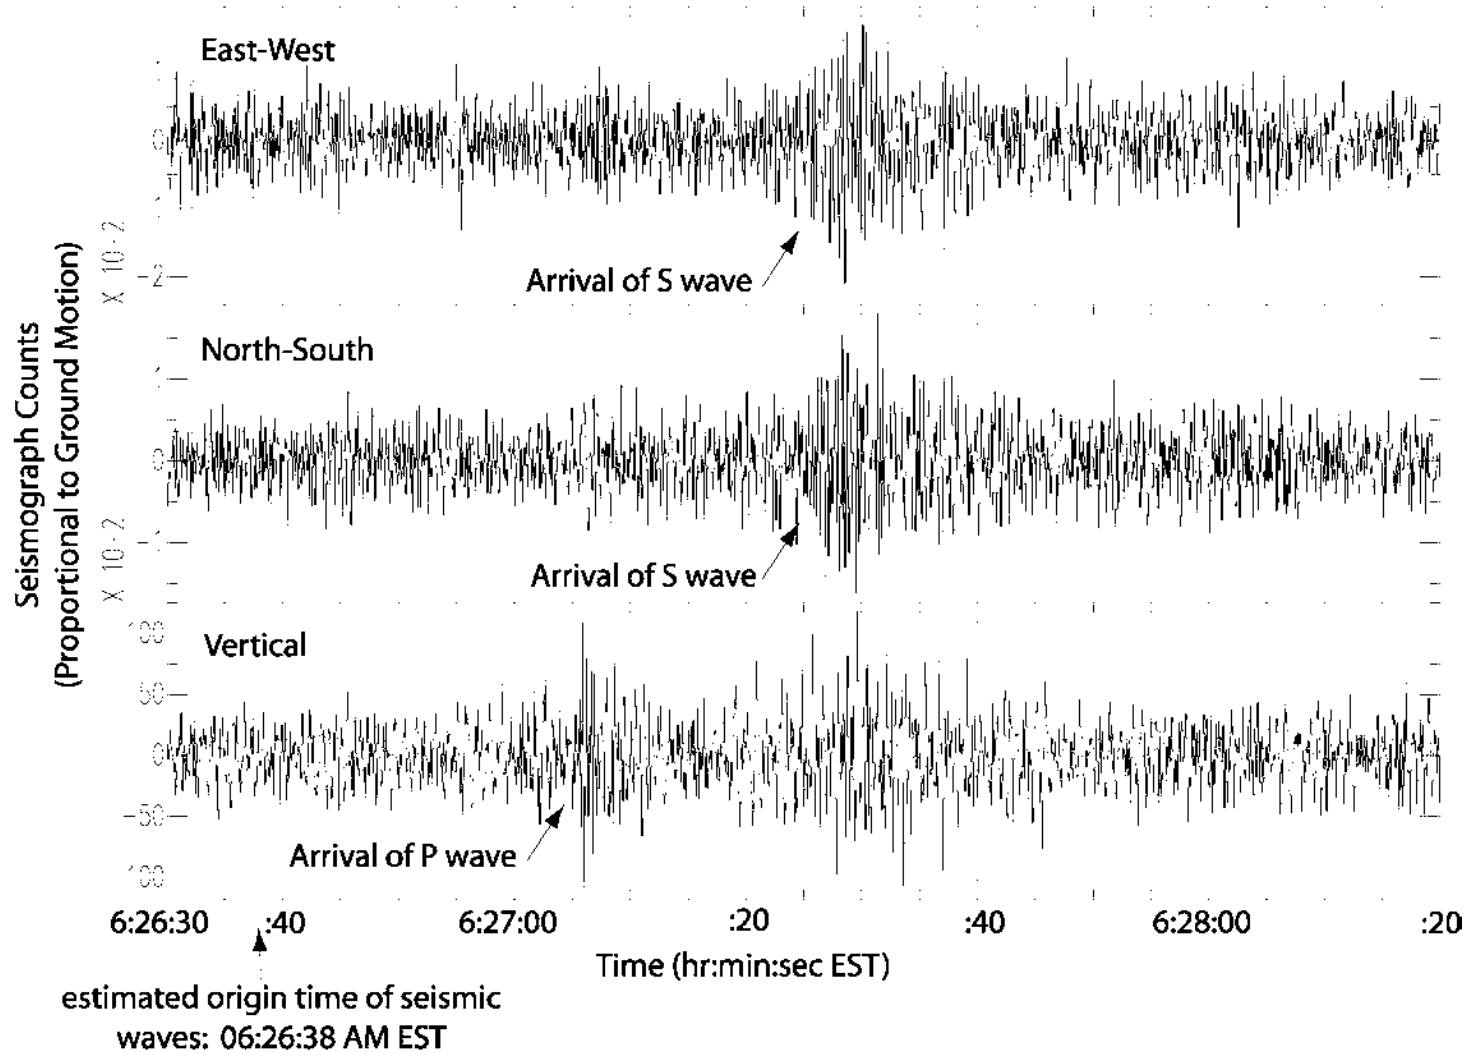
Figure 2. Waveforms recorded at station FWV, 160.1 km from the assumed epicenter at 38.94065 degrees N, 80.20295 degrees W.

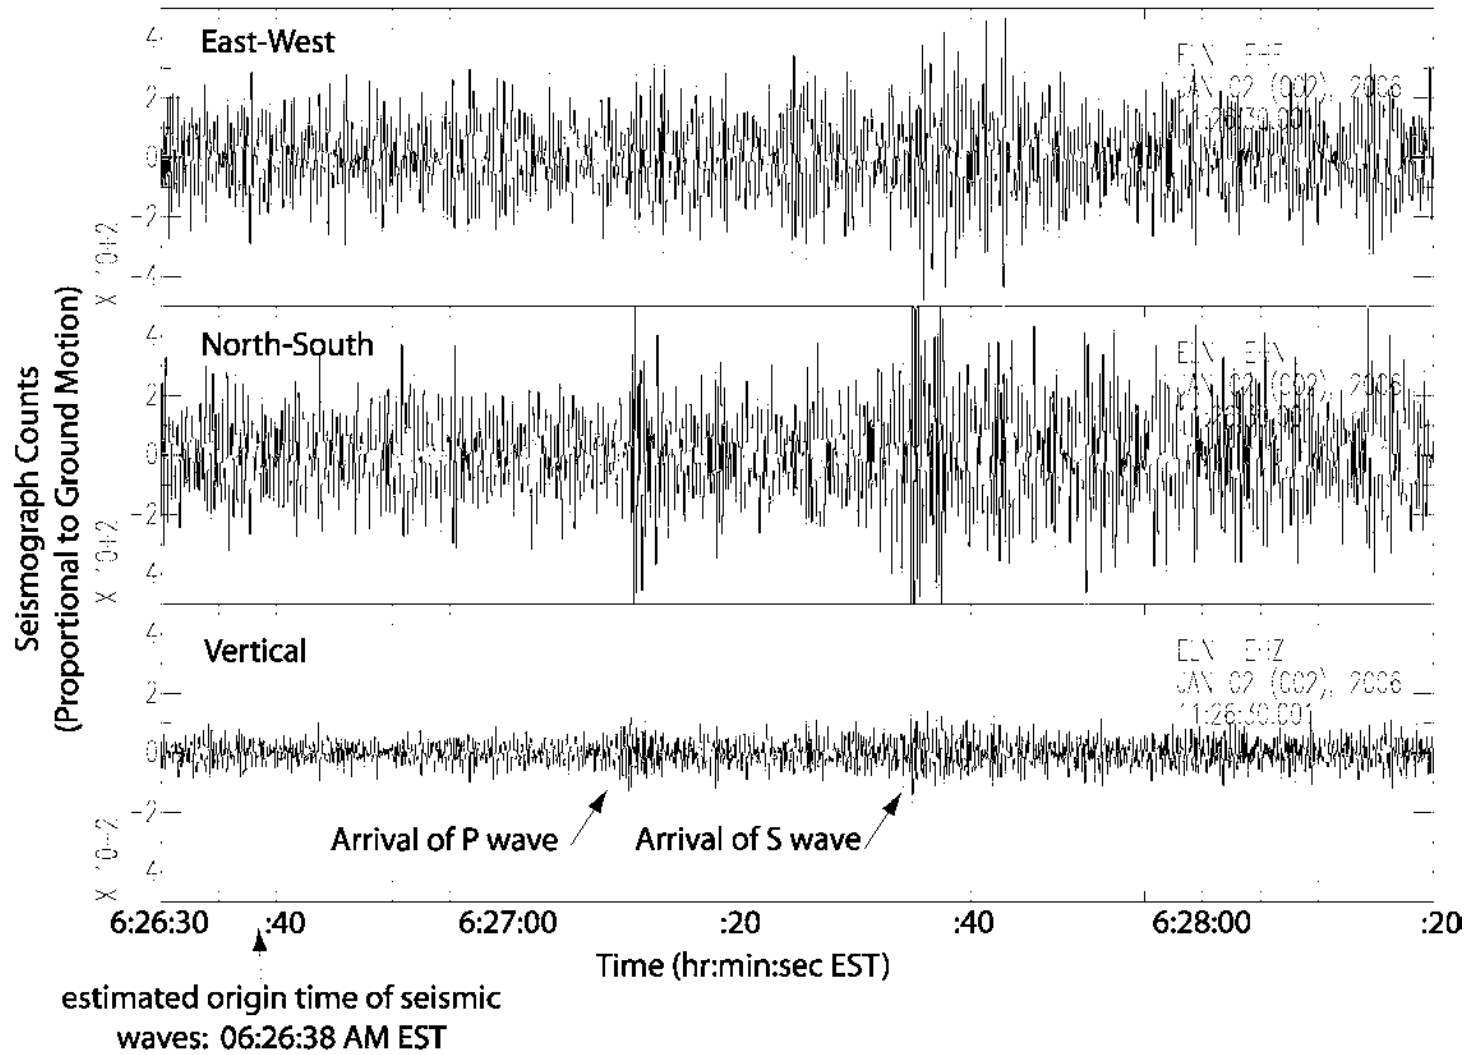
Figure 3. Waveforms recorded at station ELN, 190.5 km from the assumed epicenter at 38.94065 degrees N, 80.20295 degrees W.

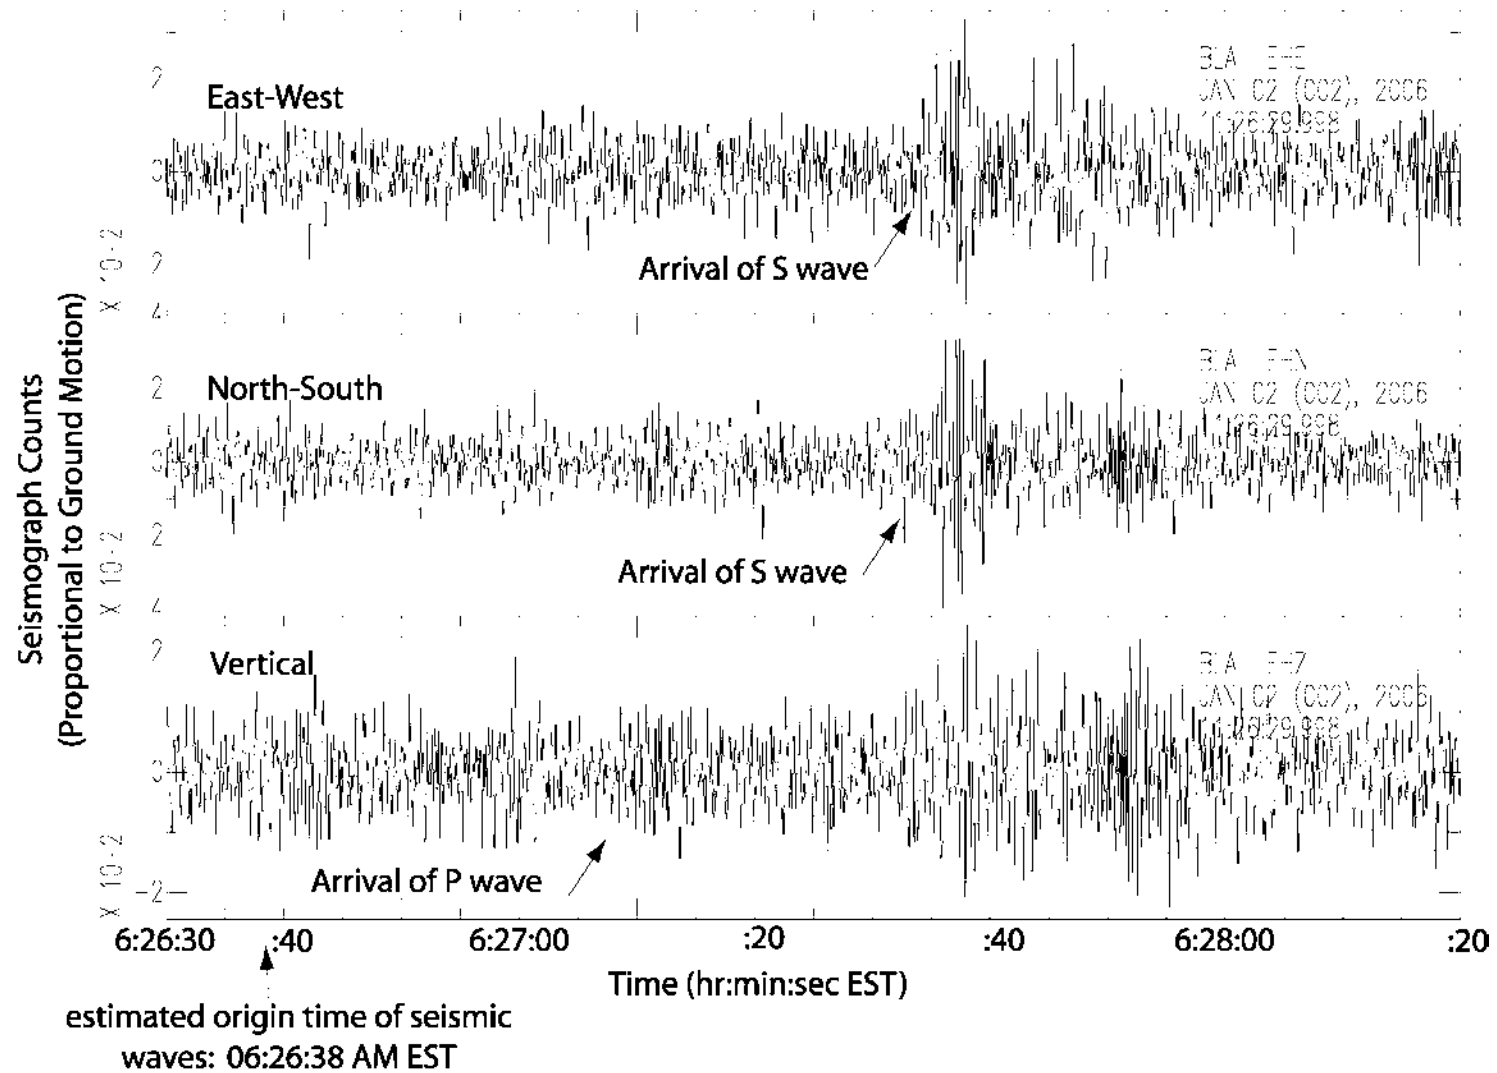
Figure 4. Waveforms recorded at station BLA, 192.9 km from the assumed epicenter at 38.94065 degrees N, 80.20295 degrees W.

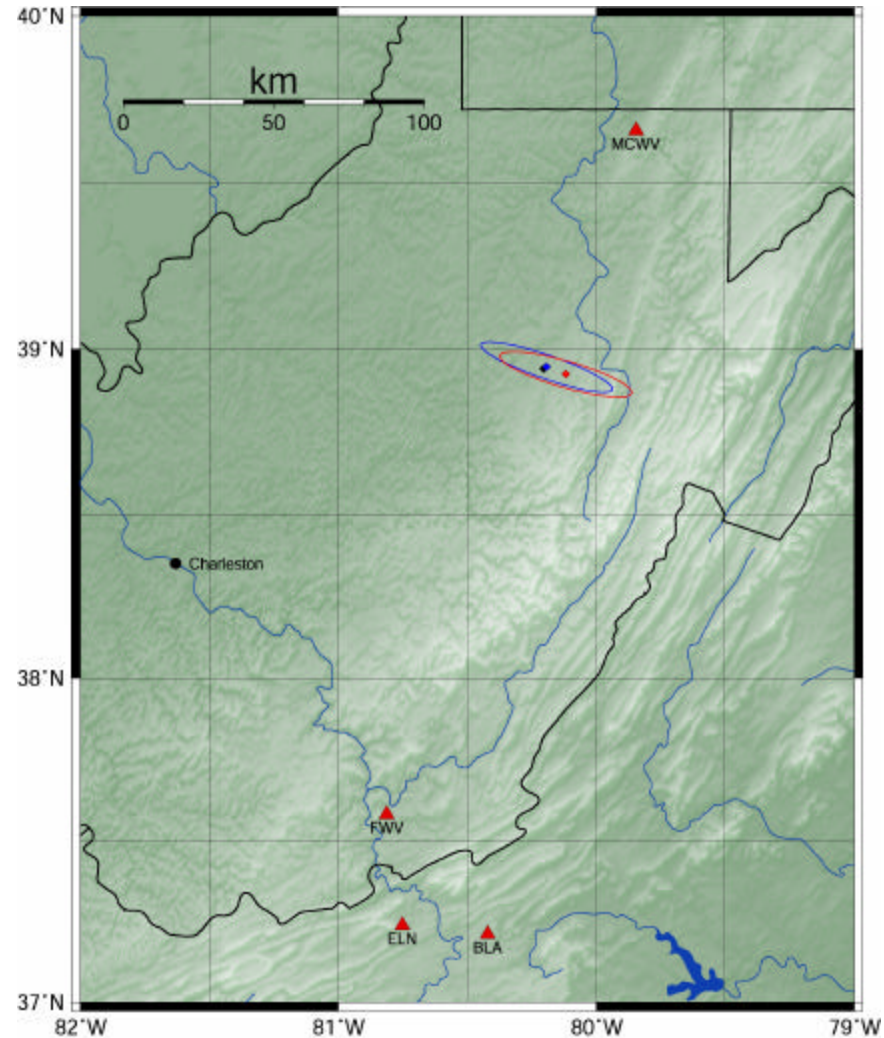
Figure 5. Map showing as a black diamond the assumed location of the Sago mine event (38.94065 degrees N, 80.20295 degrees W). The red diamond shows the epicenter determined using the arrival time data in Table 1 with focal depth fixed at the ground surface. The red line indicates 68% confidence ellipse for the epicenter location. The blue diamond is the epicenter estimated with the depth unconstrained. The blue line shows the corresponding 68% confidence ellipse. Seismic stations used in the location are indicated by the red triangles.

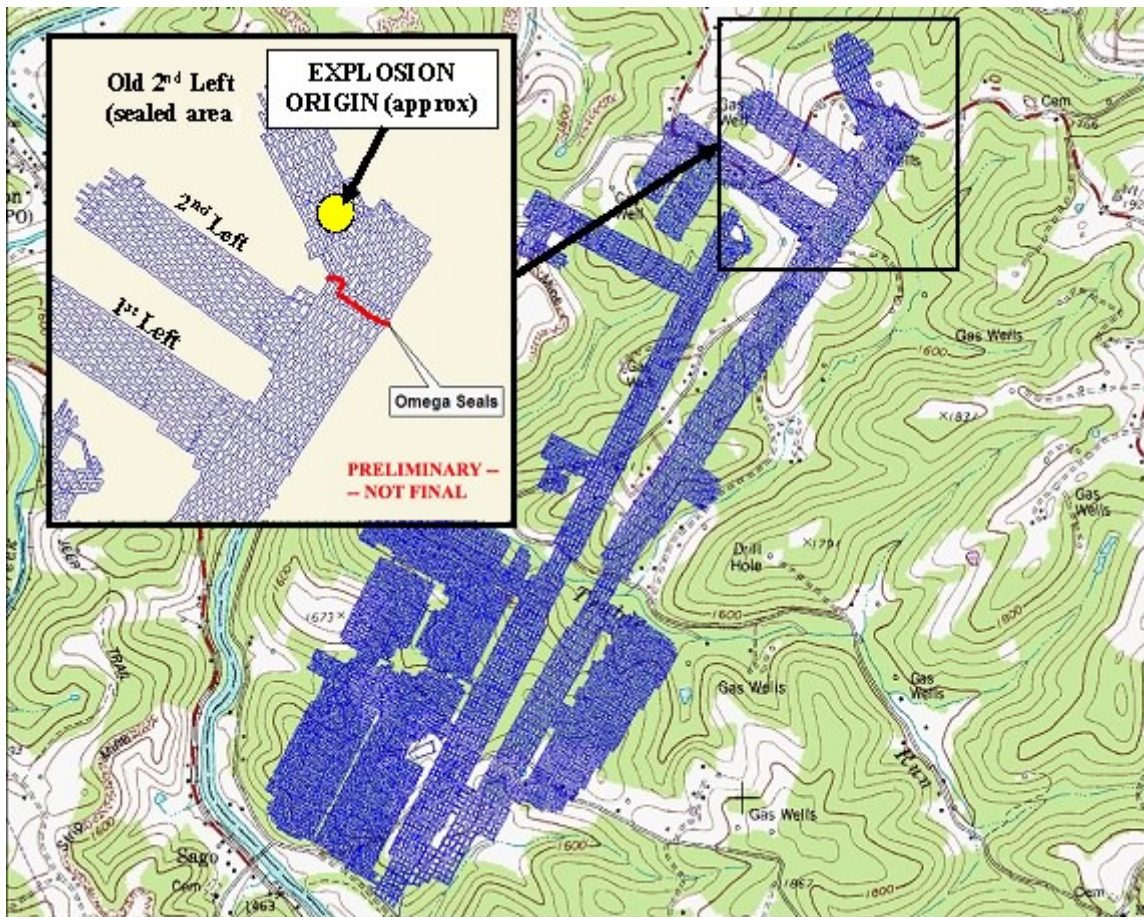
On January 2, 2006, an explosion was initiated in a methane-air mixture within a sealed area at the Sago underground coal mine near Buckhannon, WV that resulted in the deaths of twelve miners. The approximate location of the initiation of the explosion is shown in Figure 1-1.

Figure 1-1 Approximate Location of Initiation of Explosion in Sealed Area of Sago Mine.

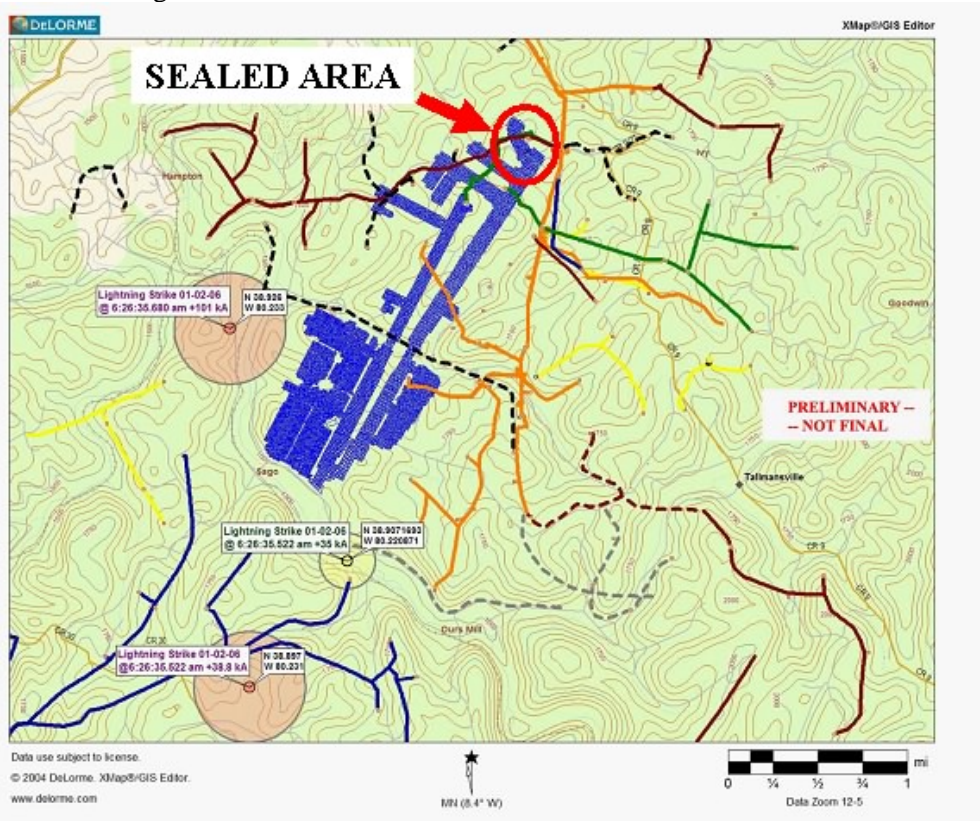
Three positive polarity lightning strokes were identified by the NLDN and the USPLN that were coincident with the Sago underground coal mine sealed area explosion. Their location, polarity, and amplitude are shown in Figure 1-2.

Figure 1-2 Location of Lightning Strokes at Sago Mine Contemporaneous with Sealed Area Explosion.

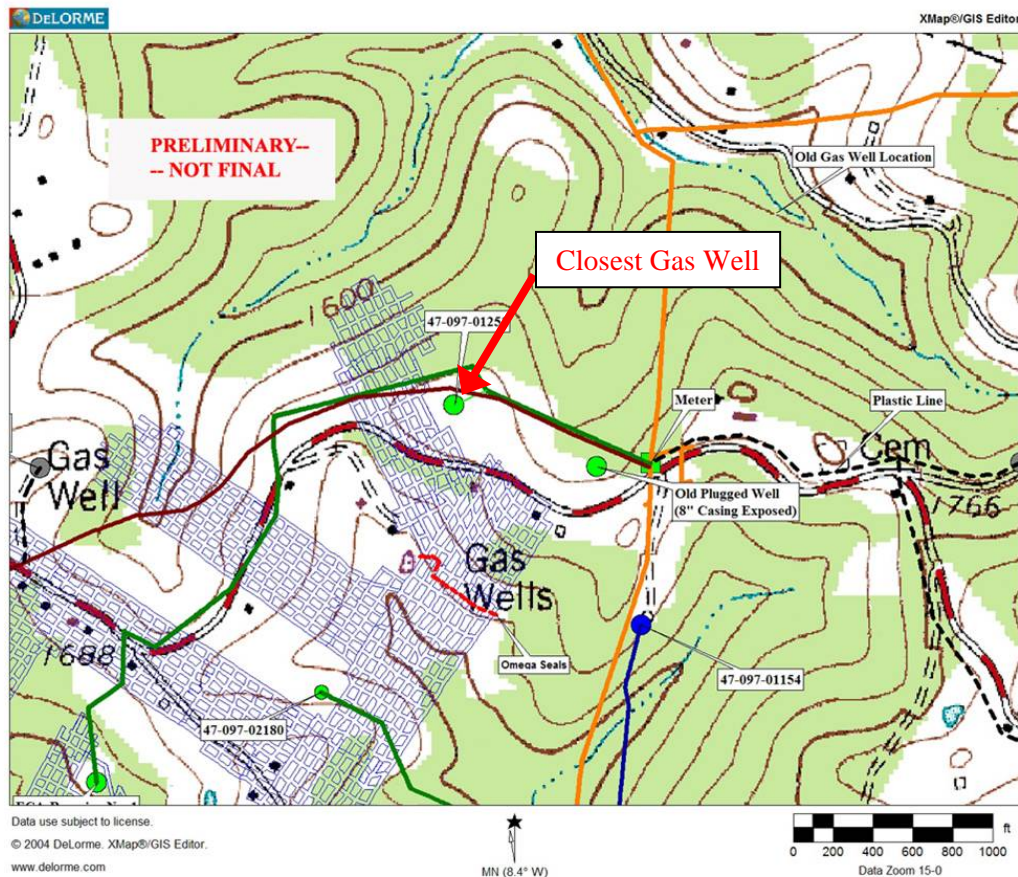
All vertical pipes in the vicinity of the sealed area are shown in Figure 1-3. The vertical pipe closest to the sealed area of the mine is the gas well pointed out in Figure 1-3. It is unlikely that any field enhancements due to the vertical pipes would induce a significant amount of voltage onto the pump cable in the sealed area because the cable is orthogonal to the pipes. However, as potential conduits for lightning energy, they are mentioned here for completeness.

The horizontal gas pipes that are in the vicinity of the sealed area are also shown in Figure 1-3. These pipes are in general buried at a depth of 2 feet from the surface. The response on the pump cable, or electric fields in the sealed area, due to the current drive of the horizontal gas pipes was not characterized because it was not planned for and was not characterized because of liability issues. The gas pipes, if driven locally to the sealed area, would have similar coupling characteristics to the pump cable as that of the indirect drive experimental setup. If the gas pipes were driven remotely, the amount of attenuation from one point on the pipes to another point is mostly dependent upon the resistivity of the soil surrounding the pipes. If the soil surrounding the pipes has low resistivity, a majority of current injected onto the pipes would attenuate in a short distance. However, if the pipes are either not in contact with the soil or the resistivity of the soil is large, then the pipes would act as insulated conductors. Attenuation on the pipes in this case would be much less.

Figure 1-3 Vertical Pipes in Vicinity of Sealed Area of Sago Mine.

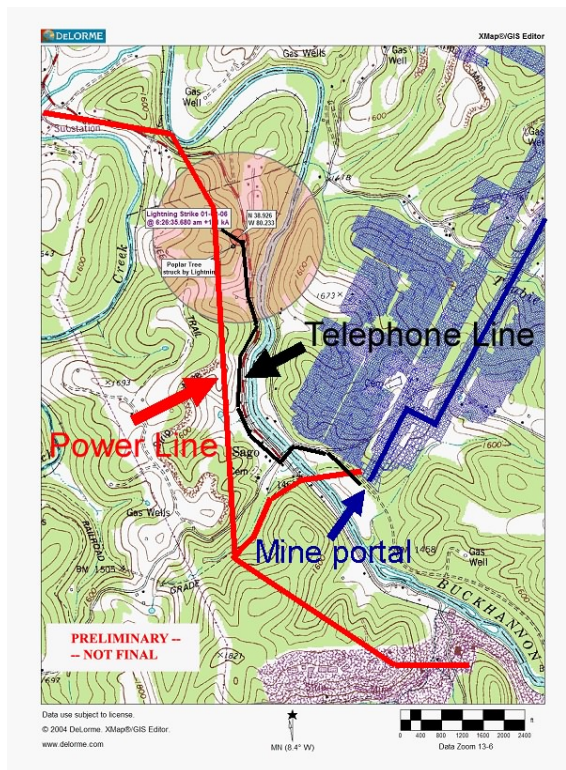
Both telephone wires and AC power lines were in the vicinity of the 101 kA positive stroke and could have provided metallic conduction paths into the Sago mine AC power system, or the telephone communication system, or to other metallic penetrations into the mine. The location and routing of this wiring with respect to the stroke are shown in Figure 1-4. The direct-drive measurements discussed in

Section 3.1 lead to the conclusion that even if the power and telephone lines were conduits of the lightning energy, they would not be a plausible source of energy to cause high voltage in the sealed area.

Figure 1-4 AC Power Distribution Lines and Telephone Lines near Positive 101 kA Stroke.

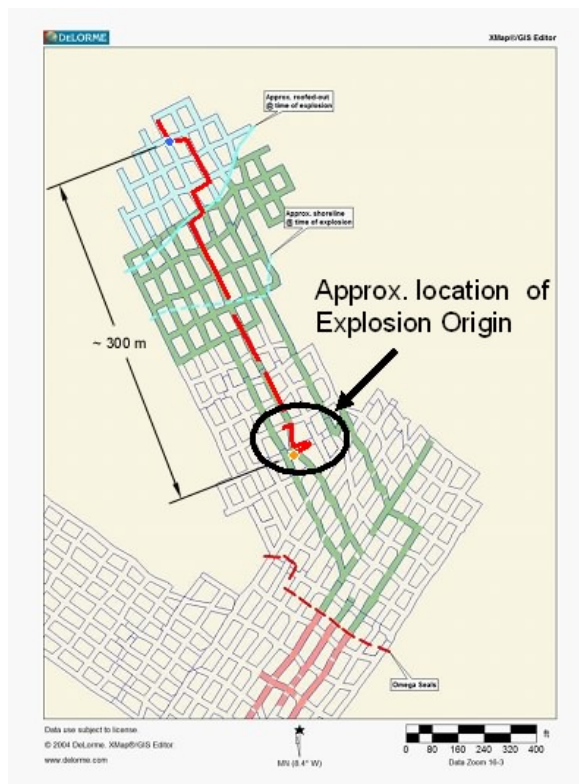
The presence of metallic roof mesh and pump cabling and its relationship to the approximate location of initiation of the explosion are shown in Figure 1-5. The pump cable is shown as the red line and the green shaded area depicts the metallic mesh. The pump cable is noted because indirect coupling measurements are made on it. With these measurements, the voltages induced on the pump cable due to lightning strokes on the surface are calculated in this report.

The metallic mesh is noted because it is used in some of the measurements for grounding purposes. It was not considered a plausible receiver or antenna of the electromagnetic energy that propagates underground because it appears to be well grounded at regular intervals to the roof of the sealed area, and, therefore, would not support a large voltage potential.

Figure 1-5 Roof Mesh and Cable in Sealed Area Where Explosion Was Initiated. The red line represents a cable from a water pump located at the top of the figure. The green lines represent metallic roof mesh.

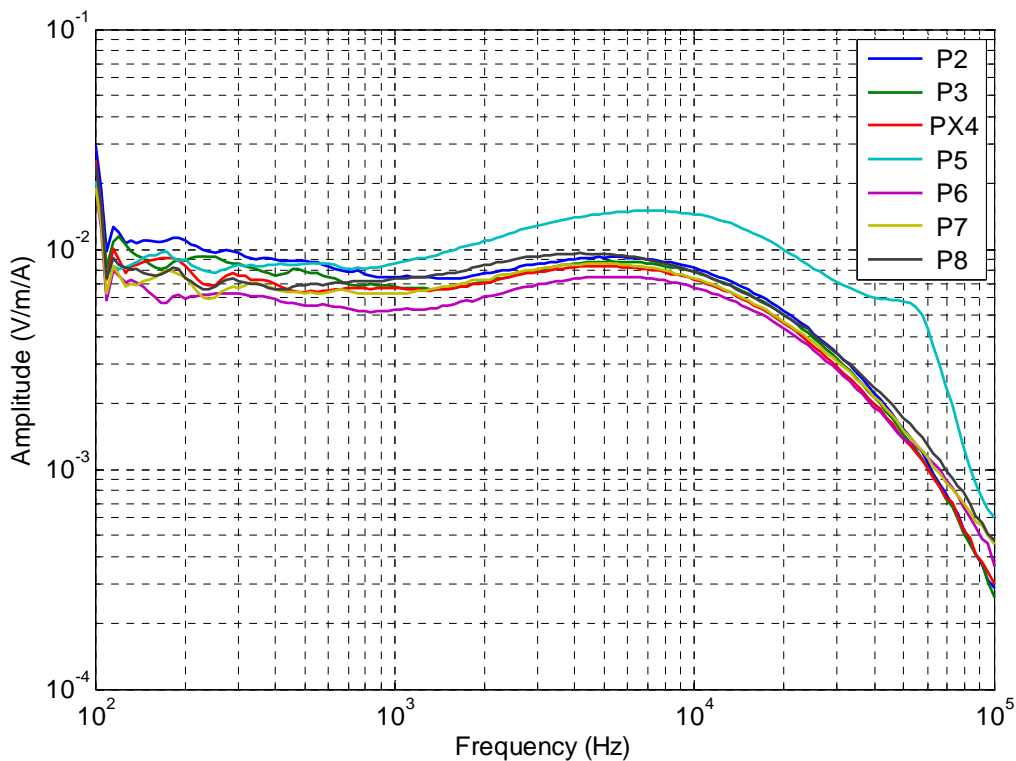
Figure 3-8 Composite Electric Field along P-direction with parallel line drive on surface.

Referring to Figure 3-8, note that the composite electric fields measured in a path parallel to and immediately below the drive are about the same amplitude. The presence of metal objects near the antenna affects the local fields somewhat. The measurement at P5 was made in the area between unconnected sections of roof mesh. The slight resonance at about 60 kHz in the P5 measurement was probably caused by a resonance of the cable that was attached for the voltage measurements. This cable was not removed for the electric field measurements, and high electric fields may have been induced on the disconnected end of the cable at resonance.

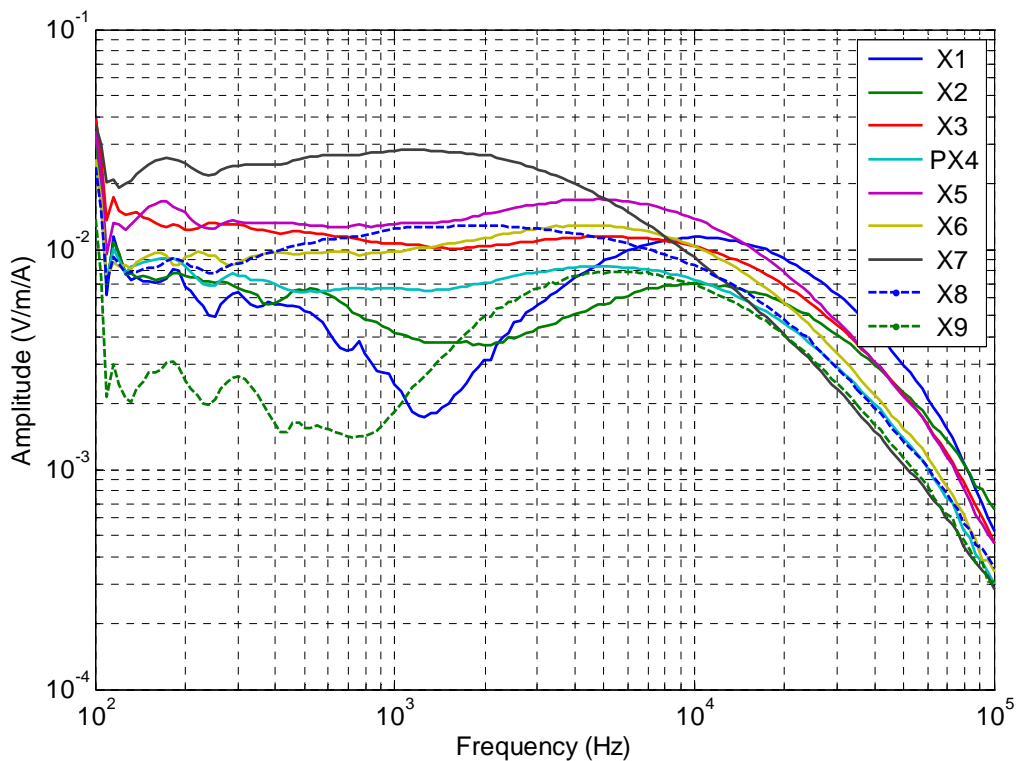
Figure 3-9 Composite Electric Field along X-direction with parallel line drive on surface.

Referring to Figure 3-9, note that the low-frequency amplitude tended to decrease as the electric field antennas were moved away from the center line immediately below the drive line.
