UNITED STATES
DEPARTMENT OF LABOR
MINE SAFETY AND HEALTH ADMINISTRATION
COAL MINE SAFETY AND HEALTH

REPORT OF INVESTIGATION
Fatal Underground Coal Mine Explosion
January 2, 2006
Sago Mine, Wolf Run Mining Company
Tallmansville, Upshur County, West Virginia
ID No. 46-08791
By

Originating Office
Mine Safety and Health Administration
Office of the Administrator
Coal Mine Safety and Health
1100 Wilson Boulevard
Arlington, Virginia, 22209
Kevin G. Stricklin, Acting Administrator
May 9, 2007

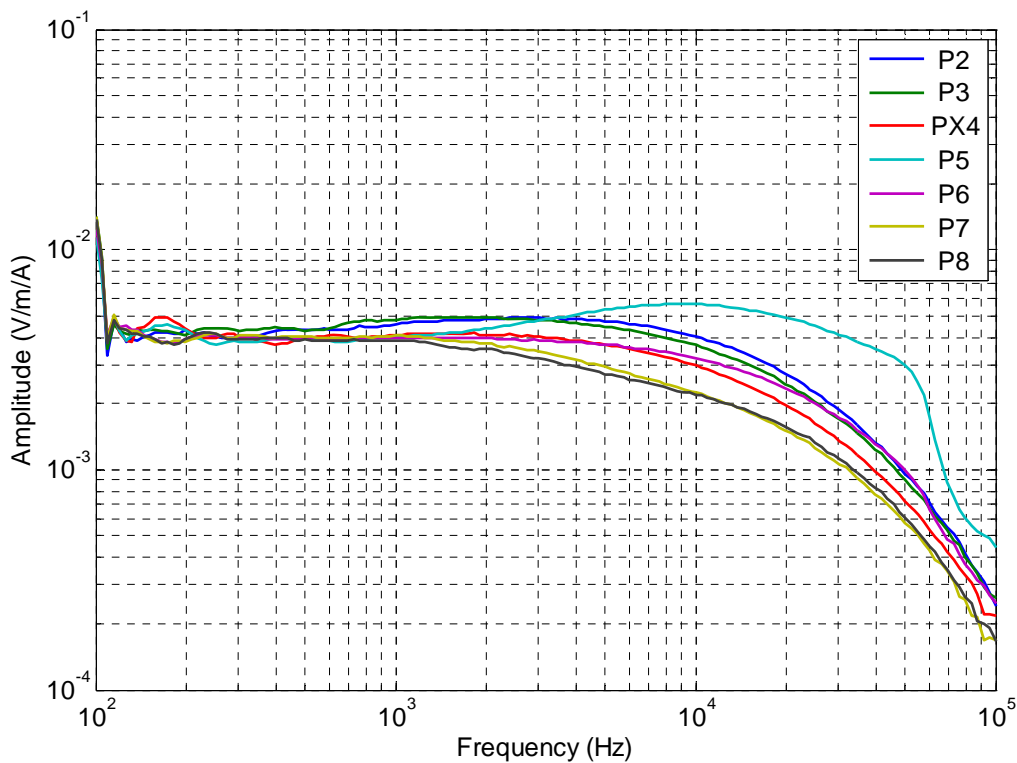
Figure 3-10 Composite Electric Field along P-direction with perpendicular line drive on surface.

Referring to Figure 3-10, the composite electric fields measured in a path perpendicular to the drive cable are reduced significantly from the field due to a parallel drive cable. Again, a slight resonance was seen at P5.

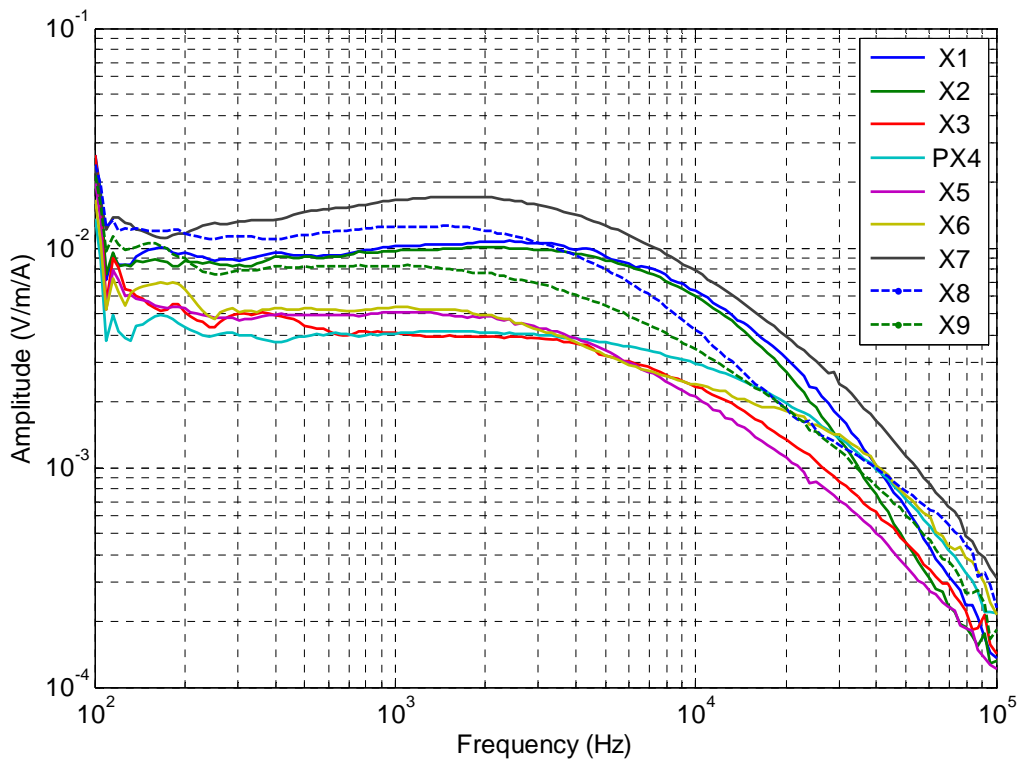
Figure 3-11 Composite Electric Field along X-direction with perpendicular line drive on surface.

Referring to Figure 3-11, the fields measured parallel to and below the perpendicular drive are comparable in amplitude to those shown in Figure 3-8. Because of the closer spacing of the ground rods on the surface, more variation was shown in the individual measurements.

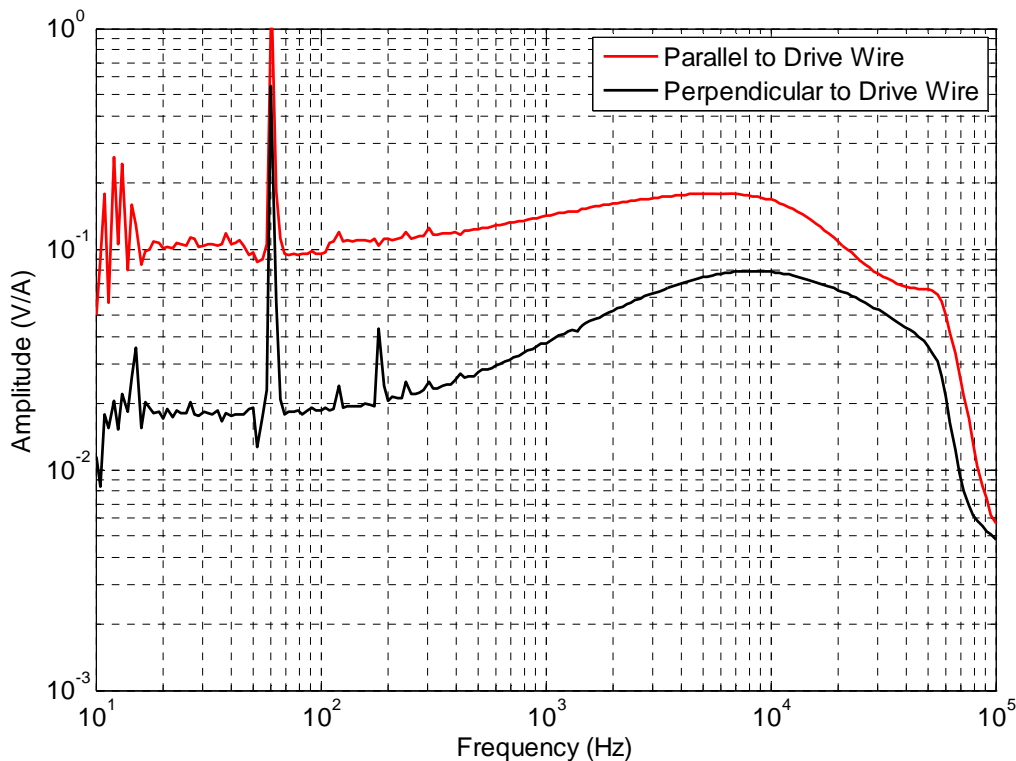
The voltage on the pump cable was measured with a high-impedance voltage probe and the network analyzer set to a 2 Hz IF bandwidth. The normalized results of the voltage amplitude plotted relative to the drive current on the surface wire, with units of Volts per Amp (V/A), are shown in Figure 3-12. There is a spike at 60 Hz due to stray signals from power lines. The data is skewed by noise only below 20 Hz.

Figure 3-12 Induced voltage on pump cable (~300 m or 984 ft. long) due to wire current drives on surface.

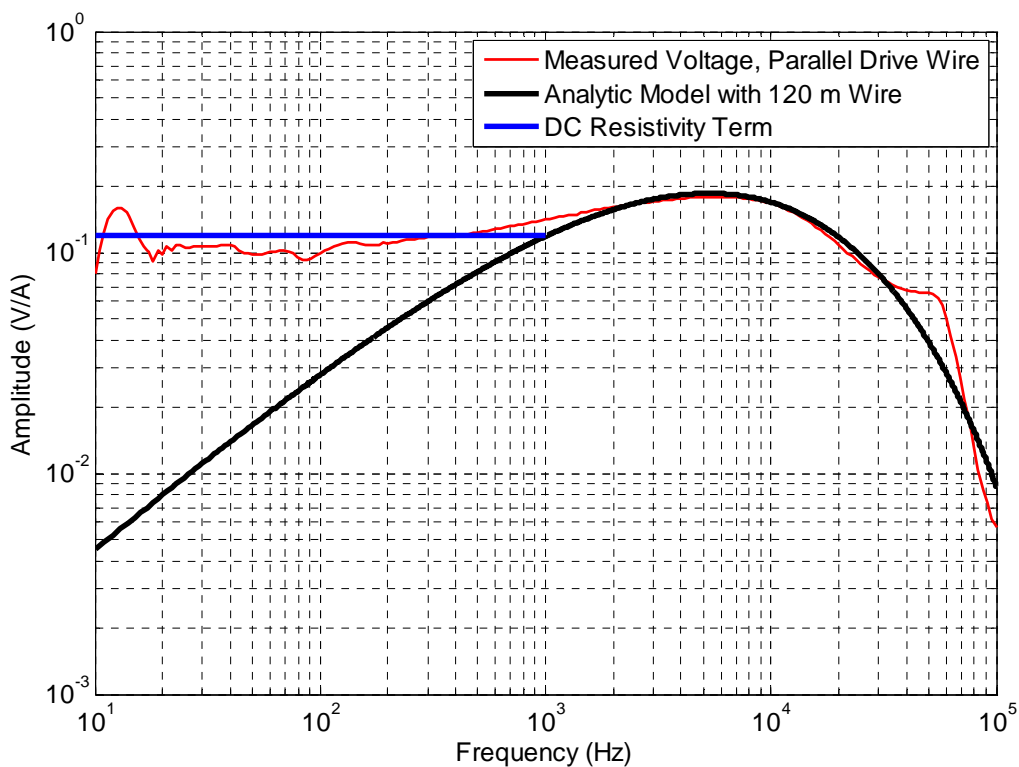
To compare the analytic model with the measured induced cable voltage, we simply integrate over the effective length of cable discussed in the previous section, 120 m (394 ft). Again, the model shows excellent agreement with the measured voltage from 1 to 100 kHz. There is a deviation from the model of coupling beneath an infinite line at frequencies below 1 kHz, where the measured data stays at a constant level of approximately 0.1 V/A. Much of this deviation is caused by the field caused by the DC component from the finite spacing of the ground rods. An estimate of this component of the electric field is shown below 1 kHz where the skin depth is much larger than the depth to the cable. The measured data has been processed to remove the 60 Hz clutter signal and its harmonics.

Figure 3-17 Induced voltage on pump cable due to parallel wire current drive on surface (with 60 Hz and harmonics removed) compared with analytic diffusion model of 120 m (394 ft) long cable and an effective soil resistivity of 80 Ω -m and the DC Resistivity term.

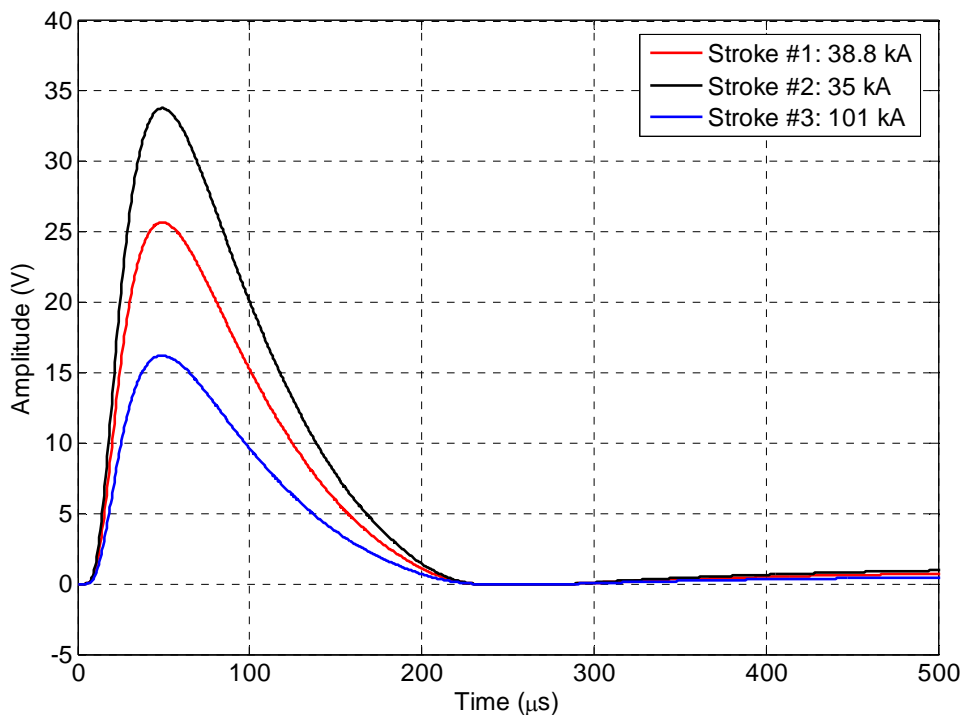
The locations of the three recorded lightning strokes, on the NLDN and USPLN, are shown in Figure 4-2 with the calculated distances and angles. Note that it is highly probable that the 38.8 kA and 35 kA strokes represent a single stroke with a location discrepancy, as discussed in Section 1.6. The angles shown are the angles between the line made up from the lightning stroke to the center of the pump cable, and the line formed by the direction where the pump cable lay. The first stroke analyzed is the 38.8 kA positive lightning stroke, 5.44 km (3.4 miles) away from the sealed area and an angle of 52.8 degrees. The second stroke has an amplitude of 35 kA at a distance of 4.02 km (2.5 miles) away from the sealed area and an angle of 49.3 degrees. The last stroke has an amplitude of 101 kA, a distance of 2.91 km (1.8 miles), and an angle of 85.5 degrees. The resulting induced voltage pulses on the pump cable (at the end of the cable nearest the explosion area) are shown in Figure 4-3, with peak amplitudes of 25.7 V, 33.8 V, and 16.2 V for the three strokes, respectively. The effective length of 120 m (394 ft.) was used for the length of the pump cable in Figure 4-3. Since there is concern about the actual length of intact pump cable present at the time of the explosion, analysis was performed on a pump cable with a length of 61 m (200 ft.) to account for the length of the cable piece found closest to the explosion area. The resulting induced voltage pulses on the 61 m (200 ft.) length of pump cable are shown in Figure 4-4. None of the induced voltages from these recorded strokes have the necessary amplitude to cause an arc inside the sealed area. It should be noted that taking the indirect coupling model approximation out to 3 km and beyond represents an upper bound on the coupling.

Figure 4-3 Voltage induced on pump cable (using an effective length of 120 m or 394 ft.) due to the three positive lightning strokes recorded on the NLDN and USPLN.

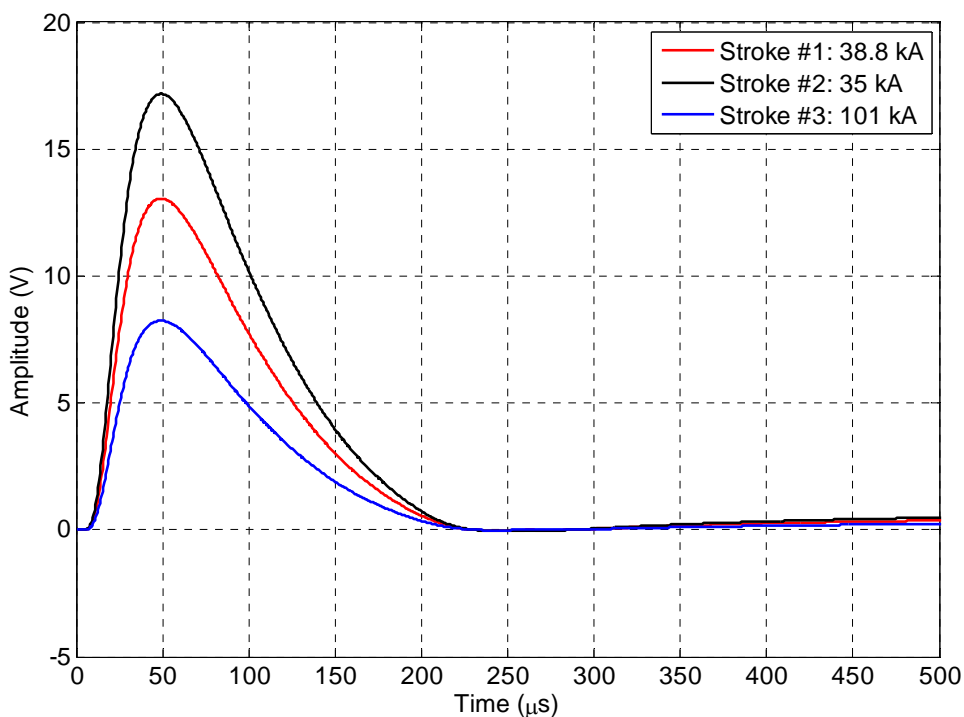
Figure 4-4 Voltage induced on pump cable (length of 61 m or 200 ft.) due to the three positive lightning strokes recorded on the NLDN and USPLN.

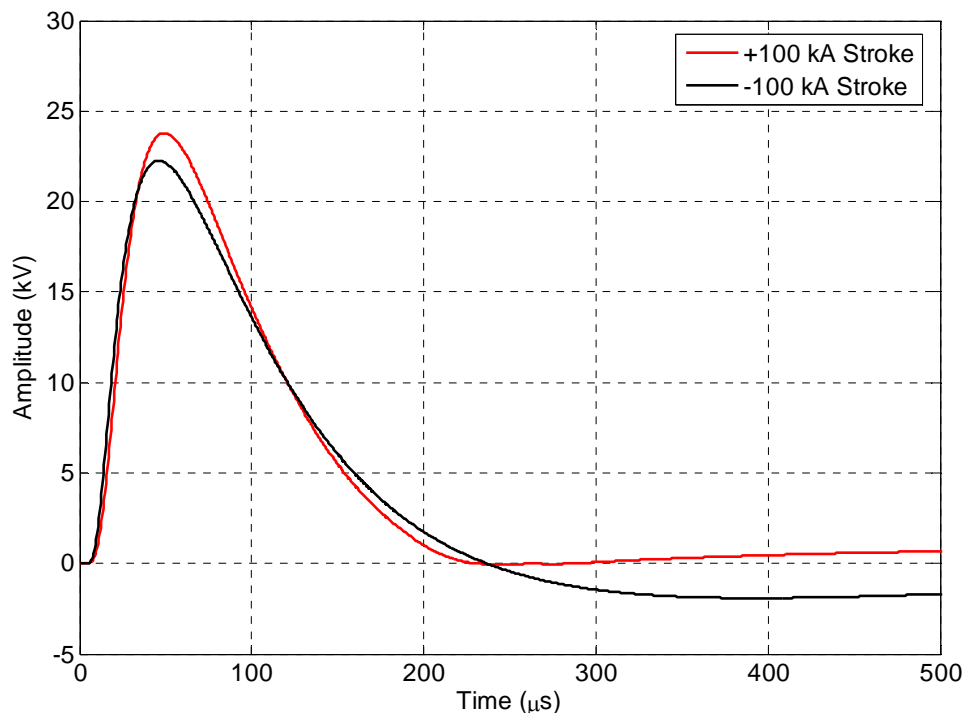
If we assume a 100 kA negative or positive lightning stroke attached within 100 m (328 ft.) from directly over the center of the pump cable in the sealed area on the surface, it could induce a sufficiently high voltage in conductors in the sealed area to cause an electrical arc. This effect would be maximized if the stroke were directly inline with the pump cable direction at an angle of zero degrees. The induced voltage on the pump cable (with an effective length of 120 m or 394 ft.) from a 100 kA positive and negative cloud-to-ground stroke is shown in Figure 4-5. The maximum voltages are 23.8 kV from the positive pulse and 22.3 kV from the negative lightning pulse. Again, since there is concern about the actual length of intact pump cable present at the time of the explosion, analysis was performed on a pump cable with a length of 61 m (200 ft.) to account for the cable piece found closest to the explosion area. The resulting induced voltage pulses on the 61 m (200 ft.) length of pump cable are shown in Figure 4-6. The maximum voltages expected on the shorter cable length are 20.5 kV from the positive pulse and 19.1 kV from the negative lightning pulse.

Lightning currents as low as 20 kA (either positive or negative), which is closer to the statistical average peak current of cloud-to-ground lightning strokes, can produce thousands of Volts on the pump cable. This level of voltage is more than capable of initiating an electrical arc under the right conditions. The peak voltage amplitude expected on the pump cable scales linearly with the peak current amplitude of the driving lightning stroke. The results from the 100 kA case shown in Figure 4-5 can be scaled to the 20 kA case by dividing the peak amplitude of the voltage on the cable by a factor of five.

Figure 4-5 Induced voltage pulse on pump cable (using an effective length of 120 m or 394 ft.) due to a hypothetical positive and negative 100 kA cloud-to-ground lightning stroke 100 m from directly above sealed area.

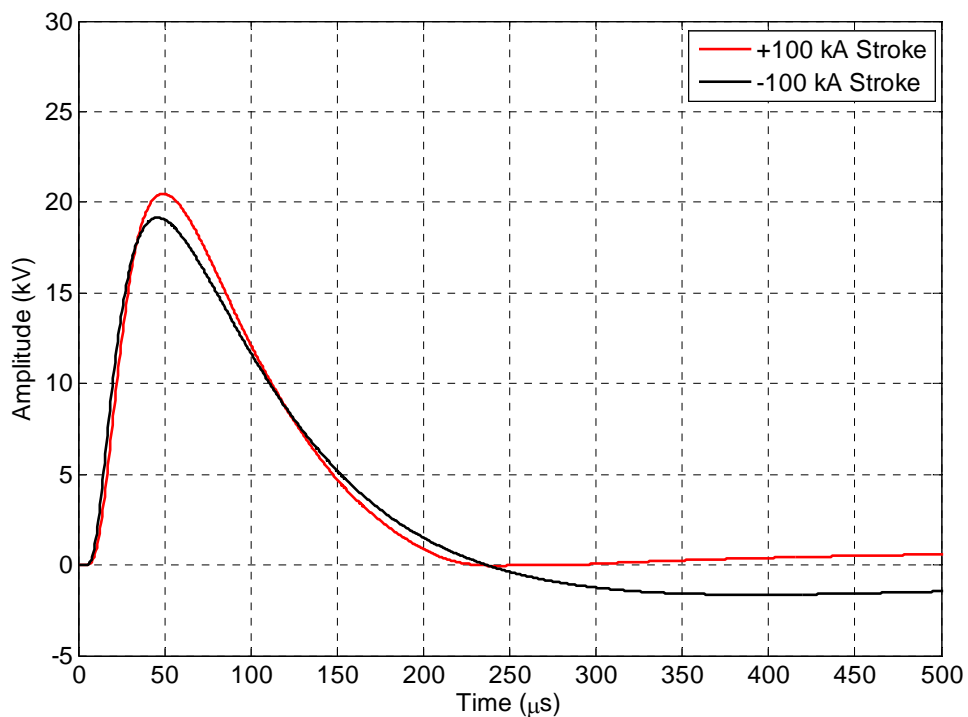
Figure 4-6 Induced voltage pulse on pump cable (length of 61 m or 200 ft.) due to a hypothetical positive and negative 100 kA cloud-to-ground lightning stroke 100 m from directly above sealed area.

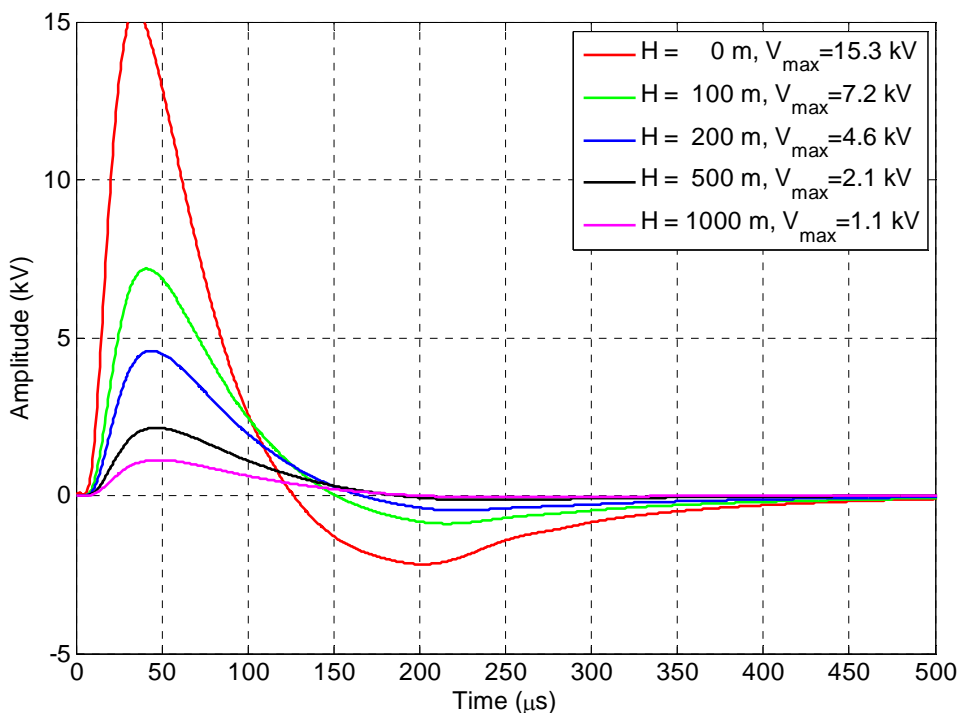
If we assume a 100 kA positive cloud-to-ground stroke with a long, low altitude horizontal current channel directly over the sealed area and inline with the pump cable direction at an angle of zero degrees, it could be capable of inducing voltages on the pump cable sufficient to produce electrical arcing. Pump cable (with an effective length of 120 m or 394 ft.) voltages are shown for a positive cloud-to-ground stroke with horizontal current channel at heights (H) of 0, 100 m (328 ft.), 200 m (656 ft.), 500 m (1640 ft.), and 1000 m (3281 ft.) above the surface in Figure 4-7. The maximum voltages from the positive current channel at the heights given are 15.3 kV, 7.2 kV, 4.6 kV, 2.1 kV, and 1.1 kV, respectively. Induced voltages for a negative cloud-to-ground stroke with a current channel directly over the sealed area are shown in Figure 4-9. The maximum voltages from the negative current channel at the heights given are 14.3 kV, 6.7 kV, 4.3 kV, 2 kV, and 1.1 kV, respectively.

Figure 4-7 Induced Voltage Pulse on Pump Cable (with an effective length of 120 m or 394 ft.) from Hypothetical Horizontal Current Channel from a Cloud-to-Ground +100 kA Stroke, H is distance of the Current Channel above the Ground.

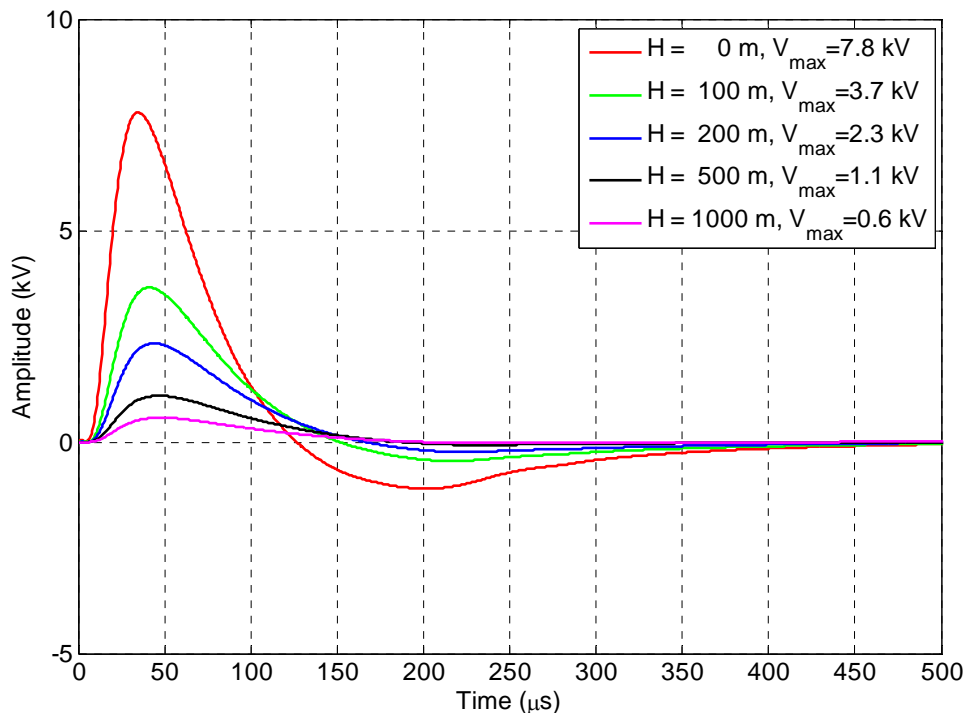
Again, since there is concern about the actual length of intact pump cable present at the time of the explosion, analysis was performed on a pump cable with a length of 61 m (200 ft.) to account for the cable piece found closest to the explosion area. The resulting induced voltage pulses on the 61 m (200 ft.) length of pump cable are shown for a positive cloud-to-ground stroke with horizontal current channel at heights (H) of 0, 100 m (328 ft.), 200 m (656 ft.), 500 m (1640 ft.), and 1000 m (3281 ft.) above the surface in Figure 4-8. The maximum voltages from the positive current channel at the heights given are 7.8 kV, 3.7 kV, 2.3 kV, 1.1 kV, and 0.6 kV, respectively. Induced voltages for a negative cloud-to-ground stroke with a current channel directly over the sealed area are shown in Figure 4-10. The maximum voltages from the negative current channel at the heights given are 7.3 kV, 3.4 kV, 2.2 kV, 1 kV, and 0.5 kV, respectively.

Figure 4-8 Induced Voltage Pulse on Pump Cable (length of 61 m or 200 ft.) from Hypothetical Horizontal Current Channel from a Cloud-to-Ground +100 kA Stroke, H is distance of the Current Channel above the Ground.

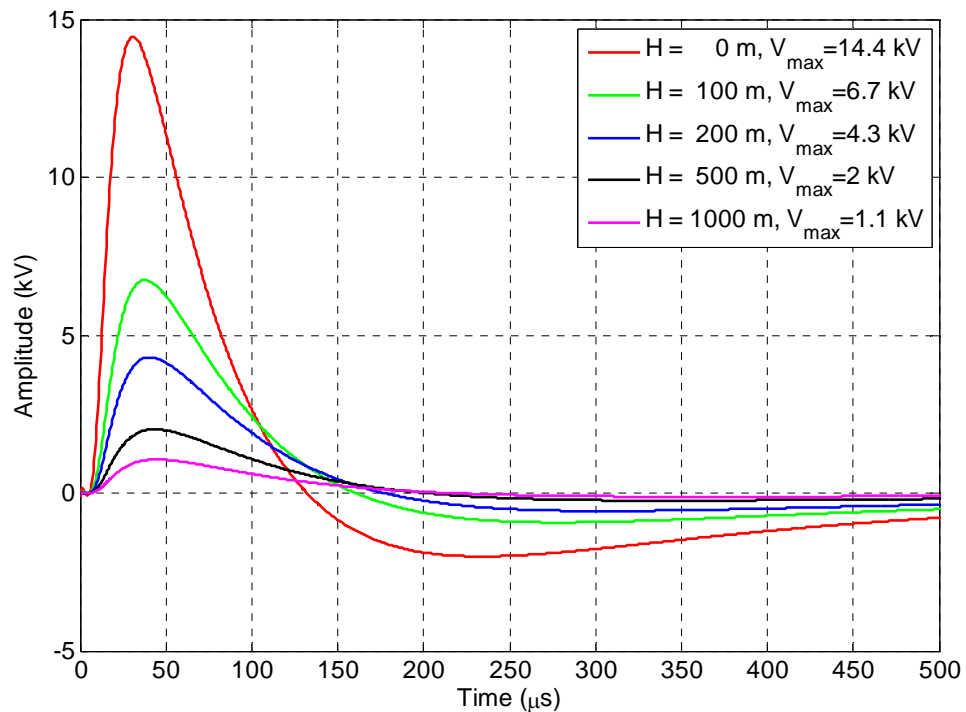
Figure 4-9 Induced Voltage Pulse on Pump Cable (with an effective length of 120 m or 394 ft.) from Hypothetical Horizontal Current Channel from a Cloud-to-Ground -100 kA Stroke, H is distance of the Current Channel above the Ground.

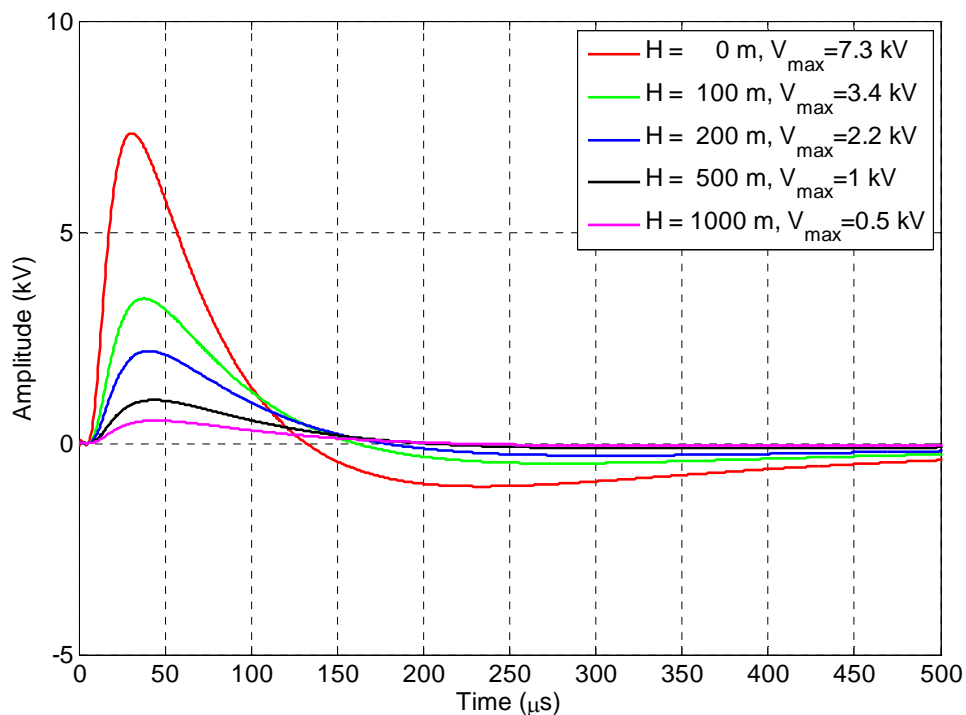
Figure 4-10 Induced Voltage Pulse on Pump Cable (length of 61 m or 200 ft.) from Hypothetical Horizontal Current Channel from a Cloud-to-Ground -100 kA Stroke, H is distance of the Current Channel above the Ground.

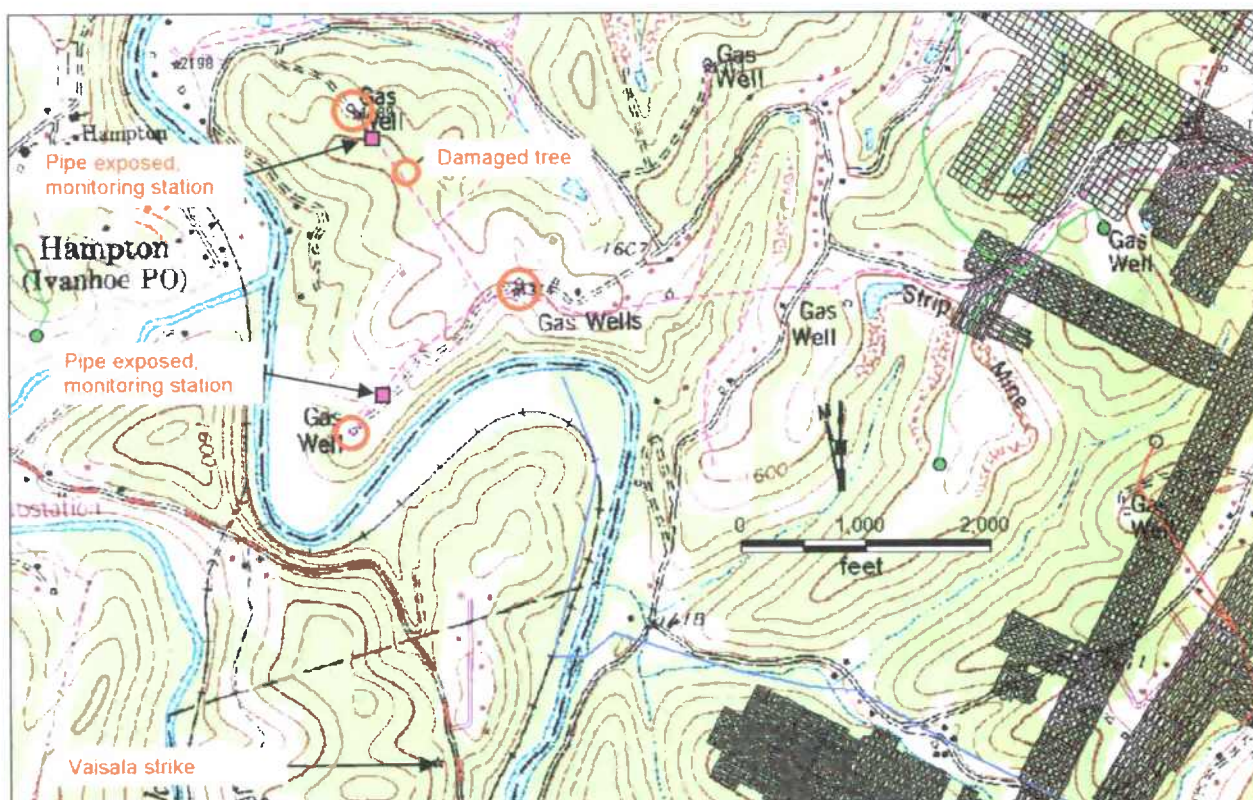
Observations began at the well located 2,800 feet north-northwest of the lightning strike recorded by Vaisala at 6:26:35 a.m. on January 2, 2006 (Figure 2). No visible damage that might be expected of high heat flow such as searing, discolored metal, or molten/beaded metal was apparent at the gas well, exposed piping, or holding tank (Figure 3). The surrounding area in an approximately 200-foot radius was visually inspected for damaged trees or fulgurite formation (glass formed from melted and recrystallized soil or rock as a result of a lightning strike). No obvious lightning damage to trees was apparent, although some small, dead trees were shedding bark. Additionally, a number of trees, identified as sycamore trees by the mine engineer, were shedding thin sheets of bark, although this appeared to be a common occurrence for

Figure 2. Gas wells (circled red) visited for this evaluation. Purple boxes represent monitoring stations for gas wells where metal gas lines are exposed at surface. A damaged tree was observed along the trend of a connecting gas line (purple dashed line), but appeared to be old damage. No lightning strike was reported at this location on January 2, 2006.

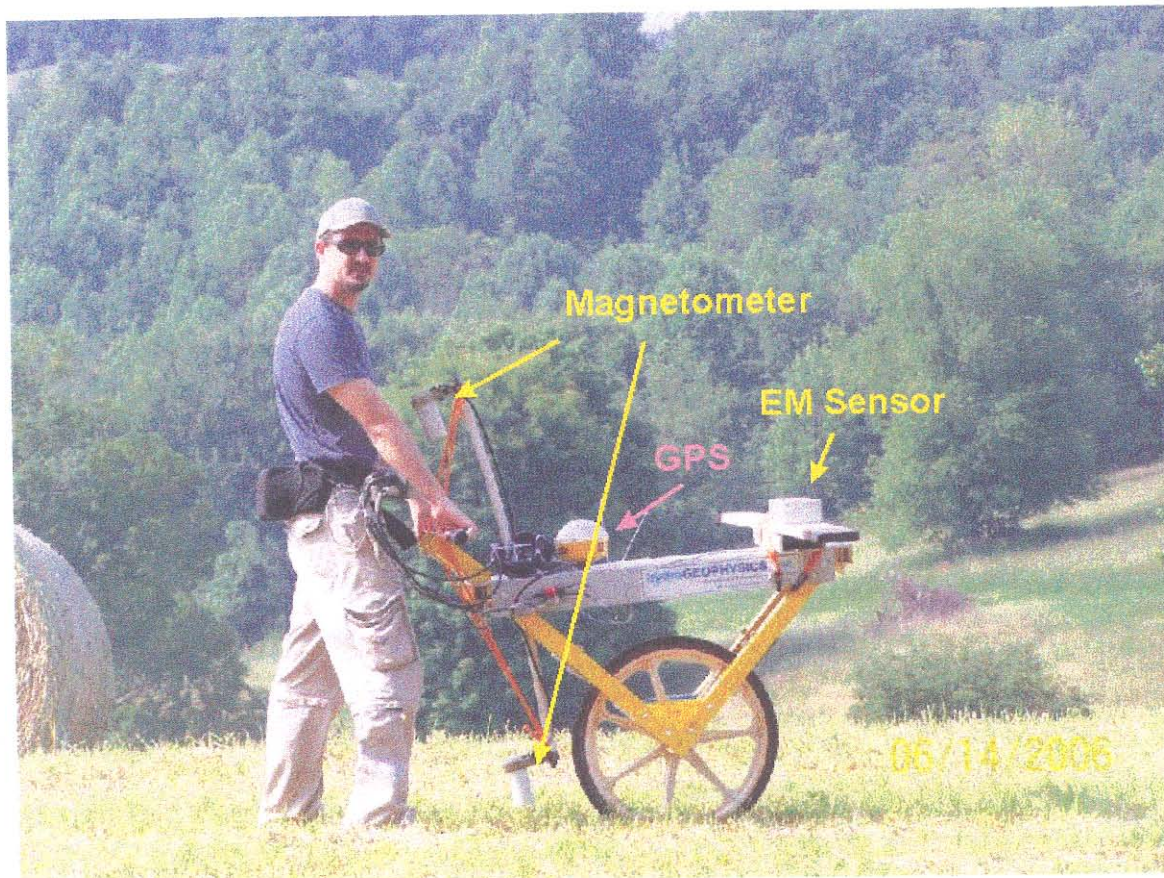
Figure 1. Push cart for simultaneous EM and MAG data acquisition. Dr. Dale Rucker

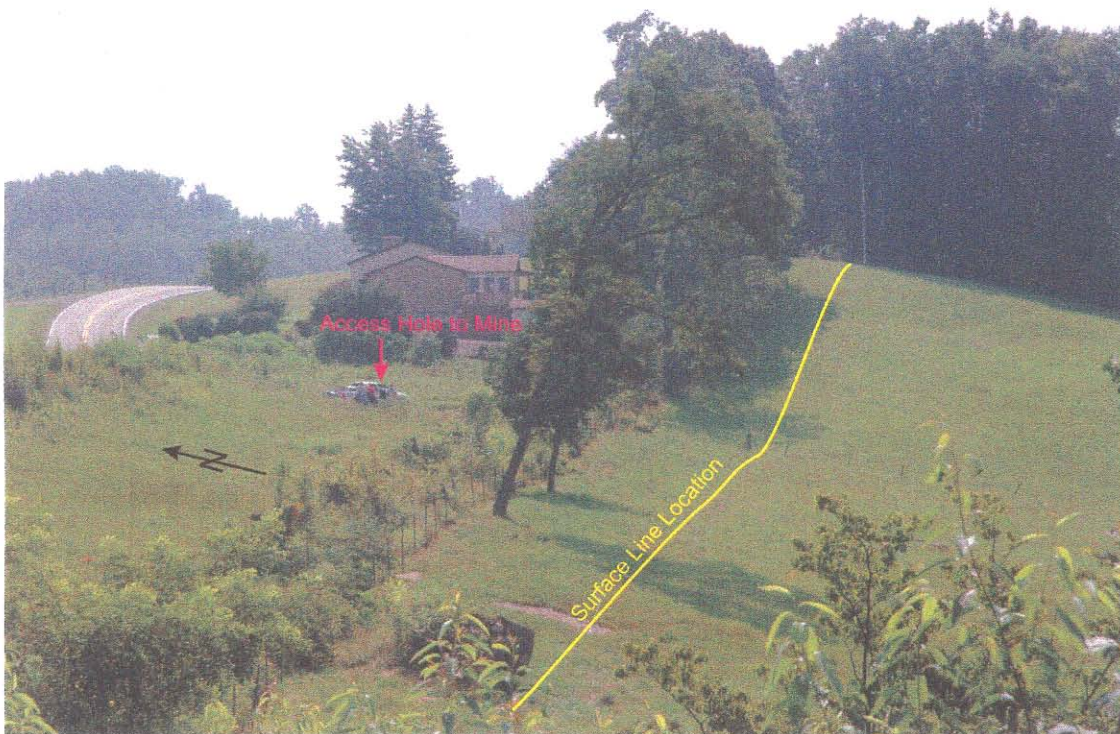
Figure 3 shows the location of the surface array, overlain on an oblique photograph of the area. The surface line was approximately 825 feet long and consisted of 56 electrodes that were spaced at 15 foot intervals. The 4010 access borehole was used to connect the surface resistivity electrodes to the underground electrodes.

Figure 3. Photo of HRR survey line area. View is towards the east.

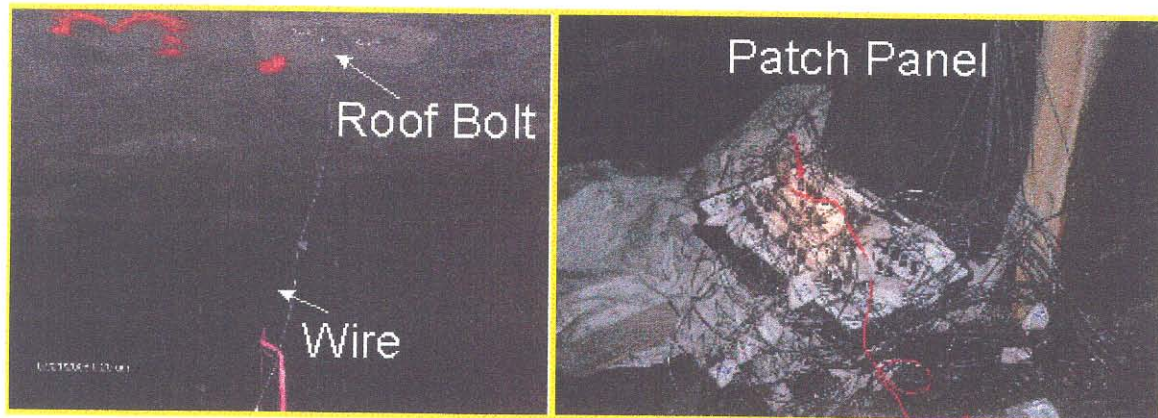
Figure 4. Photos of the underground roof bolts, wire leads, and patch panel equipment.

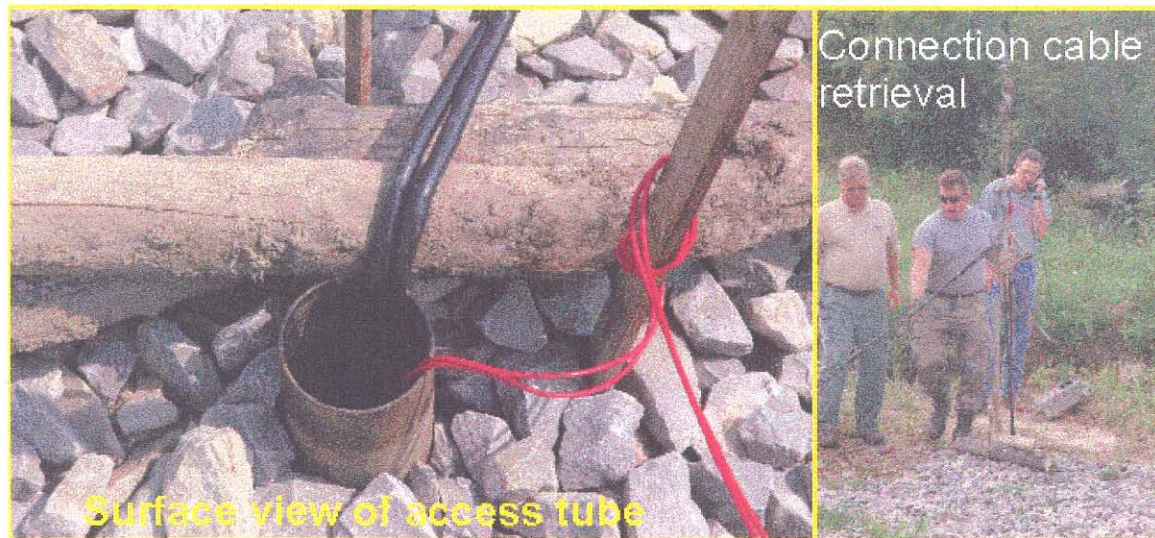
On the morning of July 21, 2006, the 56 channel patch panel was retrieved from the mine by ICG employees, the two extension cables were pulled from the borehole using a crane, and all other cabling and electrodes were retrieved from the surface. Figure 5 shows the operations necessary to retrieve the cables, which weighed approximately 90 pounds each.

Figure 5. Photos of the cable retrieval operations.

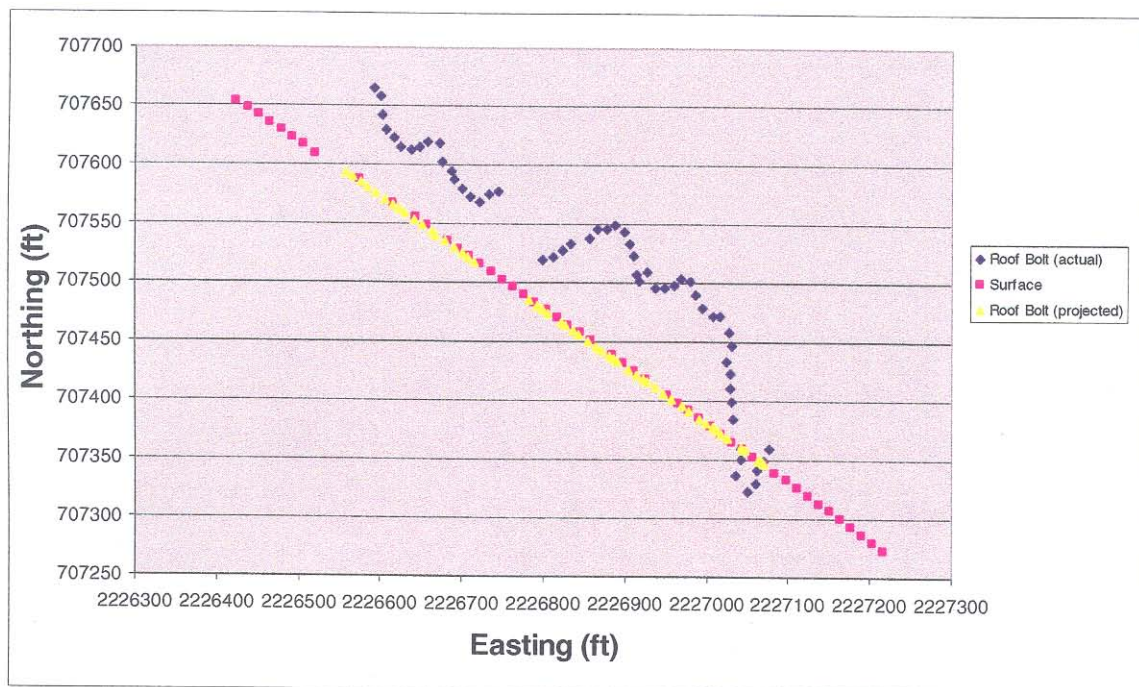
In order to create the two-dimensional inverted section, where surface and roof bolt electrode data were integrated, it was necessary to project the actual roof bolt electrode locations to coincide with the surface electrode orientation. This was completed by iteratively determining a mathematical relationship that geometrically projected the roof bolt electrode locations to the surface line. The actual and projected roof bolt locations are shown in Figure 9.

Figure 9: Graph showing projected placement of roof bolt electrodes to surface electrode orientation.

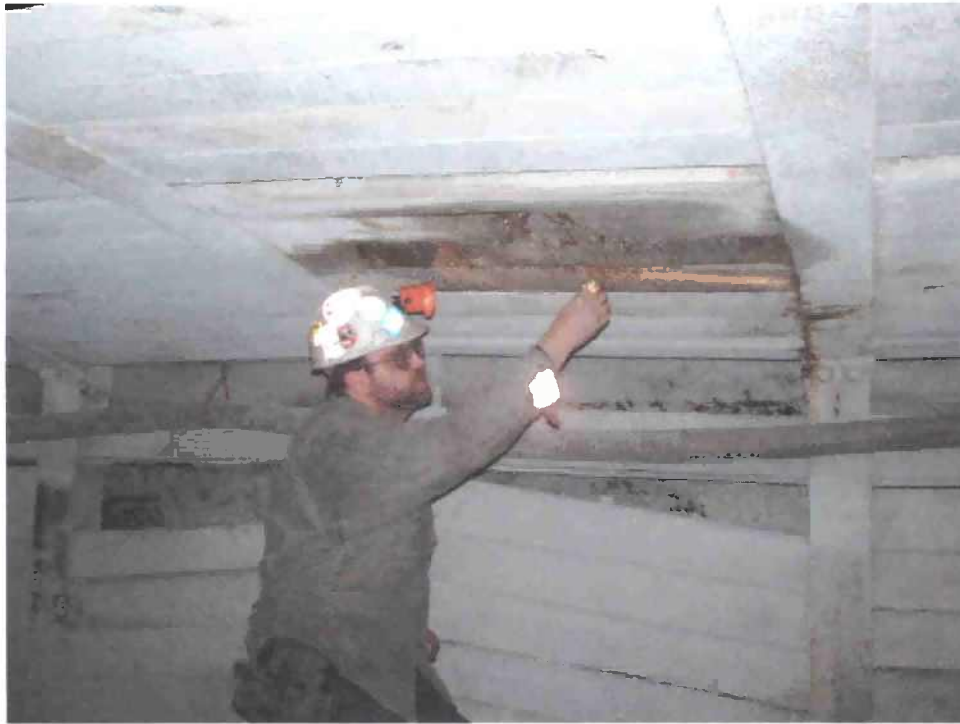
Figure 1. Collection of dripping water in the track entry of the Main, between Crosscuts 32-33.

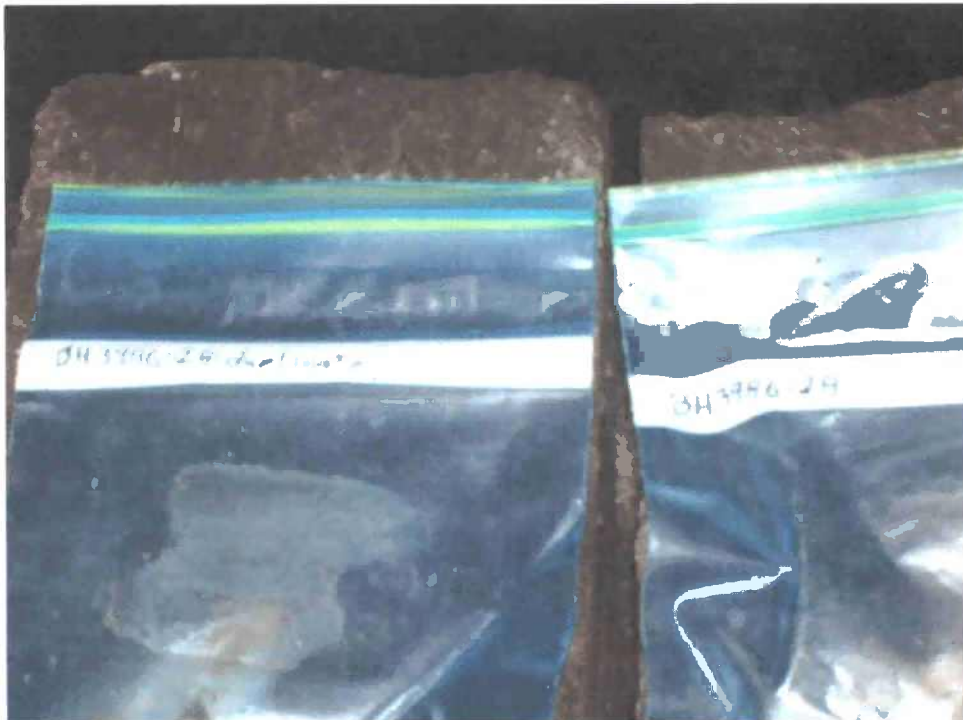
Figure 4. Photo of Sample BH3986-28, with the mine's duplicate sample. The sample was collected from the roof approximately 28 feet into the left-hand crosscut from spad 3986. The distance was measured with a laser range finder.

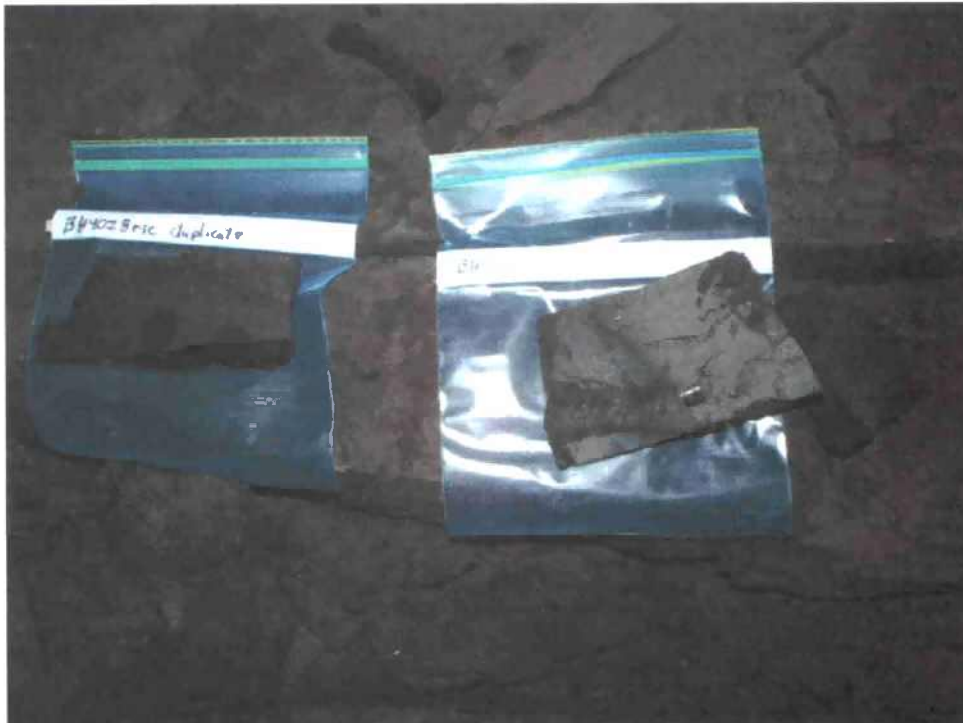
Figure 5. Samples collected from the right inby crosscut in the spad 4028 intersection. Half of the sample was retained by MSHA in a bag labeled "BH4028ric" and the other half was retained by mine personnel in a bag labeled "BH4028ric duplicate."

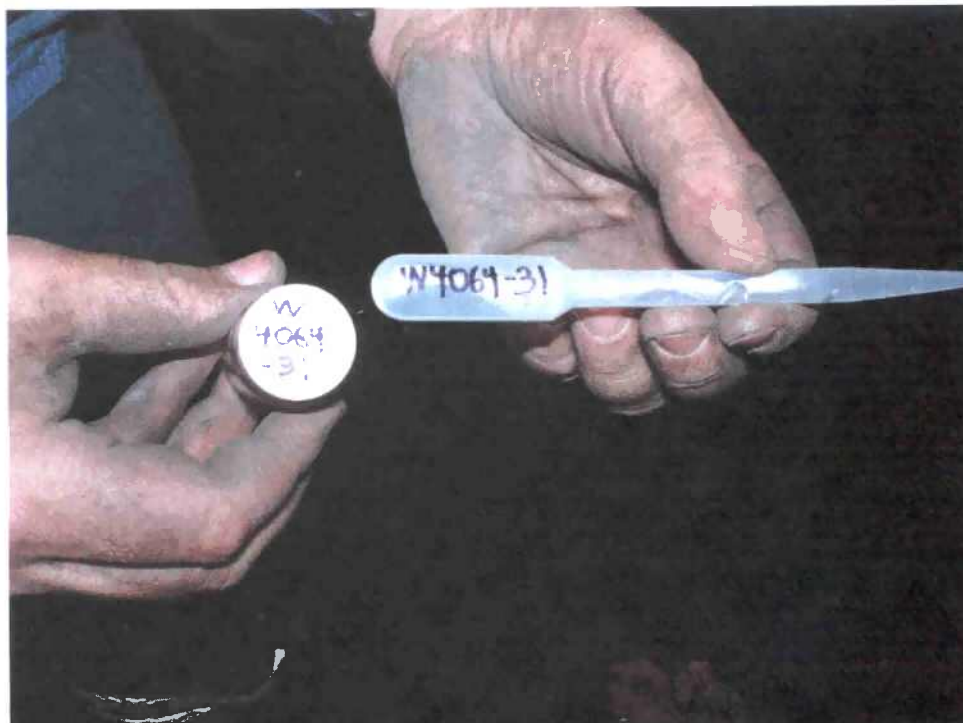
Figure 7. Water sample in glass vial collected from right rib of solid coal block in #8 Entry, 31 feet inby spad 4064. Plastic eye dropper is labeled with sample number to distinguish it from the separate dropper used in collection of sample BH3986-28.

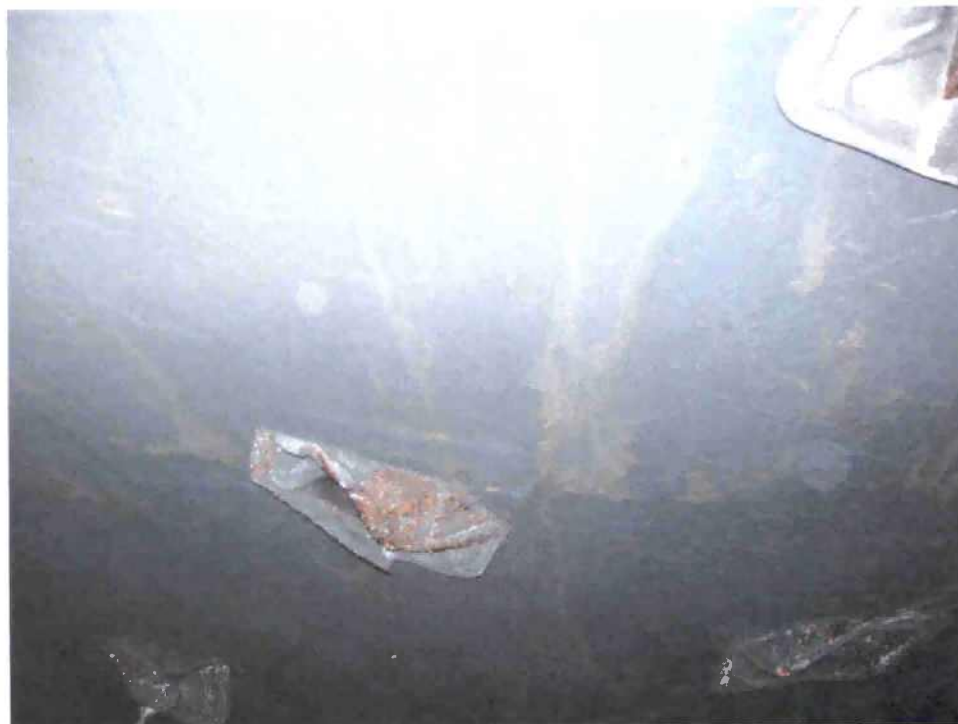
The intersection is characterized by a series of wavy brown streaks, which extend into the adjacent #8 Entry and crosscut. Each wavy brown streak has a linear, although undulatory trend that was measured with a Brunton compass. The streaks in the outby side of the #8 Entry exhibit a trend of approximately N 13-15°E, such that they project into the right inby corner of the intersection (Figure 8 and 9). Traversing from the #8 Entry inby to the left-hand crosscut, the brown wavy streaks change their orientation, and continue to trend toward the right inby corner of the intersection. Thus, the brown wavy streaks define a radiating pattern with a center point about the right inby corner of the intersection. These long, roughly linear, but wavy brown streaks are developed in flat, planar portions of the exposed roof. Several brown wavy streaks were observed that are approximately perpendicular to those developed on the planar roof horizon. These perpendicular streaks were developed along protrusions or small brows from the roof, and represented the exposed ridges of bedding asperities, and are generally less than 4 feet long. Comparatively, the longer linear, but wavy streaks are generally 7-12 feet long. The brown wavy streaks do not represent surficial dust, and instead represent actual linear exposures of rock. The brown shale is masked by a very thin bedding parting of black, carboniferous shale, except where it has been removed to expose the brown wavy streaks. The removal mechanism gave the appearance of sand blasting or scouring, rather than gouging. There were no depressions associated with the streaks that would suggest a geologic origin such as scour marks or trace fossil imprints. Despite the straight rib profiles observed even in the benched portions of this

Figure 8. Photo of linear, wavy brown streaks in the terminated #8 Entry, viewed looking inby along #8 Entry. Streaks are actually the exposed bases of the brown shale that overlies the thin black carbonaceous shale bedding parting.

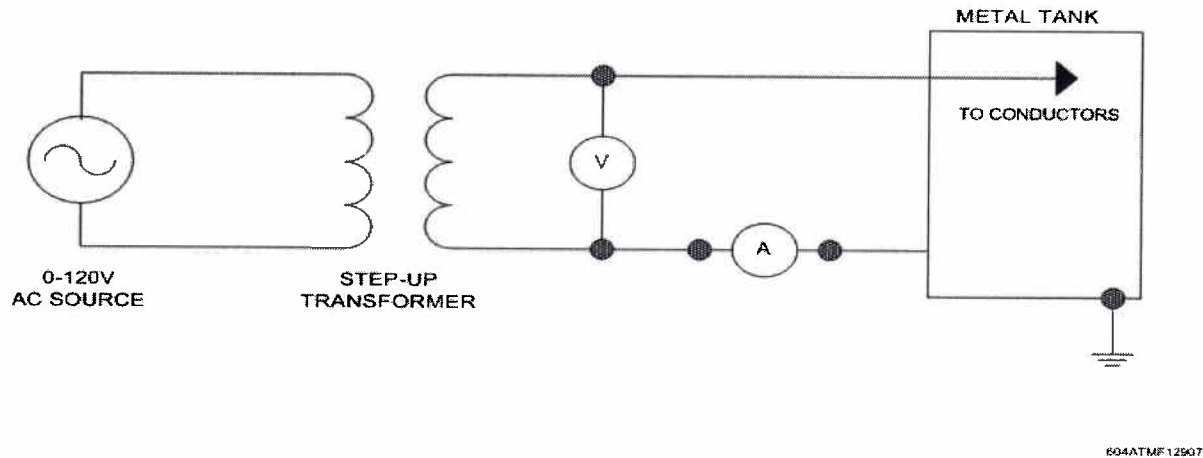
Figure 1. - Test Set-Up

The water bath testing of the pump cable revealed that the insulation on three of the four insulated conductors in the cable (red, black, and ground check) failed prior to the test voltage reaching the rated voltage of the cable (2000 volts). The white conductor reached a voltage of approximately 5,500 volts before a failure of the insulation occurred. The design of the cable did not provide insulation for the 2 ground conductors. As expected, they both failed at a very low voltage.

There were numerous locations on the cable jacket where significant damage was apparent. There were three permanent splices and one temporary splice in the section of cable tested. Based on the overall condition of this relatively short section of cable, the test results confirmed the anticipated failure of the insulation surrounding the conductors.
