# Rugged Charm

## Ranger Cabin (HS-1) Historic Structure Report

Jewel Cave National Monument  
Custer, South Dakota

November, 1999

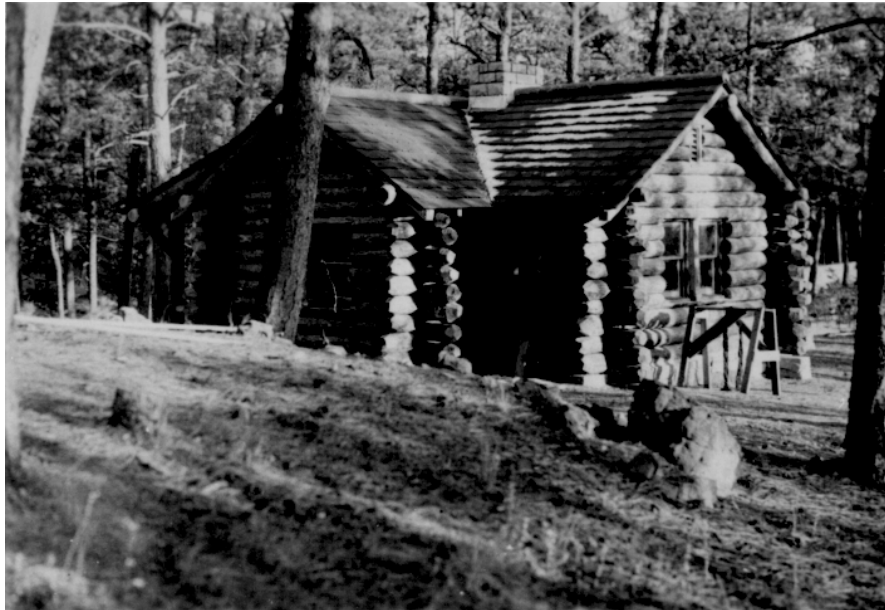
**Figure 6.** "11/30/35, Stevens Studio, Hot Springs, S.D." View to the southeast. Note that the kitchen windows are in place. Jewel Cave NM photo archives, Neg. No. 2628.

Two vent openings for the kitchen cooling and storage room are detailed in the construction drawings and show in two images taken during or soon after construction of the cabin (Figures 6 and 7). The vents were blocked at the exterior since at least the early 1950s (see Kitchen Appliances for further discussion on the cooling closet).<sup>50</sup> Because interior shelf construction conceals the vent wall, it is unknown at this time if the louvers are in place.

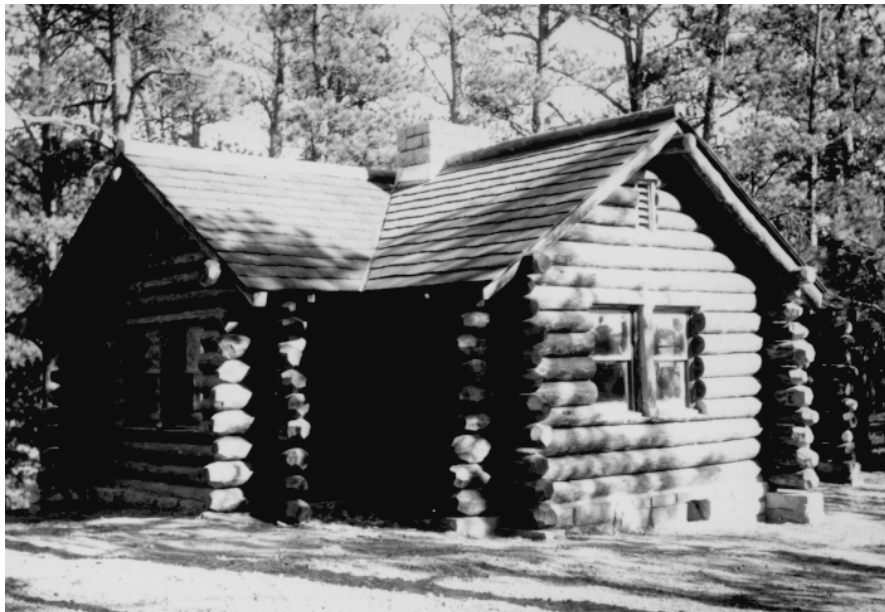
**Figure 7.** The Ranger Cabin upon exterior completion, ca. 1936, view to the southeast. Jewel Cave NM photo archives, Neg. No. 2614.

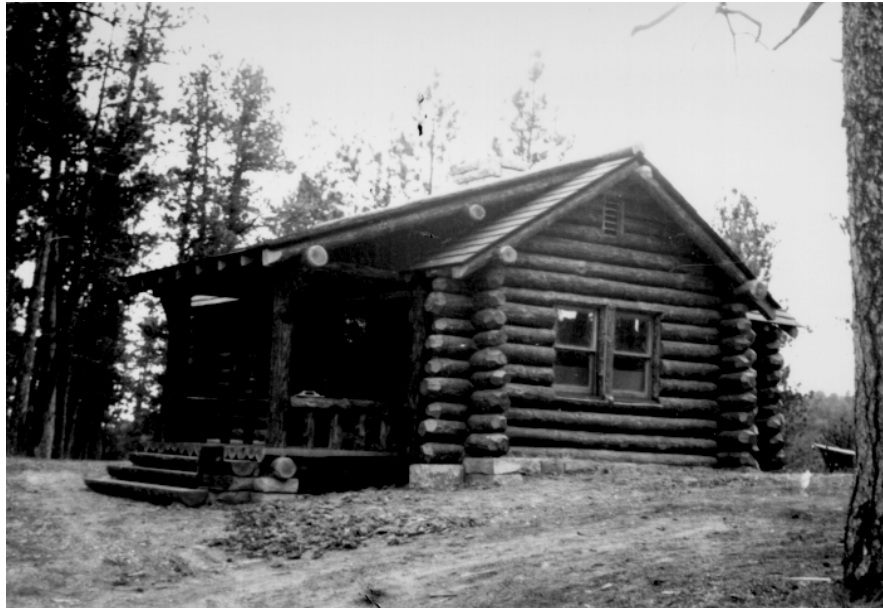
**Figure 8.** "8/9/38 Child's Ranger Station." Work was proceeding to finish the interior. Jewel Cave NM photo archives, Neg. No. 2620.

Photographic evidence suggests that the cabin may have been unoccupied for at least the first three years after log erection. In Figure 8, dated 1938, sheets of wall boards are believed to be leaning against the interior face of the living room windows. This suggests that interior finishes had yet to be installed. Interior finishes and log joint daubing may have been held off until the logs had time to season.<sup>3</sup> Also in this

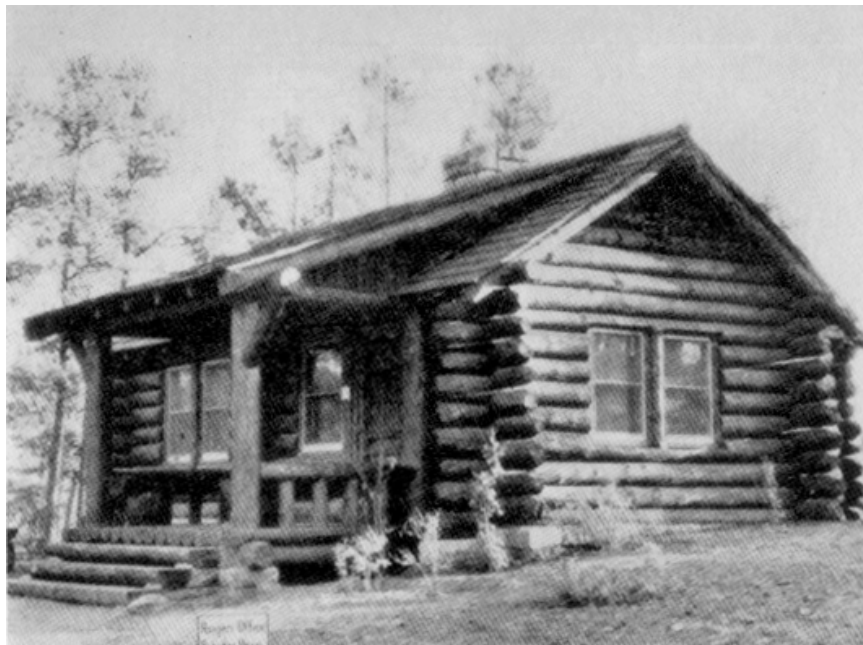
**Figure 9.** "Ranger's Station, Jewel Cave National Monument." Note the sign in the foreground indicating that the cabin was in use at the time. Log joints had yet to be daubed. From Albert Good, *Park and Recreation Structures*, Boulder, Colorado: Greybooks, 1990, (1938), 84.

Over the cabin's lifetime a series of exterior furnishings including benches, garbage cans, and signs, within arm's reach of the structure have come and gone. The earliest photograph of the structure in use occurs in Albert Good's 1938 publication. In that photo a small sign northeast along the path reads "Rangers Office Register Here." The sign may have survived into the 1940s (Figure 9).

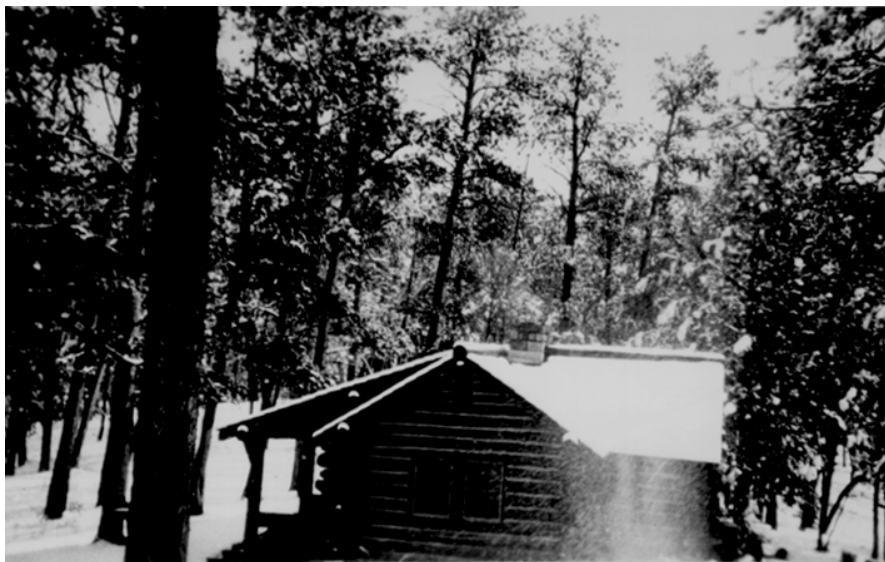
**Figure 11.** "Taken from the well (water fountain), circa 1942." This is the first image showing log joint daubing. Smoke from the chimney indicates the building was occupied during the winter. Jewel Cave NM photo archives.

According to one 1940s account the windows had no curtains. However, in a photograph dated to around 1940 and 1942, simple curtains can be seen in the north living room windows (see Figures 10 and 11).<sup>46</sup> The only other evidence for window coverings occurs in a 1965 photograph where metal blinds can be seen in living room windows.

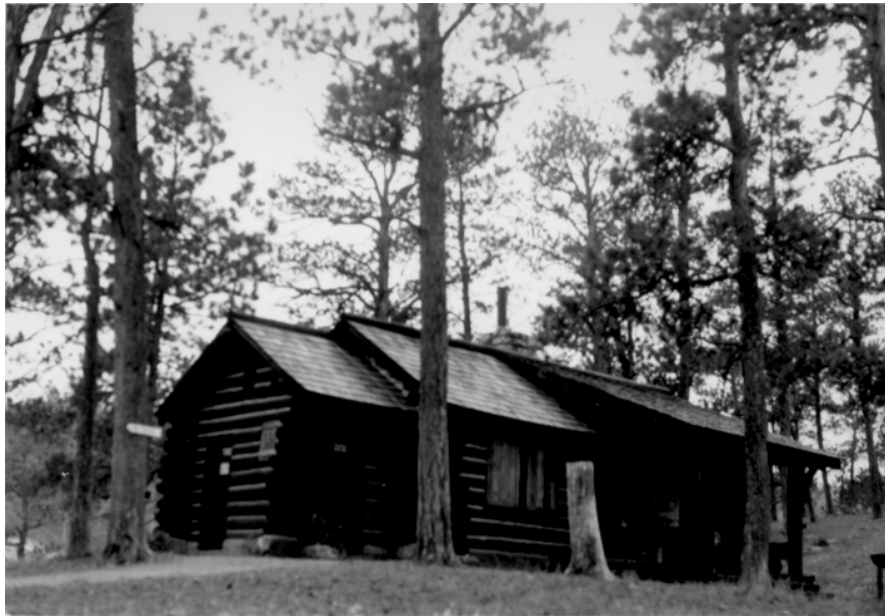
**Figure 16.** "Ranger Station," circa 1952. In this image the board shutters in place on the windows, and a clay flue pipe extends from the chimney. Jewel Cave NM photo archives, Neg. No. 2616.

During at least the 1950s simple board shutters were installed during the winter months when the structure was unoccupied (Figure 16).<sup>47</sup> It is unknown if that tradition dates back to the early 1940s.

clay flue liners have been added to presumably promote a better draw. According to historic photographs, the round kitchen flue extender was installed sometime during the 1950s (Figure 16), followed by the square fireplace flue extender around the 1960s (Figure 19). The round flue is cracked length-wise. According to the 1935 construction drawings both flues were to be furnished with fired clay liners.

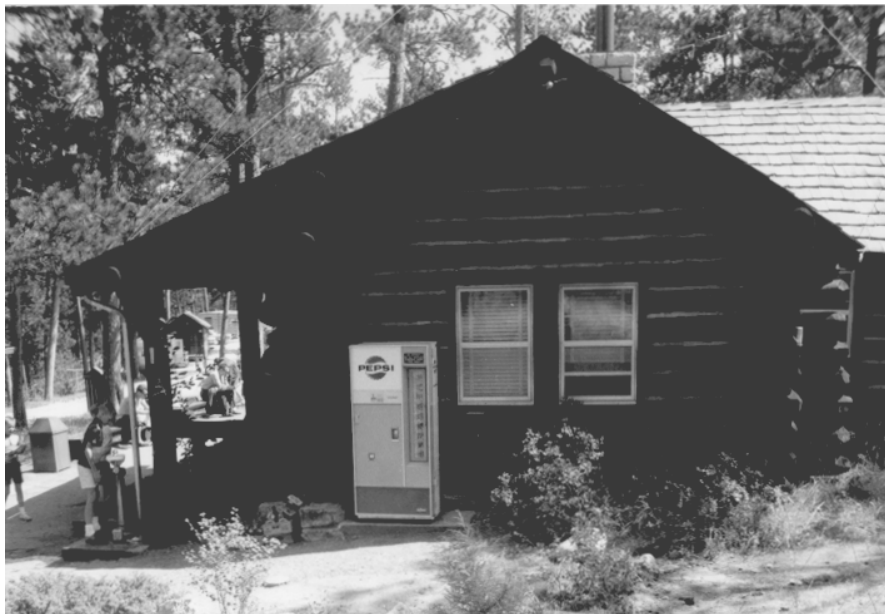
**Figure 17.** "Ranger Station and Pop Machine, Fassbender, 1965." By this time the cabin had been modernized with aluminum storm windows, a pop machine, and a drinking fountain. Jewel Cave NM photo archives, Neg. No. 2286.

The cabin had no gutter system until the 1960s (Figure 17). The existing ogee, or K-style, gutters and downspouts consist of painted galvanized steel and aluminum. Some of the gutters are in poor condition, and others were incorrectly installed

There is one account that there were screen and storm windows during the 1940s.<sup>48</sup> This is confirmed by historic photographs into the 1950s that show wooden storms or screens. These were replaced with aluminum combination storm windows by the 1960s (Figure 17), and these in turn replaced with wooden storm windows in 1986 that now exist.<sup>49</sup> There are no screen

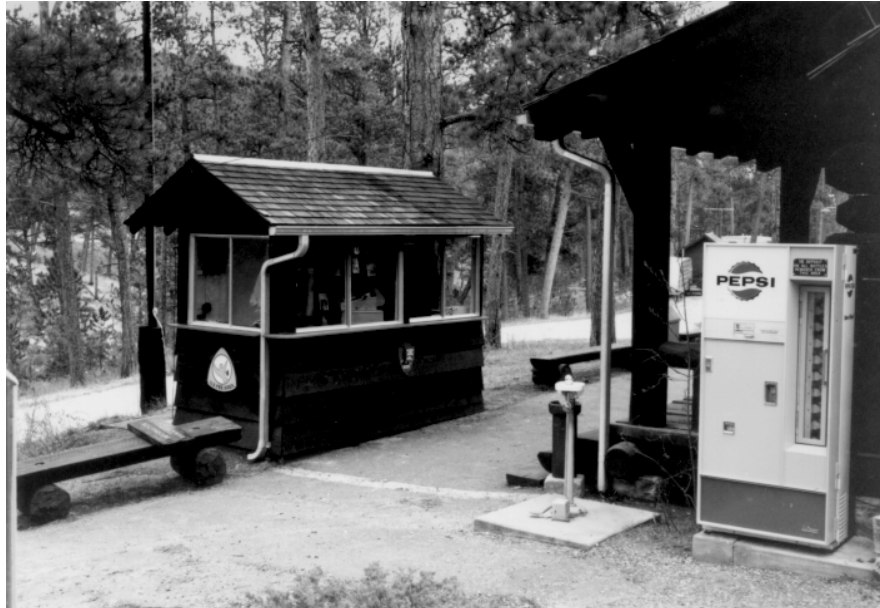
**Figure 18.** Information kiosk at the Ranger Cabin, circa 1966. The pop machine, kiosk, and other site furniture tended to crowd out the front porch at this time. Jewel Cave photo archives, Neg. No. 1908.

Changes were made to the surrounding landscape, such as the addition of paths, half log benched, railings, parking lots, and a ticket booth just outside the front porch (Figure 18). Some remodeling work may have been accomplished in 1949, but the cabin remained virtually untouched until the early 1980s.<sup>7</sup> At the exterior, wooden storm windows had been replaced with aluminum units during the 1970s, and portions of the roof eaves were furnished with gutters and downspouts. The roof was replaced, and the unusual log ridge cap removed in 1959.<sup>8</sup>

By the 1960s a pealed log railing had been added along the paths including those to the restrooms (Figures 17 and 18). A small information and ticket booth was constructed just across the path from the porch. By the 1960 a drinking fountain was placed on a concrete slab at the northeast corner of the porch. If that didn't quench visitors' thirst a soda machine was nearby pushed up against the building. At present there are no furnishings or signs near the cabin.

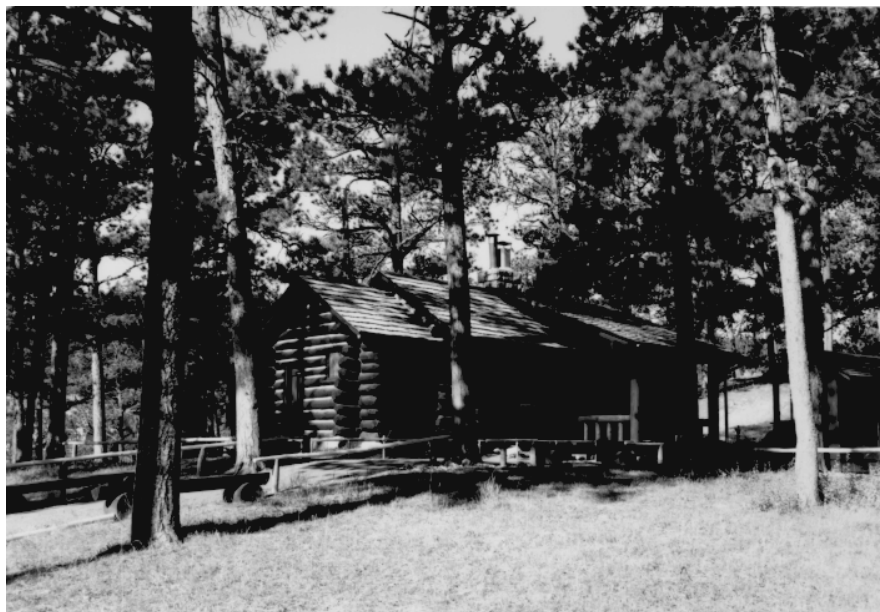
**Figure 19.** "Quarters #1 (Ranger Station), D.F.G., 10/19/67." By this time railing had been added to either side of paths leading to the cabin, and half-log benches are prolific. Jewel Cave photo archives, Neg. No. 1898.
