LA-13638

A Review of Criticality Accidents

2000 Revision

Issued: May 2000

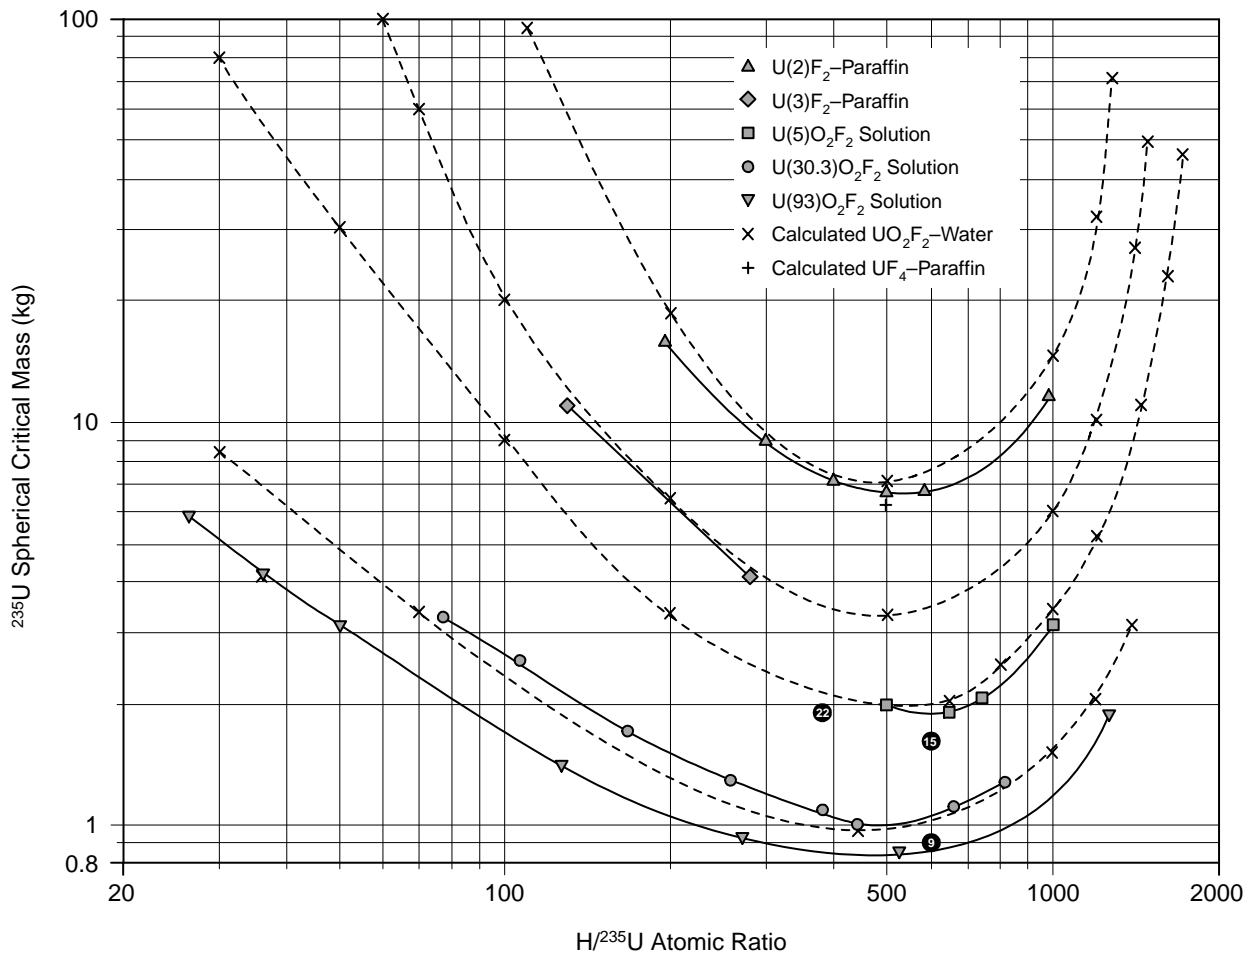
Figure 38. Critical masses of water-reflected spheres of hydrogen-moderated U(93), U(30.3), U(5.00), U(3.00), and U(2.00). The accidents are shown by numbered circles.

to 2.0, 3.0, 5.0, 30.3, and 93.0. Accidents 9, 15, and 22 are superimposed on this figure. Since the curves in Figure 38 are for water reflected systems, these points have been adjusted downward since the actual accidents were relatively unreflected.

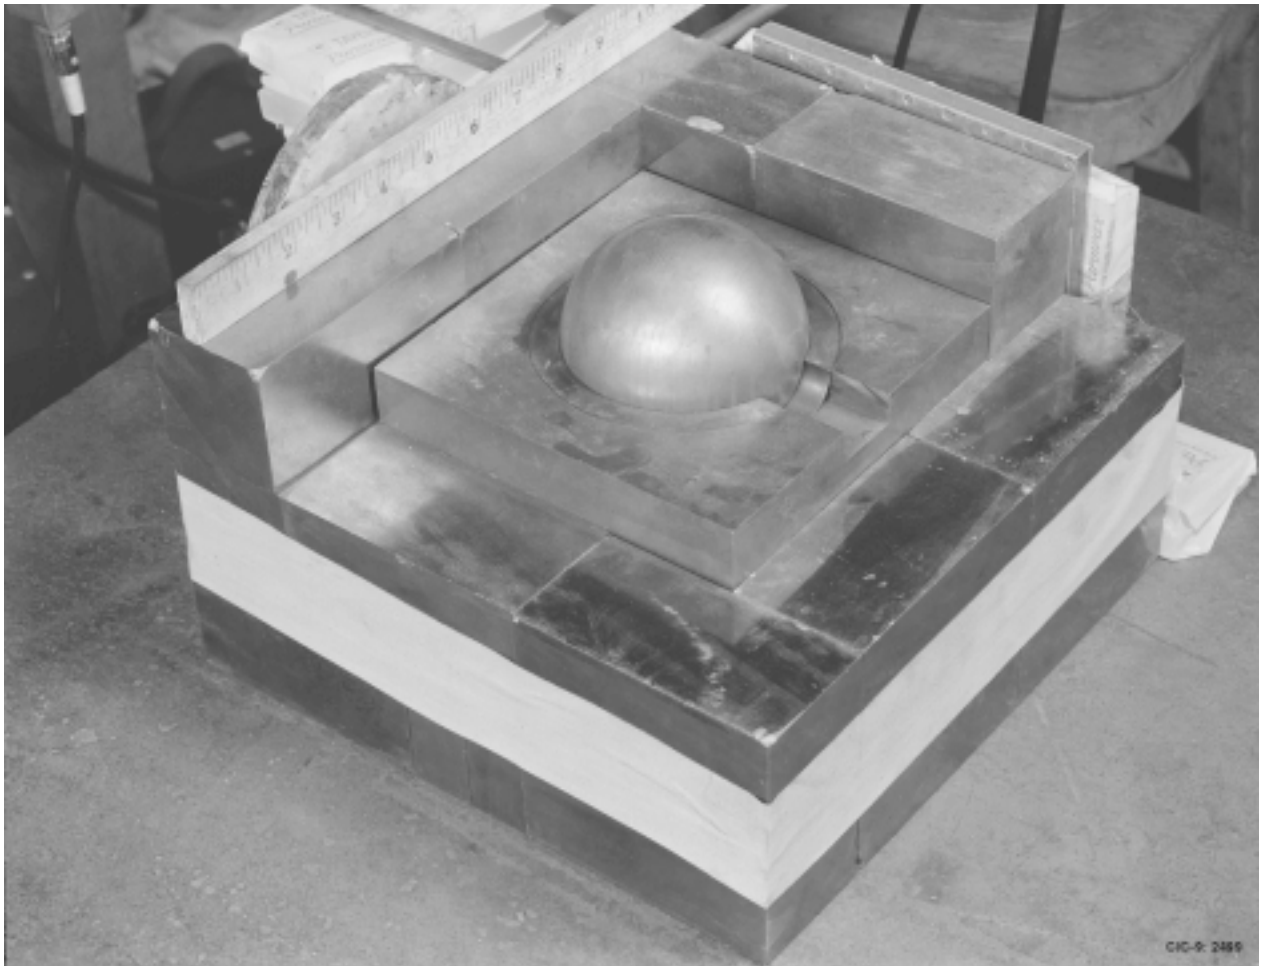
Figure 41. Plutonium sphere partially reflected by tungsten-carbide blocks.

In the first accident, a critical assembly was being created by hand stacking 4.4 kg tungsten carbide bricks around the plutonium core. Figure 41 shows a reenactment* of the configuration with about half of the tungsten blocks in place. The lone experimenter was moving the final brick over the assembly for a total

*The Los Alamos National Laboratory archives include some data and comments about a rerun performed 2 October 1945 to determine the radiation dose received in the accident of 21 August 1945. The yield of the rerun was about 6×10^{15} fissions, but the prompt critical state was not reached. The maximum reactivity of the system during this experiment was about 60 ϵ above delayed criticality.

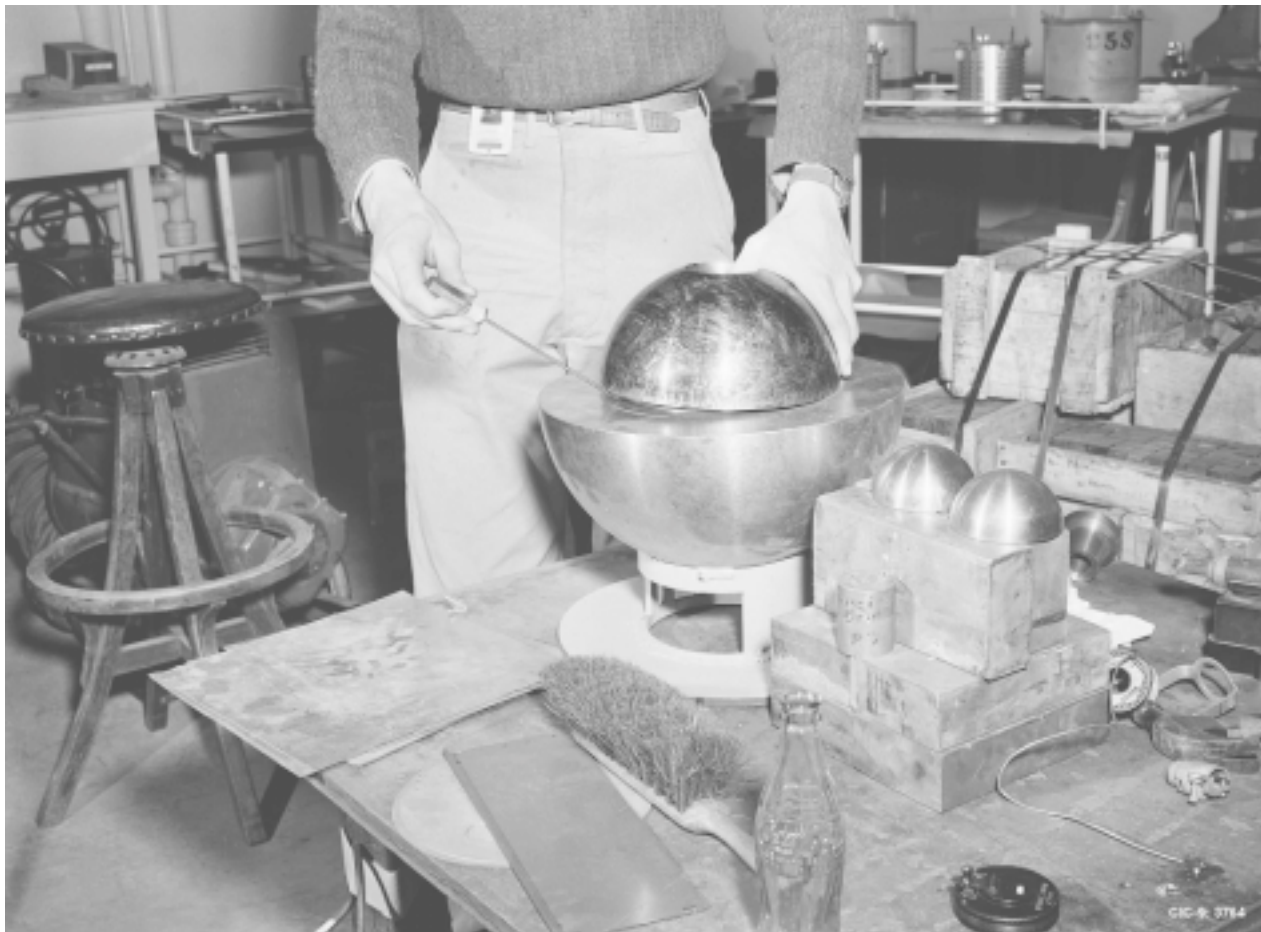
Figure 42. Configuration of beryllium reflector shells prior to the accident 21 May 1946.

(Figure 42). The person conducting the demonstration was holding the top shell with his left thumb placed in an opening at the polar point.

The yield of this excursion was 3×10^{15} fissions; again, there was no rupture of the nickel canning. The eight people in the room received doses of about 2100, 360, 250, 160, 110, 65, 47, and 37 rem. The man who performed the experiment died nine days later.

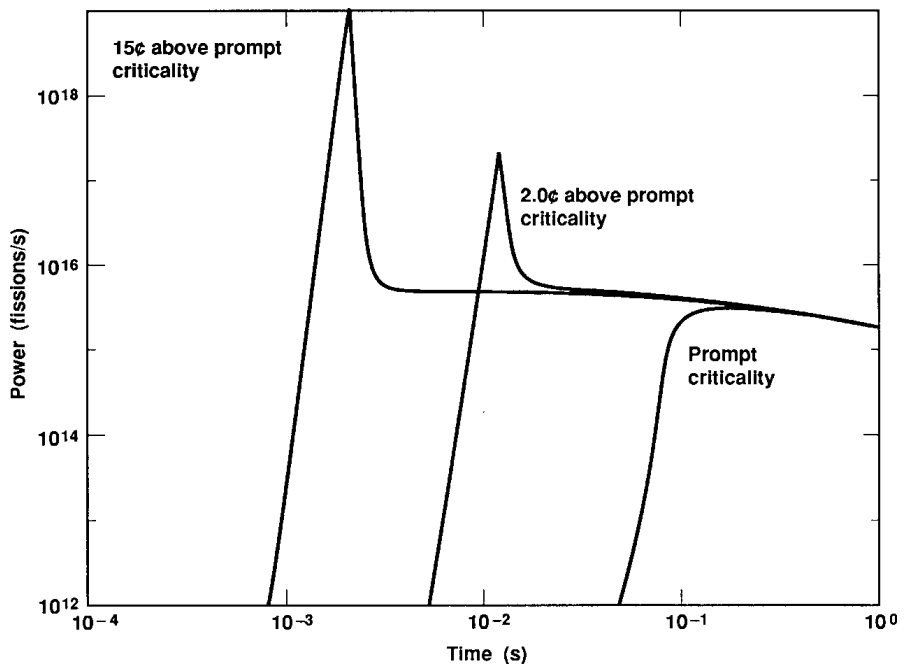
Figure 43. Calculated fission rate for the 6.2-kg plutonium sphere.

The results of fission rate calculations in this sphere, as a function of time for several values of excess reactivity, are shown in Figure 43. Figure 44 represents the total number of fissions to be expected as a function of time for the same excess reactivities. These data are applicable to both accidents because the difference in reflector material has only a small effect on the neutron kinetics. In the first excursion, if the excess reactivity did not exceed $15 \text{ } \rho$, the assembly must have been together for several seconds, which is not unreasonable. In the second event, the experimenter was better prepared to disassemble the material, and it is thought that this was done in a fraction of a second, perhaps $<1/2$ second. The known parameters would then be satisfied by an excess reactivity of about $10 \text{ } \rho$.

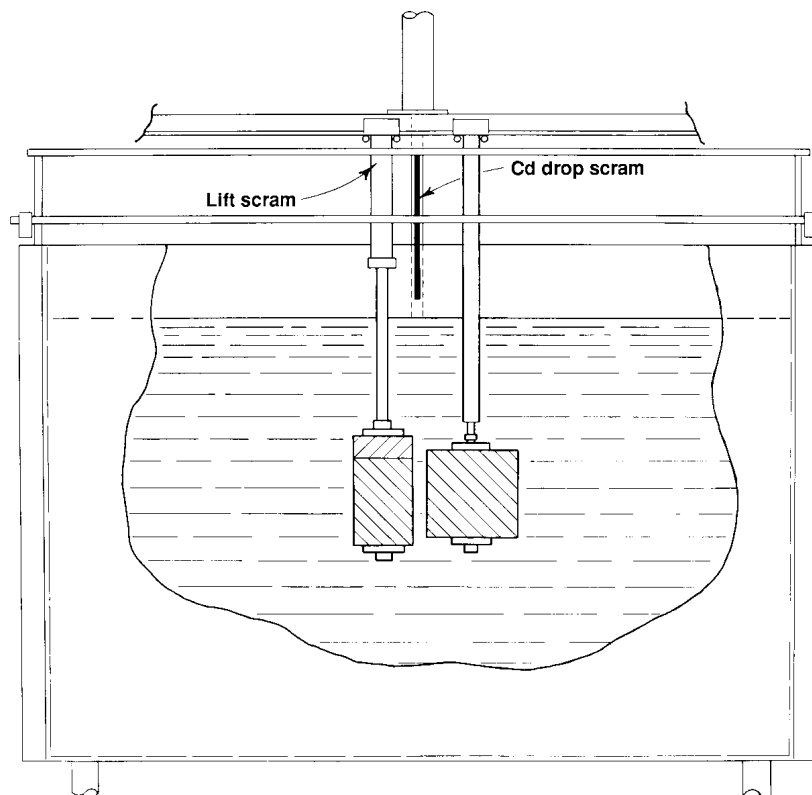
Figure 45. The Los Alamos Scientific Laboratory assembly machine employed for measurements of critical separation distances.

At the completion of the critical separation experiment (at a multiplication of 65.5), the assembly was scrammed. The water started draining, the cadmium screen dropped, the solid cylinder (left-hand body in Figure 45) was lifting, and an excursion (later deter-

Later reconstruction of the accident showed that the pneumatic tangential scram was the first to be effective and led directly to two types of difficulty. First, the center of reactivity of the left-hand cylinder (Figure 45) proved to be below that of the stationary cylinder; second, the rapid lift through the water created hydrodynamic forces that swung the cylinders closer together. The combination of the two effects was enough to drive the assembly prompt critical and to have maintained at least this much reactivity for 0.2 seconds if the power excursion had not occurred. The first power spike is estimated to have contained 6×10^{15} fissions. It is possible that one or more excursions into the prompt region followed because boiling was the primary quenching mechanism.

In this excursion of 10^{17} fissions, no radiation doses were received, and no contamination was found in the experimental area. Damage to the uranium consisted of a small amount of oxide flaking and blistering. The experimental area was in use two days later.

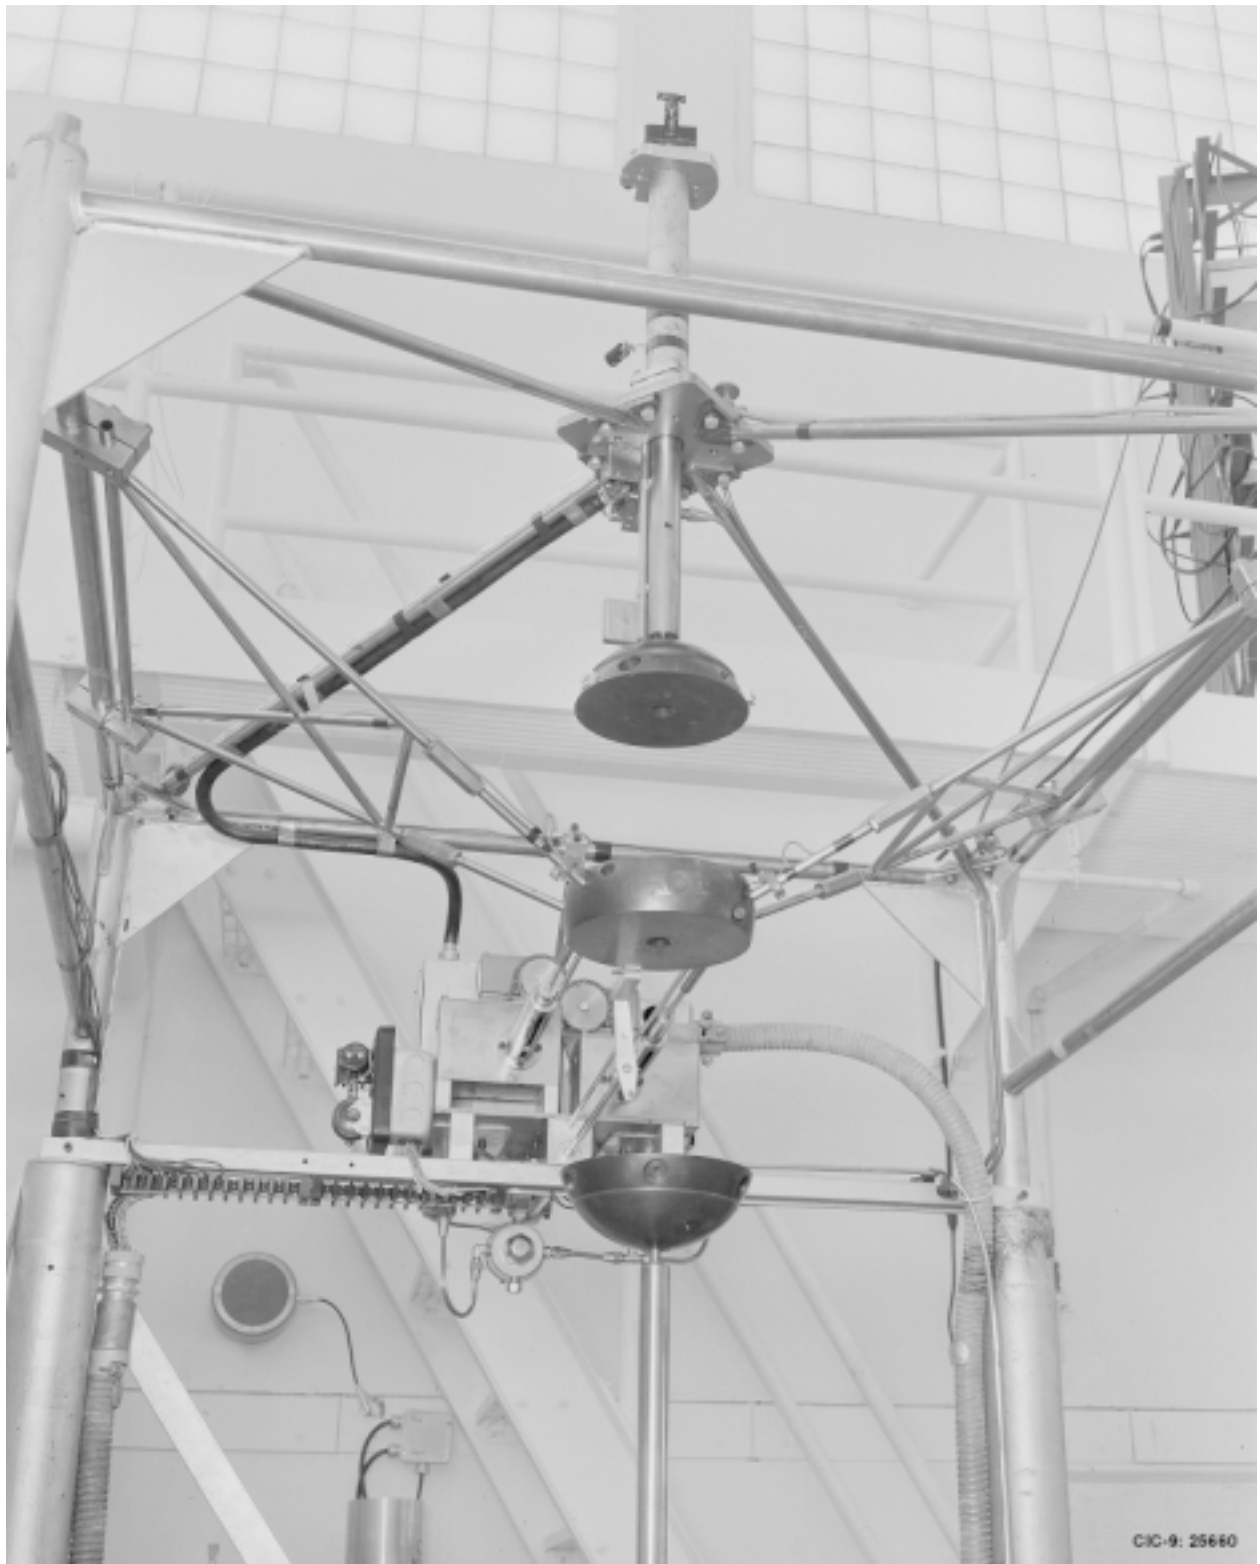
Figure 48. The Los Alamos Scientific Laboratory Lady Godiva assembly (unreflected enriched-uranium sphere) in the scrambled configuration.

These two excursions occurred in the Lady Godiva assembly, an unreflected metal reactor fabricated in three principal sections that when assembled formed a sphere. Figure 48 shows Godiva in the scrambled state. The central section was fixed in position by small tubular steel supports, while the upper and lower sections were retractable by means of pneumatic cylinders, thus providing two independent scram mechanisms. The critical mass was about 54 kg of uranium enriched to 93.7% ²³⁵U. It was operated remotely from a distance of 1/4 mile.

The fission yield of 1.2×10^{17} in the second accident is equivalent to the energy contained in 1.7 lb of high explosive (HE), but the damage was much less than would have been caused by that quantity of HE. The above mentioned code can predict the fraction of fission energy converted to kinetic energy; in this case, only about 1.4% of the energy, equivalent to 0.024 pounds of HE, was available as kinetic energy to do damage. The damage was consistent with this figure, and it is evident that most of the fission energy was deposited as heat.

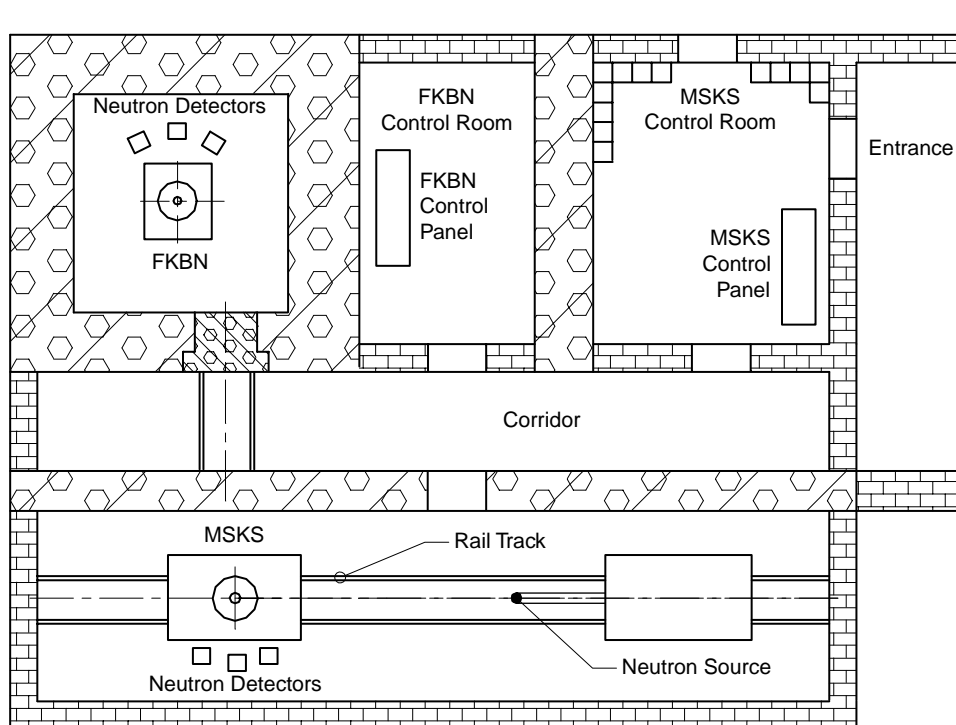
Figure 52. Building B floor plan.

This accident occurred on 11 March 1963 as modifications and maintenance were being performed on a vertical split machine, MSKS. MSKS (Figure 51) was located within Building B at a reactor site (Figure 52) and was used to perform experiments other than critical approaches. It was limited to assemblies whose shape, composition, maximum subcritical multiplication ($\leq 1,000$), safe assembly–disassembly procedures, and the contribution of fixtures and equipment in use had already been verified by experiments on the vertical split machine, FKBN-1, located in the same Building B (Figure 52). MSKS was equipped with an automatic gravity driven scram system and closure of an assembly was performed remotely from a control panel behind concrete shielding (Figure 52).

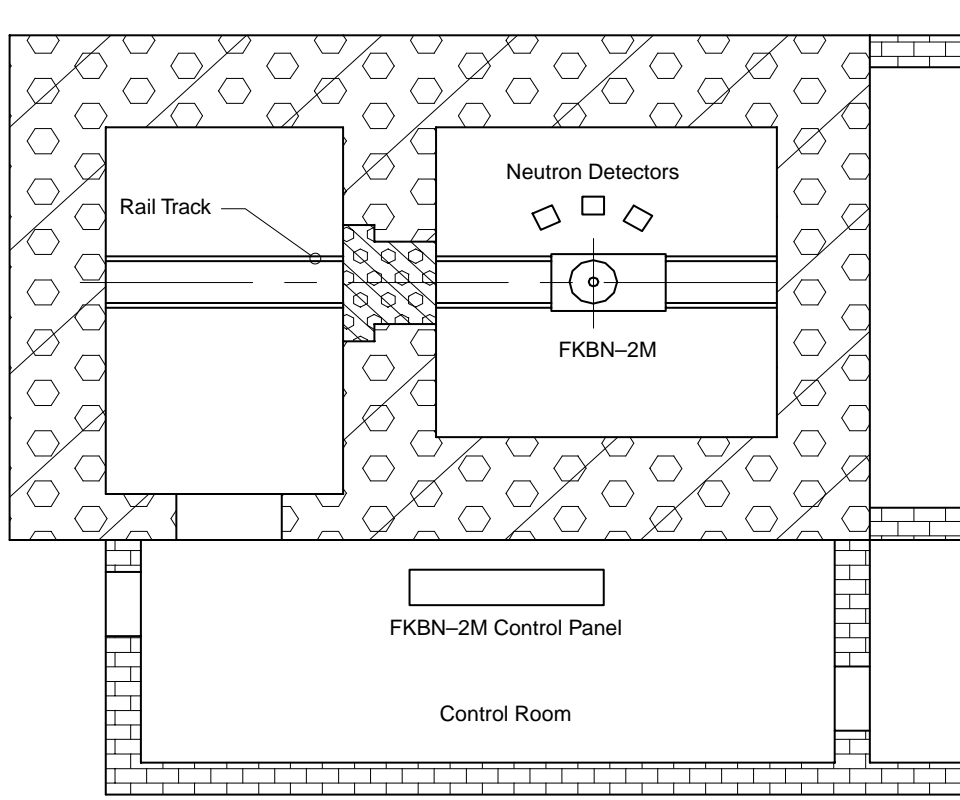
Figure 54. FKBN-2M building layout.

This accident occurred at 10:40 on 17 June 1997 as an experimental assembly was being hand constructed on a vertical split machine, FKBN-2M. FKBN-2M is located in an experimental cell (12 m \times 10 m \times 8 m) of a dedicated building (Figure 54) at a reactor site.⁶⁰ A schematic of FKBN-2M is shown in Figure 55. The lower part of a research assembly is constructed on a table that can be moved vertically up and down using hydraulics, although the table had to be in the up position during construction of an assembly. The upper part is placed on a stand consisting of a ring, upper and lower support, and a carriage that can be moved horizontally and into position over the lower part of the system. Closing of the assembly (by moving the carriage over and the table up) is performed remotely from a control room behind an ~3 meter thick concrete shielding wall (Figure 54). FKBN-2M is equipped with a fast acting gravity driven scram that automatically causes the table to drop to its down position if the neutron flux exceeds a preset value.

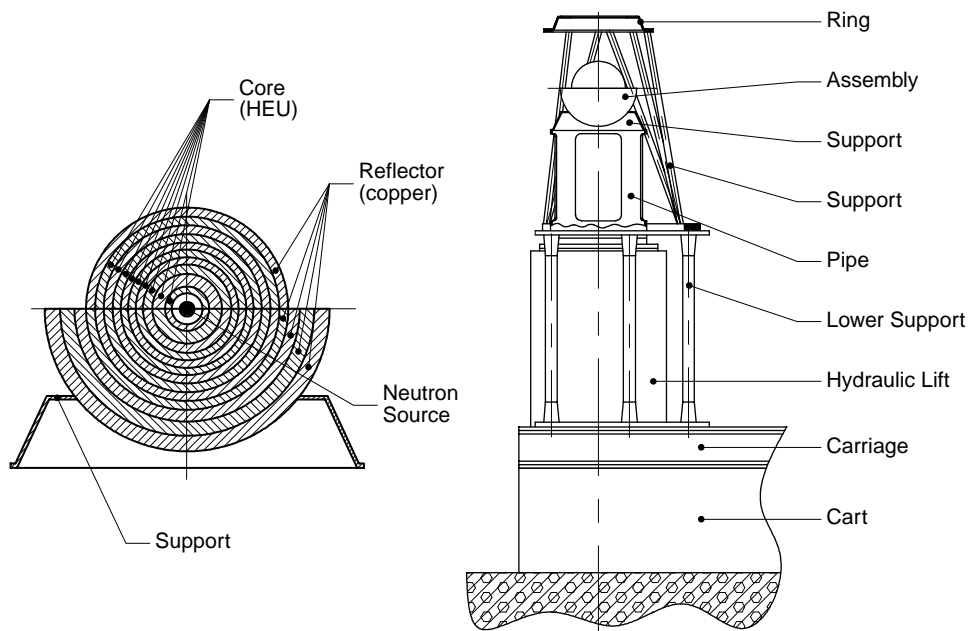
Figure 56. Accident configuration.

completed the construction of the lower half of the assembly on the table (Figure 56). This lower half consisted of the copper reflector (with an outside diameter of 258 mm since that was all that was available) and a uranium core (9 spherical layers, with an inside diameter of 28 mm and an outside diameter of 167 mm) with a neutron source ($\sim 10^5$ n/s) placed in its center. As he went to position the first upper copper hemishell (with an inside and outside diameters of 167 mm and 183 mm, respectively) into place it dropped onto the bottom assembly. This led to the initial prompt critical spike and the ~ 6.5 day excursion. The automatic scram system activated and dropped the table to its down position⁶⁰ but otherwise had no effect on the supercritical assembly. After the initial fission burst, the assembly eventually reached steady state power conditions.

The main cause of the accident was the erroneous judgment of the experimenter as to the state of the experimental assembly he was constructing. The accident resulted in virtually no damage to the machinery or equipment in the facility. The experimental cell was not contaminated. The experimenter received estimated absorbed doses of 4,500 rad from neutrons, and 350 rad from gamma-rays.^{61, 62, 63} That same day he was transported to a specialized clinic in Moscow, where he died during the night between 19 and 20 June, 1997. No other personnel were injured or received significant exposures. Radiation levels inside the control room and in the vicinity of the building remained at normal levels. The total energy released was estimated to be equivalent to 10^{19} fissions. After the accident, experiments with FKBN-2M were stopped to implement safety upgrades to the research operations.

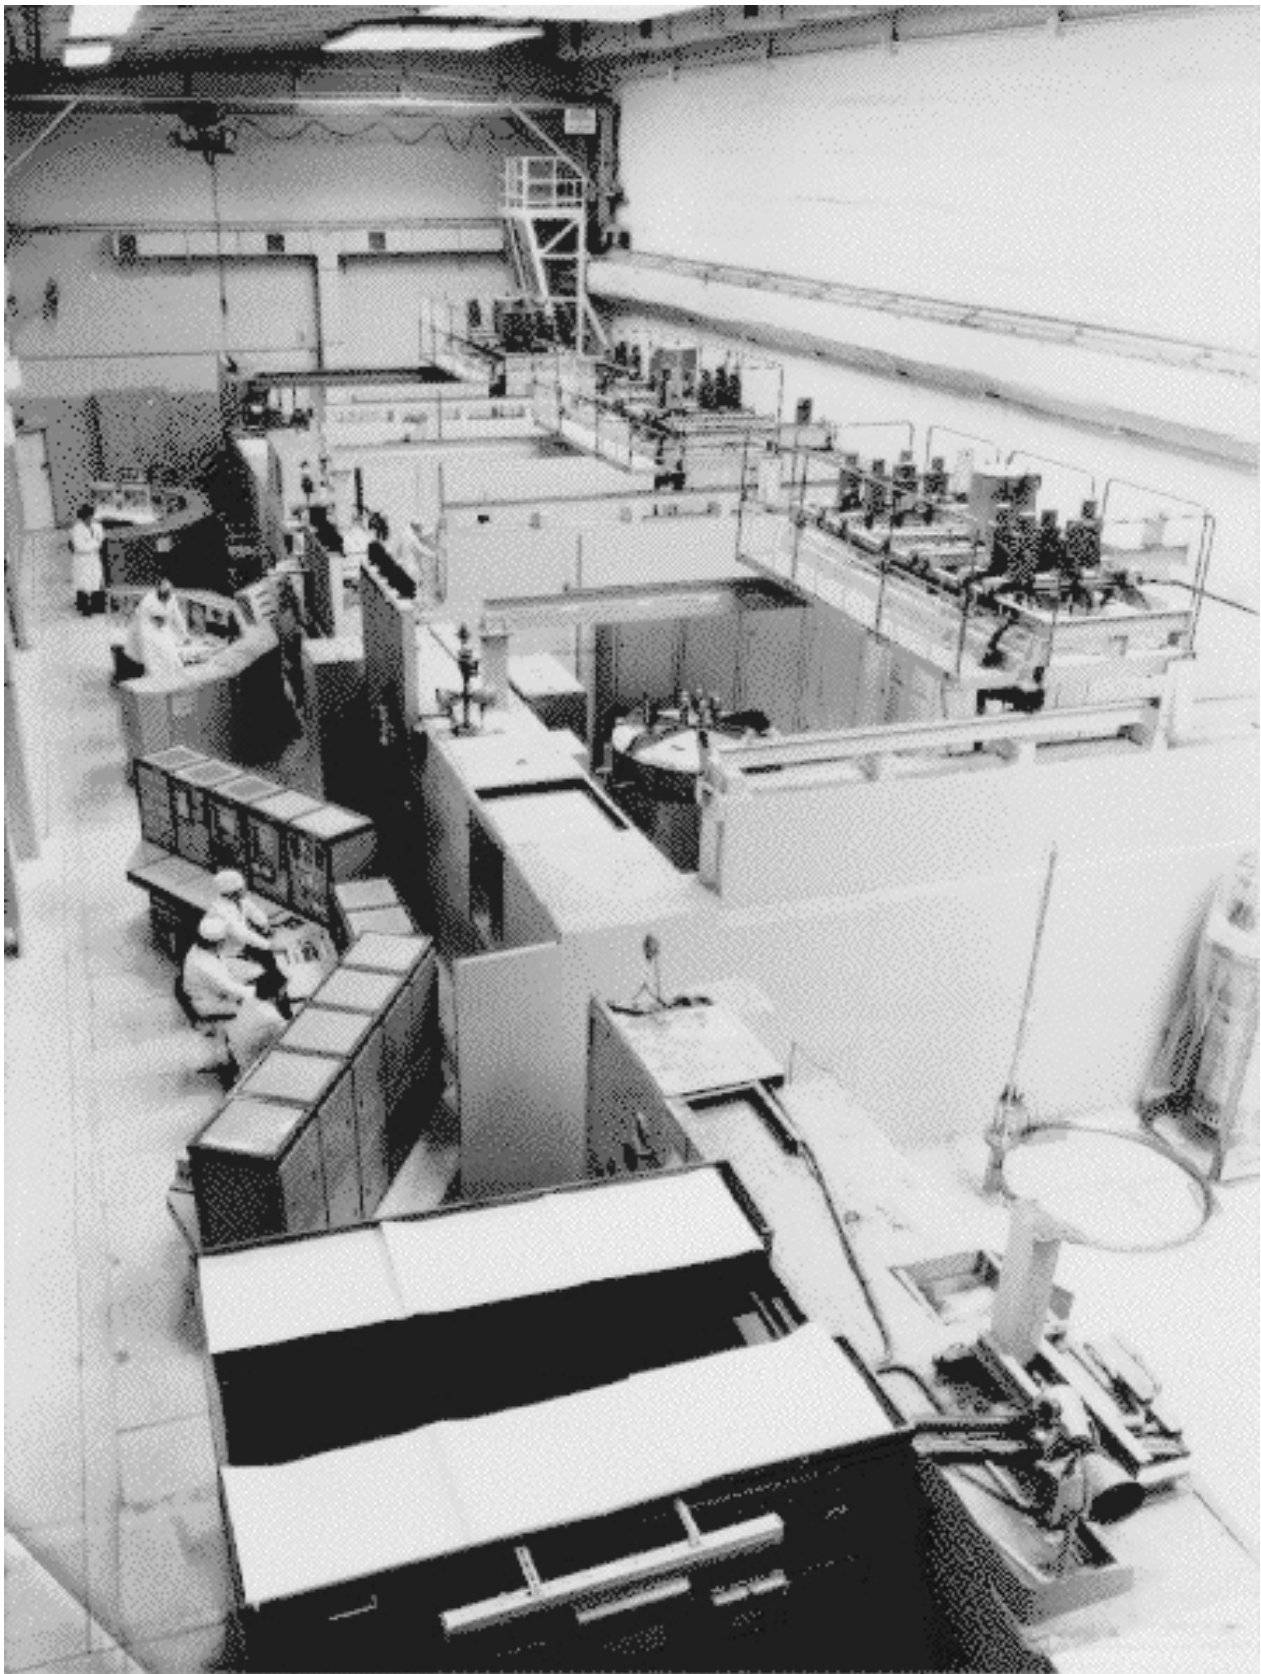
The core configuration with the beryllium reflector was assembled in the dry critical facility tank and left for the night. The next morning, the supervisor entered the facility control room (Figure 60) and without waiting for the arrival of the control console operator and the supervising physicist, switched on the pump, and began adding water to the critical assembly tank. The supervisor considered the system to be far from critical. The control equipment was switched on, but the neutron source had not been placed in the critical assembly, and the control rods were not actuated.

Figure 60. Photograph of the SF-7 control and experimental rooms where the first accident occurred.

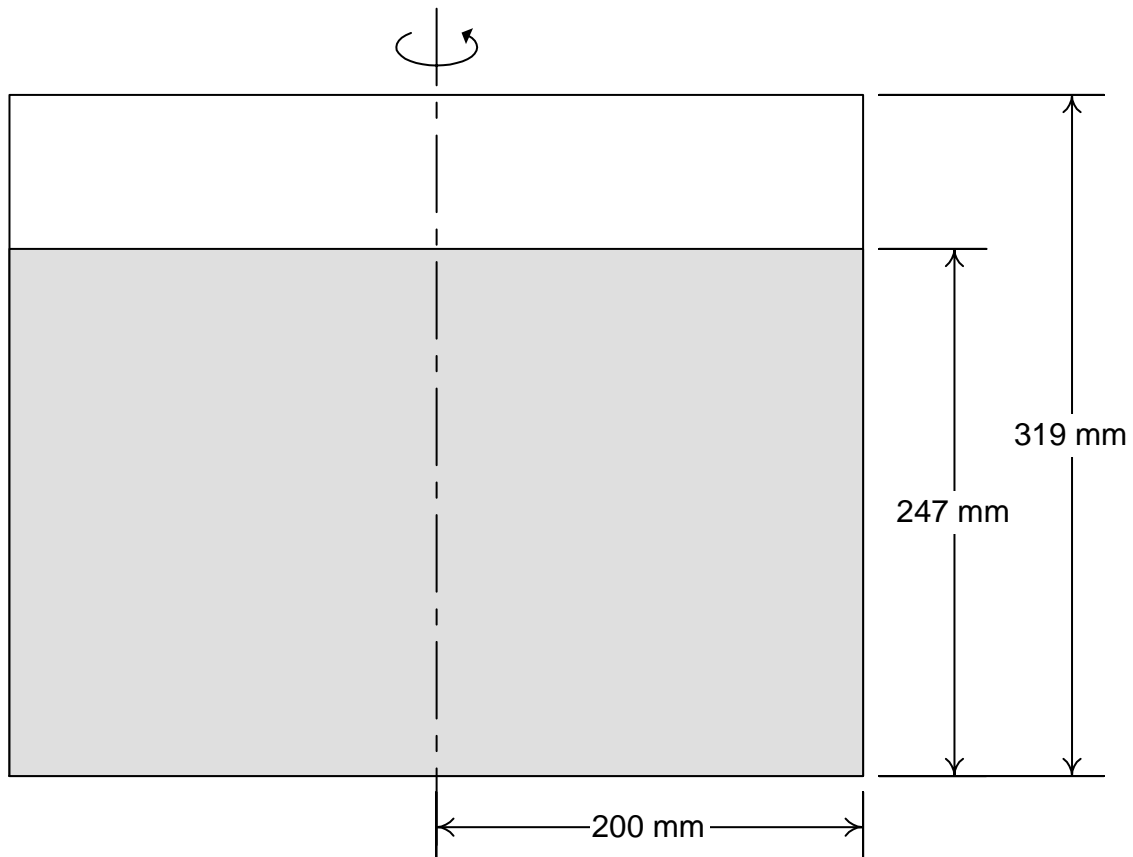
1. Mayak Production Association, 15 March 1953

Plutonium nitrate solution in an interim storage vessel; single excursion; one serious exposure, one significant exposure.

Vessel Volume	40.0 ℓ
Fissile Volume	31.0 ℓ
Fissile Mass	0.81 kg
Fissile Density	26.1 g/ℓ

Estimated Spherical Critical Mass	0.67 kg
First Spike Yield	unknown
Specific Spike Yield	unknown
Total Yield	$\sim 2.0 \times 10^{17}$

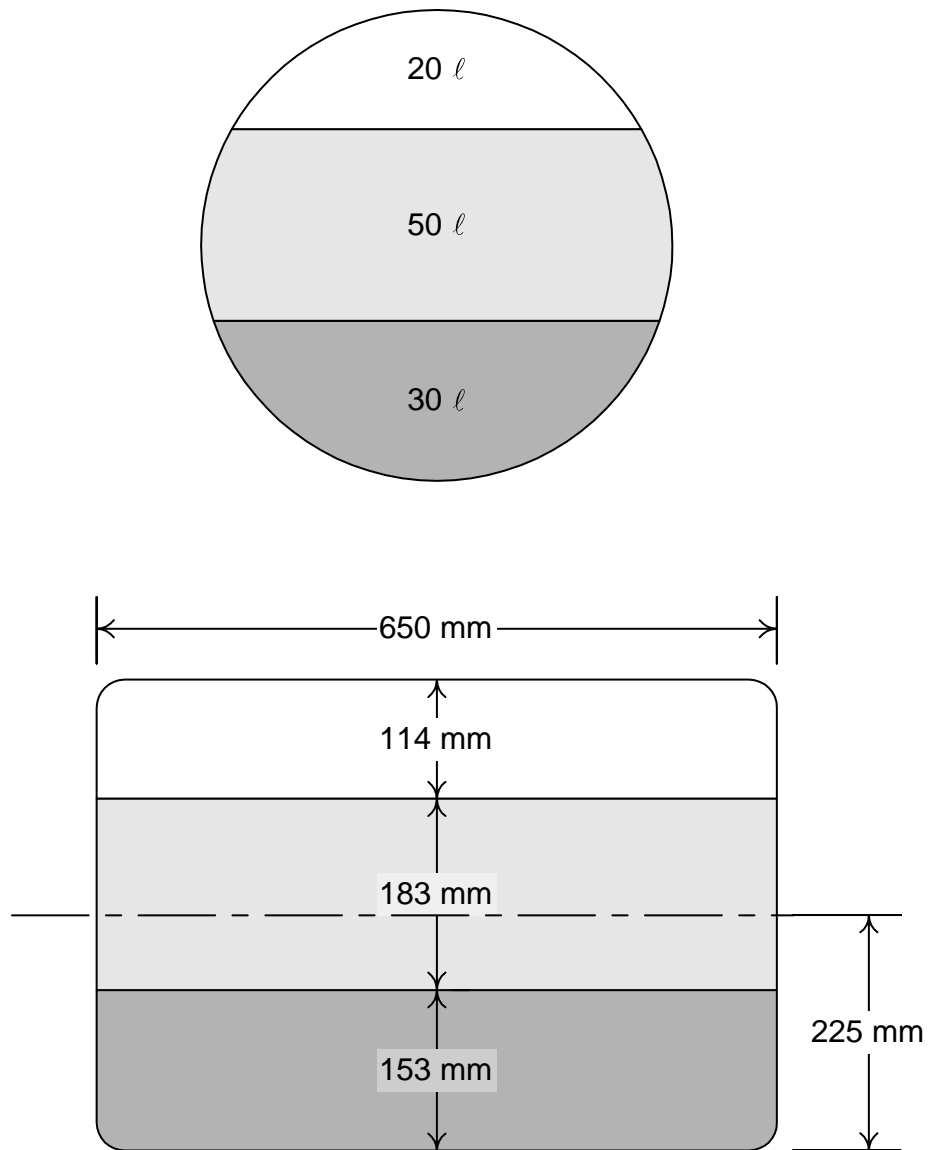
2. Mayak Production Association, 21 April 1957

Uranium precipitate, U(90), buildup in a filtrate receiving vessel; excursion history unknown; one fatality; five other significant exposures.

Vessel Volume	100.0 l
Fissile Volume	30.0 l
Fissile Mass	3.06 kg
Fissile Density	102.0 g/l

Estimated Spherical Critical Mass	1.09 kg
First Spike Yield	unknown
Specific Spike Yield	unknown
Total Yield	$\sim 1.0 \times 10^{17}$

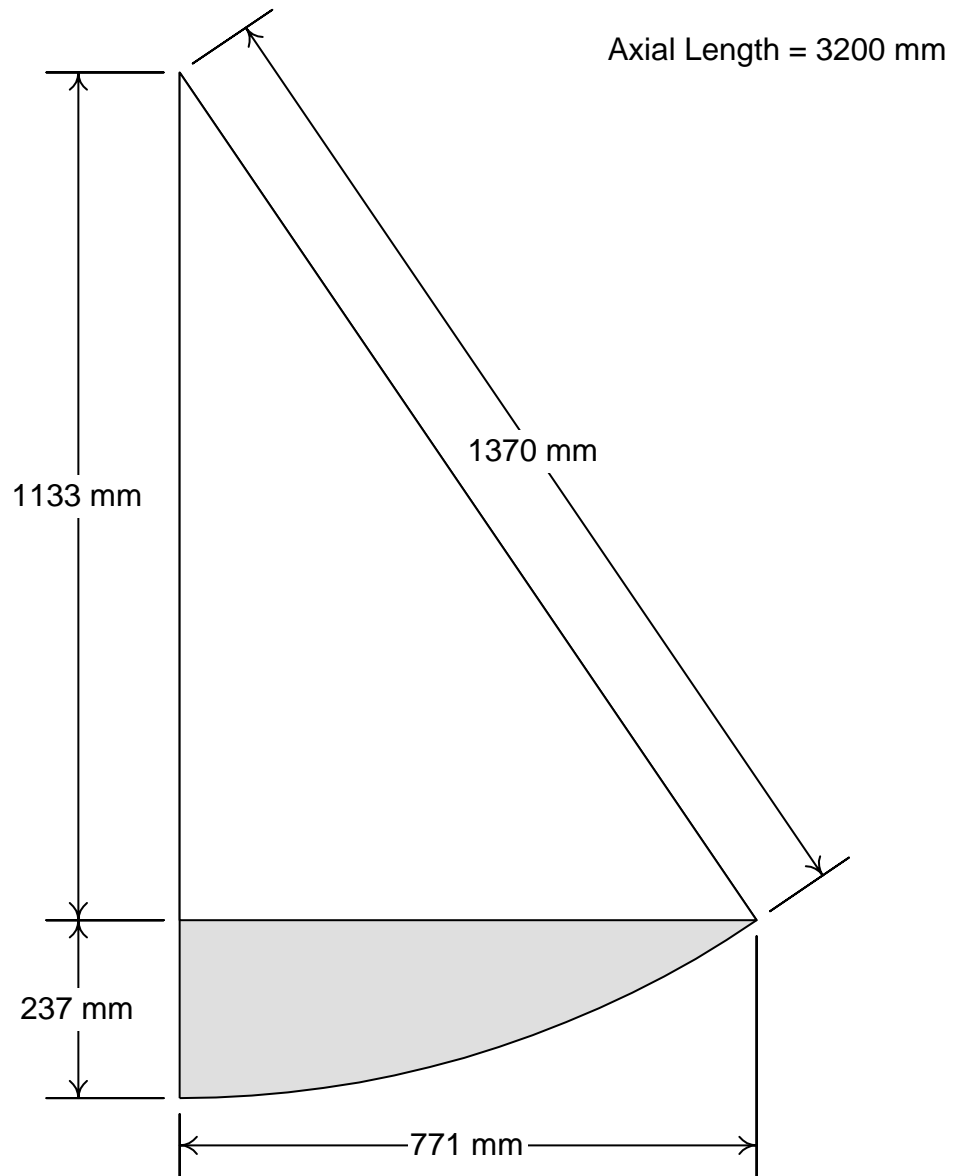
6. Idaho Chemical Processing Plant, 16 October 1959

*Uranyl nitrate solution, U(91), in a waste receiving tank; multiple excursions;
two significant exposures.*

Vessel Volume	18,900 ℓ
Fissile Volume	800.0 ℓ
Fissile Mass	30.9 kg
Fissile Density	38.6 g/ℓ

Estimated Spherical Critical Mass	1.24 kg
First Spike Yield	$\sim 1.0 \times 10^{17}$
Specific Spike Yield	$\sim 0.1 \times 10^{15}$
Total Yield	400×10^{17}

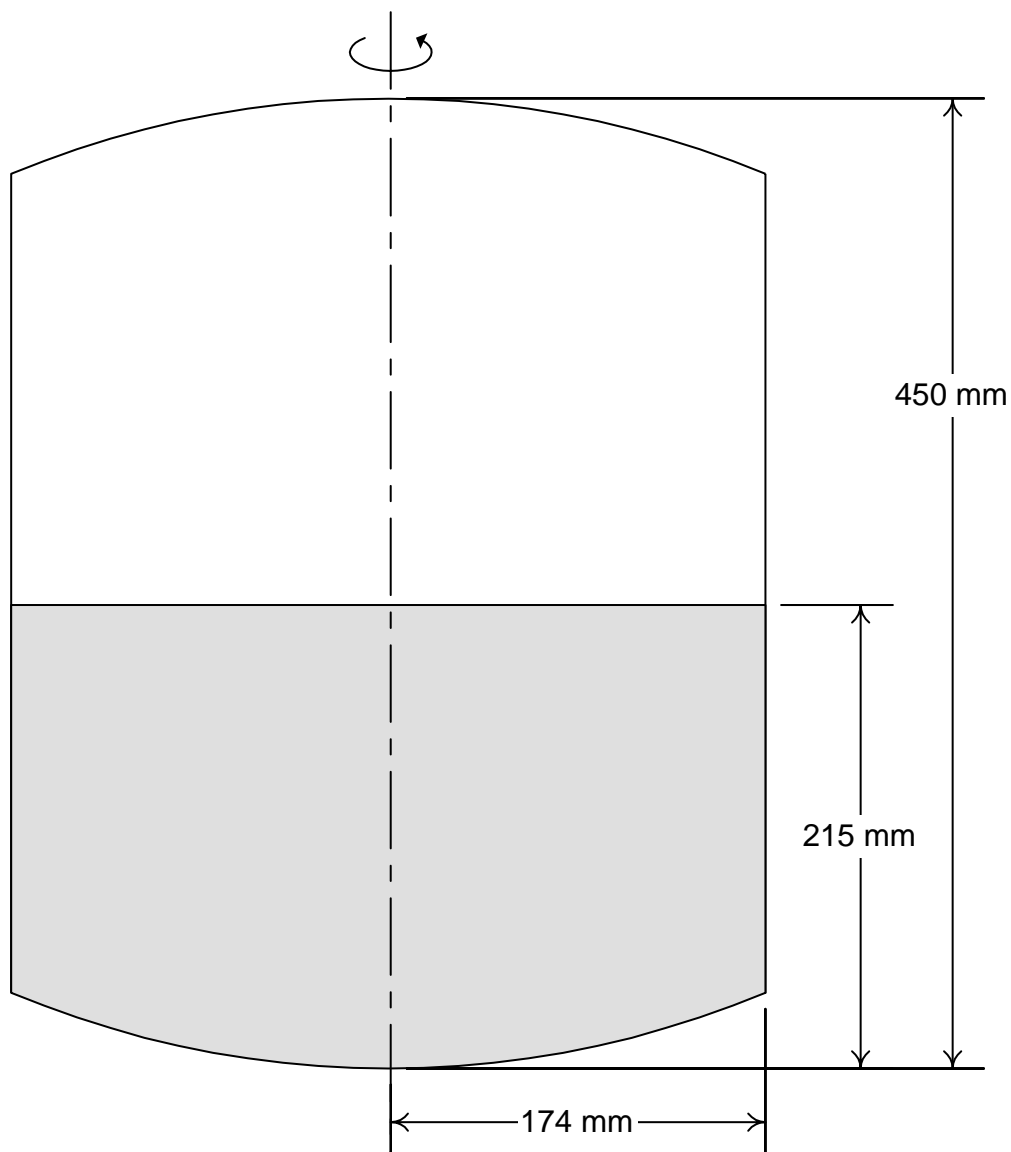
7. Mayak Production Association, 5 December 1960

*Plutonium carbonate solution in a holding vessel; multiple excursions;
insignificant exposures.*

Vessel Volume	40.0 ℓ
Fissile Volume	19.0 ℓ
Fissile Mass	0.85 kg
Fissile Density	44.7 g/ℓ

Estimated Spherical Critical Mass	0.71 kg
First Spike Yield	unknown
Specific Spike Yield	unknown
Total Yield	$\sim 2.5 \times 10^{17}$

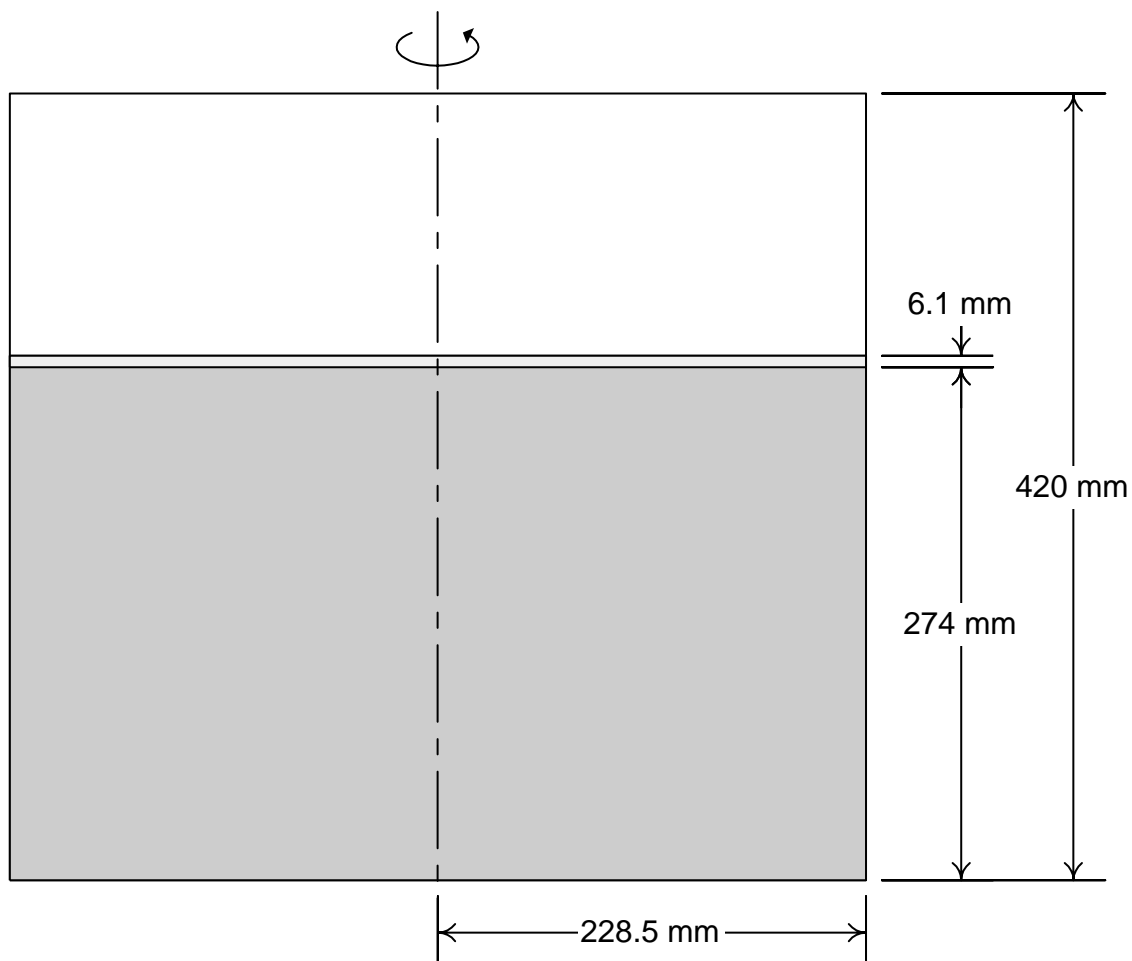
10. Hanford Works, 7 April 1962

Plutonium solution in a transfer vessel; multiple excursions; three significant exposures.

Vessel Volume	69.0 ℓ
Fissile Volume	45.0 ℓ
Fissile Mass	1.29 kg
Fissile Density	28.7 g/ℓ

Estimated Spherical Critical Mass	1.07 kg
First Spike Yield	$\sim 0.1 \times 10^{17}$
Specific Spike Yield	0.2×10^{15}
Total Yield	8.0×10^{17}

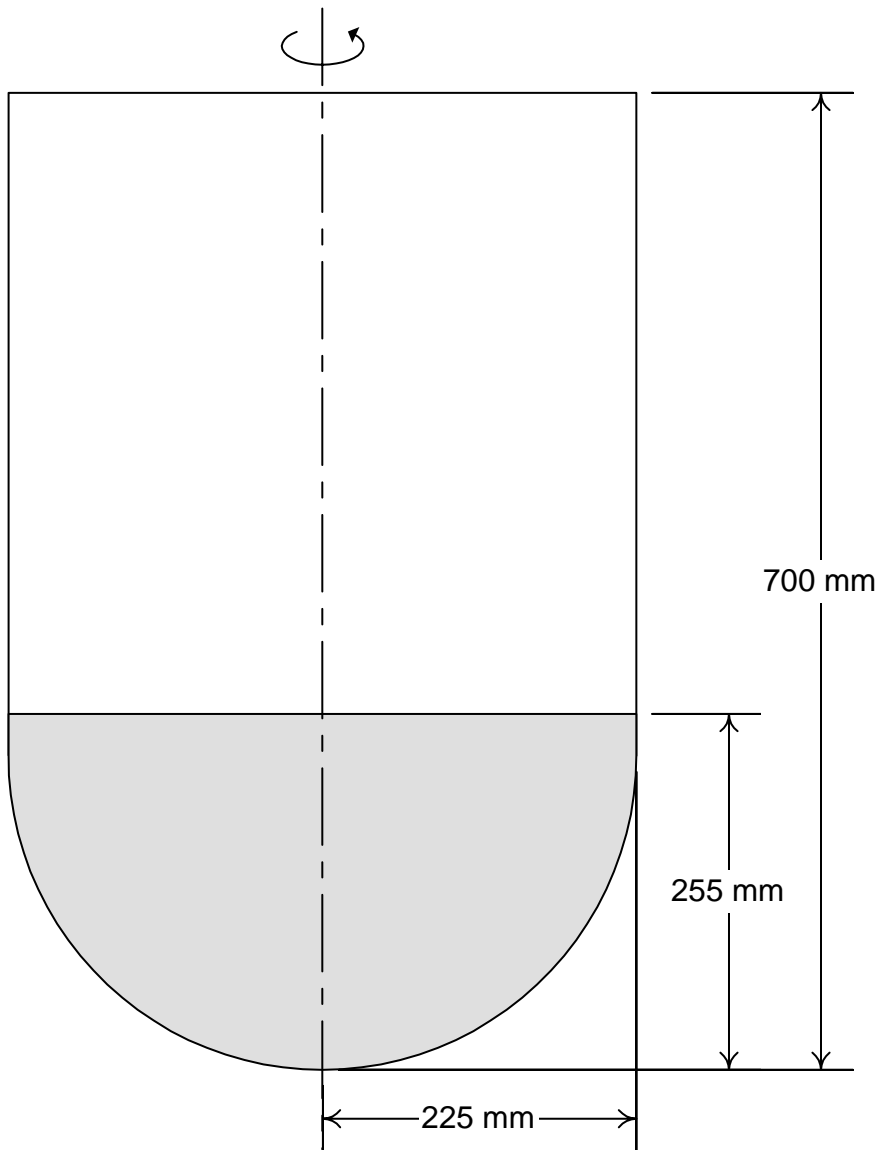
16. Mayak Production Association, 16 December 1965

*Uranyl nitrate solution, U(90), in a dissolution vessel; multiple excursions;
insignificant exposures.*

Vessel Volume	100.0 ℓ
Fissile Volume	28.6 ℓ
Fissile Mass	1.98 kg
Fissile Density	69.2 g/ℓ

Estimated Spherical Critical Mass	1.65 kg
First Spike Yield	none
Specific Spike Yield	none
Total Yield	$\sim 5.5 \times 10^{17}$

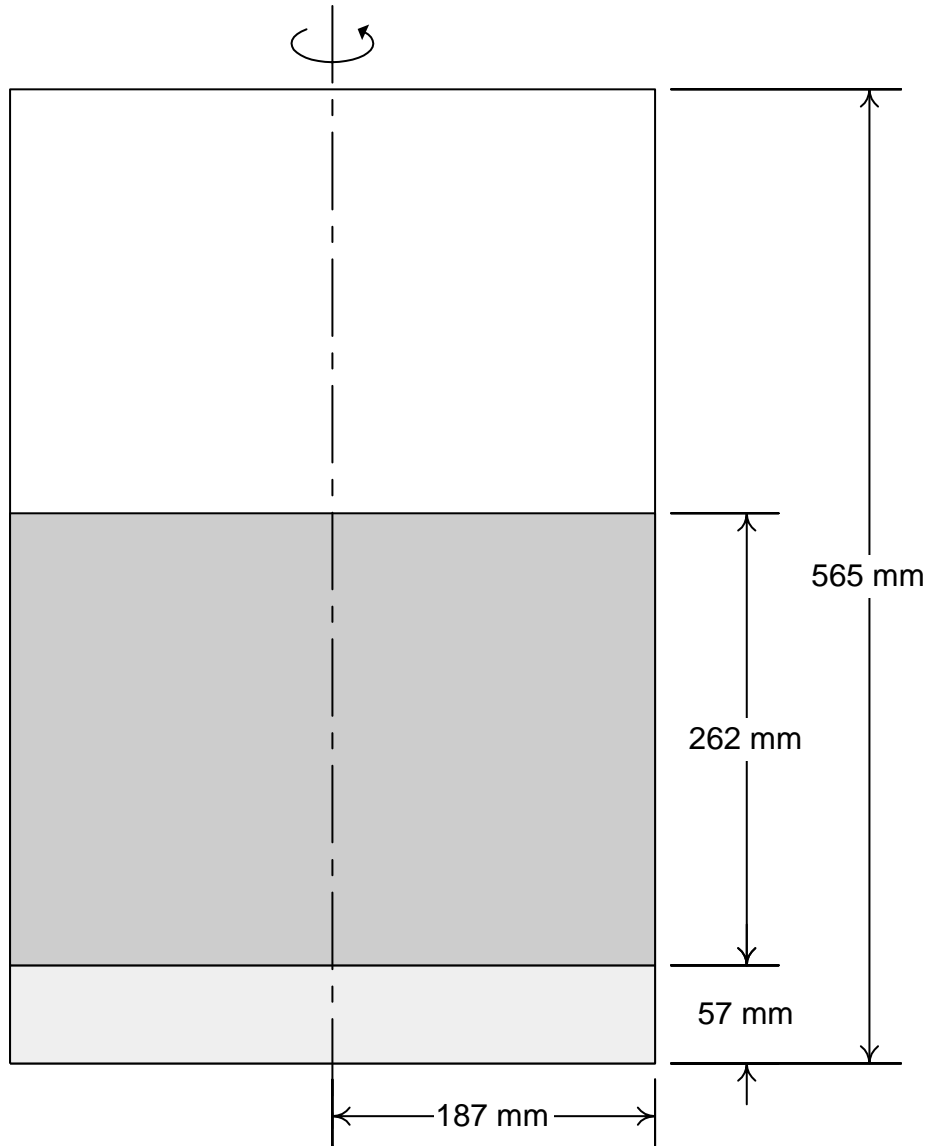
17. Mayak Production Association, 10 December 1968

Plutonium solutions (aqueous and organic) in a 60 liter vessel; three excursions; one fatality, one serious exposure.

Vessel Volume	62.1 ℓ
Fissile Volume	28.8 ℓ
Fissile Mass	1.50 kg
Fissile Density	52.1 g/ℓ

Estimated Spherical Critical Mass	1.36 kg
First Spike Yield	0.3×10^{17}
Specific Spike Yield	1.0×10^{15}
Total Yield	$\sim 1.3 \times 10^{17}$

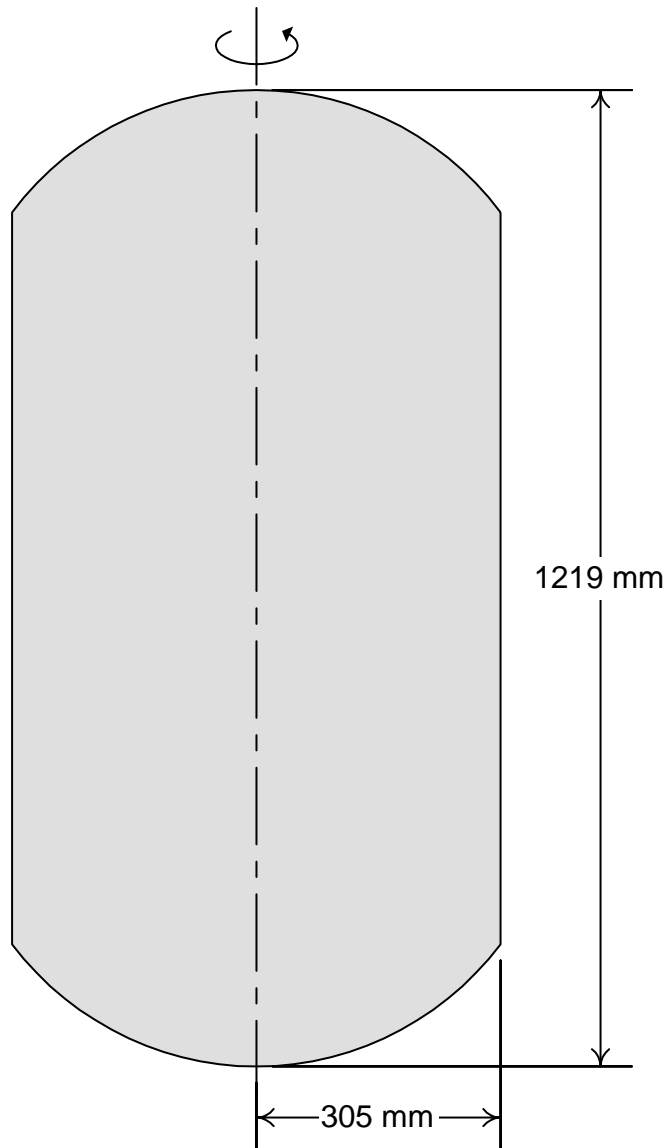
19. Idaho Chemical Processing Plant, 17 October 1978

Uranyl nitrate solution, U(82), in a lower disengagement section of a scrubbing column; excursion history unknown; insignificant exposures.

Vessel Volume	315.5 ℓ
Fissile Volume	315.5 ℓ
Fissile Mass	6.08 kg
Fissile Density	19.3 g/ℓ

Estimated Spherical Critical Mass	4.34 kg
First Spike Yield	unknown
Specific Spike Yield	unknown
Total Yield	27.0×10^{17}
