LA-13638

A Review of Criticality Accidents

2000 Revision

Issued: May 2000

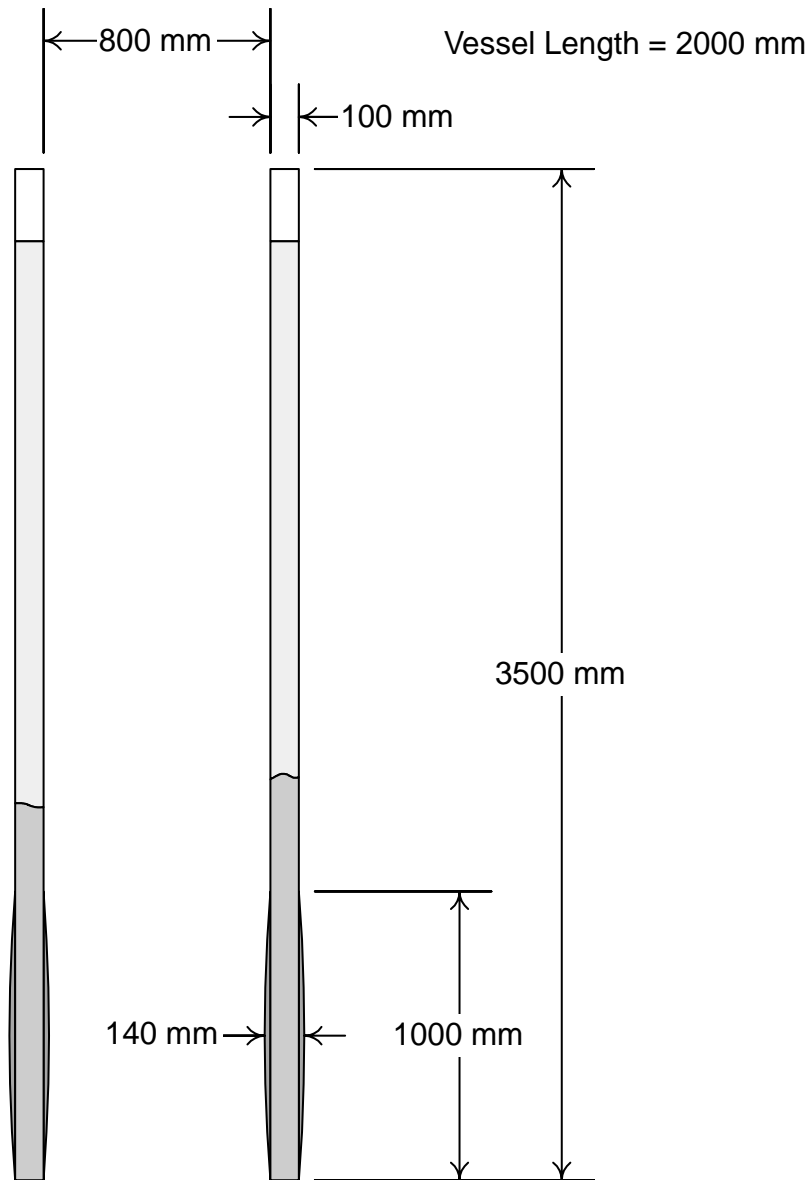
21. Novosibirsk Chemical Concentration Plant, 15 May 1997

Uranium oxide slurry and crust, U(70), in the lower regions of two parallel vessels; multiple excursions; insignificant exposures.

Vessel Volume	700.0 ℓ per vessel	Estimated Spherical Critical Mass	*
Fissile Volume	*	First Spike Yield	none
Fissile Mass	17.1 kg	Specific Spike Yield	none
Fissile Density	*	Total Yield	0.055×10^{17}
