Title: CERRO GRANDE FIRE ONE YEAR AFTER:

AN UPDATE ON ER ACTIVITIES TO REDUCE
THE POTENTIAL MOVEMENT OF
CONTAMINATION AT POTENTIAL RELEASE
SITES

Authors: STEVEN J. VEENIS, CPESC

Submitted to: WATER QUALITY & HYDROLOGY GROUP (ESH-18)
ENVIRONMENTAL RESTORATION PROJECT

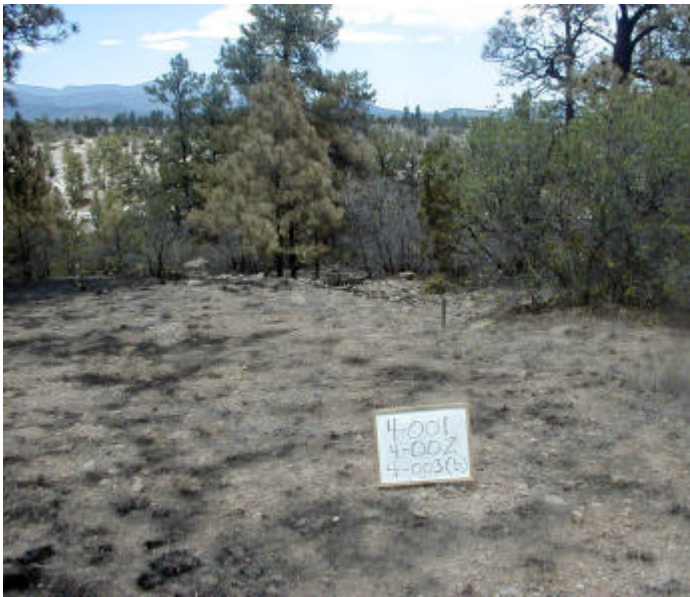
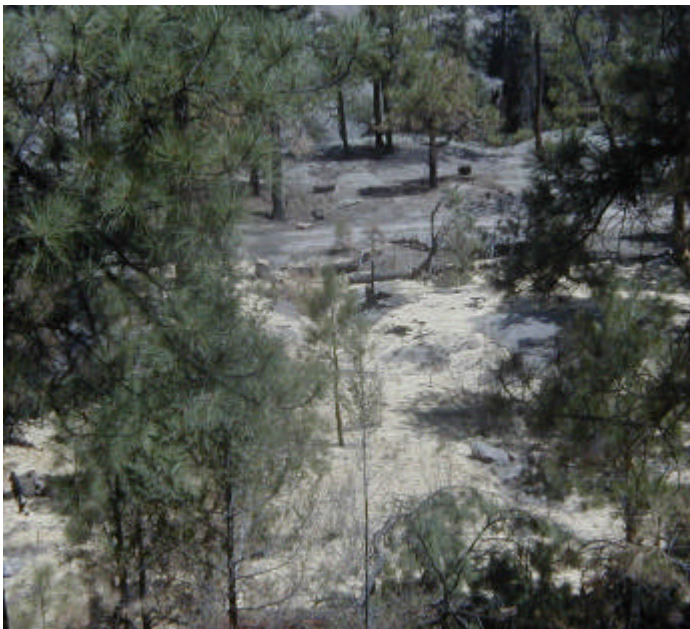
CERRO GRANDE FIRE:

These sites are located on the south rim of Ten Site Canyon within the Upper Canada del Buey Watershed Aggregate. The fire damage was minor to moderate with a majority of the damage to the ground cover and undergrowth.

BMPs:

Straw wattles were installed above the site for run-on diversion at the mesa's edge, within the north facing drainage and on the lower bench for sediment retention. Spot hand raking, reseeding and straw mulch were also applied.

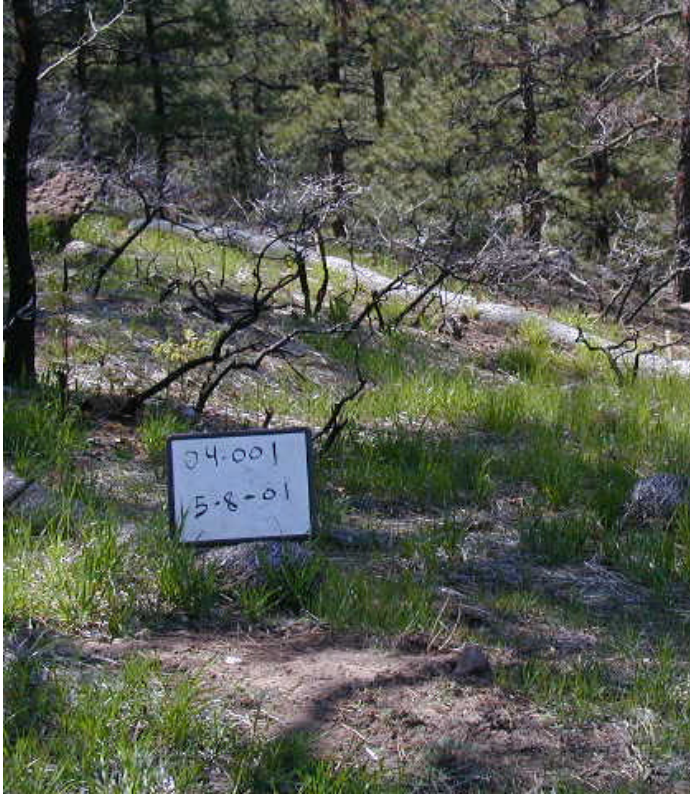
SITE STATUS

Site is in good condition, with vegetative cover of greater than 50%. The area appears stable with evidence of sediment migration being minimal.

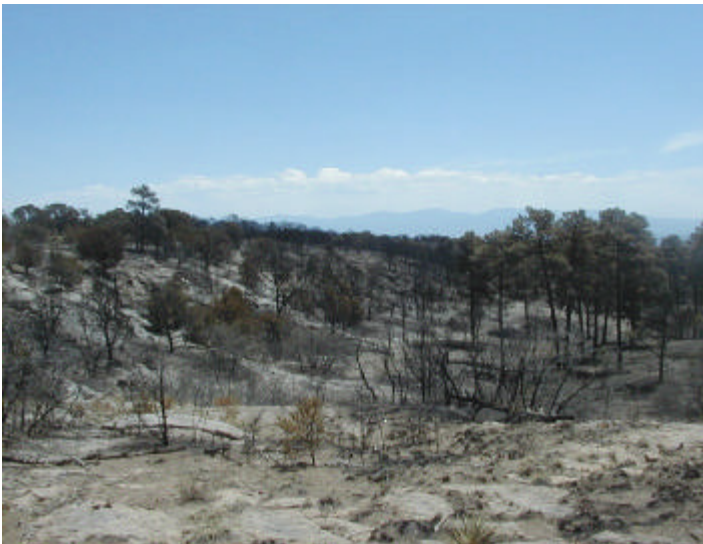
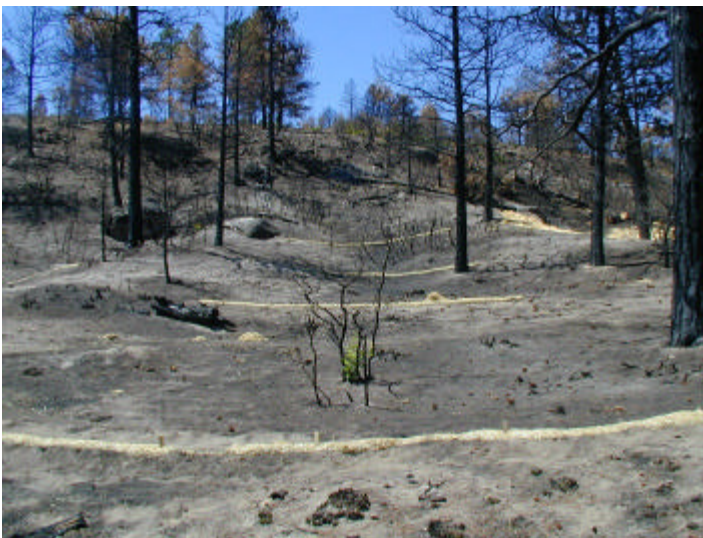
CERRO GRANDE FIRE:

This site is located on the south rim of Mortandad Canyon within the Upper Canada del Buey Watershed Aggregate. The fire damage was moderate to severe with nearly complete damage to the ground cover and canopy.

BMPs:

Contour tree felling was done to support erosion control on the largest slopes. Straw wattles were installed on the mesa for run-on diversion, within the north facing drainage channels and on the lower bench for sediment retention. Raking was completed by ATV implements and manually. Native seed mix and straw mulch were also applied.

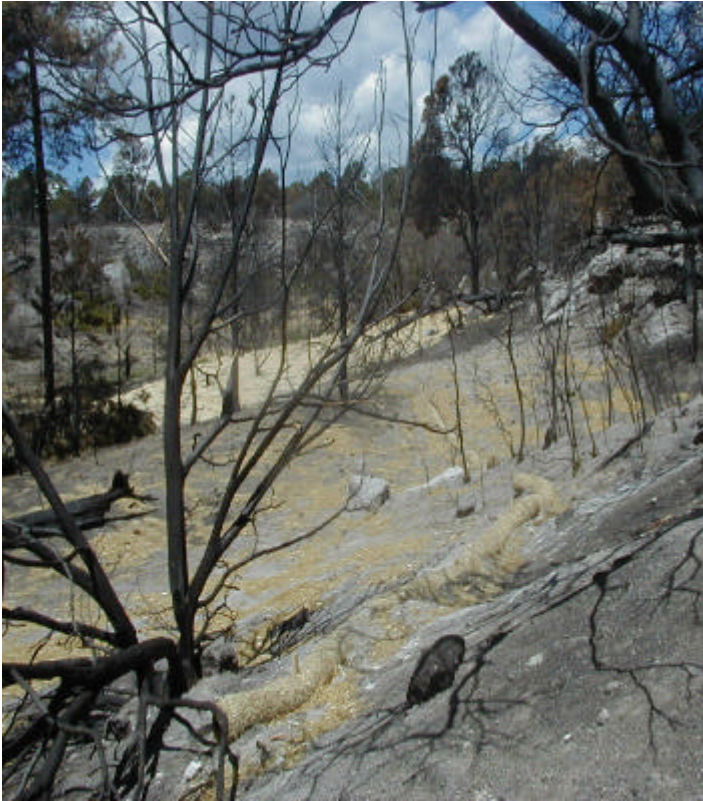
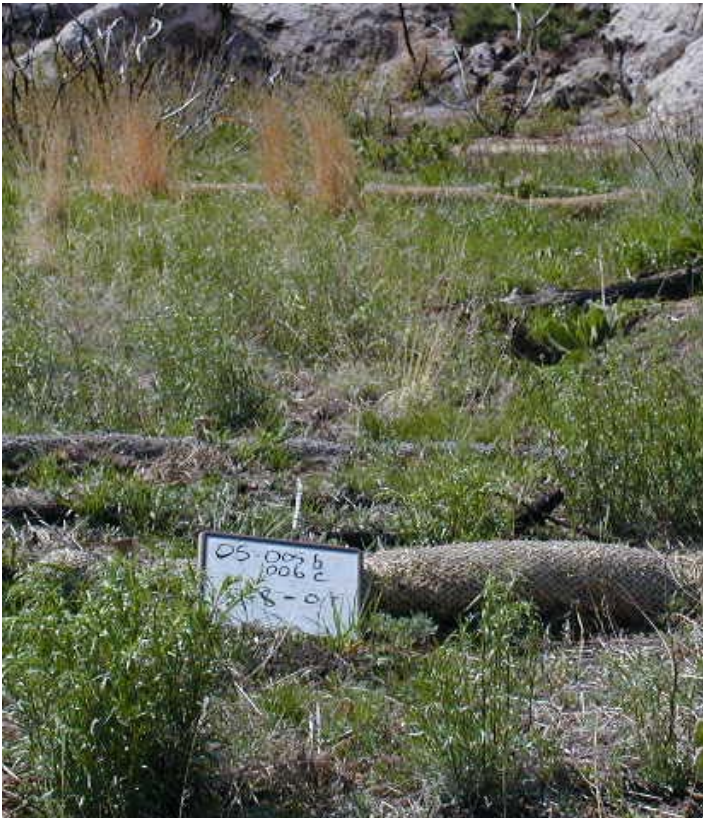
SITE STATUS

Site is in good condition, with vegetative cover of greater than 70%. The area appears stable with evidence of sediment migration being minimal.

BMPs:

Contour tree felling was done to support erosion control throughout the drainage basin. Straw wattles were installed within the south facing drainage channels and within the drainage basin for sediment retention. Raking was completed manually and native seed mix and straw mulch were also applied.

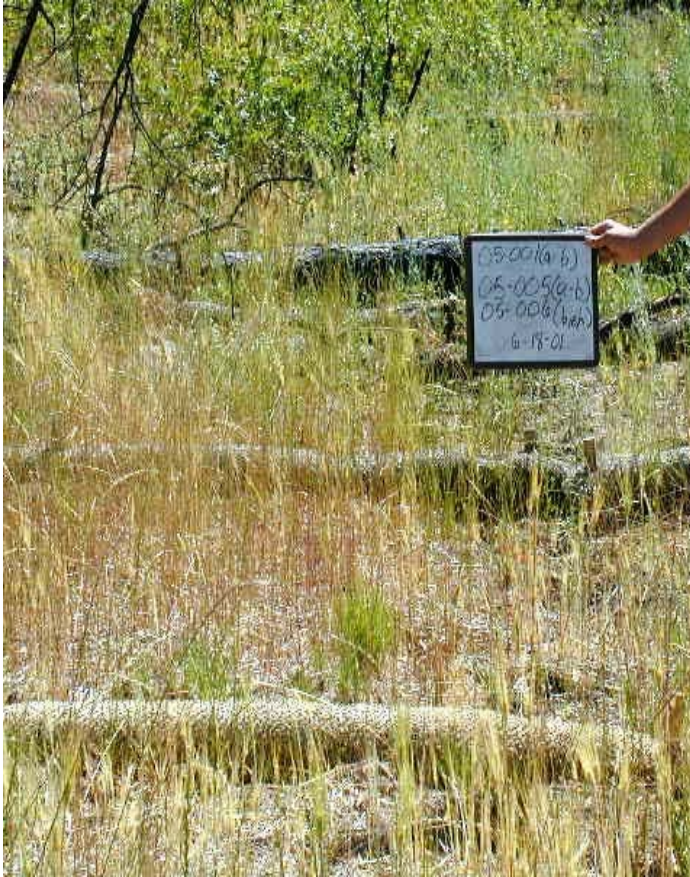
SITE STATUS

Site is in good condition, with vegetative cover of greater than 70%. Sediment migration is occurring in the steepest part of several drainage channels, but the straw wattles on the flatter bench appear to be keeping sediment from entering into Canada del Buey.

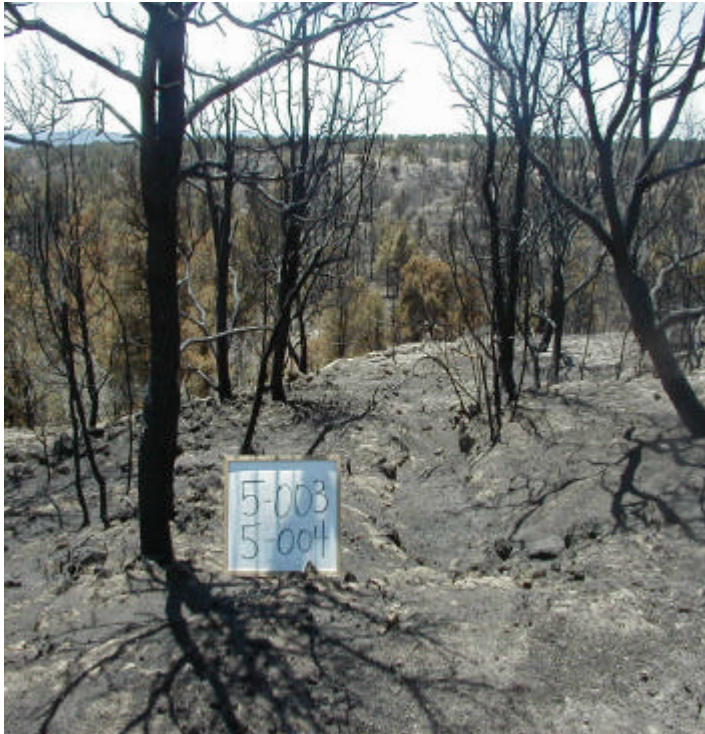
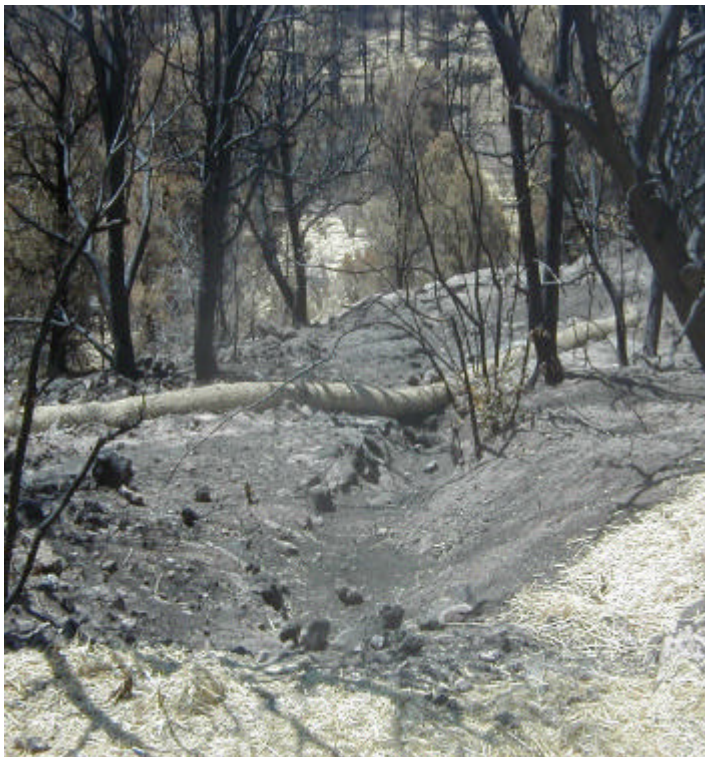
CERRO GRANDE FIRE:

This site is located on the south rim of a tributary to Mortandad Canyon within the Upper Canada del Buey Watershed Aggregate. The fire damage was moderate to severe with nearly complete damage to the ground cover and canopy.

BMPs:

Contour tree felling was done to support erosion control on the south facing slope. Straw wattles were installed within the drainage channels and within the drainage basin for sediment retention. Raking was completed manually and native seed mix and straw mulch were applied.

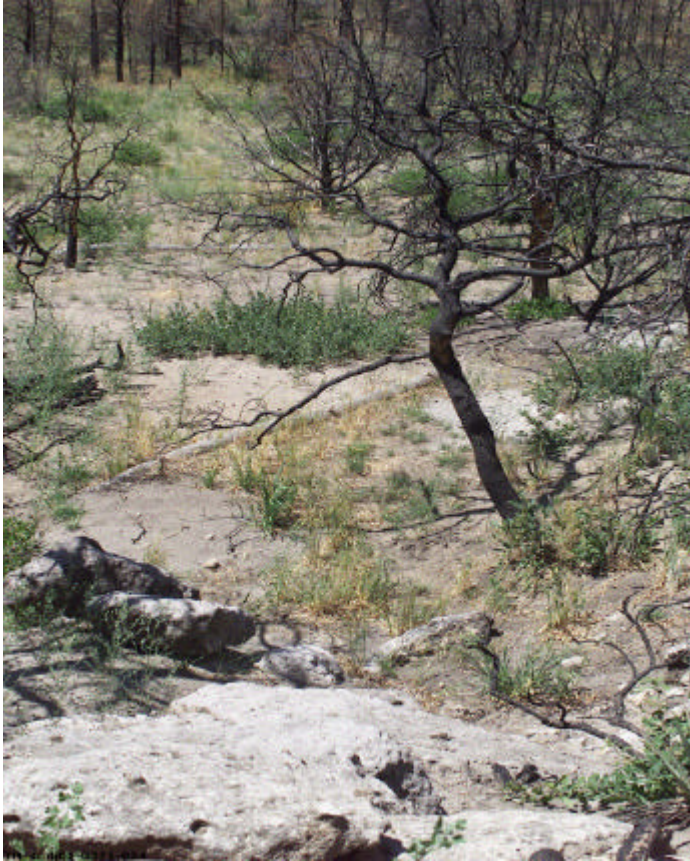
SITE STATUS

Site is in good condition, with vegetative cover of greater than 50%. Sediment migration is occurring in the steepest part of several drainage channels, but the straw wattles on the flatter bench appear to be keeping sediment from entering into tributary drainage.

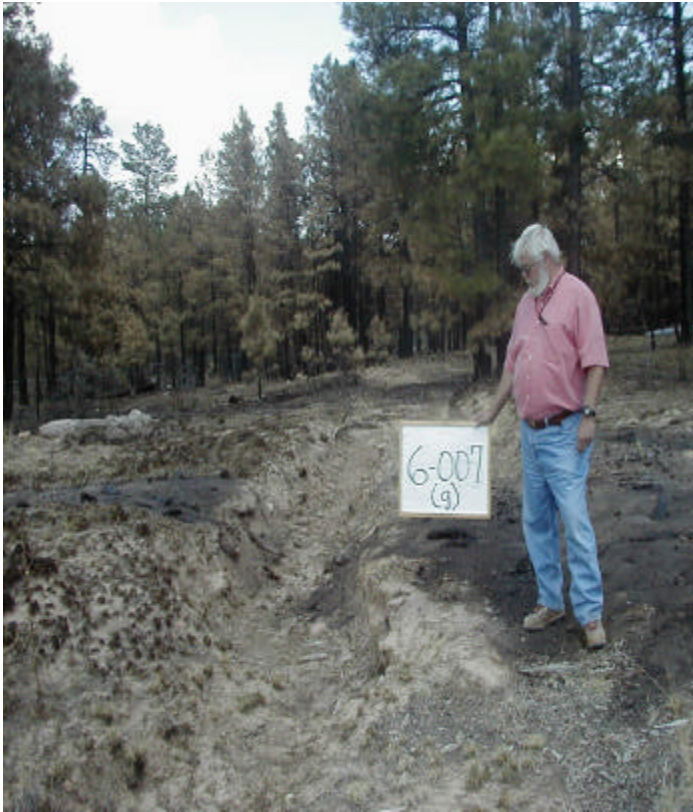
CERRO GRANDE FIRE:

This site is located on the south side of Pajarito Canyon within the Two Mile Canyon Watershed Aggregate. The drainage channel east of building TA-6-6 has minor evidence of fire damage.

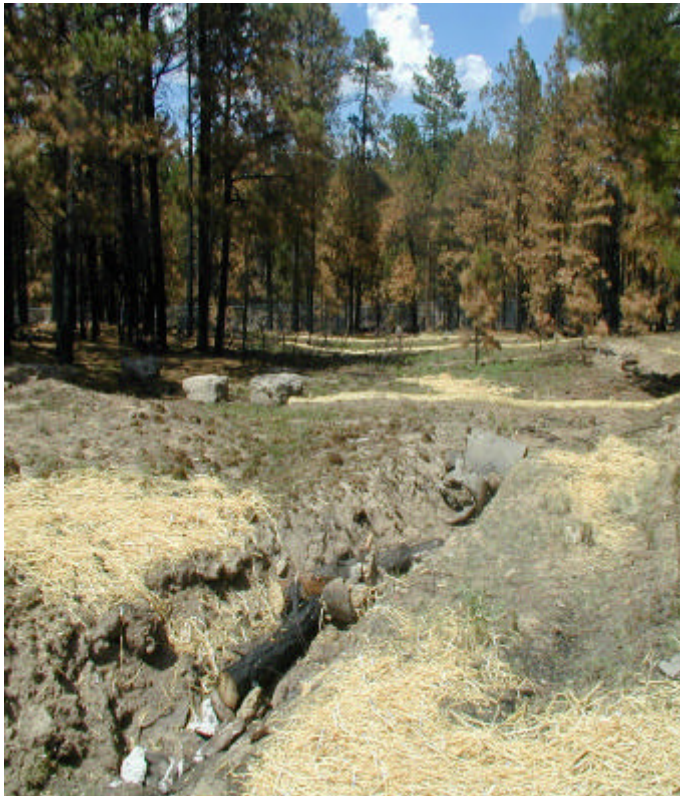
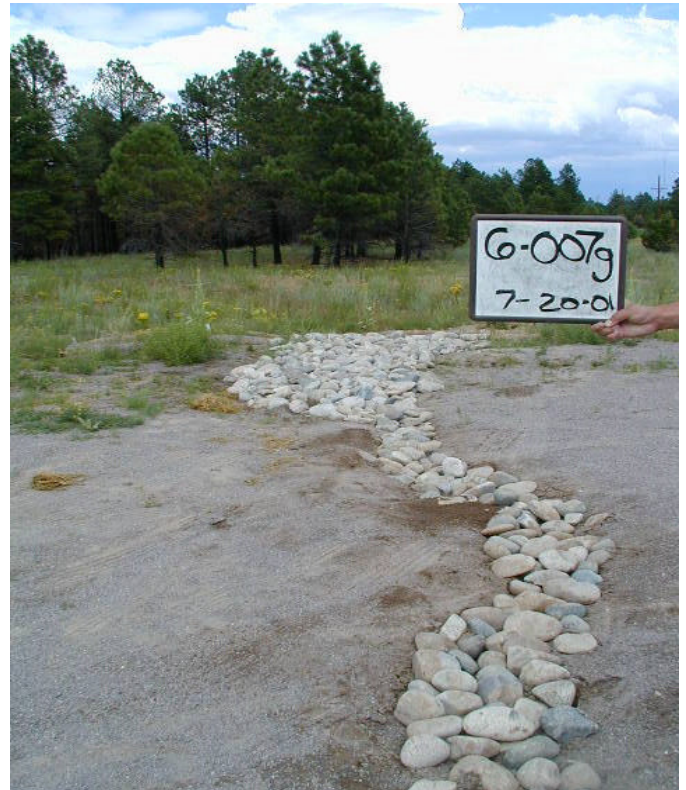
SITE STATUS

Site is in good condition, with vegetative cover of greater than 70%. The area appears stable with evidence of sediment migration being minimal.

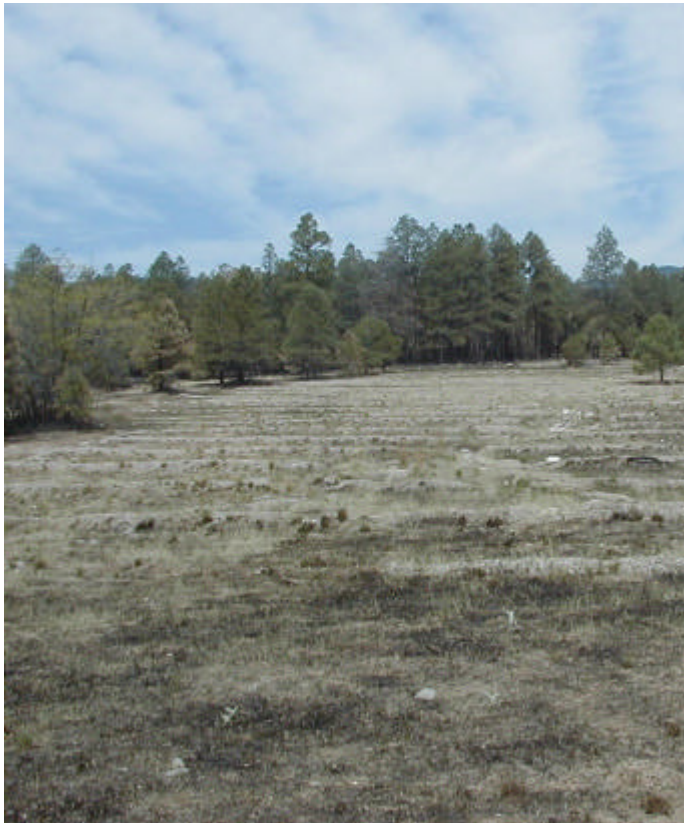
CERRO GRANDE FIRE:

This site is located south of Pajarito Canyon within the Starmer/Upper Pajarito Watershed Aggregate. The area surrounding MDA M was moderately to severely burned as was a majority of the upper Pajarito Watershed. All of the existing erosion controls at the site were destroyed.

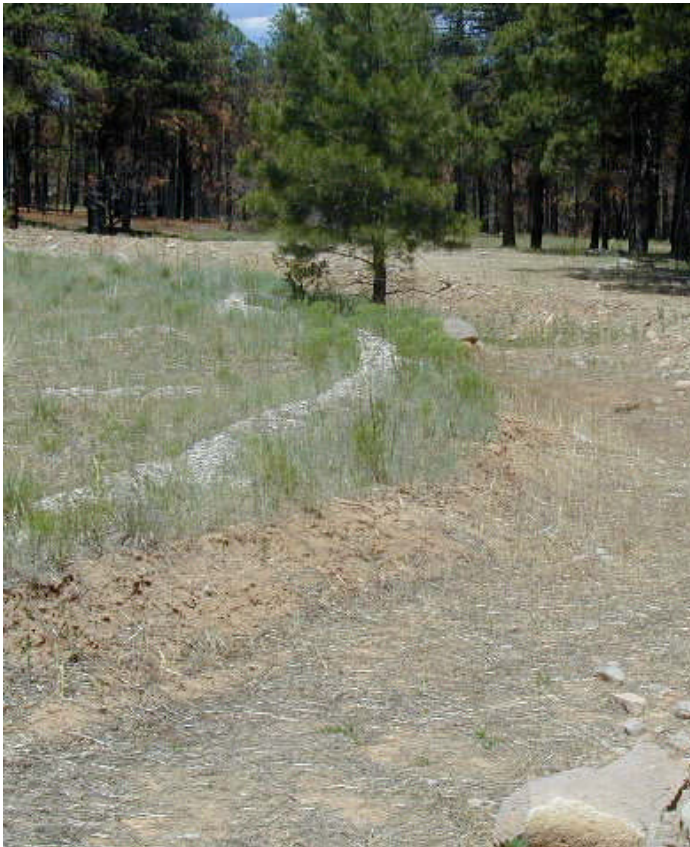
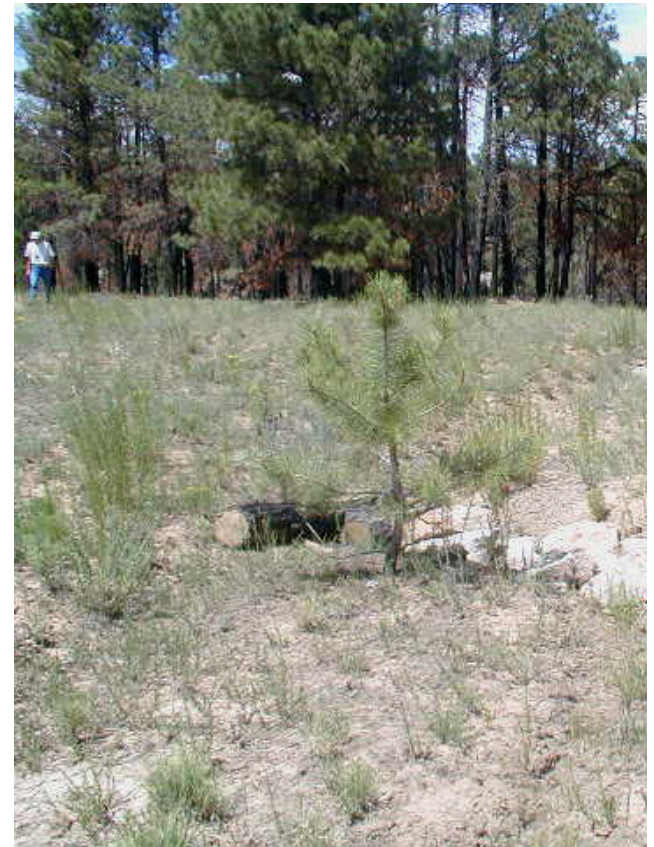
SITE STATUS

Site is in good condition, with vegetative cover of greater than 70%. The area appears stable with evidence of sediment migration being minimal.

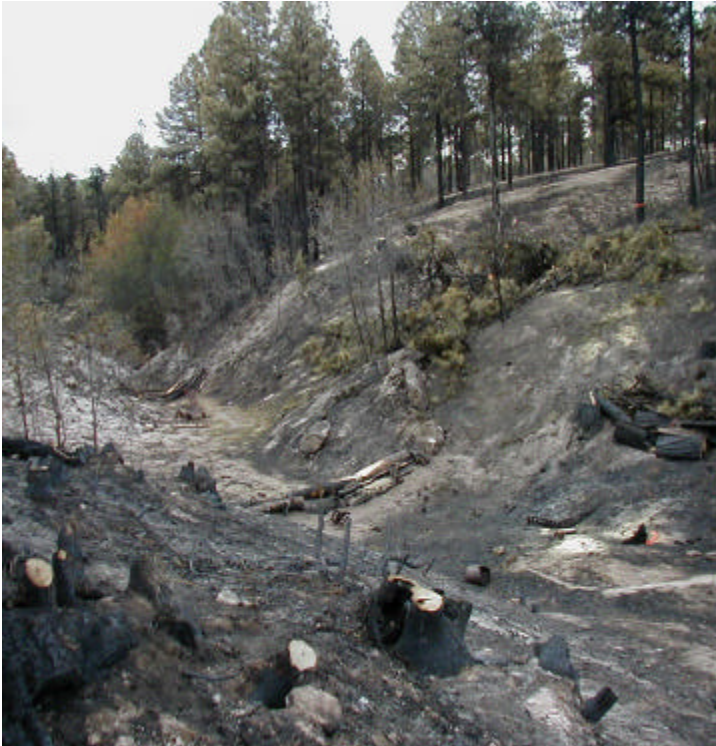
CERRO GRANDE FIRE:

This site is located north of Water Canyon within the S-Site Watershed Aggregate. The site has moderate to severe fire damage in the area surrounding the TA-11 Drop Tower. Log check dams within the major drainages received partial damage. All straw barriers installed around site were destroyed.

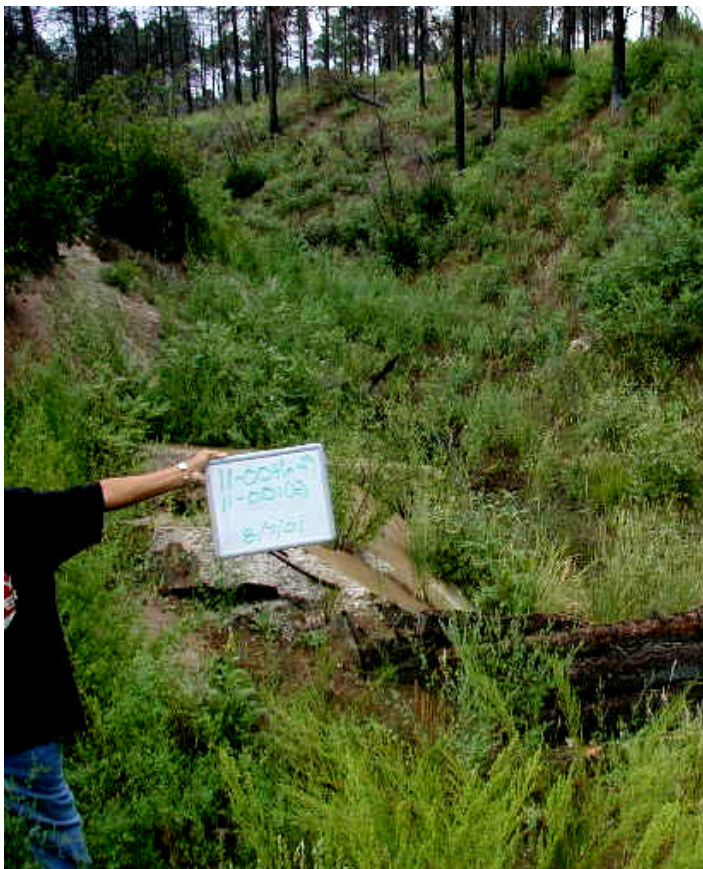
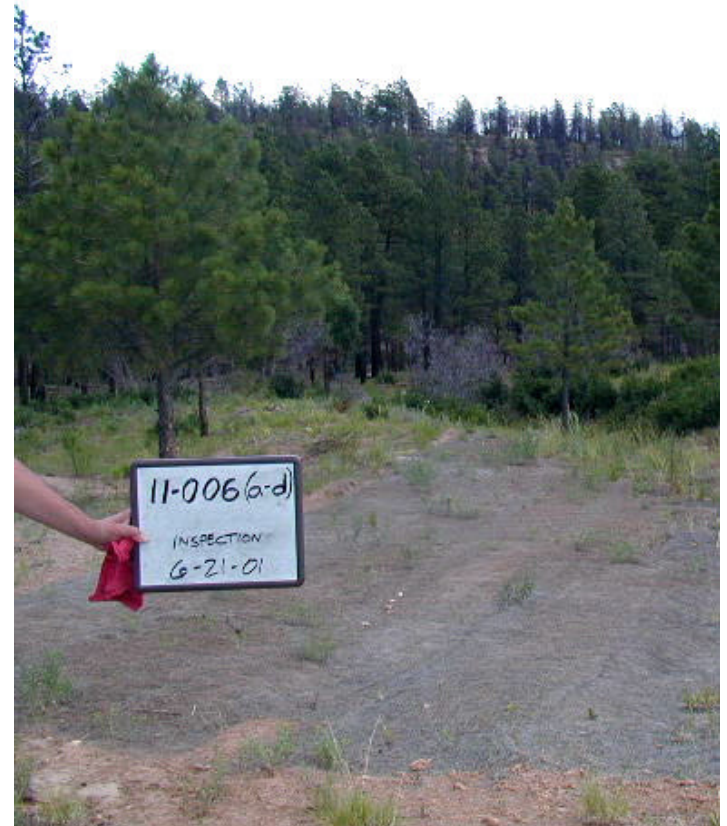
SITE STATUS

Site is in good condition, with vegetative cover of greater than 60%. The area appears stable with evidence of sediment migration being minimal.

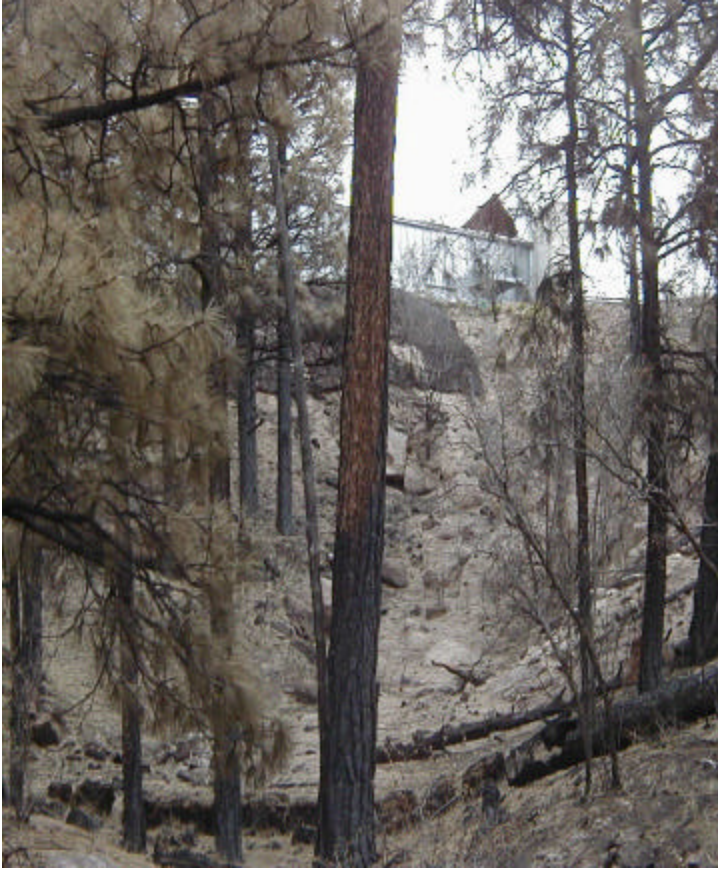
This site is located north of Canon de Valle within the Canon de Valle Watershed Aggregate. The entire south facing slope located to the south of TA-14 structures was moderately burned with substantial damage to the groundcover.

This photograph was taken on June 8th, 2000. The drainage shown is located below building 14-43.

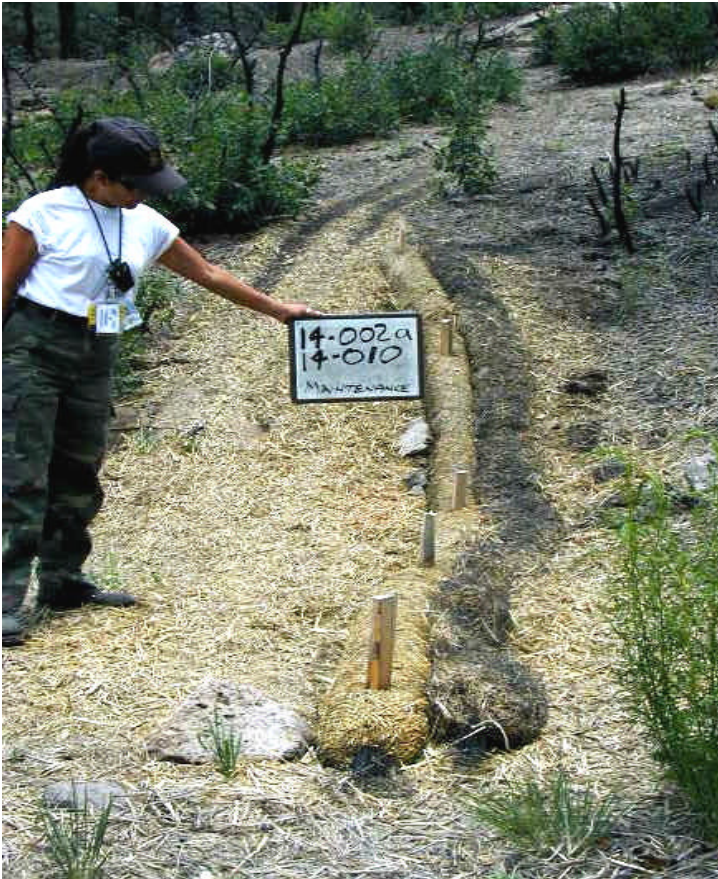
Site is in good condition, with vegetative cover of greater than 70% throughout the site. The area appears stable with evidence of sediment migration being minimal.

Several more straw wattles were installed due to damage from wildlife.

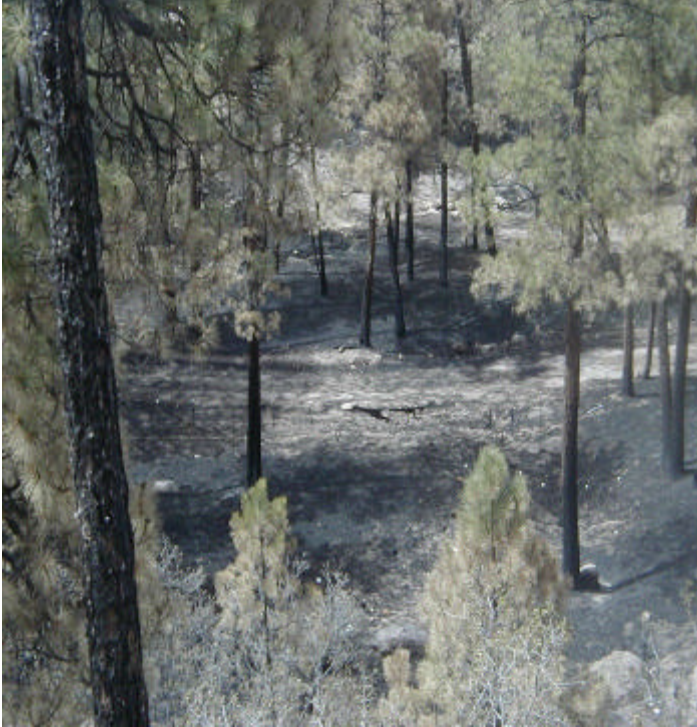
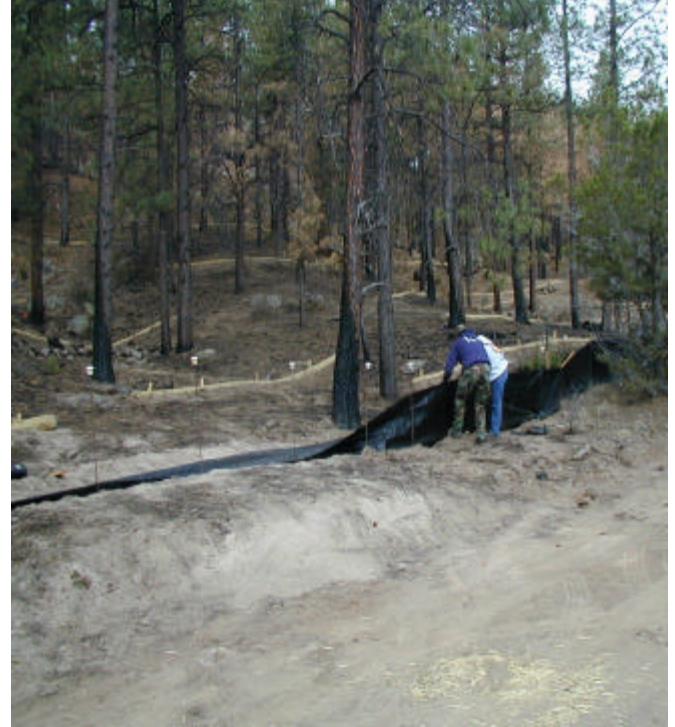
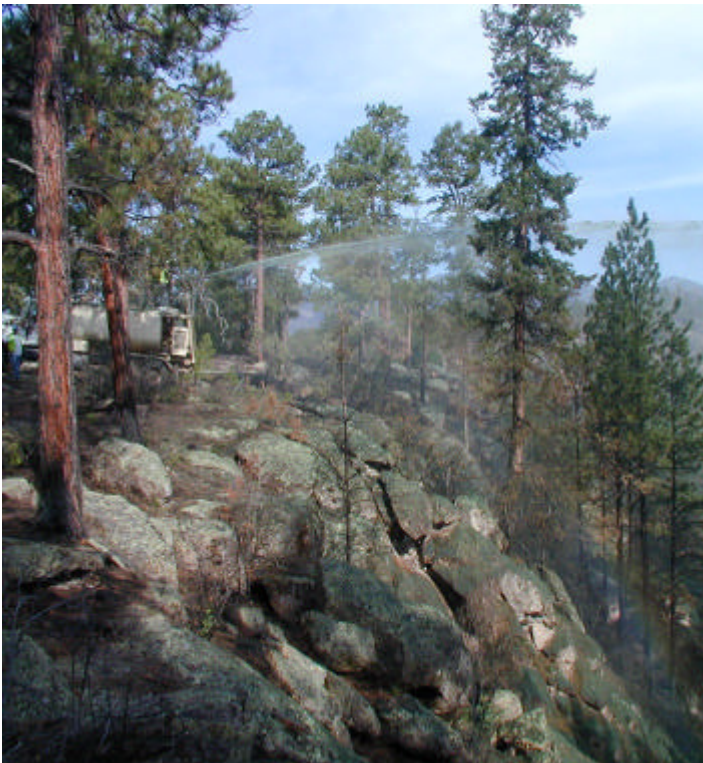
This site is located on the south rim of Three Mile Canyon within the Three Mile Watershed Aggregate. 15-006(c) has moderate to severe burn damage with most of the damage adjacent to the former R-44 Firing Pad. A large amount of firing site related debris has been exposed throughout the site (especially towards the east).

Straw wattles, rock check dams and silt fencing were installed throughout the burned areas. The area was then hydromulched to enhance the revegetation process.

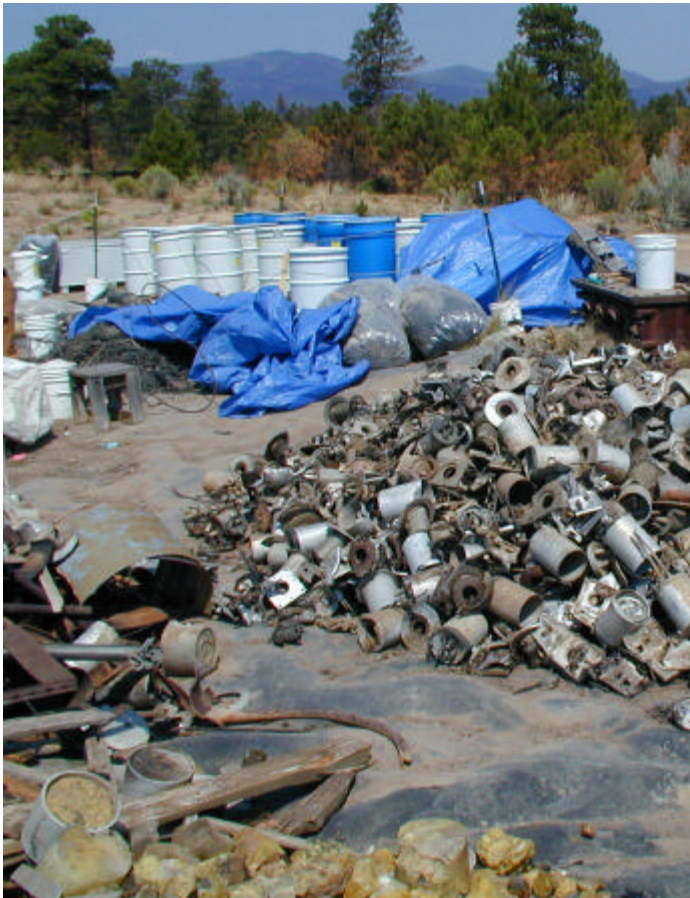
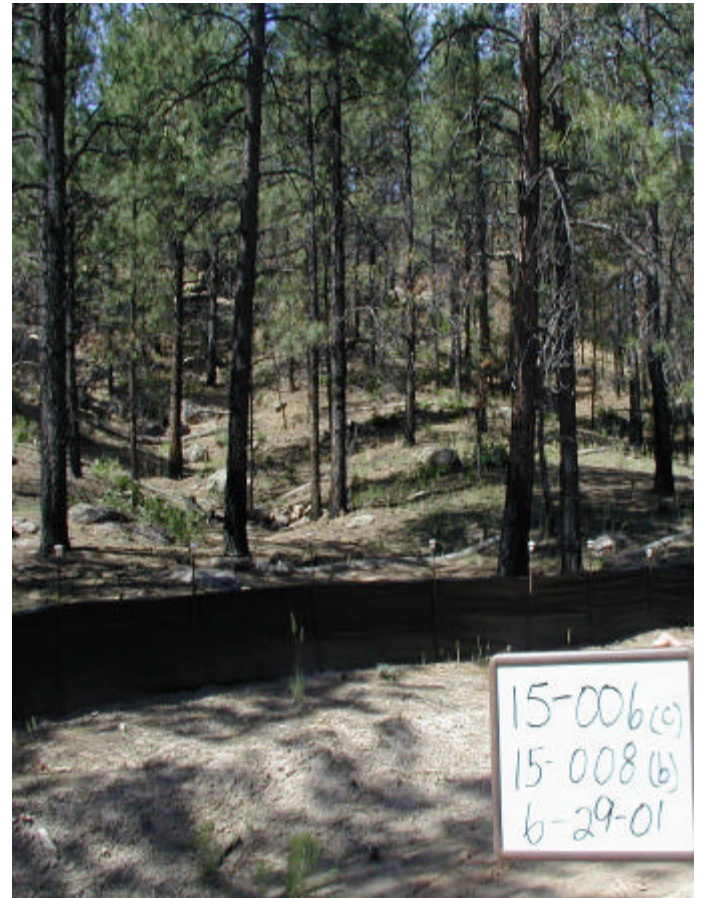
Over 20 cubic yards of firing site debris was removed from the surrounding area. Site is in good condition, with vegetative cover of greater than 70%. The area appears stable with evidence of sediment migration being minimal.

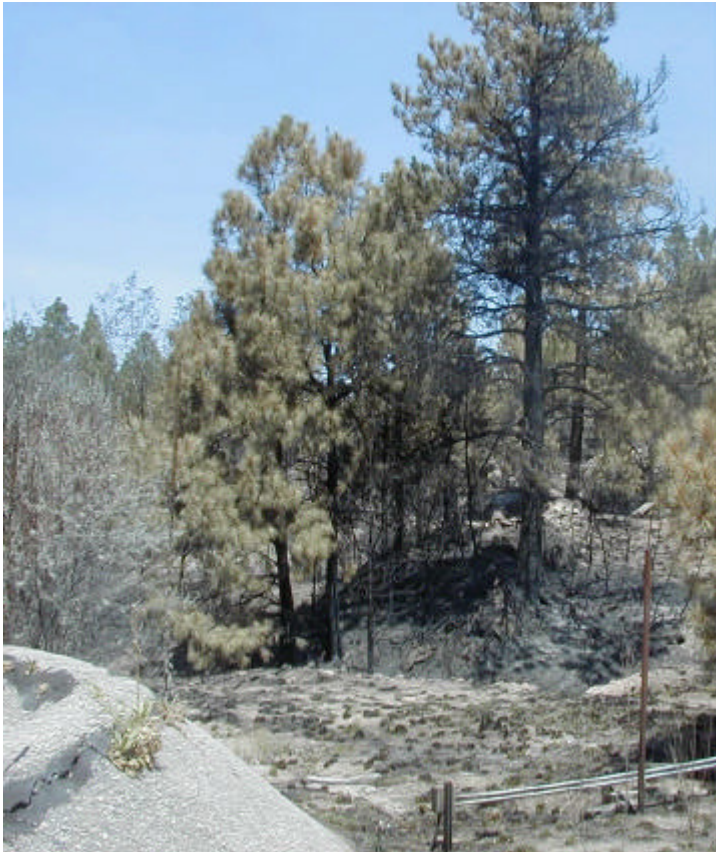
This site is located near the confluence of Canon de Valle and Water Canyon within the Canon de Valle Watershed Aggregate. The site was moderately to severely damaged including several burned structures.

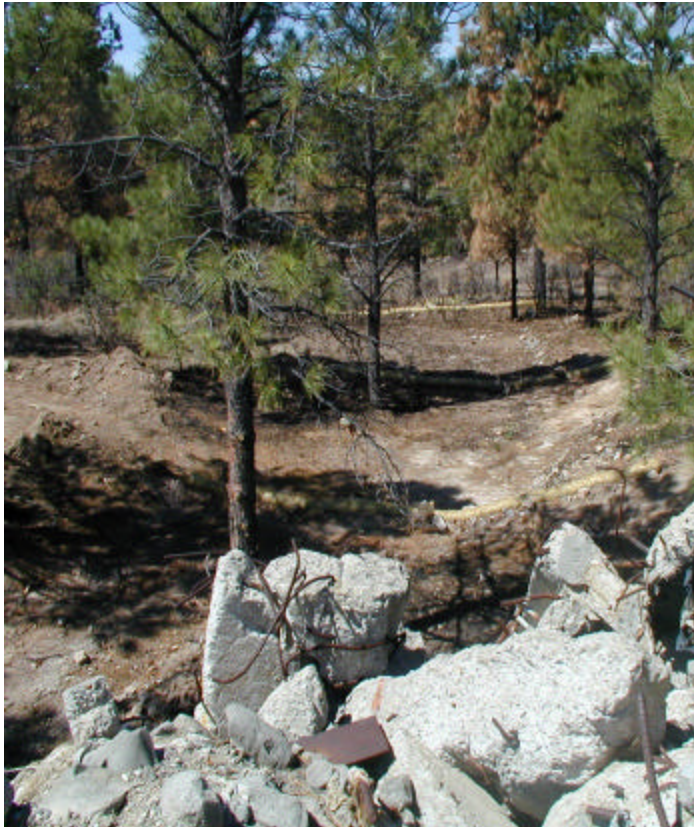
This site is located near the confluence of Canon de Valle and Water Canyon within the Canon de Valle Watershed Aggregate. The area received minor burn damage primarily to the ground cover.

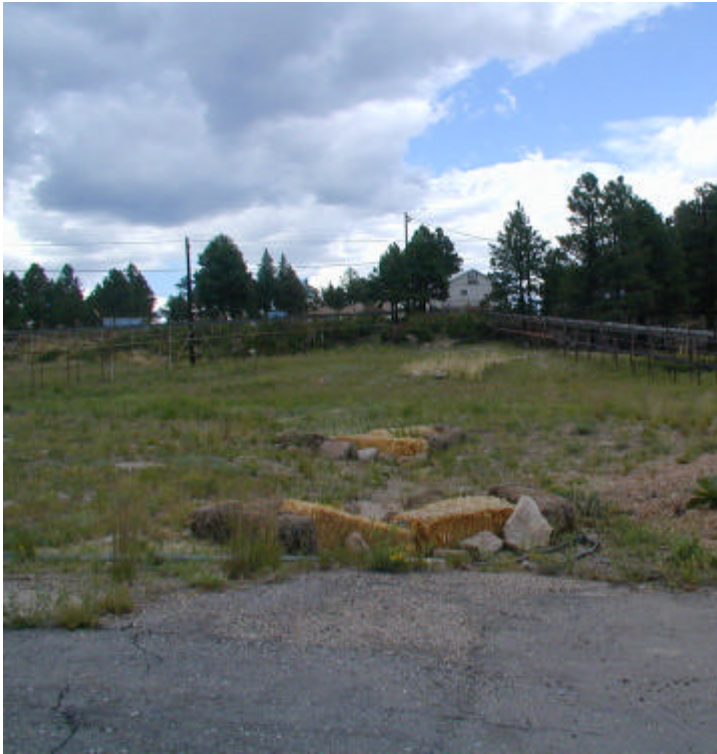
This site is located near a tributary of Water Canyon within the Canon de Valle Watershed Aggregate. The site has minimal fire damage to the west and south. Some minor burning occurred within the SWMU boundary, but consisted mostly of destroyed grasses. The HEWTF remains operational.

Straw barriers and rock check dams (existing materials found on site) were placed within the drainage swale to reduce sediment transport potential.

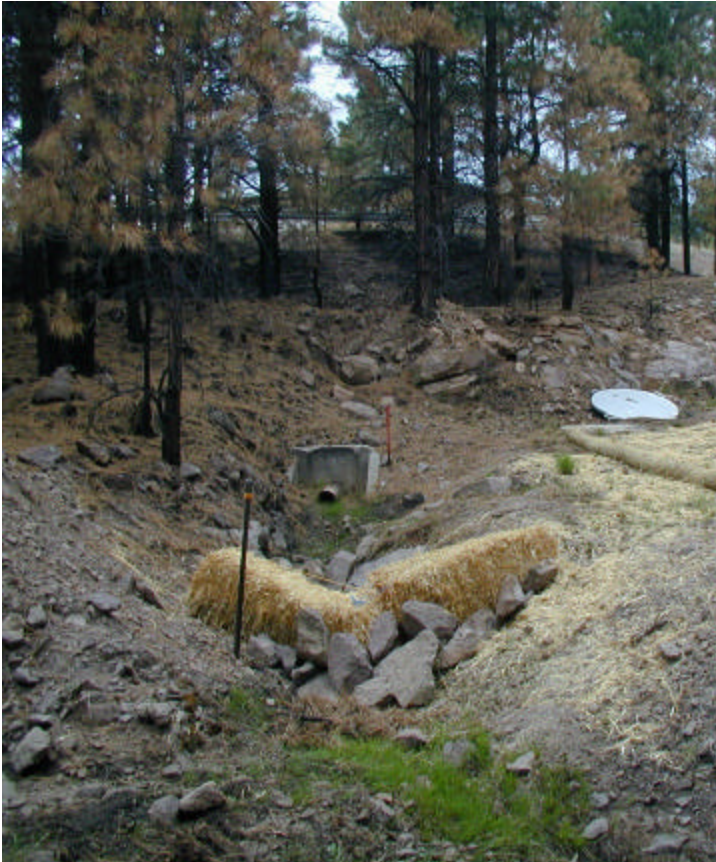
Site is located in a small tributary drainage to Water Canyon within the S-Site Watershed Aggregate. Site has minor to moderate fire damage within the outfall drainage.

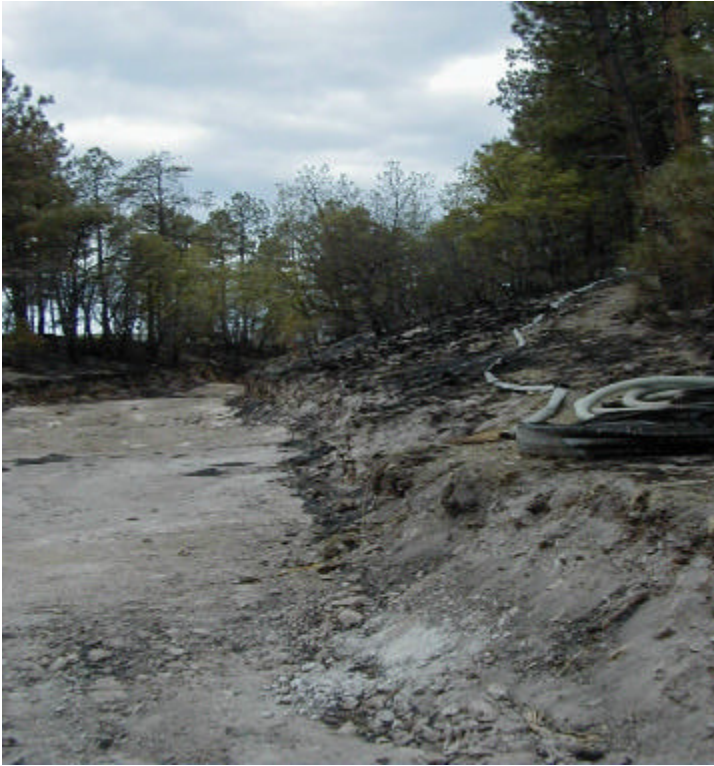
This site is located in a tributary drainage of Canon de Valle within the Canon de Valle Watershed Aggregate. Burn damage is minor to moderate within the SWMU boundary. Heavy equipment on-site was not affected by the fire, although some hoses, drums and misc. equipment were damaged. The upper drainage pond was not burned. The lower drainage received minimal damage from the fire.

Straw barriers were replaced within the drainage channel and jute matting was installed to protect the exposed slopes. All excavated material remains covered with HDPE liners and is surrounded by an earthen berm. The storm water retention pond was unharmed and remains effective as a retention area.

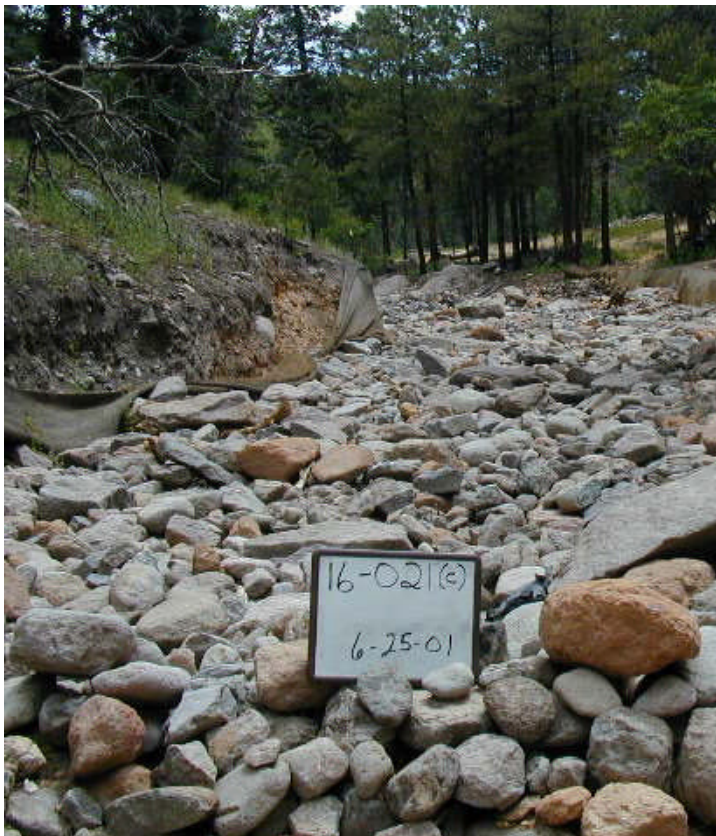
Site is in good condition, with vegetative cover of greater than 60% along the channel banks. The channel has been completely excavated of contaminated soil and river rock was placed to dissipate any future storm water runoff.

An interim measure was recently completed at the site to remove several hundred cubic yards of HE contaminated soil from the drainage channel. The excavation is complete and site restoration activities are ongoing. The site will be inspected and maintained until final stabilization is completed.

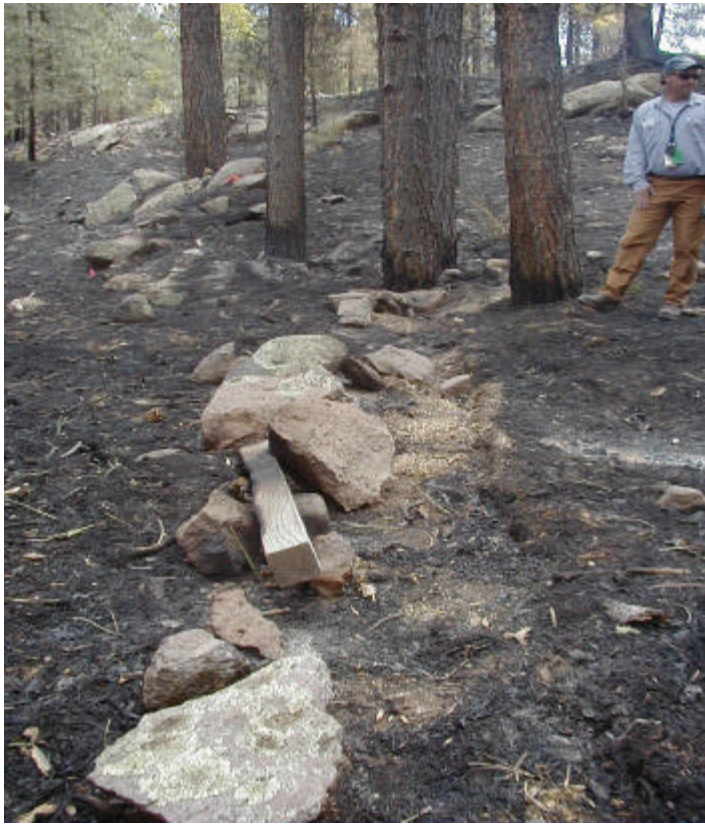
This site is located east of S-Site Road in the upper tributary of Canon de Valle within the Canon de Valle Watershed Aggregate. No damage was observed from the outfall to the first rock check dam. Below the second rock check dam, fire damaged much of the ground cover and several of the ponderosa pine trees. All straw were destroyed.

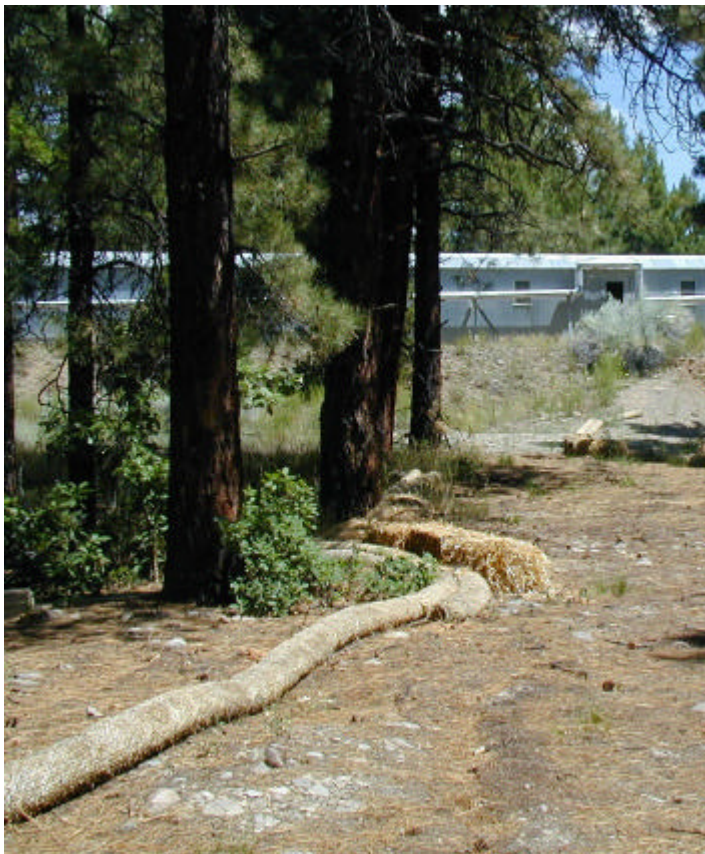
The site has a vegetative cover of around 50%. The site appears stable, but evidence of sediment migration is evident after large rain events. Upstream flood control efforts have reduced the flood potential at the site, but additional work remains. The site will be inspected frequently to assure that sediment migration is minimized.

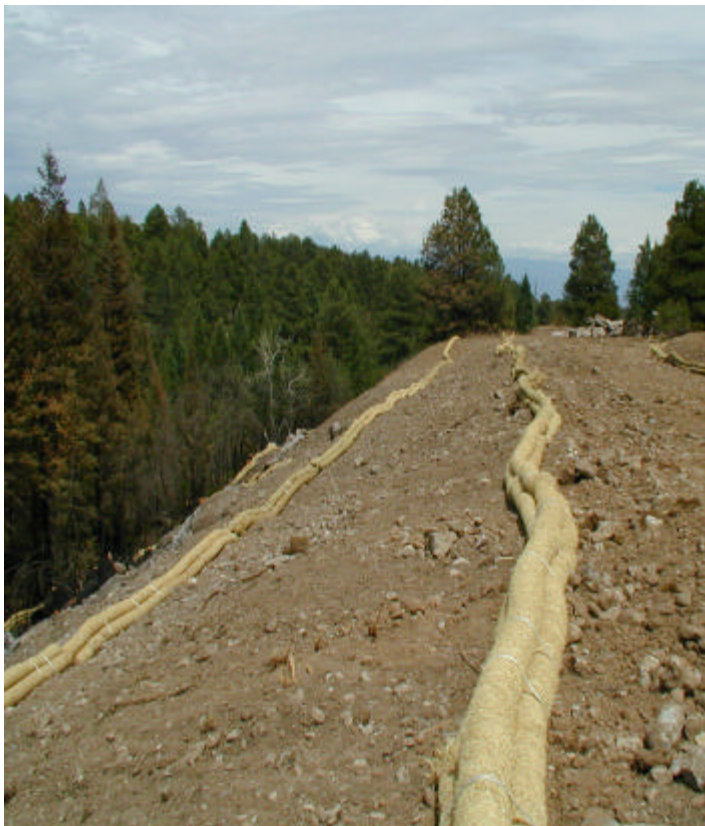
This site is located near building TA-16-260 above Canon de Valle within the Canon de Valle Watershed Aggregate. The site has moderate to severe fire damage over a majority of the area. Miscellaneous debris was exposed on the mesa and slope above canyon channel. The dissipation controls installed within the eastern drainage were destroyed. The ground and canopy cover was completely destroyed. Ash is up to 12” deep in some areas at the toe of slope. Burning occurred in the Canon de Valle leaving severe erosion potential behind.

The fire smoldered for several weeks prior to being extinguished in August 2000. The site was then excavated and 95% of the debris was staged in the area. Trees were contour felled at the toe of the slope to provide sediment retention. Straw wattles were installed across the entire slope at four locations. The entire slope was hydromulched to enhance the vegetation process.
