Title: CERRO GRANDE FIRE ONE YEAR AFTER:

AN UPDATE ON ER ACTIVITIES TO REDUCE
THE POTENTIAL MOVEMENT OF
CONTAMINATION AT POTENTIAL RELEASE
SITES

Authors: STEVEN J. VEENIS, CPESC

Submitted to: WATER QUALITY & HYDROLOGY GROUP (ESH-18)
ENVIRONMENTAL RESTORATION PROJECT

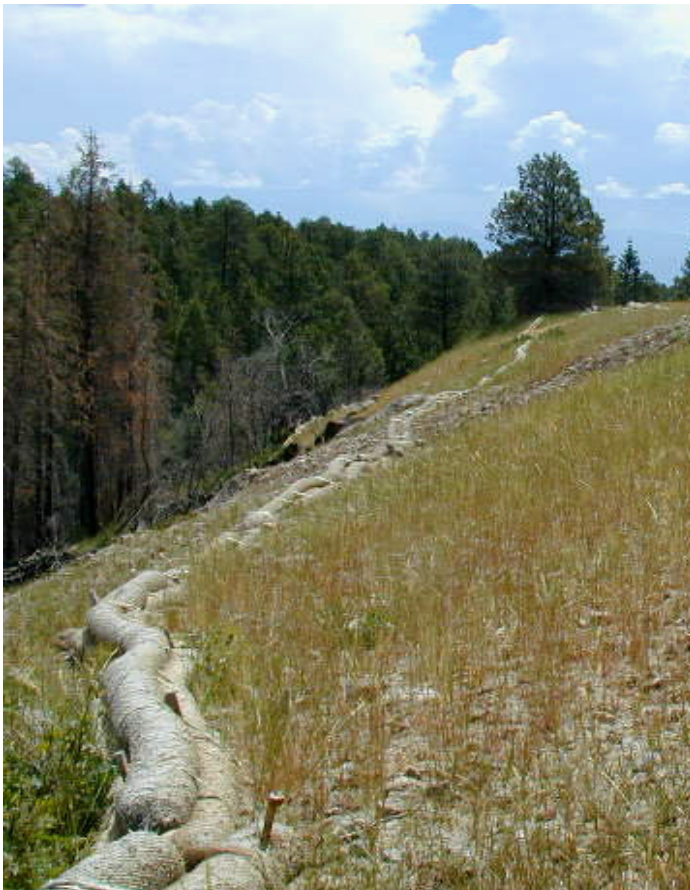
All excavated soil and debris have been removed from the site. The controls installed at the site have been very effective in stabilization of the slope. The run-on diversion trench has reduced storm water flow onto the site by more than 75%. The vegetative groundcover has reduced erosion potential on the slope and the migration of sediment at the site is minimal.

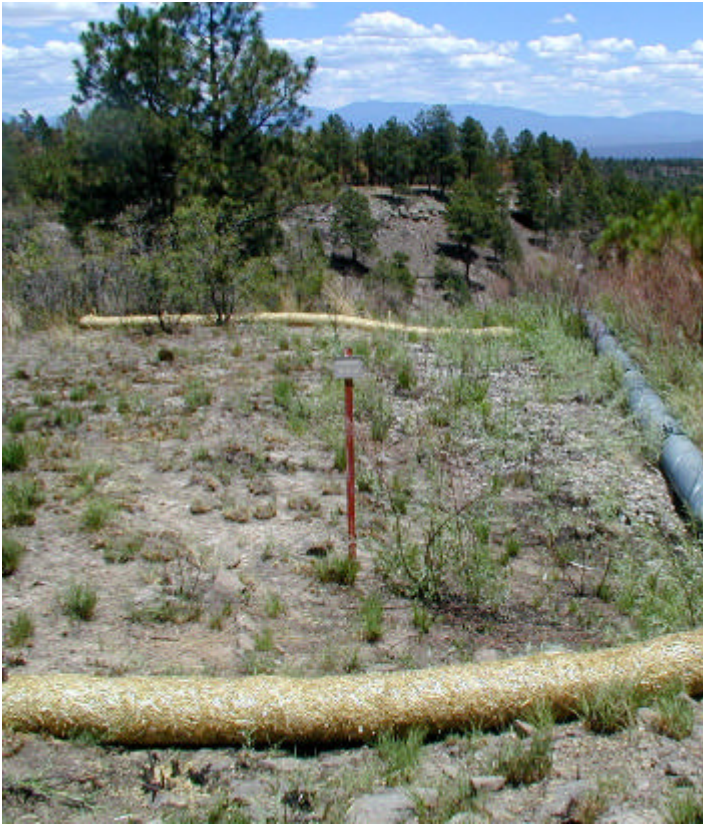
Site is located near a tributary in upper Water Canyon within the Upper Water Canyon Watershed Aggregate. The site has minor to moderate fire damage within the outfall drainage.

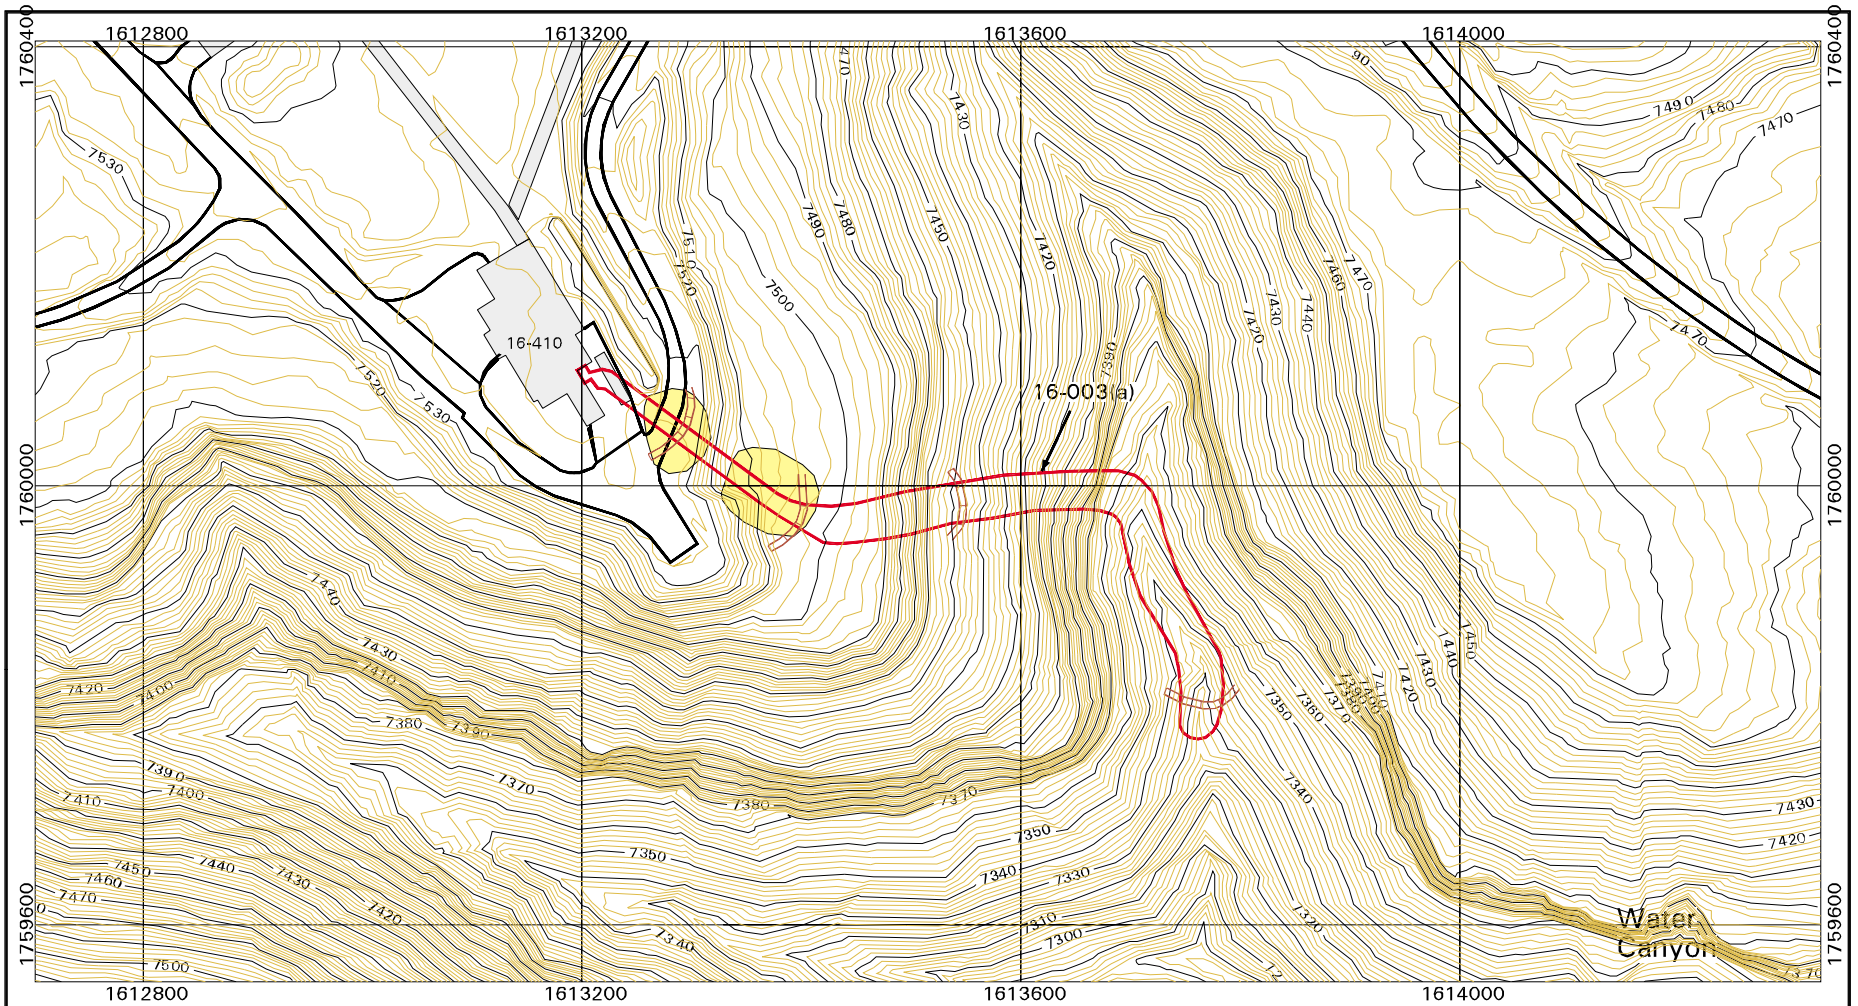
Best Management Practices at PRS 16-003(a)

Site is in good condition, with vegetative cover of greater than 70%. The area appears stable with evidence of sediment migration being minimal.

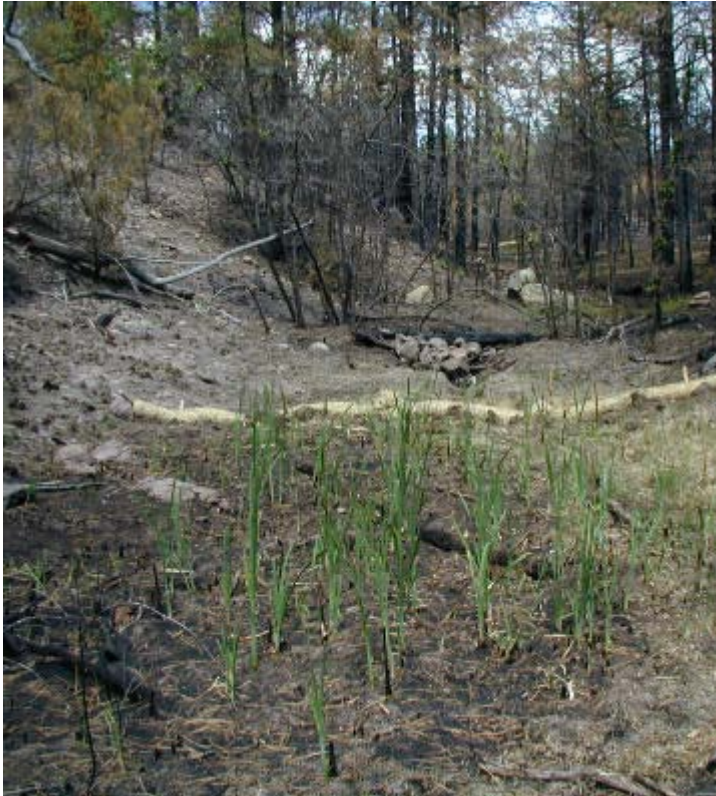
The site is located in a tributary drainage of Water Canyon within the Canon de Valle Watershed Aggregate. The site has minor to moderate fire damage within the drainage channel down to the existing wetlands located approximately ¼ mile downstream.

Straw wattles were installed above and below the wetland to help control sediment transport within the channel. Rock check dams (on-site materials used) were installed for flow dissipation. Wetland vegetation has begun to re-establish itself.

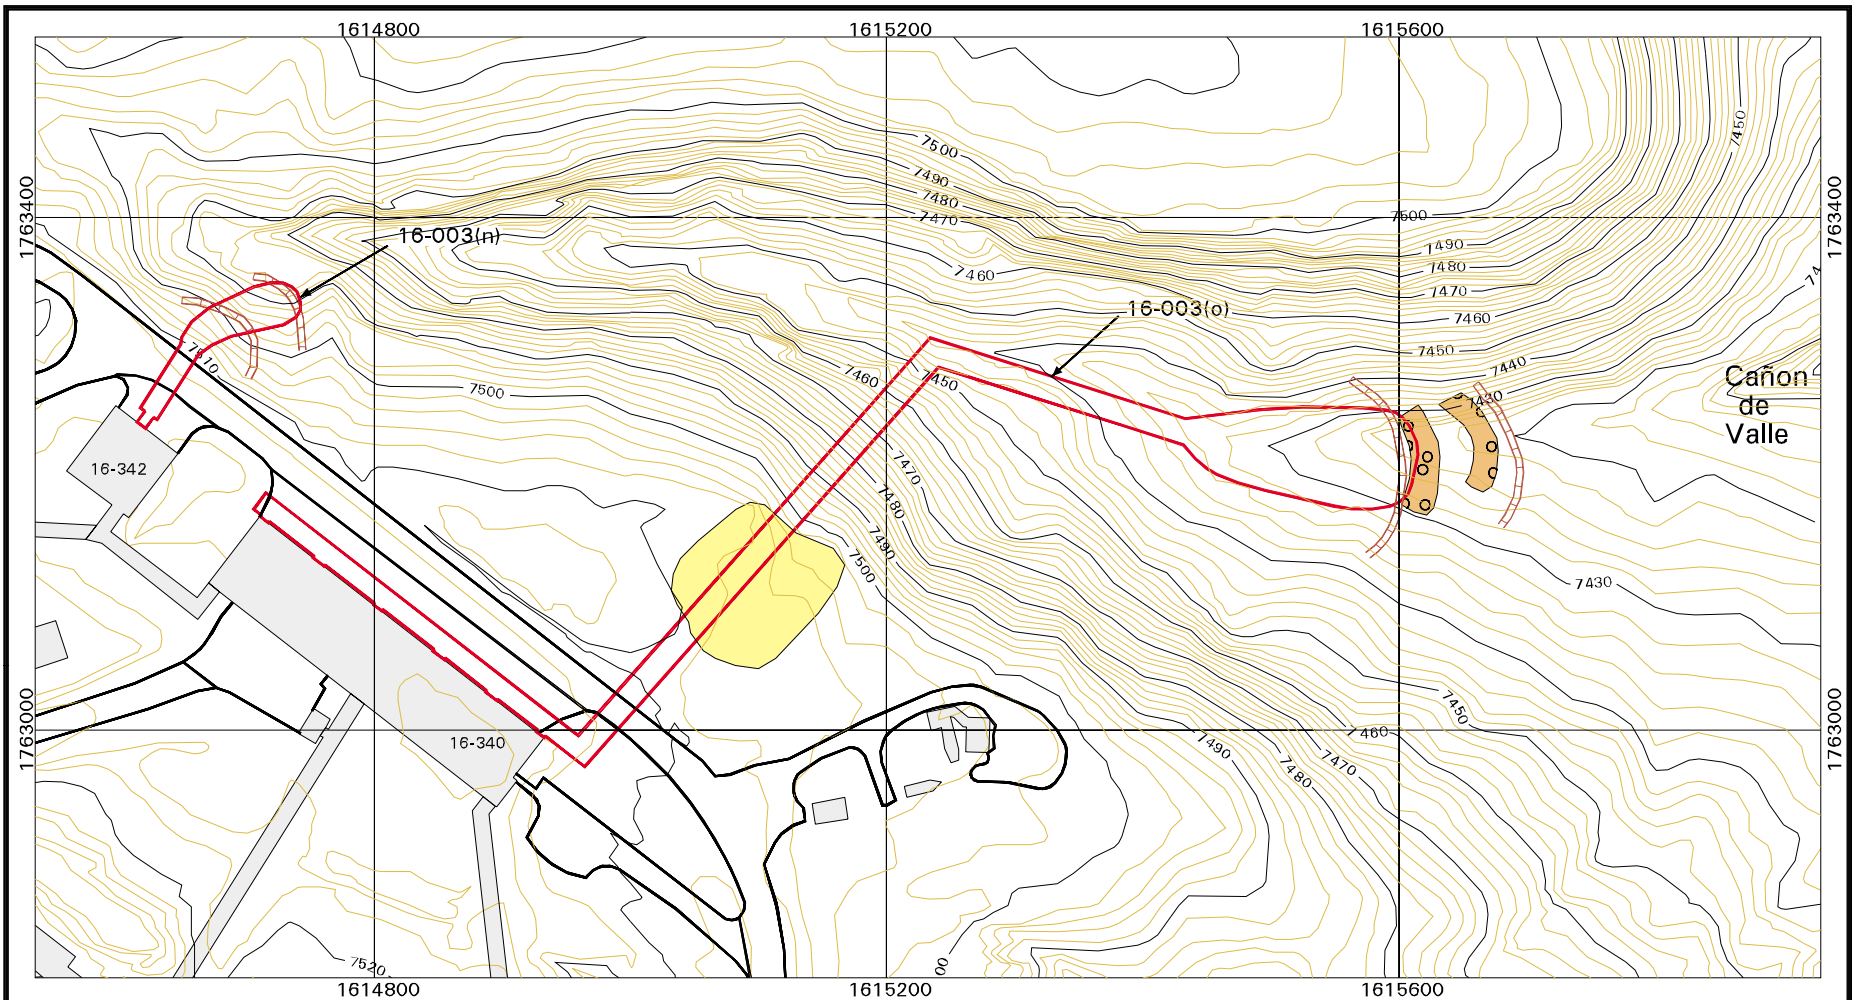
Best Management Practices at PRSs 16-003(n,o)

Revegetation efforts within the tributary drainage have been successful. The wetland grasses as well as the surrounding channel bank grasses have achieved a greater than 70% cover. The site appears stable and sediment migration at the site is minimal.

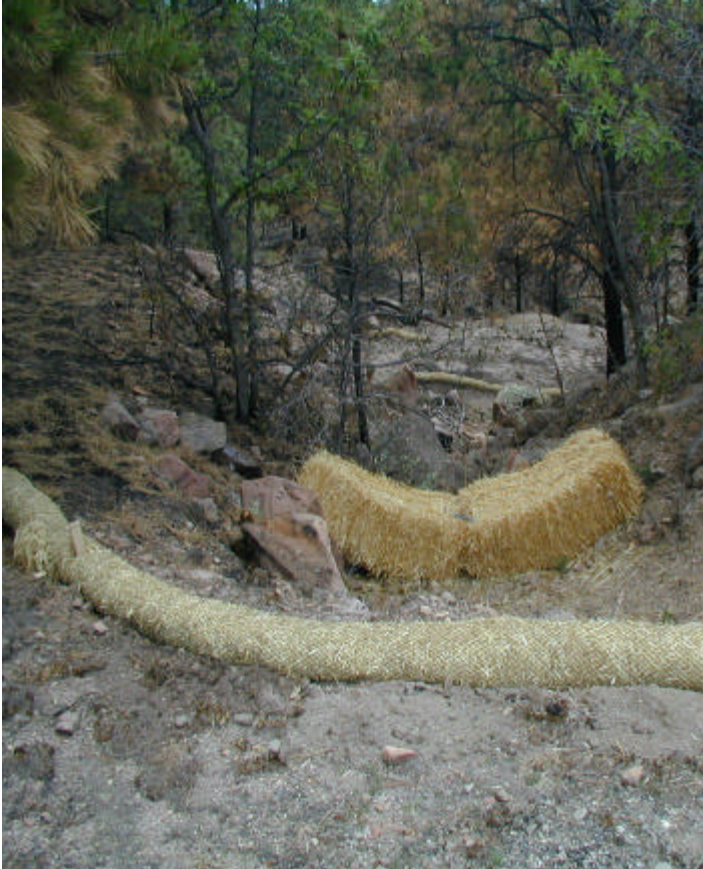
The site is located in a tributary drainage of Water Canyon within the Upper Water Canyon Watershed Aggregate. The site has minor to moderate fire damage within drainage channel.

Straw wattles and straw bale barriers were installed within the drainage channel to retain sediment and dissipate flow. Areas adjacent to the drainage were hand-raked, reseeded and covered with straw mulch.

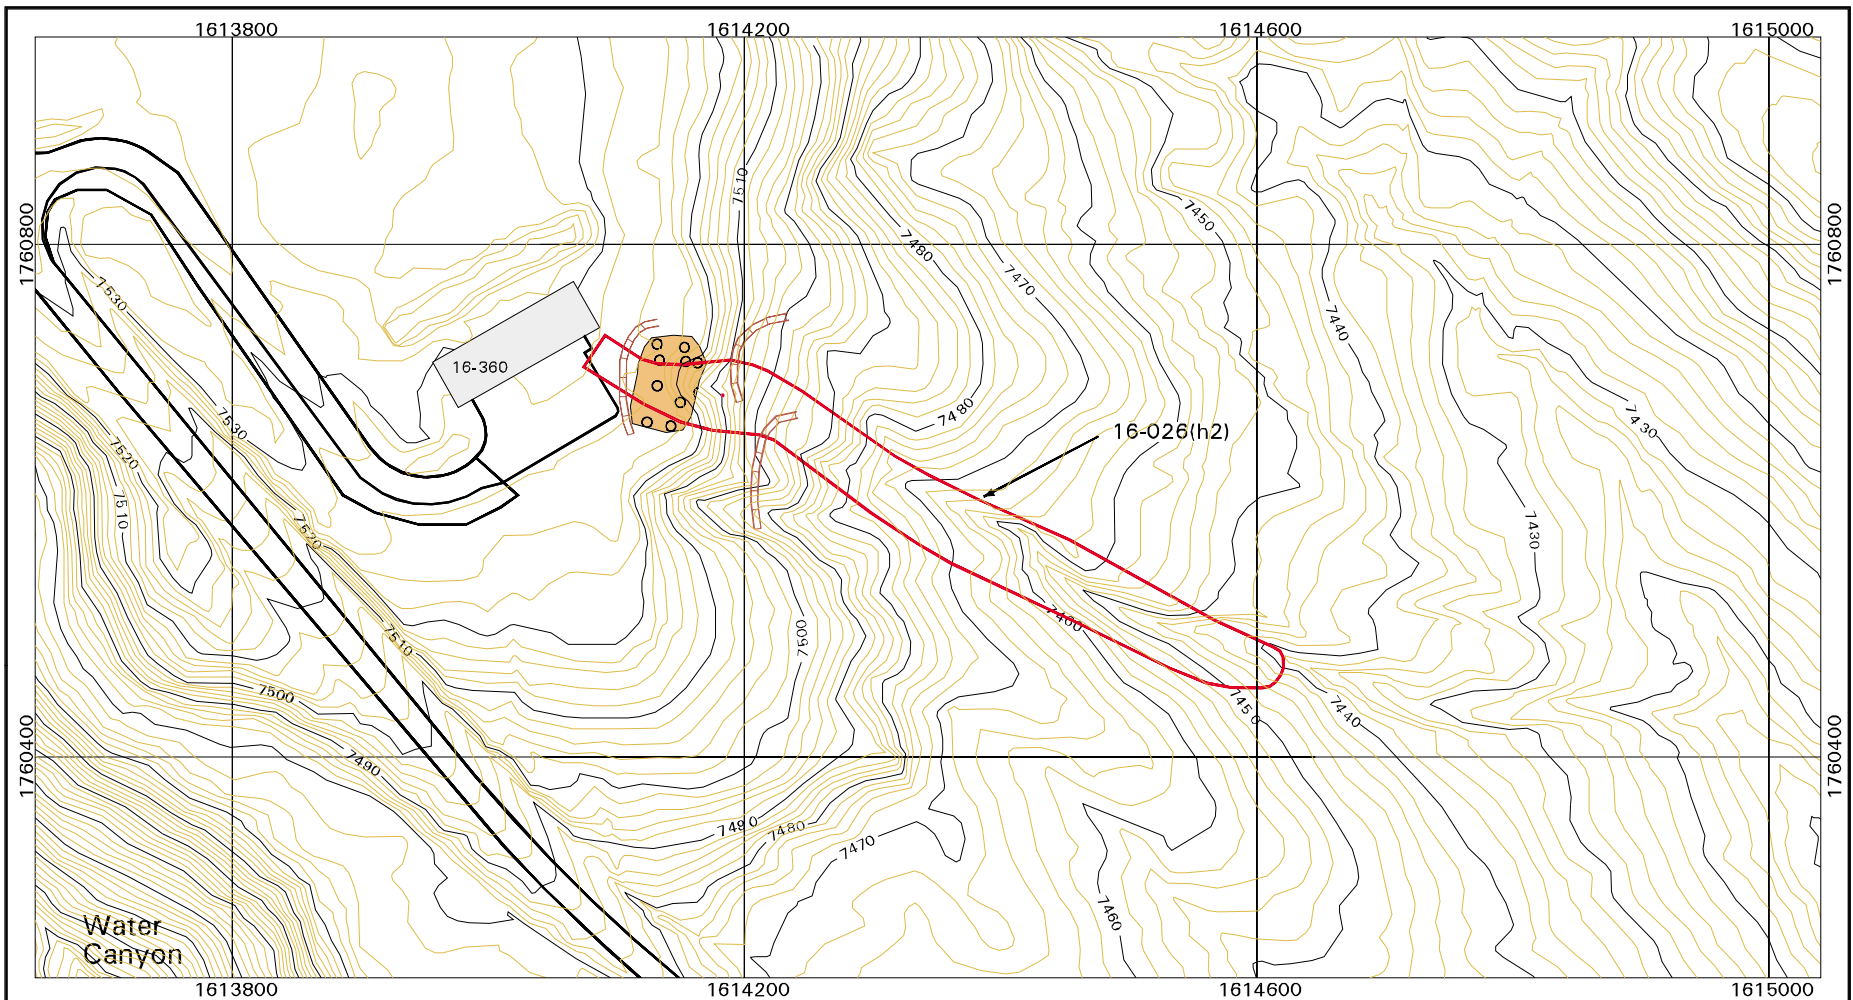
Best Management Practices at PRS 16-026(h2)

Revegetation efforts within the tributary drainage have been successful. The wetland grasses as well as the surrounding channel bank grasses have achieved a greater than 70% cover. The site appears stable and sediment migration at the site is minimal.

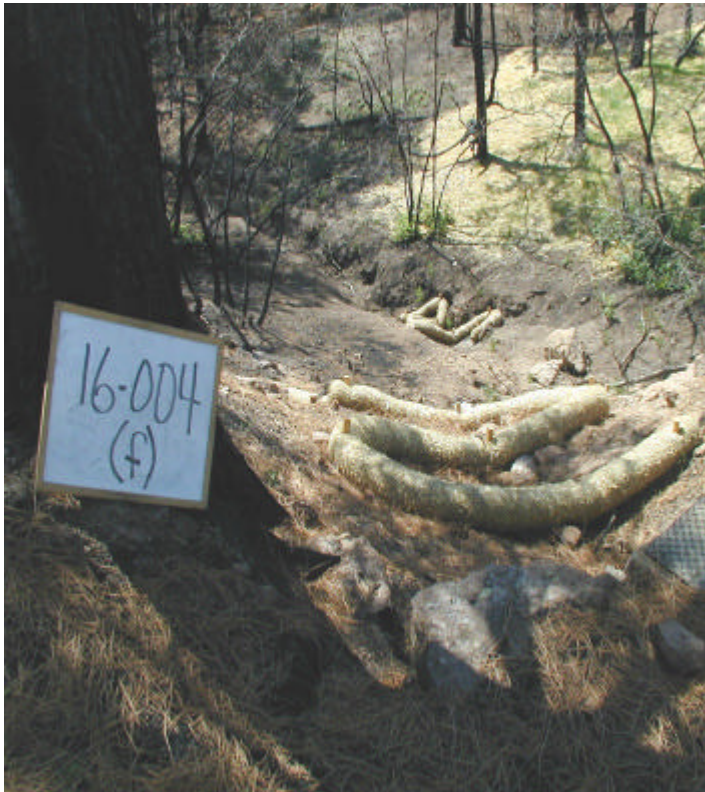
The site is located in a tributary drainage of Water Canyon within the S-Site Canyon Watershed Aggregate. The site has minor to moderate fire damage within drainage channel.

Straw wattles and straw bale barriers were installed within the drainage channel to retain sediment and dissipate flow. Areas adjacent to the drainage were hand-raked, reseeded and covered with straw mulch.

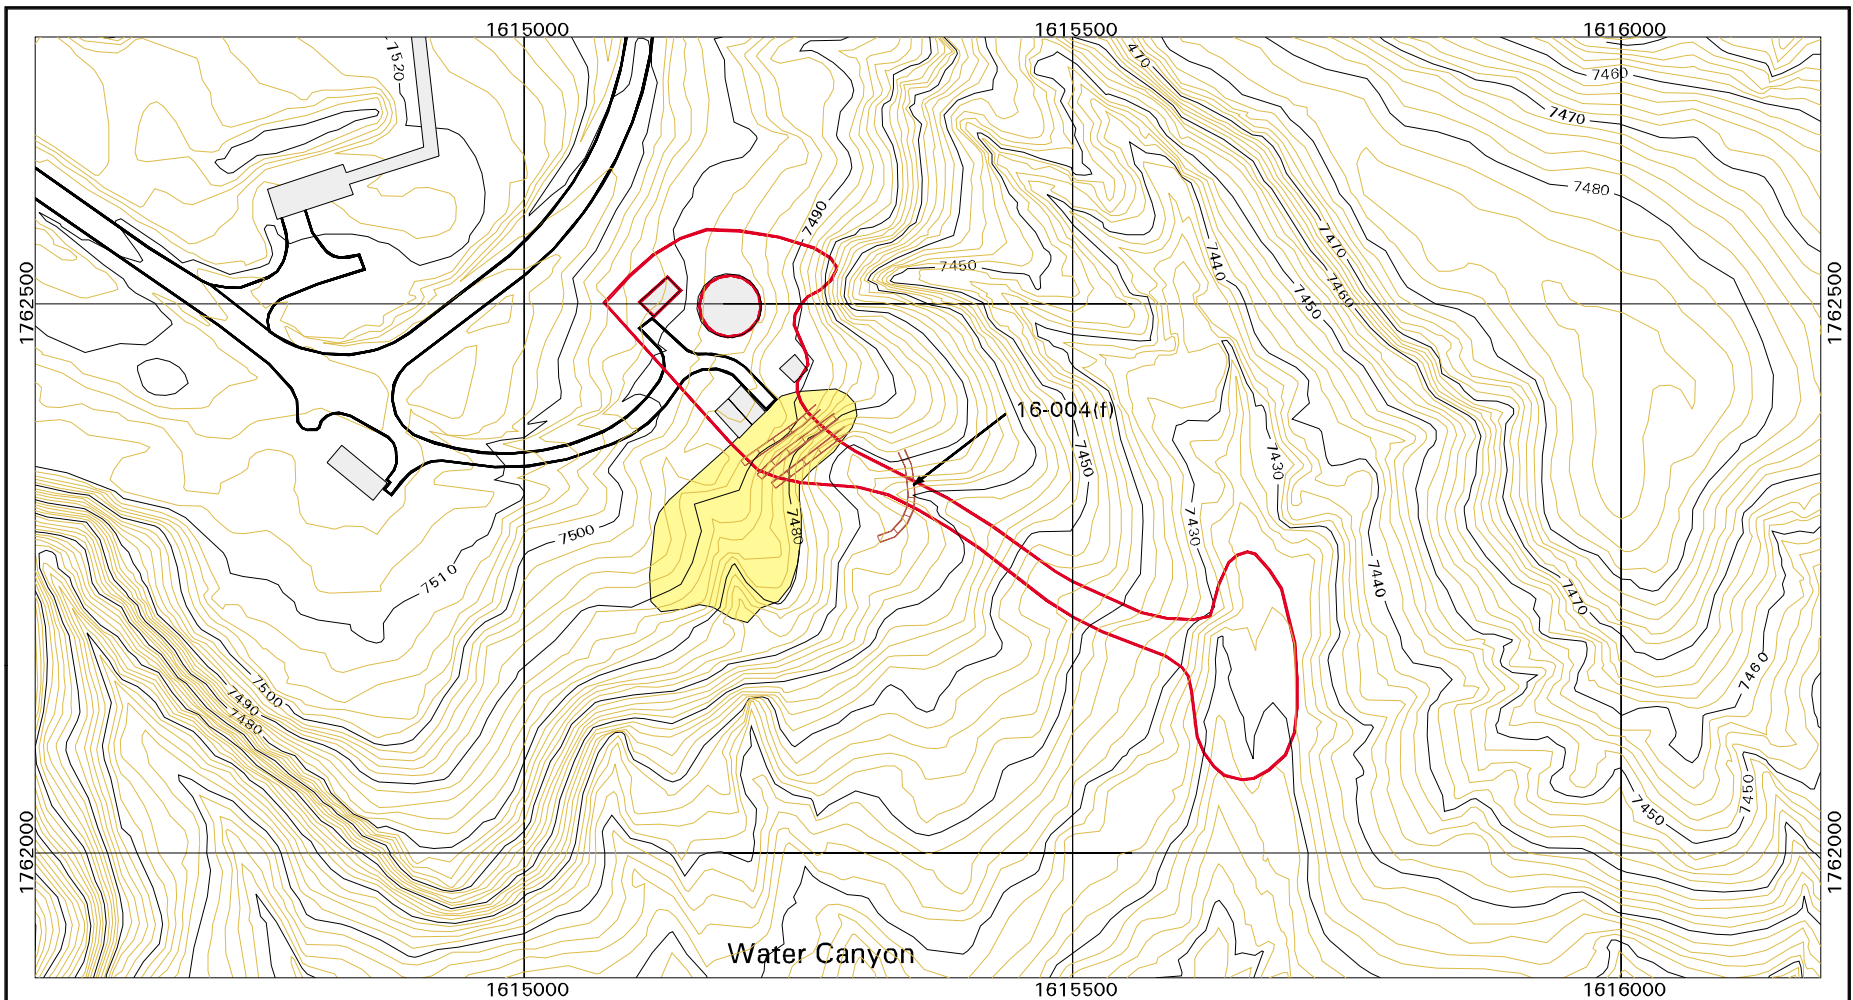
Best Management Practices at PRS 16-004(f)

Revegetation efforts within the tributary drainage have been successful. The surrounding channel bank grasses have achieved a greater than 70% cover. The site appears stable and sediment migration at the site is minimal.

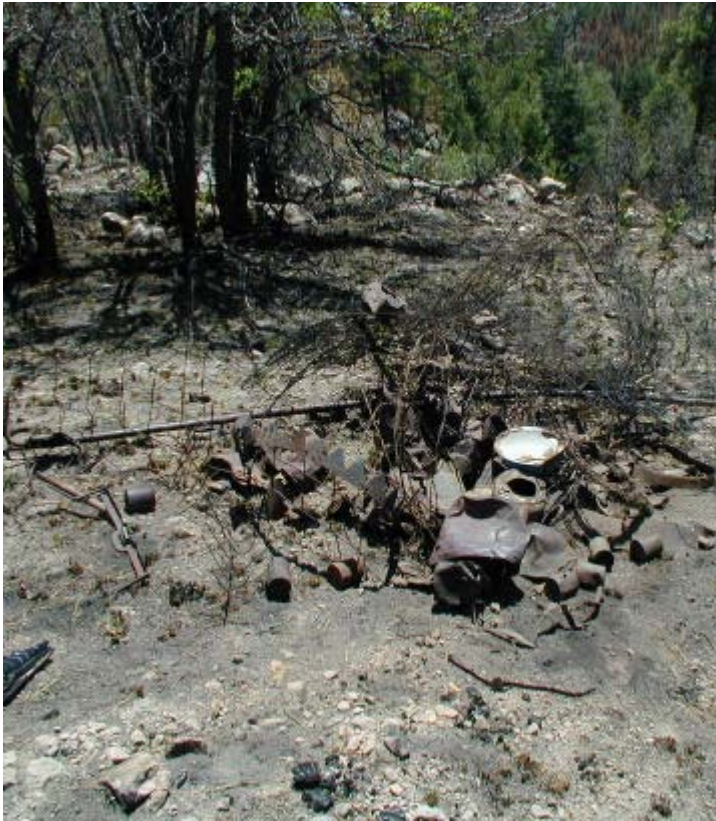
The site is located in a tributary drainage of Water Canyon within the Canon de Valle Watershed Aggregate. The site has minor to moderate fire damage within drainage channel. Debris was exposed within channel near the inactive outfall.

Straw wattles were installed upslope of and within the drainage channel to divert and dissipate storm flows. The debris was removed from the channel and the area was hydromulched to enhance the vegetation process.

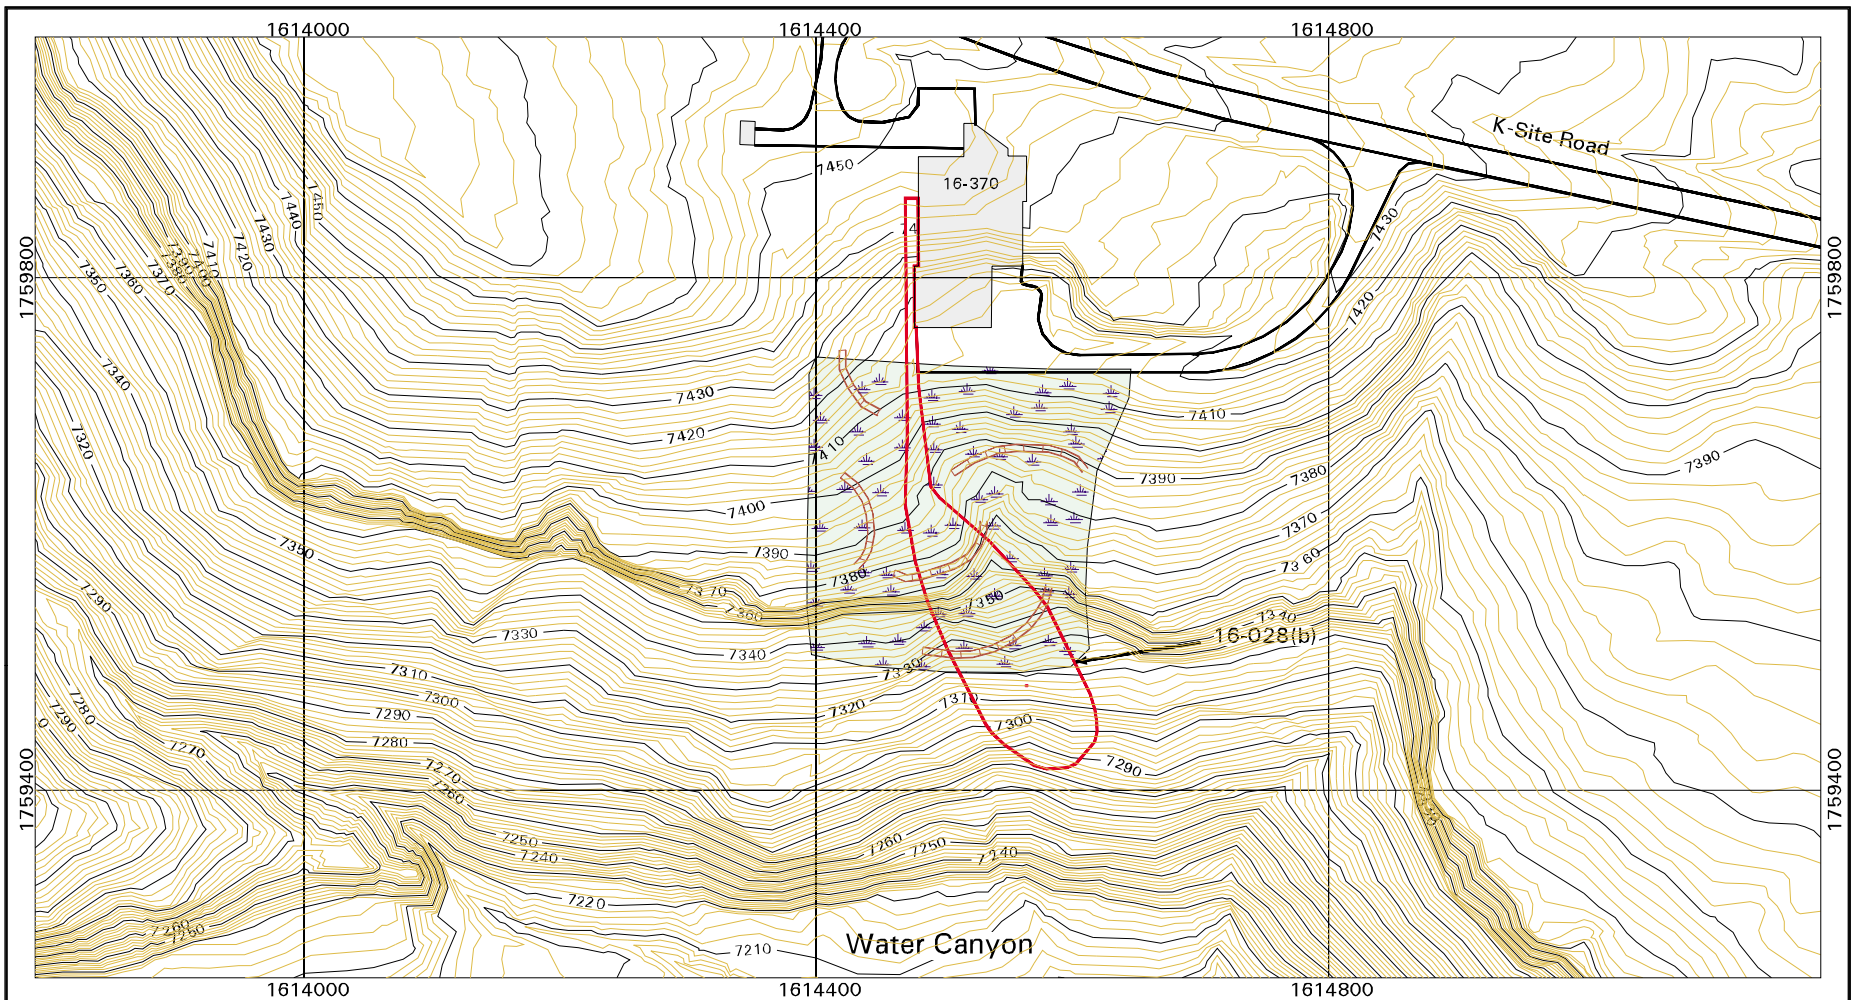
Best Management Practices at PRS 16-028(b)

Revegetation efforts within the tributary drainage have been successful. The surrounding channel bank grasses have achieved a greater than 70% cover. The site appears stable and sediment migration at the site is minimal.

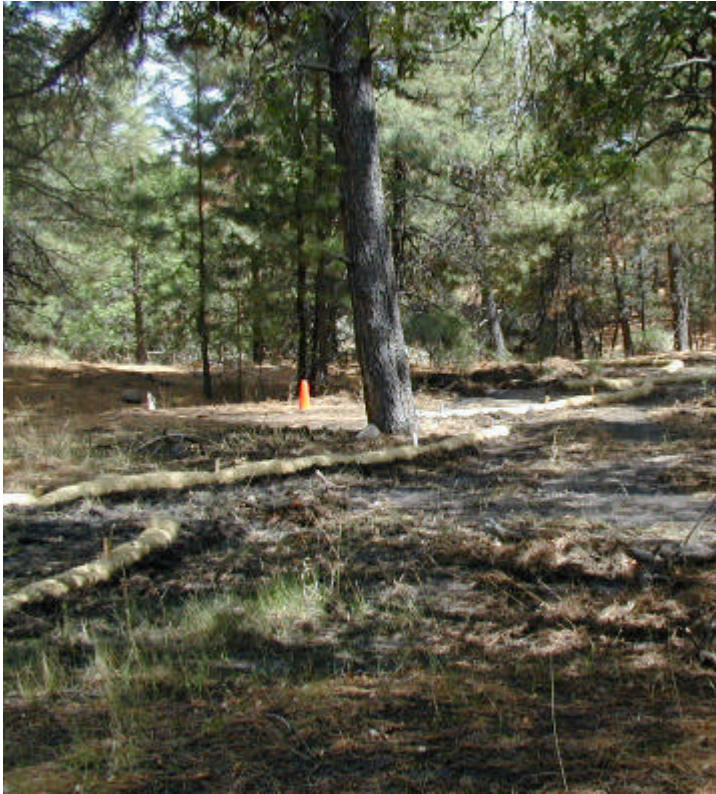
The site is located in a tributary drainage of Water Canyon within the Upper Water Canyon Watershed Aggregate. The site has moderate fire damage of the ground cover with minor canopy damage.

Straw wattles were installed throughout the site for sediment retention. The area was then hand-raked, reseeded and straw mulched.

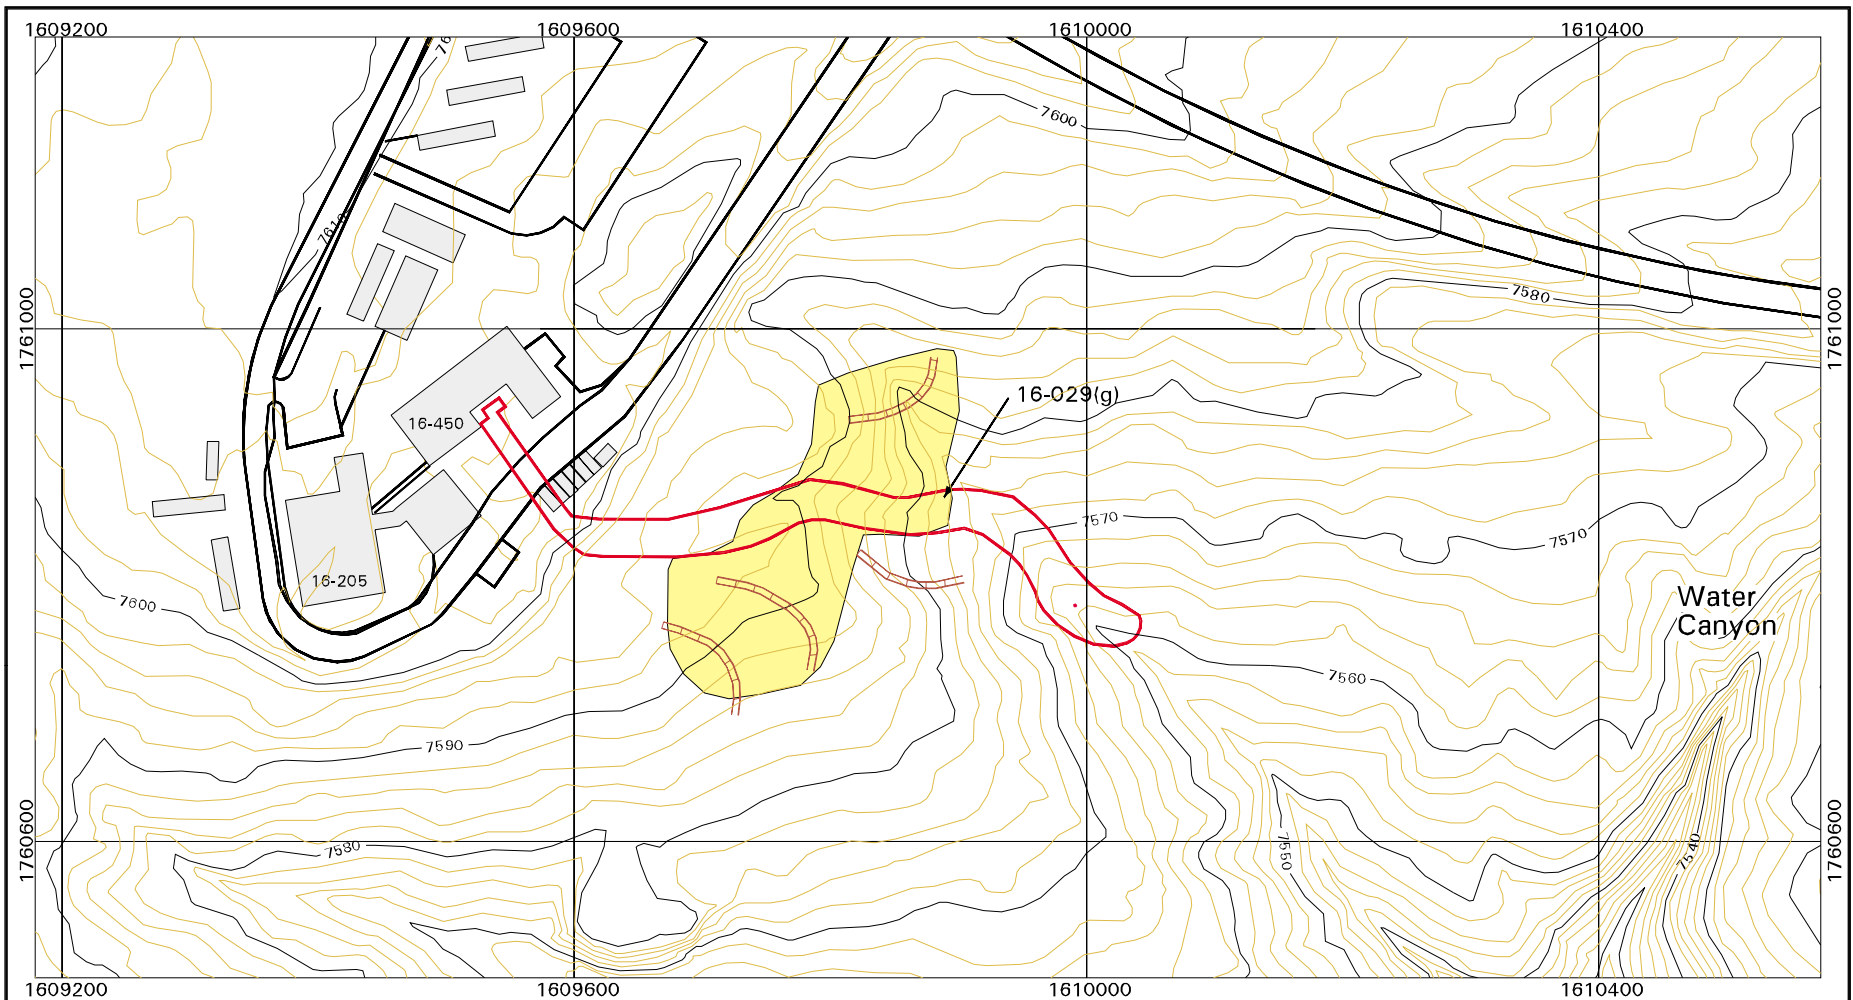
Best Management Practices at PRS 16-029(g)

Revegetation efforts throughout the site have been successful. The surrounding grasses have achieved a greater than 70% cover. The site appears stable and sediment migration at the site is minimal.

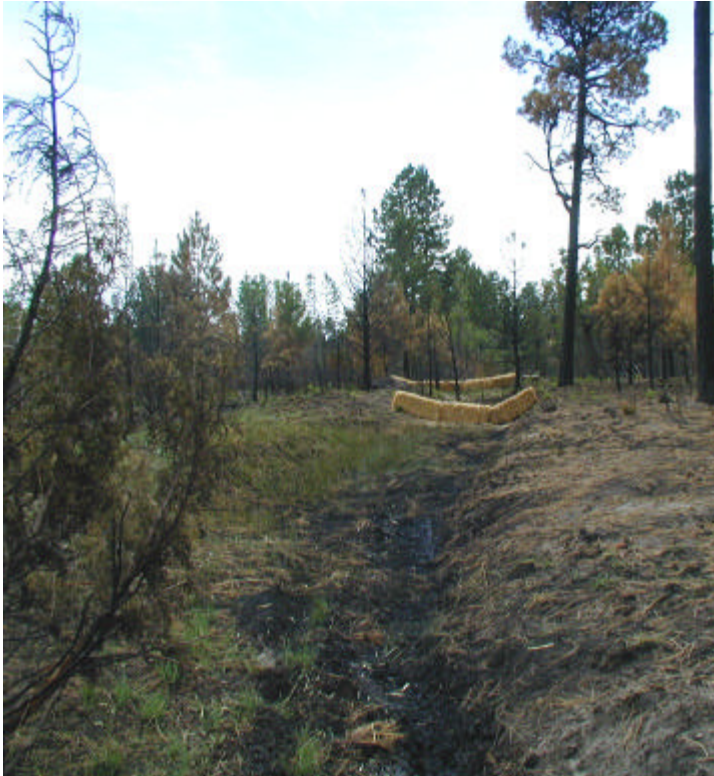
The site is located in a tributary drainage of Water Canyon within the Upper Water Canyon Watershed Aggregate. The site has moderate fire damage of the ground cover with minor canopy damage.

Straw barriers were installed within the drainage channel for sediment retention. The area was then hand-raked, reseeded and straw mulched.

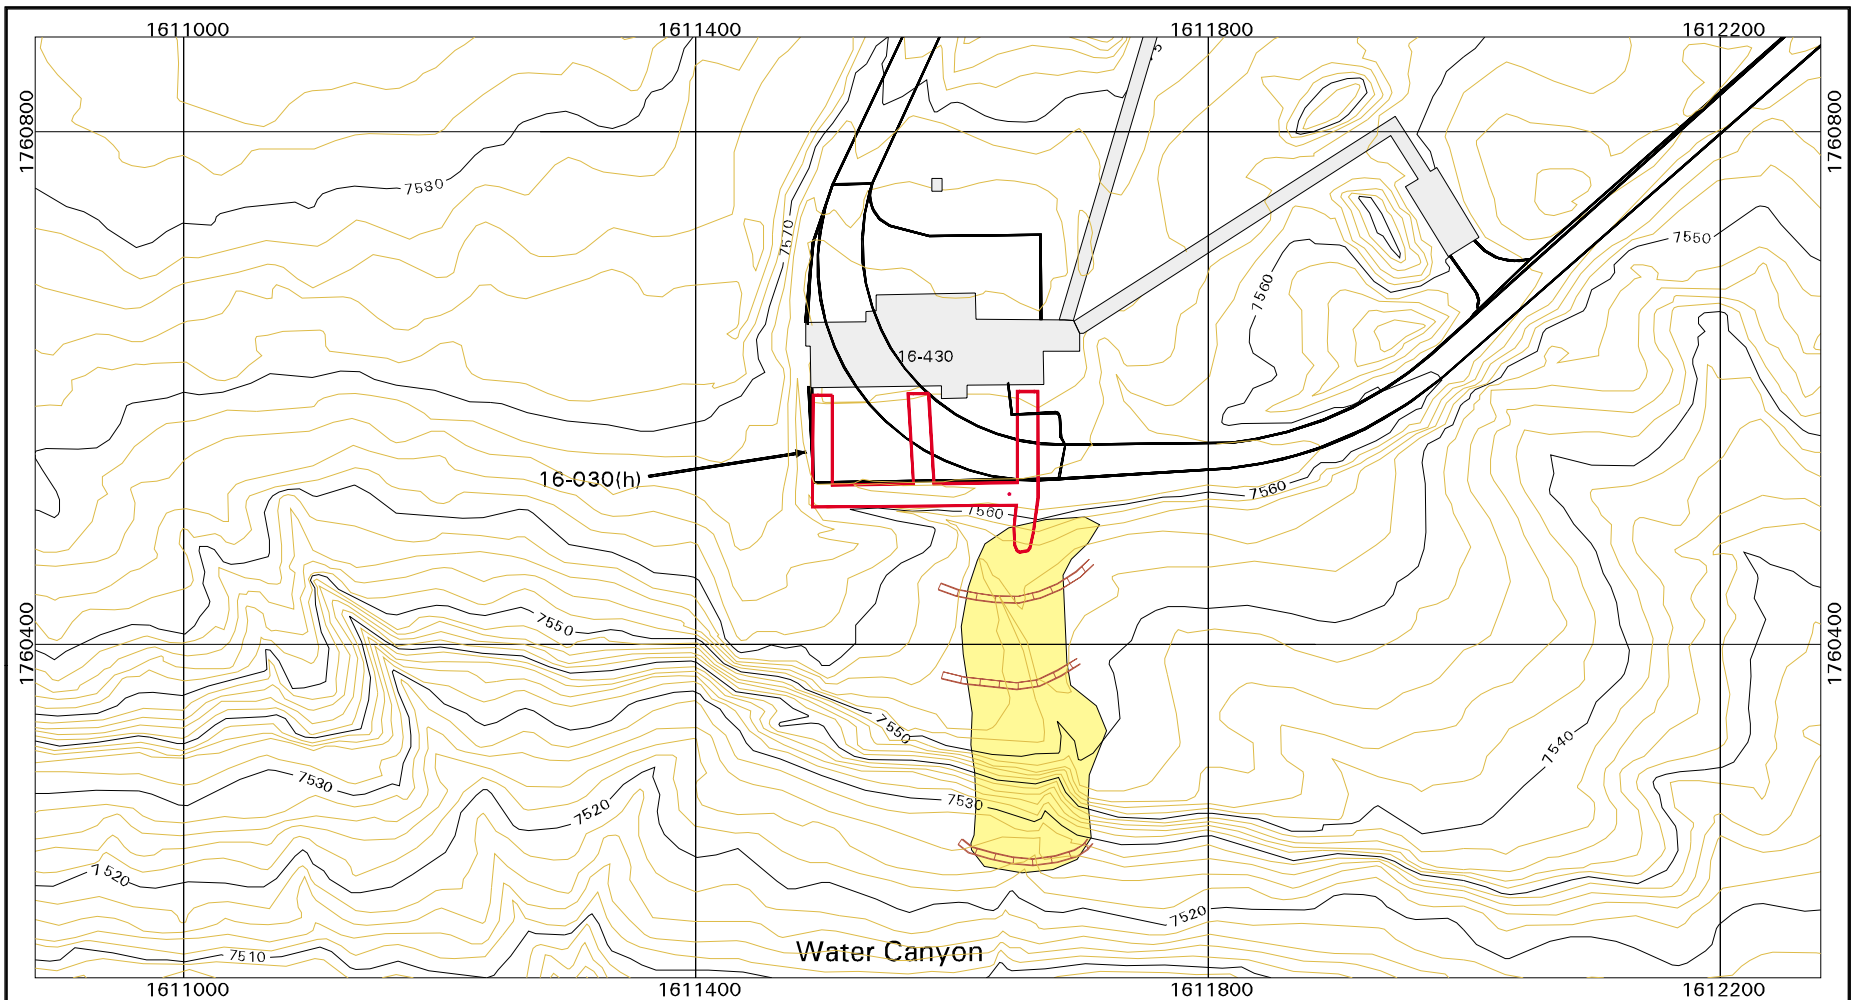
Best Management Practices at PRS 16-030(h)

Revegetation efforts within the tributary drainage have been successful. The surrounding channel bank grasses have achieved a greater than 70% cover. The site appears stable and sediment migration at the site is minimal.

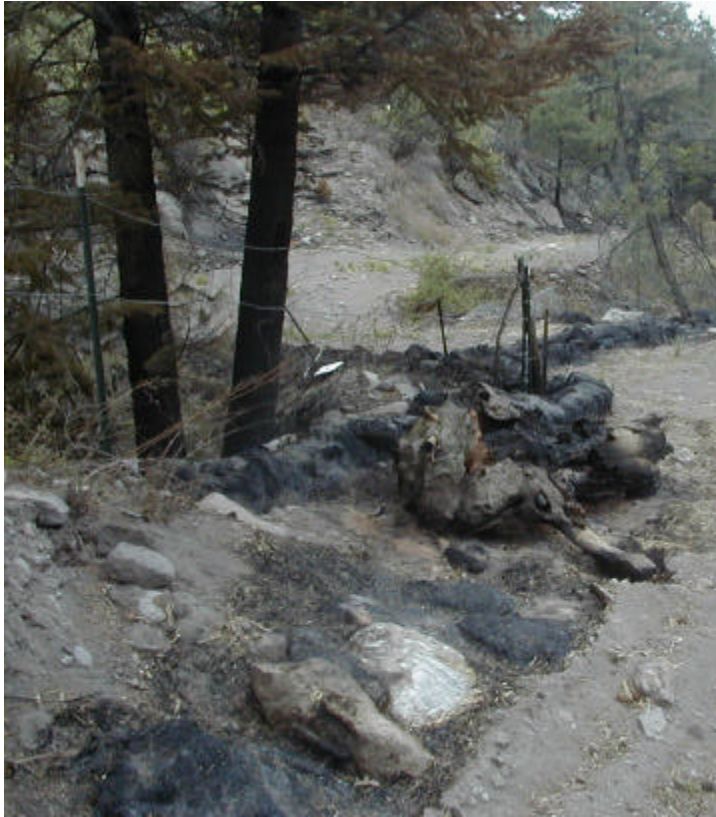
This site is located on the edge of Canon de Valle within the Canon de Valle Watershed Aggregate. MDA-P received only peripheral fire damage on the lower portion of the site. The existing straw barriers and silt fencing were destroyed. No construction equipment and project infrastructure were damaged.

The straw barriers and silt fencing were replaced and fortified with an earthen berm below the site. Soil-Sement (polymer based emulsion) was applied to exposed slopes to reduce sediment transport potential.

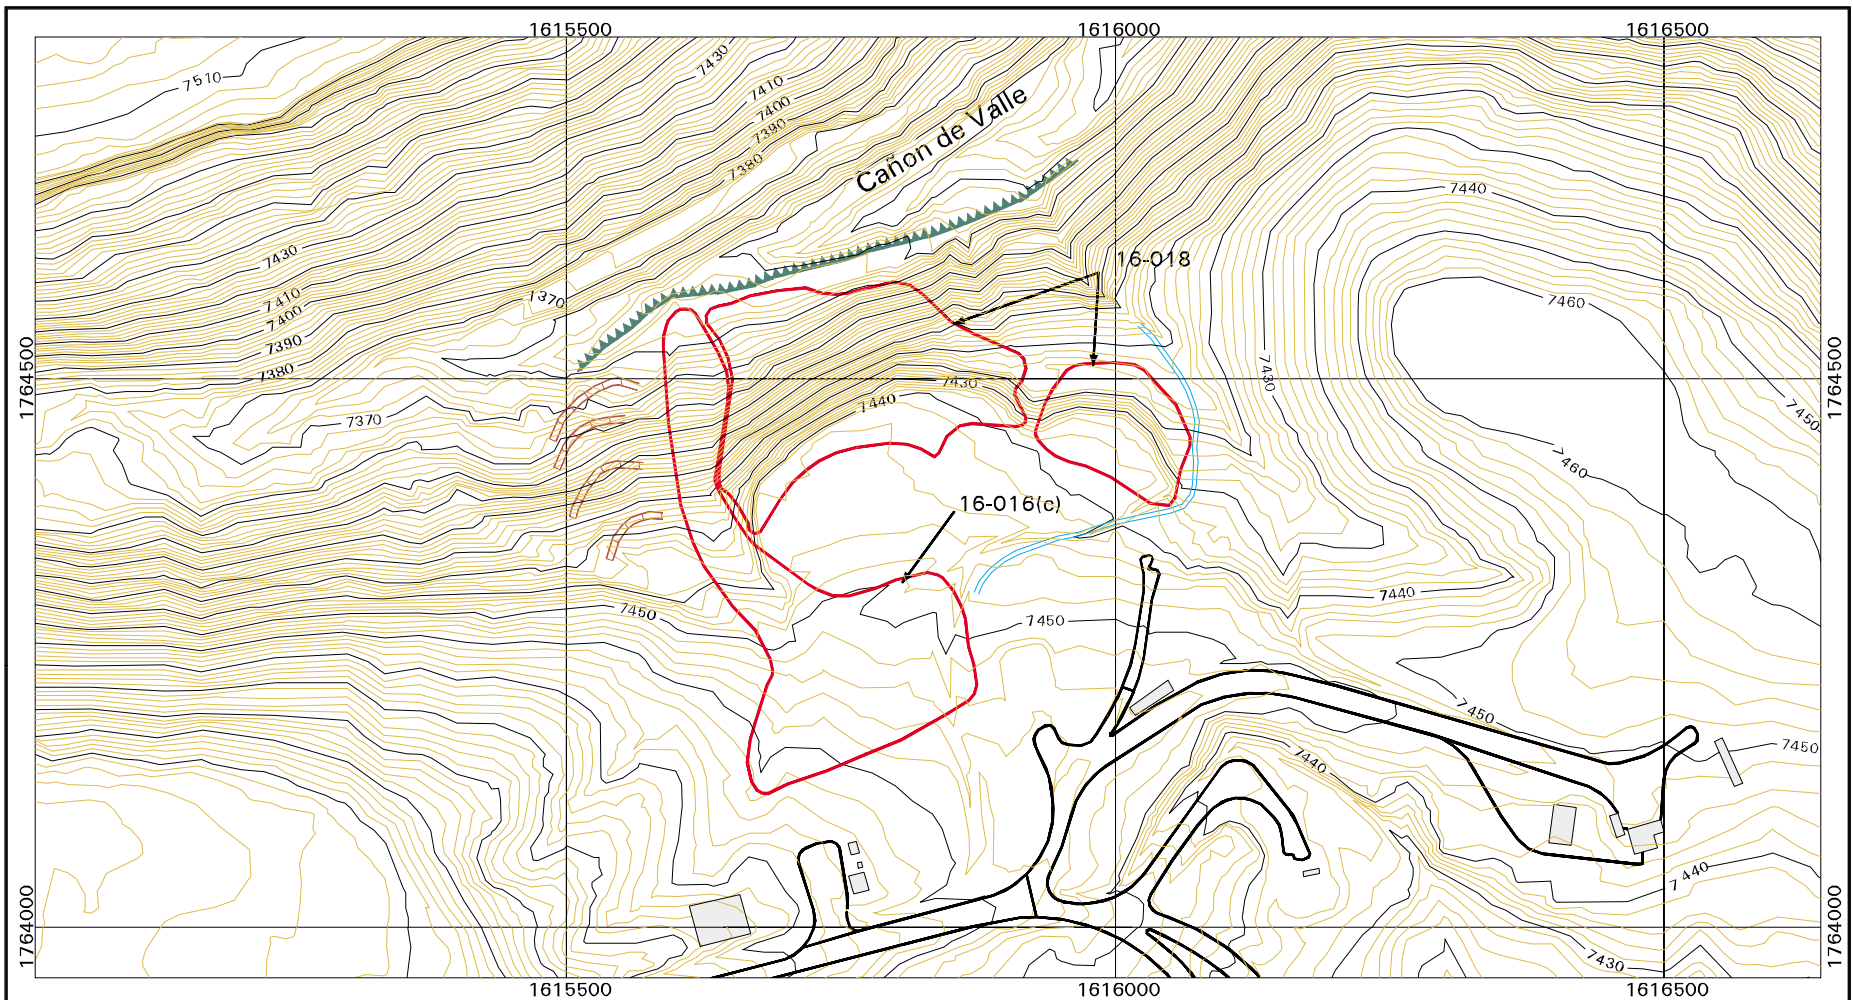
Best Management Practices at PRS 16-018 and 16-016(c)

Site is stable and the Clean Closure Project is near completion. Final restoration will occur at that time.
