Title: CERRO GRANDE FIRE ONE YEAR AFTER:

AN UPDATE ON ER ACTIVITIES TO REDUCE
THE POTENTIAL MOVEMENT OF
CONTAMINATION AT POTENTIAL RELEASE
SITES

Authors: STEVEN J. VEENIS, CPESC

Submitted to: WATER QUALITY & HYDROLOGY GROUP (ESH-18)
ENVIRONMENTAL RESTORATION PROJECT

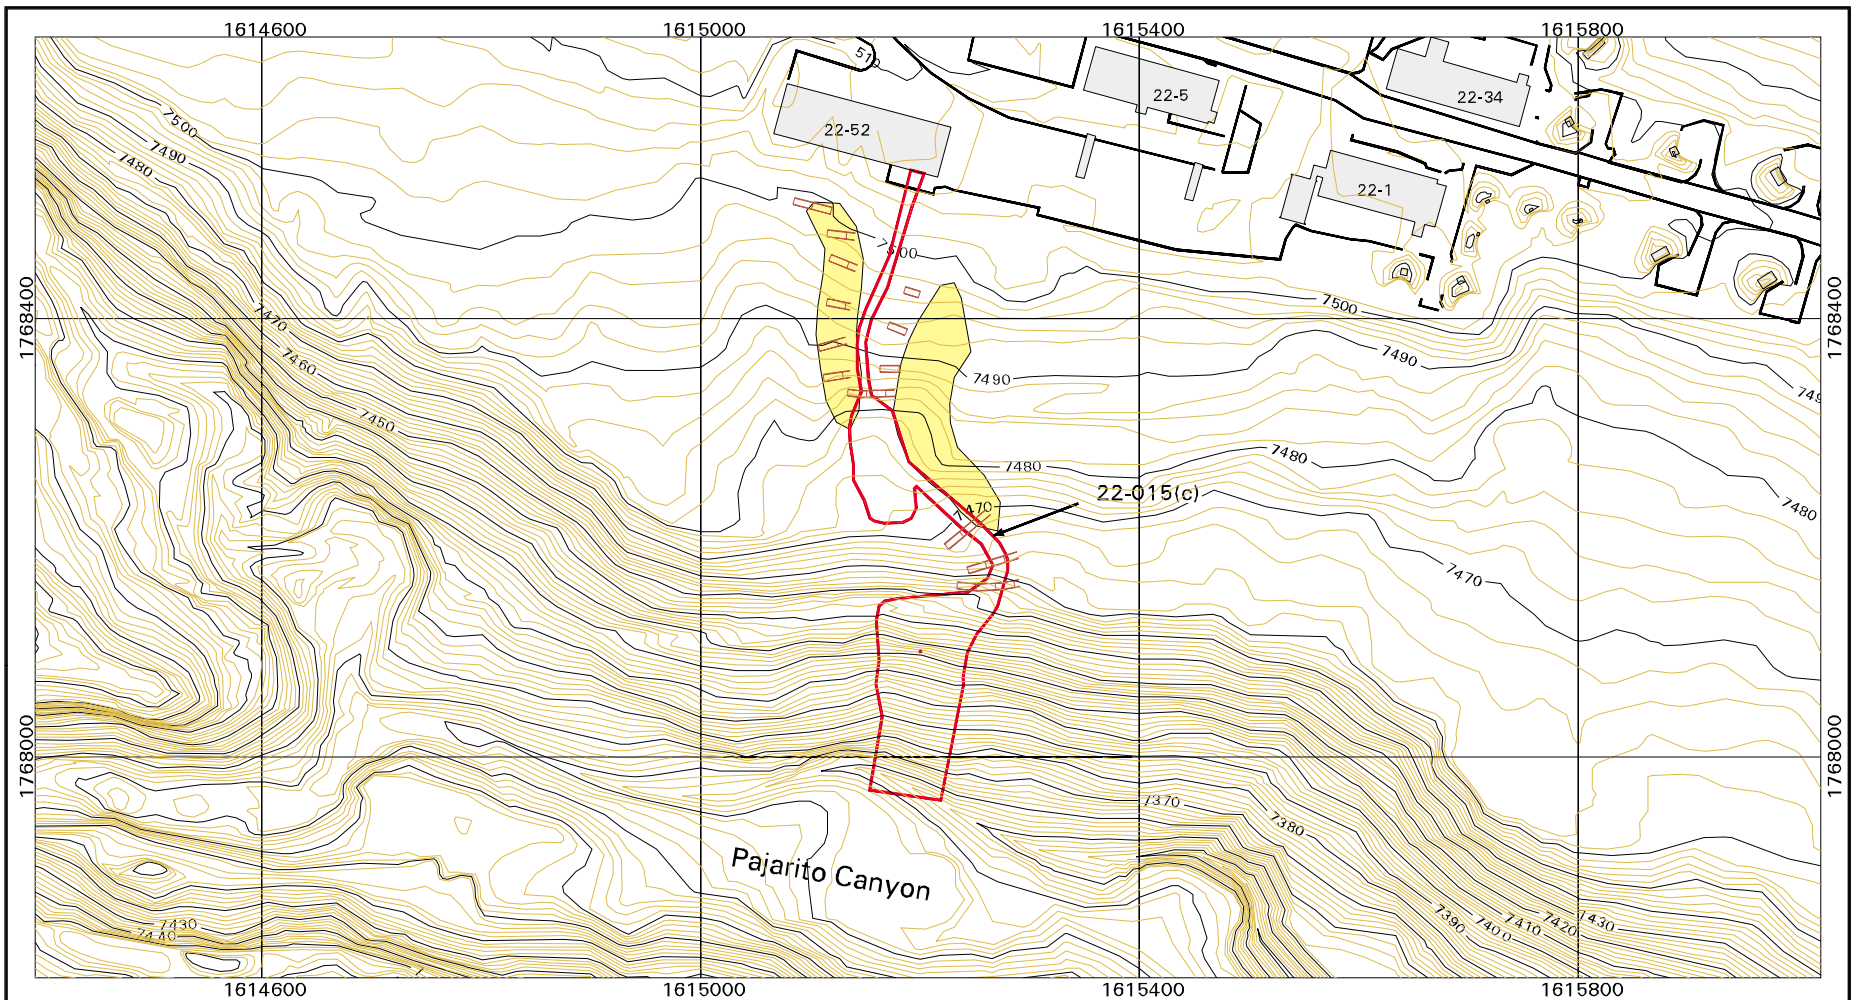
Best Management Practices at PRS 22-015(c)

Revegetation efforts throughout the site have been successful. The surrounding channel bank grasses have achieved a greater than 70% cover. The site appears stable and sediment migration at the site is minimal.

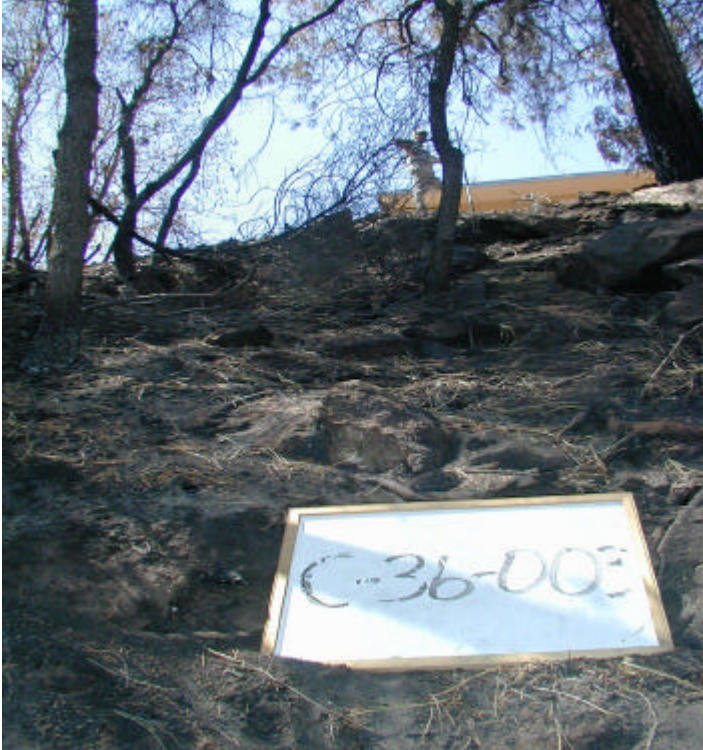
The site is located on the edge of Three Mile Canyon within the Three Mile Canyon Watershed Aggregate. A backfire was set near TA-36-1 to help protect TA-18. This fire exposed miscellaneous debris on the slope and PRS 36-008 was identified.

Straw wattles were installed on the mesa’s edge to divert storm water run-on from the parking area, within the drainage channels on the slope and at the toe of the slope. The debris that was exposed by the fire has been removed, and the area was hand-raked, reseeded and straw mulched.

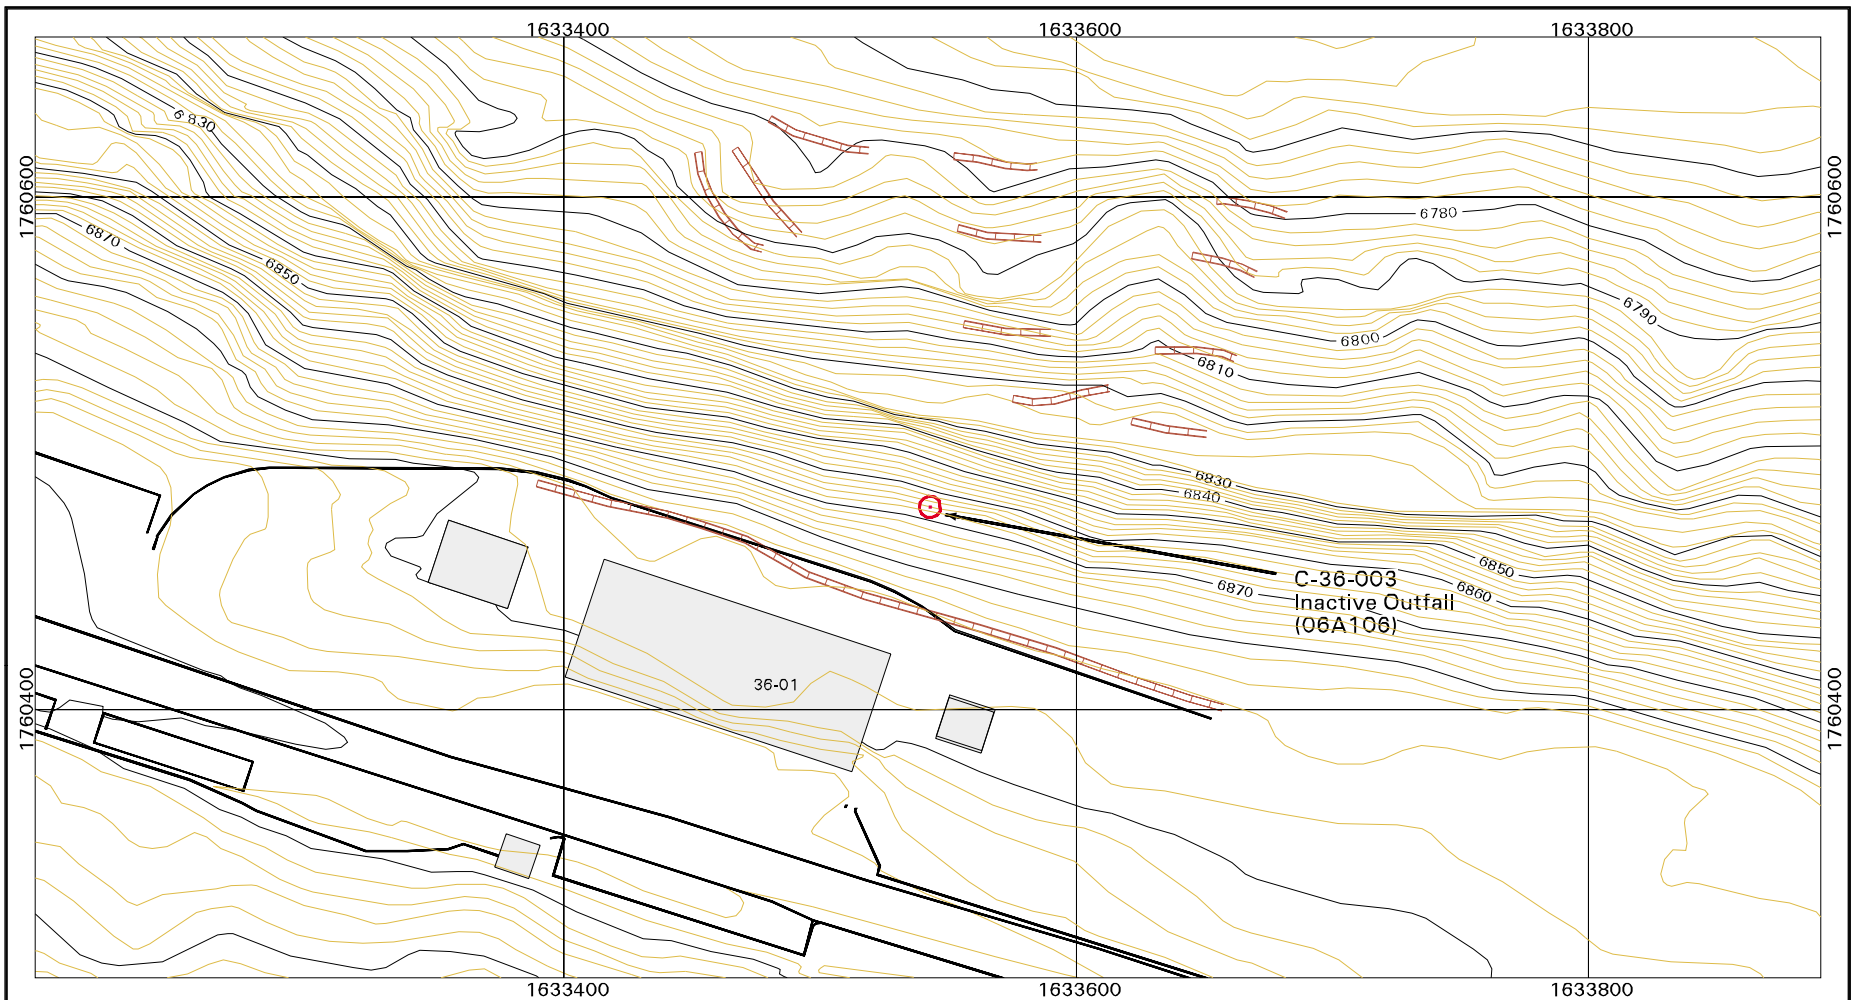
Best Management Practices at PRS C-36-003

Revegetation efforts throughout the slope have been successful. The surrounding grasses have achieved a greater than 70% cover. The site appears stable and sediment migration at the site is minimal.

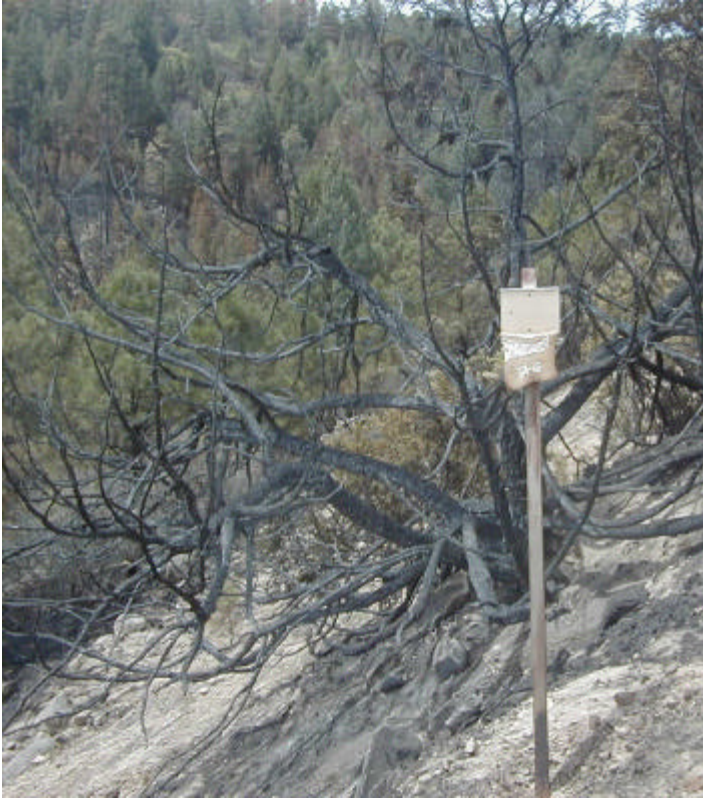
The site is located on the edge of Pajarito Canyon within the Starmer’s/Pajarito Canyon Watershed Aggregate. The fire damage was moderate to severe with several buildings destroyed near this site.

Straw wattles were installed on the steep portion of the slope to reduce the sediment migration potential. Wattles were also installed on the mesa’s edge to divert run-on from slope.

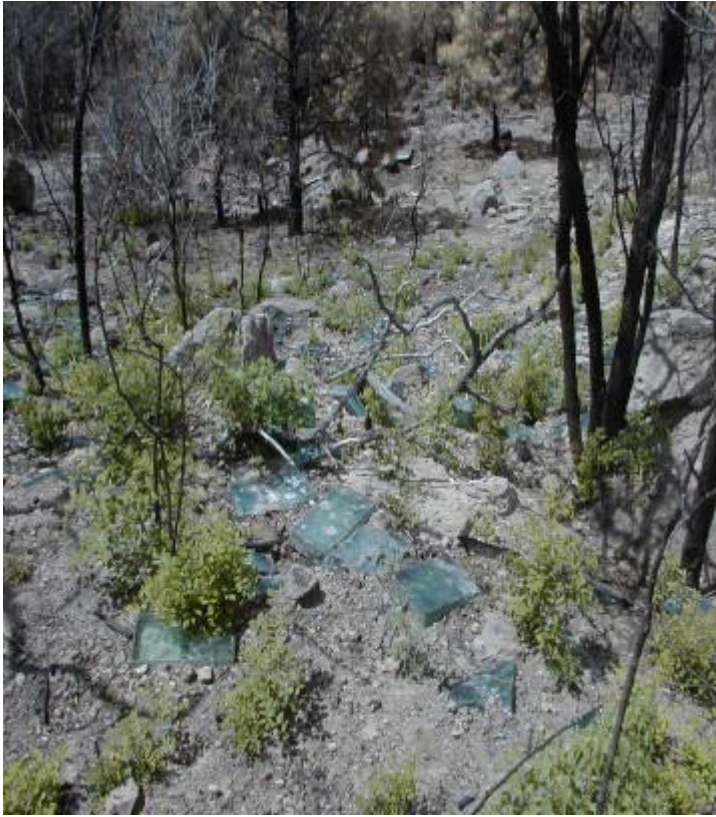
Site is located on the edge of Pajarito Canyon within the Starmer's/Pajarito Canyon Watershed Aggregate. The fire damage was moderate to severe with several buildings destroyed near this site.

Straw wattles were installed on the steep portion of the slope to reduce the sediment migration potential. Wattles were also installed on the mesa's edge to divert run-on from the slope.

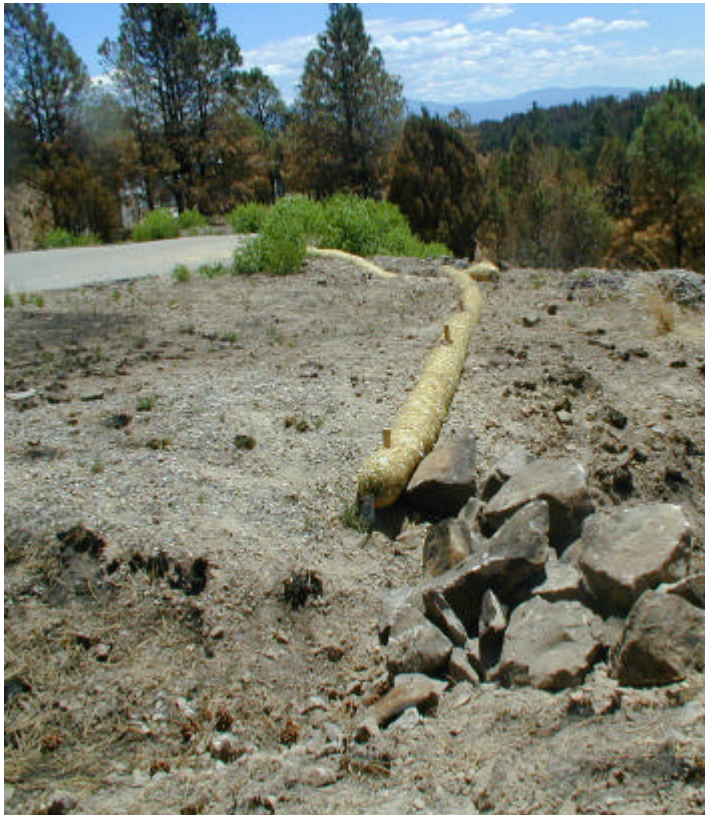
The site is located on the edge of Pajarito Canyon within the Starmer's/Pajarito Canyon Watershed Aggregate. The erosion potential on this slope increased due to lack of vegetative cover as a result of the fire.

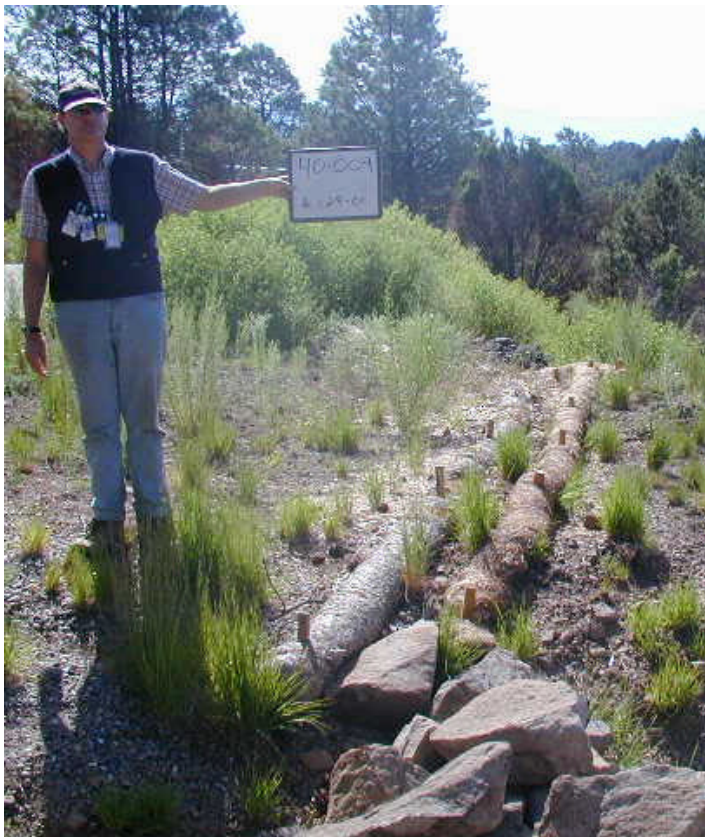
Straw wattles were installed along the mesa edge to divert run-on from the slope. Rock check dams (on-site materials used) were provided to dissipate flow within the drainage channels on both the east and west ends of the site.

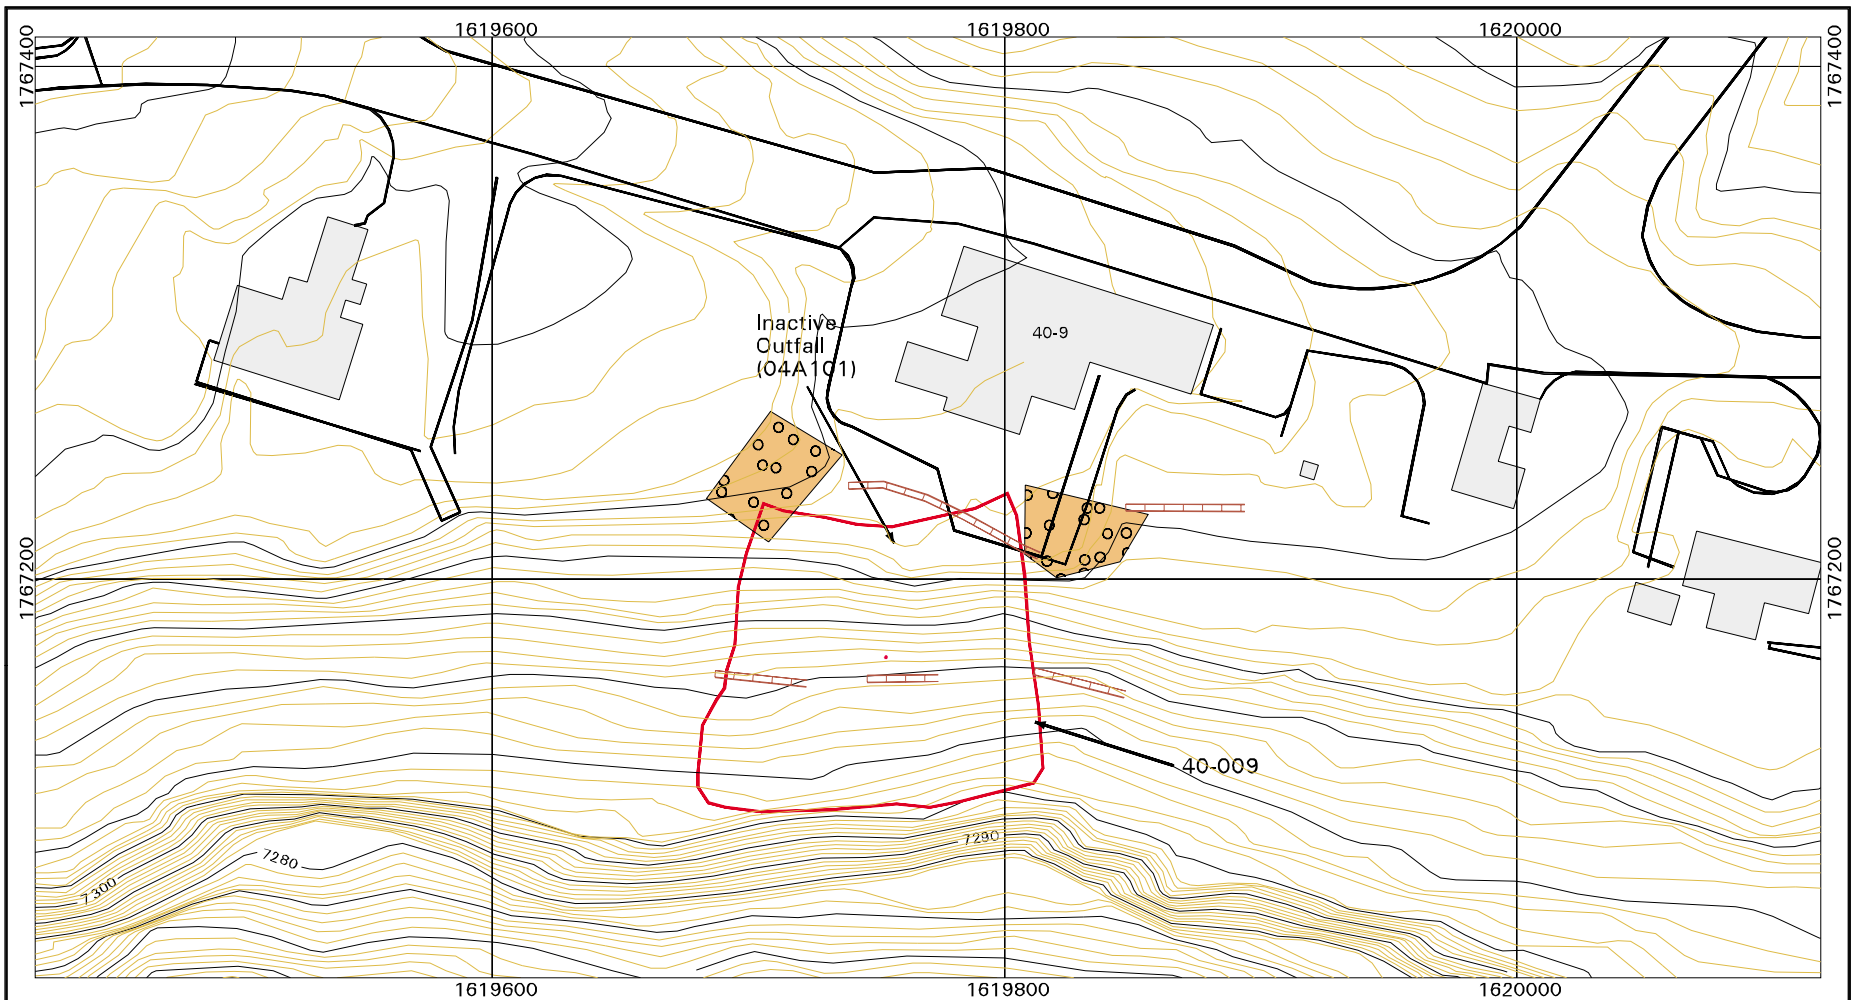
Best Management Practices at PRS 40-009

Revegetation efforts around the site have been mostly successful. The surrounding channel bank grasses have achieved a greater than 50% cover. The site appears stable and sediment migration at the site is minimal.

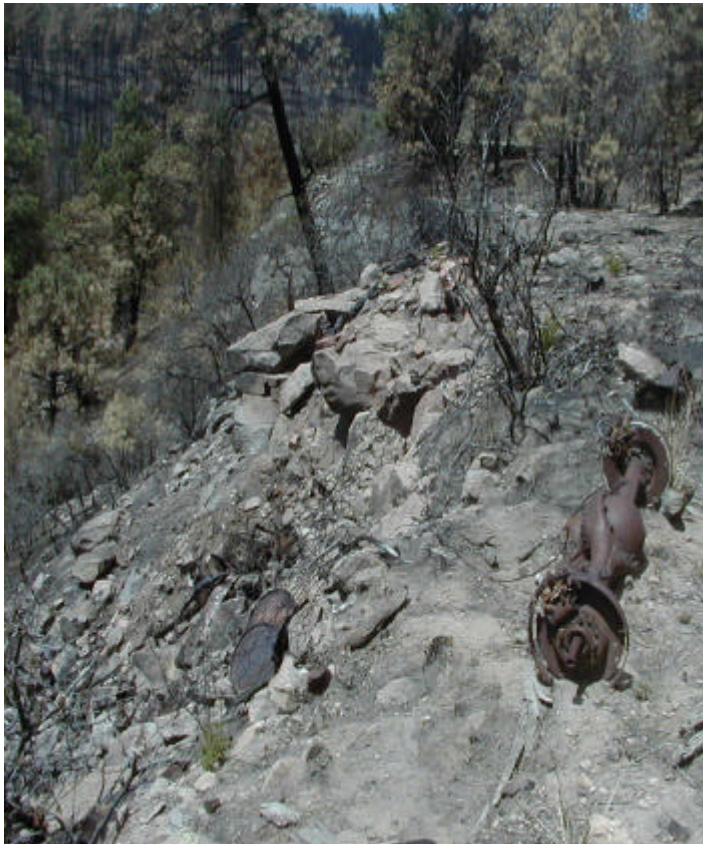
The site is located on the edge of Pajarito Canyon within the Starmer's/Pajarito Canyon Watershed Aggregate. Land disposal area 40-010 was exposed due to the fire, with debris consisting of industrial waste.

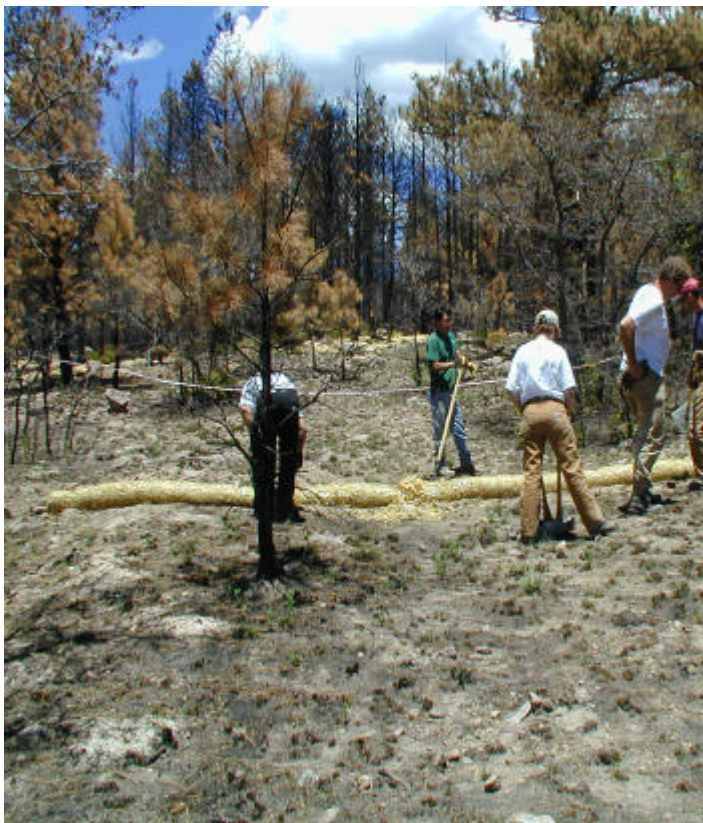
Revegetation efforts around the site have been successful. The surrounding channel bank grasses have achieved a greater than 50% cover. The site appears stable and sediment migration at the site is minimal. The debris near the mesa's edge was removed from the area and disposed of as solid waste.

Installation of two additional straw wattles for sediment retention.

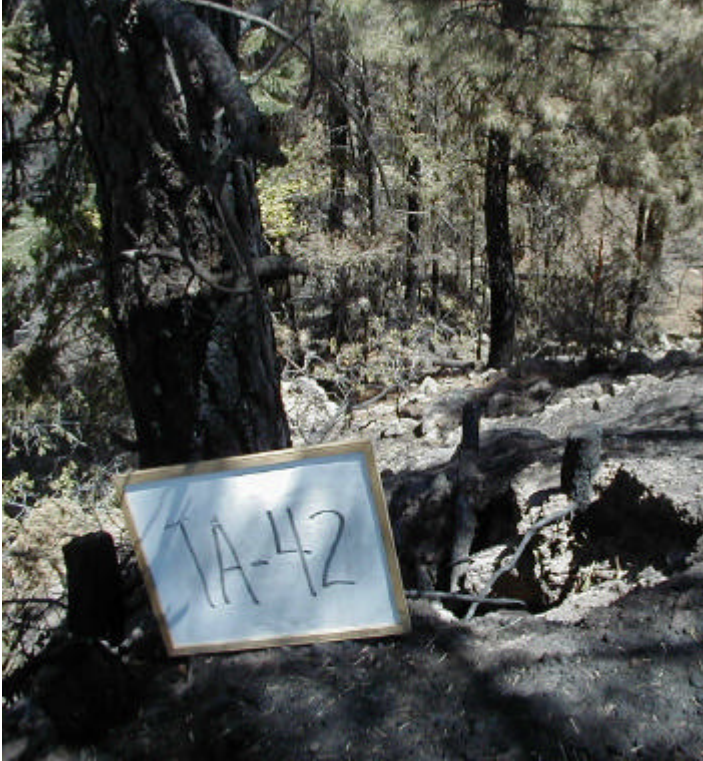
The site is located on a tributary drainage to Mortandad Canyon within the Upper Mortandad Canyon Watershed Aggregate. The entire north facing slope below former TA-42 was moderately burned. Two distinct drainage channels bisect the area behind the new building constructed near TA-55. The run-on to the western most drainage has been diverted away from the area of concern. The other drainage receives only direct rainfall, with minimal upslope sources.

Straw wattles were installed around the area to divert run-on and to impede sediment transport potential. The area was hand-raked, reseeded and straw mulched.

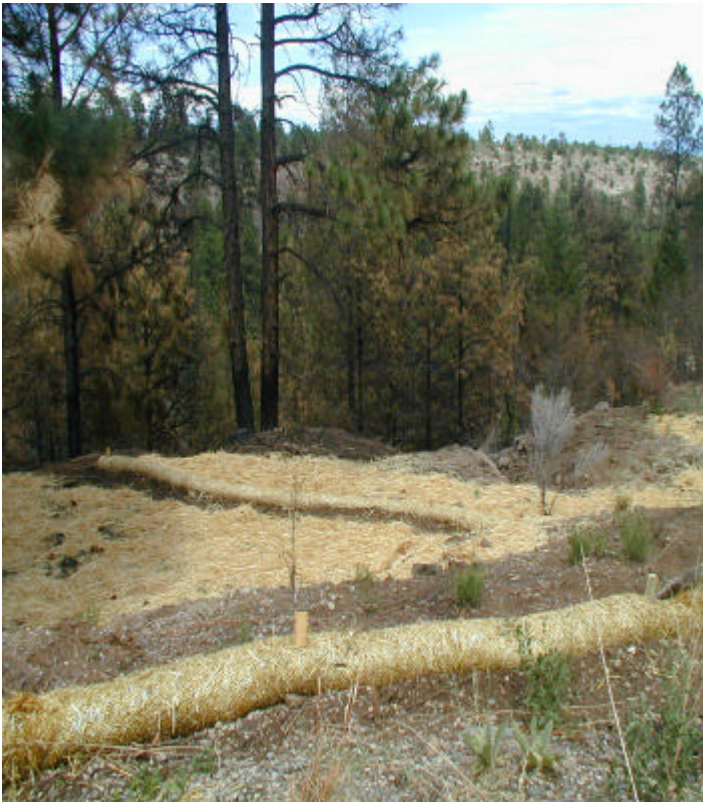
Revegetation efforts around the site have been mostly successful. The surrounding channel bank grasses have achieved a greater than 50% cover. The site appears stable and sediment migration at the site is minimal.

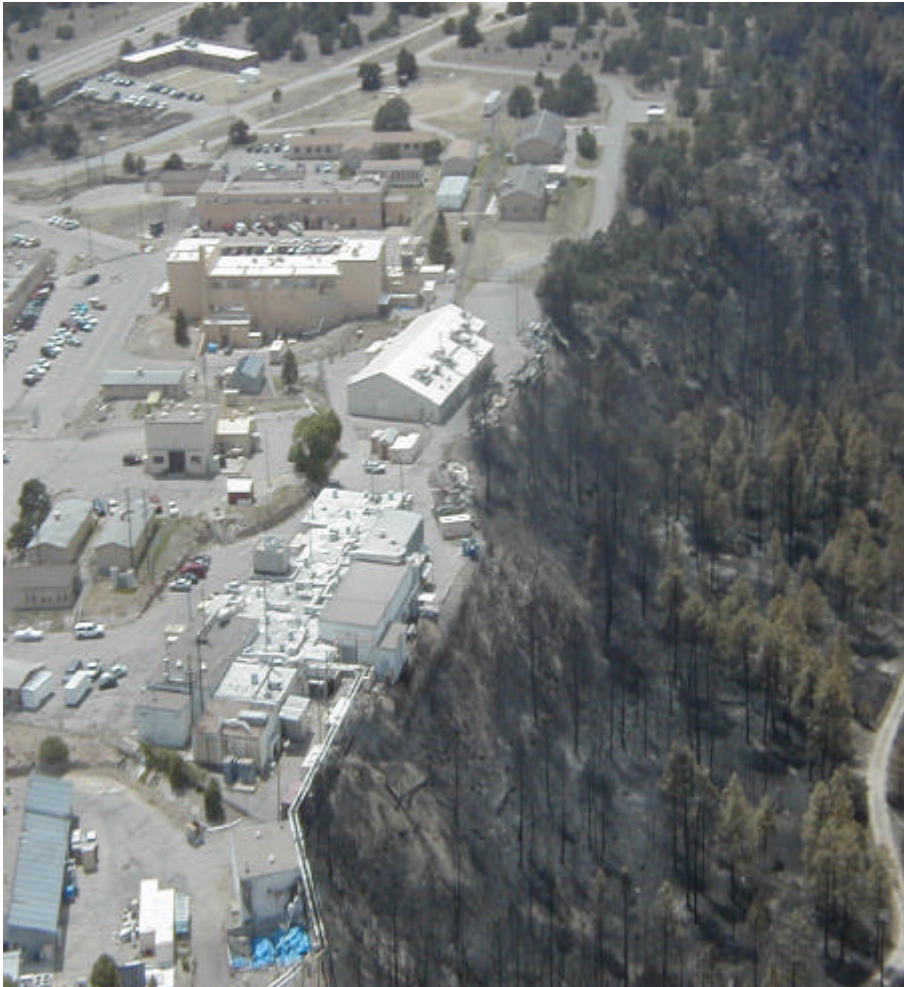
The area impacted is located on the northern edge of Mesita del Buey within the Middle Mortandad/Canada del Buey Watershed Aggregate. The entire north-facing slope below TA-46 was moderately to severely burned. Several buildings along the mesa edge were destroyed. The canopy and ground cover was mostly destroyed. The northern slope is extremely steep with several inactive outfalls, pipes and old infrastructure parts exposed.

This areal photograph was taken on May 25, 2000.

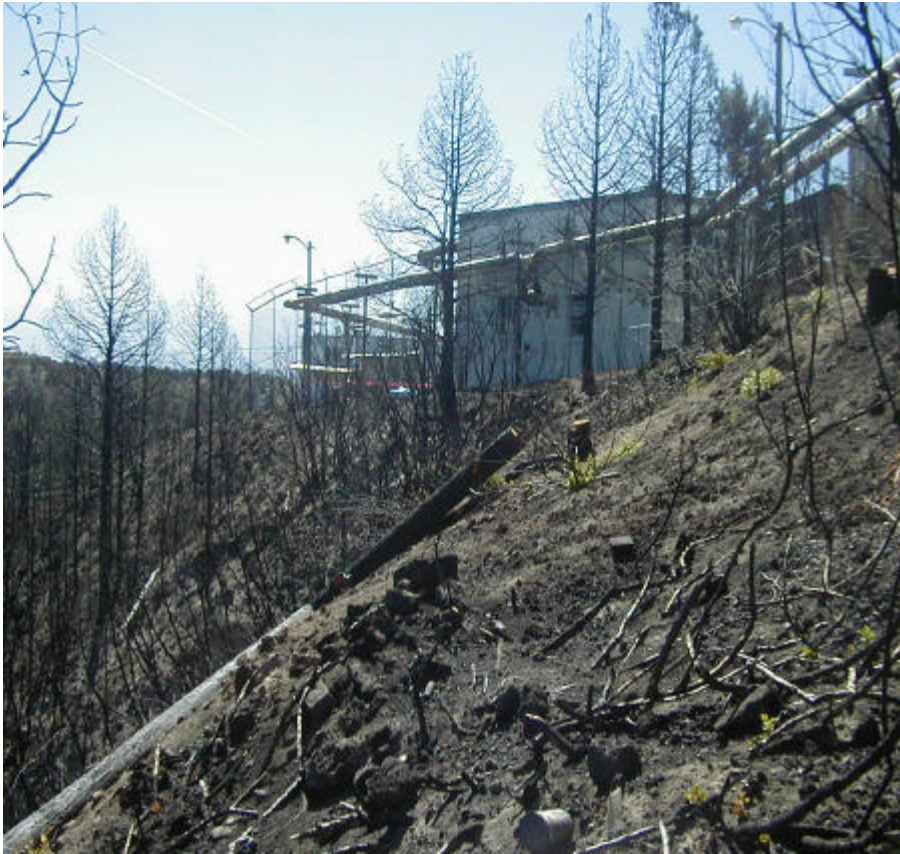
This photograph was taken on June 14, 2000. It shows the eastern most corner of the impacted north facing slope behind building 46-58. Several trees and power poles were cut down to protect the existing structures.

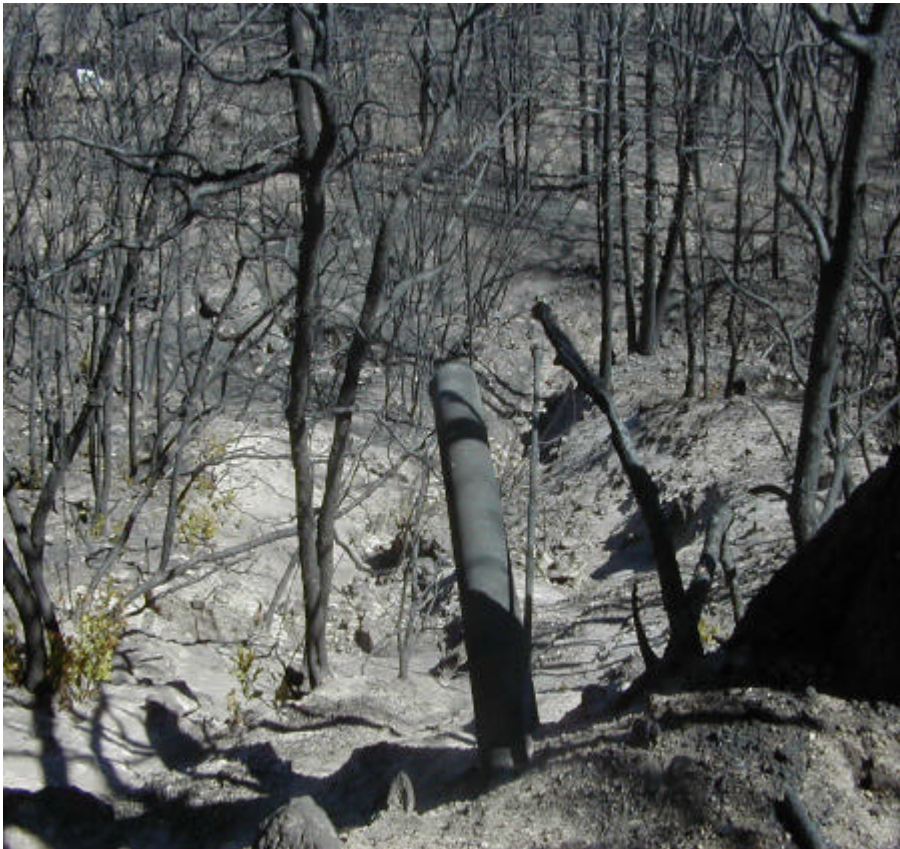
This photograph was taken on June 14, 2000. It shows one of the many inactive outfalls that discharged onto the slope below.

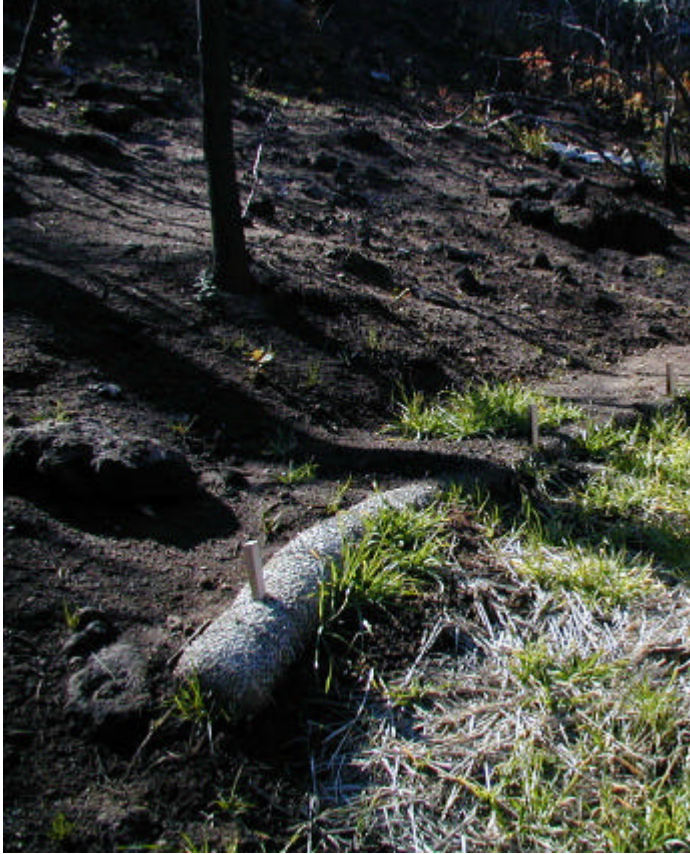
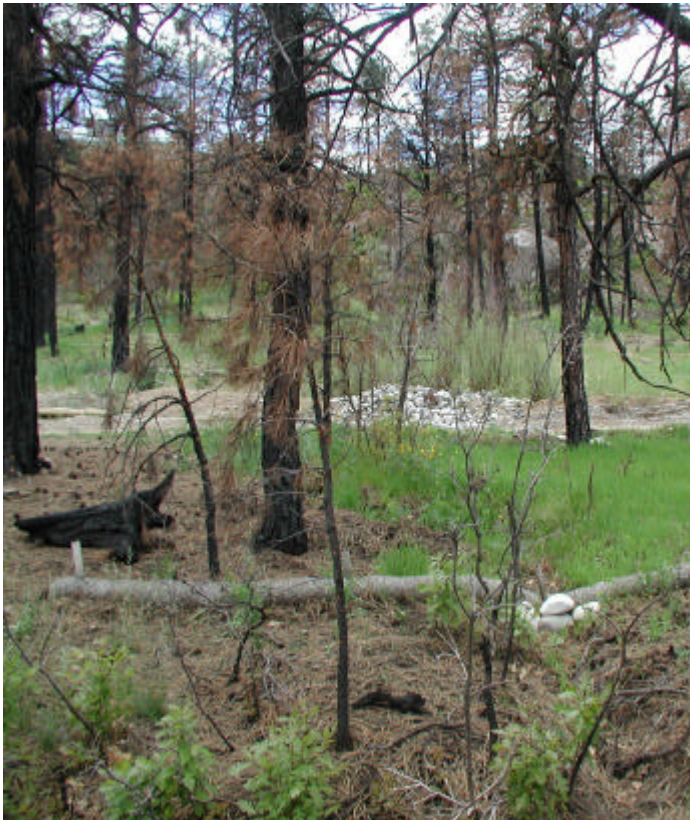
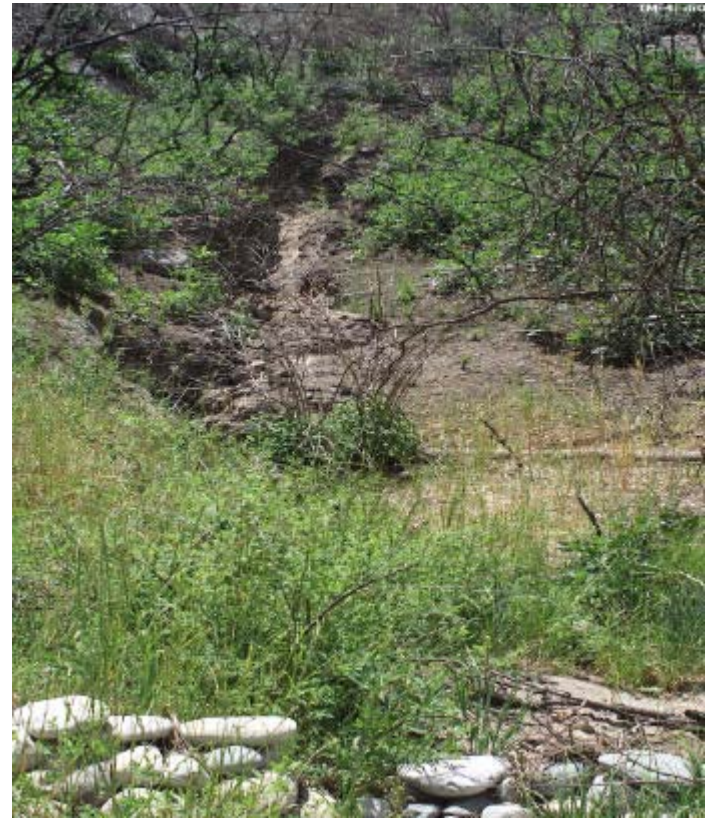
These photographs were taken during the April 2001 and June 2001 field inspections.

In April 2001, the earthen berm at the northern boundary of the site was patched in one location. Several additional straw wattles have been placed in various locations to reduce sediment migration potential.

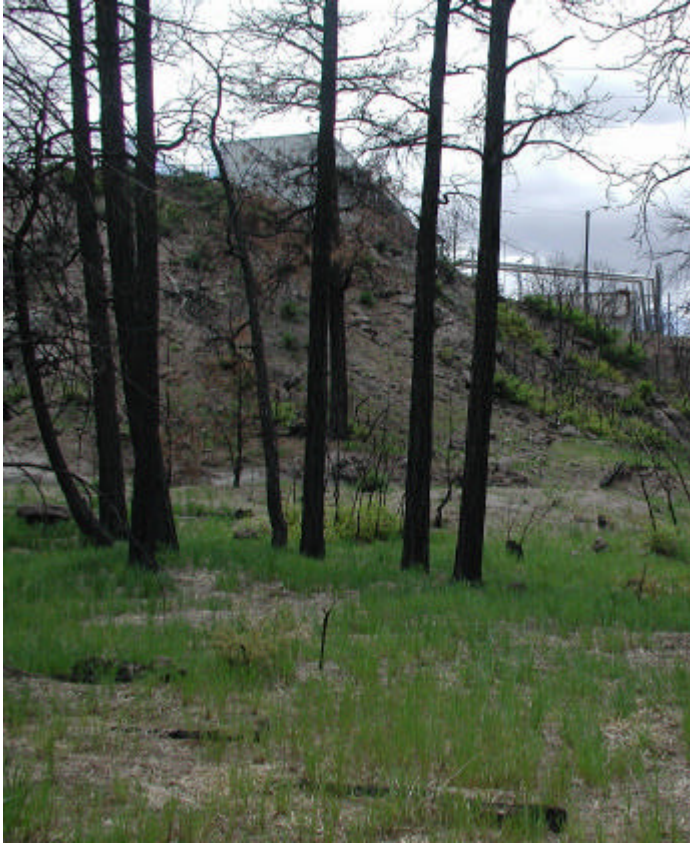
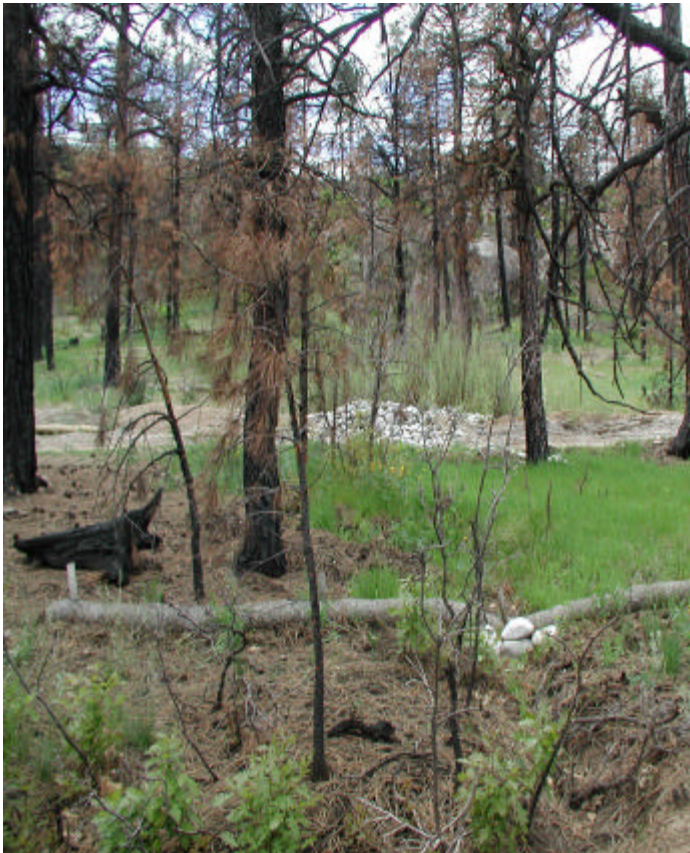
The vegetation on the north-facing slope and the bench area located below TA-46 that were impacted by the Cerro Grande Fire have recovered very well. The ground cover consisting of mixed native grasses is 6" to 18" deep, and the gamble oak trees have come back thicker than ever.

The multiple levels of erosion control including; rock check dams, straw wattles, contour tree felling and an earthen berm have been very effective in keeping sediment from migrating from the site.

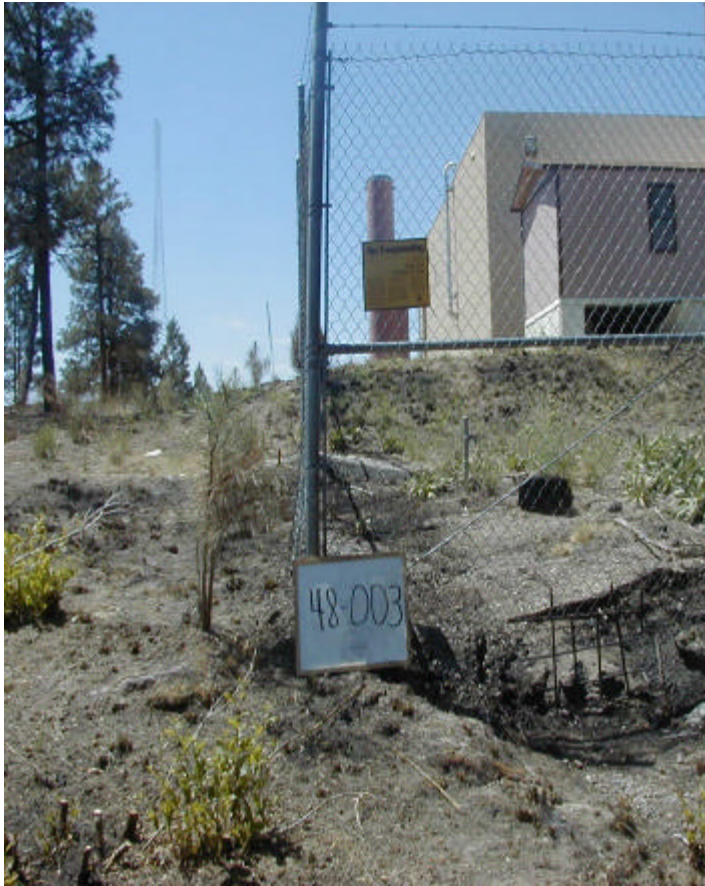
This site is located on the northern edge of Mortandad Canyon within the Upper Mortandad Watershed Aggregate. The northern part of TA-48 was moderately burned, with damage to ground cover and canopy.

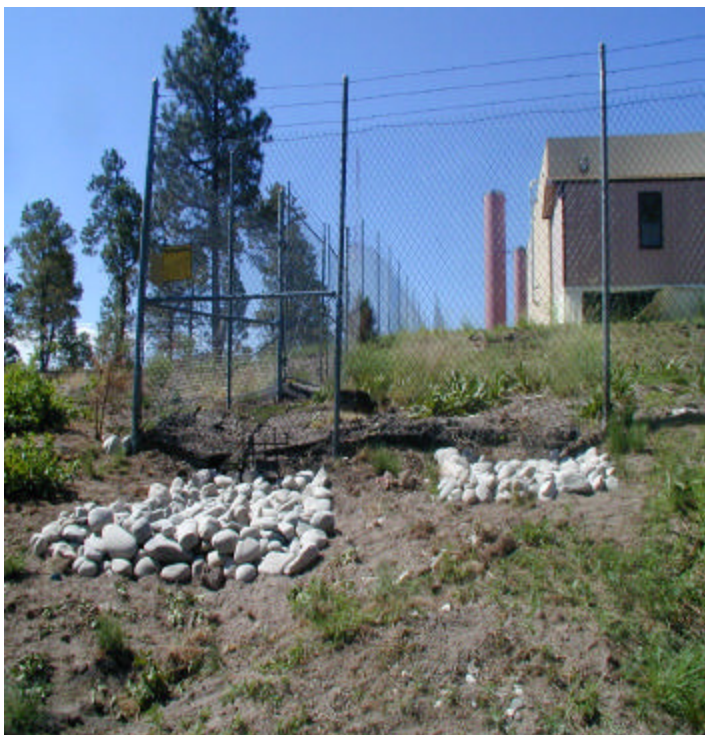
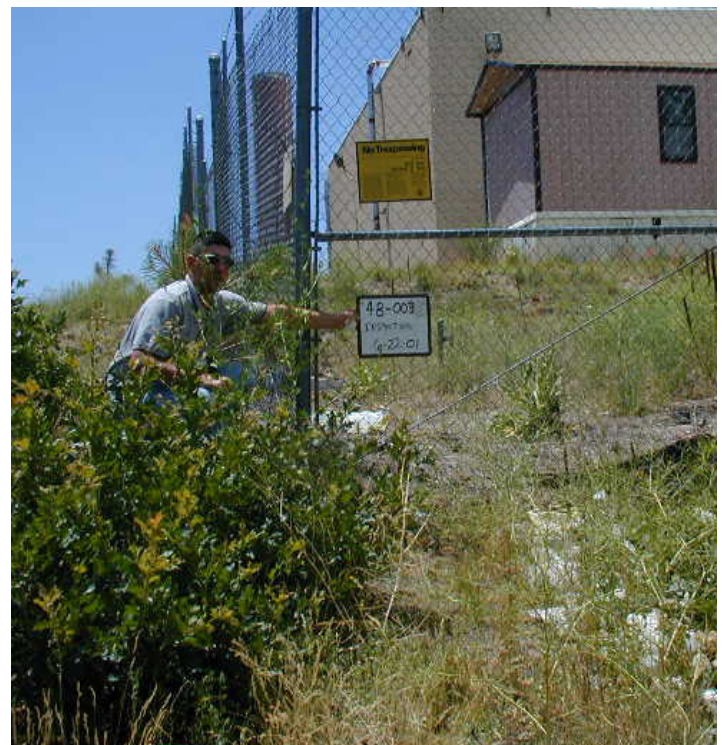
Site is in good condition, with vegetative cover of greater than 50%. The area appears stable with evidence of sediment migration being minimal.

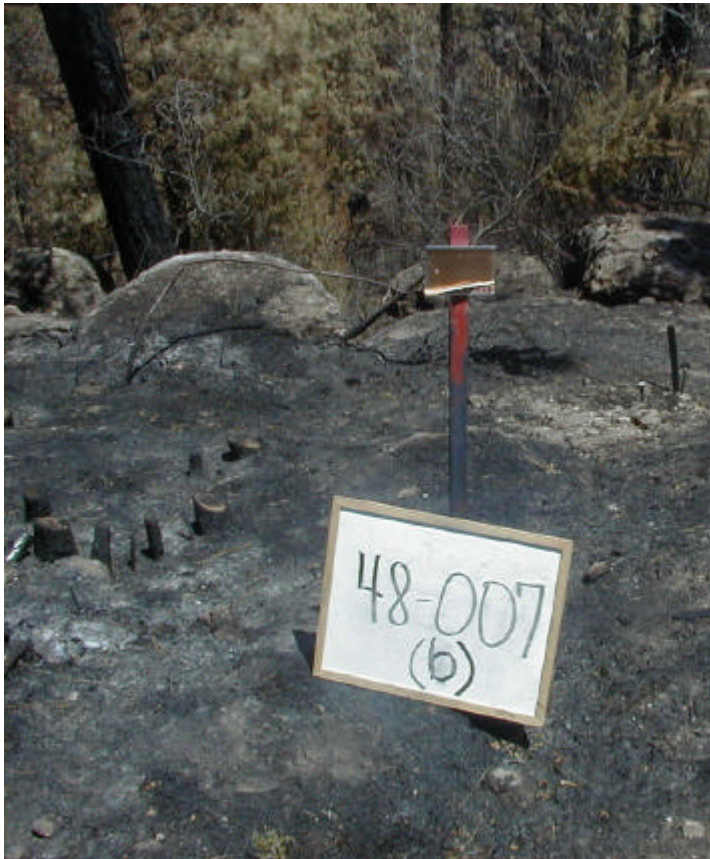
This site is located on the northern edge of Mortandad Canyon within the Upper Mortandad Watershed Aggregate. The northern part of TA-48 was moderately burned, with damage to ground cover and canopy.

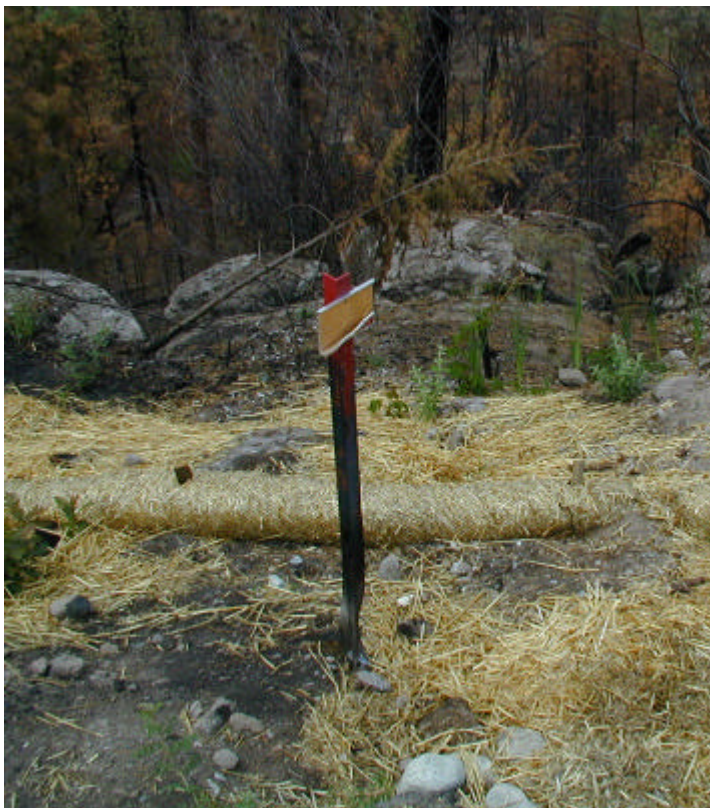
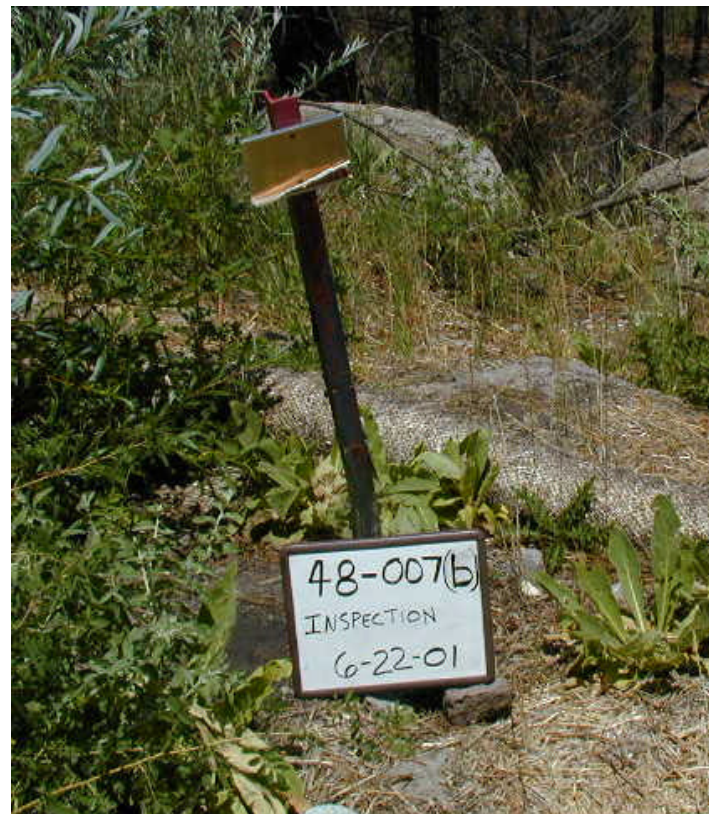
Site is in good condition, with vegetative cover of greater than 70%. The area appears stable with evidence of sediment migration being minimal.

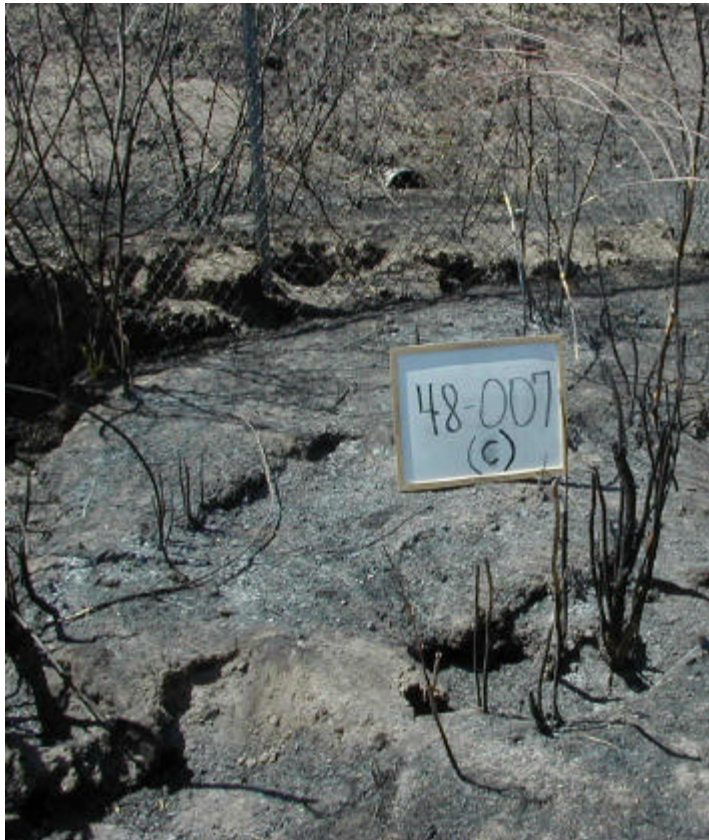
This site is located on the southern edge of Mortandad Canyon within the Upper Mortandad Watershed Aggregate. The northern part of TA-48 was moderately burned, with damage to ground cover and canopy.

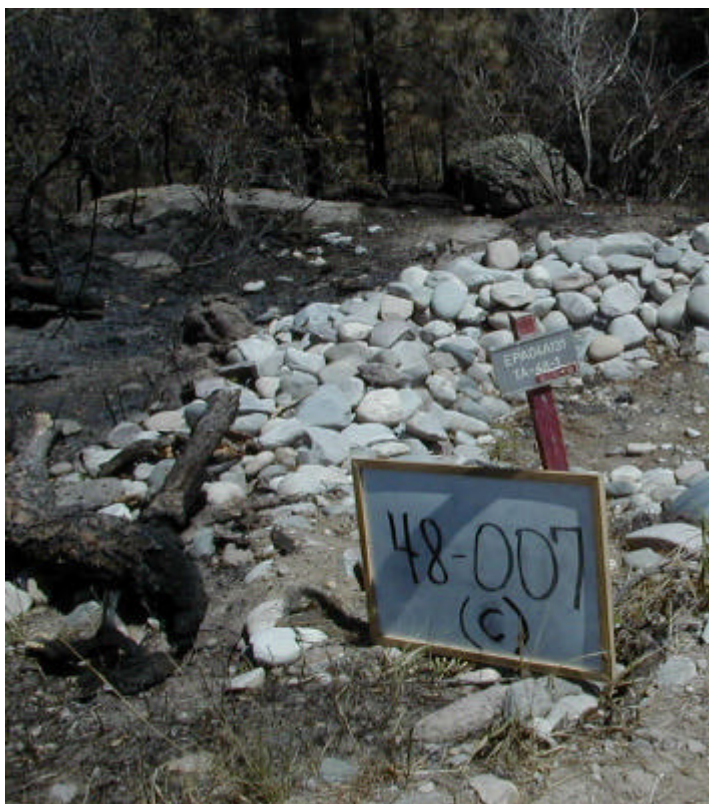
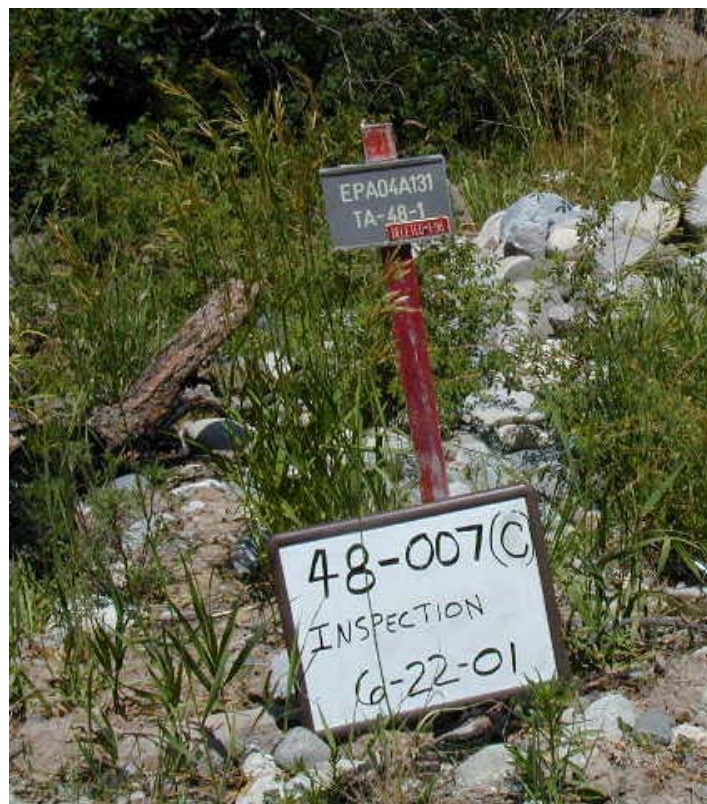
Site is in good condition, with vegetative cover of greater than 70%. The area appears stable with evidence of sediment migration being minimal.
