Title: CERRO GRANDE FIRE ONE YEAR AFTER:

AN UPDATE ON ER ACTIVITIES TO REDUCE
THE POTENTIAL MOVEMENT OF
CONTAMINATION AT POTENTIAL RELEASE
SITES

Authors: STEVEN J. VEENIS, CPESC

Submitted to: WATER QUALITY & HYDROLOGY GROUP (ESH-18)
ENVIRONMENTAL RESTORATION PROJECT

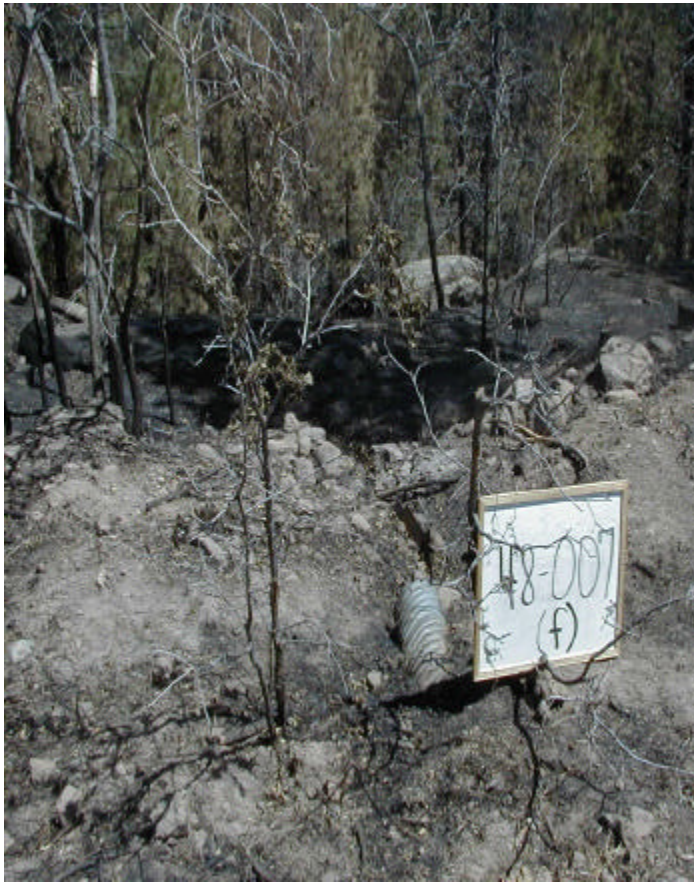
This site is located on the southern edge of Mortandad Canyon within the Upper Mortandad Watershed Aggregate. The northern part of TA-48 was moderately burned, with damage to ground cover and canopy.

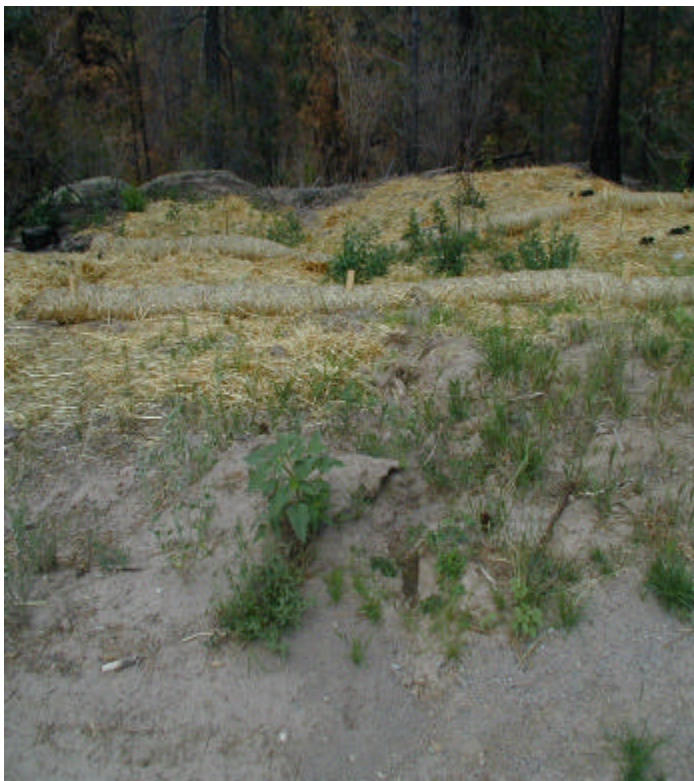
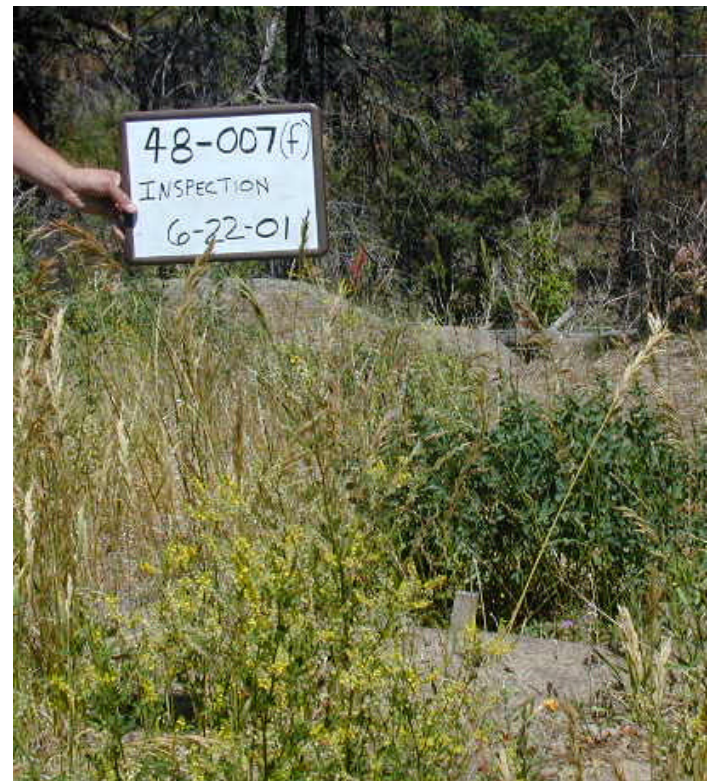
Site is in good condition, with vegetative cover of greater than 70%. The area appears stable with evidence of sediment migration being minimal.

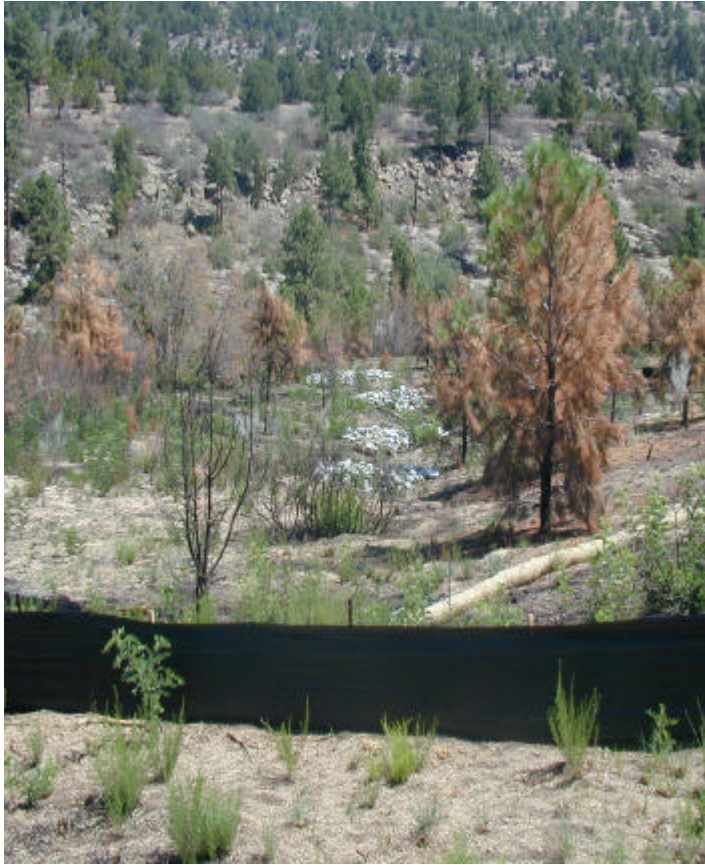
This site is located on a tributary to Water Canyon within the Lower Water/Indio Watershed Aggregate. The area was lightly to moderately burned from MDA AB towards the canyon edge. All existing BMPs were destroyed

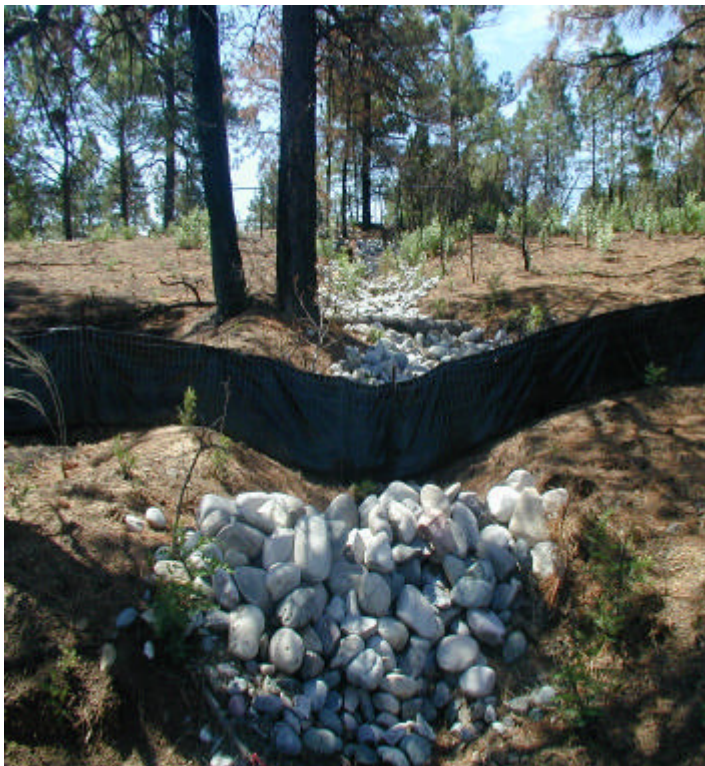
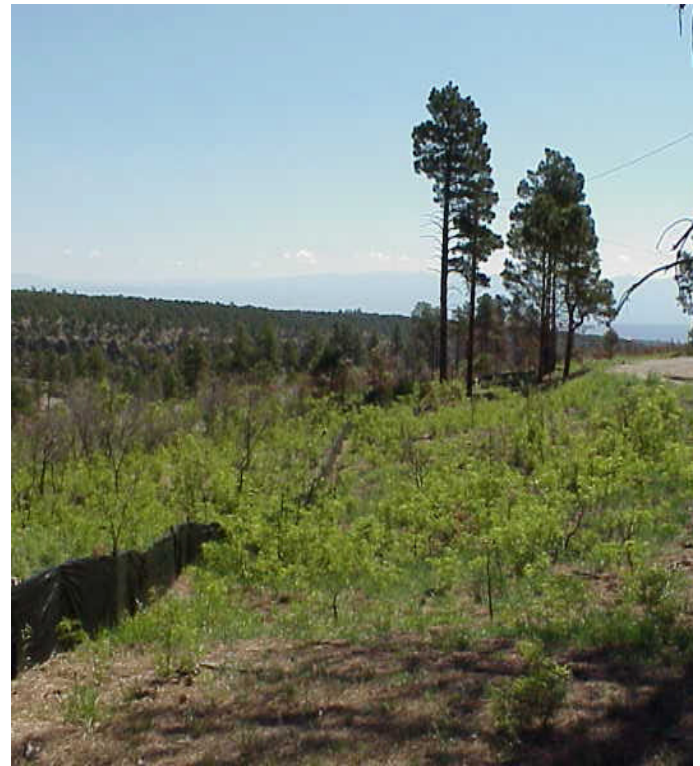
Site is in good condition, with vegetative cover of greater than 70%. The area appears stable with evidence of sediment migration being minimal.
