LTPP Pavement Maintenance Materials: SHRP Joint Reseal Experiment, Final Report

PUBLICATION NO. FHWA-RD-99-142

SEPTEMBER 1999

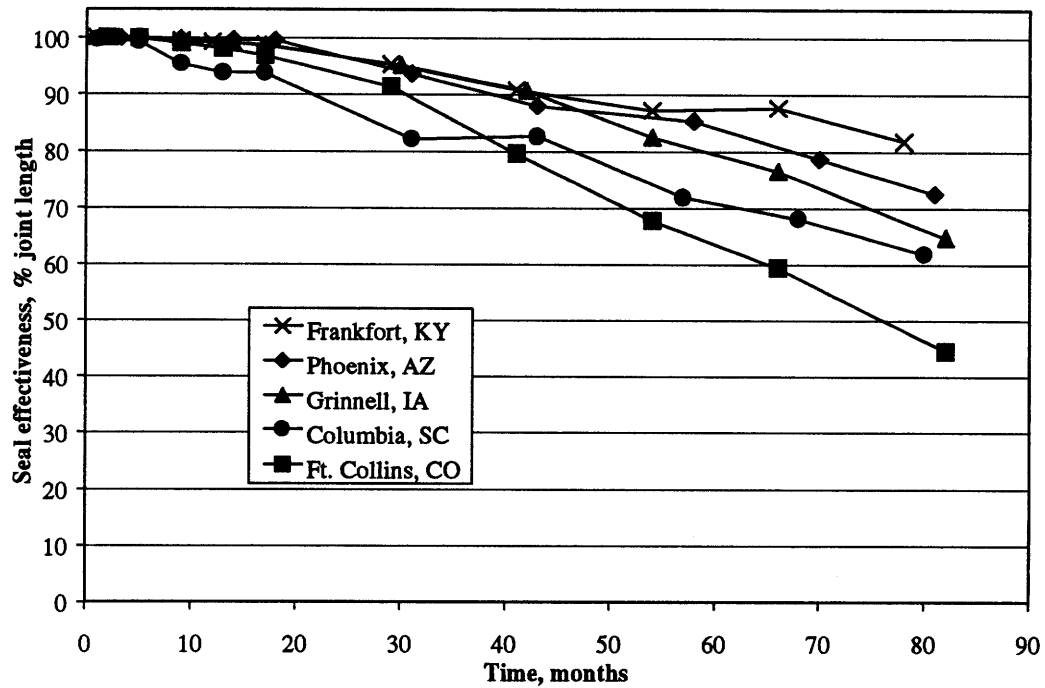
Figure 27. Overall performance of primary seals at each test site.

As seen in figure 27, a comparison by State of the overall performance of the primary seals indicates that the effectiveness has continued to decrease now that the seals have weathered six to seven winters and seven summers. Moreover, the seals at South Carolina and Colorado were not performing as well as those at other sites. A primary reason for the large amount of failure at the South Carolina site was the excessive adhesion failure in the configuration 3 joints. In these joints, unfailed silicone sealant was incompletely removed by the available plowing equipment. The silicone that remained on the joint walls inhibited bonding of the new hot-applied sealants and led to significant adhesion loss. The failure at the Colorado site was possibly due to the large amount of joint movement and the rapid temperature changes that occur as storm fronts cross the mountains into the plains. This test site is situated just east of the foothills of the Colorado Rocky Mountains. Another possible reason for the large Colorado site failure was the low quality of the available sandblasting equipment.

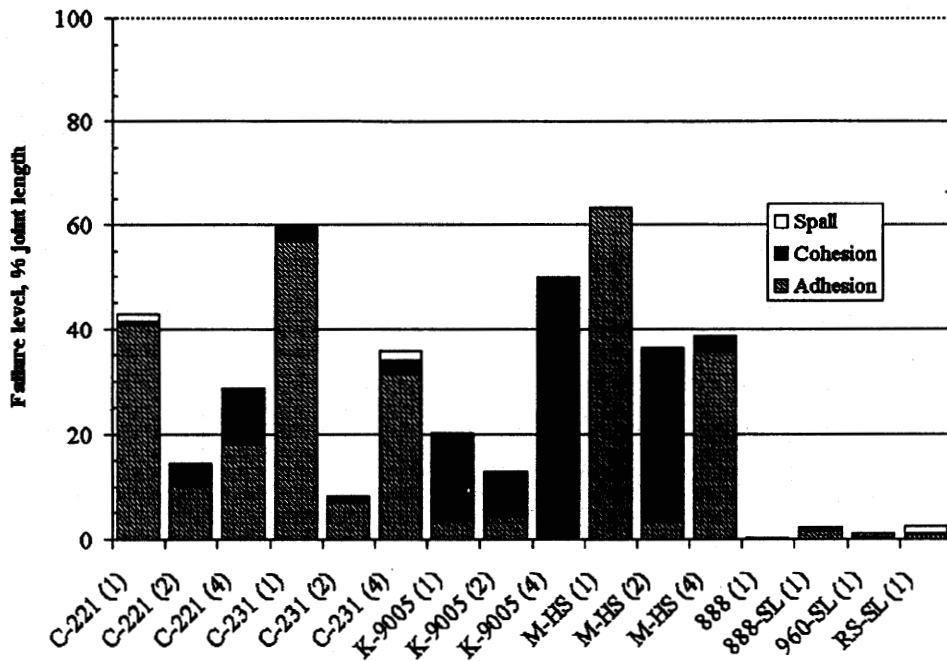
Figure 28. Overall failure at Arizona I-17 site after 81 months.

Unshaded rows in this table represent a summation for each treatment replicate—10 joints prepared with the same materials and preparation procedures. Shaded rows are an average of the percent joint length effectiveness for both replicates of a treatment. The remaining performance summary tables for each site and distress are included in appendix D. Summaries of the full-depth adhesion, cohesion, and spall failures after 82 months for each site, material, and installation method are shown in figures 28 through 32.

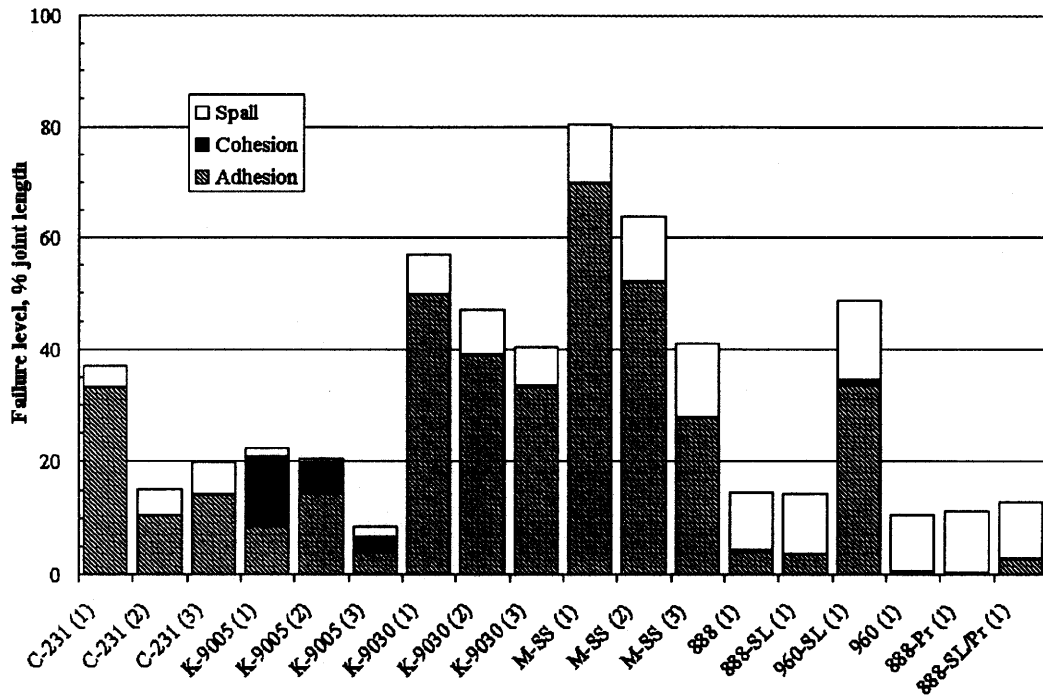
Figure 29. Overall failure at Colorado I-25 site after 81 months.

As shown previously in figures 29 and 30, full-depth spall failure was much more prevalent at the Colorado and Iowa sites. These sites are in cold climatic regions where joints experience large opening widths at the same time that sealant materials are colder and stiffer. Spalling at the Iowa site was generally greater than at the Colorado site, possibly because of differences in aggregate and mortar strength or a difference in the amount of moisture present.

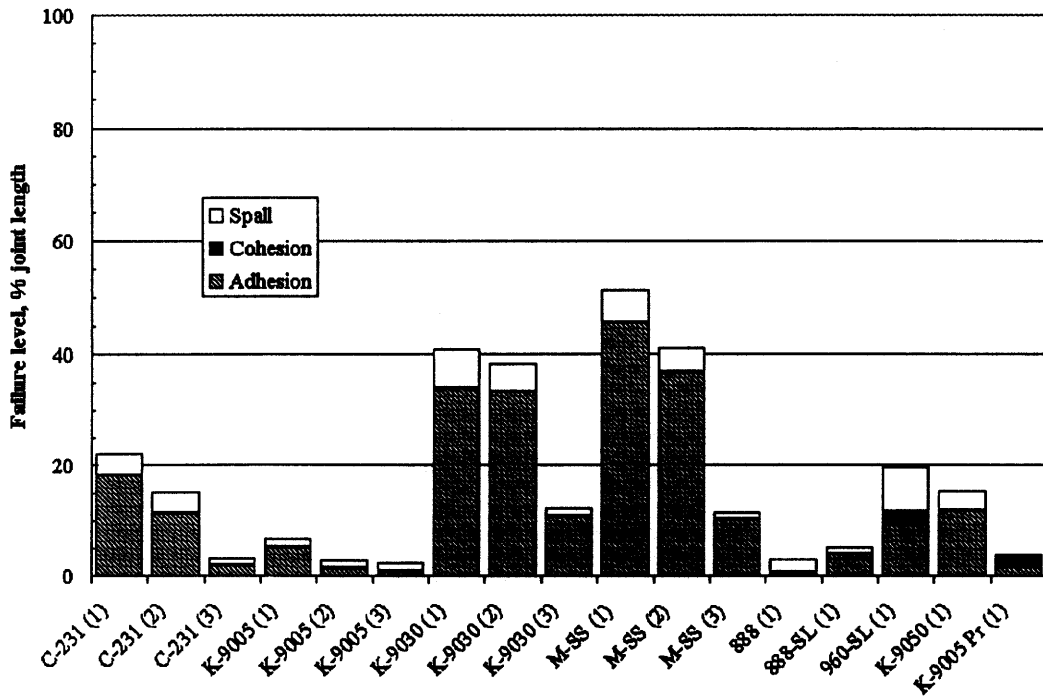
Figure 30. Overall failure at Iowa I-80 site after 82 months.

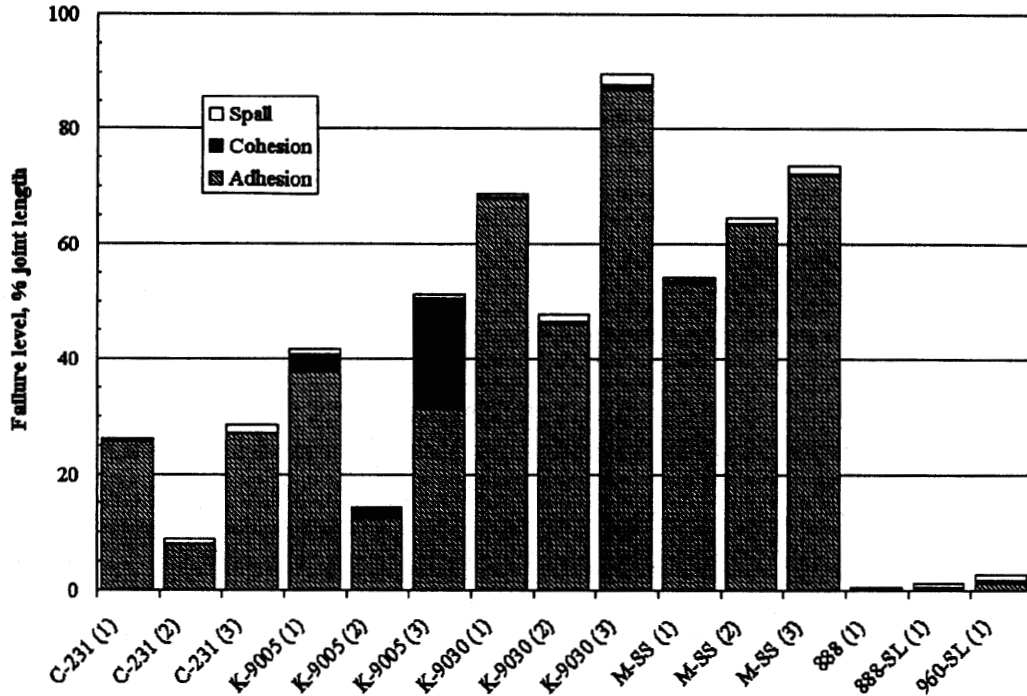
Figure 31. Overall failure at Kentucky U.S. 127 site after 78 months.

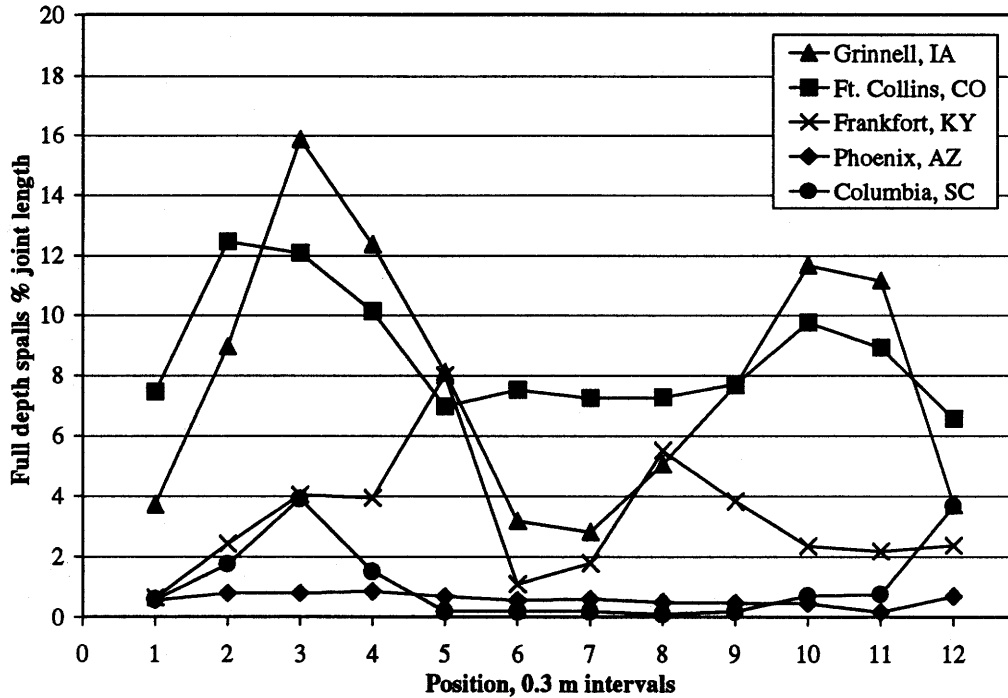
Figure 39. New full-depth spalls vs. distance from shoulder.

more partial- and full-depth spalls occurred at positions 2, 3, and 10. Sliver spalls were also prominent in the wheelpaths at the Kentucky site and were statistically greater in the wheelpaths at the Arizona site. Spalls at positions 3 and 12 in the wheelpath at the South Carolina site were a result of pavement damage from a dragging object and from normal pavement deterioration.

The effect of sliver spalls on joint seal performance at some sites is evident from figure 39. Water and debris entered the pavement system along more than 10 percent of the length at several positions through spalled joint edges. Research into the causes of this spalling (e.g., sawing methods) and methods to reduce its occurrence (e.g., beveled joint edges) appears warranted.

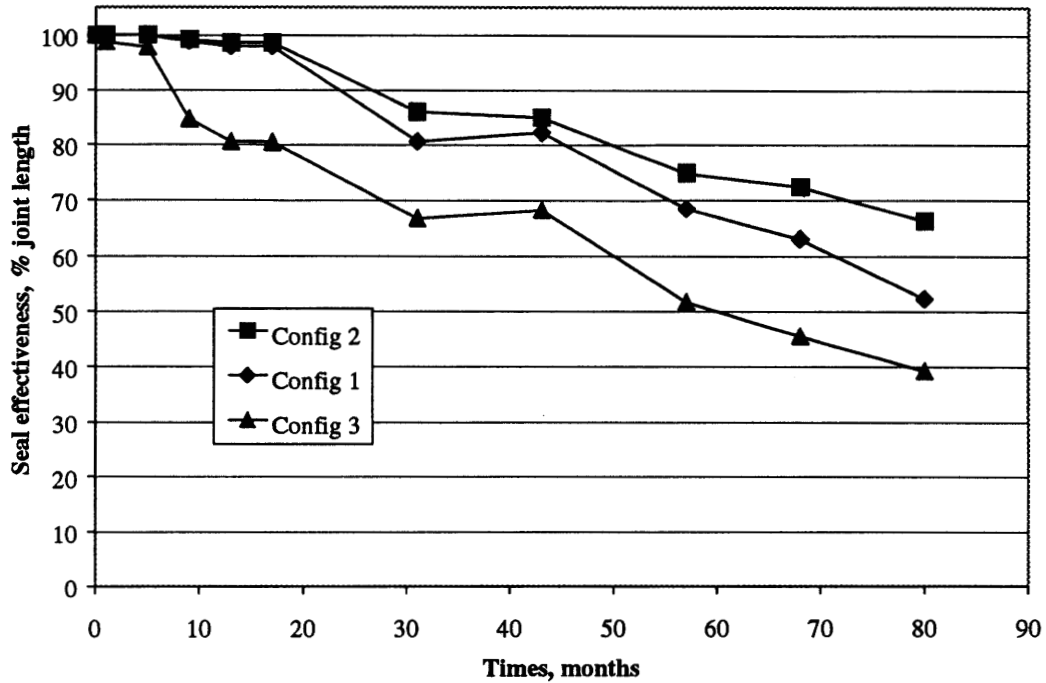
The South Carolina site developed much more failure in configuration 3 joints, as can be seen in figure 44. This failure was due to the silicone sealant that remained on the joint walls at the South Carolina site after the plowing operation. The plowing equipment used for installation was nearly ineffective at this site, resulting in less than 25 percent of the joint face being effectively cleaned. As a result, within a year of installation, seal effectiveness in the plowed joints at the South Carolina site was less than 85 percent. In the most recent evaluation, configuration 3 seal effectiveness was 39 percent. It can be concluded that when effective joint plowing is used, seal performance can be as good or better than when using standard installation practices. Since the plow equipment was not as effective as currently available state-of-the-art equipment and only airblast cleaning methods were used, improved performance can be expected using joint plows that are more than 95 percent effective in combination with sandblasting and airblasting.

Figure 44. Overall configuration effectiveness for South Carolina I-77 site.

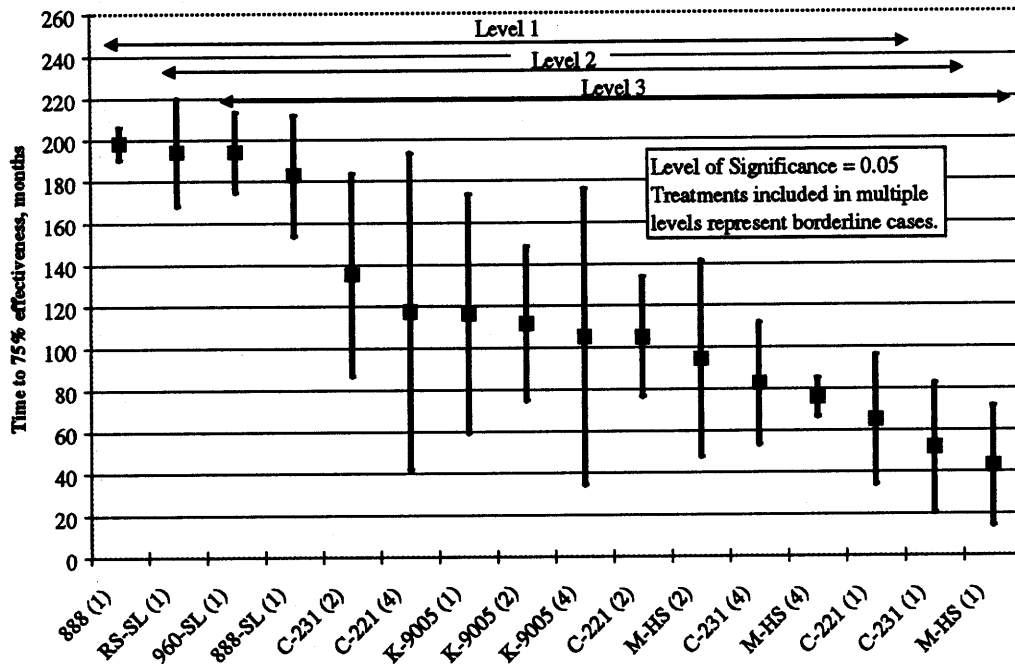
A large amount of variability in the Arizona sealant service life for each joint, shown in figure 45, allowed only one conclusion to be drawn. Dow 888 had a statistically longer service life than Meadows Hi-Spec at this site. Service lives at the Colorado site (figure 46) were greatest for silicone materials and least for low-modulus ASTM D 3405 sealants. The Crafcro RS 231 service life was on par with the Mobay 960-SL silicone, and Koch 9005 was slightly below these sealants.

Figure 45. Service-life ranking for overall effectiveness at Arizona I-17 site.

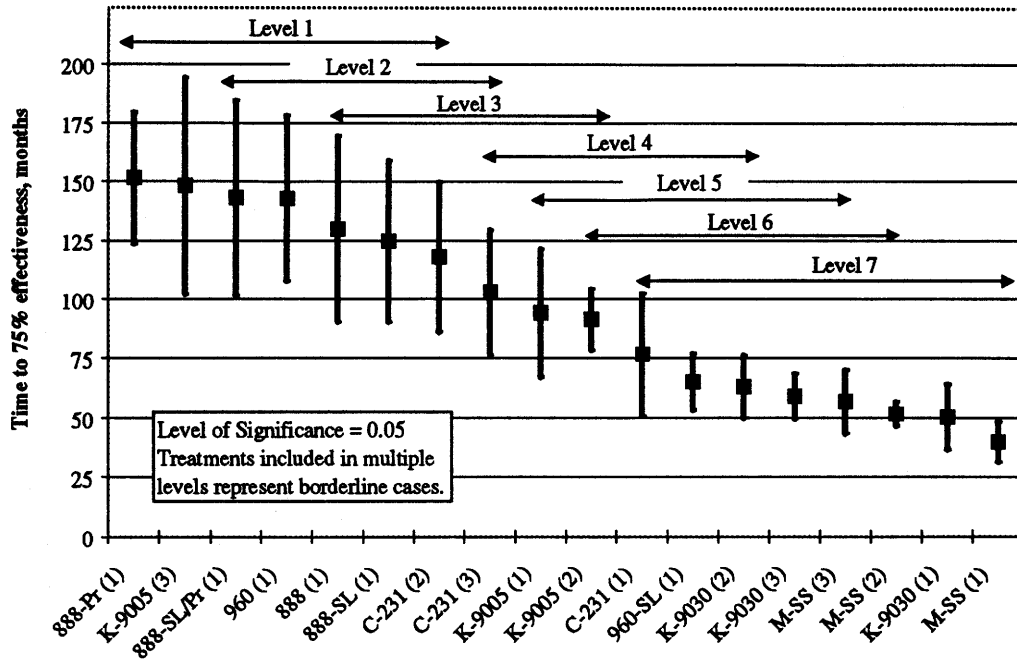
A similar pattern was experienced at the Iowa site (figure 47). Low-modulus ASTM D 3405 sealants Meadows Sof Seal and Koch 9030 had the shortest service lives, and most silicone sealants exhibited the longest lives. An exception to the silicones was the Mobay 960-SL silicone that had recently failed in adhesion from the bottom upward. Crafcro RS 231 (configuration 2) and Koch 9005 (configuration 3) exhibited the same service life characteristics as the good-quality silicone sealants, although none had reached the 75 percent effectiveness level.

Figure 47. Service-life ranking for overall effectiveness at Iowa I-80 site.
