# Section Four

## ALARA Activities at DOE

### 4.1 ALARA Activities at Fermi National Accelerator Laboratory (Fermilab)

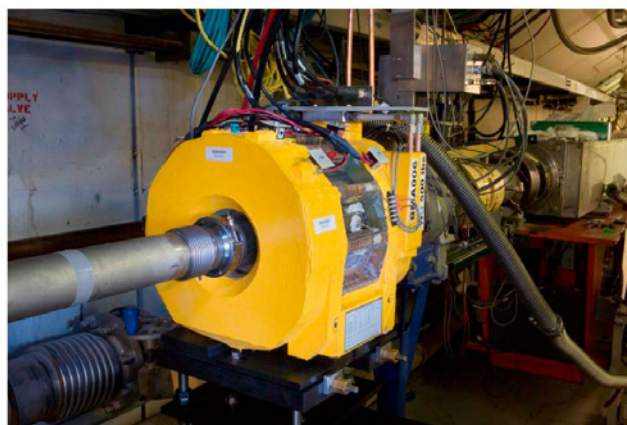
**Exhibit 4-2:**  
**Booster Corrector Prototype Installation**

The Booster is the first circular accelerator, or synchrotron, in the chain of accelerators at Fermilab. It consists of a series of magnets arranged around a 75-meter radius circle (see *Exhibit 4-2*). A prototype corrector magnet was installed in the Booster during the summer of 2007. A total of 15 people participated in this work. The estimated collective dose for this job was 310 person-mrem and the actual collective dose received was 163 person-mrem. Actual doses were lower than estimated for several reasons. First, the general area exposure rates were estimated to be 10 mR/hr. In actuality, general area exposure rates were less than half of the estimate. Second, the surveyors and electricians completed their work much faster than estimated in the ALARA plan. A third reason for actual doses being lower is that the shielding placed in the 8 GeV beamline was more effective than the ALARA plan had estimated. This task was very successful because basic radiation dose reduction principles of time and shielding were integrated into the work.

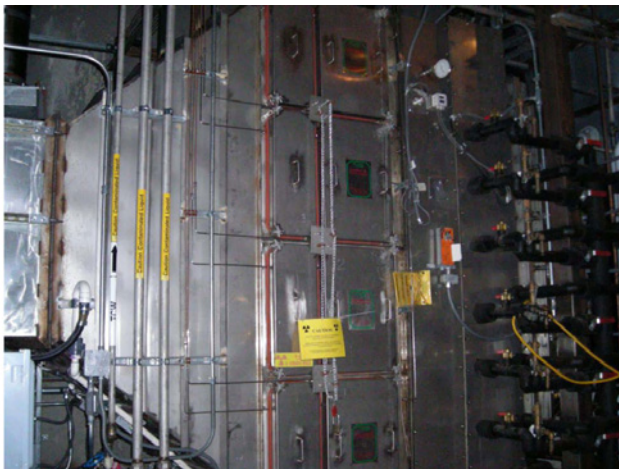
**Exhibit 4-3:**  
**NuMI Target Chase Ventilation Bank**

During the summer 2007 shutdown, work was performed to change out high-efficiency air bank filters in the NuMI target chase inside the NuMI target hall (see *Exhibit 4-3*). The air filter banks consisted of four levels of filters with each containing three pre-filters and three high-efficiency filters. The three pre-filters measured approximately 20 mR/hr at 1 foot. The other filters read about 2 mR/hr at 1 foot. The procedure used a bag-in bag-out procedure to prevent airborne contamination. Because the air filters were known to be highly contaminated, workers wore forced-air hoods, personal air monitors, and full anti-contamination clothing. The collective dose estimate for this work was 100 person-mrem and the actual collective dose received was 34 person-mrem. The reason the actual dose was much lower than estimated is that the workers were very efficient in their work despite the difficult conditions of the job. Also, the bag-in bag-out procedure for changing the filters proved to work well because no airborne radioactivity was created. Analysis of the worker's personal air monitors showed no detectable airborne activity.

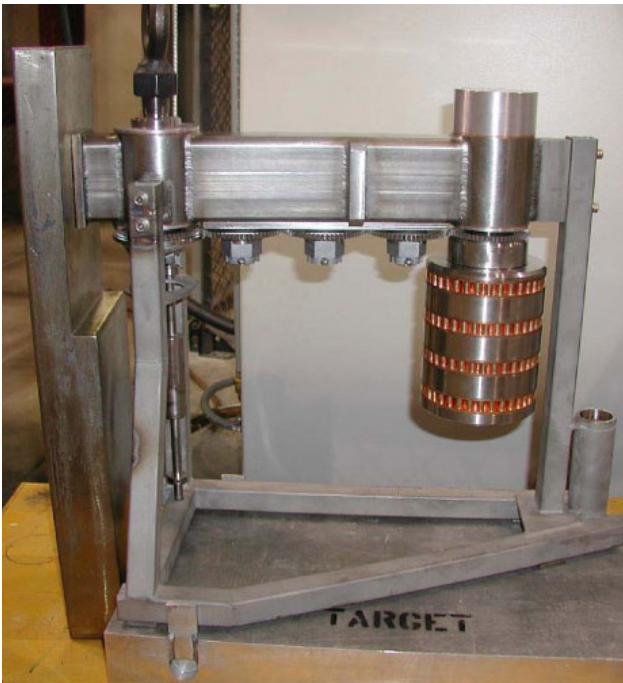
**Exhibit 4-5:**  
**New Nickel Antiproton Target**

Fermilab creates antiprotons by striking a nickel target with protons. It takes 100,000 to a million protons to make an antiproton. Over time, these nickel targets become damaged by the proton beam and must be replaced (see *Exhibit 4-4*). In May of 2007, work was performed to replace a target and also replace a drive shaft. Before the work began, the Accelerator Division ordered beam to be shut off from the area approximately 4 hours to allow for cool down. Plastic was placed on the floor and the alcove before the target module was moved. When the used target was removed and placed into the alcove, it measured approximately 300 R/hr at 1 foot from the upstream side of the target. It is interesting to note that several pieces of the target were observed on the antiproton target stand frame. When the target was placed into the coffin, it measured about 150 mR/hr at 1 foot. The coffin was wrapped in plastic to contain any highly activated material fragments. Once the work was completed, the plastic on the floor between the alcove and the lower vault was placed into a bag. The bag measured approximately 700 mR/hr on contact from highly activated particles. Next, the drive shaft on the target module was replaced (see *Exhibit 4-5*). Plastic was placed over the old shaft and the shaft was transferred to the storage vault. The drive shaft measured about 600 mR/hr at 1 foot. All areas were carefully surveyed to ensure that there were no highly activated material fragments present. During this work, pictures of the lithium lens and the pulsed magnet were also taken. Unexpected difficulties in obtaining photos of these items added 16 person-mrem to the overall collective dose. The collective dose estimate for the target and drive shaft replacement was 285 person-mrem and the actual collective dose was 290 person-mrem. This actual dose was well within the contingency estimate of 340 person-mrem. This job was carefully planned, well-executed, and workers diligently followed ALARA. The time estimated for this work was 12 hours, but it was completed in 10 hours.

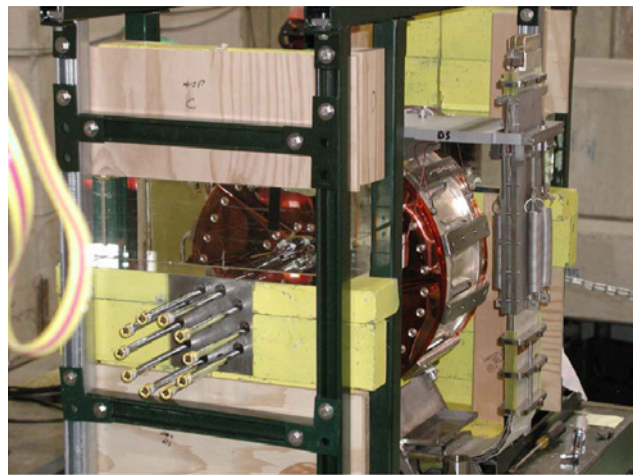
**Exhibit 4-6:**  
**Lithium Lens in New Transformer**

The purpose of a lithium lens is to focus newly created antiprotons into a beam. In September of 2007, a used lithium lens was placed into a new transformer (see *Exhibit 4-6*). This work required continuous Radiological Control Technician coverage and an extensive, detailed ALARA plan. The dose rate on contact with the lithium lens was approximately 10 R/hr (2.8 mR/sec). The dose rate at 1 foot upstream and downstream of the lens was approximately 2.8 R/hr (0.8 mR/sec). Due to the high exposure rates, ALARA plan time estimates were made in seconds rather than minutes. The work was completed in about 5 hours. During the work, circles were drawn on the floor to indicate the lowest exposure rates in each of the work areas. The workers were very careful to stand inside these circles to minimize their exposure. The collective dose estimate for this job was 114 person-mrem and the actual collective dose received was 65 person-mrem. The workers practiced installing the new transformer on a mock setup of the lens assembly prior to performing the work. The primary reasons the actual doses were almost half of the dose estimate were due to thorough prior job planning, successful use of a mock-up, and conscientious ALARA work practices.

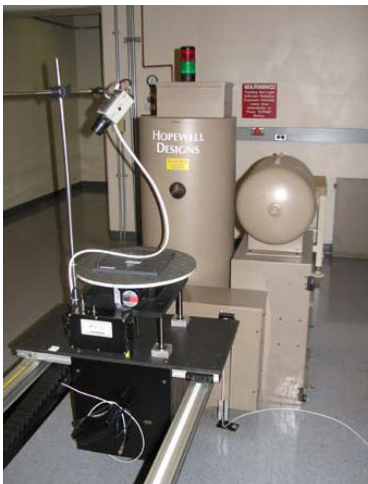
**Exhibit 4-9:**  
**GBI System**

The Gamma Beam Irradiator (GBI) (see *Exhibit 4-9*) is located in building 735-2B at the Health Physics Calibration Laboratory. It contains 3 cobalt-60 and 3 cesium-137 sources and 1 dummy source (non-radioactive). Each source is encapsulated in a rabbit, a small aluminum container, and stored in a carousel 10 feet below the floor. The center of the rabbit contains a source, 2 washers, and a spacer (see *Exhibit 4-10*). The rabbit lid is screwed down and held in place with a set screw. These sources are used to calibrate radiation monitoring instruments used at the Savannah River Site.

During routine operation, in June 2007, the vacuum failed to capture and hold one of the Co-60 sources (1 Ci) at the suction cup. Several attempts were made, but all attempts failed. The carousel was then rotated to another source position and an attempt was made to transport it to the top of the transport tube. Instead, the carousel jammed. A time-out was called and the HPS Technical Director was notified.

The HPS Technical Director decided to insert a boroscope into the source transfer tube to determine the cause of the obstruction. The boroscope revealed the rabbit's lid containing the 1 Ci Co-60 source had become unscrewed causing the obstruction (see *Exhibit 4-11*). The HPS Technical Director notified the vendor and scheduled an appointment to come out to resolve the jam.

All other sources in the GBI had a second, longer set screw added to ensure that their rabbit's lid would remain intact during operation of the GBI.

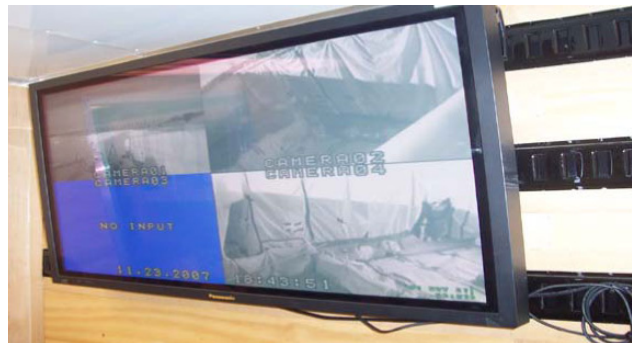
**Exhibit 4-15:**  
**Plasma screen with multiple camera**

- ◆ A ROVER was setup for the command post at the job site.
  - Plasma screens to support all camera feeds
  - Tele Trax system (tracking dose)
  - Communication center
  - Used headsets and hand held radios to communicate into the work area
  - Plasma screen with multiple camera angles (see Exhibit 4-15).

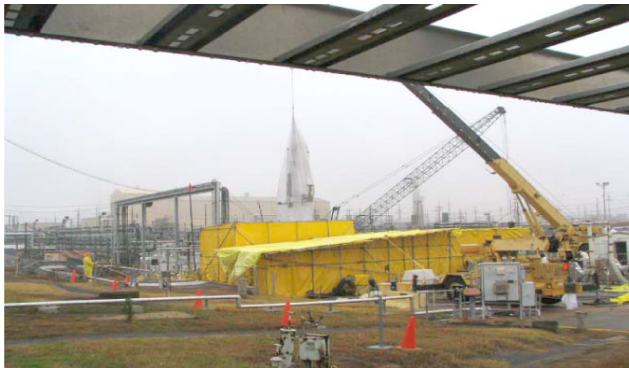
**Exhibit 4-16:**  
**Windbreak and two separate huts**

- ◆ A windbreak was installed around pump pit-1 and diversion box-2 (see *Exhibit 4-16*).
- ◆ Two (2) separate huts were installed.
  - A repair hut was connected to the windbreak (via false wall).
  - Storage hut (storing large jumpers prior to de-sizing) prior to cutting valve stems to fit in JB-2 box, pending the completion of the photomultiplier tube (PMT).

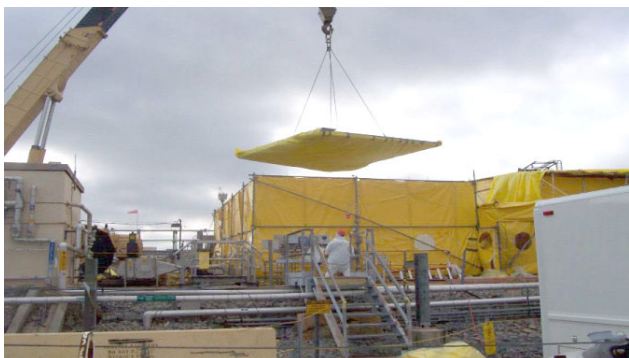
**Exhibit 4-17:**  
**Removable roofs to allow access.**

- ◆ Removable roofs were installed to allow access for installation and removal of the jumpers (see *Exhibit 4-17*).
- ◆ A wind speed limit of 8 mph was enforced throughout the evolution (during the open pit/cell and while the hut roofs were removed), to minimize the risk of spreading contamination.

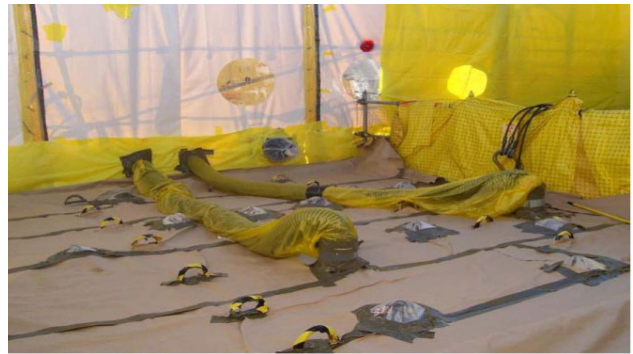
**Exhibit 4-18:**  
**Secondary portable HEPA exhausters.**

- ◆ The installed pump pit ventilation system was the primary ventilation with the secondary ventilation of 2 newly designed 2500 cmf portable HEPA exhausters (see *Exhibit 4-18*). (Note: The negative airflow into the pit was at a minimum at best).

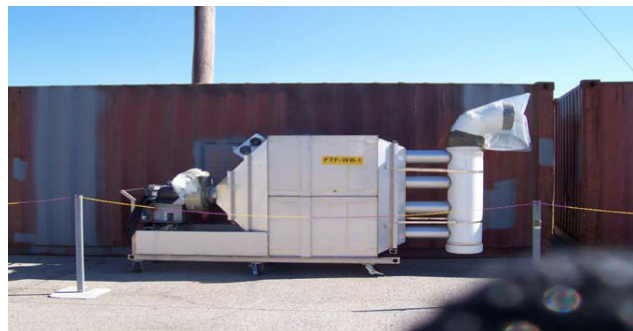
**Exhibit 4-19:**  
**Mock-up of adapter design.**

- ◆ Mock-ups were performed to design an adapter (see *Exhibit 4-19*), to be lowered into the cell area (approximately 3 ft.).

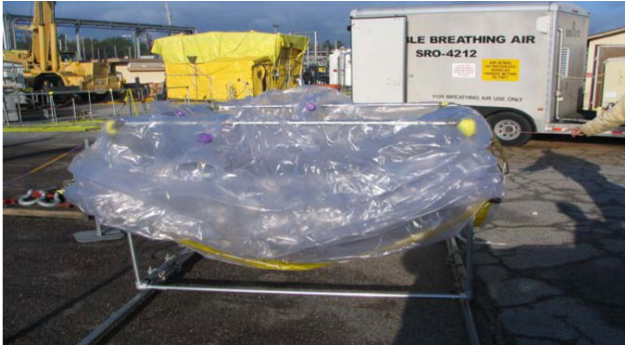
**Exhibit 4-20:**  
**Sleever containment for jumpers.**

A uniquely designed containment for sleeving the jumpers was a Sleever Device (see *Exhibit 4-20*).

- ◆ Mock-ups were performed with the sleever and improvements were made to the sleever during the mock-ups and throughout the job.
- ◆ The sleever was staged across the pump pit (including the heavy sleeving and choker).
- ◆ After the choker was connected to the jumper, the crane started lifting the jumper through the sleever. The sleeving deployed off the sleever with a hands-off approach.

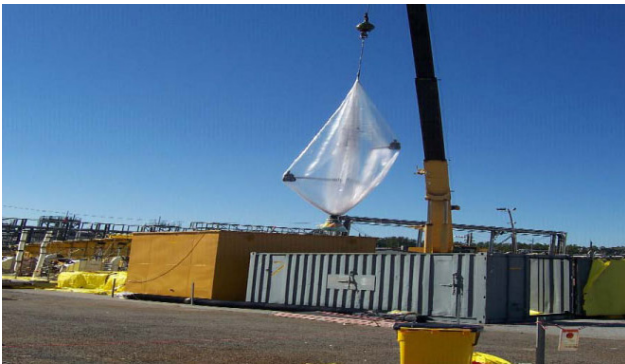
**Exhibit 4-21:**  
**Sleeved jumper lifted out of the pit.**

- ◆ The jumpers being replaced with newly fabricated ones were directly placed in their respective disposal container (e.g., Sealand, JB-2 Box, etc.).
- ◆ Sleviers provided a hands-off approach to sleeving the jumpers (over an open pit 15' x 15' x 25').
- ◆ The sleeving deployed off the sleever (positioned over the pit) as the jumper was lifted out of the pit (see *Exhibit 4-21*).

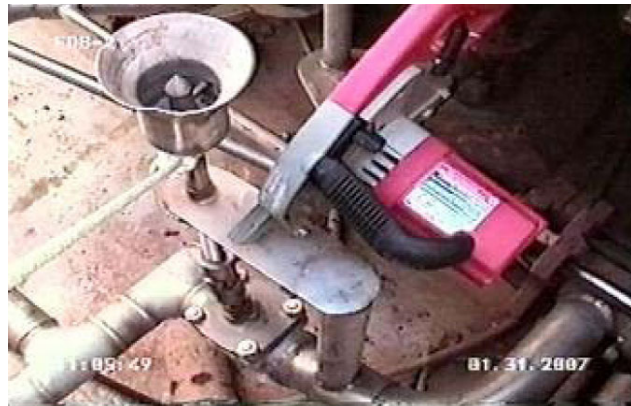
**Exhibit 4-22:**  
**Cutting Tool with Extension Handle**

- ◆ Due to the spent equipment being overlapped on the jumpers, contamination was released inside the walls of the windbreak and on the extra layers of plastic flooring. Work was temporarily suspended for decontamination activities. Contamination was not released outside of the windbreak.
- ◆ While the jumpers were being re-installed, one of the jumpers would not connect to the wall nozzle. A time out was declared and upon investigation, it was determined the jumper identification plate was interfering with the alignment. A plan was developed to remove the name and a section of the jumpers lifting bail.
- ◆ Mock-ups were performed to determine the cutting tool required to handle the weight on a 25' rod (see *Exhibit 4-22*).
- ◆ A minimum amount of dose was received.
- ◆ The mechanics were stationed behind the shield wall.

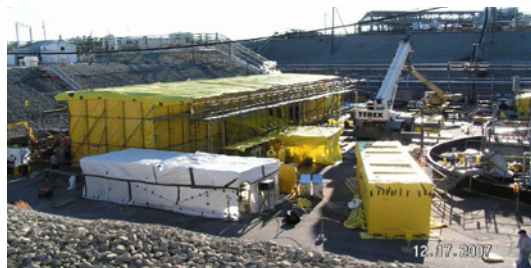
**Exhibit 4-23:**  
**HDB-2 and Tank 11 Overview**

HDB-2 re-jumping and Tank 11 transfer pump replacement field activities were completed without incident and with minimum personnel exposure (see *Exhibit 4-23*).

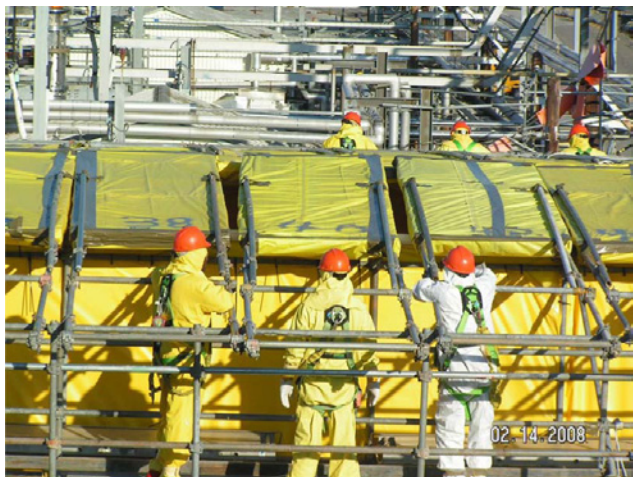
**Exhibit 4-24:**  
**Sliding roof panels**

- ◆ A modified containment hut with sliding roof panels was erected around the diversion box (see *Exhibit 4-24*). The sliding roof panels minimized the containment roof opening during jumper removal. A wind speed limit of 8 mph was maintained during the job.

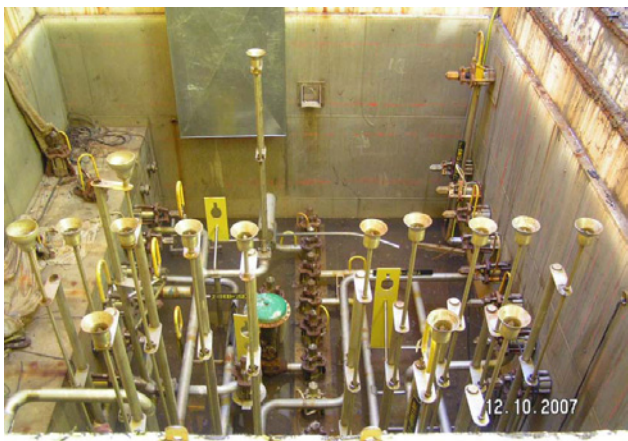
**Exhibit 4-25:**  
**Jumpers prior to removal**

- ◆ A coating of Sherwin Williams ProBlock Primer Sealer paint was applied to all jumpers prior to removal to further fix contamination (see *Exhibit 4-25*).
