**United States Department of the Interior
Bureau of Reclamation**

***Tyler Creek
Wasteway
Stabilization***

Environmental Assessment

Geology Appendix

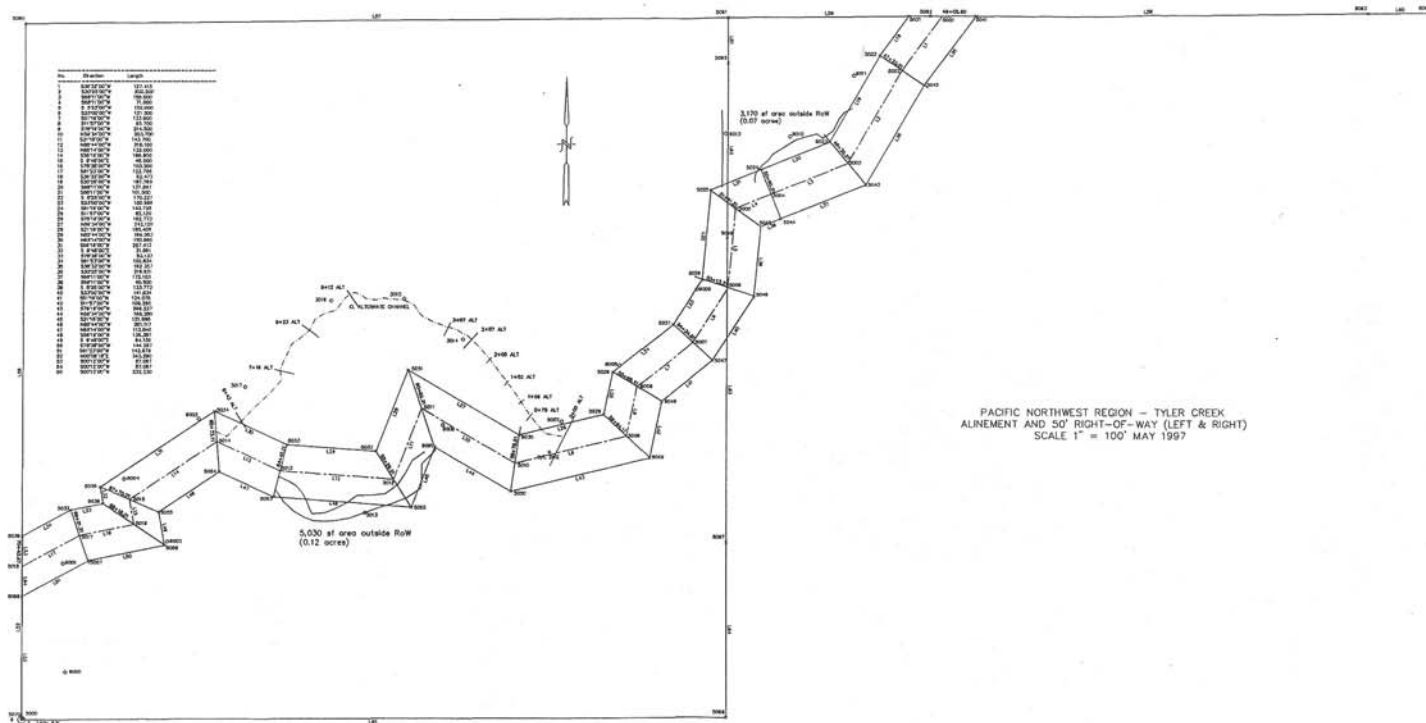
An estimated 75 percent of the alternate alignment has exposed bedrock in the channel section. Some lateral channel erosion has occurred locally as shown in Photograph No. 11. Also, alluvial bars, debris bars, and fallen trees are common.

Photograph No. 11. Tyler Creek Wasteway.
Control Point 3015, alternate channel, looking
upstream to the east. Channel bottom is mantled
with heavy rock, but stream is migrating laterally
into soft, fine-grained, altered/weathered volcanics.
USBR Photograph by B.H. Carter, 6/26/97.
