**SCENIC DRIVE LANDSLIDE OF JANUARY-MARCH 1998, LA HONDA, SAN MATEO COUNTY, CALIFORNIA**  
BY  
Angela S. Jayko, Michael J. Rymer, Carol S. Prentice, Ray C. Wilson, and Ray E. Wells  
1998

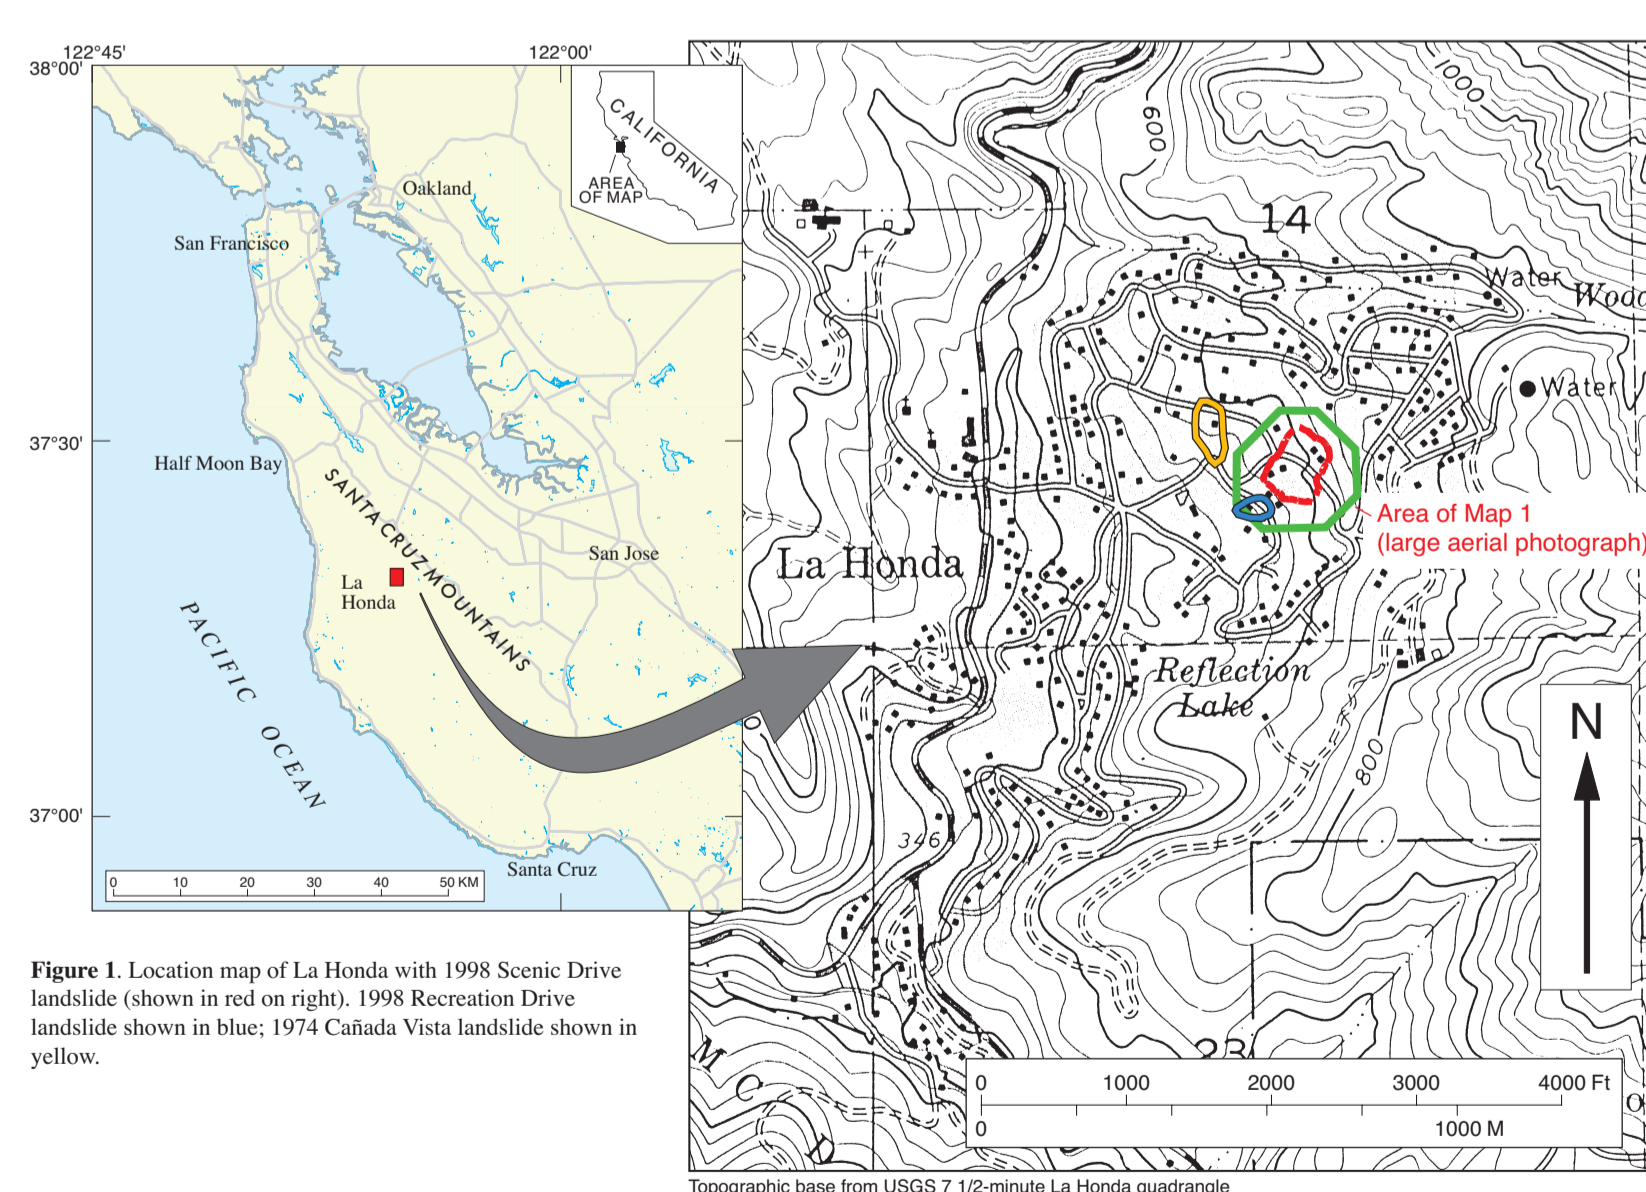
Map 1. Plan of Scenic Drive landslide boundaries and internal features. Features base not rectified. Features shown suggest on 21 March 1998.

Minor other small-scale, mainly tensional fractures are present within the slide zone. The larger of these are portrayed on Map 1. Deformation also occurred down-slope from the toe, as expressed by tension fractures, with distinct blocks, over steep slopes, and measurement of a suspended slope on a tree trunk suggesting enlargement of the slide in the down-slope direction. Cracking of the ground surface is widespread above the head scarp, but major new scarp have not developed as of 21 March 1998.
