**Collision of Union Pacific Railroad Train  
MHOTU-23 With BNSF Railway Company  
Train MEAP-TUL-126-D With Subsequent  
Derailment and Hazardous Materials Release  
Macdona, Texas  
June 28, 2004**

**NTSB/RAR-06/03**

**NTSB/RAR-06/03  
PB2006-916303  
Notation 7675D  
Adopted July 6, 2006**

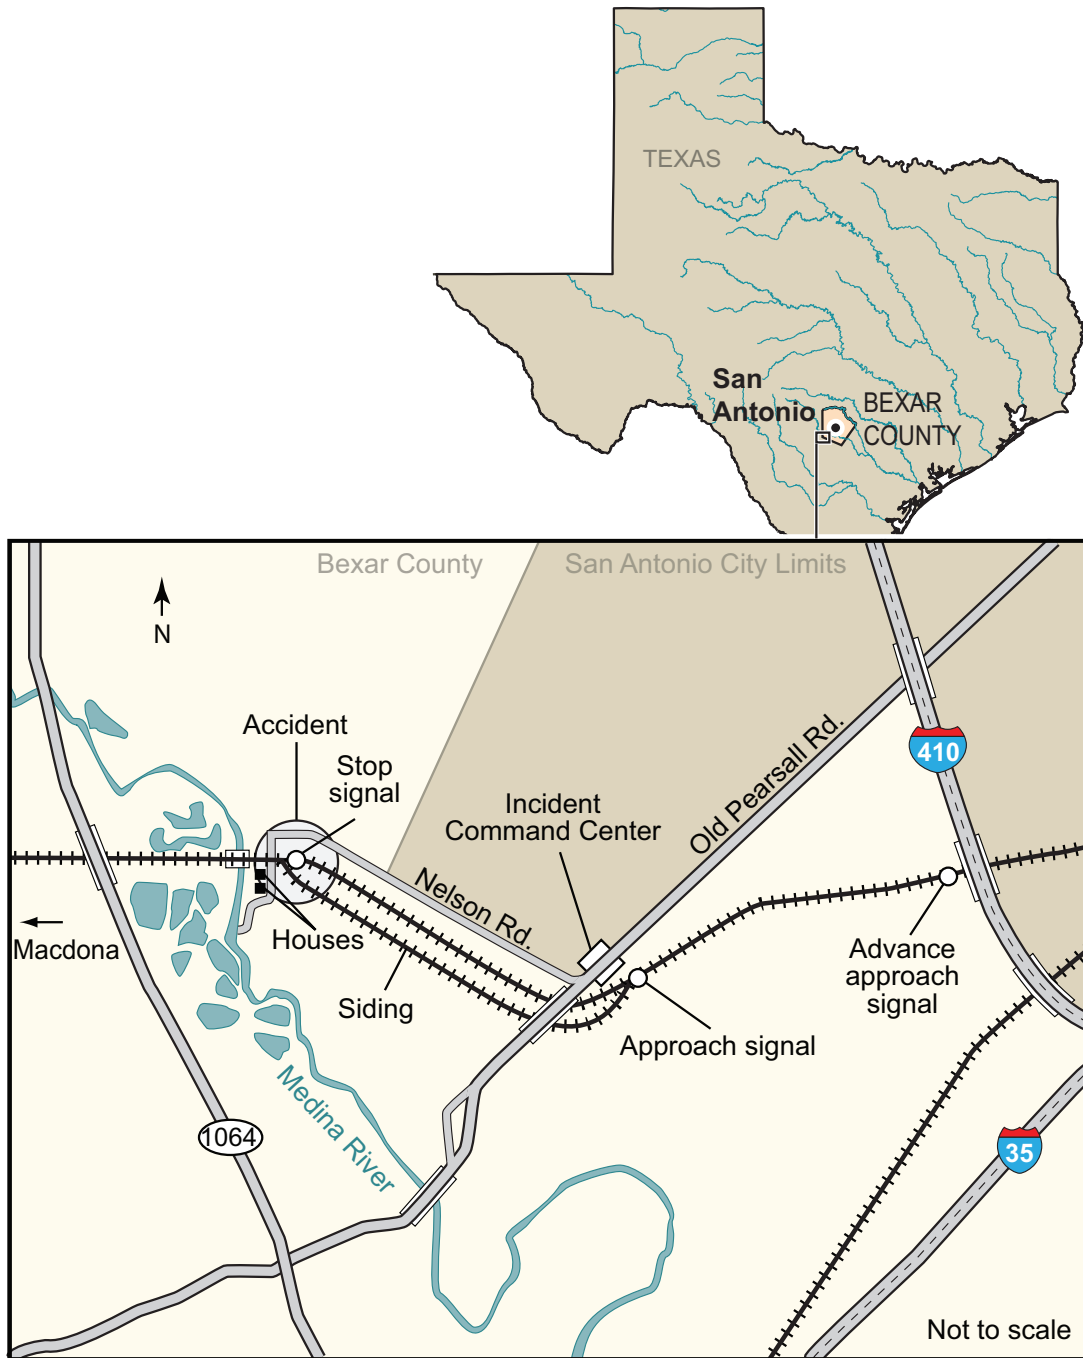
**Figure 2.** Portion of Union Pacific Railroad main line between San Antonio, Texas, and accident site at Macdona. Signals are identified with indications displayed for accident Union Pacific Railroad train.

The accident train continued westbound, with the throttle handle manipulated between idle and notch 4 and the speed fluctuating but remaining under 20 mph. After the Laredo train had diverted to the south, about 4:49, the engineer moved the throttle to notch 5. At 4:52:33, the train proceeded past the *clear* signal at Withers, traveling 44 mph with the throttle in notch 4.

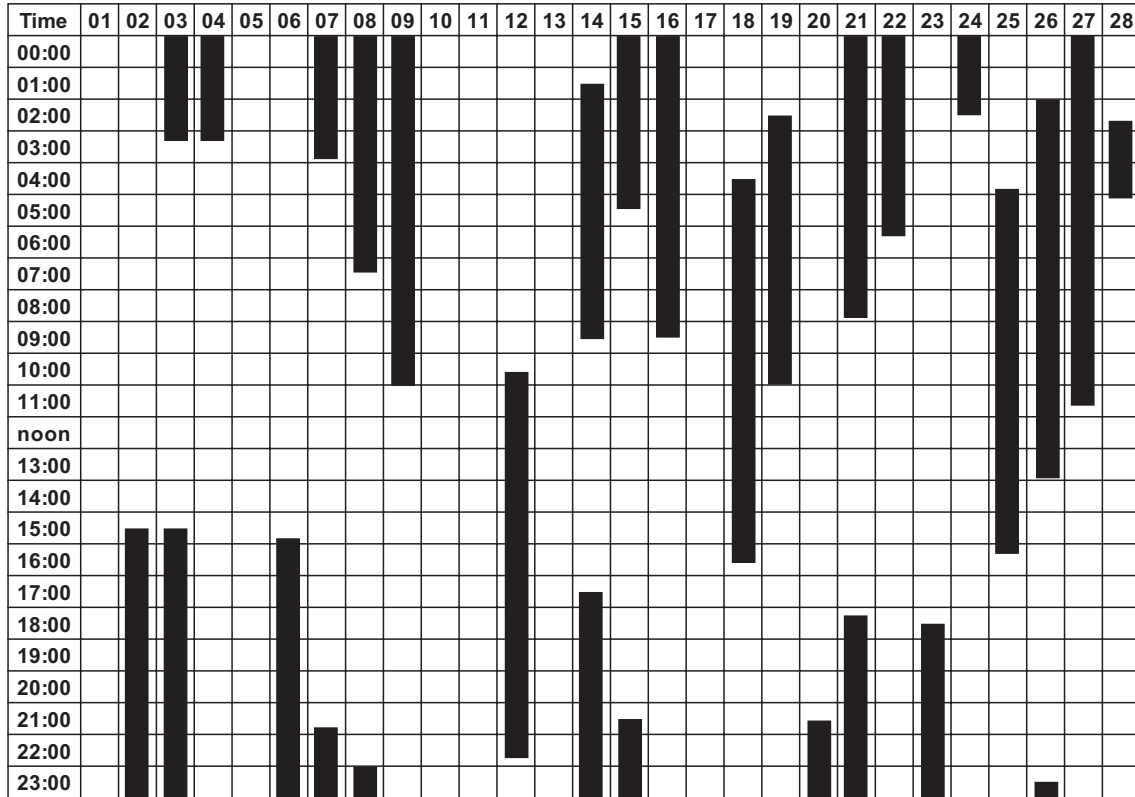
**Table 1.** UP engineer’s work history June 1-28, 2004.

**UP Engineer.** The UP train engineer’s work schedule for the first 3 weeks of June 2004 is shown in table 1.

Black bars indicate hours on duty.

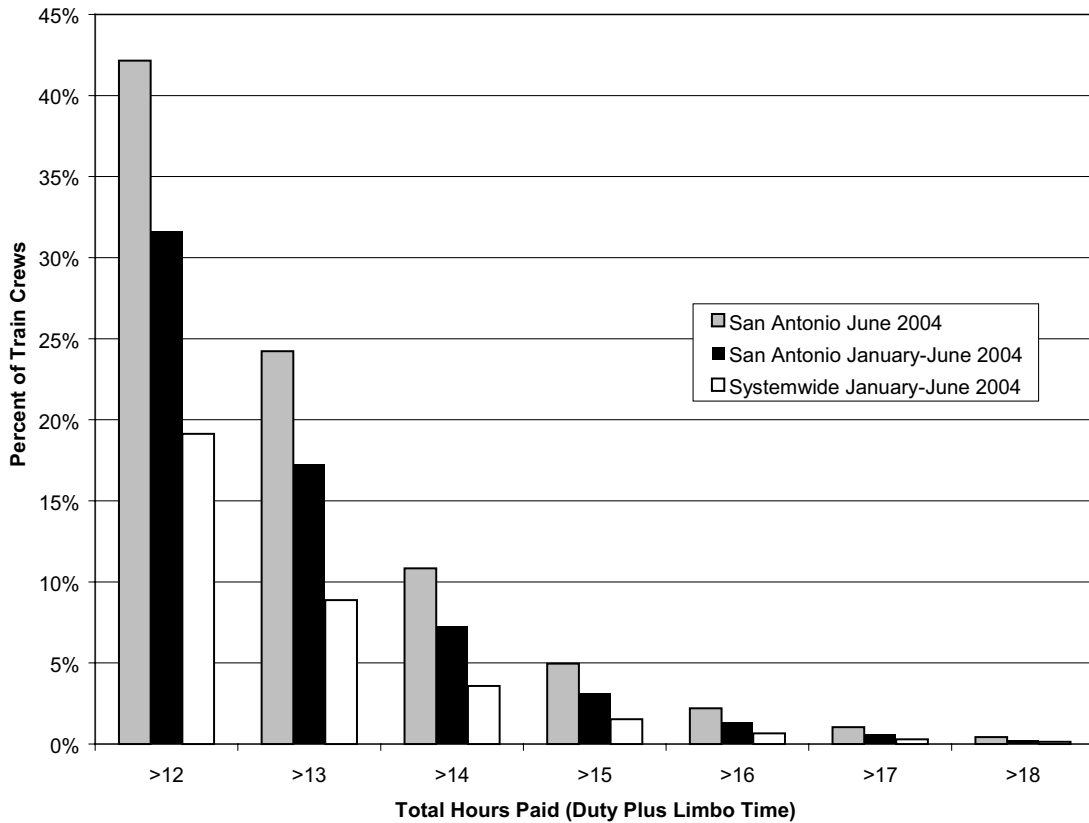
time spent in limbo is technically classified as neither on-duty nor off-duty time, it is paid time for the crew, and any required minimum rest period does not begin until the limbo period ends. As part of this accident investigation, the Safety Board examined records of the time spent in pay status by UP train crews on the San Antonio Service Unit and systemwide during the 6 months preceding the accident. Figure 5 shows the percentage of UP crew assignments held beyond 12 hours for the time periods indicated.

**Figure 5.** Percent of Union Pacific Railroad train crews working in extended pay status.
