National Transportation Safety Board

Flora Investigation

- Focused on:
 - Canadian National's Track Maintenance
 - Federal Railroad Administration's Oversight of Railroad's Track Maintenance
 - Amtrak's Emergency Preparation
- More than 4,000 man-hours

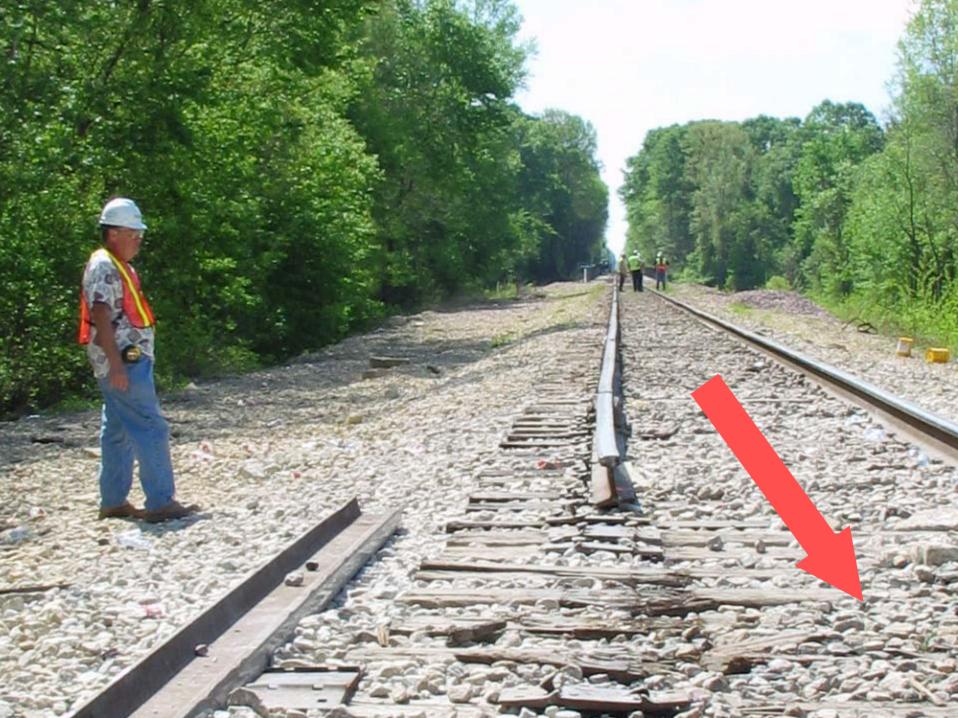
- Track conditions at the accident site
- Maintenance history
- Federal Railroad Administration's inspection and oversight

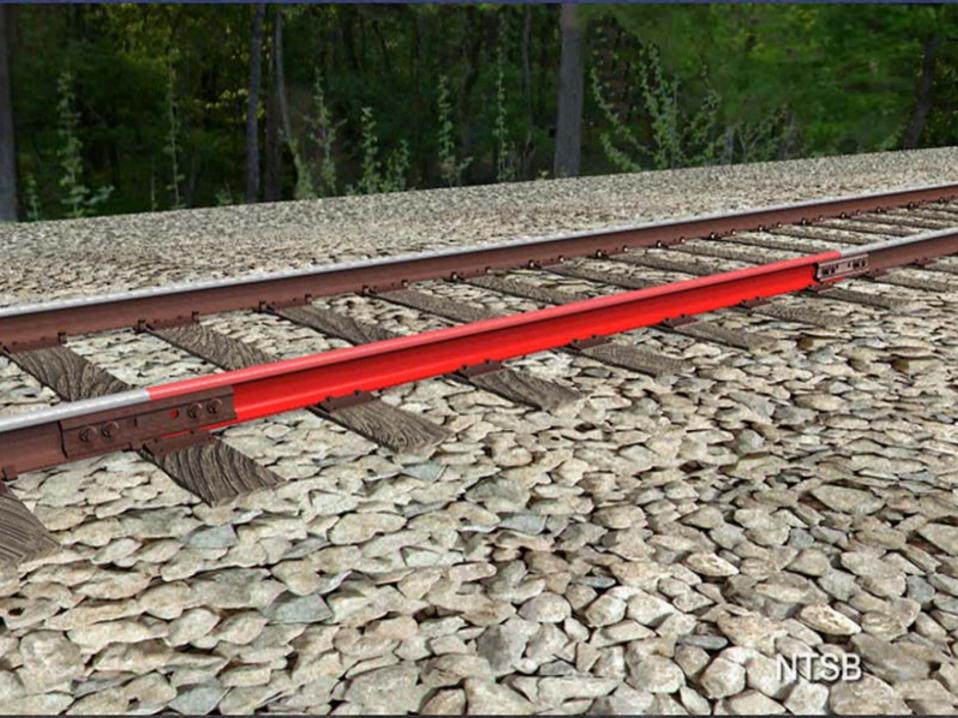
- Selection of a preferred rail laying temperature
- Maintaining continuous welded rail to the preferred rail laying temperature
- Preferred Rail Laying Temperature: 105° F
