**National Transportation Safety Board**

# Factors in Tamaroa Rail Failure

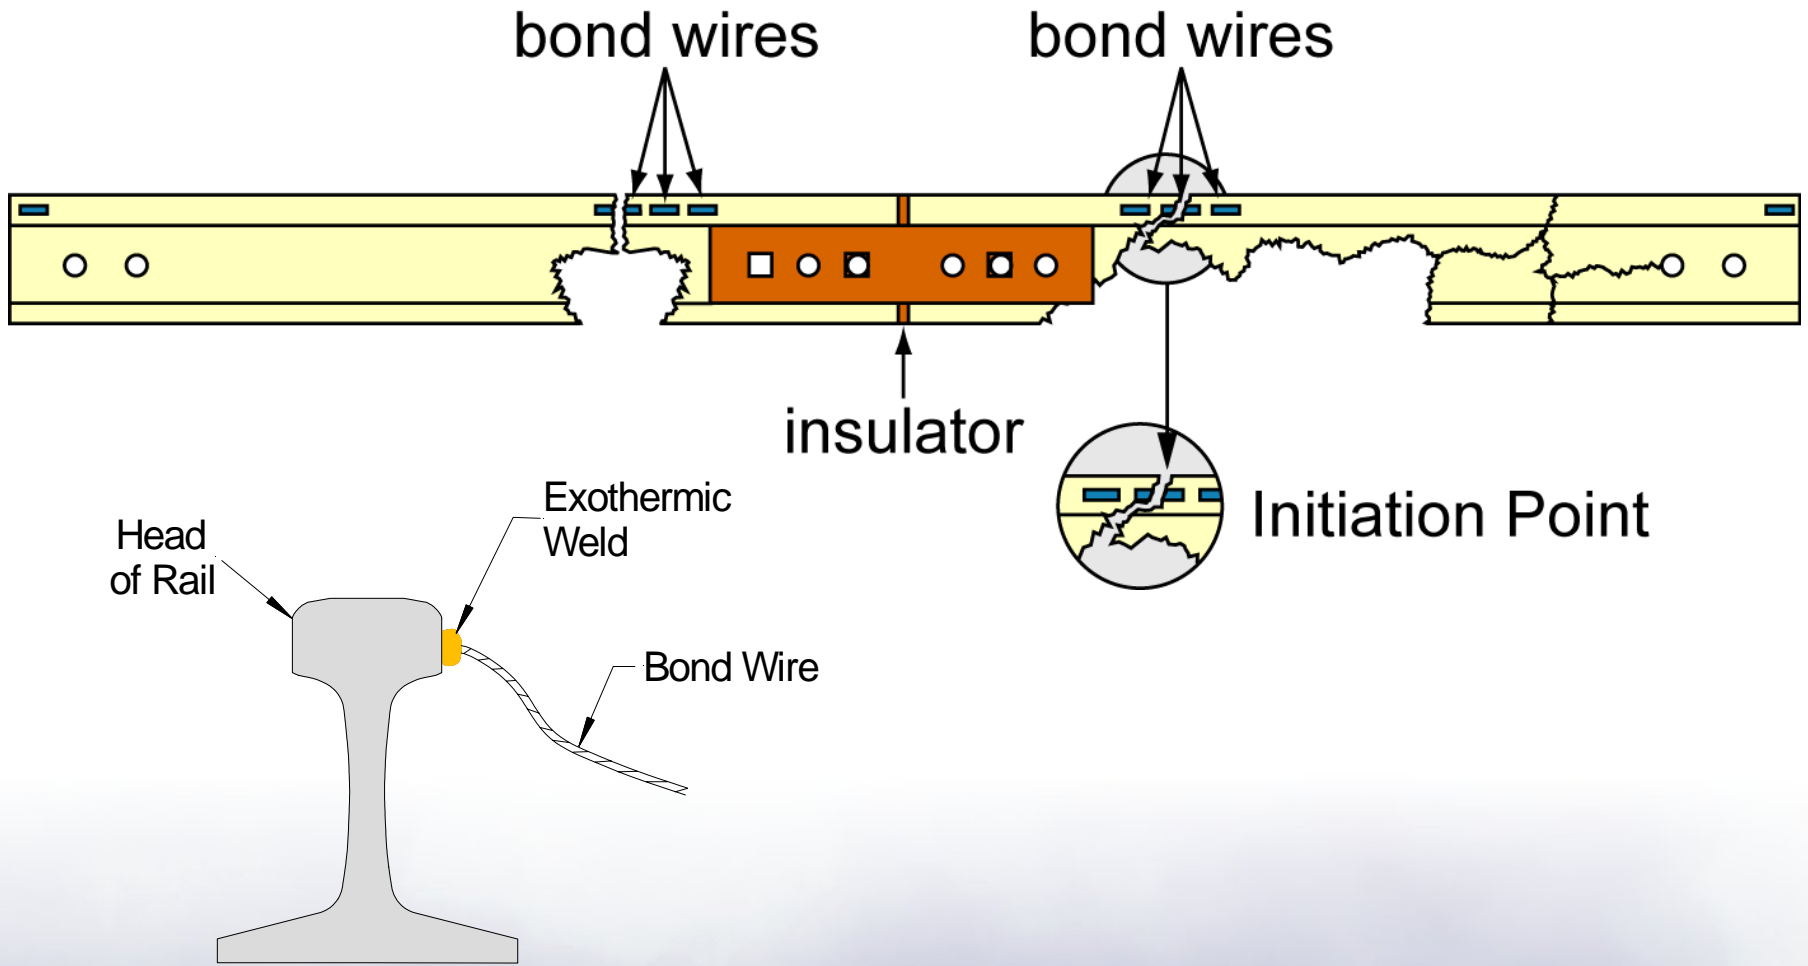
High Bending Stress  
Caused by Change in  
Rail Stiffness

# Tamaroa Track Conditions

- Soft ballast conditions
- Increased bending stresses

- The known soft ballast condition in the area of the insulated joint increased the amount of rail flexing in that area which, in turn, significantly increased stresses in the rail.

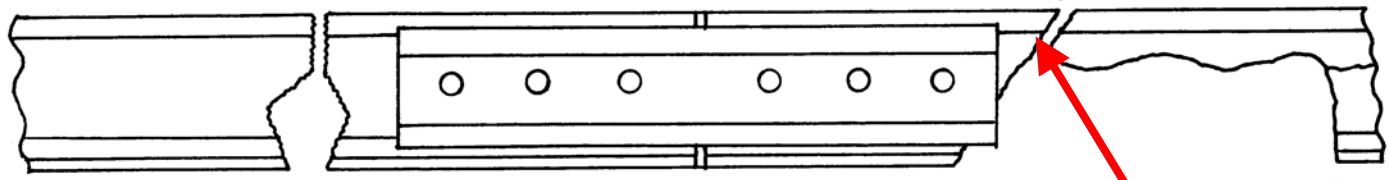
# Fracture Face North of Insulated Joint

- The increased stresses due to the flexing of the rail in the area of the insulated joint caused the propagation of the cracks that had originated in areas of untempered martensite at the rail head, causing the rail to fail only 17 days after installation.
