Mech

Winter 2008-09

**Warnings Are Given
for a Reason**

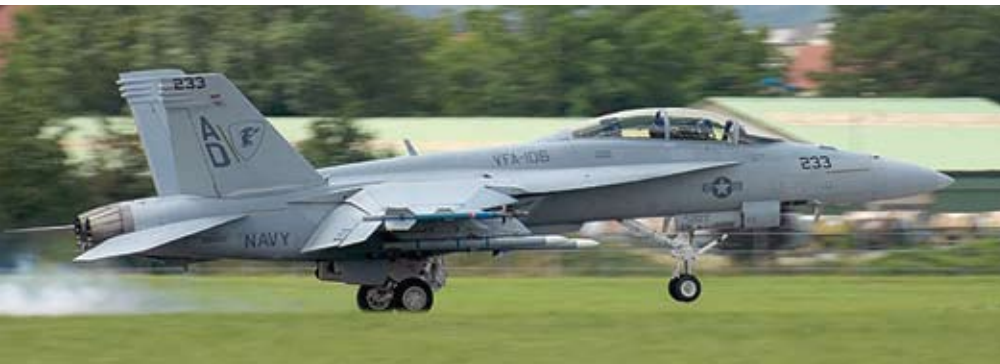
was on the inboard side of the tire, which didn't allow the bearings to seat. The bearings had worked loose and pushed out onto the dust cover. The pressure on the dust cover was so great that the metal retaining clip popped.

cover was sticking out over the bearings. Maintenance Control and the airframes work center immediately were notified of the discrepancy. It was apparent the metal retaining ring that holds the dust cover over the nose-wheel bearings had popped out and was nowhere in sight. The ring probably had gotten sucked down the port intake and into the engine.

During installation of the nose tire, a metal spacer fits between the lock ring and the outboard side of the bearing. This metal spacer allows the bearing to seat when the axle nut is tightened. There is a warning in the maintenance instruction to ensure this metal spacer is installed correctly: Not doing so could result in failure of the wheel bearings.

But what had happened to the metal spacer? Once the port nose tire was removed, it was discovered that the metal spacer was installed wrong. The metal spacer

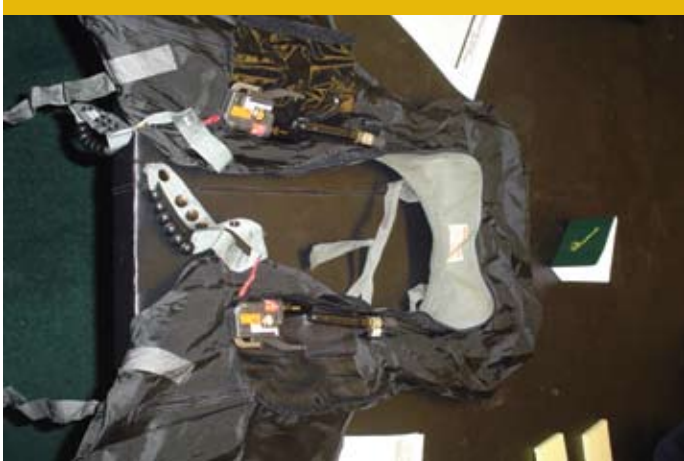
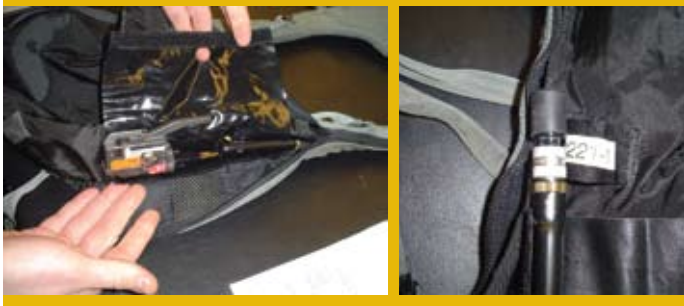
the cylinder cap, or you can try gently bending the lobes to feel for the cartridges. I decided to check another LPU to see if there was a difference. The second LPU was quite firm and did not bend nearly as easy. I checked a third LPU to confirm my findings, and it was firm, as well.

I immediately notified Maintenance Control and my leading petty officer. My LPO inspected the LPU, and he could not feel the CO₂ cartridges, either. Squadron personnel are not authorized to open and inspect the

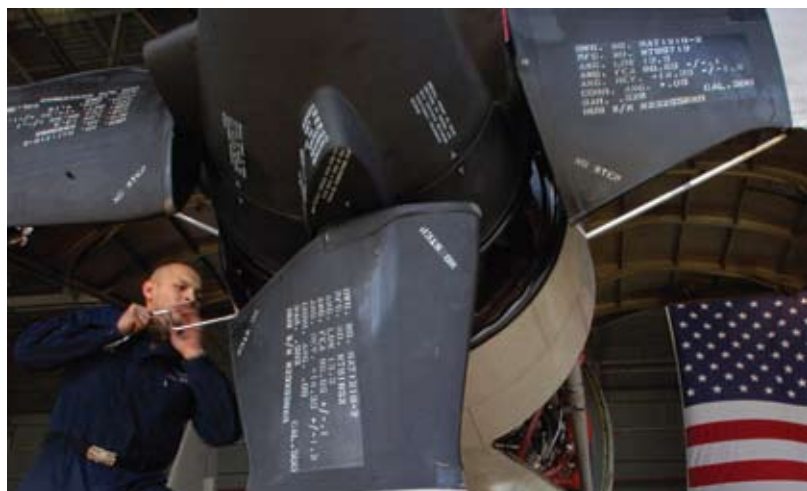
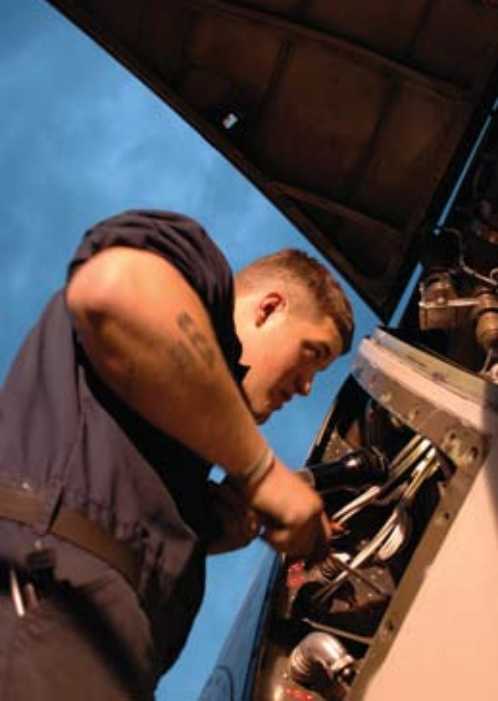
With a B-4 stand in hand, a co-worker and I walked to the aircraft and removed the top propeller afterbody. We hooked the prop weight up to the top air-baffle assembly in order to simulate an in-flight condition. This is part of the procedure to check the engine rigging. In reality, I didn't even need to do this because I needed to check E-handle rigging. The procedure to check the engine rigging directs the maintainer to position the No. 1 prop blade at the 12 o'clock position and to pull the prop-feather-control circuit breaker in the flight station. At this point, I failed to do these steps because I was using the procedure for checking E-handle rigging. With the prop weight in place, I pulled the E-handle and

cringed as the weight nearly tore off the prop cuff. Despite referencing my checklist as required, I had combined two different procedures into one and, as a result, did both wrong.

Representatives from AIMD couldn't fix the cuff, and they recommended a prop replacement. Luckily, once the prop was removed and sent to AIMD, they were able to fix it and downgrade what easily could have been a Class-C mishap.
