NIST Response to the World Trade Center Disaster

**Federal Building and Fire Safety Investigation
of
the World Trade Center Disaster**

November 19, 2008

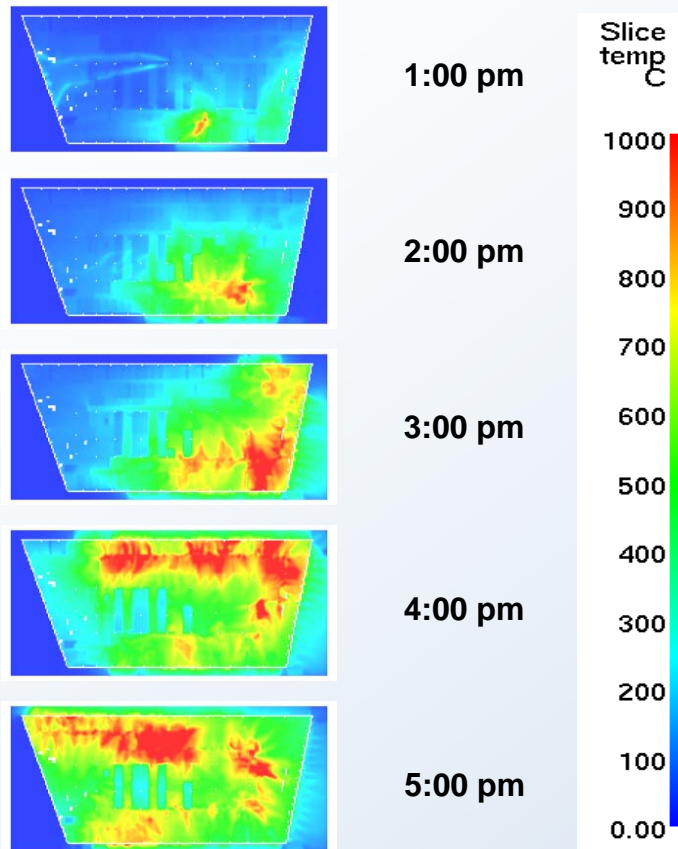
Progression of fires on Floor 12

- The major fires in WTC 7 were modeled using the Fire Dynamics Simulator (FDS) in a manner similar to those for the WTC towers.
- There were far fewer photographs and videos of WTC 7 than of the towers; thus, details of the WTC 7 fires were not as precise as for the towers.
- The fire simulations for WTC 7 were conducted for each floor individually; there were no obvious pathways for the flames and heat to pass from one floor to another, aside from the debris-damaged area in the southwest corner of the building.
- Sustained and/or late fires were observed only on floors 7 through 9 and 11 through 13.
- The actual fires on these floors were most likely initiated at the time of the incidence of the debris from the collapsing towers.
- A typical single floor simulation took up to two days on a Linux cluster with 8 processors.

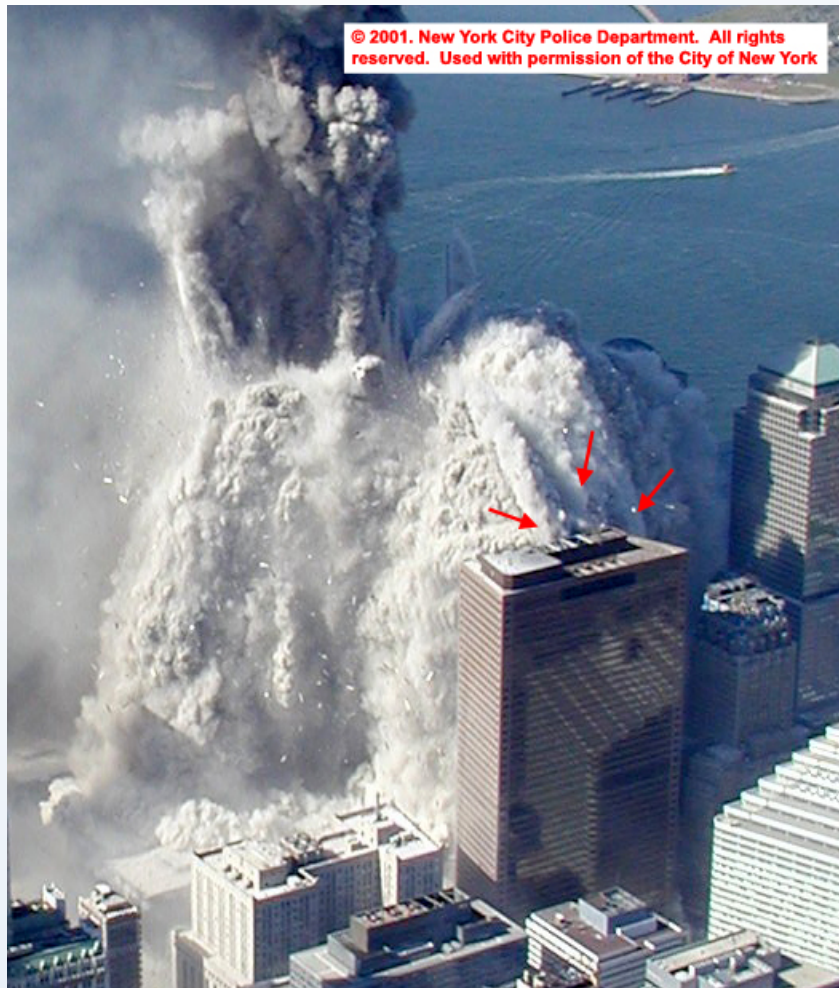
- Collapse of the WTC Towers.
 - Collapse of WTC 2 did not cause any structural damage or start any fires in WTC 7.
 - Collapse of WTC 1 damaged seven exterior columns on the lower floors of the south and west faces and initiated fires on 10 floors between Floors 7 and 30.
- Aerial photograph shot $14 \text{ s} \pm 0.5 \text{ s}$ after WTC 1 began to collapse.
- Arrows mark arcs formed by debris that seemed to be ejected outwards from the debris cloud

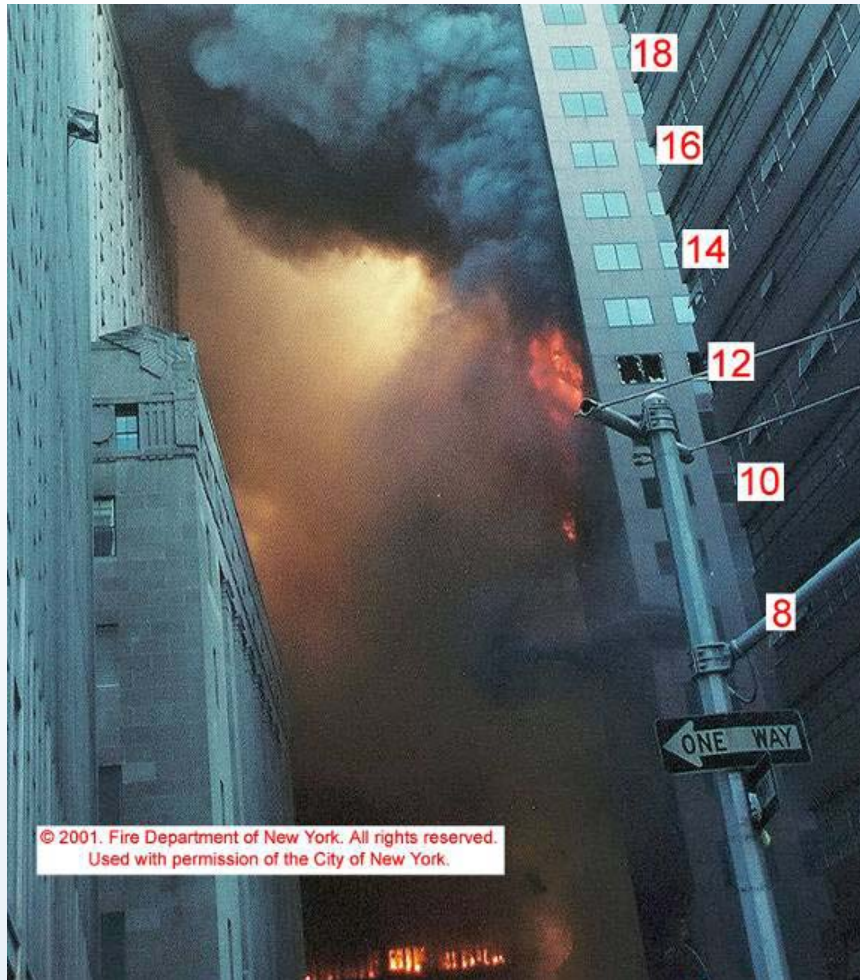
- Growth and Spread of Fires.
 - Fires on the lower floors (Floors 7 to 9 and 11 to 13) grew and spread since they were not extinguished either by the automatic sprinkler system or by FDNY because water was not available.
 - Fires were generally concentrated on the east and north sides of the northeast region beginning at about 3 p.m. to 4 p.m.
 - The local fires on the upper floors (Floors 19, 22, 29, and 30) were not observed after approximately 1 p.m.
- Cropped photograph showing east edge of the north face and oblique view of east face of WTC 7.
- It was likely taken between 3:20 p.m. and 3:40 p.m.

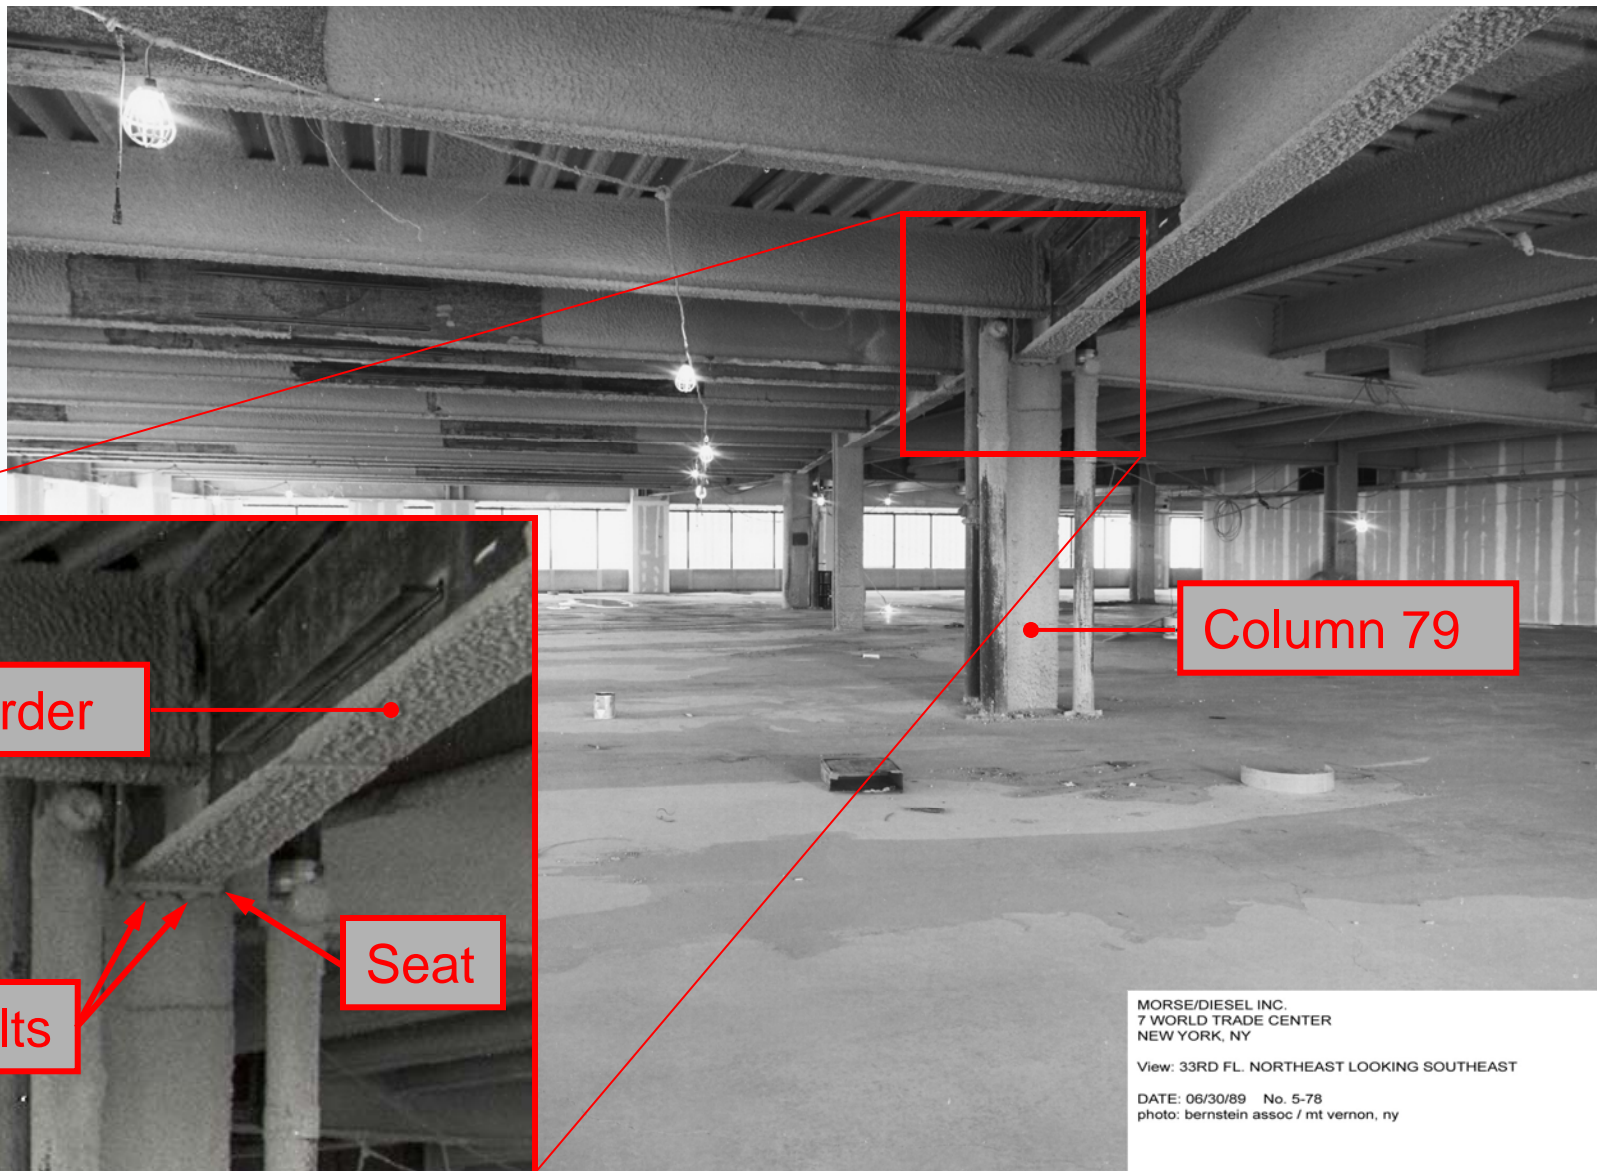
North East Floor System Near Column 79

- Initial Local Failure for Collapse Initiation.
 - Fire-induced thermal expansion of the floor system surrounding Column 79 led to collapse of Floor 13 that triggered a cascade of floor failures.
 - This, in turn, led to loss of lateral support to Column 79 over nine stories, resulting in the buckling failure of Column 79.

- **The probable collapse sequence that caused the global collapse of WTC 7 was initiated by the buckling of Column 79, which was unsupported over nine stories, after local fire-induced damage led to a cascade of floor failures.**

- Despite extensive thermal weakening of connections and buckled floor beams, **fire-induced damage in the floor framing surrounding Column 79 over multiple stories was the determining factor causing the buckling of Column 79 and, thereby, initiating progressive collapse.**

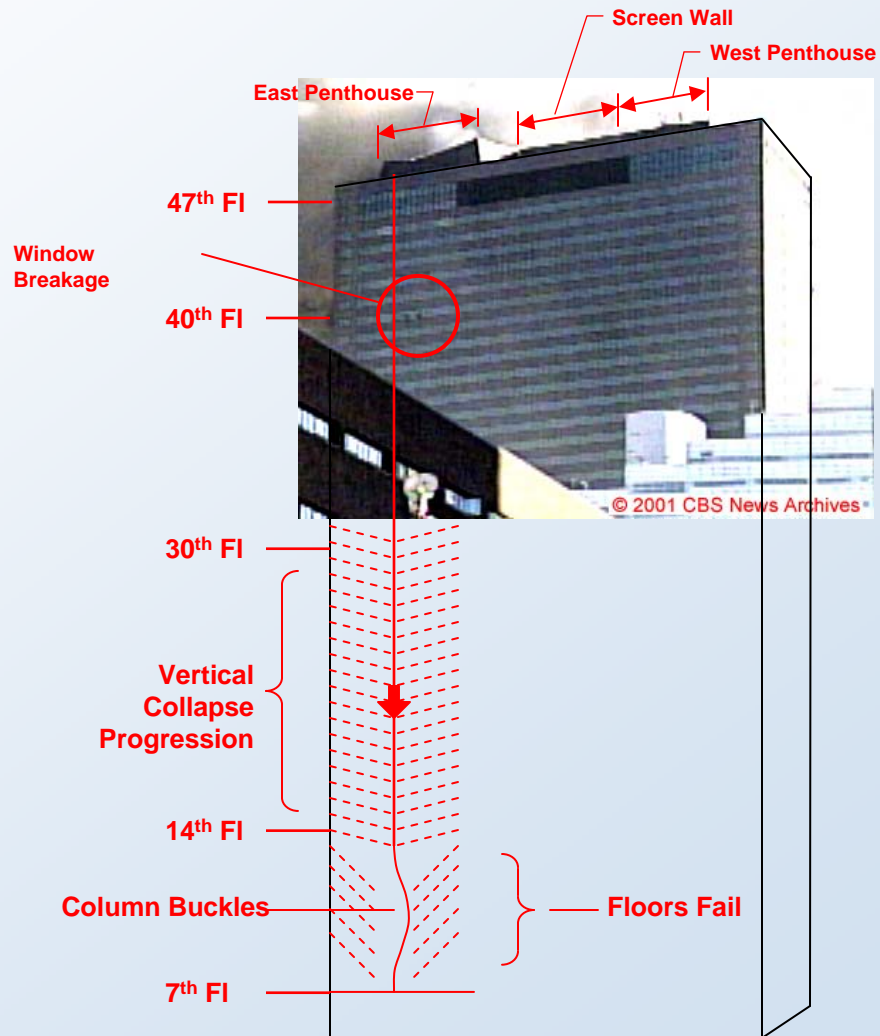
Exterior Observations

- ❑ East Penthouse Kinks
- ❑ Windows break on East Side of North Face

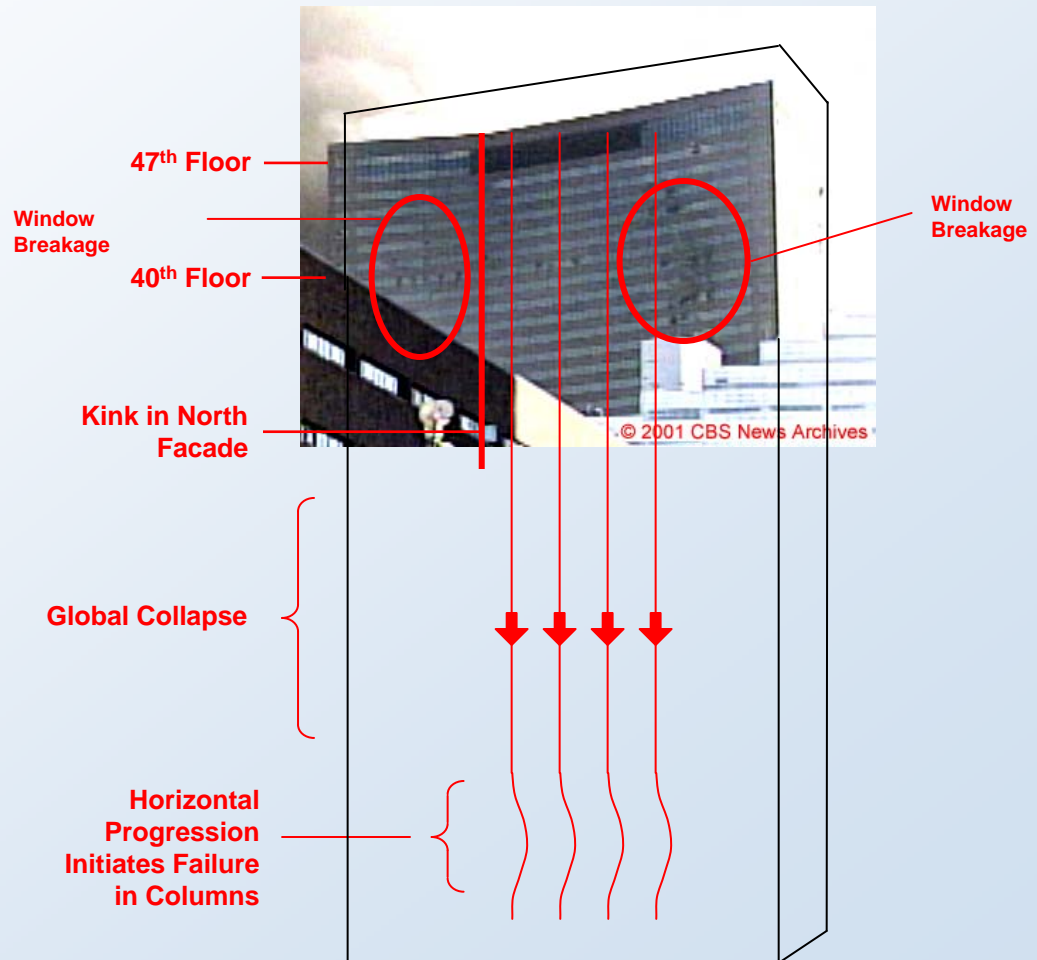
Exterior Observations

- ❑ Screenwall and West Penthouse Sink
- ❑ North Façade Kinks at Edge of Core
- ❑ Windows break on West Side of North Face

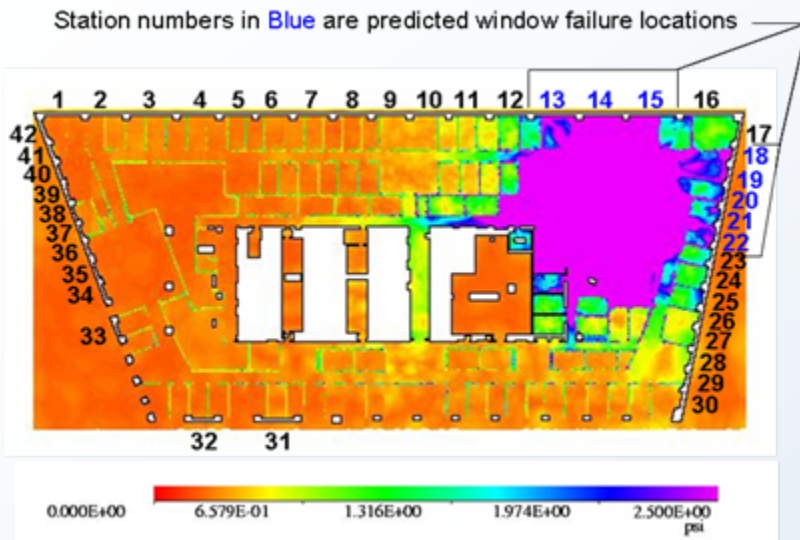
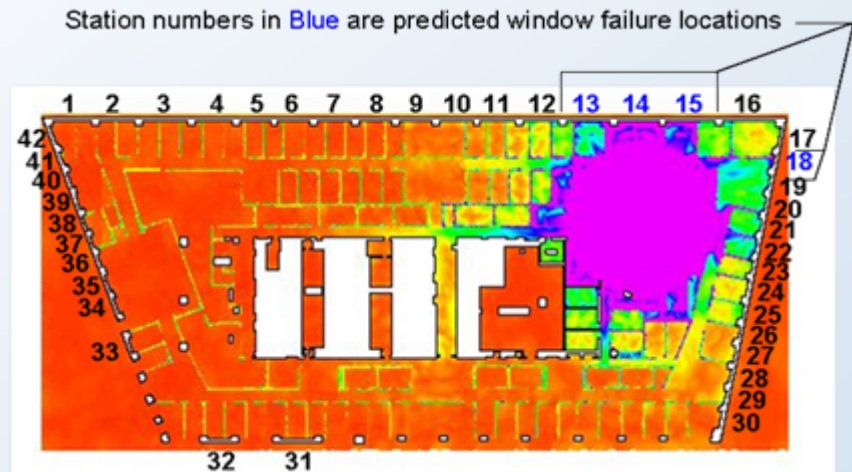
Peak over pressures for 9 lb shaped charge (left) and 2lb charge (right).

- **Hypothetical blast events did not cause the collapse of WTC 7. NIST concluded that blast events did not occur and found no evidence of any blast events.**

- The minimum explosive charge (lower bound) required to fail a critical column (i.e., Column 79) would have:
 - produced a pressure wave that would have broken windows on the north and east faces of the building near Column 79.

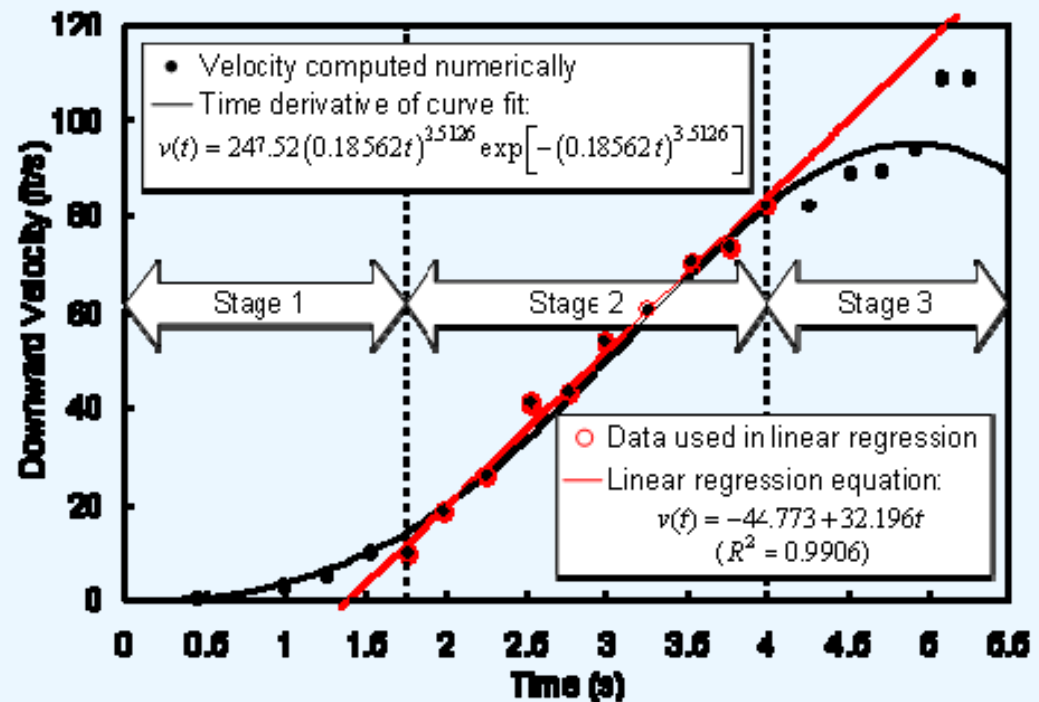
- ❑ Collapse time of the north face (the floors clearly visible in video evidence) was 40 percent greater than the computed free fall time.
 - The actual time for the north face to descend 18 stories, based on video evidence, was approximately 5.4 s and the computed free fall time was 3.9 s.
- ❑ A detailed analysis of the descent of the north face found 3 stages:

- A slow descent at less than gravitational acceleration, corresponding to column buckling
- A free fall descent at gravitational acceleration over approximately 8 stories
- A decreasing acceleration, as the north face encountered resistance from the structure below.

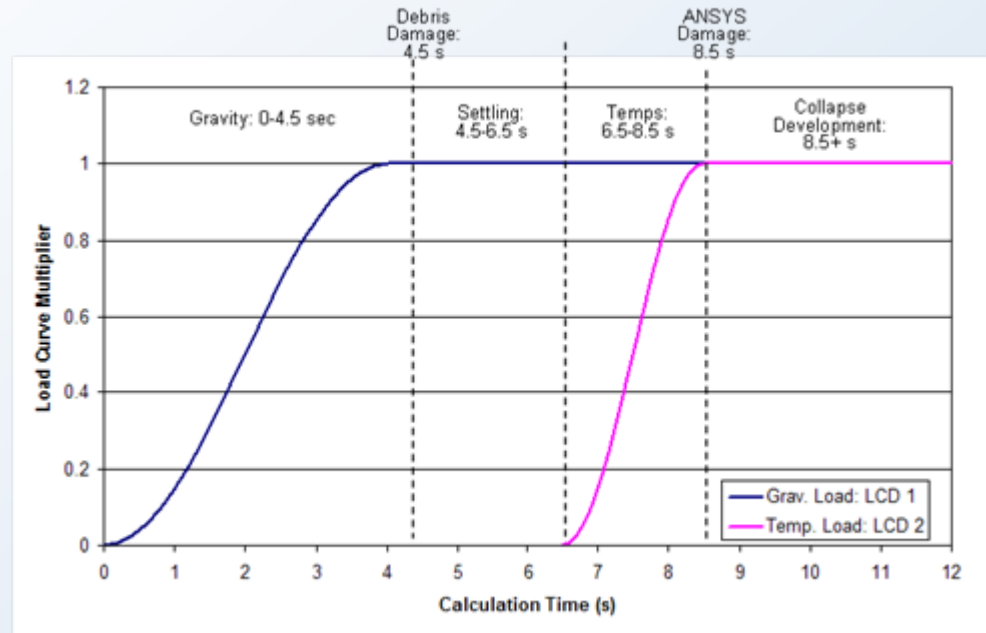
LS-DYNA Model Loading Sequence

1. Gravity loads were applied smoothly over 4.5 s using a sinusoidal curve to eliminate dynamic response.
2. Debris impact damage from the collapse of WTC 1 was then applied instantaneously by removing elements from the model. The structure was then allowed to damp residual vibrations over 2 s.
3. Elevated temperatures from the ANSYS thermal analysis were next applied smoothly over 2 s using a sinusoidal curve to eliminate dynamic response.
4. Fire-induced damage (buckled beams and connection capacities that were reduced) obtained from the 16-story ANSYS structural analysis was finally applied instantaneously and the computation model proceeded to initiate and propagate collapse, up to global collapse.

- The response of the building with fire-induced damage from the 16-story ANSYS analysis at 4.0 h (both with and without debris impact damage) was consistent with the timing of key events in the recorded videos of the collapse.
- The response of the building to fire-induced damage from the 16-story ANSYS analysis at 3.5 h (damage in the south and southeast regions of WTC 7 on multiple floors) did not result in collapse of the building.
- **The LS-DYNA analysis approach minimized any spurious dynamic effects associated with loading sequence.**

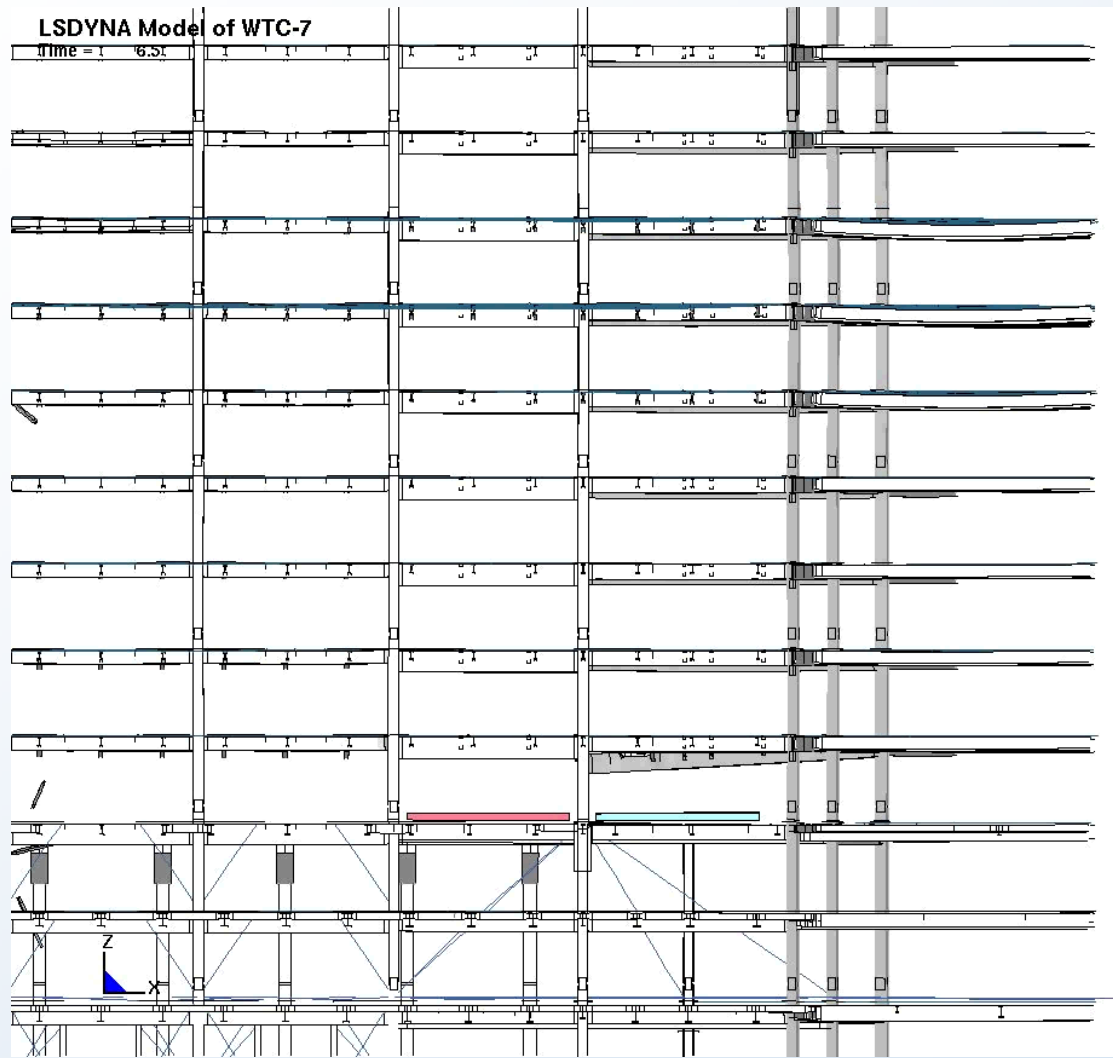
WTC 7 Collapse Initiation w/o Debris Damage

- The simple shear connection between Column 79 and the girder that spanned the distance to the north face (to Column 44) failed on Floor 13.
 - The connection failed due to shearing of erection bolts, caused by lateral thermal expansion of floor beams supporting the northeast floor system.

- Further thermal expansion of the floor beams pushed the girder off its seat.
 - The displaced girder and other local fire-induced damage led to the failure of the floor system surrounding Column 79 on Floor 13.

- The collapse of Floor 13 onto the floors below—some of which were already weakened by fires—triggered a cascade of floor failures in the northeast region.

- This, in turn, led to loss of lateral support to Column 79 in the east-west direction over nine stories (between Floors 5 and 14).
- The increase in unsupported length led to the buckling failure of Column 79, which was the collapse initiation event.

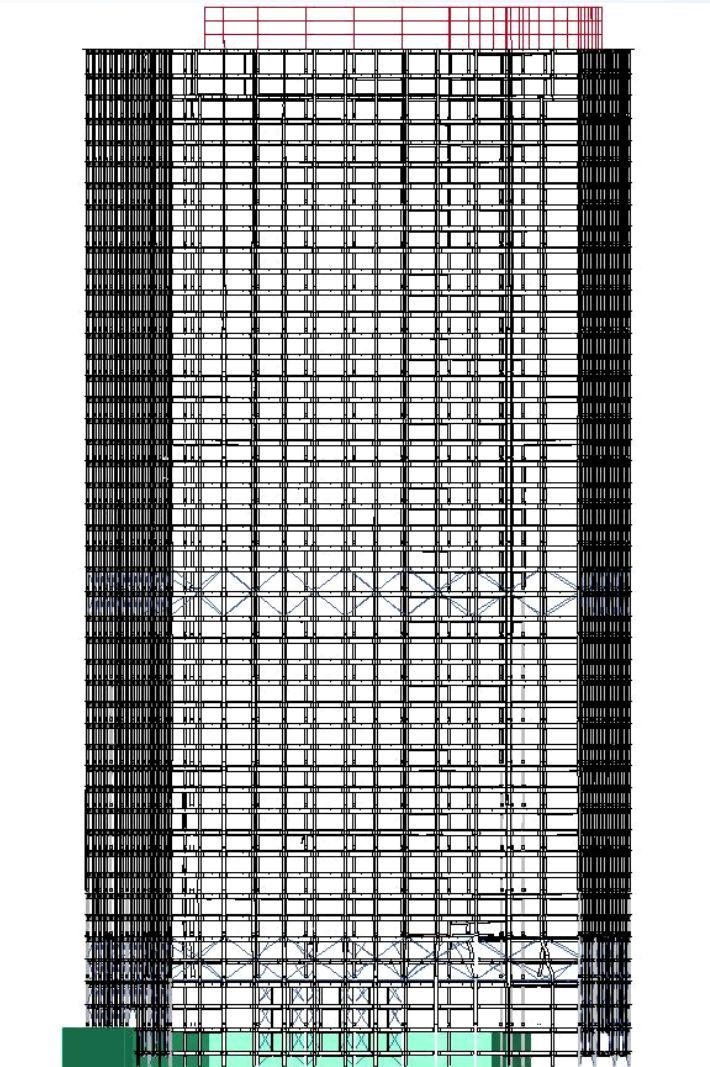
WTC 7 Collapse Visualization w/o Damage

- The first north-south line of core columns (i.e., Columns 76 to 78) buckled since they had lost lateral support, were impacted by falling debris, and had loads redistributed to them from adjacent buckled columns.
- Truss 2, which collapsed due to accumulated weight and impact loads from falling debris, precipitated the buckling of Columns 77 and 78 a few moments earlier than Column 76. The failure of Truss 2 caused the failure of the transfer girder linking Columns 77 and 78A which supported Column 78.
- Truss 2 was not critical to the horizontal progression of failure.
