Appendix 1

Soil Data Report for 17th Street Canal

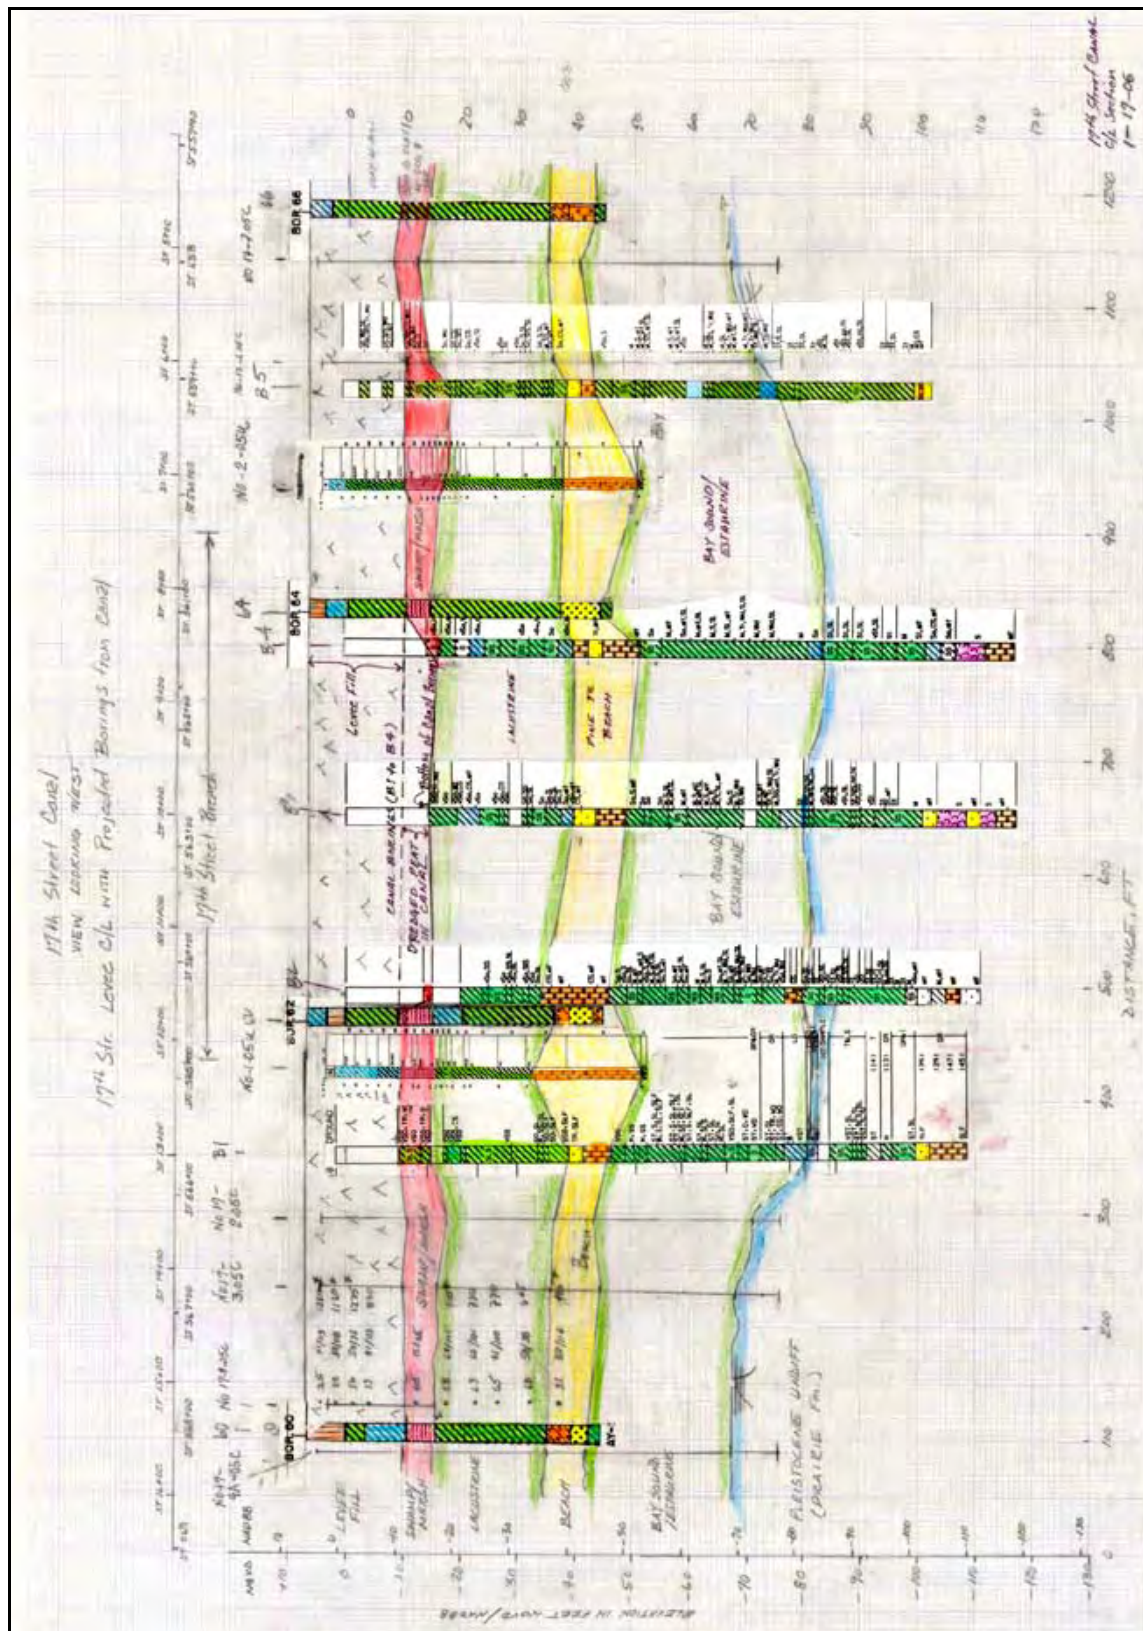
Figure 1-9. Centerline (CL) Cross-section of Breach

A more detailed representation of the soil stratigraphy profile along the centerline in the breach area is shown in Figure 1-9. This profile was constructed using additional soil data acquired during the post-Katrina soil exploration conducted during September through October 2006. The additional borings included B1, B2, B3, B4, B5, NO-1-05U, and NO-2-05U. A plan view showing the locations of both old and new borings is shown in Figure 1-10. The new borings were needed because only the two old borings, B62 and B64 (reported in GDM No. 20), were in the immediate vicinity of the breach. The new borings extended the depth of the investigation in this area from approximately Elevation -50 ft NGVD to Elevation -115 ft NGVD. Additionally, data from cone penetration testing, from the new exploration program, were used to supplement soil data from the old and new borings and refine the stratigraphy in the breach area. Since the levee was destroyed in the breach area during the storm, the new borings, B1 through B4, were drilled from a barge in the canal and were offset from the centerline. Data acquired from these borings were projected back to the centerline in an effort to improve the interpretation of the stratigraphy.

The information presented on Figure 1-9 yielded the following interpretation of the subsurface stratigraphy in the breach area. The subsurface in the breach area was simplified into six basic groups of soil types over the depth of the investigation:

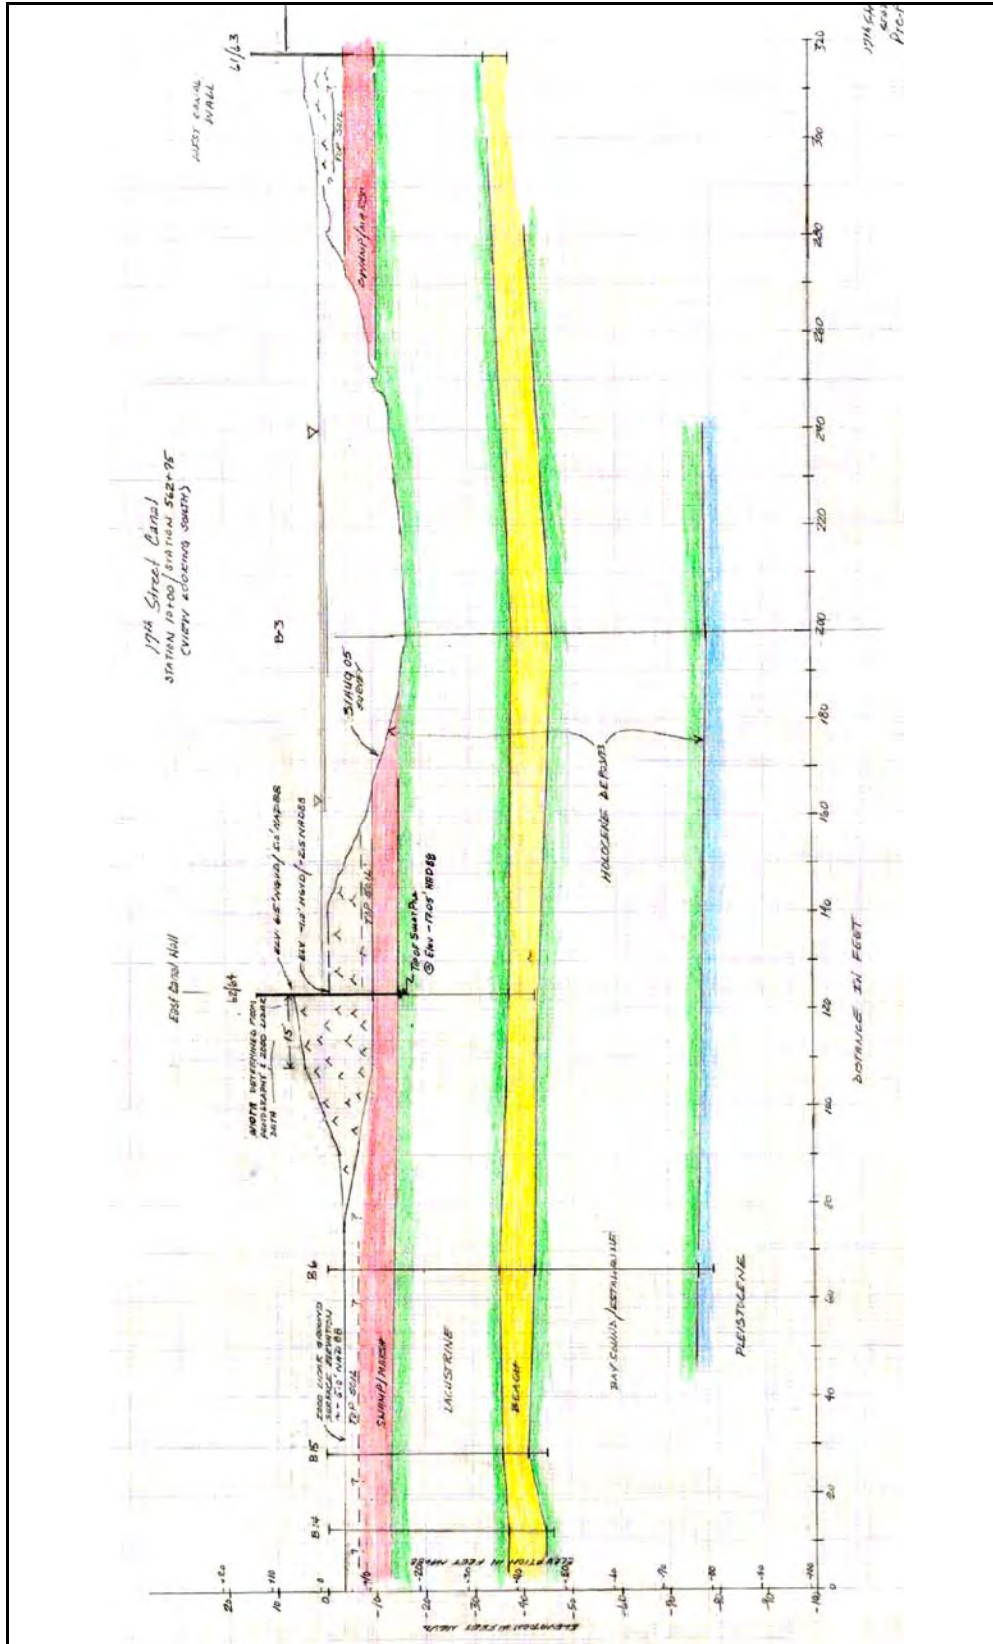
Figure 1-12: Prefailure Cross-Section at Sta 10+00 (New Stationing)/ Sta. 562+75 (GDM Stationing)

The three representative cross sections for Station 8+30, Station 10+00, and Station 11+50 are shown in Figures 1-11, 1-12, and 1-13, respectively. Three sections were prepared because the levee dimensions are variable in the breach area on the east bank. Each cross section shows the conditions across the entire canal from the west bank to the east bank where the breach site is located. A degree of interpretation was necessary, particularly pertaining to the east bank

protected side, to complete the cross sections because of the lack of soil boring data in this area. Thus, the marsh/peat layer was interpreted to be thinner under the centerline of the levee than at the toe due to consolidation from the surcharge caused by the weight of the levee. Also, an interpretation was made to include a 2- to 3-ft layer of topsoil over the top of the peat in this area. This effect may be cultural in nature because the protected side of the east bank was located in a residential area with houses having well-kept lawns.

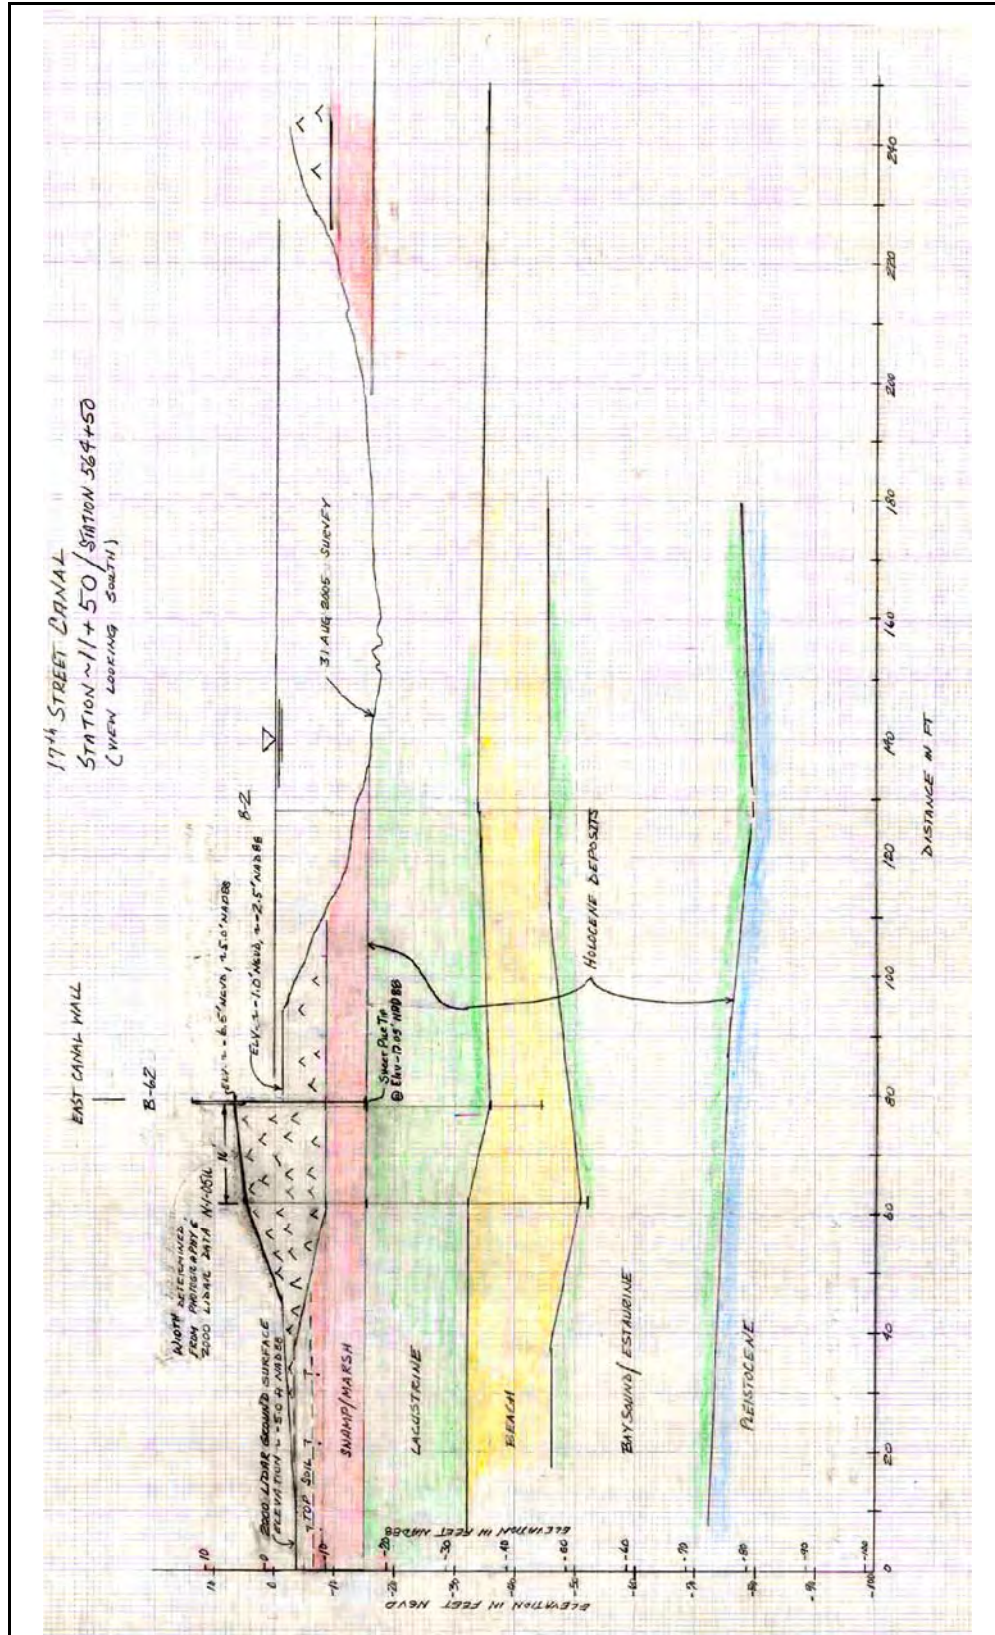
Figure 1-13. Prefailure Cross-Section at Sta 11+50 (New Stationing)/ Sta. 564+50 (GDM Stationing) (Note: Most scour occurred near this station)

It is also noted that the levee cross section at Station 11+50, the southernmost section of the three and shown in Figure 1-13, is the location where the post-Katrina surveys showed that the most scour occurred while water was flowing through the breach.

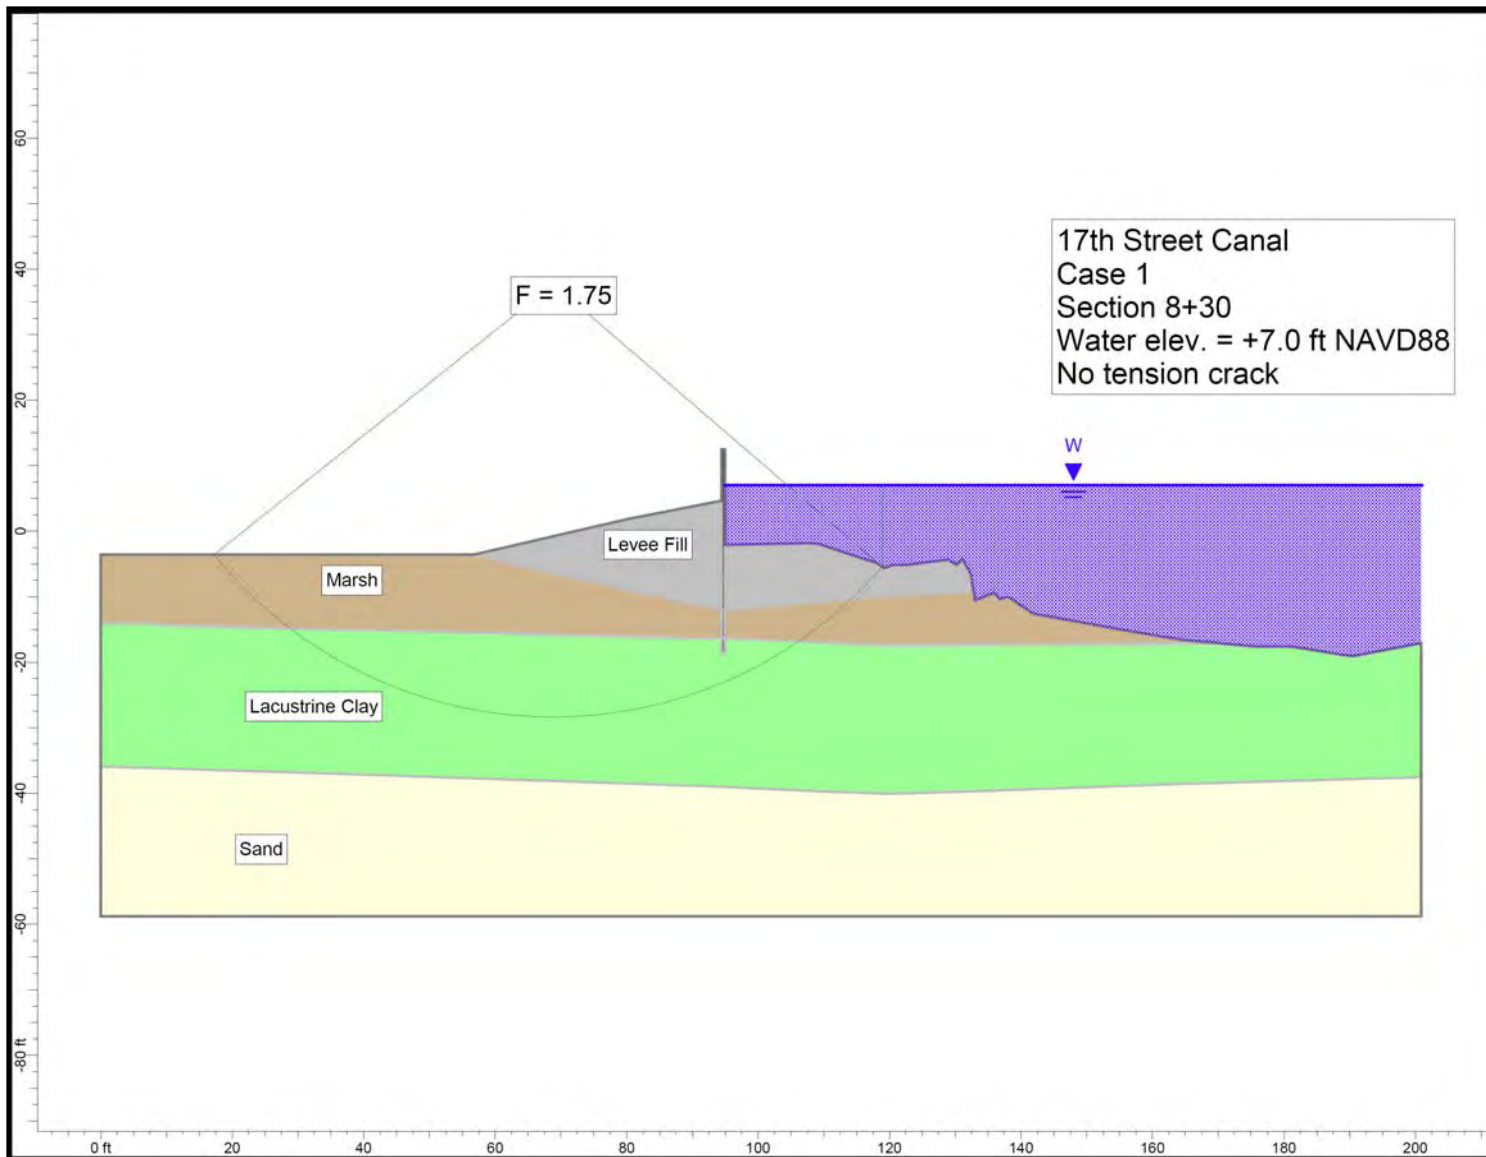
Figure 4-1. Critical Circle for 17th Street Canal Station 8+30 – Water Elevation 7.0 ft, No Tension Crack

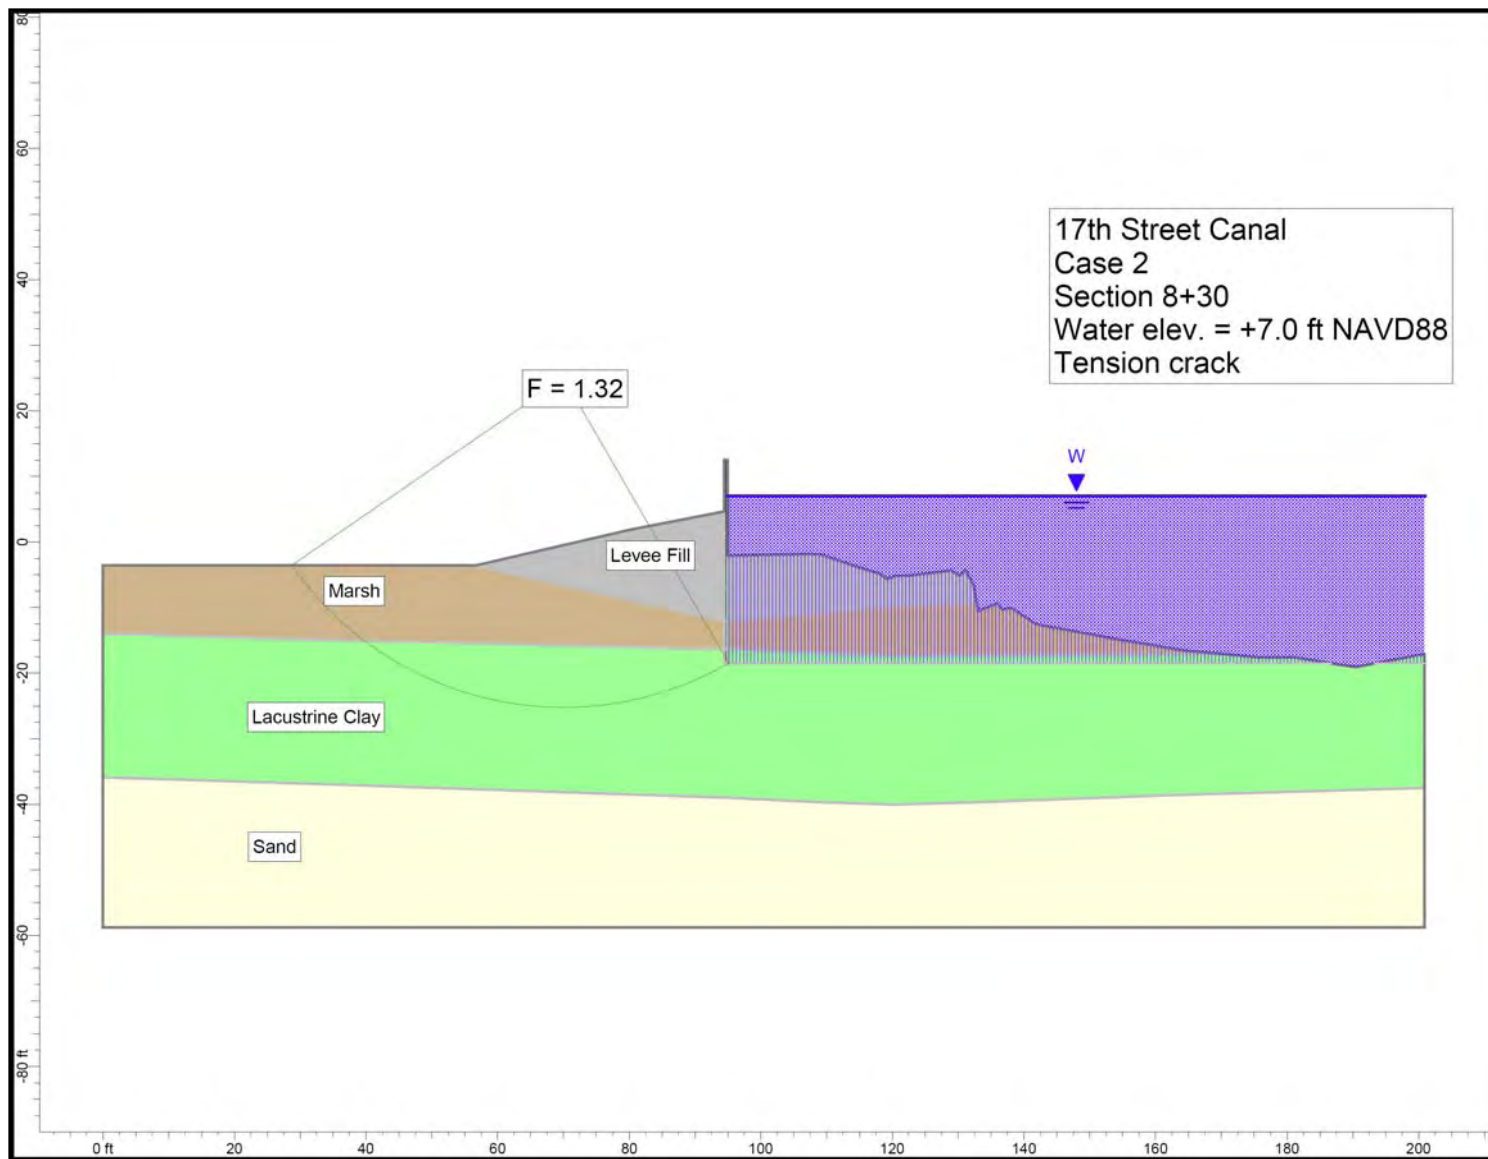
Figure 4-2. Critical Circle for 17th Street Canal Station 8+30 – Water Elevation 7.0 ft, Tension Crack

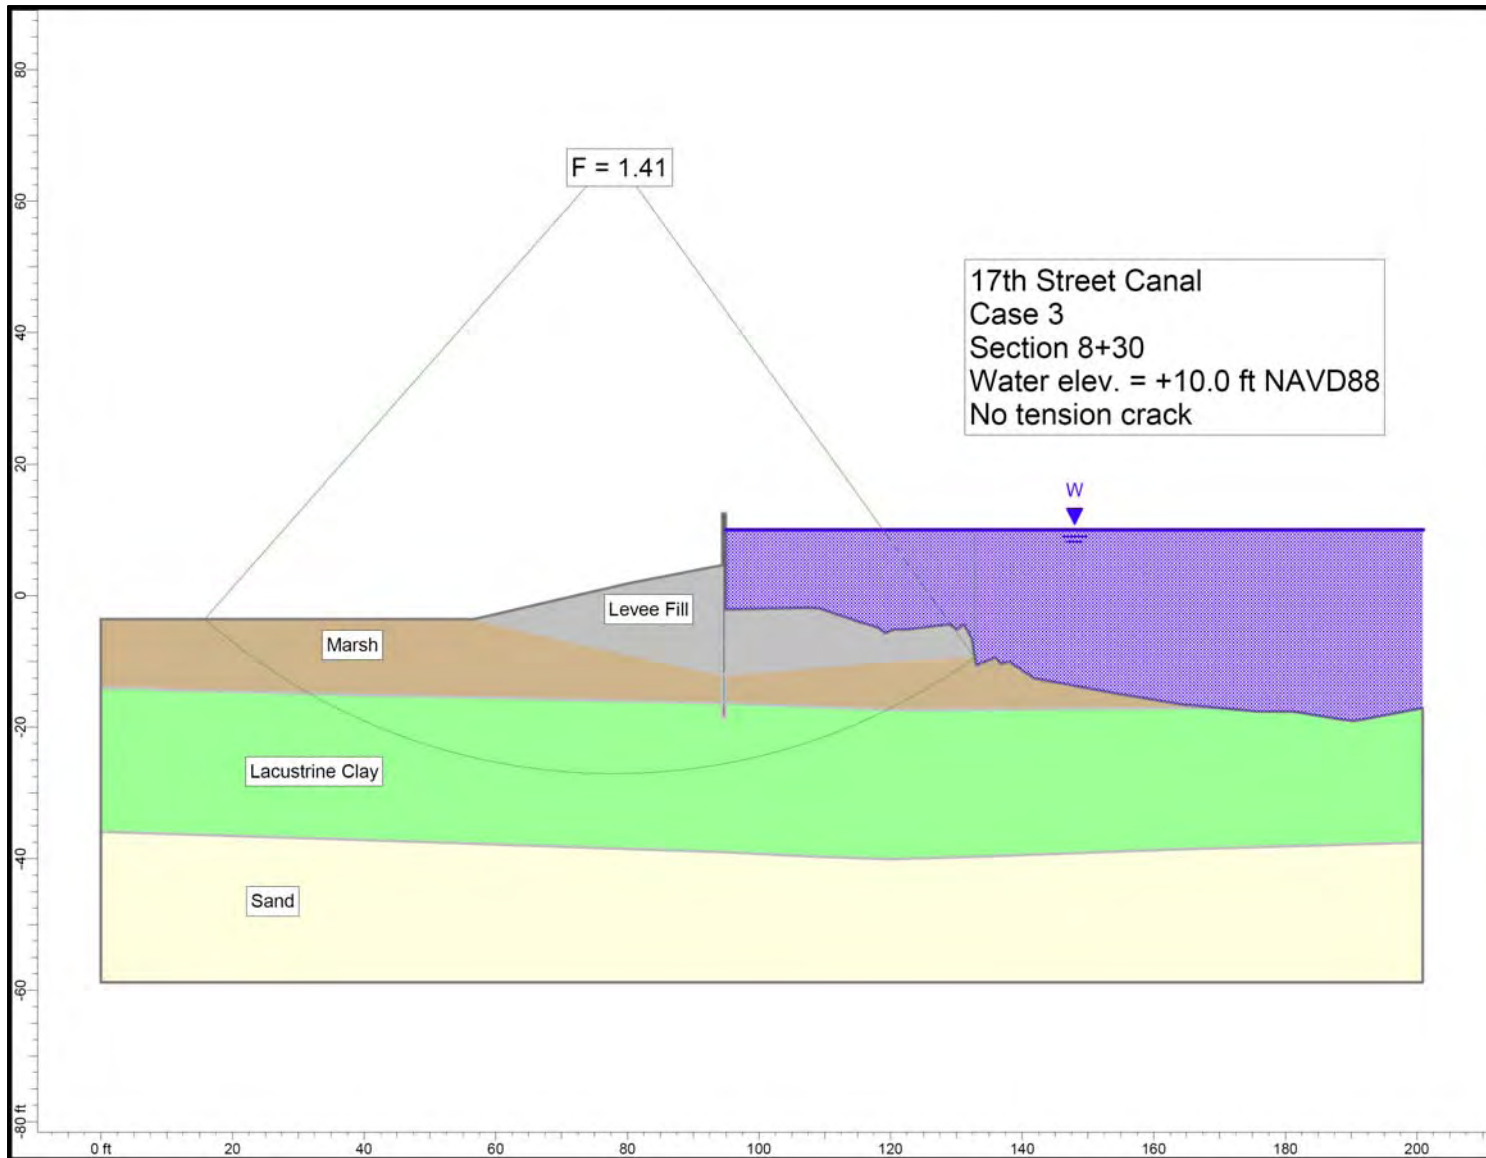
Figure 4-3. Critical Circle for 17th Street Canal Station 8+30 – Water Elevation 10 ft, No Tension Crack

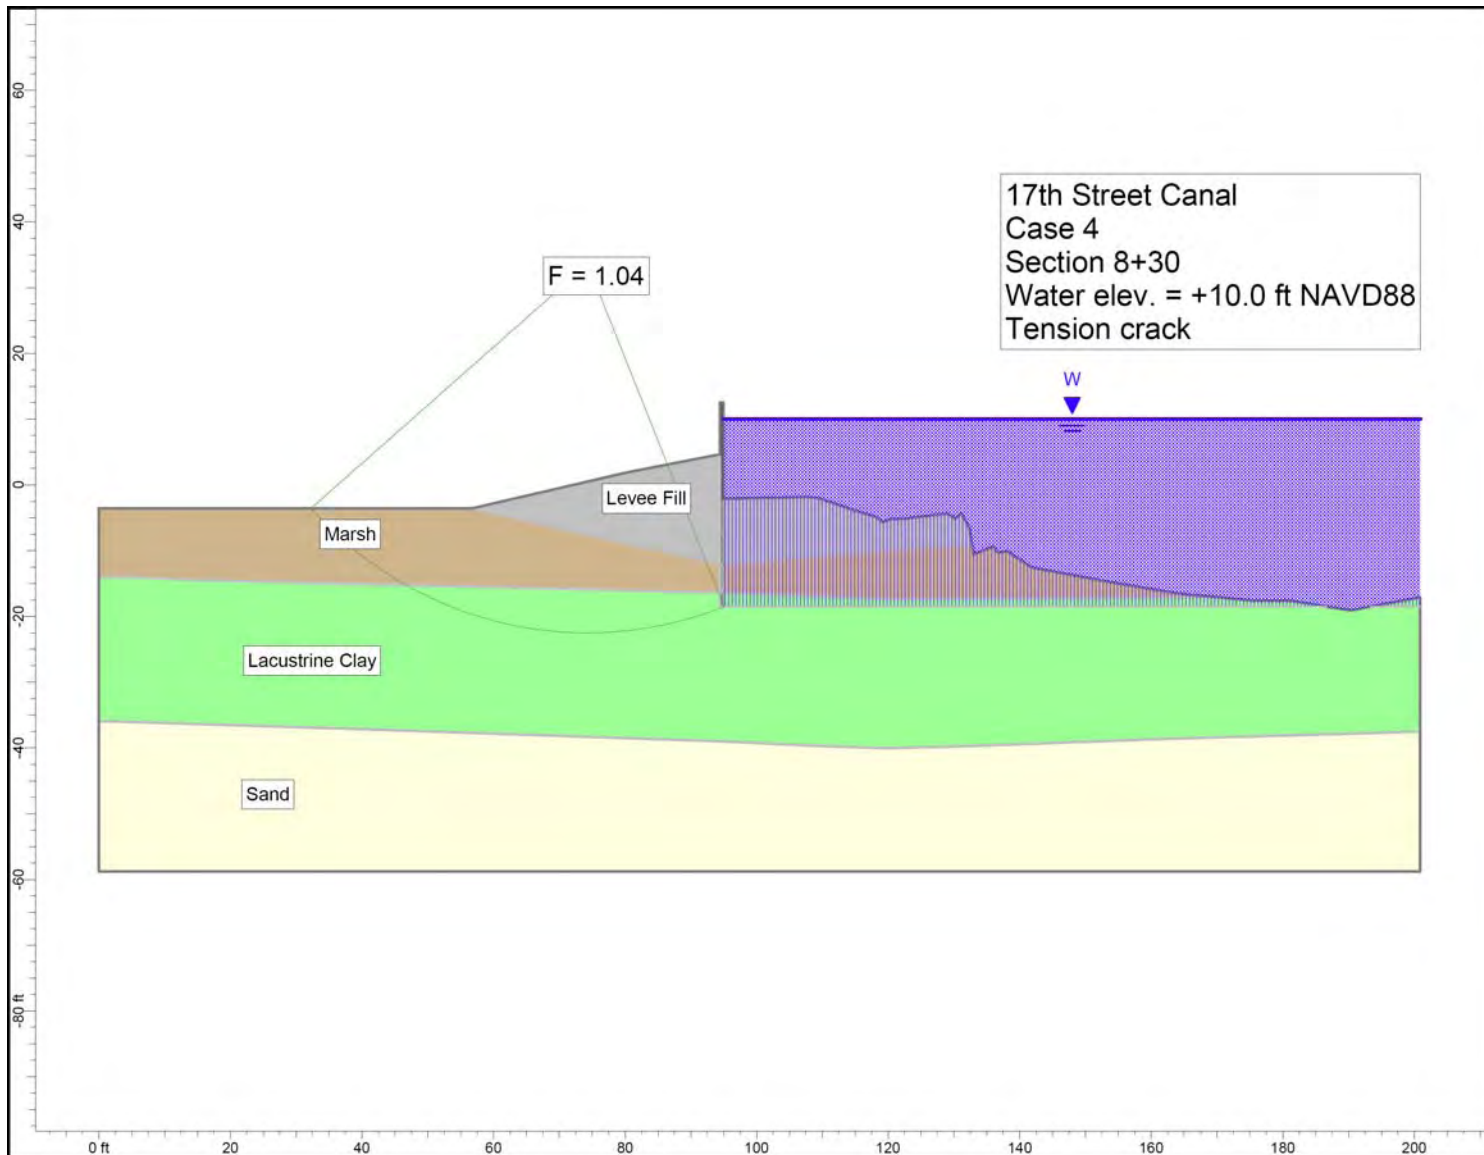
Figure 4-4. Critical Circle for 17th Street Canal Station 8+30 – Water Elevation 10 ft, Tension Crack

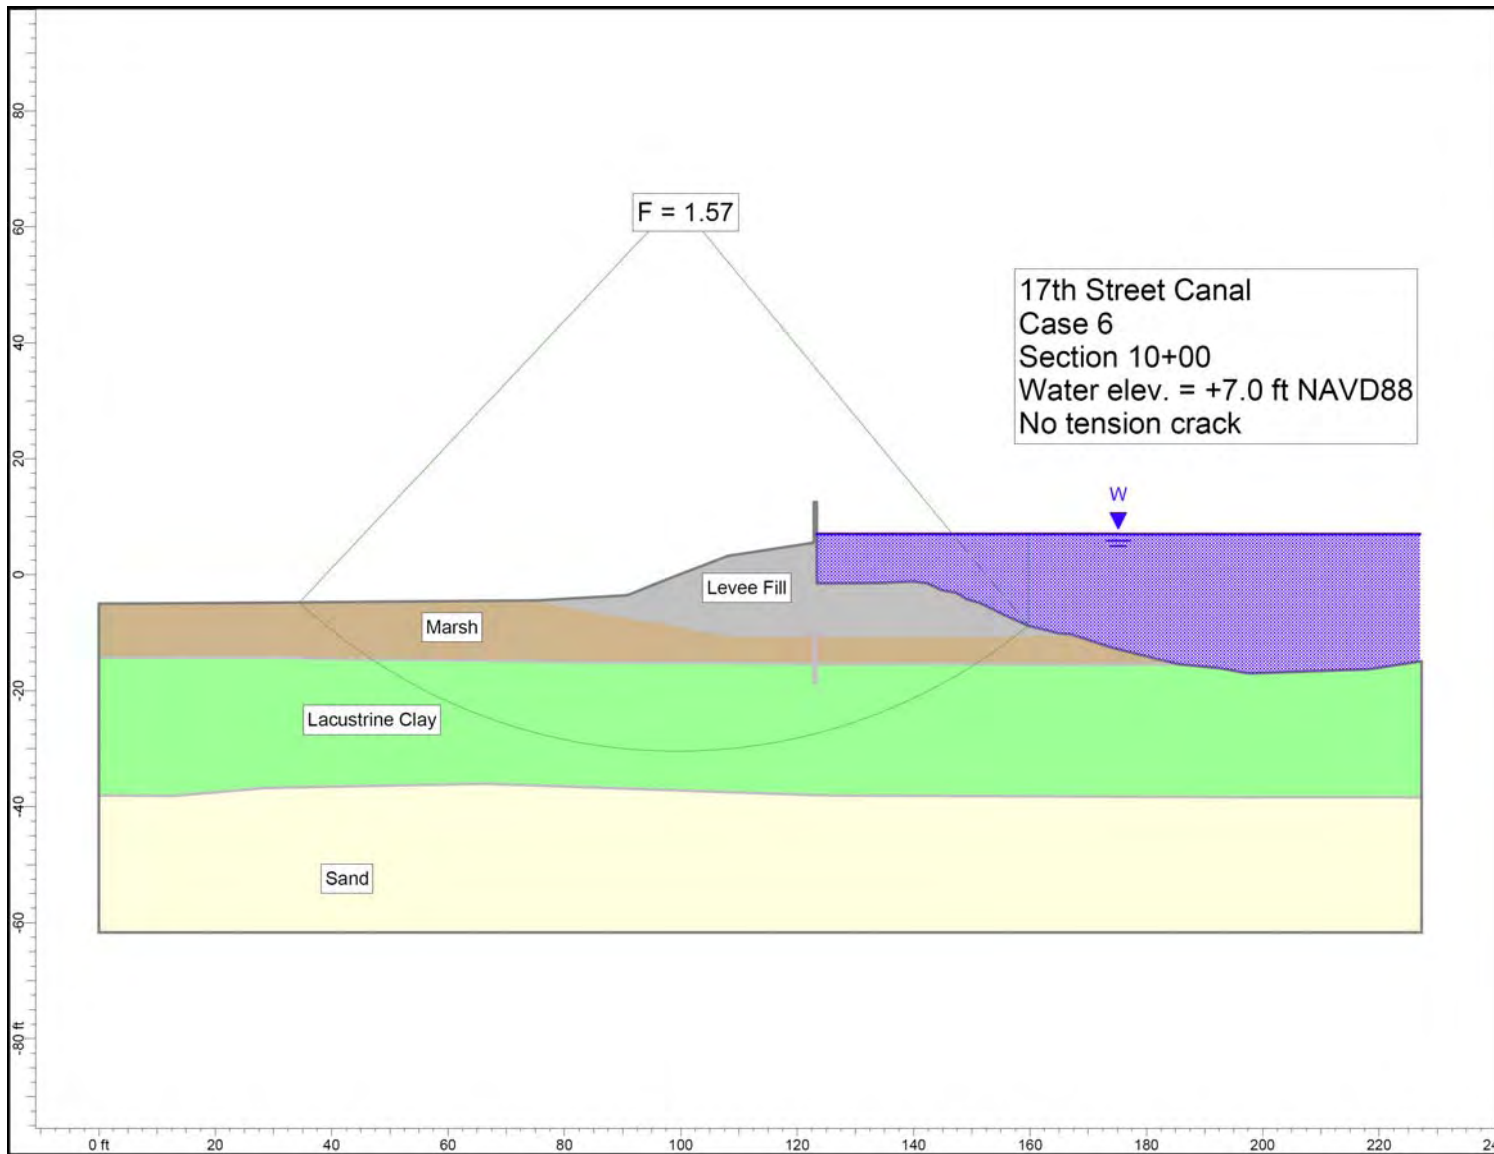
Figure 4-6. Critical Circle for 17th Street Canal Station 10+00 – Water Elevation 7.0 ft, No Tension Crack

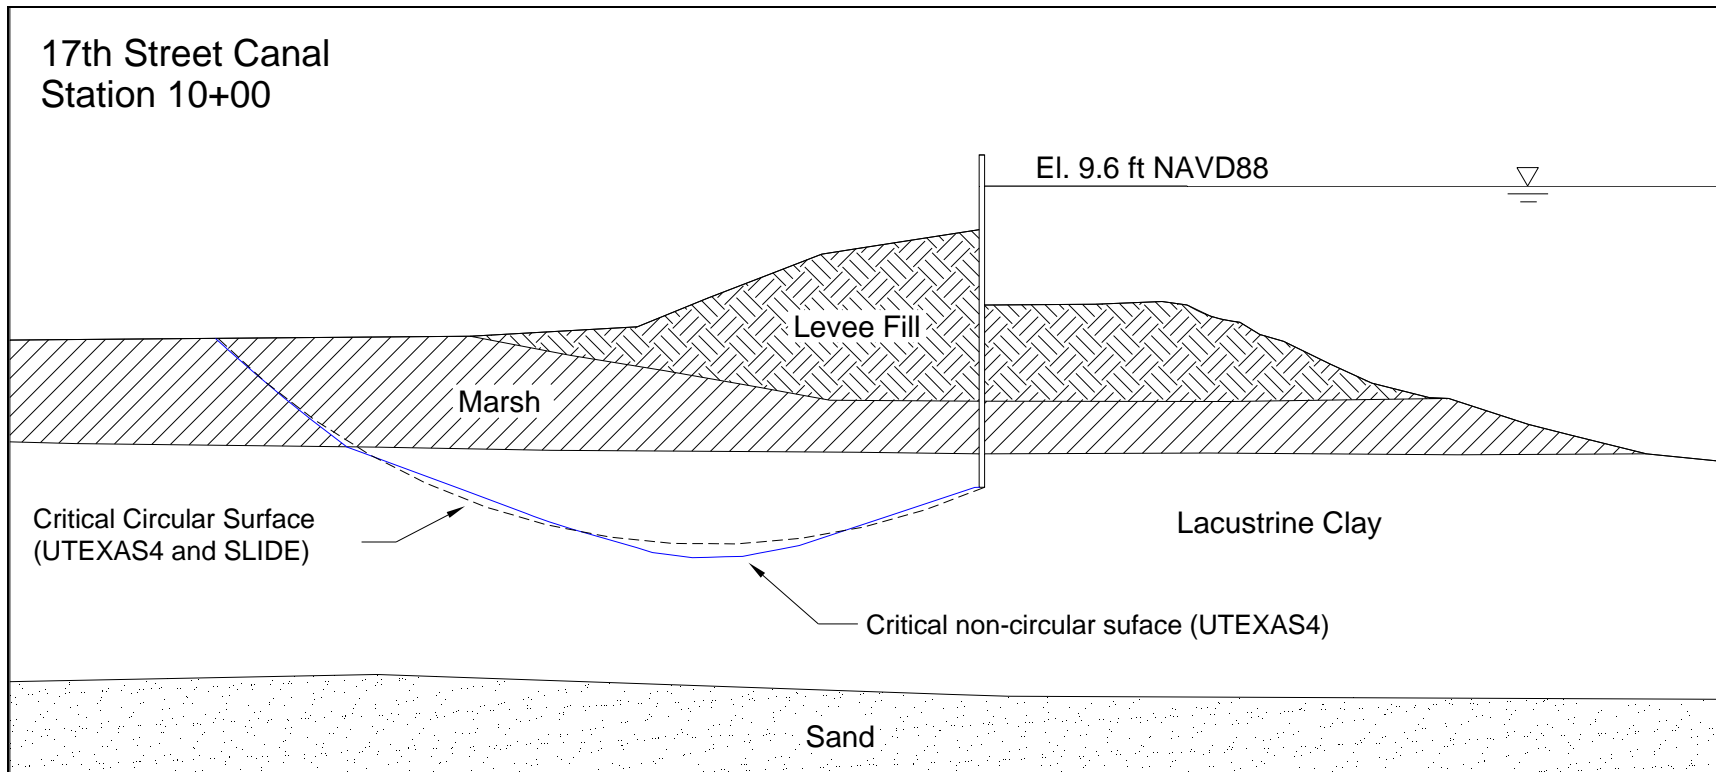
An additional factor to be considered is the fact that the analyses discussed so far used circular slip surfaces. Additional analyses have been performed using noncircular slip surfaces with UTEXAS4. A comparison of the critical circular surface with the critical noncircular surface is shown in Figure 4-22. Although the critical noncircular surface is very similar in shape and position to the critical circle, the factor of safety for the noncircular surface is 6% lower. This 6% lower factor of safety corresponds to a water level for $F = 1.00$ that is 0.8 ft lower than the $F = 1.00$ water level found using circular slip surfaces.

Figure 4-22. Critical Circular and Noncircular Slip Surfaces for 17th Street Canal, Station 10+00, Fully Cracked Condition

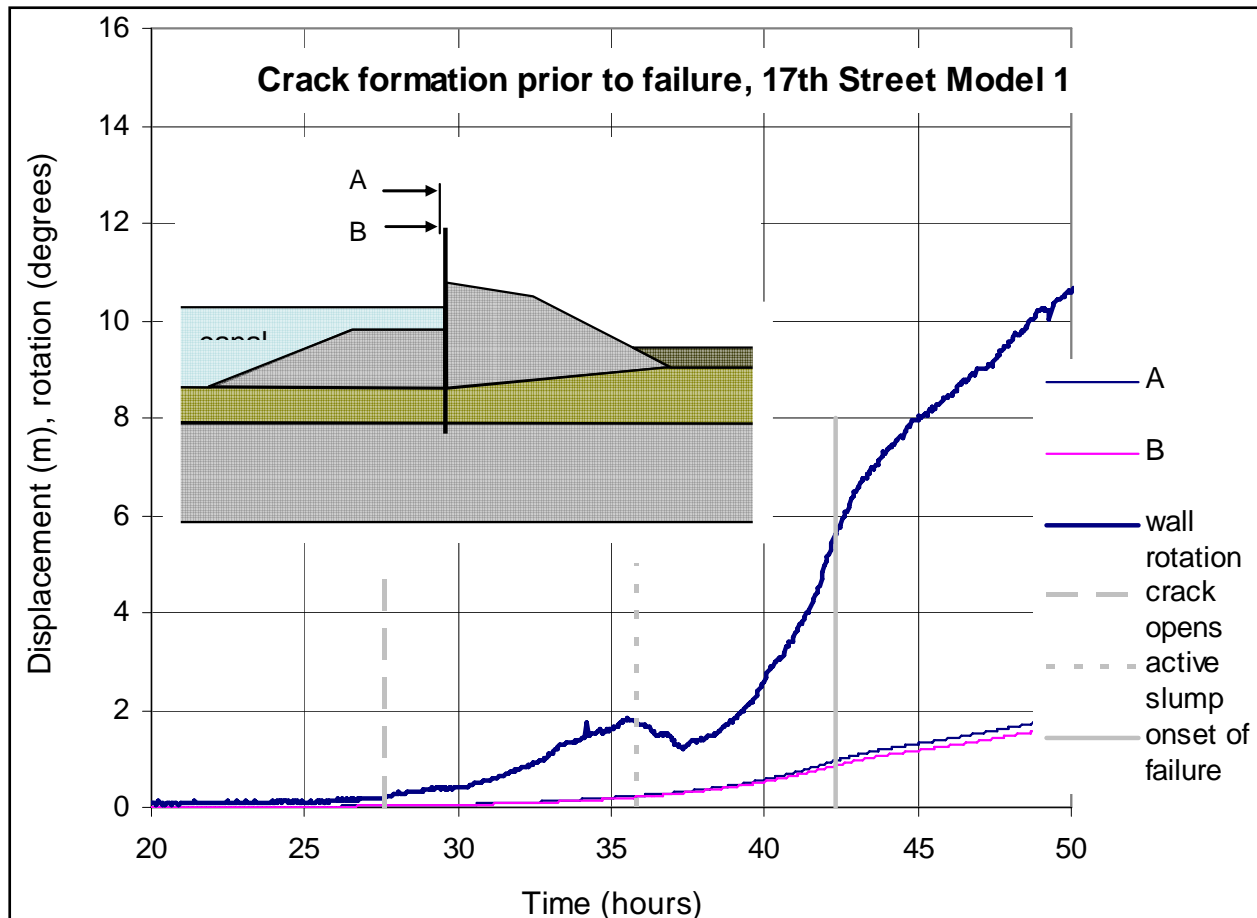
The observation of crack formation in the 17th Street levee models has been described above and was shown in Figure 5.16 for one case. A second example is shown here, Figure 5.29, from 17th Street Model 1, which shows an early rotation that briefly stabilises before the main failure commences (Scale time 28 to 36). (Note time scales in the centrifuge models are unrelated to the actual time line of the Katrina flooding. Time in the centrifuge models is therefore referred to in the text here as ‘Scale time’ to distinguish the two time lines.) Video imagery of the phase between the initial opening of the crack and the onset of the main failure shows active slumping behind the wall, which may explain the increase in rotation between around Scale time 37 and 42 hours.

Figure 5.29. Crack formation prior to wall failure, 17th Street Model 1

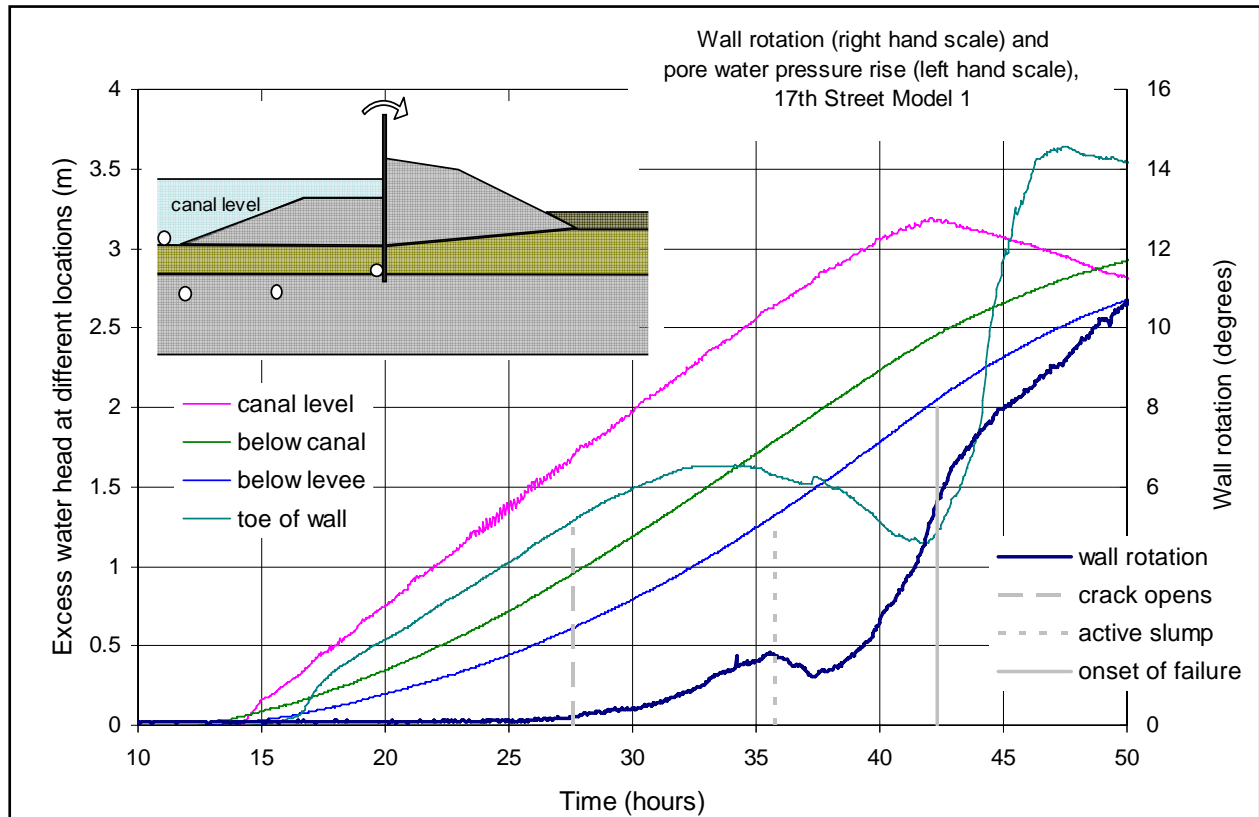
Comparing the wall rotation with the pore water pressure measurements at locations in the clay on the canal side of the wall, at the toe of the wall and the canal level (expressed as head in m of water) with the wall rotation gives further insight into the mechanism of failure, Figure 5.30. The crack formation phase is marked by a small rotation, up to 2 degrees movement, following which the wall briefly stabilises. As noted above, active slumping starts towards the end of the crack formation phase, perhaps as early as Scale time 30, indicated by the change of slope and reduction in excess head near the toe of the wall on the canal side. During this period, the pore pressures beneath the levee on the canal side reflect the increase in total stress but show no evidence of the wall movement.

The reduction in excess head near the toe of the wall continues as the wall ceases to rotate but continues to translate (between Scale time 36 – 37.5) before rotation starts again, leading to a sharp transition in performance around Scale time 42 as the wall fails. At this moment, the canal

level drops due to the rapid lateral movement, the water pressure at the bottom of the wall changes slope again and rapidly rises (to reach and exceed the canal level), and the rate of rotation slightly decreases as the main translational movement commences.

Figure 5.30. Comparison between wall rotation and excess head at onset of failure, 17th Street, Model 1

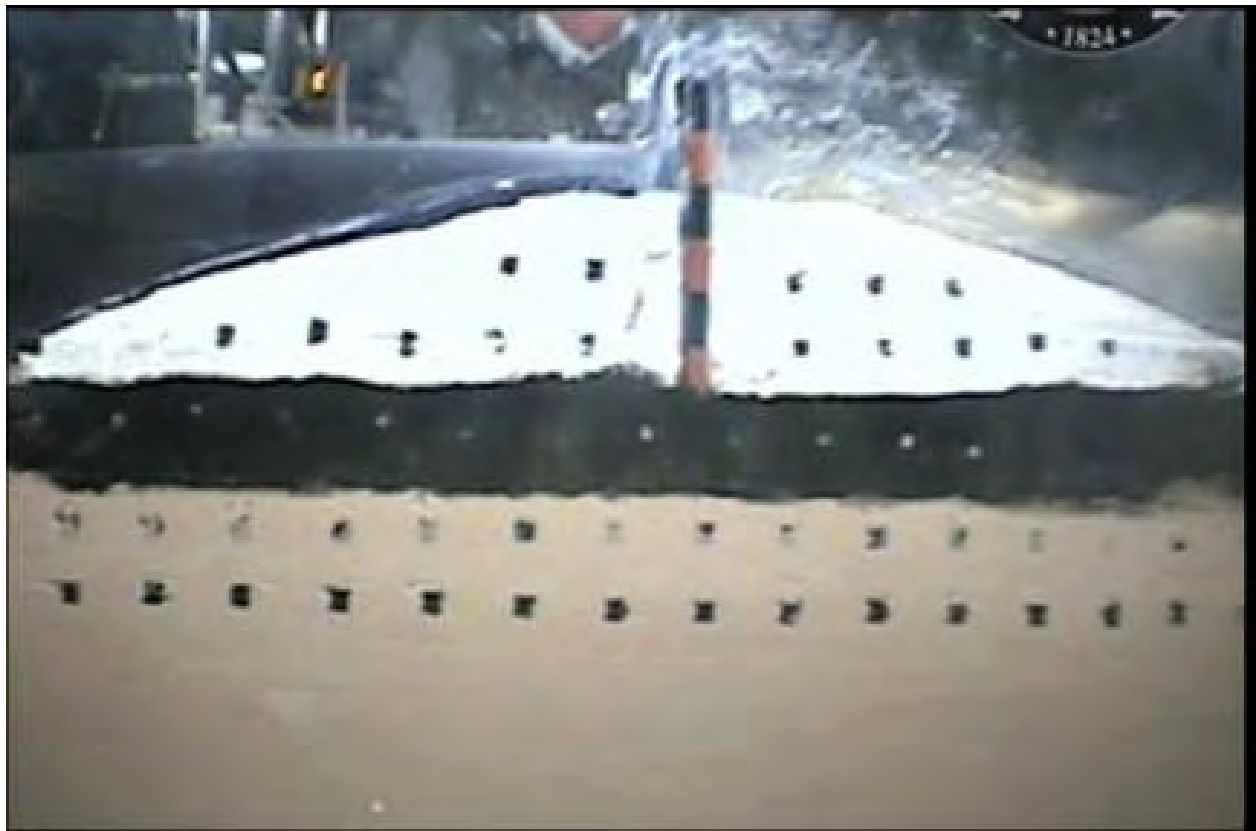
Figure 5.35. Orleans South model at Katrina flood level

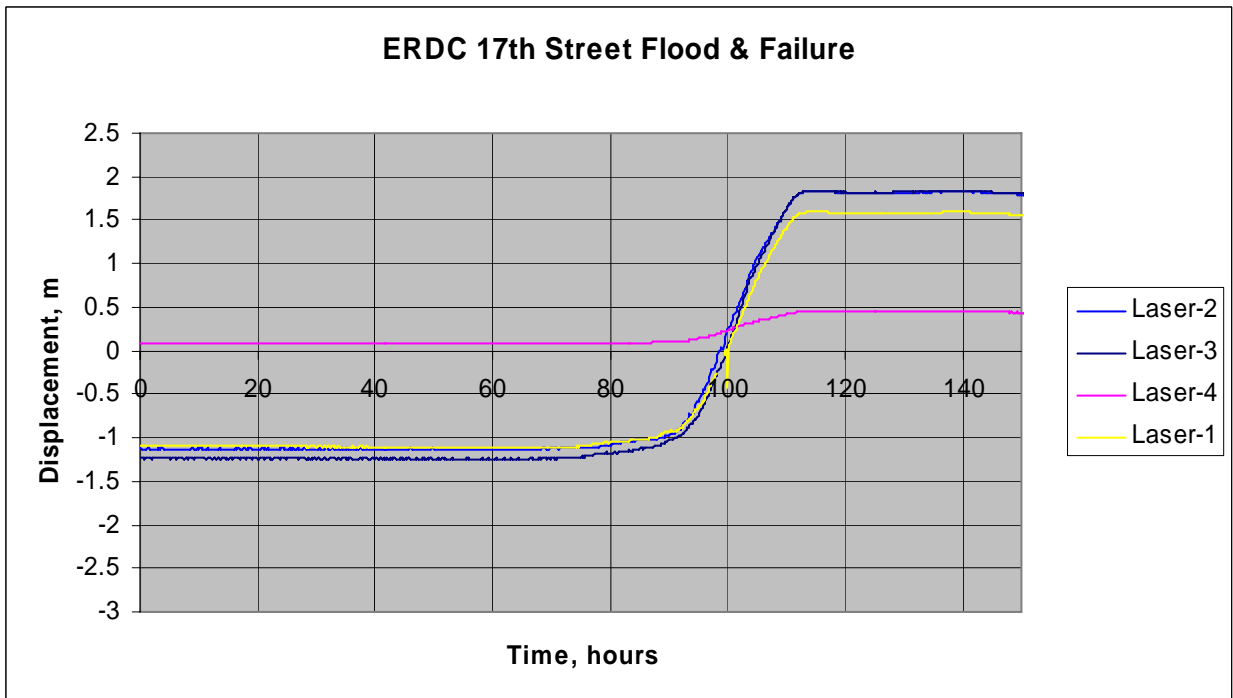
Figure 5.50. Displacement data from lasers during flood loading

The next series of plots will show the recorded data during the actual flood event. Recall that the model is at 50 g such that everything is properly scaled to field weights and pressures, the water is held at normal canal operating elevation, and all instruments have equalized under those conditions prior to addition of the flood load. The data is presented in Figures 5.47 through 5.50. Figure 5.47 is a plot of the PPT's located mid-depth of the foundation clay layer. Detailed discussions related to the processes and mechanisms occurring during the flood load and subsequent failure were previously discussed. Figure 5.48 is a plot of the PPT's located near the top of the foundation clay layer, revealing a similar characteristic as the mid-depth PPT's. Figure 5.49 is a plot of the PPT's located in the swampy/marsh layer and the levee both canal and land side. Finally, Figure 5.50 is a plot of the lasers, three on the sheet pile wall and one on the land side surface away from the toe. Notice that there is some heaving of the foundation away from the toe on the land side as the failure occurs.

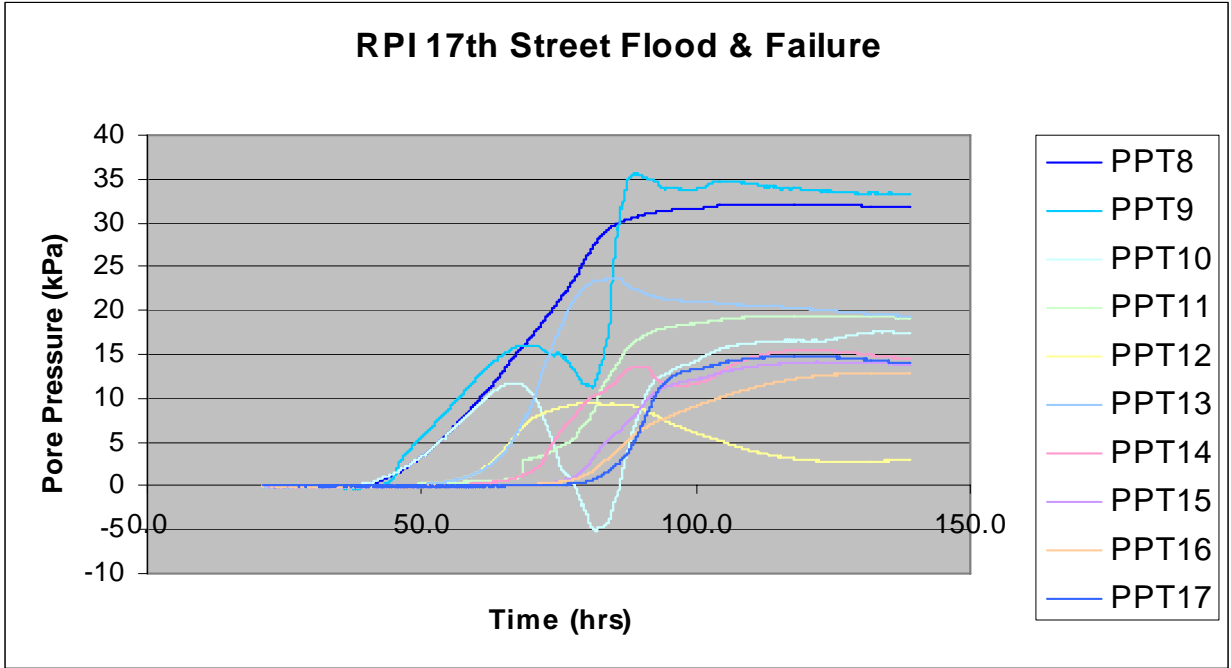
Figure 5.53. PPT data along the foundation clay swampy/marsh interface during flood and failure

Data from the PPT's located along the foundation clay swampy/marsh interface is shown in Figure 5.53. Notice that some of the PPT's show an initial rise in values followed by a drop in values then a sudden increase in values. These PPT's are located very near the sheet pile and are indicative of development of the crack. A second observation is the value of each PPT reading. The PPT values in Figure 5.53 from highest to lowest represent sensors located in the model moving from the canal side to the land side. So, the highest recorded values are in the material under the canal/land side with decreasing values under the land side levee and out into the free field. This is exactly as would be expected for this type of foundation material. Figure 5.54 is the recorded PPT data in the levee. Behavior is consistent with that previously discussed.
