Appendix 1

Soil Data Report for 17th Street Canal

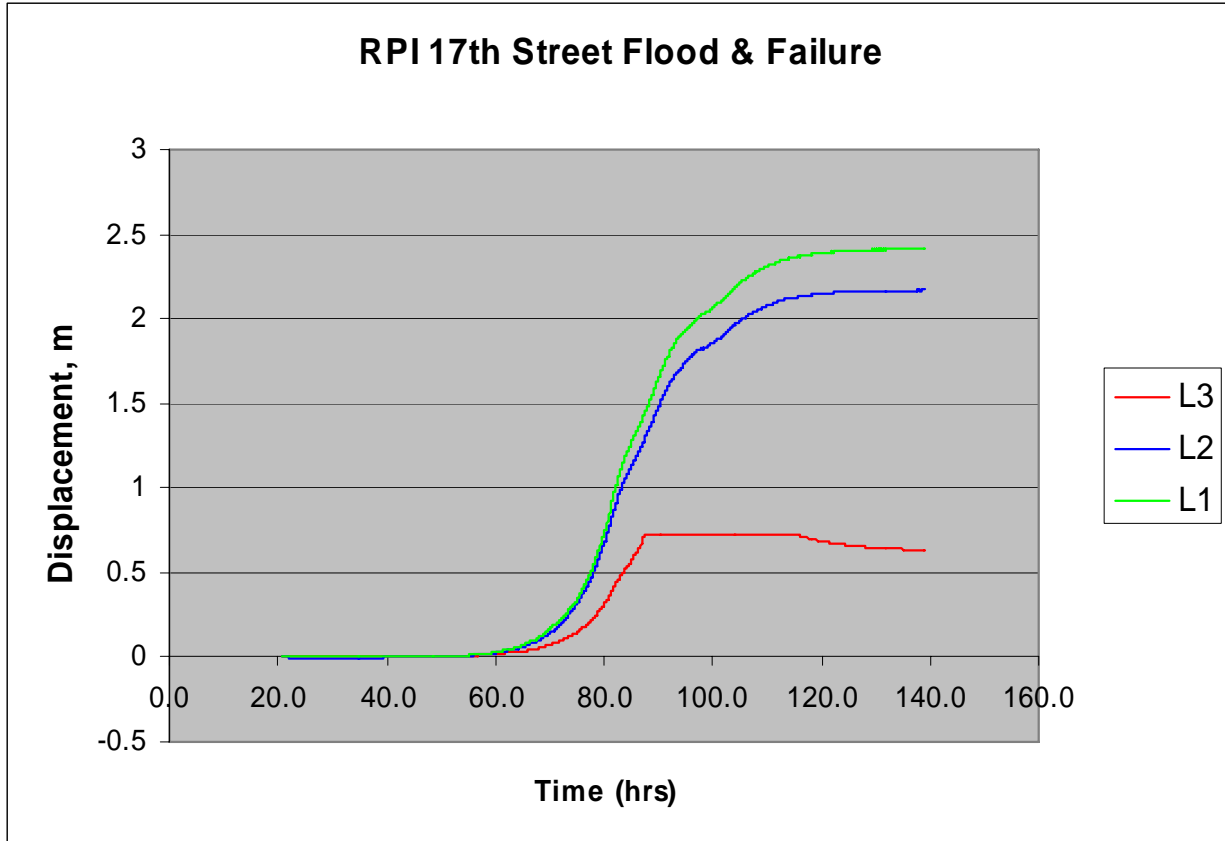
Figure 5.55. Displacement recordings of the sheet pile and canal side levee

Figure 5.55 shows the recordings of the lasers on the sheet pile wall and top of the levee canal side. In the figure, the green and blue curves show movement of the wall with the two measurements on the same vertical plane of the wall but separated some distance apart. This arrangement allows determination of how the wall moved in terms of rotation, translation, etc. The data show that from start of movement until sometime thereafter, the wall movement was translational and at the very end became more rotational (the lines are diverging). This is an important point in confirming that the failure was translational. The red curve in the plot is the displacement of the canal side levee during the flood and failure.

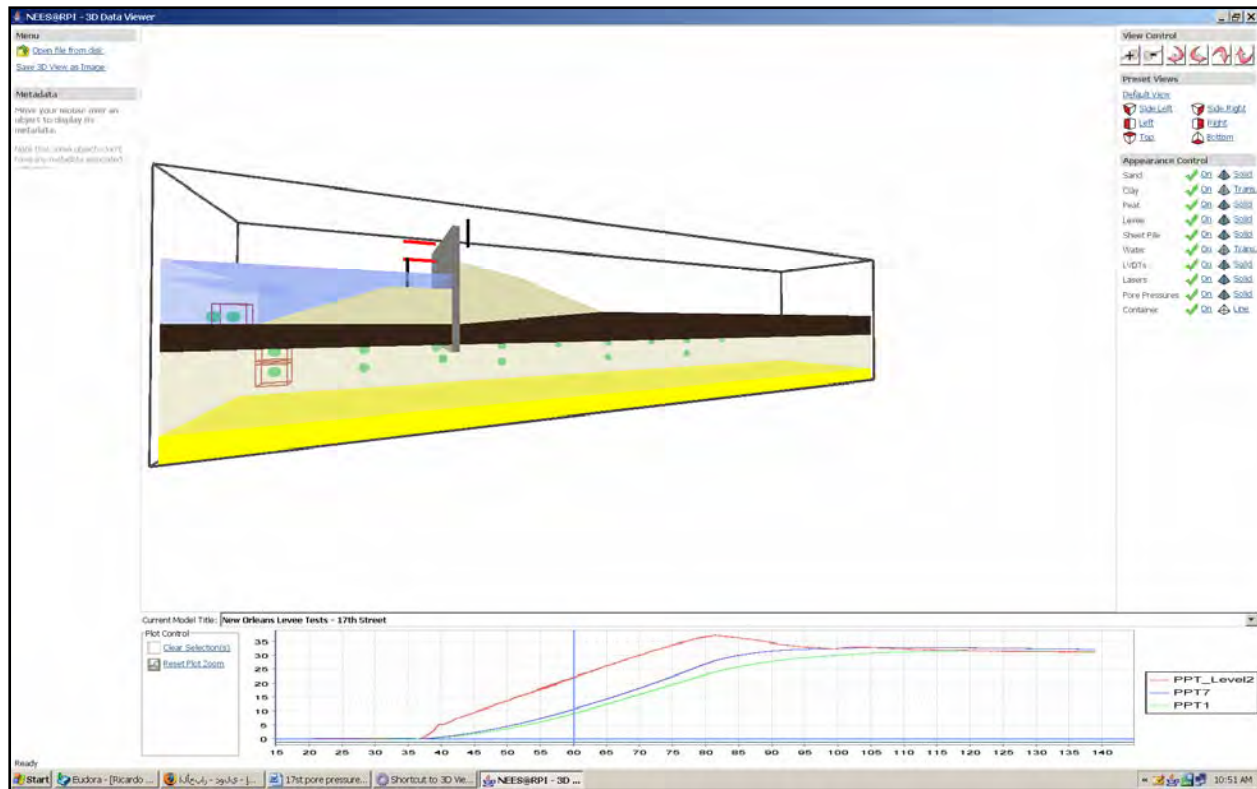
Figure 5.60. PPT data for transducers as indicated in the figure

As shown in Figure 5.60, in the early stages of water rise, with the canal level very low, the ratio between the increase in water pressure $\Delta\sigma_w$ (red line) and the increase in measured (blue and green lines) near the toe varies between 0.4-0.55 (comparing the slope of the lines). As the water rises higher, the rate of increase of water pressure Δu increases to match the rate of increase of total vertical stress, $\Delta\sigma_w$, indicating one dimensional loading in the clay layer at higher water levels.

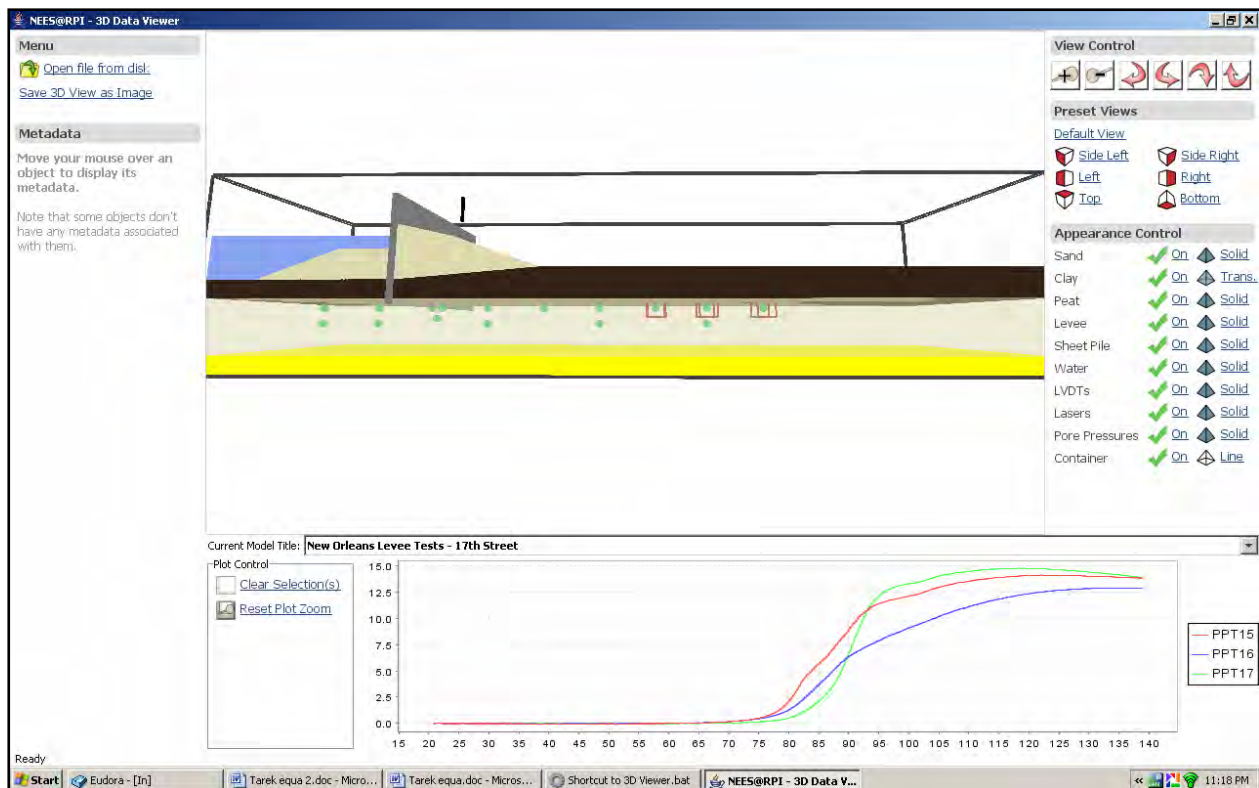
Figure 5.62. PPT data for the transducers as indicated in the figure

As shown in Figure 5.62 the pore pressure measured by the three pore pressure sensors just outside of the failure zone recorded about 14kpa. It is important to note that the measured Δu indicate that it started to increase at the same time the levee started to fail.

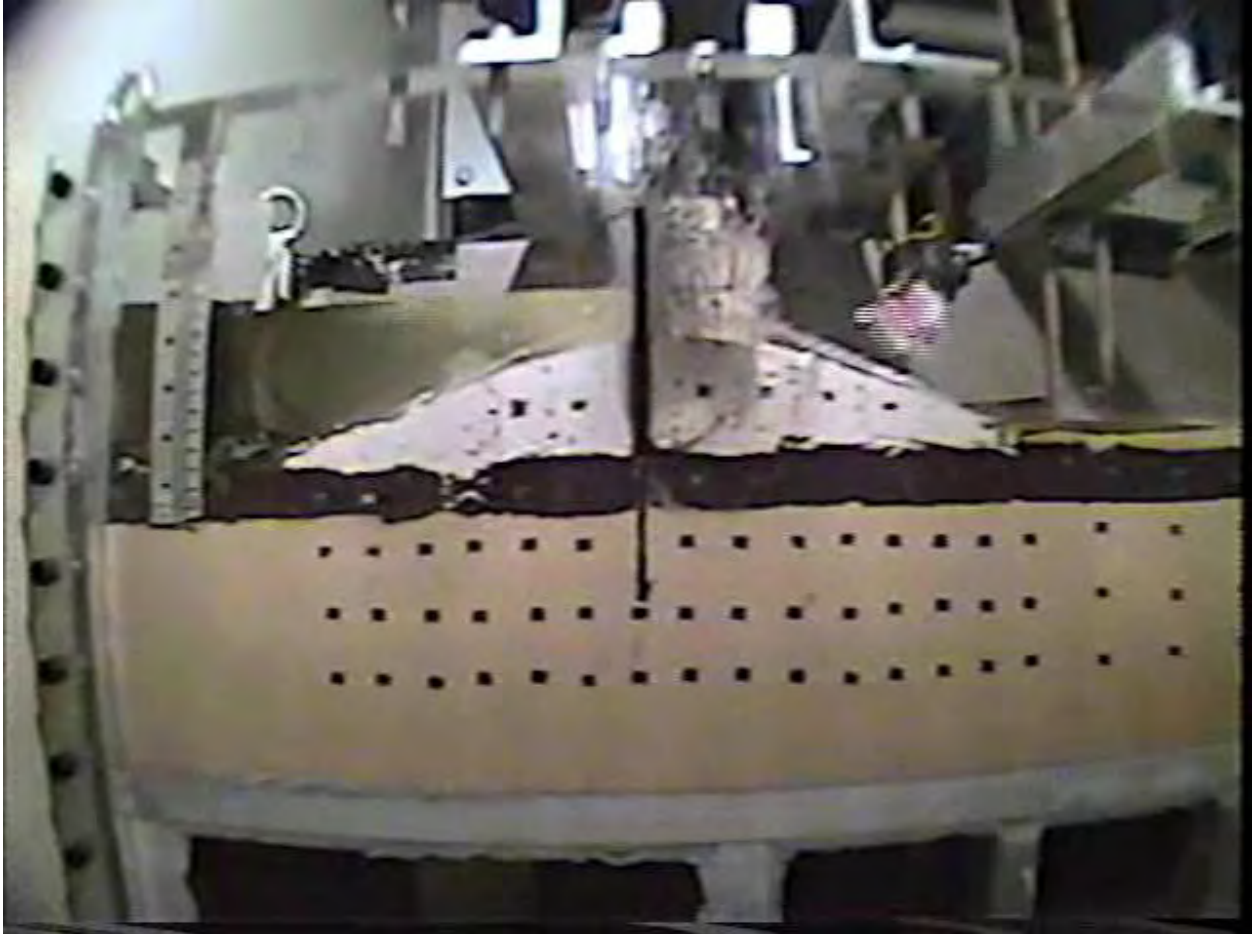
Figure 5.66b. ERDC London Avenue south model at flood level just prior to any wall movement

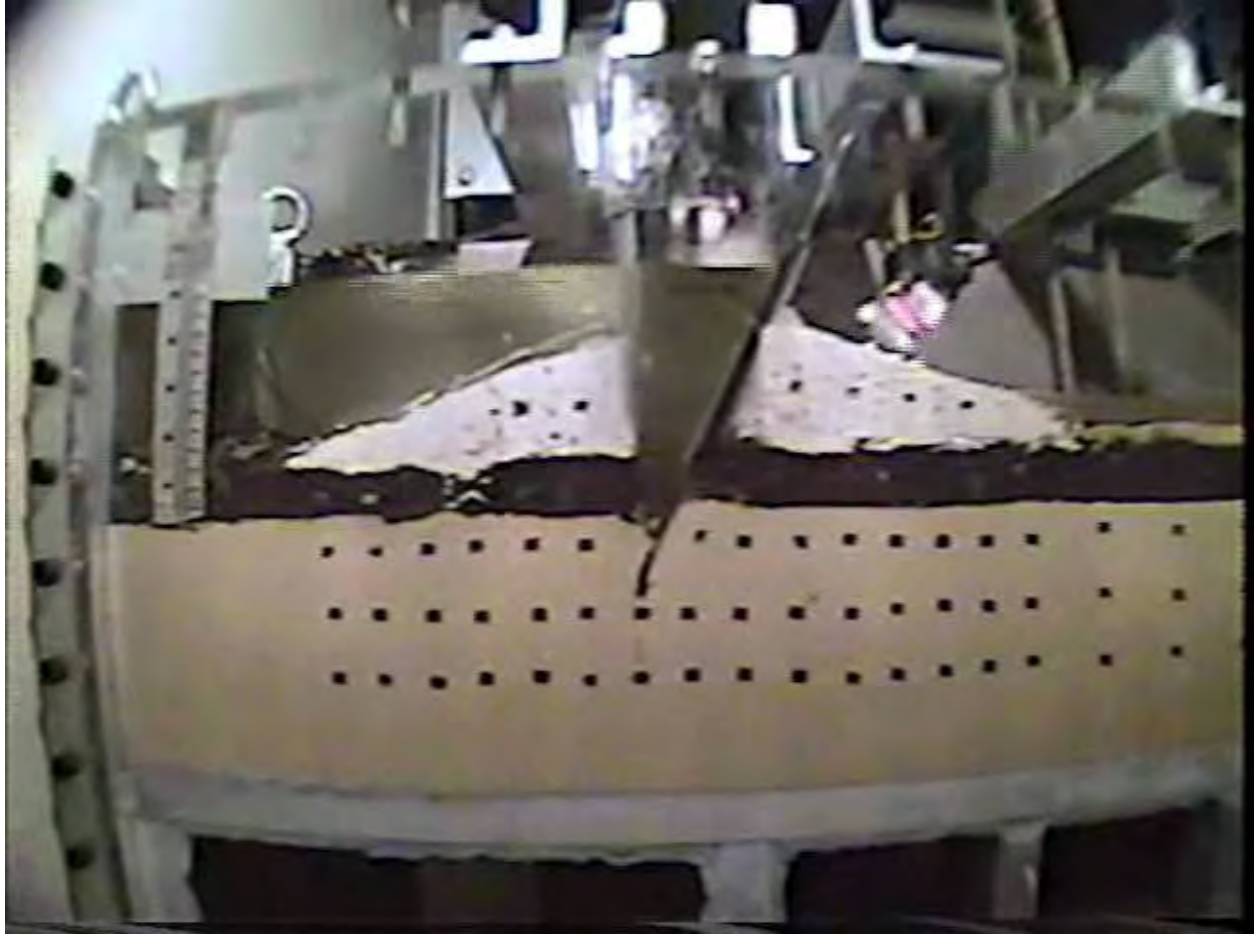
2. A crack begins to form between the sheet wall and canal side levee and propagates downward.
3. The crack extends all the way through the levee and the swampy/marsh layer to the top of the sand layer.
4. Full hydrostatic pressure is allowed to reach the foundation sand layer causing a sudden increase in pore water pressure.
5. This increase in pore water pressure reduces the vertical effective stress of the overlying swampy/marsh and levee material. Effectively the land side material approaches zero effective stress and begins to 'float'.
6. Load from the flood pushes the wall over in a rotational manner with no resisting force from the land side material.

Figure 5.66e. ERDC London Avenue south model at end of test

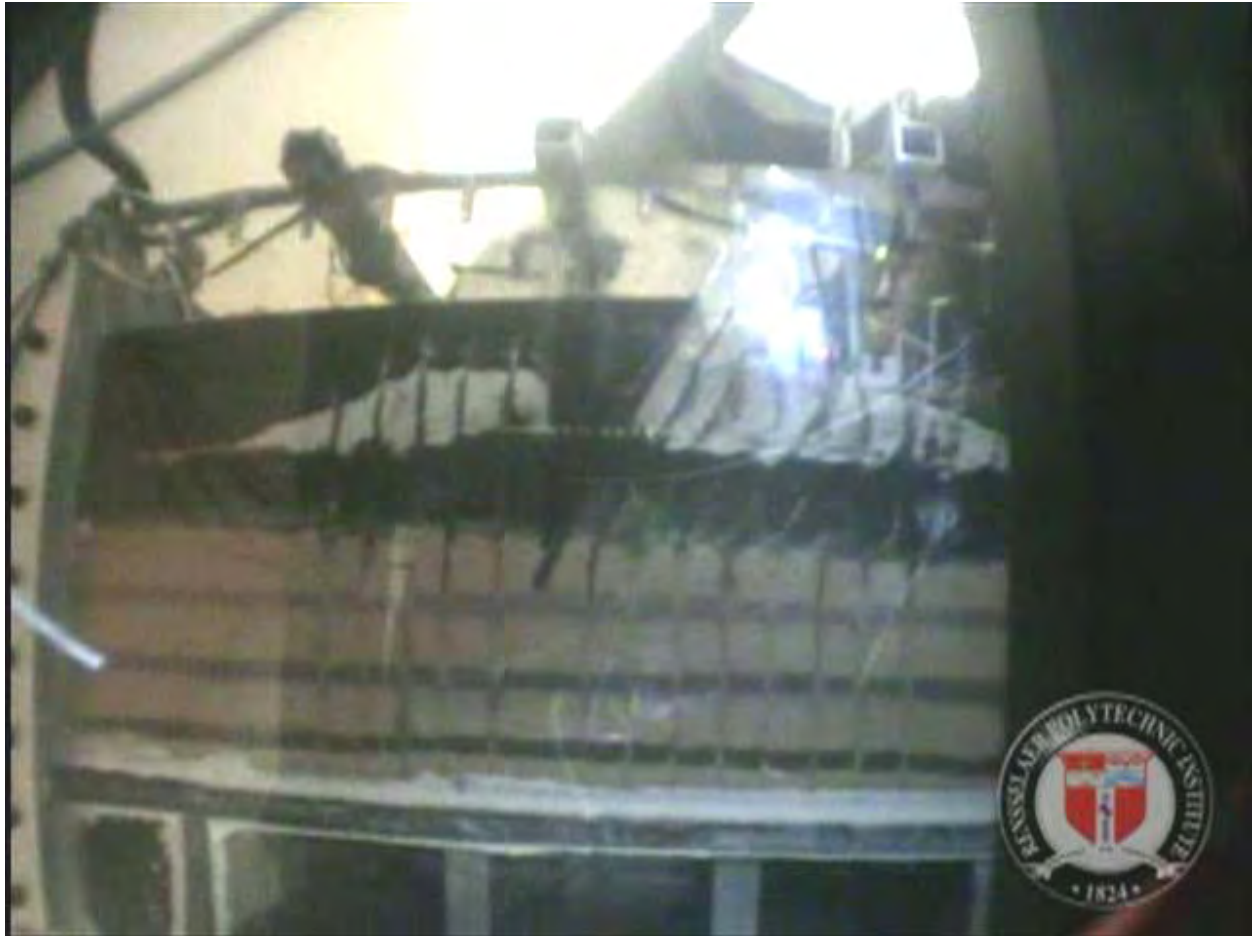
Figure 5.91e. RPI London north model at flood level end of failure

A synopsis of the failure event that occurred in the RPI London north model is as highlighted following. This is exactly the same failure event as was observed in the ERDC London north model and confirms the event.

1. Water level increases to a point on the wall where initial movement of the wall begins to occur. This movement starts out as a rotation of the wall.
2. A crack begins to form between the sheet wall and canal side levee and propagates downward.
3. The crack extends all the way through the levee and the swampy/marsh layer to the top of the sand layer.
4. Full hydrostatic pressure is allowed to reach the foundation sand layer causing a sudden increase in pore water pressure.
5. This increase in pore water pressure reduces the vertical effective stress of the overlying swampy/marsh and levee material. Effectively the land side material approaches zero effective stress and begins to 'float'.
6. Load from the flood pushes the wall over in a rotational manner with no resisting force from the land side material.

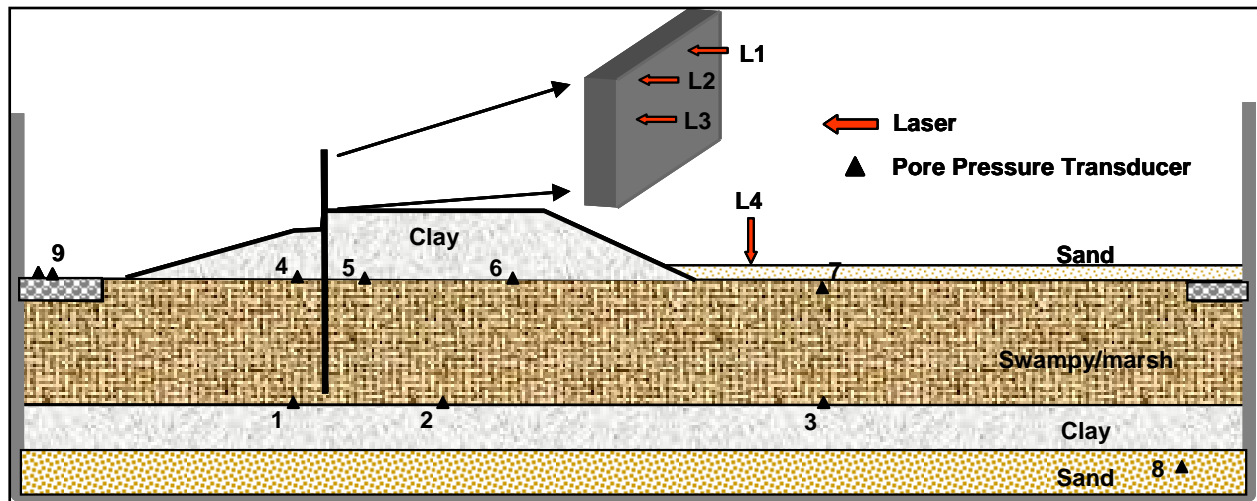
Figure 5.92. ERDC model of Orleans Avenue canal, north area

The model representative of a section through the north end of the Orleans Avenue canal is shown in Figure 5.92. The sheet pile extends through the swampy/marsh layer almost to the bottom. The height of the wall above the levee crest on the canal side is approximately 1.5 m, and the normal canal elevation does not reach the top of the levee.

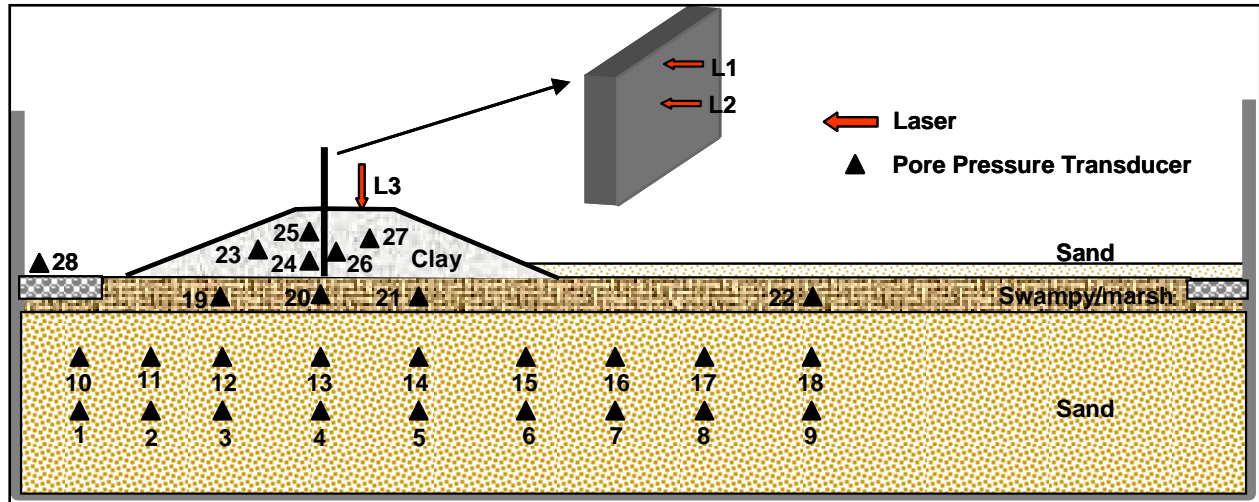
Figure 5.96. RPI model of the Orleans Avenue canal, south area

The model representative of a section through the south end of the Orleans Avenue canal is shown in Figure 5.96. The sheet pile extends through the levee to the top of the swampy/marsh

layer. The height of the wall above the levee crest on the canal side is approximately 1.5 m, and the normal canal elevation does not reach the top of the levee.

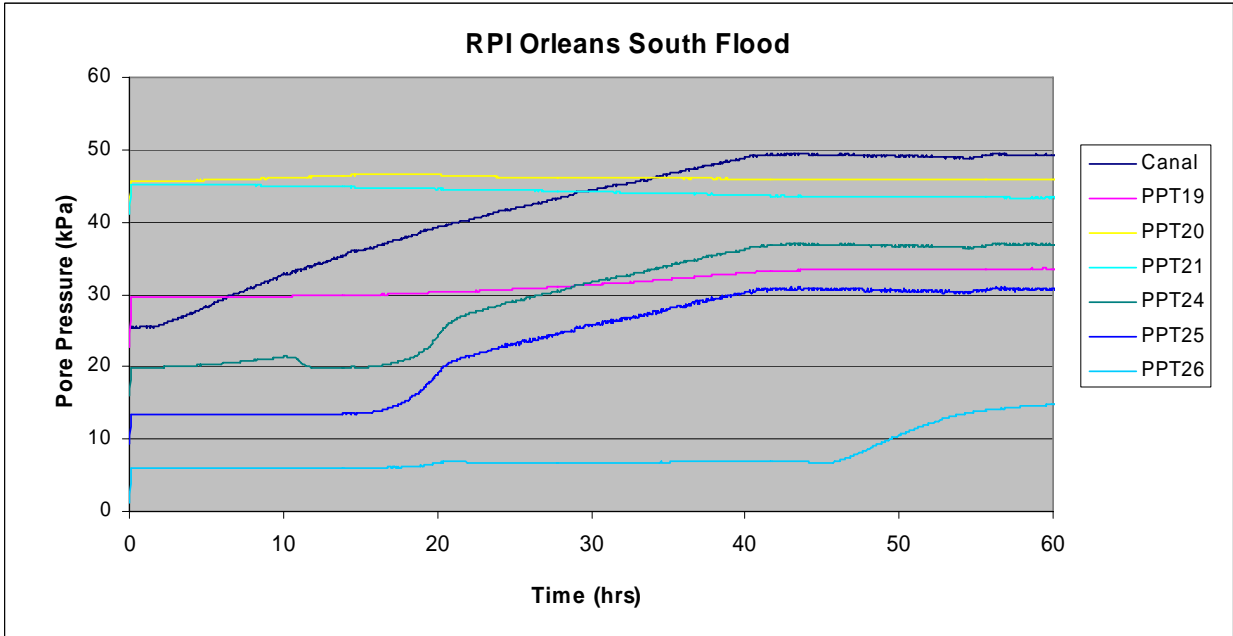
Figure 5.98 is a plot of the PPT data in the sand layer near top during flood event. The character is very much like that of the data in Figure 5.97. Figure 5.99 is the PPT data recorded in the levee and swampy/marsh layer during the flood. There is very little to no response from any of the PPT's located in the swampy/marsh layer. This is not an unexpected event since increase in canal water level would have little effect on these readings over the relatively short duration of the flood event. Notice that there is an increase in PPT's 24, 25 and 26. Instruments 24 and 25 are located near the wall on the canal side and are feeling the load of the increased water level. There is a delayed response in the rise of pressure recorded by PPT 26 which would be expected.

Figure 5.98. PPT data in the sand layer, near top during flood event

Figure 5.99. PPT data in the levee and swampy/marsh layer during flood

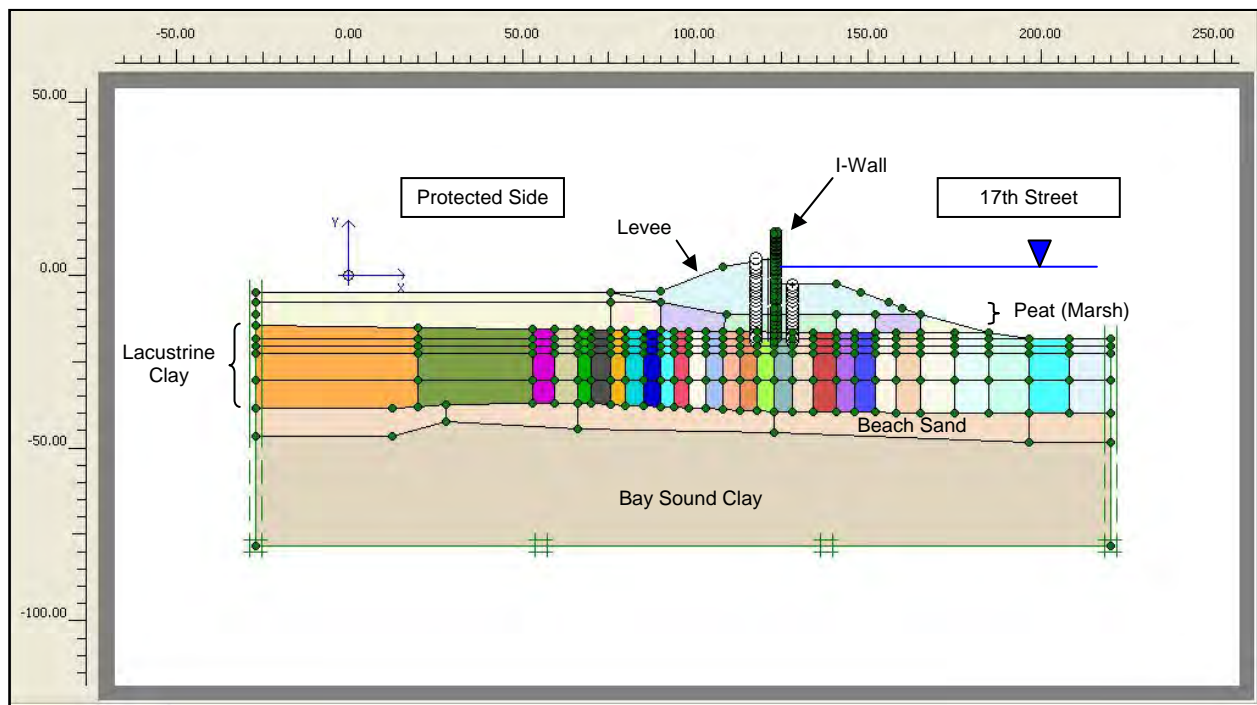
Figure 6-1. Two-Dimensional Cross-Section Model used in the Complete SSI Analysis of Station 10+00 at the 17th Street Canal – East Side

The 2-D cross section within the failed section of the east side of the 17th Street Canal at Station 10+00 analyzed for flood loading is shown in Figure 6-1.¹ The 2-D section is 247-ft wide and extends from x-coordinate equal to -27 ft to the centerline of the canal at x equal to 220 ft. The top of the I-wall is at El 12.5. The crest of the earthen levee on the protected (east) side of the I-wall is at El 5, with a crest width of approximately 15 ft. Note that the I-wall extends above the crest of the soil-founded levee. The protected side of the levee has a 1 on 3 side slope to approximately El -4.5. The protected side ground surface is assigned El -5 for this section. A bench exists at El -2.5 on the canal side of the I-wall. This bench is submerged for the normal water level in the canal, El 1. In the canal and beyond the end of the bench, the submerged levee face has a 1 on 3 side slope to approximately El -11.5. Between El -11.5 and El -16.5, the face of the peat soil layer is exposed to canal water. Below El -16.5, the Lacustrine clay soil layer is exposed to water in the canal. The deepest point in the canal is at the canal centerline (i.e., x = 220 ft in Figure 6-1), with a top of Lacustrine clay at El -18.5 at this location.

Proceeding from top to bottom in Figure 6-1, this cross section contains layers of levee fill (clay), peat (also referred to as marsh), lacustrine clay, beach sand, and Bay Sound clay. The top of the I-wall is at El 12.5, and the base of the Figure 6-1 cross section is assigned to El -78.5. El -78.5 corresponds (approximately) to the bottom of the Bay Sound clay at Station 10+00. The soil layering is consistent with that used in the slope stability evaluations made for this cross section.

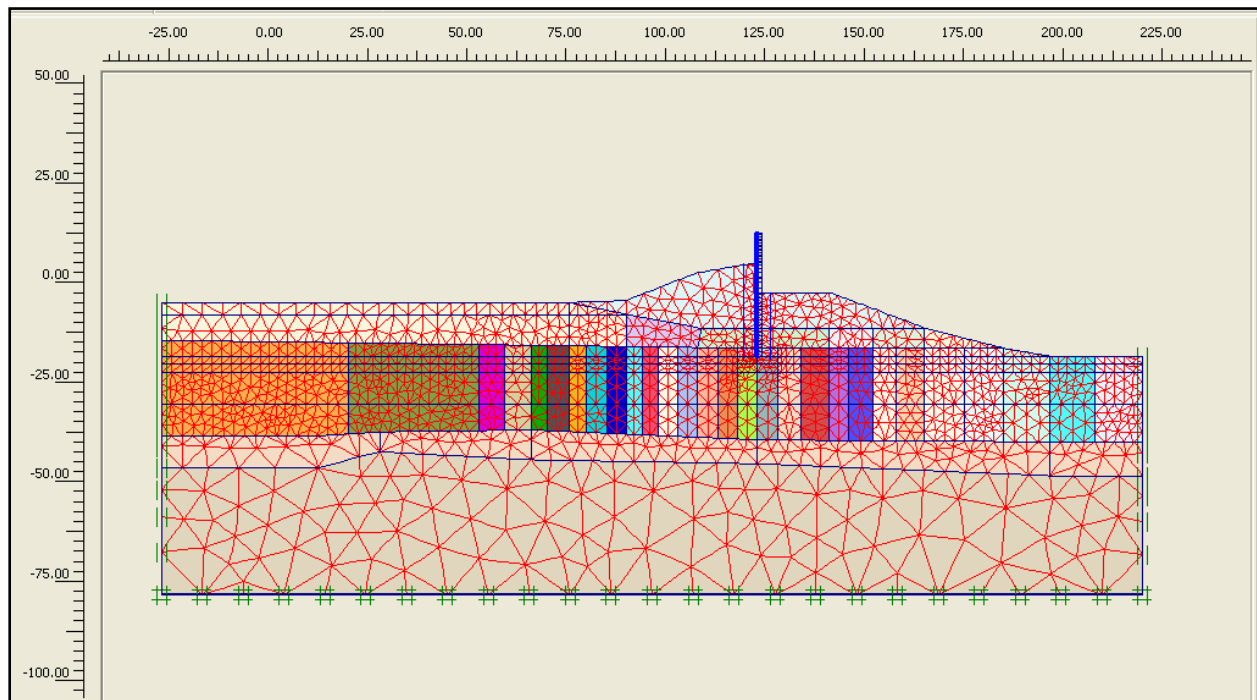
Figure 6-2. Finite-Element Mesh used in the Complete SSI Analysis of Station 10+00 at 17th Street Canal – East Side

Key Plaxis modeling features used in the plane strain analysis of the 17th Street include the use of 15-node triangular elements to model the soil, plates (i.e., special beam elements) to model the bending of the I-wall and the sheet pile wall, and interface elements to model SSI between the sheet pile wall and the adjacent soil elements. A total of 26,858 nodes and 3,374 elements, containing 39,492 stress points, were used to define the Figure 6-2 mesh. Details regarding the quantity of each of the three types of plane strain elements used in the finite-element model, as well as select characteristics of each type of element, are summarized in Table 6-1.

A zero horizontal displacement is specified along the left- and right-hand side vertical boundaries of the Figure 6-2 finite-element mesh. However, these nodes are free to displace in the vertical direction. Along the bottom boundary of the mesh, zero horizontal and vertical displacements are specified at these nodes.

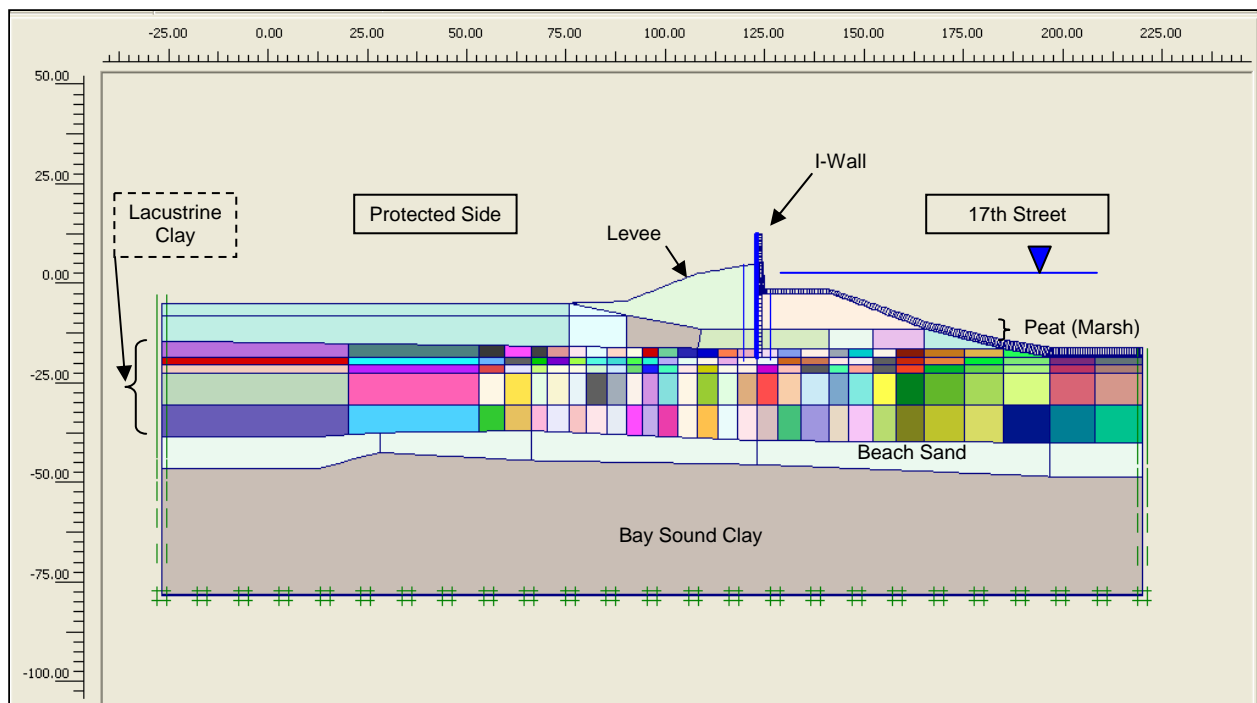
Figure 6-3. The 219 Soil Clusters used in the SSI Analysis of Station 10+00 at 17th Street Canal – East Side

The soil material properties used in this complete SSI analysis are the same as those used in the slope stability analyses of this cross section. Figure 6-3 shows the 219 soil clusters used to define the regions of common soil properties for the five categories of soil within the mesh (i.e., the levee clay, peat (or marsh), lacustrine clay, beach sand, Bay Sound clay). Note that each soil layer comprises many clusters, each of which is designated by a different color. Spatially varying soil properties are assigned in the slope stability analyses. Accordingly, multiple soil clusters are used in the nonlinear finite-element mesh to assign material properties within each soil layer to accommodate the spatially varying (i.e., vertically as well as horizontally) soil properties. Table 6-2 summarizes the engineering material properties and, for some layers, the range in assigned engineering soil properties used in the complete SSI analysis.

There are five rows of soil clusters used to define the lacustrine clay layer (refer to Figure 6-3). Shear strengths for the top row of soil clusters are assigned undrained shear strength values using the data discussed in the previous paragraph and based on its center x-coordinate. Interpretation of cone test results shows an increase in undrained shear strength with depth equal to 11 psf per ft depth. Undrained shear strengths for the lower four rows of lacustrine clay are assigned based on the value for S_u at the top of the lacustrine clay, plus the product of 11 psf per ft depth times the vertical distance between cluster center and the top of the lacustrine clay layer.

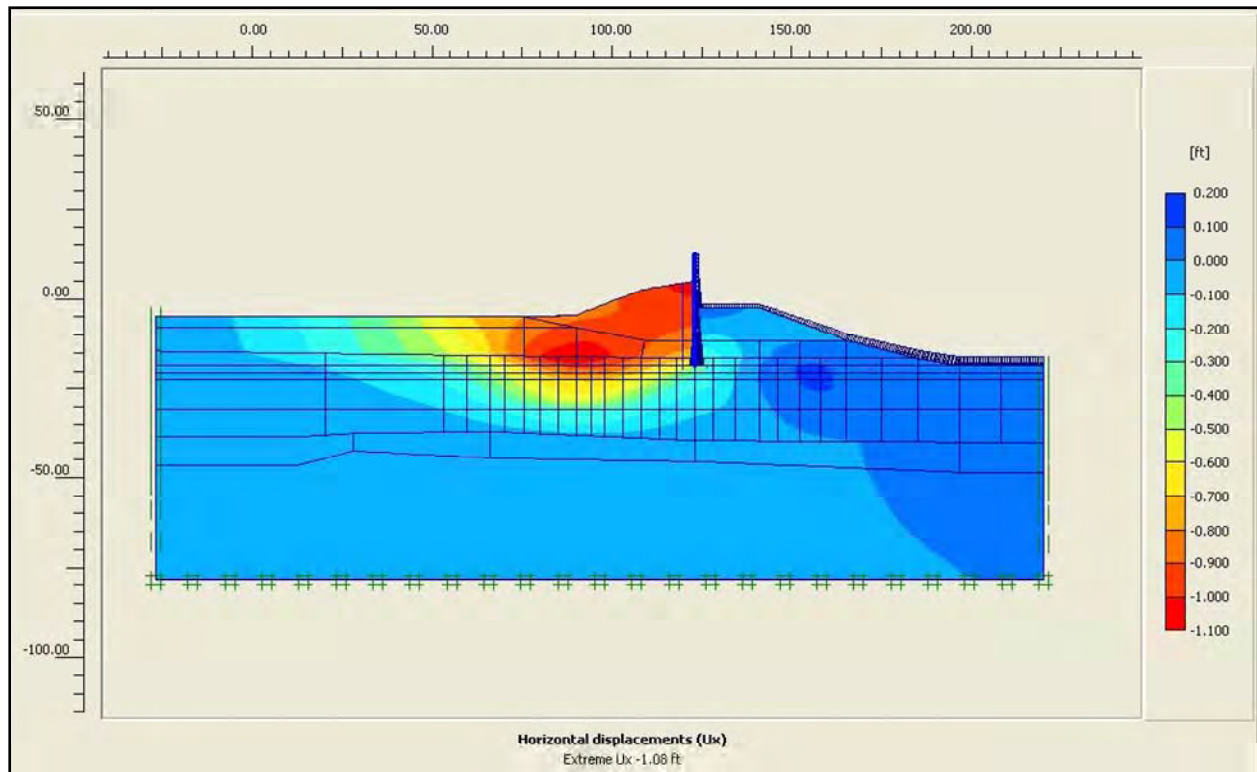
Figure 6-29. Horizontal Deformation Shadings for Canal EI 7.5 and Crack to EI -18.5

Figure 6-29 shows the horizontal displacements of the soil regions within the mesh, relative to their position at a canal water elevation of 1.0. This figure shows the deformation of the protected side levee, the peat below the levee, and the top layer of the lacustrine clay, all to be moving away from the canal with a displacement of between -0.7 to -1.1 ft under an El 7.5 flood loading and including a full crack.

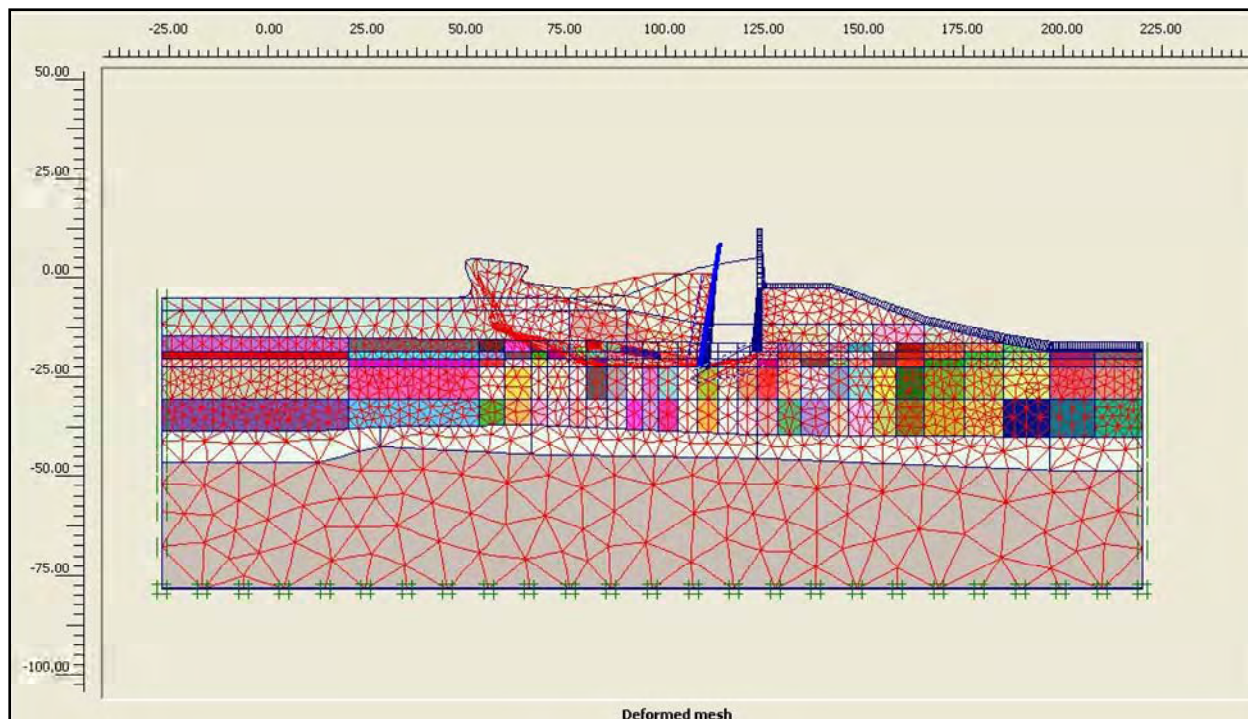
Figure 6-39. Failure Mechanism from Phi/C Reduction for Canal EI 9 and Crack to EI -18.5

Figure 6-39 shows the failure mechanism based on a Plaxis Phi/C reduction procedure resulting in a computed factor of safety against shear failure of 0.98, while the corresponding Figure 6-40 shear strains show that the zone of higher shear strains extend to the upper layer of the lacustrine clay. Note the mechanism “daylighting” beyond the toe of the levee. This result is consistent with the Figure 6-36 displacements, showing the bulging upwards of the peat/marsh layer beyond levee toe; the zone of high values for the computed fraction of mobilized shear strength within this region in Figure 6-37; and the Figure 6-38 high shear strains also computed within this region.

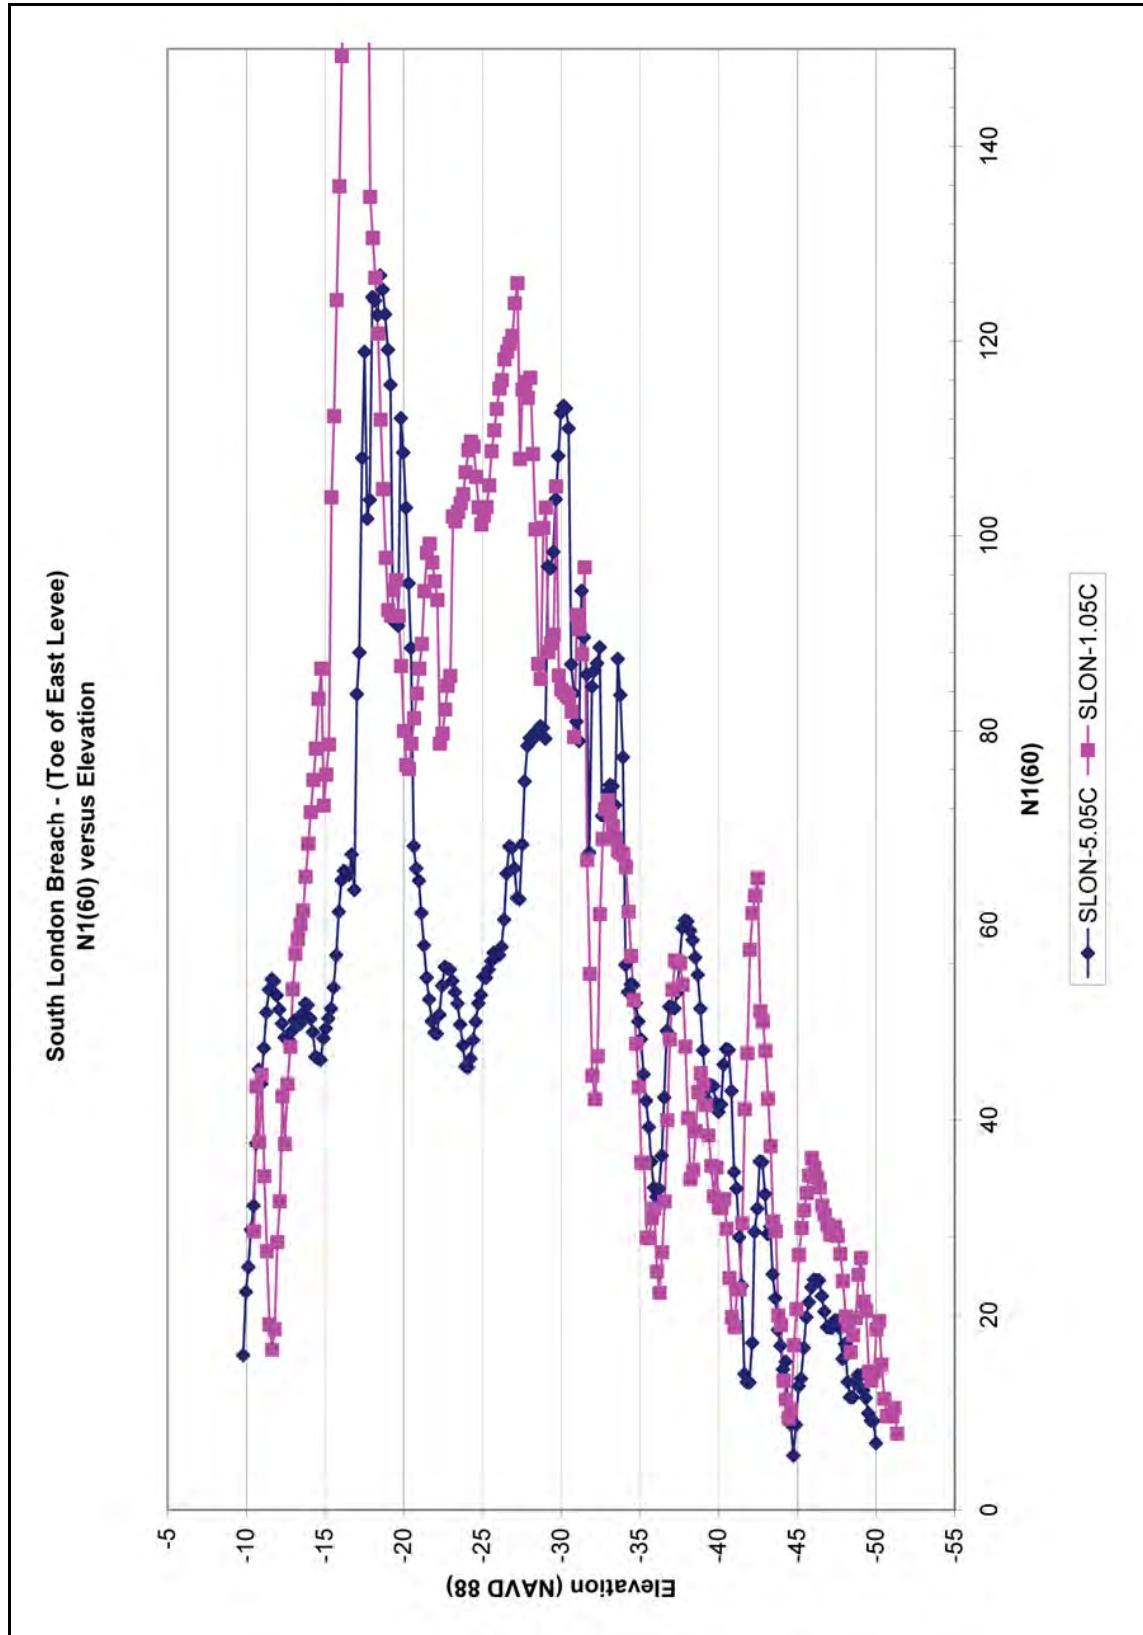
Figure 7-47. South London Breach – Beach Sand Stratum (Toe of East Levee), N1(60) versus Elevation for CPTs SLON-5.05c and SLON-1.05c

On Figure 7-47, NLON-5.05c also shows a dense sand layer (N₁₍₆₀₎ values range from 50 to over 100) from elevations -15 to -35. Both NLON-5.05c and NLON-1.05c show N₁₍₆₀₎ values over 100. This occurs because of the process in which the N₁₍₆₀₎ values are determined. Because of shallow depths and low overburden pressures, the C_n correction factor is greater than 1; and when multiplied to the N₍₆₀₎ values, will often produce an N₁₍₆₀₎ over 100. Liao and Whitman's (1986) relationship between C_n and vertical effective stress was used to convert the field blowcounts to their N₁₍₆₀₎ values. However, in some cases, the N₍₆₀₎ values are already near or at 100 at overburden pressures less than 1 tsf. Usually, N values greater than 50 are accepted as refusal. NLON-1.05c shows that dense sand layer N₁₍₆₀₎ values range from 50 to over 100) from elevations -13 to -35.

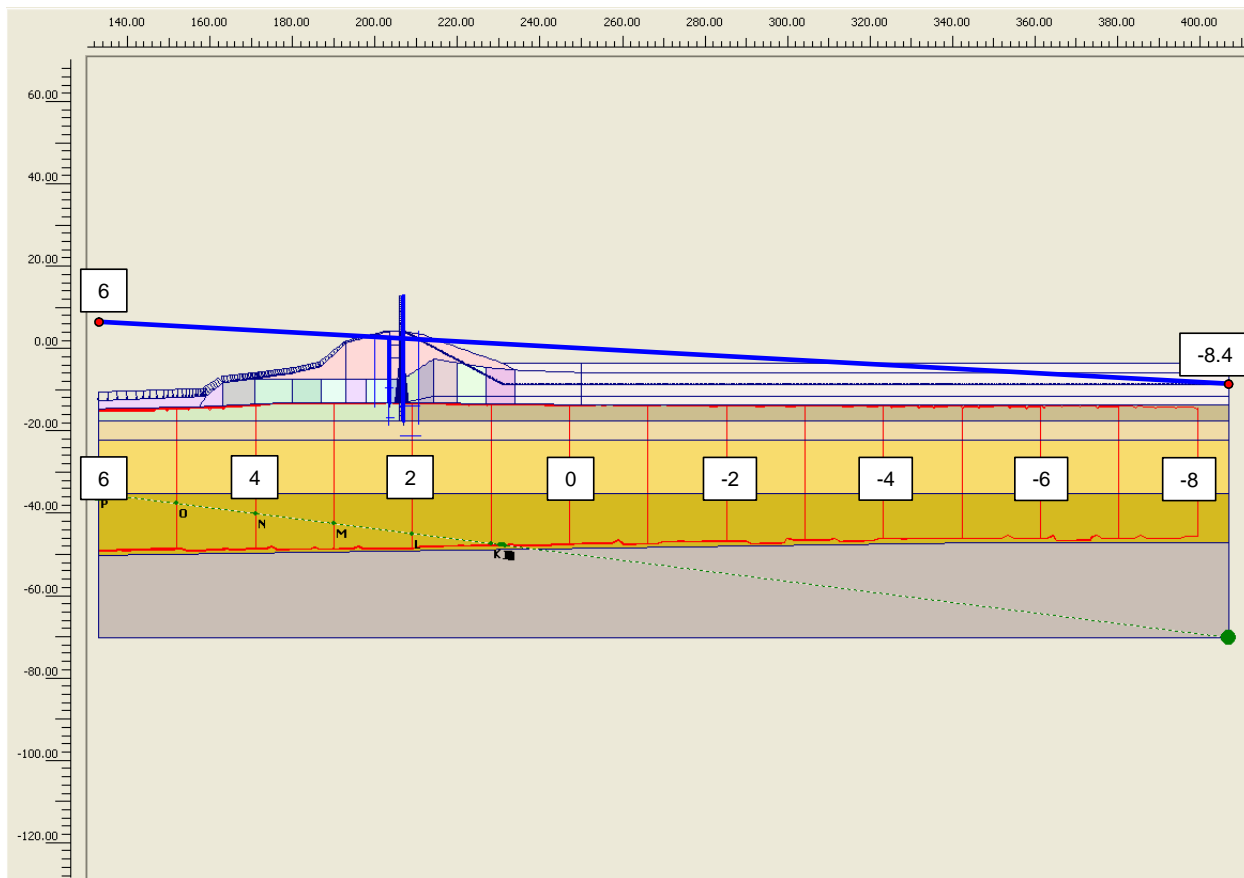
Due to numerical convergence issues, a linear phreatic surface assumption is used to establish the pore water pressures within the Beach sand for loading phases 13 through 16 (Table 9-5) of the first complete set of SSI analysis in which depth of cracking extends to the top of Beach sand layer (EL -12.9). This results in a less severe uplift pressure regime within the Beach sand below the toe of the protected side of the Levee as seen, for example, by comparing computed values and positions of equipotential lines for the Figure 9-5 steady state seepage results with the Figure 9-6 results for an analysis using a linear phreatic surface assumption. A linear phreatic surface assumption results in a less severe uplift pressure regime within the top of the Beach sand below and immediately beyond the toe of the protected side of the Levee. This results in a lower computed value for the Factor of Safety for the loading phases 13 through 16 in which this procedure is applied. Again, this compromise in accuracy is required in order to achieve convergence by Plaxis for these higher Canal water elevations with cracking to the top of the Beach sand.

Figure 9-6. Equipotential Lines Based on a Linear Phreatic Surface for Canal Water El 6 and a Crack to the Top of Beach Sand (El -12.9) on the Canal Side of the New Sheet Pile Wall

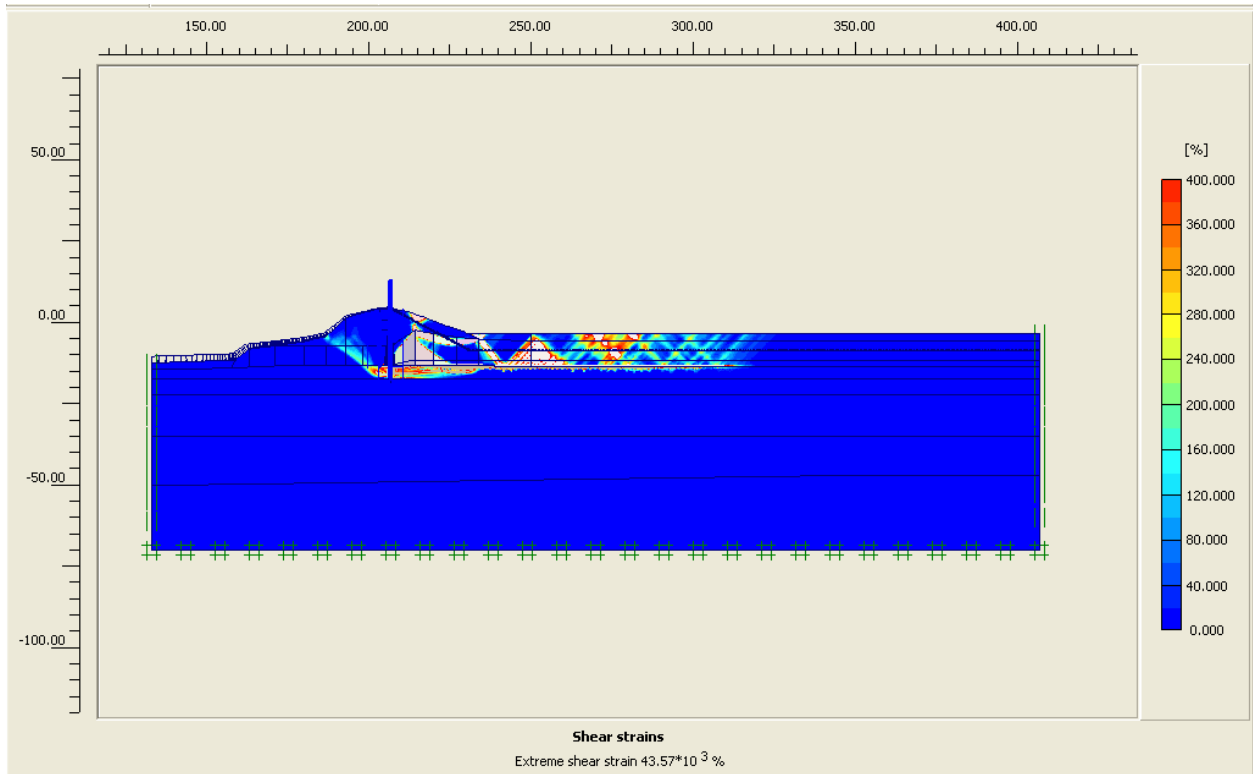
Failure Mechanism: Figures 9-16 and 9-17 show that for the analysis using average stiffness values with Canal El 6 and Crack to El -12.9, there is a loss of effective vertical stress at the top of the Beach sand layer within the region beyond the toe of the Levee. This results in zero shear strength along the top of the Beach sand layer as demonstrated in the Figure 9-18 fraction of mobilized shear strength being equal to unity within this Beach sand region. Figure 9-19 shows that this, in turn, results in the beginning of the development of a mechanism as demonstrated by the concentration of large shear strains within this region for Canal water El 6 and crack to El -12.9. Figures 9-20 and 9-21 show the development of the ultimate mechanism (i.e., the failure mechanism) computed in a phi/c reduction analysis for Canal water El 6 and crack to El -12.9, with the computed Factor of Safety of 1.84. Note the vertical “bulging” in the Marsh beyond the toe of the Levee. The reaches of large shear strain shown in Figure 9-21 shows the complete failure wedge will form along the top of the Beach sand layer and “day light” beyond the toe of the Levee. All subsequent phi/c computations for higher canal water elevations and for the E_{stiff} analyses show this same Figures 9-20 and 9-21 failure mechanism to form.

Figure 9-21. Reach of Large Shear Strains from the Phi/C Reduction Analysis Using Average Stiffness Values with Canal EI 6 and Crack to EI -12.9

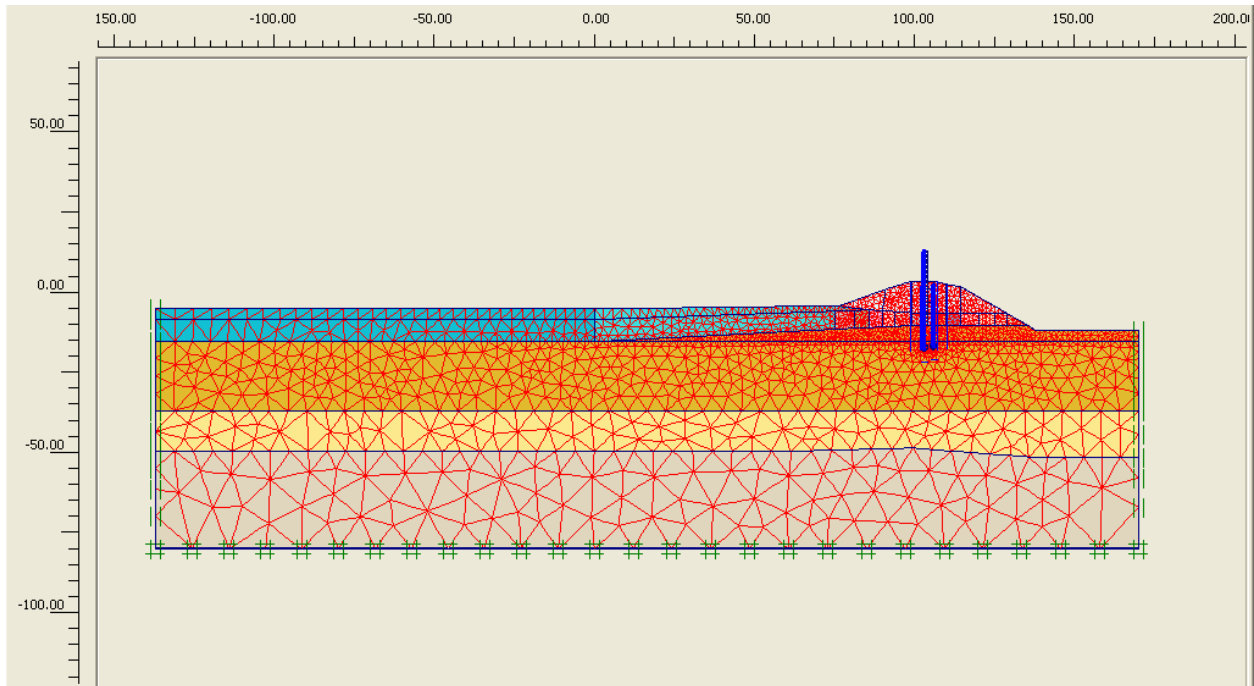
Figure 9-23. Finite Element Mesh used in the Complete SSI Analysis of Station 53+00 at London Canal – East Side
