Appendix 1

Soil Data Report for 17th Street Canal

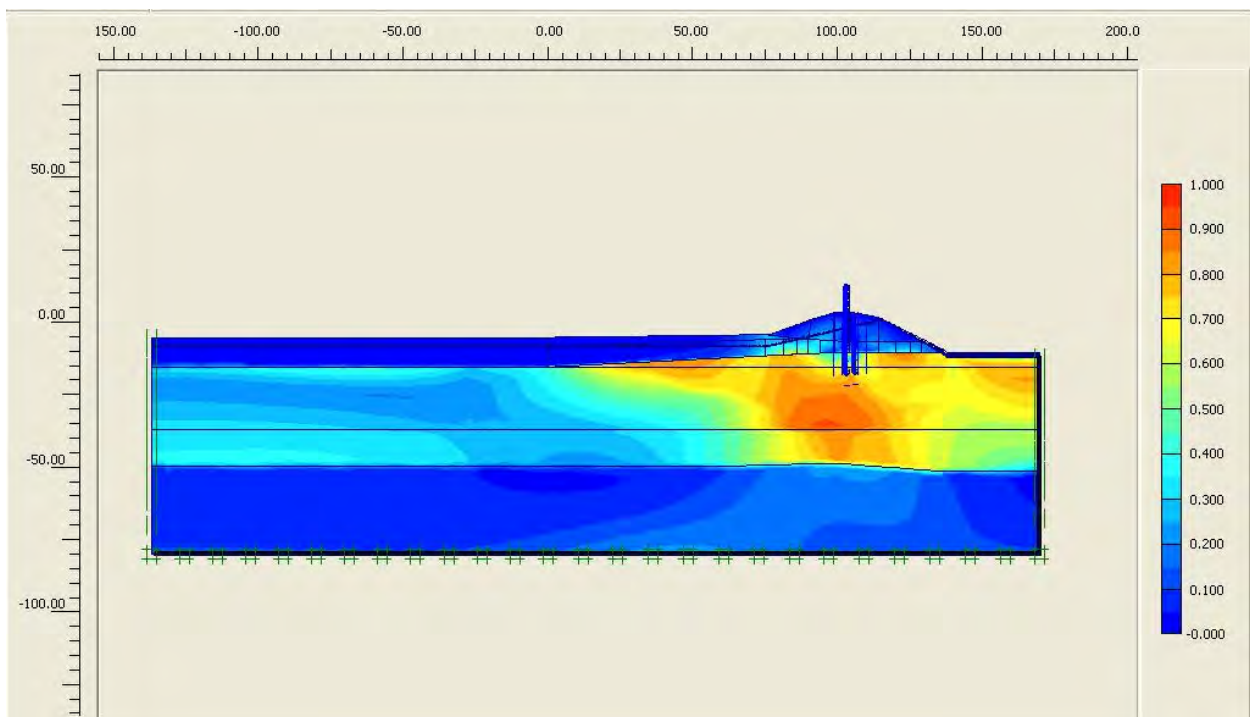
The initial steady-state, total stress condition for the usual canal water elevation of 1 is established by using the average stiffness modulus values given in Table 9-8 in the Mohr-Coulomb soil model for loading phases 0 through 3 for both sets of complete SSI analyses. The results from the IPET Task 7 slope stability analyses for this usual canal elevation indicate a stable cross-section with an ample Factor of Safety, i.e., above 1.5. Consequently, an important aspect of the total stress regime achieved within the Figure 9-23 finite element mesh is that the mobilized shear stress at the strain integration points within the finite elements contained in the soil clusters shown in this figure be less than the shear strength of the soil. The resulting computed fraction of mobilized shear strength (referred to as relative shear stress in Plaxis output) from the resulting initial total stress condition is shown in Figure 9-24. The fraction of mobilized shear strength is less than or equal to 0.9 at the stress integration points for the four soil types.

Figure 9-24. Fraction of Mobilized Shear Strength for Canal El 1

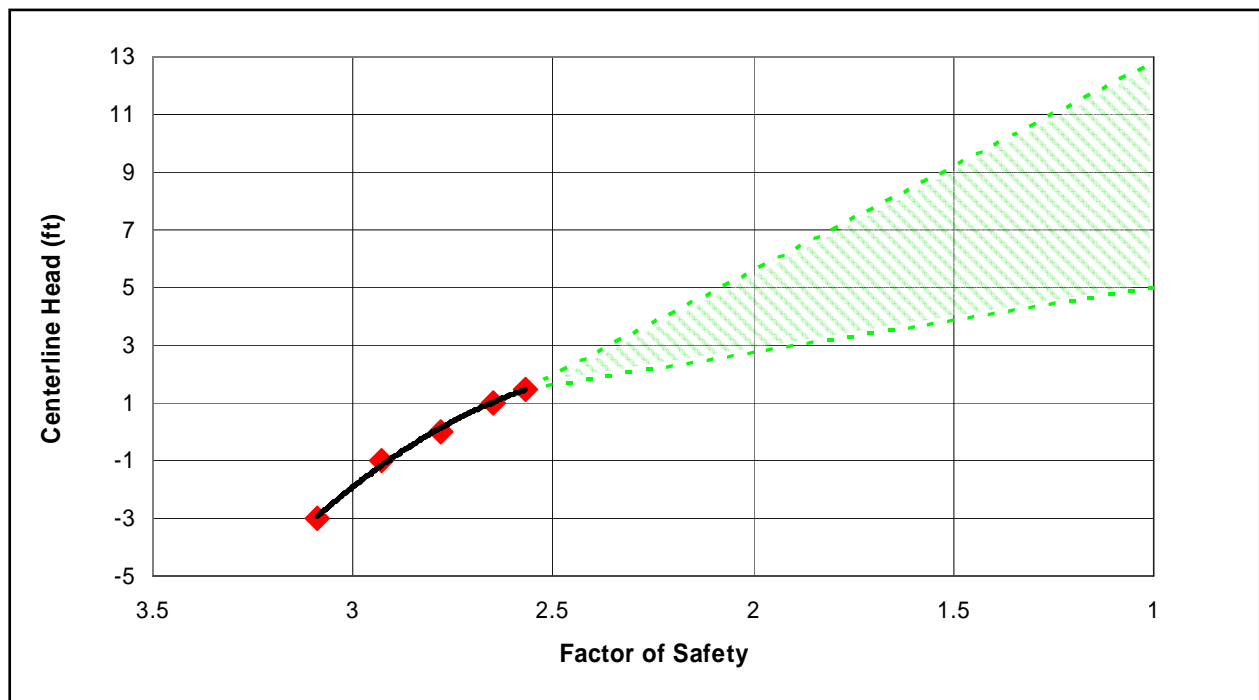
Factor of Safety: The factor of safety is computed for flood loading of the I-wall/sheet pile wall using the phi/c reduction method of analysis in Plaxis by means of incremental multipliers. Problems with numerical convergence occurred in nearly all Phi/c reduction analyses of this cross-section, even for the Canal water El 5 flood loading case with a crack extending to El -10.2 (i.e., the top of the Beach sand layer). It is speculated by the authors of this document that these numerical problems stem from the change in the hydraulic boundary condition when a crack forms to the top of the Beach sand, resulting in new, higher uplift pressures at the top of the Beach sand layer, below and immediately beyond the toe of the Levee combined with the shallow (total) overburden pressure of the Marsh layer within this region. Converting from a steady state seepage analysis to a linear phreatic surface assumption with a head specified at

Figure 9-25. Factor of Safety Versus Centerline Head

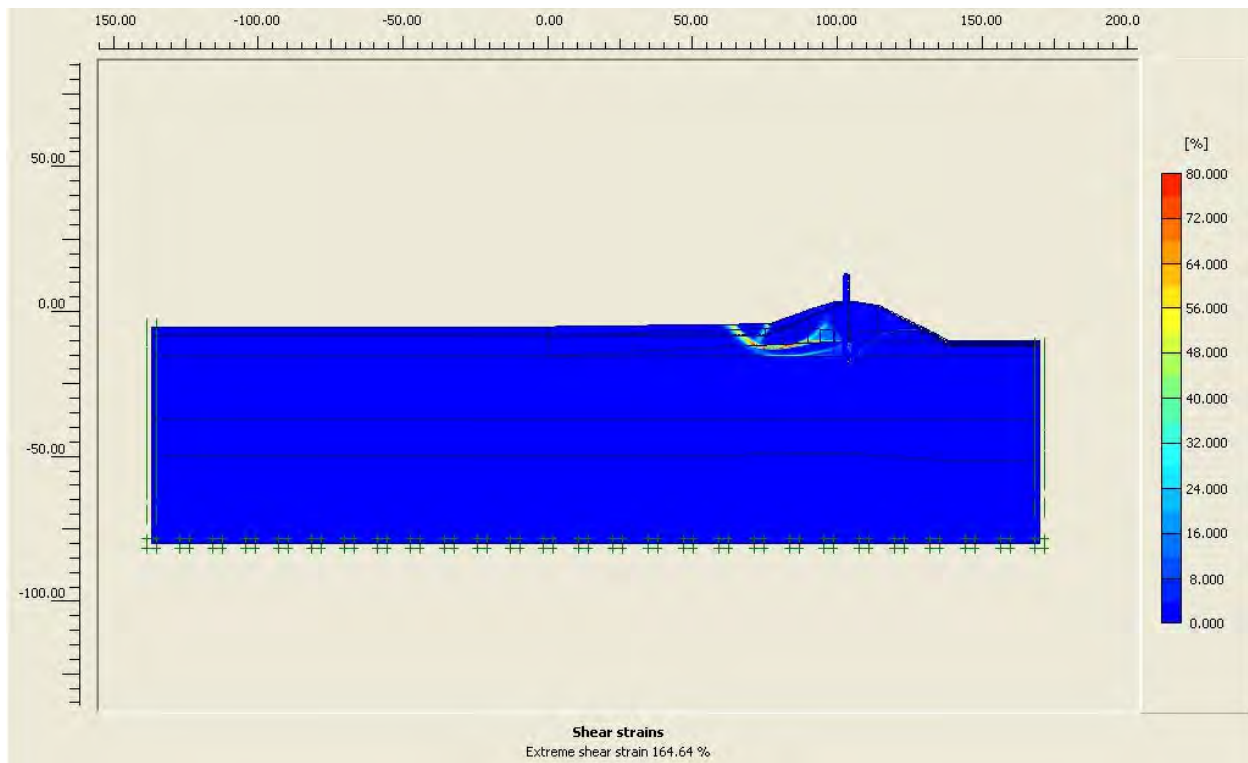
Failure Mechanism: Figures 9-32 and 9-33 show that for the analysis set using stiff modulus values assigned to the Levee clay and the Marsh on the protected side of the I-wall with Canal water El 5 and Crack to El -10.2, there is a loss of effective vertical stress at the top of the Beach sand layer within the region beyond the toe of the Levee. This results in zero shear strength along the top of the Beach sand layer as demonstrated in the Figure 9-34 fraction of mobilized shear strength being equal to unity within this Beach sand region. Figure 9-35 shows that this, in turn, results in the beginning of the development of a mechanism as demonstrated by the concentration of large shear strains within this region for Canal water El 5 and crack to El -10.2. Figure 9-36, with a close-up of the Levee region shown in Figure 9-37, and Figure 9-38 show the development of the ultimate mechanism (i.e., the failure mechanism) computed in a phi/c reduction analysis for Canal water El 5 and crack to El -10.2, for a linear phreatic surface Canal centerline head at El 0 with the computed Factor of Safety of 2.78 (actual value will be lower when the more realistic, larger pore water pressures are specified in an analysis). Note the vertical “bulging” in the Marsh beyond the toe of the Levee. The reaches of large shear strain shown in Figure 9-38 shows the complete failure wedge will form along the top of the Beach sand layer and “day light” beyond the toe of the Levee. All subsequent phi/c computations (that converged to a solution) for higher canal water elevations and for the E_{stiff} analyses show this same Figures 9-36, 9-37 and 9-38 failure mechanism to form.

Figure 9-36. Ultimate Mechanism from Phi/C Reduction for the Analysis Using Stiff Modulus Values for the Levee Clay and Marsh on the Protected Side with Canal EI 5 and Crack to EI -10.2

Figure 9-37. Close-up of the Ultimate Mechanism from Phi/C Reduction for the Analysis Using Stiff Modulus Values for the Levee Clay and Marsh on the Protected Side with Canal EI 5 and Crack to EI -10.2

Figure 9-38. Reach of Large Shear Strains from the Phi/C Reduction Analysis Using Stiff Modulus Values for the Levee Clay and Marsh on the Protected Side with Canal EI 5 and Crack to EI -10.2

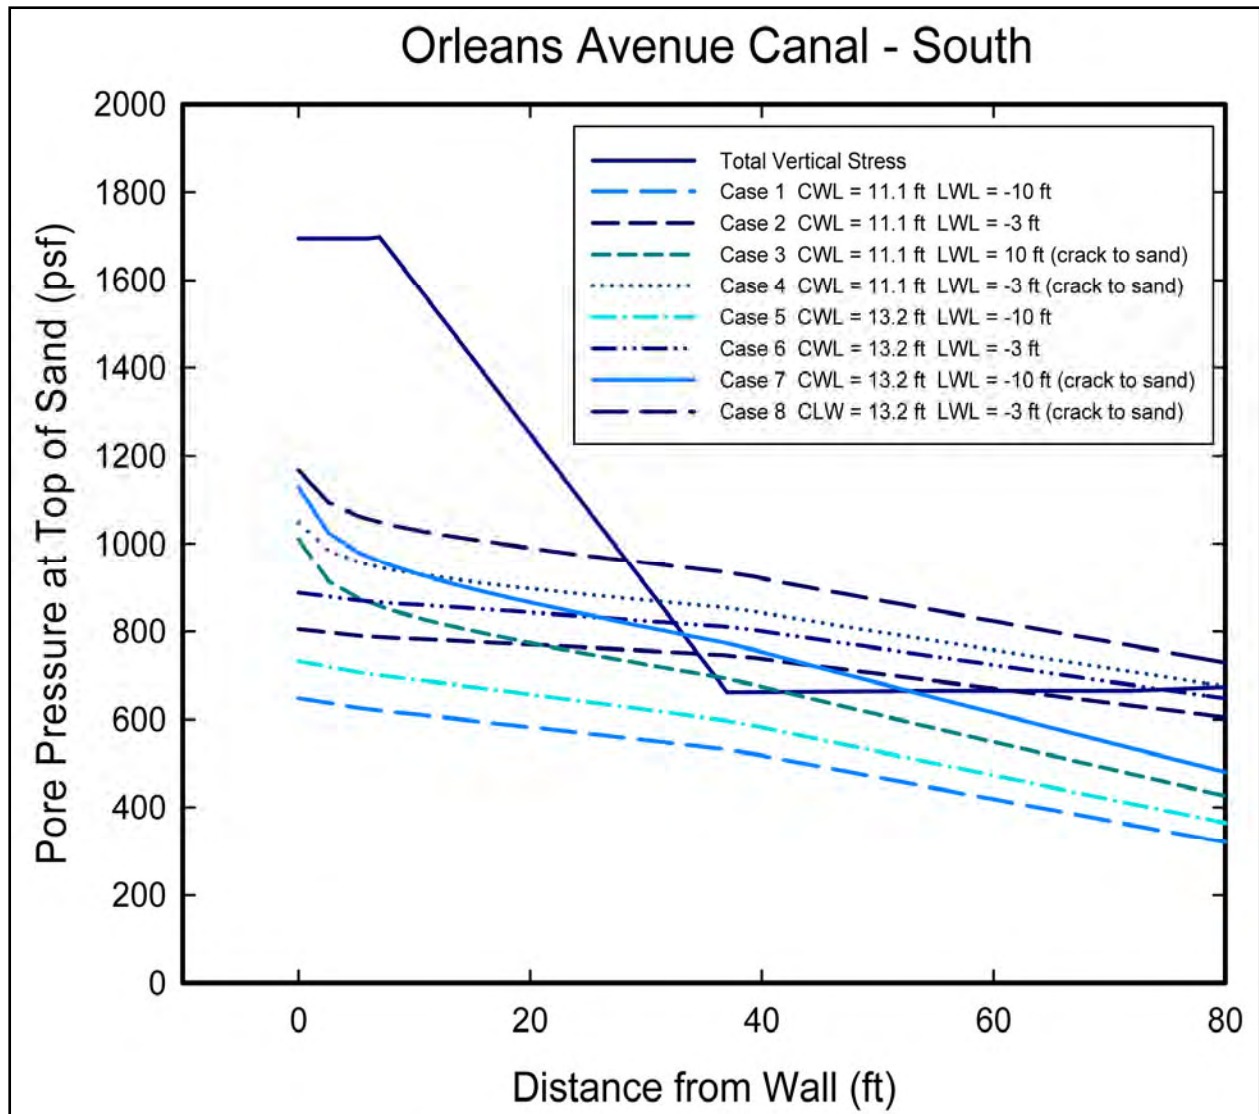
Computed pore water pressures, or uplift pressures, at the base of the marsh layer are shown in Figure 10-7 for the eight cases analyzed, together with the total overburden pressure at the base of the marsh layer. For Cases 1 and 5, where the landside water level was -10 and the crack extended only to the bottom of the wall, the computed pore pressures are smaller than the total overburden pressure at the base of the marsh layer. In all other cases the computed pore pressures exceed the overburden pressure in some locations. This result indicates that in these cases the marsh layer would be heaved off the underlying sand by the uplift water pressures. A likely result of this heave would be rupture of the marsh layer at one or more weak points, and upward flow of water through the rupture through the marsh material. This flow would relieve the high water pressure locally, and create a new hydraulic boundary condition at the point of rupture.

Figure 10-7. Calculated Uplift Pressures and Total Overburden Pressure for Orleans South

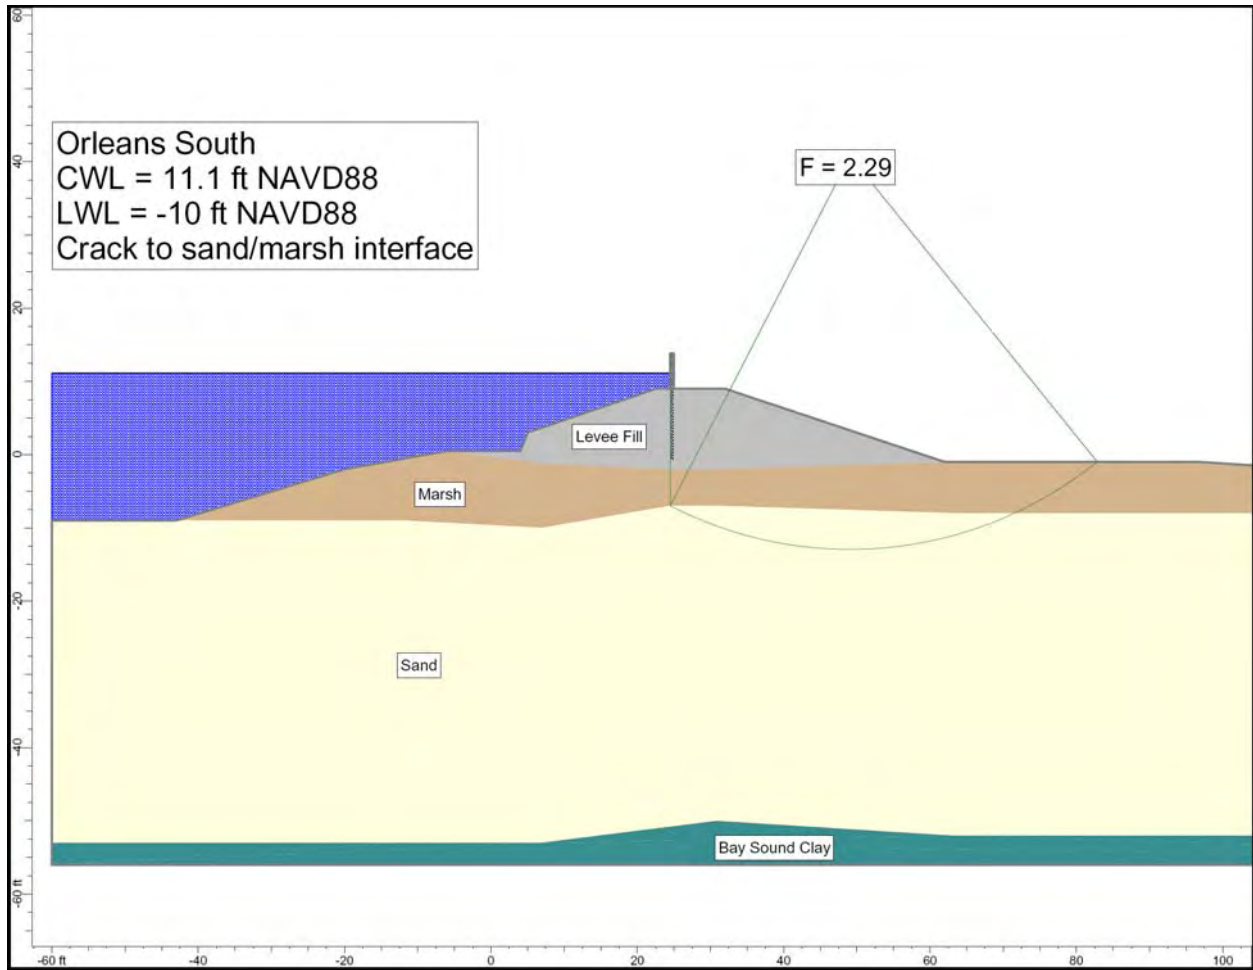
As discussed earlier, it was assumed in all analyses that deflection of the wall toward the land side would result in formation of a crack through the levee fill and the marsh in back of the wall, down to the bottom of the wall, or by hydraulic fracturing, down to the top of the sand. It was assumed that the crack would not extend below the top of the sand, because the sand is cohesionless, and would be expected to slump and fill any incipient crack. A crack to the bottom of the wall was assumed for Cases 1, 2, 5 and 6 (Figures 10-10, 10-11, 10-14 and 10-15), and a crack to the top of the sand was assumed for Cases 3, 4, 7, and 8 (Figures 10-12, 10-13, 10-16 and 10-17).

The factors of safety calculated in these analyses are shown in Figures 10-10 through 10-17, and are summarized in Table 10-4. The values range from 1.38 to 2.71. Thus, even under the most severe conditions of water loading and possible crack formation considered here, the results of the analyses indicate that the wall would remain stable. For the highest water level observed at the Orleans south area, the lowest computed factor of safety is 1.86, which exceeds the minimum allowable for most conditions.

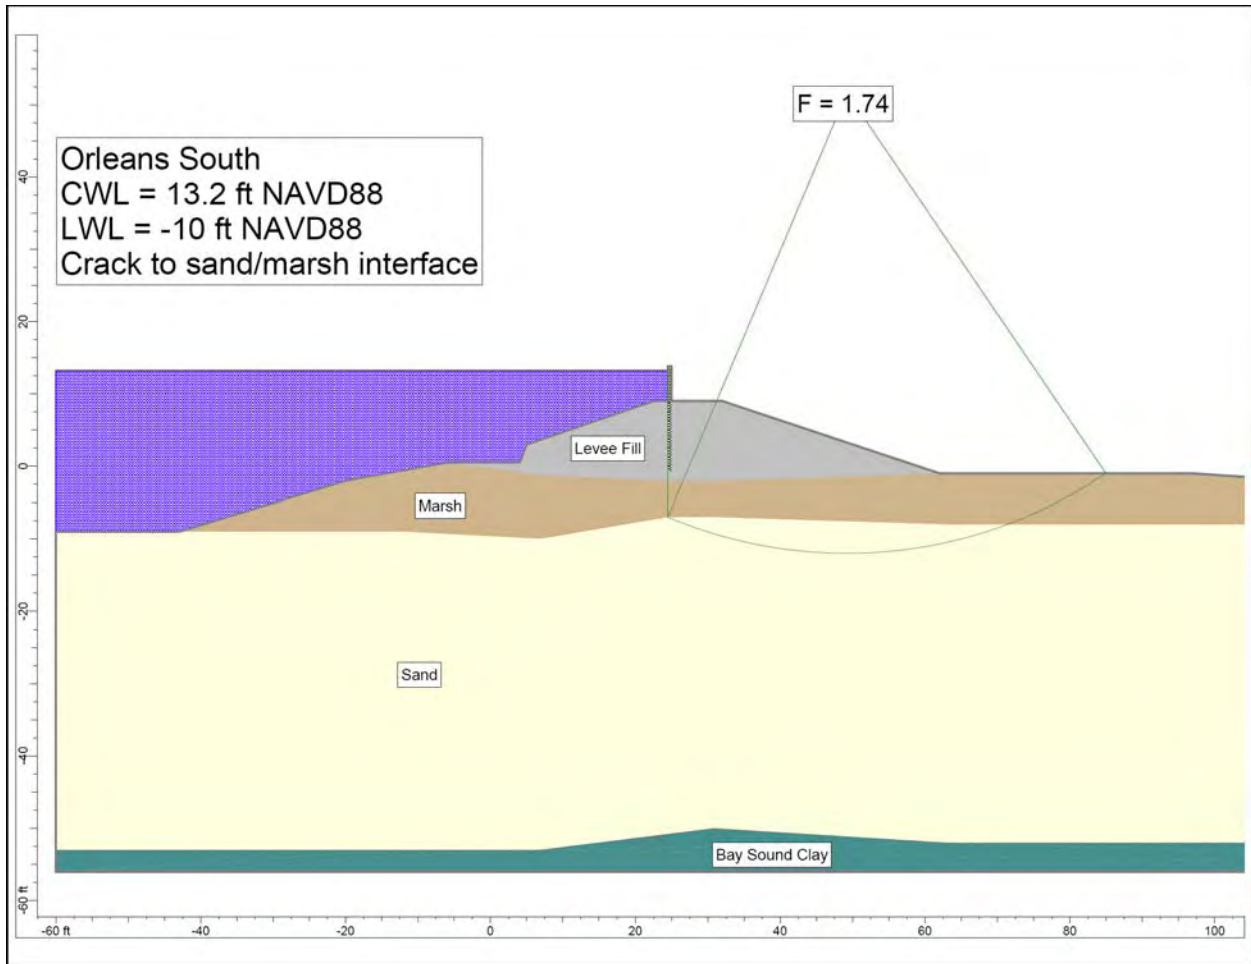
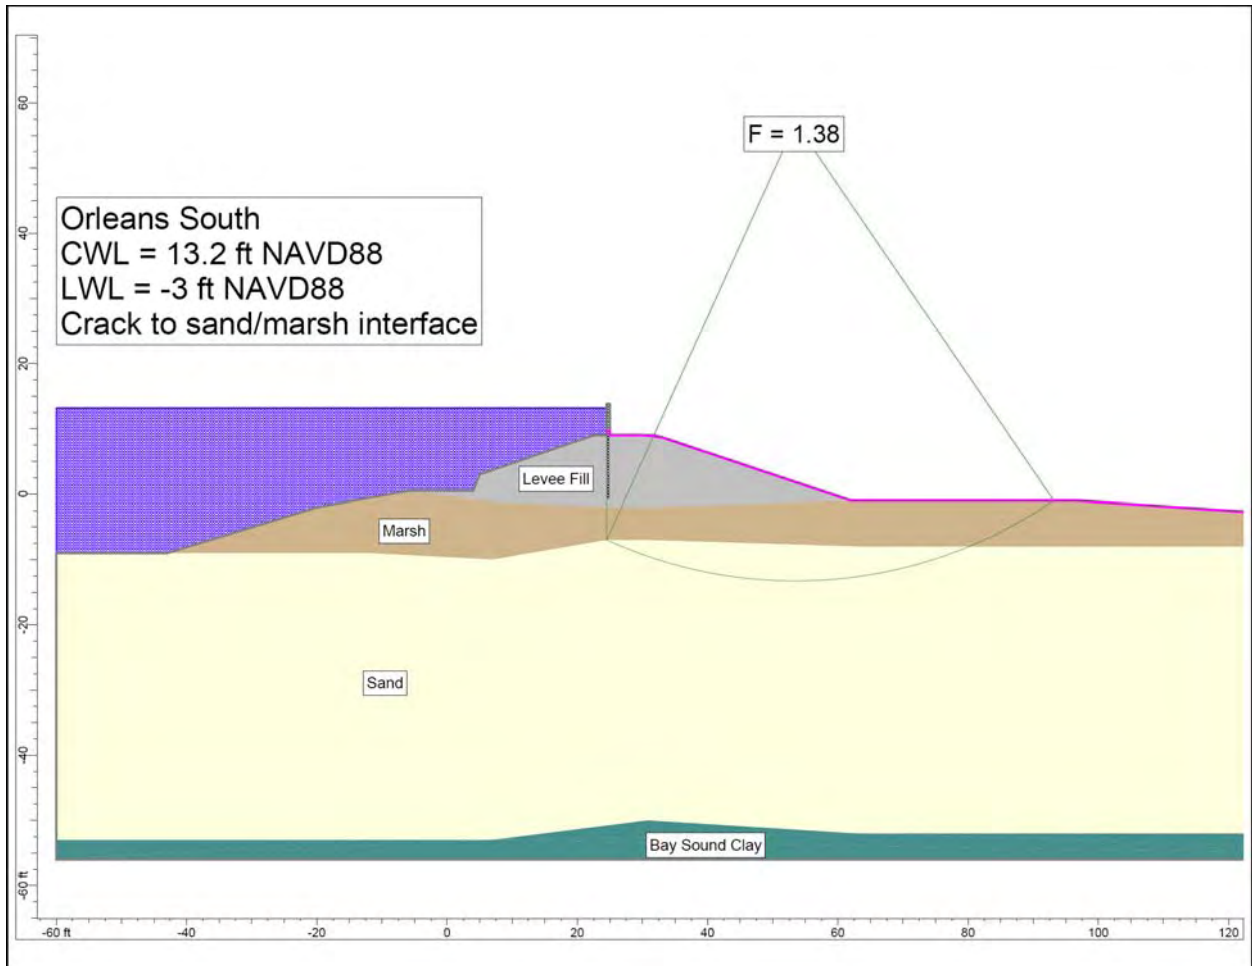
Figure 10-16. Orleans South Case 7 Stability Analysis

Figure 10-17. Orleans South Case 8 Stability Analysis

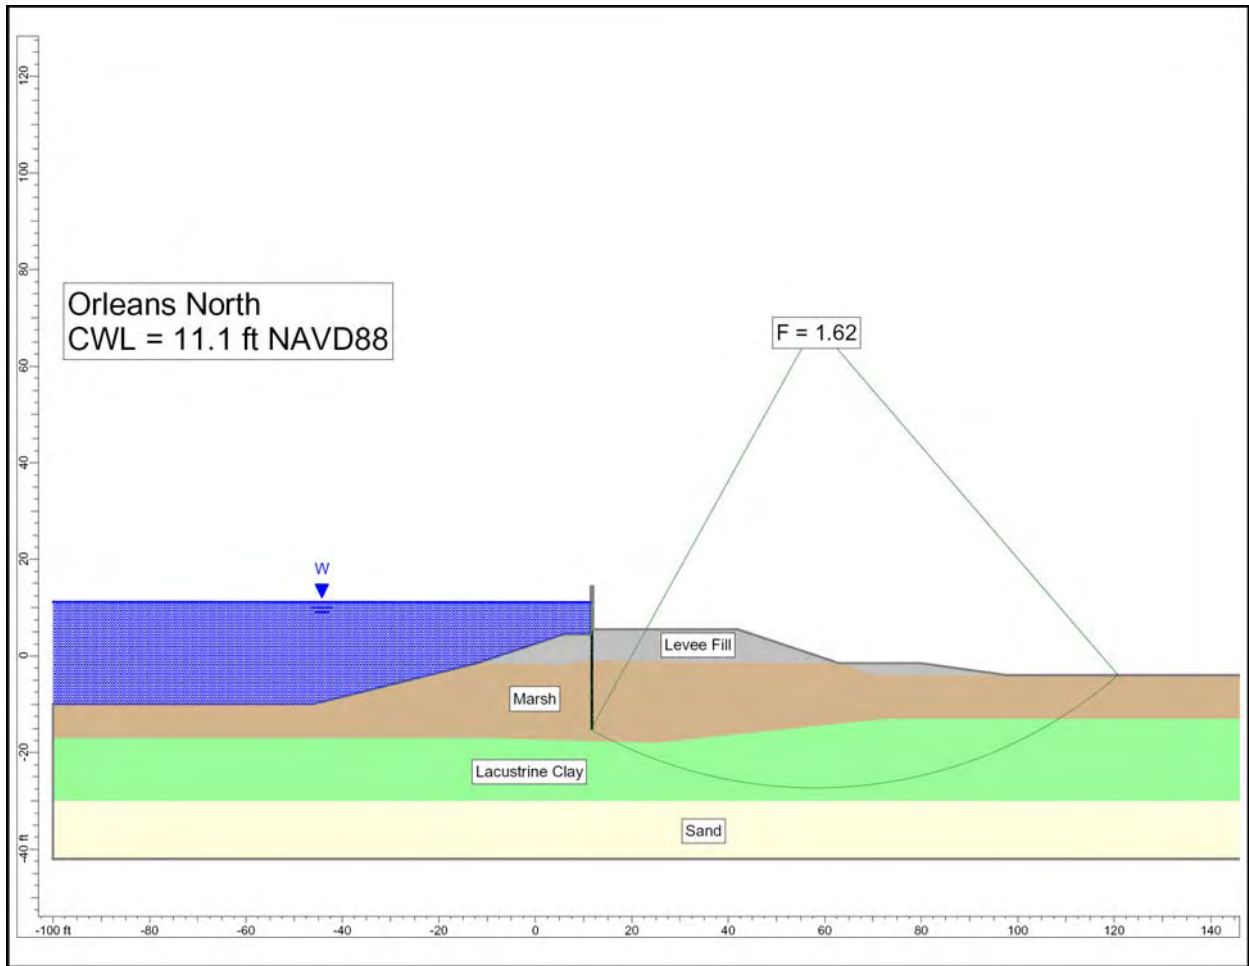
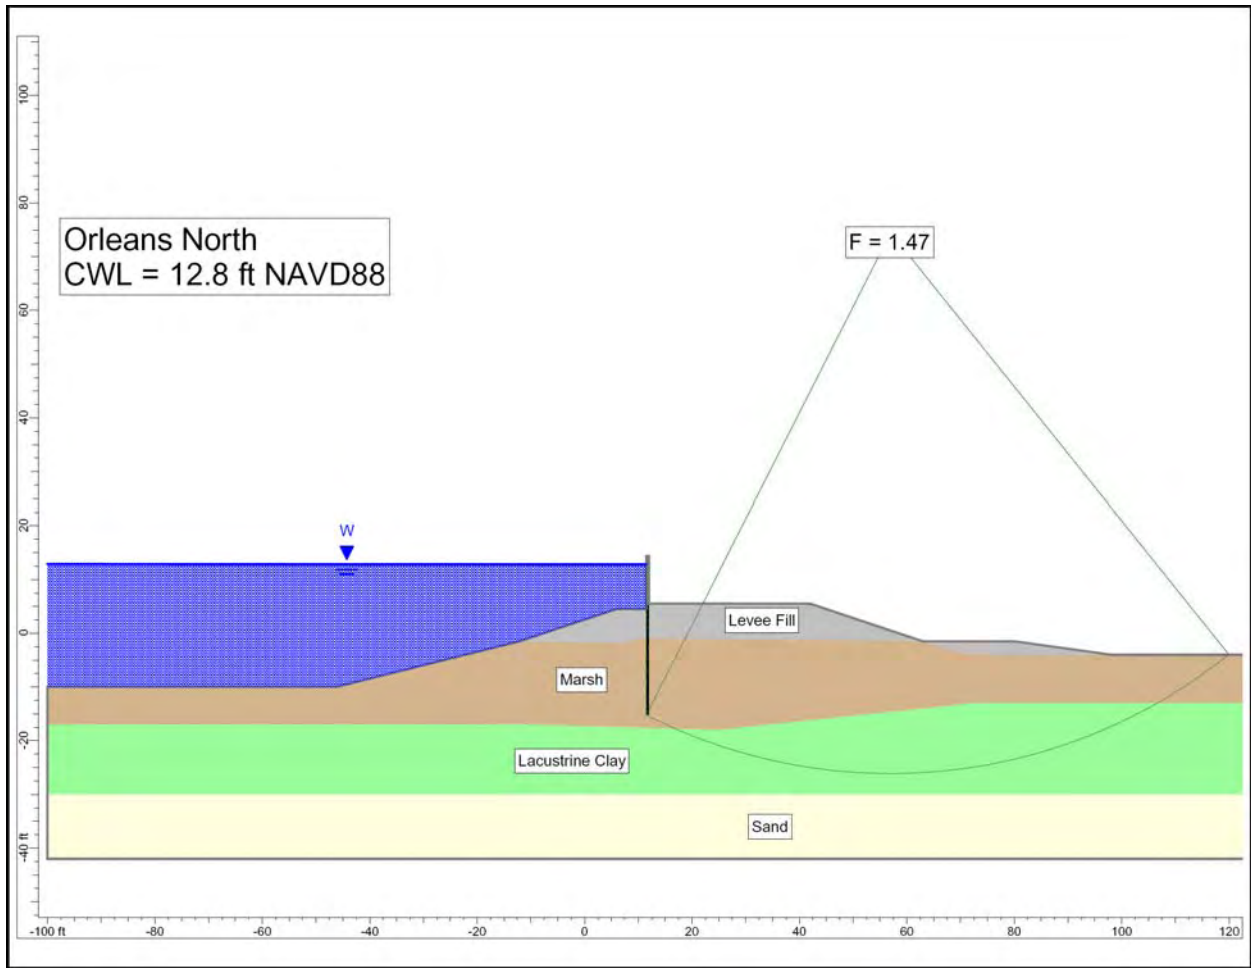
The critical circles and factors of safety calculated in these analyses are shown in Figures 10-20 and 10-21, and the factors of safety are given in Table 10-6. The factors of safety are 1.62 for the highest observed water level (11.1 ft), and 1.47 for the water at the top of the wall (12.8 ft in this area). Thus, even under the most severe conditions of water loading and possible crack formation considered here, the results of the analyses indicate that the wall would remain stable. For the highest water level observed at the Orleans north area, the computed factor of safety is 1.62, which exceeds the minimum allowable for most conditions.

Figure 10-20. Orleans North Case 1 Stability Analysis

Figure 10-21. Orleans North Case 2 Stability Analysis

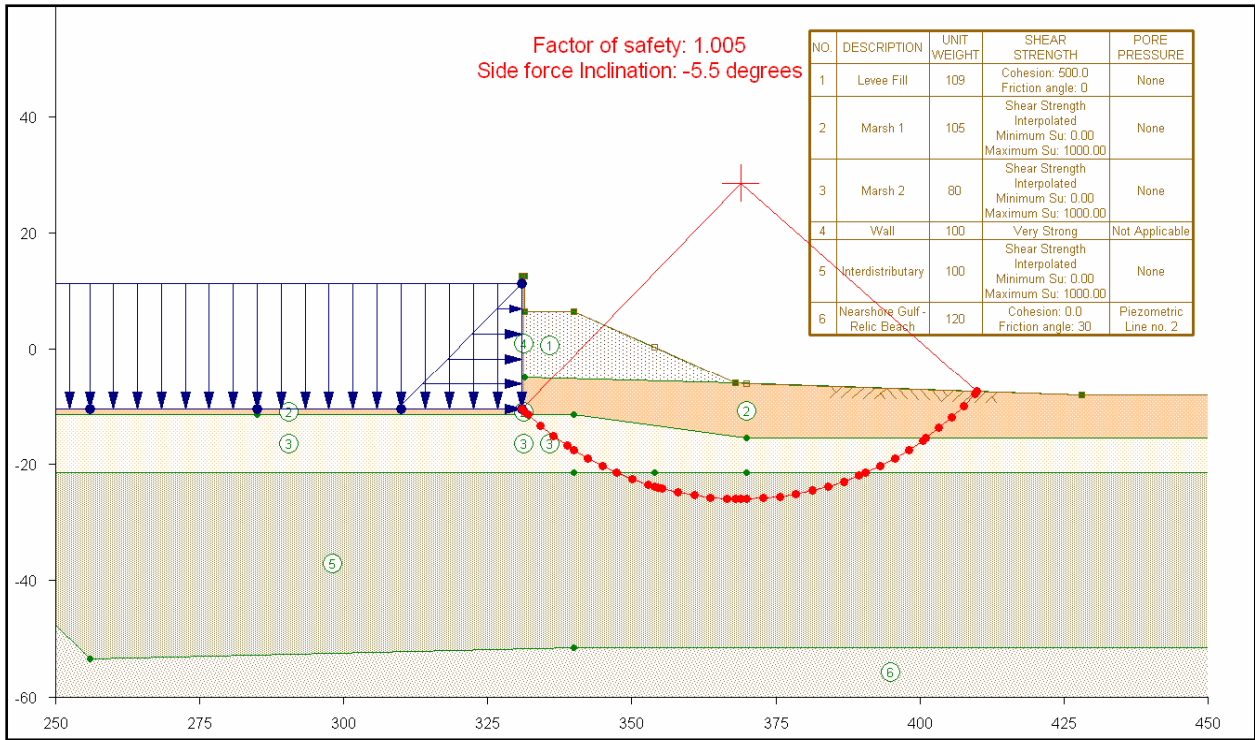
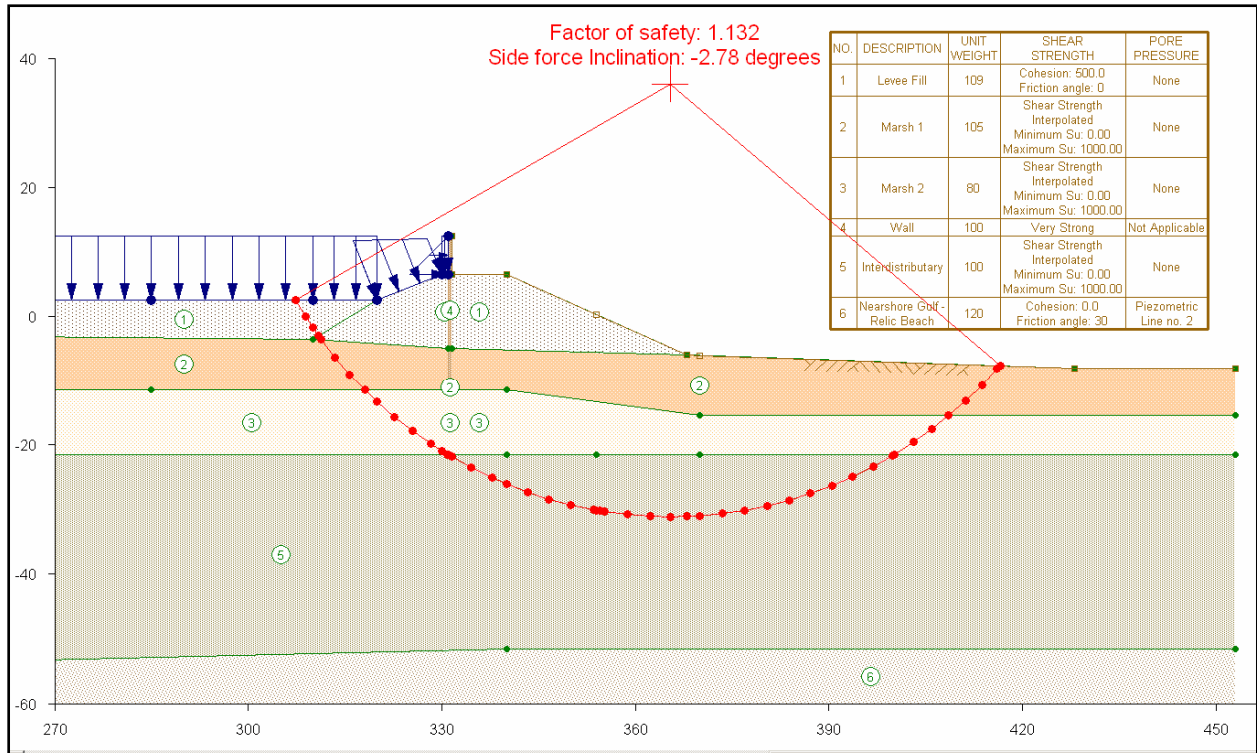
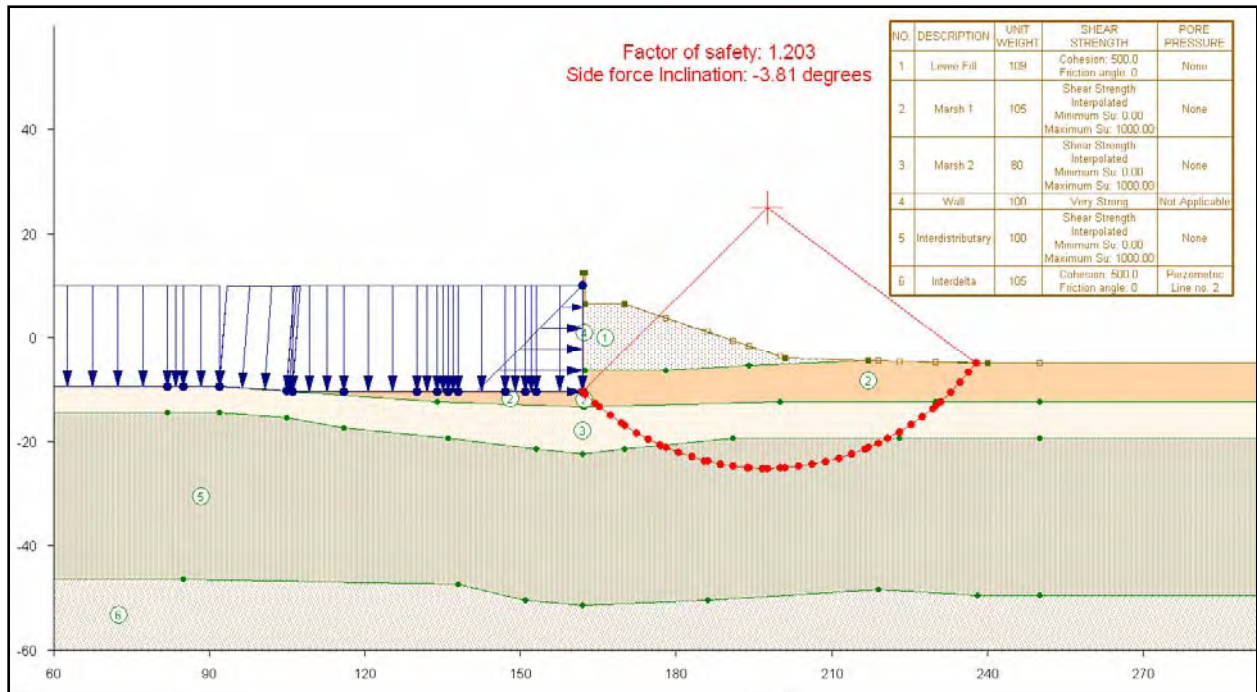
For the north breach (Station 55+00), with the canal water level at elevation 12.5 ft (top of the wall), the calculated factor of safety for the cracked condition is 0.96, as compared to 1.13 for the uncracked condition (Cases 5 and 5a). A canal water elevation of 11.2 ft produces a factor of safety of unity for the cracked condition (Case 4). Figures 11-20 through 11-25 show the critical circles from UTEXAS4 analyses for the north breach for Cases 1 through 5 and Case 5a.

Figure 11-20. IHNC – East Bank (North Breach), Case 1, Canal Water Level = 10.0 ft (NAVD 88), with Crack

Figure 11-21. IHNC – East Bank (North Breach), Case 2, Design Canal Water Level = 10.5 ft (NAVD 88), with Crack

Figure 11-22. IHNC – East Bank (North Breach), Case 3, Design Canal Water Level = 10.5 ft (NAVD 88), without Crack

Figure 11-23. IHNC – East Bank (North Breach), Case 4, Canal Water Level = 11.2 ft (NAVD 88), with Crack

Figure 11-24. IHNC – East Bank (North Breach), Case 5, Canal Water Level = Top of Wall = 12.5 ft (NAVD 88), with Crack

Figure 11-25. IHNC – East Bank (North Breach), Case 5a, Canal Water Level = Top of Wall = 12.5 ft (NAVD 88), without Crack

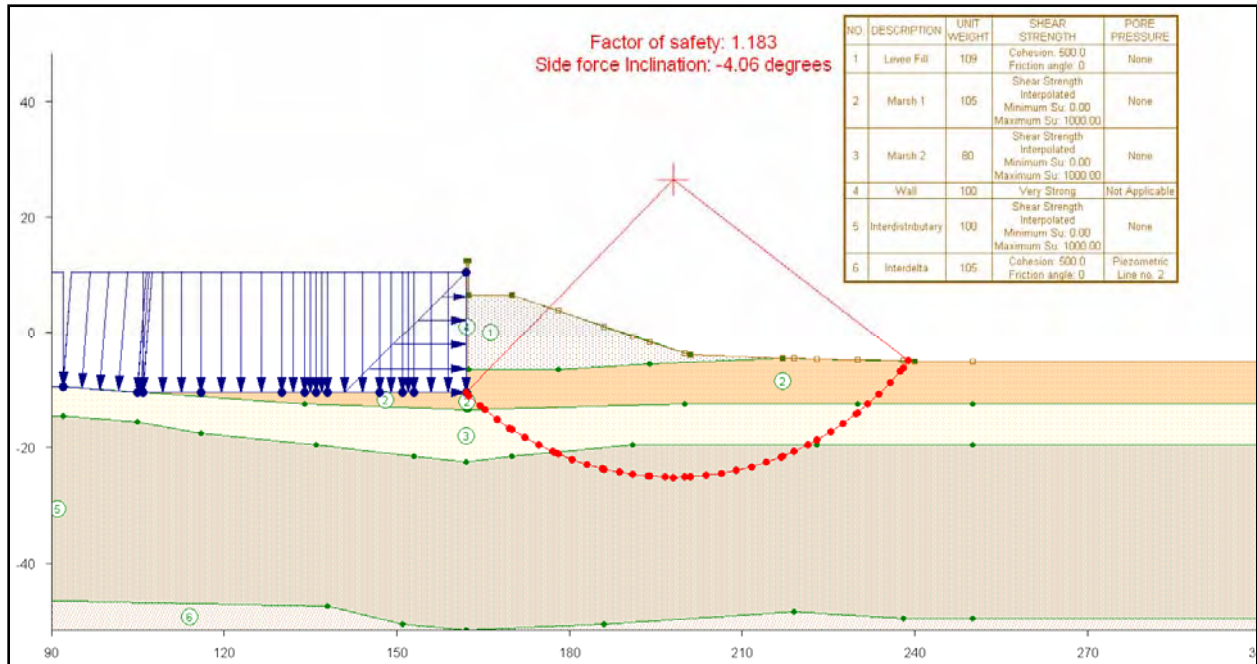
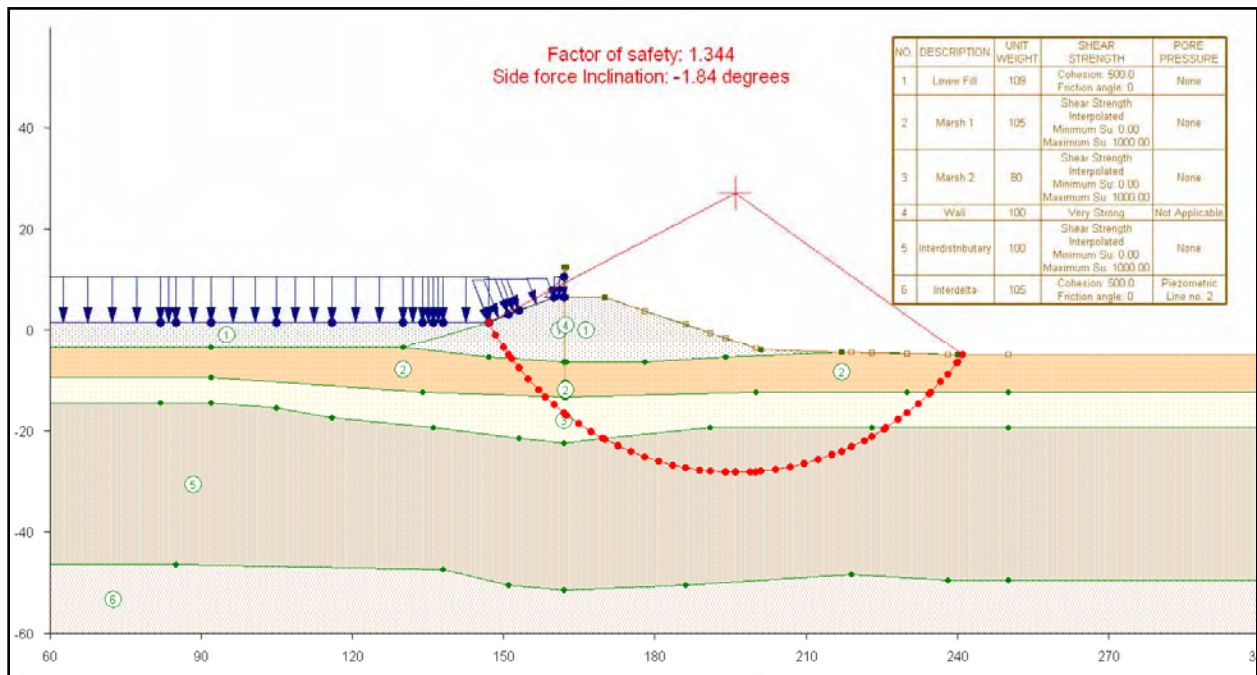
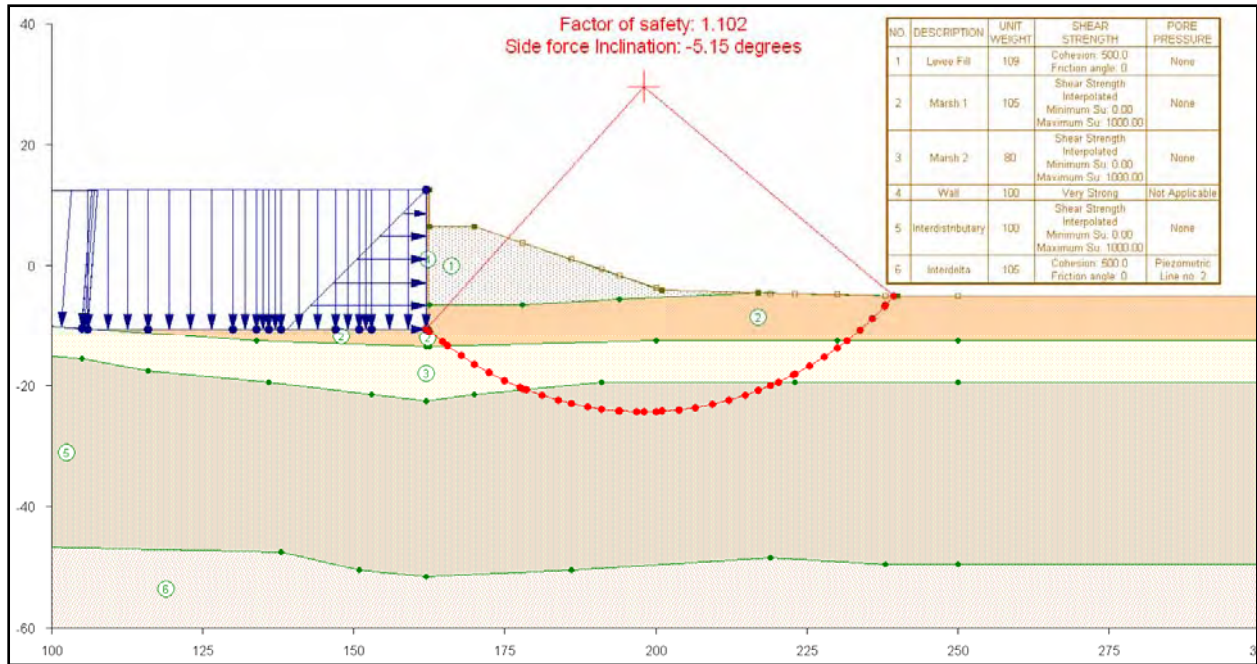
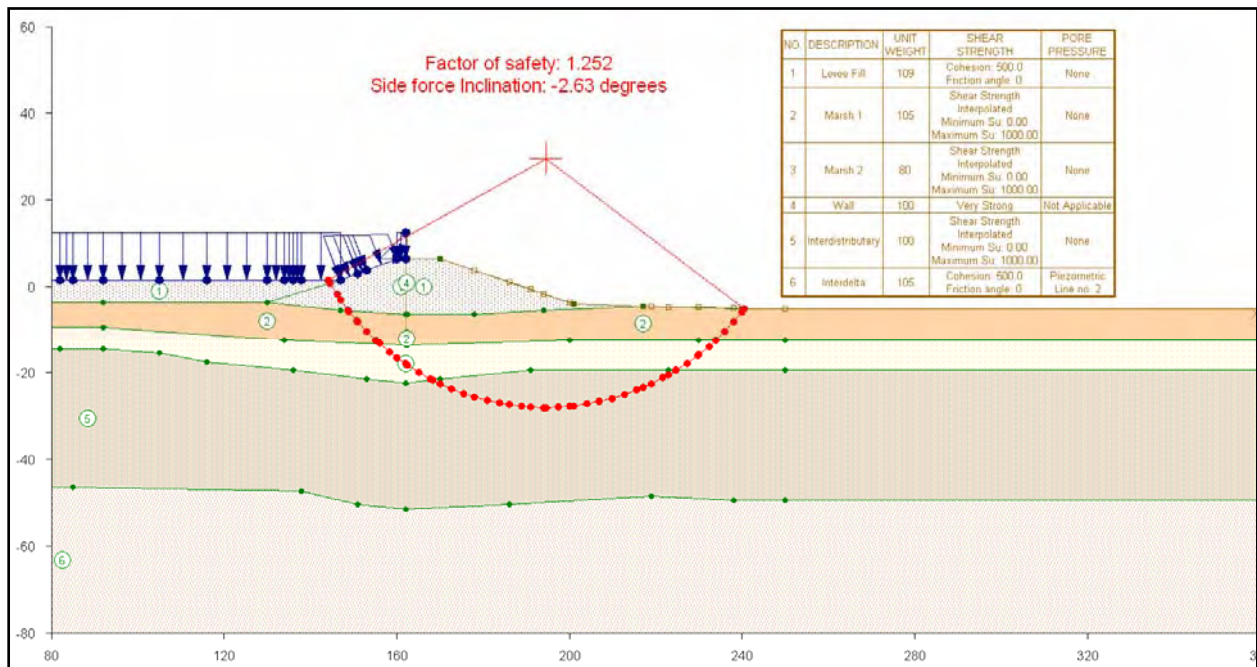
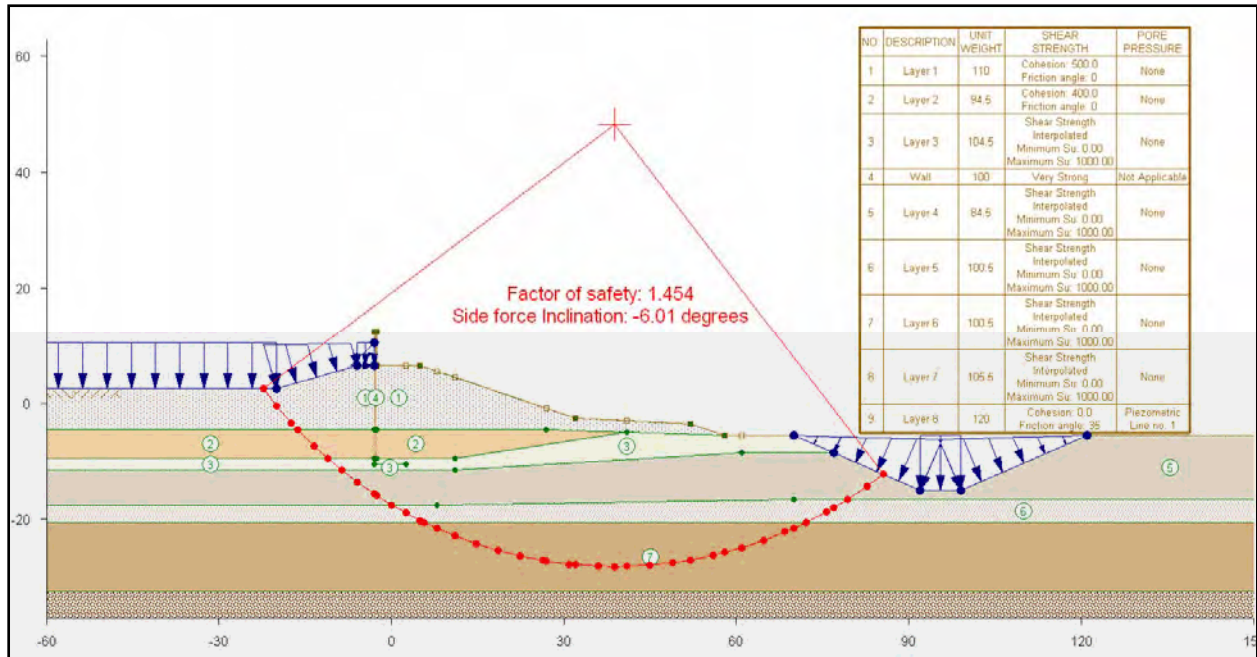
For the south breach (Station 26+00), the factor of safety was greater than unity for all canal water elevations analyzed using the IPET strength model. For the most extreme case of the canal water level at elevation 12.5 ft (top of the wall), the calculated factor of safety for the cracked condition is 1.10. The critical circles for the stability analyses performed on the south breach for Cases 1 through 5 are shown in Figures 11-26 through 11-30.

Figure 11-26. IHNC – East Bank (South Breach), Case 1, Canal Water Level = 10.0 ft (NAVD 88), with Crack

Figure 11-27. IHNC – East Bank (South Breach), Case 2, Design Canal Water Level = 10.5 ft (NAVD 88), with Crack

Figure 11-28. IHNC – East Bank (South Breach), Case 3, Design Canal Water Level = 10.5 ft (NAVD 88), without Crack

Figure 11-29. IHNC – East Bank (South Breach), Case 4, Canal Water Level = Top of Wall - 12.5 ft (NAVD 88), with Crack

Figure 11-30. IHNC – East Bank (South Breach), Case 5, Canal Water Level = Top of Wall - 12.5 ft (NAVD 88), without Crack
