Appendix 1

Soil Data Report for 17th Street Canal

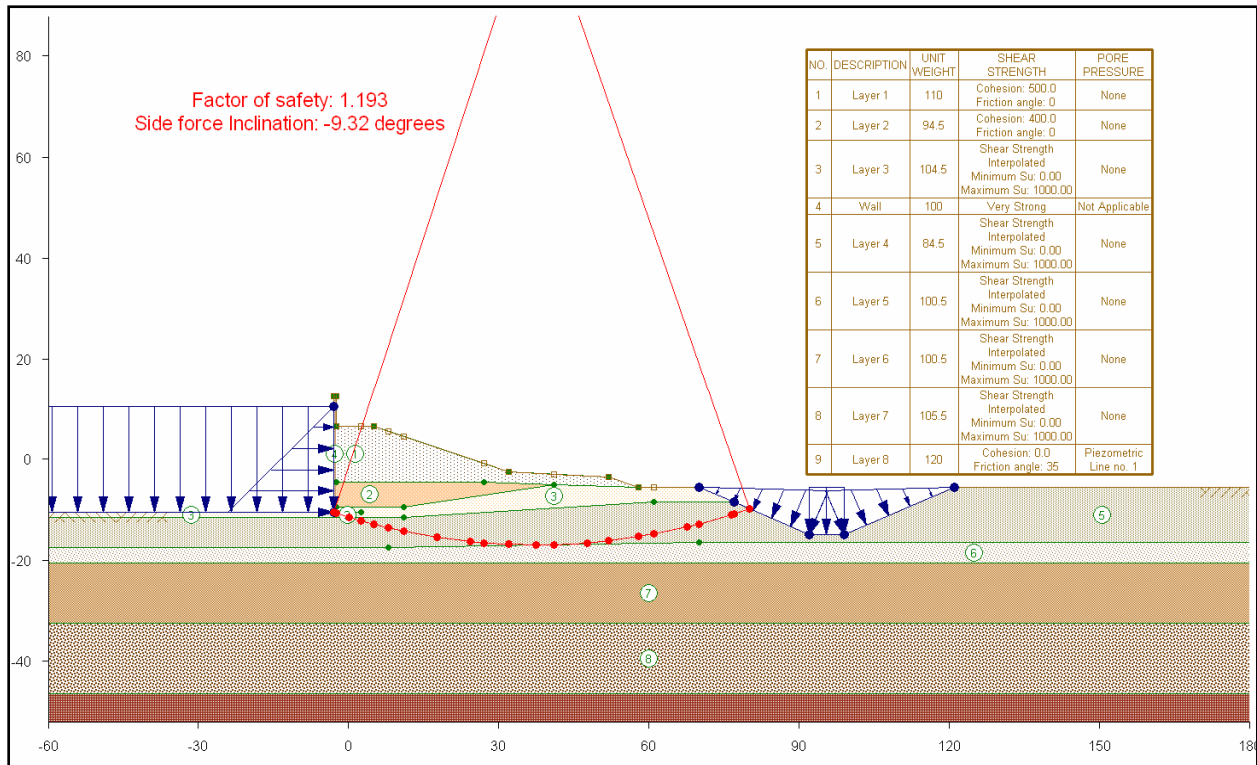
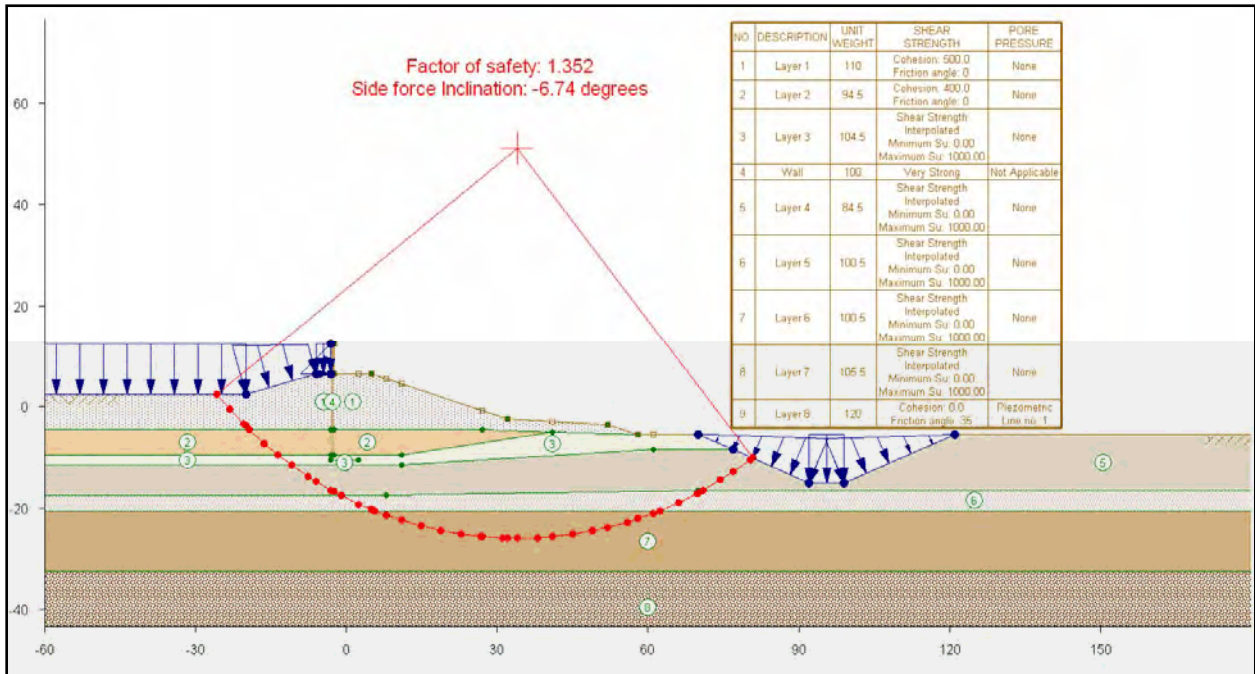
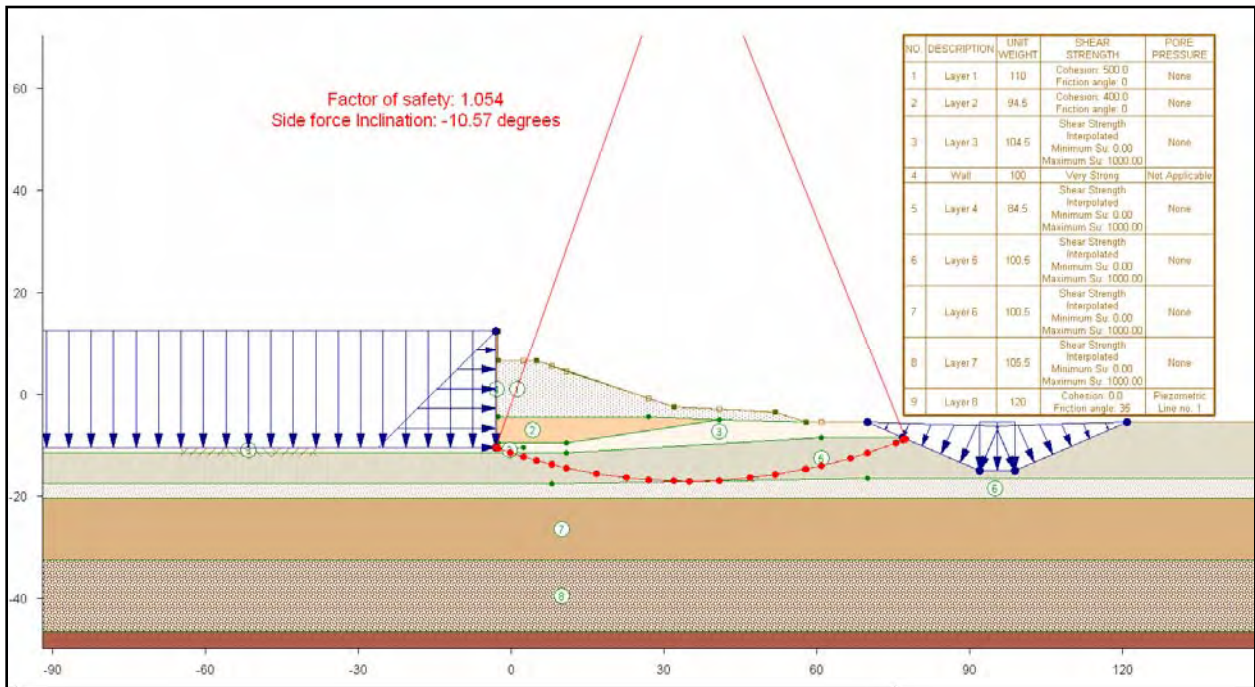
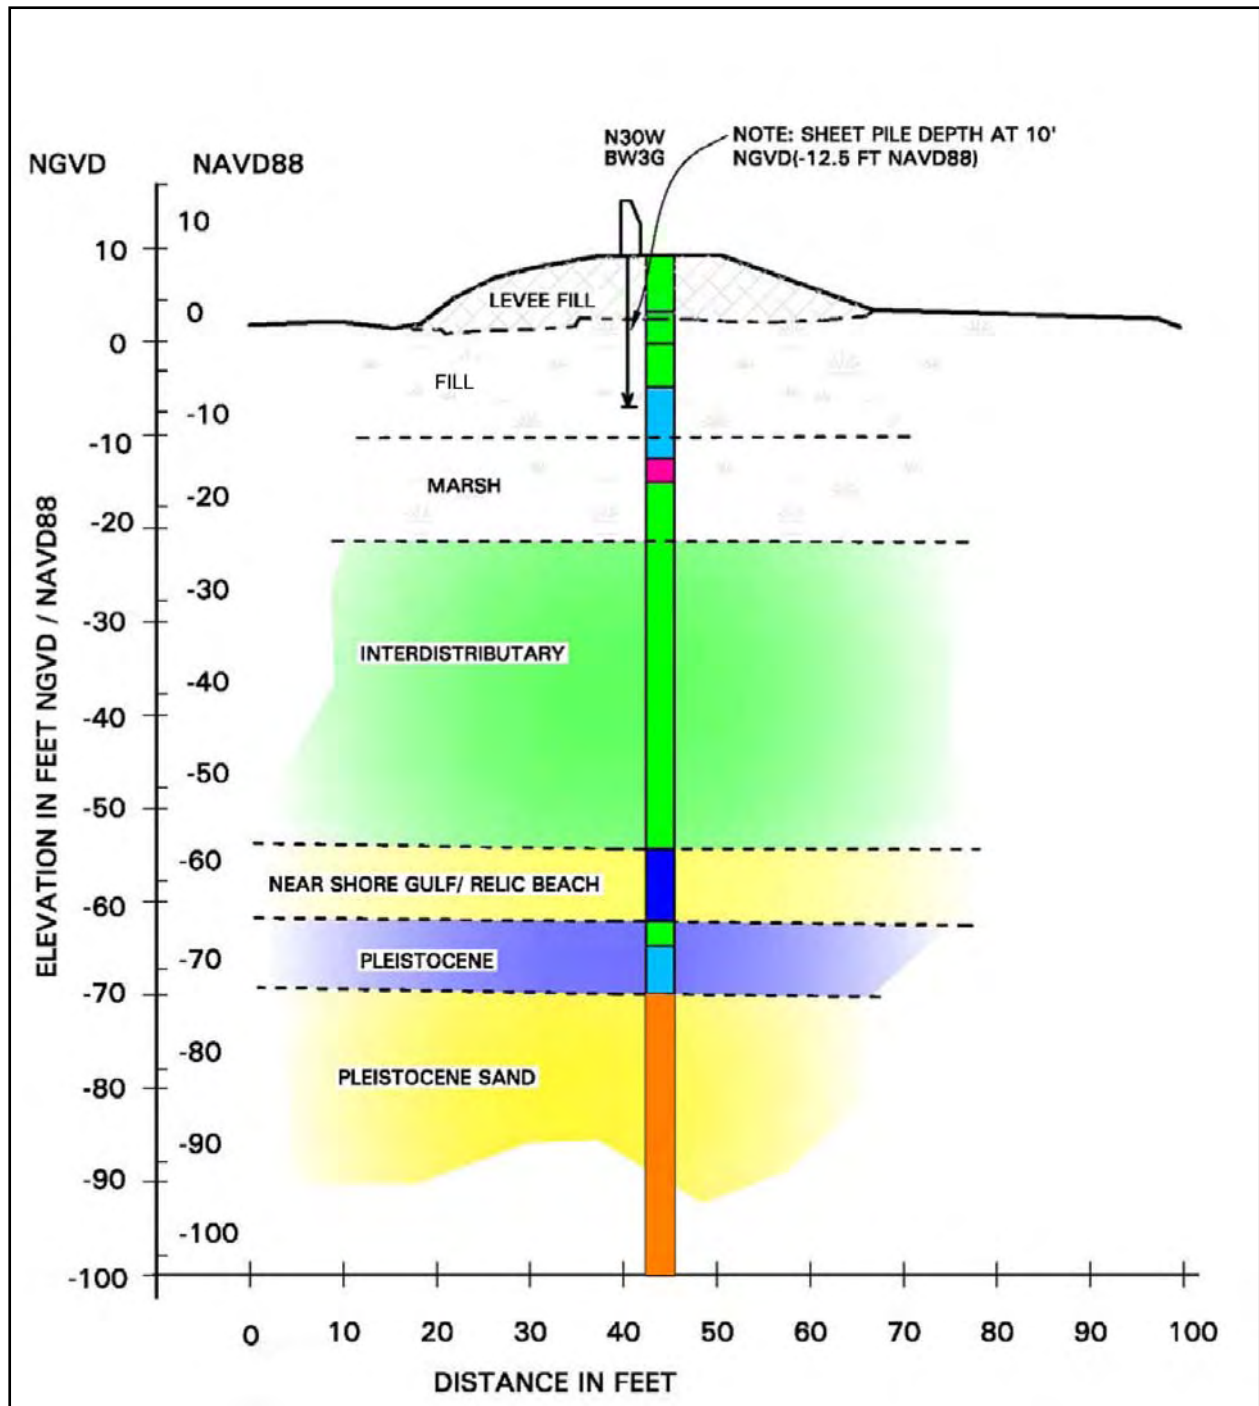
Three other variations of the design cross section were analyzed. Introducing a crack behind the wall for the design water level decreases the factor of safety to 1.19. For a canal water elevation at the top of the wall (12.5 ft NAVD88), the factor of safety is 1.35 for the uncracked condition and 1.05 for the cracked condition. The results of all analyses performed on the GDM cross section are presented in Table 11-8. Figures 11-31 through 11-34 show the critical circles for the UTEXAS4 analysis.

Figure 11-31. IHNC – East Bank (GDM Stability Plate), Case 1, Canal Water Level = Design - 10.5 ft (NAVD 88), without Crack

Figure 11-32. IHNC – East Bank (GDM Stability Plate), Case 2, Canal Water Level = Design - 10.5 ft (NAVD 88), with Crack

Figure 11-33. IHNC – East Bank (GDM Stability Plate), Case 3, Canal Water Level = Top of Wall - 12.5 ft (NAVD 88), without Crack

Figure 11-34. IHNC – East Bank (GDM Stability Plate), Case 4, Canal Water Level = Top of Wall - 12.5 ft (NAVD 88), with Crack

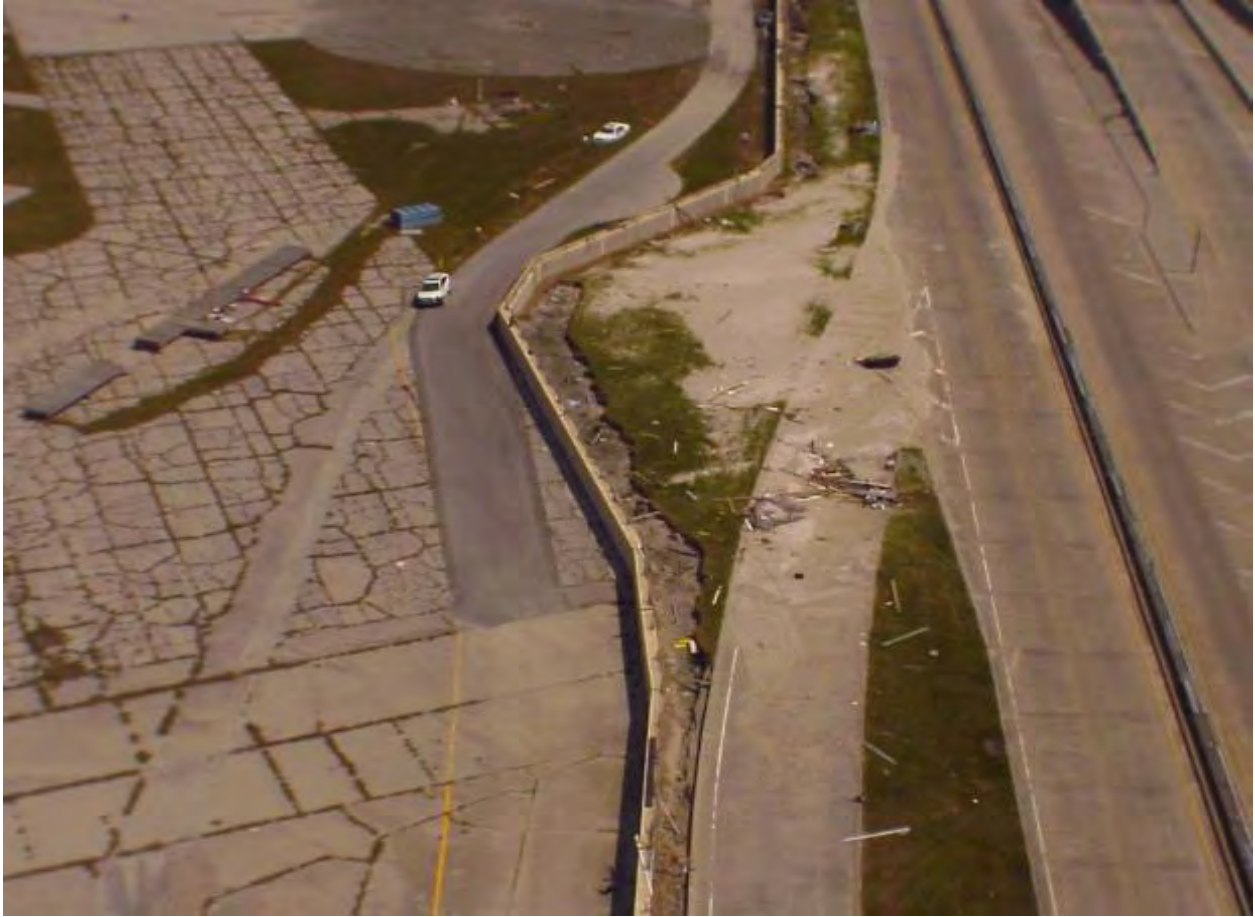
Figure 12-6. NOE6_B. Scoured Section on Protected Side at Lakefront Airport Floodwall

Project NOE06 consists of filling in and paving over the scour holes next to the concrete wall. It also includes filling in the scour hole and paving the damaged road section with concrete at the interface of the Floodgate L-15 concrete wall and levee. The damage in this reach was primarily scouring along the landside of the floodwall and levee sections at several distinct locations. The severity of the scouring varies from minor to severe. Scouring occurred to some degree at each of the tie-in to the closure structures located within this reach. The total quantity of materials removed by scouring along the entire Lakefront reach is estimated to be less than 5000 cys. January 31, 2006 was scheduled completion date.

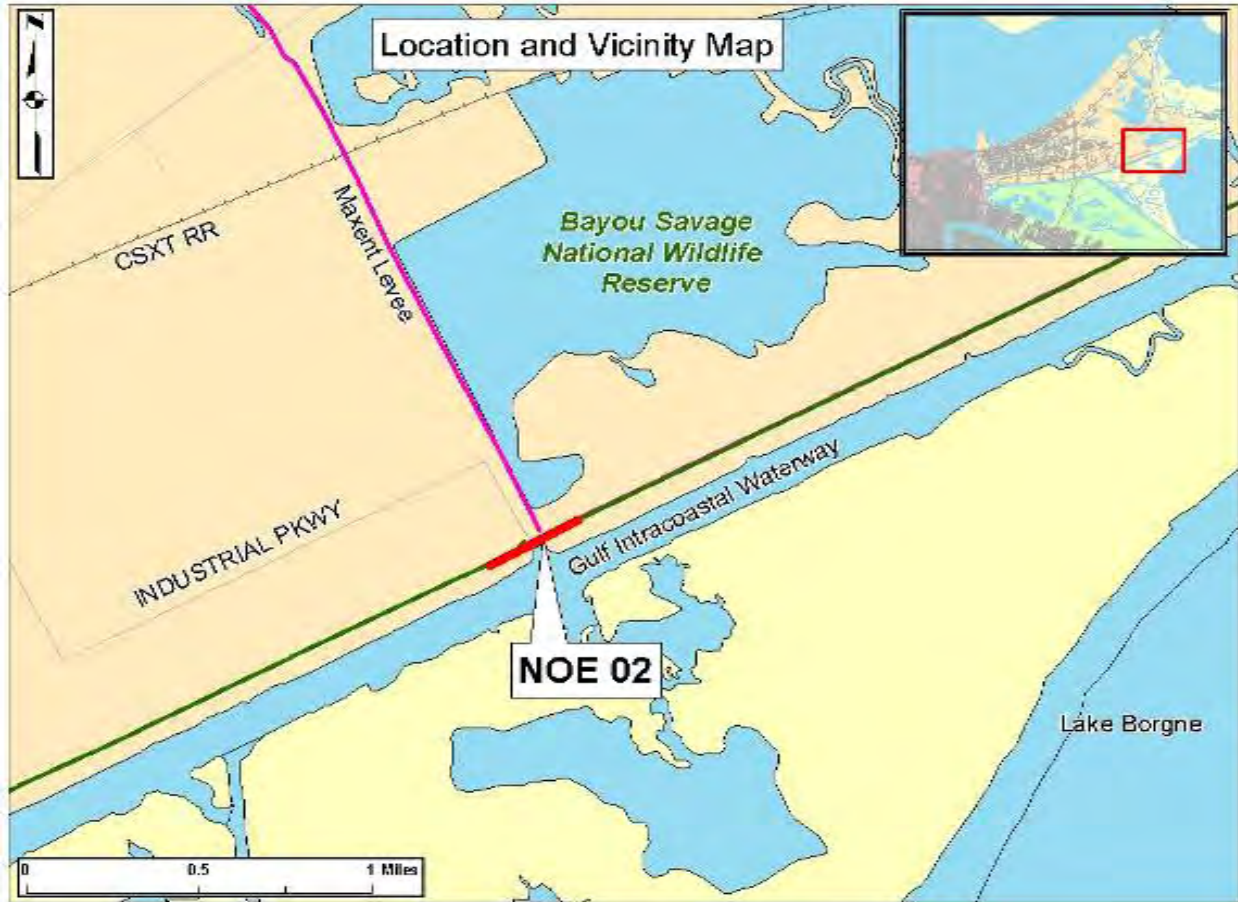
Figure 12-21. NOE2_A Location of Pumpstation 15

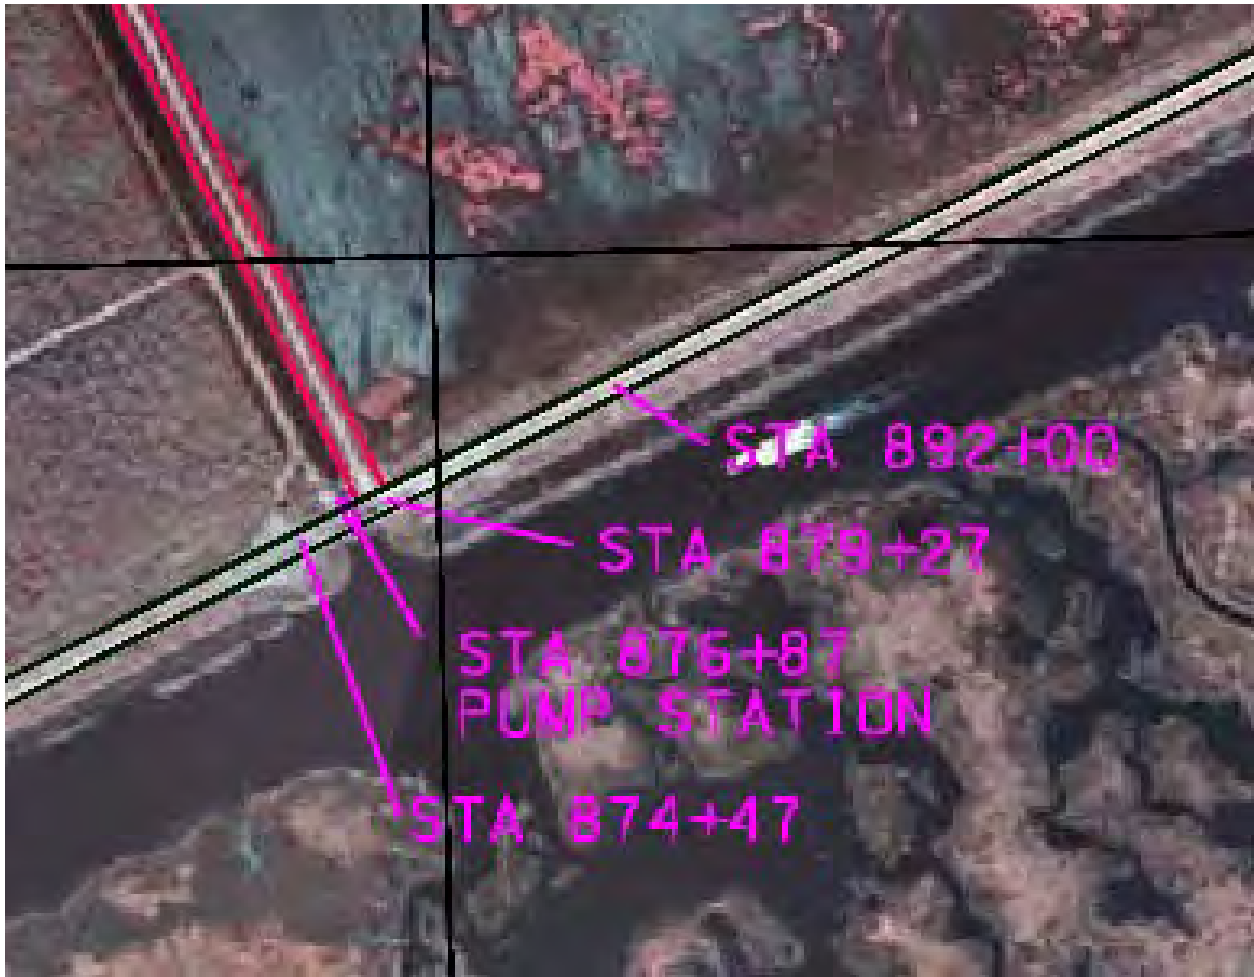
Figure 12-22. NOE2_B Pump Station 15 Coordinates are 30 deg 01 min 45.74 sec N, 89 deg 52 min 03.89 sec W (located at termination of Shell Rd)

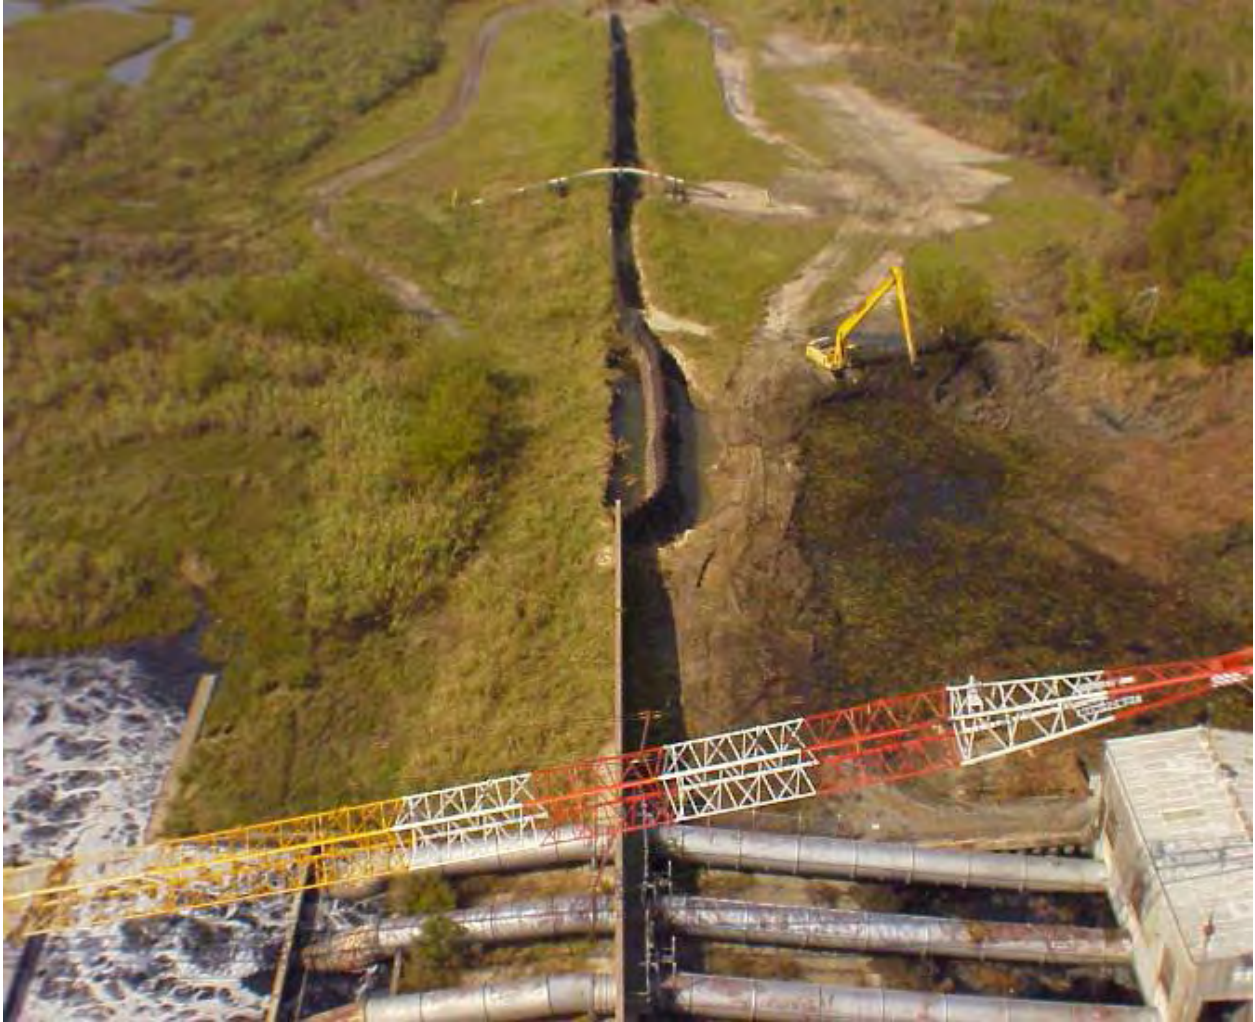
Figure 12-24. NOE2_D View from Above

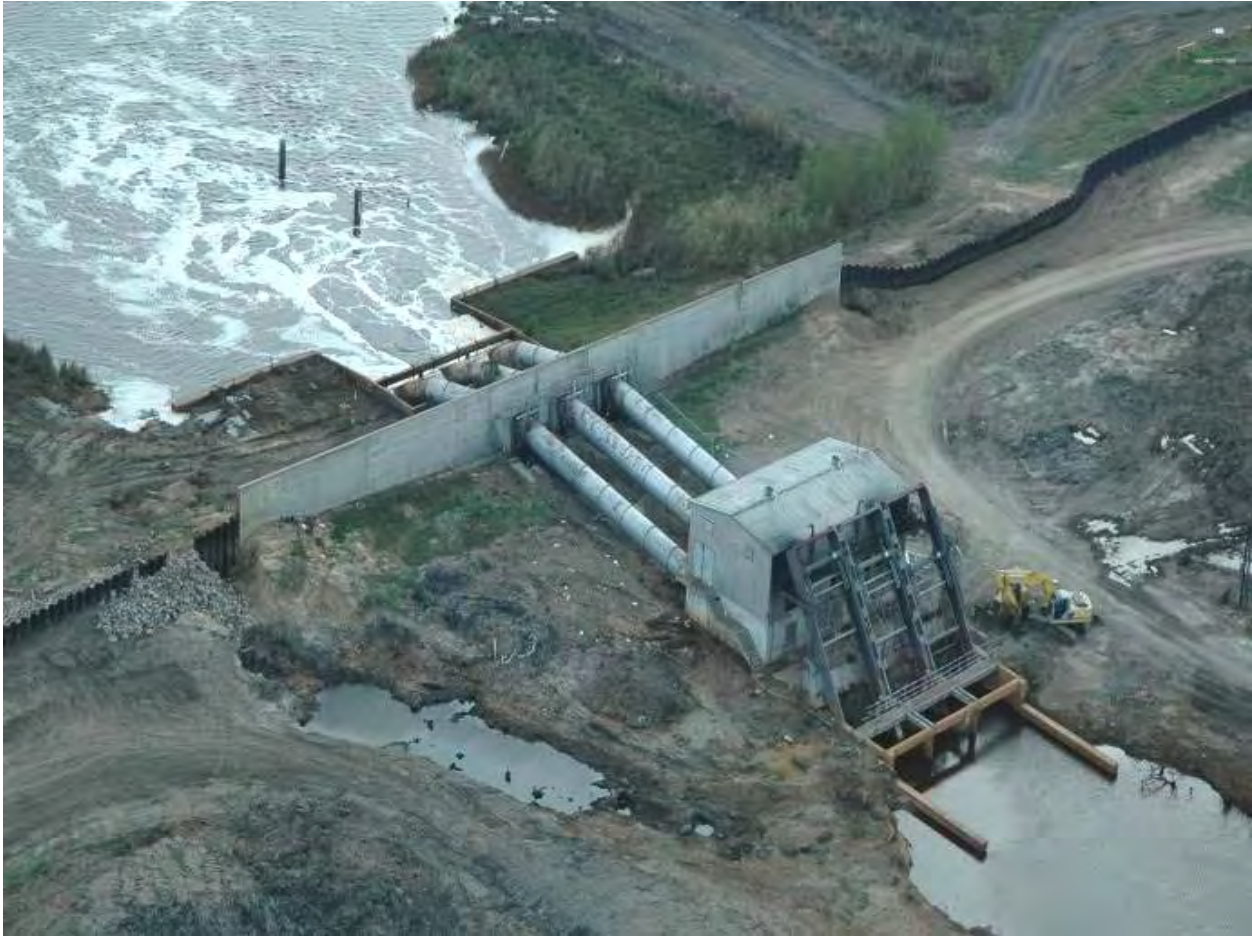
Figure 12-25. NOE2_E PS 15

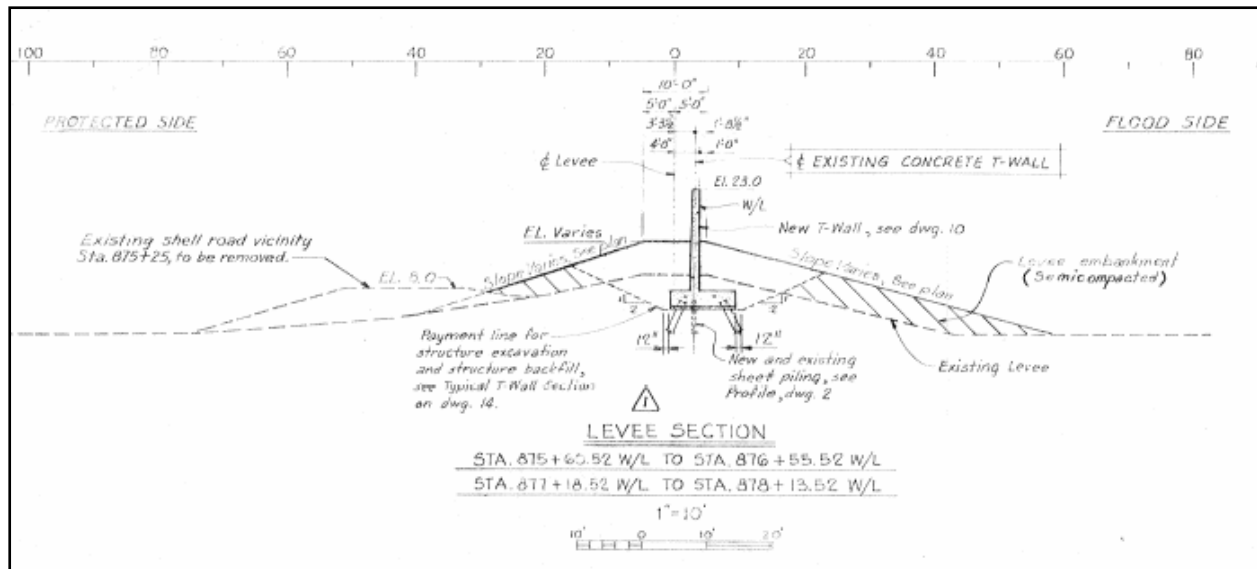
Figure 12-28. NOE2_H Newer (1977) Cut and Fill Sections for T-Wall, Same Contract as Above

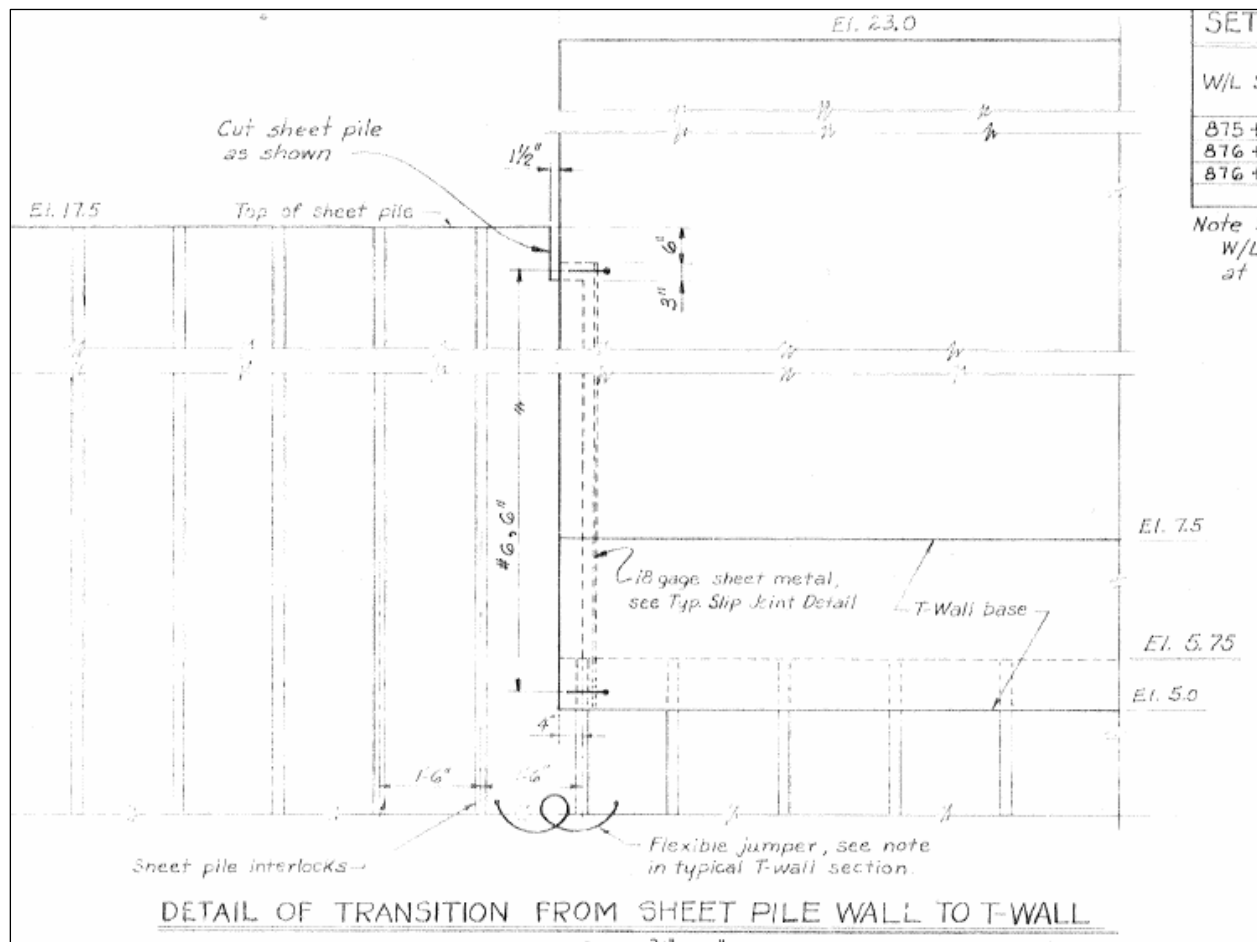
Figure 12-29. NOE2_I Top Elevation Difference of 5.5' Between Sheet Pile and T-Wall (plate 14 of 16 from above contract)

Figure 13-38. Pump Station 15 Top Elevation Difference of 5.5' Between Sheet Pile and T-Wall (plate 14 of 16 from Contract DACW29-77-C-0037, Mod P00001). If pre-Katrina sheetpile elevation was 17.5 ft and storm surge in the MRGO/GIWW was up to 18 ft, then there was minimal overtopping, and the sheetpile breach may have had contributing factors other than overtopping scour

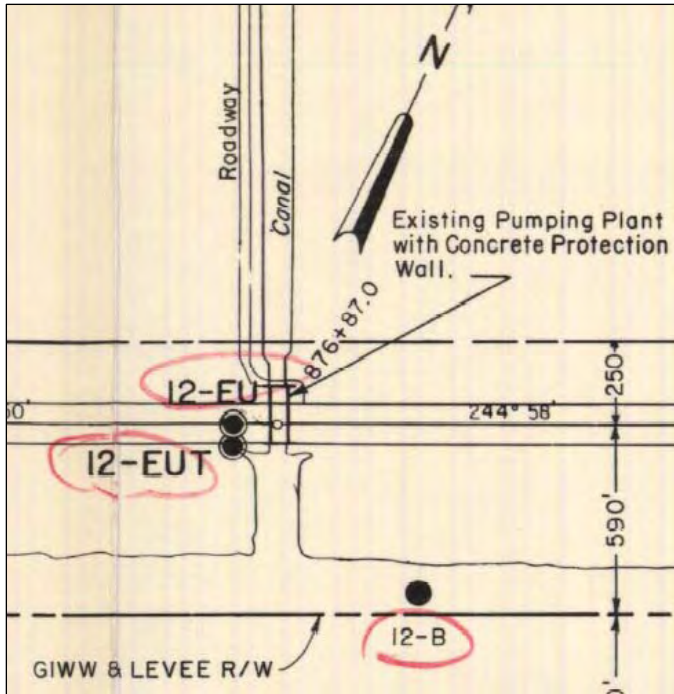
Figure 12-30. NOE2_J Soil Borings (from page 81 of 238, DM2 Gen Design Supp 4 N.O. East Back Levee (Mar 1971).pdf). Boring logs are shown on pages 88 and 89 of 238 (plates 10 and 11)

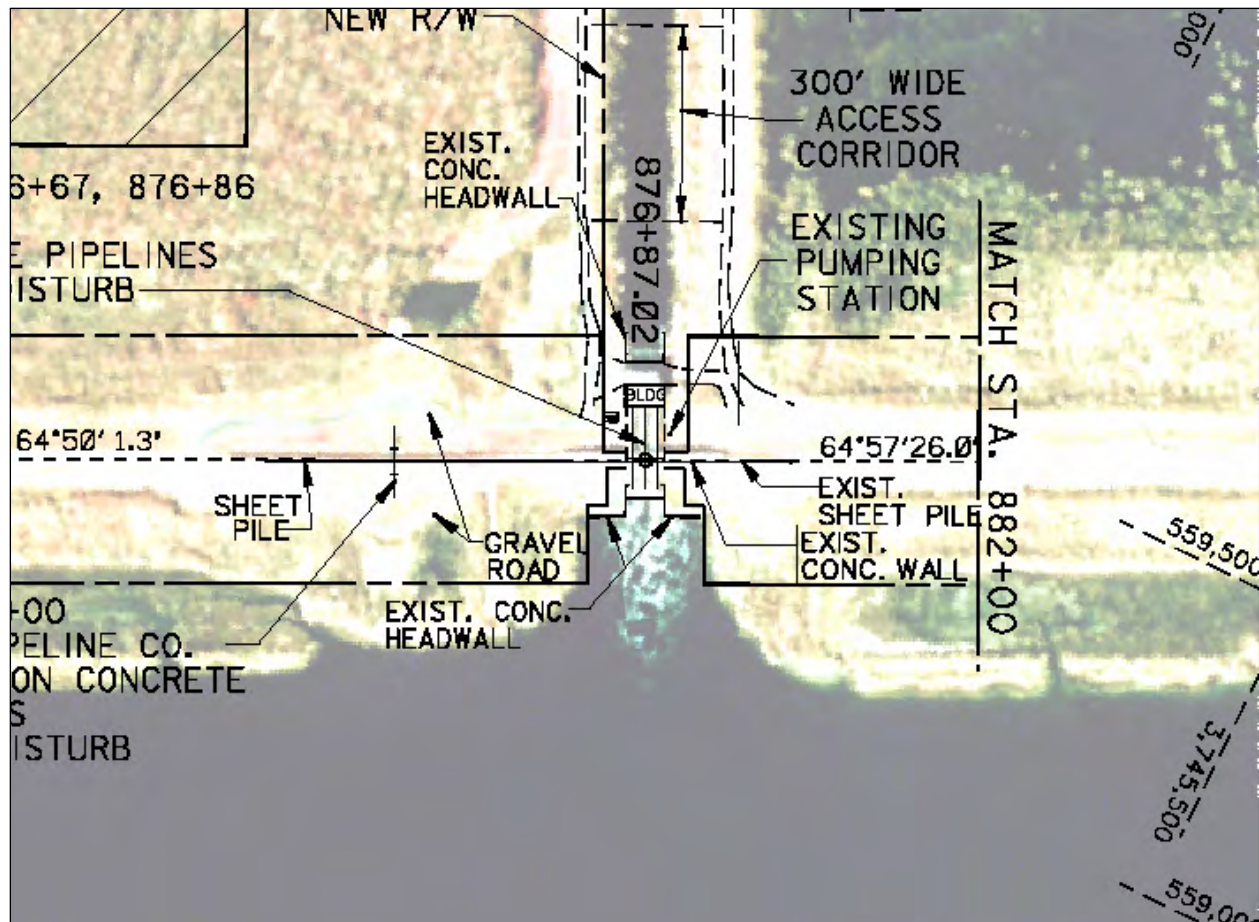
Figure 12-32. NOE2_L Plan view from Contract Solicitation NOE1 Drawing

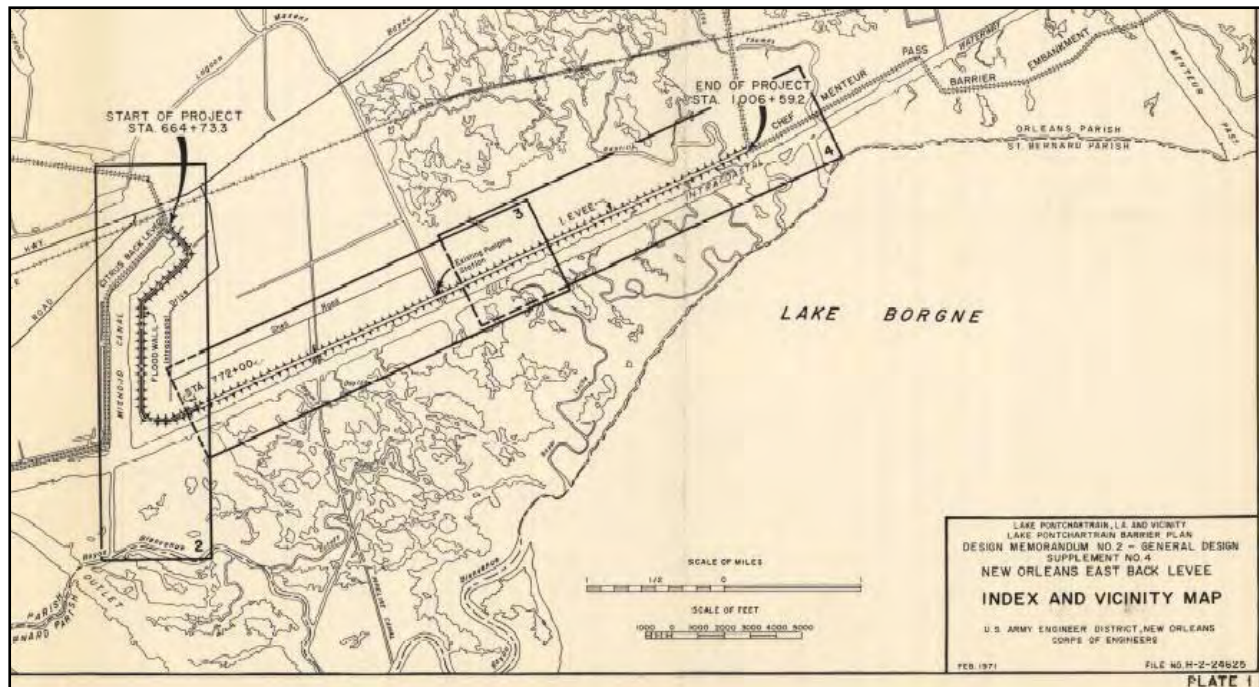
Figure 12-35. NOE1_B Page 79 of 238, DM2 Gen Design Supp 4 N.O. East Back Levee (Mar 1971).pdf

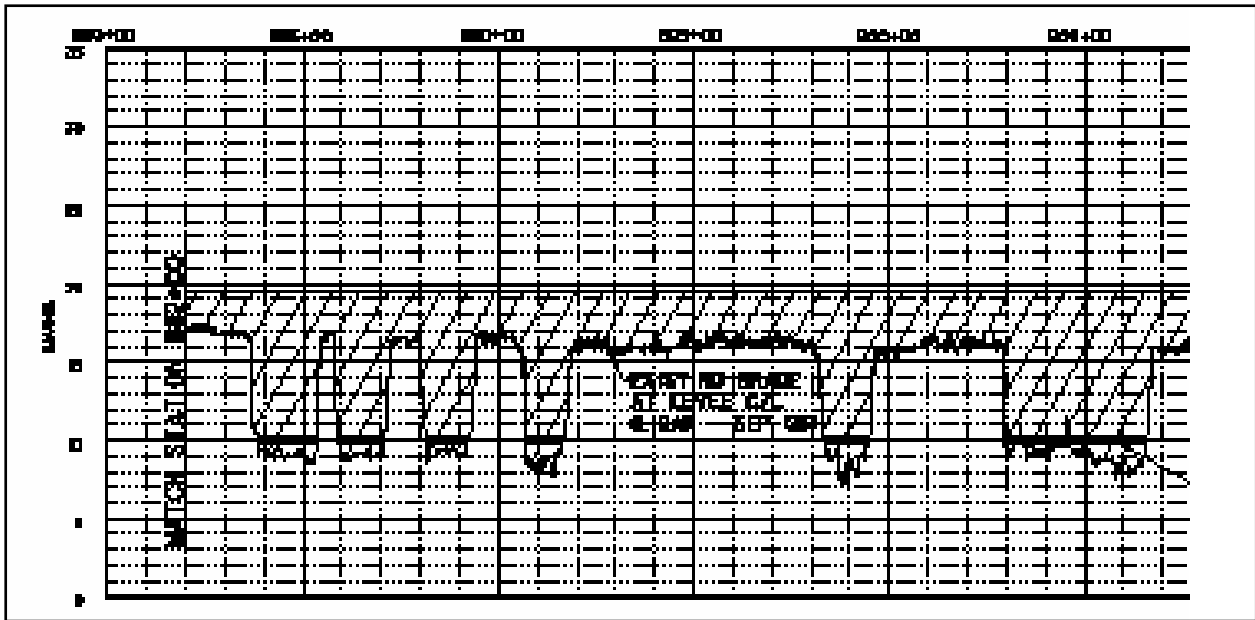
Figure 12-37. NOE1_D LIDAR Profiles of Levee East of Pump Sta 15 (from Contract Solicitation NOE1 drawings)

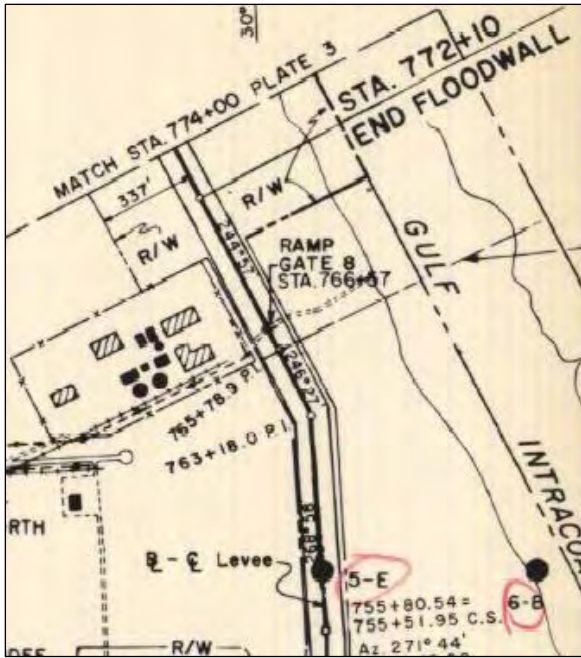
Figure 12-42. NOE3_A. Page 80 of 238, DM2 Gen Design Supp 4 N.O. East Back Levee (Mar 1971).pdf

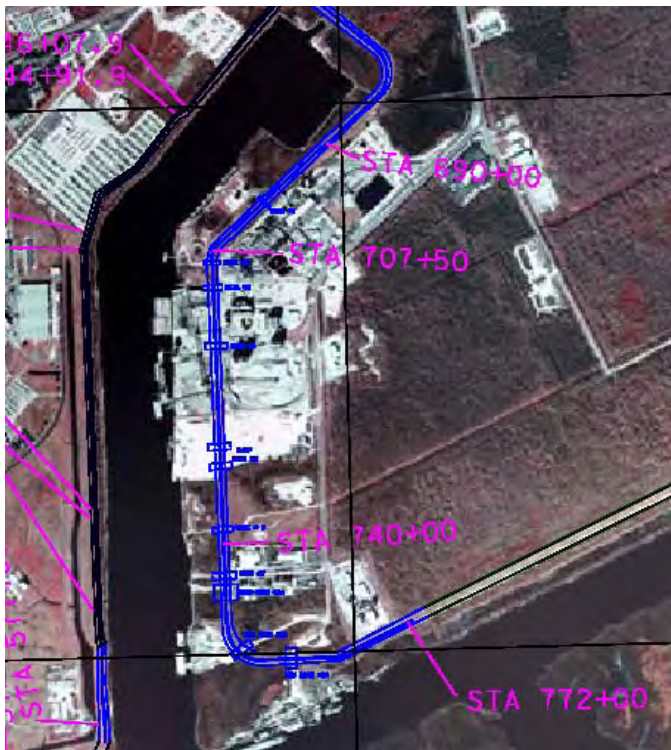
Figure 12-43. NOE3_C. Blue Color is Top of Wall Elevation 20 ft

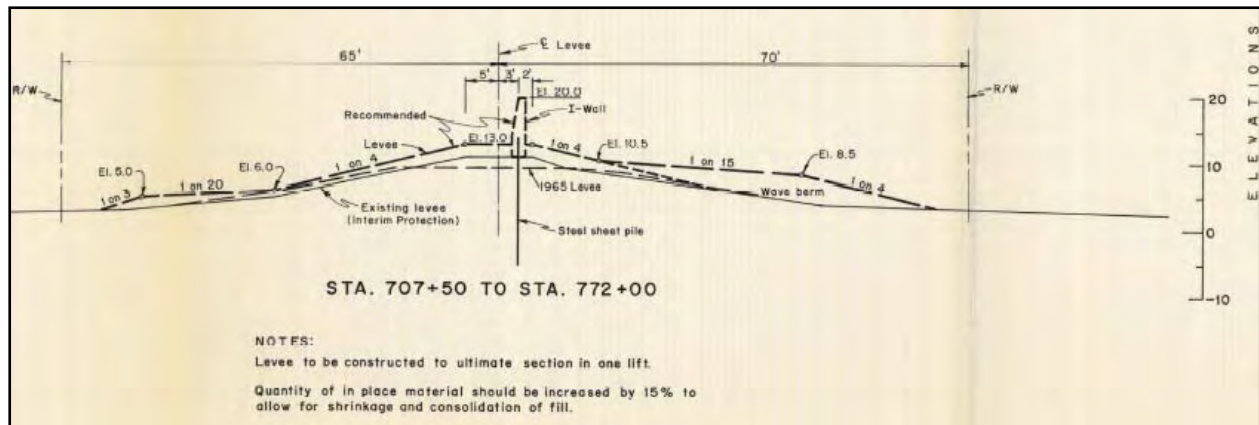
Figure 12-45. NOE3_E. Page 107 of 238, DM2 Gen Design Supp 4 N.O. East Back Levee (Mar 1971).pdf Showing Add-On to Existing Levees (1965 and interim add-on)

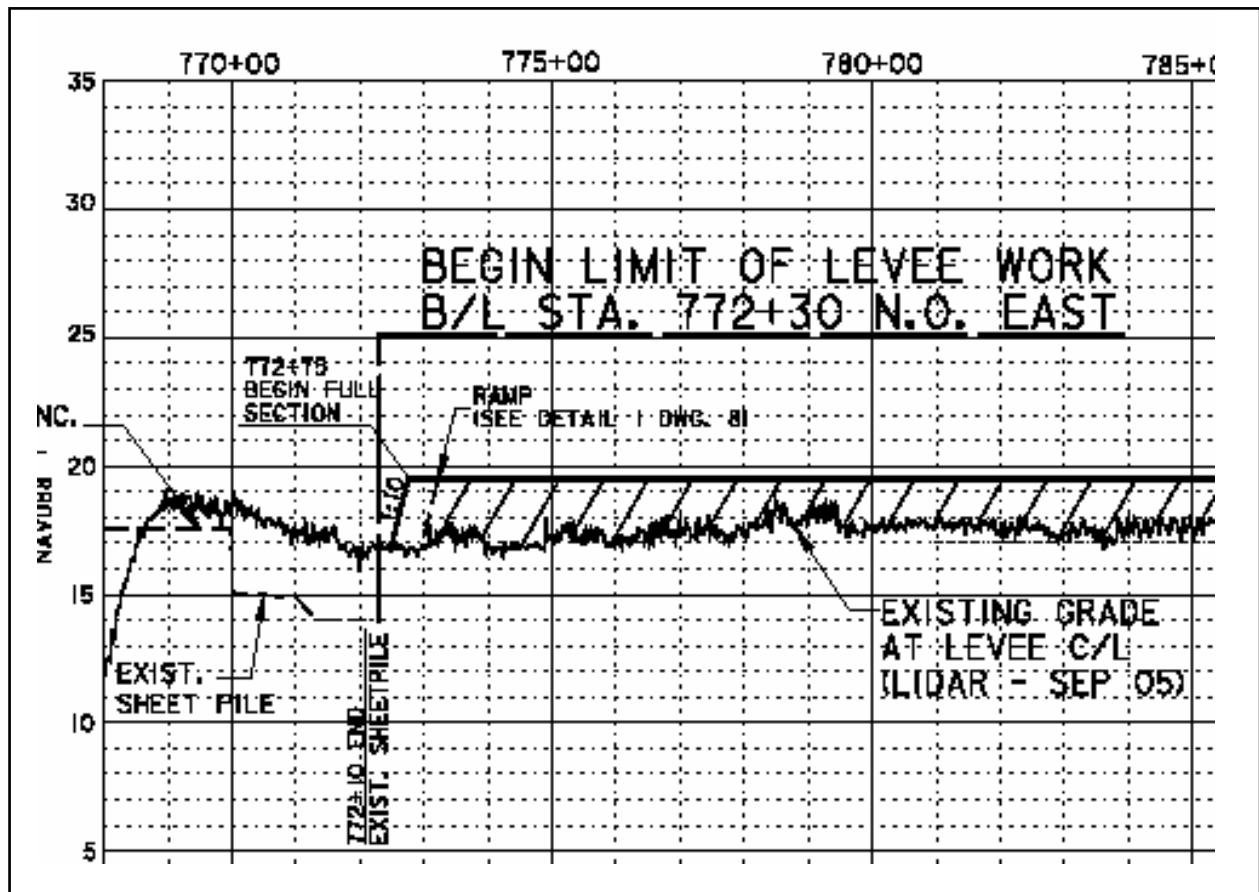
Figure 12-46. NOE3_F. Post-Damaged Lidar Elevations Show Scour Hole (approx Sta 768+00) Depth was About 8' deep (from Contract Solicitation NOE1 drawing H-8-45594, sheet 2 of 16)

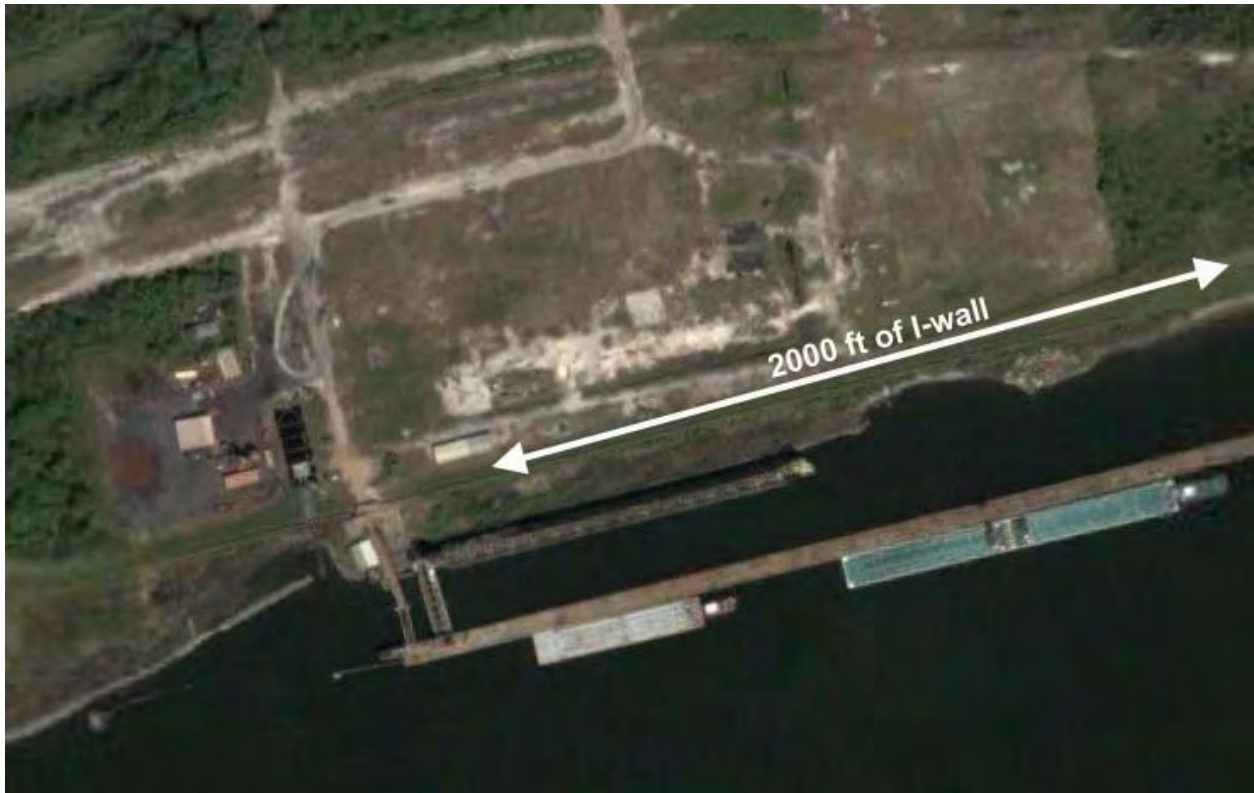
Figure 12-57. NOE4_D. Bulk Loading Facility on the GIWW. Note Tool Shed Metal Building Location

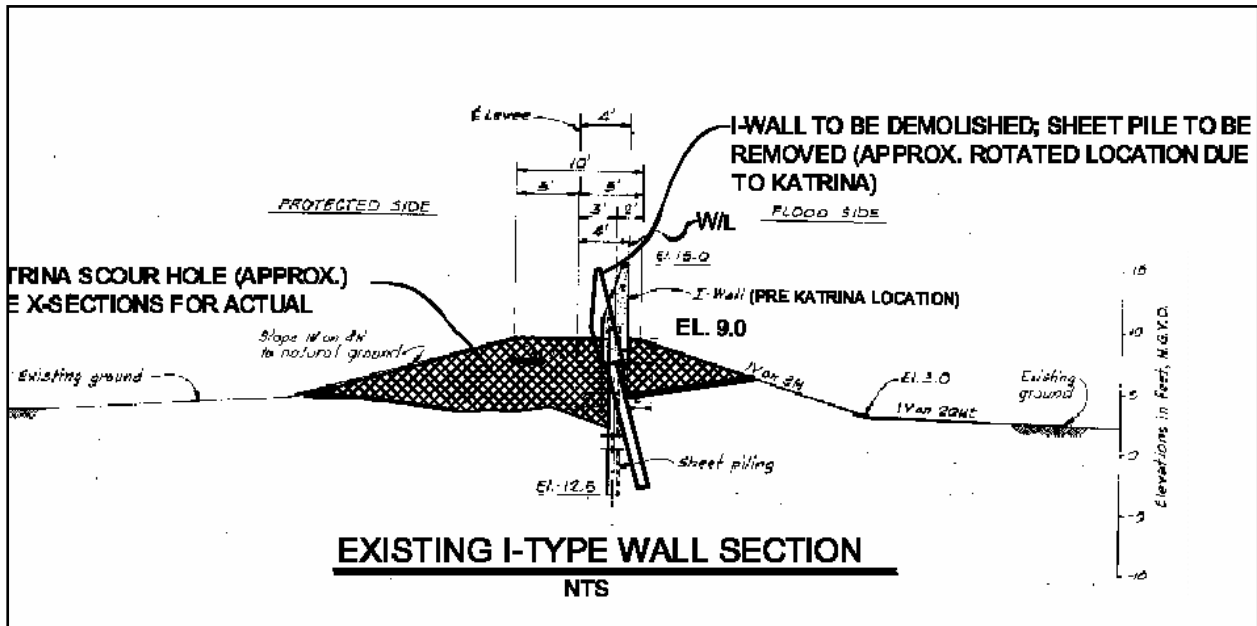
Figure 12-58. NOE4_E. Post-Katrina Condition

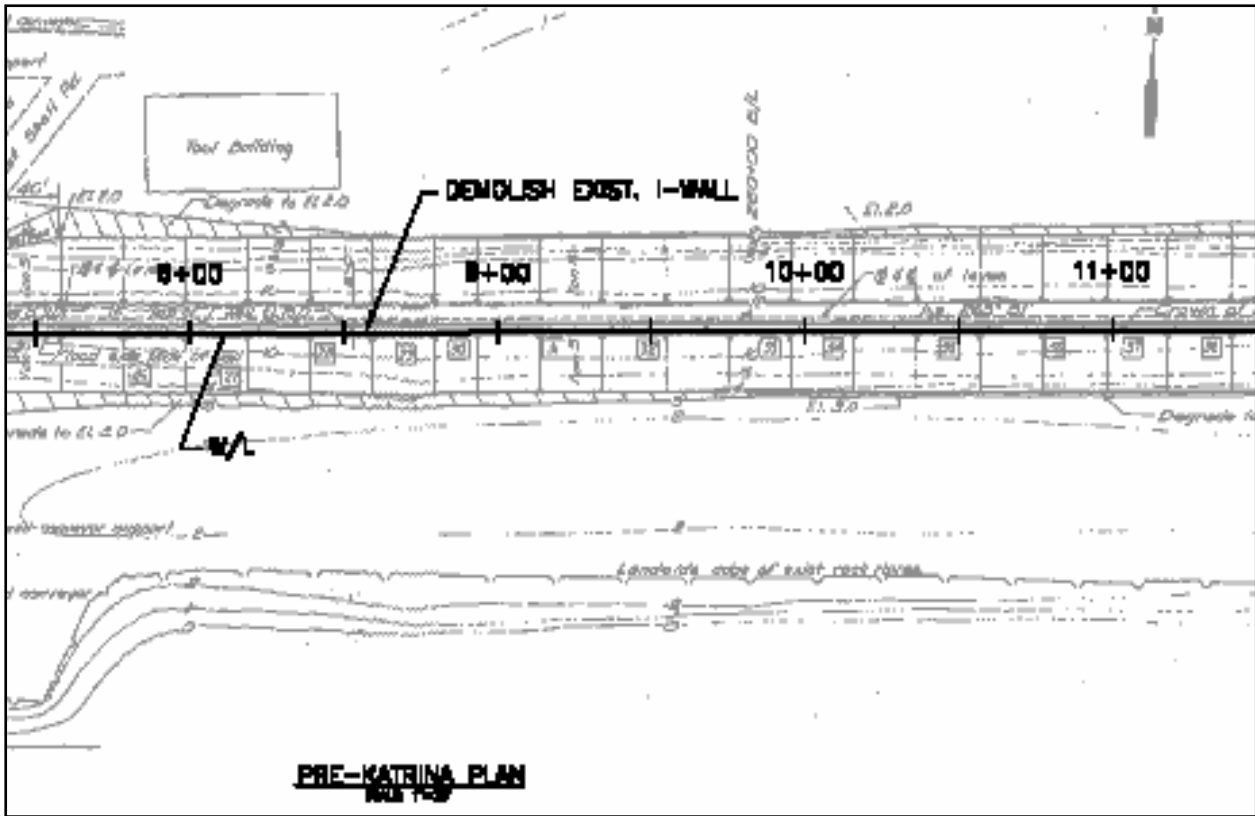
Figure 12-59. NOE4_F. Sections are from the Lake Pontchartrain, Louisiana and Vicinity, New Orleans East Area Plan Emergency Restoration, Modifications to Citrus Back Levee Floodwall Sta. 250+17.5 B/L to Sta. 279+44.50 B/L (Sta. 0+02.0 W/L to Sta. 29+41.71 W/L) Construction Contract Solicitation

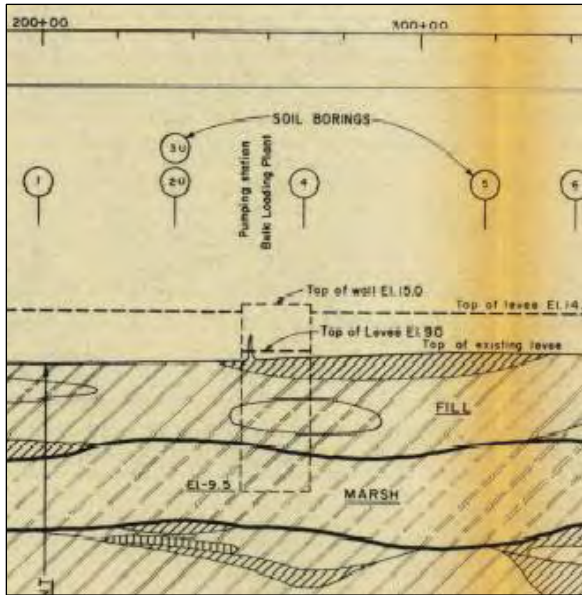
Figure 12-69. NOE4_P. Plate 35, Geology Profile. Note that Sta 240+ to Sta 300+ of the 1965 levee was approximately 5 ft of CL (lean clay) from top elevation 10' MSL down to 5' MSL. Organic clay fill lies beneath.

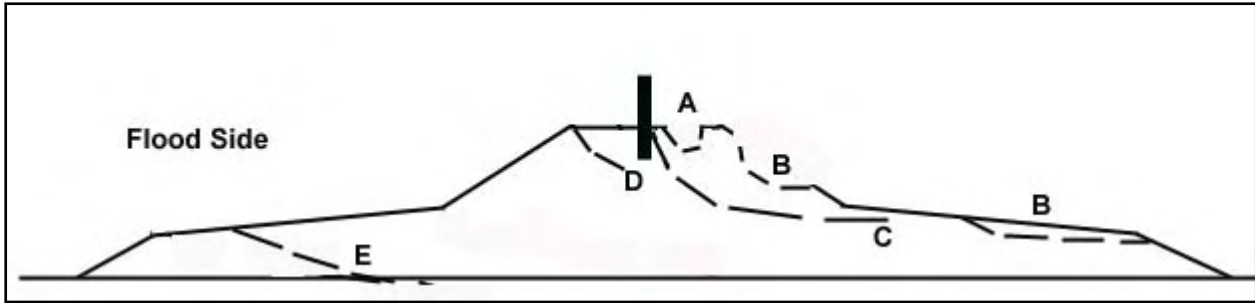
Figure 13-1. Erosion Progression Patterns for Earthen Levees, Floodwalls, and Exposed Sheetpile

Scour pattern “A” indicates scour located on the protected side levee slope (or located immediately adjacent to the floodwall or sheetpile protected side), “B” indicates erosion on the protected slopes including stabilizing transition slopes, “C” indicates erosion progressing to the levee crown and adjacent to the floodwall or sheetpile protected side, “D” indicates scour on both the flood side and the protected side of the levee or floodwall, and “E” indicates the original levee footprint has been significantly altered due to erosion and the original foundation base may have scour holes or washouts.
