Appendix 1

Soil Data Report for 17th Street Canal

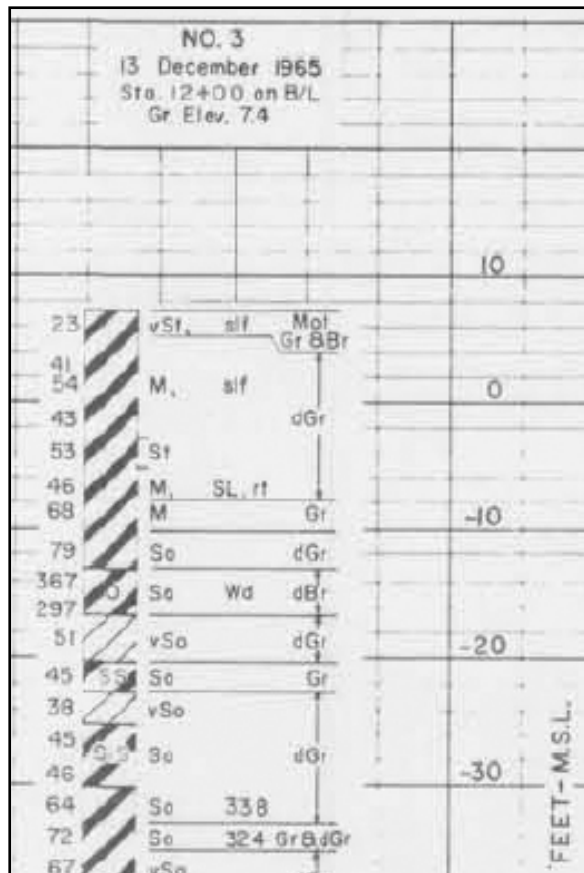
Figure 13-7. Nearest Soil Boring, No. 3, 100 ft Distant, Shows Fat Clay (CH) at Center Line Surface

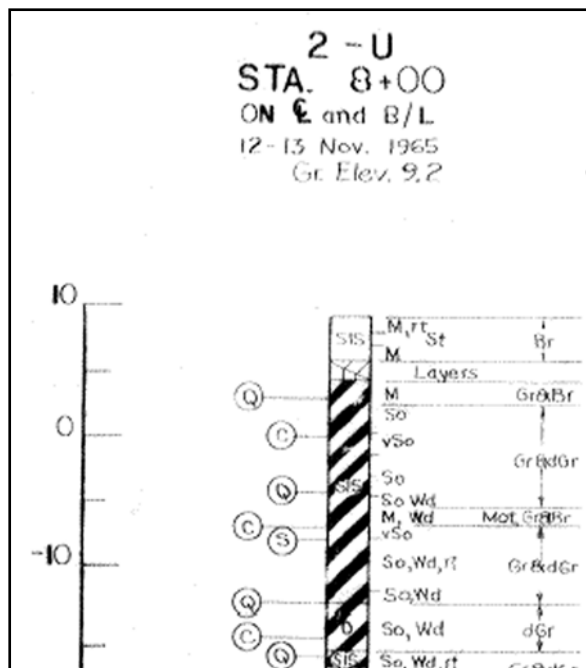
Figure 13-9. Undisturbed Boring 2U Located 100 ft to the North Shows Silt / Sand Lenses in Lean Clay in the Upper 5 ft. Undrained shear strength in the upper 3.2 ft was approximately 500 psf

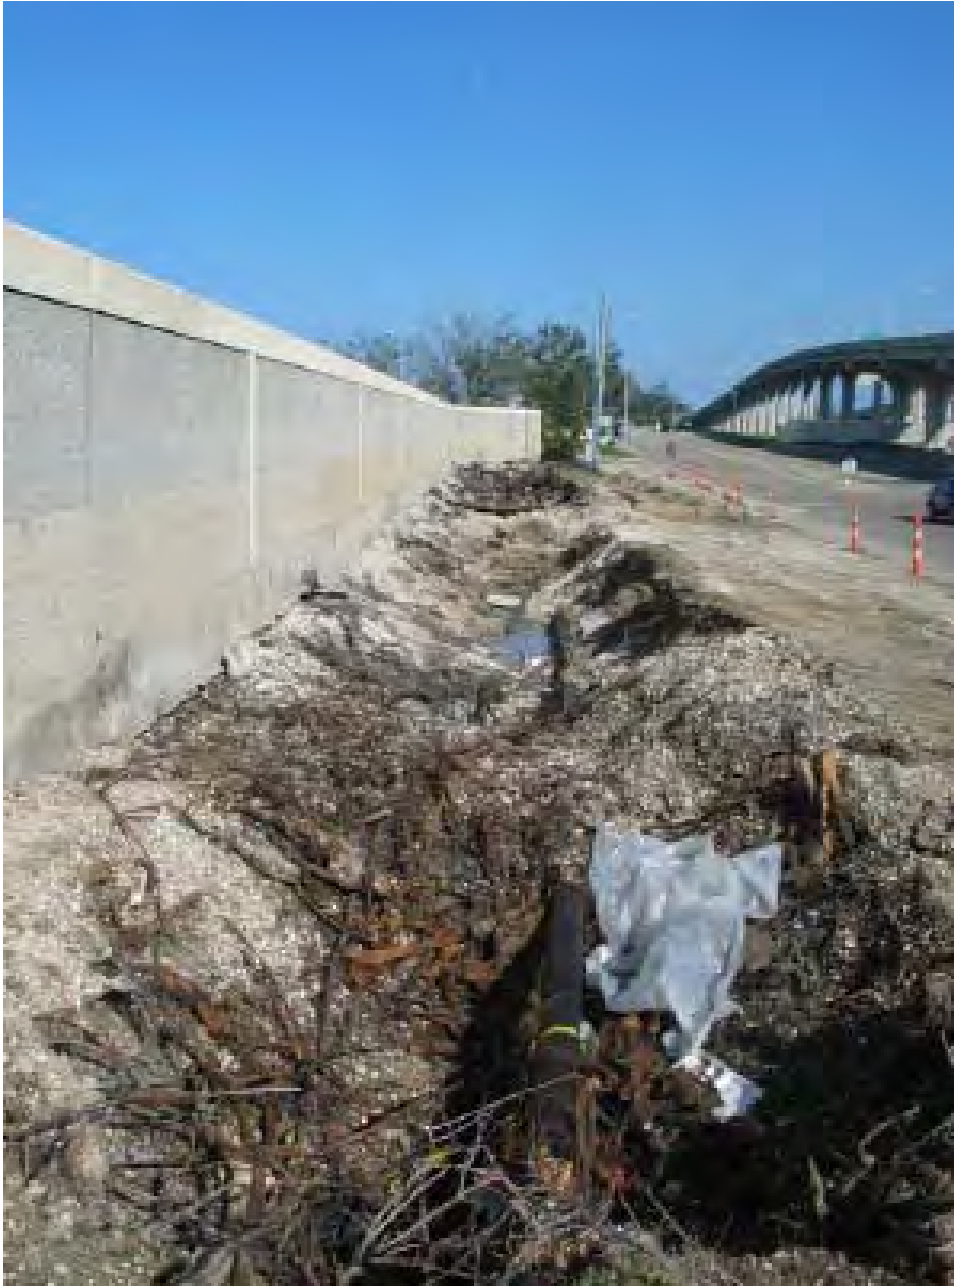
Figure 13-12. Scour Along Lakefront Airport Floodwall Measures 305' (L) x 14' (w) x 48" (d). Existing levee crown appears to be composed of sandy material, based on visual observation. Nearby soil boring 1-C (5/29/1969) at Sta. 8+85, 57 ft right of B/L shows sand, silt, and lean clay lenses to 9-ft depth. Soil boring 4-A (11/3/1970) at Sta 18+00, 200 ft landside of B/L also shows sand, silt, and lean clay lenses to 9-ft depth

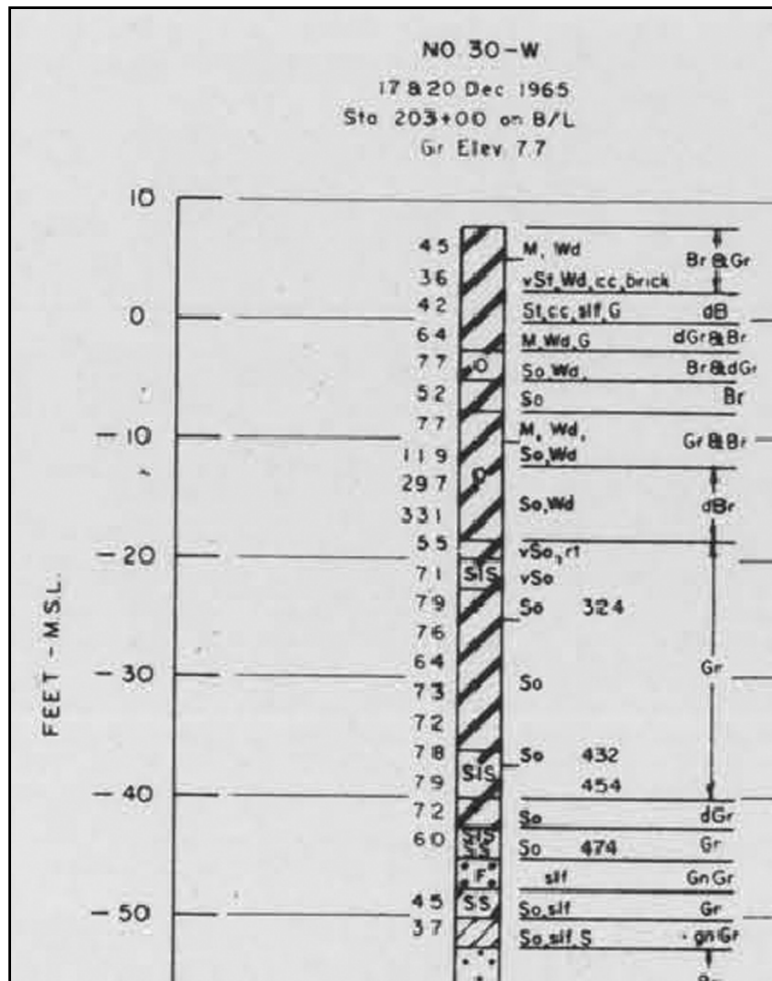
Figure 13-19. Boring 30W About 300 ft from Benefit St Gate Shows Fat Clay Soil Layers in Pre-1965 Levee

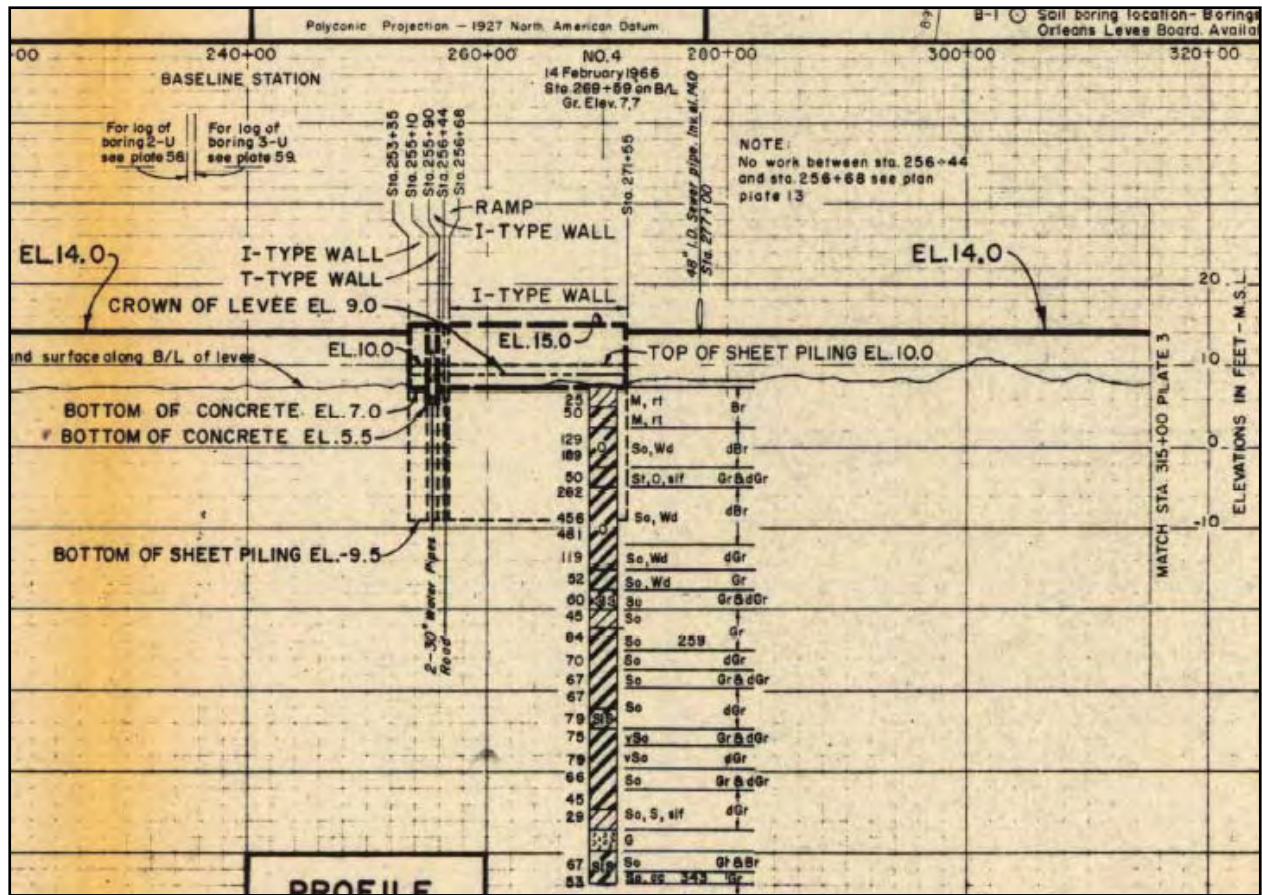
Figure 13-35. Nearby Boring 4 Shows Top Layer of Lean Clay (CL) (from Plate 2 profile section of DM2, General Design Citrus Back Levee, Aug 1967, drawing file H-2-23908)

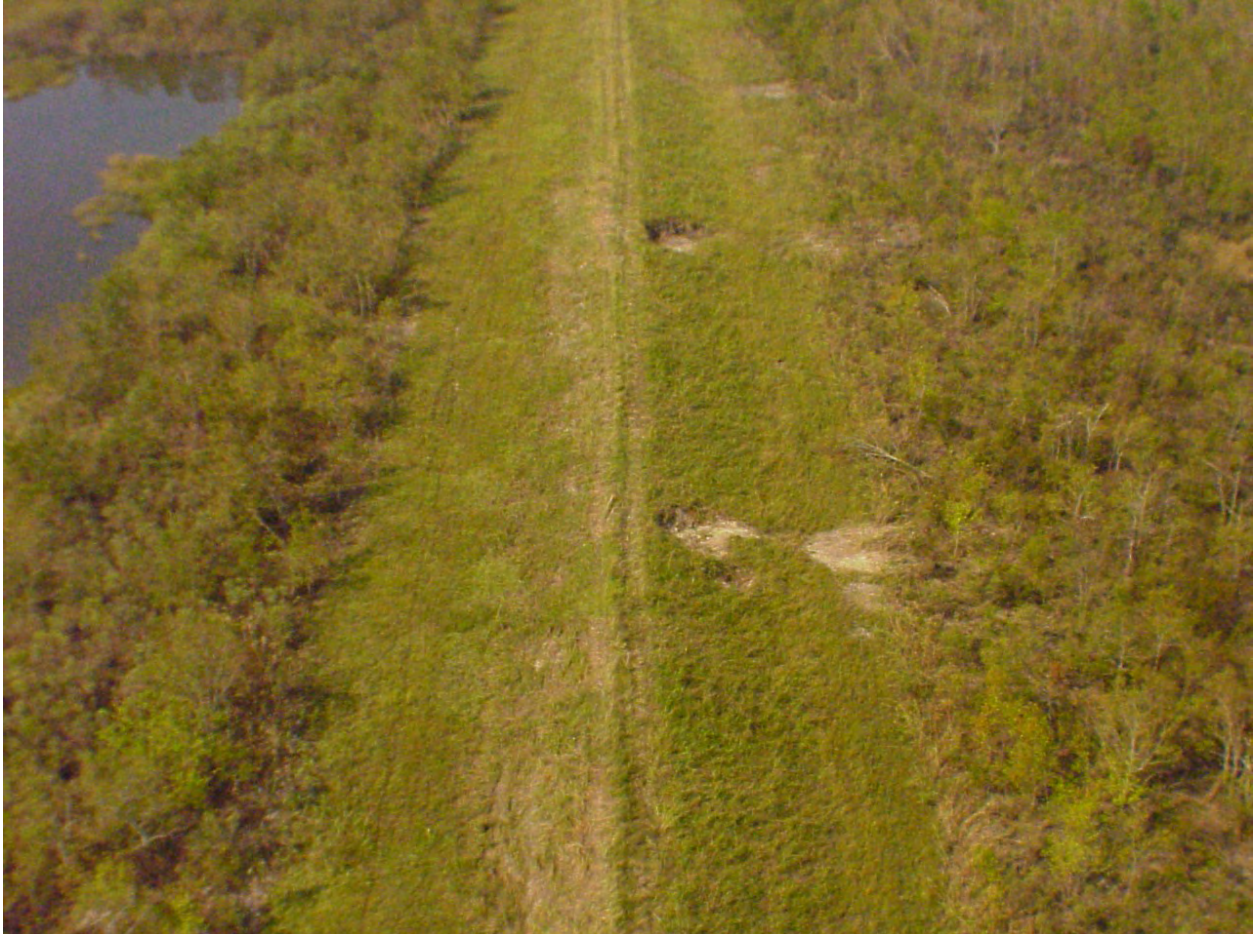
Figures 13-42 and 13-43 show examples of initial overtopping erosion on the Citrus Back Levee backside along the north bank of the GIWW in New Orleans East. The levee crown was elevation 14 to 15 ft and storm surge was 15 to 17 ft from the GIWW, so the overtopping crest

depth was approximately 1 to 2 ft. Approximate surge velocity down a 1:4 slope was 40 fps with shear stress 30 psf. Soil borings along this reach indicated non-homogeneity in the surficial layers of the levee crest and slopes, and cohesive soils with interbedded layers of silt and/or sand were typical.

Figure 13-42. Backside Levee Erosion Pattern “B” on the Citrus Back Levee, N.O. East

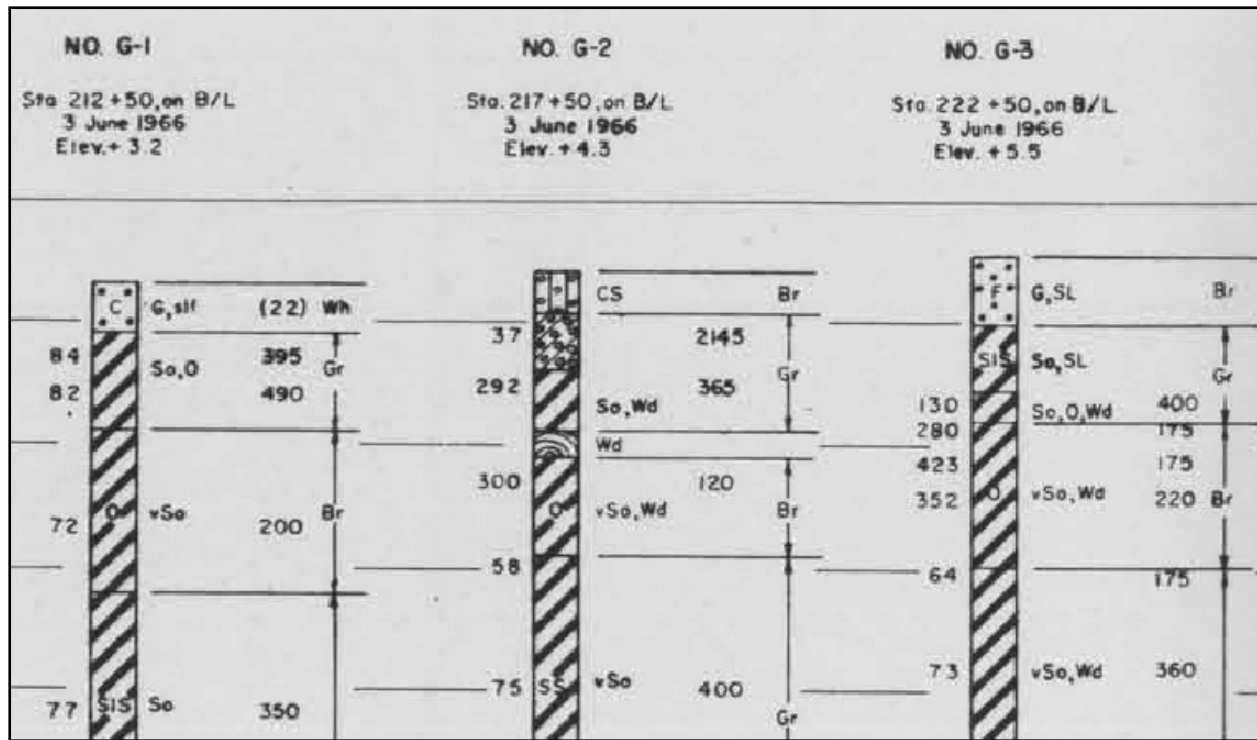
Figure 13-54. Nearest Boring, G-3, Shows Original Ground at Elev 5.5 ft is Sandy Soil

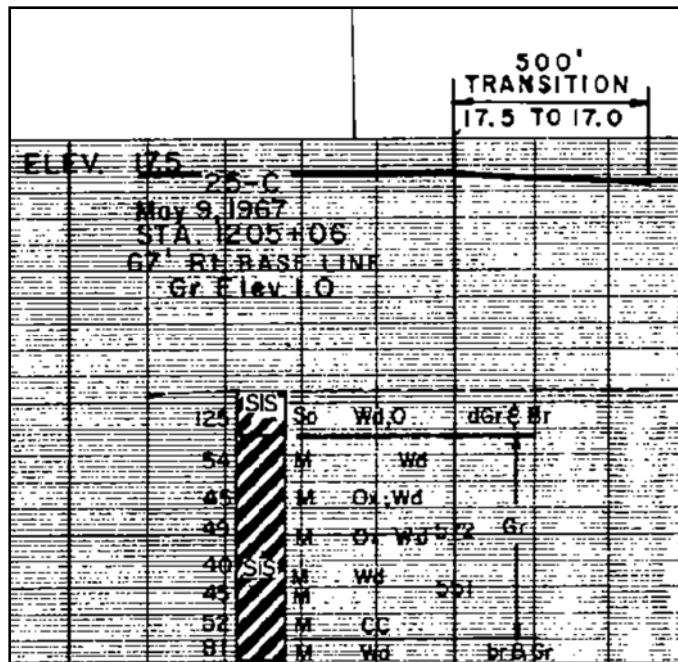
Figure 13-58. Original 1967 Boring at Ground Elevation 1 ft shows Fat Clay With Silt / Sand Lenses (from DM3 Chalmette Extension drawing file H-2- 24306, plate 7). The levee along this reach was constructed of Miss. River hydraulic sand fill, capped with local borrow clay, and shaped to grade with Miss. River batture soil (truck-hauled fill)

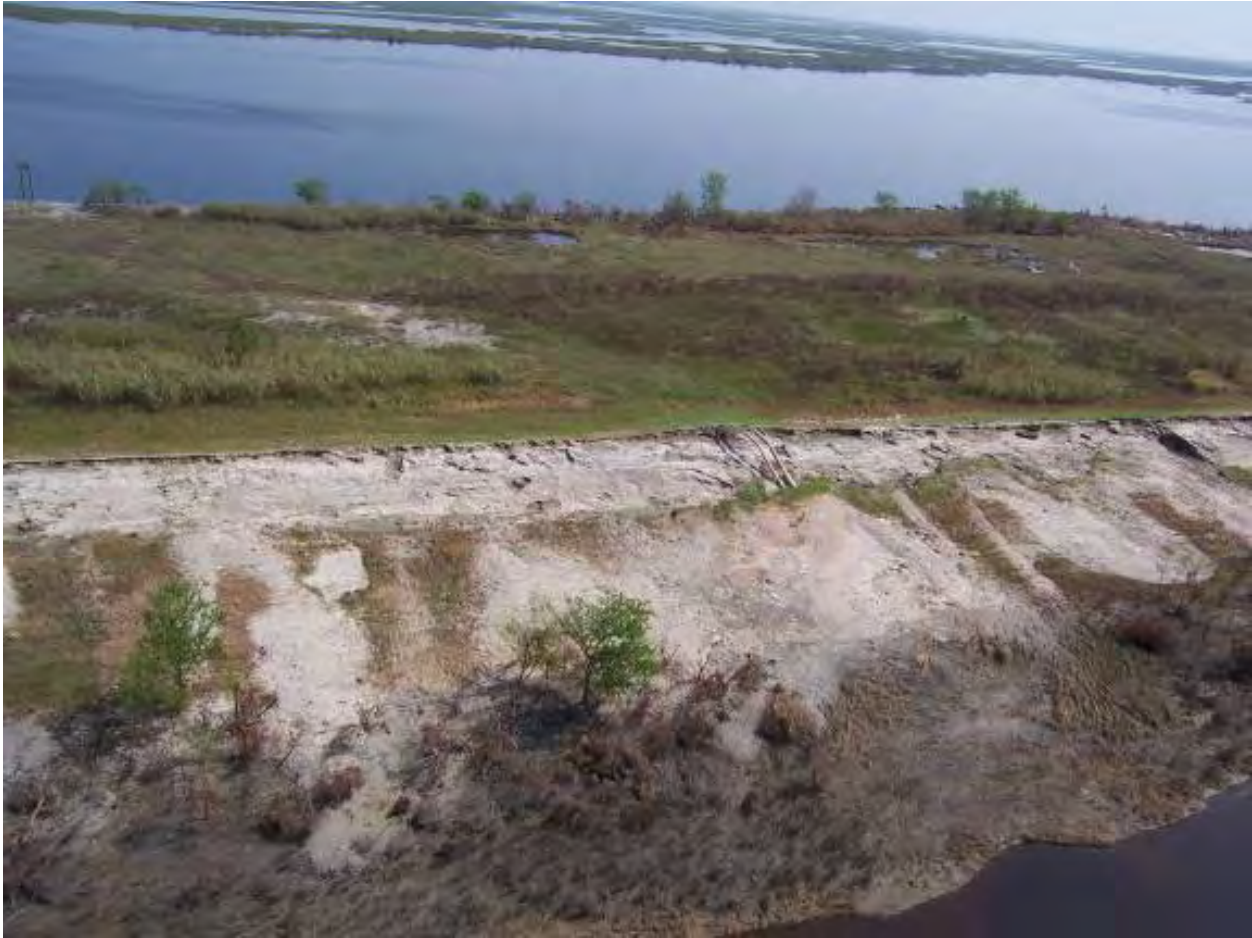
Figure 13-63. 19,000 ft. of Levee Between Bayou Bienvenue (Sta 383+00) and Bayou Dupre (Sta 704+00) Lost Approximately 12' of Levee Height From Original (design) Height 17.5 ft. Pre-Katrina elevation was approximately 12 ft, and storm surge along the MRGO was approximately 18 ft, causing an overtopping crest of up to 6 ft

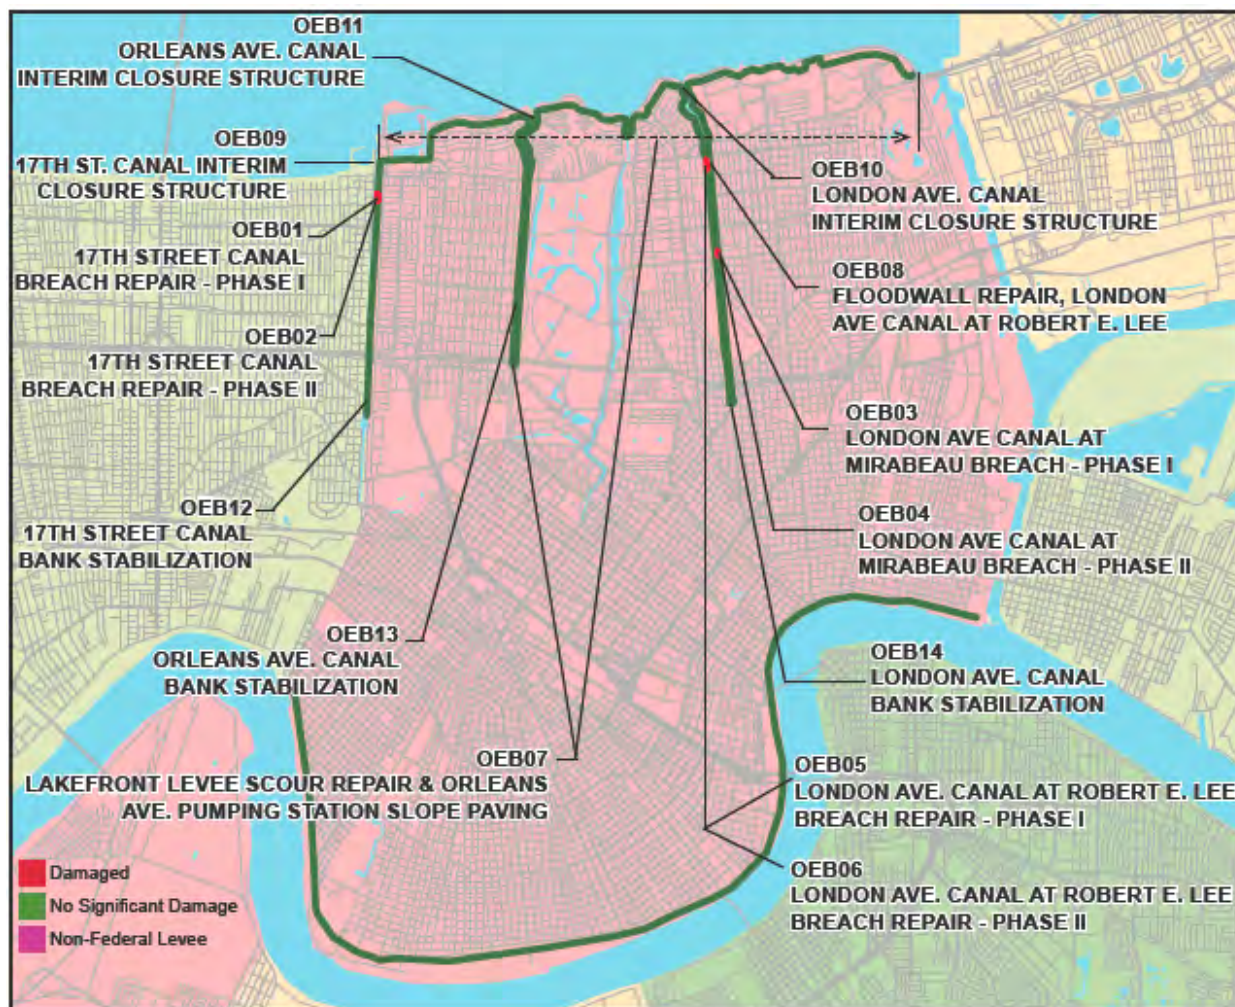
Figure 14-4. Damages and Repair Contracts – New Orleans East Bank

Primary damages to the flood protection in the Orleans East Bank basin consists of a 455- ft breach in the east side I-wall along 17th St. Canal, breaches on both the east side (425 ft) and west side (720 ft) I-wall along London Ave. Canal, breaches along the west side of IHNC floodwall and damages to all fifteen pumping stations.

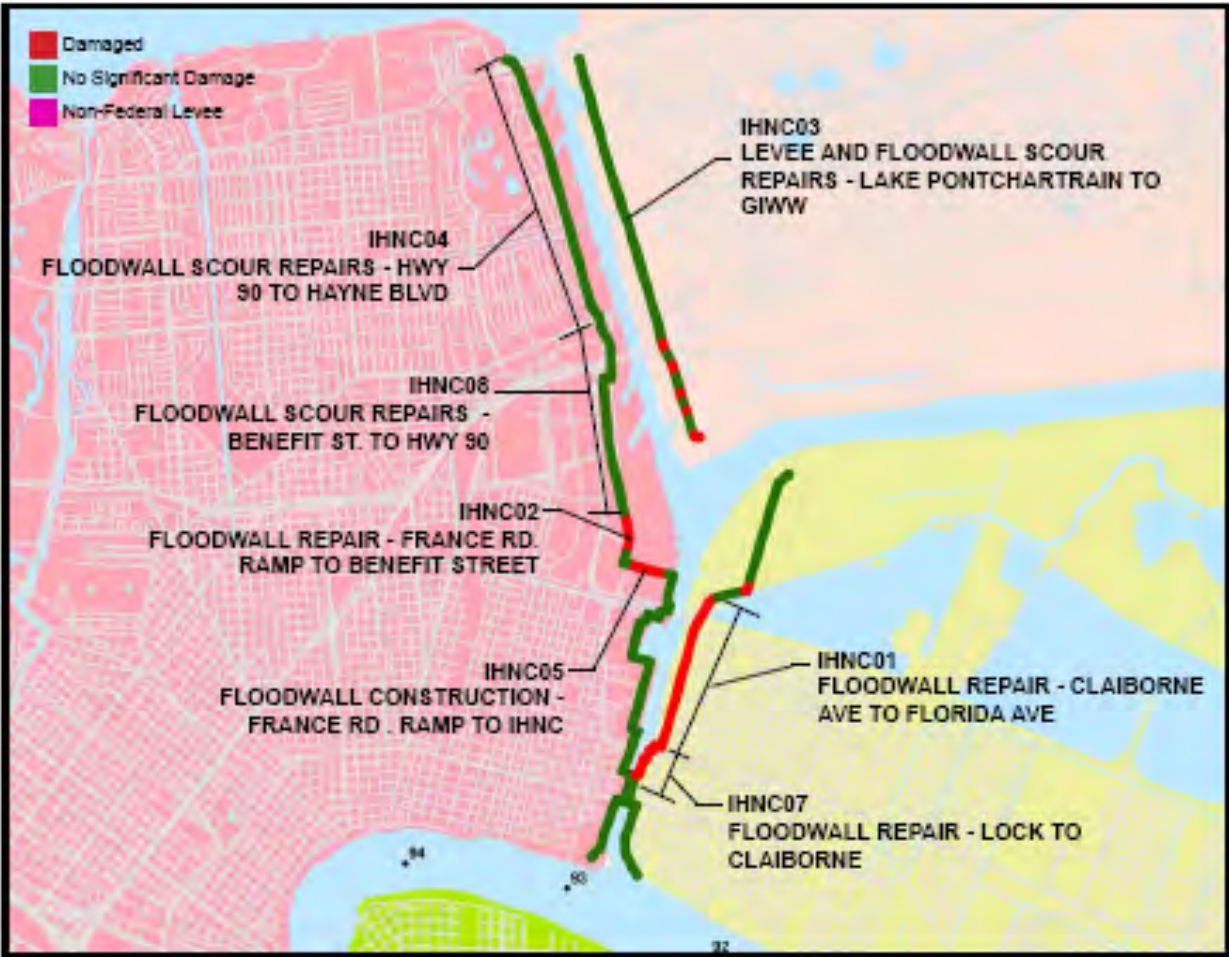
Figure 14-8. Hurricane Protection Features and Damages– IHNC

IHNC Damages. Overtopping of the hurricane protection by Hurricane Katrina was evident along nearly all portions of the canal. There were four breaches in the protection system, two on the east side and two on the west side. The east side breaches are both located in the lower 9th ward neighborhood and the west side breaches are both in the vicinity of France Road and Benefit Street.

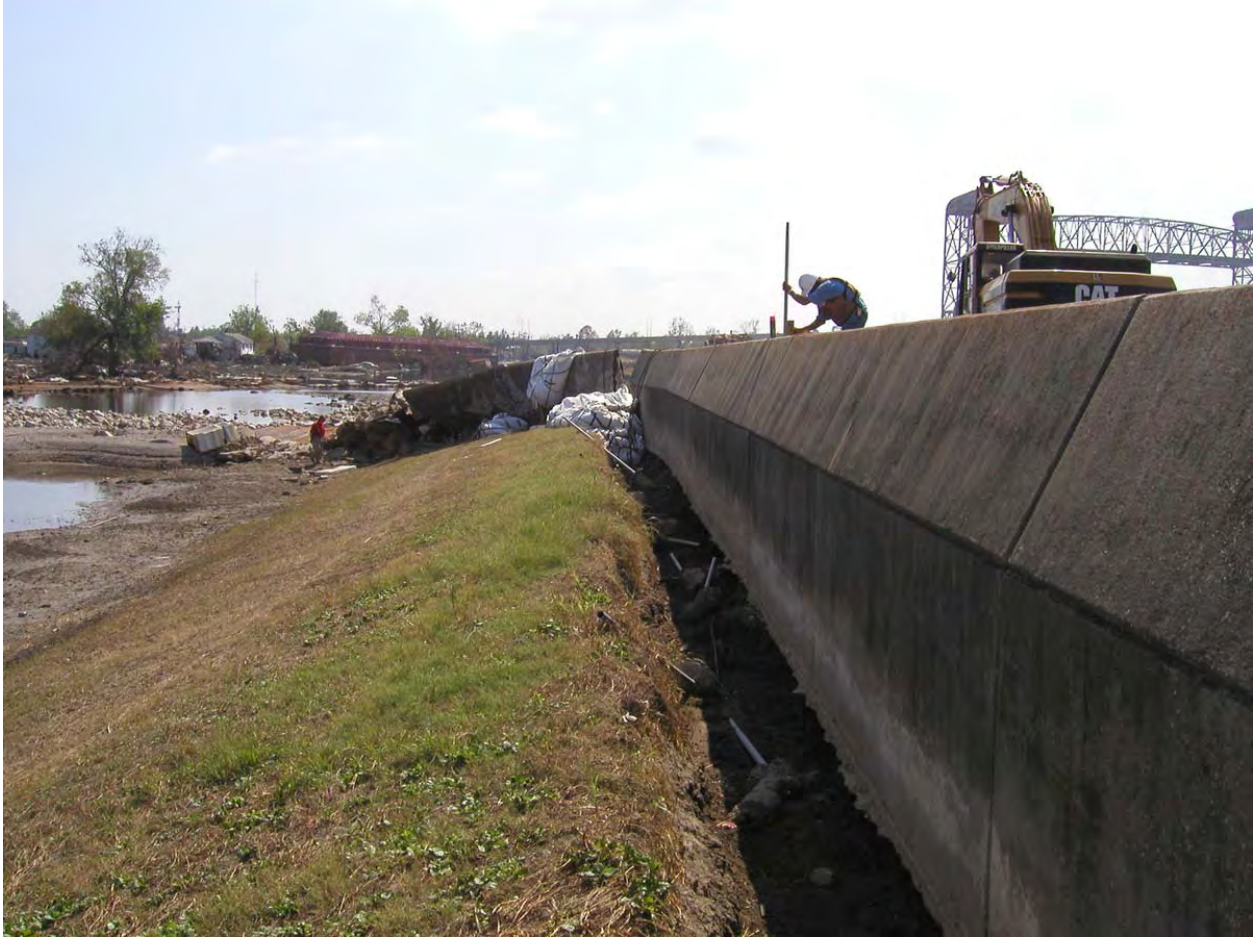
Figure 14-26. Northernmost Transition From Failed Wall to Intact Wall

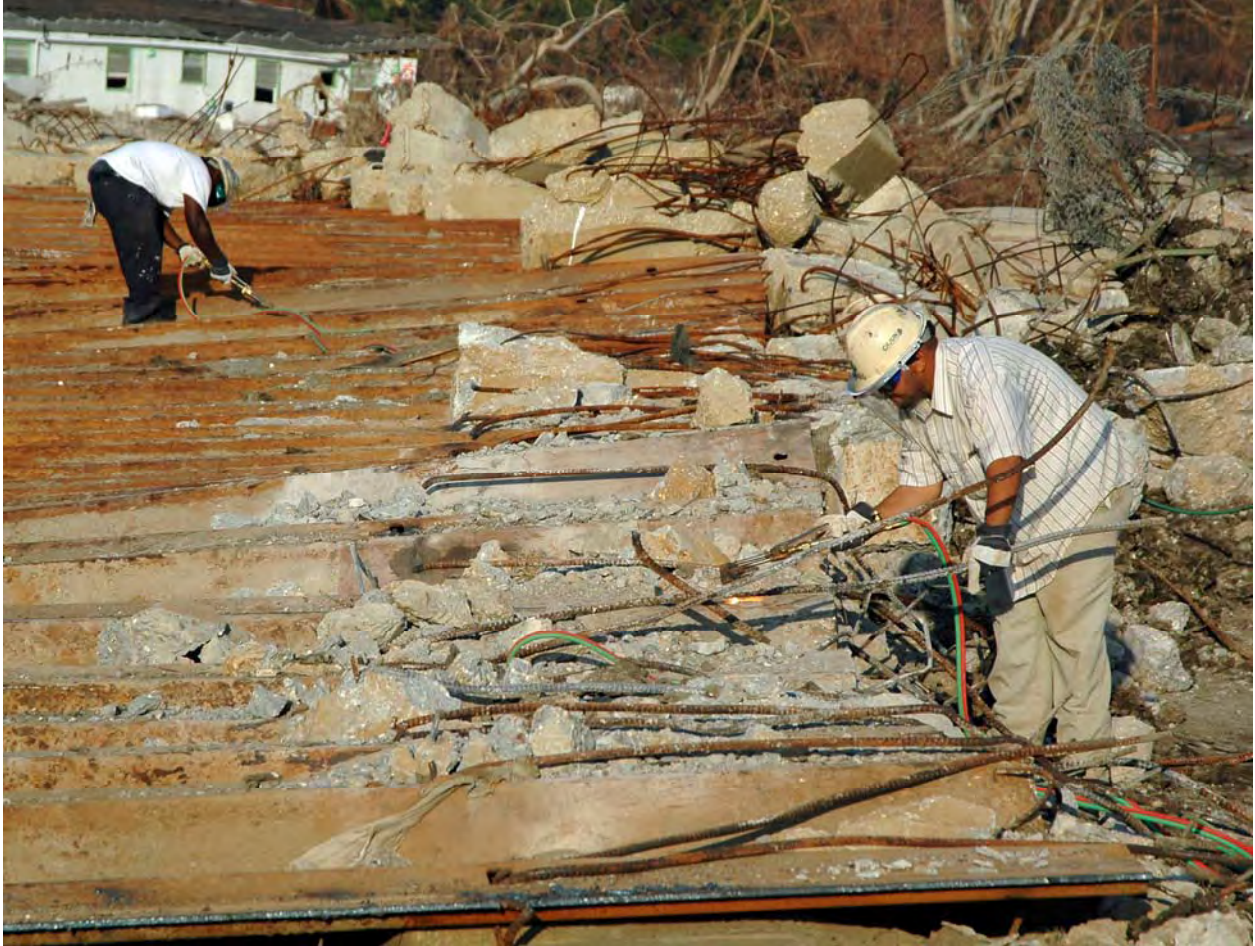
Figure 14-27. Demolishing Flattened I-Wall North of Claiborne Ave.

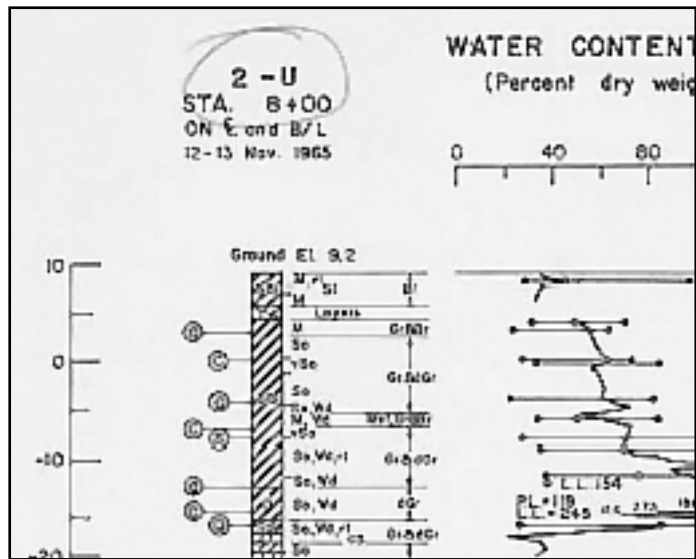
Figure 14-48. Undisturbed Boring 2U Located 100 ft Distant, Shows Fat Clay (CH) With Silt / Sand Lenses in Upper 5 ft. Undrained shear strength in upper 3.2 ft was approximately 500 psf

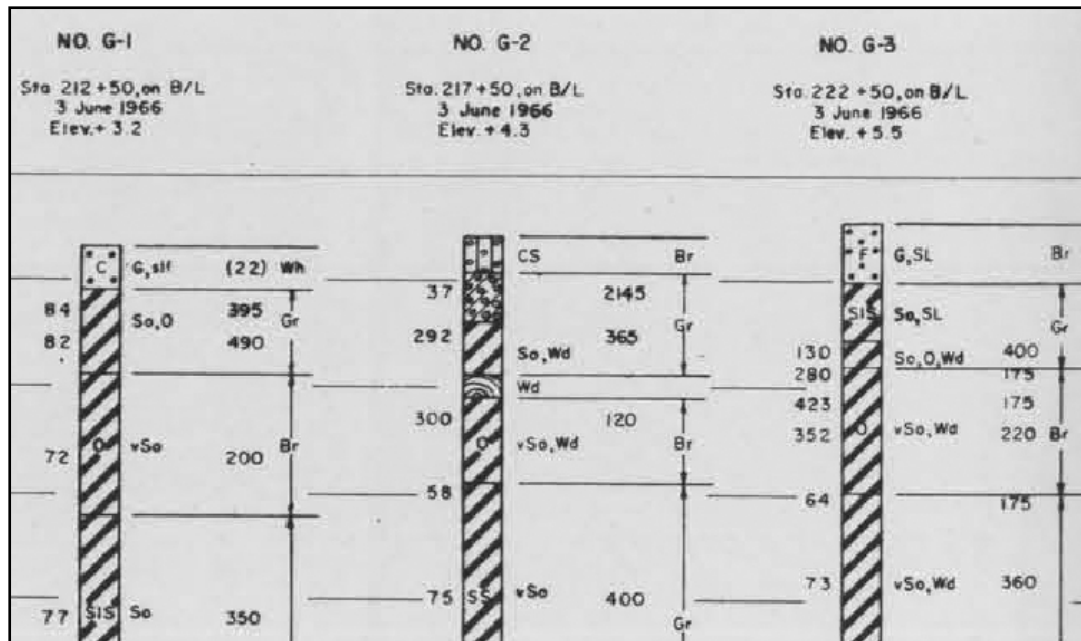
Figure 14-55. Nearest Boring G-3 Shows Original Ground Surface (elev 5.5 ft MSL) to be Sandy (from drawing file H-2-24111, plate IV-33)

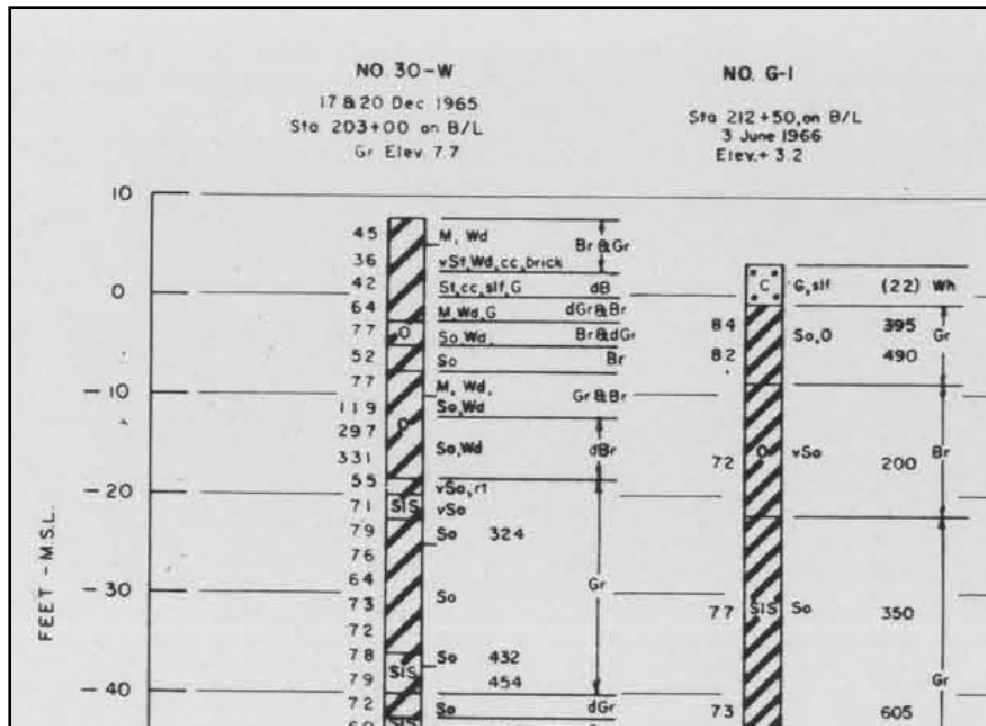
Figure 14-57. Nearest Boring G-1 Shows Sandy Material at Original Ground Surface (may have provided a zone facilitating levee failure)

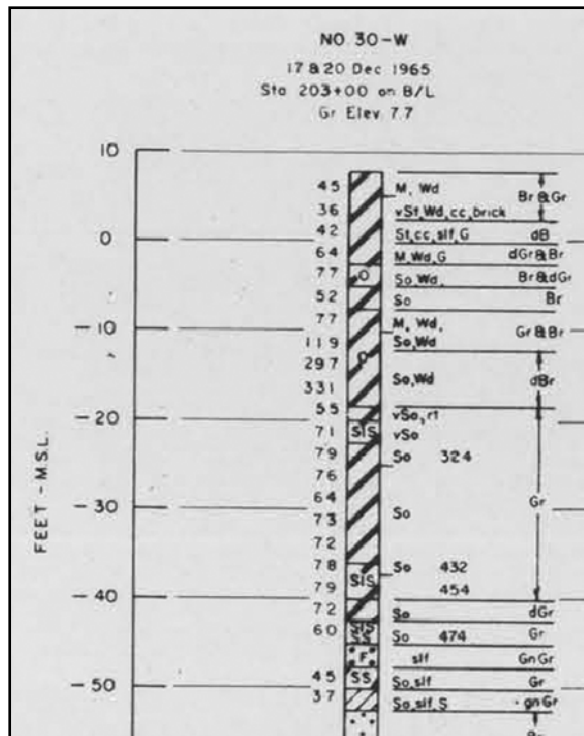
Figure 14-61. Boring 30W Near Benefit St Gate Shows Fat Clay Soil Layers

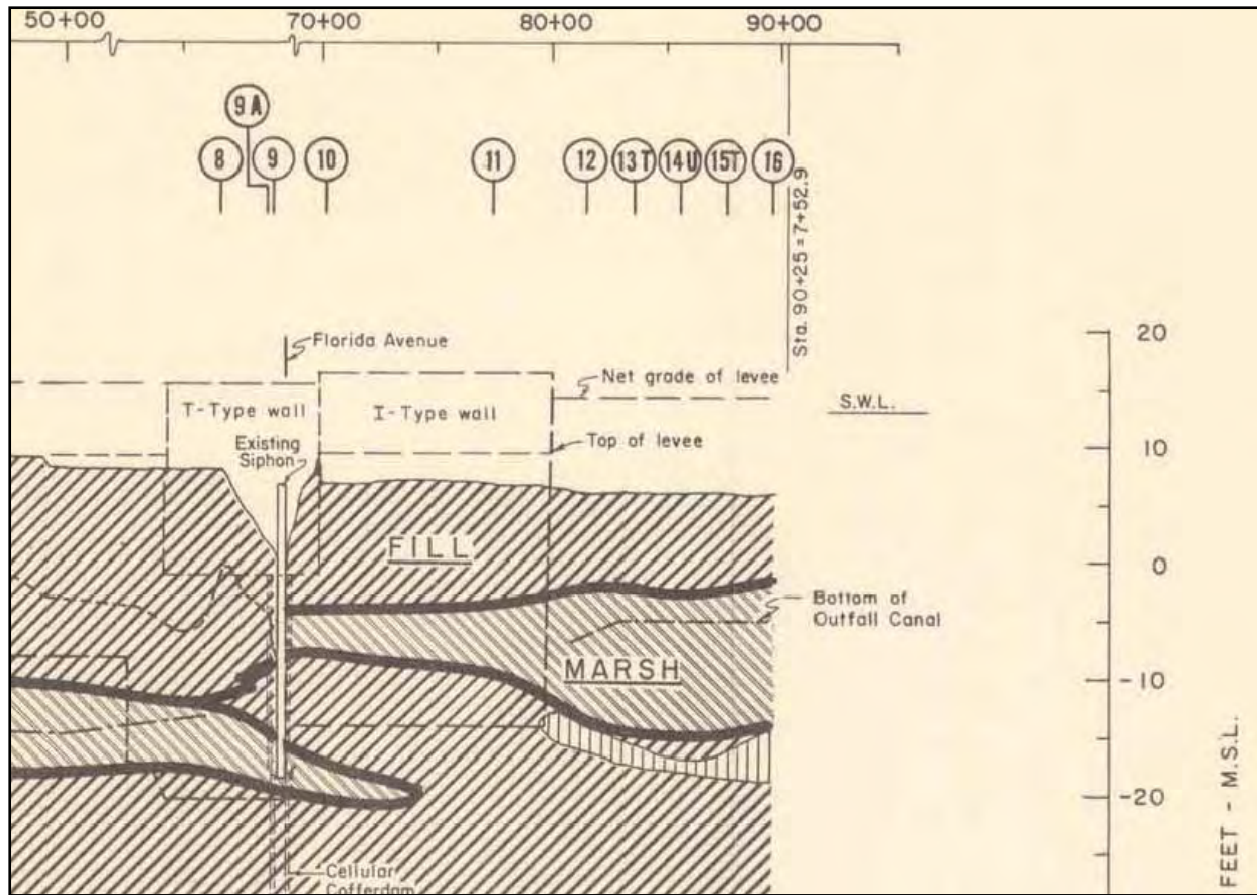
Figure 14-83. Geology Profile Between Florida Ave North to the GIWW Shows Fat Clay Layer at the Original Ground Surface

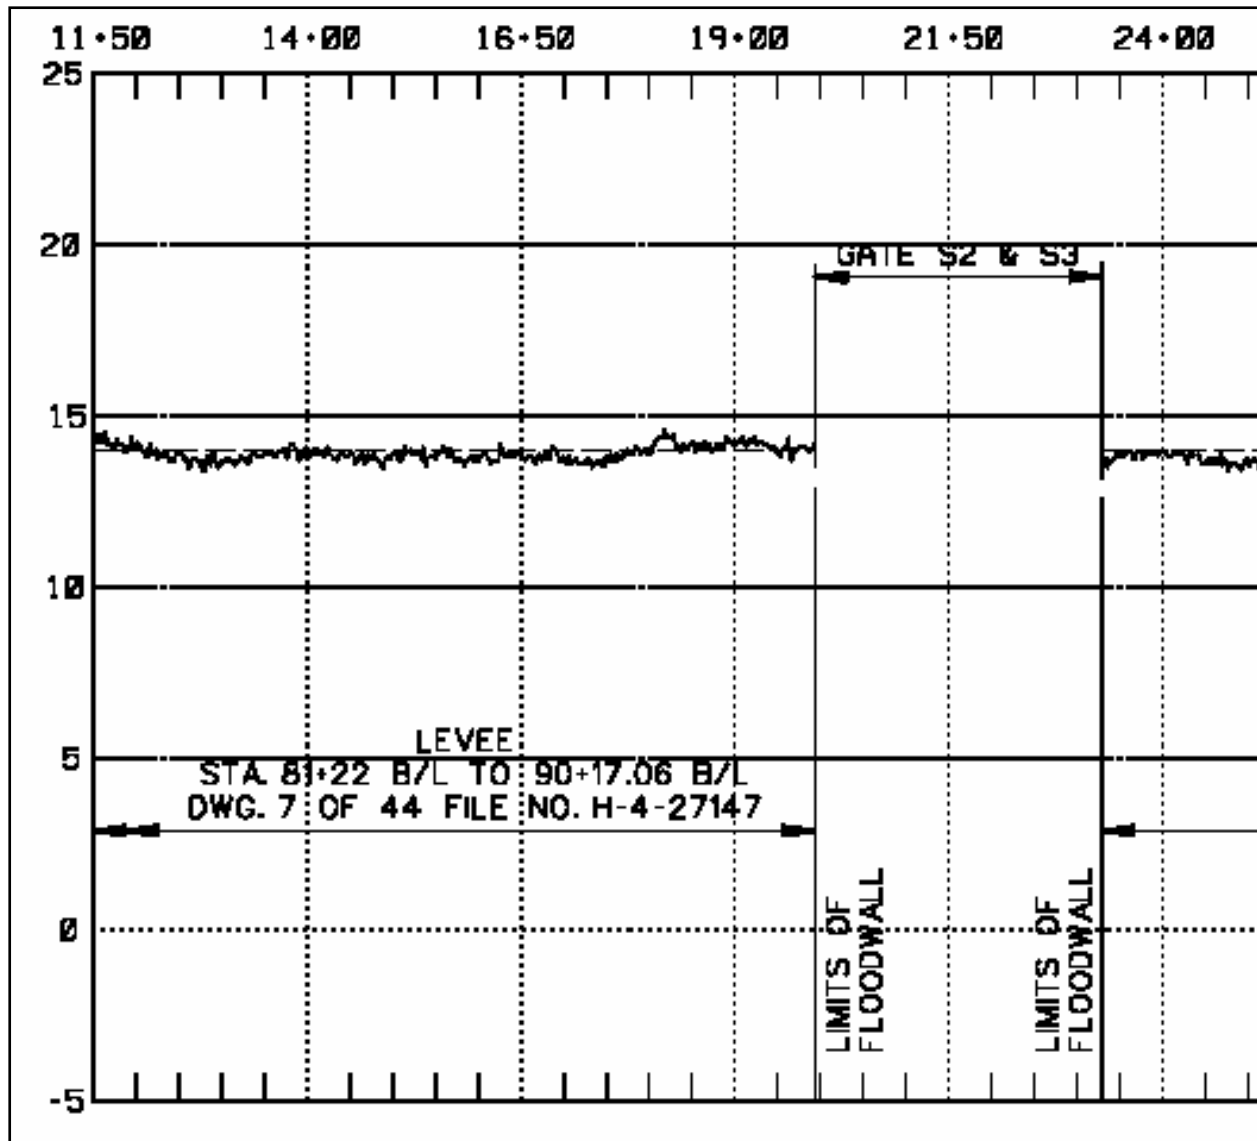
Figure 14-88. Elevations of S2, S3, and Adjacent Levee (from Chalmette Area Plan Emergency Restoration contract solicitation W912P8-06-R-0022 drawings, October 2005)

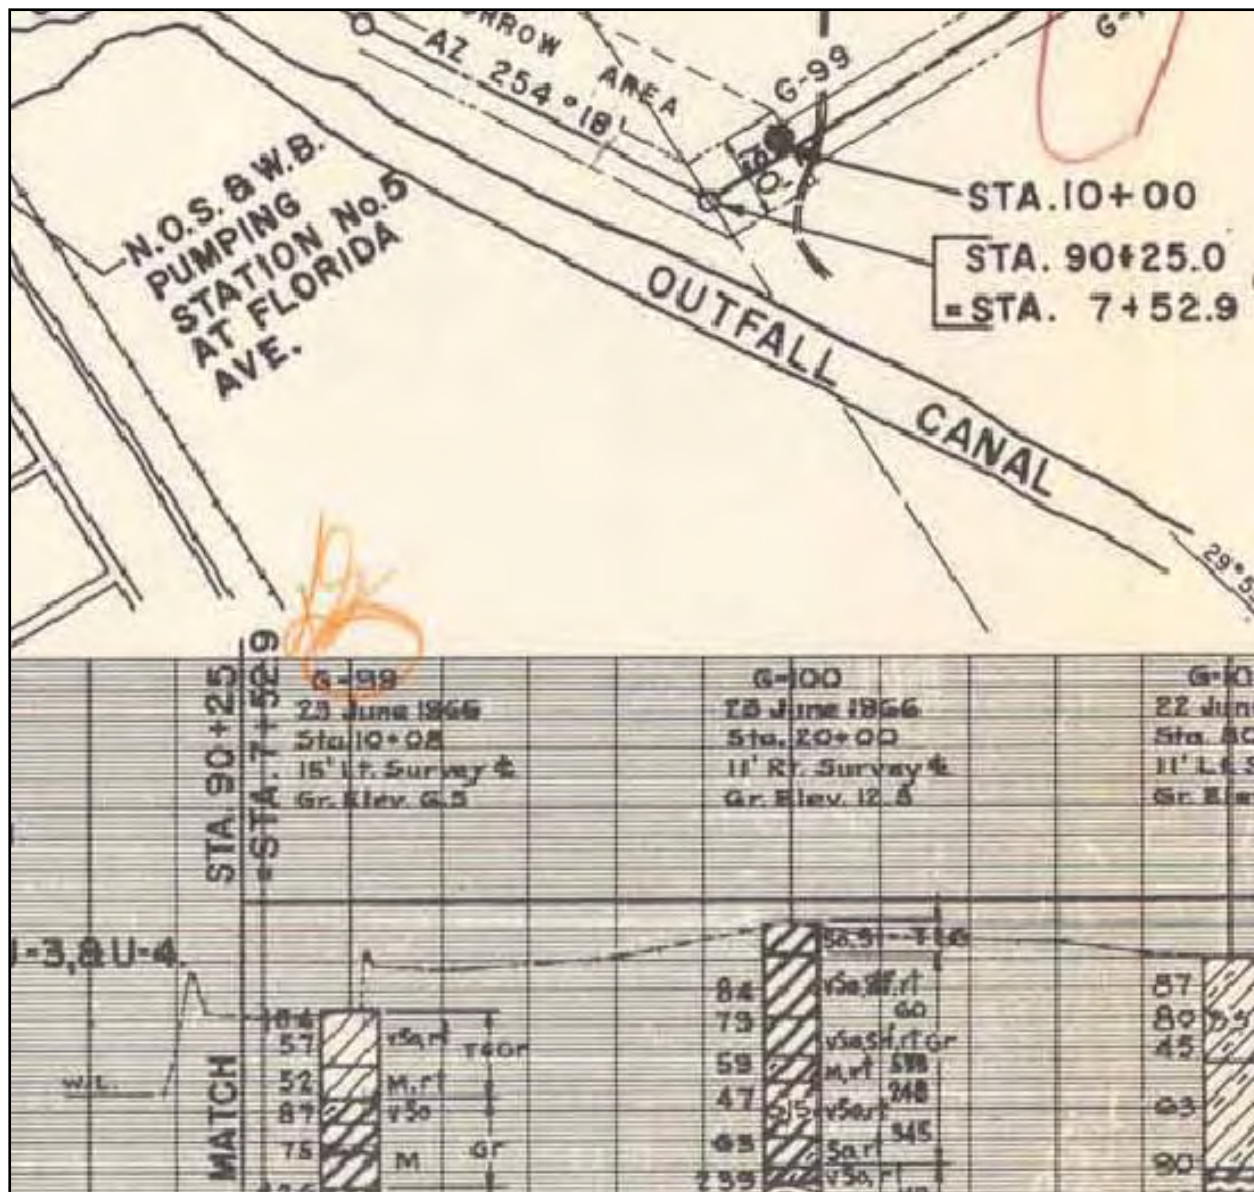
Figure 14-90. Boring G-99 Near Future Gates S2 and S3 Shows Lean Clay (CL) at Existing Ground Surface (Approximately 6' MSL). From Plate 7, DM3

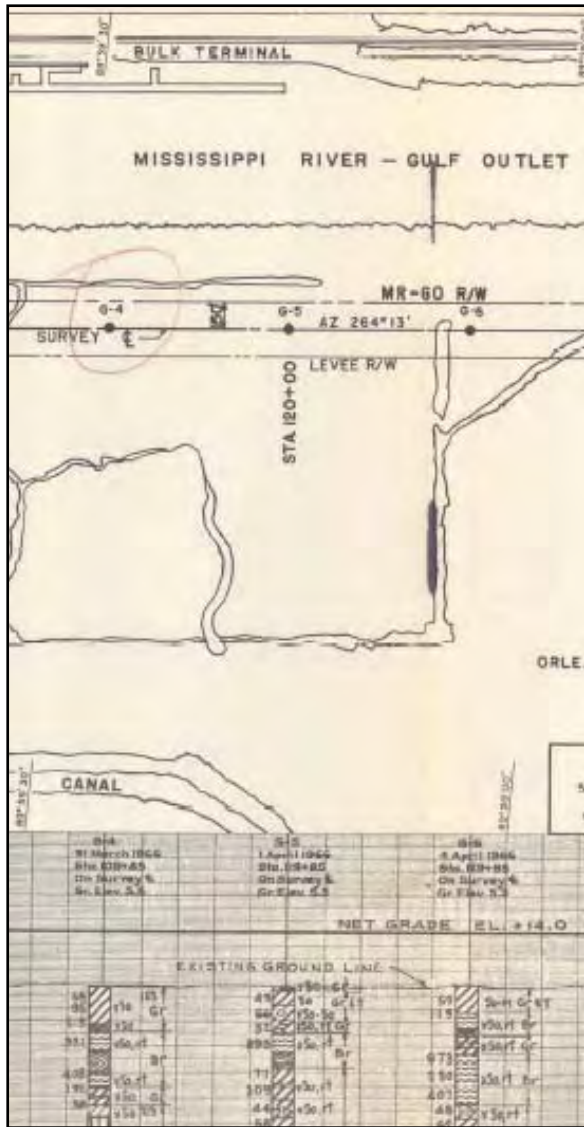
Figure 14-100. Plate 6, DM3 (1966) Soil Boring G-6 at Sta 129+80 at Levee Centerline Shows Fat Clay (CH) at Original Ground Surface

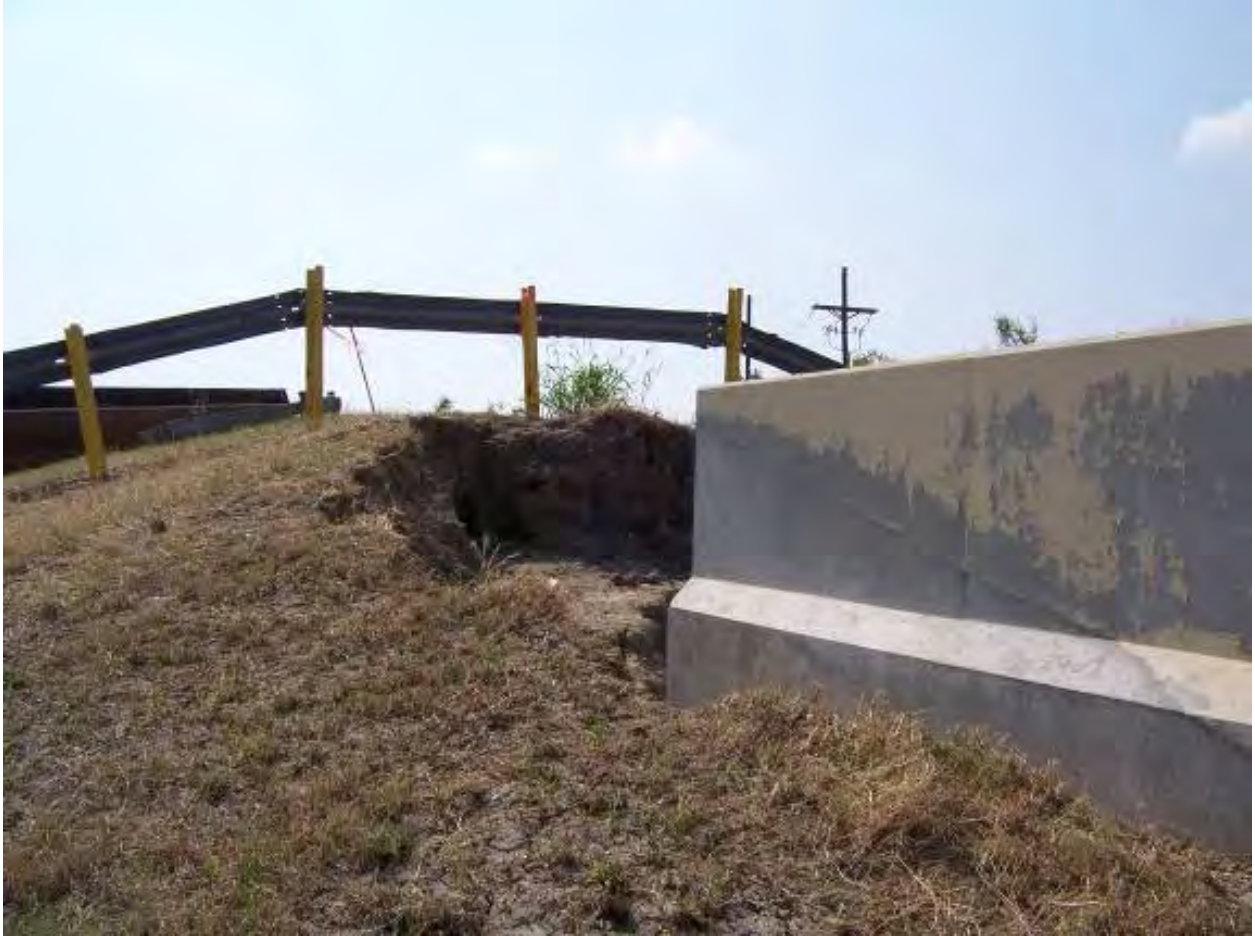
(4) Closure Structure and I-Wall West of Bienvenue. This closure structure and adjacent I-wall segments were damaged during the storm event. There was scour of the structural backfill resulting from overtopping of the closure gate and I-wall.

Figure 14-104. View Looking East Toward the Bayou Bienvenue Control Structure

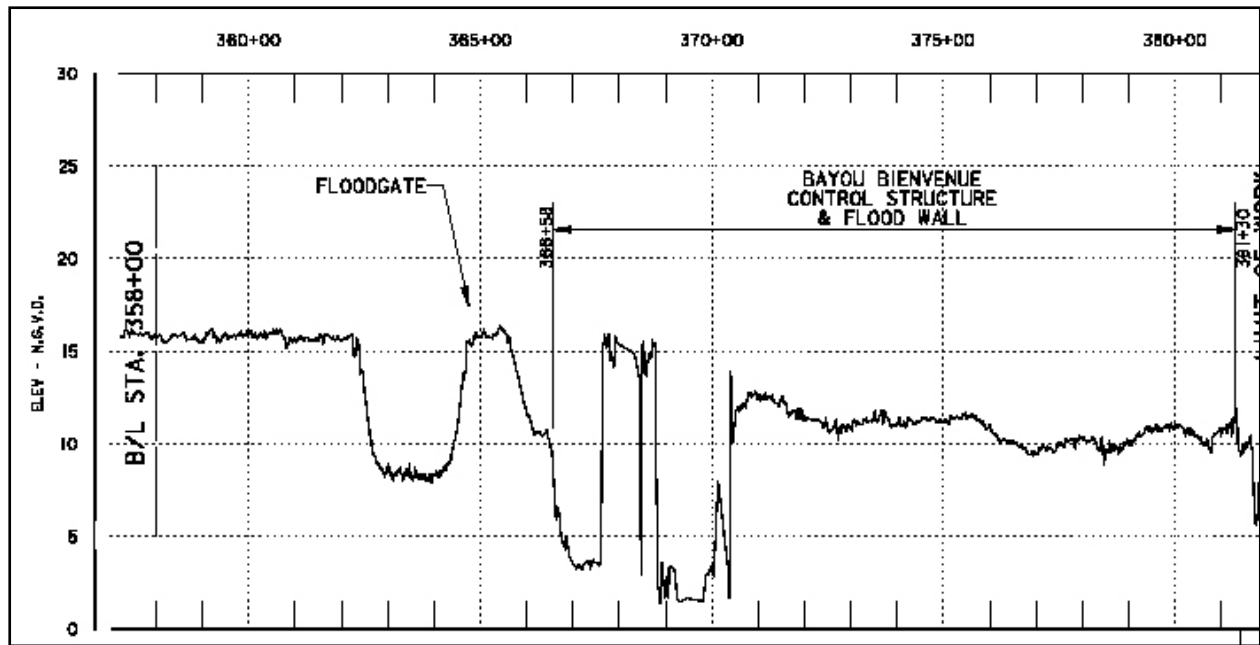
Figure 14-115. Centerline Scour Depths of Floodgate and Control Structure (From Dwg 1 of 8, Emergency Restoration B/L 383+00 to 704+00 Contract Solicitation)
