Appendix 1

Soil Data Report for 17th Street Canal

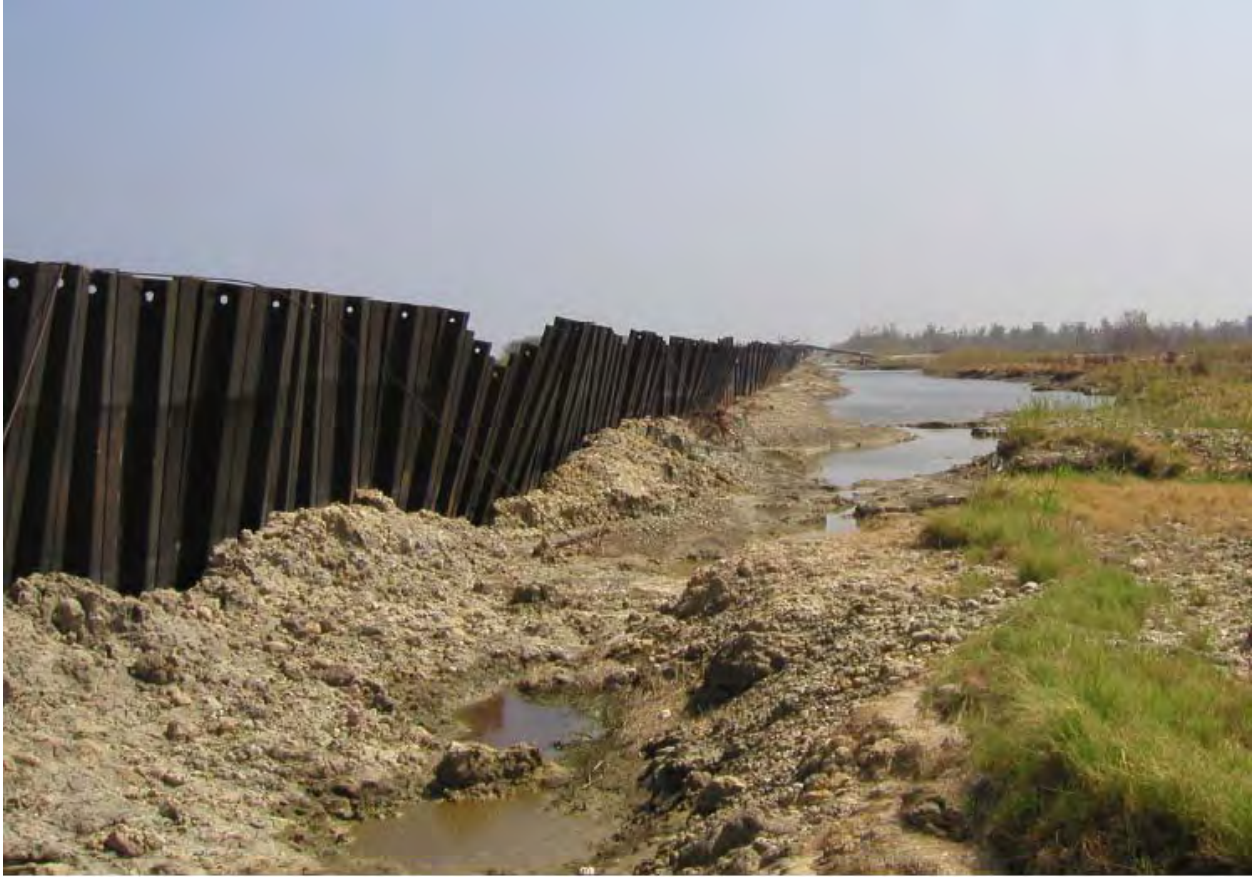
Figure 14-123. Note Sheetpile Elevation Differences

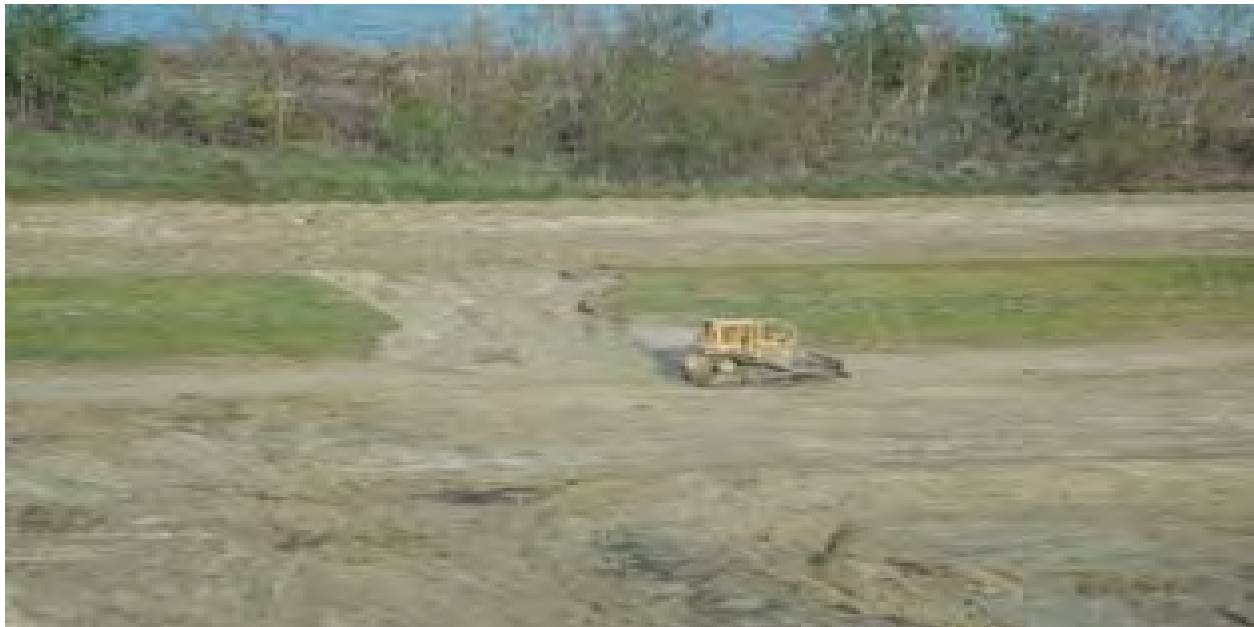
Figure 14-130. Repairs Underway, Filling Scour Holes

TFG Project **STB01** included site preparation work in the areas of levee damage between the Bayou Bienvenue and Bayou Dupre Control Structures. The contracted work (rental agreement contract) is complete.

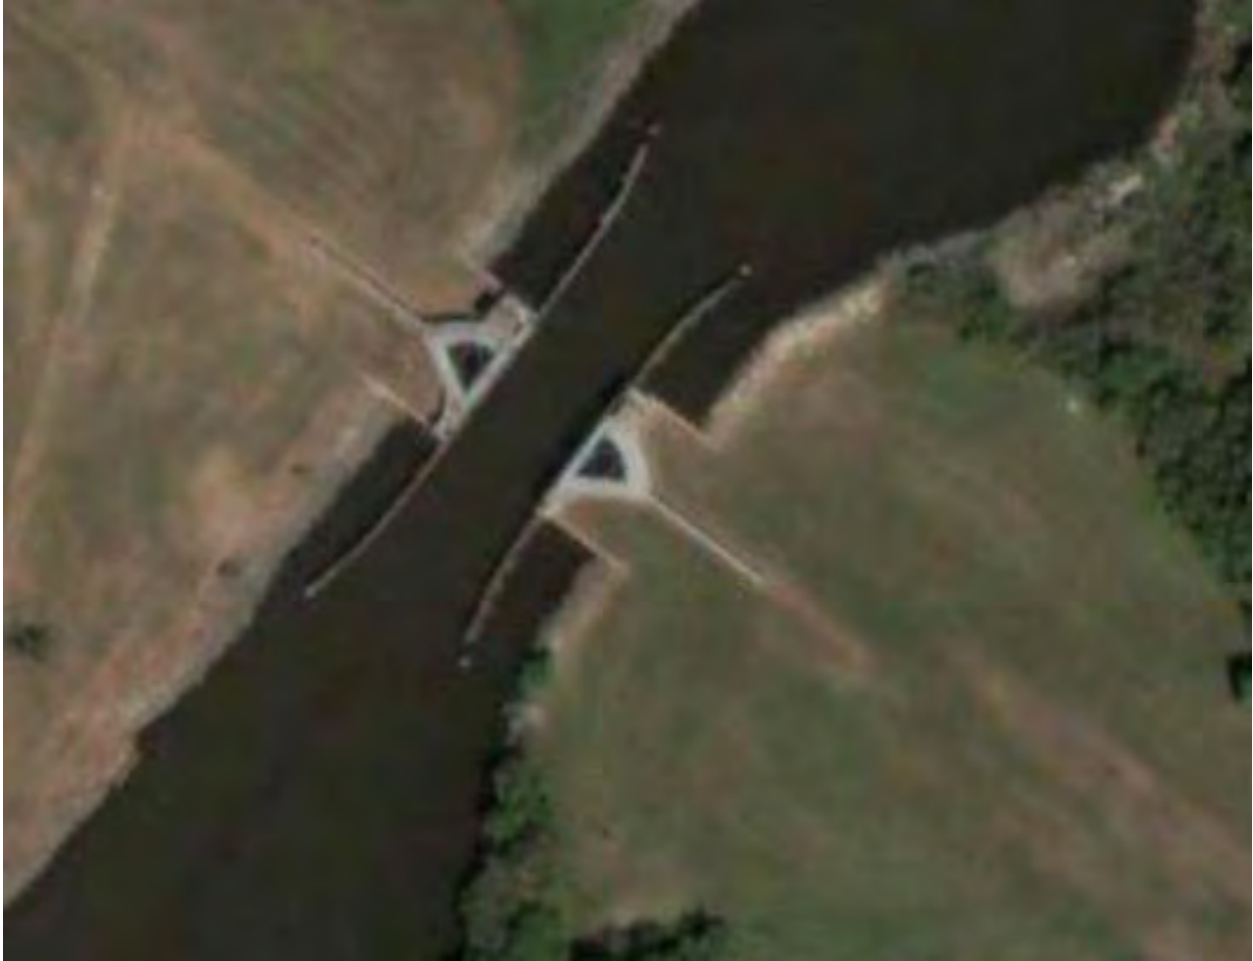
Figure 14-138. Bayou Dupre Control Structure, Pre-Katrina View. Note the concrete walls transitioning to earth levee on both sides of the structure

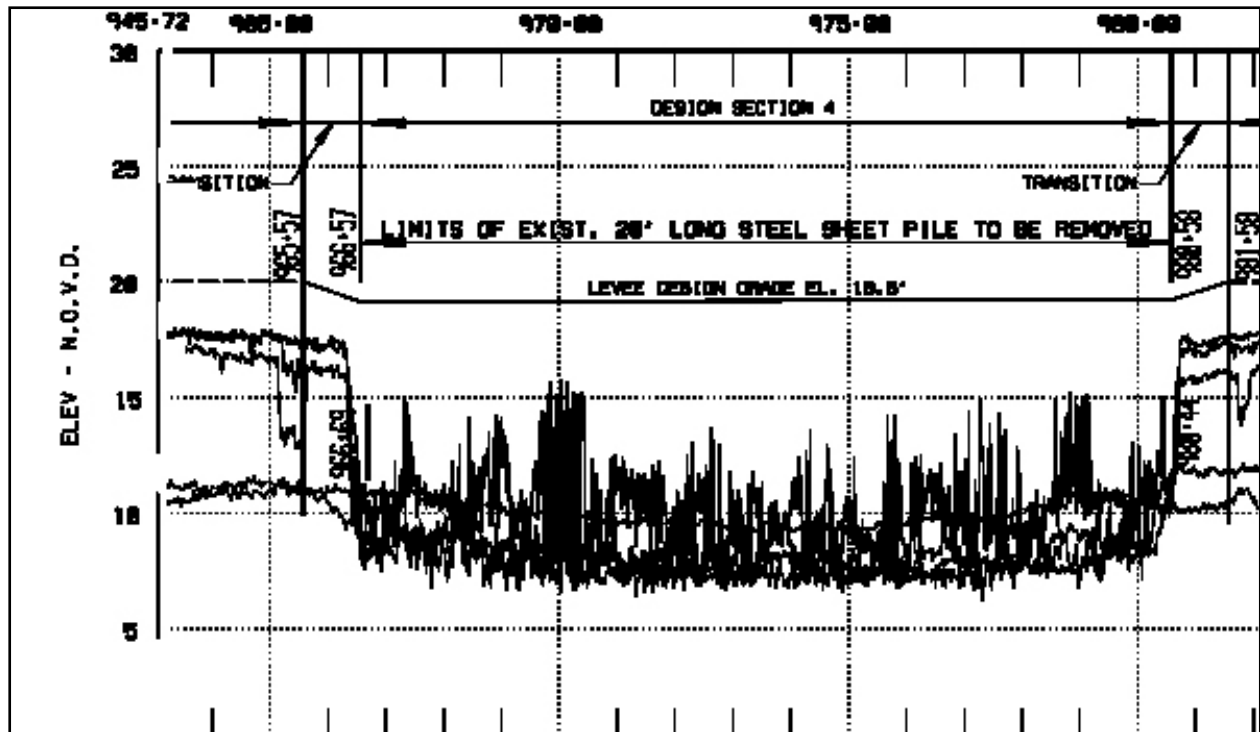
Figure 14-152. Scour Depths Along Sheetpile and at Transition to Levee. Note that scour occurred along the sheetpile reach, not at the sheetpile / levee transition (also seen in Figure 14-151), from drawing 7 of 10, contract solicitation W912P8-06-R-0002

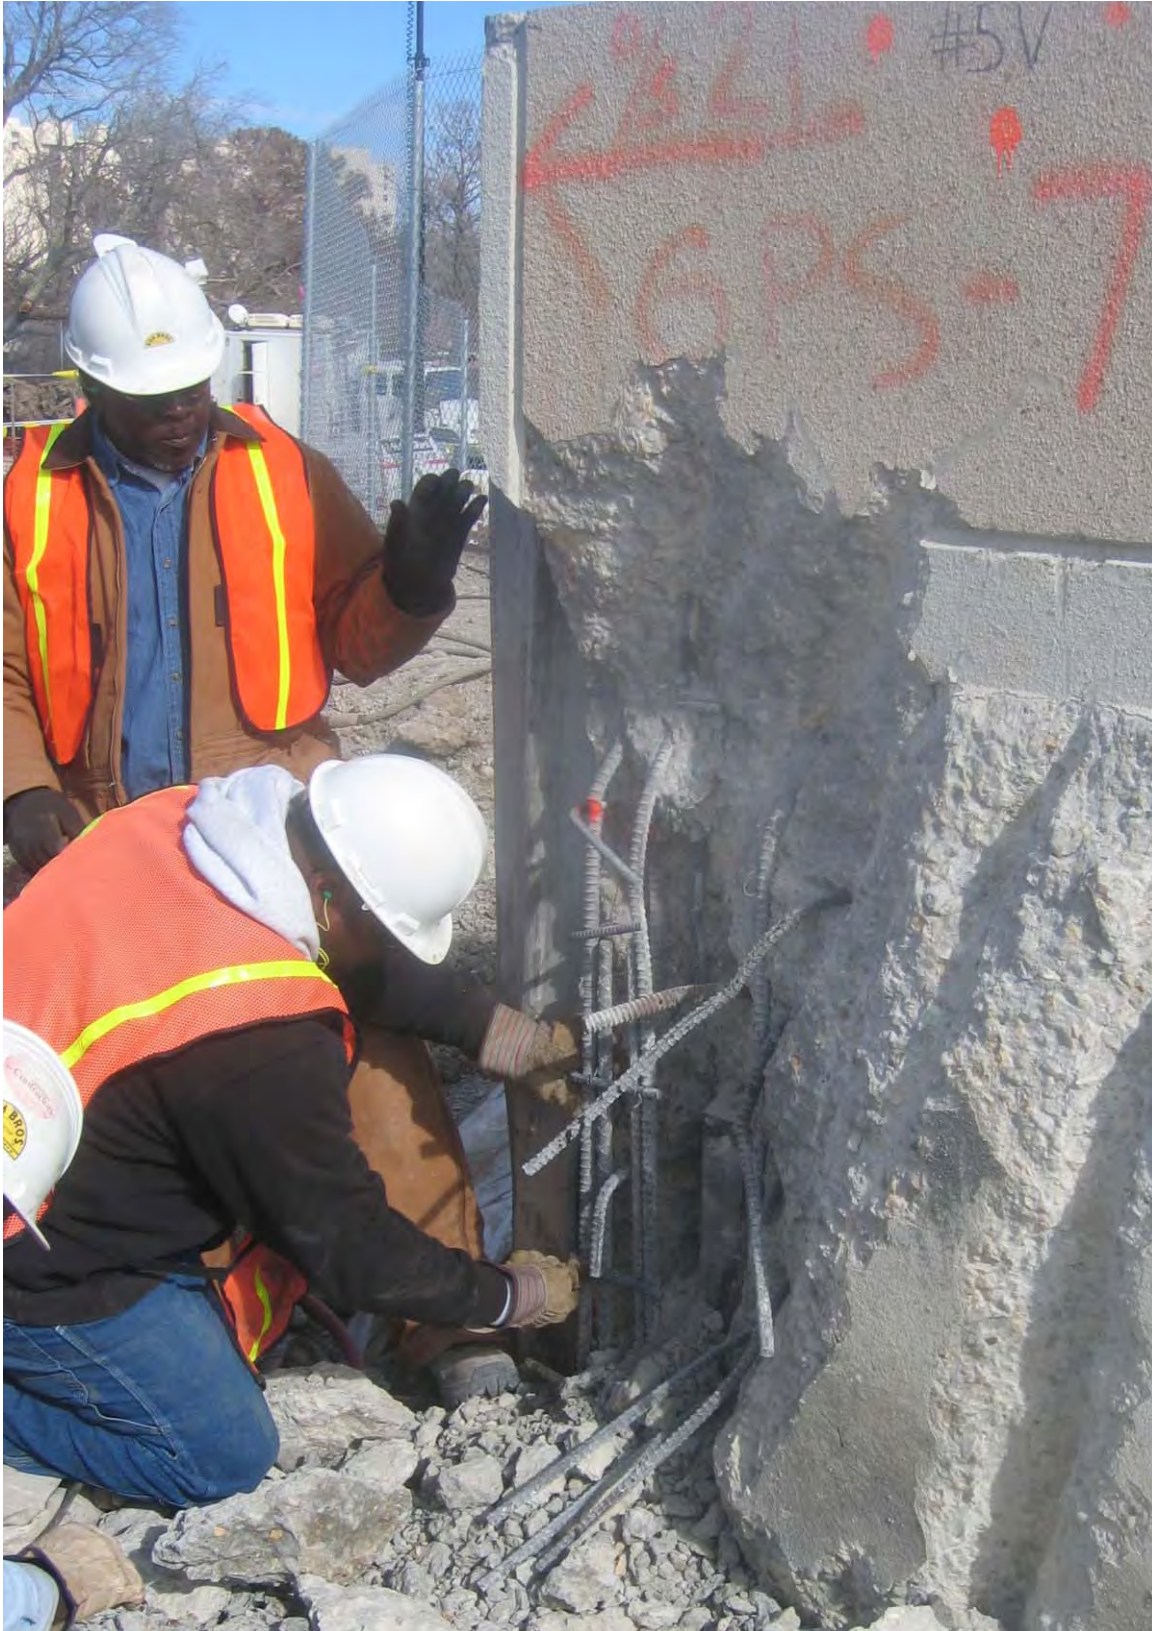
At wall panel H38 a two foot long sample of the following rebar were obtained: 1) A #4 horizontal bar from the east face of the wall approximately 29 inches down from the top of the wall. The north end of the sample terminated at the vertical sawcut for the wall sample MH38C1. 2) A #5 vertical approximately 76 inches from the north end of panel H38. 3) A #6 vertical from the west face of the lower section of the wall. This #6 bar was approximately 8 inches from the north end of panel H38. (This sample has the orange paint shown in Fig. 15-15.) These rebar samples were marked and tagged MH38R1, MH38R2 and MH38R3, respectively.

Figure 15-15. Number 6 Rebar Sample Being Taken from Panel H38

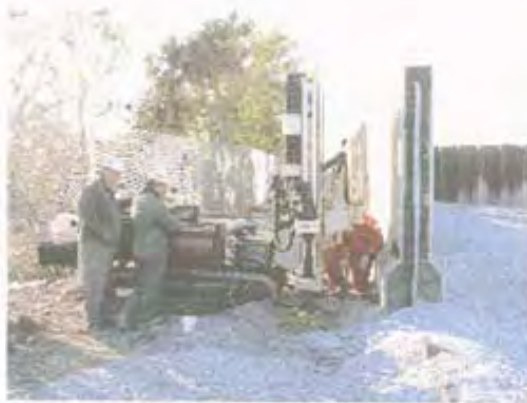
Photo 1 - Geoprobe Rig for PS/SCPT testing at South End of Breach of 17th Street Levee at Station 17+78 where sheet piles were exposed by USACE PS Cased Borehole (white PVC cap visible)

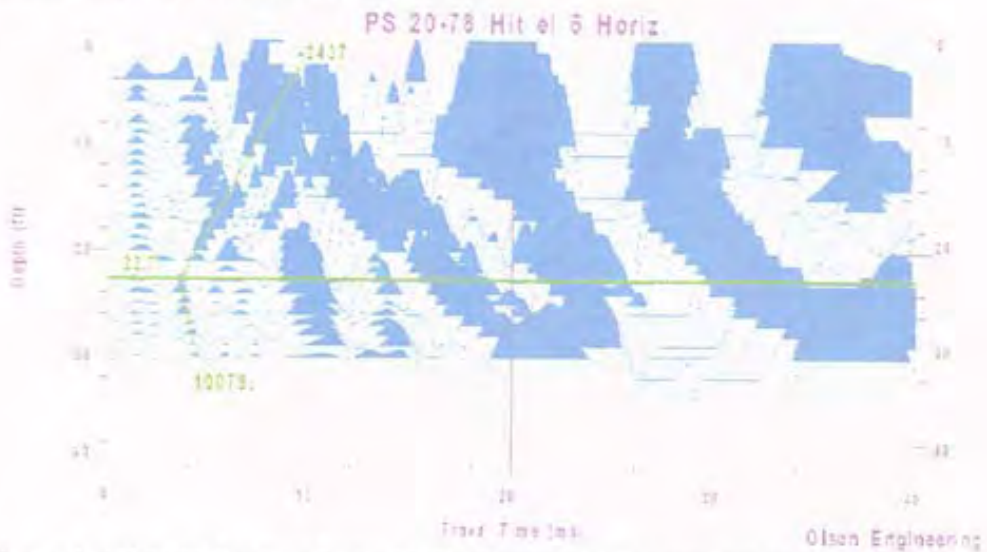
Figure 2 - 17th St. PS Results at Station 20+78 - Concrete Wall impacted horizontally at ~ el. 5 (~0.5 ft below chamfer edge on protected side)

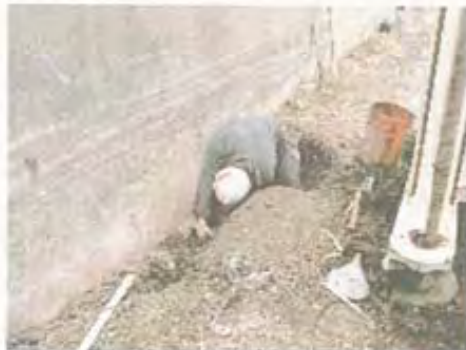
Photo 9 - IHNC 3-lb Impulse hammer impacts to sheet pile on canal side at Station 17+11

The exposed sheet pile at the north end of the south IHNC breach showed a total length of 19 ft - 6.5 inches. Of this, about 4 ft - 7 inches of the piles had been embedded in the 8 ft tall concrete wall. Thus, about 15 ft of the sheet piles are typically embedded in the levee soils. Given the 1 ft higher elevation of the top of the PVC casing on the levee soils versus the bottom of the concrete wall, the sheet pile tip is expected to be at a depth of about 16 ft in the PS hydrophone signal versus depth results which are presented below in Figures 6-8. Horizontal impacts were applied just below the concrete wall to the canal side of the exposed sheet pile (Fig. 6) and to the concrete wall at 6.5 ft below the top of the wall (Fig. 7) which was 1.5 ft above the bottom of the concrete wall while vertical impacts were applied to the top of the wall (Fig. 8).

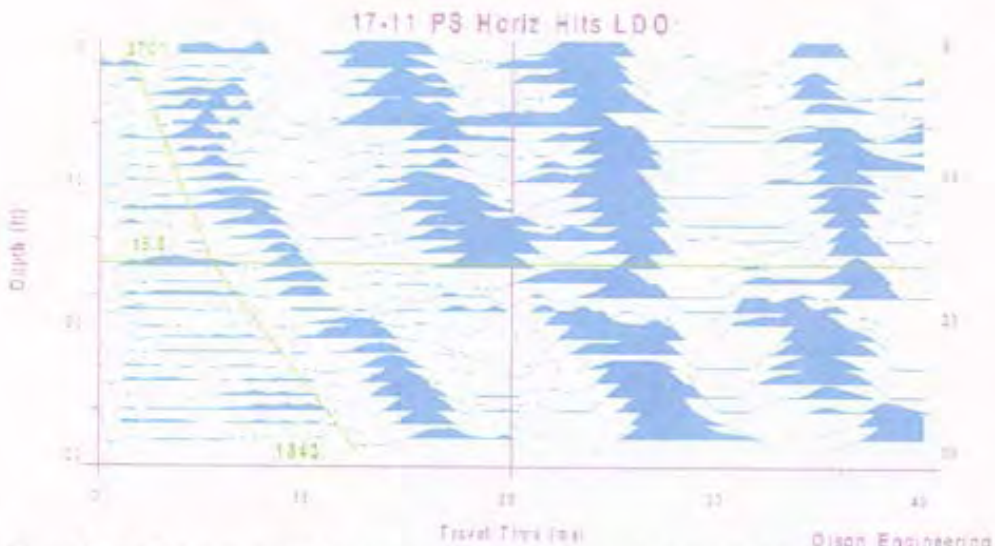
Review of Figures 7 and 8 for horizontal and vertical impacts to the concrete wall does not show clear direct arrivals when the apparent weak energy was picked as shown in the figures. No diffraction events are clearly evident in the figures either. These results further support the possibility that there is poor soil contact to the sheet pile on the canal side that diminished the diffraction effect in the IHNC re-tests.

Figure 7 - PS Results at IHNC Sta. 17+11 - Horizontal Impact to Concrete Wall at ~6.5 ft below top of Wall on Canal Side

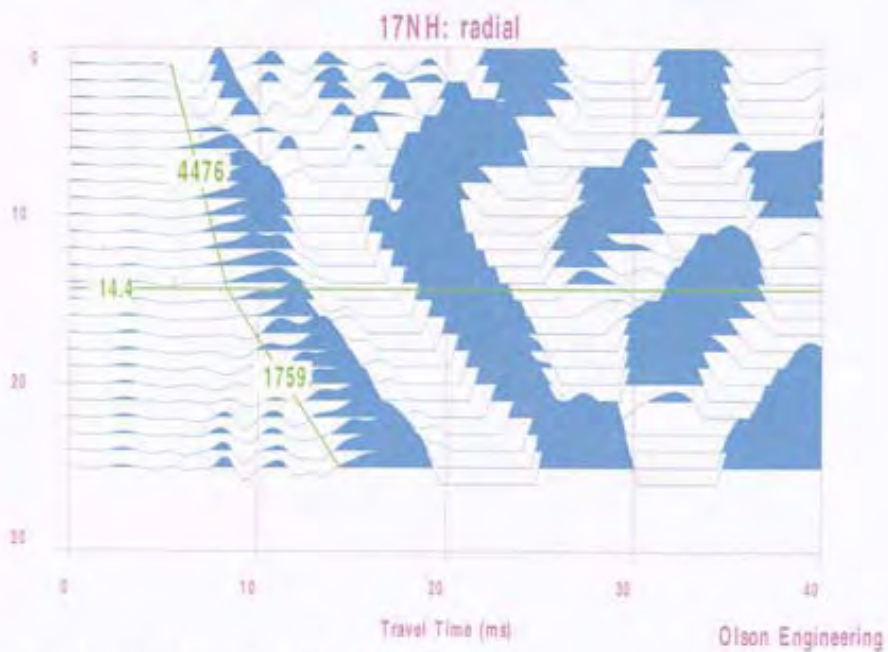
Figure A-1: 17th Street site, North borehole, depth is referenced to top of casing

The Parallel Seismic data and results for the 17th Street Site can be found in Figures A-1 and A-2 in the Appendix. The Parallel Seismic data and results for the London Avenue Sites can be found in Figures A-3 to A-5, where Figures A-3 and A-4 are from the North breach and Figure A-5 is from the South breach. The Parallel Seismic data and results for the IHNC can be found in Figures A-6 to A-8, where Figure A-6 is from the breach near Florida Street and Figures A-7 and A-8 are

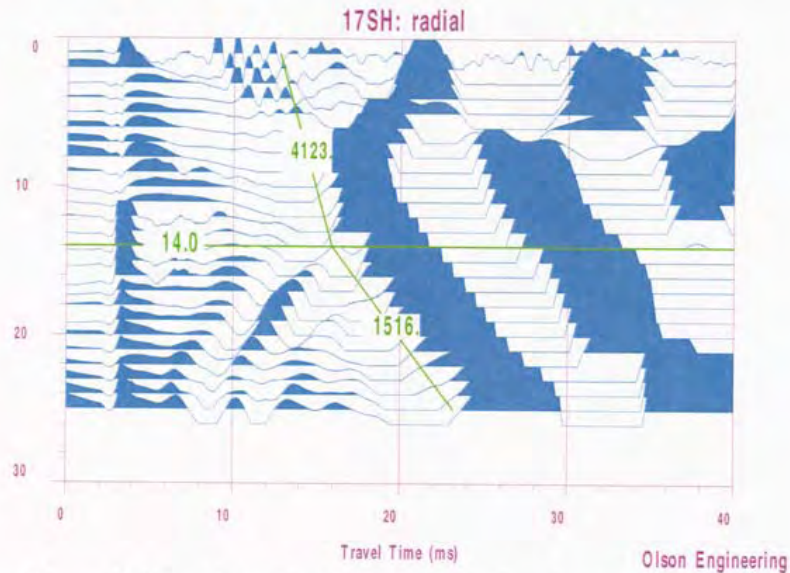
It is our understanding that four sheet piles at the north end and 4 sheet piles at the south end of the 17th Street levee breach area have been pulled, and that the our data interpretation of nearby PS results in north and south cased borings was shown to be incorrect. The actual embedded lengths were found to be approximately 17 feet below mean sea level (20-22 feet below the casing top elevation used in our investigation) with total sheet pile lengths of 23.5 ft.

Figure 3 17th Street Levee South Site, Initial PS Data Interpretation

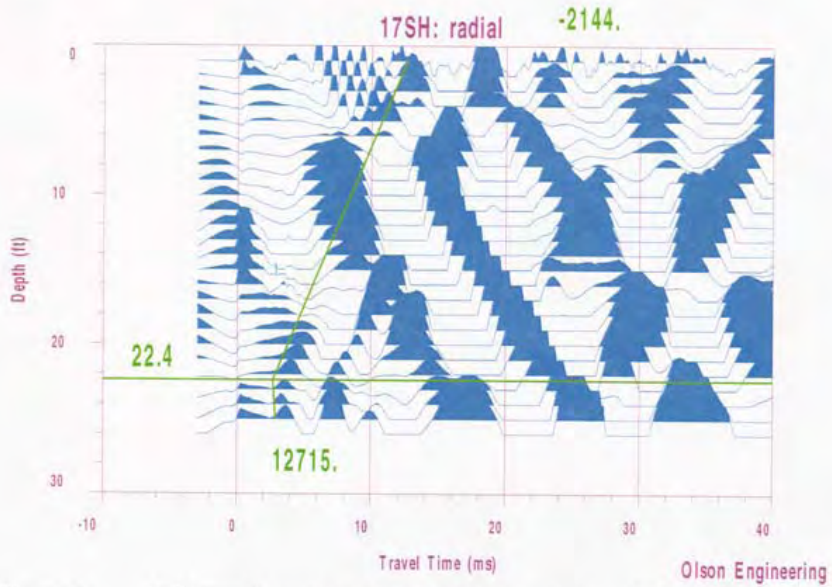
Figure 4 17th Street Levee South Site, Re-interpretation of PS Results

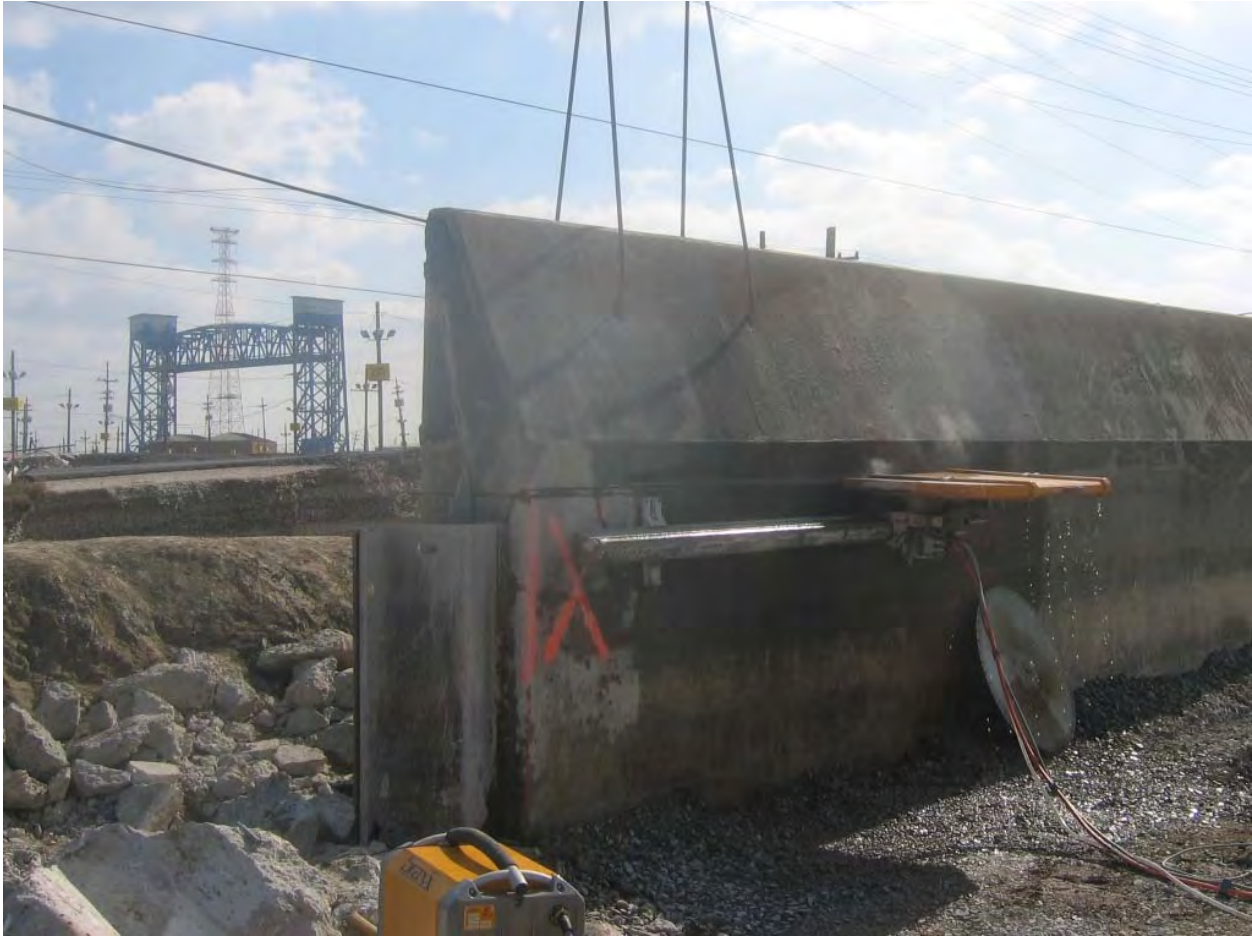
An approximately eight foot long by 44 inch high section was sawcut from the top of the concrete I-wall as shown in Figure 16-1. The sample was taken from a location at approximately Station 0+44 and was labeled IPET-WE-EW 0+44.

Figure 16-1. Sawcutting Concrete Wall Sample

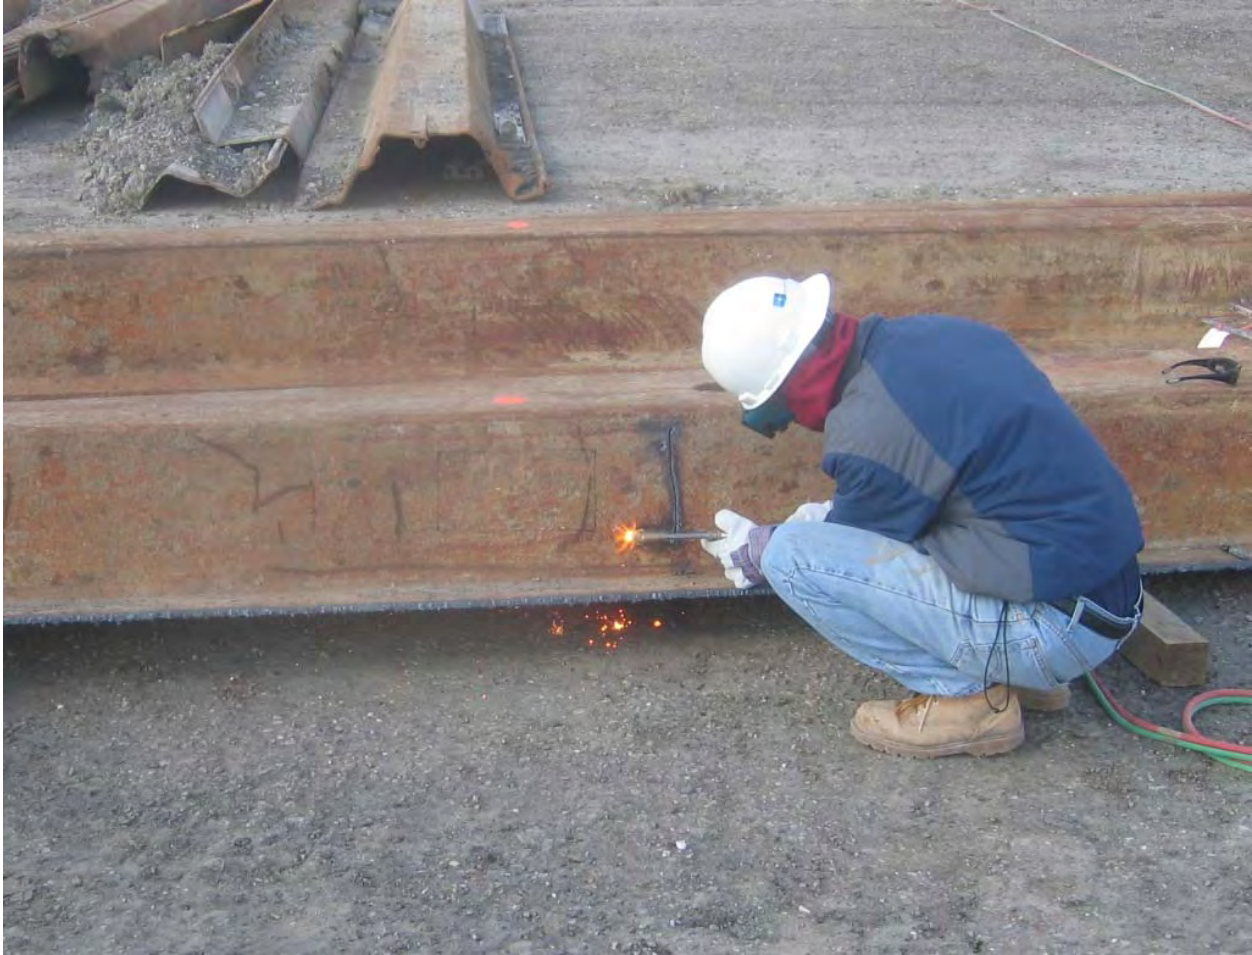
An 8 by 24 inch sample was taken from the web each of two sheet piling at the site. (See Figures 16-2 and 16-3.) The pilings were labeled IHNC-SP-WS-B1 and IHNC-SP-WS-B2 and the corresponding samples were labeled IHNC-WS-B1A and IHNC-WS-B2A. The samples were provided to Beta Testing & Inspection for testing. The sheet piling was transported to the warehouse at the New Orleans District office.

Figure 16-2. Flame Cutting of Material Samples from Piling IHNC-SP-WS-B2

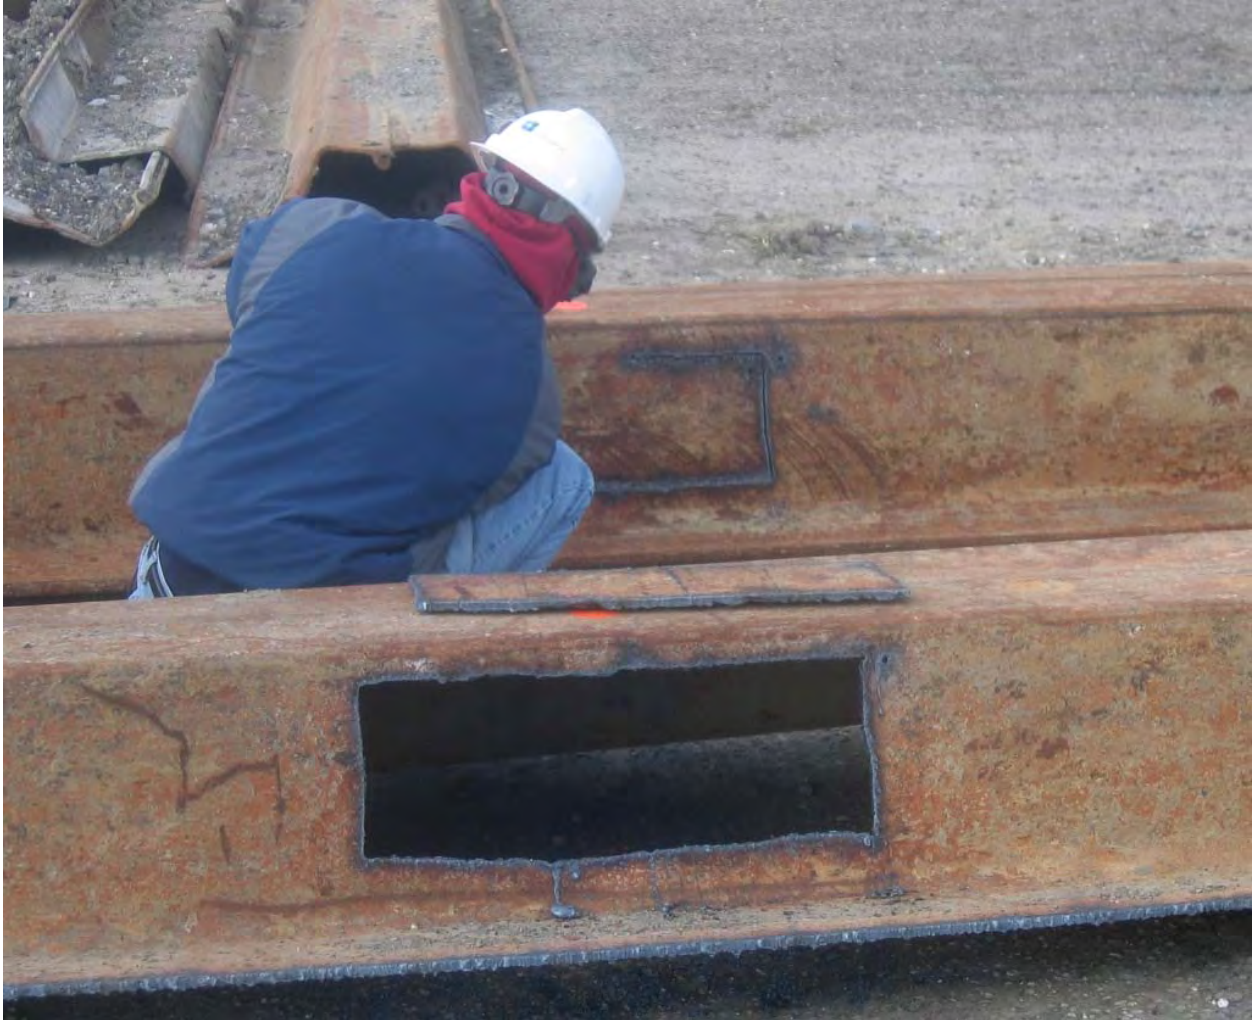
Figure 16-3. Flame Cutting Material Samples from Sheet Piling IHNC-SP-WS-B1

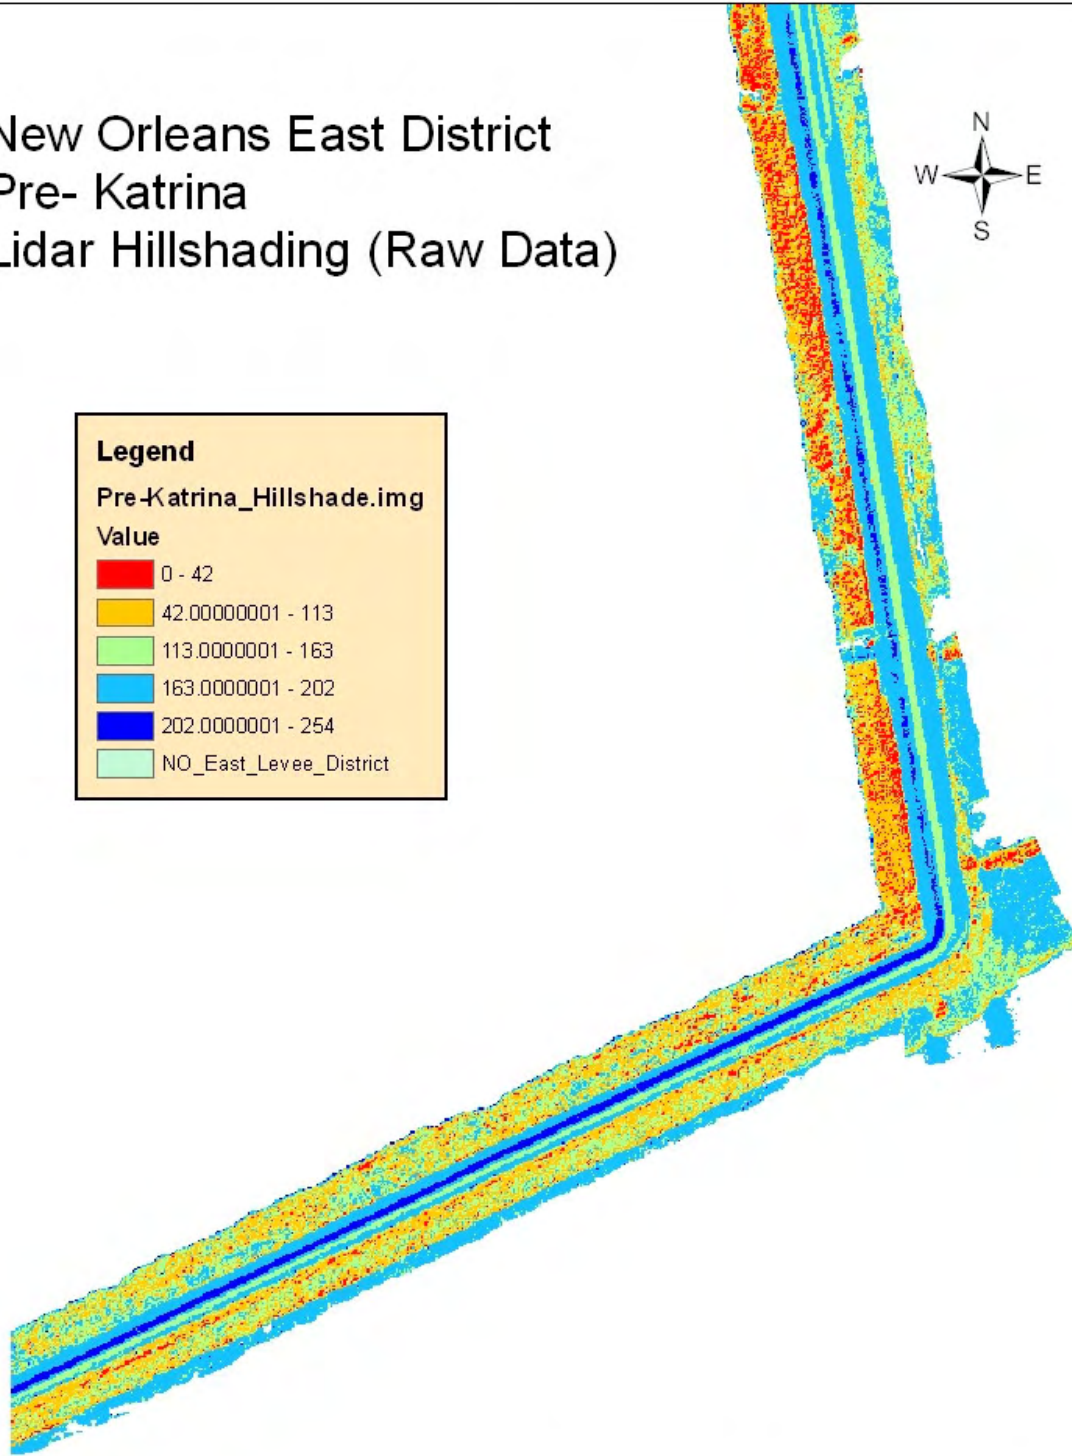
Figure 18-3. Hillshading from pre-Katrina LIDAR, southeast corner of New Orleans East Basin

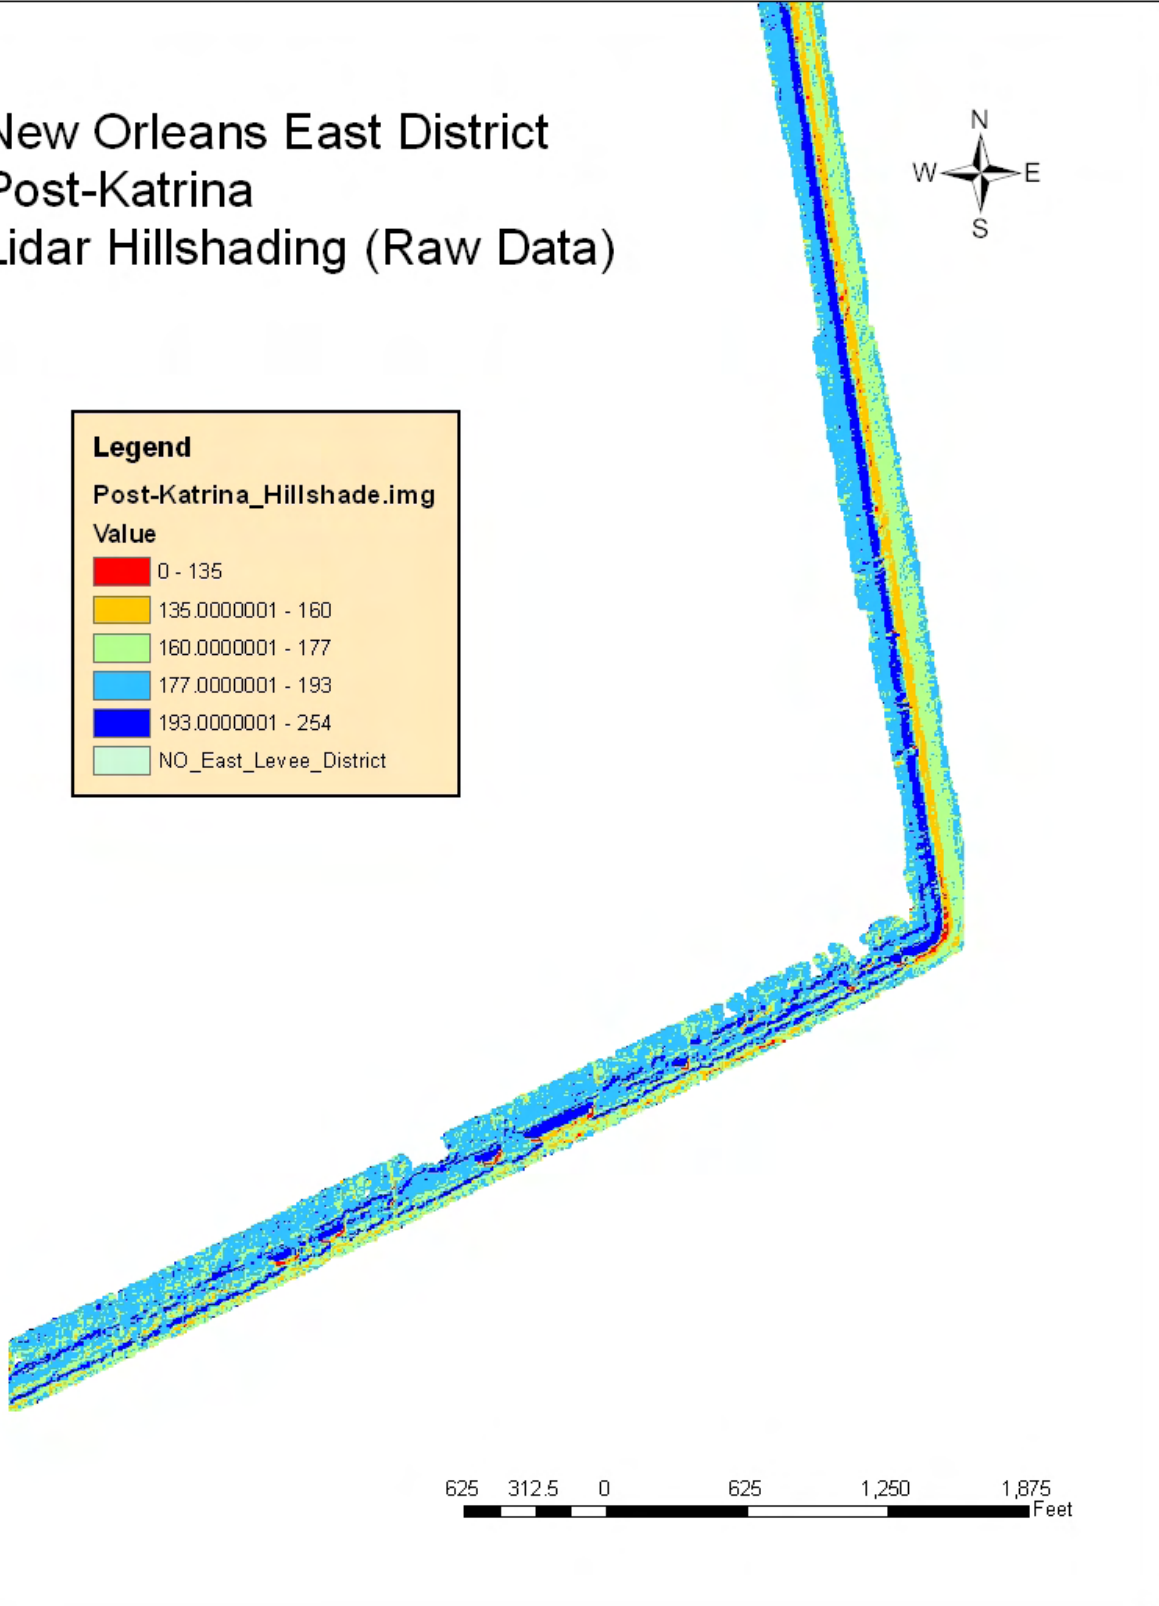
Figure 18-4. Hillshading from post-Katrina LIDAR, southeast corner of New Orleans East Basin

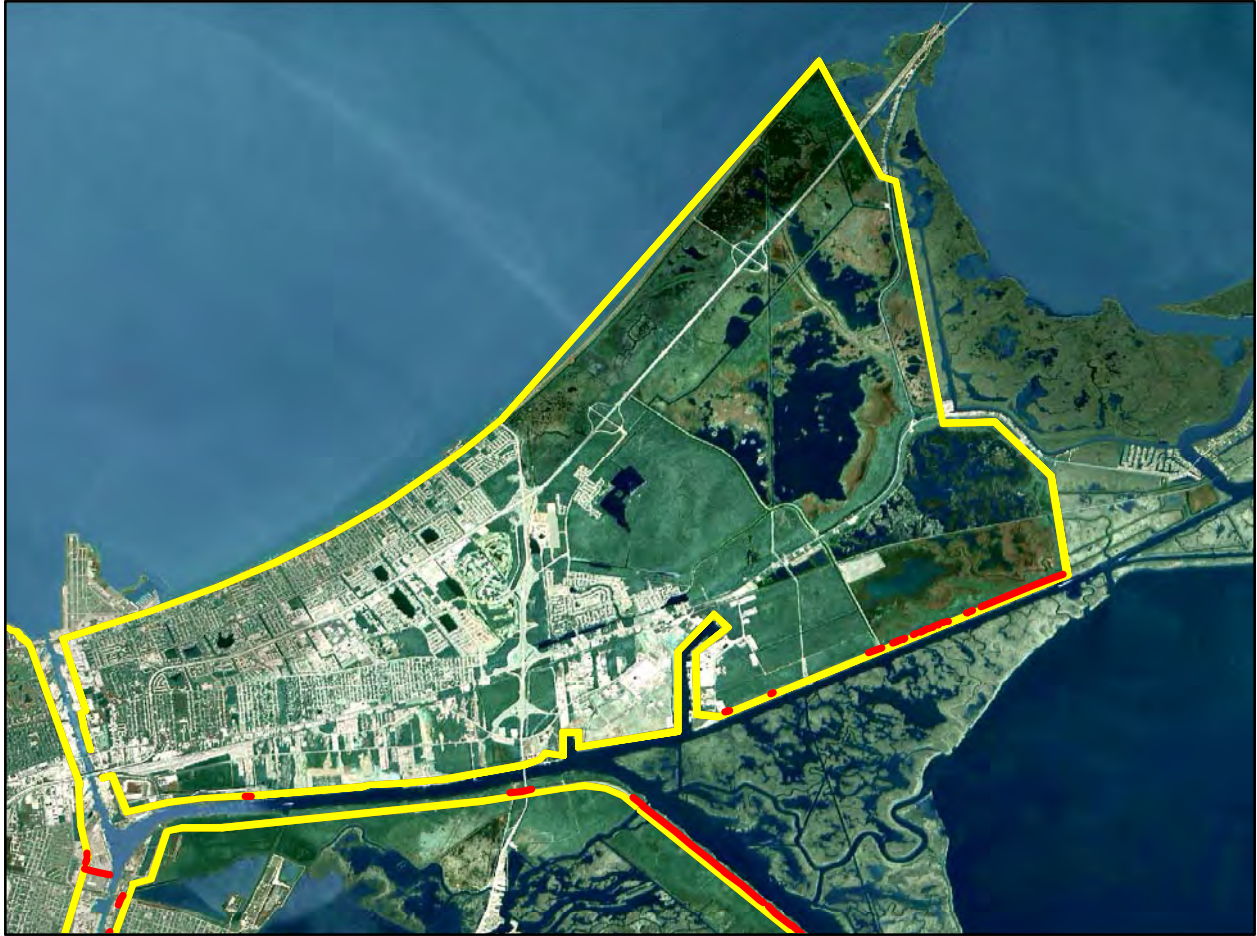
Figure 18-6. NOE Basin post-Katrina breaches

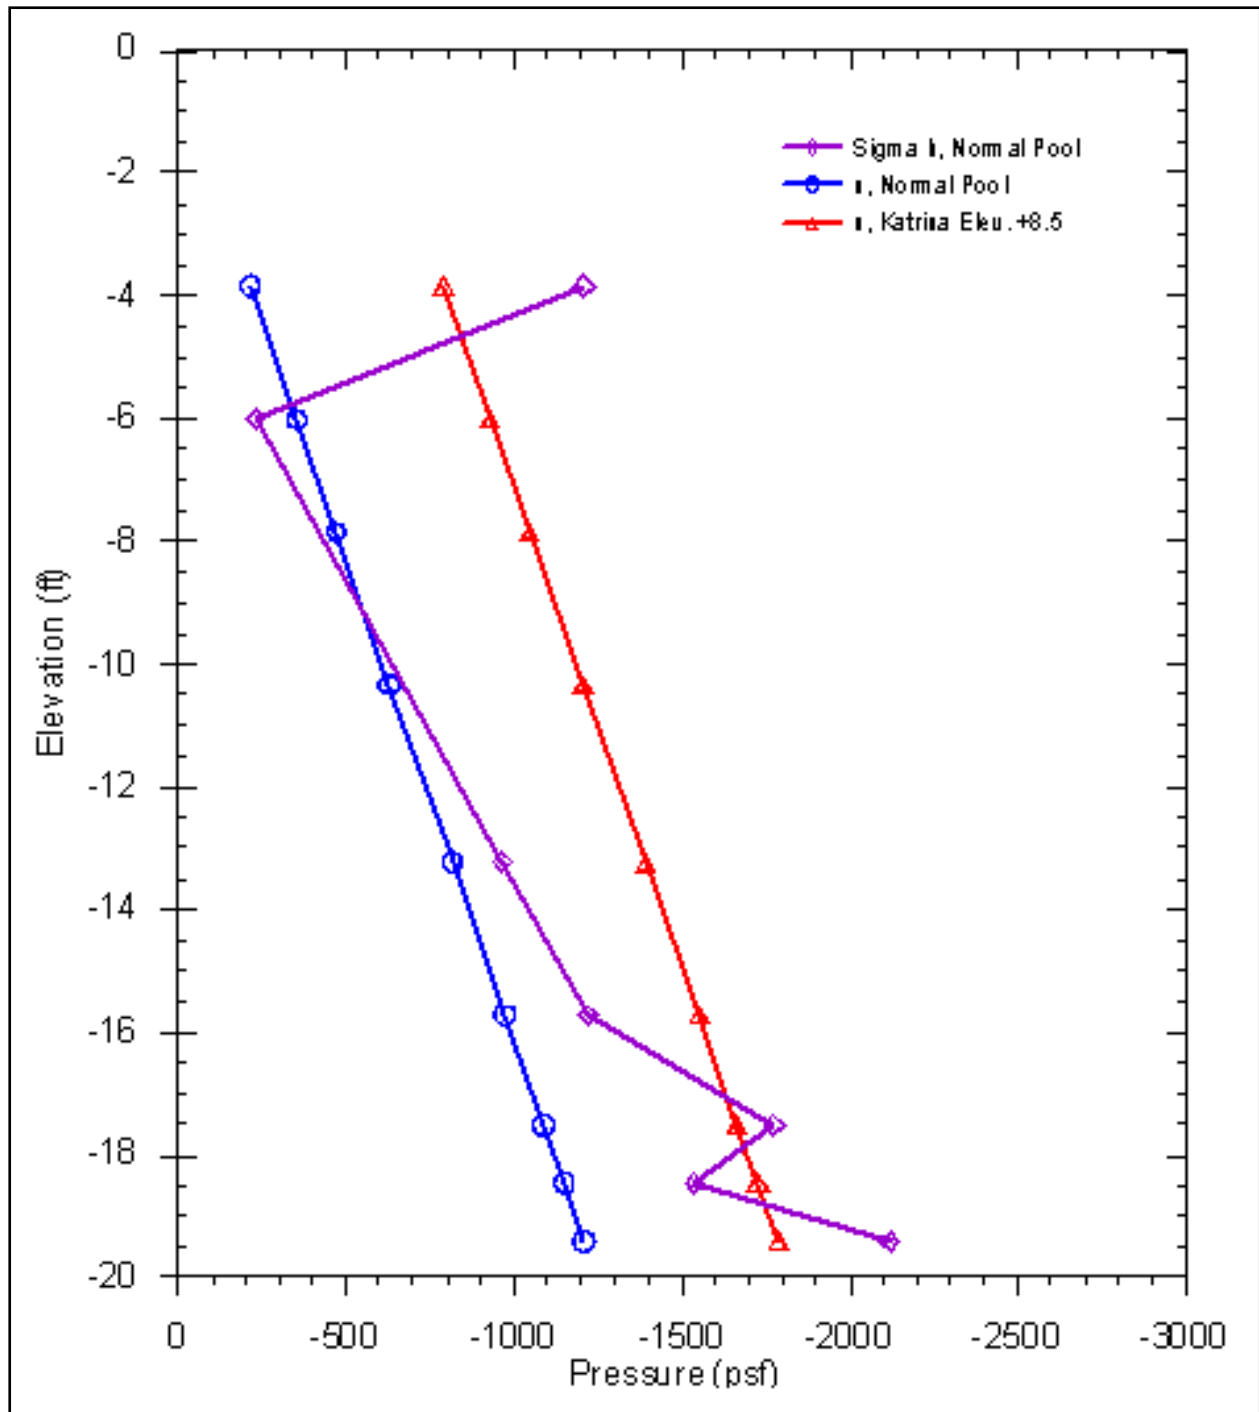
Pore water pressures associated with Katrina high flood water level exceeded the total horizontal normal stresses computed from normal pool water level in the clay layers down to about elevation 19 feet, indicating the potential for crack formation between the levee soil and the sheet pile wall (Figure 19-18).

Figure 19-18. Comparison of water pressure and horizontal total stress 17th St. breach sta. 10+00

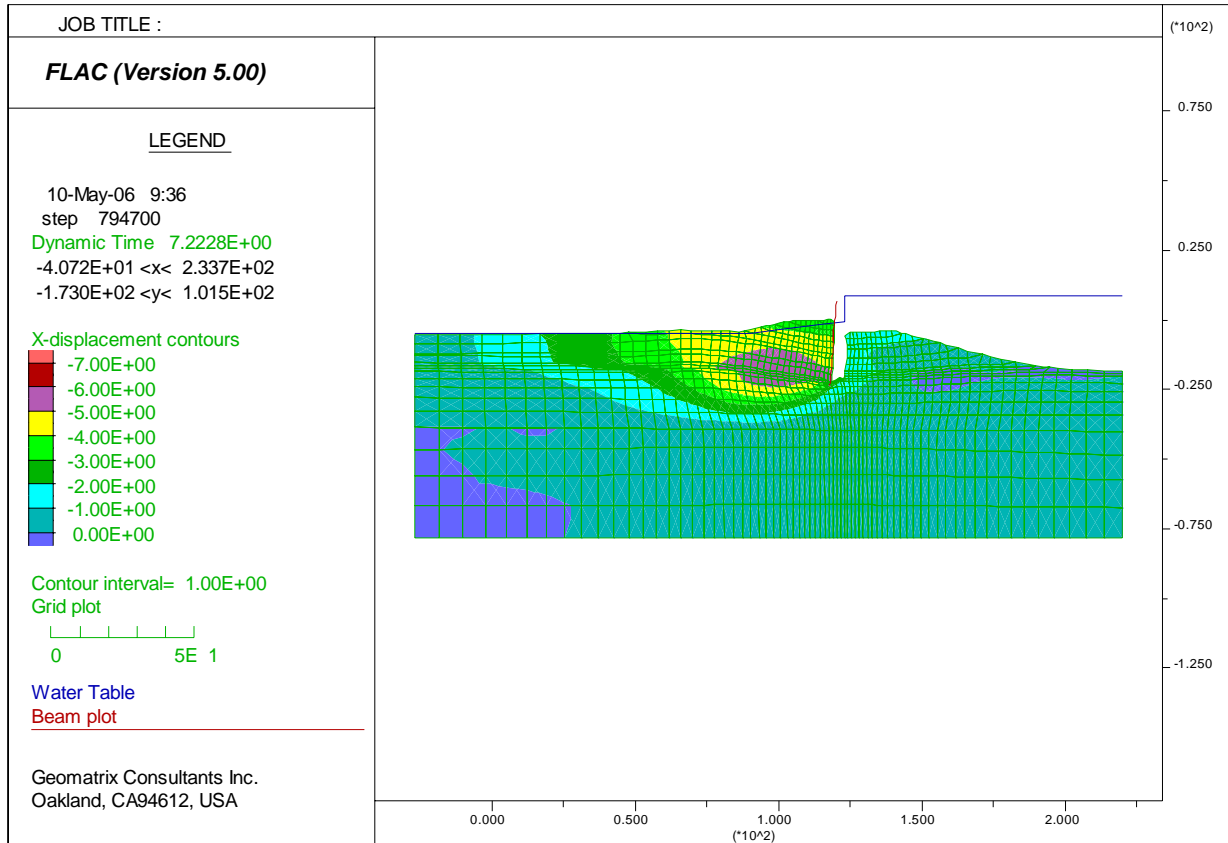
When incorporating a horizontal interface at the top of the soft lacustrine clay layer (at the elevation of pile tip), the computed deformation for the Katrina flood water level at El. 8.5 ft was about 5 to 6 ft, indicating the potential for failure (Figure 19-20).

However, the introduction of “crack” or gap between the canal side sheet pile wall and levee soil embankment and use of an interface along the failure surface were needed to induce significant displacements (5 to 6 ft) and probable failure. Continuing analyses with lower stiffnesses for the levee and marsh deposits may alter these results. Use of this non-linear soil model may be important in obtaining a better estimate of initial stresses effecting the formation of the crack or gap needed to trigger this failure mode.

Figure 19-20. Deformed grid (with crack simulation and interface) Katrina flood water level at El. +8.5 feet, non-linear model for 17th St. breach sta. 10+00

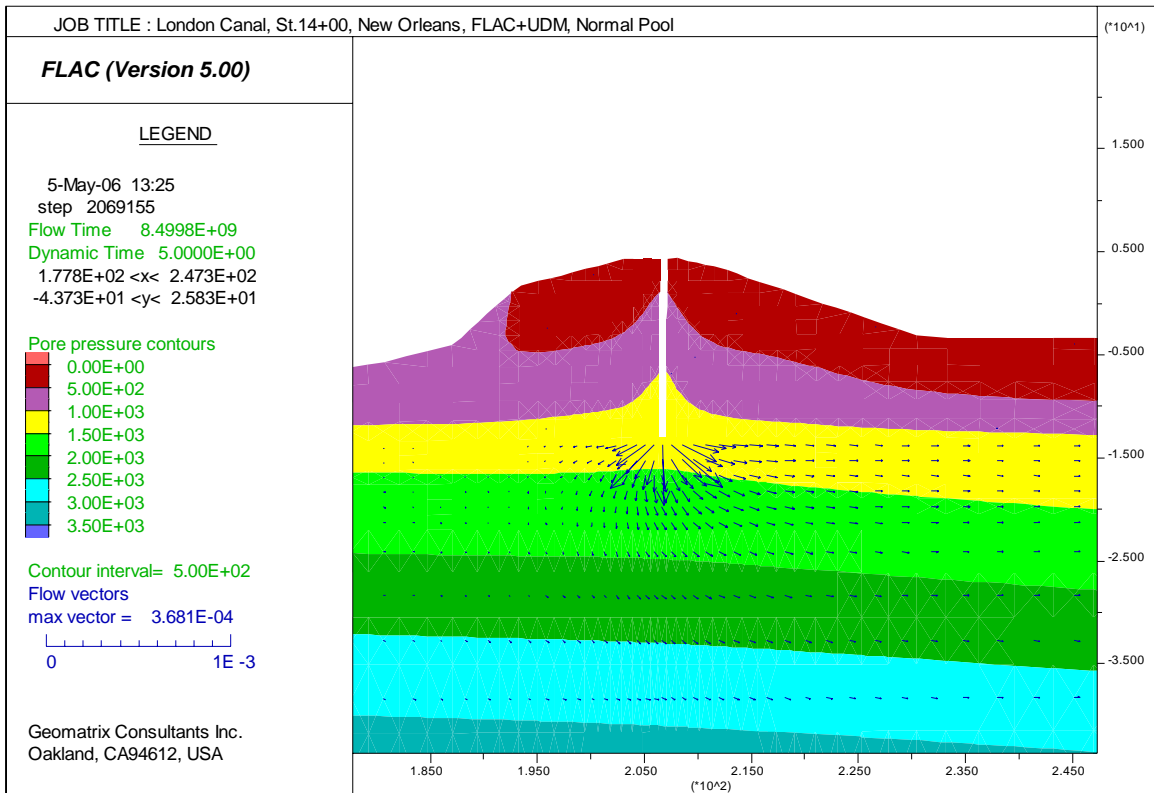
The possible crack formation was simulated in the analysis, and water flow into the underlying sand layer indicated significant increases in the pore pressures, and a corresponding reduction in effective stresses and shear strength. The water flow vector in the sand layers is presented in Figure 19-27. The detailed flow vectors and the simulated crack are presented in Figure 19-28.

Figure 19-28. Detailed flow vectors from near tip of pile and into top sand layer for London north breach sta. 14+00
