Appendix 11

Analysis of Performance of the Inner Harbor Navigation Canal

Executive Summary

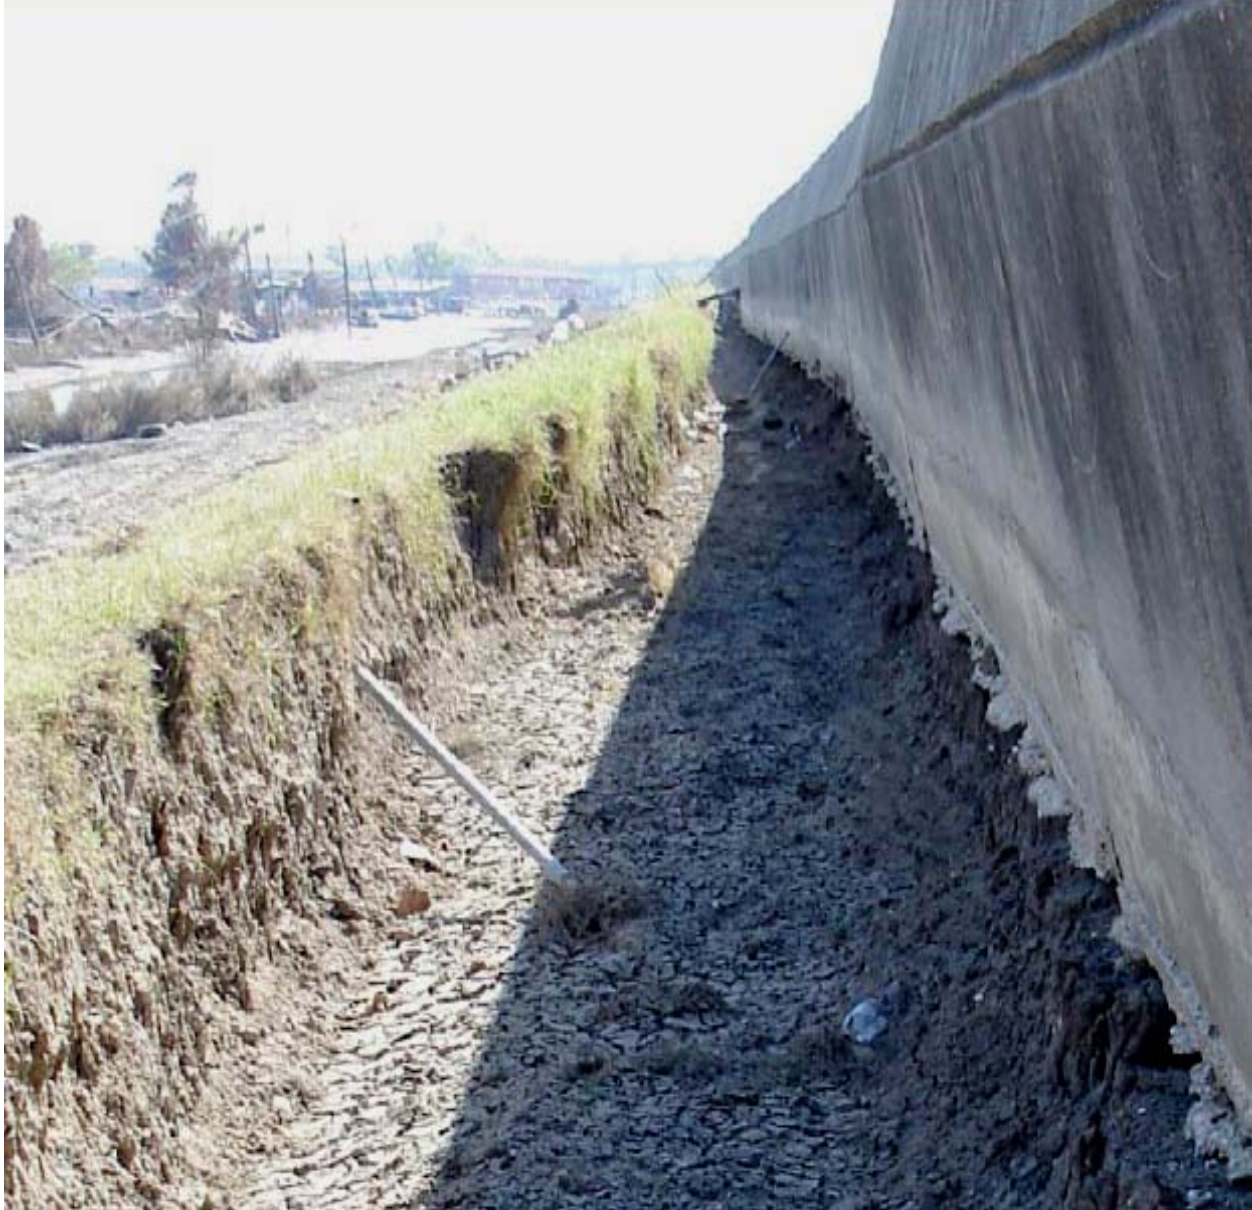
Water flowing over the I-walls when they were overtopped eroded trenches on the protected side of the walls as it cascaded onto the levee fill. Soil that was providing support for the walls eroded away, making the walls less stable.

Figure 11-4. Scour and Erosion on the Protected Side of the IHNC Adjacent to the Ninth Ward in the Vicinity of the South Breach

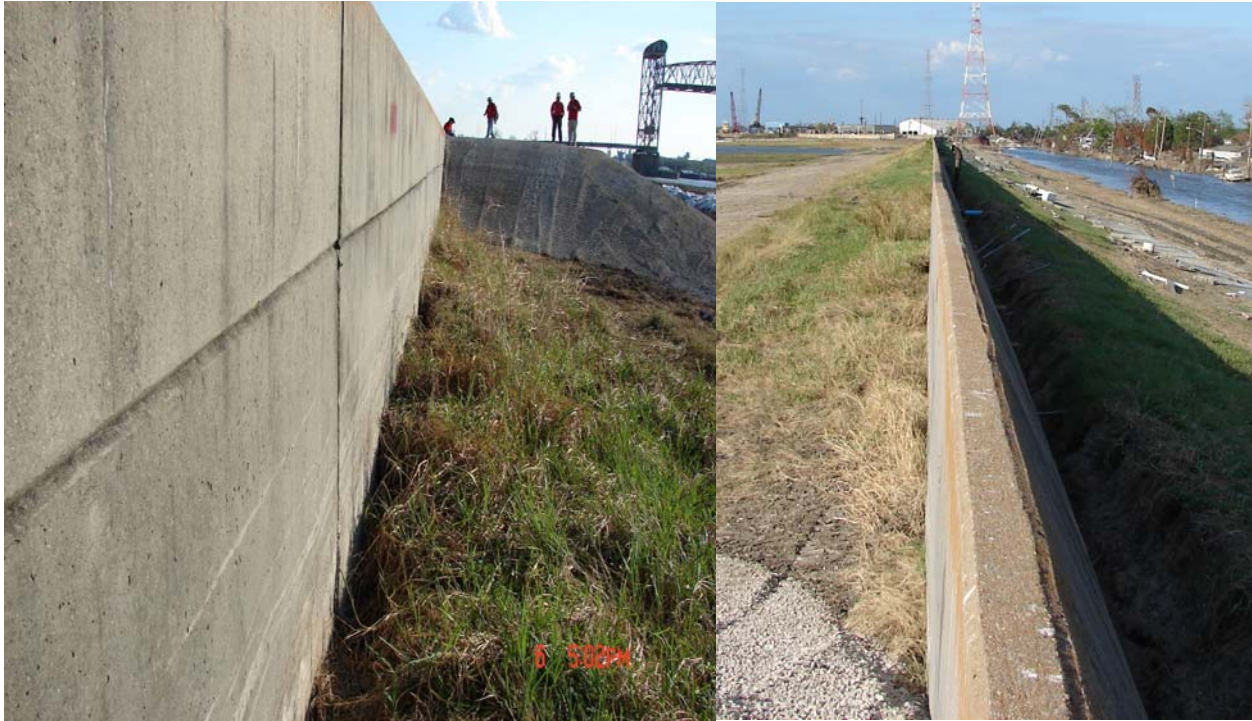
Formation of a crack on the canal side of the wall, allowing hydrostatic water pressure acting through the full depth of the crack, causes a very significant reduction in the value of the calculated factor of safety. Evidence that a crack did form behind the wall near the breaches can be seen in Figures 11-6 and 11-7.

Figure 11-6. IHNC East Bank – South Breach – Wall Movement

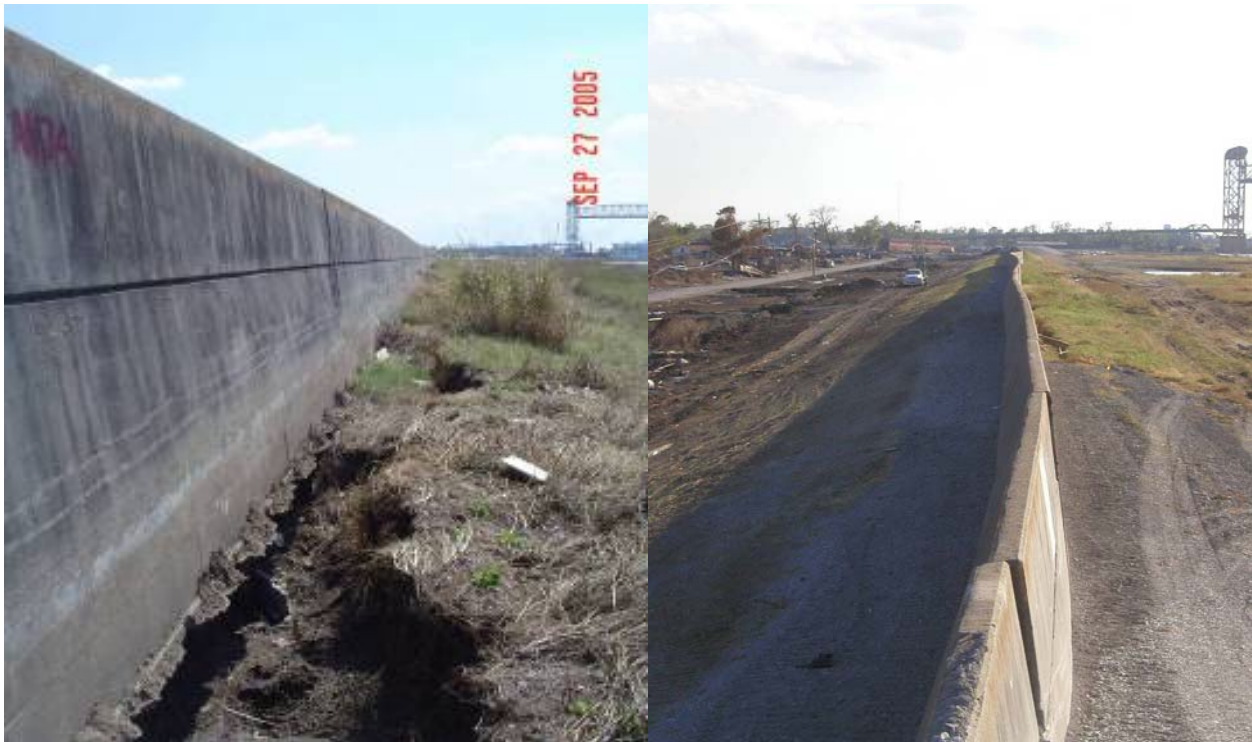
Figure 11-7. IHNC East Bank – North Breach – Wall Movement (View looking south)

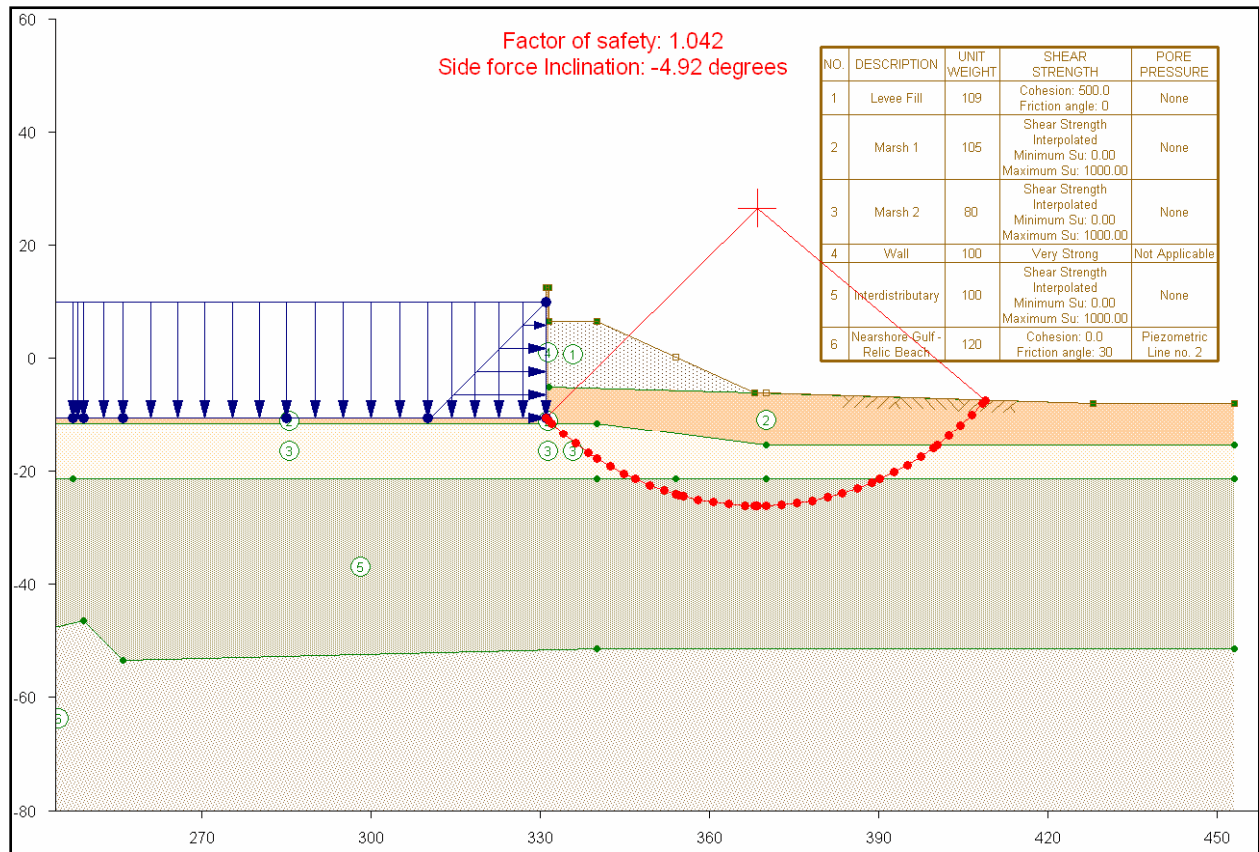
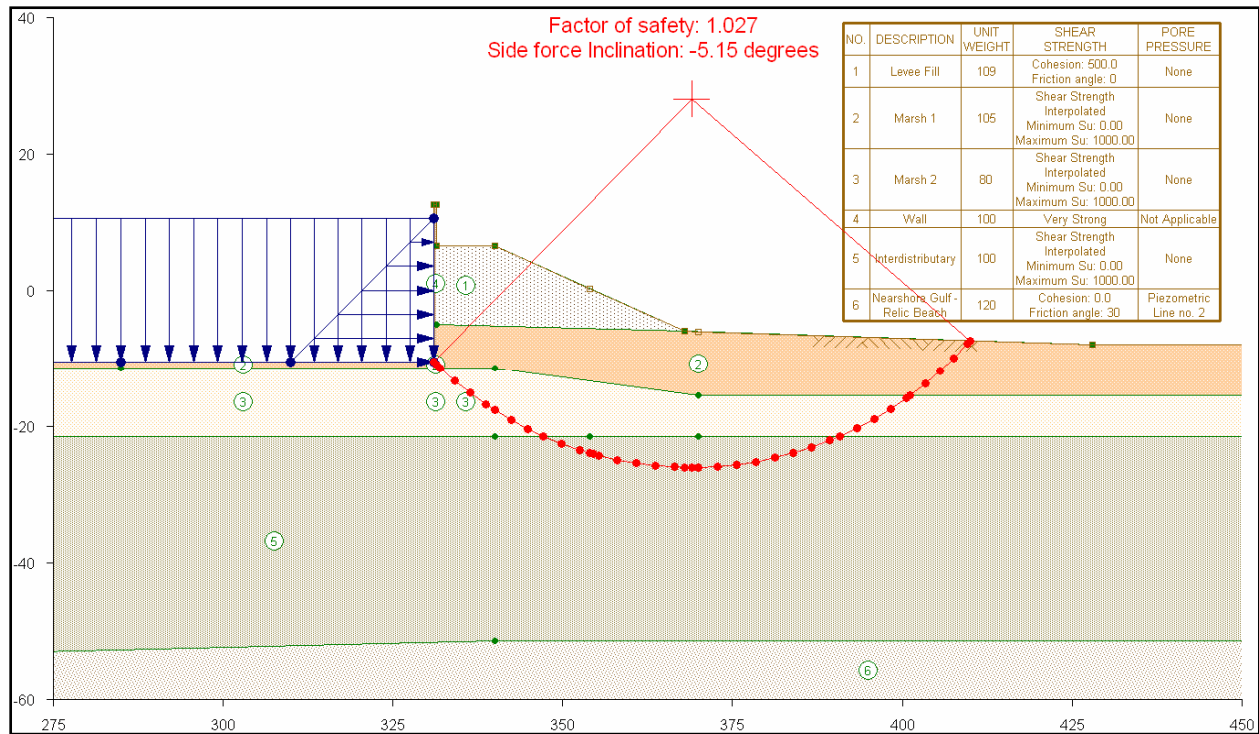
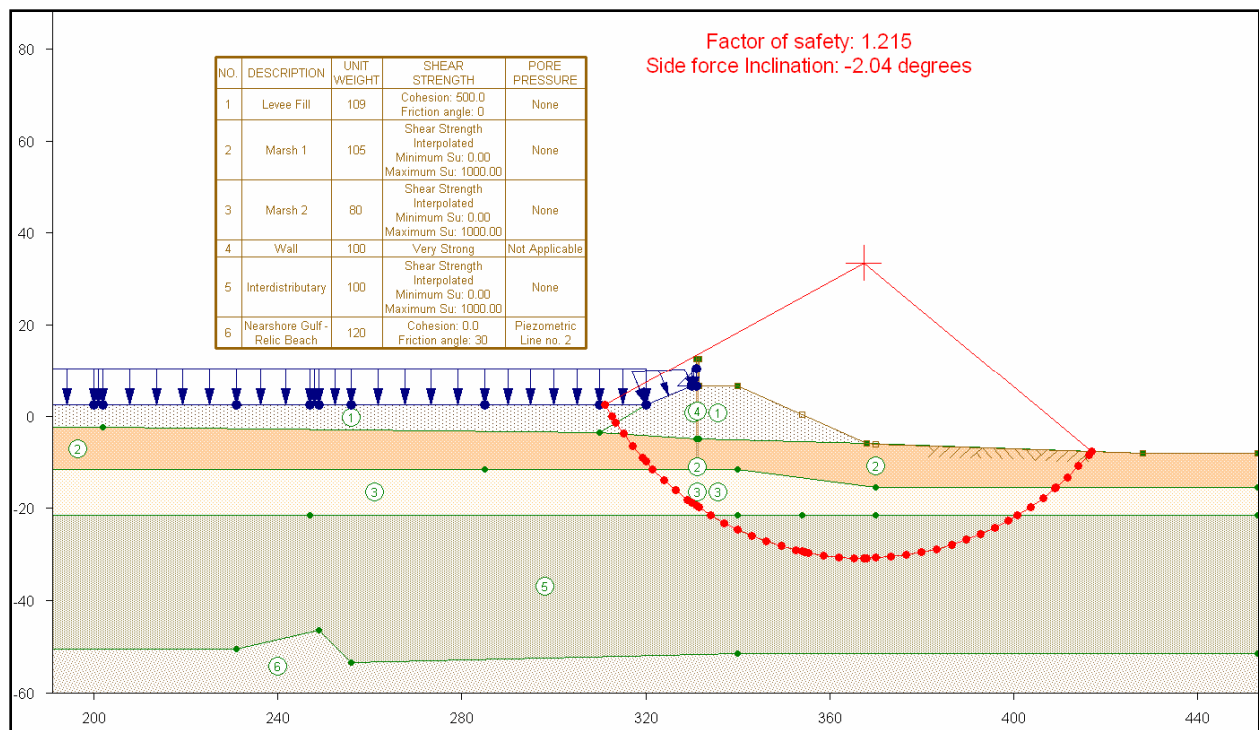
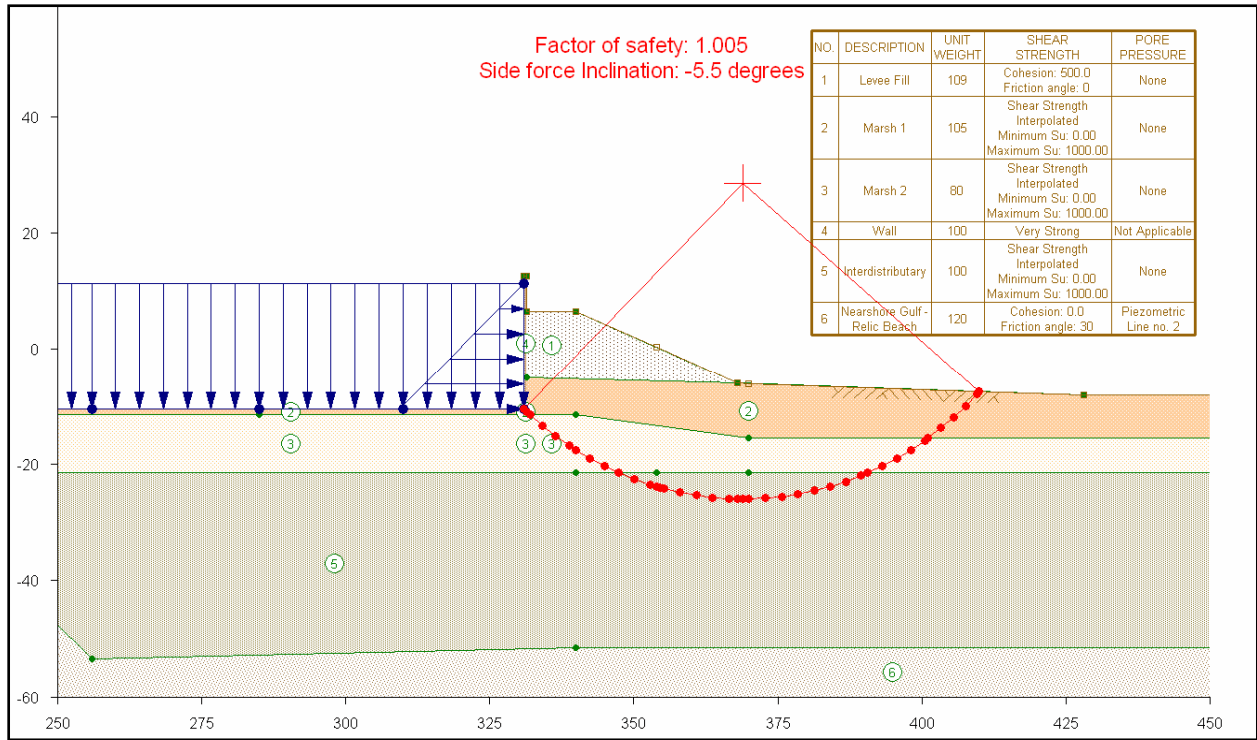
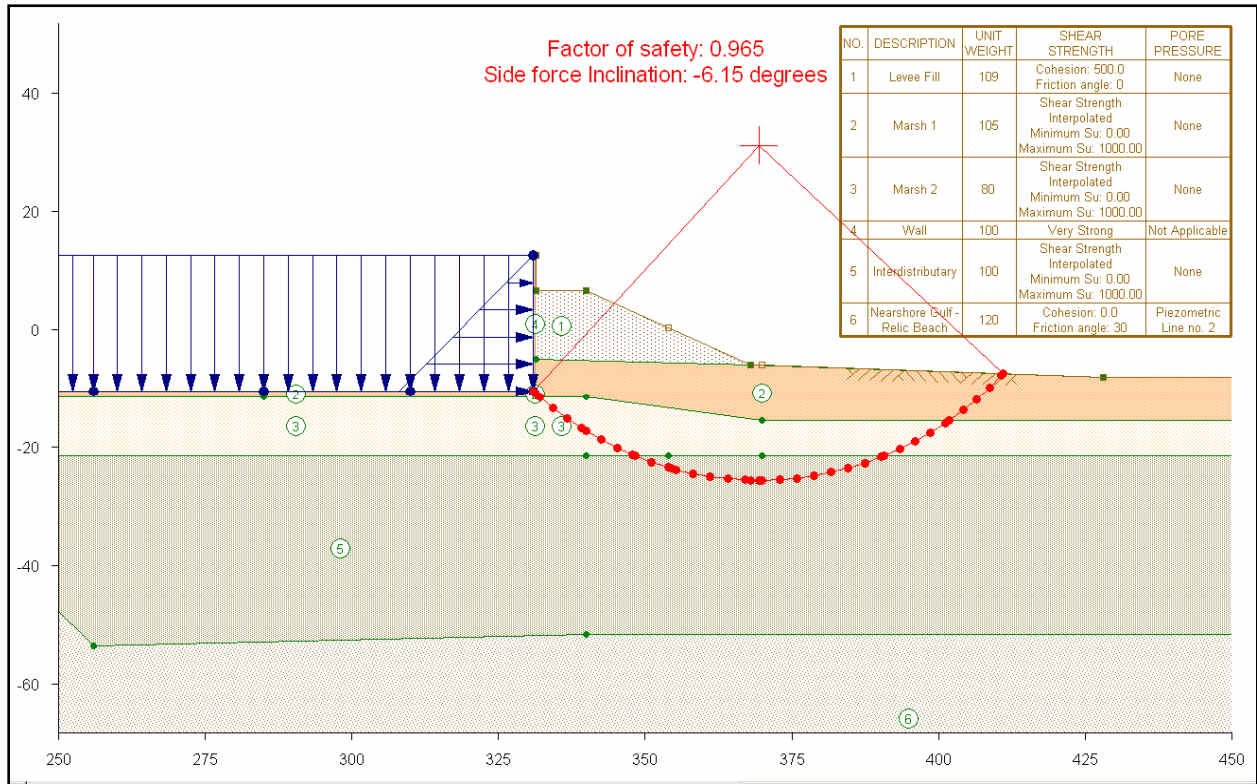
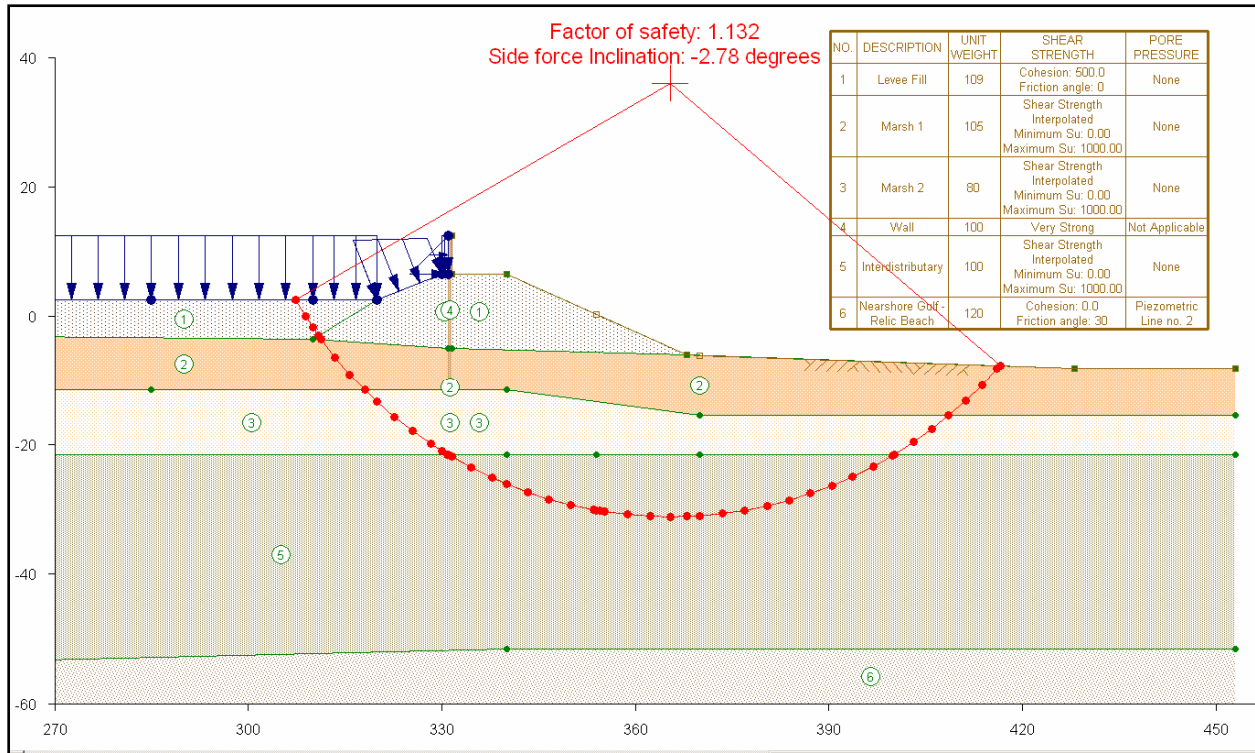
For the north breach (Station 55+00), with the canal water level at elevation 12.5 ft (top of the wall), the calculated factor of safety for the cracked condition is 0.96, as compared to 1.13 for the uncracked condition (Cases 5 and 5a). A canal water elevation of 11.2 ft produces a factor of safety of unity for the cracked condition (Case 4). Figures 11-20 through 11-25 show the critical circles from UTEXAS4 analyses for the north breach for Cases 1 through 5 and Case 5a.

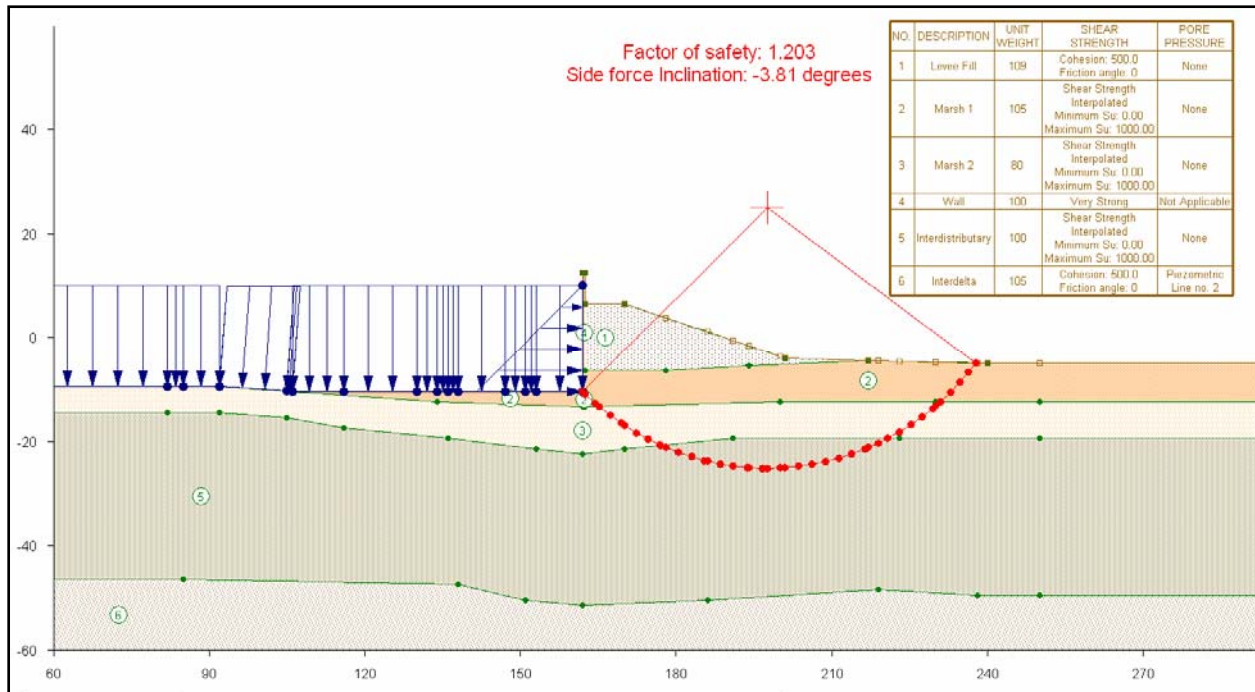
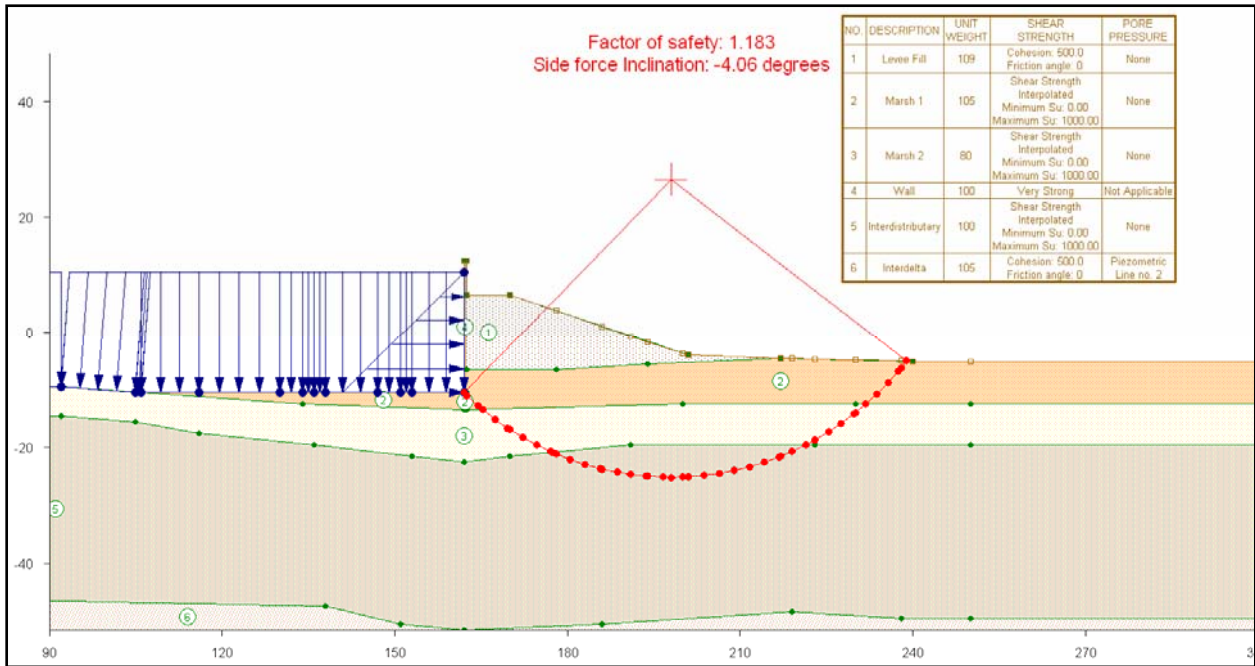
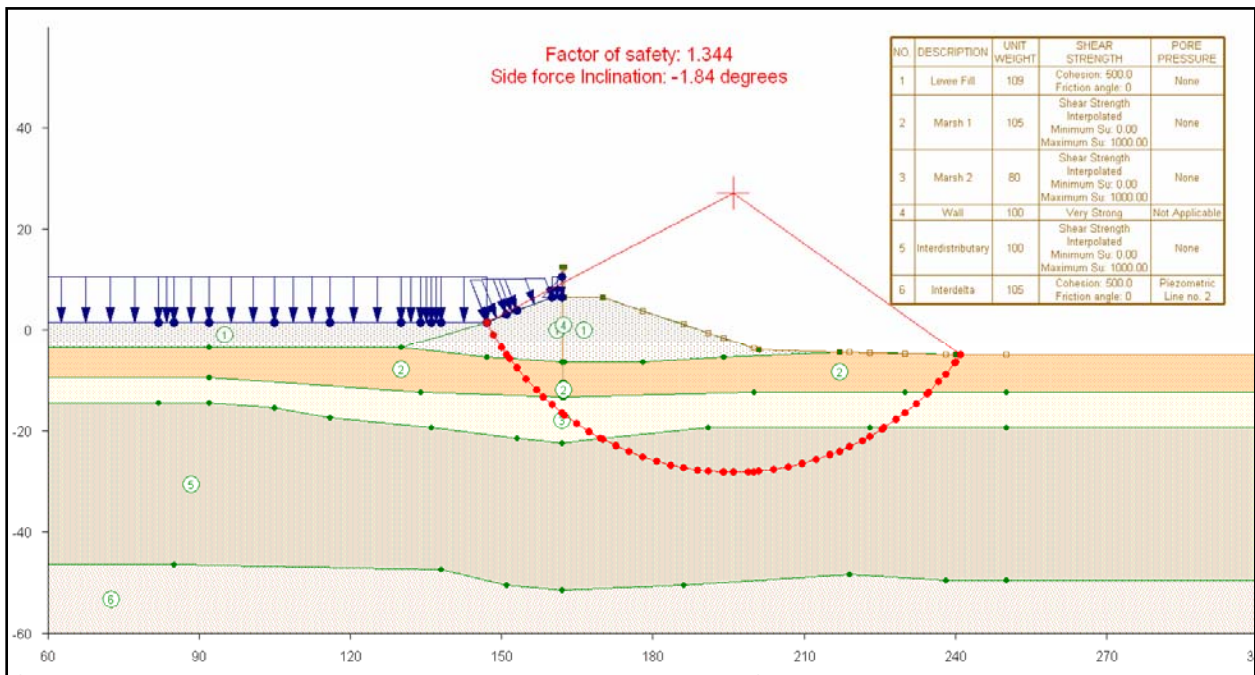
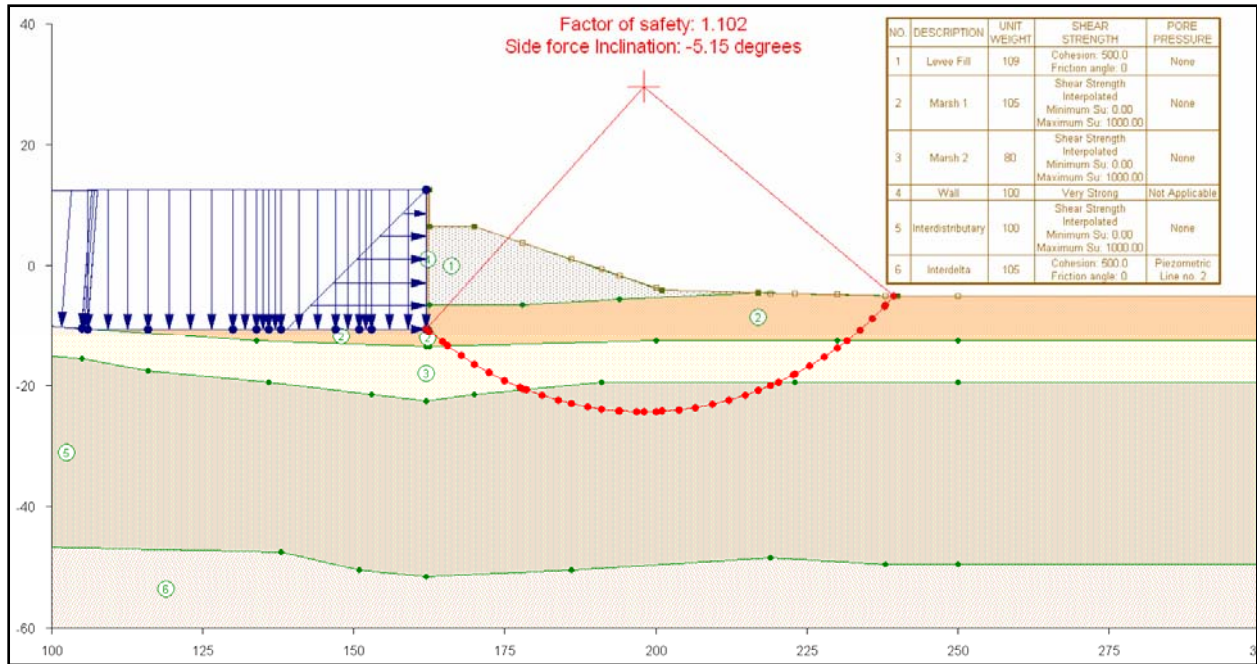
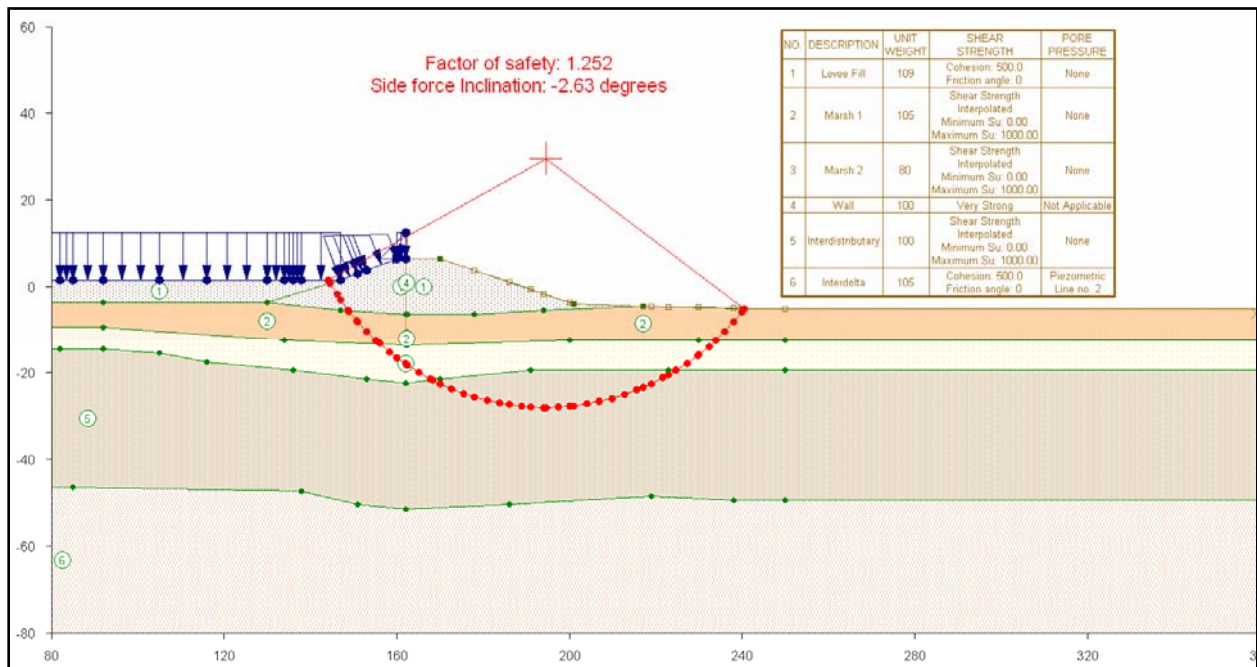
For the south breach (Station 26+00), the factor of safety was greater than unity for all canal water elevations analyzed using the IPET strength model. For the most extreme case of the canal water level at elevation 12.5 ft (top of the wall), the calculated factor of safety for the cracked condition is 1.10. The critical circles for the stability analyses performed on the south breach for Cases 1 through 5 are shown in Figures 11-26 through 11-30.

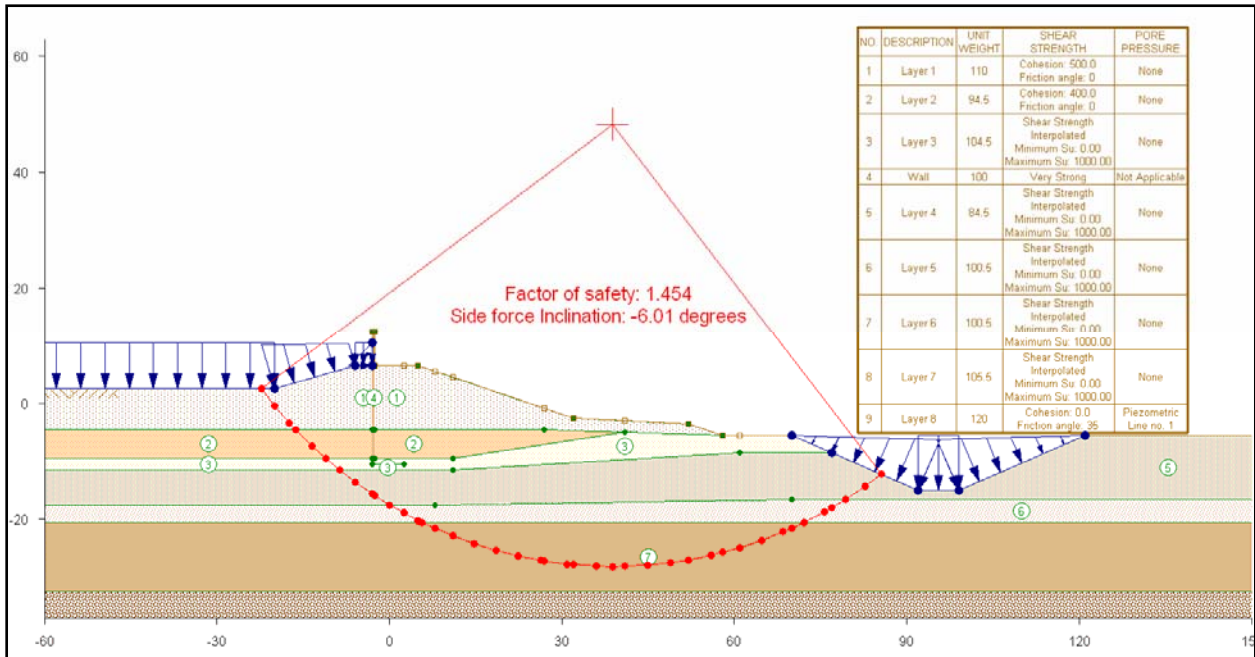
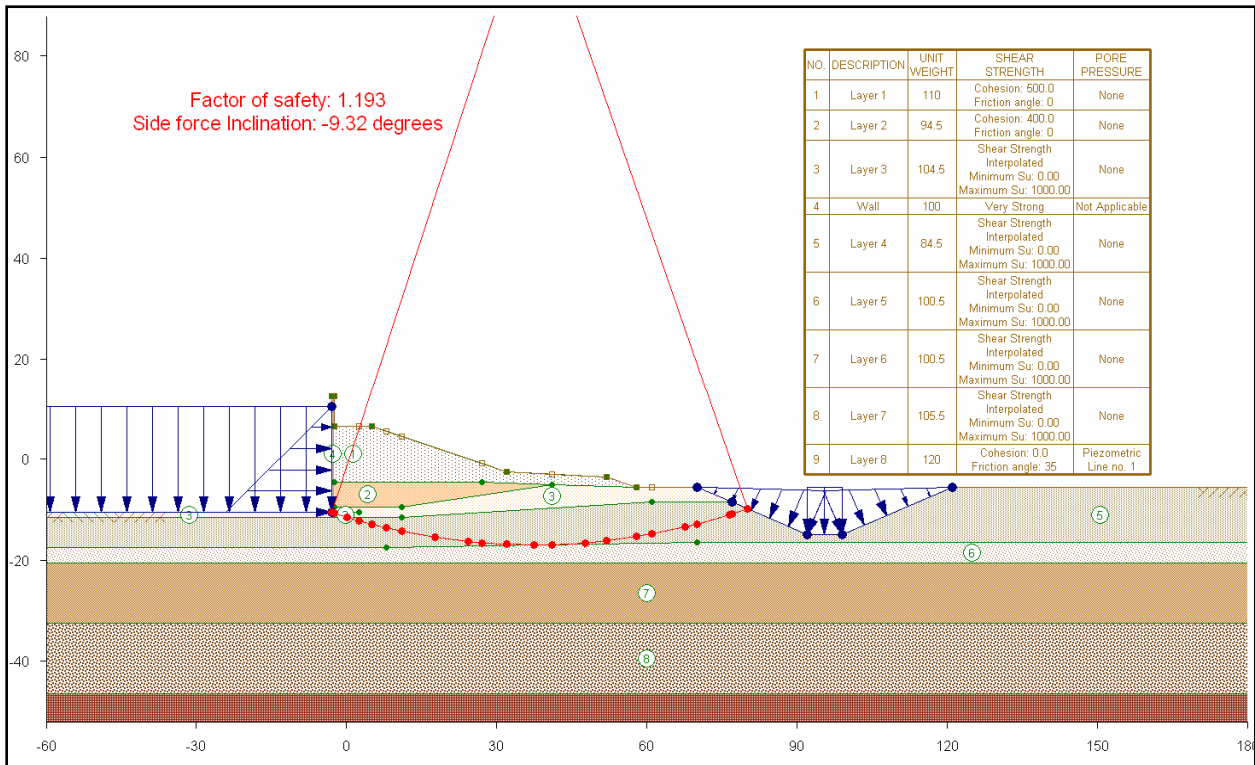
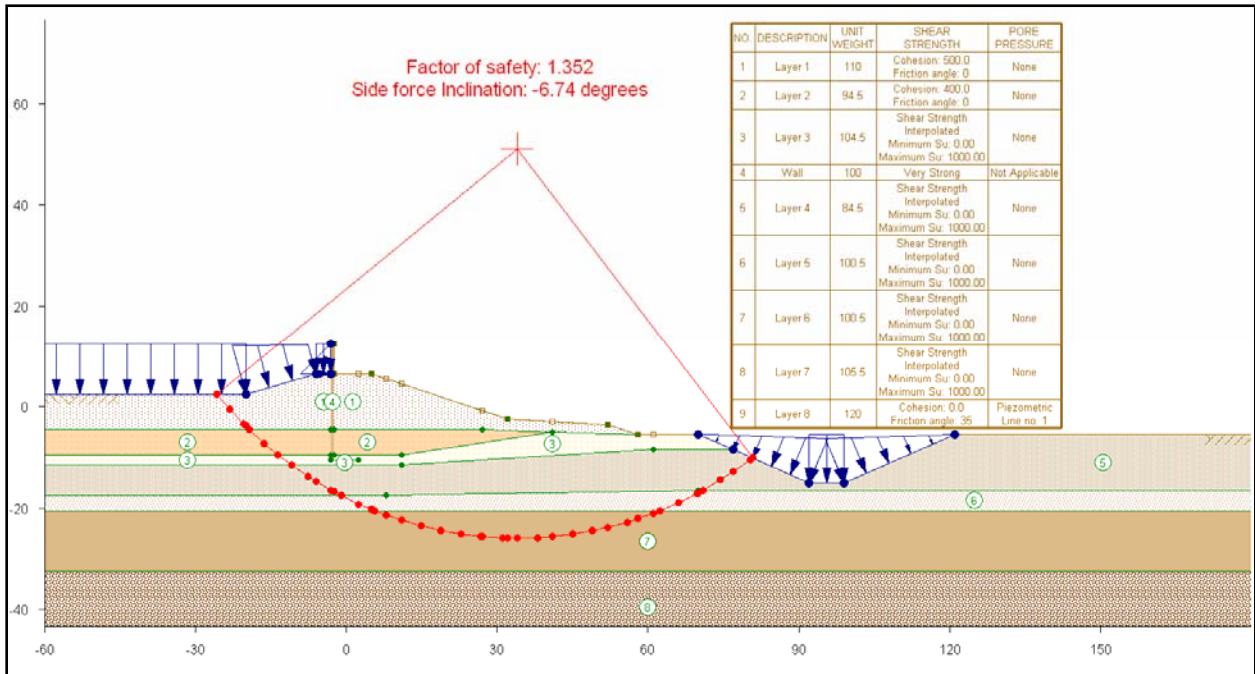
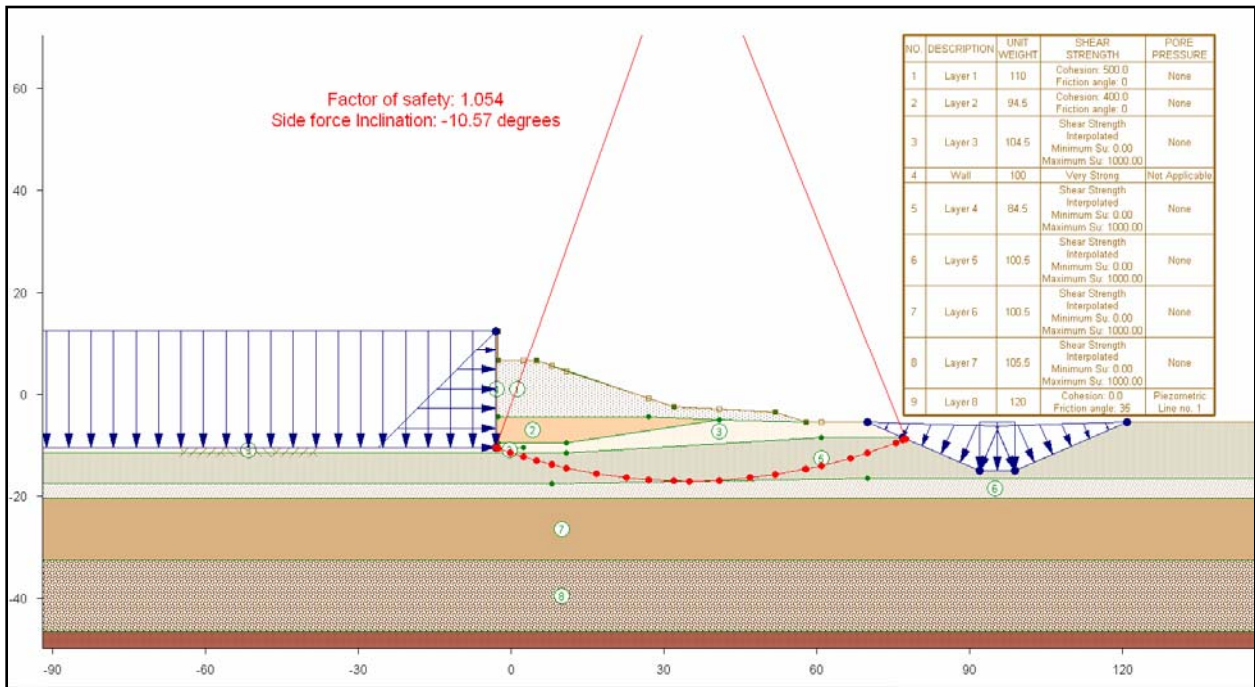
Three other variations of the design cross section were analyzed. Introducing a crack behind the wall for the design water level decreases the factor of safety to 1.19. For a canal water elevation at the top of the wall (12.5 ft NAVD88), the factor of safety is 1.35 for the uncracked condition and 1.05 for the cracked condition. The results of all analyses performed on the GDM cross section are presented in Table 11-8. Figures 11-31 through 11-34 show the critical circles for the UTEXAS4 analysis.

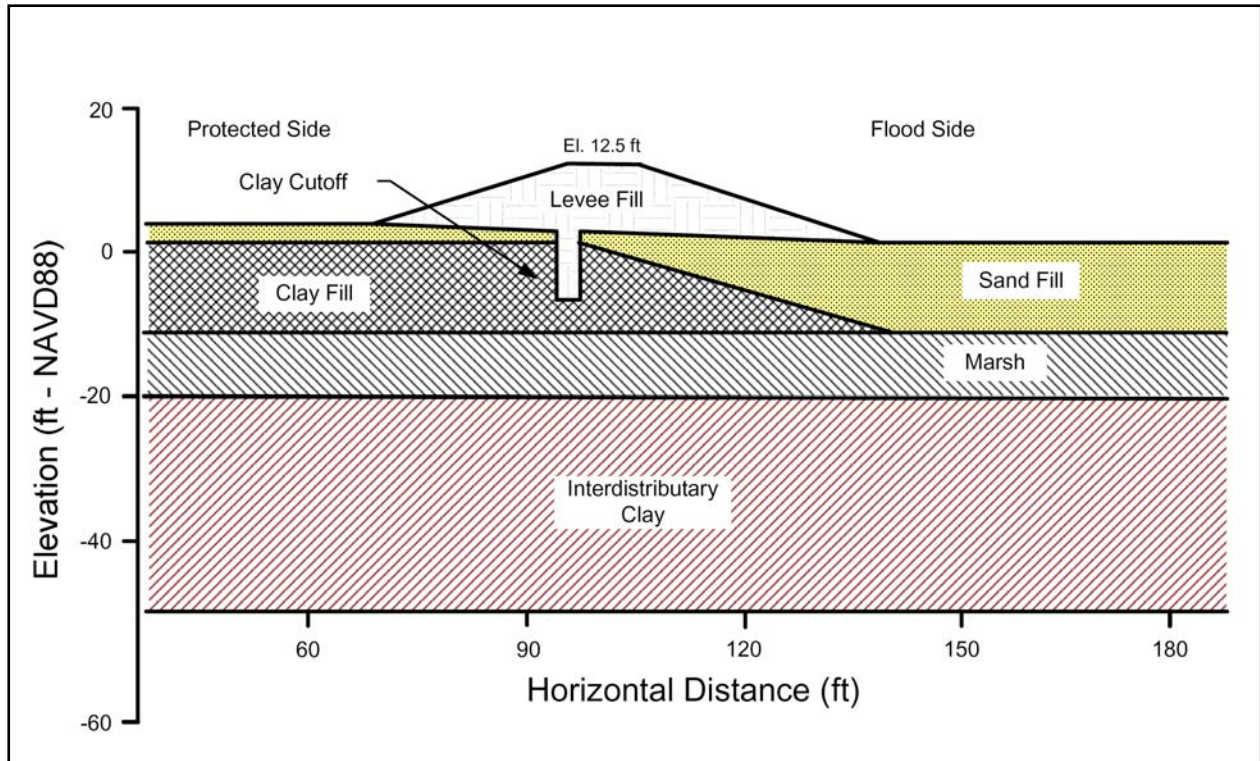
Figure 11-36. IHNC – West Bank – Cross Section of South Breach

The southern breach, between stations 0+80 and 2+80¹⁴, occurred when the levee at that location was overtopped and eroded. There was no I-wall in this levee reach. The elevation of the top of the levee was 12.5 ft. A cross section through the levee is shown in Figure 11-36.

The levees at both locations were founded on about 8 ft to 10 ft of fill. The fill at the north breach was clay. At the south breach the fill consisted partly of silty sand and partly of clay, as shown in Figure 11-36. At both locations the fill was underlain by a layer of marsh material, about 11 to 12 ft thick, and a layer of normally-consolidated interdistributary clay 30 to 35 ft thick.

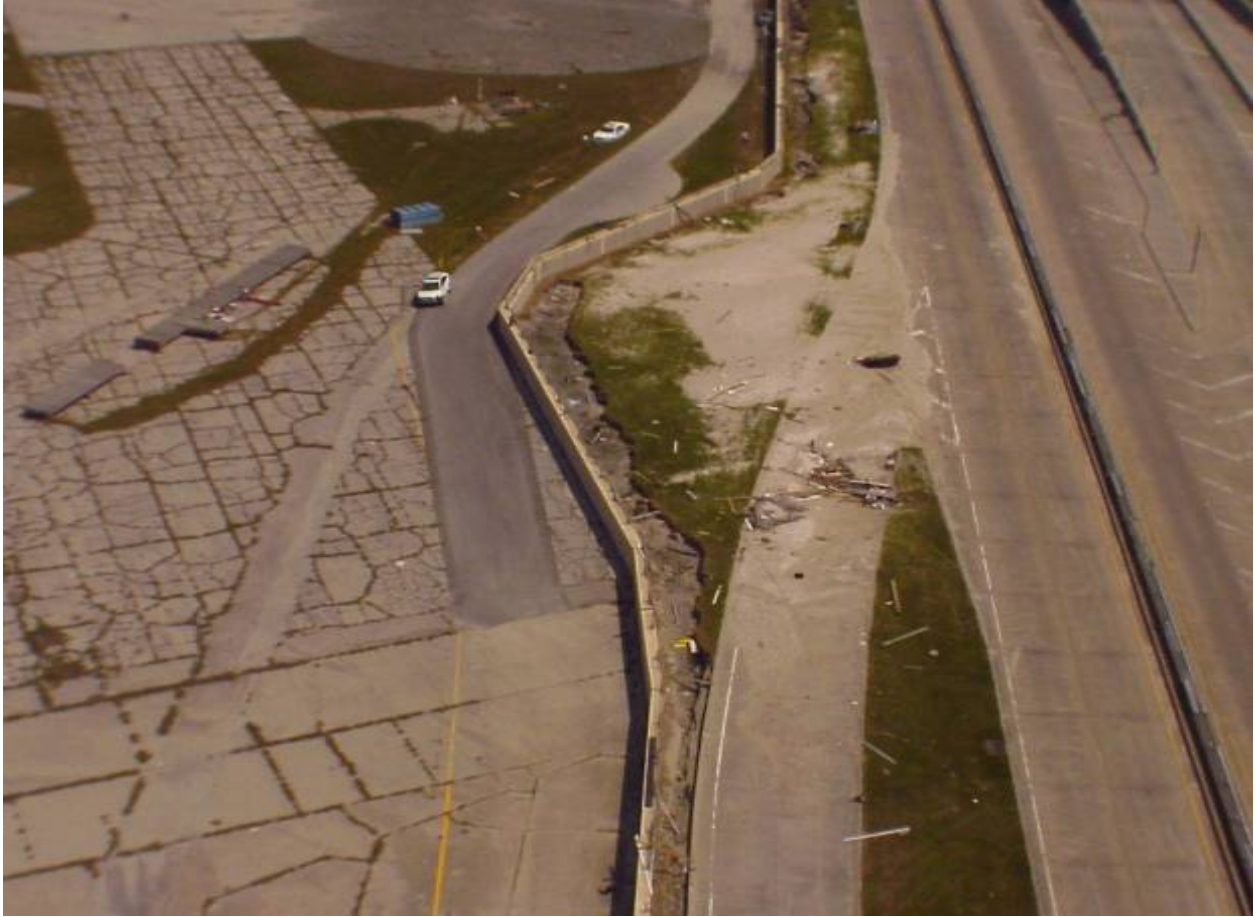
Project NOE06 consists of filling in and paving over the scour holes next to the concrete wall. It also includes filling in the scour hole and paving the damaged road section with concrete at the interface of the Floodgate L-15 concrete wall and levee. The damage in this reach was primarily scouring along the landside of the floodwall and levee sections at several distinct locations. The severity of the scouring varies from minor to severe. Scouring occurred to some degree at each of the tie-in to the closure structures located within this reach. The total quantity of materials removed by scouring along the entire Lakefront reach is estimated to be less than 5000 cys. January 31, 2006 was scheduled completion date.

Figure 12-6. NOE6_B. Scoured Section on Protected Side at Lakefront Airport Floodwall

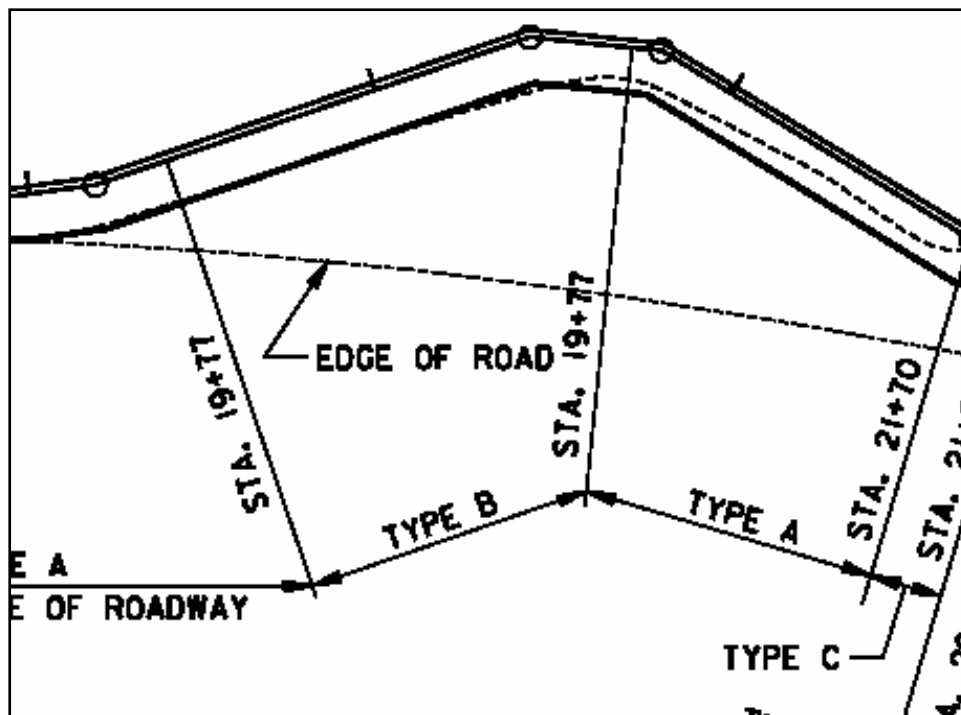
Figure 12-7. NOE6_C Rotated Plan View of Above Picture Defining Scour Extent and Type (from NOE6 Contract Solicitation drawing 4 of 9)

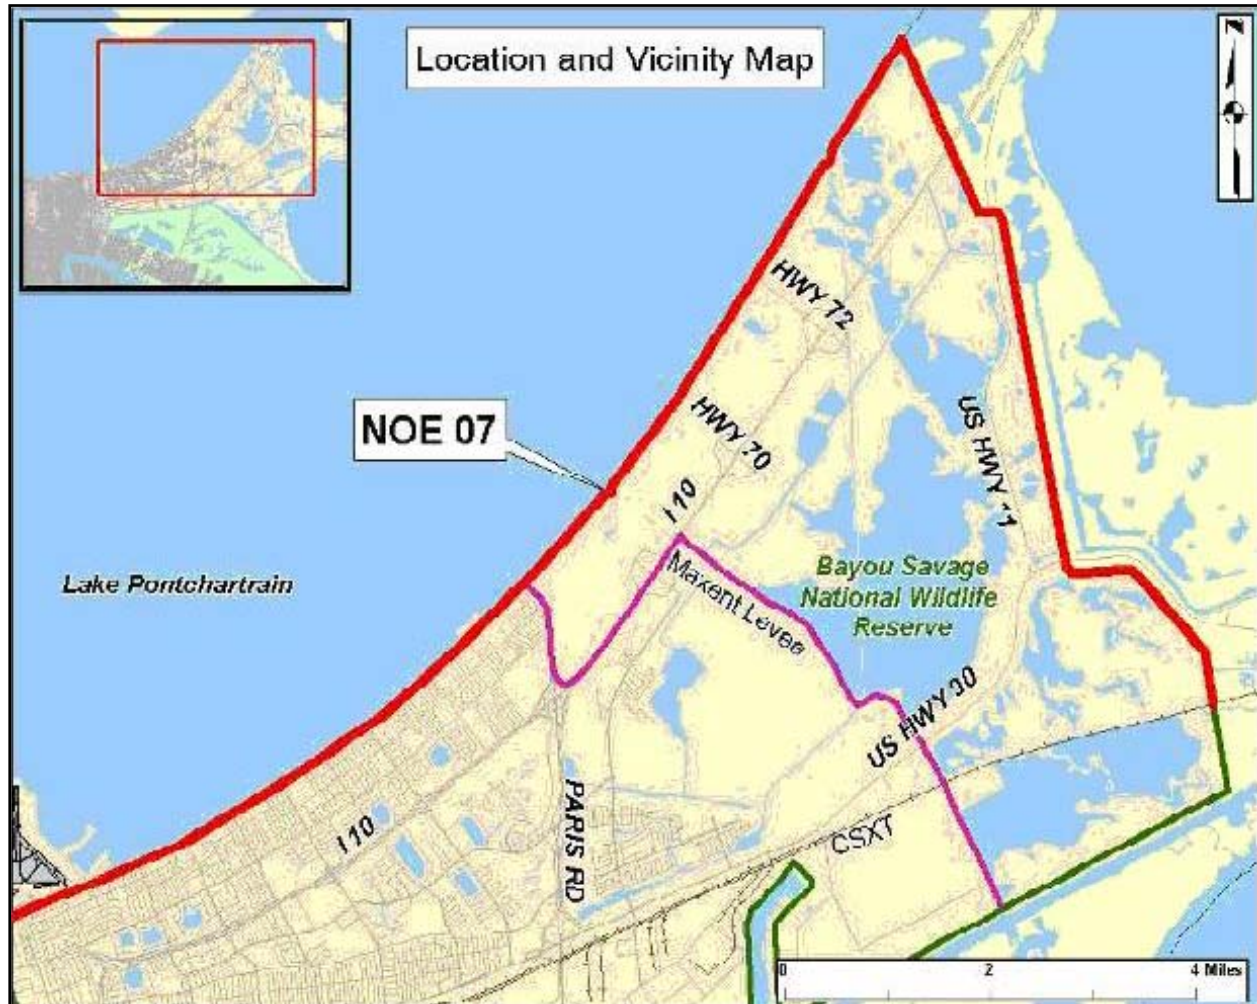
Figure 12-9. NOE7_A Project NOE10 Addresses Levee/Wall Repairs Near the Lakefront Airport, at Specific Locations. This project will provide scour aprons and concrete /pavement repair at less than 10 locations

Project NOE07 includes intermittent scour repair along approximately 19 miles of earthen levee along the Lake Pontchartrain Lakefront and the eastern boundary of the Bayou Sauvage National Wildlife Preserve. The work consists of filling in the scour areas with semi-compacted fill, reshaping where needed, and seeding and fertilizing. January 31, 2006 was scheduled completion date.
