Appendix 11

Analysis of Performance of the Inner Harbor Navigation Canal

Executive Summary

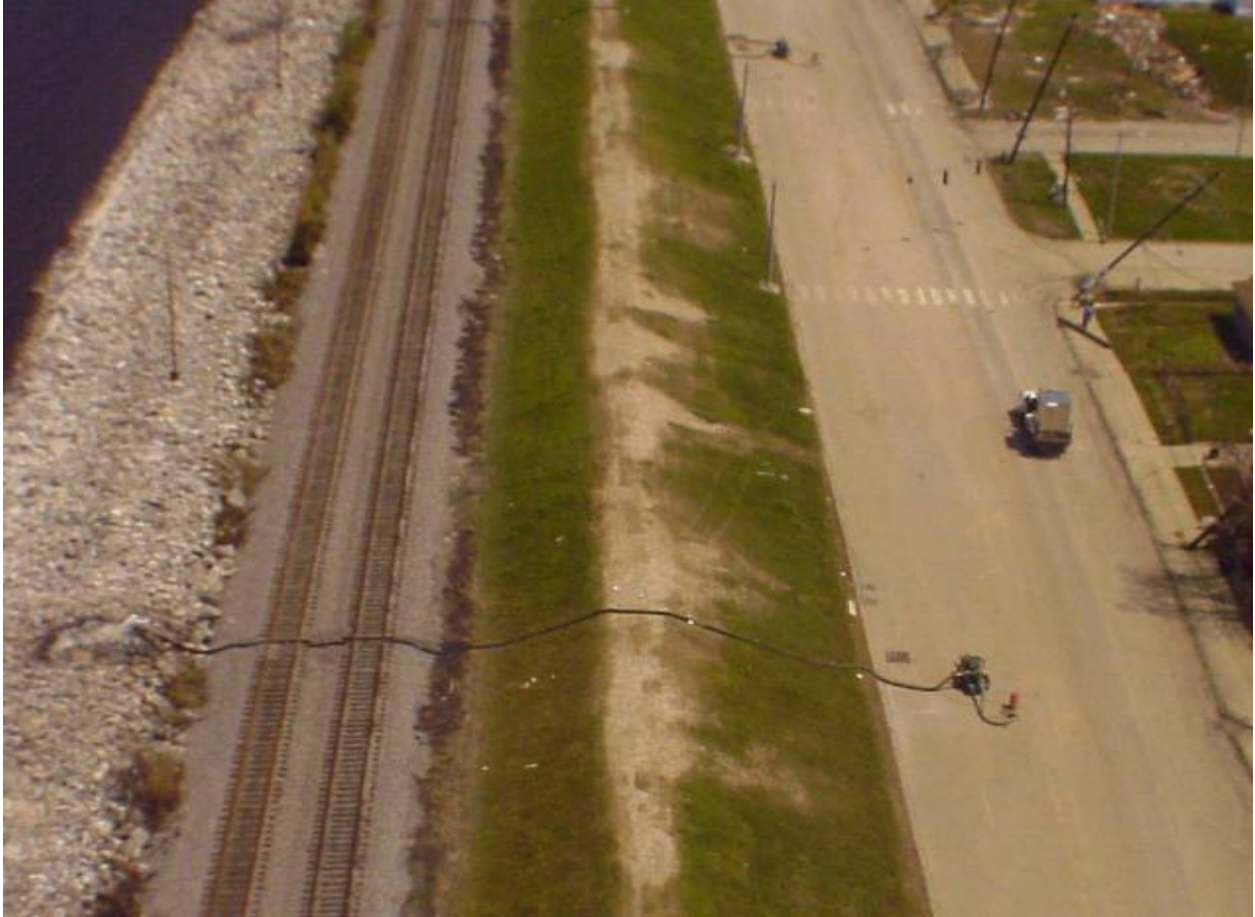
Figure 12-10. NOE7_B Typical Crown and Landside Scouring

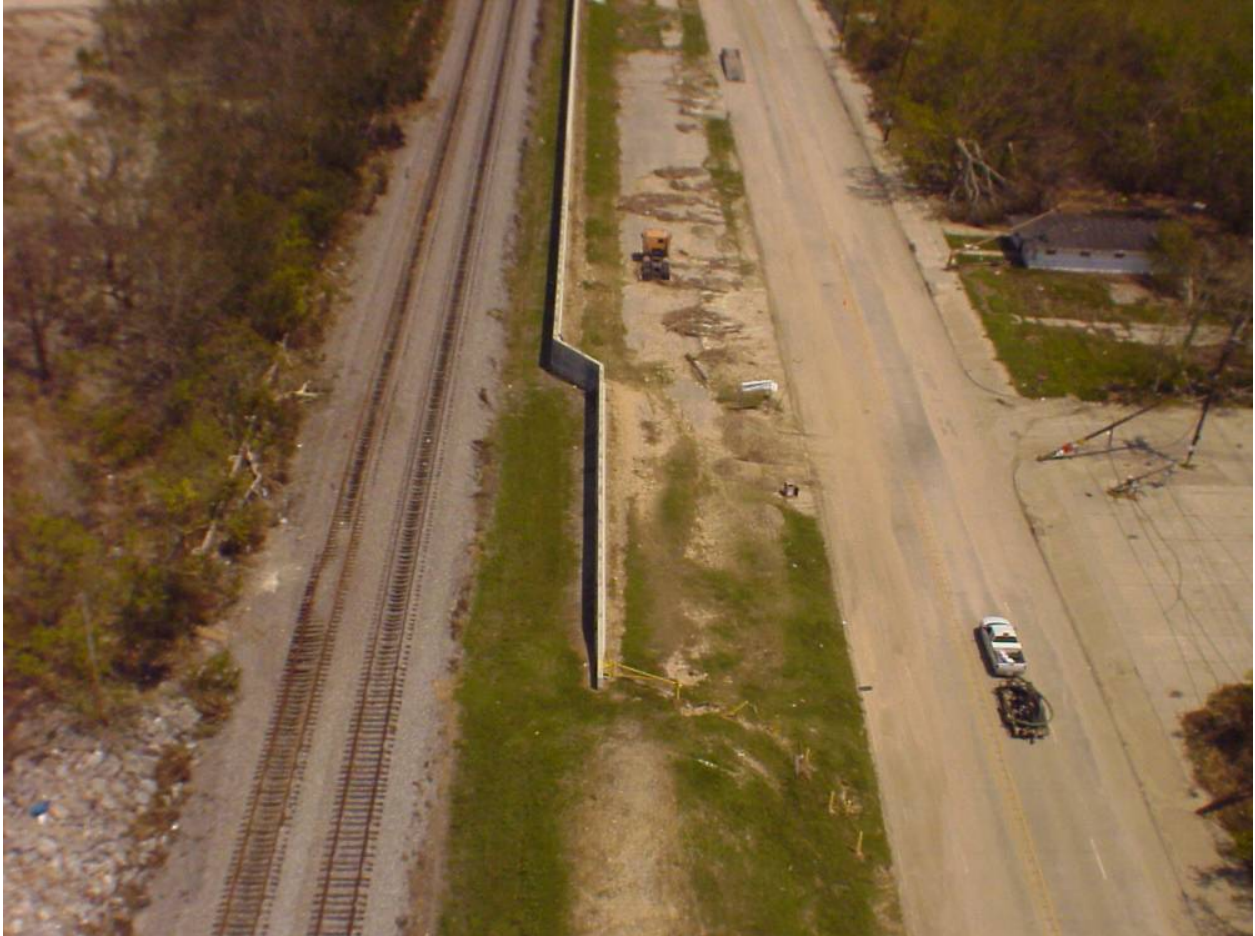
Figure 12-11. NOE7_C Floodwall Landside Scouring on Hayne Blvd. East of Downman Rd.

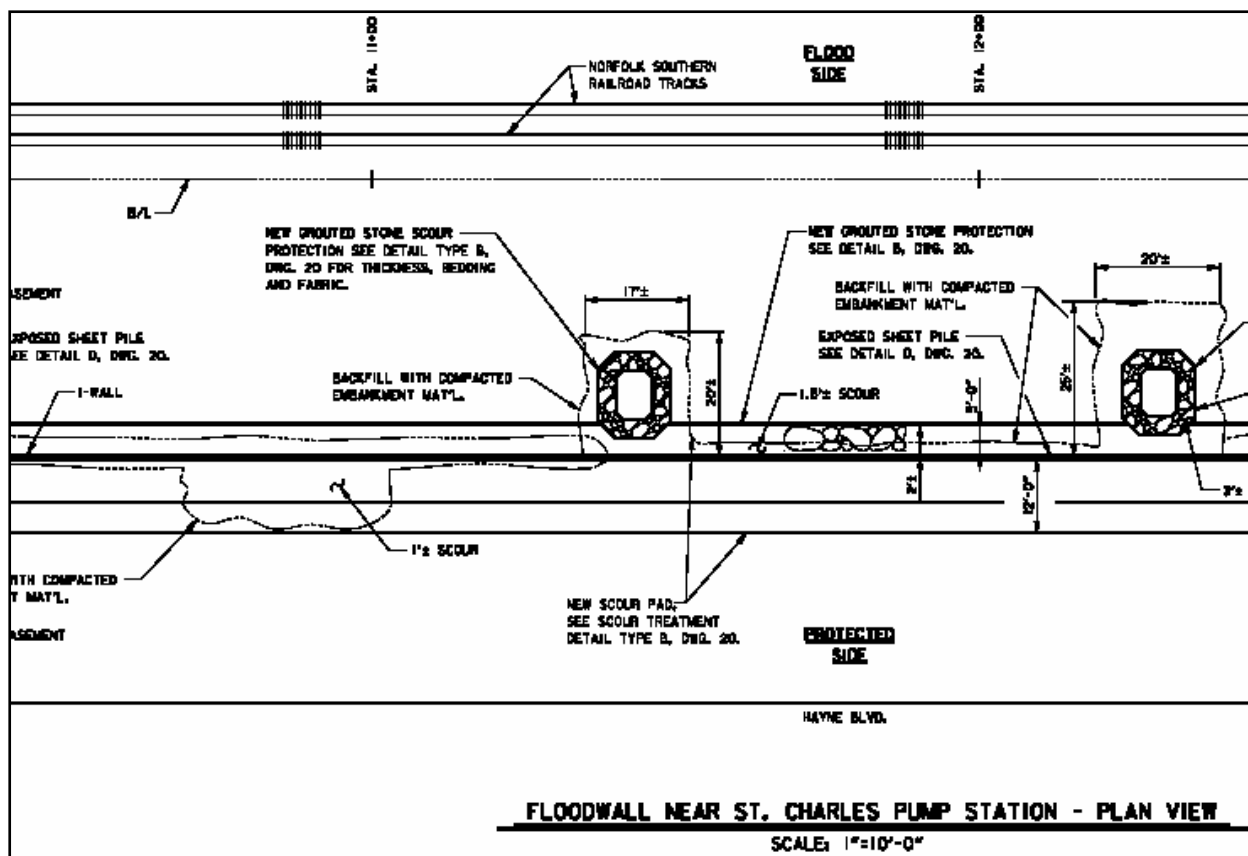
Figure 12-13. NOE7_E Scoured Areas Near St. Charles Pump Station (B/L Sta 74+00)

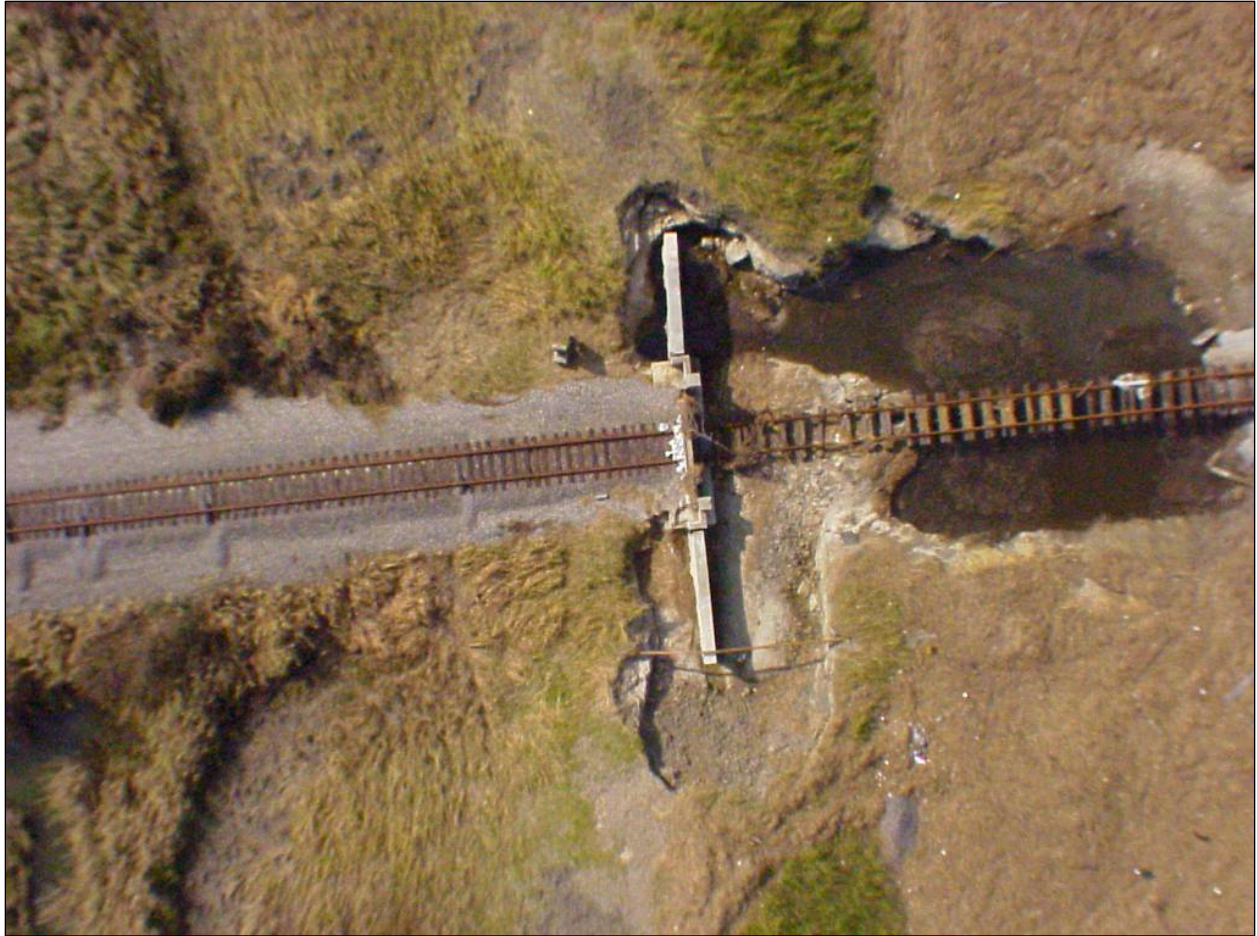
Project NOE05 includes the removal of the existing concrete wall and railroad closure gate, filling the scoured areas, constructing a new closure gate and new concrete T-walls and I-walls, placement of rip rap, concrete slope paving and concrete roadway. The CSX railroad floodgate and adjacent section of the levee were damaged during the storm event. There was scour of the structural fill material resulting from overtopping of the closure gate and levee. April 1, 2006 is scheduled completion for repairs.

Figure 12-19. NOE5_C. View of Scour Around T-Wall

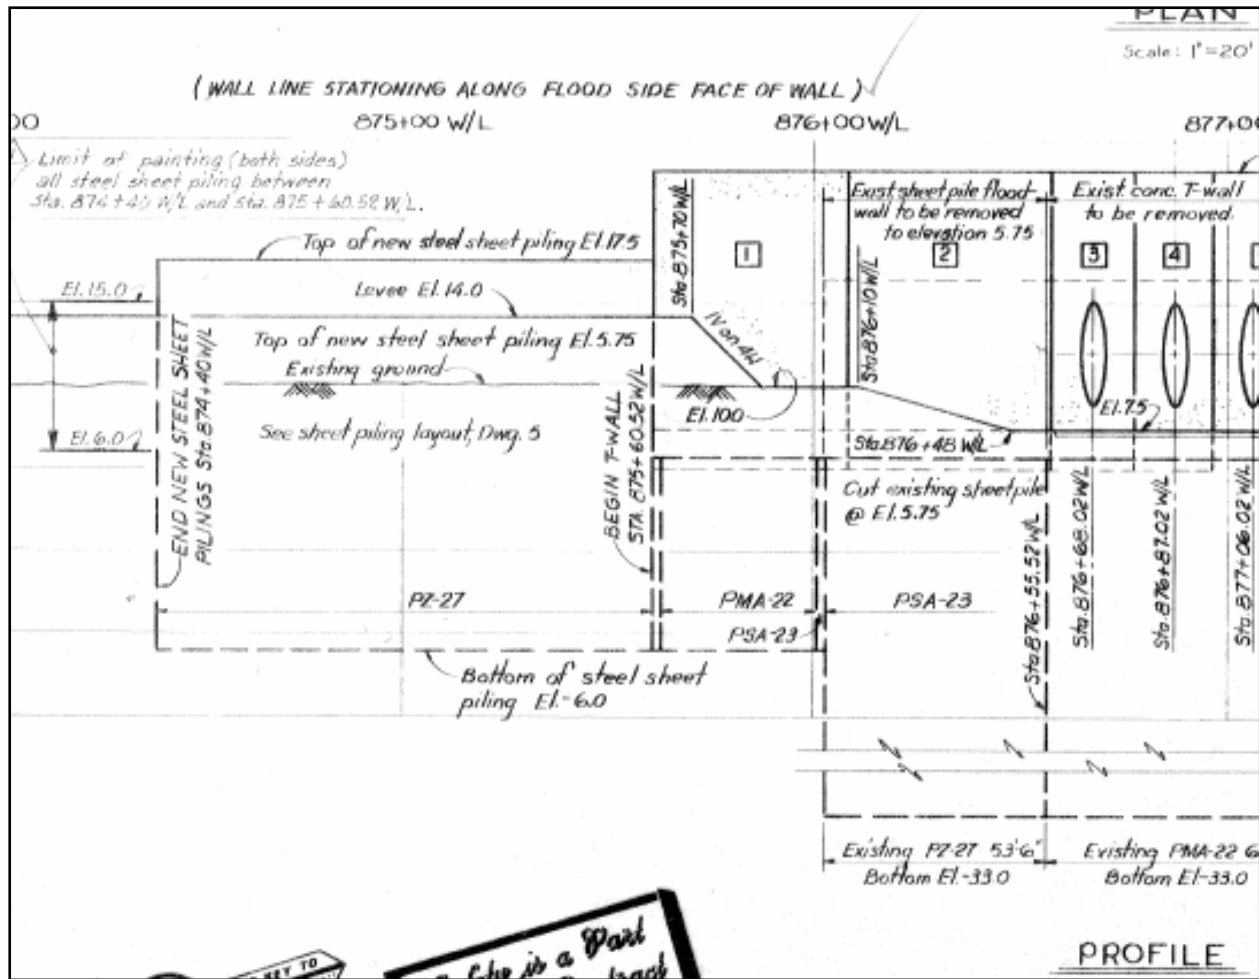
Figure 12-27. NOE2_G Profile View Showing 27' Difference Between Bottom Elevations of Existing (pre-1977) and Newer (1977 construction) Sheet Pile. Sections are from Plate 2 of 16, Mod P0001, Contract DACW29-77-C-0037

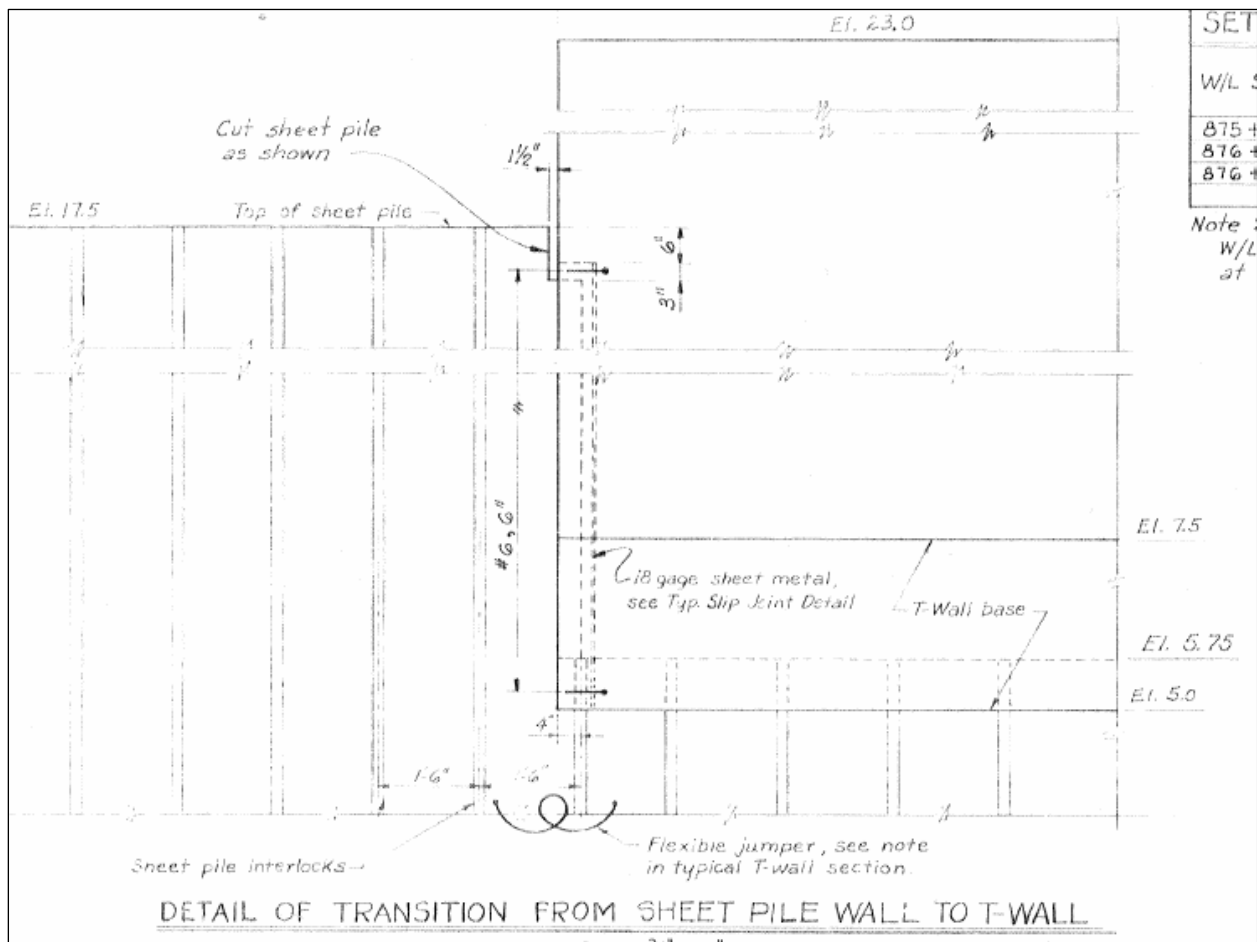
Figure 12-29. NOE2_I Top Elevation Difference of 5.5' Between Sheet Pile and T-Wall (plate 14 of 16 from above contract)

Figure 13-38. Pump Station 15 Top Elevation Difference of 5.5' Between Sheet Pile and T-Wall (plate 14 of 16 from Contract DACW29-77-C-0037, Mod P00001). If pre-Katrina sheetpile elevation was 17.5 ft and storm surge in the MRGO/GIWW was up to 18 ft, then there was minimal overtopping, and the sheetpile breach may have had contributing factors other than overtopping scour

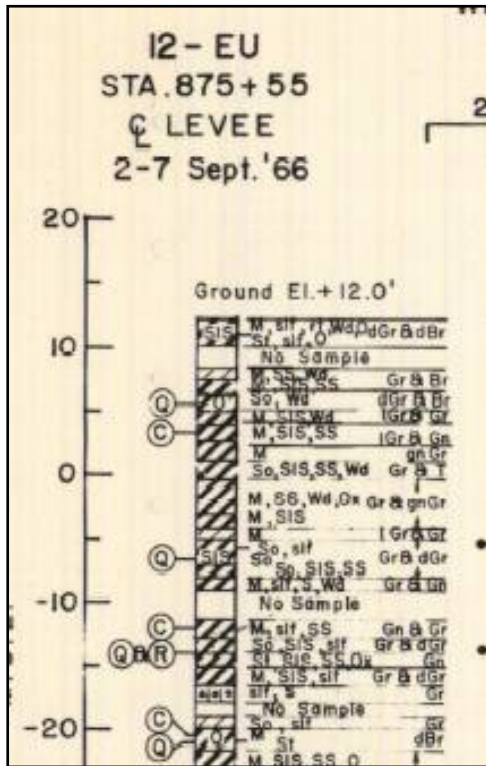
Figure 12-31. NOE2_K Nearest Boring Log (from plate 10 DM2 Sup 4) Showing Thin CL Layer in pre-1977 Levee

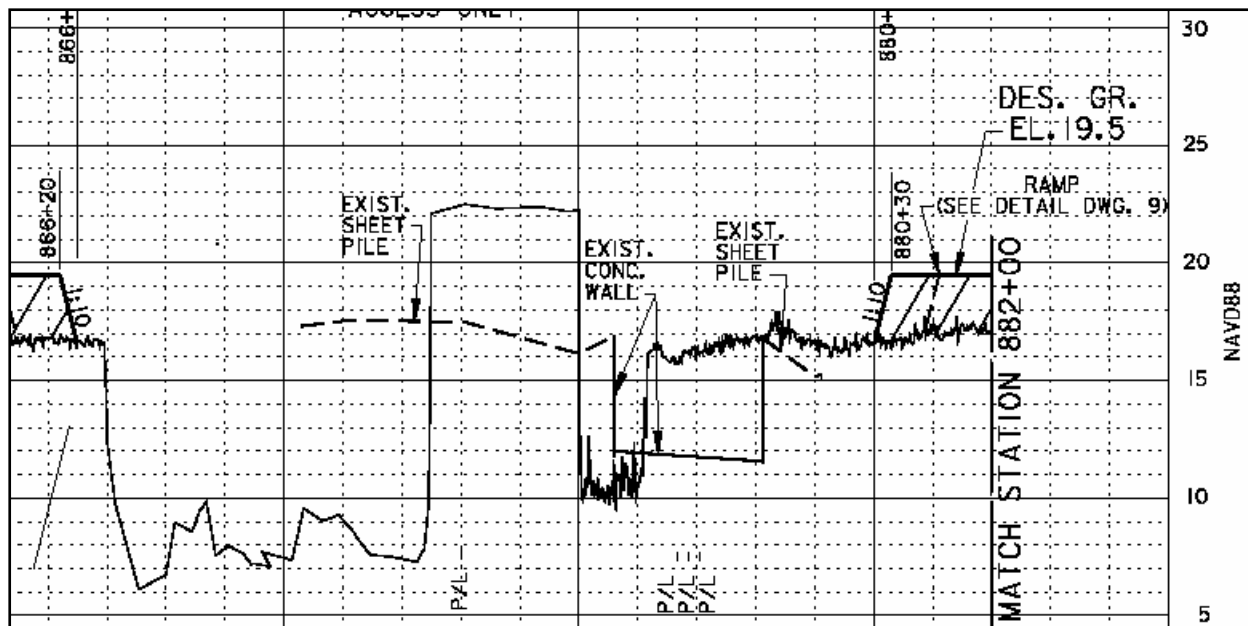
Figure 12-33. NOE2_M Plan and Post-Damage Scour Profile Immediately West of Pump Station 15 (from Contract Solicitation NOE1 drawing H-8-45594, sheet 3 of 16)

Project NOE02 includes removing the damaged steel sheet pile wall, installing a new concrete T-wall, filling in scour holes and bringing the damaged levee back up to pre-hurricane Katrina elevation. Damaged I-wall length is 900 ft (beginning at Sta 876+87 B/L). Approximately 240 ft of sheetpile failed by rotation. April 1, 2005 is scheduled completion date. (see NO East Back Levee Floodwall at Intracoastal Pumping Station.pdf for drawings). Plate 56 in DM2 Gen Design Supp 4 N.O. East Back Levee (Mar 1971).pdf shows original (pre-1977 modification) plan drawings.

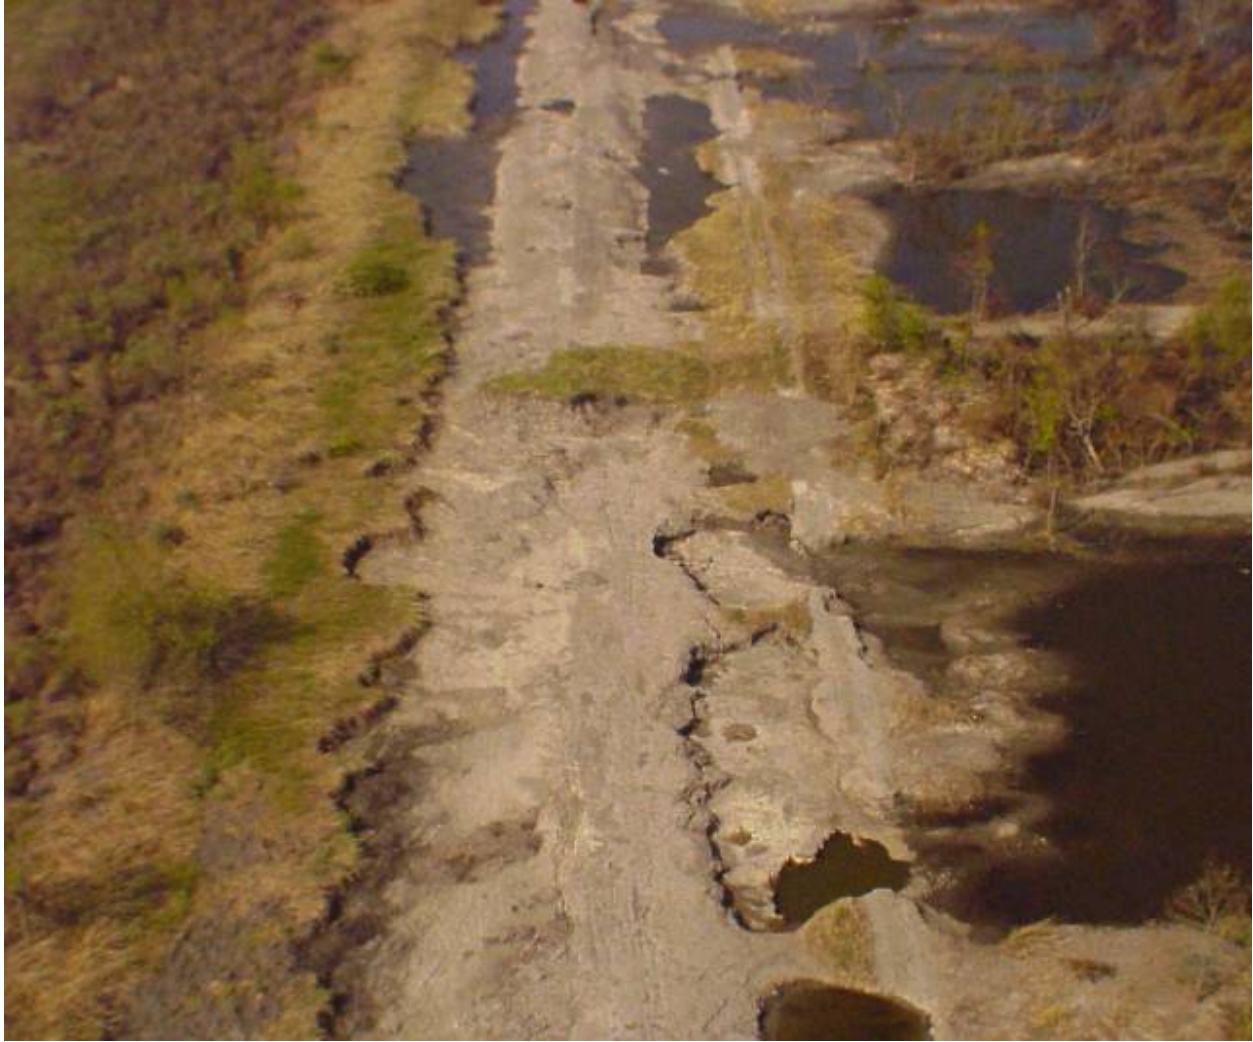
Project NOE01 consists of rebuilding approximately 4.3 miles of the existing levee back up to its constructed grade with 680,000 CY of earthen material, then seeding and fertilizing. There is 12,750 feet of levee east of Pump Station #15 that is completely degraded (Station 876+87 B/L to 1101+90 B/L). Plate 4 of DM2 Gen Design Supp 4 N.O. East Back Levee (Mar 1971).pdf shows the original soil borings and profile. The levees in the section 879+27 and 1006+59 were constructed from hydraulic fill in stages over three years (see plates 31 and 32).

Figure 12-36. NOE1_C Complete Breach East of Pump Station 15

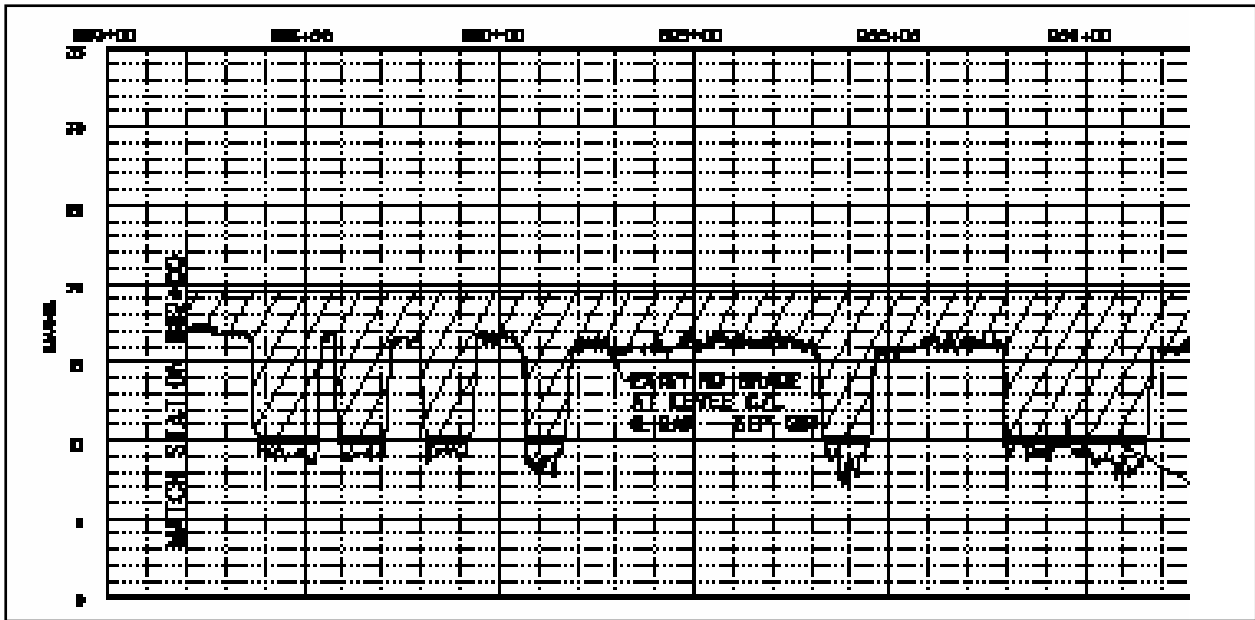
Figure 12-37. NOE1_D LIDAR Profiles of Levee East of Pump Sta 15 (from Contract Solicitation NOE1 drawings)

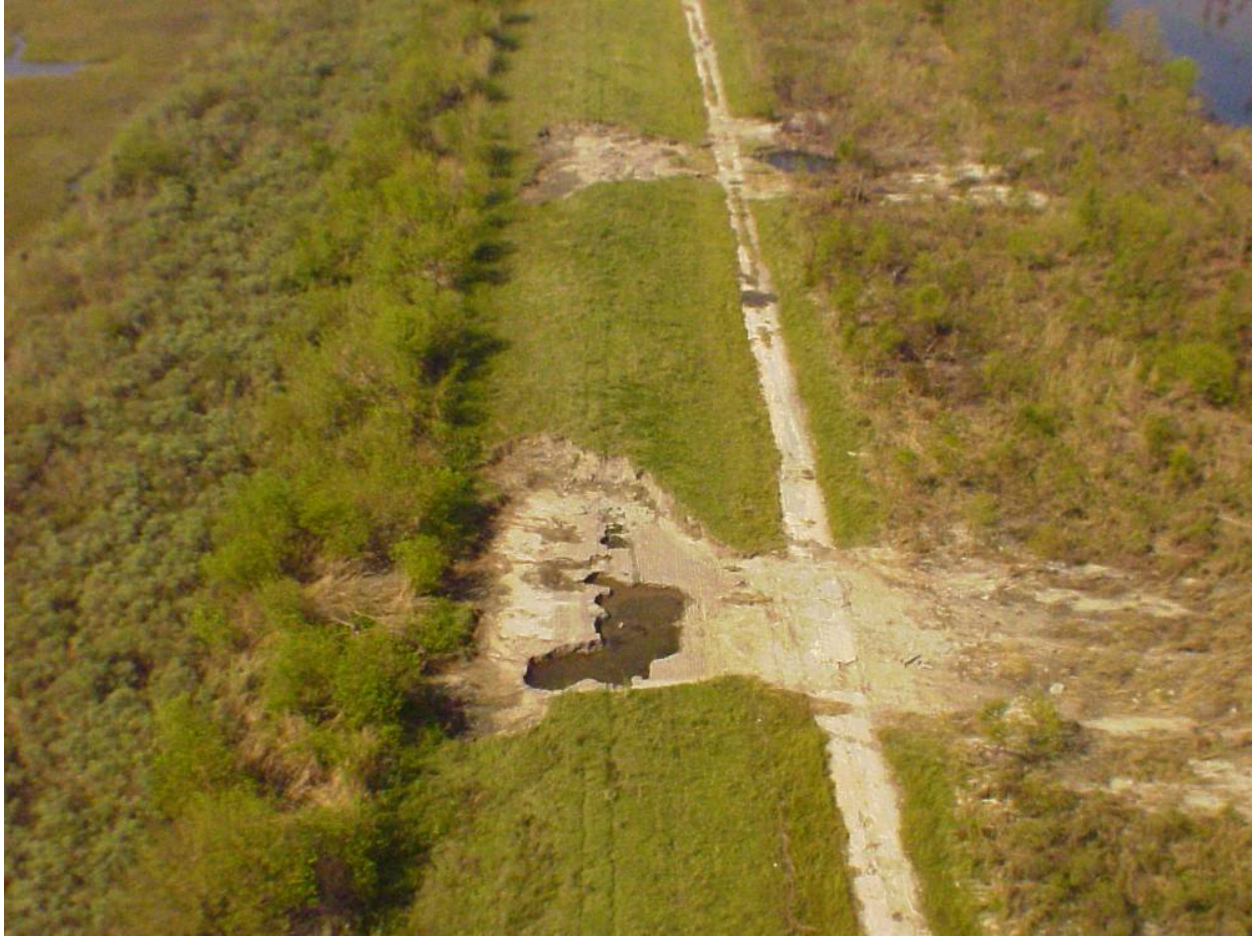
Figure 12-38. NOE1_E Partial Breach East of Pump Station 15

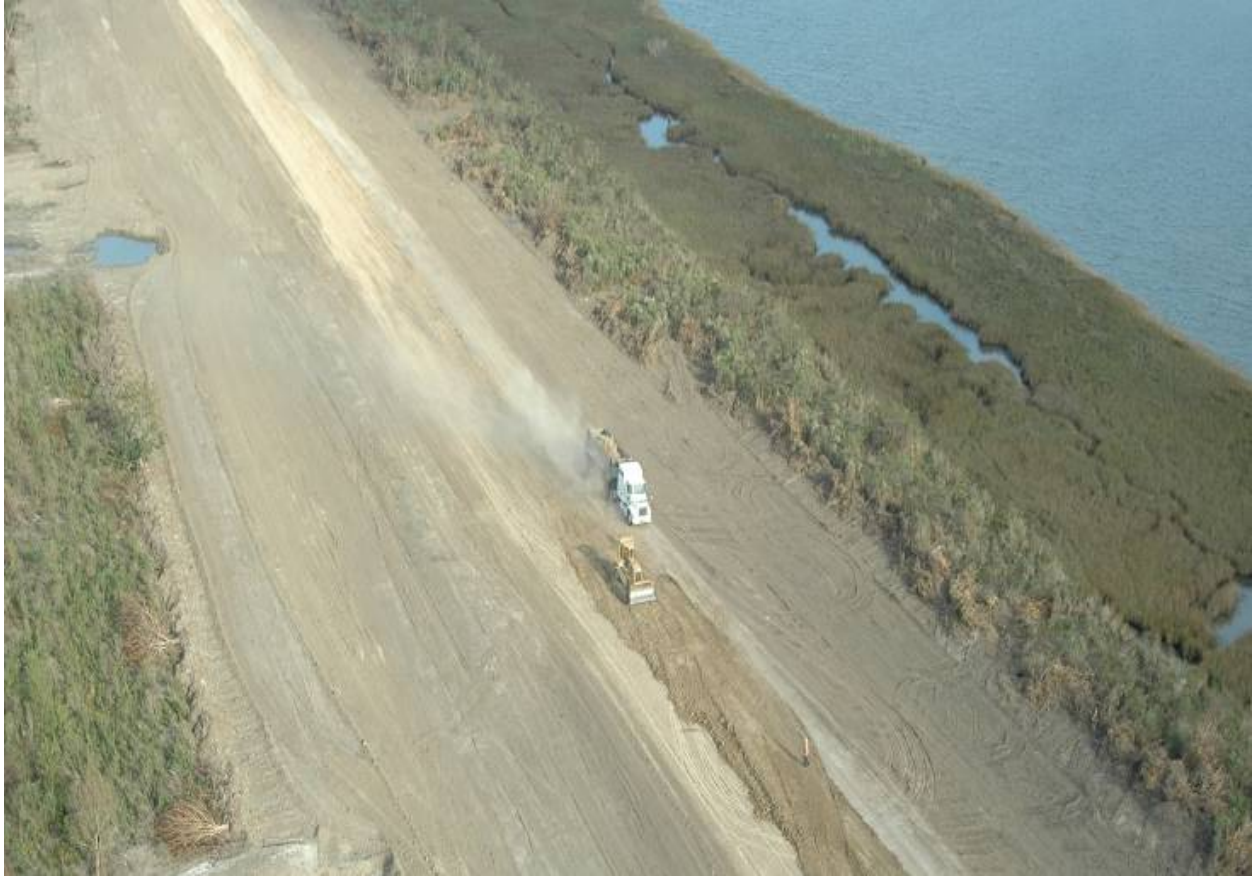
Figure 12-39. NOE1_F Rebuilding to Initial Elevation 10'

The remaining level of protection was EL 4.0. The entire reach of levee was brought up to an interim level of protection of elevation +10 by November 15, 2005. April 1, 2006 is scheduled completion date.

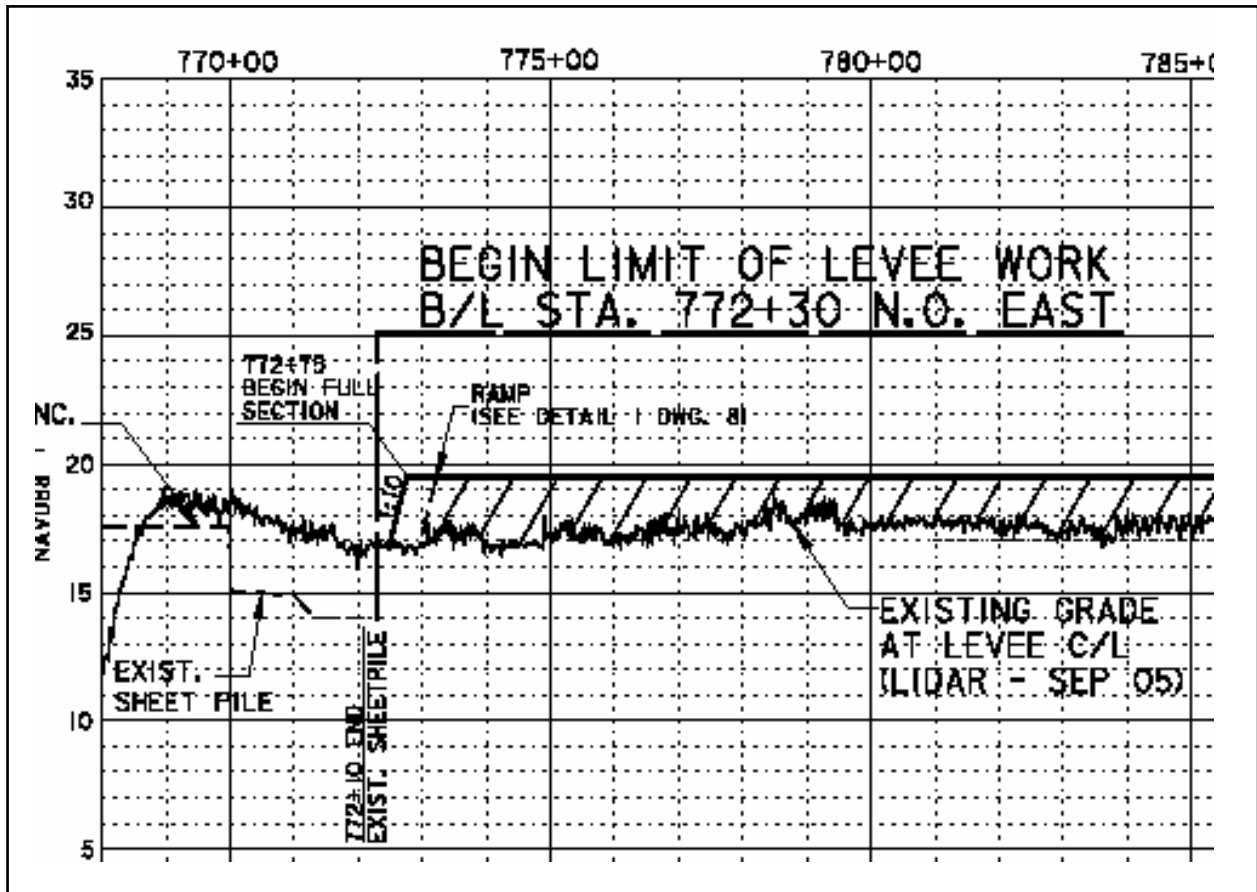
Figure 12-46. NOE3_F. Post-Damaged Lidar Elevations Show Scour Hole (approx Sta 768+00) Depth was About 8' deep (from Contract Solicitation NOE1 drawing H-8-45594, sheet 2 of 16)

Figure 13-32 shows the Air Products plant breach near Sta 772+00 B/L (New Orleans East Back Levee). Scour depths were 10 to 12 ft on both floodside and protected side of the sheetpile wall. Nearest borings (Figure 13-29) on either side of the failure, 5-E and 6-E (from plate 5, DM2 Supp 4, March 1971) shows CH material with sand / silt lenses in the pre-existing (1965) levee at crown elevation ~12 ft, prior to construction of the sheetpile wall. The storm surge in the GIWW was approximate elevation 15 to 17 ft, and Figures 13-3 and 13-4 show the estimated impact velocity ranged up to about 23 ft/sec and impact force ranged up to about 700 lb/ft. Note that the breach occurred in the sheetpile reach, not along the adjacent transitions to earthen levee on the east side and connection to the T-wall on the west side.

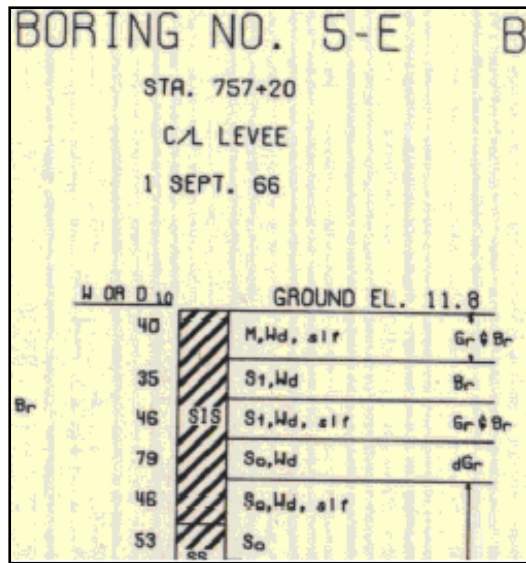
Figure 12-48. NOE3_H. Boring 5-E from plate 5, DM2 Supp 4 (March 1971) Shows CH Material in Pre-Existing 1965 Levee

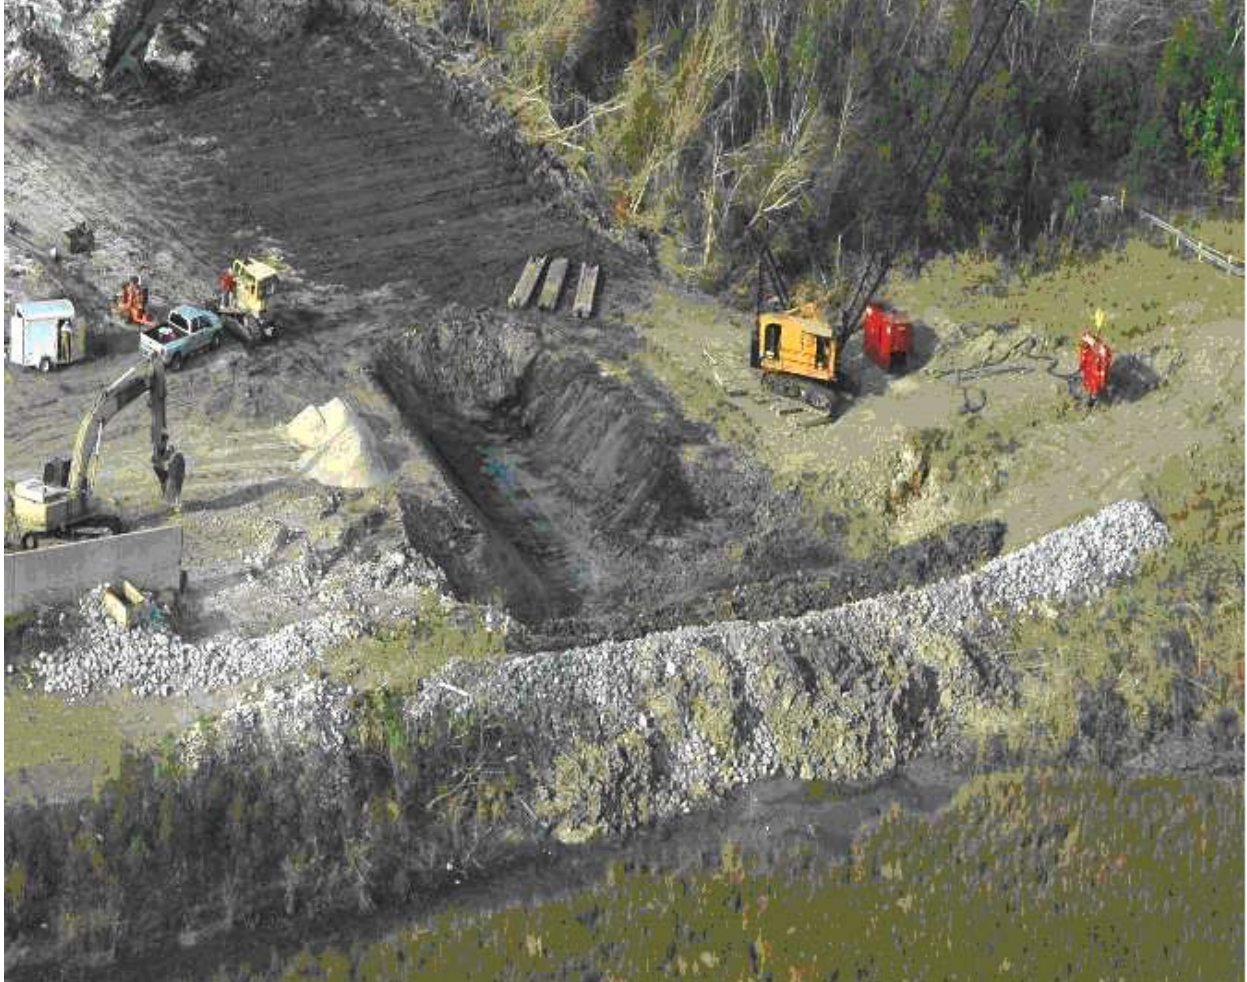
Figure 12-49. NOE3_I. Repair Progress

Project NOE03 includes removing the damaged concrete I-wall and steel sheet pile wall, filling in scour holes, installing a new concrete I-Wall, and raising the damaged levee to pre-hurricane Katrina elevation and then seeding and fertilizing. The damaged reach was first brought up to an interim level of protection of elevation +10 by November 15, 2005 before final repairs are made. Breach length was 300' at transition between sheet pile and concrete I-wall. April 1, 2006 is scheduled completion date.

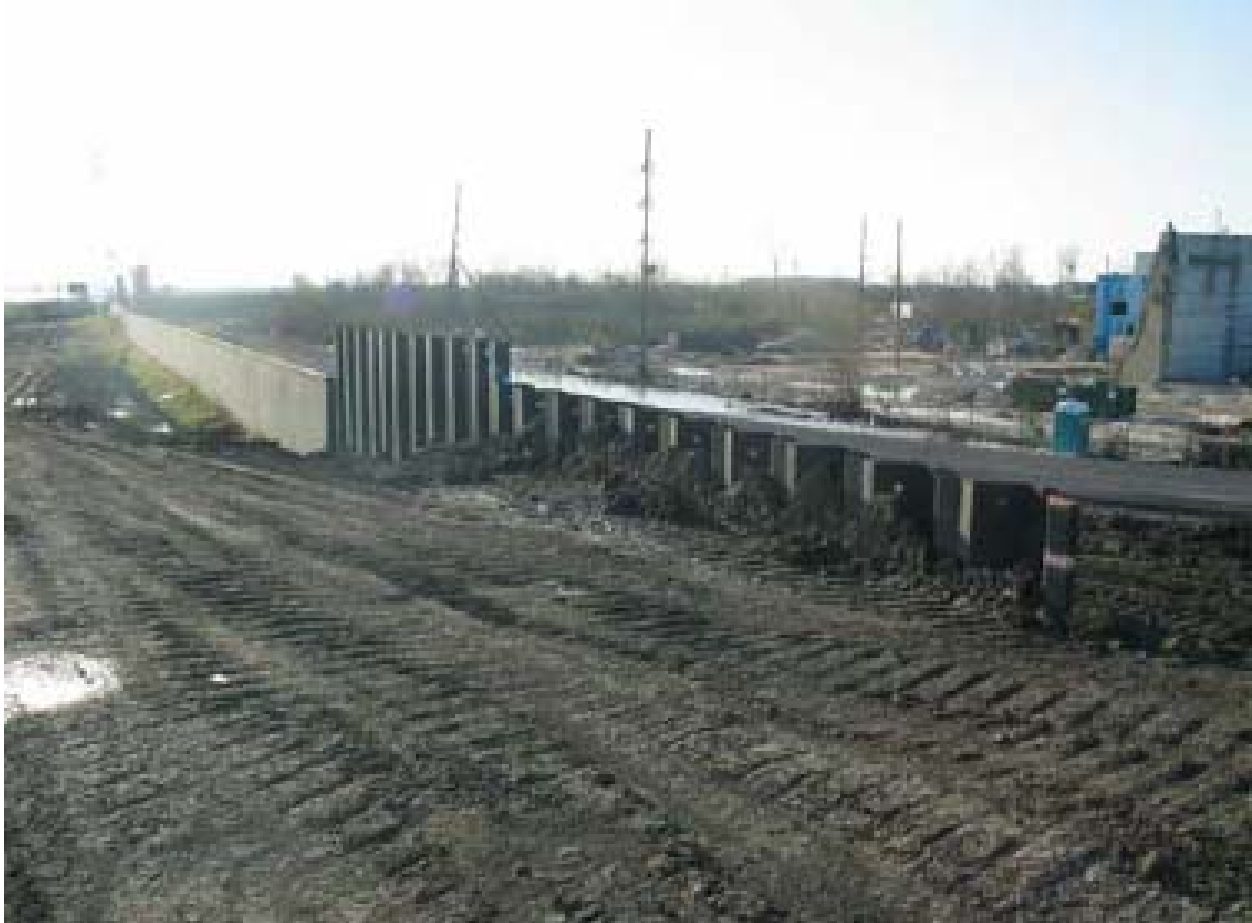
Figure 12-50. NOE3_J. Repair Sheetpile View to the West

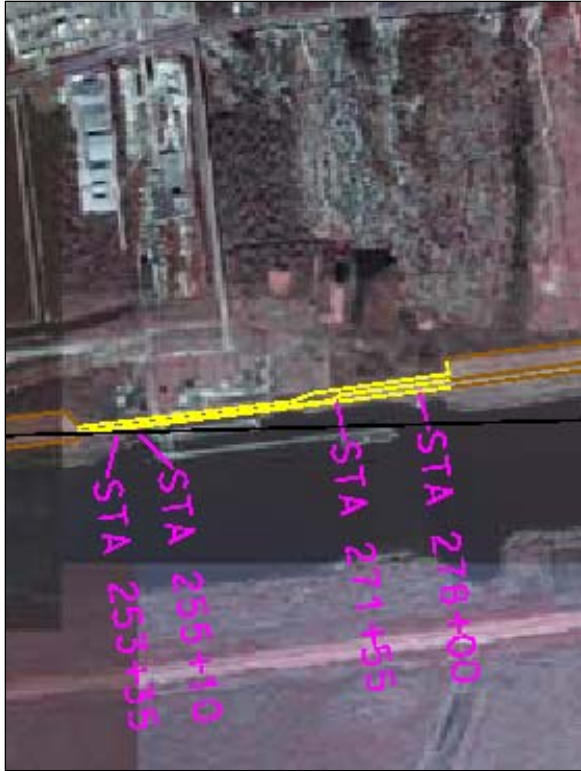
Project NOE04 includes removing the damaged concrete I-wall sections, filling in the scour holes, regrading the damaged levee, constructing new concrete wall, and putting in an earthen stability berm on the landside of the wall. The most severe damage in this reach is a 2000 ft. section of I-wall that failed by rotation, with attendant erosion and scouring. The extend of material below the water surface that has been removed by the scouring is unknown. Localized scouring occurred at several locations along this reach. The total quantity of material removed by scouring within this reach is estimated at 150,000 cys.

Figure 12-56. NOE4_C. Begin I-Wall Rotation at 30 deg 00 min 00.91 sec N, 89 deg 59 min 39.53 sec W.
Pre-Existing Wall Elevation was 15 ft and Levee Elevation was 14 ft

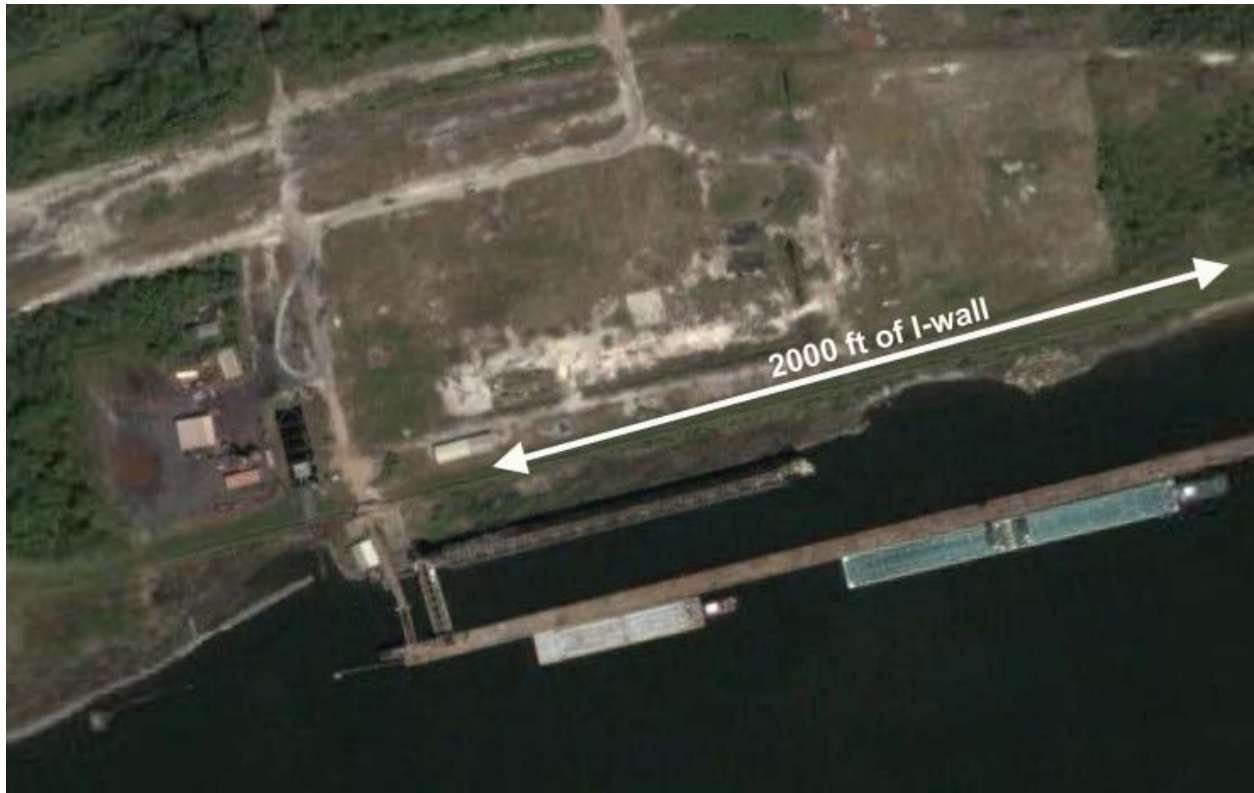
Figure 12-57. NOE4_D. Bulk Loading Facility on the GIWW. Note Tool Shed Metal Building Location

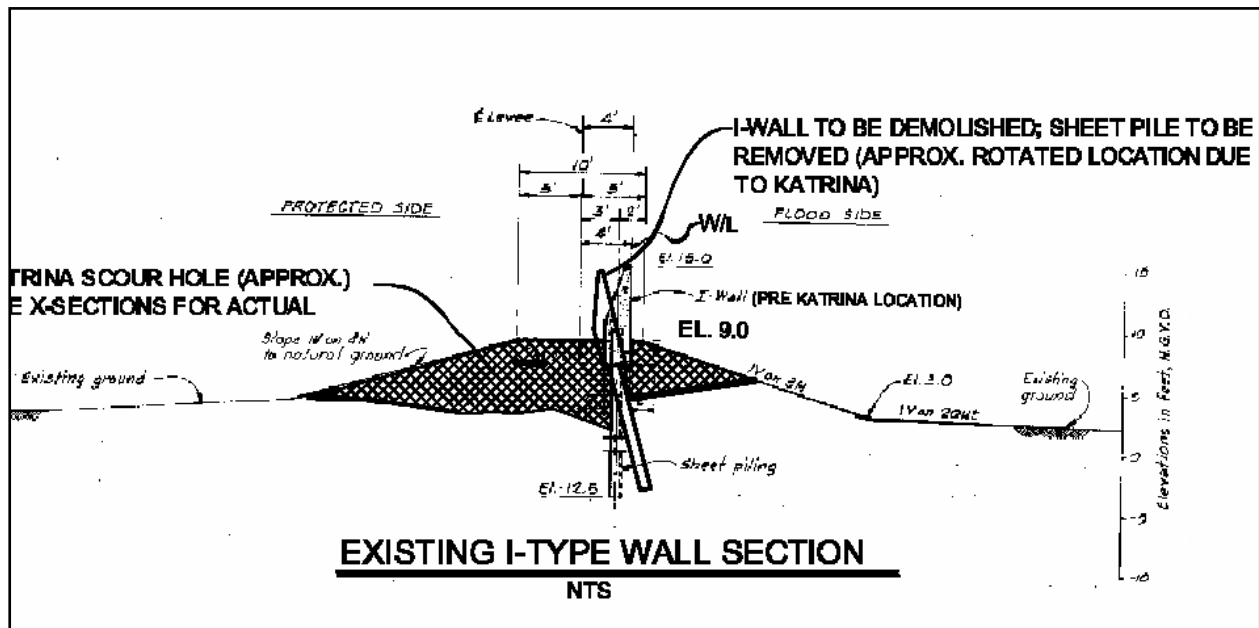
Figure 12-58. NOE4_E. Post-Katrina Condition

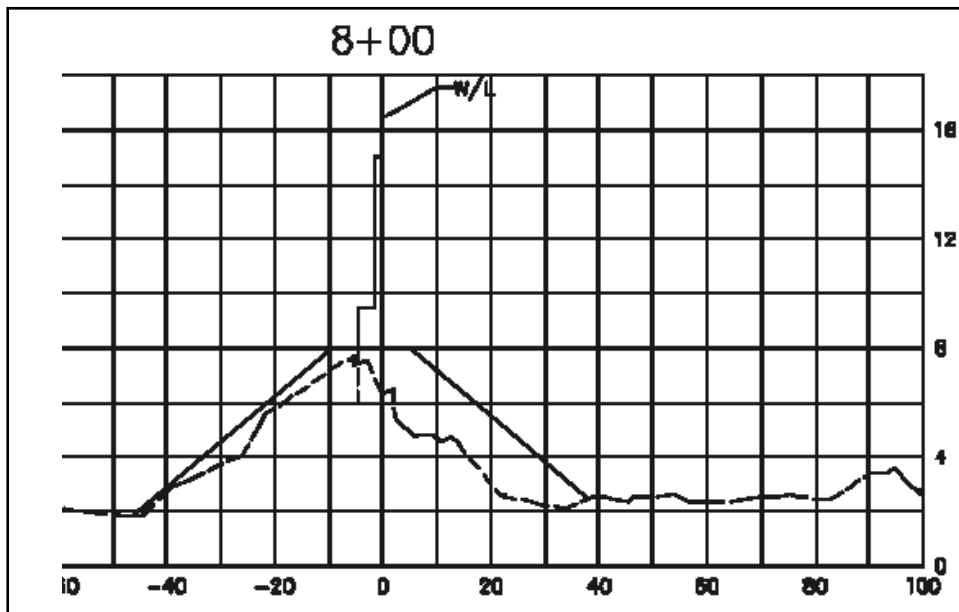
Figure 12-60. NOE4_G. Scour Pattern Along the I-Wall Immediately Adjacent to the Tool Shed Building

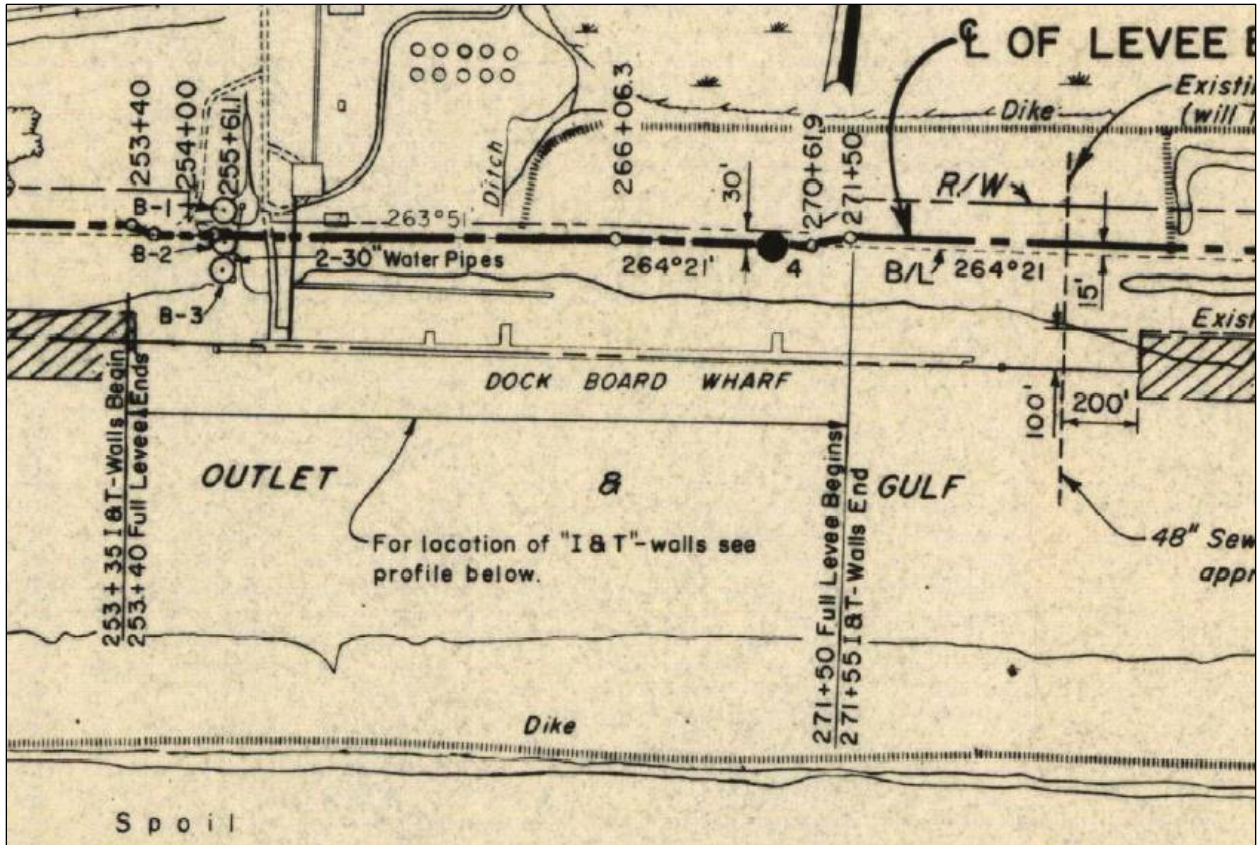
Figure 12-64. NOE4_K. Plate 2, Sta 250+ to Sta 279+

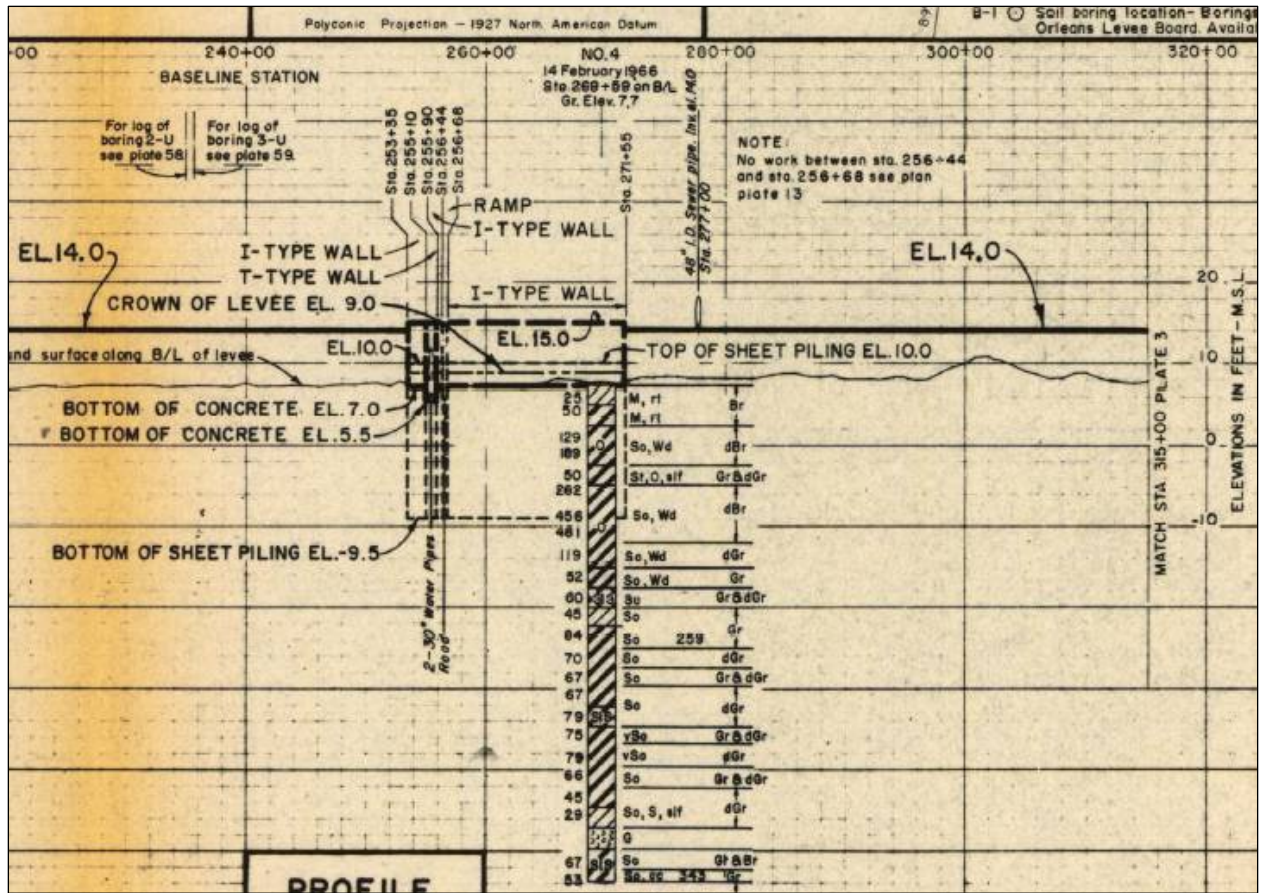
Figure 12-65. NOE4_L. Nearby Boring 4 Shows Top Layer of CL (from Plate 2 profile section)
