Appendix 11

Analysis of Performance of the Inner Harbor Navigation Canal

Executive Summary

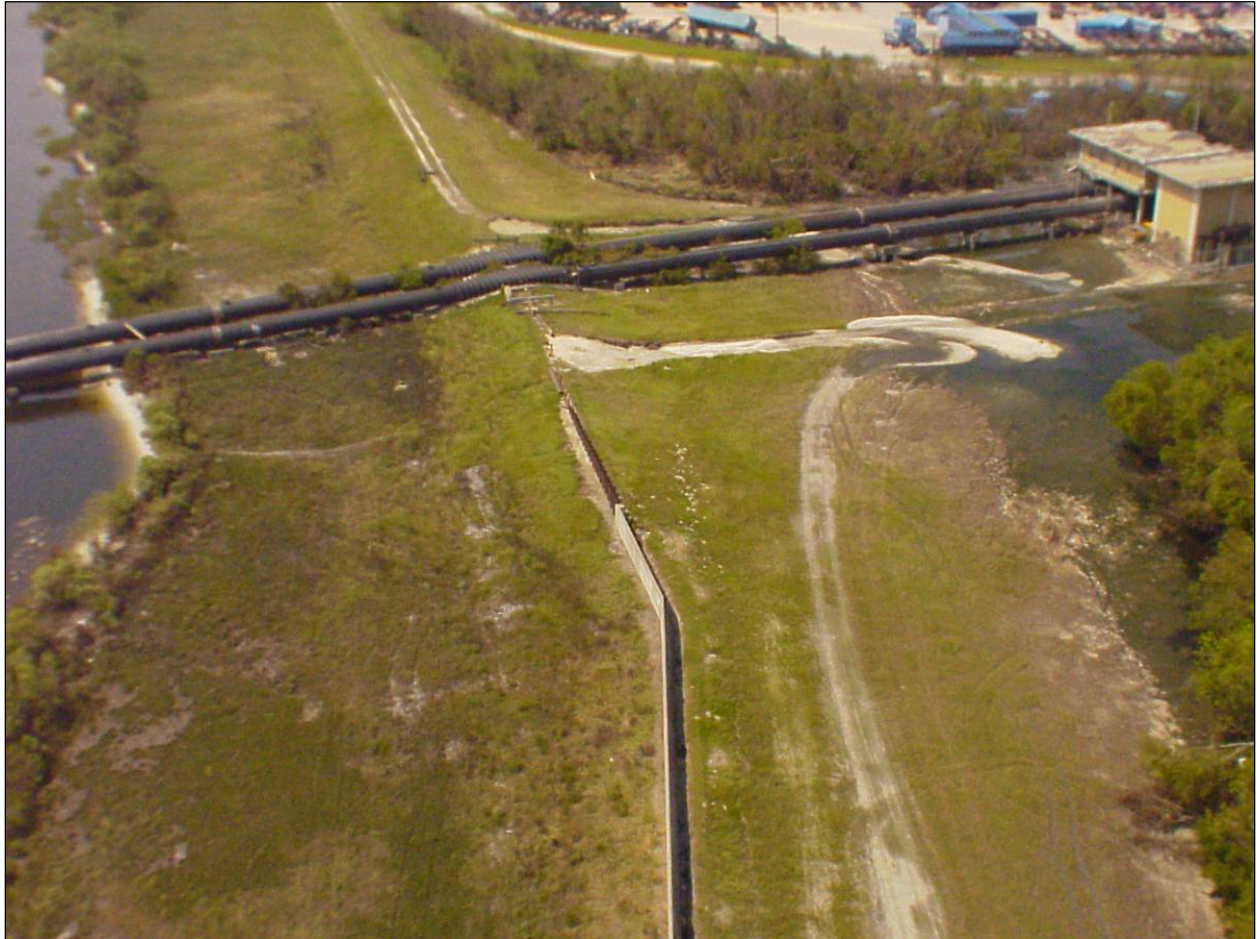
Figure 12-70. NOEX_Q. Amid Pump Station Landside Slope Erosion from Overtopping at Transition

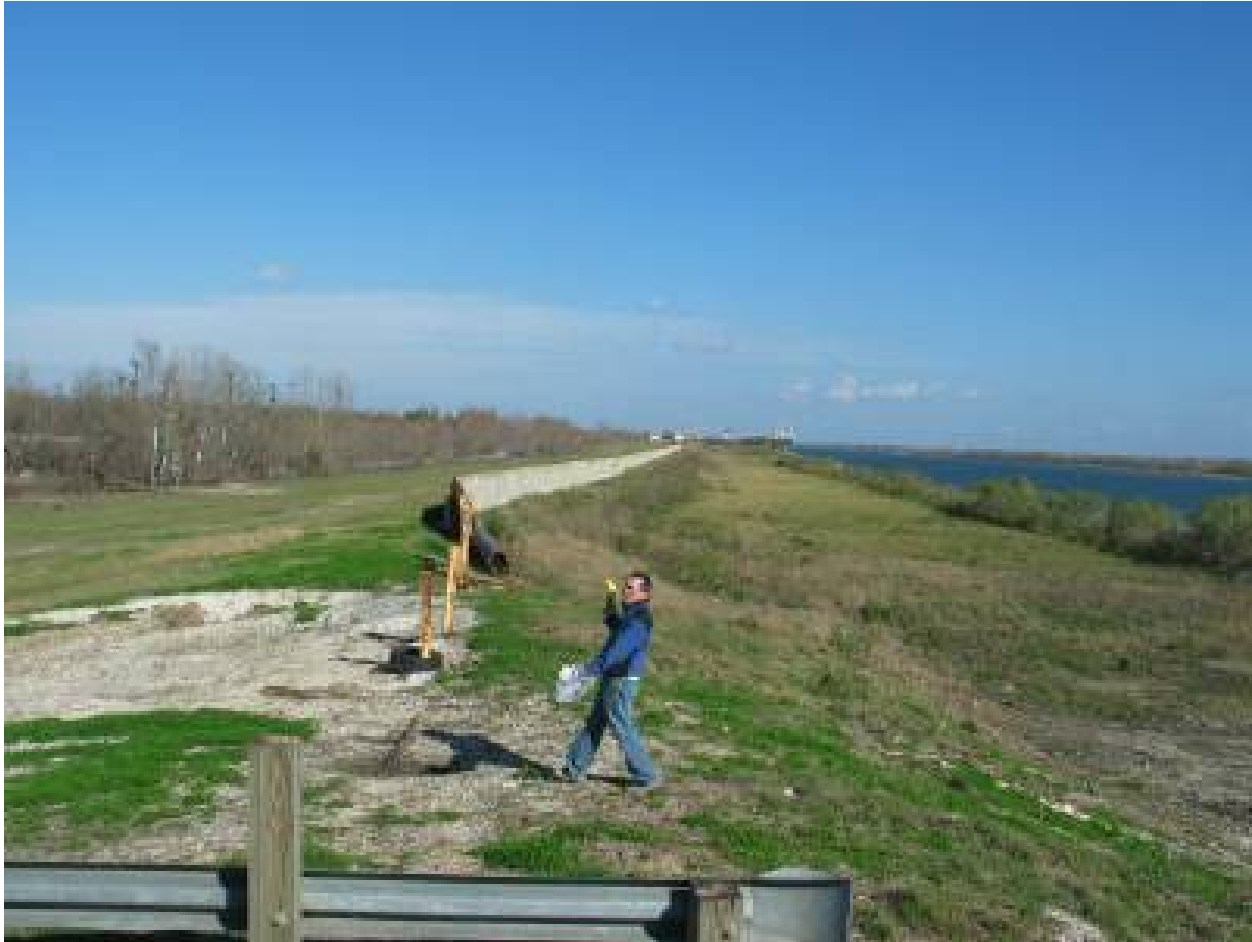
Figure 12-73. NOEX_T. Closeup of Scoured Road at Levee Crown, Amid Pump Station

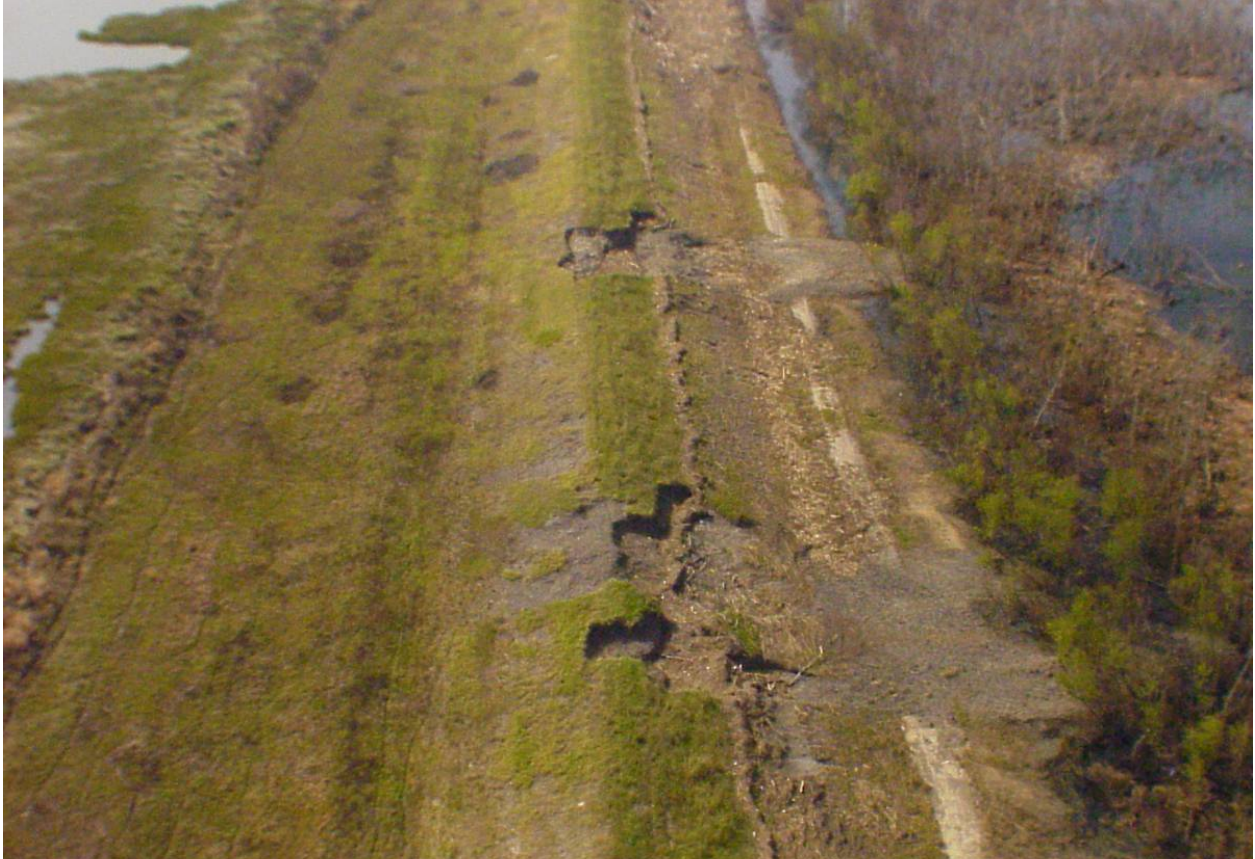
Figure 12-74. NOEX_U. Overtopping Erosion on Flood Side and Land Side

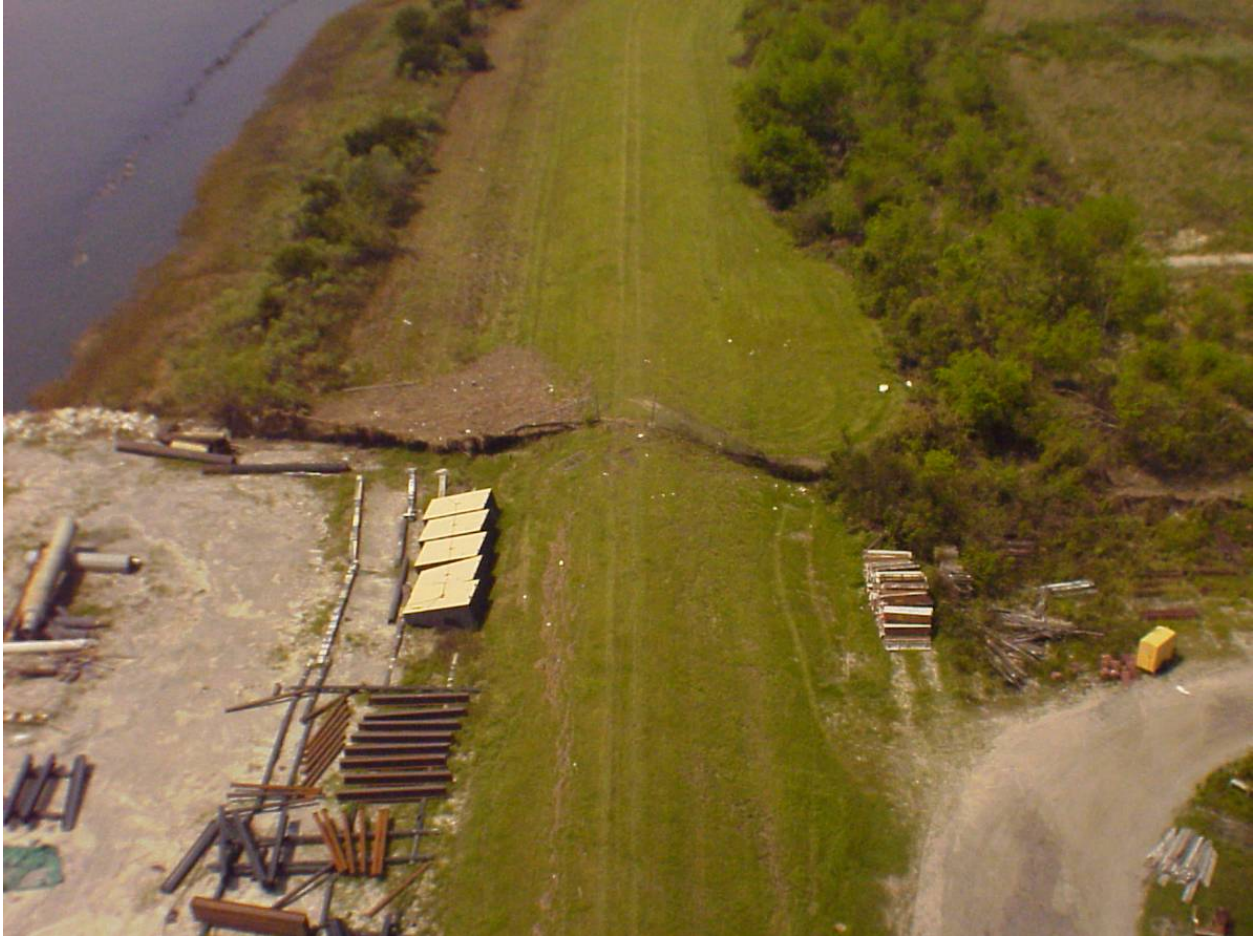
Figure 12-75. NOEX_V. Narrow Localized Breach at Pre-Existing Pipeline Crossing. Coords
30 deg 00 min 10.66 sec N, 89 deg 57 min 49.31 sec W (Approximate Sta 349+00 B/L)

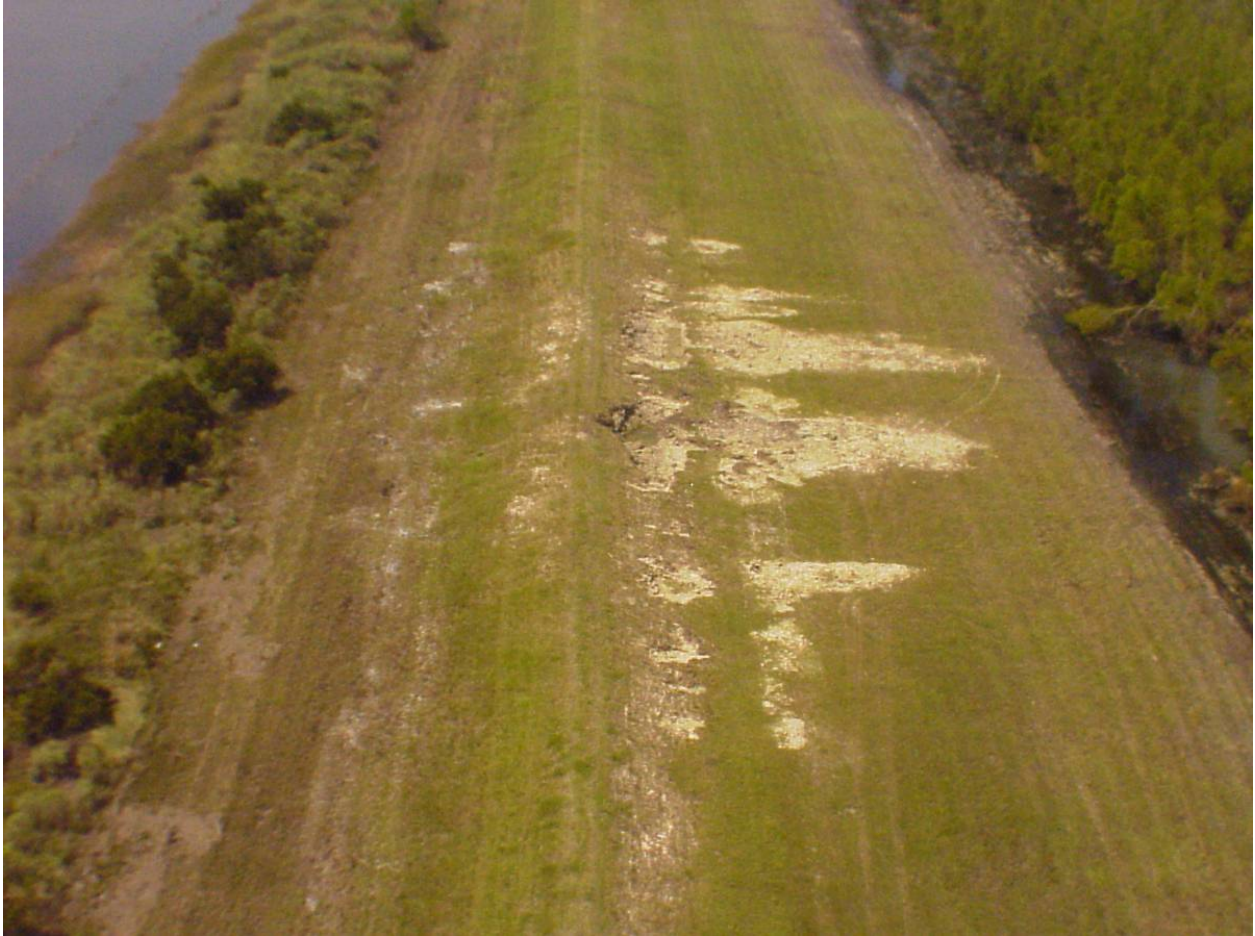
Figure 12-76. NOEX_W. 600' Reach of Levee with Landside Scouring

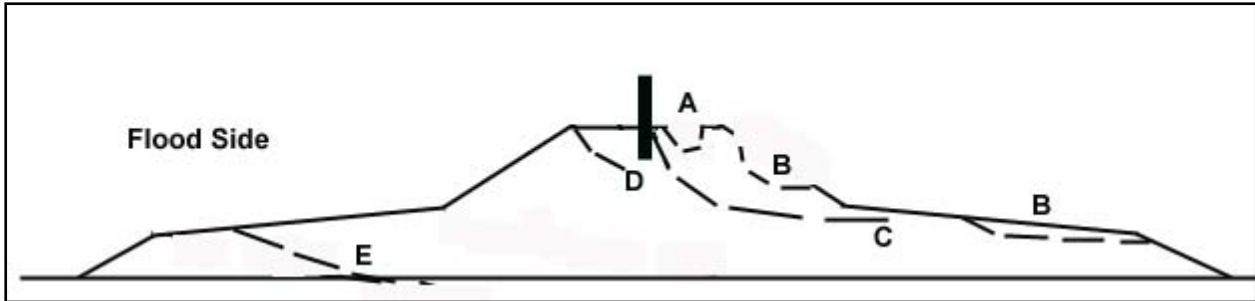
Figure 13-1. Erosion Progression Patterns for Earthen Levees, Floodwalls, and Exposed Sheetpile

Scour pattern “A” indicates scour located on the protected side levee slope (or located immediately adjacent to the floodwall or sheetpile protected side), “B” indicates erosion on the protected slopes including stabilizing transition slopes, “C” indicates erosion progressing to the levee crown and adjacent to the floodwall or sheetpile protected side, “D” indicates scour on both the flood side and the protected side of the levee or floodwall, and “E” indicates the original levee footprint has been significantly altered due to erosion and the original foundation base may have scour holes or washouts.

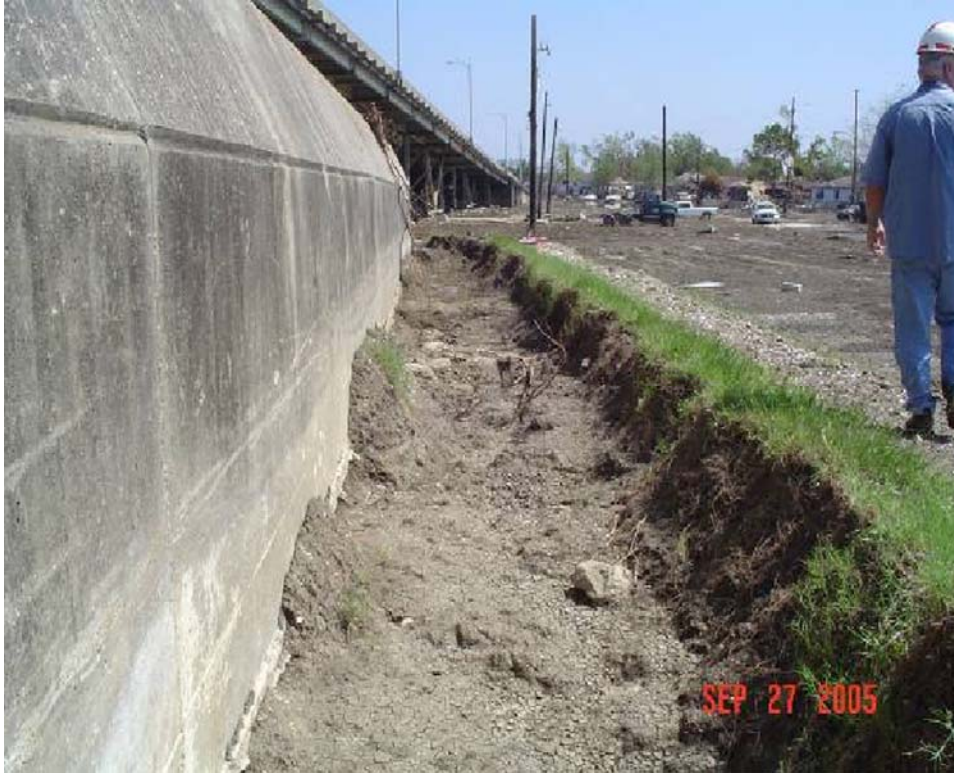
Figure 13-5 shows the I-wall along the east side of the IHNC at approximate B/L Sta 11+00 (DM3 Chalmette Area Plan), looking toward the Claiborne Avenue bridge. Depth of scour was to the bottom of the I-wall concrete cap (2 ft), and scour width was approximately 7 ft. The I-wall elevation was designed to height of 15 ft above mean sea level, the bottom of the concrete cap was elevation 7 ft, and the levee crown was elevation 9 ft. Actual wall height was reported to be 12.5 ft converted to local mean sea level, and the storm surge height was reported to be up to 15 ft. As an approximation of the overtopping water impact, a 2.5 ft crest of water cascaded from a 6-ft height onto the levee crown. Figures 13-3 and 13-4 show the estimated impact velocity was about 23 ft/sec and impact force was about 700 lb/ft. The water impact removed a portion of the levee crown, including all of the structural backfill zone adjacent to the concrete wall.

Figure 13-5. Scour Pattern "A" on East Side IHNC near N. Claiborne Ave. Bridge

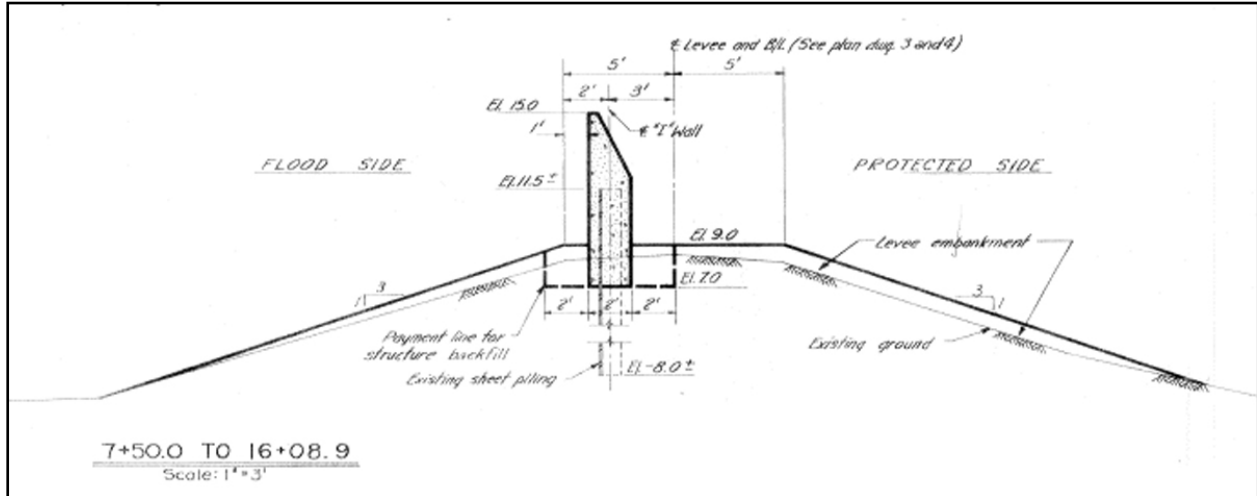
Figure 13-6. Existing Levee and I-Wall Drawing for IHNC East. Note that scoured soil included the "structure backfill" zone (from drawing file H-4-25157, IHNC East Levee from Lock to Florida Ave. Floodwall, sheet 12 of 15)

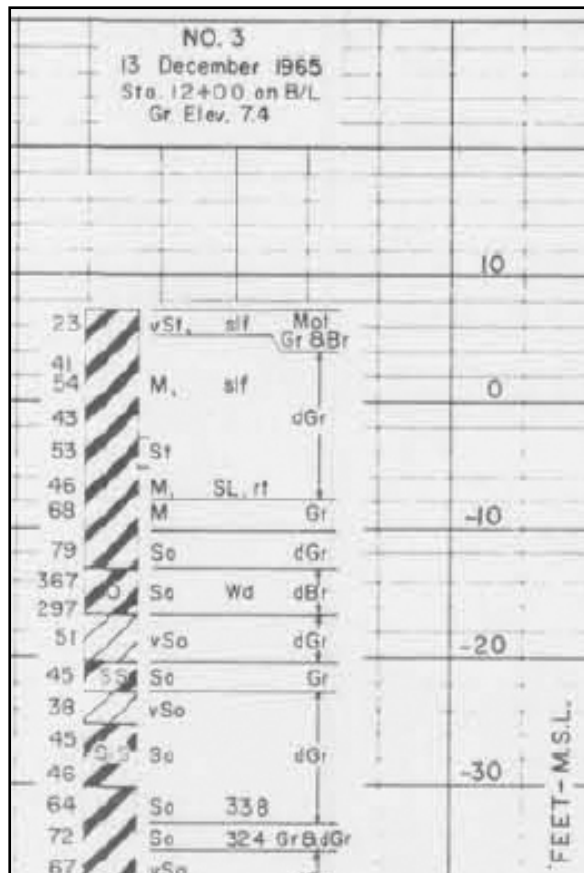
Figure 13-7. Nearest Soil Boring, No. 3, 100 ft Distant, Shows Fat Clay (CH) at Center Line Surface

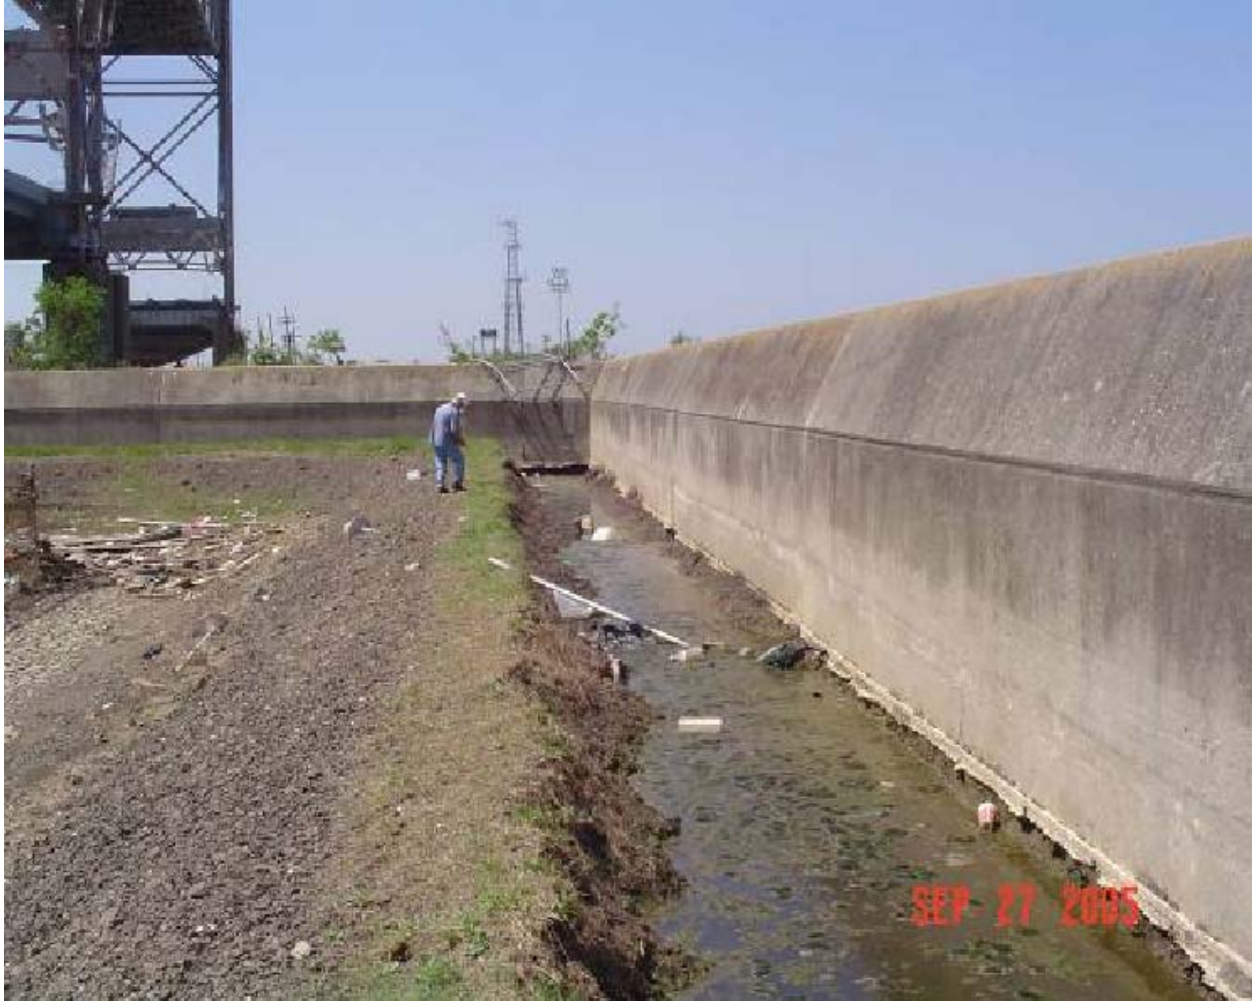
Figure 13-8. IHNC East, Approximate B/L Sta 7+00 (DM3 Chalmette Area Plan), North of the Claiborne Avenue Bridge. Depth of scour was to the bottom of the I-wall concrete cap. I-wall elevation was designed 15 ft above mean sea level (MSL), bottom of concrete was elevation 7 ft (MSL), and levee crown was elevation 9 ft (MSL). Actual wall height was reported to be 12.5 ft converted to local mean sea level (LMSL), and storm surge height was reported to be up to 15 ft. As an approximation of the overtopping water impact, a 2.5 ft crest of water cascaded from a 6-ft height onto the levee crown. Nearby soil boring 2U (Figure 13-9) indicates the upper 5 ft was fat clay (CH) with sand / silt lenses

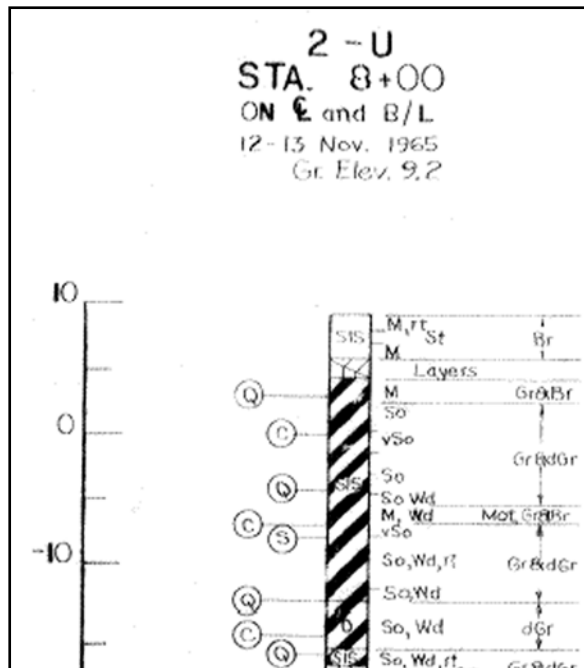
Figure 13-9. Undisturbed Boring 2U Located 100 ft to the North Shows Silt / Sand Lenses in Lean Clay in the Upper 5 ft. Undrained shear strength in the upper 3.2 ft was approximately 500 psf

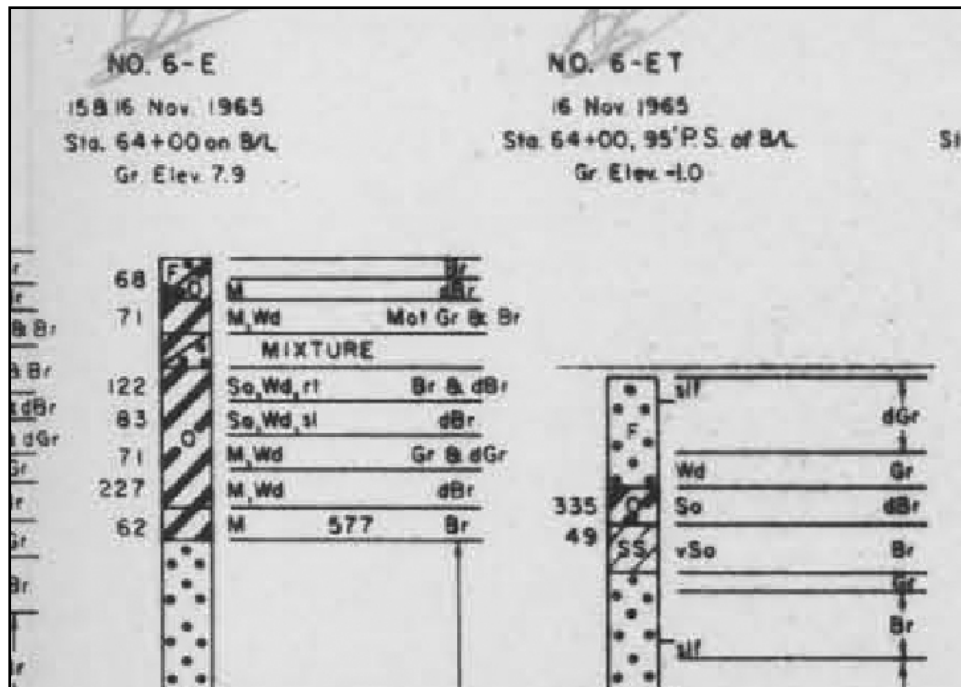
Figure 13-11. Nearest Soil Boring 6-E Shows Built-Up Levee at Elevation 7.9 ft (MSL), but Boring 6-ET, Offset 95 ft to the Protected Side of the B/L, Shows Original Ground Surface Elevation -1.0 ft (MSL) was Approximately a 10-ft Layer of Sandy Material (from drawing file H-2-24111, plate IV-34). The vertical and horizontal scour pattern indicates that the T-wall base structural backfill had lower erosion resistance than the original levee soil

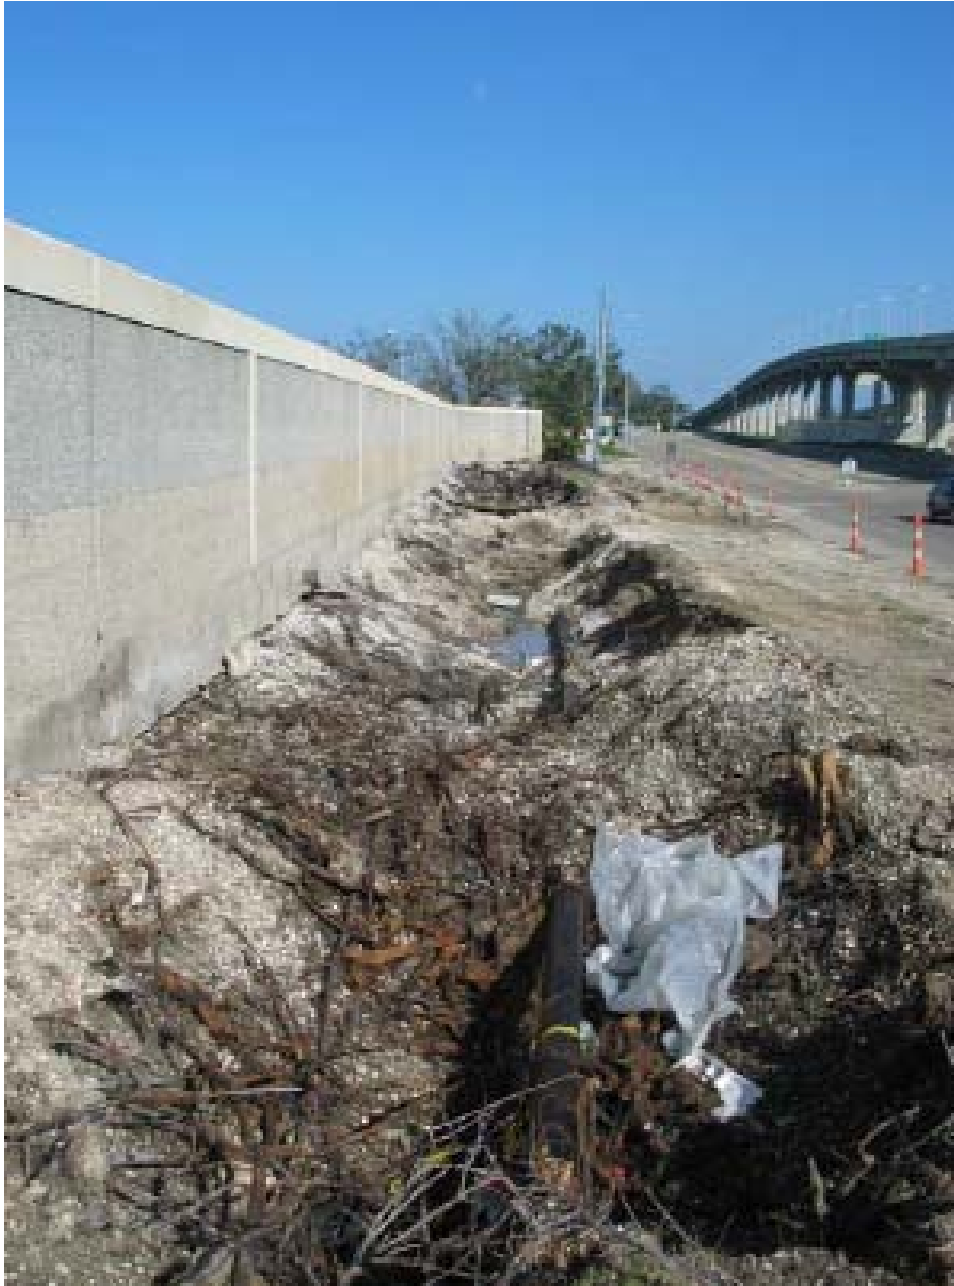
Figure 13-12. Scour Along Lakefront Airport Floodwall Measures 305' (L) x 14' (w) x 48" (d). Existing levee crown appears to be composed of sandy material, based on visual observation. Nearby soil boring 1-C (5/29/1969) at Sta. 8+85, 57 ft right of B/L shows sand, silt, and lean clay lenses to 9-ft depth. Soil boring 4-A (11/3/1970) at Sta 18+00, 200 ft landside of B/L also shows sand, silt, and lean clay lenses to 9-ft depth

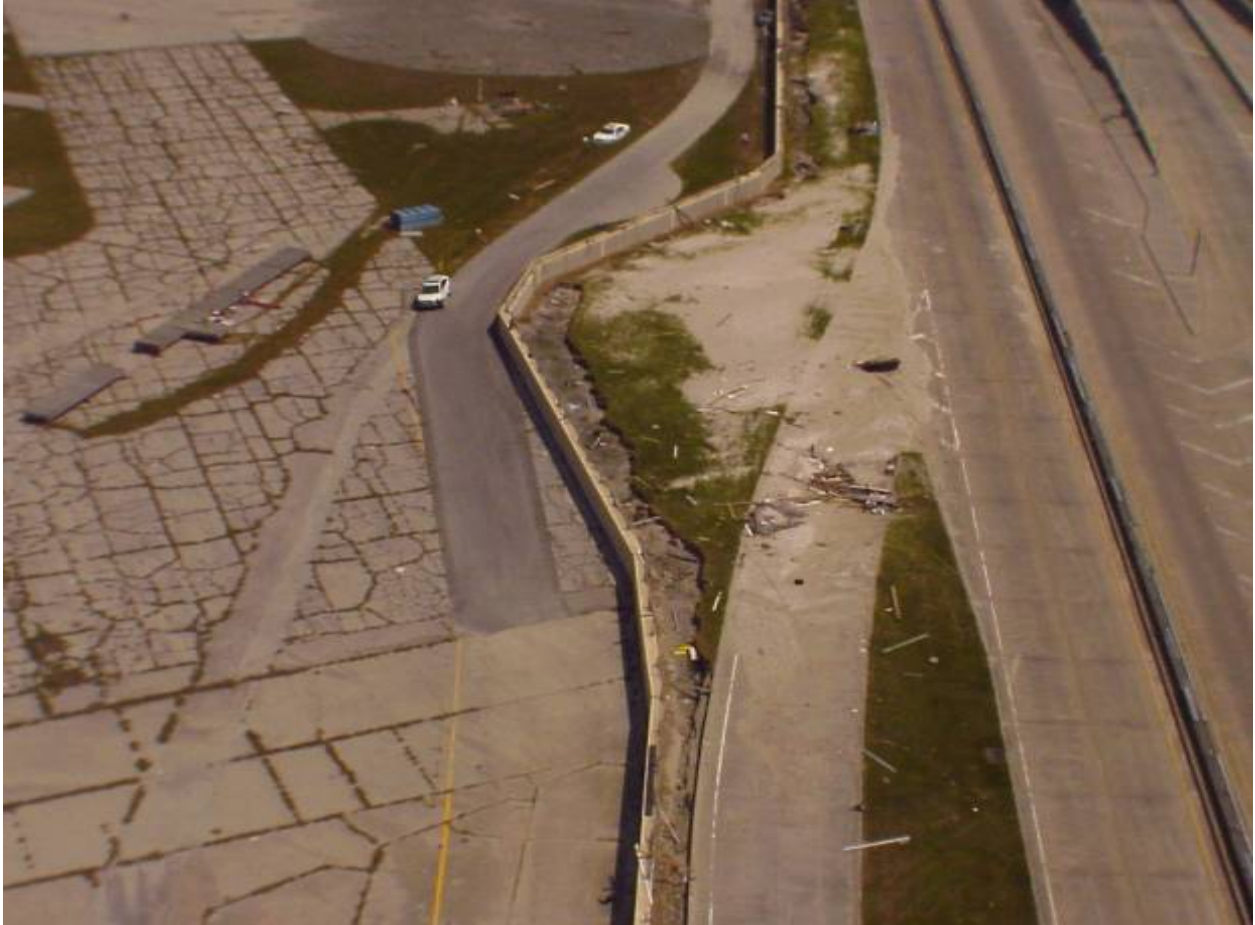
Figure 13-13. Lakefront Airport Floodwall. Scour is approximately 11 ft wide by 2 ft deep. Floodwall elevation is approximately 13.5 ft, ground elevation is approximately 6 ft, and wall height is approximately 7.5 ft

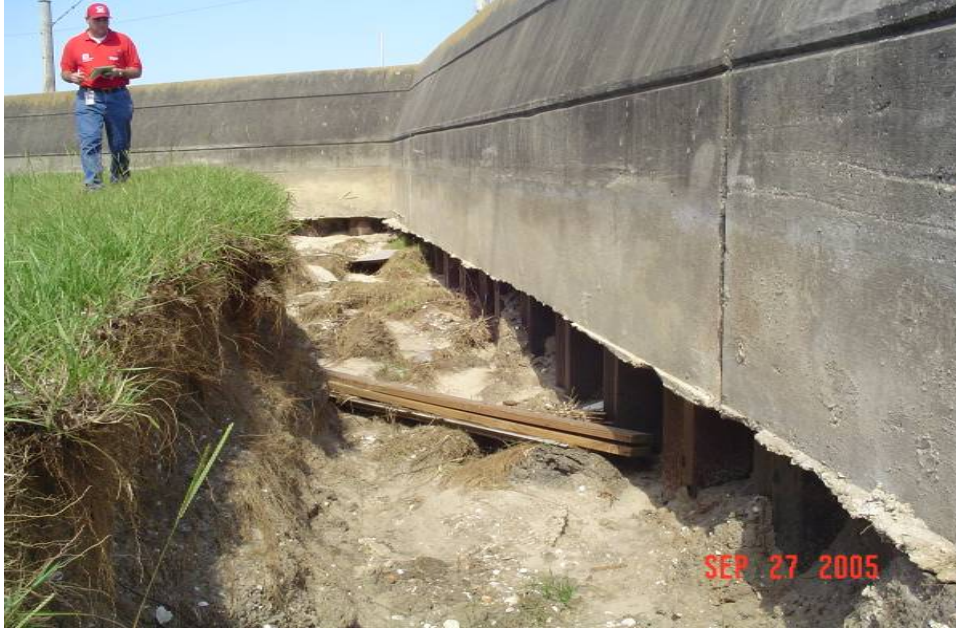
Figure 13-14. IHNC East, Approximate B/L Sta 101+00 (from drawing file H-2-24111, plate IV-23, DM2 Supp 8 IHNC Remaining Levees), North of Chef Menteur Hwy Bridge. Top of I-wall is elev 14.75, bottom of concrete is elev 7, and levee crown is elev 9. Nearest B/L boring is Sta 96+00 (No. 9EU), 500 feet distant. Approximate storm surge impact was a 2.5-ft water crest cascading over the 6-ft concrete wall. Note that the scour was deeper than the concrete base, indicating that the structural backfill and the original levee material eroded

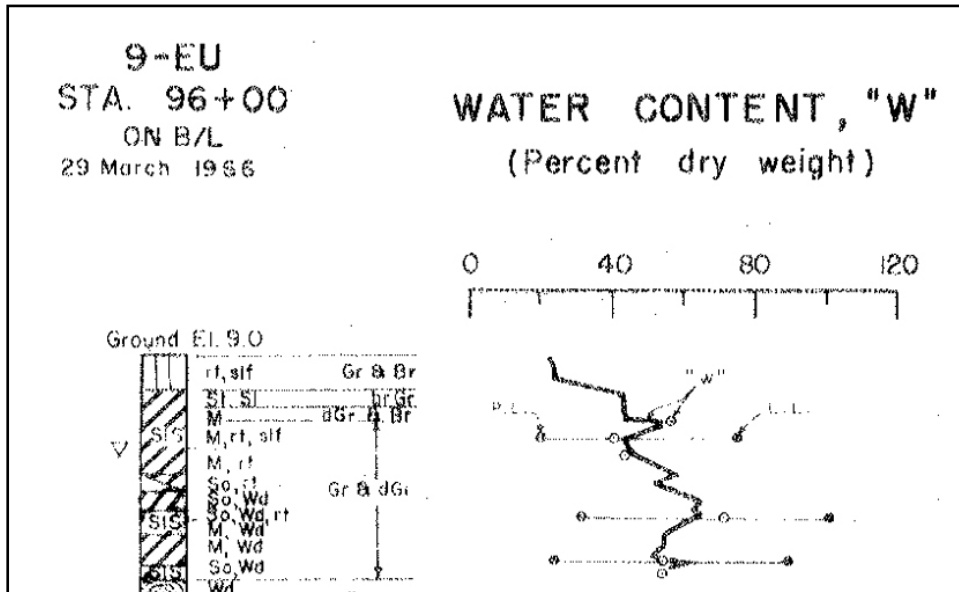
Figure 13-15. Boring 9EU (Sta 96+00 B/L, East Side IHNC) Shows a Top Layer of Silt at Levee Crown Elevation 9 ft, Possibly Explaining the Low Erosion Resistance of the Original Levee Material

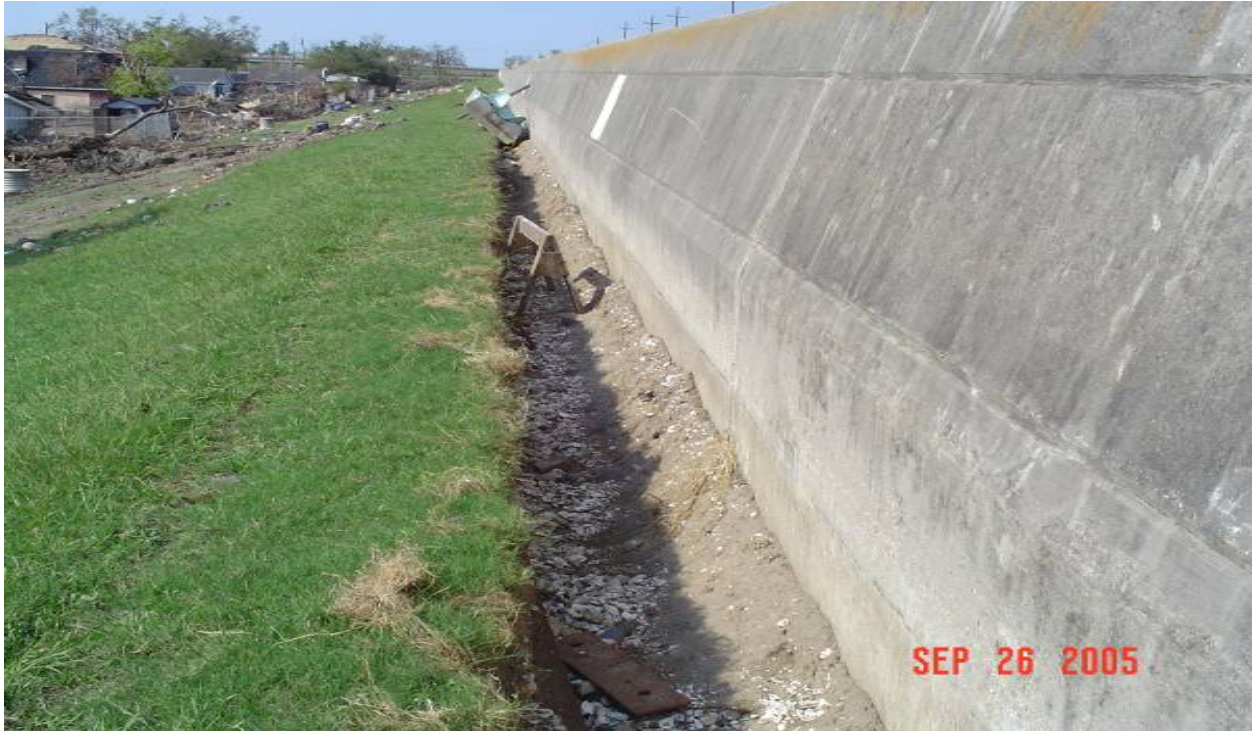
Figure 13-16. IHNC West Side Between Chef Menteur Hwy. and Hayne Blvd, Approx 8400 LF. Top of I-wall elevation is 14.75 ft(MSL), bottom of concrete is elevation 7 ft (MSL), and levee crown is elevation 8 ft (MSL). Borings in this reach (B/L Sta 31+06 to Sta 109+00, borings 1W to 14W) show the top 2 ft to 3 ft layer at crown elevation is composed of sandy and/or silty soil instead of fat clay

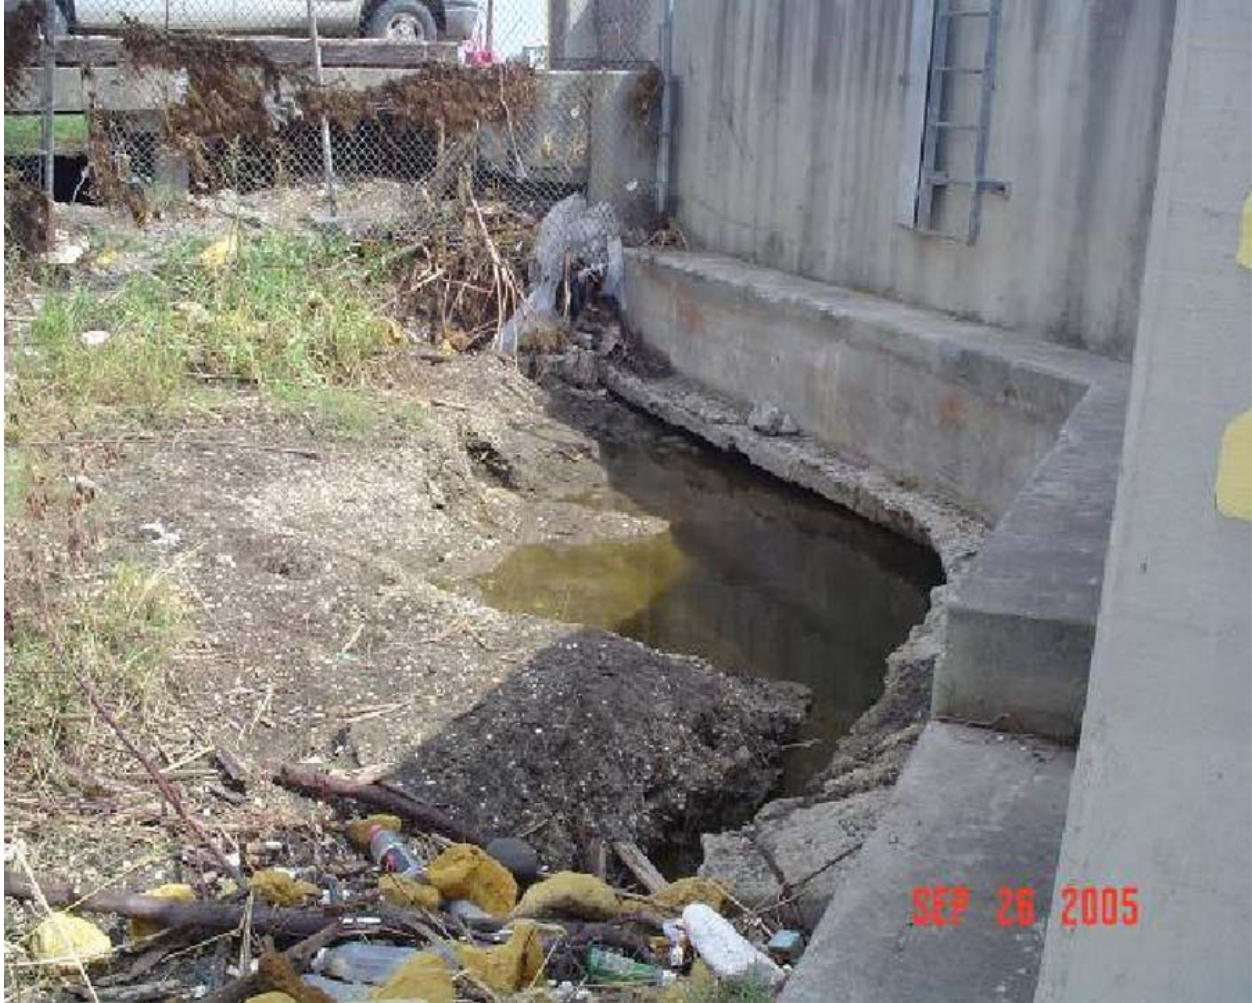
Figure 13-17. Scour at T-Wall Base of Gate W23, West Side IHNC

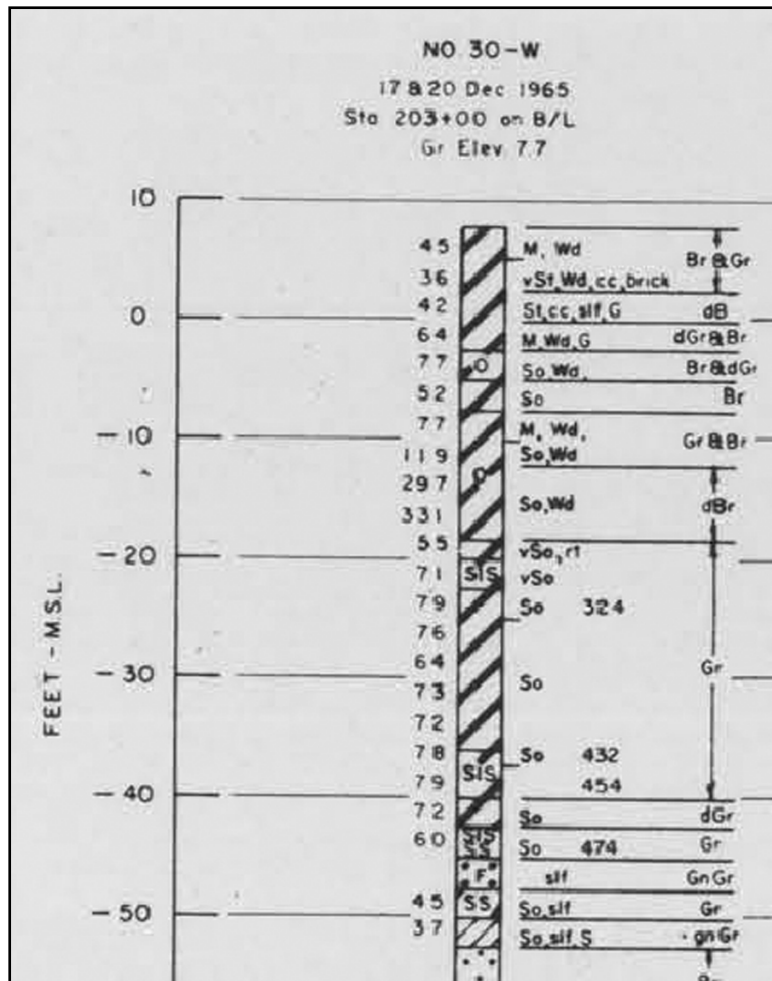
Figure 13-19. Boring 30W About 300 ft from Benefit St Gate Shows Fat Clay Soil Layers in Pre-1965 Levee

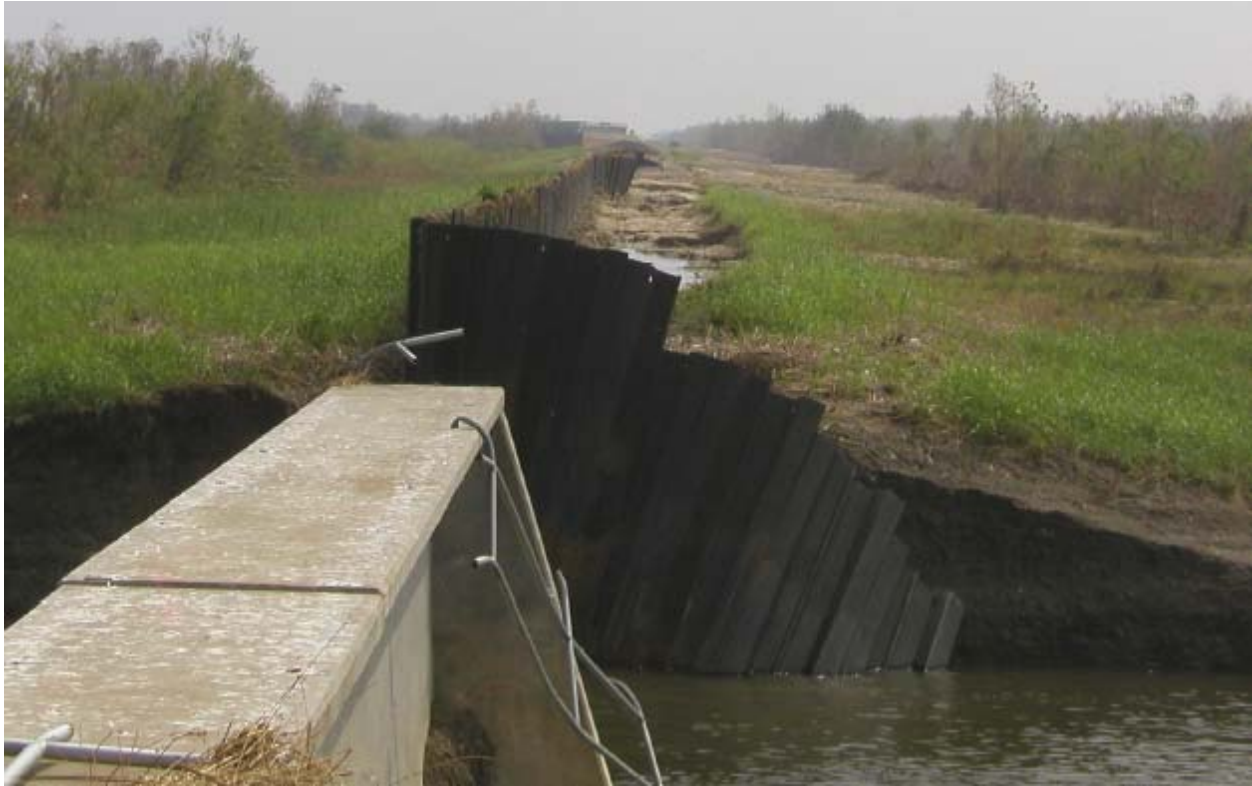
Figure 13-20. View Looking Southeast from the Bayou Bienvenue Control Structure Showing Backside Scour Beyond the Structure

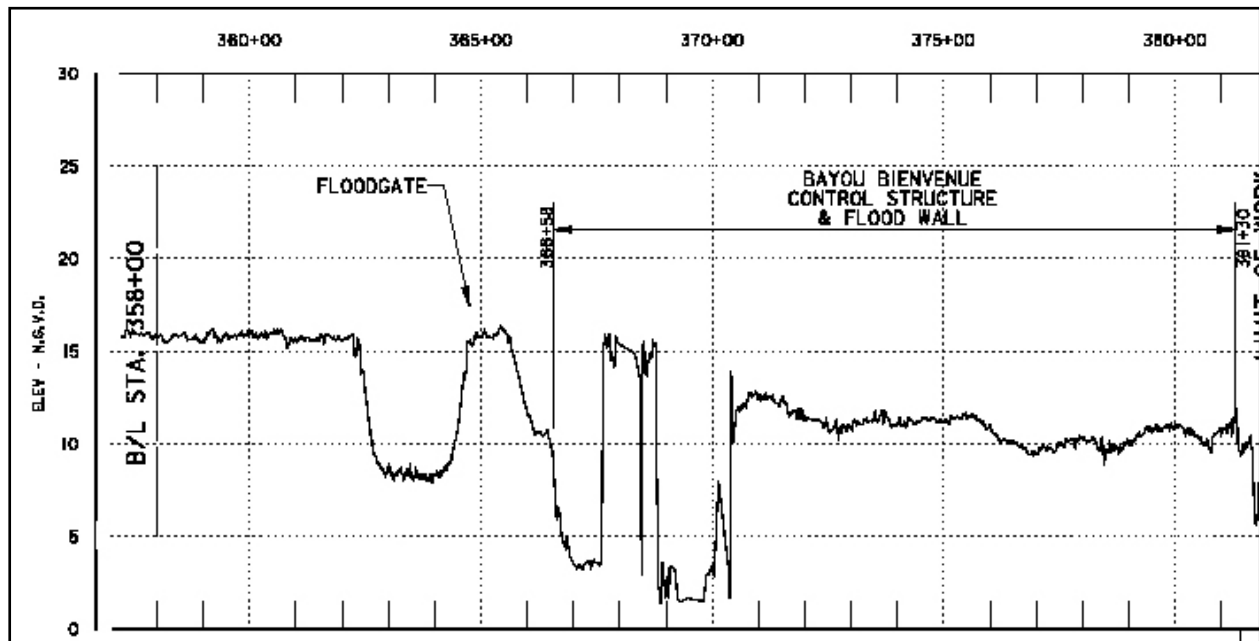
Figure 13-21. Centerline Scour Depths of Floodgate and Control Structure (from dwg 1 of 8, Emergency Restoration B/L 383+00 to 704+00 contract solicitation)

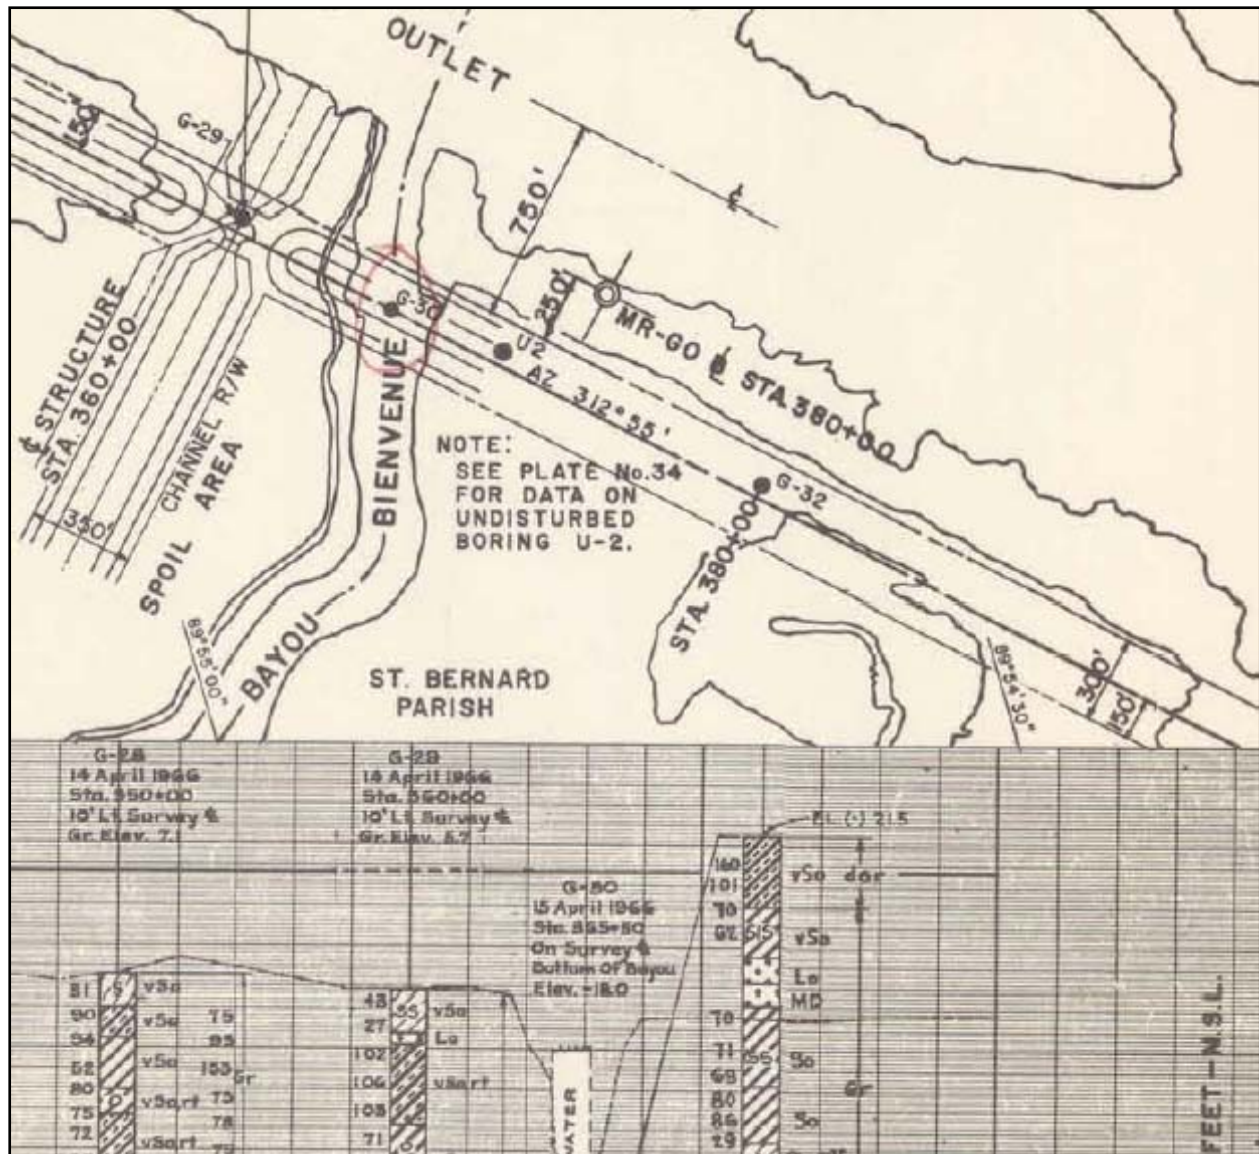
Figure 13-22. Original Ground Surface (1966) Had Sand / Silt Lenses Overlying Very Soft Organic Clay (plate 10, DM3). Note that the sheetpile east of structure (Figure 13-20 above) was driven to cut off the old Bayou channel in addition to reducing loading on the top layer of very soft organic clay seen in boring G-32.

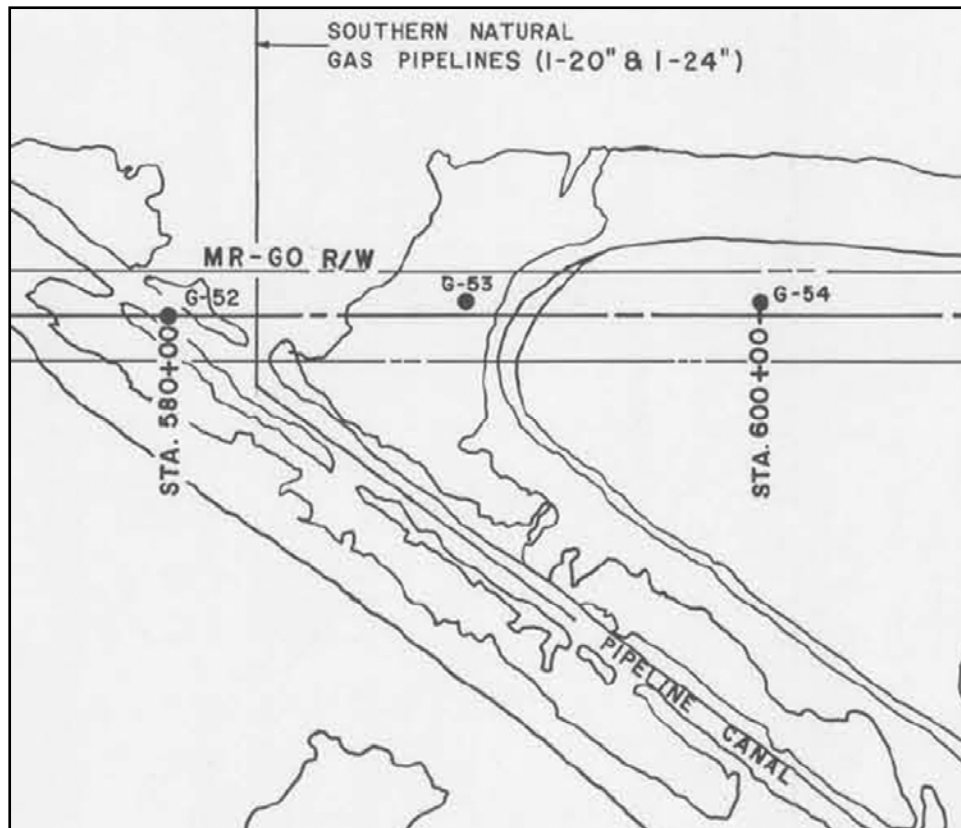
Figure 13-24. Original Pipeline Canal Prior to Backfilling and Sheetpile (from drawing file H-2-23820, plate 13)
