Appendix 11

Analysis of Performance of the Inner Harbor Navigation Canal

Executive Summary

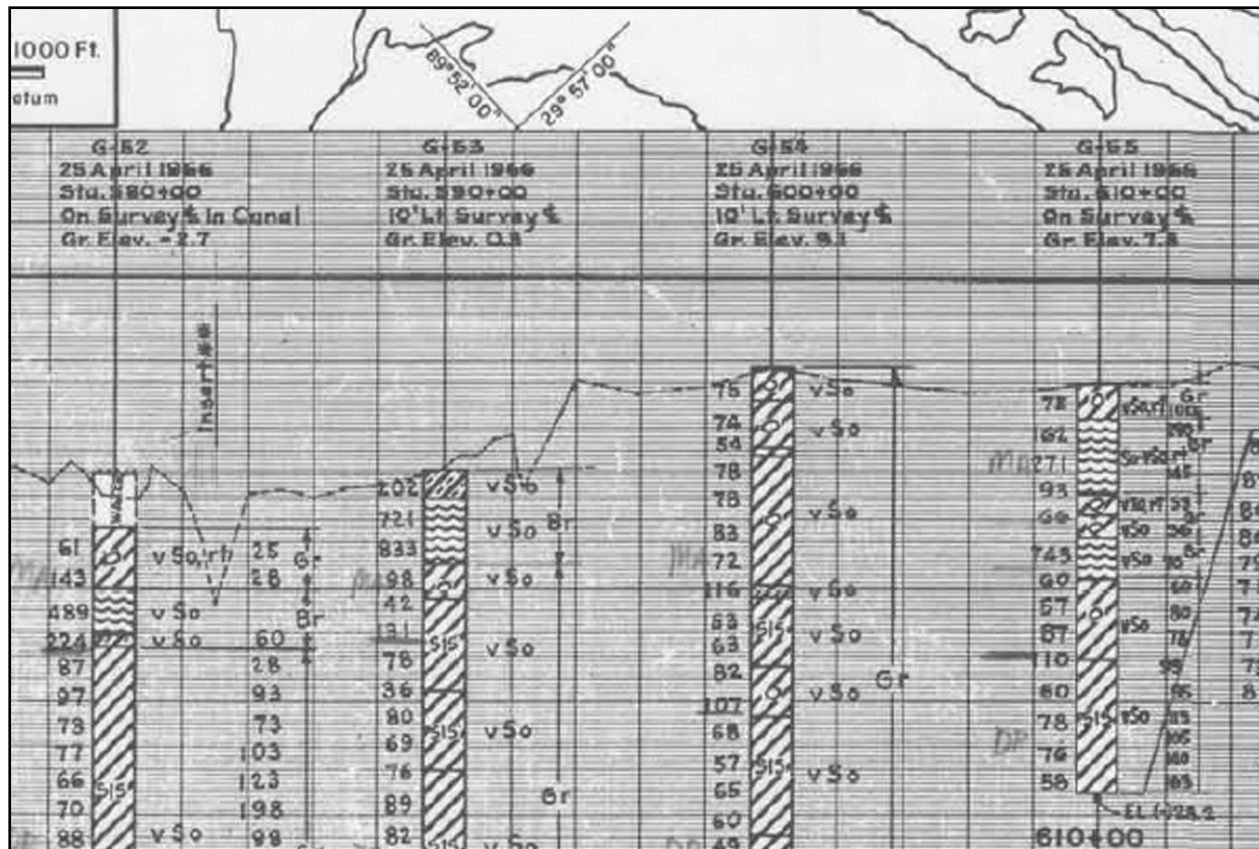
Figure 13-25. Adjacent Borings Show Very Soft Fat Clay and Peat Layer Stratification

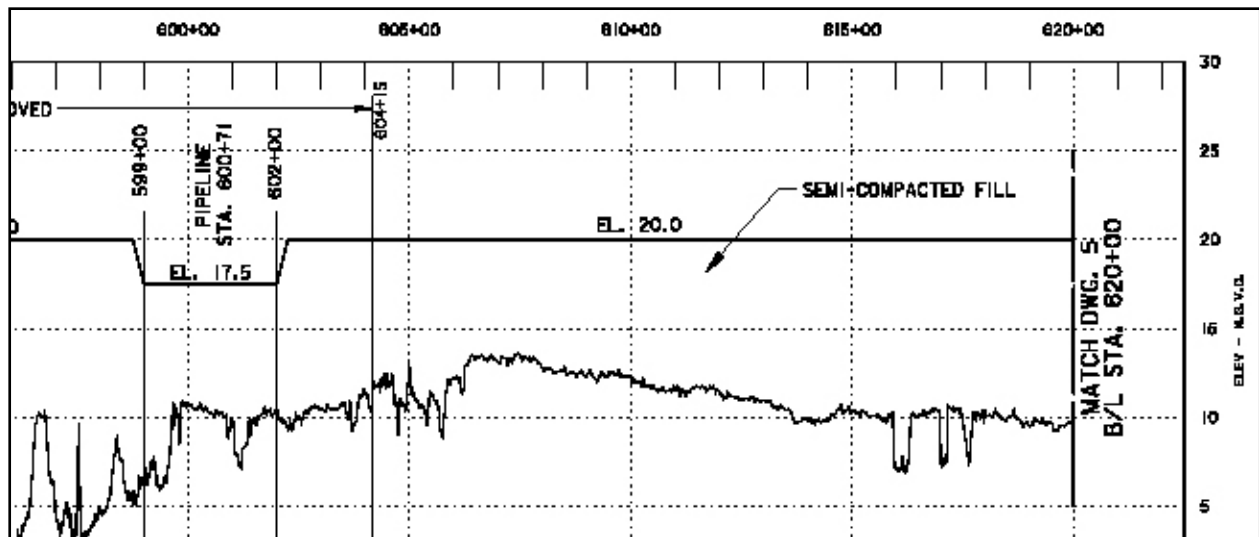
Figure 13-26. Scour Depths and Levee/Sheetpile Elevations Between B/L Sta 600+00 to 620+00 (from SB04 Contract Solicitation W912P8-05-R-0063, B/L 383+00 to 704+00 Emergency Restoration)

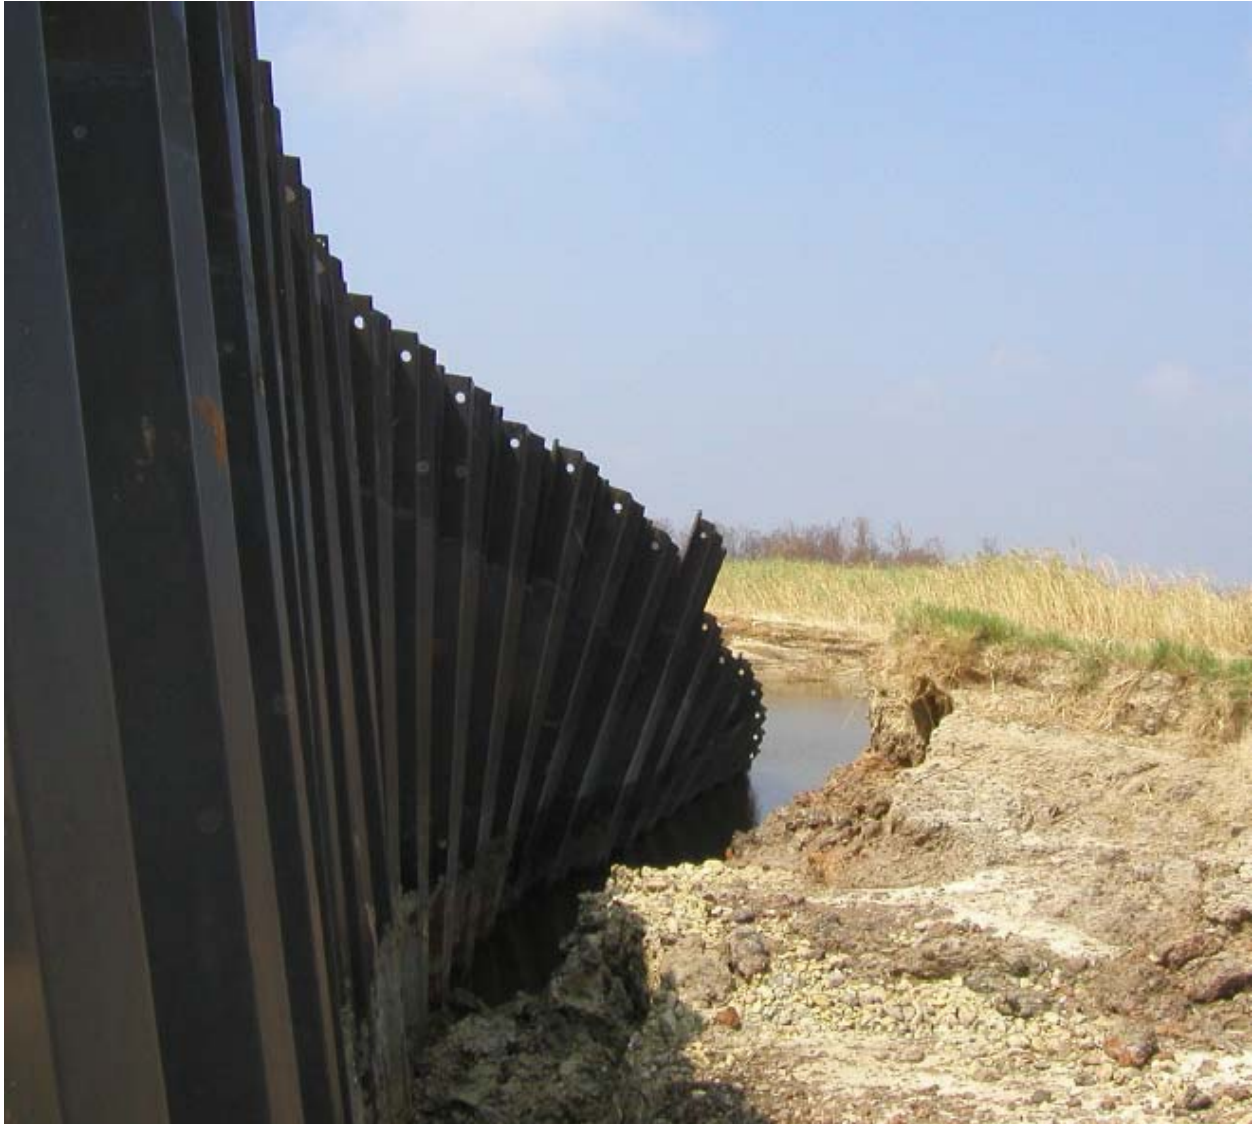
Figure 13-27. Closeup of Adjacent Breached Sheetpile with Backside Scour. Note the stratified layers in the soil profile representing existing hydraulic fill historically dredged from the MRGO

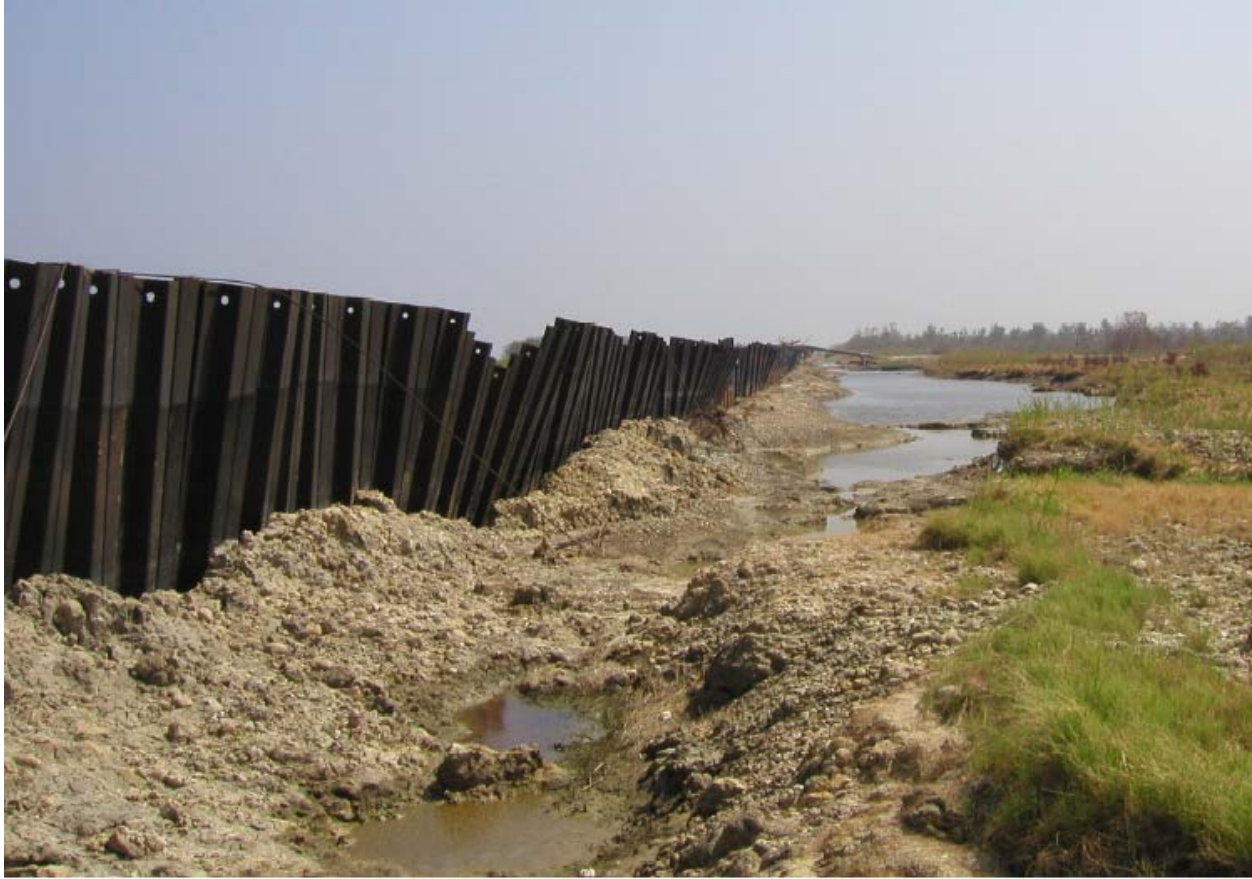
Figure 13-28. Sheetpile Between Bienvenue and Dupre Control Structures. Note the sheetpile elevation differences

Soil boring 18-UBD (91-02) from 1991 at B/L Sta 596+00 shows the top 5.8 ft of levee (at elevation 14.4) was composed of sandy silt (SM), with CH layers underneath. At a depth of 12 ft below the crown, a shear Q test indicated cohesion value 396 psf at 27% water content and 95 pcf dry density in a CL layer.

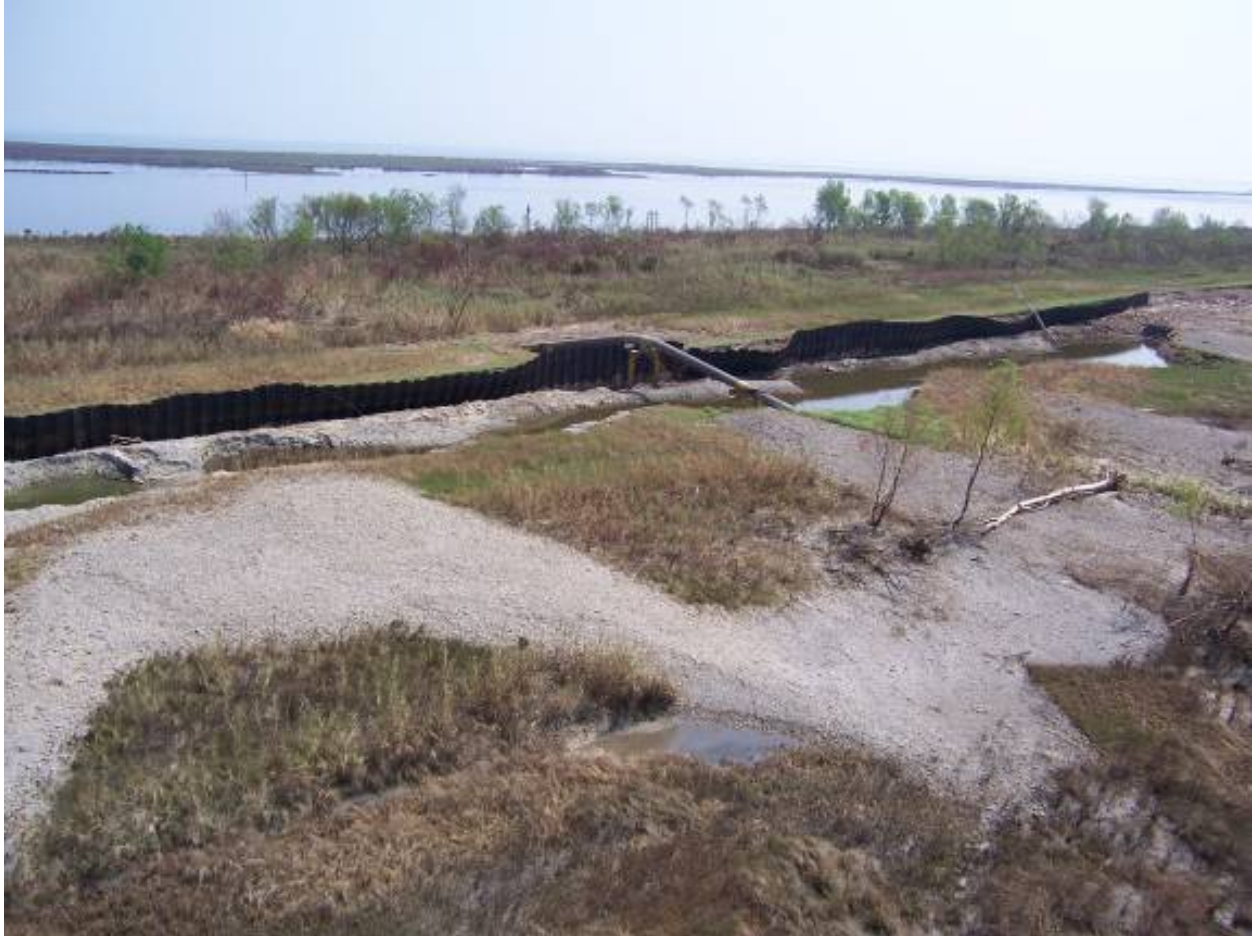
Figure 13-29. Sheetpile Reach Along the MRGO Southeast of Bayou Bienvenue at Approximate B/L Sta 600+00. Top of sheetpile was elevation 17 ft (MSL) and levee crown elevation was approximately 12 ft (MSL), for an exposed sheetpile height of approximately 5 ft. Storm surge on the MRGO was approximately 18 ft, resulting in approximate overtopping velocity of 20 ft per second with approximate 250 lbs/ft impact force. The end of the sheetpile section with transition to the severely eroded levee is approximate B/L Sta 604+15

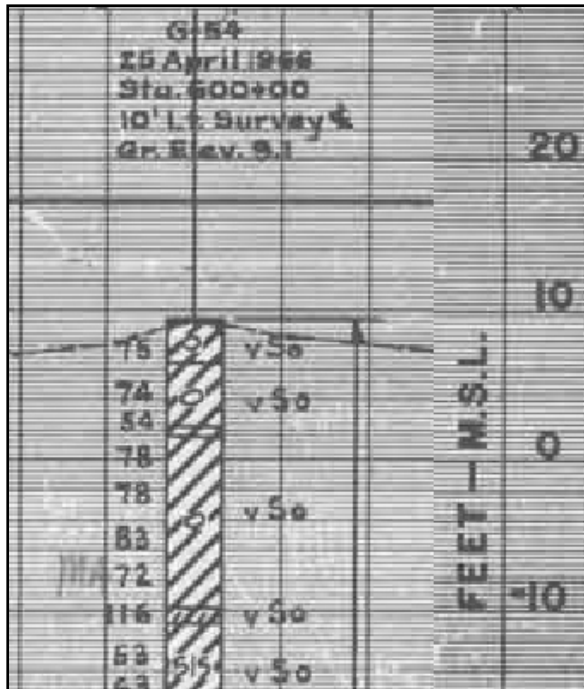
Figure 13-30. Nearest Boring at 10 ft Offset from B/L Sta 600+00 (from drawing file H-2-23820, plate 13) Shows 1966 Hydraulic Fill (dredge spoil) Surface at Elevation 10 ft Was Very Soft Fat Clay

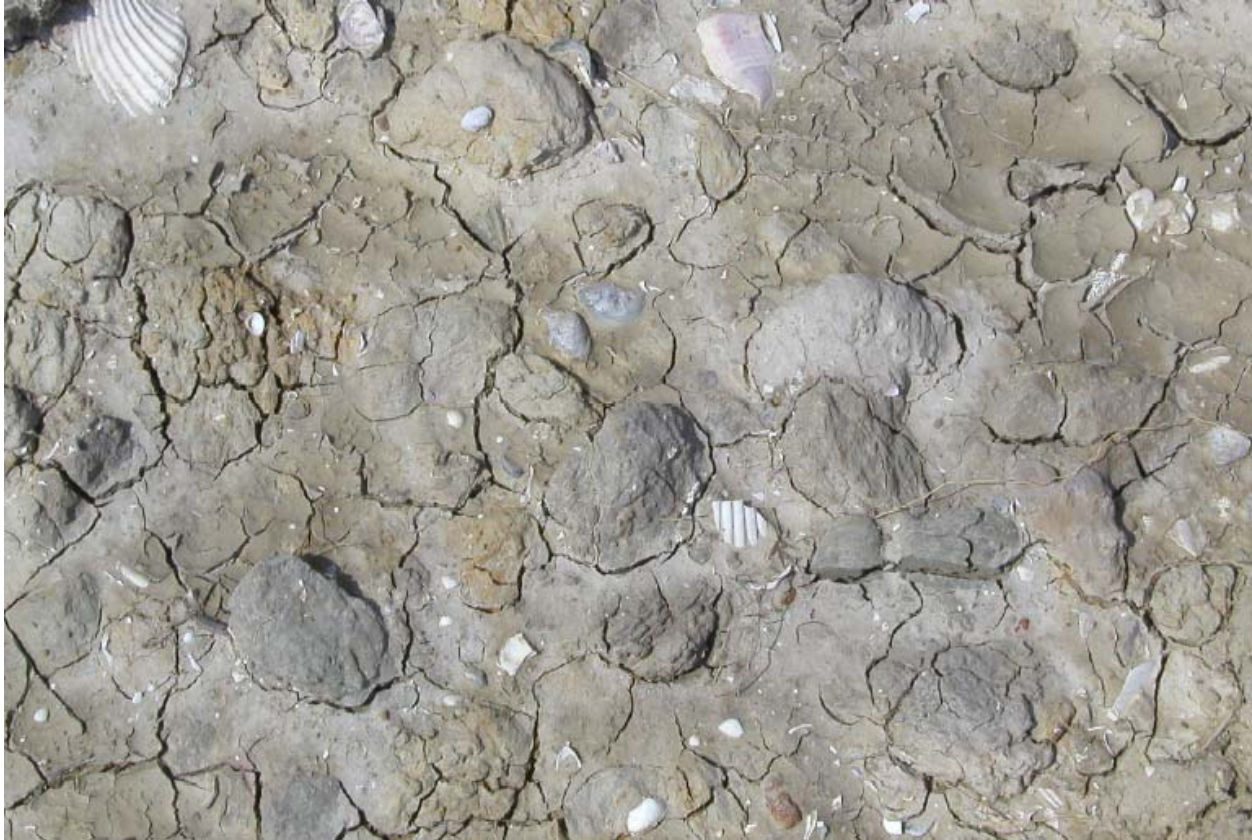
Figure 13-31. Exposed Soil Layer (final eroded surface) on Sheetpile Wall Backside Appears to be In-Situ Fat Clay with Embedded Shell Hash, Possibly an Exposed Estuarine Deposit

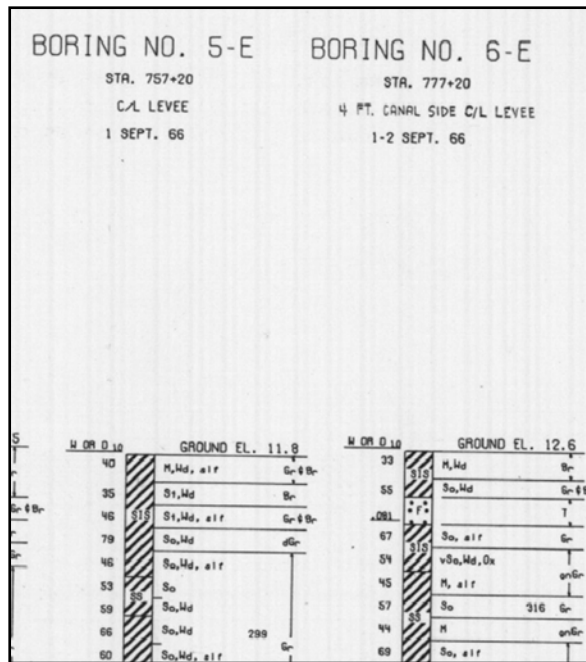
Figure 13-33. Nearest Borings on Either Side of the Breach, 5-E and 6-E (from plate 5, DM2 Supp 4, March 1971) Show CH Material With Sand / Silt Lenses in the Pre-Existing (1965) Levee at Crown Elevation ~12 ft, Prior to Sheetpile Wall. Storm surge in the GIWW was approximately 15 to 17 ft elevation

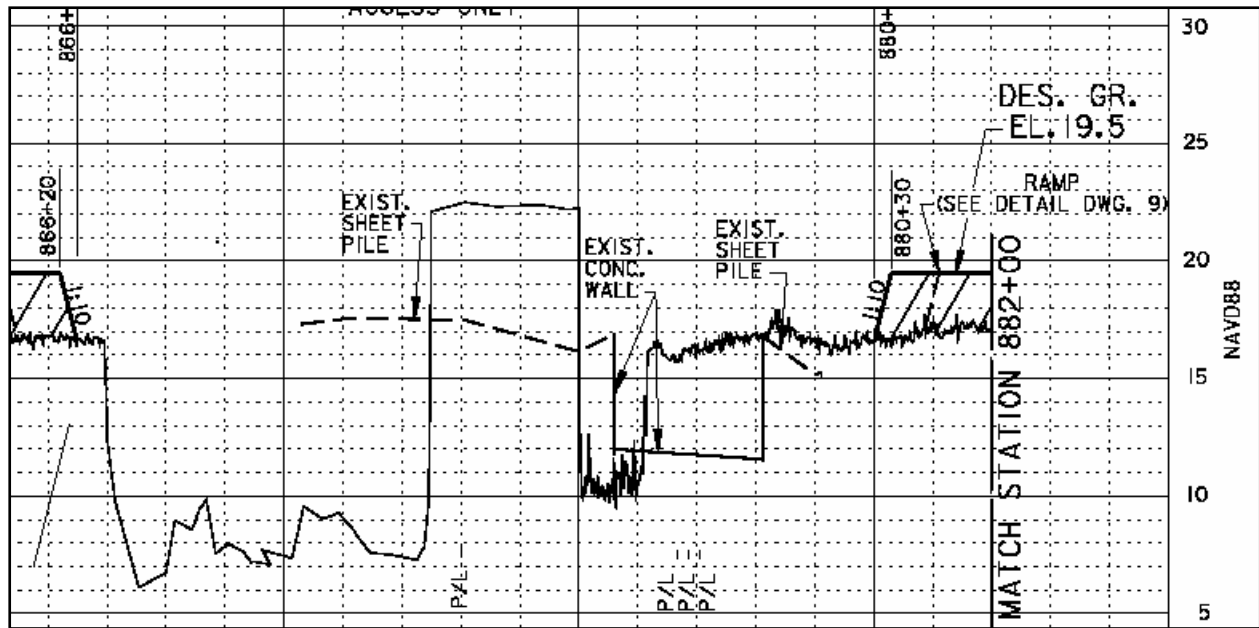
Figure 13-37. Plan and Post-Damage Scour Profile Immediately West of Pump Station 15 (from Contract Solicitation NOE1 drawing H-8-45594, sheet 3 of 16)

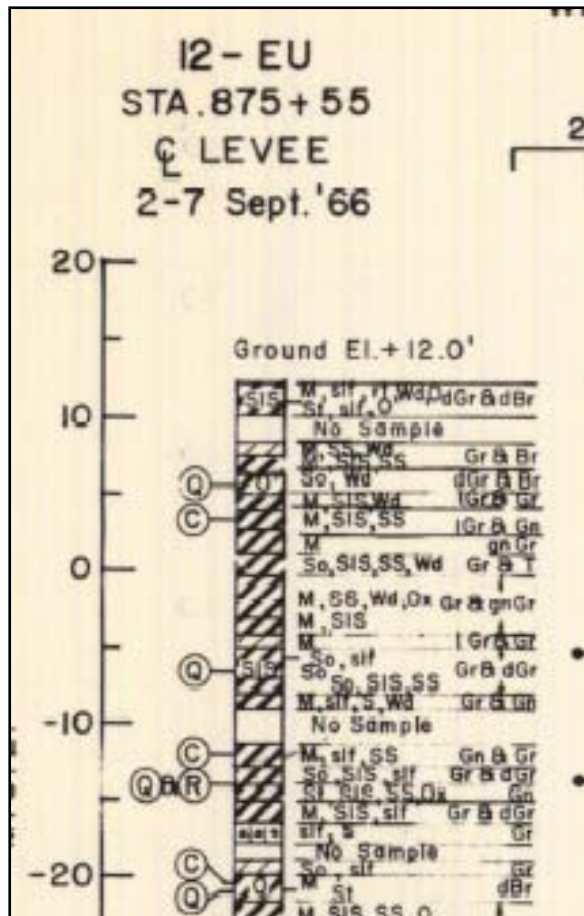
Figure 13-39. Pump Station 15 Nearest Boring 12EU Shows Levee Crown Elevation at 12 ft (MSL) with Fat Clay / Sand / Silt Lenses Overlying Lean Clay (CL) in the Upper 5 ft (from drawing file H-2-24625, plate 3)

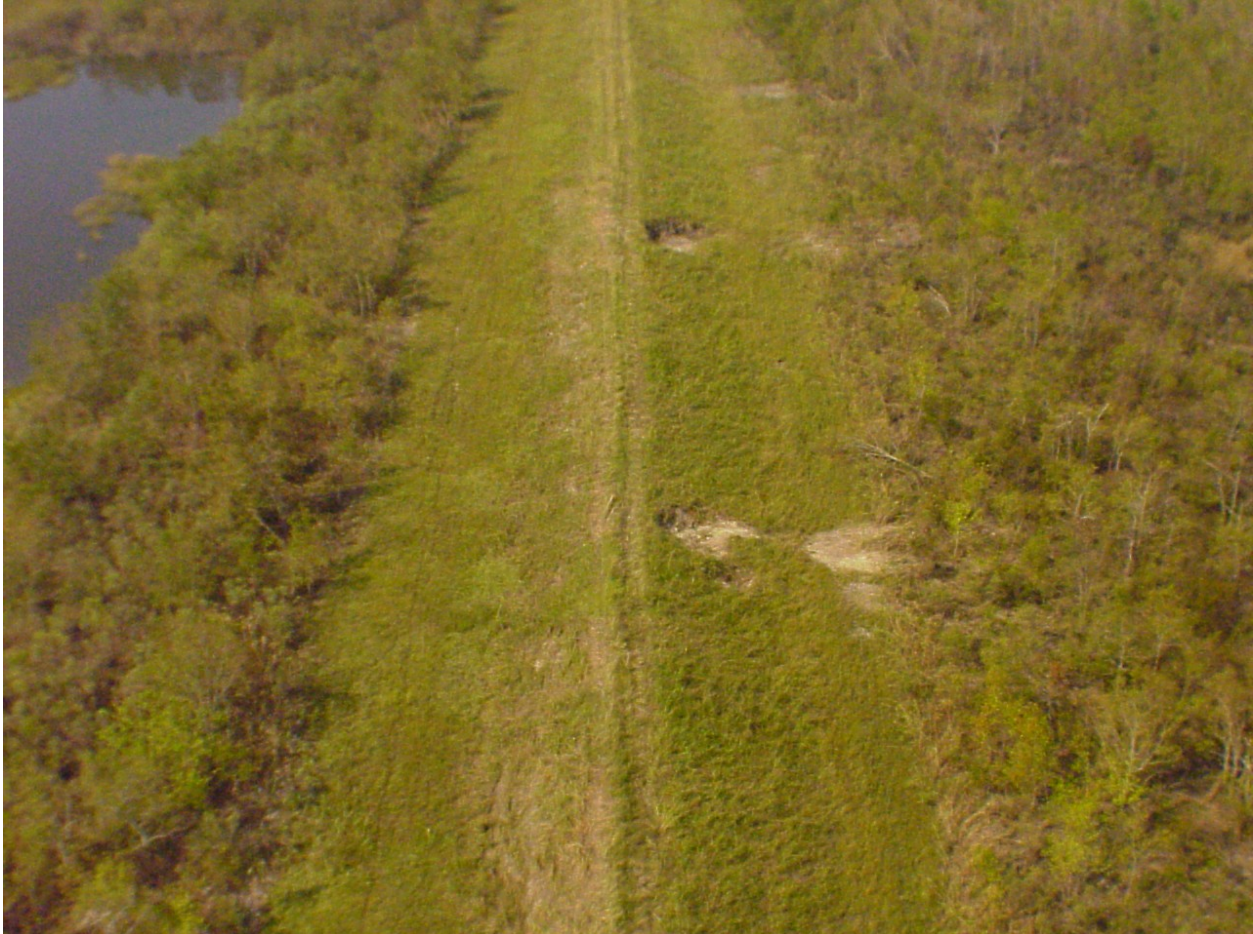
Figures 13-42 and 13-43 show examples of initial overtopping erosion on the Citrus Back Levee backside along the north bank of the GIWW in New Orleans East. The levee crown was elevation 14 to 15 ft and storm surge was 15 to 17 ft from the GIWW, so the overtopping crest

depth was approximately 1 to 2 ft. Approximate surge velocity down a 1:4 slope was 40 fps with shear stress 30 psf. Soil borings along this reach indicated non-homogeneity in the surficial layers of the levee crest and slopes, and cohesive soils with interbedded layers of silt and/or sand were typical.

Figure 13-42. Backside Levee Erosion Pattern “B” on the Citrus Back Levee, N.O. East

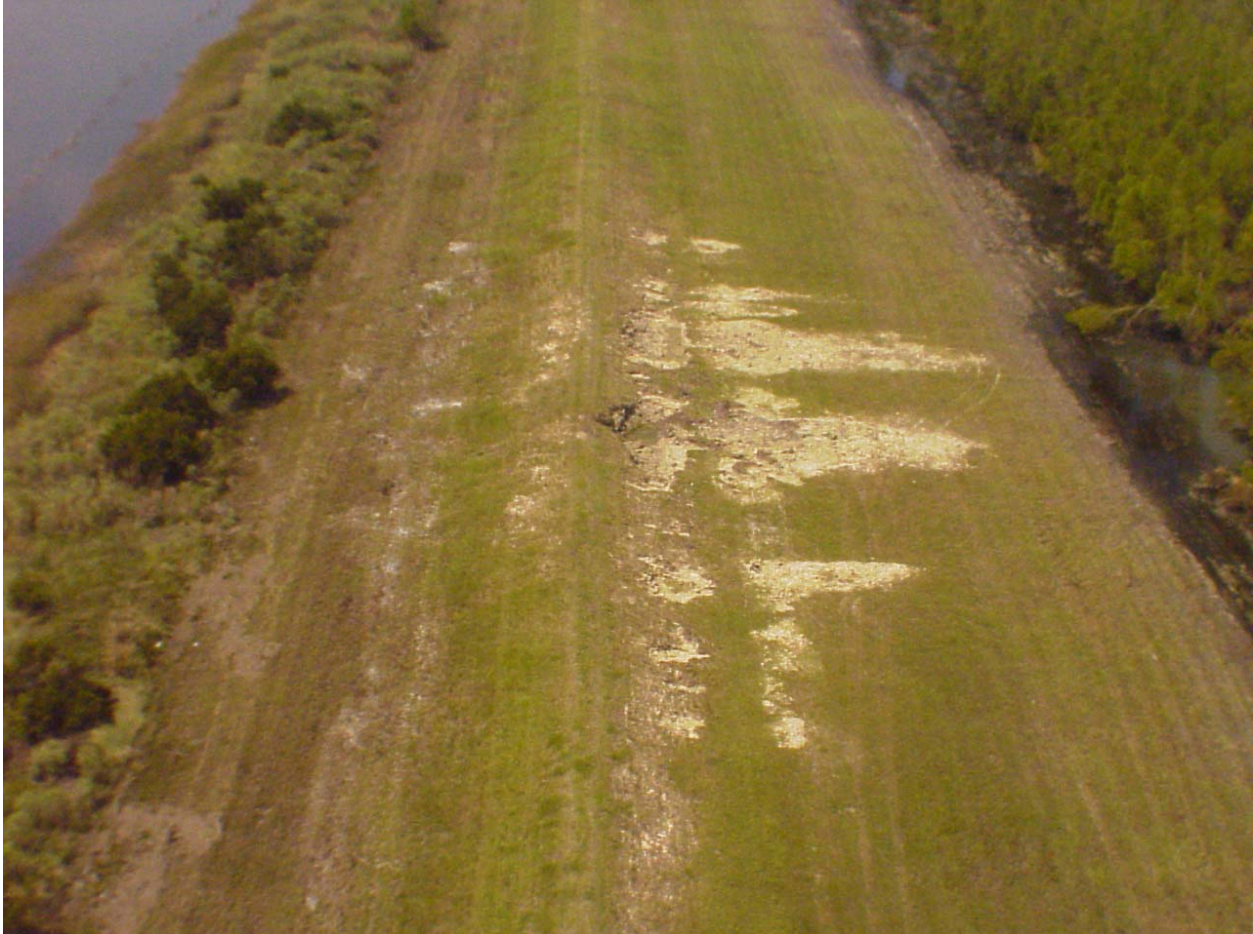
Figure 13-43. 600' Reach of Levee Along the North Bank of the GIWW (Citrus Back Levee, New Orleans East) Between Elaine Pump Station and Paris Road

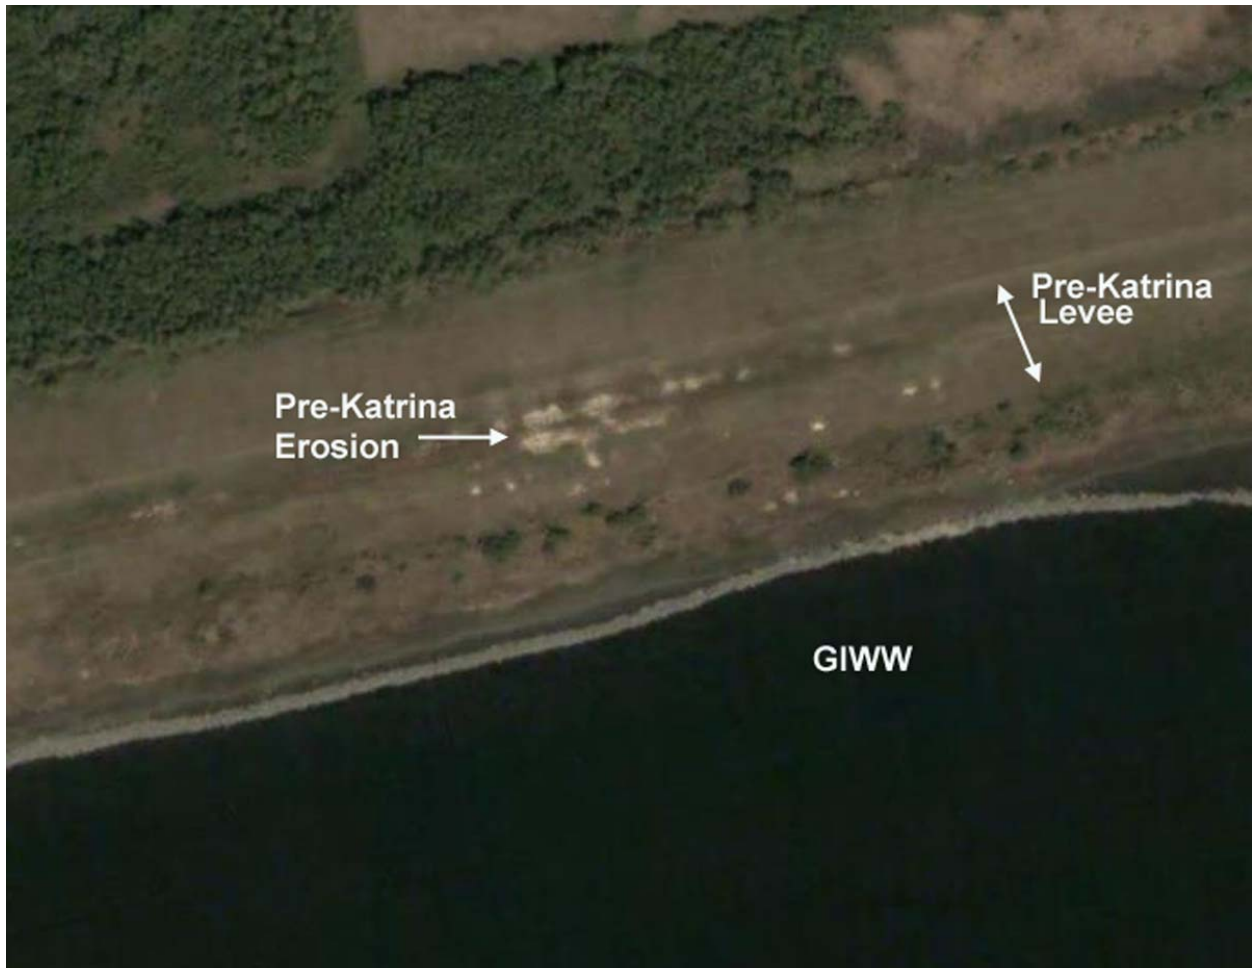
There is a possibility that the Figure 13-44 erosion was pre-Katrina, as seen in pre-Katrina satellite photo below (Figure 13-45).

Figure 13-45. Possible Pre-Existing Surface Erosion on Levee Slopes Along the North Bank of the GIWW (Citrus Back Levee) at N 30deg 0 min 7 sec W 89deg 58min 31 sec. (pre-Katrina image from GoogleEarth website). Possible erosion is evidenced by vegetation distress and bare spots along the levee

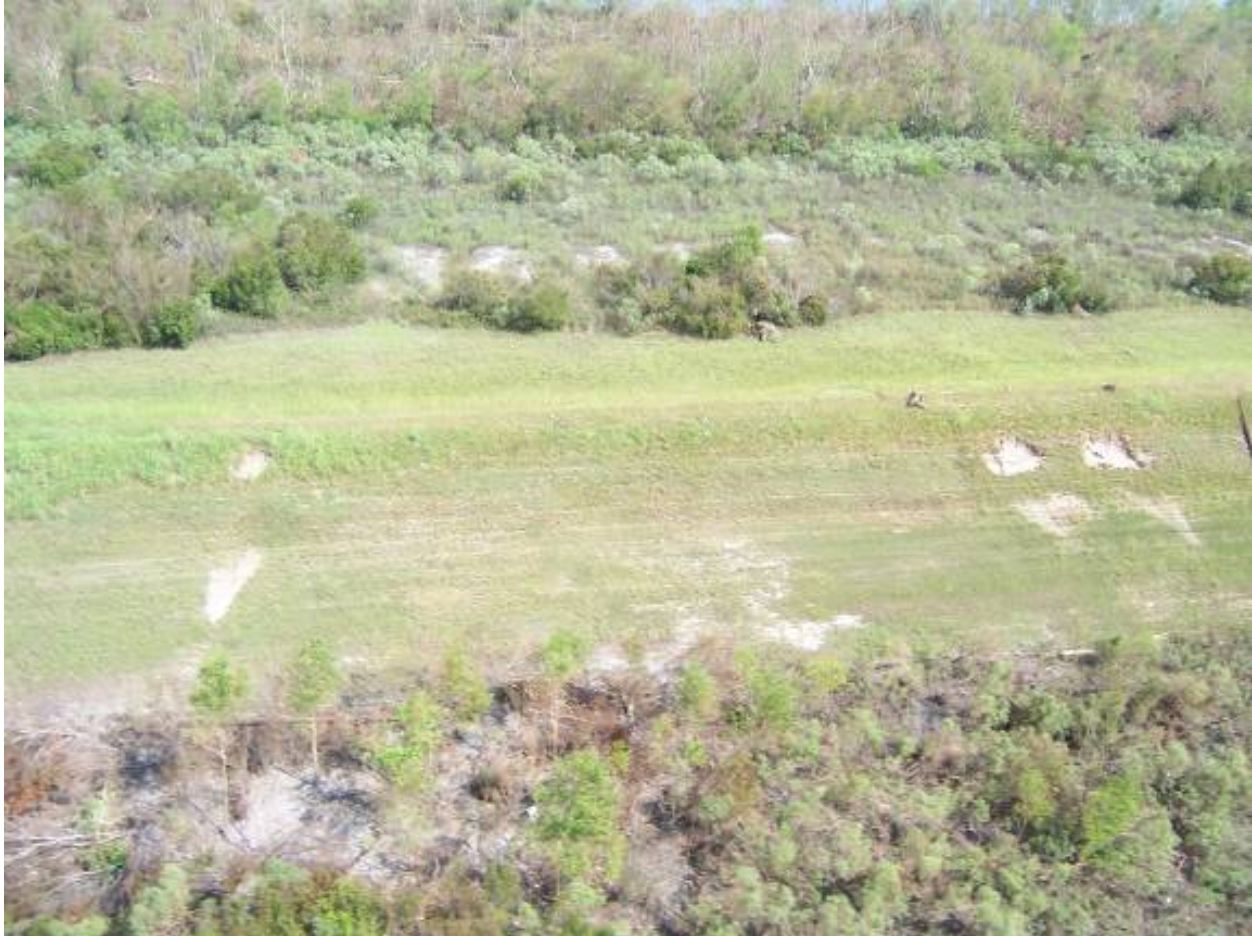
Figure 13-46 shows backside slope erosion and minor erosion on the stabilizing berm slope along the south bank GIWW levee between Sta. 65+008 and STA. 277+20 in St. Bernard Parish. The General Design section for the south bank GIWW indicated that the levee was built to approximate elevation +14 ft. circa 1970, and an additional lift up to elevation 19 was added circa 1985 (Figure 13-47). Post-Katrina LIDAR along the south bank GIWW shows the uneroded levee crown was up to approximate elevation 16 ft (Figures 13-48 and 13-49). Storm surge along the GIWW was approximately 15 to 17 ft, causing an estimated overtopping depth of approximately 1 to 2 ft and an approximate overtopping velocity of 40 fps. Drawing 9 of 19, New Orleans District file H-8-45533, shows several layers of hard lean clay (CL) at centerline top of levee (boring elevation 16.8 ft) from the 5/11/2000 soil boring 5A-CAU, B/L Sta 135+50 (Figure 13-51).

Figure 13-46. Scour on the Backside of the South Bank GIWW Levee Between STA. 65+008 and STA. 277+20, St. Bernard Parish, Minor Scour on the Protected Side Levee Transition Slope. The Paris Rd (I-510) high rise bridge is over approximate B/L Sta 270+00

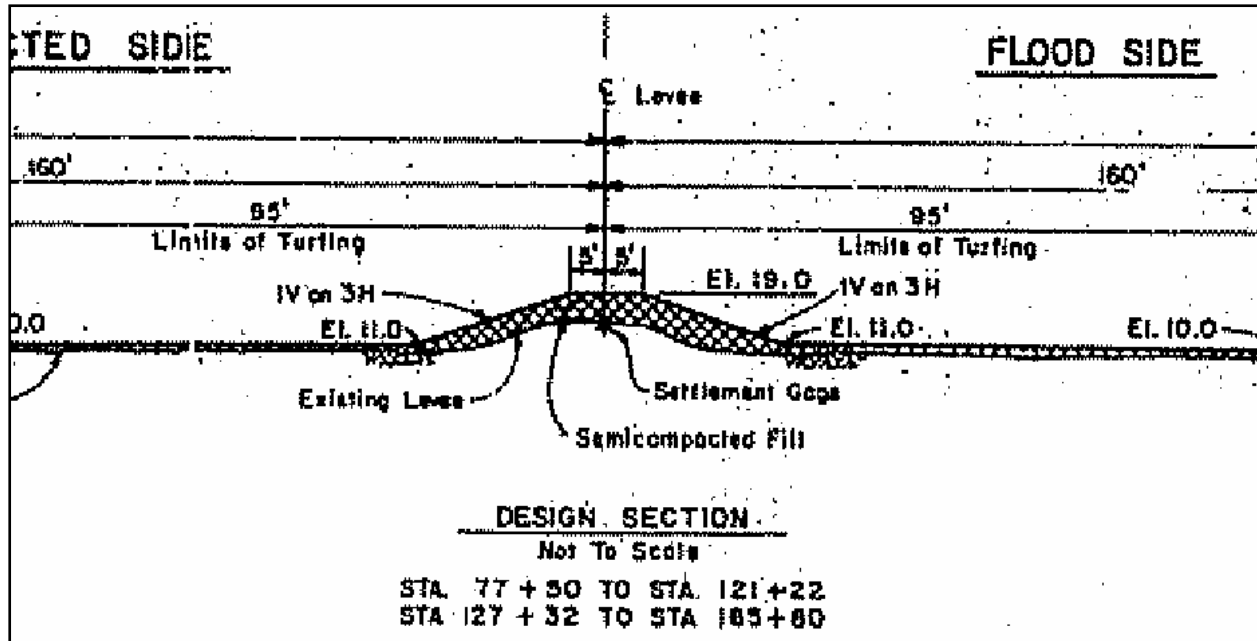
Figure 13-47. Design Section for South Bank GIWW Levee Enlargement in 1985. Levee was built to approximate elevation +14 ft. circa 1970. Additional lift up to elevation 19 was added circa 1985. Post-Katrina LIDAR along the south bank GIWW shows the unscoured levee crown was up to approximate elevation 16 ft. Storm surge along the GIWW was approximately 15 to 17 ft, causing an overtopping crest of 1 to 2 ft

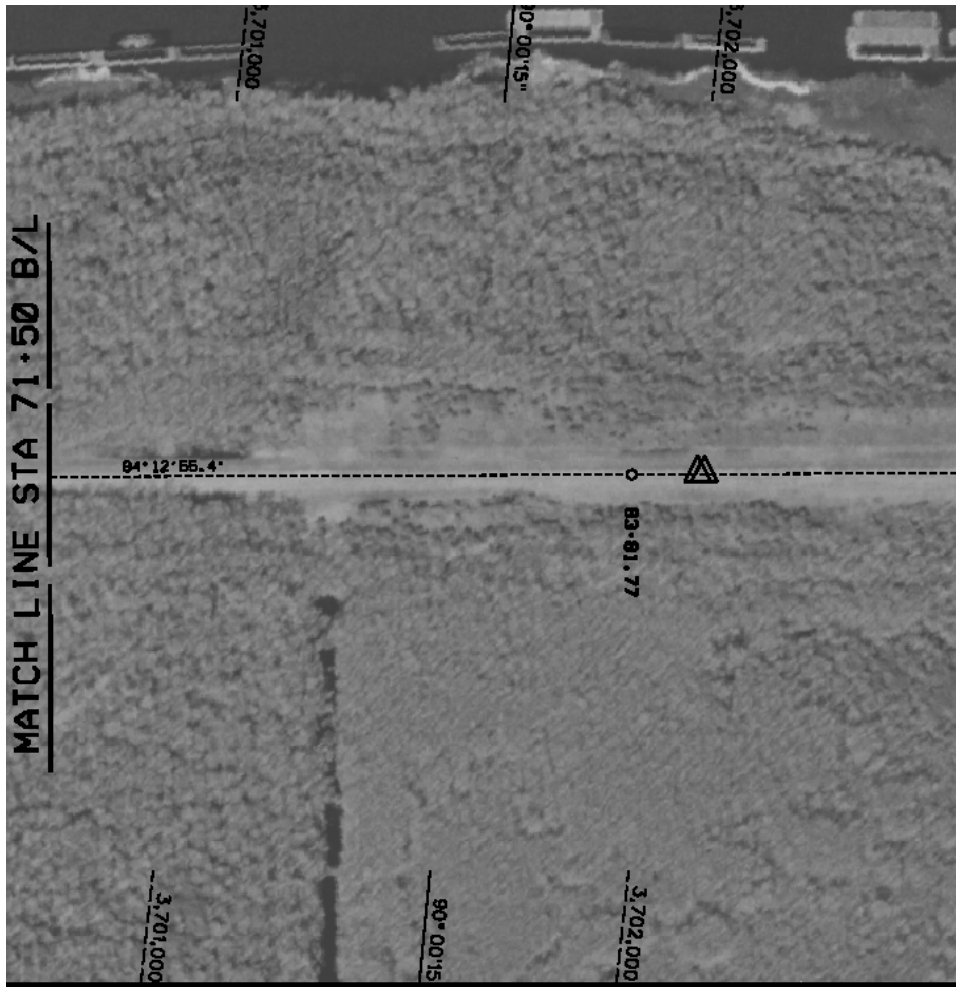
Figure 13-48. Scour Damage (Marked with Triangle) Identified East of B/L Sta 81+50 (from TFG Contract Solicitation W912PB-06-R-0022, drawing 3 of 12)

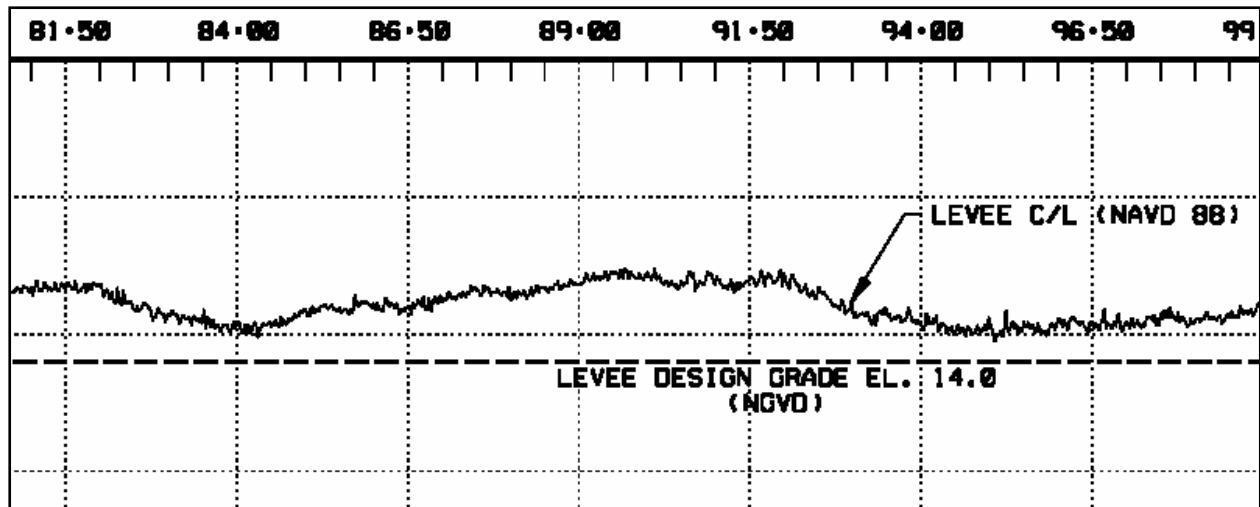
Figure 13-49. Levee Profile East of B/L Sta 81+50 (dwg 3 of 12). Note design grade elev 14 (NGVD) and lidar post-Katrina elev between 14 and 16 (NAVD 88). Also note crown grade change up to 2 ft along this 1750-ft reach

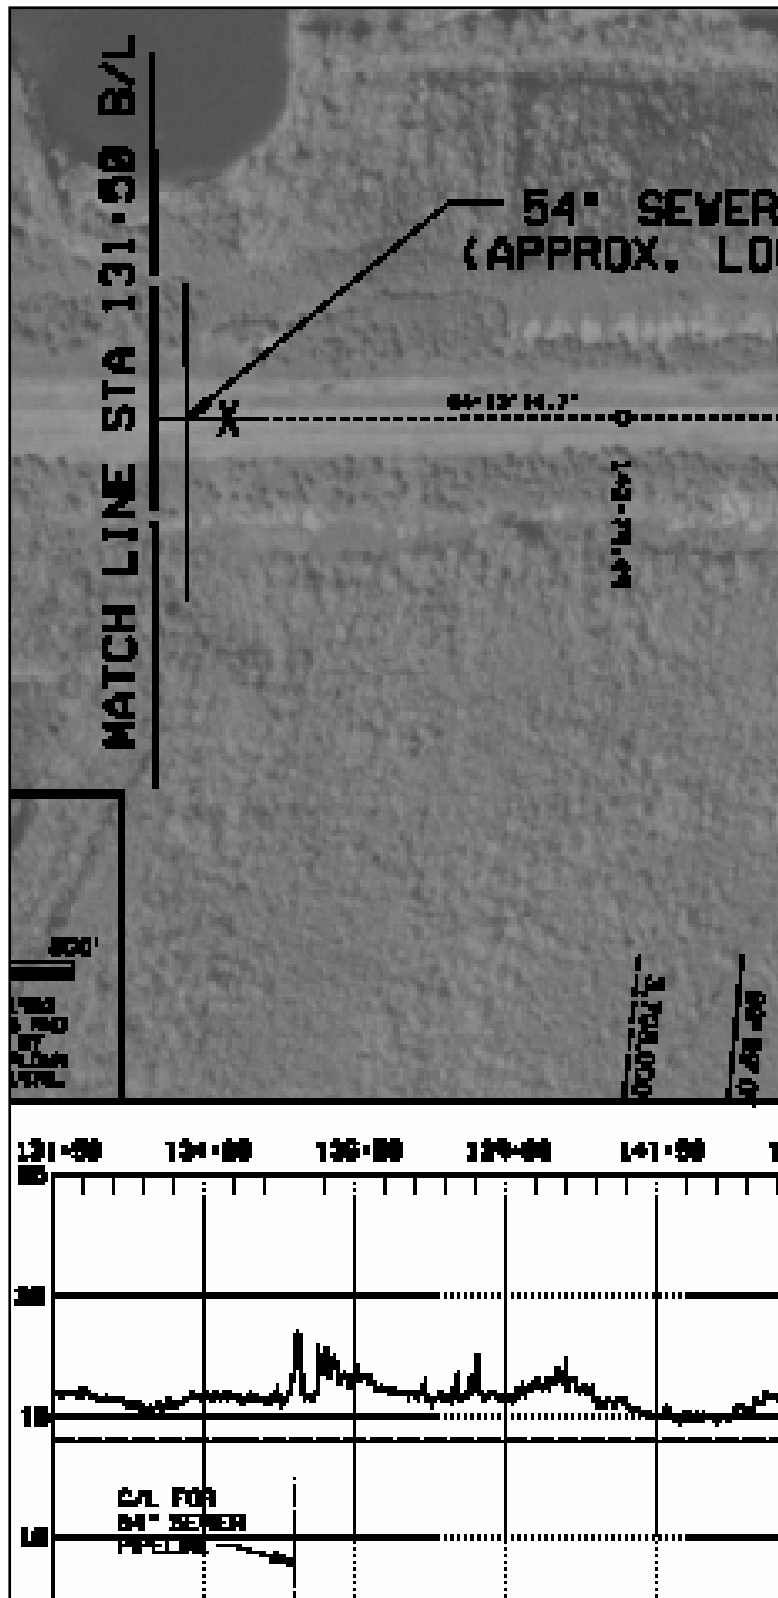
Figure 13-50. A Minor Scour Location on St. Bernard Parish South Bank GIWW Levee (marked with X) at B/L Sta 135+00 (from dwg 4 of 12, Contract Solicitation W912P8-06-R-0022)

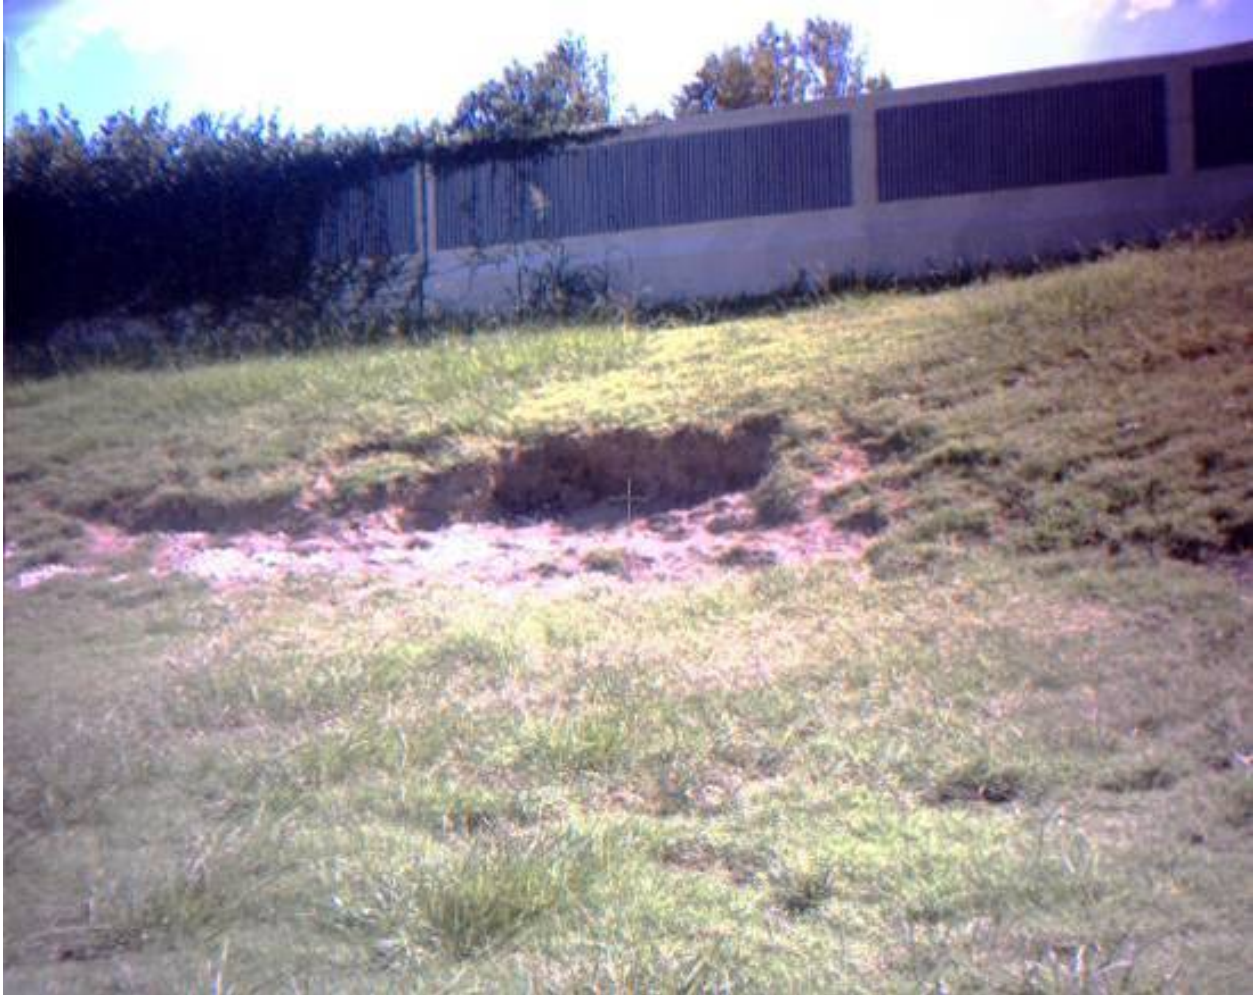
Figure 13-52. New Orleans East Bank Lake Pontchartrain Floodwall Scour, 20ft long x 10ft wide x 2ft deep. GPS coords N90 deg 05min 17.3 sec, W30deg 01 min 39.3 sec

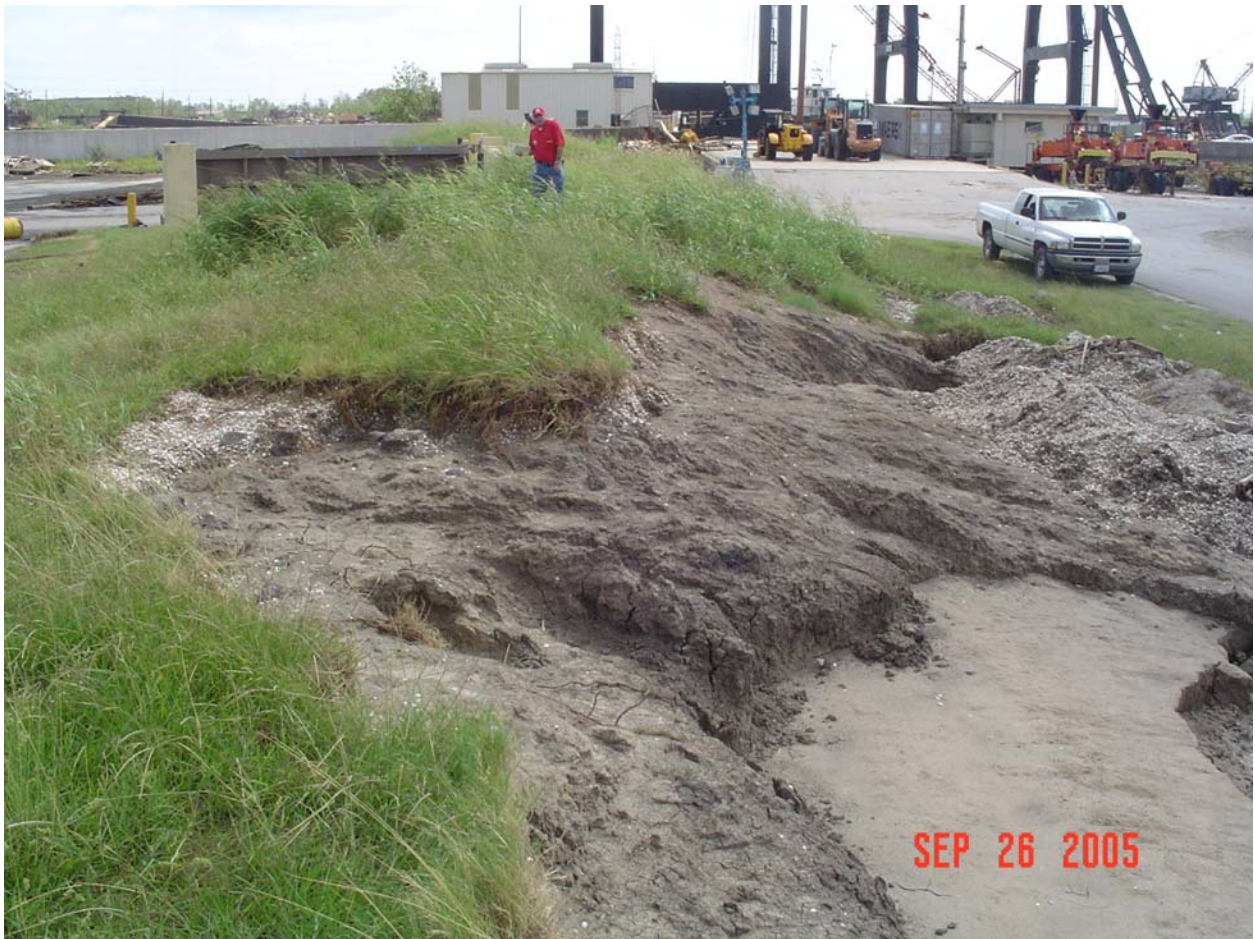
Figure 13-53 shows a short levee section with progressive erosion on the west side of the IHNC protecting the container terminal between France Rd. and IHNC. The headcut extends to the top crest elevation, and was beginning to cut through the crown. Although the nearest historical boring pre-dates the levee (Figure 13-54), the unscoured soil surface appears to be a fat clay and the eroded soil visually appears to be a shell hash mixture of clay and oyster shell fragments.

Figure 13-53. Eroded Levee Crown on the IHNC West Side at Container Facility

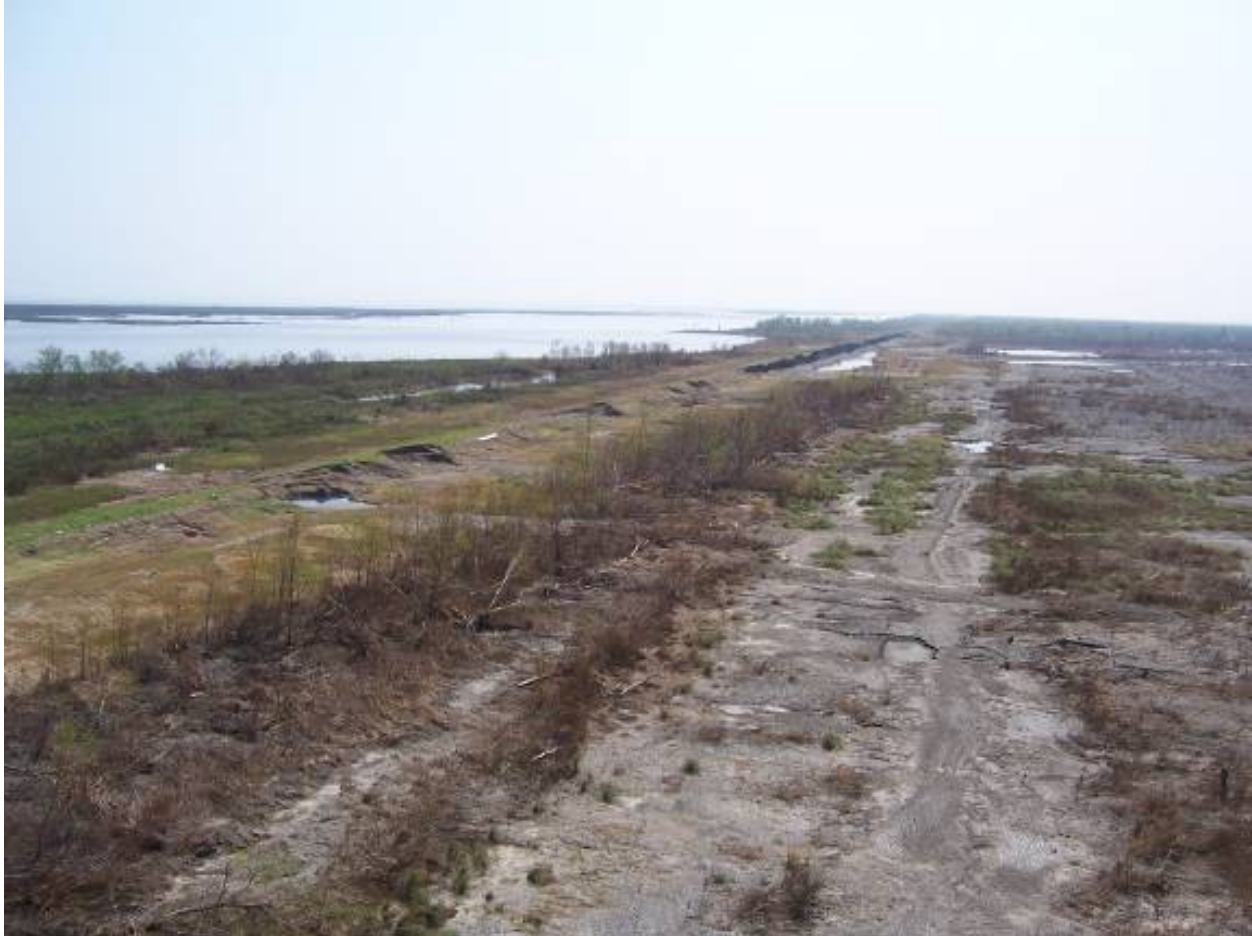
Figure 13-55. Levee with Eroded Crown Between Bienvenue and Dupre Bayous, View South From Approximate B/L Sta 570+00. MRGO is to the Left of Photo

Soil boring 12BU-CHBD (01-16834) from 2001 at Sta 570+00 (Martello Castle) shows the top 1.4 ft of levee (elevation 16) was composed of lean clay (CL), with CH layers underneath. At a depth of 8.5 ft below the crown, a shear Q test indicated cohesion value 270 psf at 51% water content and 68 pcf dry density in a CH layer. At a depth of 16.8 ft, cohesion was slightly higher (396 psf) at 62% water content and 62 pcf dry density, also in a CH layer.
