Appendix 11

Analysis of Performance of the Inner Harbor Navigation Canal

Executive Summary

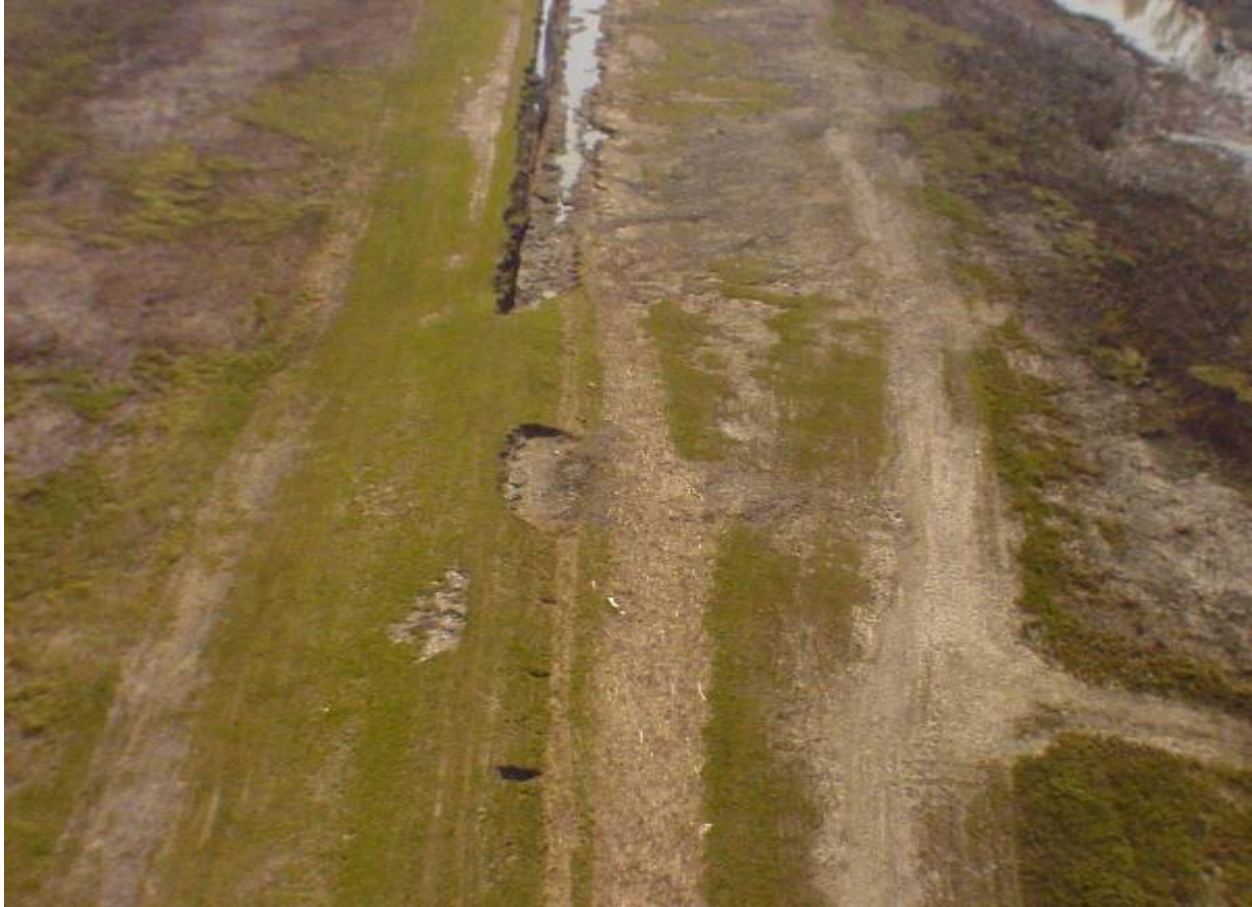
Figures 13-56 through 13-58 show progressive crown scour along approximate B/L Sta 1203+00 to Sta 1230+00 on the St. Bernard levee between the MRGO and the Mississippi River. Crown elevation was approximately 15 ft, but dropped to about 12 ft for about a mile in this eroded section. The levee along this reach was constructed of Mississippi River hydraulic sand fill, capped with local borrow material fat clay interbedded with silt and/or sand lenses, and shaped to grade with Mississippi River batture soil (truck-hauled fill). Similar to other levee’s construction materials and history, this section contains heterogeneous soil layering probably compacted to different densities over a half-century or so timeframe.

Figure 13-56. Crown Scour Along Approximate B/L Sta 1203+00 to Sta 1230+00, St. Bernard Levee Between MRGO and Miss. River. Crown was Approximate Elevation 15 ft

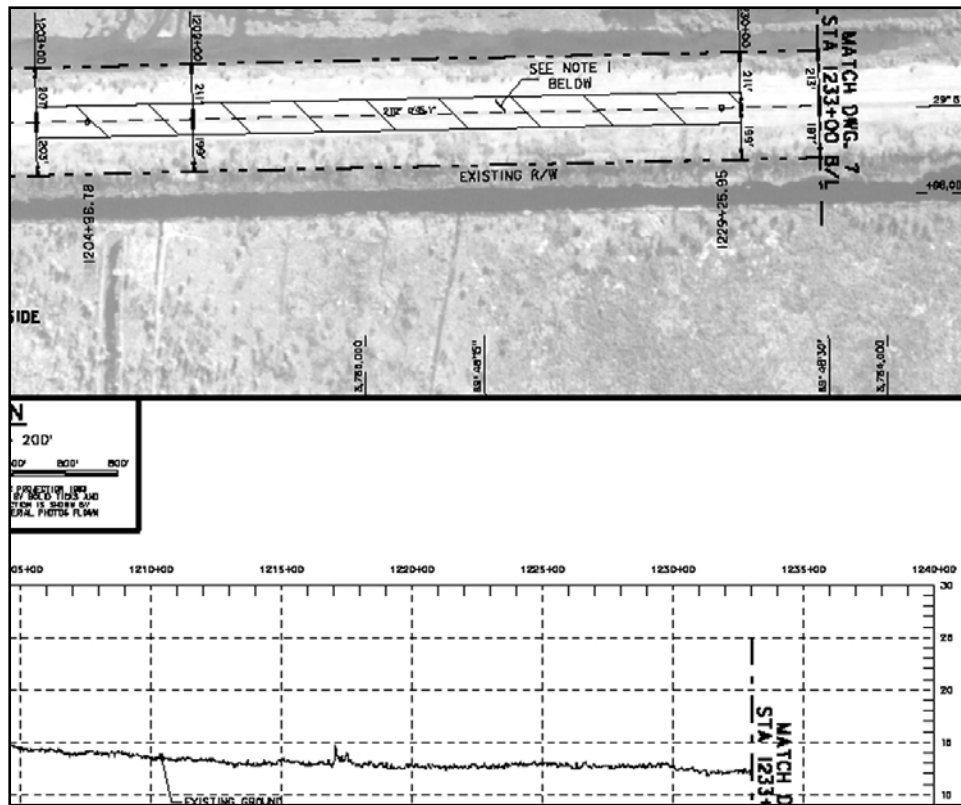
Figure 13-57. Levee Crown Elevation Drops from Elev 15 ft to Elev 12 ft in the Scour Area. Elevation 12 ft remains fairly constant along the reach for about a mile beyond the scour section. From Contract Solicitation STB08 W912P8-06-R-0094, drawing sheet C-06

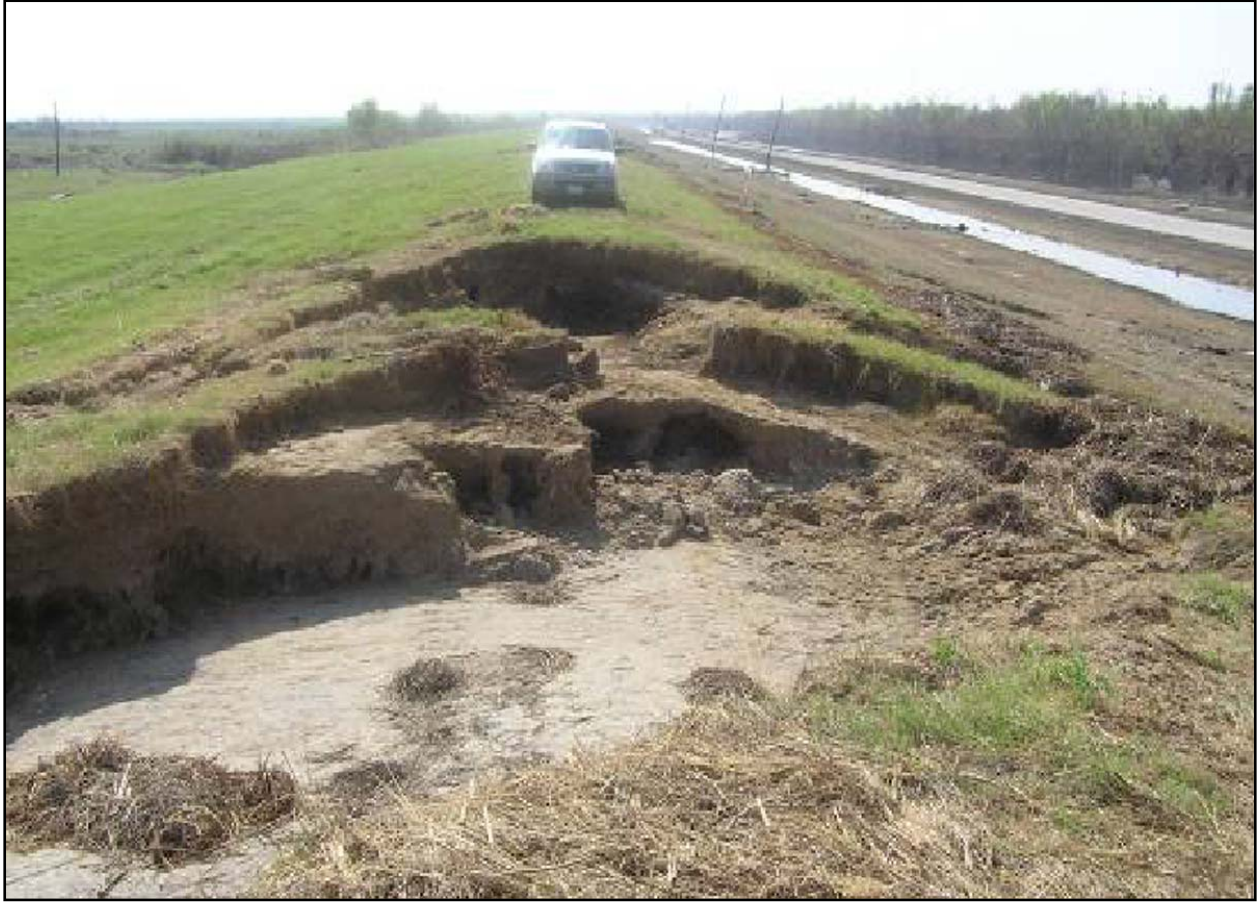
Figure 13-59 shows a section of Plaquemines Parish east bank back levee along Reach C (Phoenix to Bohemia, between river miles 59.3 and 44.3). Approximately 3 miles of crown erosion were noted along this 16-mile reach. This levee is approximate elevation 17 ft, and consists of a hydraulic-filled sand core with trucked-in clay blanket cap. Note the erosion has cut through the clay cap, moving clay blocks as erosion progressed downward to the sand layer.

Figure 13-59. Plaquemines Parish East Bank Back Levee Erosion

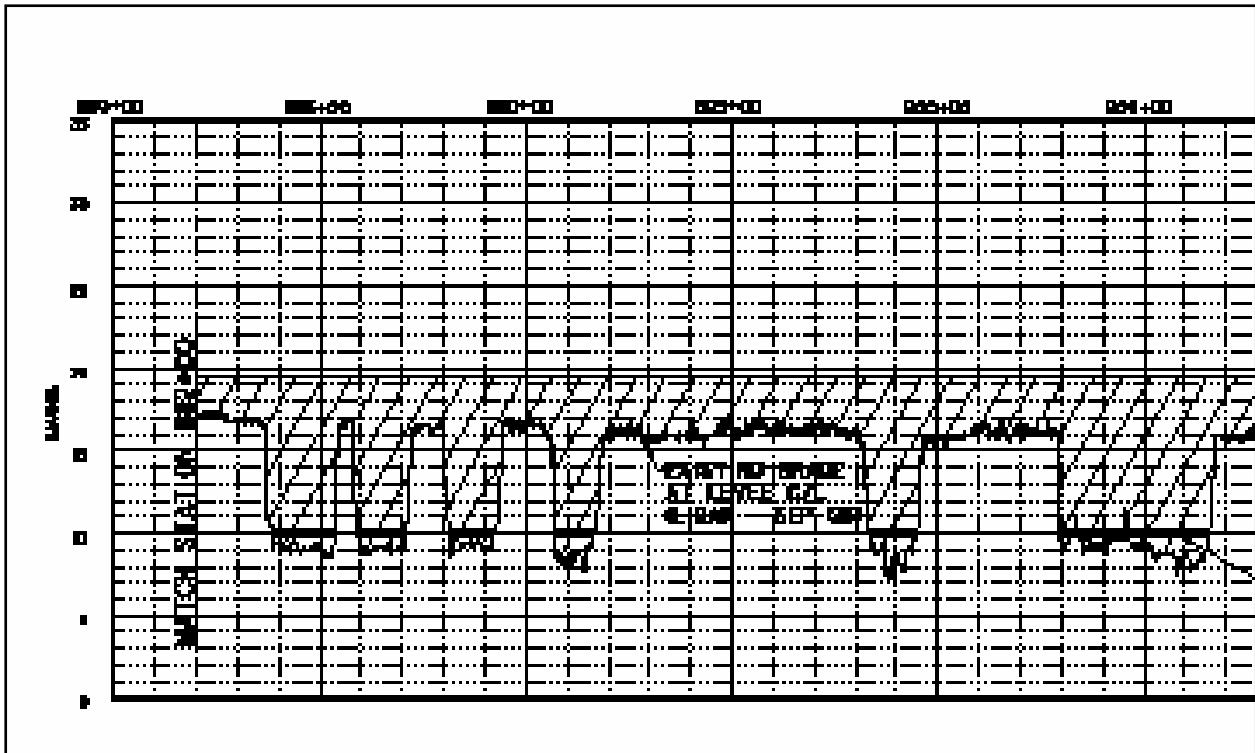
Figure 13-61. LIDAR Profiles of Levee East of Pump Sta 15 (from Contract Solicitation NOE1 drawings)

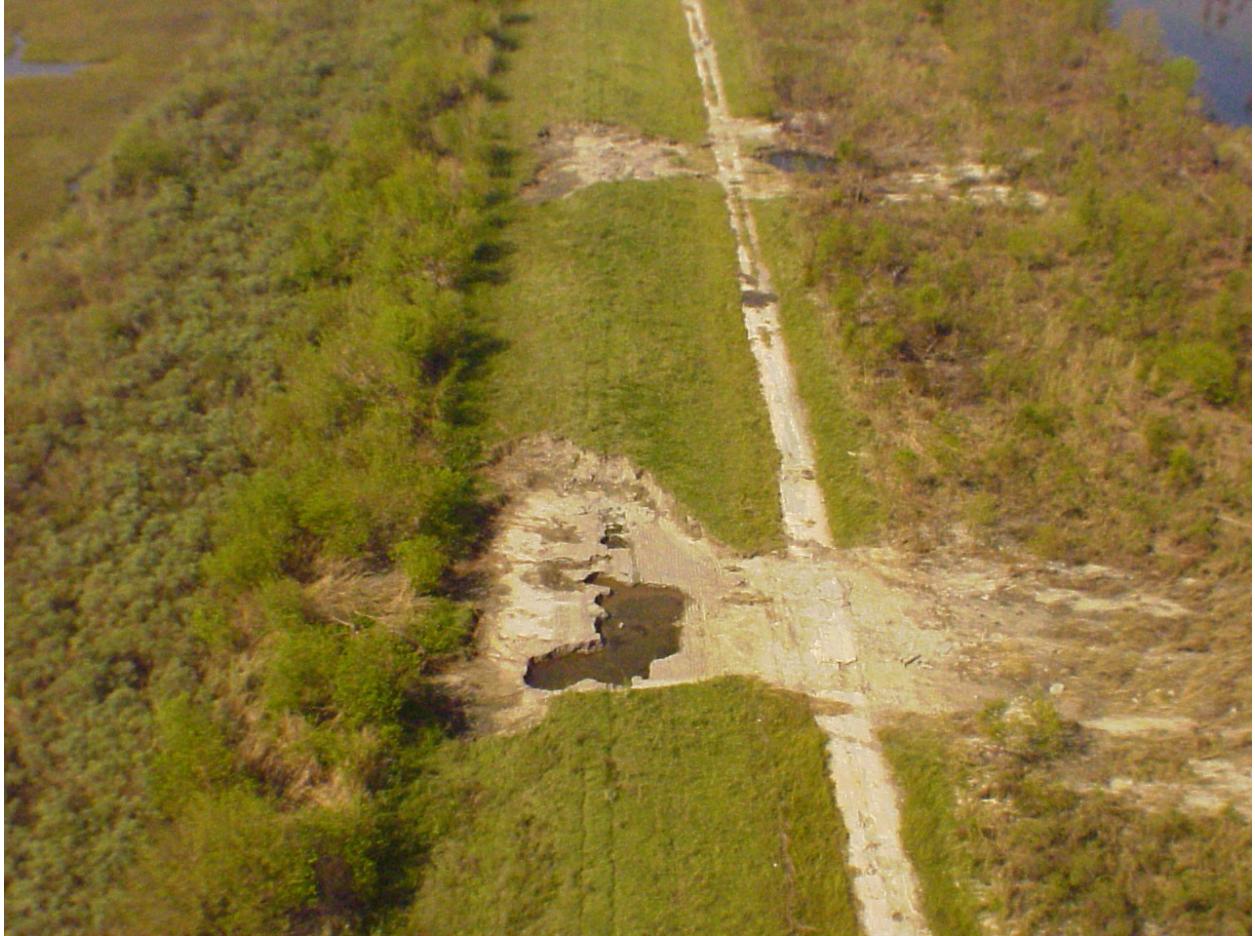
Figure 13-62. Partial Breach East of Pump Station 15

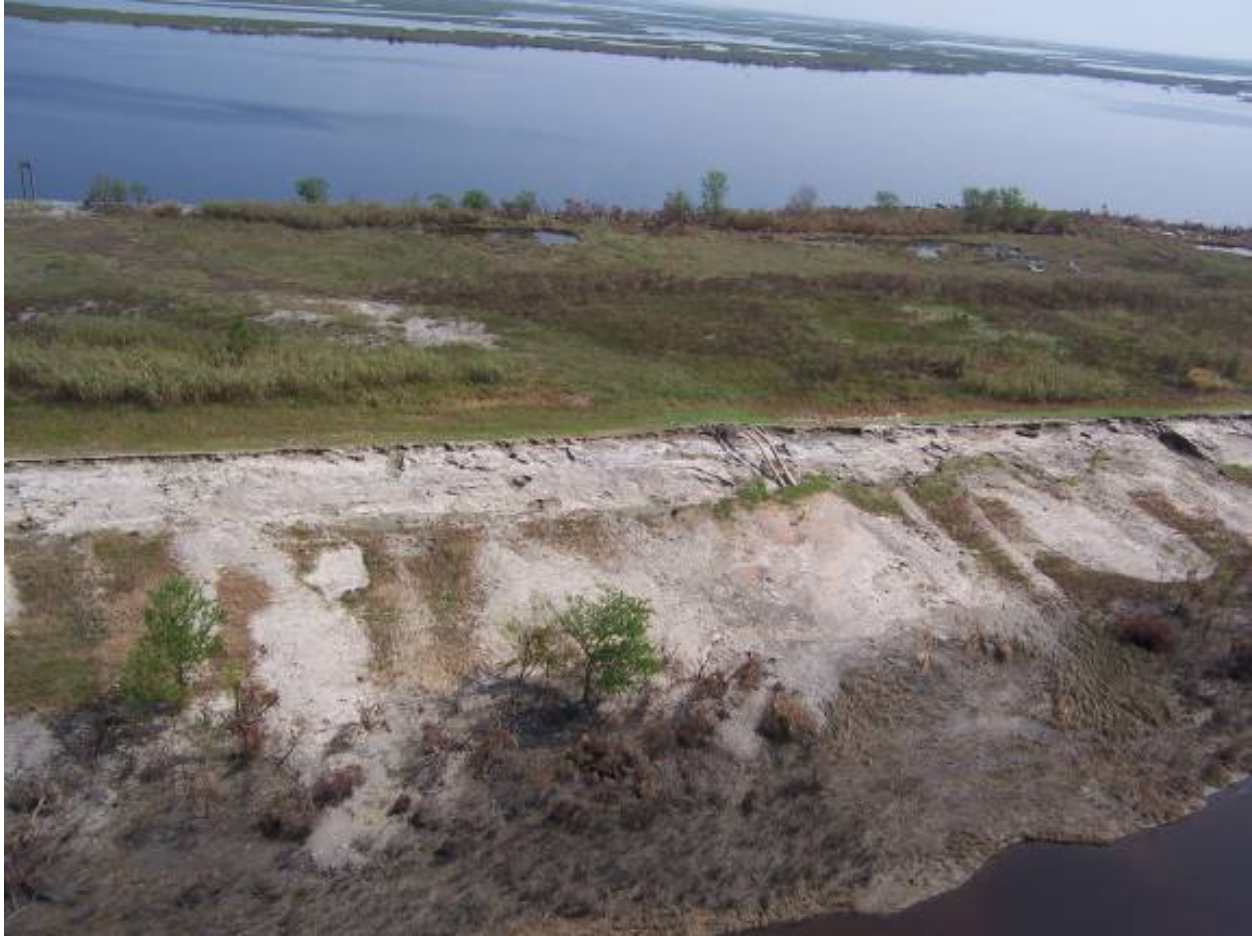
Figure 13-63. 19,000 ft. of Levee Between Bayou Bienvenue (Sta 383+00) and Bayou Dupre (Sta 704+00) Lost Approximately 12' of Levee Height From Original (design) Height 17.5 ft. Pre-Katrina elevation was approximately 12 ft, and storm surge along the MRGO was approximately 18 ft, causing an overtopping crest of up to 6 ft

Hydraulic fill from the MRGO channel formed the levee between Bienvenue and Dupre. Soil boring 9BU-CHBD (01-16834) from 2001 at Sta 445+00 shows the top 1.5 ft of the levee (elevation 18.1 ft) was composed of lean clay (CL). The underlying layers are mostly fat clay (CH) with interbedded lean clay layers. At a depth of 9.7 ft below the crown, a shear Q test indicated cohesion value 238 psf at 32% water content and 88 pcf dry density in a CH layer.

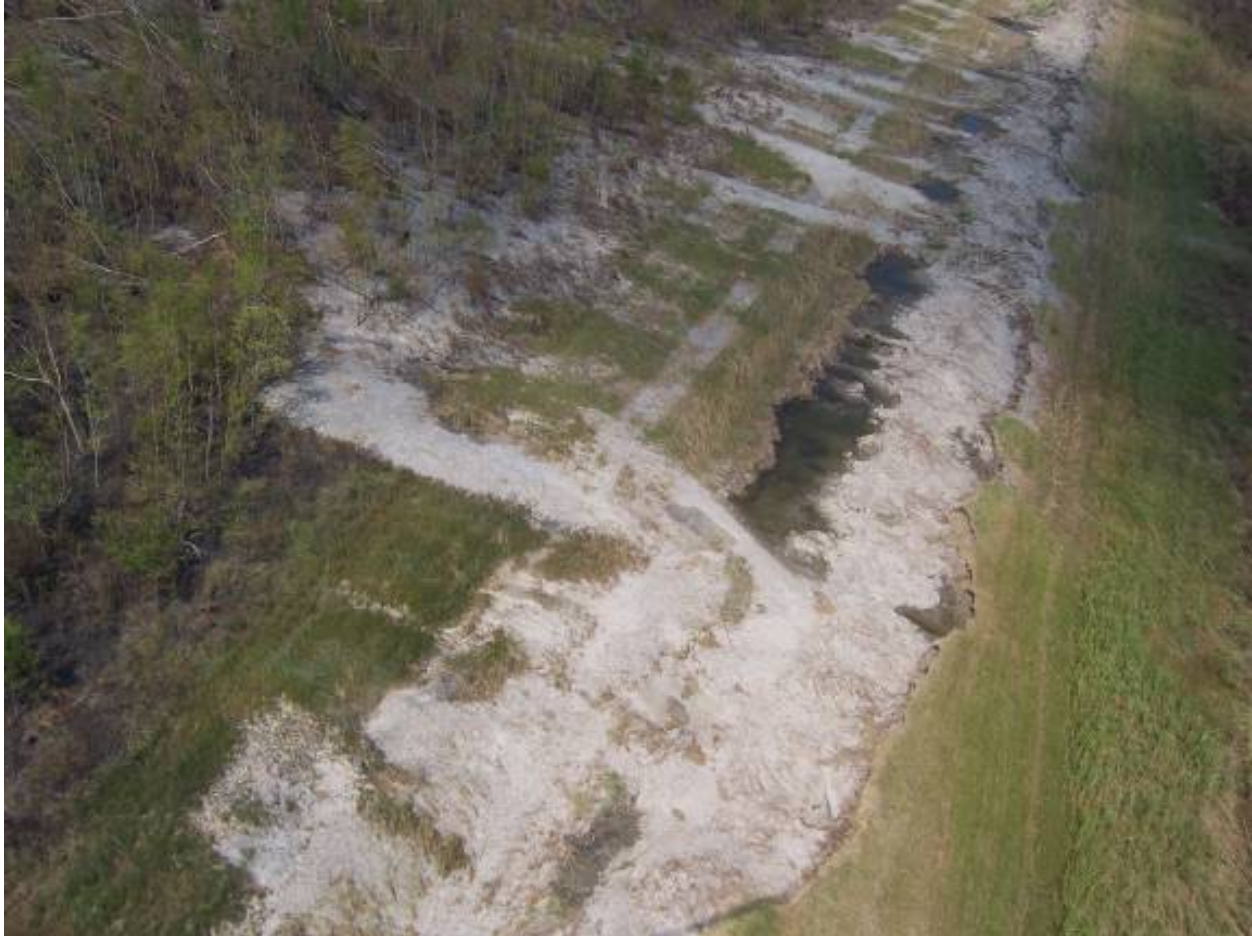
Figure 13-64. 2,300 ft. of Levee Between Bayou Bienvenue (Sta 383+00) and Bayou Dupre (Sta 704+00) That Only Lost 50% of Height

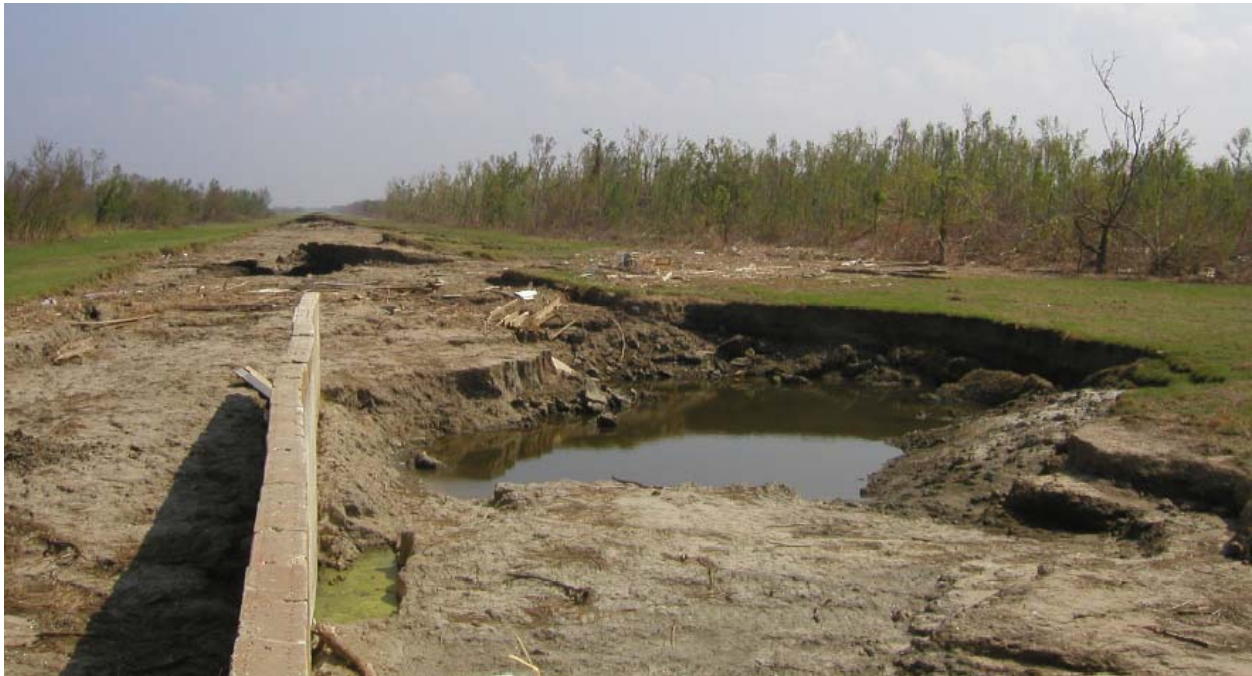
Figure 13-65. Wall / levee on the Southeast Side of Bayou Dupre Control Structure

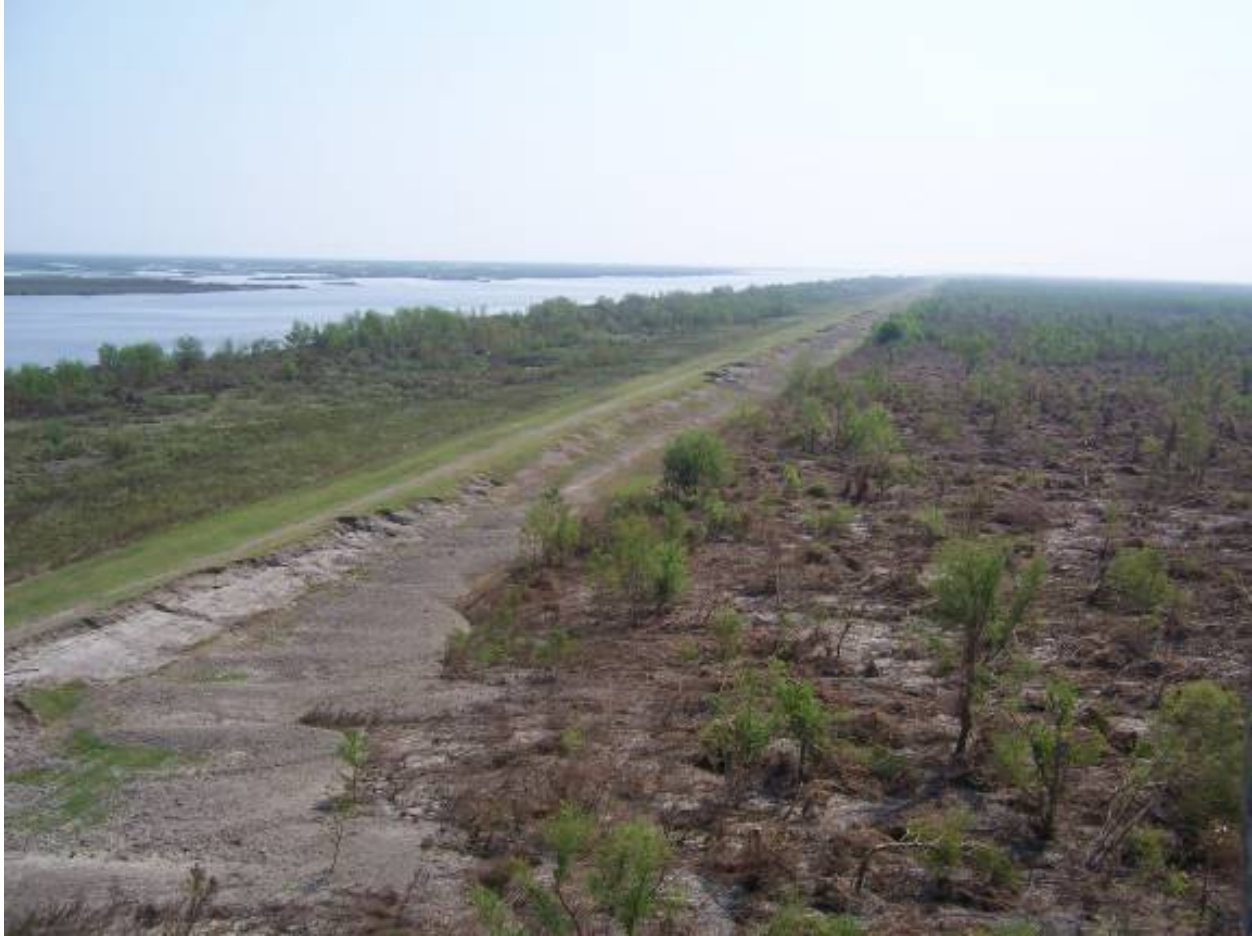
Figure 13-68. 2,500 ft. of levee along MRGO from Bayou Dupre to Sta 1007+91 that lost approximately 8' of elevation

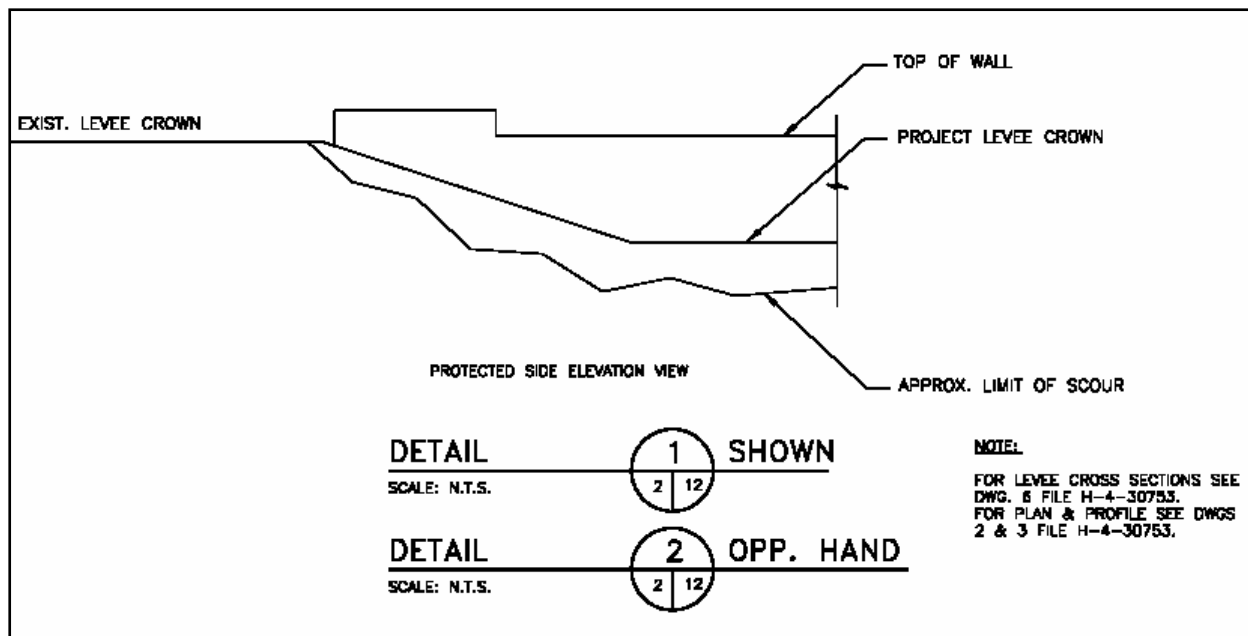
Figure 13-70 shows non-breaching scour caused by overtopping behind the concrete floodwall at closure gates S2 and S3 on the east side of the IHNC. Although the earthen levee abuts the concrete wall, the majority of scour occurred behind the concrete wall. Figure 13-71 depicts the scour pattern that developed along the levee slope behind the wall instead of the levee slope on the abutting earthen levee.

Figure 13-71. S2/S3 Erosion Pattern (From Levee Restoration, Misc. Gates and Floodwall Repairs, IHNC to Bienvenue, Chalmette Area Plan Emergency Restoration solicitation W912P8-06-R-0022, October 2005 contract drawing H-8)

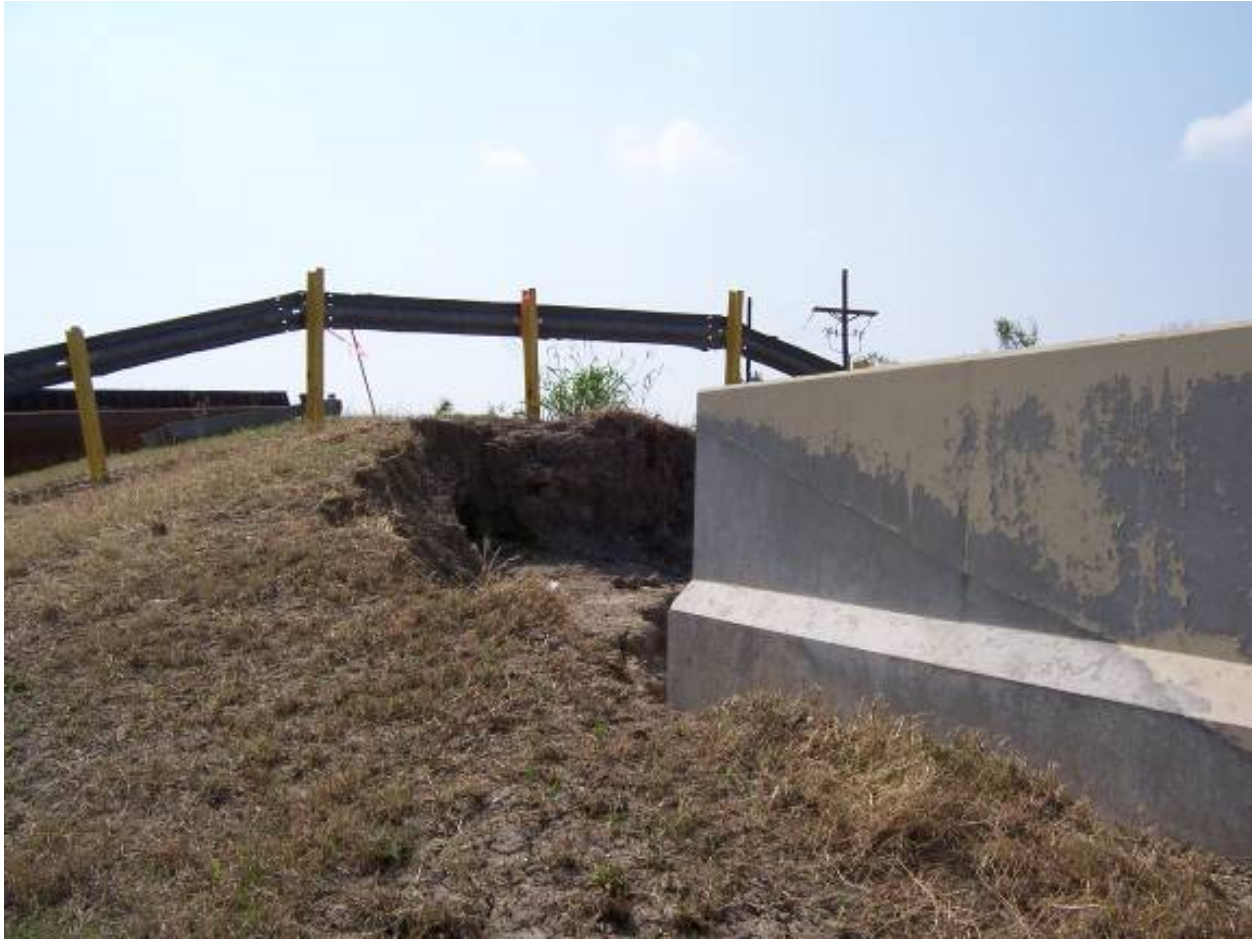
Figure 13-73 shows breached levee erosion at east end of floodgate structure S5, located about 100 yards west of the Bayou Bienvenue control structure. Although the levee was higher

than the wall (Figure 13-74) beyond the transition, it appears that the overtopping erosion began at the wall / levee transition where the wall was higher than the soil backfill.

Figure 13-73. Floodgate S5 Near Bienvenue Control Structure

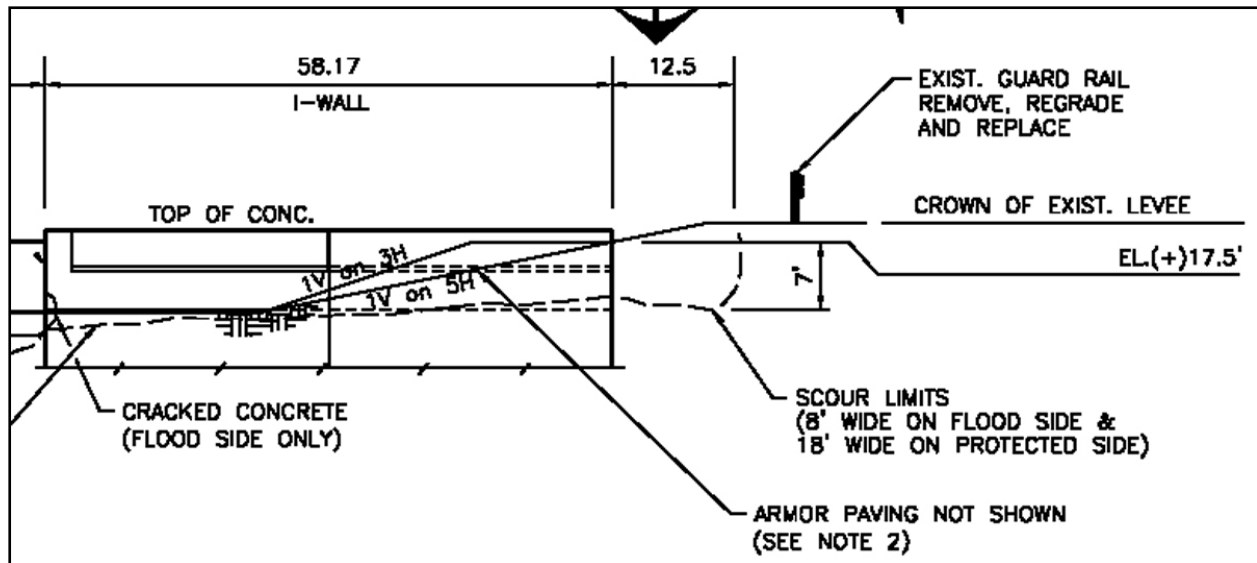
Figure 13-74. Scour pattern (From Levee Restoration, Misc. Gates and Floodwall Repairs, IHNC to Bienvenue, Chalmette Area Plan Emergency Restoration solicitation W912P8-06-R-0022, October 2005 contract drawing H-8)

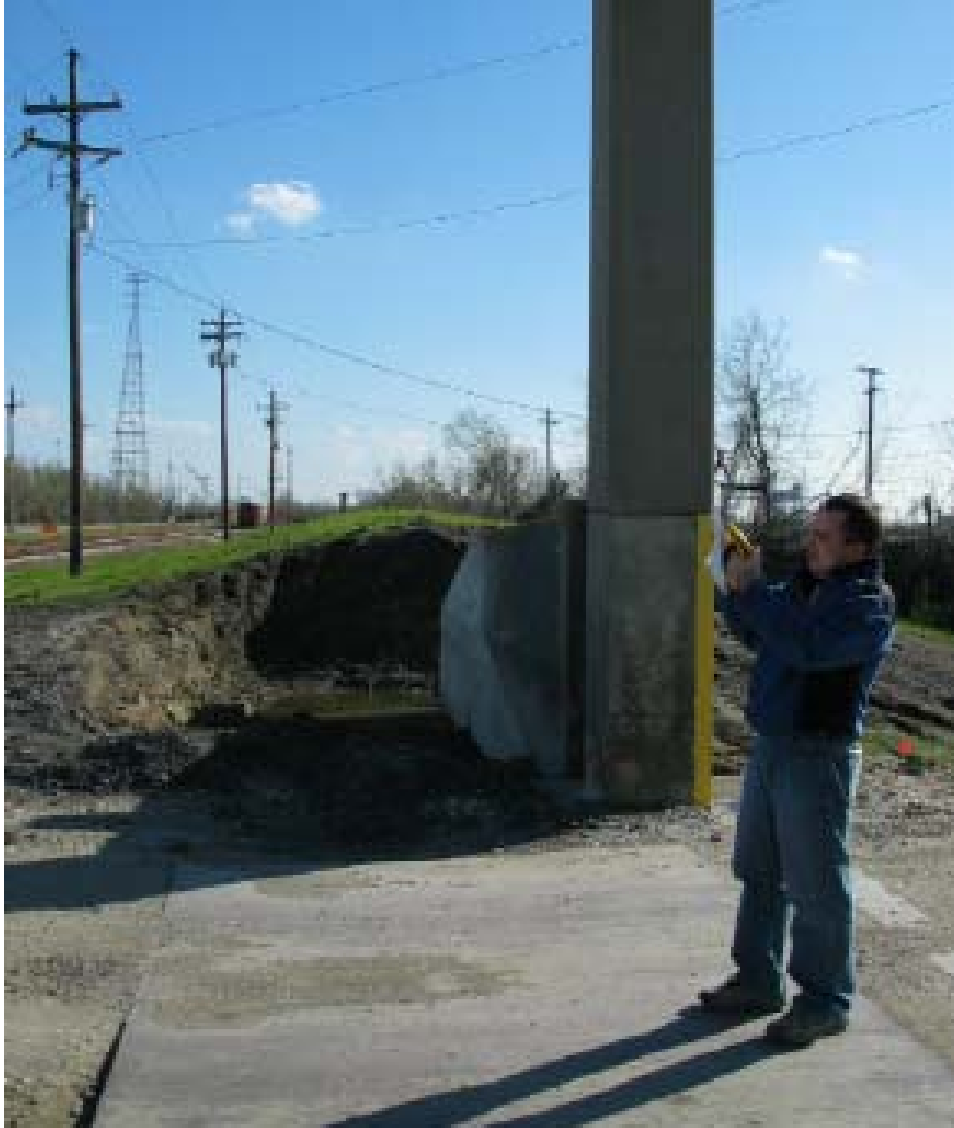
Figure 13-75 shows an earthen levee breach at east side IHNC floodgate E5 looking south from inside the protected area. Scour damaged 7' (w) x 7' (d) around the adjacent flood wall. Top of wall at gate is approximate elevation 13 ft.

Figure 13-75. IHNC Floodgate E5 Transition to Levee

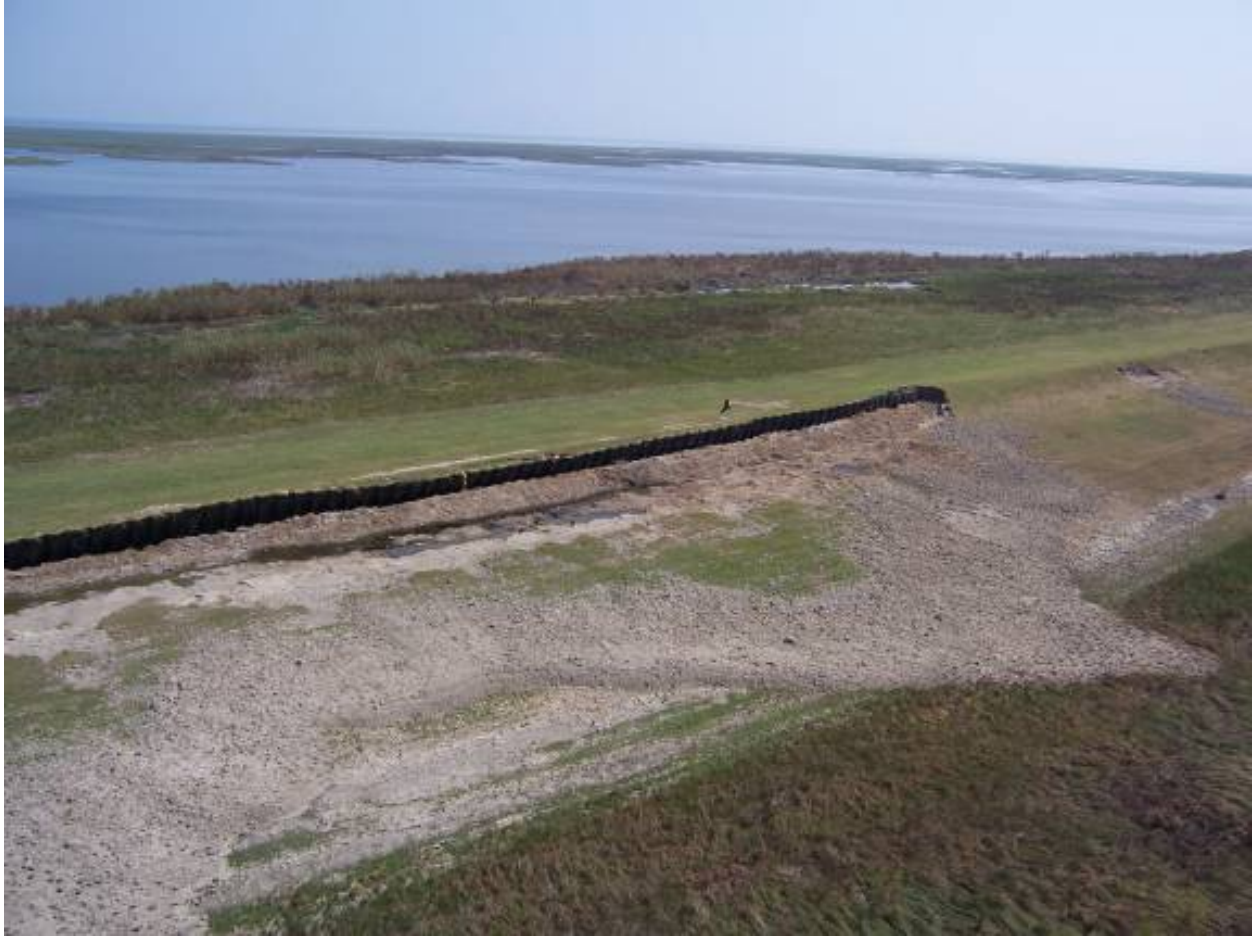
Figure 13-76. End of Sheetpile Wall at B/L Sta 980+58, along the MRGO (St. Bernard Parish). Note that scour occurred along the sheetpile wall and minimally beyond the levee transition. Approximate sheetpile elevation was 17 ft and levee crown elevation was 13 ft. Beyond the transition, the levee crown elevation was approximately 17 ft. The approximate storm surge overtopping crest was 4 ft over the sheetpile and 1 ft over the transition levee

Pre-Katrina soil boring 10-CUHA (91-02) from 1991 at Sta 976+00 in the sheetpile reach shows the top 4 ft of levee (elevation 13) was composed of lean silt and clay (ML and CL) with CH layers underneath. At a depth of 4.6 ft below the crown, a shear Q test indicated cohesion value 770 psf at 45% water content and 75 pcf dry density in the uppermost CH layer.

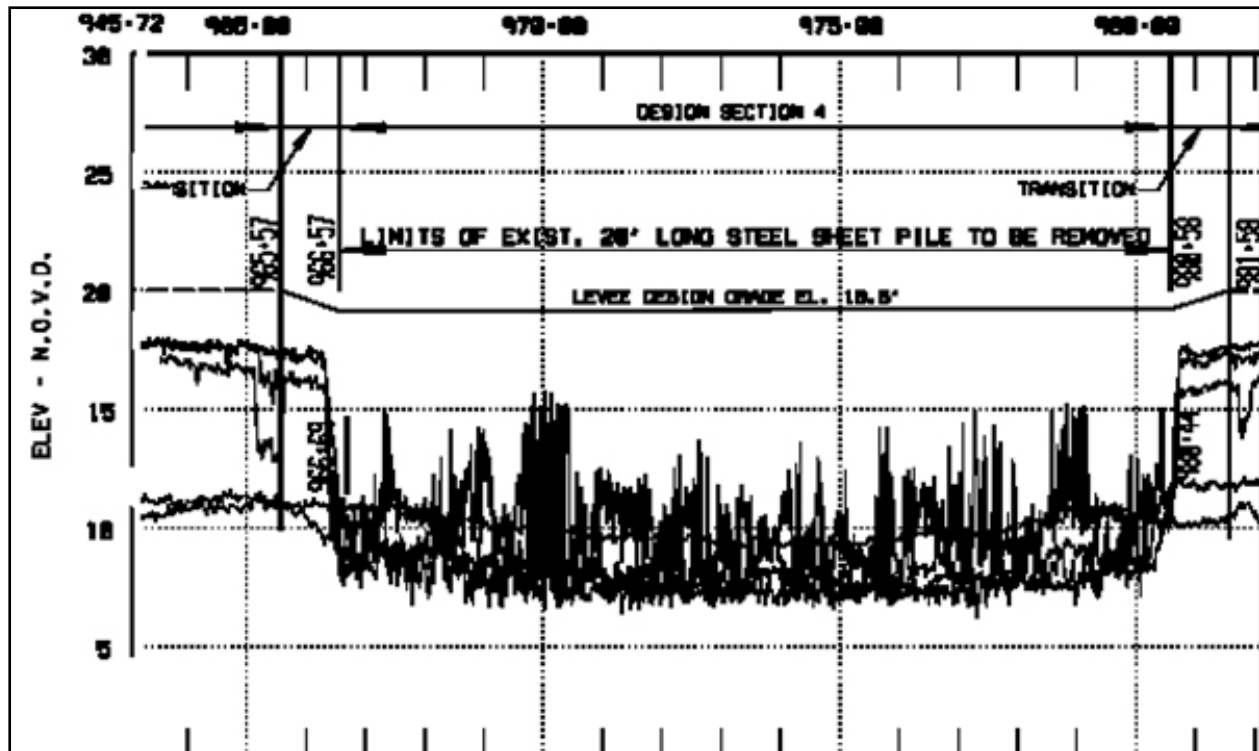
Figure 13-78. Scour Depths Along Sheetpile and at Transition to Levee. Note that scour occurred along the sheetpile reach, not at the sheetpile / levee transition (also seen in Figure 13-76), from drawing 7 of 10, contract solicitation W912P8-06-R-0002

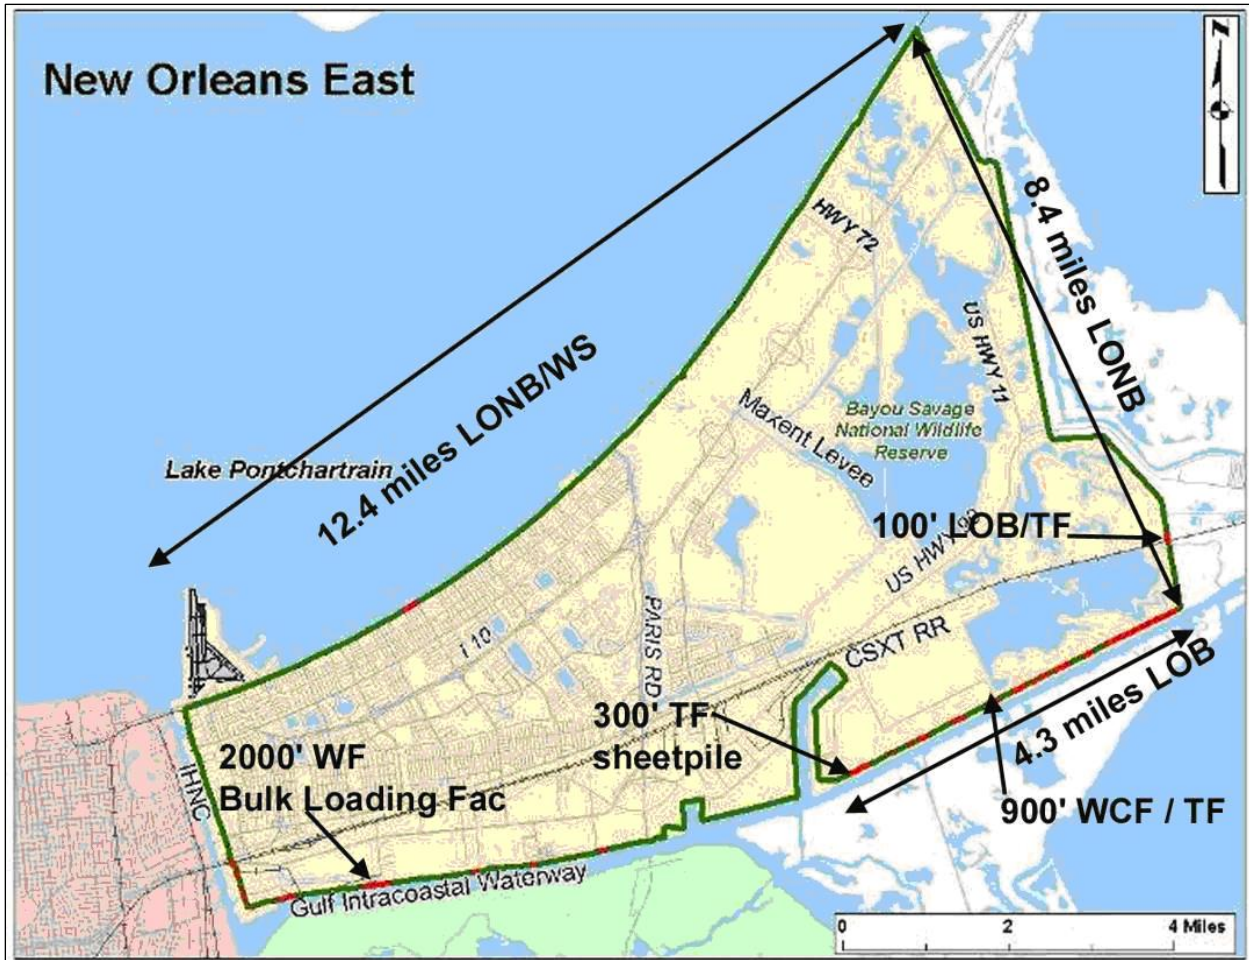
Figure 14-7. New Orleans East IPET Characterization of Damages

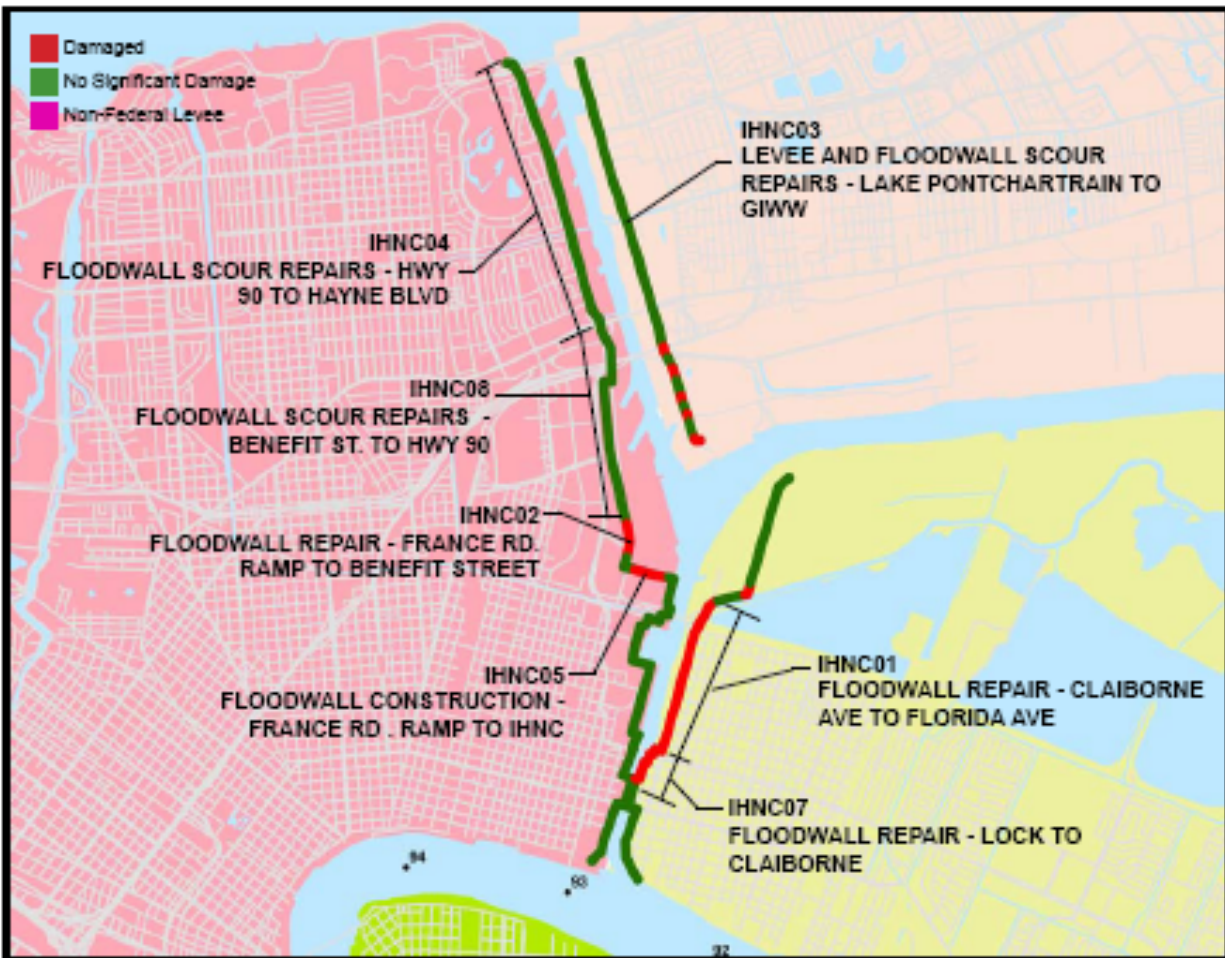
IHNC Damages. Overtopping of the hurricane protection by Hurricane Katrina was evident along nearly all portions of the canal. There were four breaches in the protection system, two on the east side and two on the west side. The east side breaches are both located in the Lower Ninth Ward neighborhood and the west side breaches are both in the vicinity of France Road and Benefit Street.

Figure 14-8. Hurricane Protection Features and Damages– IHNC

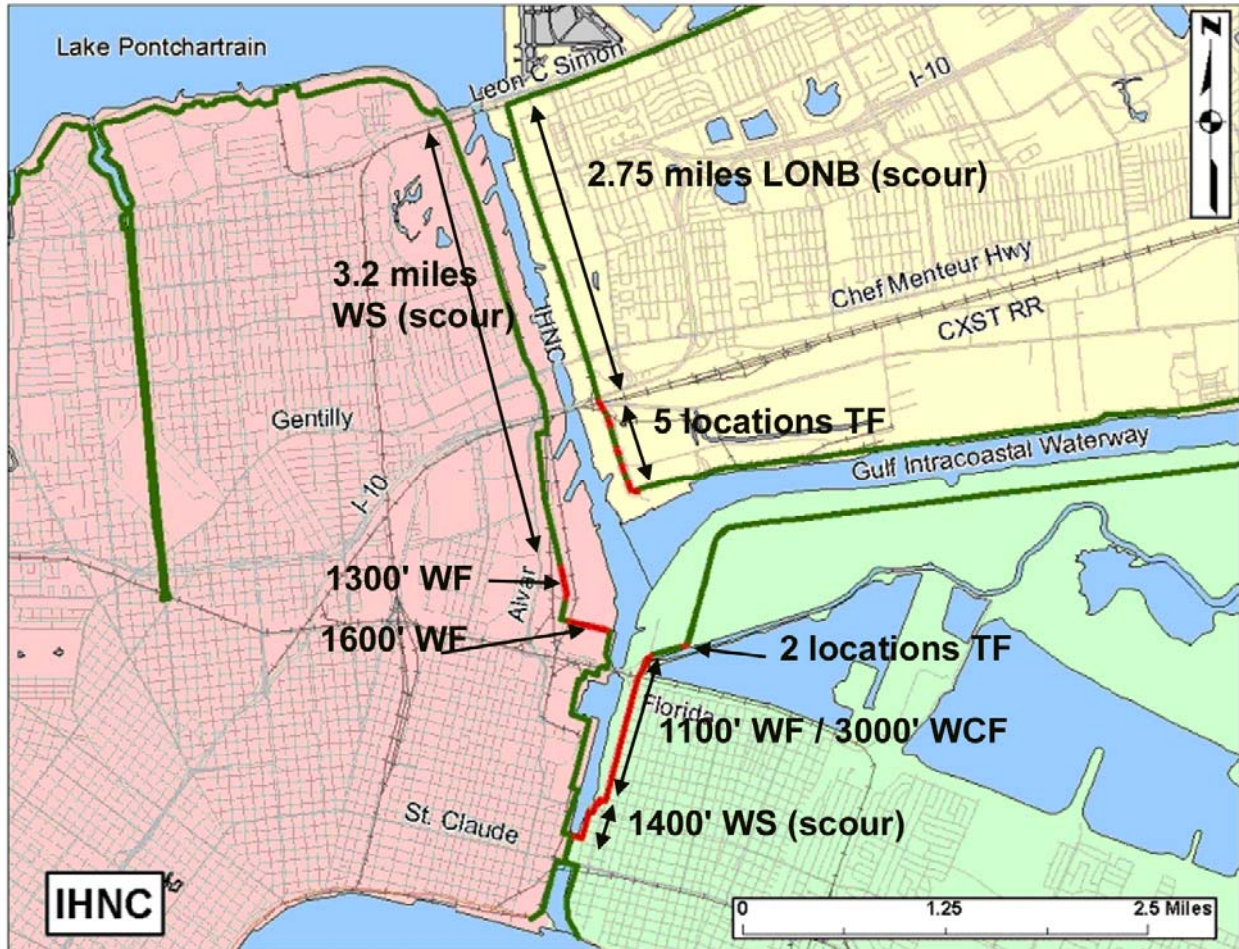
Figure 14-15. IHNC Flood Protection Damage

Overtopping was generally associated with varying degrees of scour (surface erosion), generally on the levee landside.

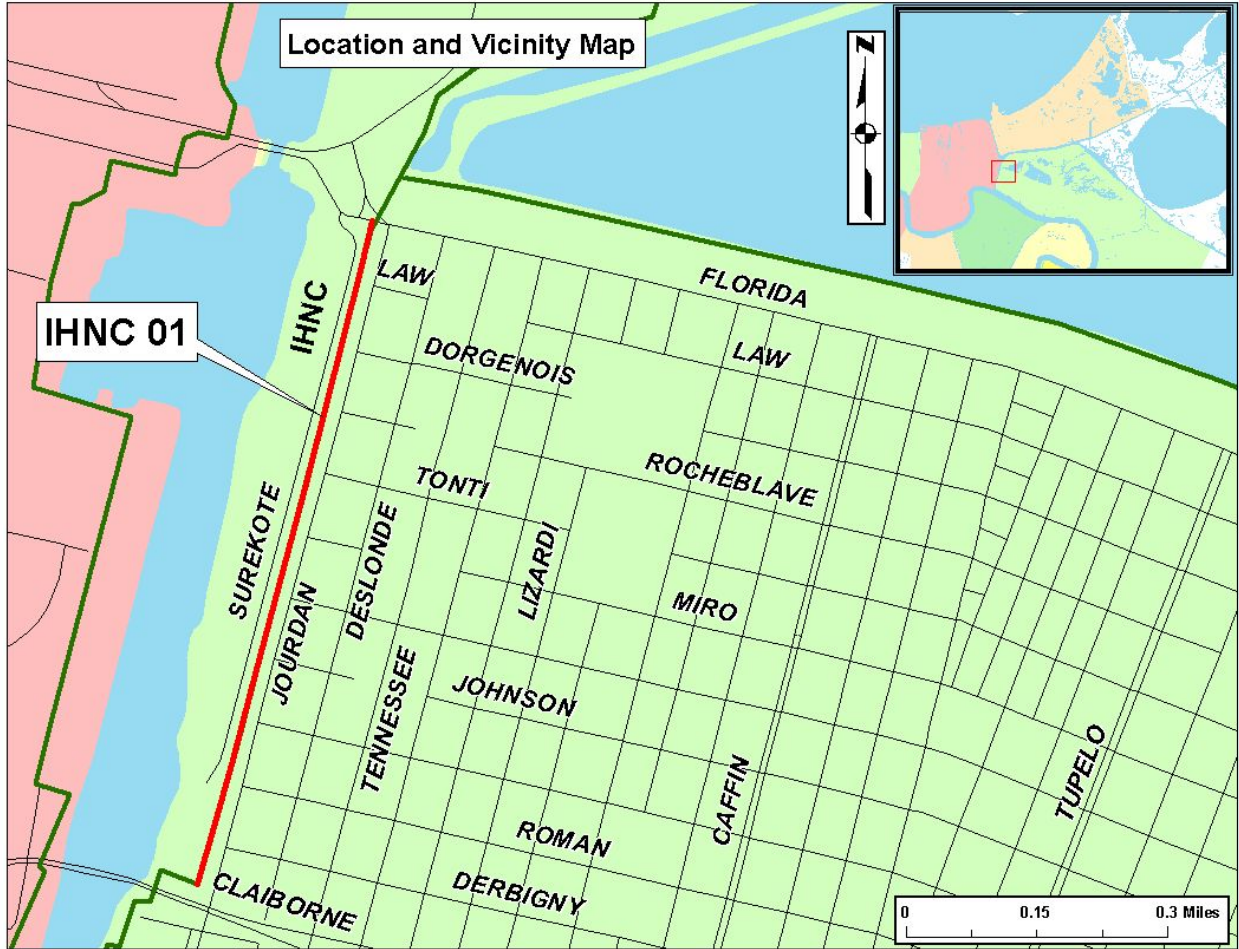
- 250' breach (WF) I-wall, south of Florida Ave
- 850' breach (WF) I-wall, 100 yds north of Claiborne Ave.
- ~3000' (WNF / WCF)

Figure 14-22. East Side IHNC Between Claiborne Ave. and Florida Ave.

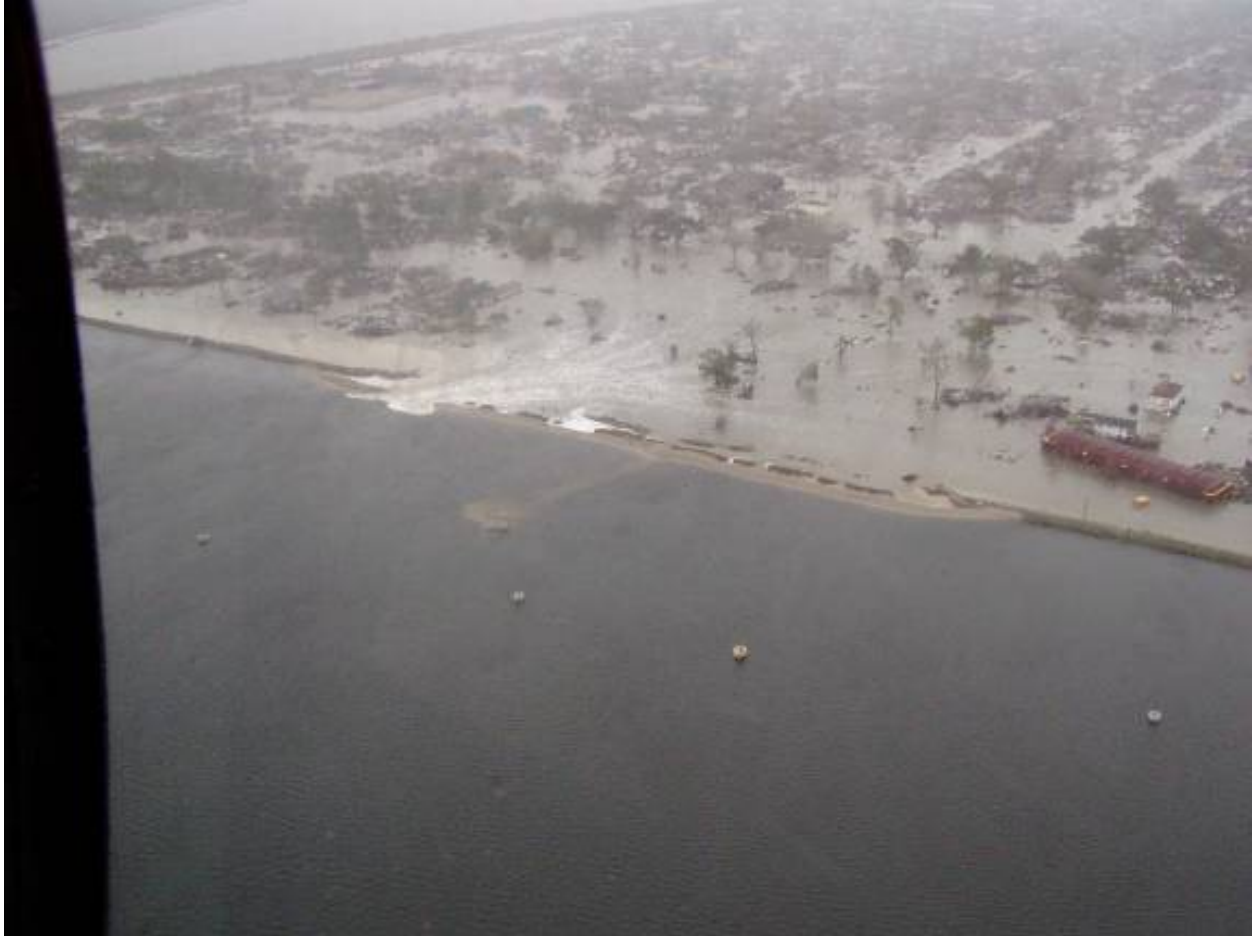
Figure 14-23. During Katrina; View to East Side of IHNC South of GIWW. Breach began approximately 300 ft north of Claiborne Ave.
