Appendix 11

Analysis of Performance of the Inner Harbor Navigation Canal

Executive Summary

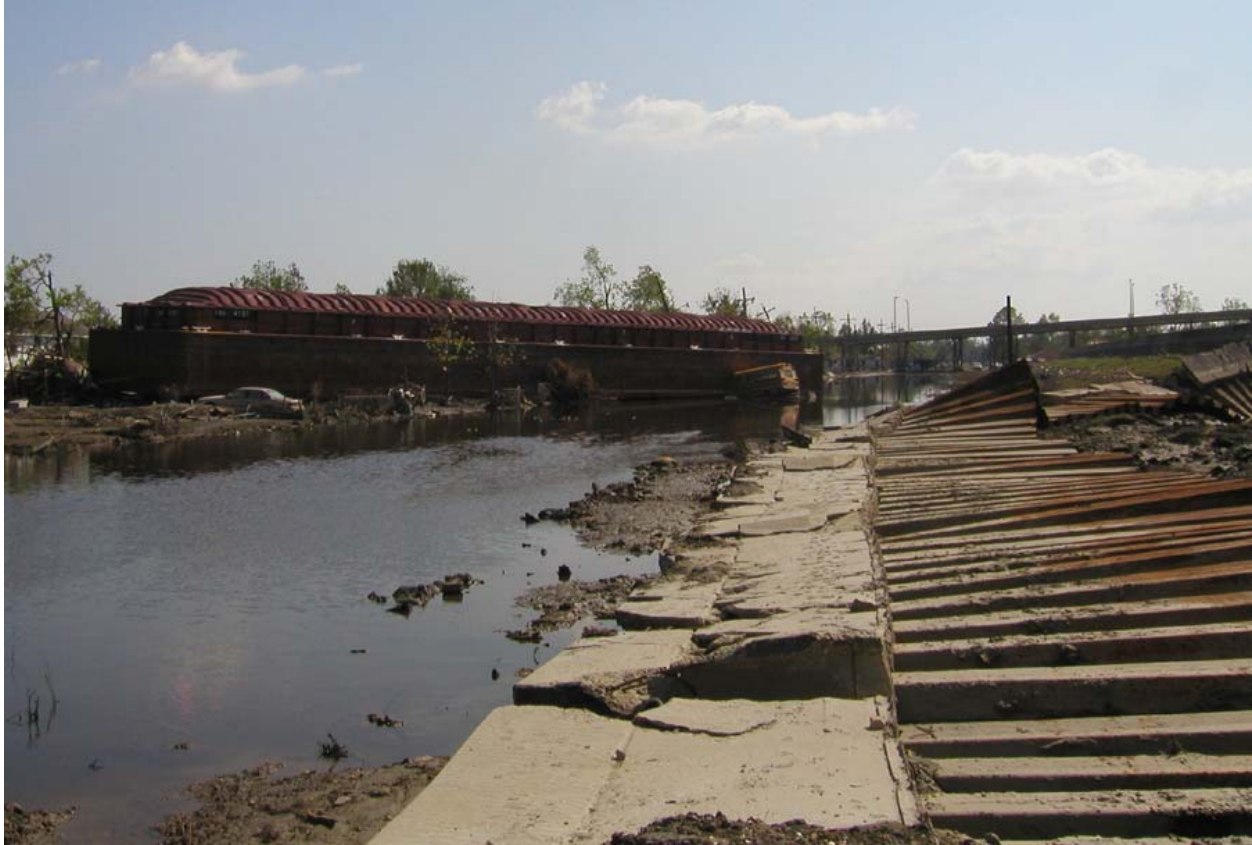
Figure 14-24. Closeup of Flattened I-Wall and Barge, View Toward Claiborne Ave.

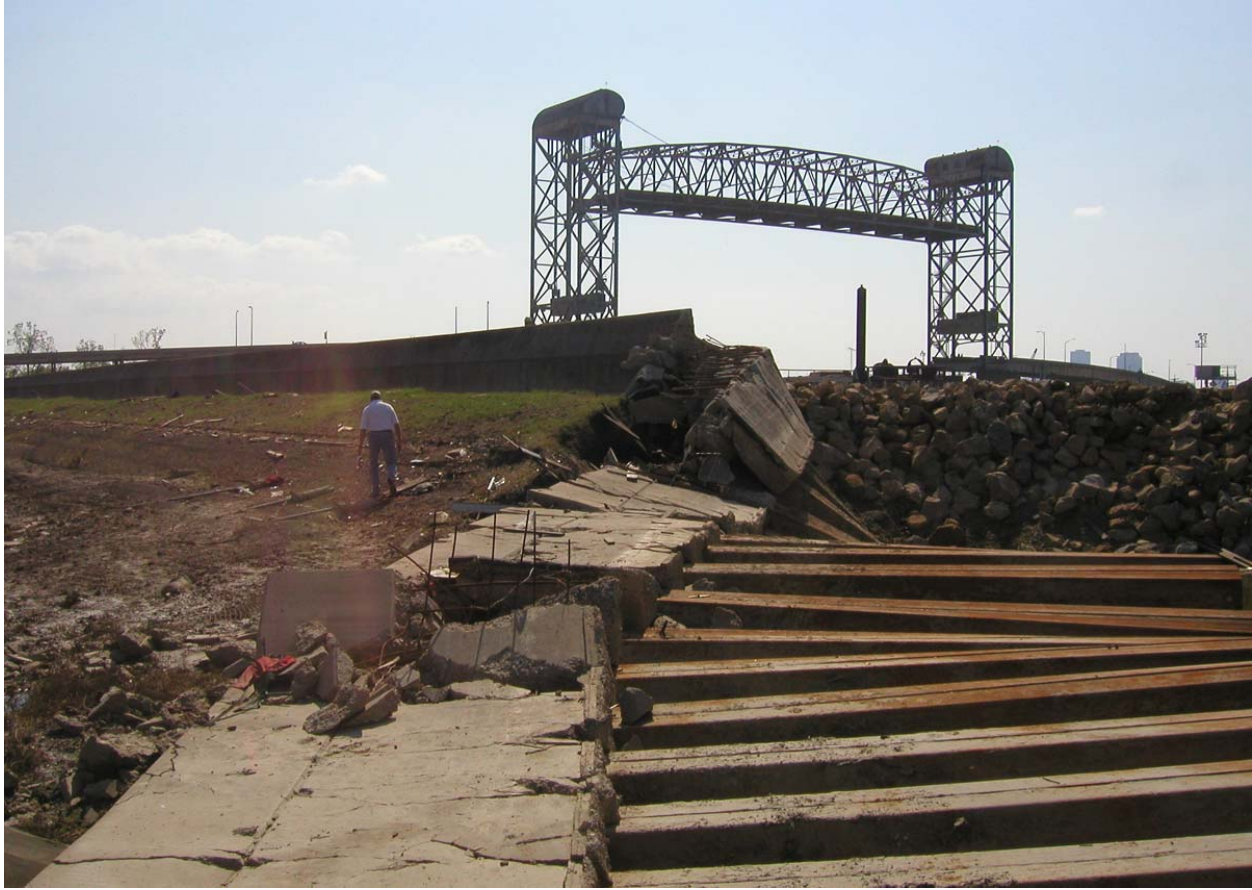
Figure 14-25. Transition From Failed Wall to Intact Wall, View Toward Claiborne Ave.

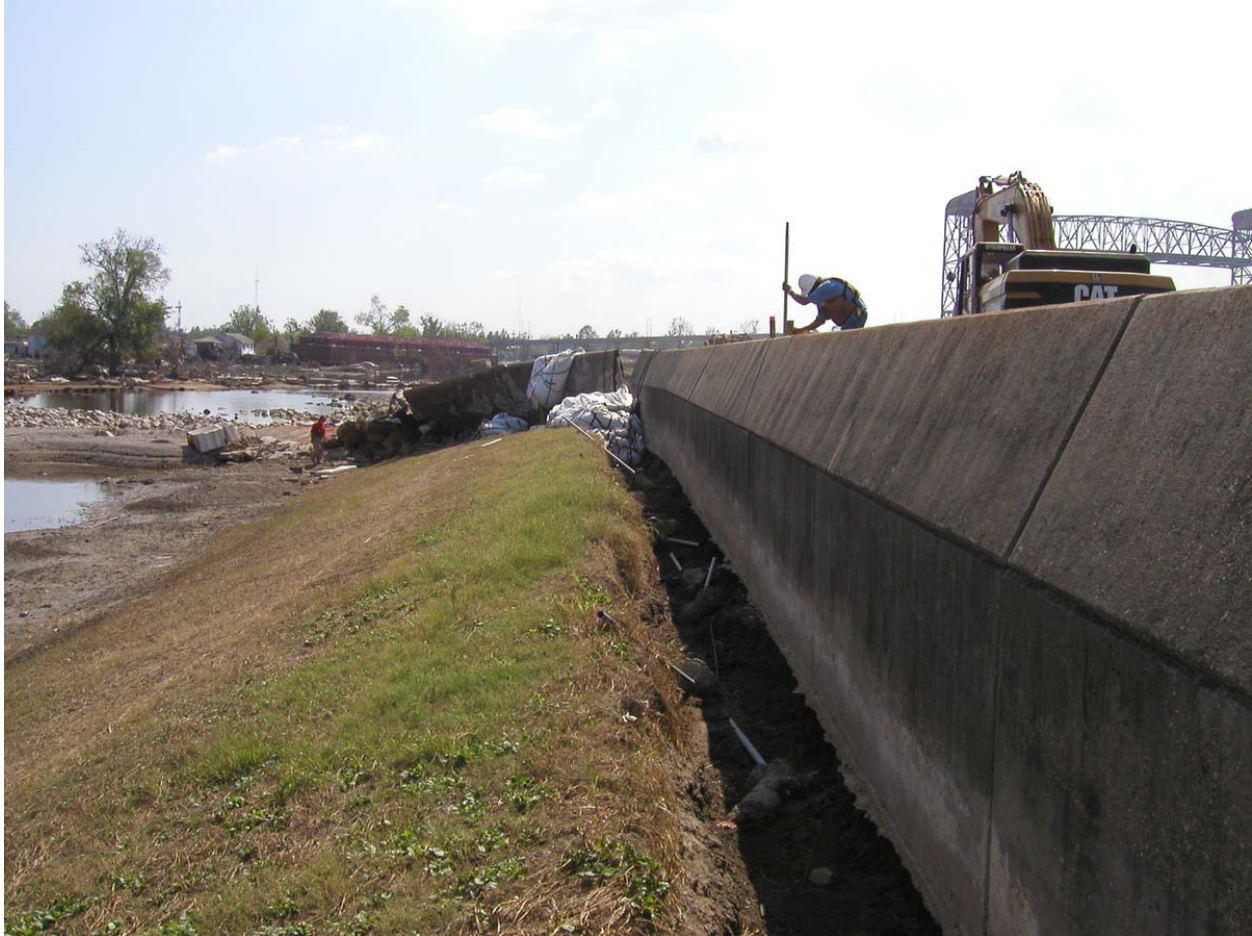
Figure 14-26. Northernmost Transition From Failed Wall to Intact Wall

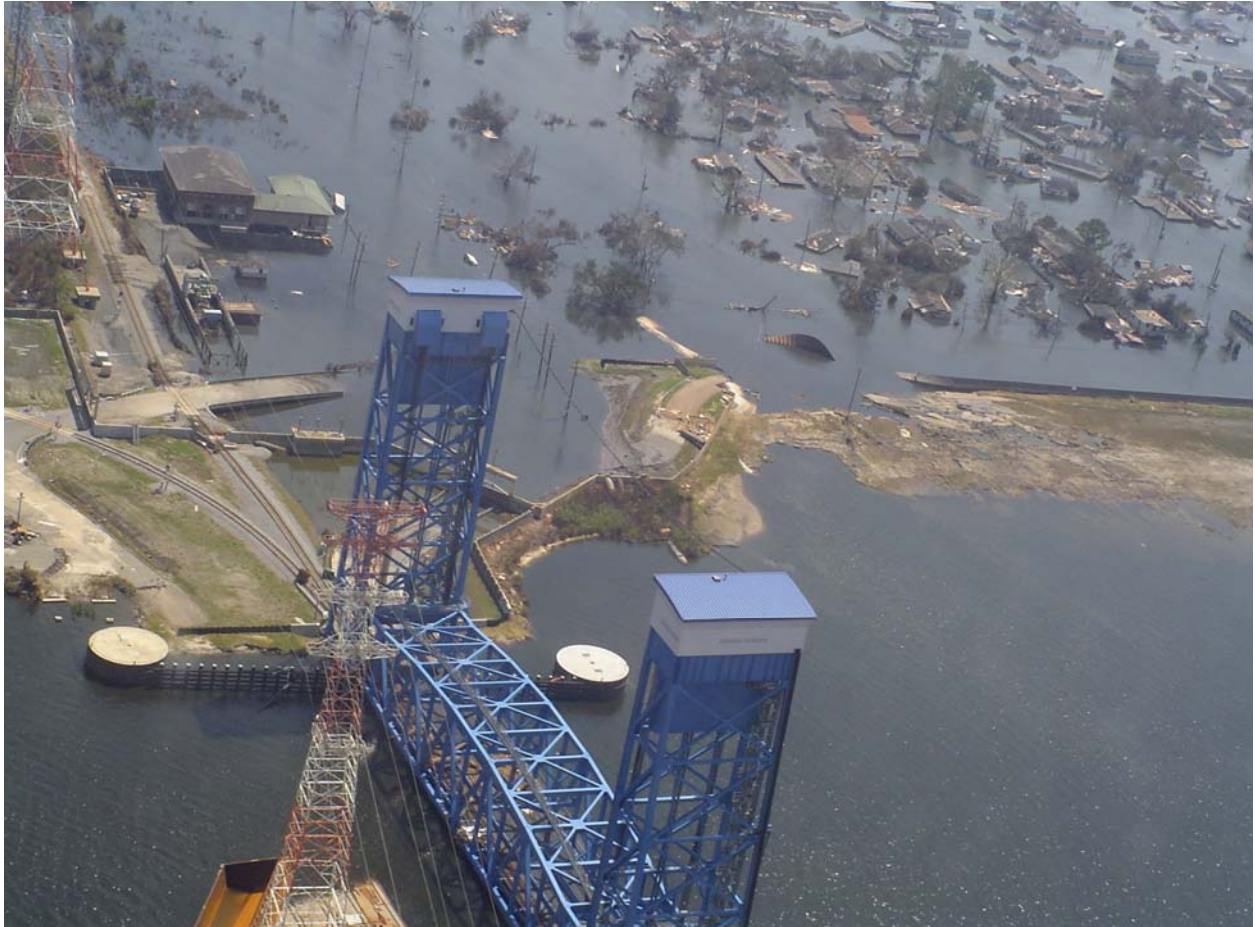
Figure 14-29. Florida Ave Bridge, View East. I-Wall Failure is Seen to Right of Bridge

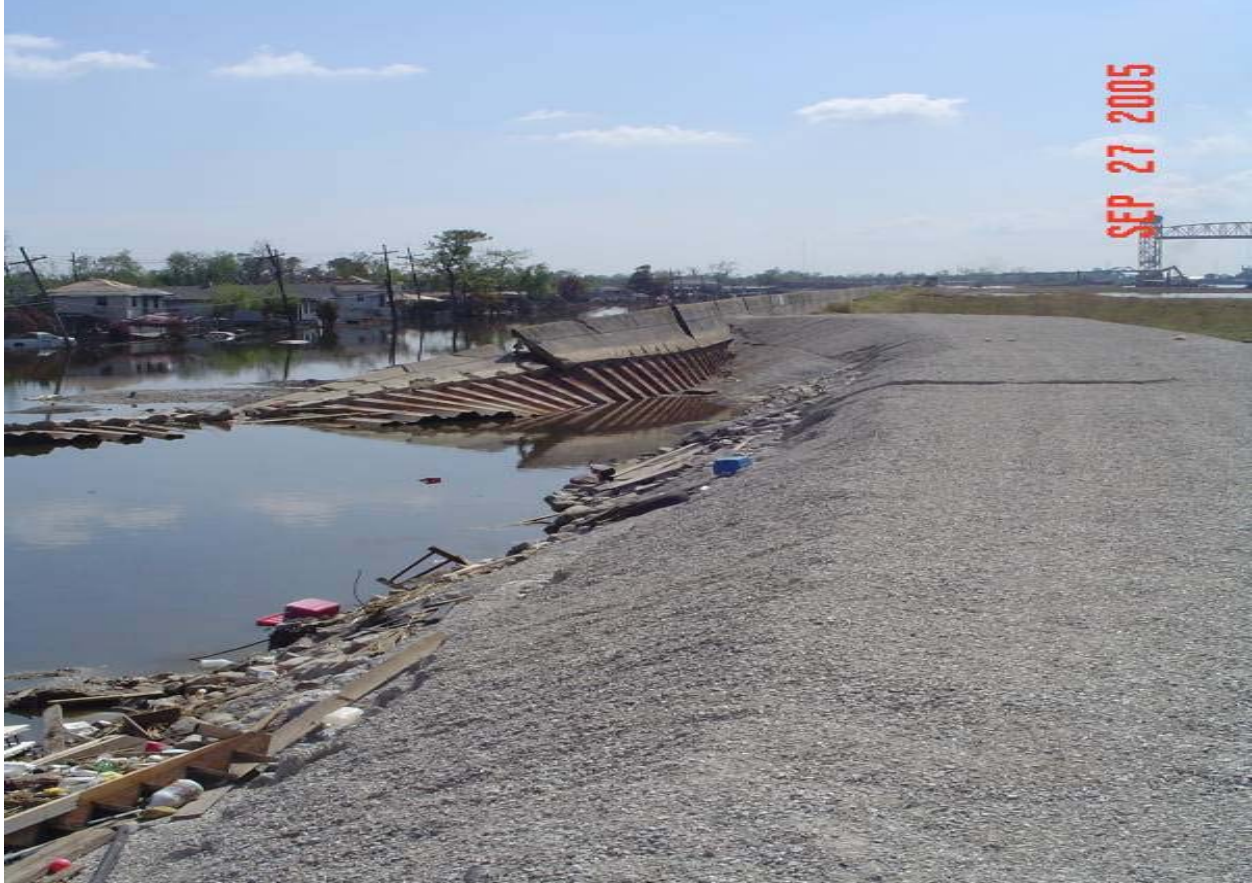
Figure 14-30. Southernmost I-Wall Failure Transition Between Florida Ave and Claiborne Ave.

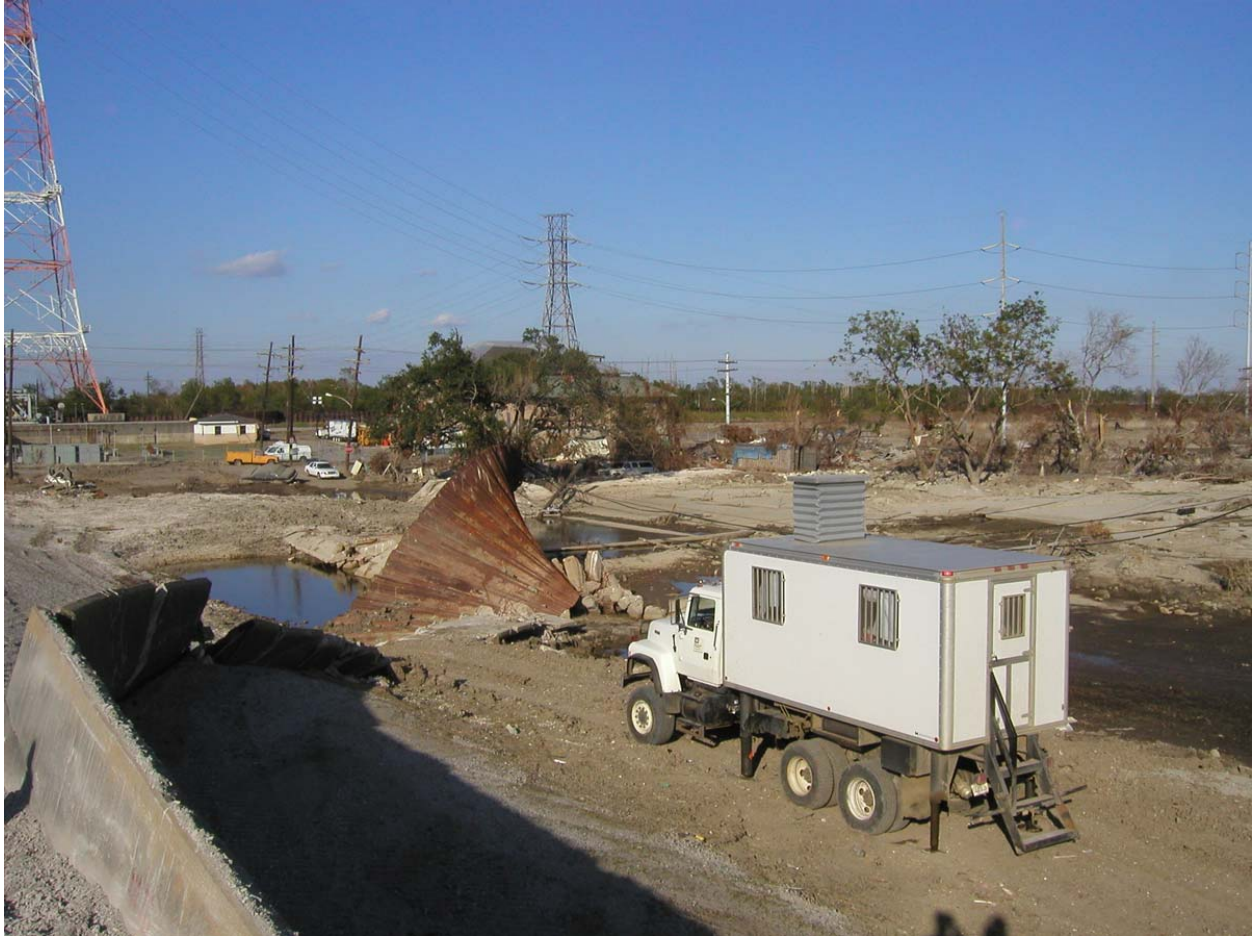
Figure 14-31. CPT Truck at Levee Toe on Protected Side at the Southernmost I-Wall Failure Transition Between Florida Ave and Claiborne Ave., View Toward Pump Station

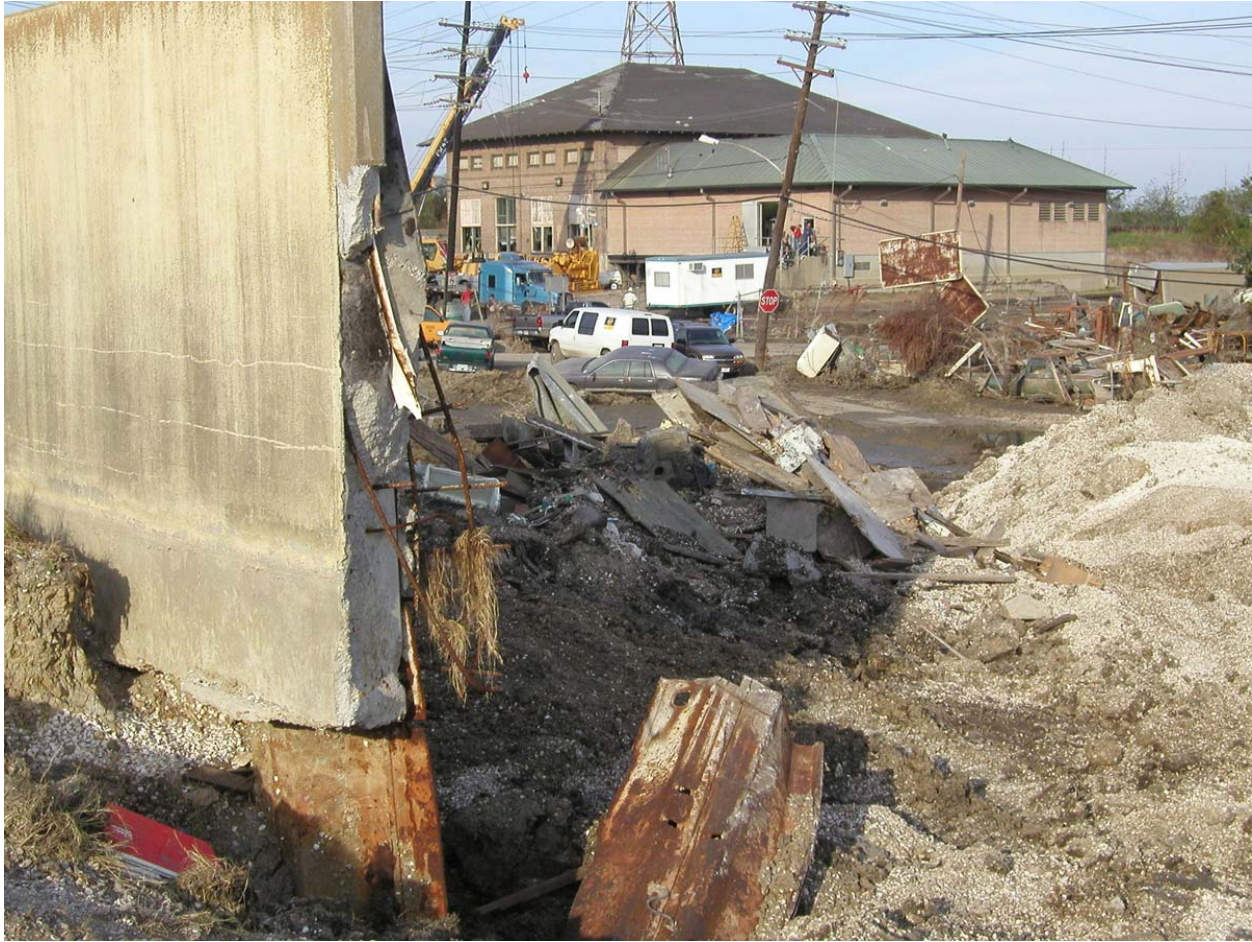
Figure 14-32. Northernmost I-Wall Failure Transition Between Florida Ave and Claiborne Ave., View Toward Pump Station on the Protected Side

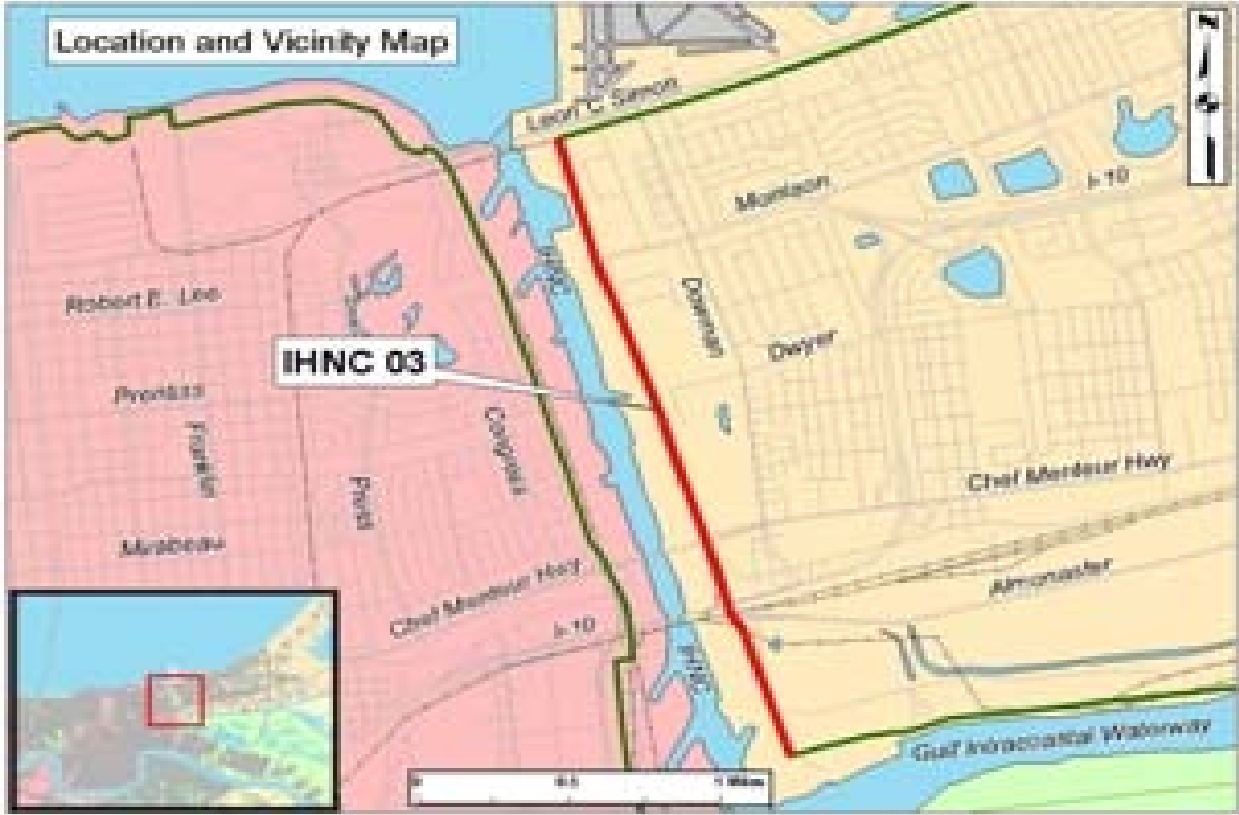
Figure 14-36. Pre-Existing Top of Wall Elevation Along IHNC 03 Was 15 ft. Gate Top Elevations Were 14 ft

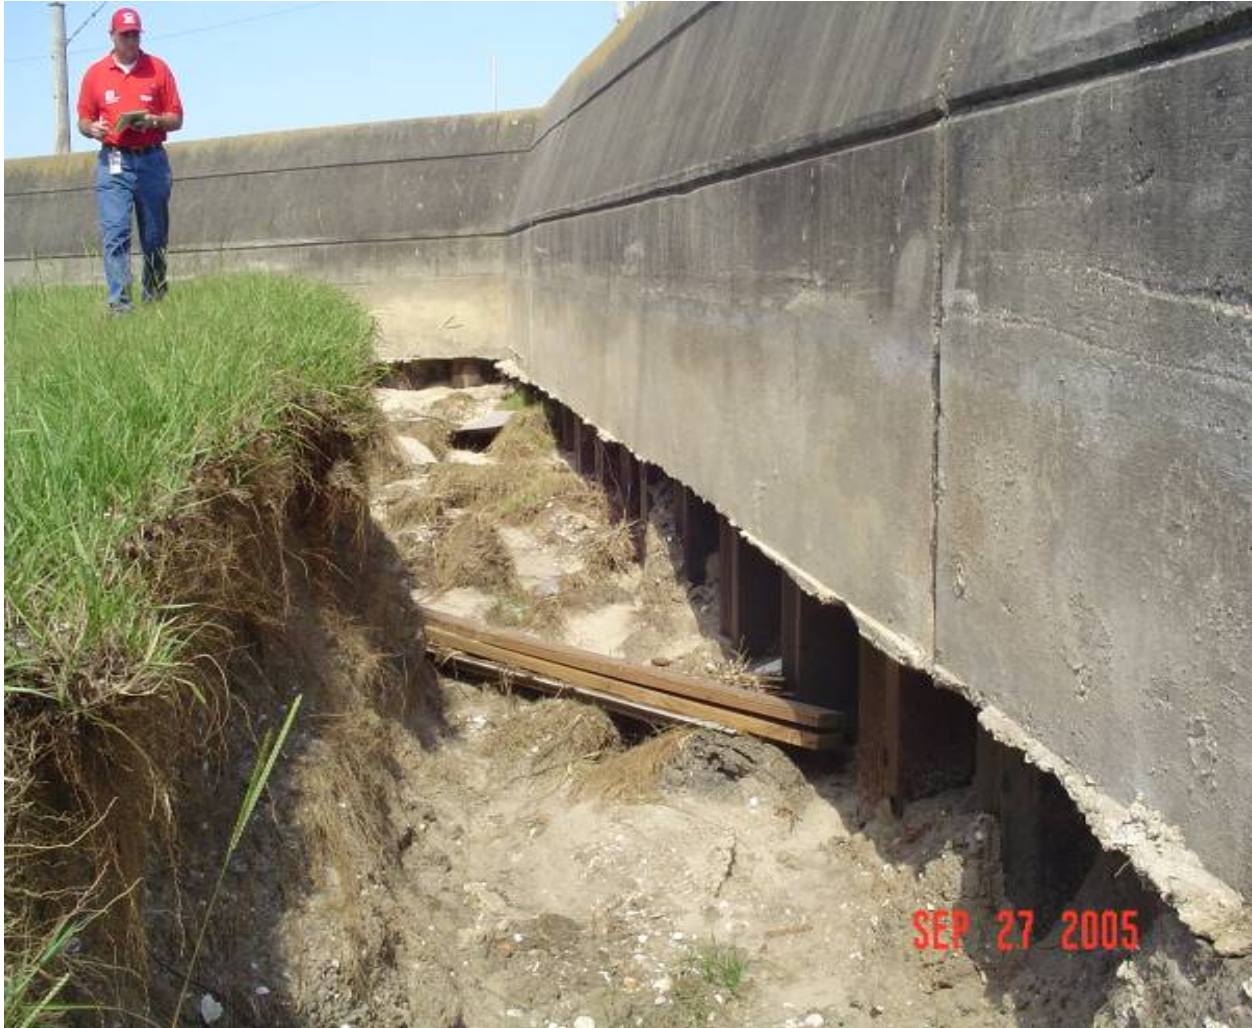
Figure 14-37. Approximate B/L Sta 101+00. Top of I-wall is elev 14.75, bottom of concrete is elev 7, and levee crown is elev 9. Nearest B/L boring is Sta 96+00 (No. 9EU), 500 feet distant

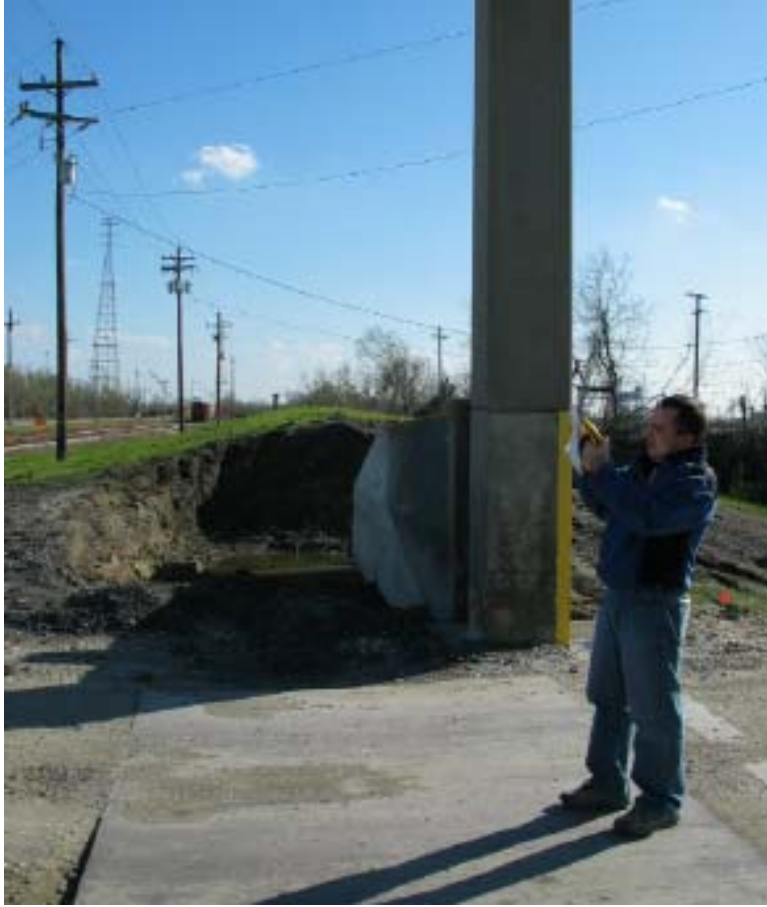
Figure 14-42. Gate E5 Looking South From Inside the Protected Area. Scour damage 7' (w) x 7' (d) around adjacent flood wall. Top of wall at gate is Elev. 13.2 +/-

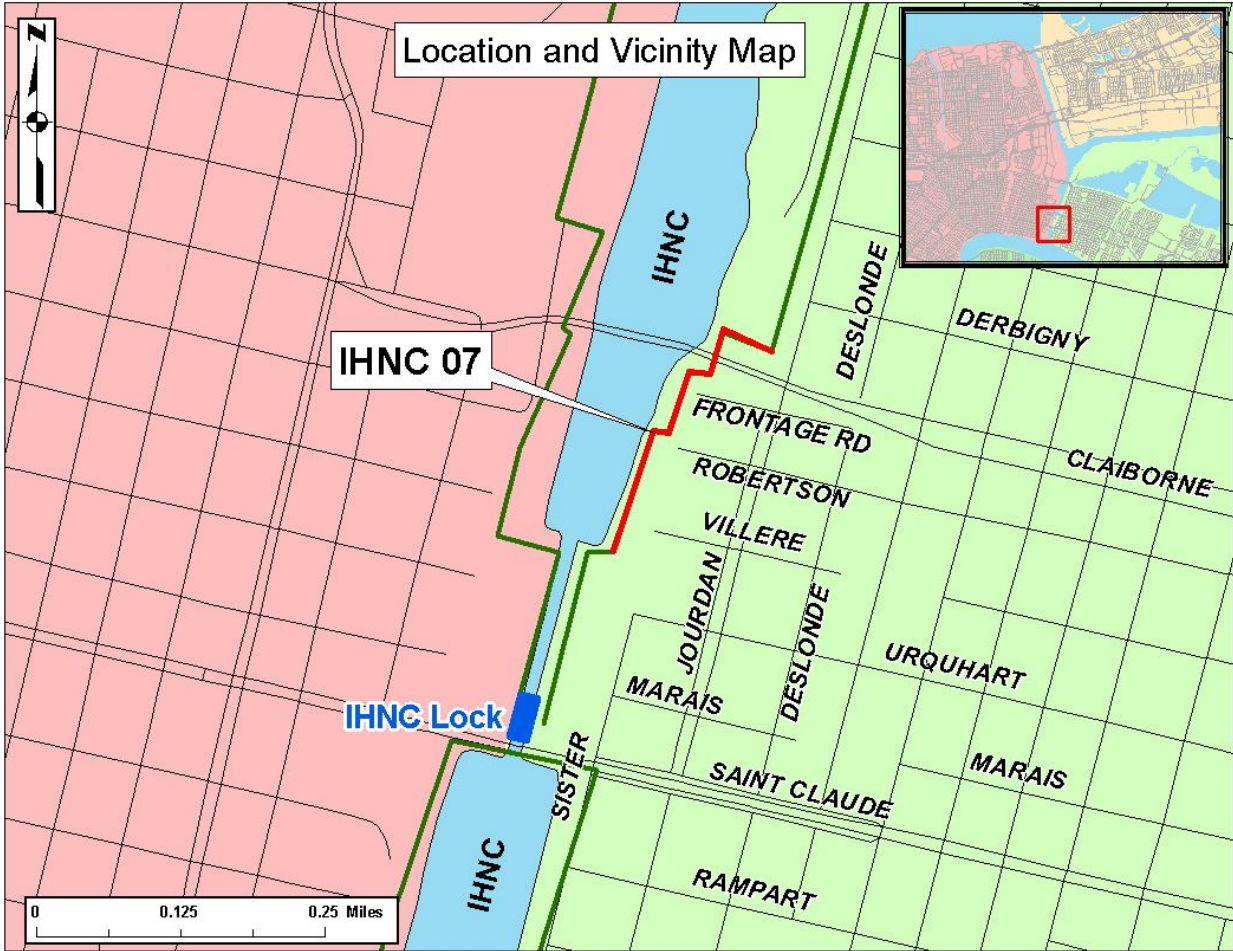
Figure 14-45.

1400' WNF / WS (base scour on landside)

Description: There is approximately 1,400 lineal feet of concrete I-wall flood barrier along the east side of the IHNC Canal between the IHNC lock and North Claiborne Avenue. The damages along this reach consisted of intermittent scour along the base of the floodwall. The work includes filling in the scour repairs and providing erosion protection. Contract Award NTP scheduled for early February, 2006.

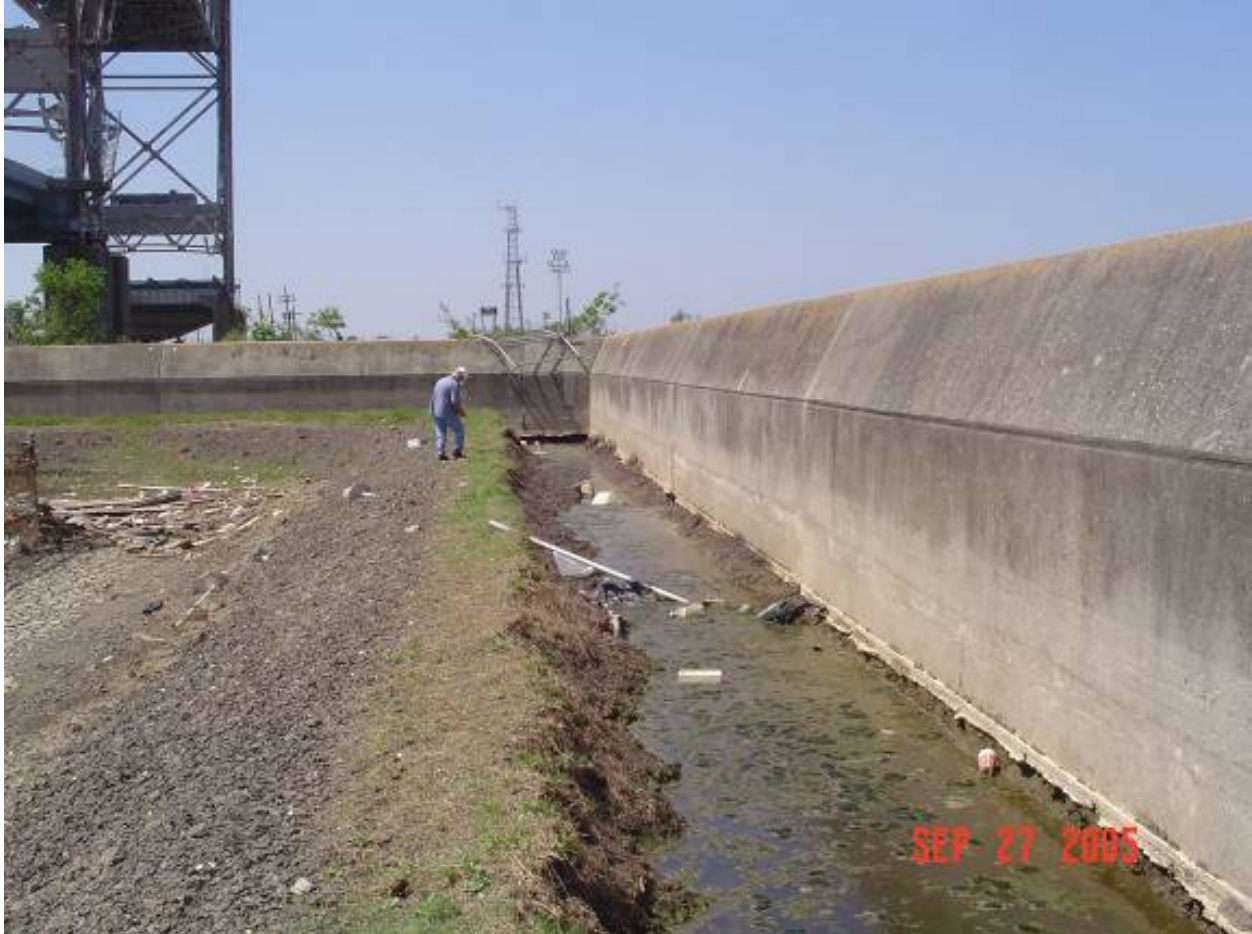
Figure 14-47. Approximate B/L Sta 7+00, View Toward Claiborne Ave. Bridge. Depth of scour was to the bottom of the I-wall concrete cap. Nearby soil boring 2U indicates the upper 5 ft was fat clay (CH) with sand / silt lenses

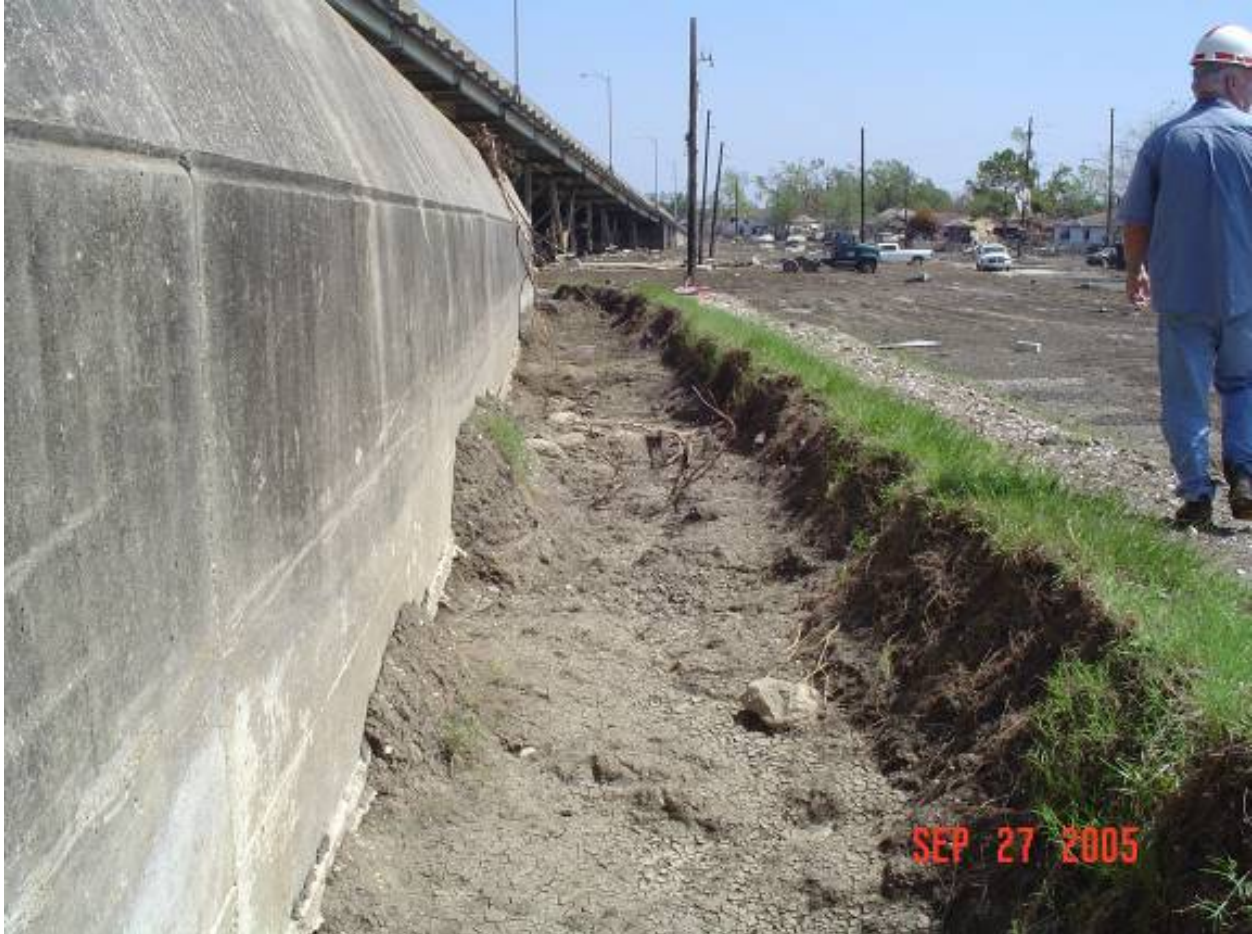
Figure 14-49. East Side IHNC Near N. Claiborne Ave, Approximate B/L Sta 11+00. I-wall elevation designed 15 ft (MSL), bottom of concrete elevation 7 ft (MSL), and levee crown elevation 9 ft (MSL). Nearest soil boring, No. 3, shows fat clay (CH) at surface

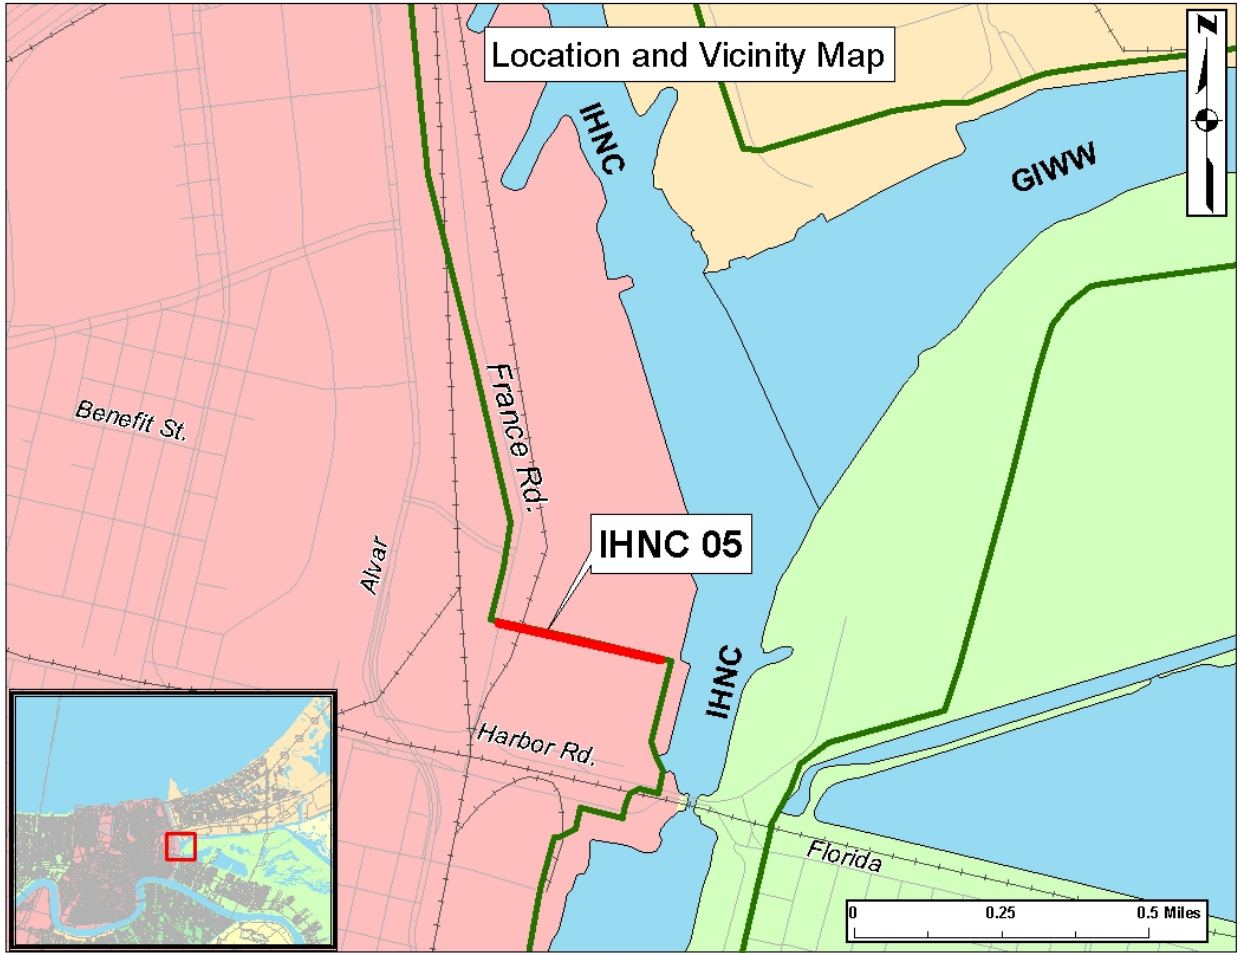
Figure 14-50.

1600' WF (soil boring Plate IV-16 in DM2Supp8)

Description: This portion of the project consists of approximately 1,600 feet of existing levee and concrete floodwall that extends from the vicinity of France Road ramp towards the IHNC. This area was breached and experienced severe scour. The repair consists of replacement with a new concrete T-Wall. Scheduled completion is April 15, 2006.

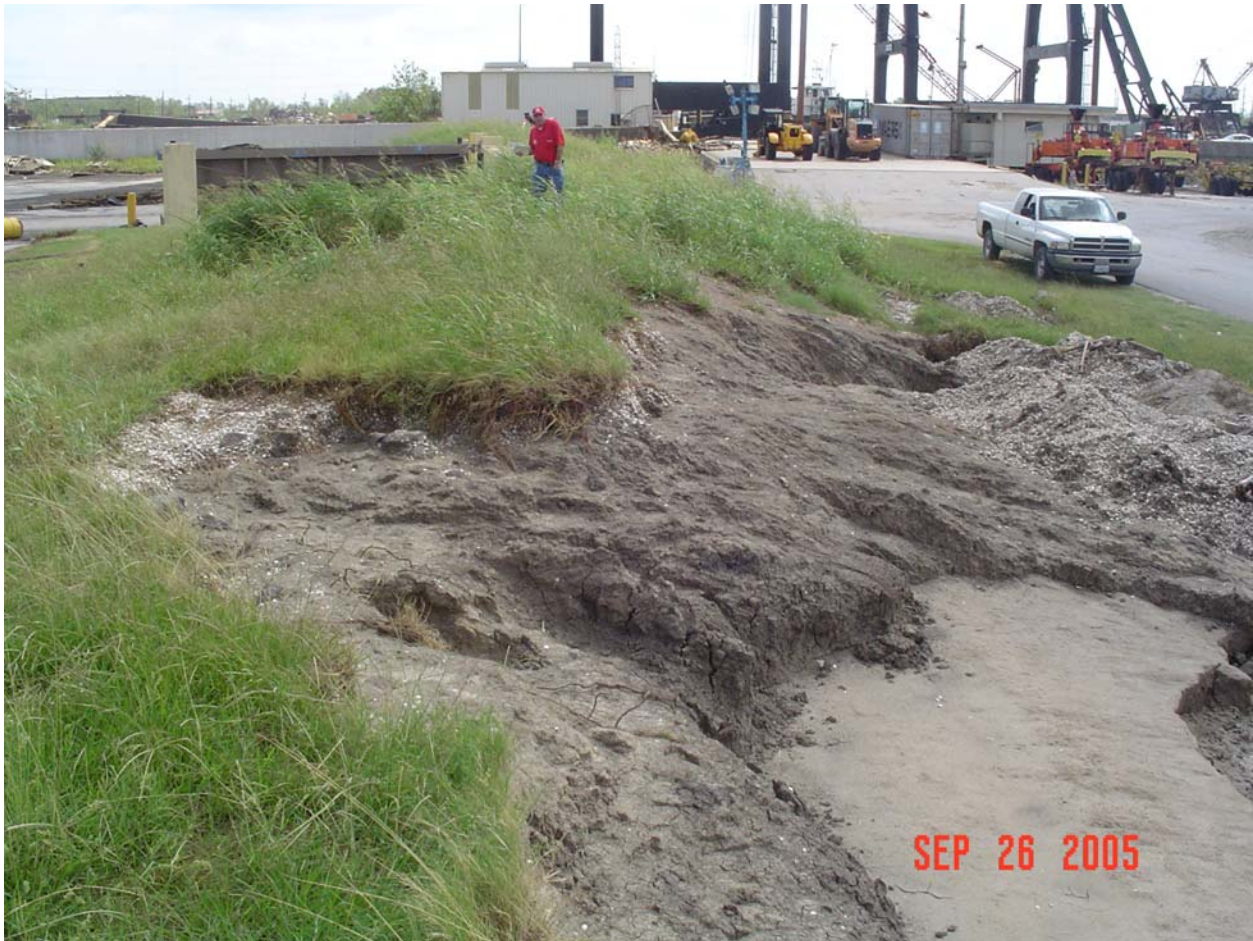
Figure 14-53. Overtopped Levee Section With Scour. View west from approximate CL Sta 14+00, B/L Sta 222+00

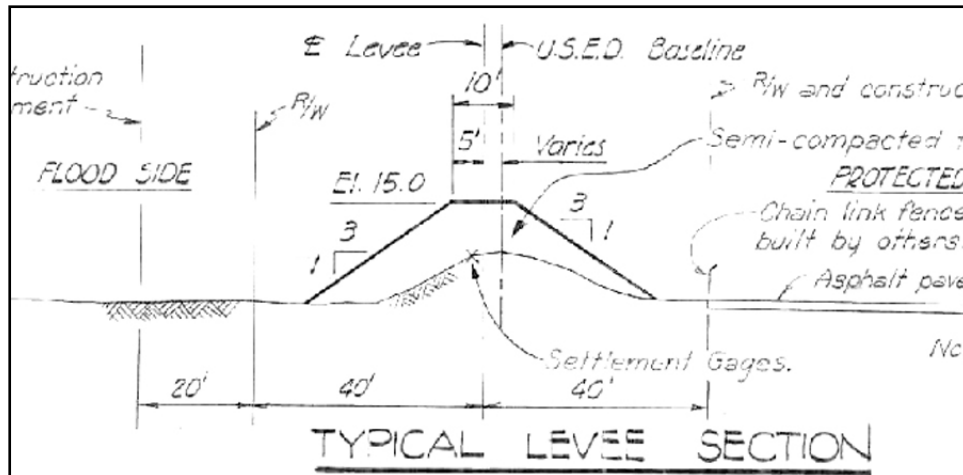
Figure 14-54. Levee Section Between IHNC and France Rd Ramp Shows Elevation 15 ft on Top of Existing Levee

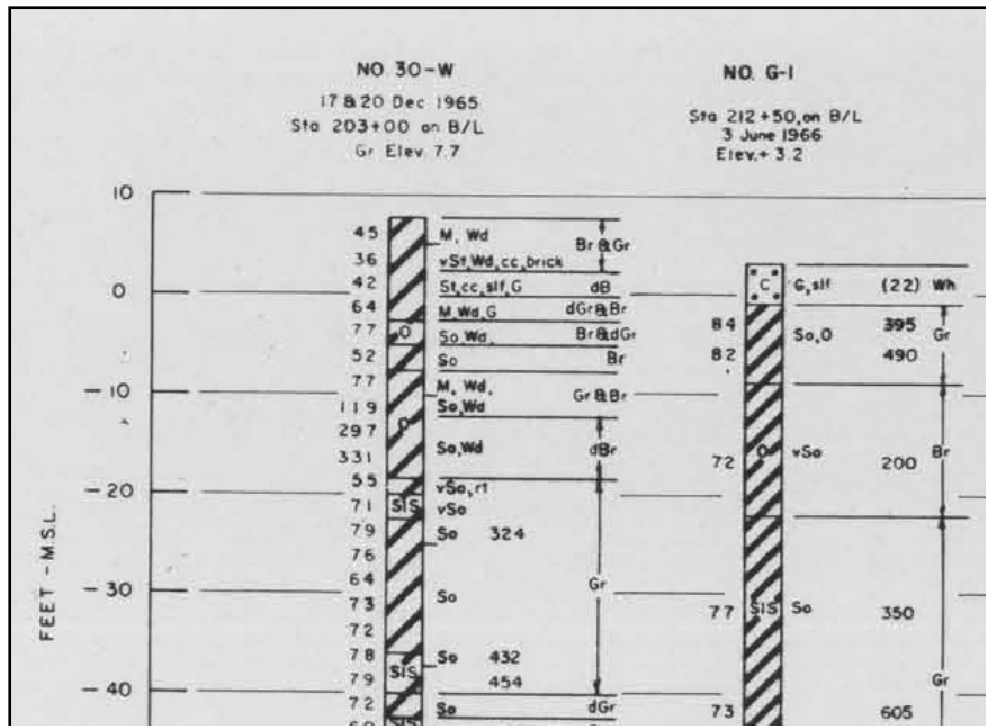
Figure 14-57. Nearest Boring G-1 Shows Sandy Material at Original Ground Surface (may have provided a zone facilitating levee failure)

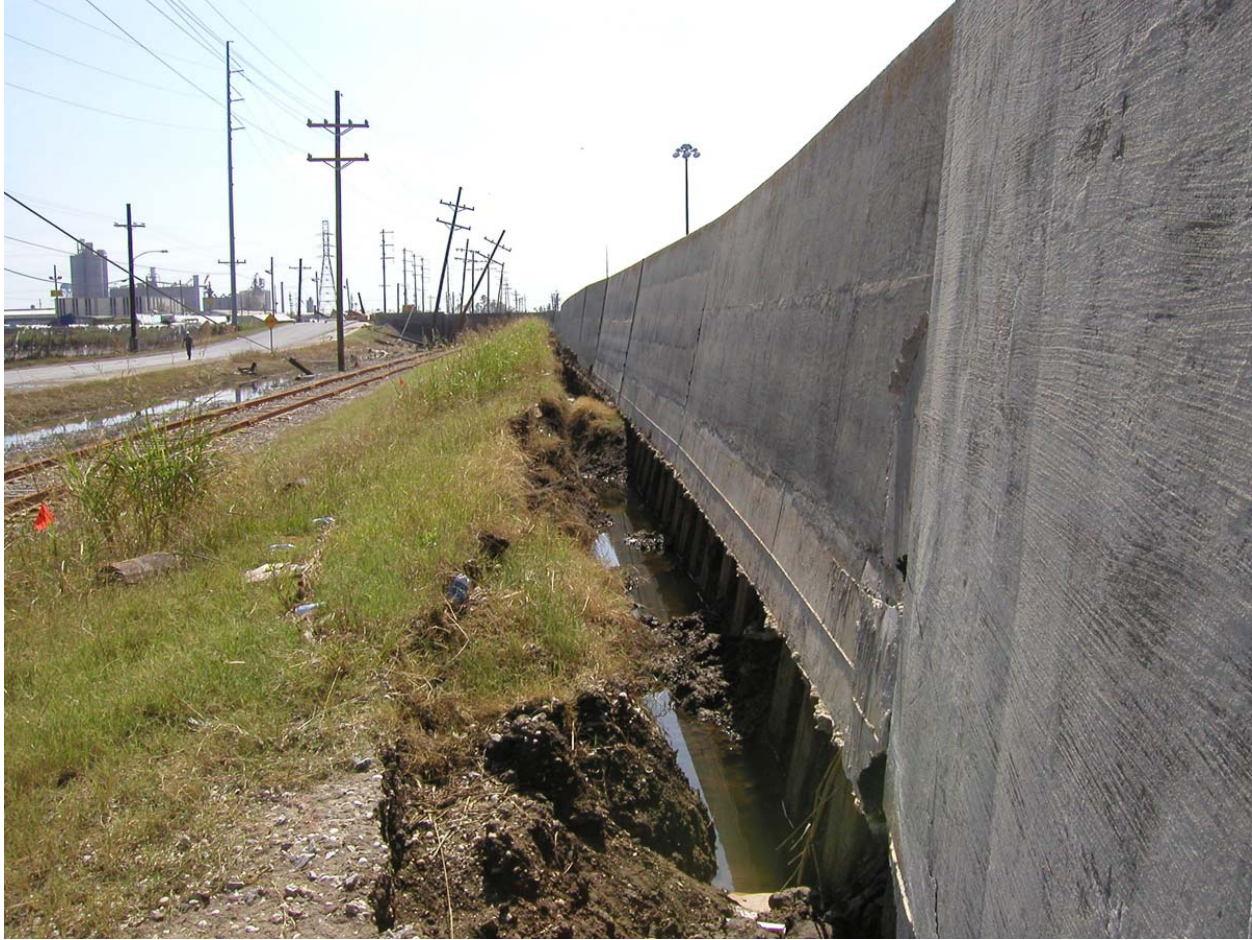
Figure 14-60. View South From Benefit St. Gate Toward France Rd Ramp. Approximate W/L Sta 5+56 (B/L Sta 205+44). Top of I-wall elevation 15 ft, levee crown 9 ft, bottom of concrete 7 ft, bottom of pre-existing Z-27 sheet pile (by Orleans Levee Board) at -10ft (MSL). From drawing file H-2-24111, plate IV-15. Nearest soil boring is 30W at B/L Sta 203+00

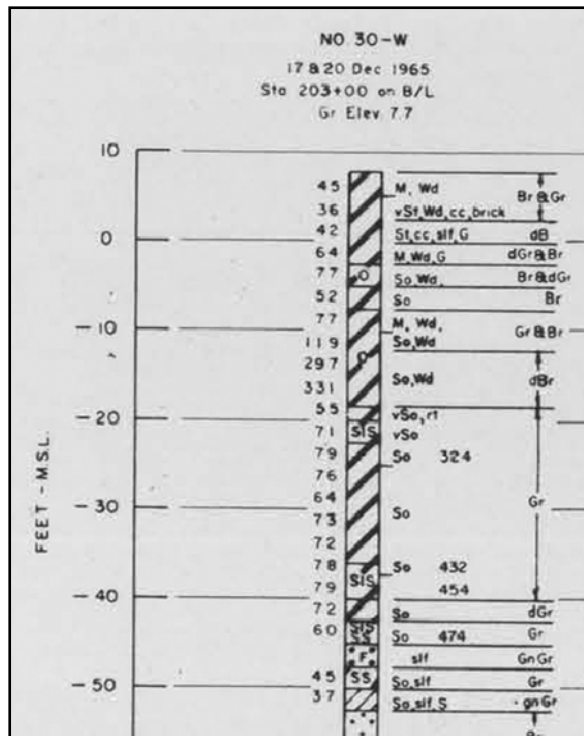
Figure 14-61. Boring 30W Near Benefit St. Gate Shows Fat Clay Soil Layers

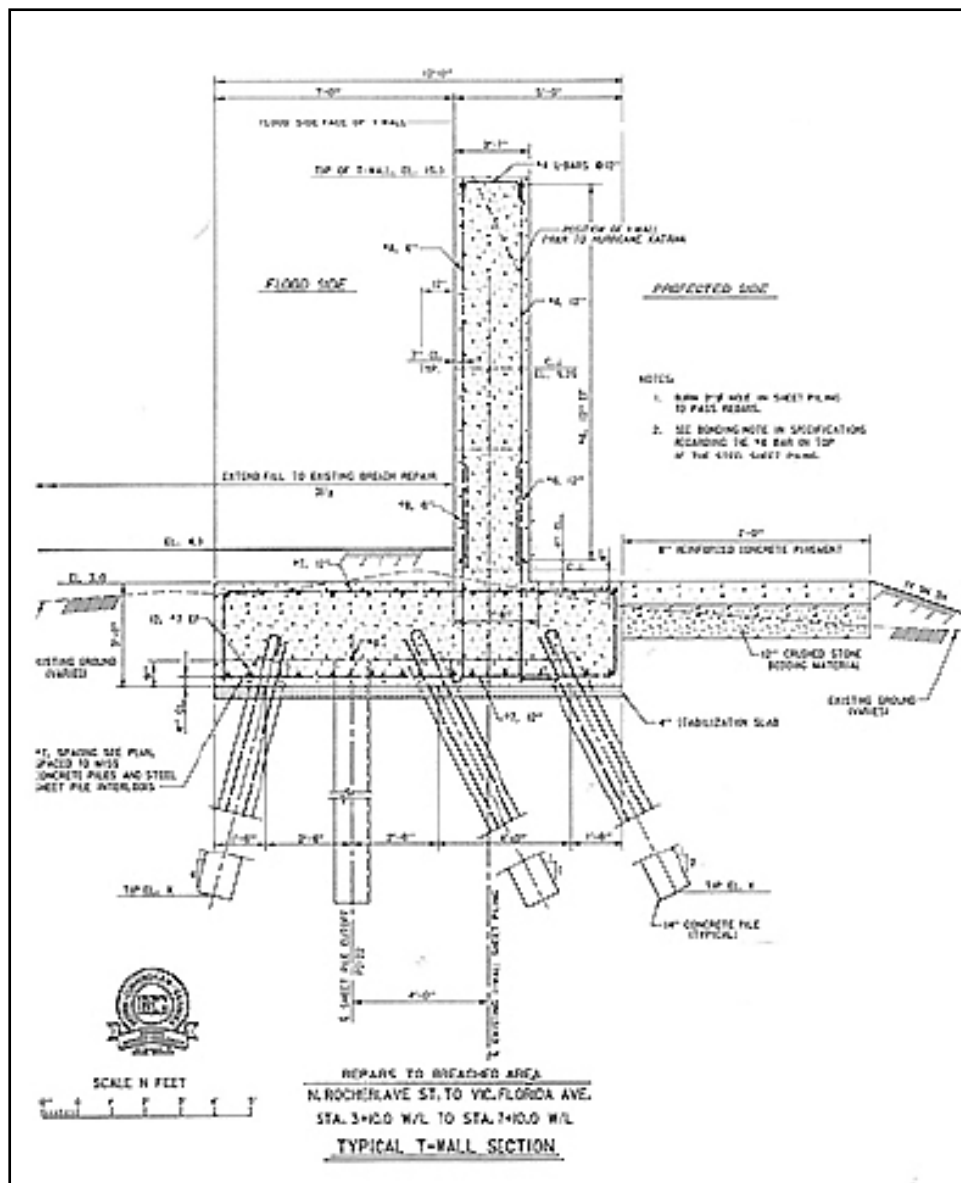
Figure 14-70. New "T" Wall Design, Sta 3+00 to 7+00

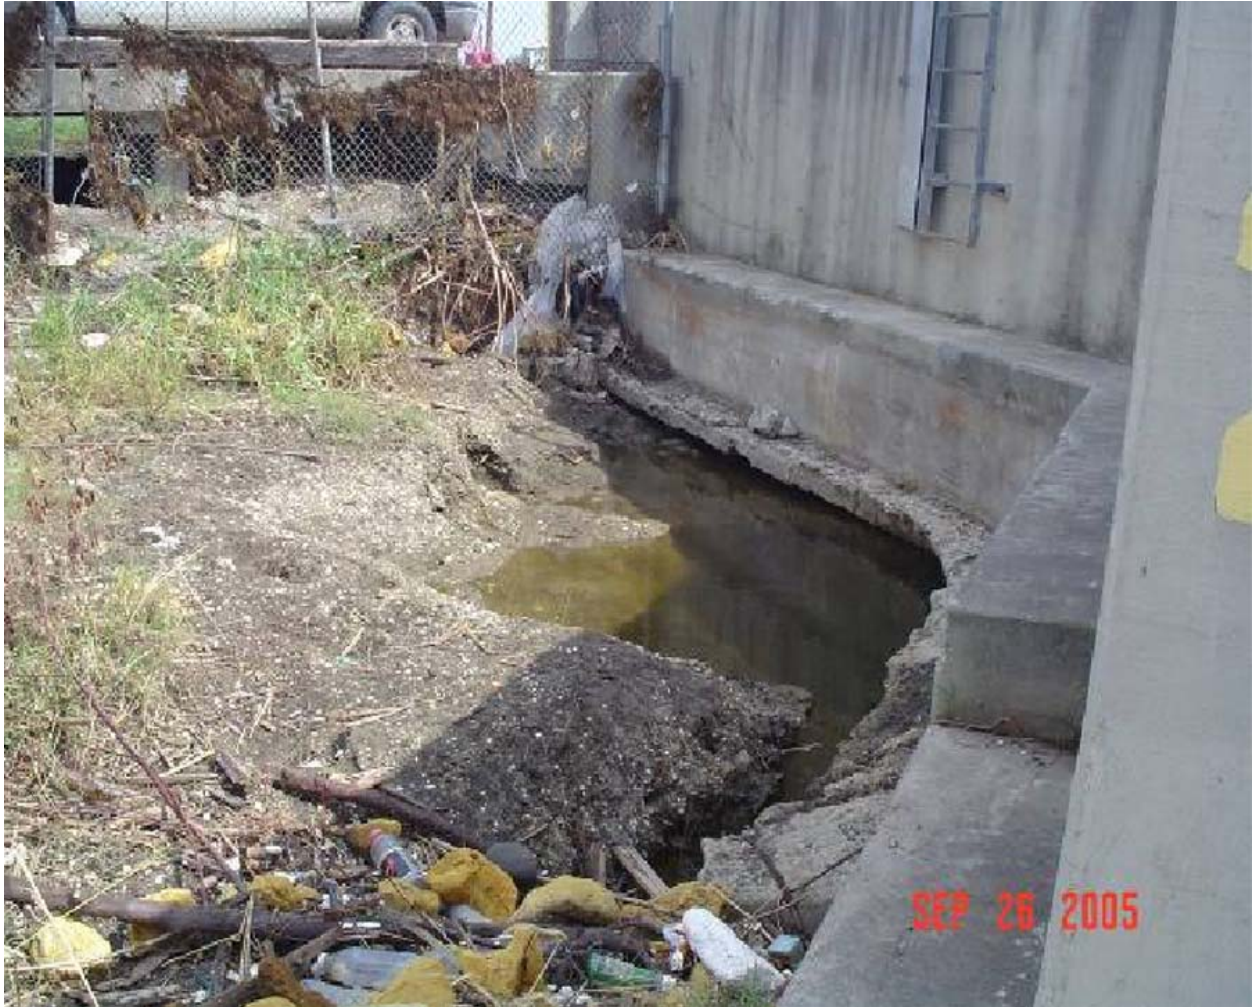
Figure 14-72. Scour at T-Wall Base of Gate W23
