Appendix 11

Analysis of Performance of the Inner Harbor Navigation Canal

Executive Summary

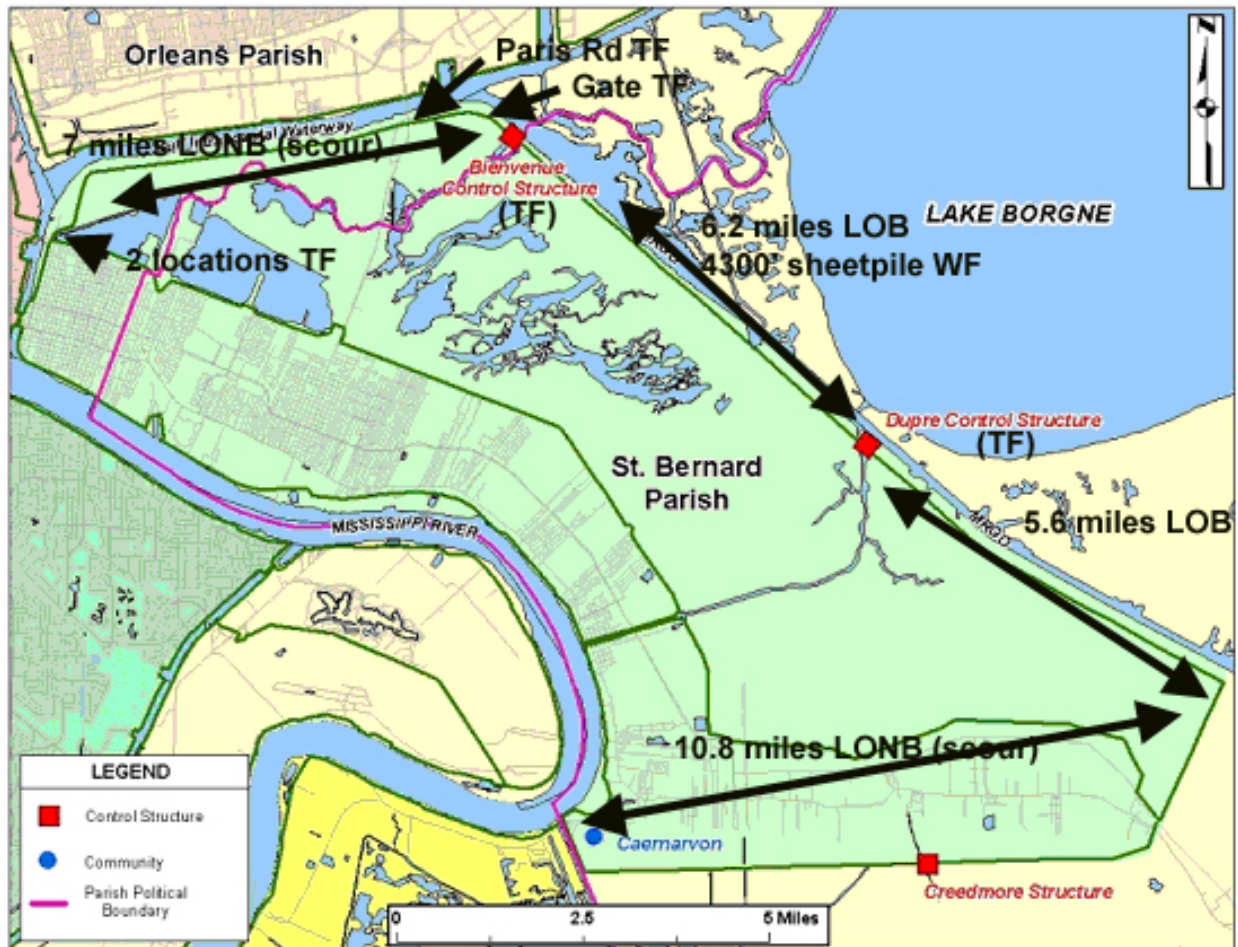
Figure 14-76. Damaged Areas in the St Bernard Basin

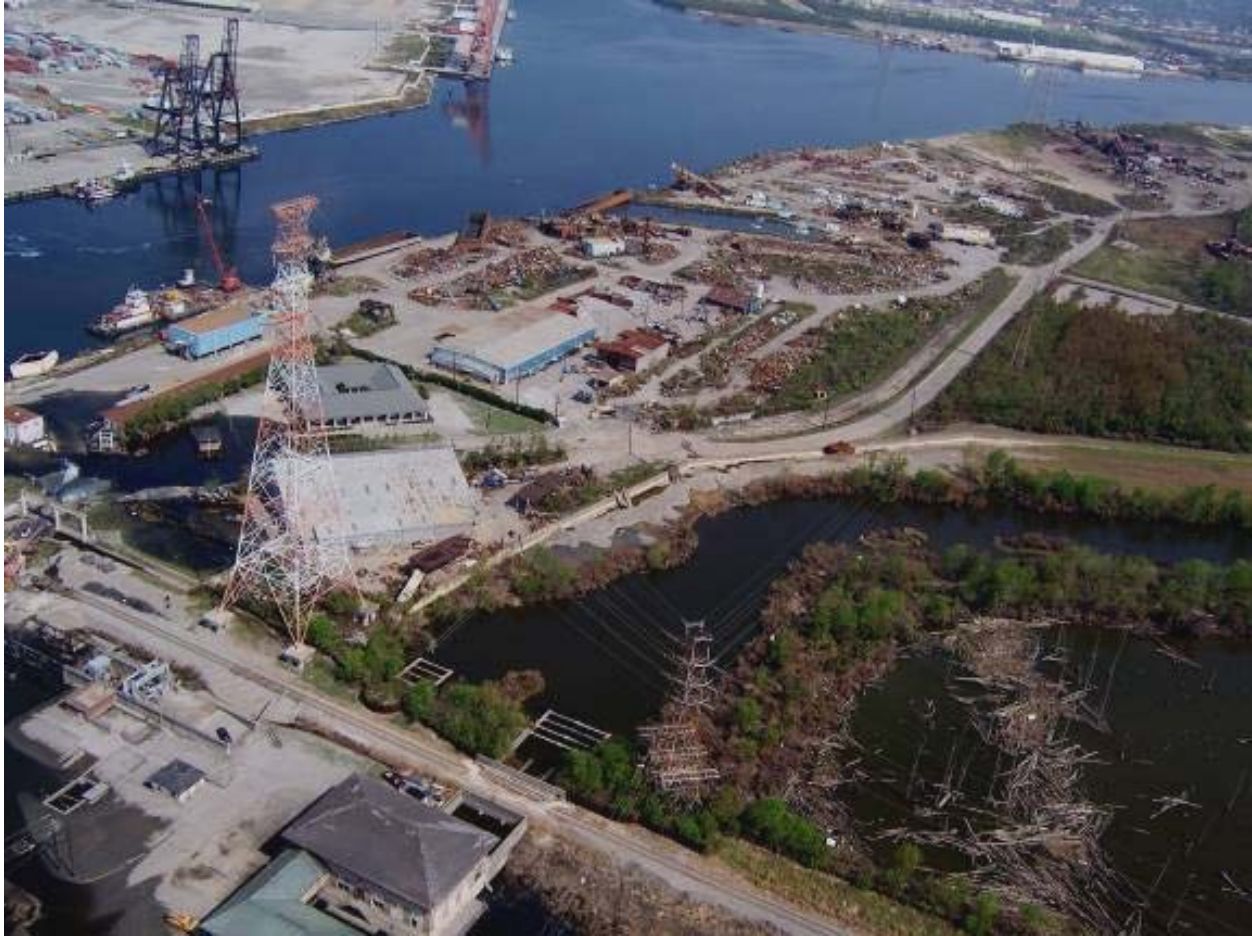
(1) Closure Structures Near Southern Scrap. There are two road closure structures that were damaged during the storm event. These closure structures are located at STA. 45+00 and STA. 67+94 at Orleans Rd. There was scour of the structural backfill resulting from overtopping of the floodwall and the closure gates.

Figure 14-84. Floodwall Between Fla Ave (IHNC East) and Southern Scrap Facility

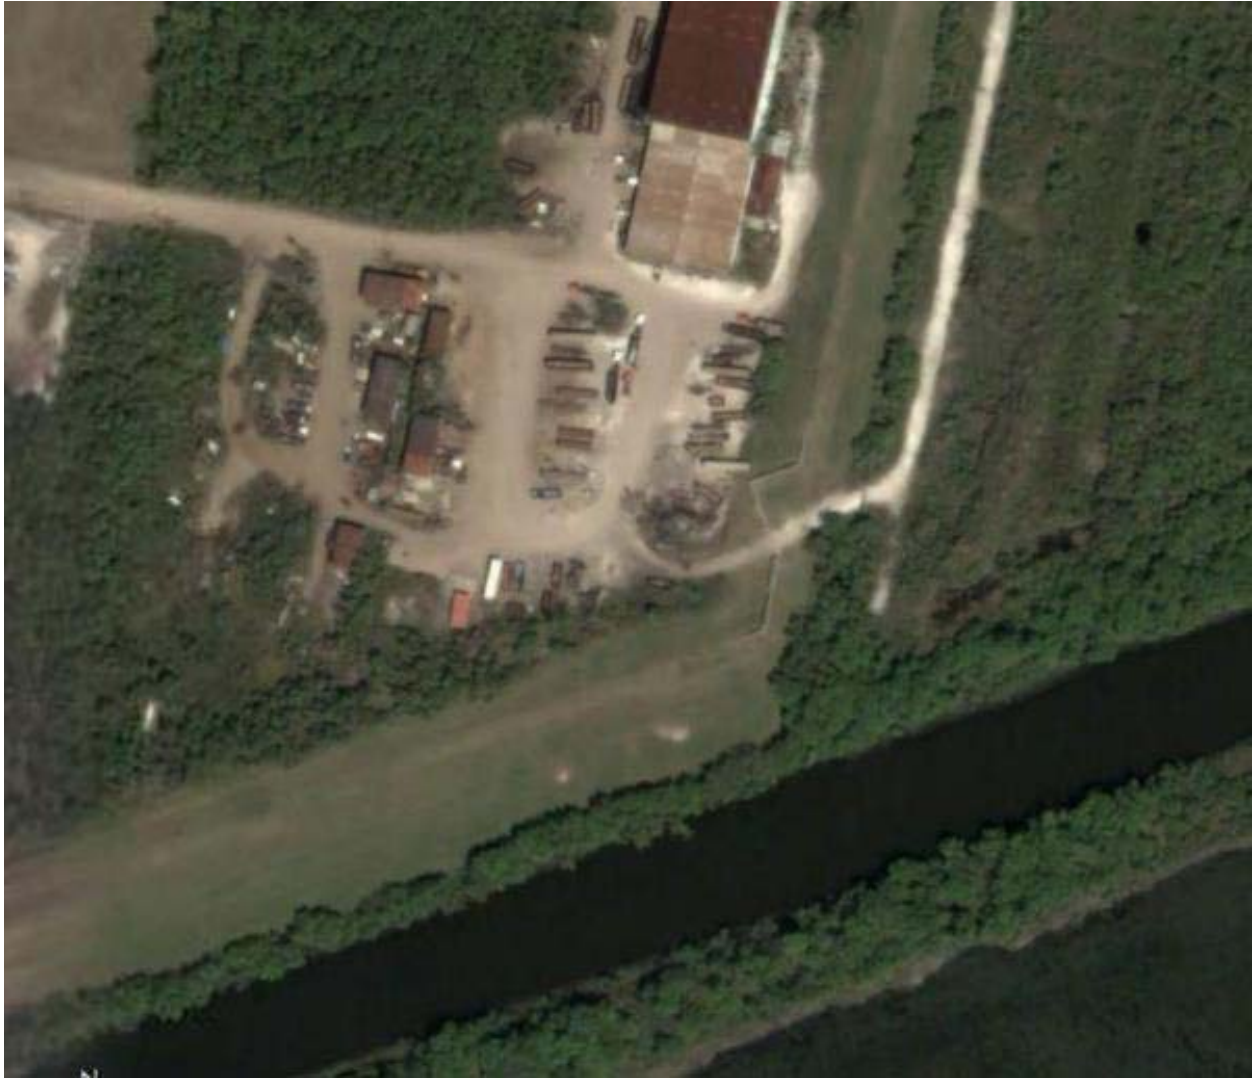
Figure 14-85. Southern Scrap Facility Gates S2 and S3

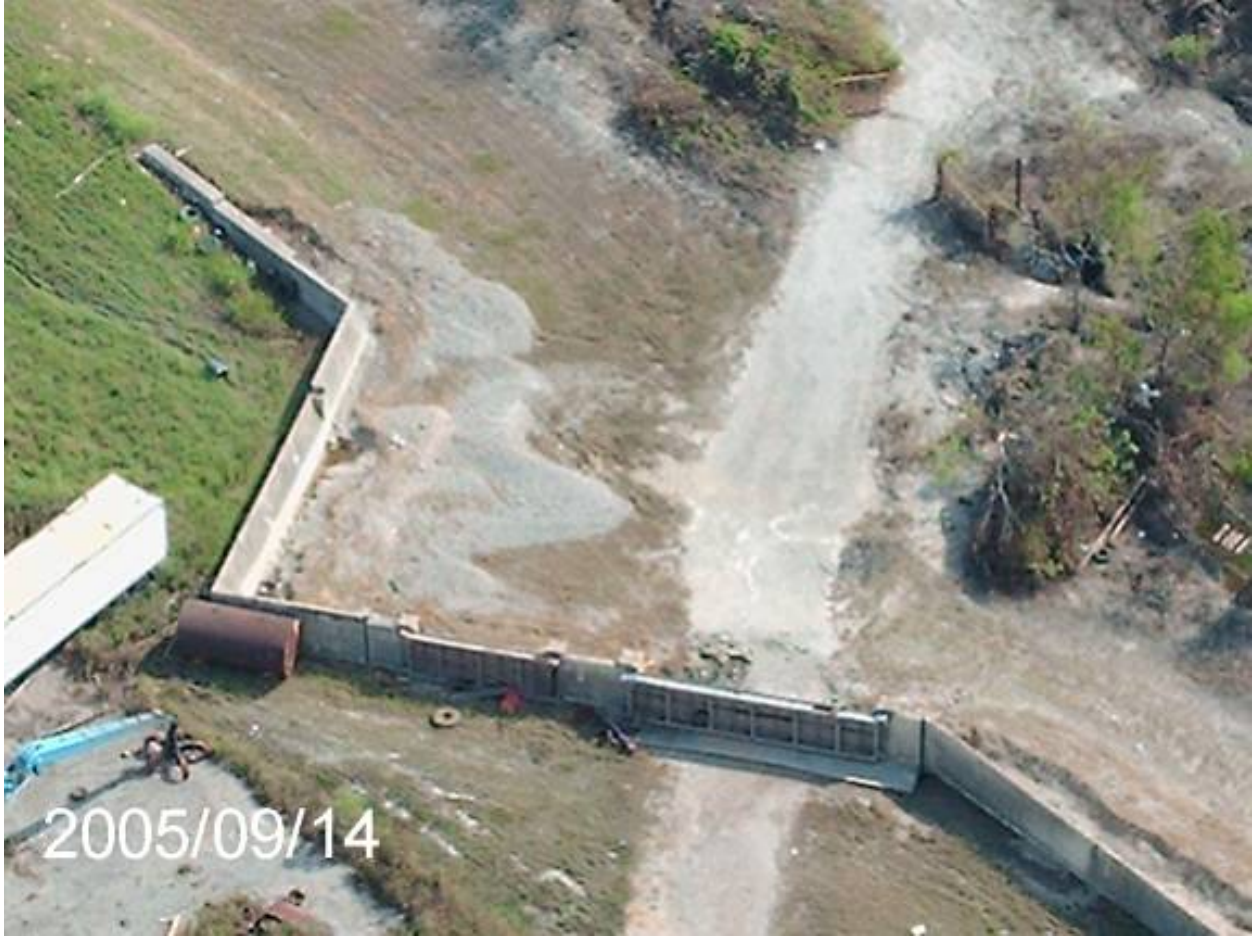
Figure 14-86. View of Scour Outside Gates S2 and S3. IHNC/GIWW and Southern Scrap sites are on the left side of photo

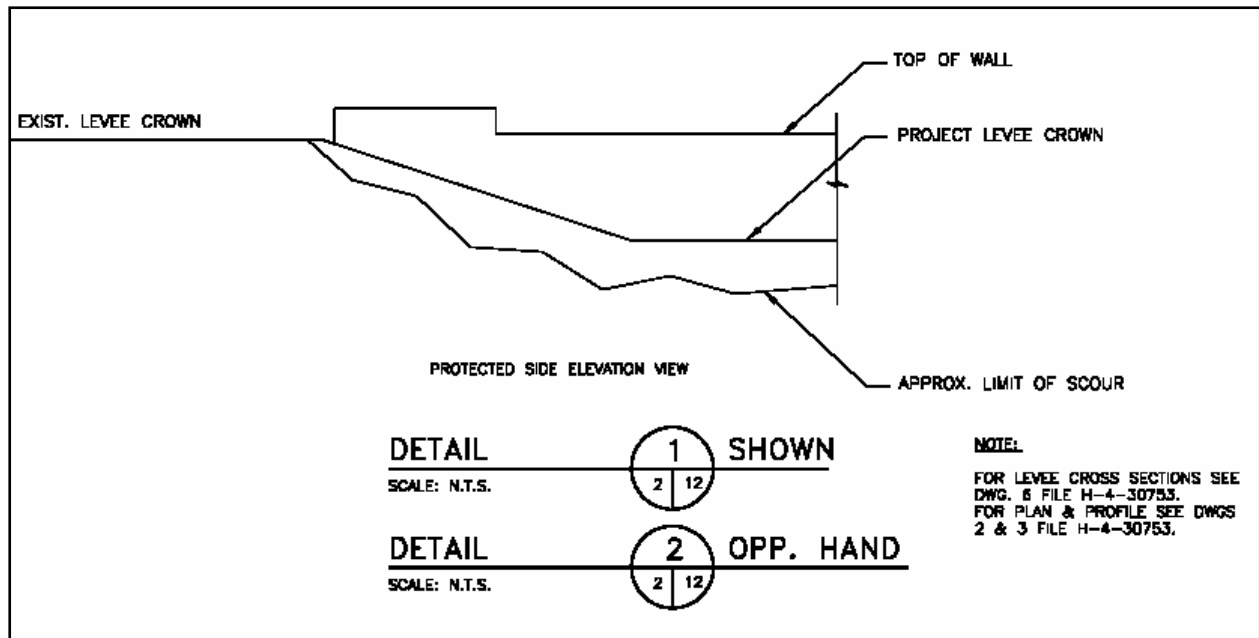
Figure 14-87. Details at Floodwall / Levee Abutments, Both Ends of Gates S2 and S3

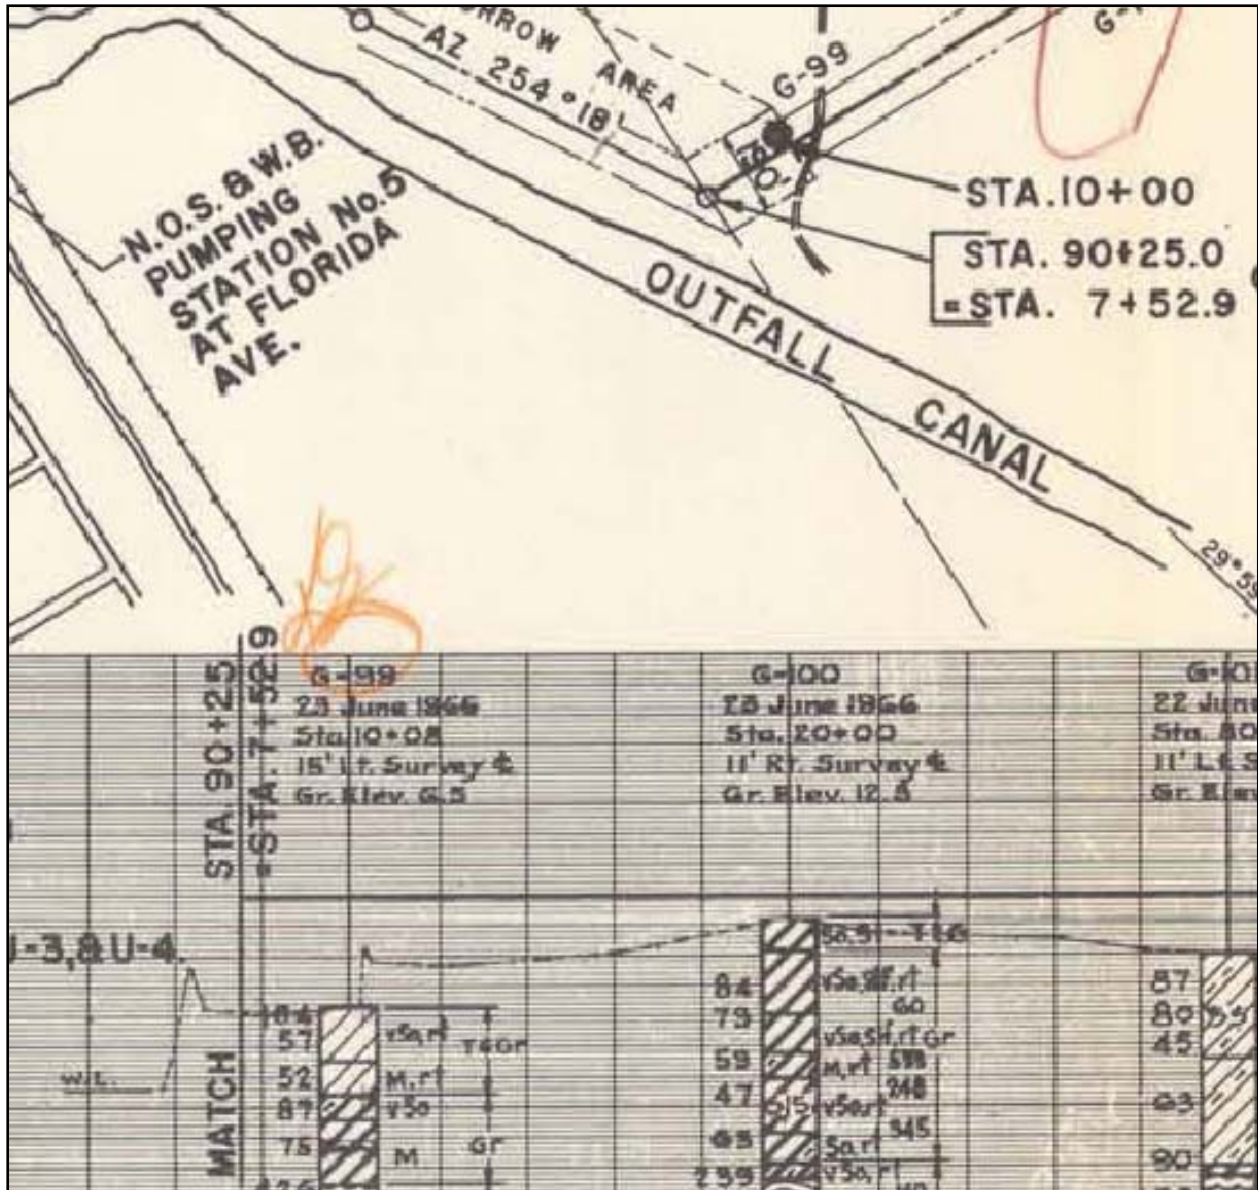
Figure 14-90. Boring G-99 Near Future Gates S2 and S3 Shows Lean Clay (CL) at Existing Ground Surface (Approximately 6' MSL). From Plate 7, DM3

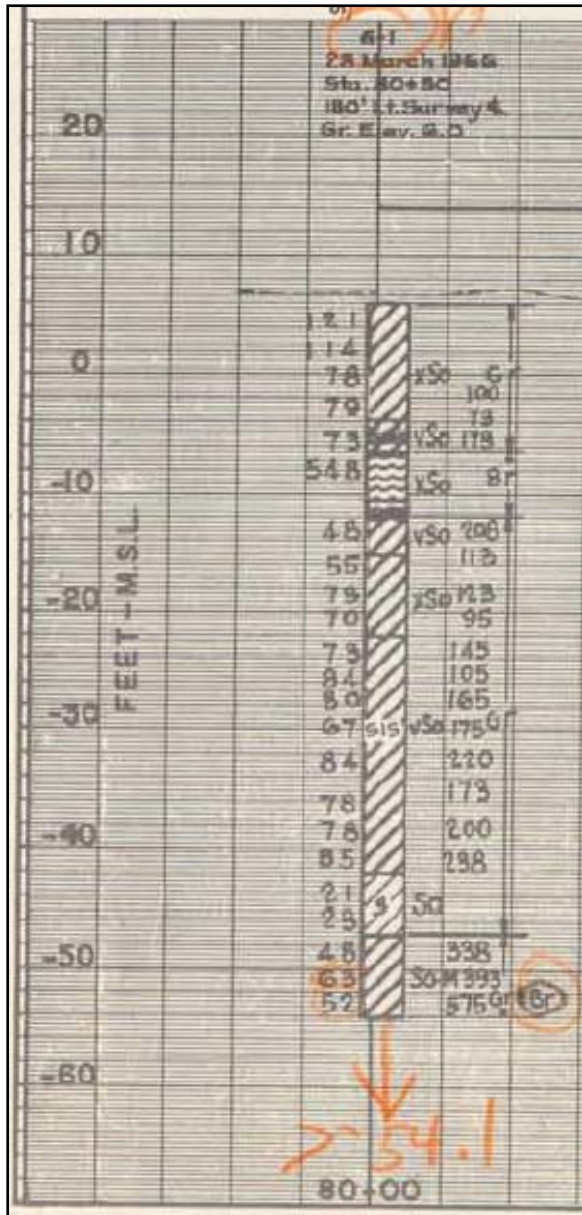
Figure 14-94. Nearest Boring at Sta 80+50, G-1, Circa 1966, From DM3, Plate 8. Original ground elevation was approximately 6 ft MSL, and surface soil was CH. Levee was built to approximate elevation +14 ft. circa 1970. Additional lift up to elevation 19 was added circa 1985

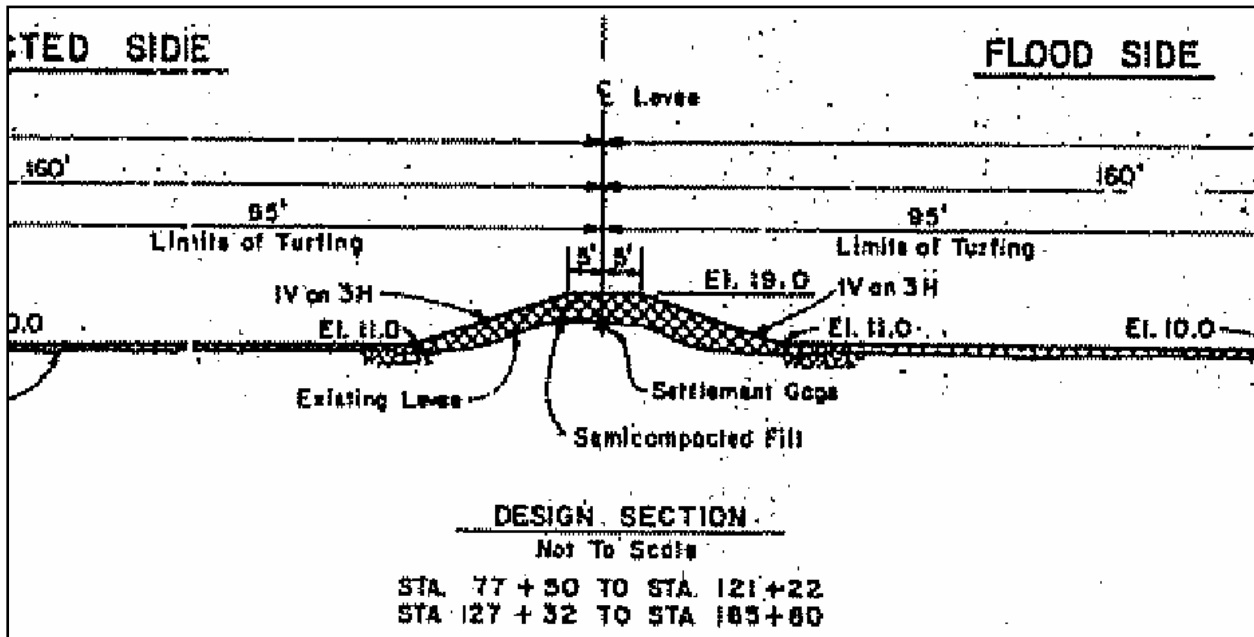
Figure 14-96. Design Section for Levee Enlargement, From Above 1985 Drawing

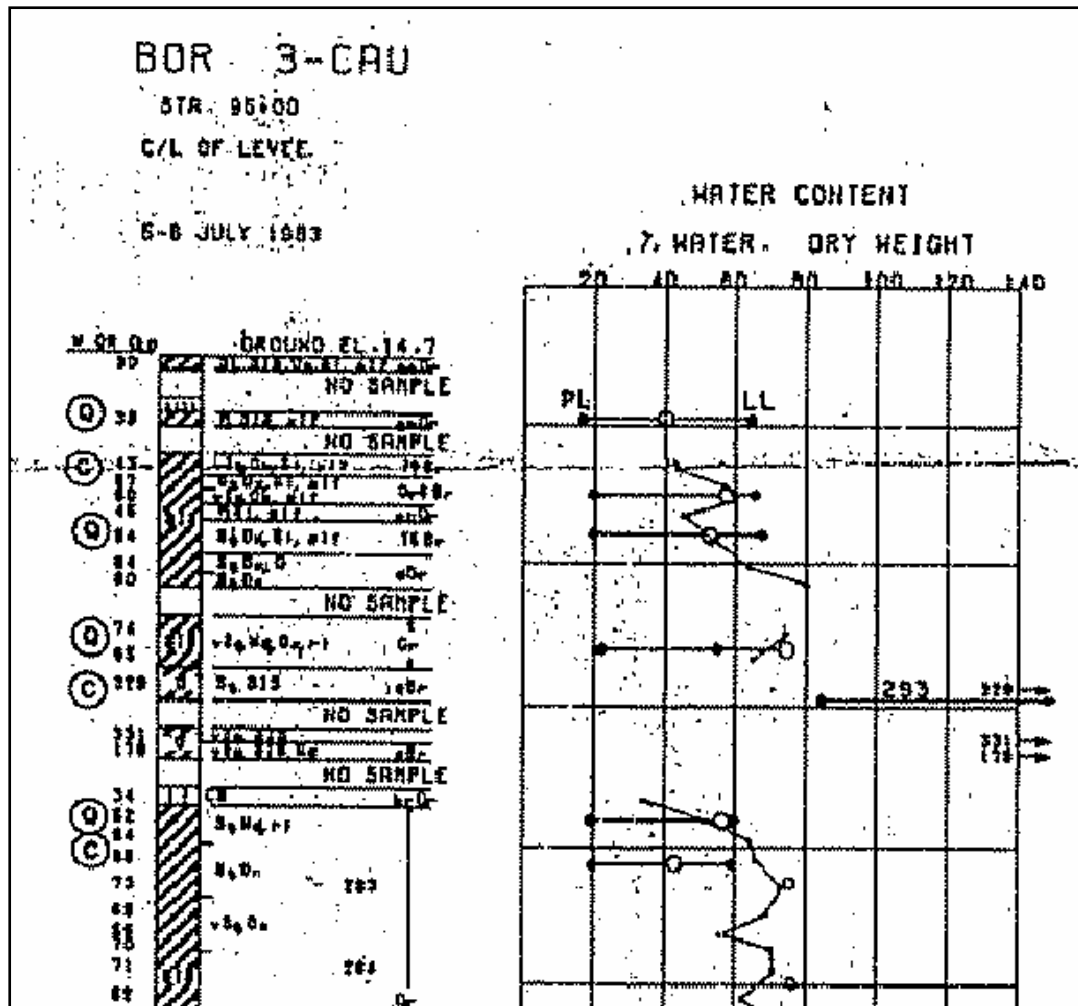
Figure 14-97. Sta 95+00 boring, 1983, shows CH soil at top of pre-existing 14' levee over a thin lens of sandy material. Note ground elevation (14.7 ft) comparison with lidar elevation (15 ft) at Sta 95+00 in Figure 14-93 above

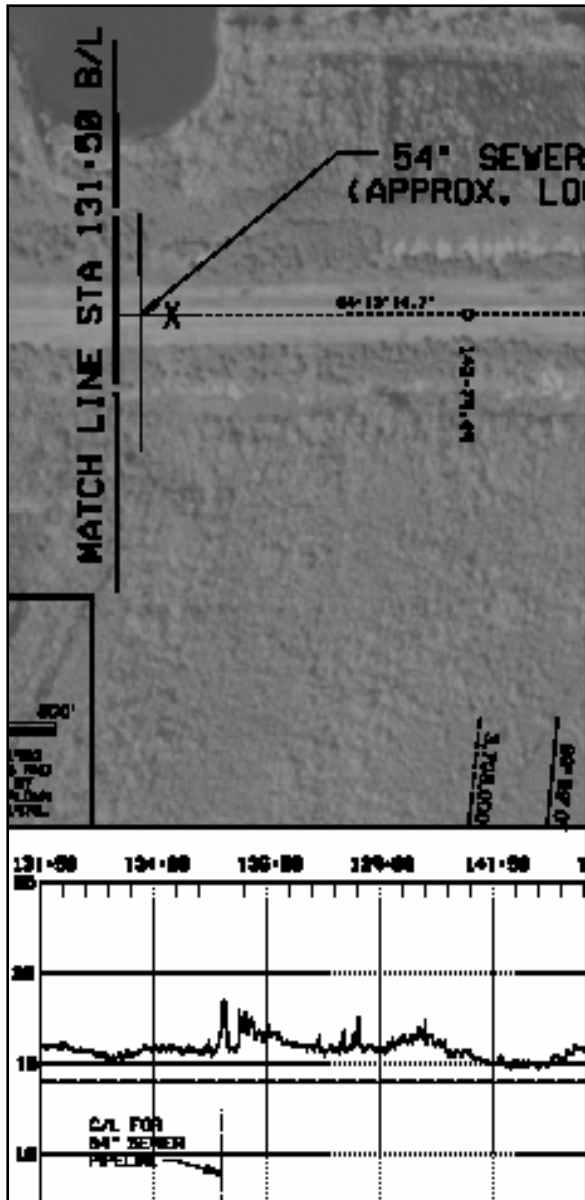
(2) Levee Damage Along Intracoastal Waterway (GIWW). There are small areas of scour on the backside of the levee between STA. 65+008 and STA. 277+20 (the Paris Rd high rise bridge is approximately over Sta 270+00). This scour was the result of localized overtopping of the levees in this reach.

Figure 14-98. A Minor Scour Location (Marked With X) at B/L Sta 135+00 (from dwg 4 of 12, Contract Solicitation W912P8-06-R-0022)

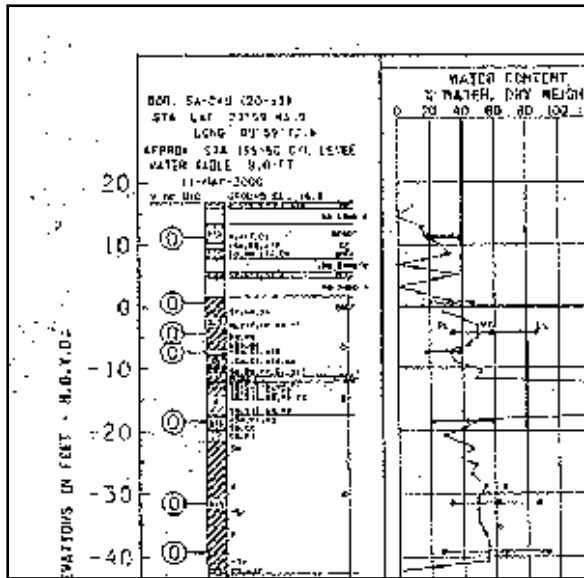
Figure 14-99. Dwg 9 of 19, New Orleans District File H-8-45533 Shows a Thin Layer of Lean Clay (CL) at Centerline Top of Levee from the 2001 Soil Boring 5A-CAU, B/L Sta 135+50

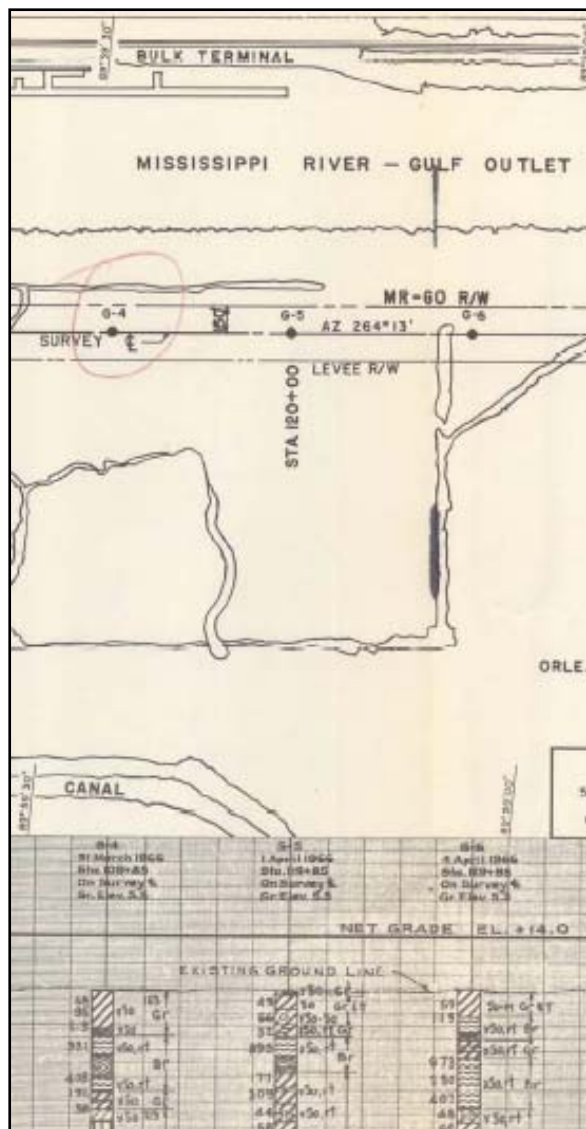
Figure 14-100. Plate 6, DM3 (1966) Soil Boring G-6 at Sta 129+80 at Levee Centerline Shows Fat Clay (CH) at Original Ground Surface

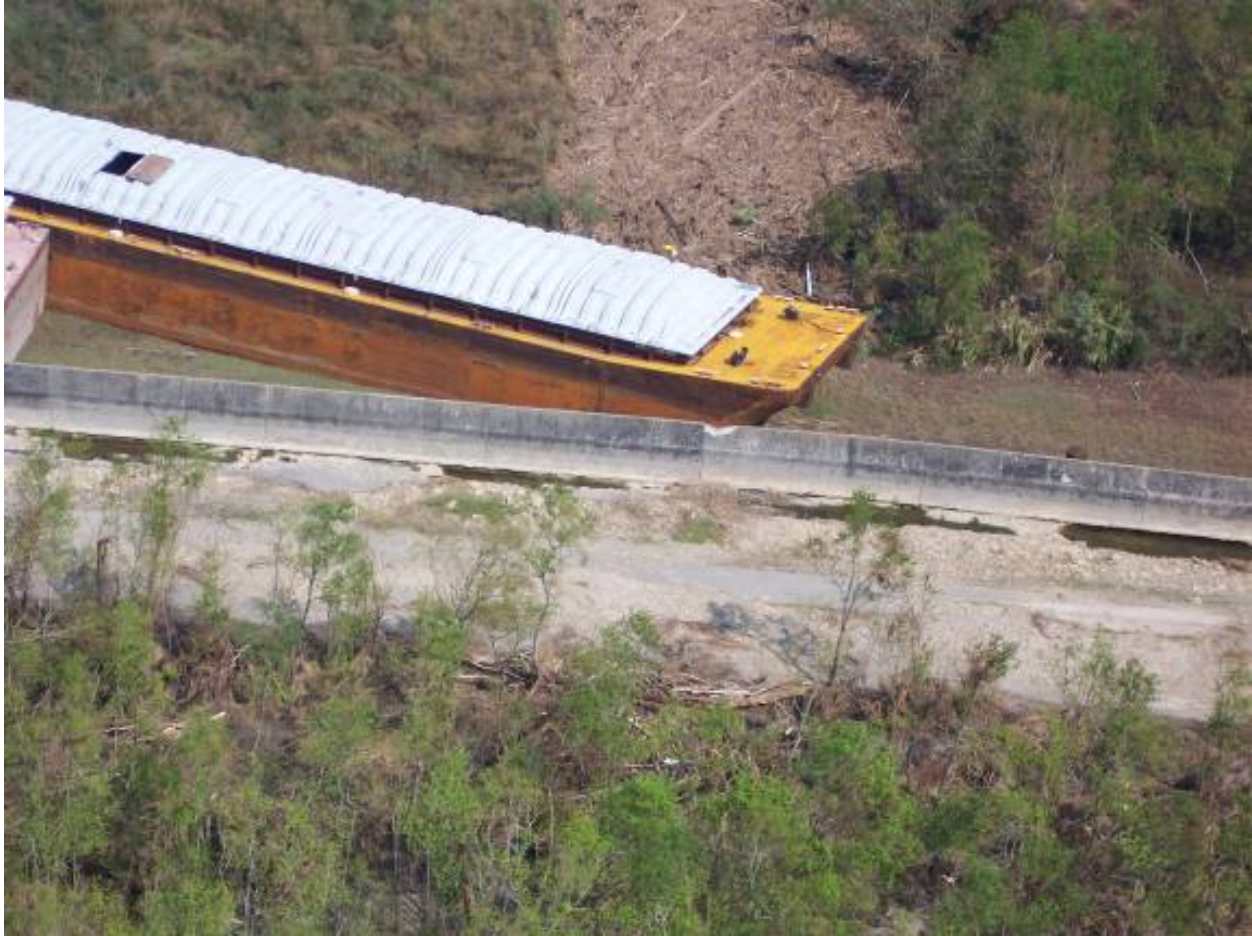
Figure 14-103.

(4) Closure Structure and I-Wall West of Bienvenue. This closure structure and adjacent I-wall segments were damaged during the storm event. There was scour of the structural backfill resulting from overtopping of the closure gate and I-wall.

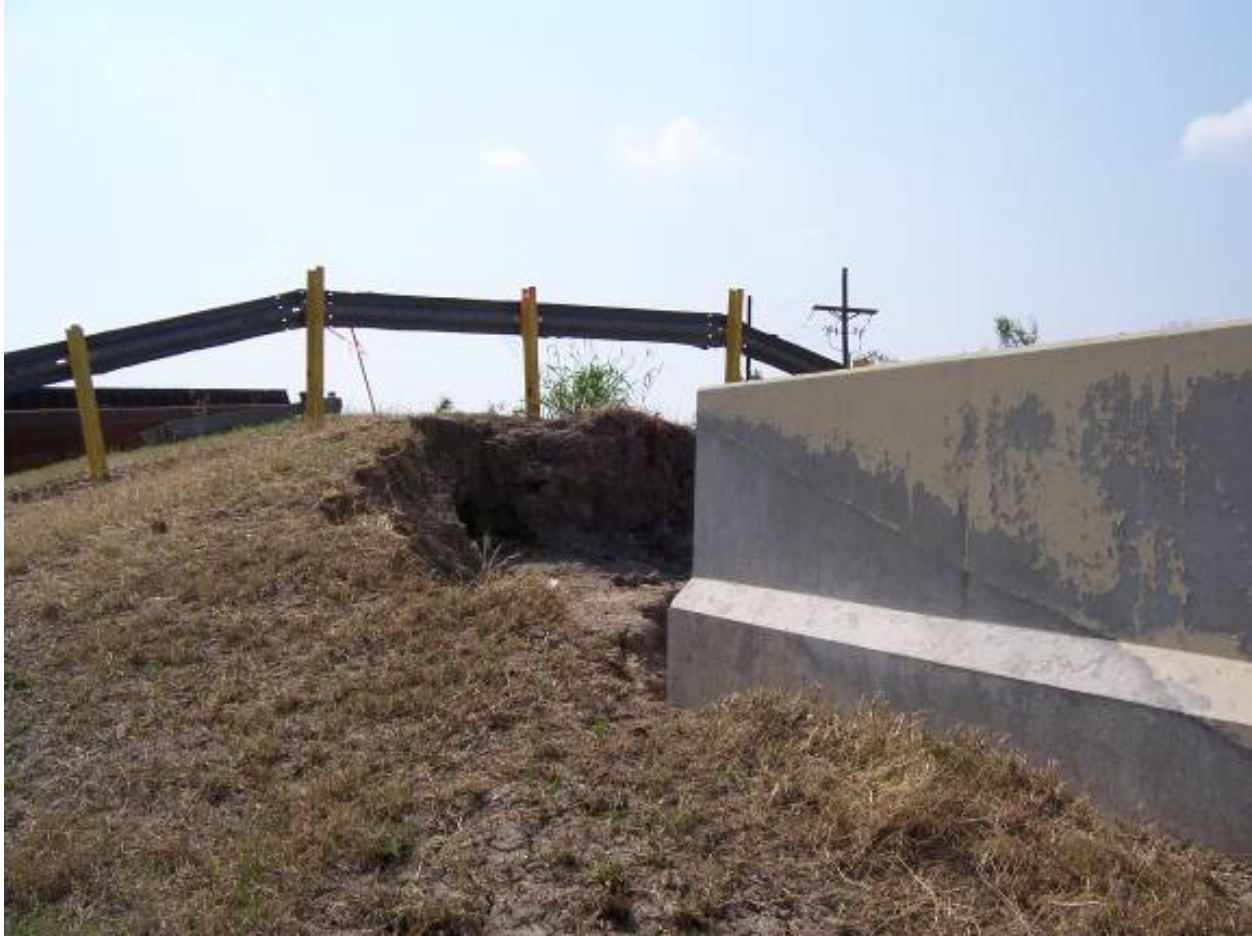
Figure 14-104. View Looking East Toward the Bayou Bienvenue Control Structure

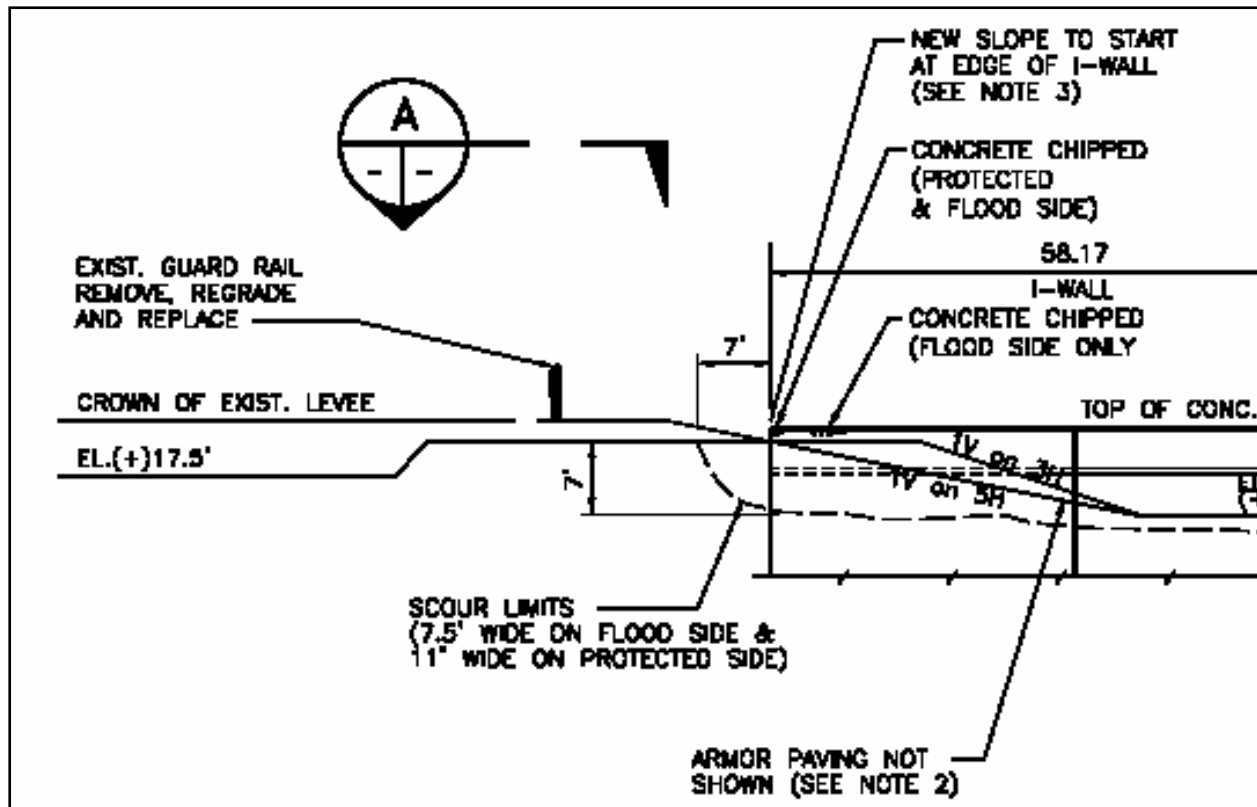
Figure 14-105. Gate S5 Scour Hole (From Levee Restoration, Misc. Gates and Floodwall Repairs, IHNC to Bienvenue, Chalmette Area Plan Emergency Restoration solicitation W912P8-06-R-0022, October 2005 contract drawing H-8)

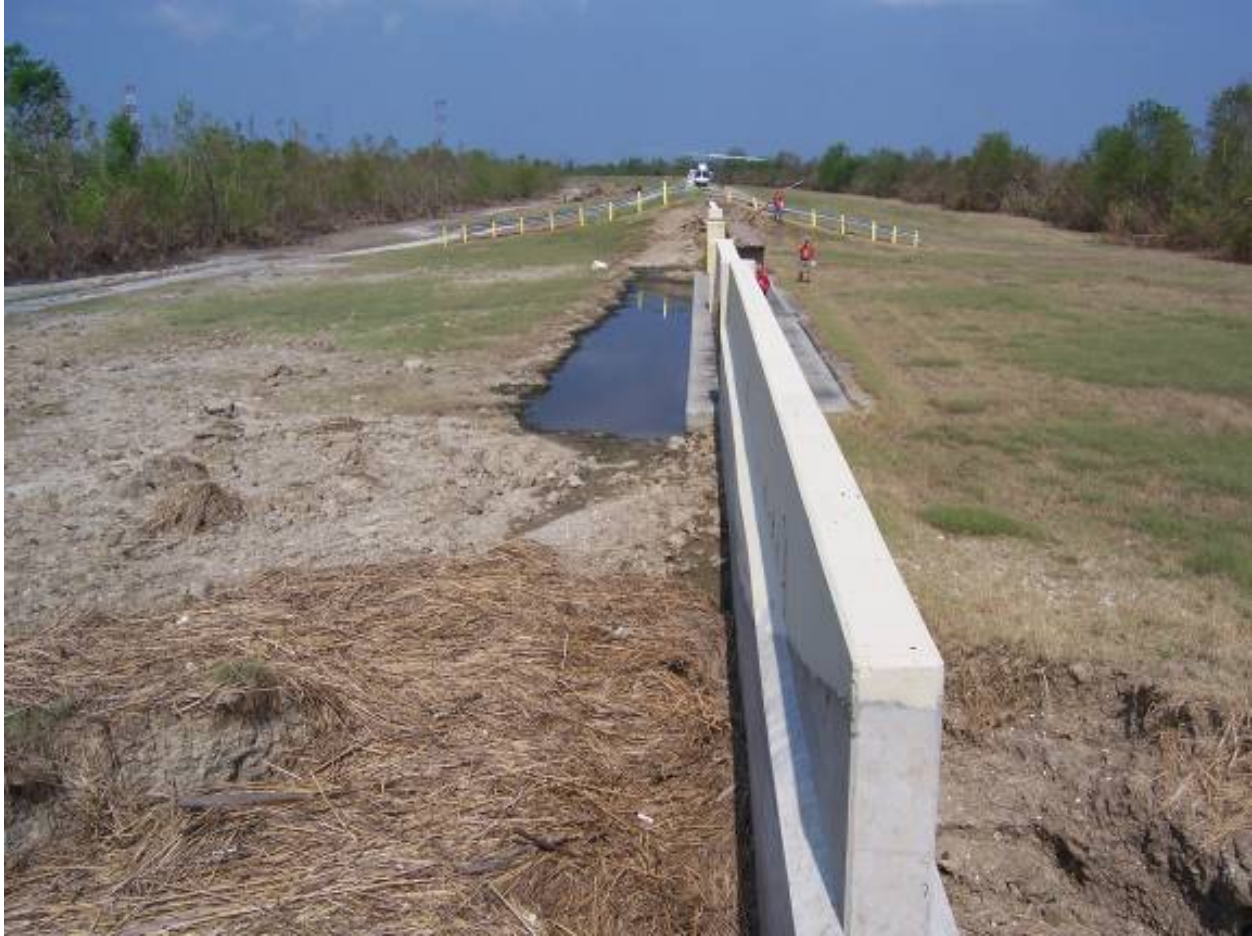
Figure 14-106. View West From Bienvenue Control Structure Toward the Unused Floodgate Structure

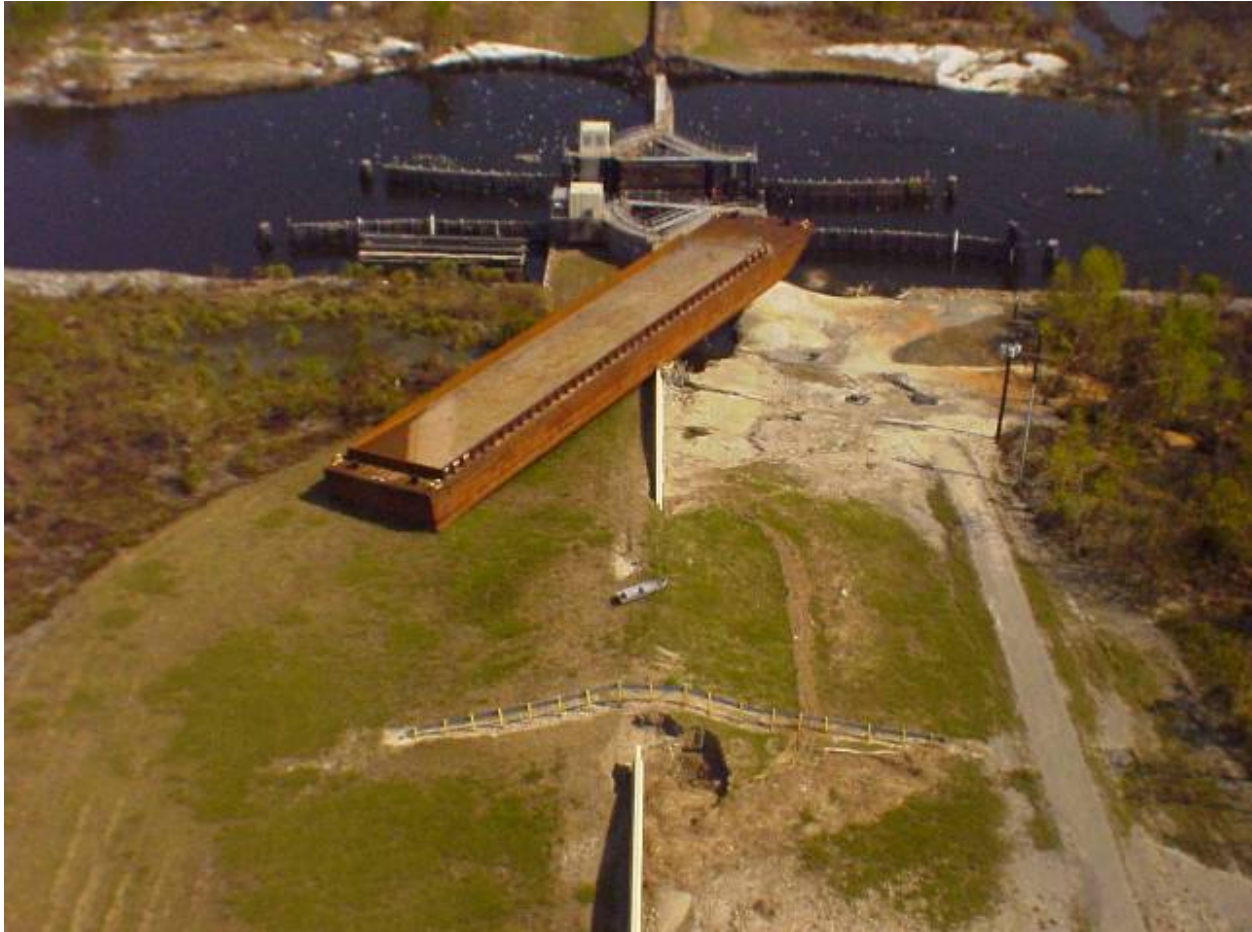
Bayou Bienvenue Control Structure. This control structure was damaged during the storm event. The adjacent floodwall was hit by a loose barge and the fill around the adjacent floodwalls was eroded away due to overtopping. In addition there was damage to the mechanical and electrical systems that operate the sector gates.

Figure 14-109. Post-Katrina. Note scour near guardrail shown in Figure 14-104

TFG Project **STB07** includes repair of structural damage and loss of structural backfill at the Bayou Bienvenue Control Structure. A significant scour hole is to be filled with 28,600 cubic yards of granular backfill and protected with grouted riprap. An estimated 32,100 tons of riprap and 3,400 cubic yards of embankment fill will be required for the repairs. All materials are to be furnished by the contractor, and scheduled completion is 1 April 2006.

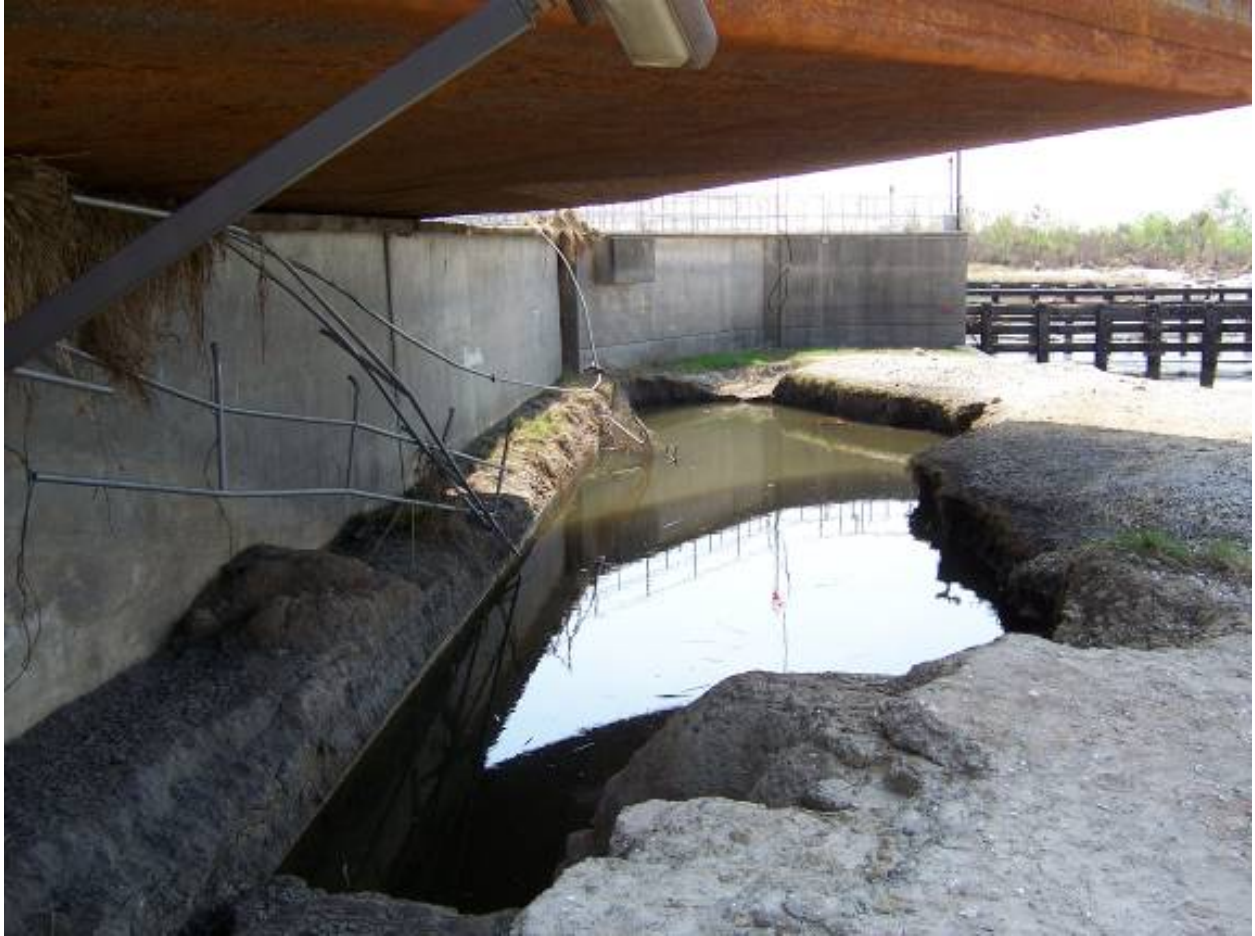
Figure 14-110. Barge Resting on T-Wall

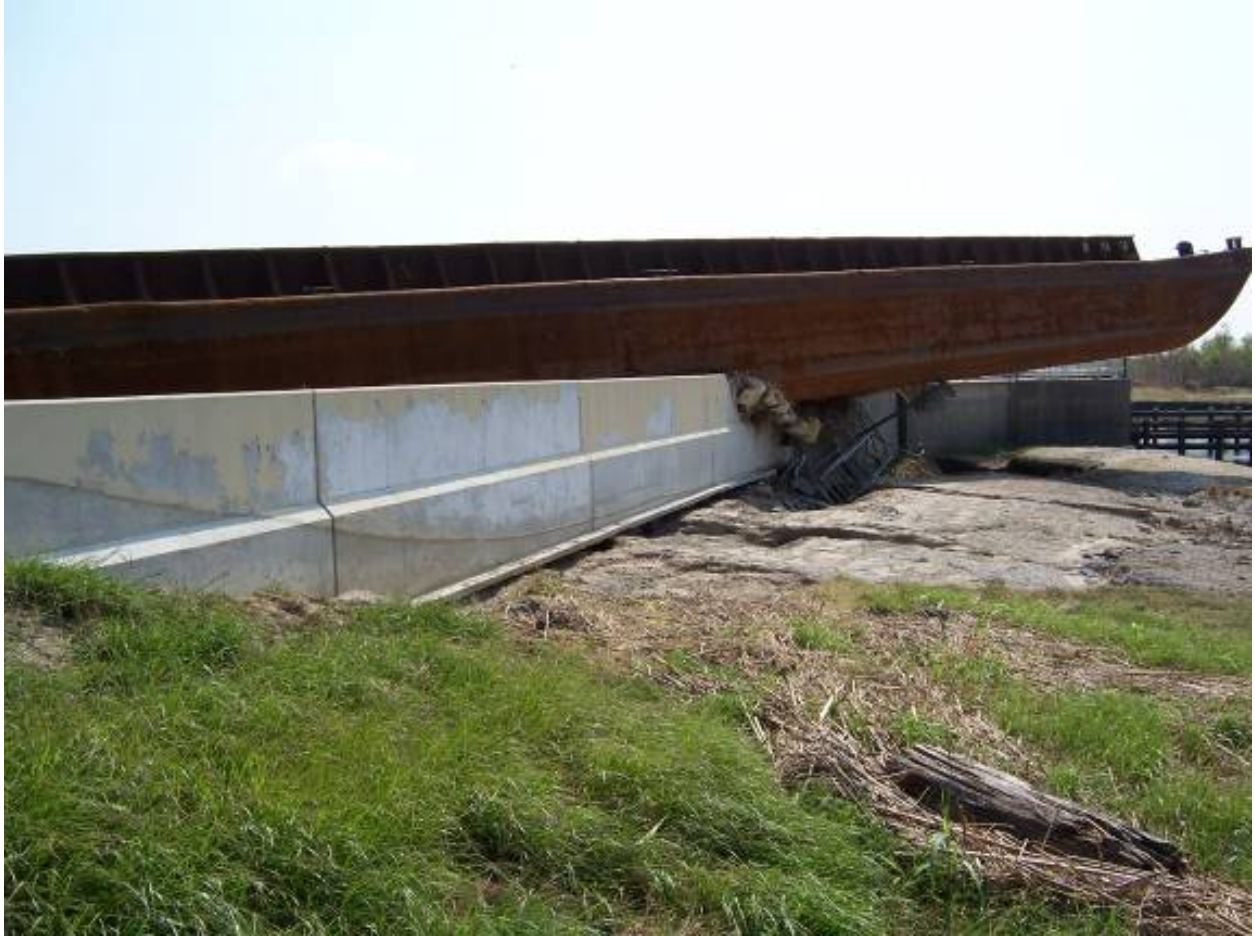
Figure 14-111. View East, From Protected Side

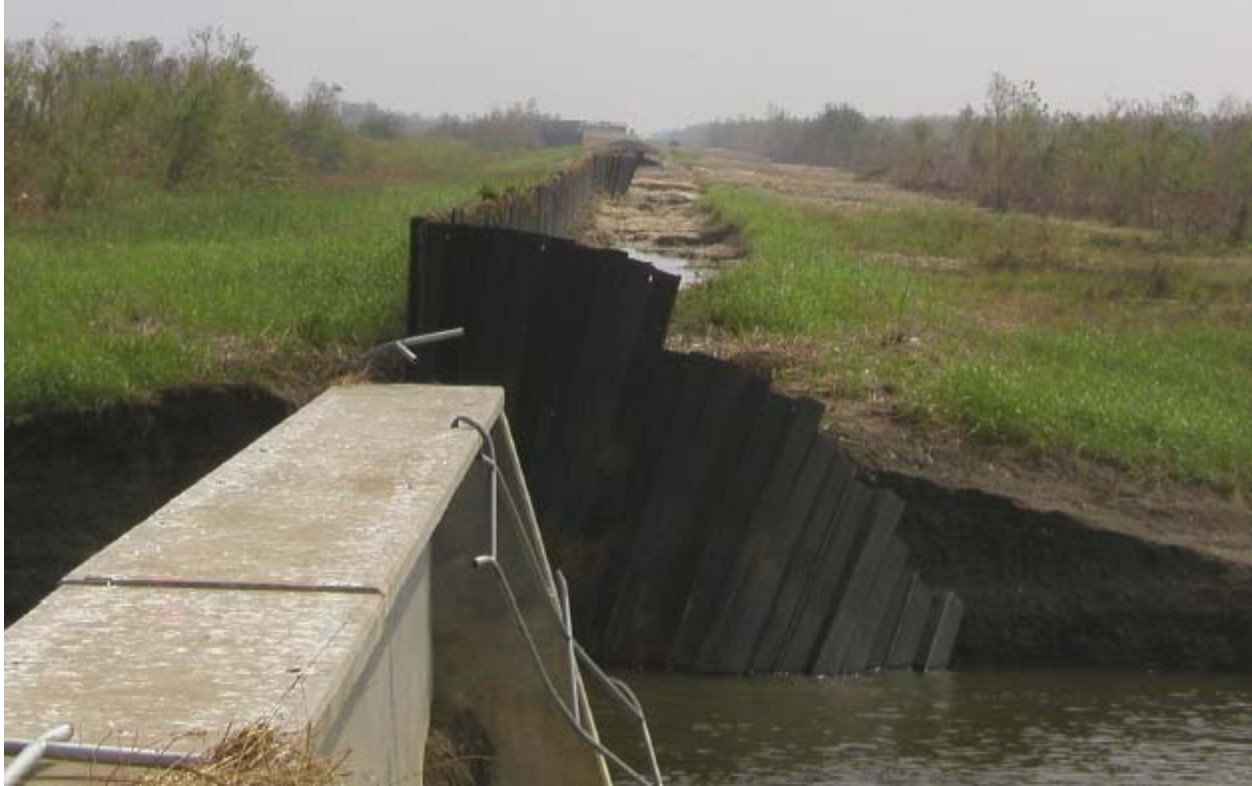
Figure 14-112. View Looking East of the Bayou Bienvenue Control Structure Showing Sheetpile Damage From Scour. From this picture there is no obvious layer stratification in the scoured section profile

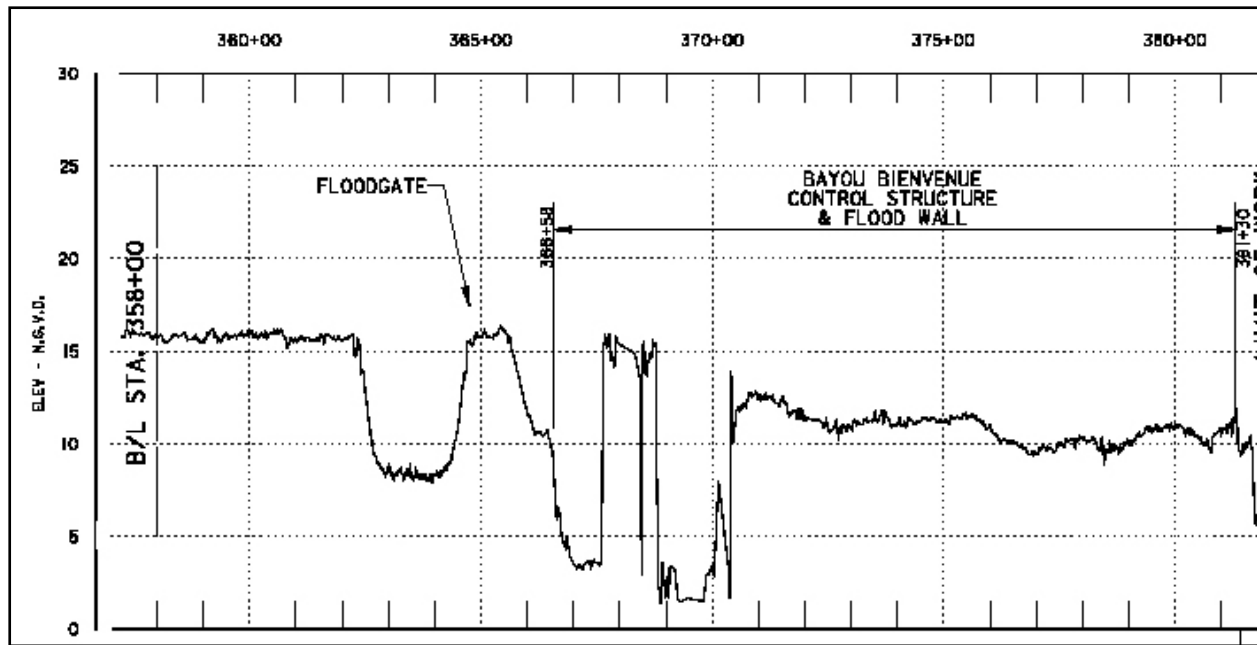
Figure 14-115. Centerline Scour Depths of Floodgate and Control Structure (From Dwg 1 of 8, Emergency Restoration B/L 383+00 to 704+00 Contract Solicitation)
