Appendix 11

Analysis of Performance of the Inner Harbor Navigation Canal

Executive Summary

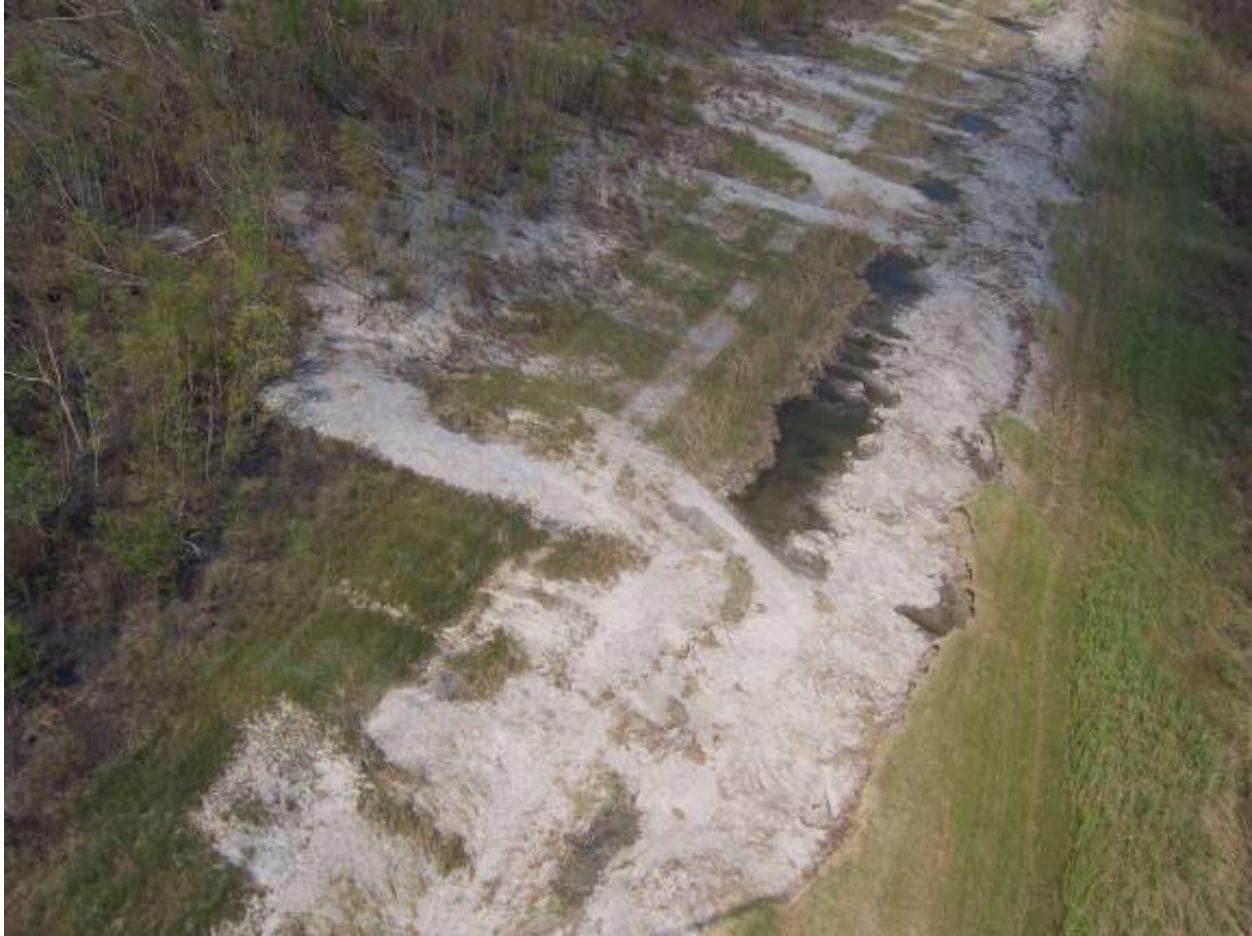
Hurricane Levee Between Bayou Bienvenue and Bayou Dupre. There is 19,000 ft. of levee between Bayou Bienvenue (Sta 383+00) and Bayou Dupre (Sta 704+00) that was severely damaged from overtopping and scour, and has lost approximately 12' of levee section and was at EL 5.0.

Figure 14-117. More Missing Levee

TFG Project **STB04** (MRGO Baseline Station 380+00 to 705+00 - Between Bayou Dupre and Bayou Bienvenue Control Structures) includes repairing a 6.2-mile reach of levee along the MRGO between the Bayou Bienvenue and the Bayou Dupre Control Structures. Several barges are located on the levee and borrow areas. The entire levee reach will be restored to the design grade elevation (17.5'), requiring the placement of an estimated 1,000,000 cubic yards of fill material. The borrow area for this fill material is a strip of land adjacent to the levee (260 acre borrow area), which was used as a dredged disposal area during the construction of the MRGO canal. Scheduled completion is 1 April 2006.

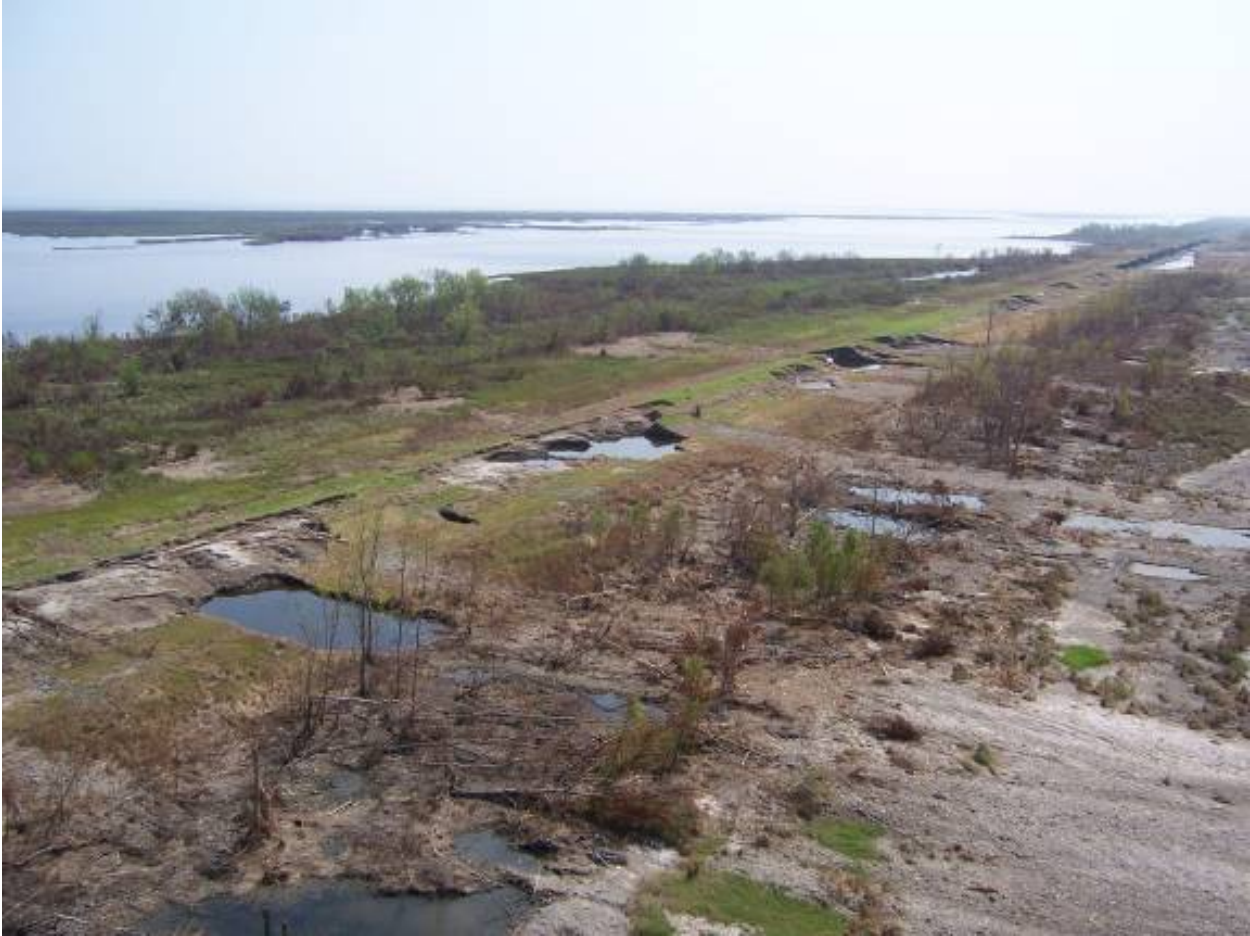
There is an additional 2,300 ft. of levee in this reach that has some damage (approximately 50% of the levee section was eroded away).

Figure 14-118. Partial Levee Eroded

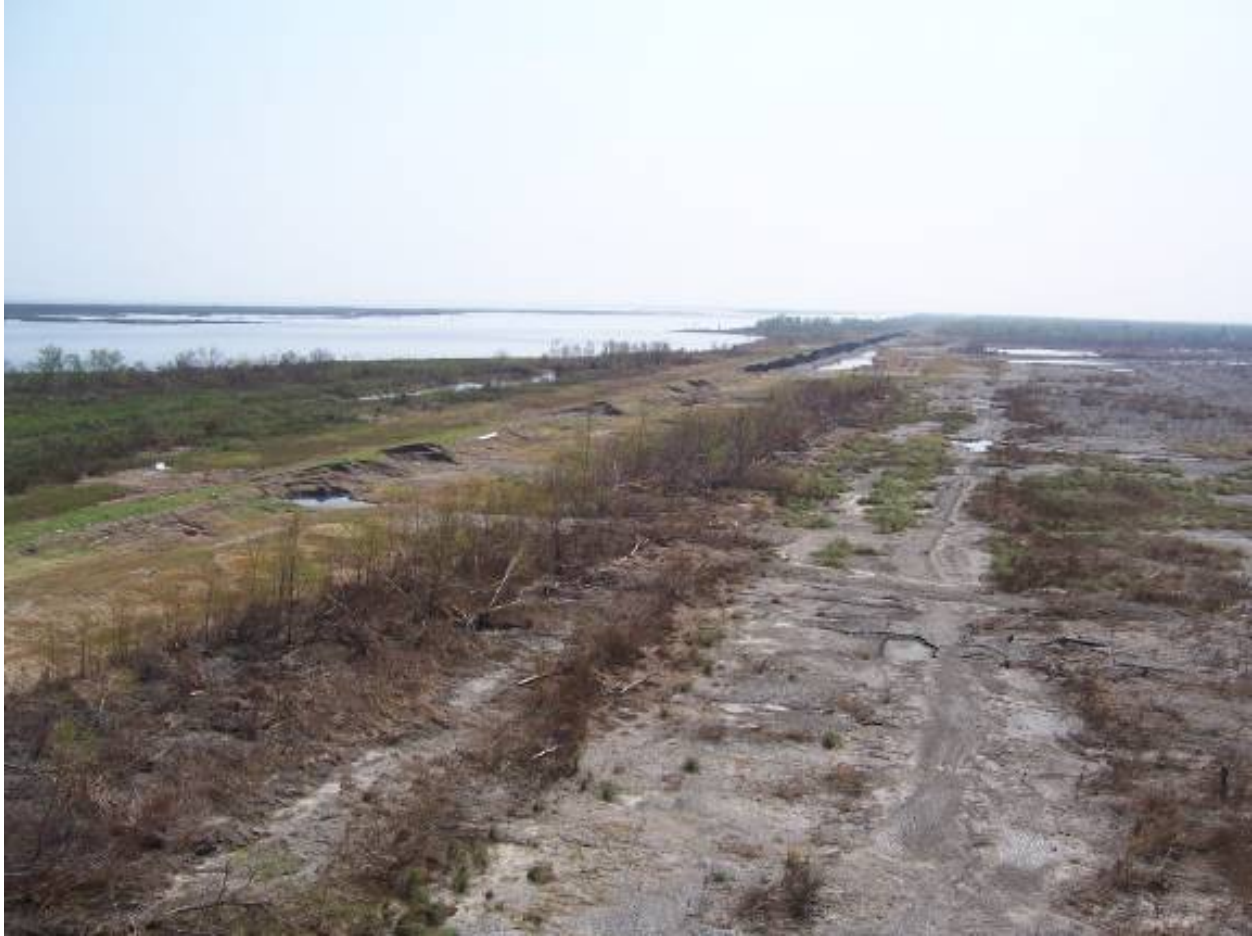
Figure 14-119. View South From Approximate B/L Sta 570+00. MRGO is to the left of photo

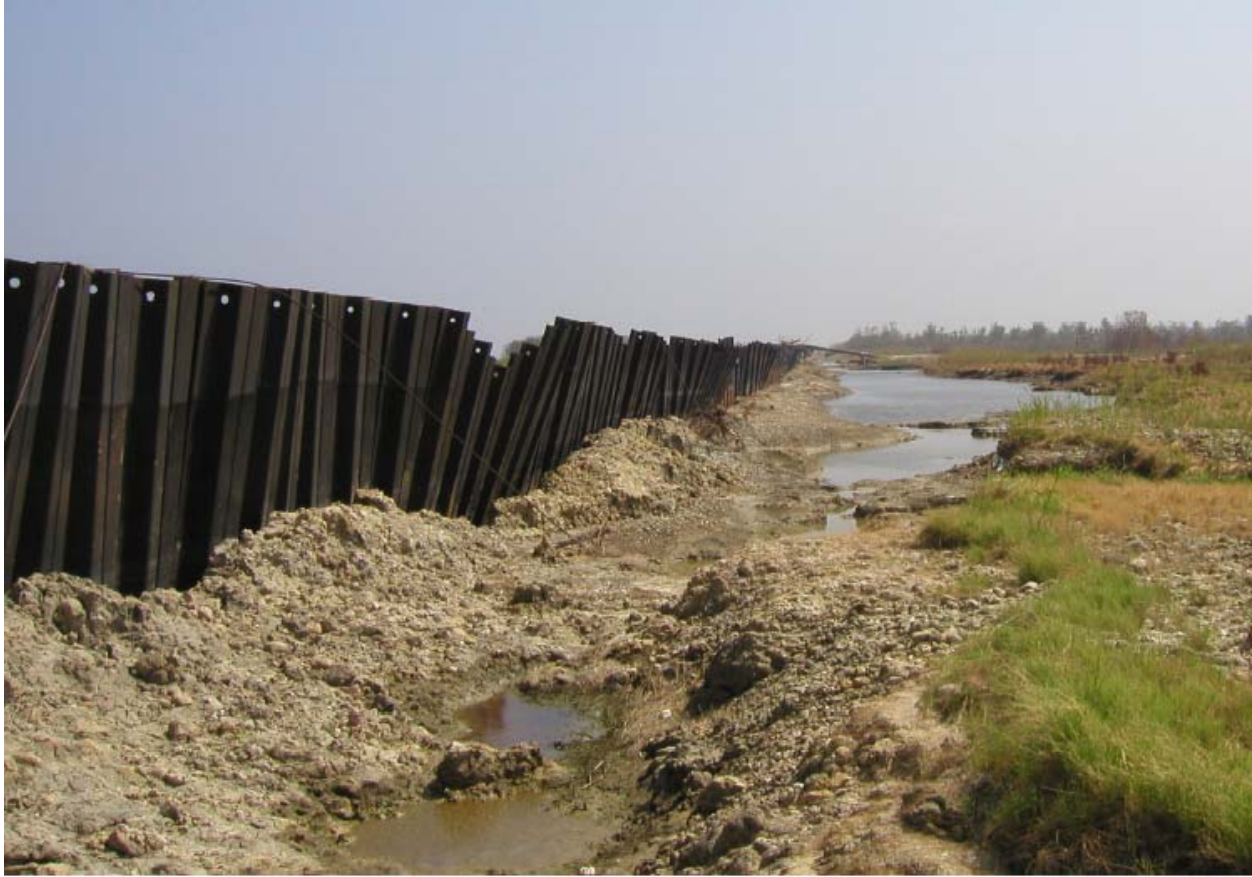
There is a total of 4,300 ft. of sheet pile floodwall in this reach that was badly damaged and will require replacement. There are three segments of sheetpile which makeup this quantity. These were initially planned to be replaced with 30' sheets – see section below.

Figure 14-123. Note Sheetpile Elevation Differences

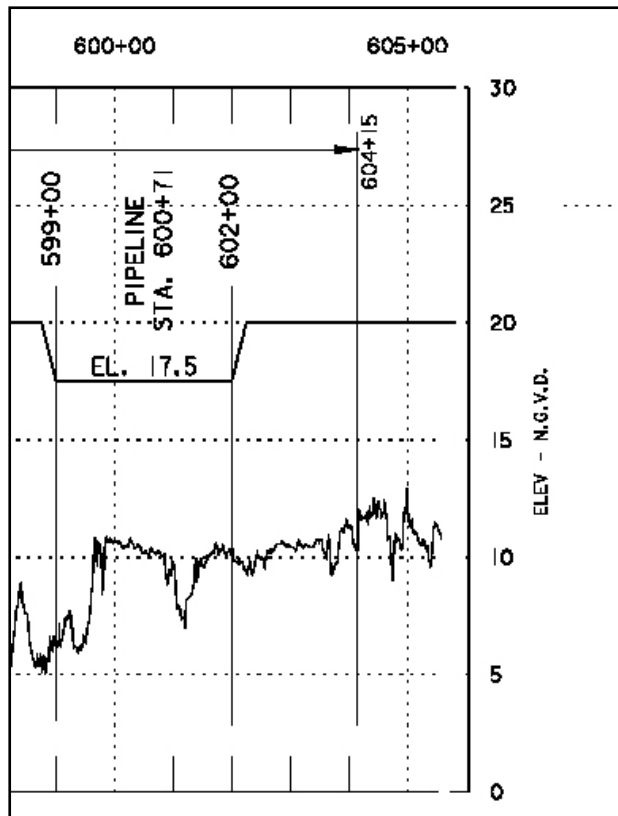
Figure 14-125. Scour Depths at Pipeline Crossing and End of Sheetpile (Sta 604+15) Transition to Levee

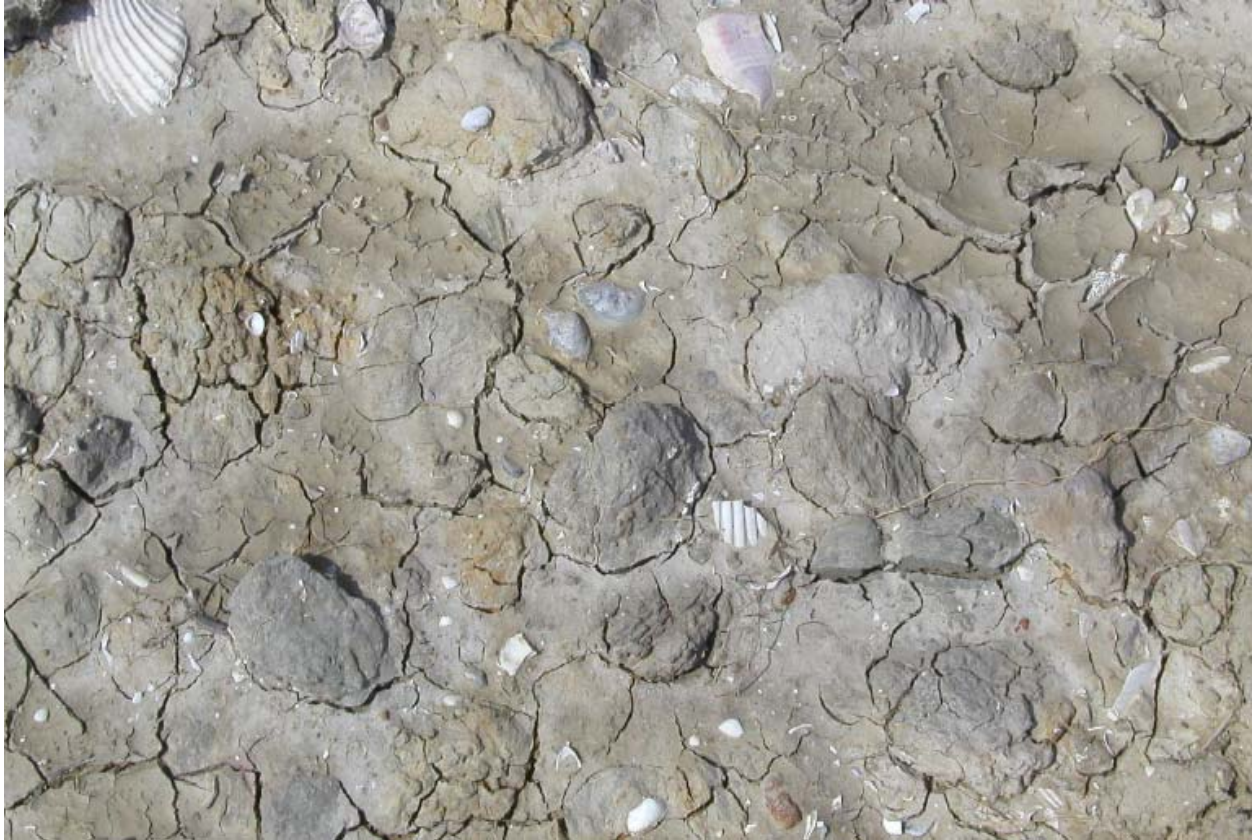
Figure 14-126. Exposed Soil Layer at Horizontal Scour Surface Appears to be In-Situ Fat Clay With Embedded Shell Hash, Possibly an Exposed Estuarine Deposit

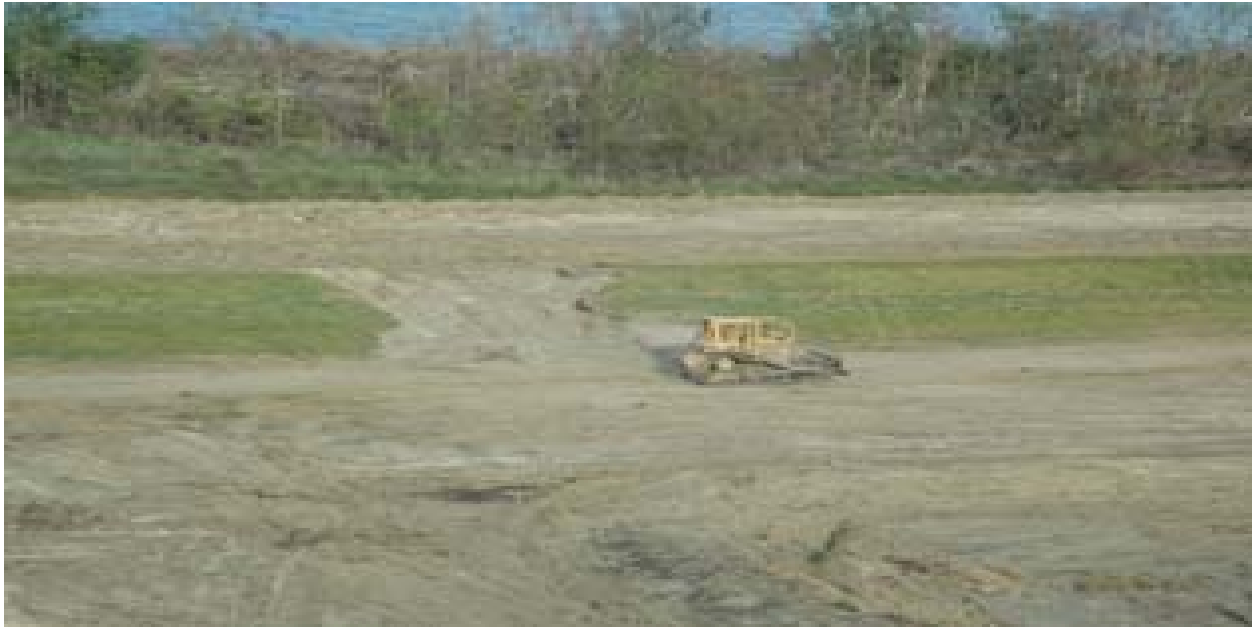
Figure 14-130. Repairs Underway, Filling Scour Holes

TFG Project **STB01** included site preparation work in the areas of levee damage between the Bayou Bienvenue and Bayou Dupre Control Structures. The contracted work (rental agreement contract) is complete.

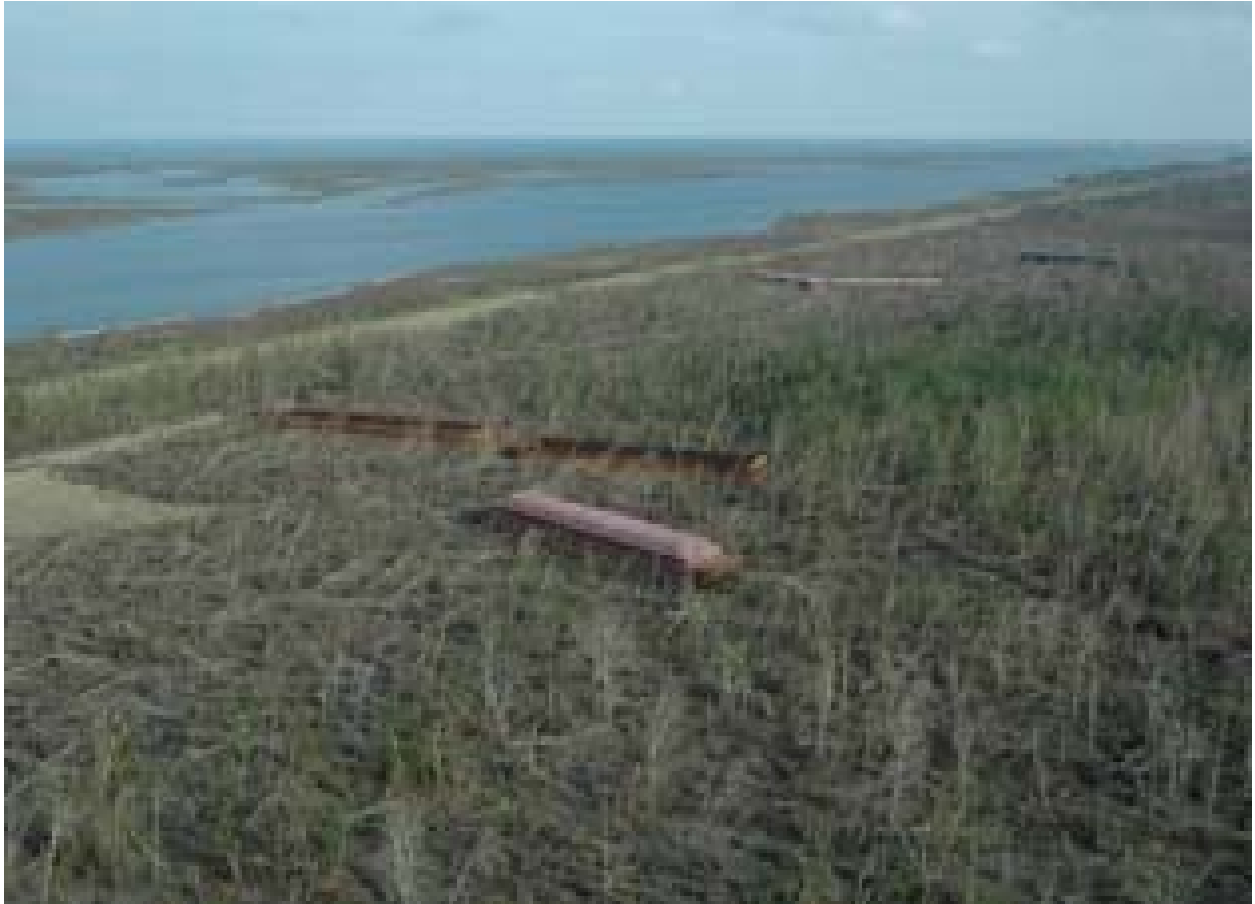
Figure 14-132. Barges From the MRGO

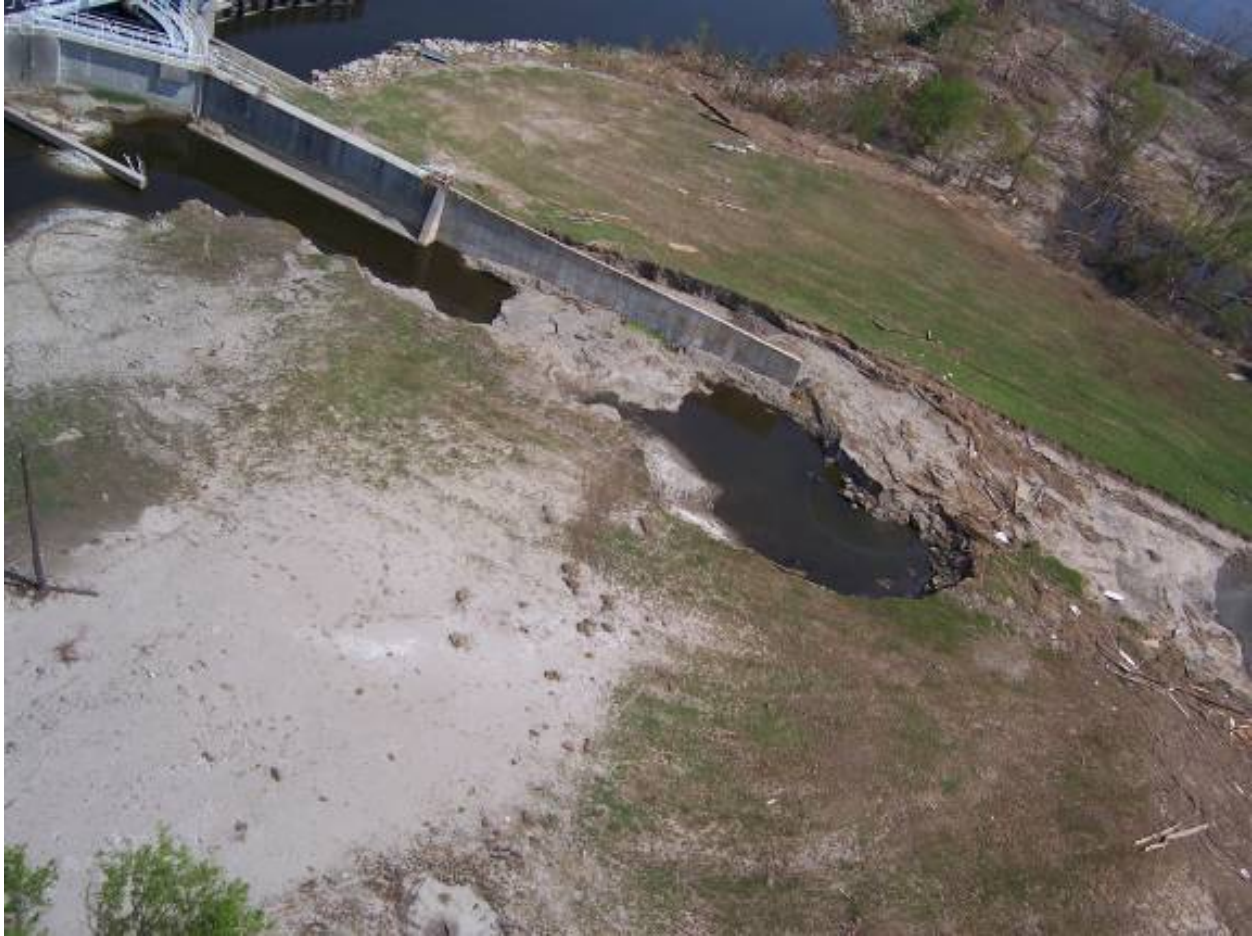
Bayou Dupre Control Structure. This control structure was damaged during the storm event. Adjacent sections of floodwall failed and the fill around other sections of floodwalls was eroded away due to overtopping. In addition there was damage to the mechanical and electrical systems that operate the sector gates.

Figure 14-141. Severe Scour on East Side of Structure

TFG Project **STB06** includes repair of structural damage and loss of structural backfill at the Bayou Dupre Control Structure. A significant scour hole is to be filled with 17,500 cubic yards of granular backfill and protected with grouted riprap. An estimated 22,500 tons of riprap and 13,400 cubic yards of embankment fill will be required for the repairs. Scheduled completion date is 1 April 2006.

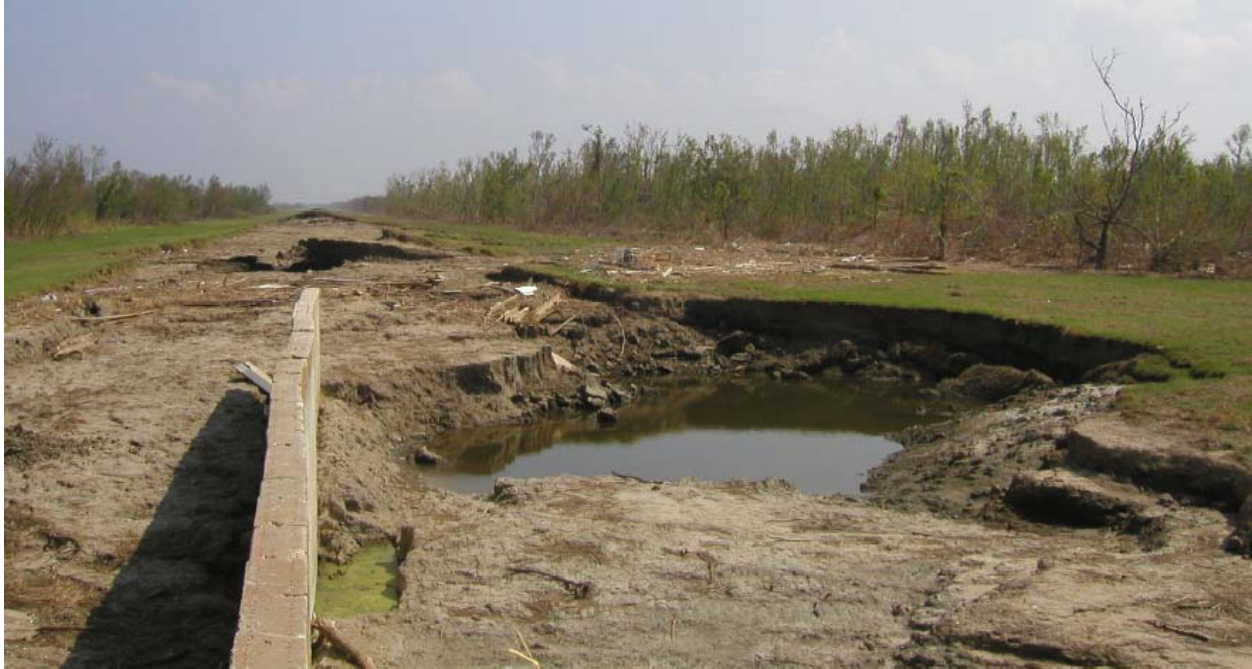
Figure 14-142. Closeup of East View, End of Concrete Wall, Showing Major Scour Holes and Complete Erosion of Levee

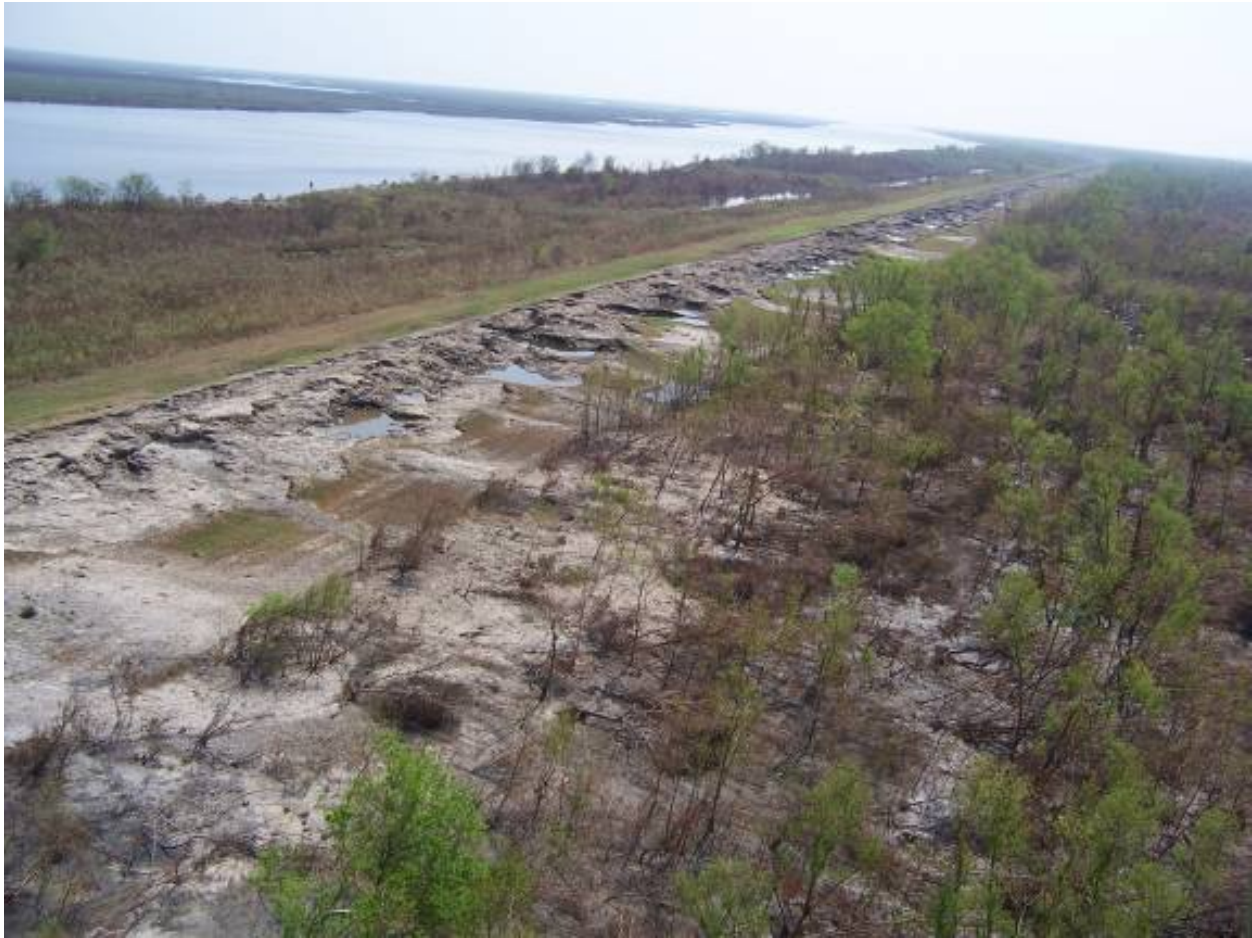
Hurricane Levee Between Bayou Dupre and STA. 1054+00. There is an 8,000 ft. section of the levee immediately southeast of Bayou Dupre that is severely damaged and has lost approximately 12 feet of levee section and is at approximately El. 5.0.

Figure 14-145. Scour Depths Below the Original Levee Footprint

TFG Project STB03 (Levee Restoration East of Bayou Dupre - MRGO Baseline Station 714+55 to 1007+91) includes repairing a 5.6-mile reach of levee along the MRGO extending east from the Bayou Dupre Control Structure. The entire levee reach will be restored to the design grade elevation (17.5'), requiring the placement of an estimated 1,120,000 cubic yards of fill material. The borrow area for this fill material is a strip of land adjacent to the levee, which was used as a disposal area during the construction of the MRGO canal. Scheduled completion date is 1 April 2006.

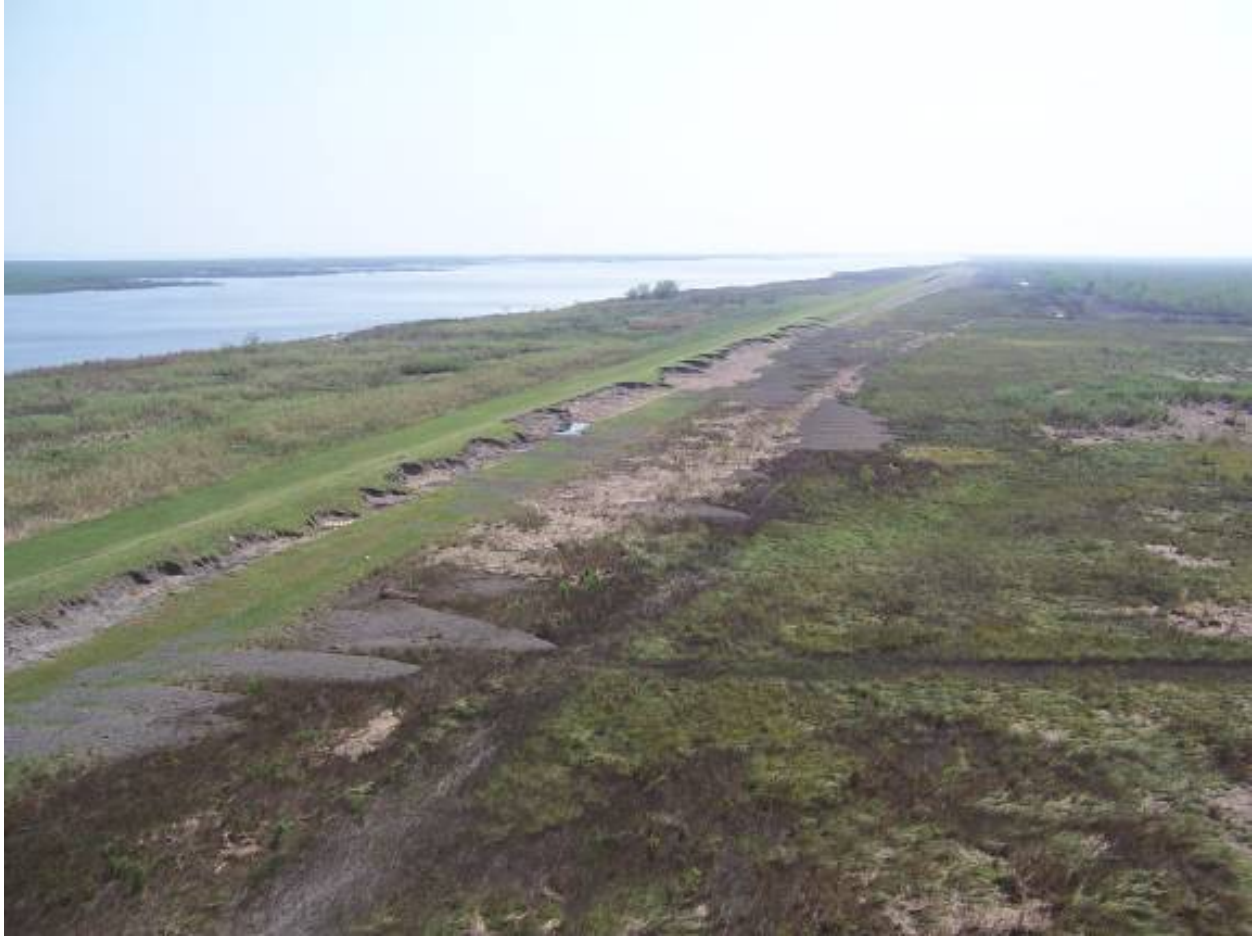
There is 2,500 ft. of levee from Bayou Dupre to STA 1007+91 that lost approximately 8' of elevation (assume that 50% of the levee section is gone).

Figure 14-147. Major Scour on Protected Side of Levee

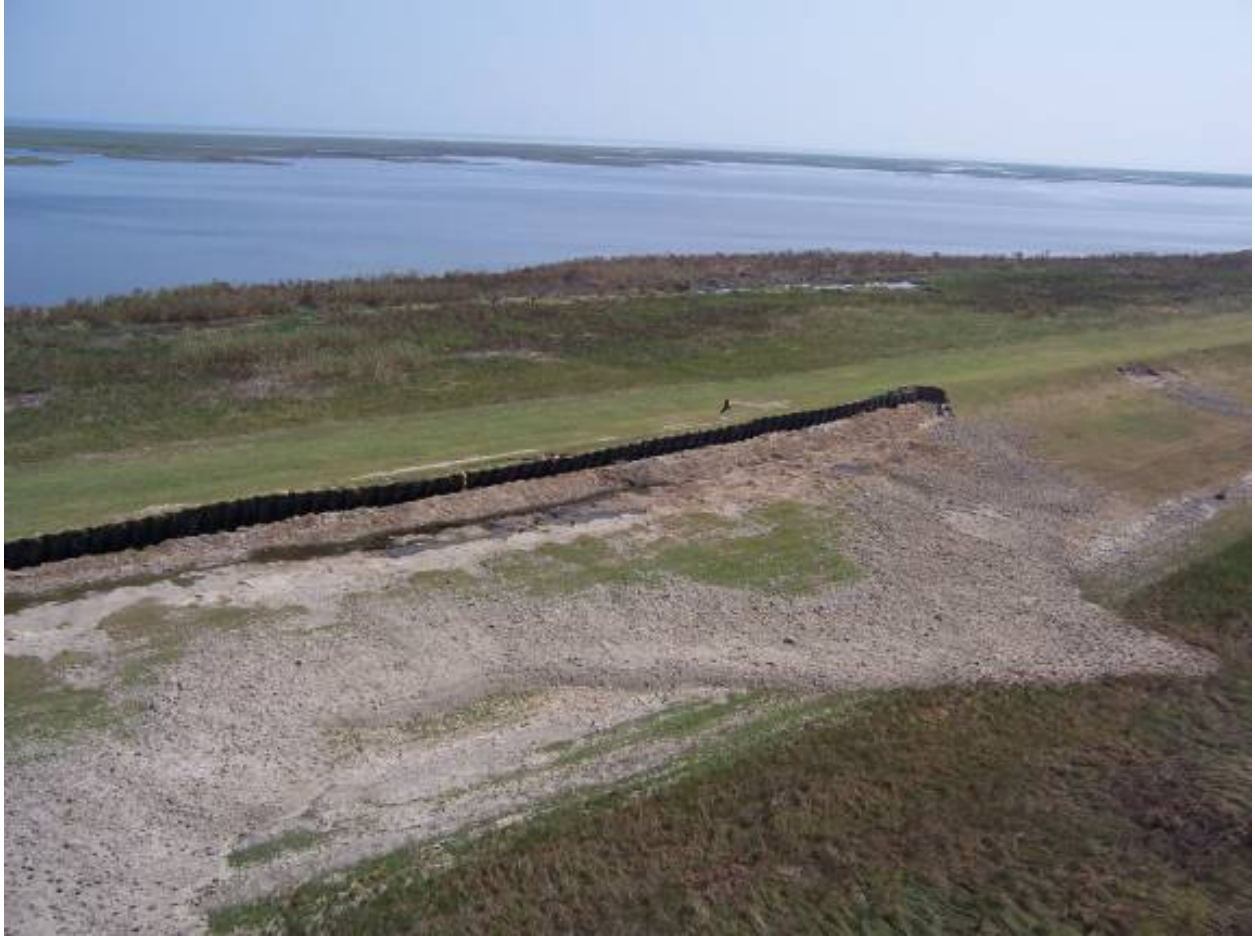
There is 700 ft. of this reach that is sheet pile floodwall that has been damaged and will be replaced with earthen levee. The above diagram was used to estimate required quantities.

Figure 14-151. End of Sheetpile Wall at B/L Sta 980+58

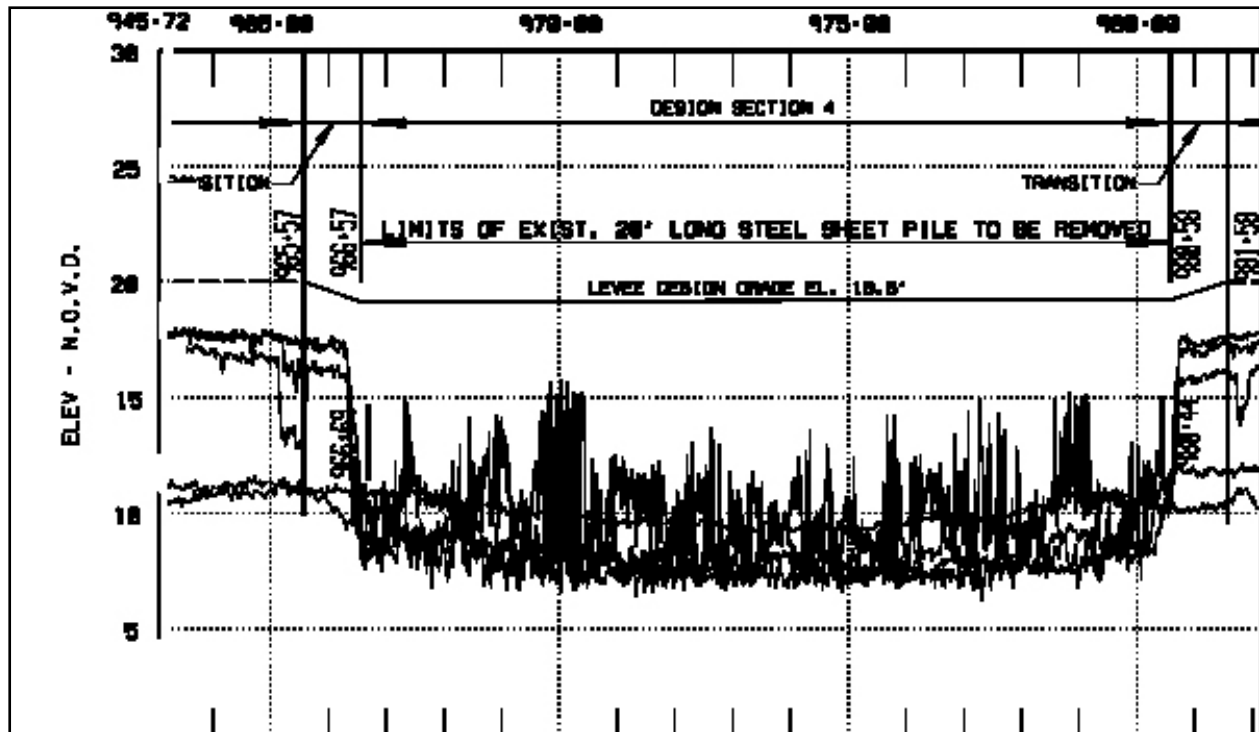
Figure 14-152. Scour Depths Along Sheetpile and at Transition to Levee. Note that scour occurred along the sheetpile reach, not at the sheetpile / levee transition (also seen in Figure 14-151), from drawing 7 of 10, contract solicitation W912P8-06-R-0002

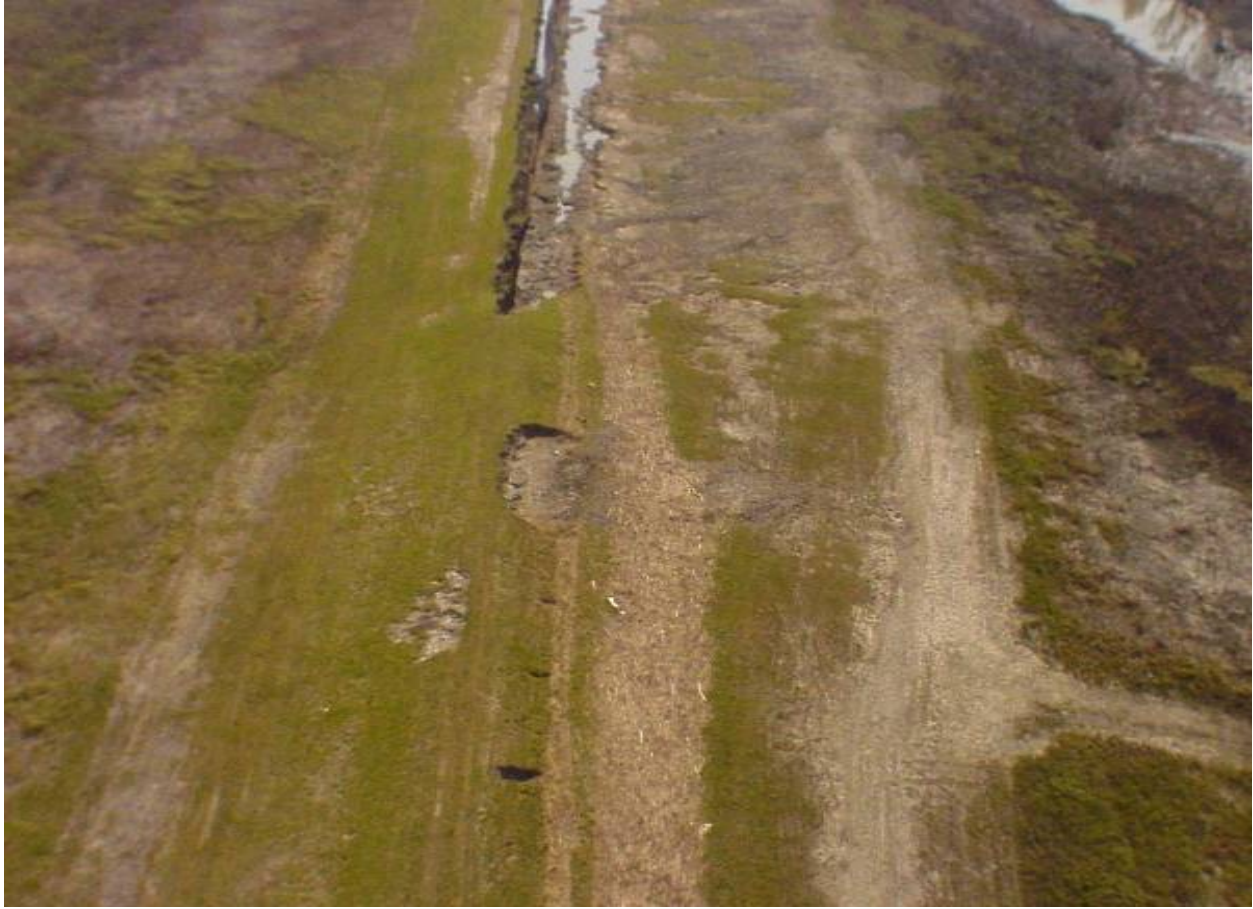
MRGO to Caernarvon Levee. TFG Project **STB08** (Miscellaneous Scour Repair) includes repair of minor scour on the backside of the levee from the Mississippi River Gulf Outlet (MRGO) to Caernarvon, which is about 10.8 miles in length. An estimated 36,000 cubic yards of fill material will be required for this work. Scheduled completion date is 15 April 2006.

Figure 14-155. Crown Scour Along Approximate B/L Sta 1203+00 to Sta 1230+00

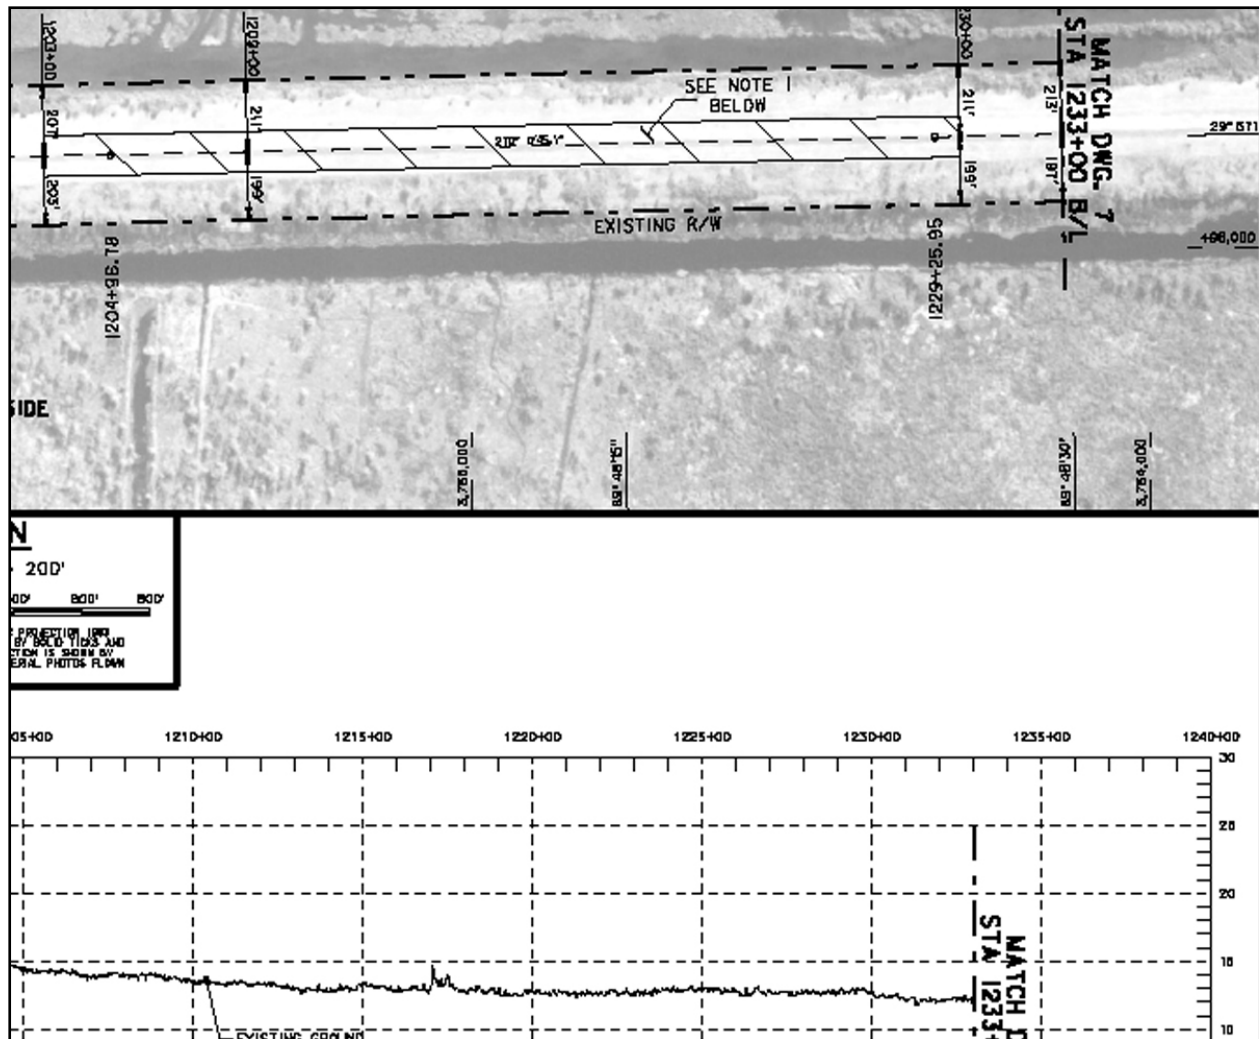
Figure 14-156. Levee Crown Elevation Drops From Elev 15 ft to Elev 12 ft in the Scour Area. Elevation 12 ft Remains Fairly Constant Along the Reach for About a Mile Beyond The Scour Section. From Contract Solicitation STB08 W912P8-06-R-0094, drawing sheet C-06

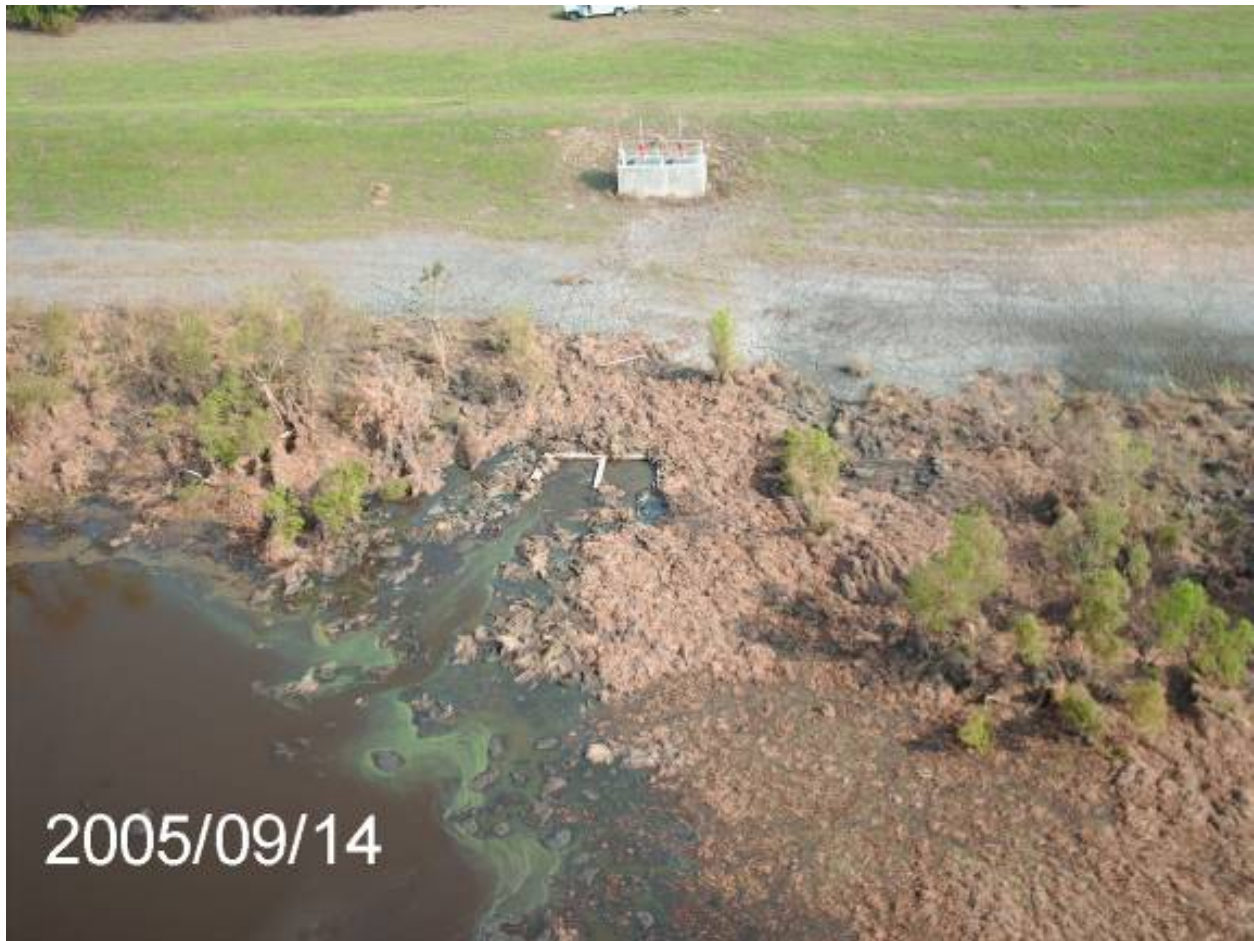
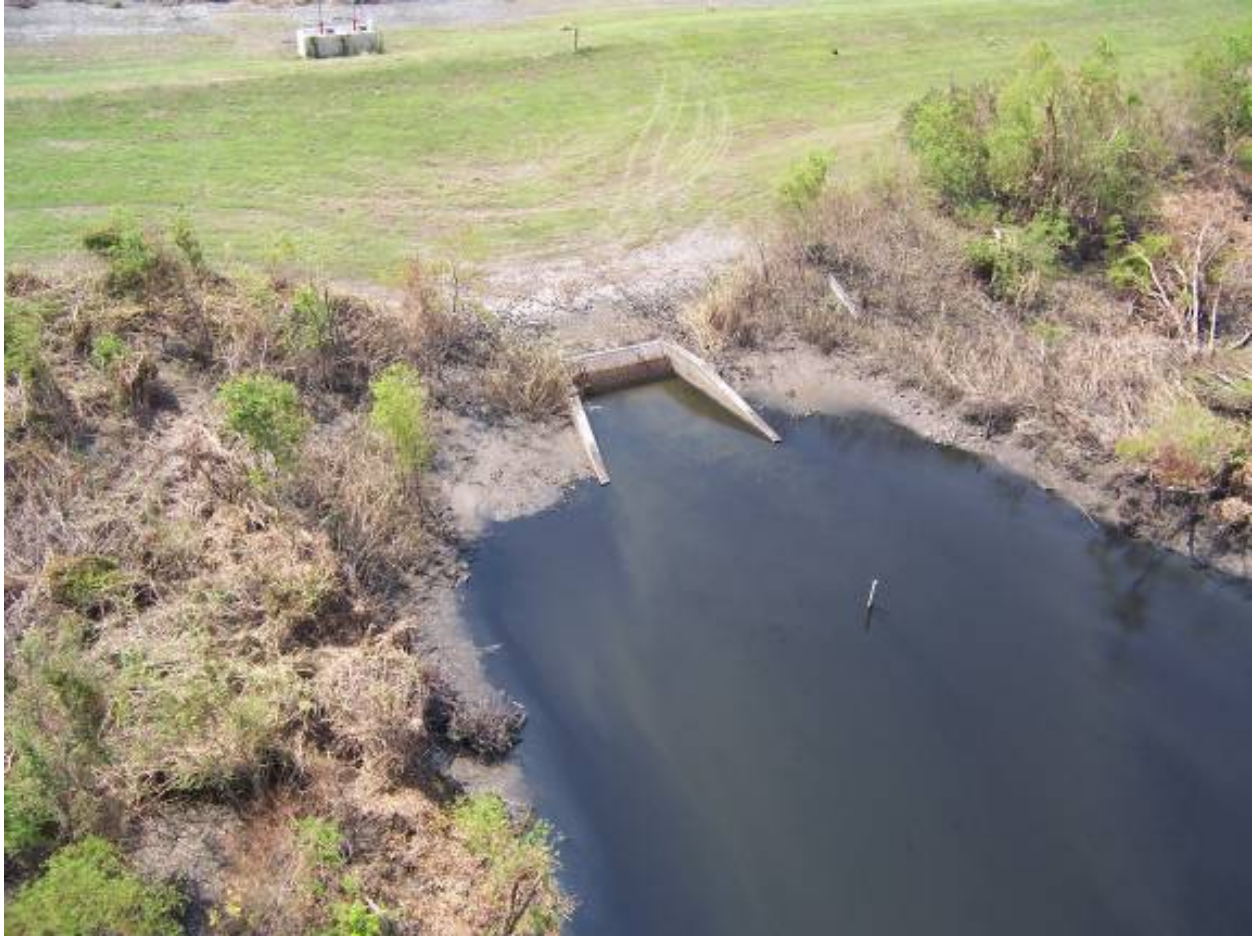
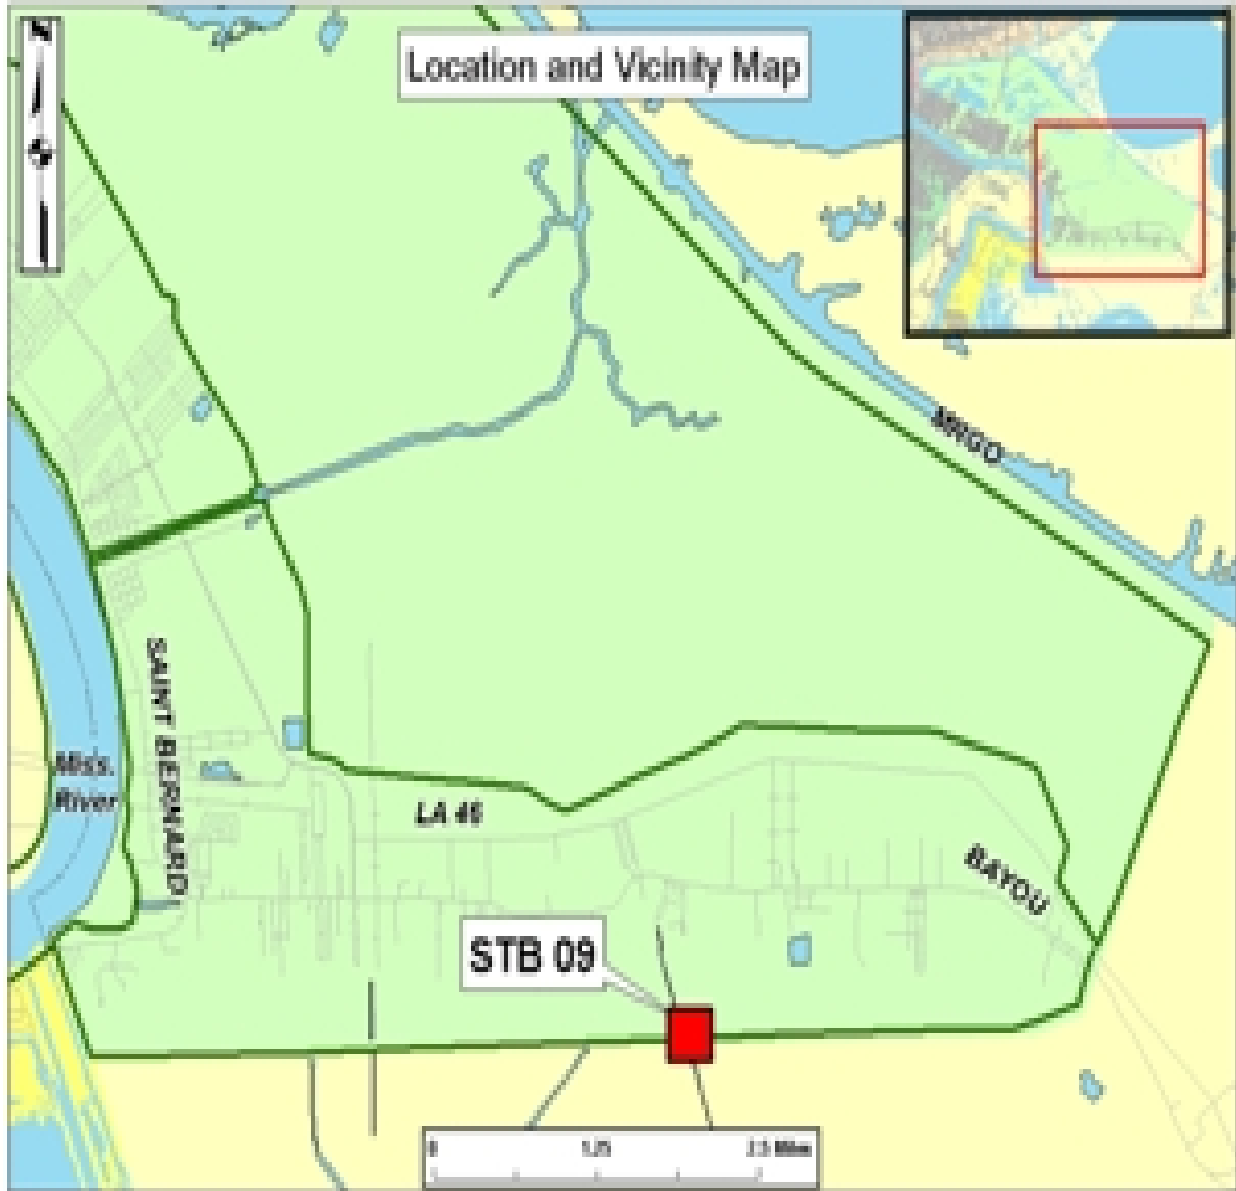
Creedmore Gravity Drainage Structure. The levee district has been unable to fully close the two 72-inch sluice gates on drainage structure. One sluice gate is approximately 50% closed and the other is approximately 90% closed. The cause of the sluice gates being stuck is apparently debris under the gate slides. Since there are trash racks on the inlet structure to these drains the debris must have come in through the outlet structure. While attempting to close the sluice gates against this debris the gate hoists were both damaged.

TFG Project **STB09** (Repair Creedmore Structure) includes constructing a cofferdam and removing debris from the structure to permit closure of the gates and inspection of the structure to determine if further repairs are necessary. Scheduled completion date is 1 April 2006.
